**MECHANICAL INSPECTION REPORT OF MOTOR CAR SLC 6126Z**

1. I refer to your request on 11<sup>th</sup> May 2021 to conduct a physical inspection of a Motor Car bearing registration number SLC 6126Z (herein referred to as "**Motor Car**"), which was involved in a road traffic accident on 31<sup>th</sup> March 2021.
2. The objective of the inspection is to determine if there was any possible mechanical failure to the Motor Car that may have contributed to the accident.
3. Following the request, I had carried out a physical inspection of the Motor Car on 28<sup>th</sup> July 2021 at the premises of Traffic Police vehicle pound, 517 Airport Road Singapore 539942. I now set out below my observations and comments with respect to this inspection.

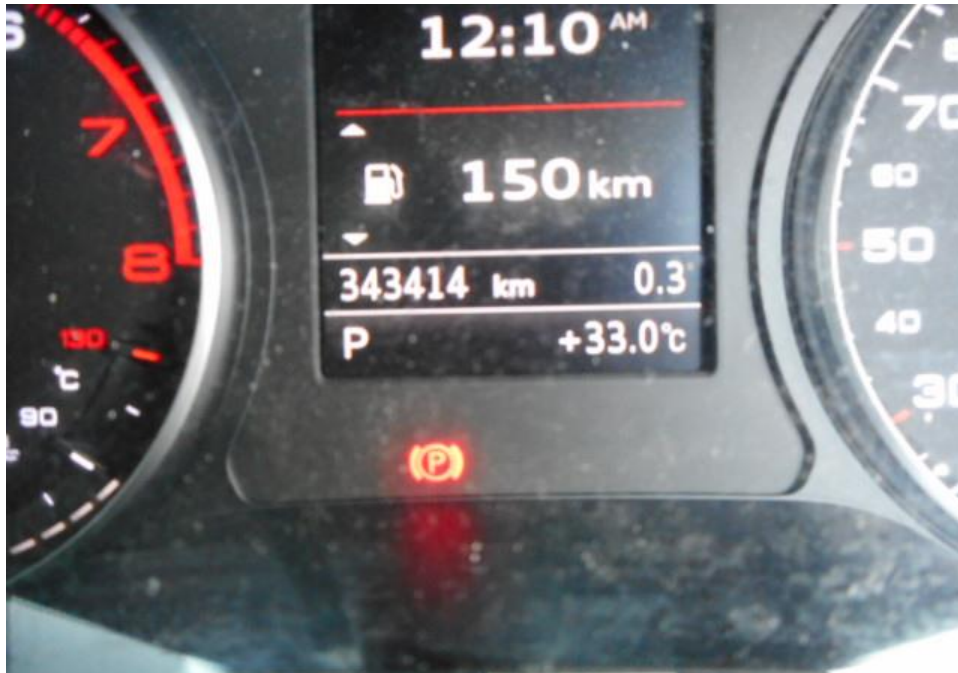
**Photo 1** shows the mileage of the Motor Car at the time of my inspection. The mileage observed was 343,414km.

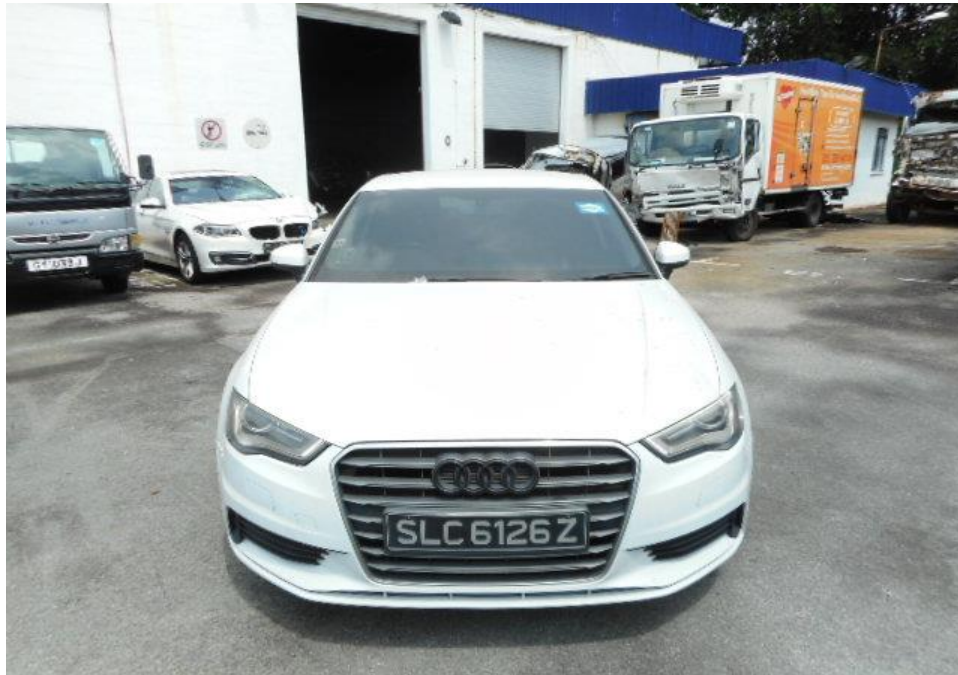
4. The mileage of the Motor Car at the time of my inspection was 343,414km.
5. The Motor Car was observed to have sustained damage at its front and right portion. Its front bumper, right door and right rear fender was the body parts that were damaged as a result of the accident.

**Photo 2** shows a general view of the Motor Car's front body at the time of my inspection. The front portion of the Motor Car was observed to have sustained damage. It's front and right portion. Its front bumper, right door and right rear fender was the body parts that were damaged as a result of the accident.

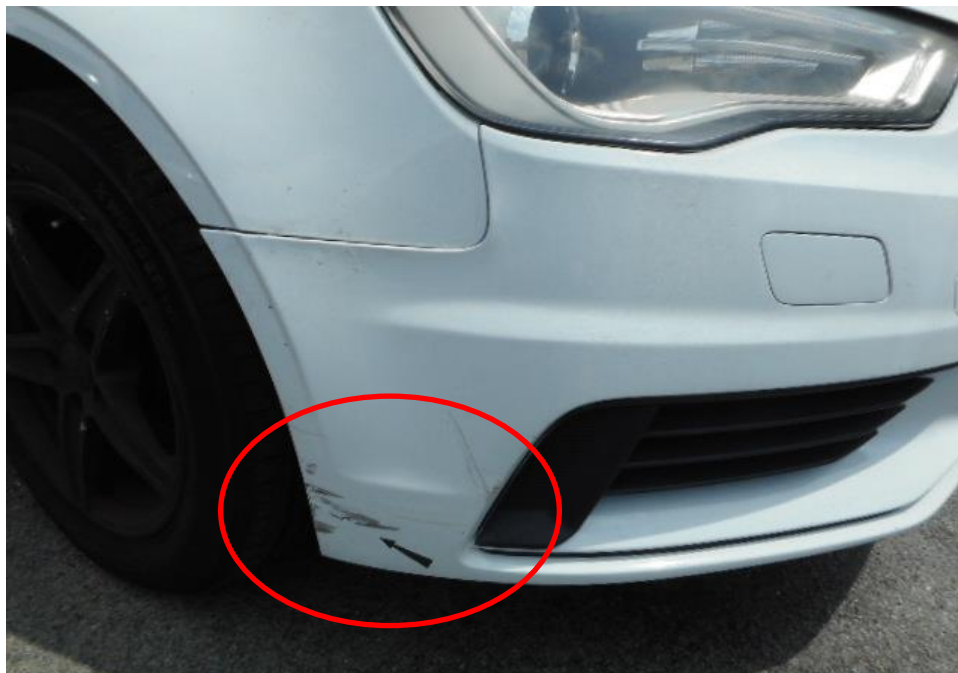
**Photo 3** shows a close up view of the Motor Car's front body at the time of my inspection. The front portion of the Motor Car was observed to have sustained damage. Its front bumper (circled) was the body part that were damaged as a result of the accident.

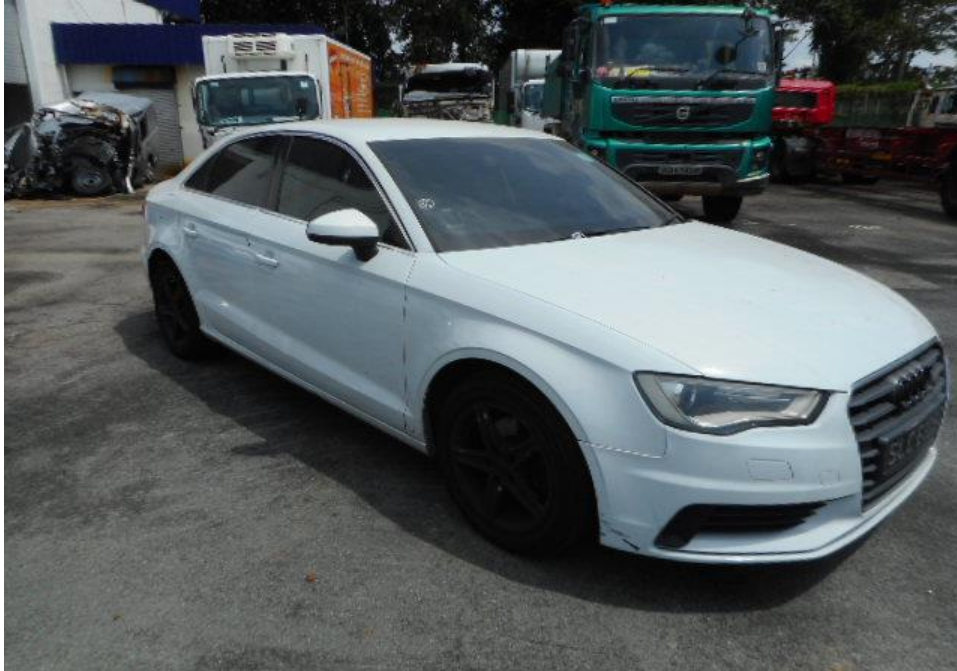
**Photo 4** shows a general view of the Motor Car's right body at the time of my inspection. The right portion of the Motor Car was observed to have sustained damage. Its right door and right rear fender was the body part that were damaged as a result of the accident.

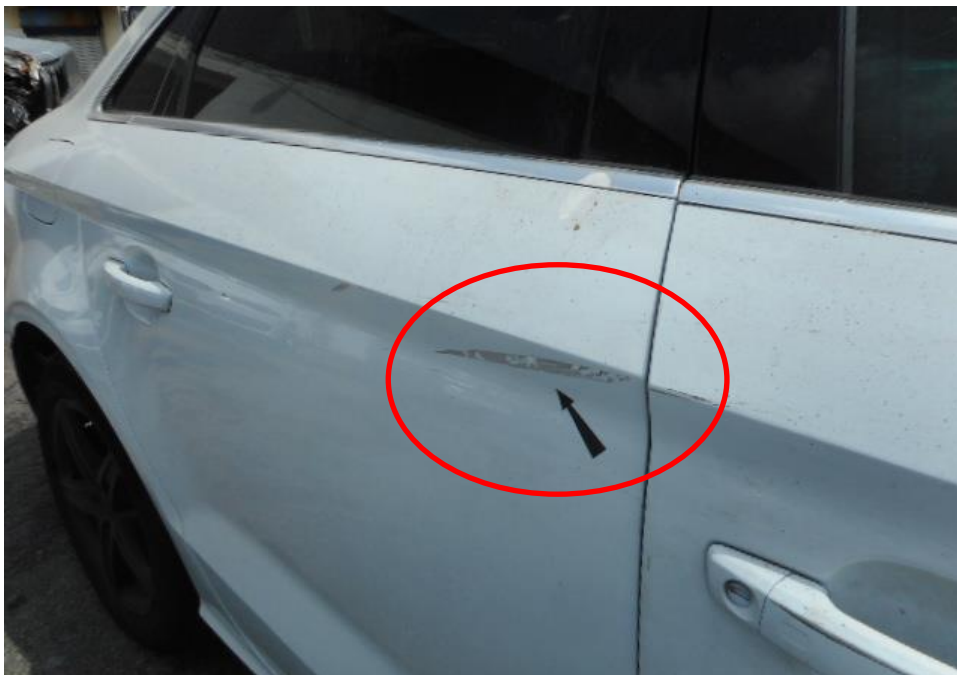
**Photo 5** shows a close up view of the Motor Car's front body at the time of my inspection. The right portion of the Motor Car was observed to have sustained damage. Its right door (circled) was the body part that were damaged as a result of the accident.

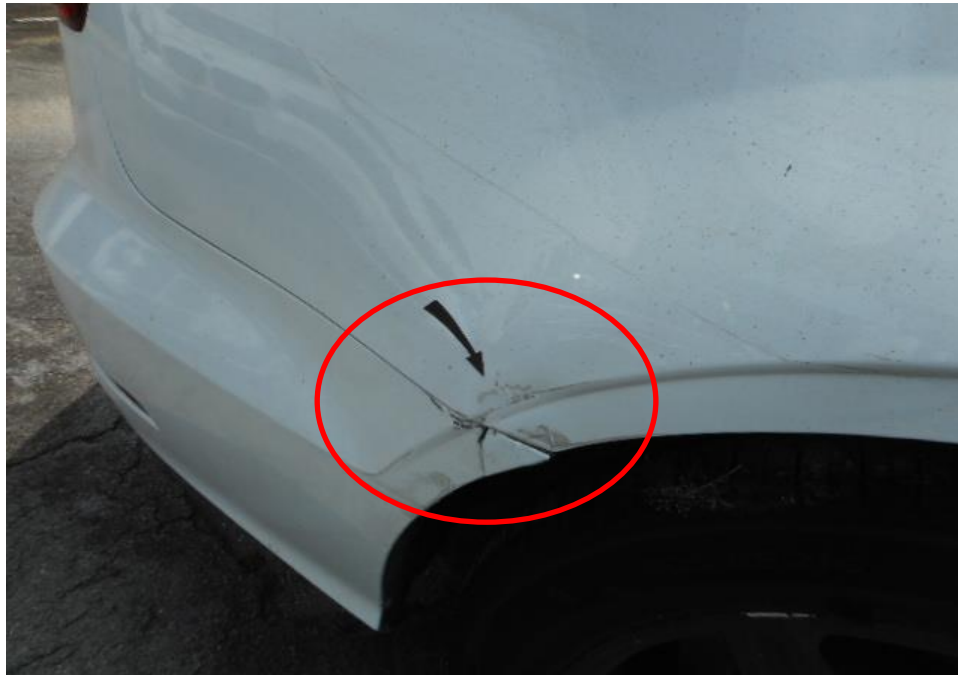
**Photo 6** shows a close up view of the Motor Car's front body at the time of my inspection. The right portion of the Motor Car was observed to have sustained damage. Its rear right fender (circled) was the body part that were damaged as a result of the accident.

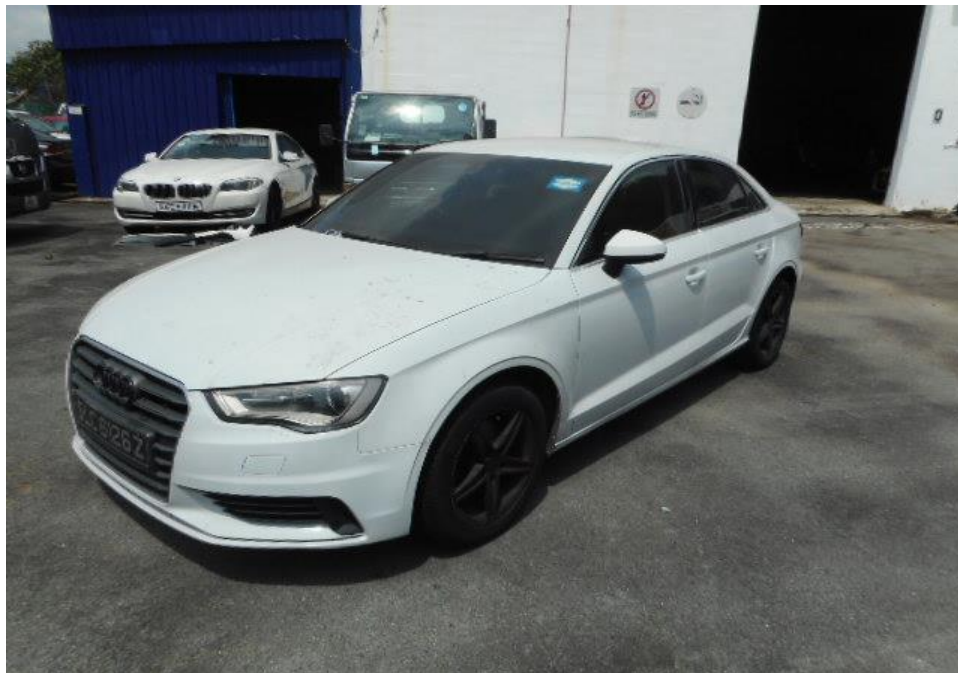
**Photo 7** shows a general view of the Motor Car's left body at the time of my inspection. The left portion of the Motor Car was observed to have been unaffected by the accident.

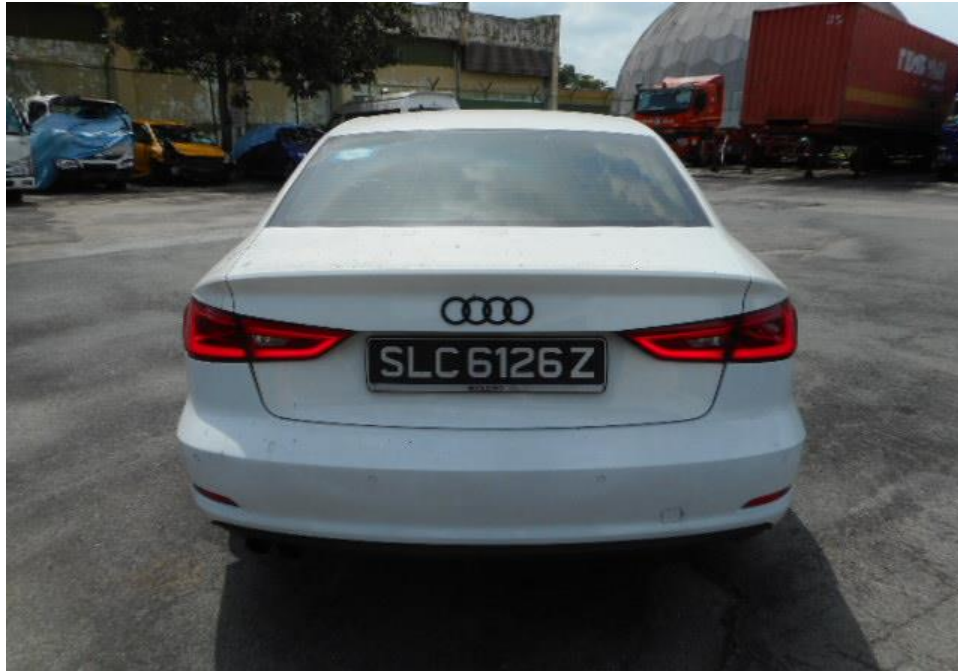
**Photo 8** shows the general view of the Motor Car's rear body at the time of my inspection. The Motor Car rear was observed to be unaffected by the accident.

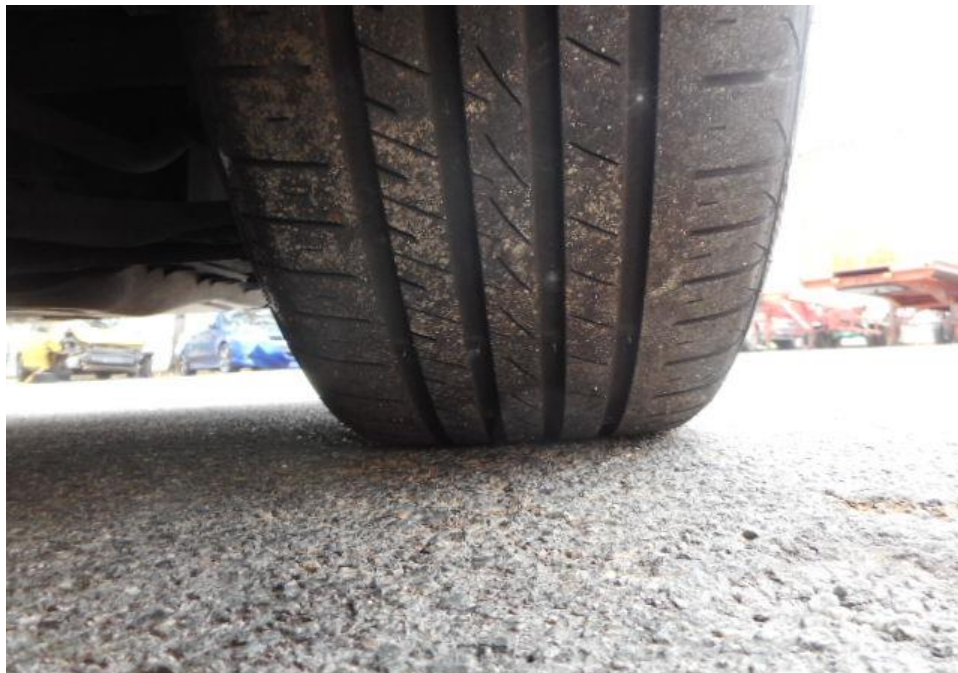
**Photo 9** shows the condition of the front right tyre of the Motor Car, which was observed to be in serviceable condition with remaining tread depth of approximately 4.1mm. The tyre was sufficiently inflated for vehicular operation with no tear, cut or burst mark(s) on the outer and the inner sidewalls as well as across the tread. The 4 tyres of the Motor Car were wrapped around standard steel wheel rims without any damage.

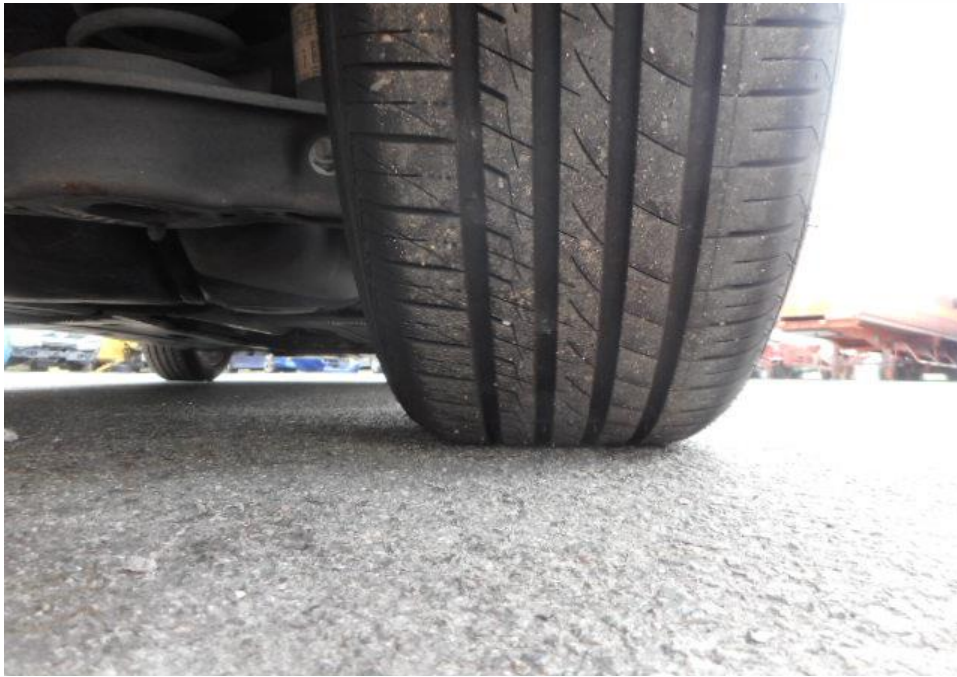
**Photo 10** shows the condition of the rear right tyre of the Motor Car, which was observed to be in serviceable condition with remaining tread depth of approximately 6.4mm. The tyre was also observed to be sufficiently inflated for vehicular operation with no tear, cut or burst mark(s).

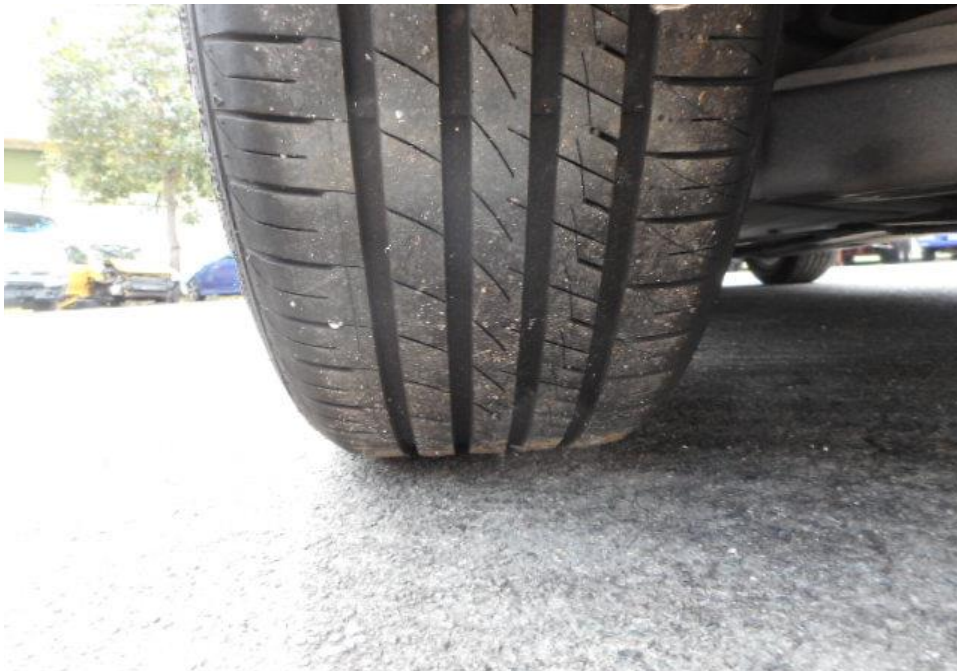
**Photo 11** shows the condition of the rear left tyre of the Motor Car, which was observed to be in serviceable condition with remaining tread depth of approximately 6.1mm. The tyre, which was wrapped around steel wheel rim, was also observed to be sufficiently inflated for vehicular operation. The 4 tyres of the Motor Car were wrapped around standard steel wheel rims.

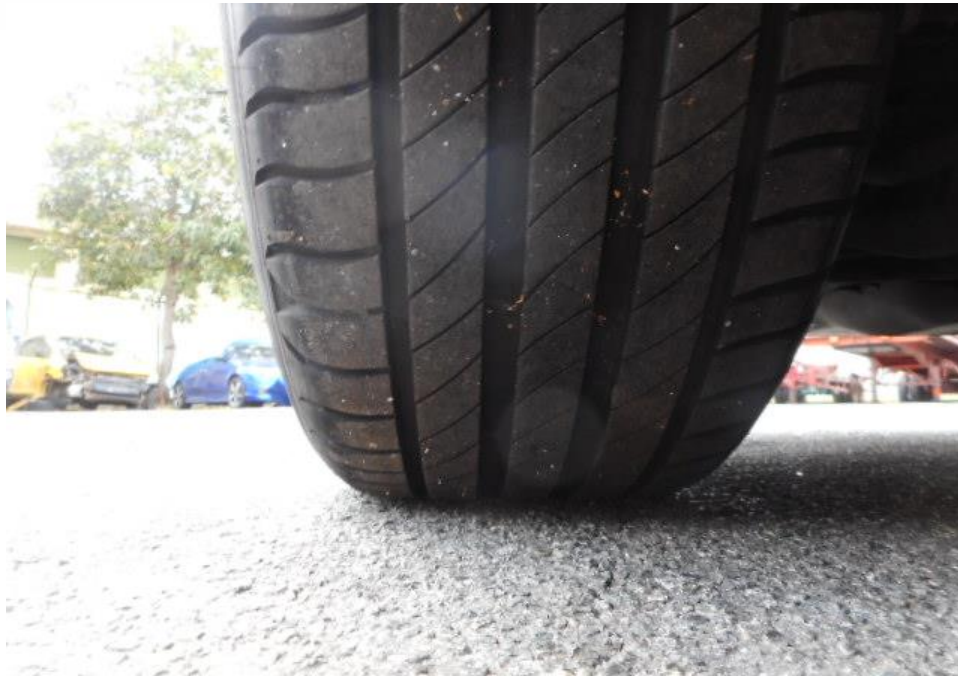
**Photo 12** shows the condition of the front left tyre of the Motor Car, which was observed to be in serviceable condition with remaining tread depth of approximately 6.1mm. There was also no tear, cut or burst mark(s) on the outer and the inner sidewalls as well as across the tread of the Motor Car's 4 tyres.

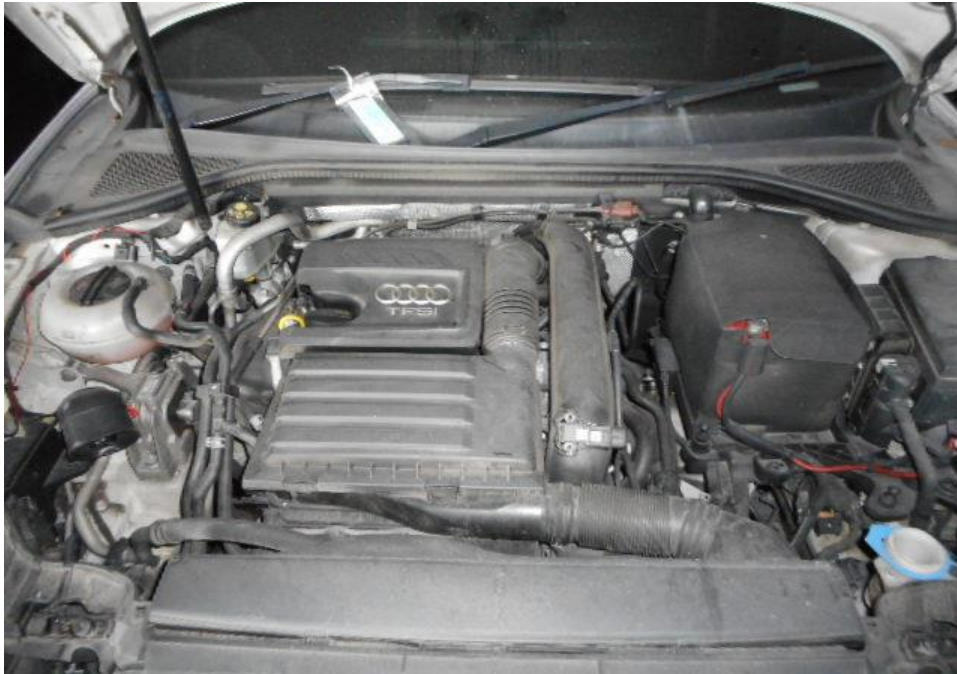
**Photo 13** shows a general view of the Motor Car's engine compartment. The various parts and components inside the engine compartment were unaffected by the accident. There was also no sign(s) or indication(s) of fluid leakage and/or fluid stain within the engine compartment.

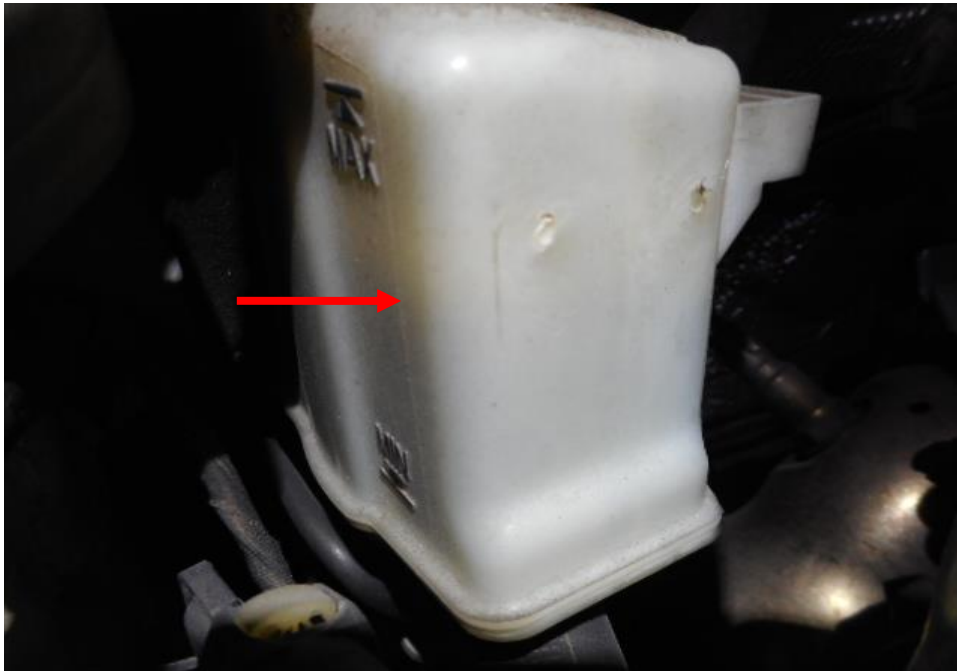
**Photo 14** shows the brake fluid reservoir of the Motor Car at the time of my inspection. The brake fluid was observed to be of sufficient level (arrowed) and without any visible contamination.

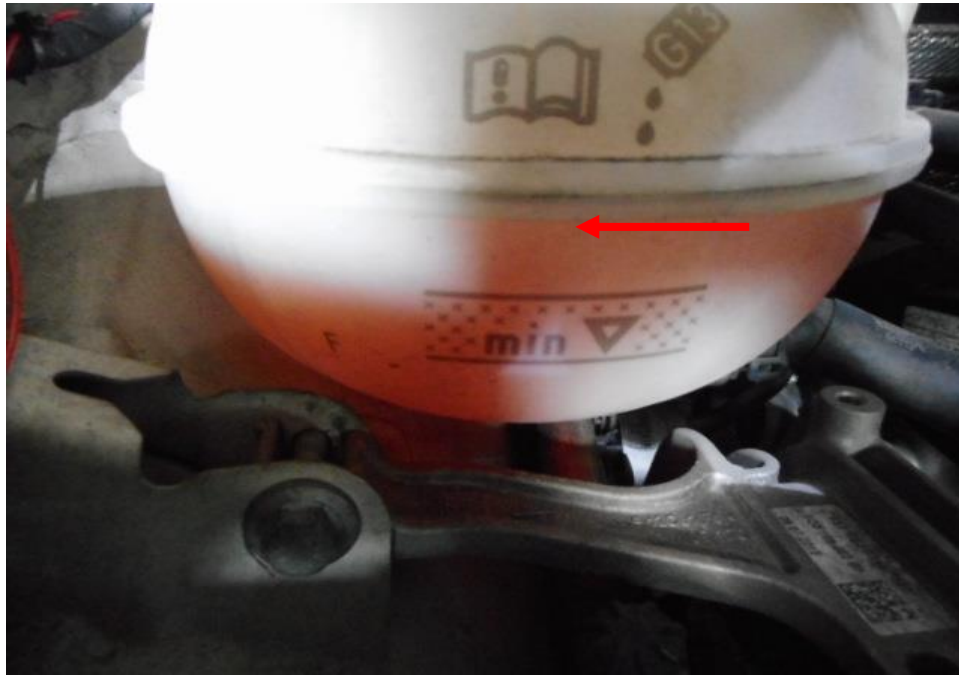
**Photo 15** shows checks being carried out to the engine coolant of the Motor Car at the time of my inspection. The engine coolant was observed to be of sufficient level (arrowed) and without any visible contamination.

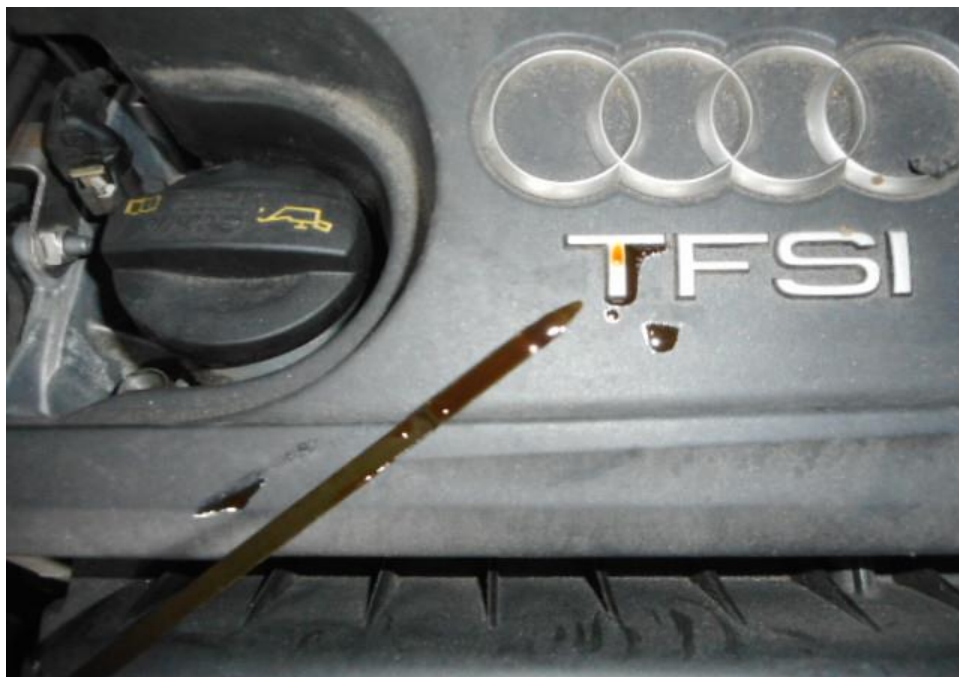
**Photo 16** shows the engine oil dipstick of the Motor Car at the time of my inspection. The engine oil was observed to be of sufficient level and without any visible contamination.

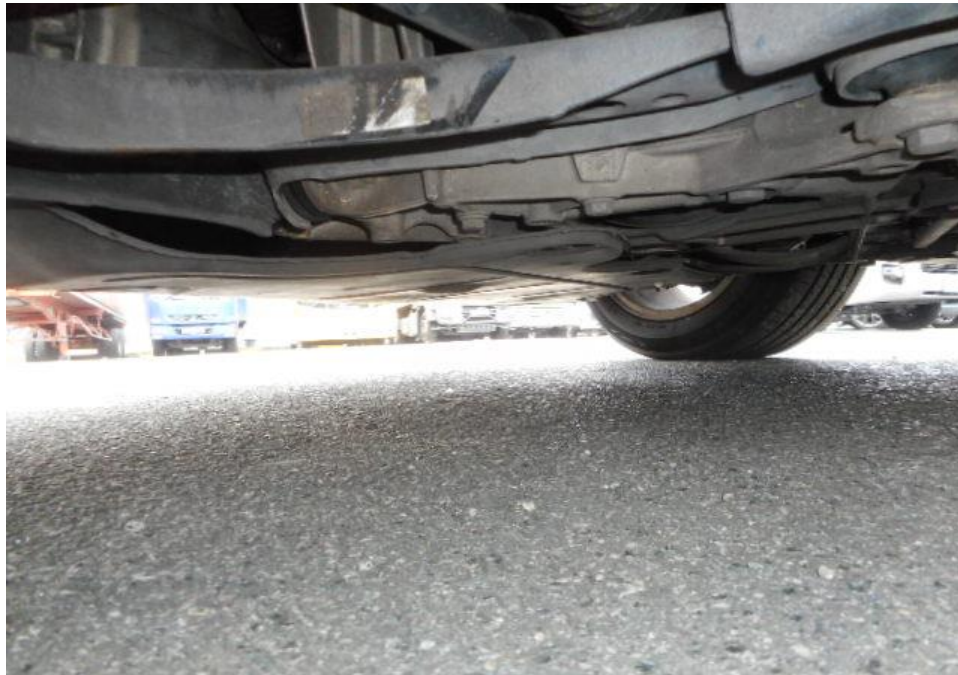
**Photo 17** shows the undercarriage of the Motor Car, at the area where the engine housing and transmission housing are located. I did not find any sign(s) or indication(s) of fluid leak and/or fluid stain(s) on the underside of the Motor Car.

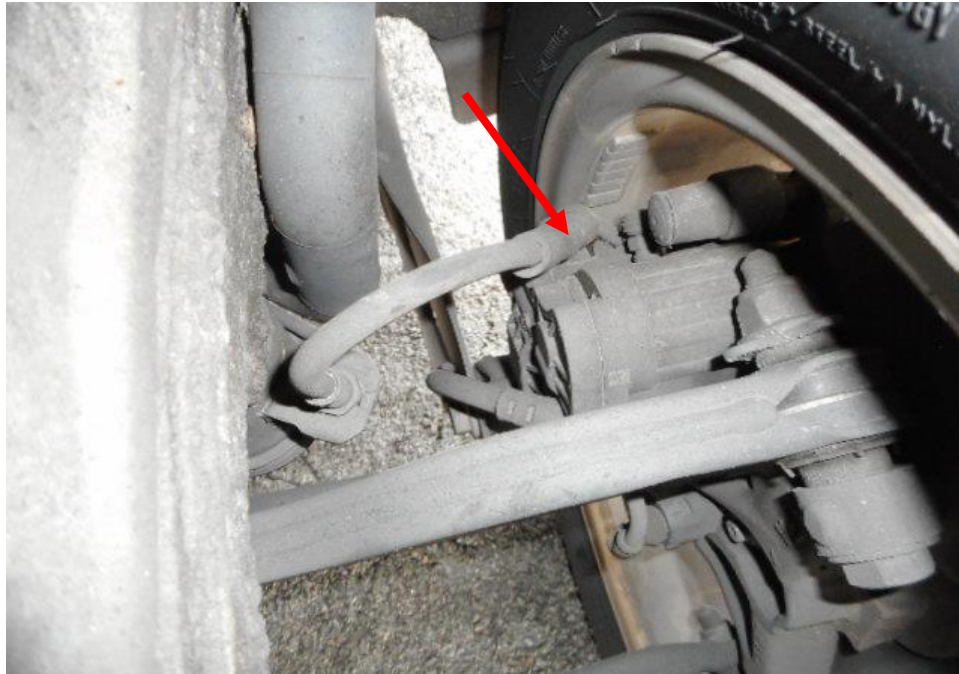
**Photo 18** shows the brake hose/pipe (arrowed) at the rear right wheel of the Motor Car. No leakage of brake fluid was observed. Visual examination of the various components of the braking system like the drum brake, brake booster, brake pedal etc. had revealed all to be intact and without visible damage.

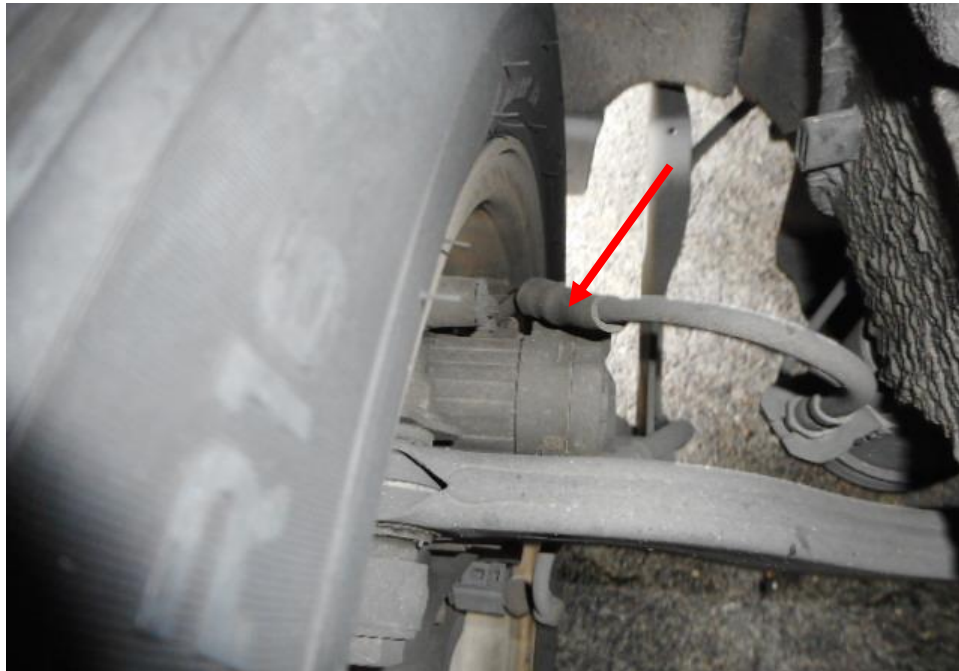
**Photo 19** shows the brake hose/pipe (arrowed) at the rear left wheel of the Motor Car. I did not observe any leakage of brake fluid at the time of my inspection of the Motor Car. Static tests of the Motor Car's braking system had indicated that there was no internal leakage of pressure/vacuum. The undercarriage components of the Motor Car were also all found to be intact and without any visible damage.

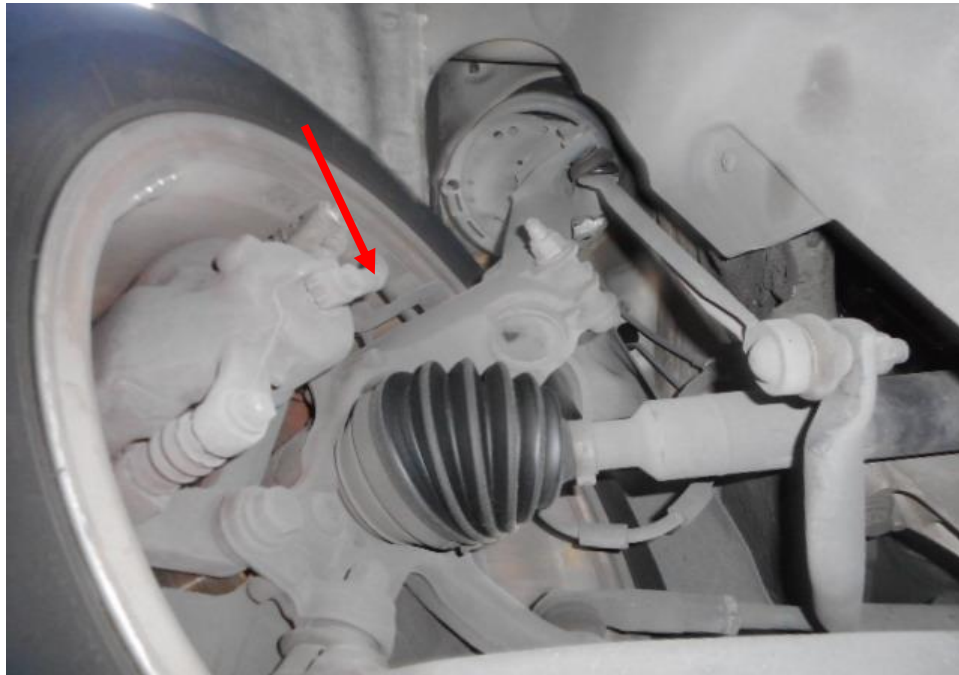
**Photo 20** shows the brake hose/pipe (arrowed) at the front right wheel of the Motor Car. I did not observe any leakage of brake fluid at the time of my inspection of the Motor Car. Static tests of the Motor Car's braking system had indicated that there was no internal leakage of pressure/vacuum. The undercarriage components of the Motor Car were also all found to be intact and without any visible damage.

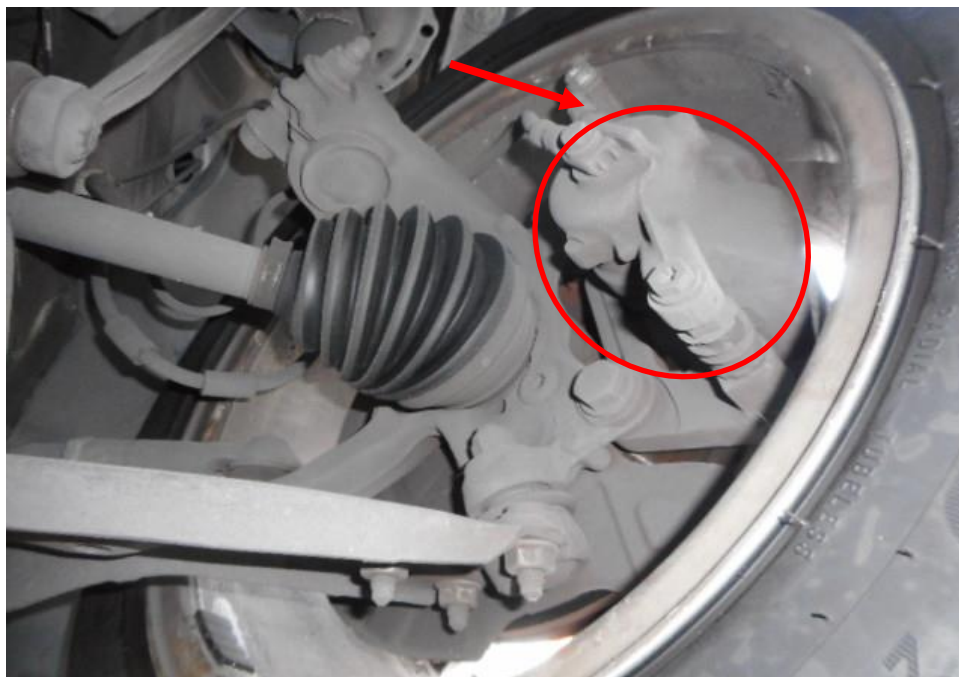
**Photo 21** shows the brake hose/pipe (arrowed) at the front left wheel of the Motor Car. No leakage of brake fluid was observed. Visual examination of the various components of the braking system like the brake caliper (circled), brake booster, brake pedal etc had revealed all to be intact and without visible damage.

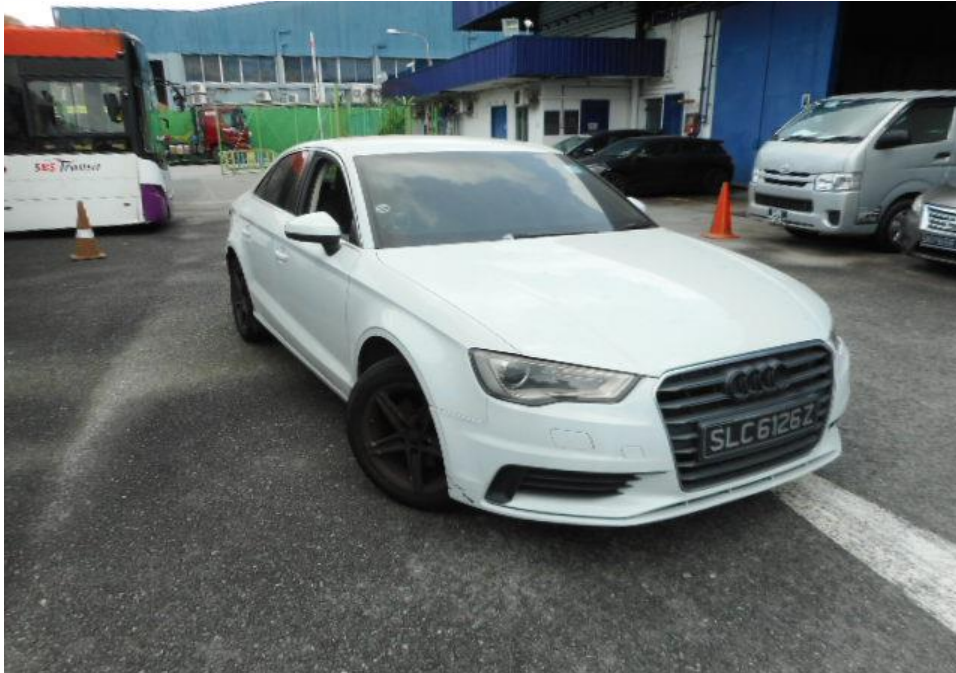
**Photo 22** shows the front right wheel of the Motor Car turned to its full left. During my steering system test, I did not experience any abnormal free play and/or resistance when I had turned the steering wheel towards the left and right. This would suggest that the steering system of the Motor Car was likely to be in serviceable condition at the material time of accident.

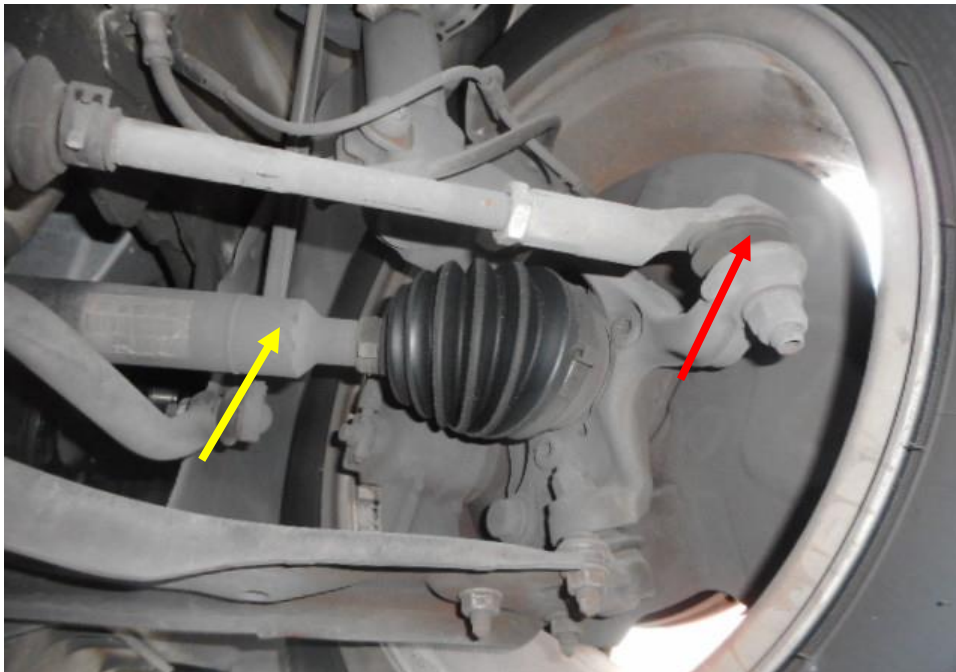
**Photo 23** shows the various undercarriage components at the front right wheel of the Motor Car, in particular the steering tie rod (red arrow) and drive shaft (yellow arrow). The various steering components were all found to be intact, suggesting that the steering system of the Motor Car was likely to be in serviceable condition at the material time of accident. There was also no sign of fluid stain observed on the various undercarriage components at the front right wheel of the Motor Car.

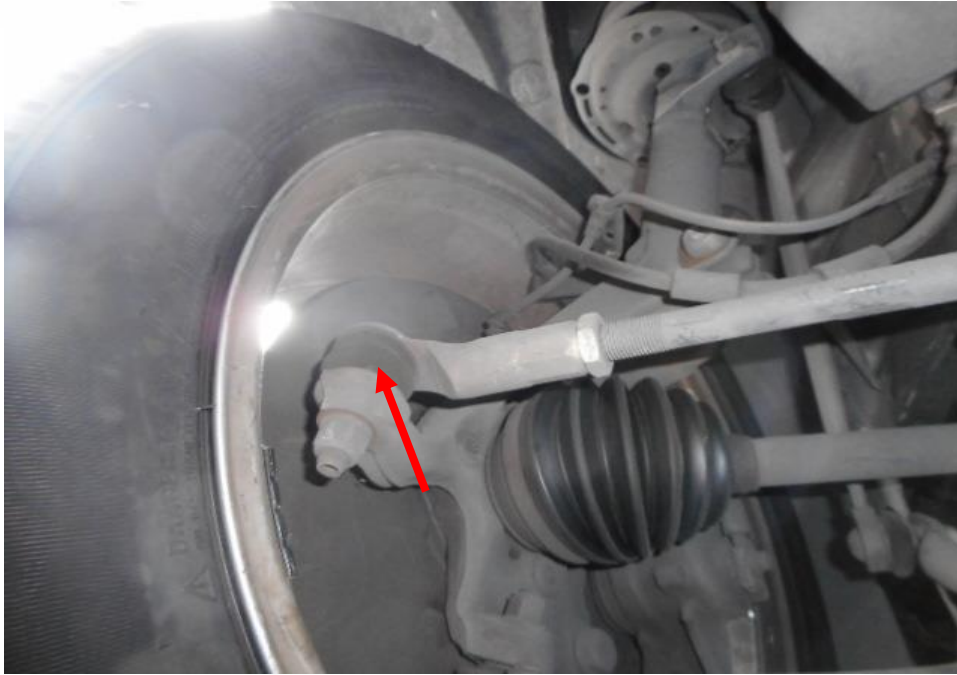
**Photo 24** shows the various undercarriage components at the front left wheel of the Motor Car, which had included the steering tie rod (red arrow). The various undercarriage components of the Motor Car were all found to be intact without any visible damage.

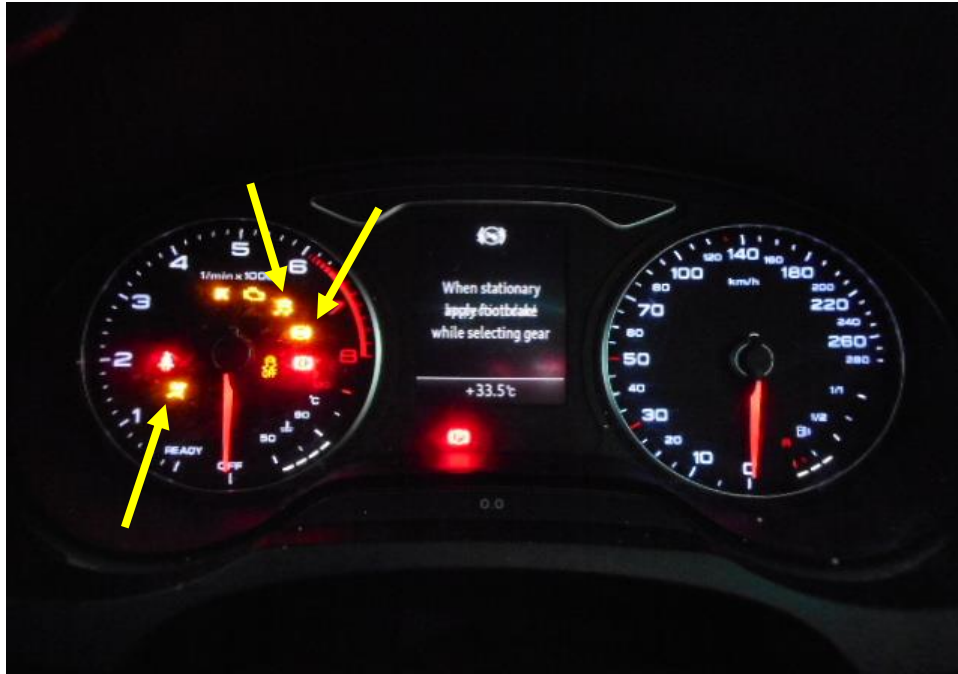
**Photo 25** shows the warning light for Anti-Lock Brake System (ABS), Traction Control System (TCS) and Supplemental Restraint System (SRS) (arrowed) appearing on the instrument panel of the Motor Car during the self-test of its various electronic operating systems when its engine was cranked.

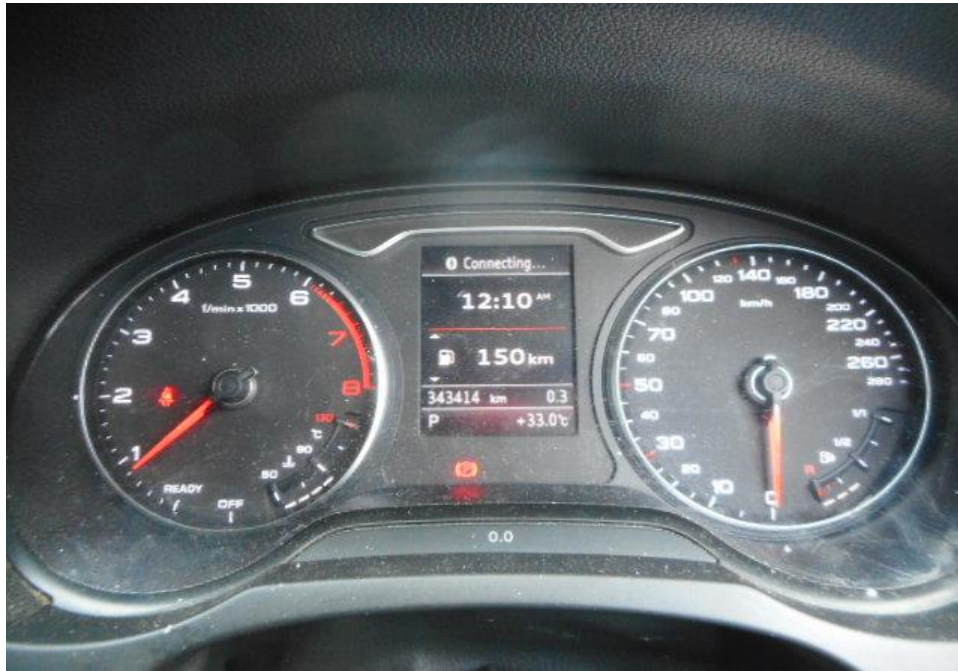
**Photo 26** shows no warning lights illuminated on the instrument panel of the Motor Car after the engine was cranked. This would suggest that there was no abnormality to the electronic operating system of the Motor Car, like the ABS, TCS and SRS etc.
