Your Ref: TP/IP/20677/2021
Our Ref : CI/TPD21005757/P

11th August 2021

MECHANICAL INSPECTION REPORT OF MOTOR LORRY YM 9808M

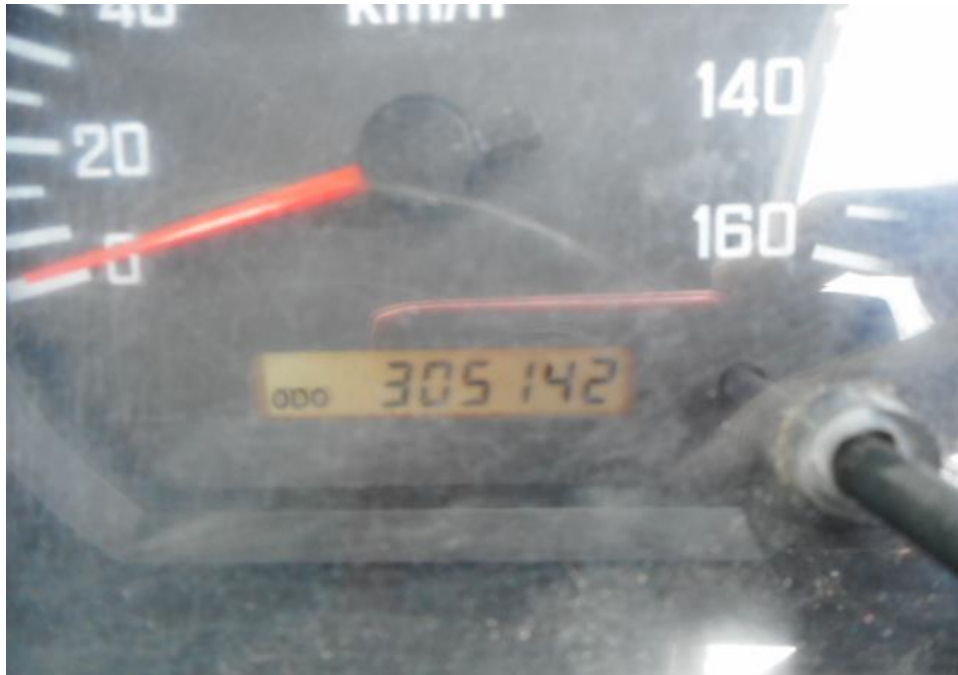
Photo 1 shows a general view of the instrument cluster of the Motor Lorry at the time of my inspection. The mileage of the Motor Lorry was 305,142 km

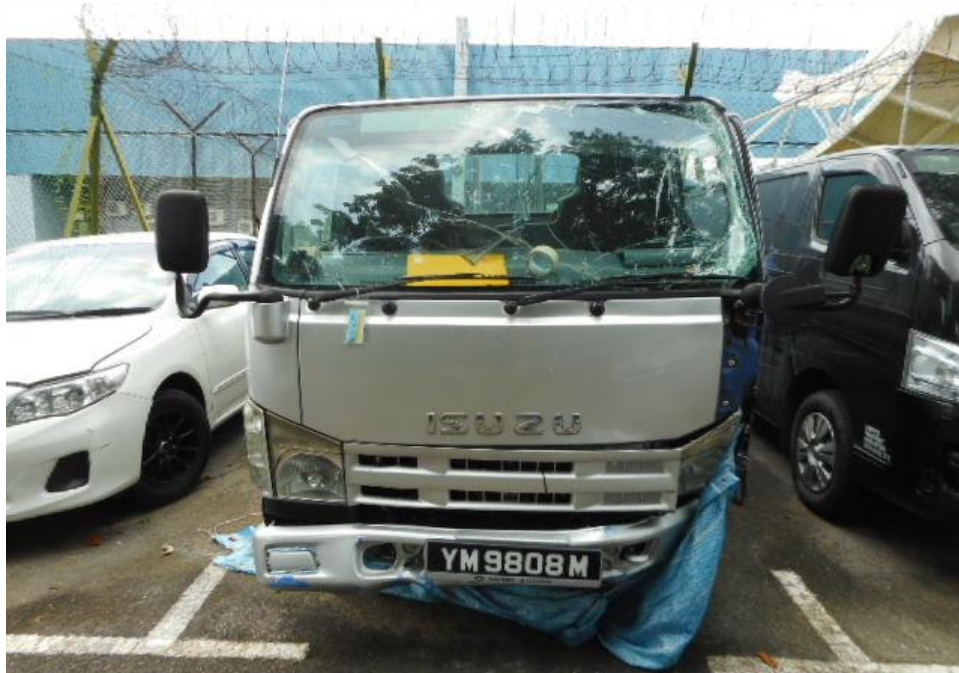
Photo 2 shows a general view of the Motor Lorry's frontal portion at the time of my inspection. It appeared to have sustained damage at its front portion. Its front windscreen, front bumper, front left headlamp and front left door were damage at the time of my inspection as a result of the accident.

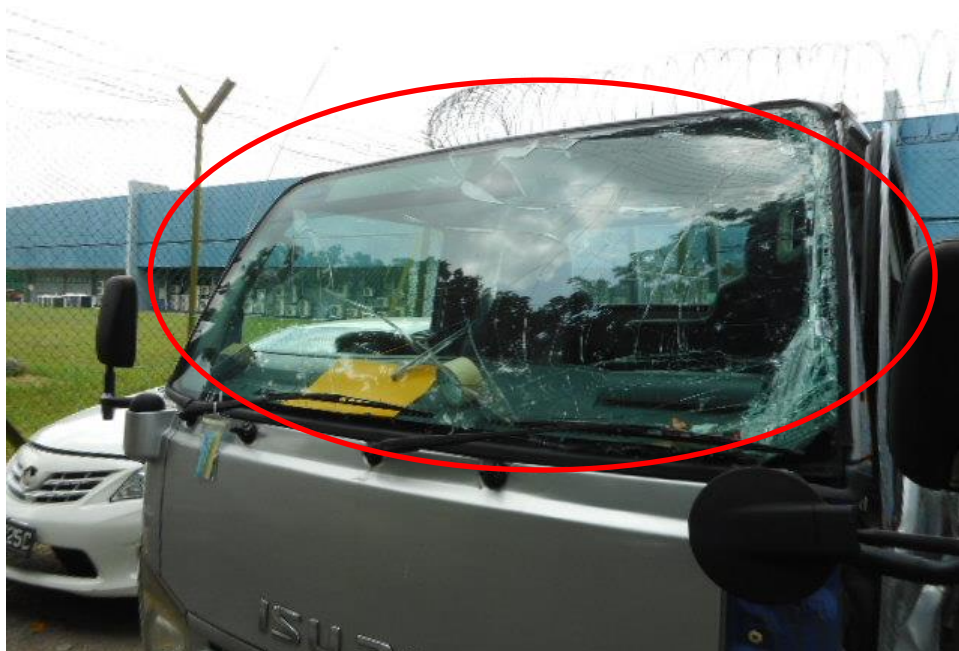
Photo 3 shows a close up view of the Motor Lorry's front portion at the time of my inspection. Its front windscreen (circled) was damage at the time of my inspection as a result of the accident.

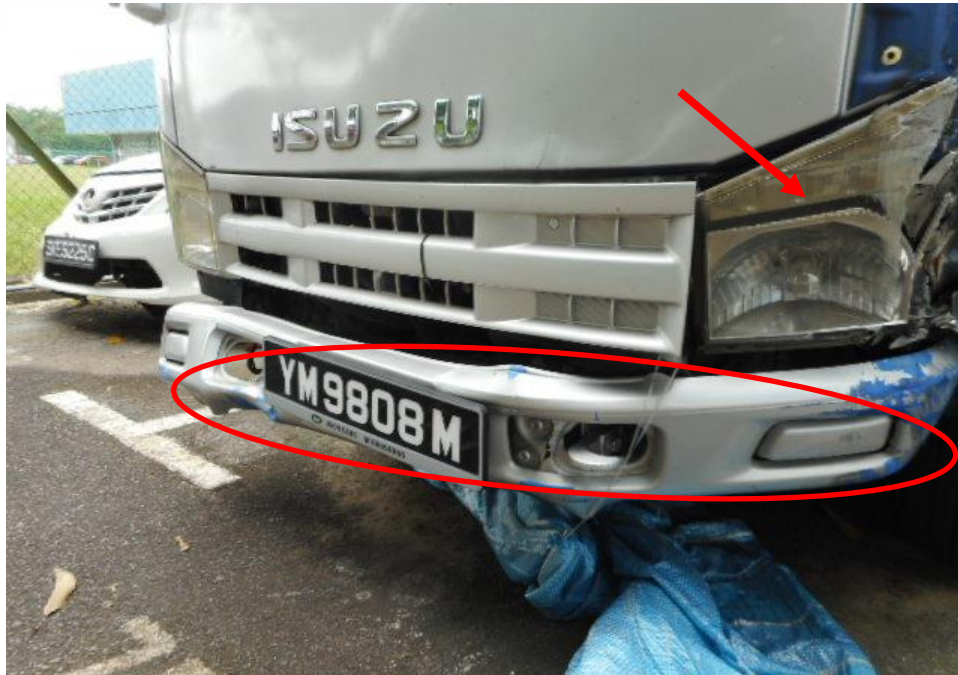
Photo 4 shows a close up view of the Motor Lorry's front portion at the time of my inspection. Its front bumper (circled) and front left headlamp (arrowed) was damage at the time of my inspection as a result of the accident.

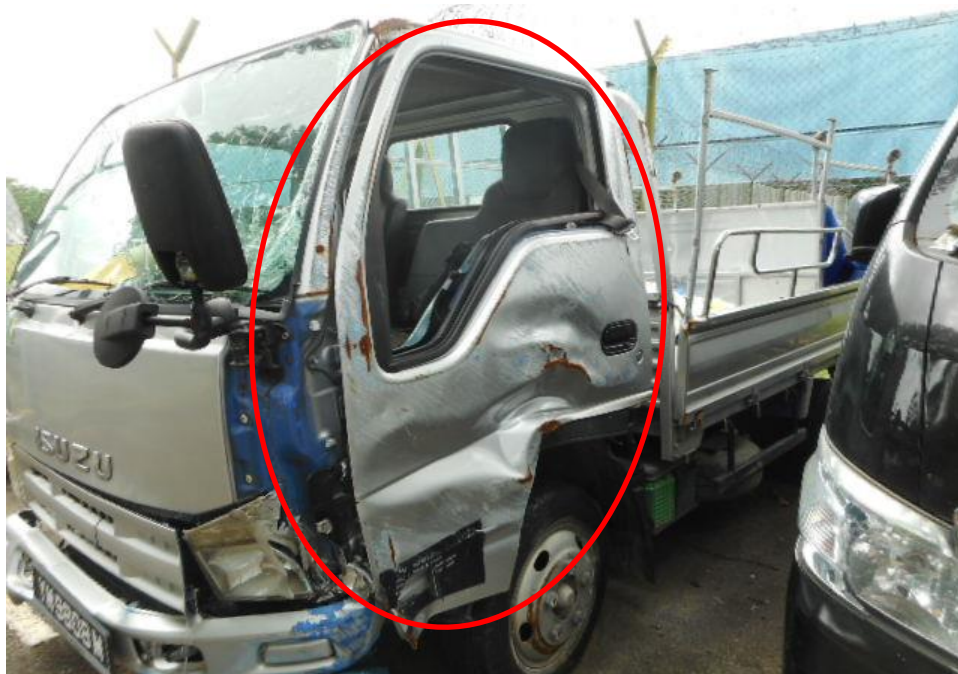
Photo 5 shows a close up view of the Motor Lorry's front portion at the time of my inspection. Its front left door (circled) was damage at the time of my inspection as a result of the accident.

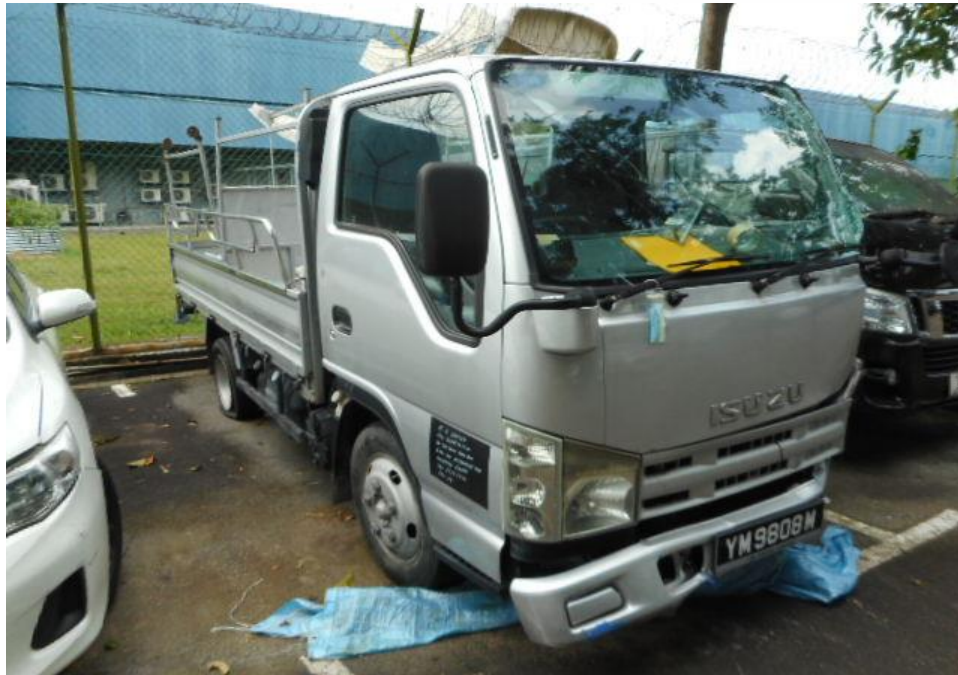
Photo 6 shows a general view of the right body of the Motor Lorry at the time of my inspection. The Motor Lorry was observed to be intact and unaffected by the accident.

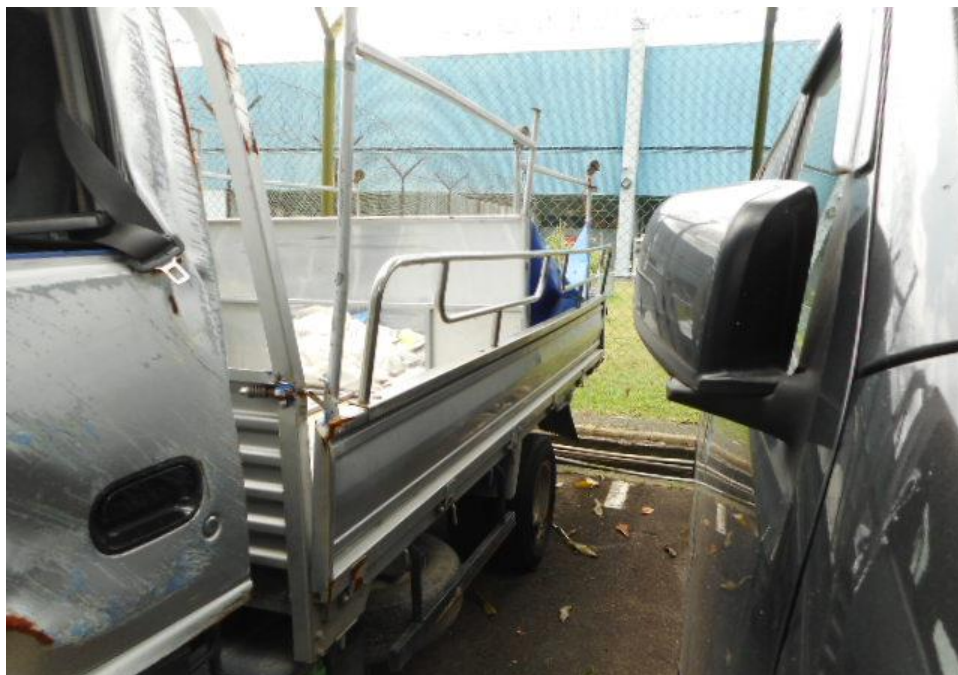
Photo 7 shows a general view of the left body of the Motor Lorry at the time of my inspection. The Motor Lorry was observed to be intact and unaffected by the accident.

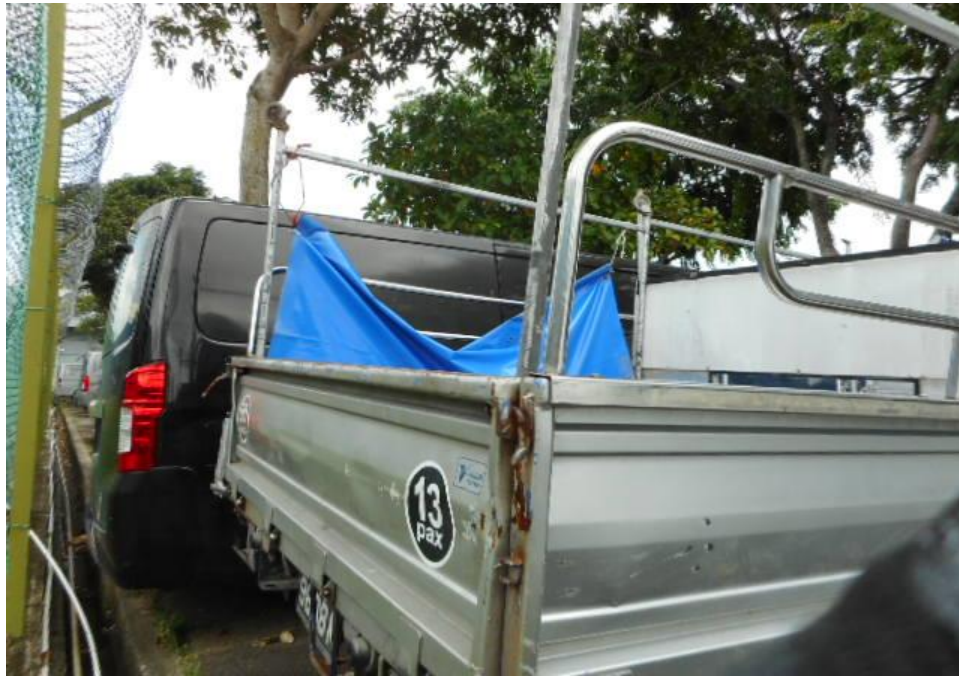
Photo 8 shows a general view of the rear body of the Motor Lorry at the time of my inspection. The Motor Lorry was observed to be intact and unaffected by the accident.

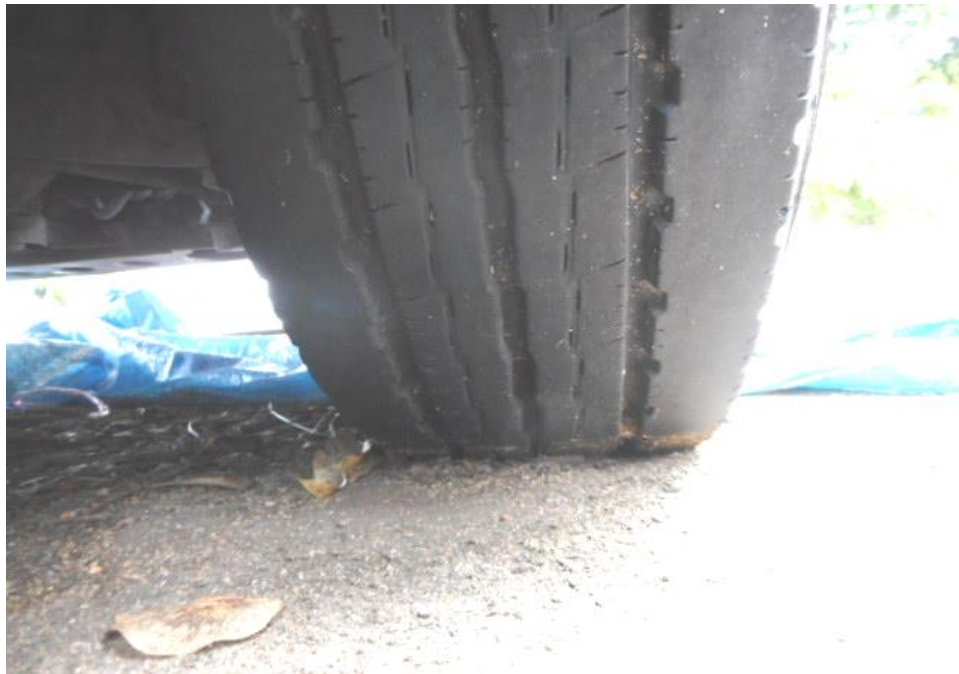
Photo 9 shows the condition of the front right tyre of the Motor Lorry, which was observed to be in serviceable condition with remaining tread depth of approximately 7.4mm. The tyre, which was wrapped around standard steel wheel rim, was also observed to be sufficiently inflated for vehicular operation. There was no tear, cut or burst mark(s) on the outer and the inner sidewalls as well as across the tread of the 6 tyres that were fitted on the Motor Lorry.

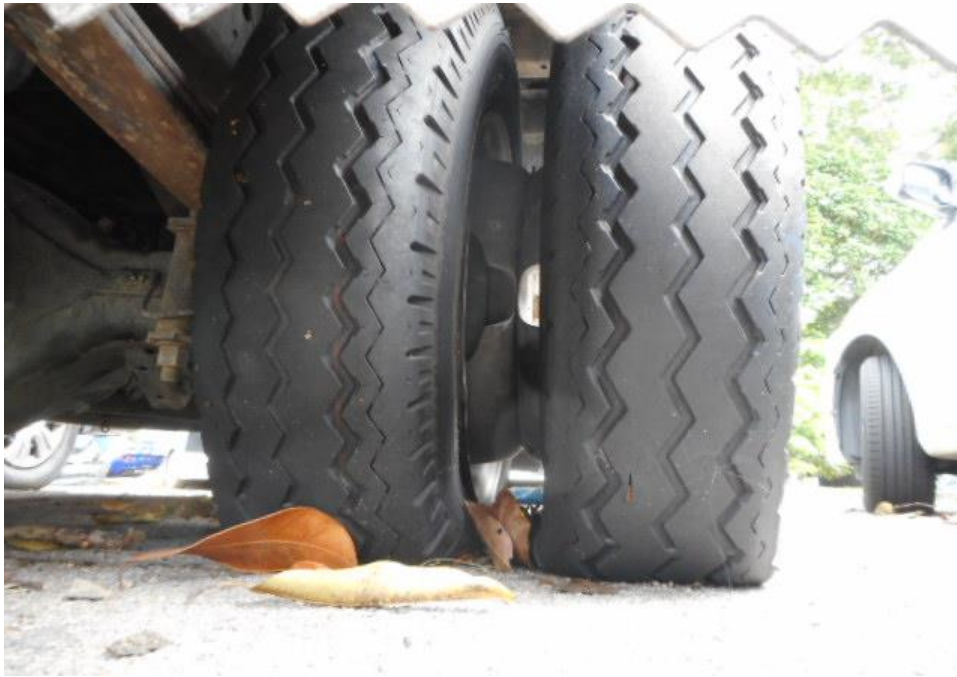
Photo 10 shows the condition of the rear right tyre of the Motor Lorry, which was observed to be in serviceable condition with remaining tread depth of approximately 1.8mm. The tyre, which was wrapped around standard steel wheel rim, it was observed to be sufficiently inflated for vehicular operation.

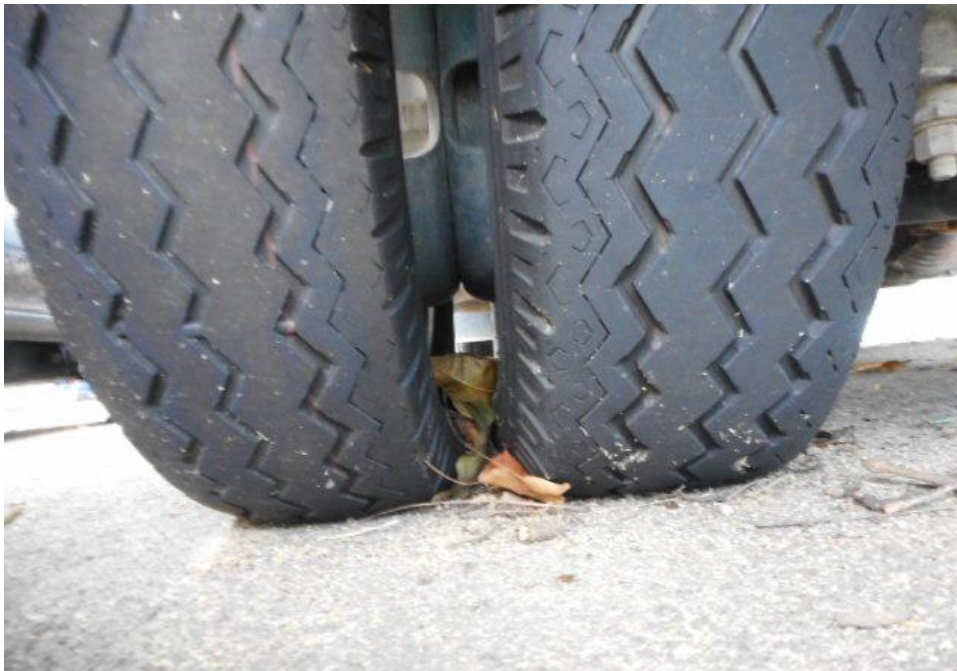
Photo 11 shows the condition of the rear left tyres of the Motor Lorry, which was observed to be in serviceable condition with remaining tread depth of approximately 1.9mm. The tyres, which were wrapped around standard steel wheel rim, were also observed to be sufficiently inflated for vehicular operation.

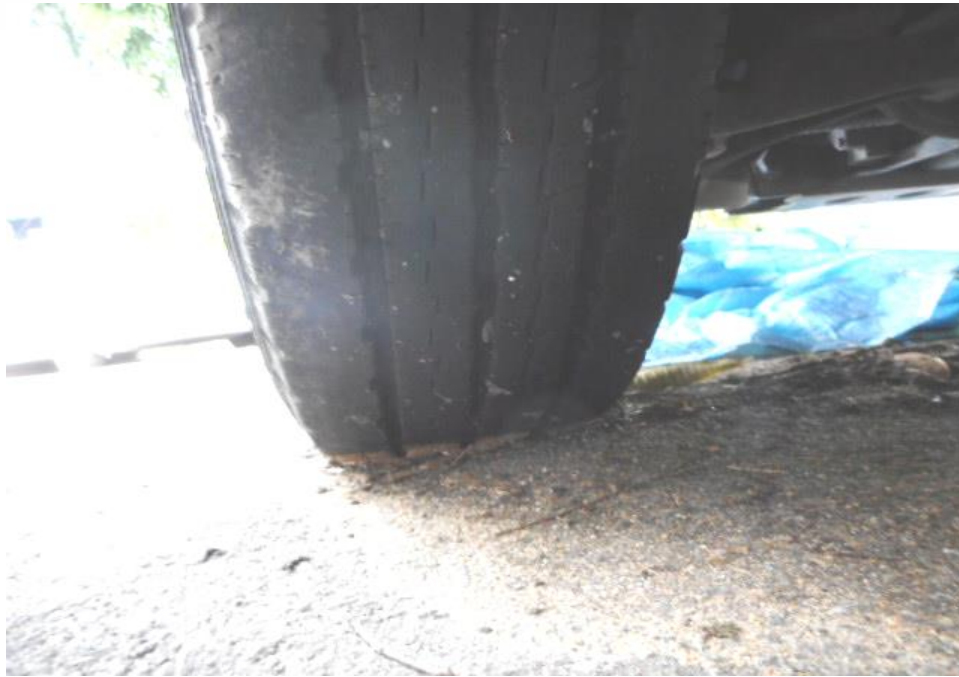
Photo 12 shows the condition of the rear right tyres of the Motor Lorry, which were observed to be in serviceable condition with remaining, tread depth of approximately 7.4mm. There was also no tear, cut or burst mark(s) on the outer and the inner sidewalls as well as across the tread of the 6 tyres that were fitted on the Motor Lorry.

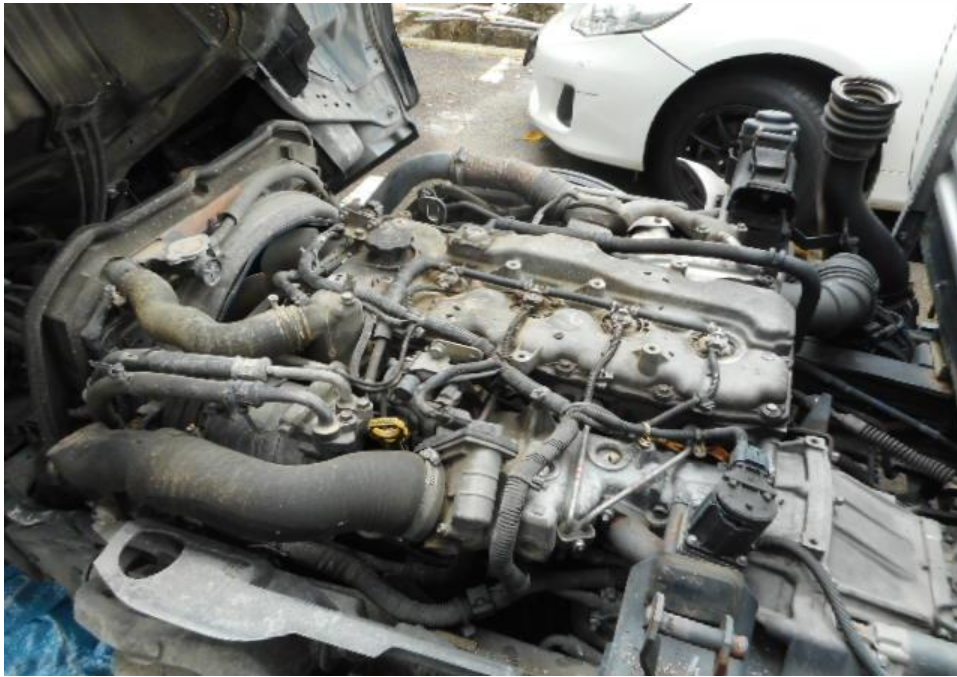
Photo 13 shows a general view of the Motor Lorry's engine compartment, which was accessed by lifting the front cabin of the Motor Lorry. The various parts and components inside the engine compartment were unaffected by the accident. There was also no sign(s) or indication(s) of fresh fluid leakage and/or fluid stain within the engine compartment

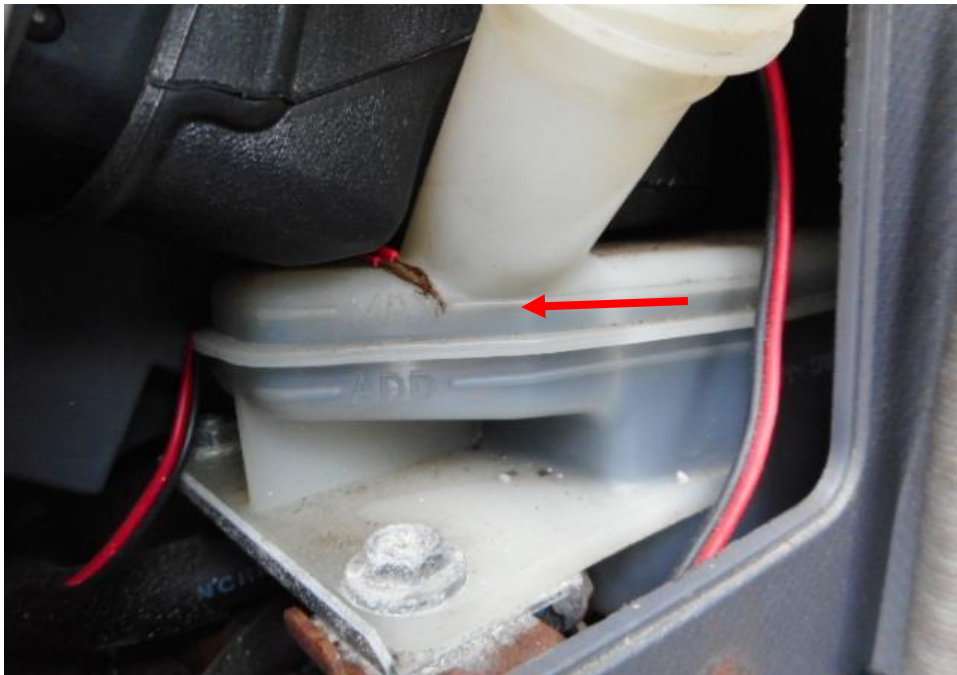
Photo 14 shows the brake fluid reservoir of the Motor Lorry at the time of my inspection. The brake fluid was observed to be of sufficient level (arrowed) and without any visible contamination.

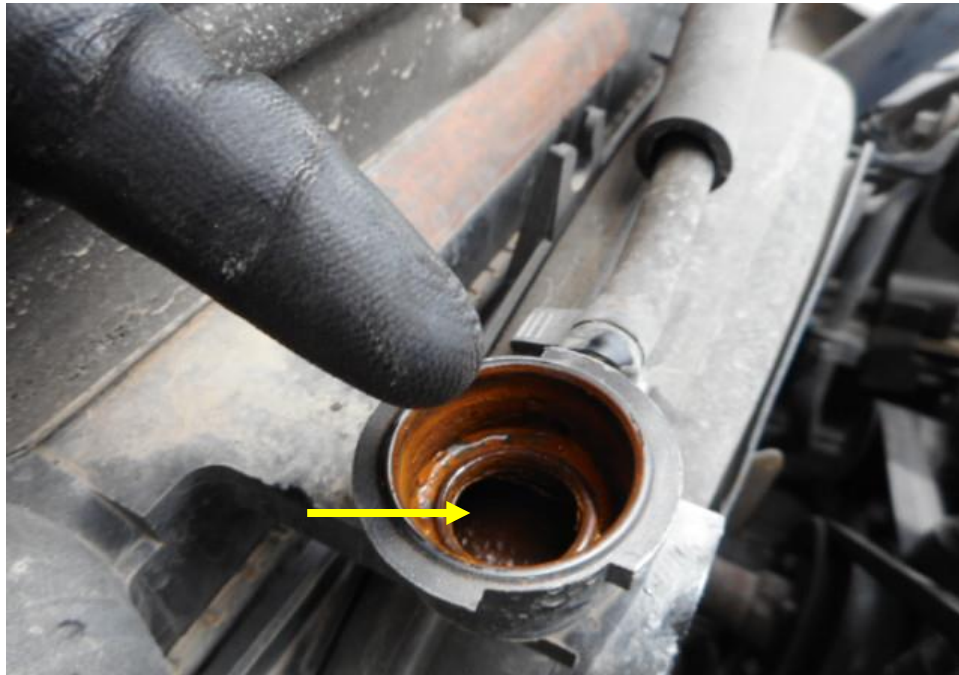
Photo 15 shows the engine coolant reservoir of the Motor Lorry at the time of my inspection. The engine coolant was observed to be of insufficient level (arrowed) which was likely caused by a leakage as a result of the accident.

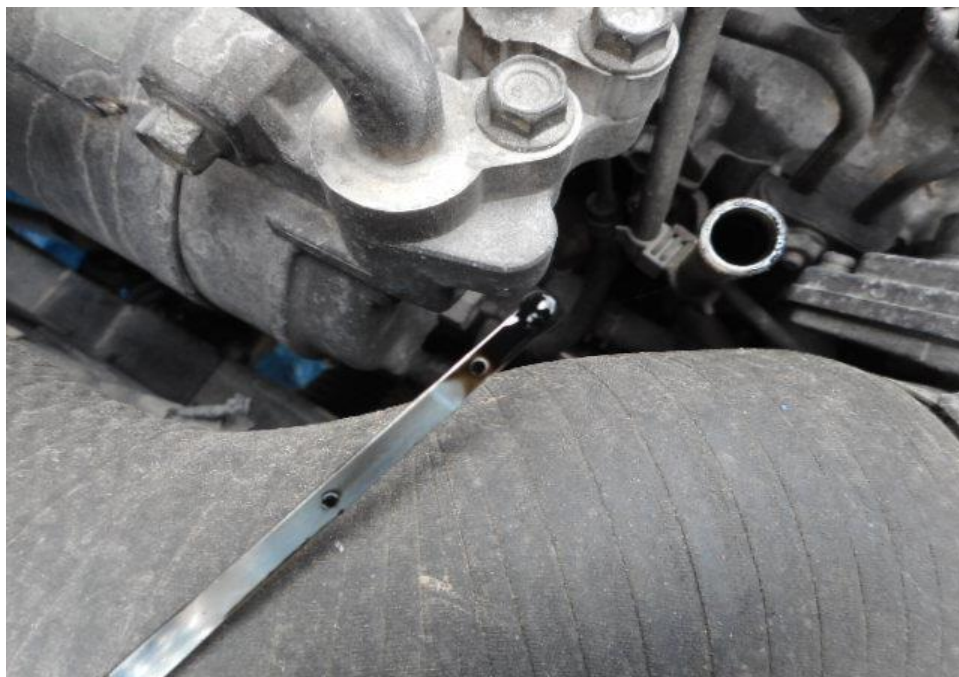
Photo 16 shows the engine oil dip stick of the Motor Lorry at the time of my inspection. The engine oil was observed to be of sufficient level and without any visible contamination.

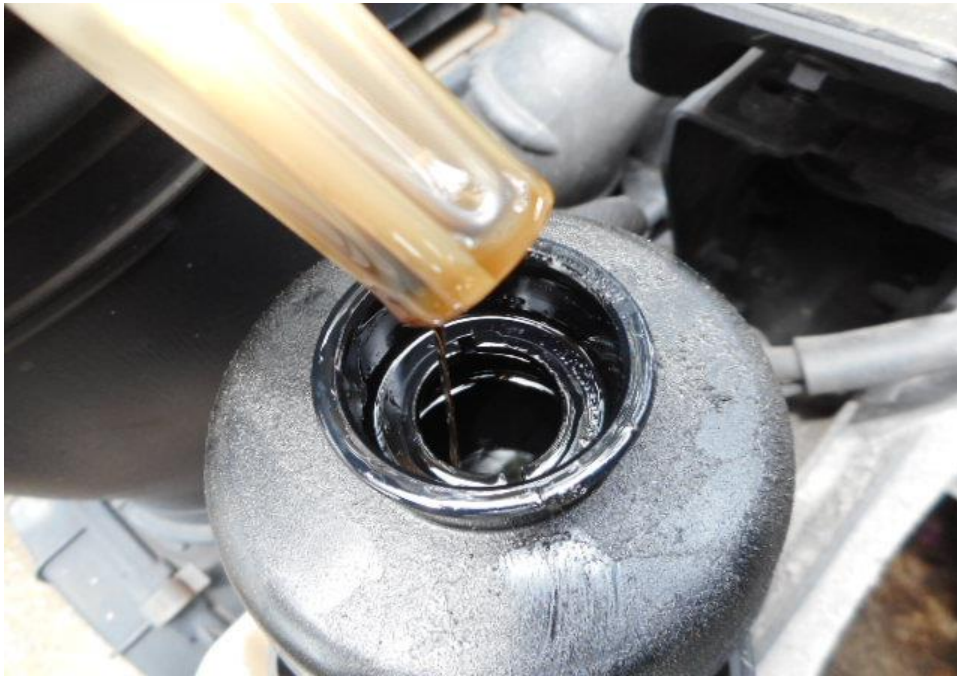
Photo 17 shows the power steering fluid reservoir of the Motor Lorry at the time of my inspection. The power steering fluid was observed to be of sufficient level and without any visible contamination.

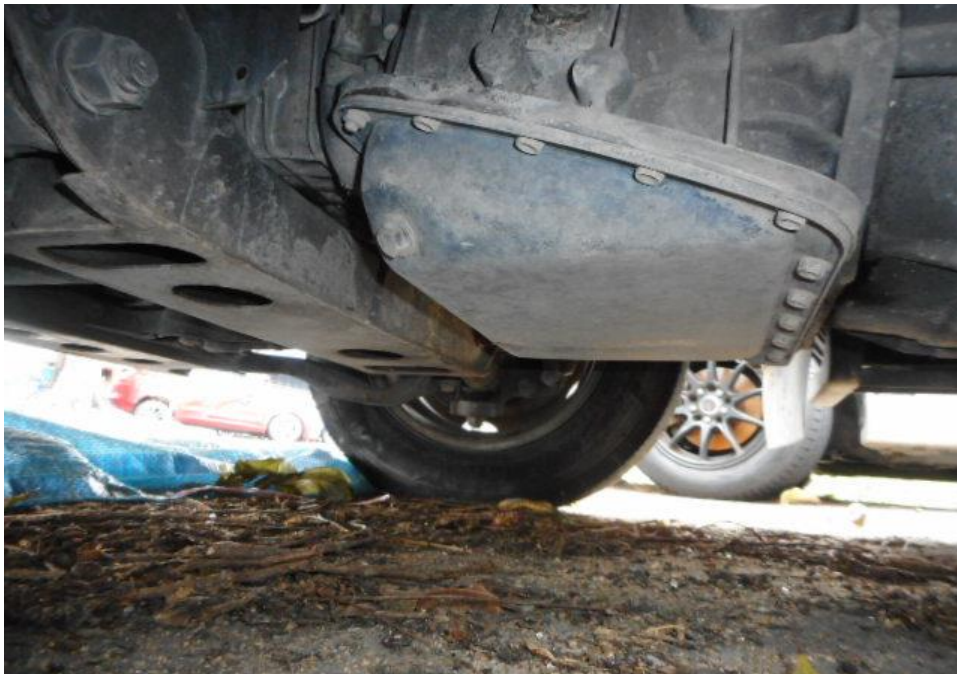
Photo 18 shows the undercarriage of the Motor Lorry, at the area where the engine housing and transmission housing are located. I did not find any sign(s) or indication(s) of fluid leak and/or fluid stain(s) on the underside of the Motor Lorry.

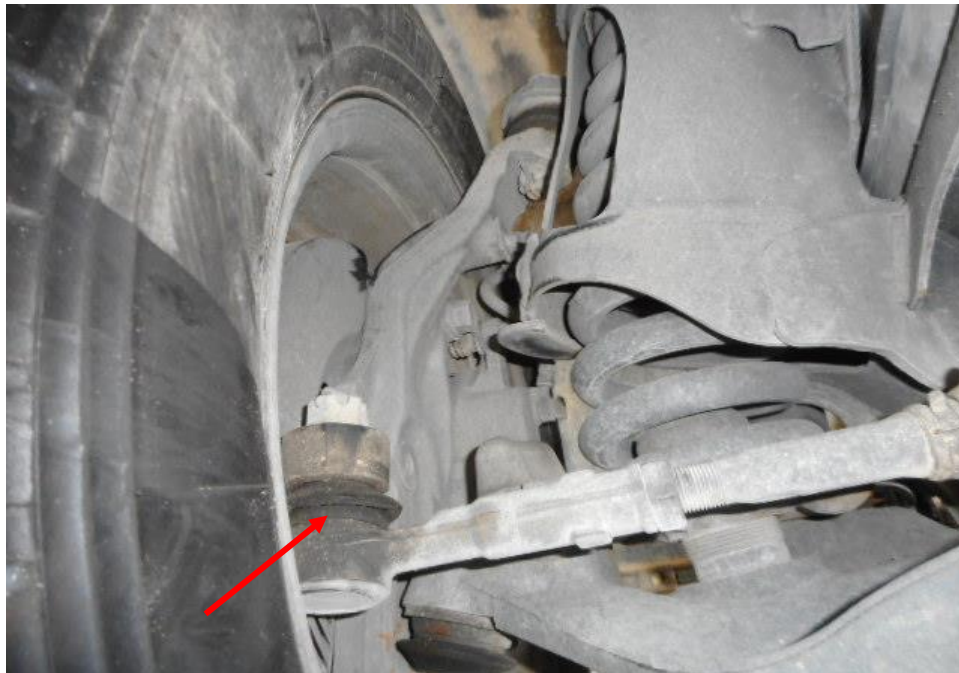
Photo 19 shows the various undercarriage components at the front right wheel of the Motor Lorry, in particular the steering tie rod end (arrowed). The various steering components were all found to be intact, suggesting that the steering system of the Motor Lorry was likely to be in serviceable condition at the material time of accident. There was also no sign of fluid stain(s) observed on the various undercarriage components.

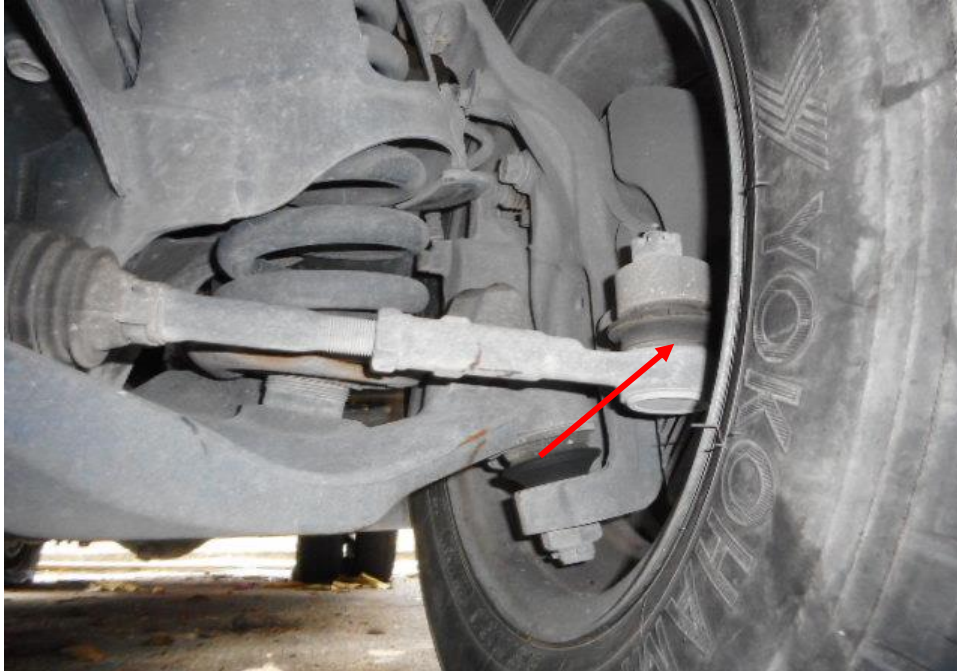
Photo 20 shows the various undercarriage components at the front left wheel of the Motor Lorry, in particular the steering tie rod end (arrowed). The various undercarriage components of the Motor Lorry were all found to be intact without any visible damage. There was also no sign of fluid stain(s) observed on the various undercarriage components.

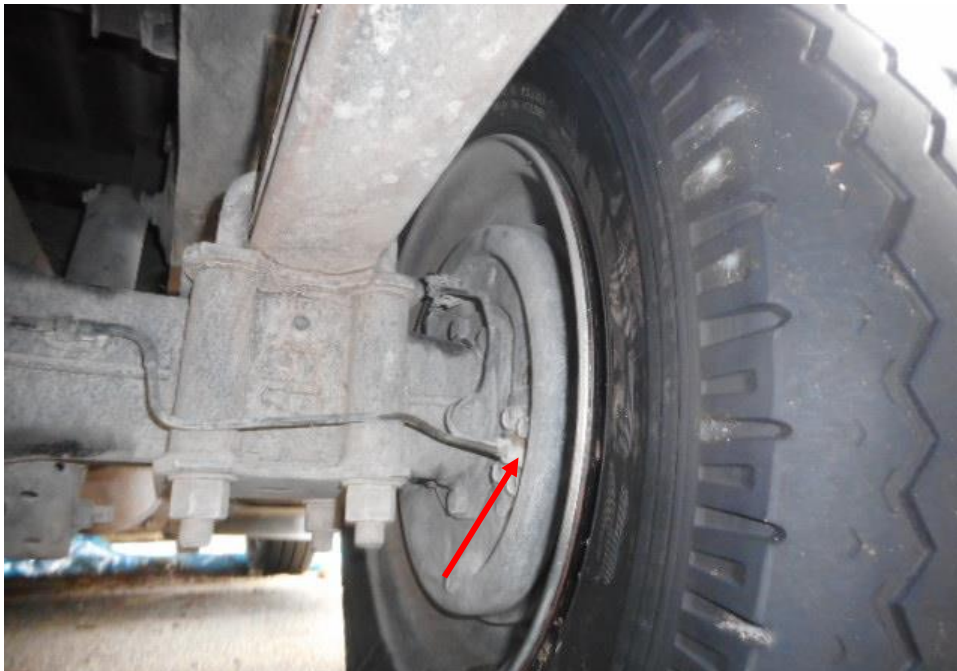
Photo 21 shows the brake pipe (arrowed) at the rear right wheel of the Motor Lorry. I did not observe any leakage of brake fluid at the time of my inspection of the Motor Lorry. My static tests of the Motor Lorry's braking system, along with my visual examination of the various mechanical components in the braking system, had indicated that there was no internal leakage of pressure/vacuum. Hence the braking system of the Motor Lorry was likely to be in serviceable condition at the material time of accident.

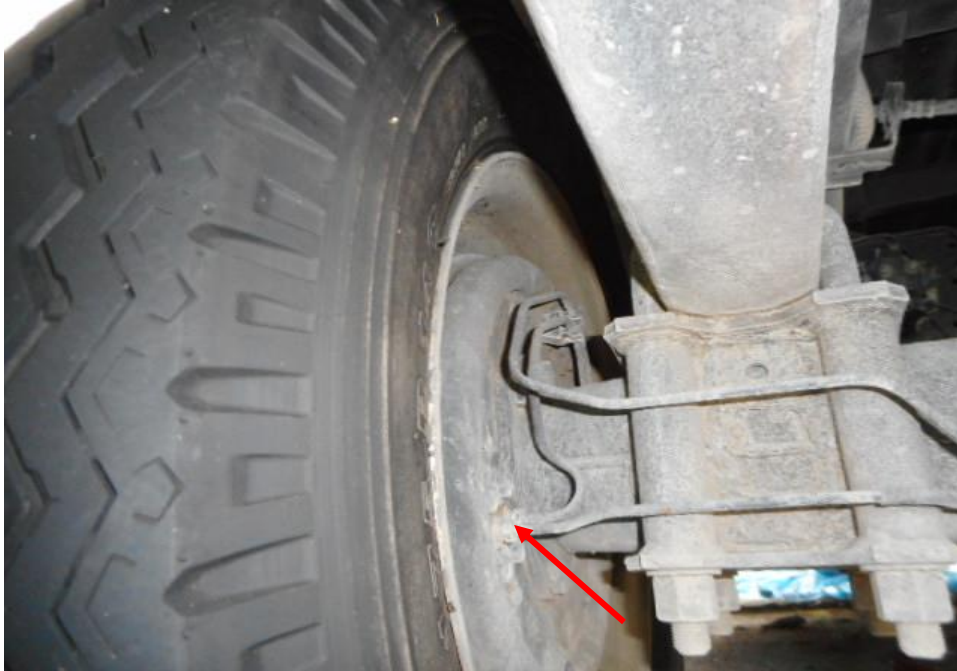
Photo 22 shows the brake pipe (arrowed) at the rear left wheel of the Motor Lorry. I did not observe any leakage of brake fluid at the time of my inspection of the Motor Lorry. My static tests of the Motor Lorry's braking system, along with my visual examination of the various mechanical components in the braking system had indicated that there was no internal leakage of pressure/vacuum. Hence the braking system of the Motor Lorry was likely to be in serviceable condition at the material time of accident.

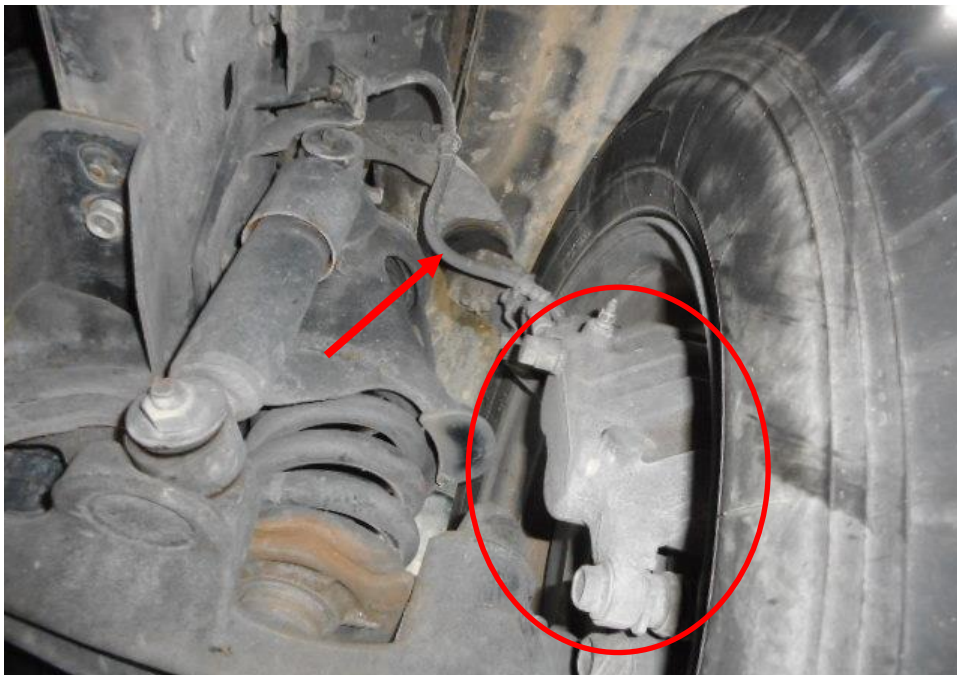
Photo 23 shows the brake hose/pipe (arrowed) at the front right wheel of the Motor Lorry. No leakage of brake fluid was observed. Visual examination of the various components of the braking system like the brake caliper (circled), brake booster, brake pedal etc had revealed all to be intact and without visible damage at the time of accident. There was also no sign of fluid stain(s) observed on the various undercarriage components.

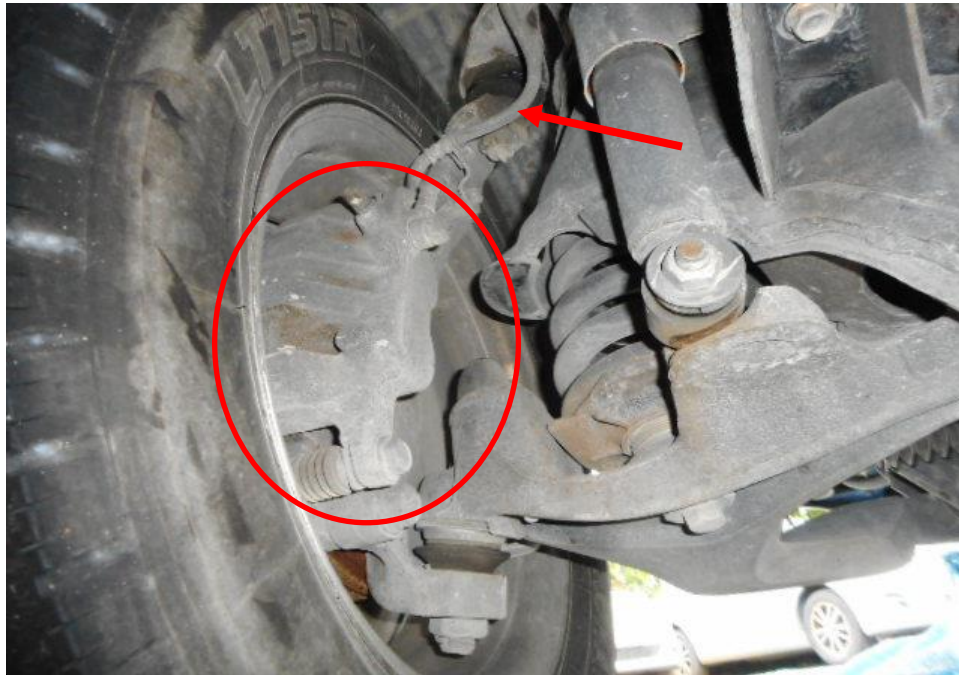
Photo 24 shows the brake hose/pipe (arrowed) at the front left wheel of the Motor Lorry. No leakage of brake fluid was observed. Visual examination of the various components of the braking system like the brake caliper (circled), brake booster, brake pedal etc had revealed all to be intact and without visible damage at the time of accident. There was also no sign of fluid stain(s) observed on the various undercarriage components.
