Your Ref: TP/IP/21603/2021
Our Ref : CI/TPD21005758/P

19th May 2021

MECHANICAL INSPECTION REPORT OF TOW-TRUCK GT 7606T

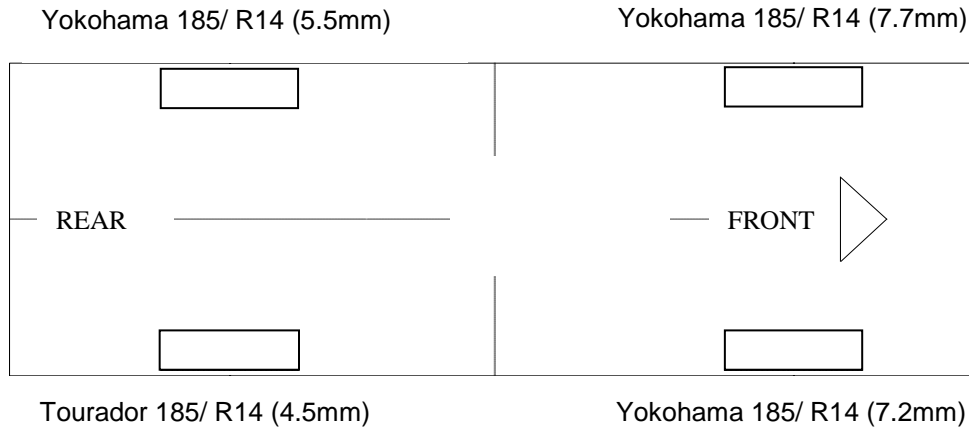
6. The 4 tyres of the Tow-Truck were observed to be in serviceable condition and sufficiently inflated for vehicular operation. I did not find any tear, cut or burst mark(s) on the outer and the inner sidewalls as well as across the tread of the 4 tyres. The tyre brand, tyre size and remaining tread depth of the 4 tyres of the Tow-Truck were recorded as follows:-

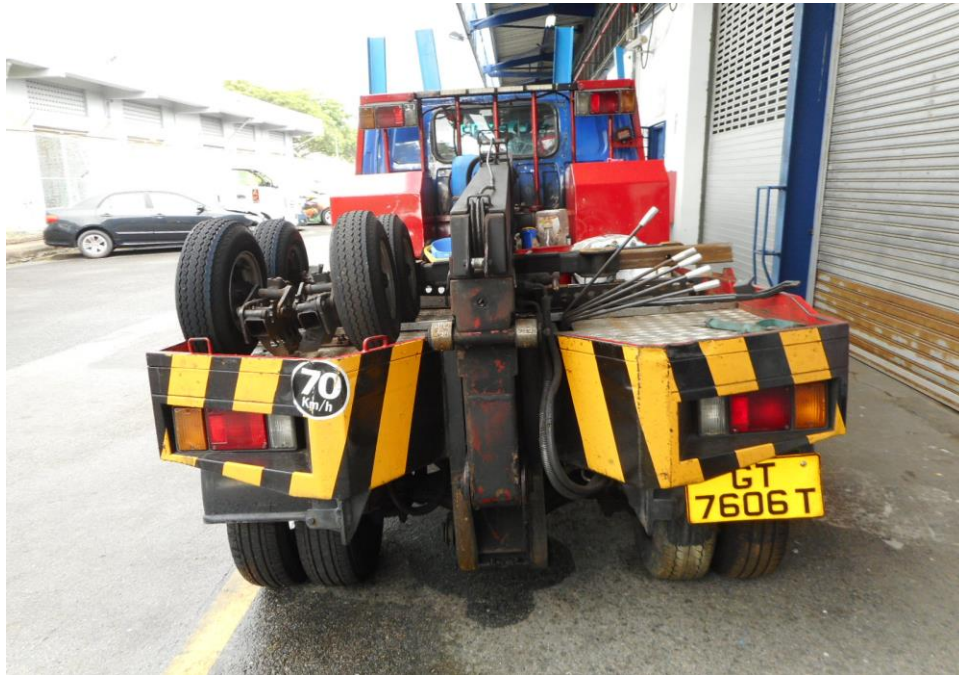
Photo 1 shows a general view of the rear body of the Tow-Truck at the time of my inspection. The Tow-Truck was observed to be intact and unaffected by the accident.

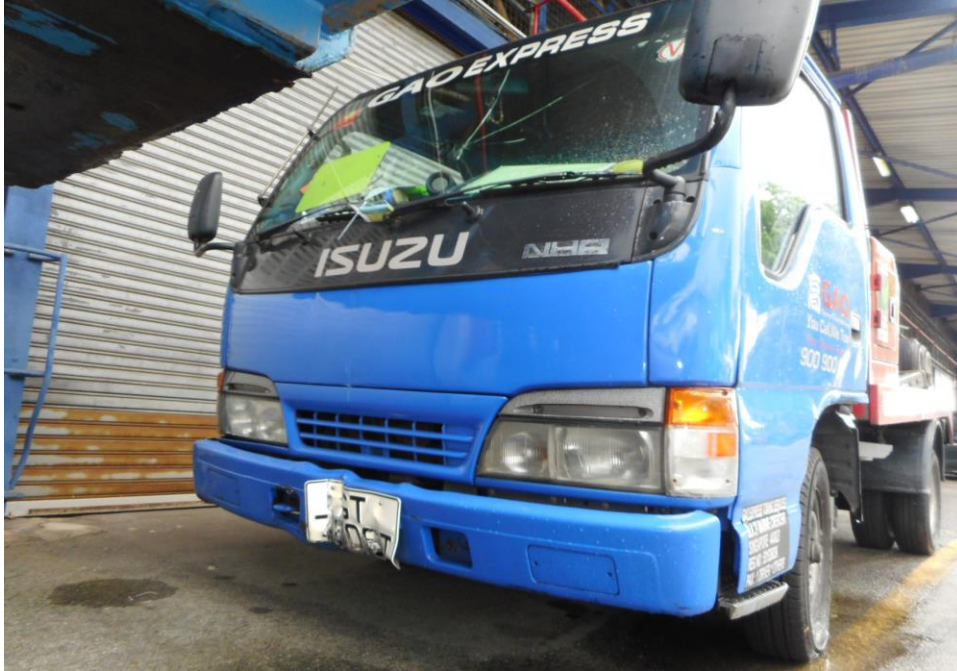
4. The mileage of the Tow-Truck at the time of my inspection was not recorded.
5. The Tow-Truck appeared to have sustained damage at its frontal portion. Its front windscreen, front bumper and number plate were damaged at the time of my inspection.

Photo 2 shows a general view of the Tow-Truck's frontal portion at the time of my inspection. It appeared to have sustained damage at its frontal portion. Its front windscreen, front bumper and number plate were damage at the time of my inspection.

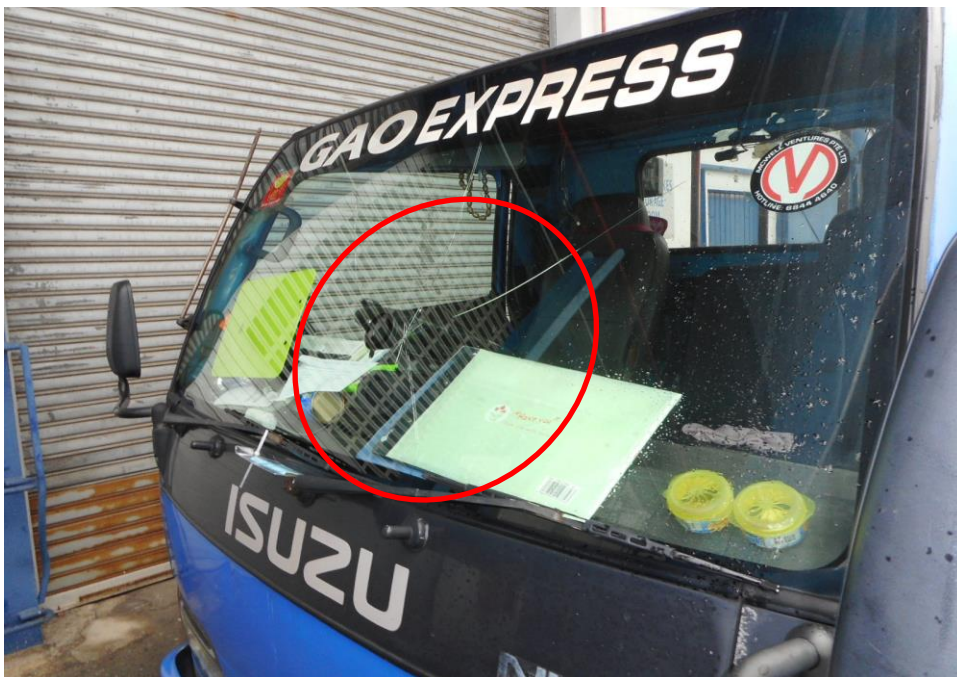
Photo 3 shows a close up view of the Tow-Truck's frontal portion at the time of my inspection. It appeared to have sustained damage at its frontal portion. Its front windscreen (red circle) was damage at the time of my inspection as a result of the accident.

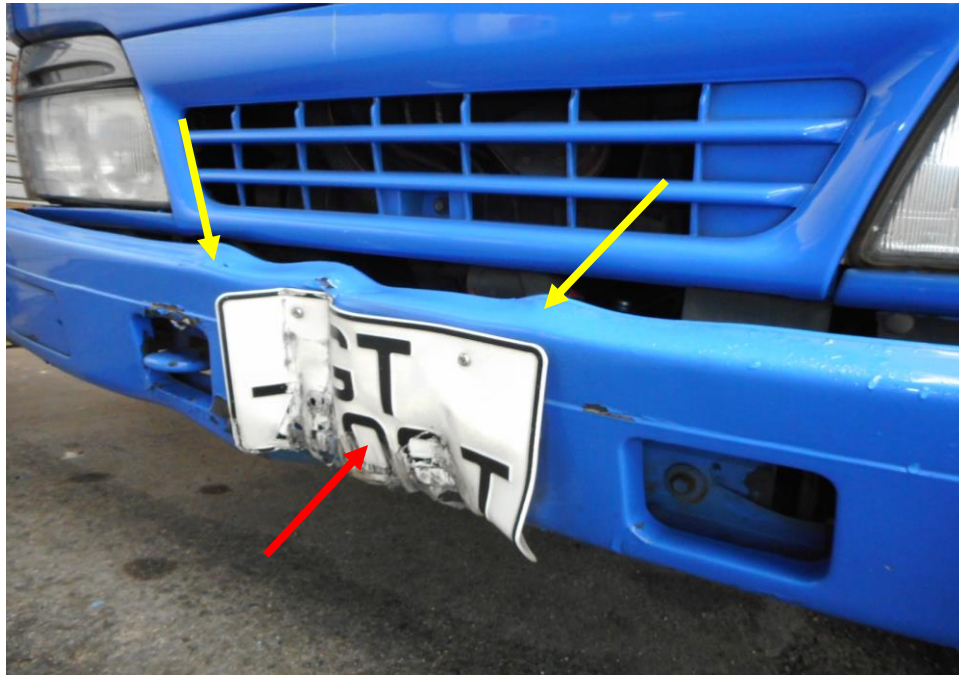
Photo 4 shows a close up view of the Tow-Truck's frontal portion at the time of my inspection. It appeared to have sustained damage at its frontal portion. Its front bumper (yellow arrow) and front number plate (red arrow) was damage at the time of my inspection as a result of the accident.

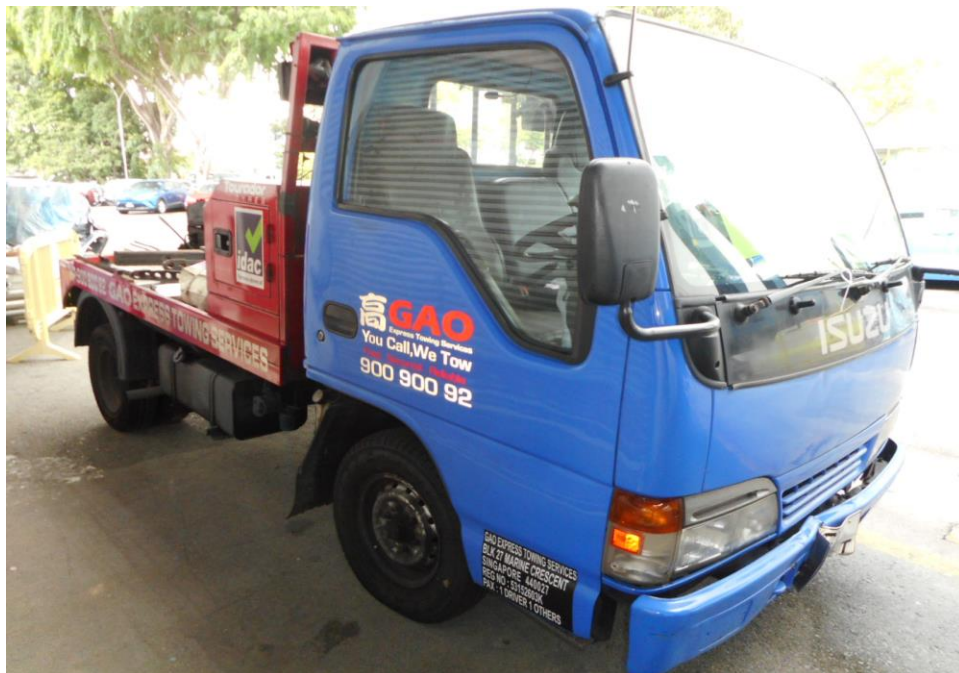
Photo 5 shows a general view of the right body of the Tow-Truck at the time of my inspection. The Tow-Truck was observed to be intact and unaffected by the accident.

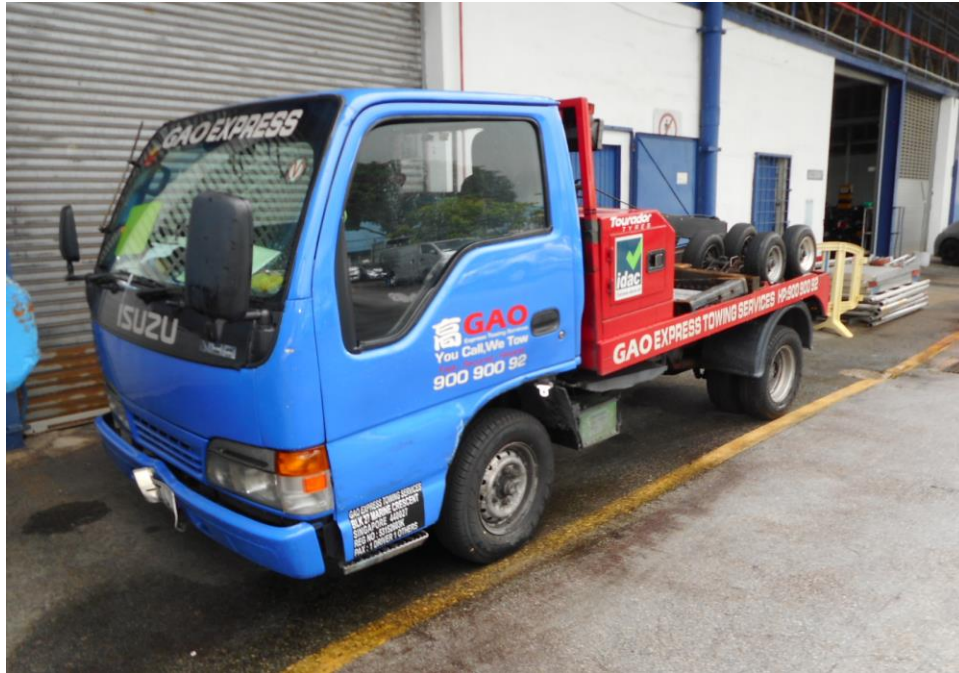
Photo 6 shows a general view of the left body of the Tow-Truck at the time of my inspection. The Tow-Truck was observed to be intact and unaffected by the accident.

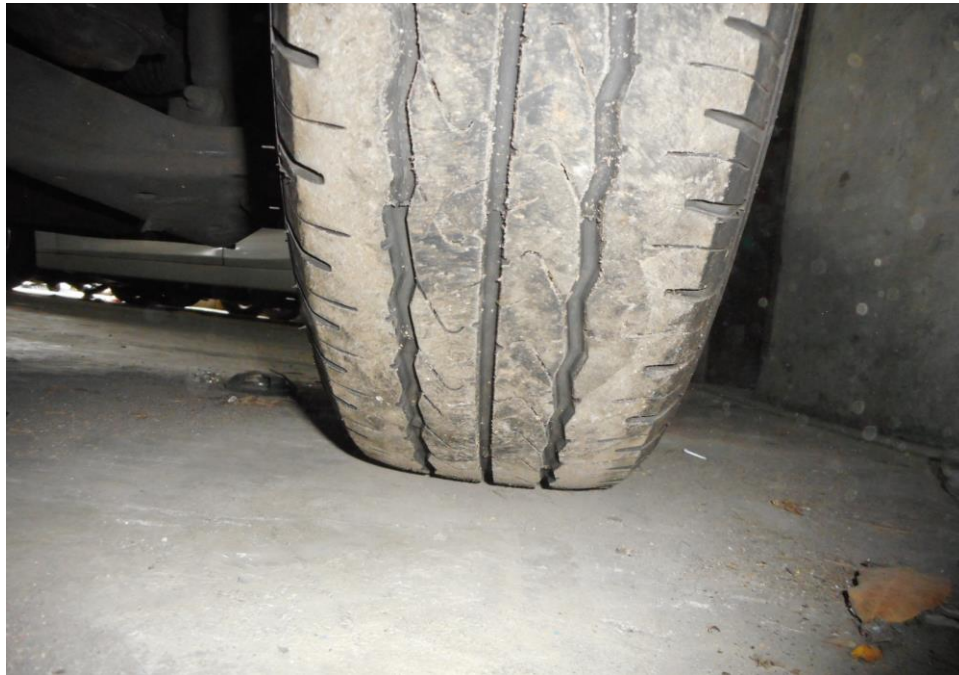
Photo 7 shows the condition of the front right tyre of the Tow-Truck, which was observed to be in serviceable condition with remaining tread depth of approximately 7.2mm. The tyre, which was wrapped around standard steel wheel rim, was also observed to be sufficiently inflated for vehicular operation. There was no tear, cut or burst mark(s) on the outer and the inner sidewalls as well as across the tread of the 4 tyres that were fitted on the Tow-Truck.

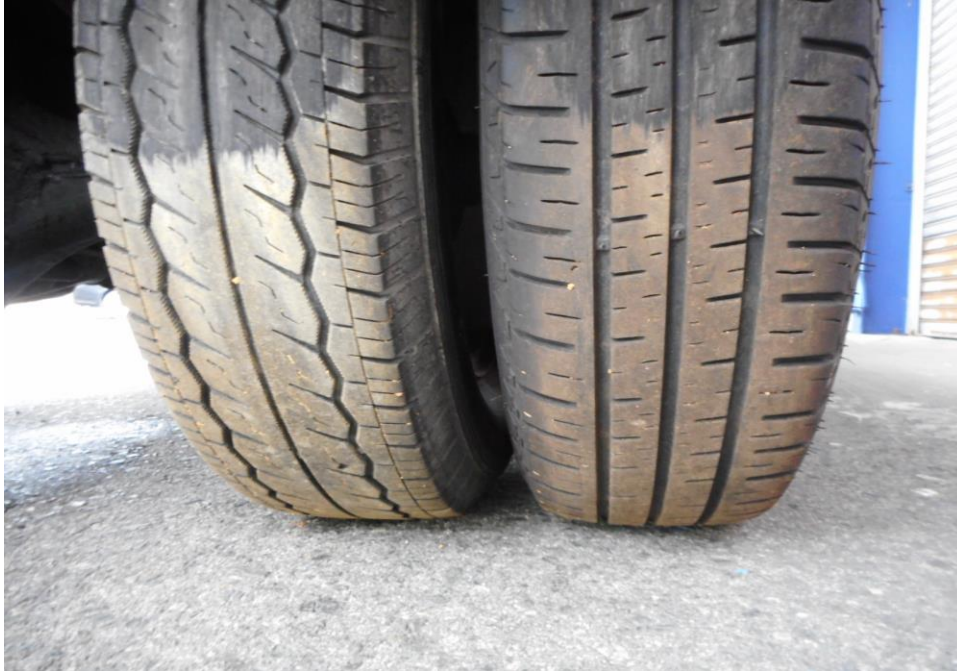
Photo 8 shows the condition of the rear right tyre of the Tow-Truck, which was observed to be in serviceable condition with remaining tread depth of approximately 4.5mm. The tyre, which was wrapped around standard steel wheel rim, it was observed to be sufficiently inflated for vehicular operation.

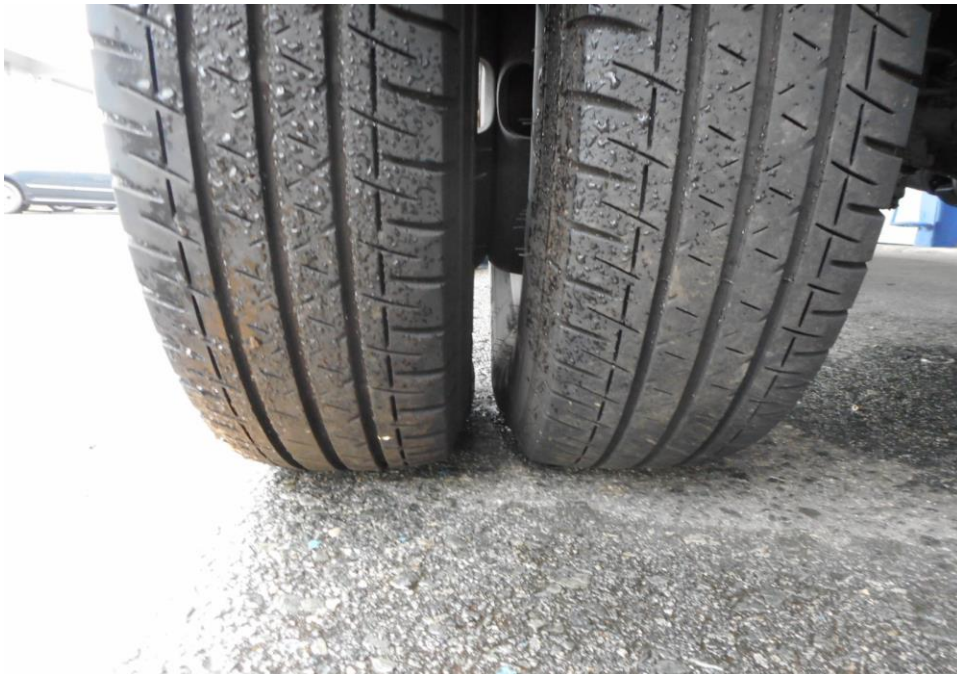
Photo 9 shows the condition of the rear left tyres of the Tow-Truck, which was observed to be in serviceable condition with remaining tread depth of approximately 5.5mm. The tyres, which were wrapped around standard steel wheel rim, were also observed to be sufficiently inflated for vehicular operation. There was also no damage found on all 4 steel wheel rims of the Tow-Truck.

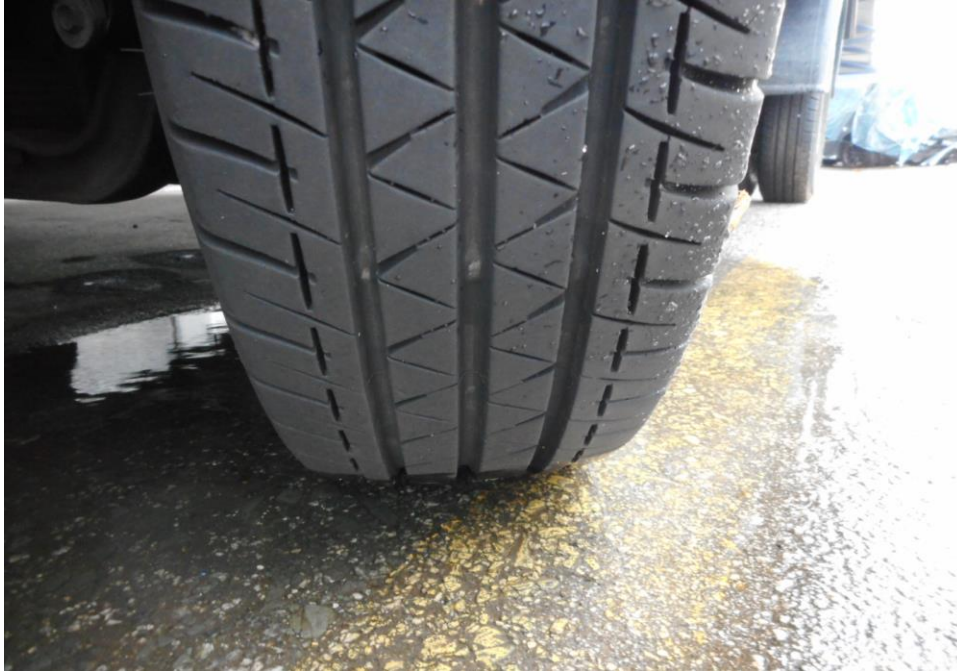
Photo 10 shows the condition of the rear right tyres of the Tow-Truck, which were observed to be in serviceable condition with remaining, tread depth of approximately 7.7mm. There was also no tear, cut or burst mark(s) on the outer and the inner sidewalls as well as across the tread of the 4 tyres that were fitted on the Tow-Truck.

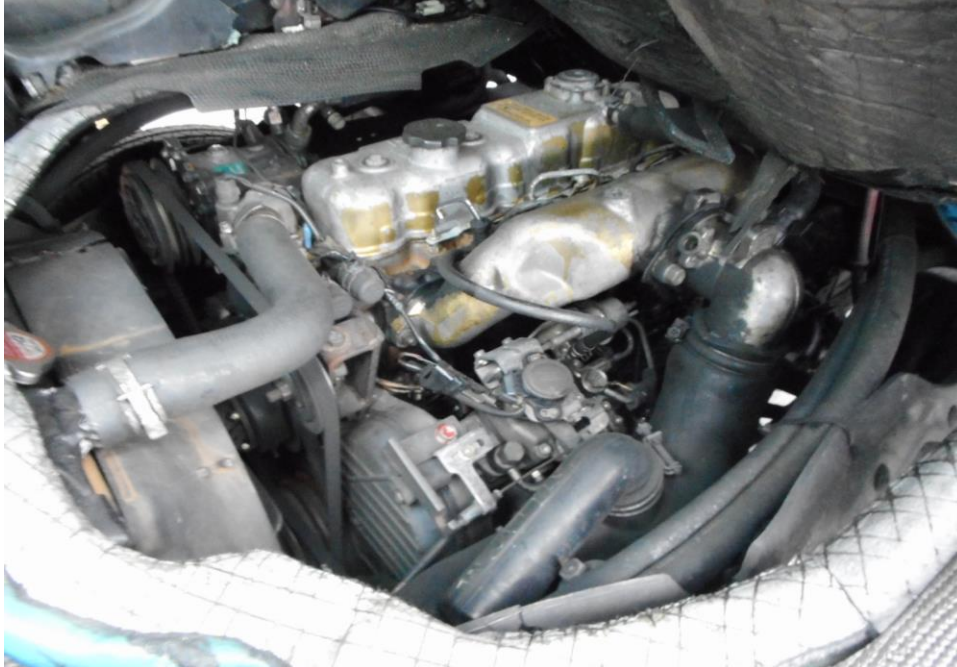
Photo 11 shows a general view of the Tow-Truck's engine compartment, which was accessed by lifting the front cabin of the Tow-Truck. The various parts and components inside the engine compartment were unaffected by the accident. There was also no sign(s) or indication(s) of fresh fluid leakage and/or fluid stain within the engine compartment

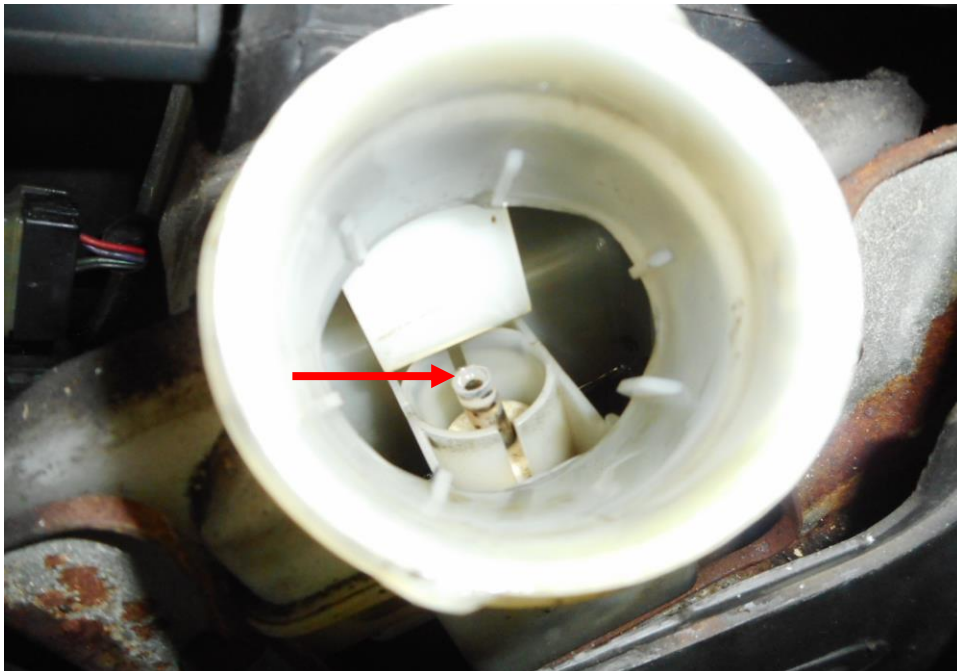
Photo 12 shows the brake fluid reservoir of the Tow-Truck at the time of my inspection. The brake fluid was observed to be of insufficient level (arrowed).

11. Static brake tests conducted on the Tow-Truck revealed abnormality. The brake booster had not responded well to the various tests conducted. There was abnormal movement of the brake pedal when it was depressed. This was due to the insufficient level of brake fluid, which had caused air to leak into the braking system and caused the abnormal and decreased braking efficiency to the Tow-Truck's braking system. However, there was no fluid leakage observed around the braking components at the time of inspection. Refer to photo12 above.

14. A short operational test of the Tow-Truck conducted by driving the Tow-Truck was not conducted as it was unsafe to be operated as the braking system of was not working due to the insufficient braking fluid in the system.

15. From my physical inspection of the Tow-Truck, it appears that its engine system, steering system and transmission system were all in serviceable condition. However, I found evidence(s) to suggest that there was possible mechanical failure to the braking system as there was insufficient braking fluid in the system of the Tow-Truck and that may have caused and/or contributed to the accident. As the braking efficiency of the brakes has been reduced.
16. The 4 tyres fitted on the Tow-Truck were also found to be in serviceable condition. I did not find any tear, cut or burst mark(s) on the outer and the inner sidewalls as well as across the tread of the 4 tyres. The 4 tyres were also observed to be sufficiently inflated for vehicular operation with remaining tread depth of approximately 4.5mm – 7.7mm.

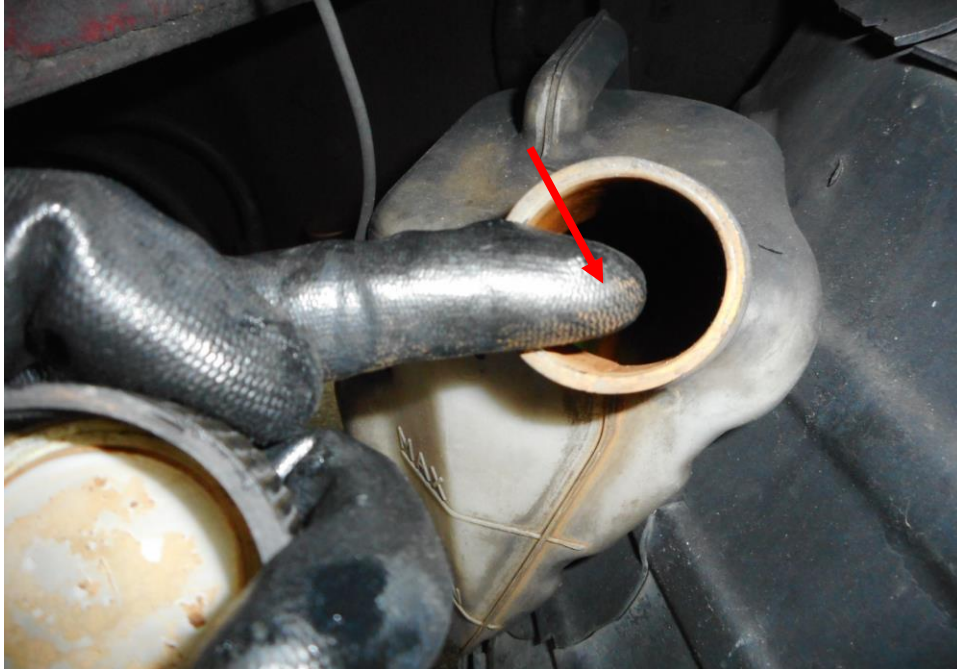
Photo 13 shows the engine coolant reservoir of the Tow-Truck at the time of my inspection. The engine coolant was observed to be of insufficient level (arrowed).

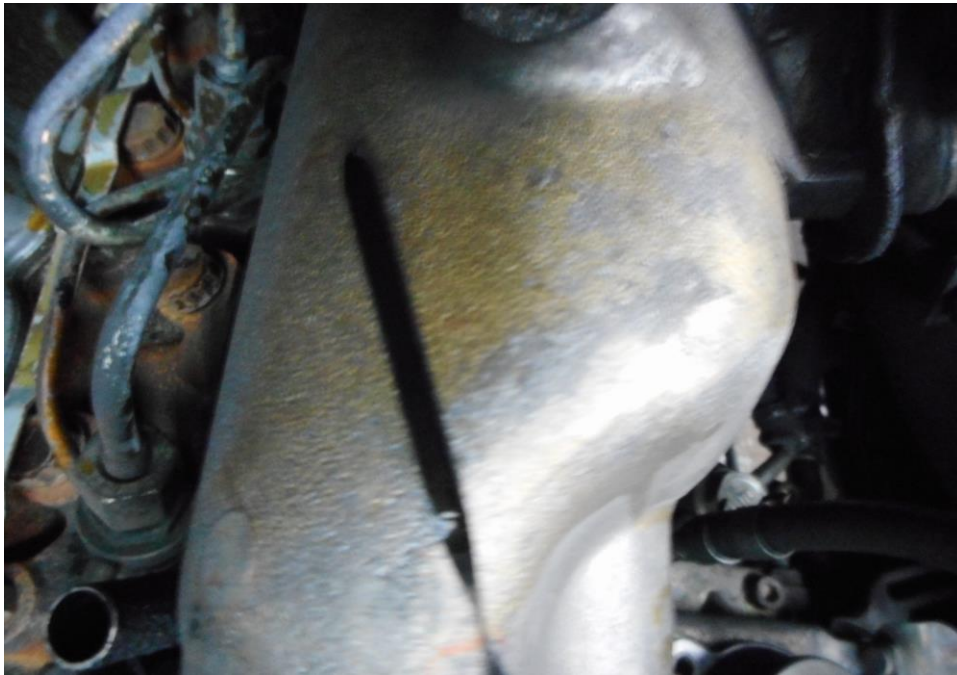
Photo 14 shows the engine oil dipstick of the Tow-Truck at the time of my inspection. The engine oil was observed to be of sufficient level and without any contamination.

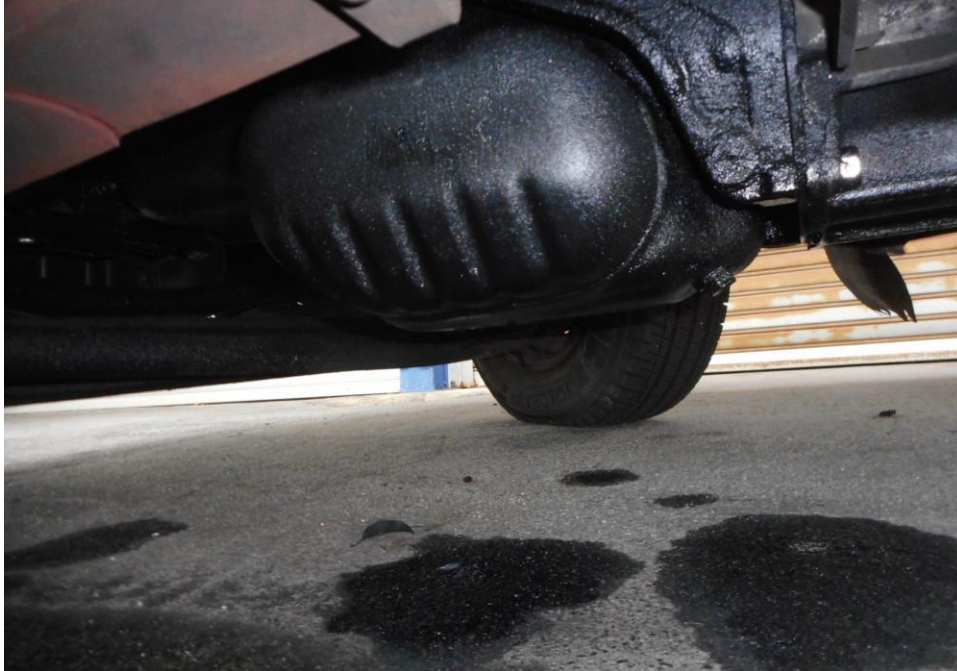
Photo 15 shows the undercarriage of the Tow-Truck, at the area where the engine housing and transmission housing are located. I observed sign(s) of fluid leakage on the ground and old fluid stain(s) on the underside of the Tow-Truck.

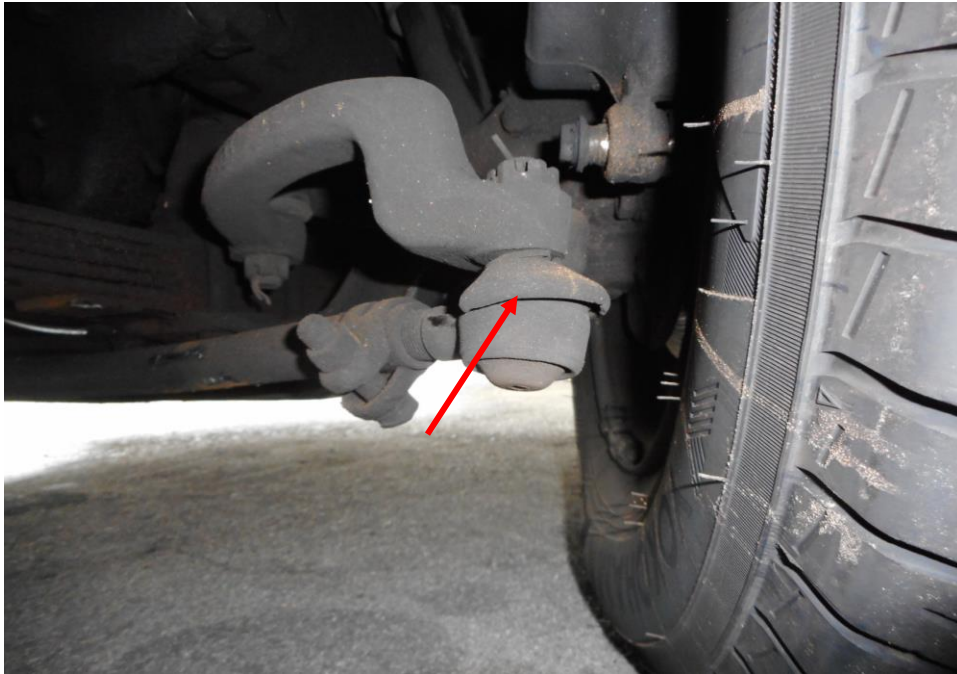
Photo 16 shows the various undercarriage components at the front right wheel of the Tow-Truck, in particular the steering tie rod end (arrowed). The various steering components were all found to be intact, suggesting that the steering system of the Tow-Truck was likely to be in serviceable condition at the material time of accident. There was also no sign of fluid stain(s) observed on the various undercarriage components.

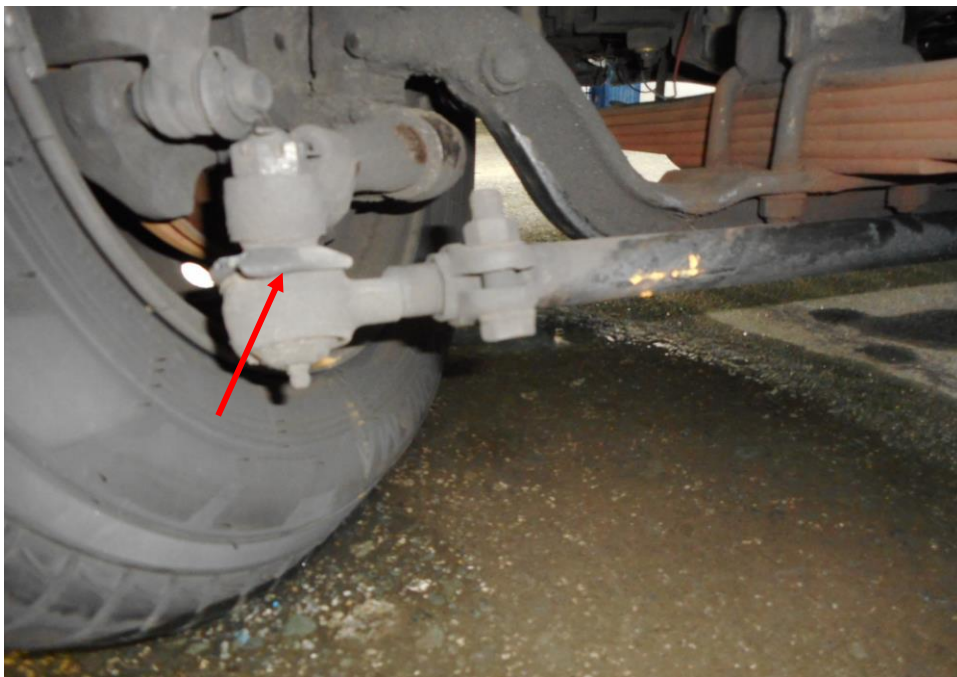
Photo 17 shows the various undercarriage components at the front left wheel of the Tow-Truck, in particular the steering tie rod end (arrowed). The various undercarriage components of the Tow-Truck were all found to be intact without any visible damage. There was also no sign of fluid stain(s) observed on the various undercarriage components.

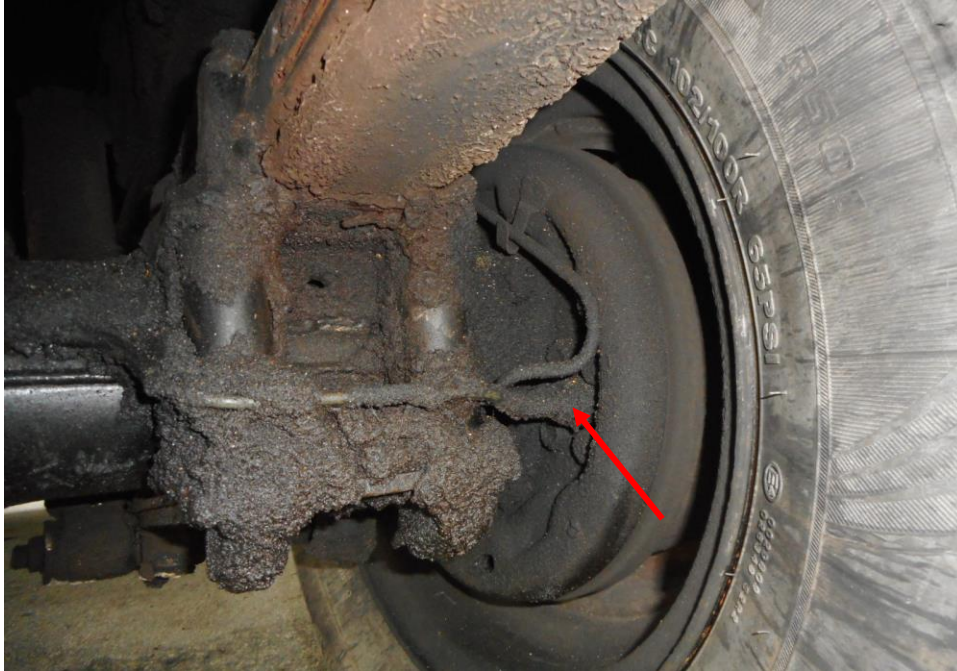
Photo 18 shows the brake pipe (arrowed) at the rear right wheel of the Tow-Truck. I did not observe any leakage of brake fluid at the time of my inspection of the Tow-Truck. However, we observed old fluid stain on the braking components.

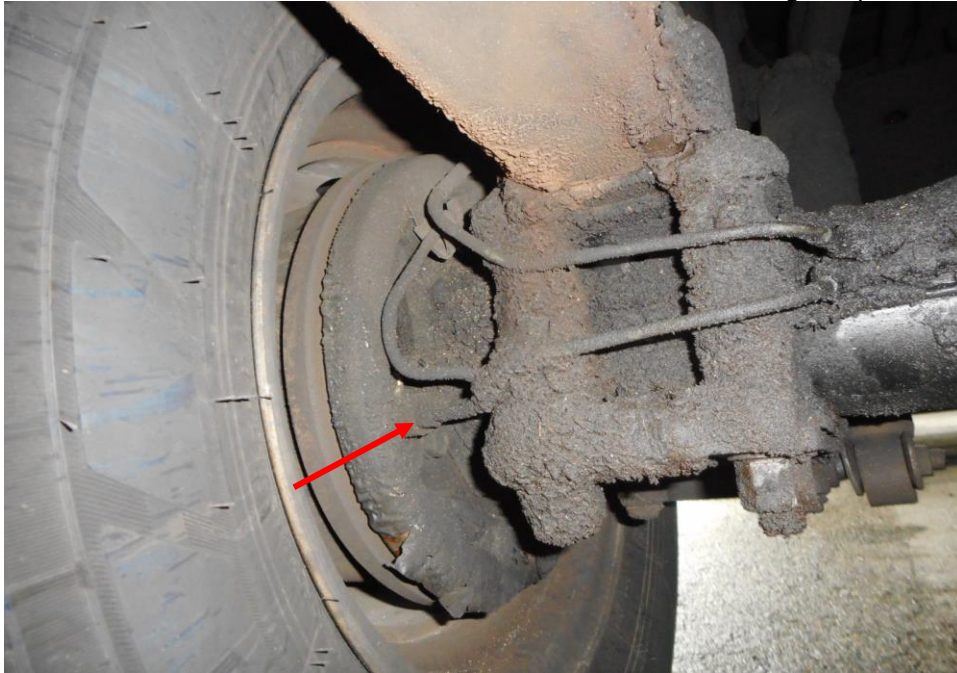
Photo 19 shows the brake pipe (arrowed) at the rear left wheel of the Tow-Truck. I did not observe any leakage of brake fluid at the time of my inspection of the Tow-Truck. However, we observed old fluid stain on the braking components.

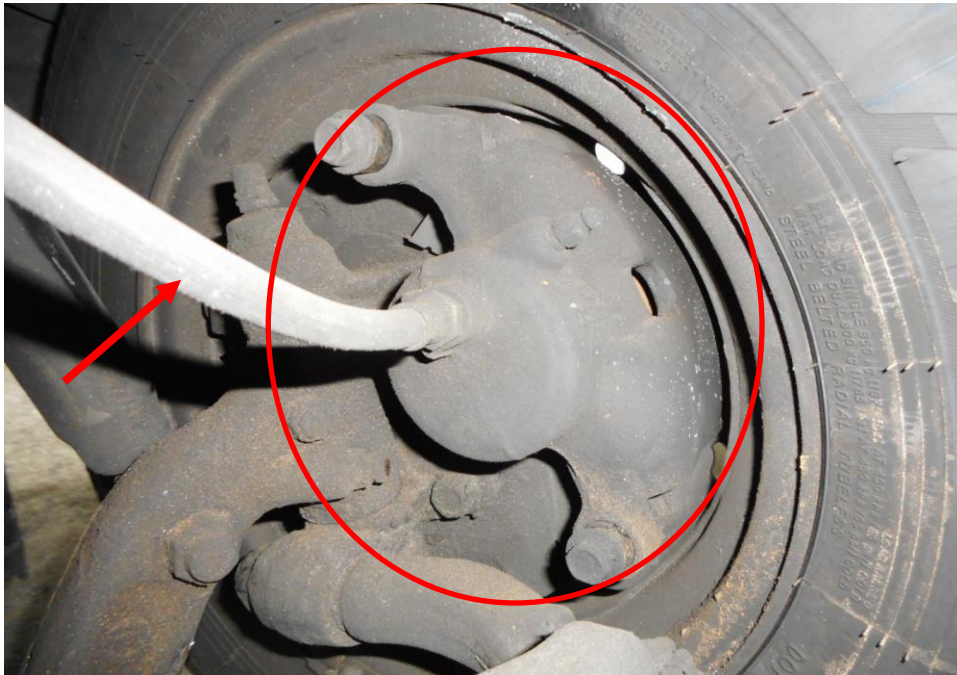
Photo 20 shows the brake hose/pipe (arrowed) at the front right wheel of the Tow-Truck. No leakage of brake fluid was observed. Visual examination of the various components of the braking system like the brake caliper (circled), brake booster, brake pedal etc had revealed all to be intact and without visible damage at the time of accident. There was also no sign of fluid stain(s) observed on the various undercarriage components.

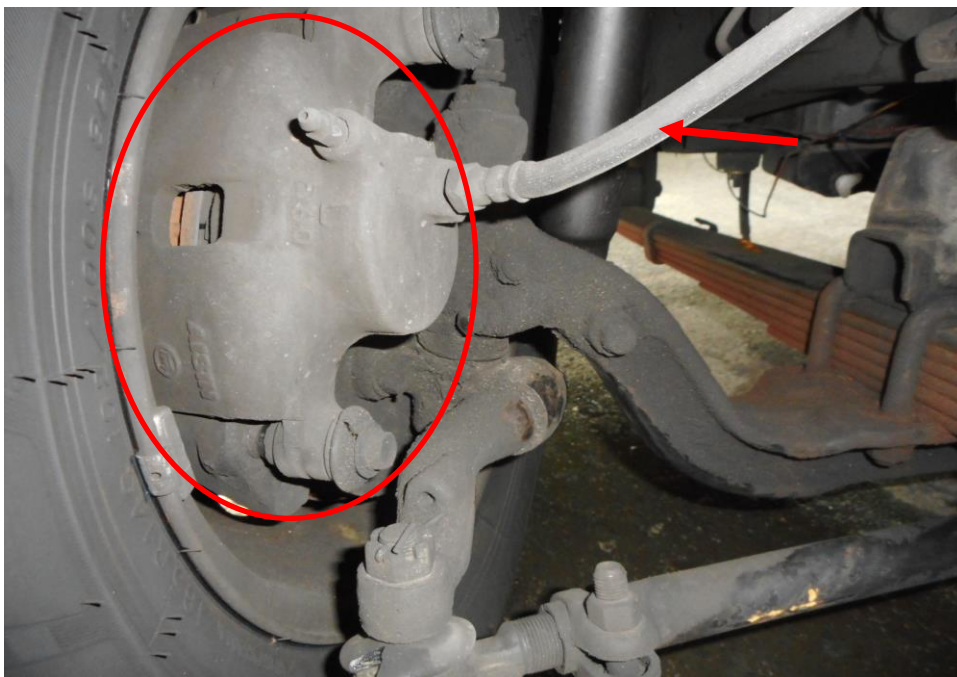
Photo 21 shows the brake hose/pipe (arrowed) at the front left wheel of the Tow-Truck. No leakage of brake fluid was observed. Visual examination of the various components of the braking system like the brake caliper (circled), brake booster, brake pedal etc had revealed all to be intact and without visible damage at the time of accident. There was also no sign of fluid stain(s) observed on the various undercarriage components.

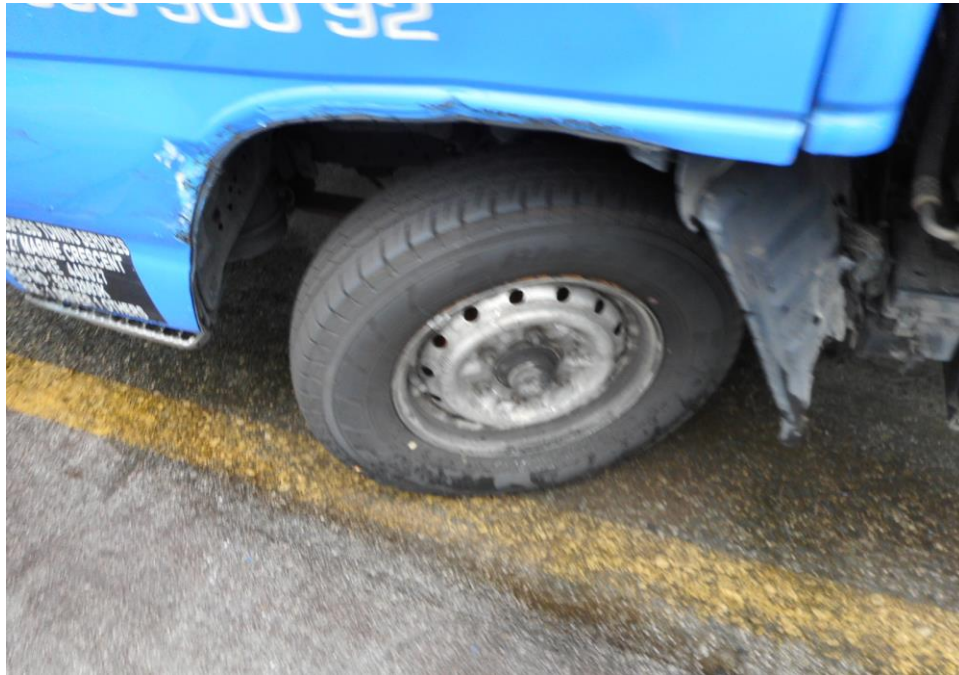
12. Static test on the steering system of the Tow-Truck also revealed no abnormality to the steering system. I did not experience any abnormal free play and/or other resistance when turning the steering wheel left and right to full lock positions. My visual examination of the various steering components which had included the rack and pinion, tie rods, tie rod ends and ball joints had revealed that these components were all generally in good condition. See photo 16 - 22 below.

Photo 22 shows the front left wheel of the Tow-Truck turned to its right. During my steering system test, I did not experience any abnormal free play and/or resistance when I had turned the steering wheel towards full left and full right. This would suggest that the steering system of the Tow-Truck was likely to be in serviceable condition at the material time of accident.
