Your Ref: Mercedes Benz C63s  
(chassis number WDD2050872F827881)  
Our Ref : CI/TP21005777/D

**INSPECTION REPORT OF AN UNREGISTERD MERCEDES BENZ C63s  
MOTOR CAR WITH CHASSIS NUMBER WDD2050872F827881**

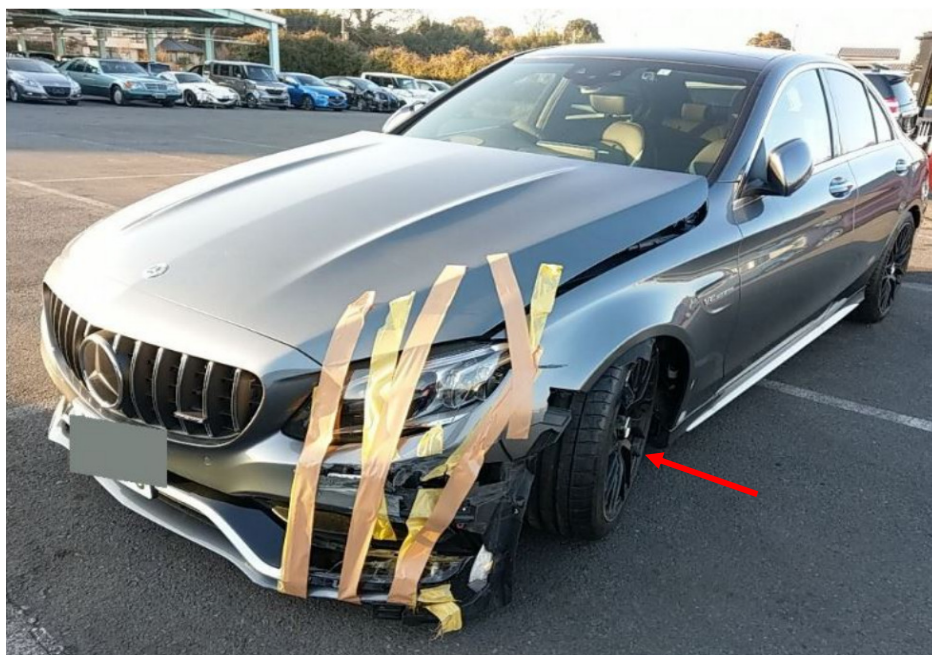
**Photo 1** shows the front left body of the Motor Car (photograph provided to me). The Motor Car was observed to have sustained damage at its front left portion. The front bumper, front left headlamp and front bonnet were amongst the parts that were observed to have been damaged. The orientation of the front right wheel (refer to photograph 3 below) and front left wheel (arrowed) indicates to me that there was damage to the front left undercarriage parts of the Motor Car.

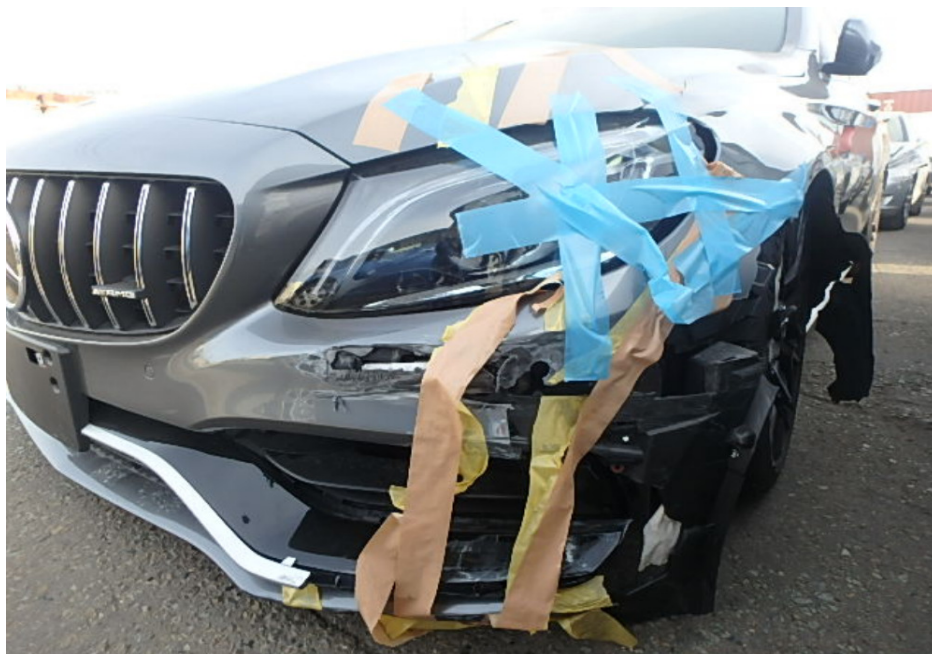
**Photo 2** shows a closer view of the damage at the front left portion of the Motor Car (photograph provided to me). The front bumper, front bumper left lower grille, front bumper left lower grille garnish, front bumper lower lip, front left headlamp, front left fender and front left fender inner shield were amongst the parts that were observed to have been damaged.

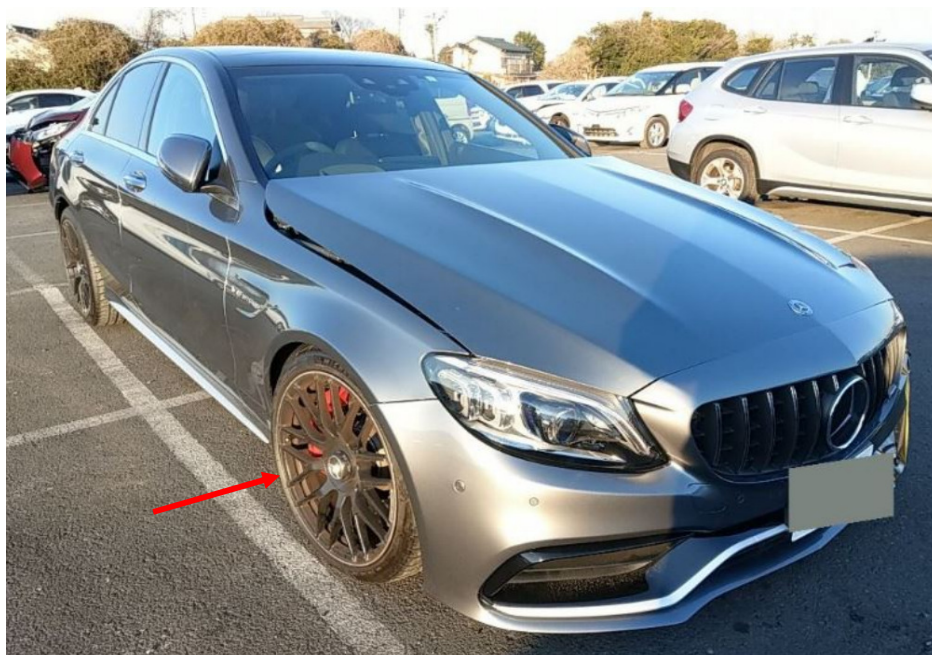
**Photo 3** shows the front right body of the Motor Car (photograph provided to me). The orientation of the front right wheel (arrowed) and front left wheel (refer to photograph 1 above) indicates to me that there was damage to the front left undercarriage parts of the Motor Car. The airbags were not affected as seen from the photographs that were provided to me.

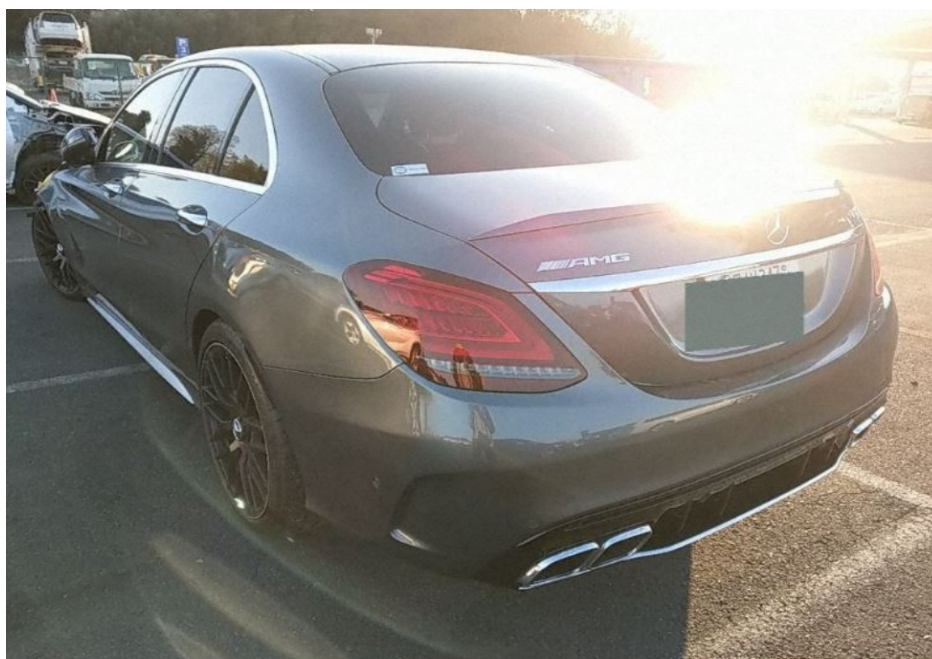
**Photo 4** shows the rear left body of the Motor Car (photograph provided to me). Apart for the front left portion, there was no physical damage seen to other areas of the Motor Car.

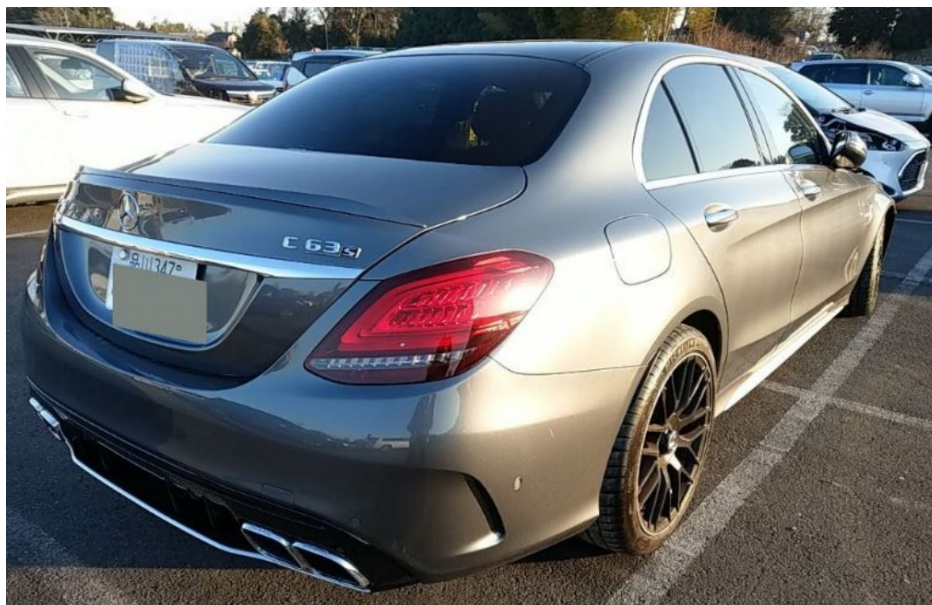
**Photo 5** shows the rear right body of the Motor Car (photograph provided to me). Apart for the front left portion, there was no physical damage seen to other areas of the Motor Car.

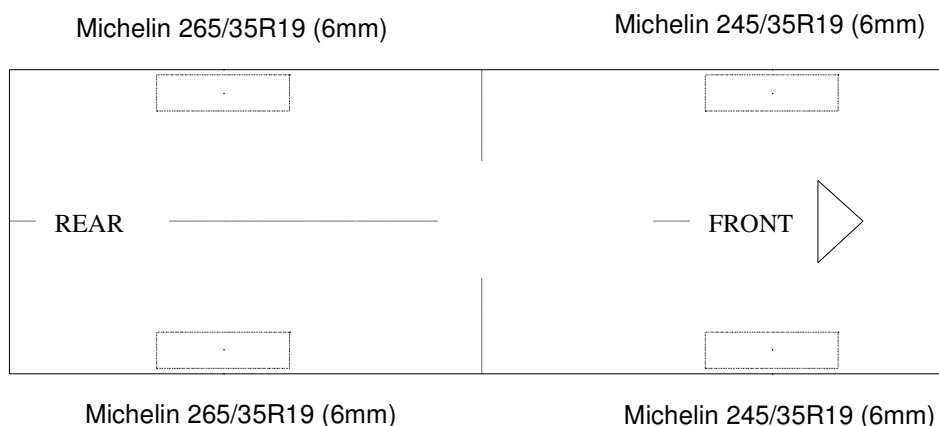
9. It was fitted with 19inch sport wheel rims that were wrapped with tyres that were observed to be of serviceable condition. The tyres were also sufficiently inflated for vehicular operation. The tyre brand, tyre size and approximate remaining tread depth of the 4 tyres of the Motor Car were recorded as follows: -

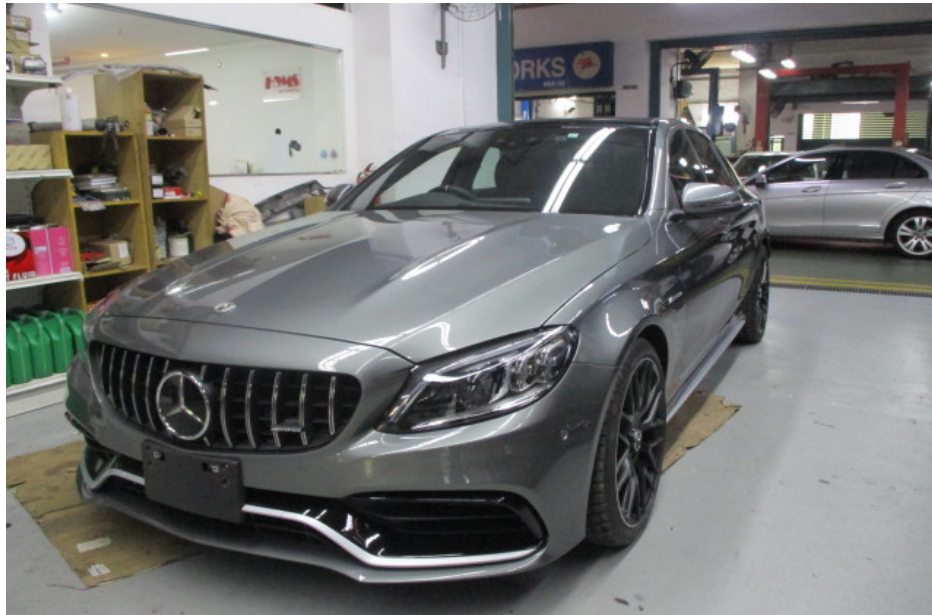
**Photo 6** shows a general view of the front left body of the Motor Car at the time of my inspection. The Motor Car was observed to be in a relatively good general condition with no loose exterior fittings observed. The body parts at the front left portion of the Motor Car were visually examined and it was observed that the repair/restoration works carried out to the damaged area of the Motor Car (refer to photograph 1 & 2 above) were reasonably adequate and in order.

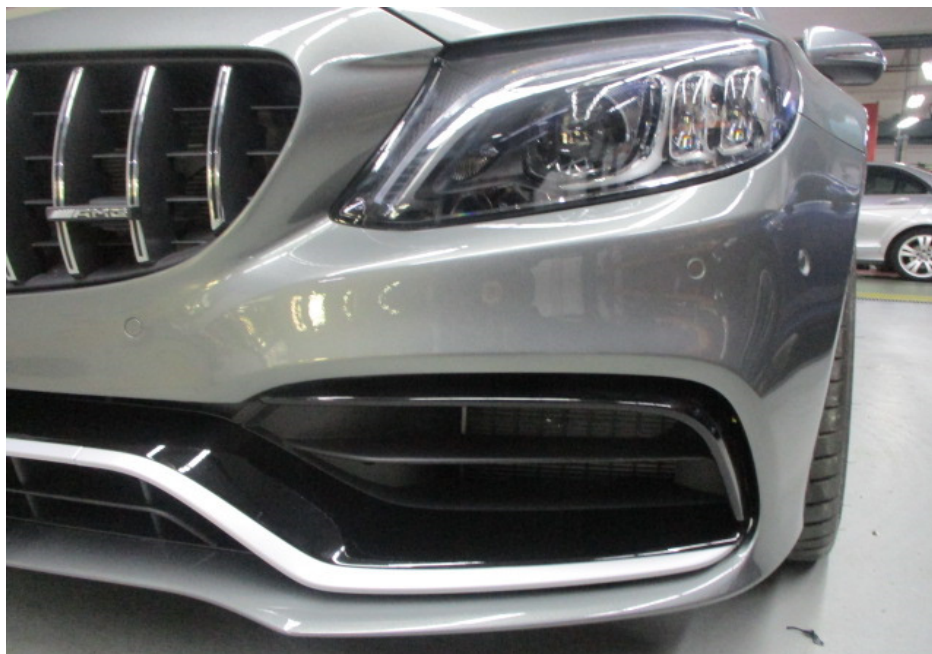
**Photo 7** shows a closer view of the front bumper, front bumper left lower grille, front bumper left lower grille garnish, front bumper lower lip and front left headlamp of the Motor Car at the time of my inspection. The body parts at the front left portion of the Motor Car were visually examined and it was observed that the repair/restoration works carried out to the damaged area of the Motor Car (refer to photograph 1 & 2 above) were reasonably adequate and in order.

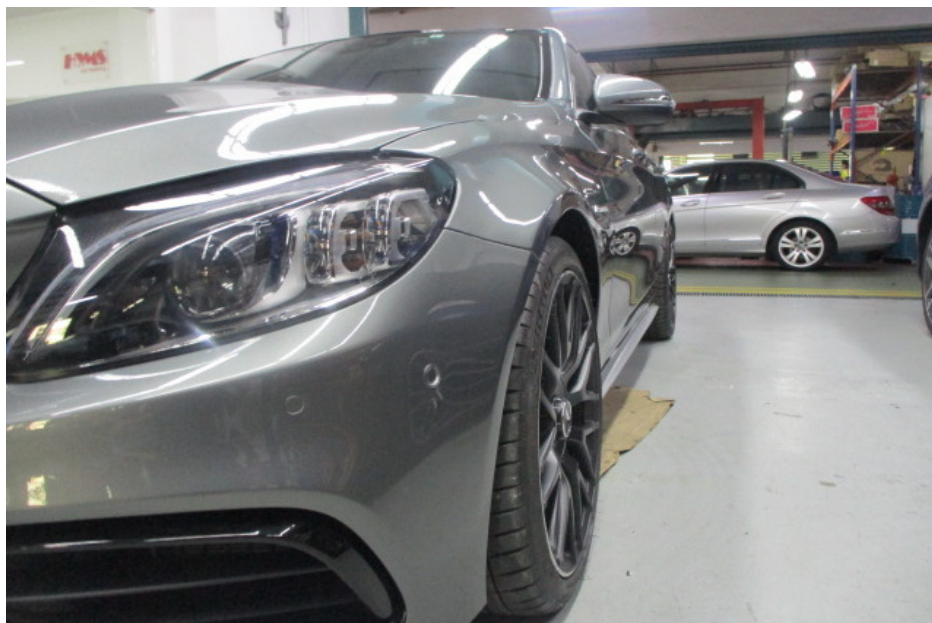
**Photo 8** shows a closer view of the front bumper, front bonnet, front left headlamp and front left fender of the Motor Car at the time of my inspection. The body parts at the front left portion of the Motor Car were visually examined and it was observed that the repair/restoration works carried out to the damaged area of the Motor Car (refer to photograph 1 & 2 above) were reasonably adequate and in order.

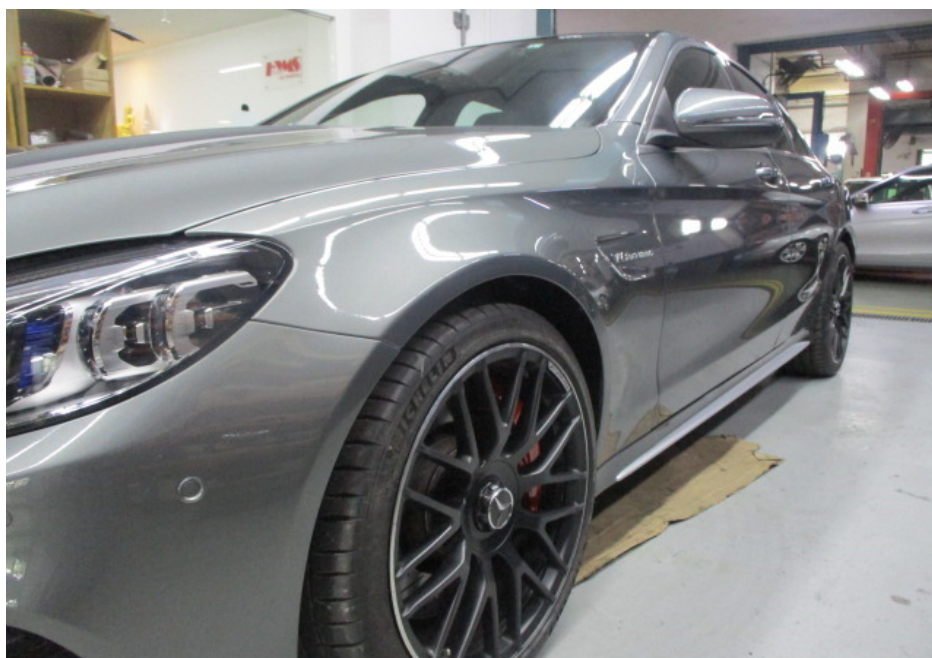
**Photo 9** shows a closer view of the front bumper, front bonnet, front left fender and front left wheel rim of the Motor Car at the time of my inspection. The body parts at the front left portion of the Motor Car were visually examined and it was observed that the repair/restoration works carried out to the damaged area of the Motor Car (refer to photograph 1 & 2 above) were reasonably adequate and in order.

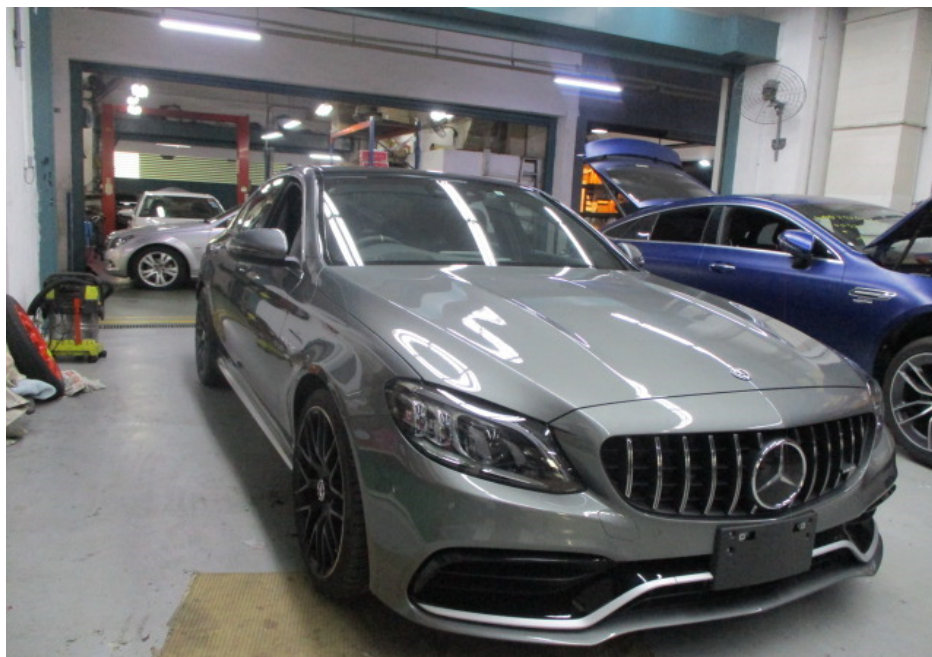
**Photo 10** shows a general view of the front right body of the Motor Car at the time of my inspection. The Motor Car was observed to be in a relatively good general condition with no loose exterior fittings observed. The body parts at the front left portion of the Motor Car were visually examined and it was observed that the repair/restoration works carried out to the damaged area of the Motor Car (refer to photograph 1 & 2 above) were reasonably adequate and in order.

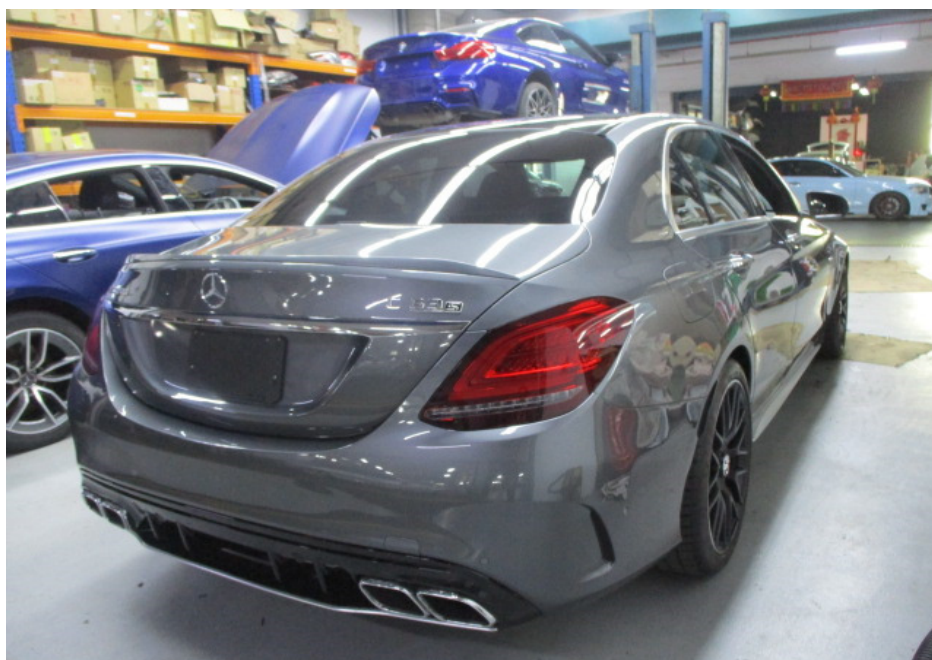
**Photo 11** shows a general view of the rear right body of the Motor Car at the time of my inspection. The Motor Car was observed to be in a relatively good general condition with no loose exterior fittings observed. The mileage of the Motor Car recorded at the time of my inspection was 3,072km.

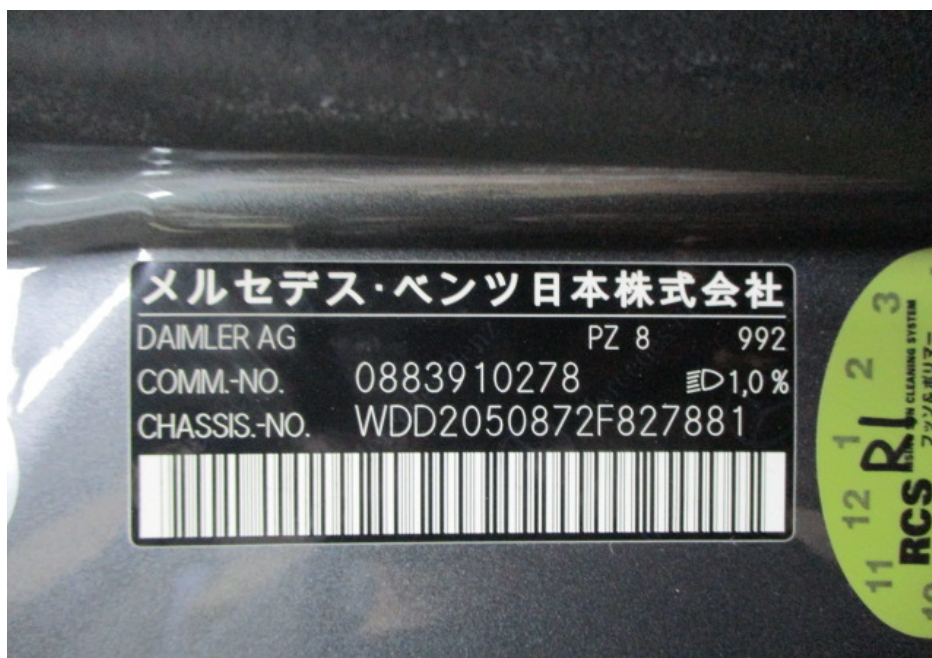
**Photo 12** shows the chassis number of the Motor Car. The chassis number recorded was WDD2050872F827881.

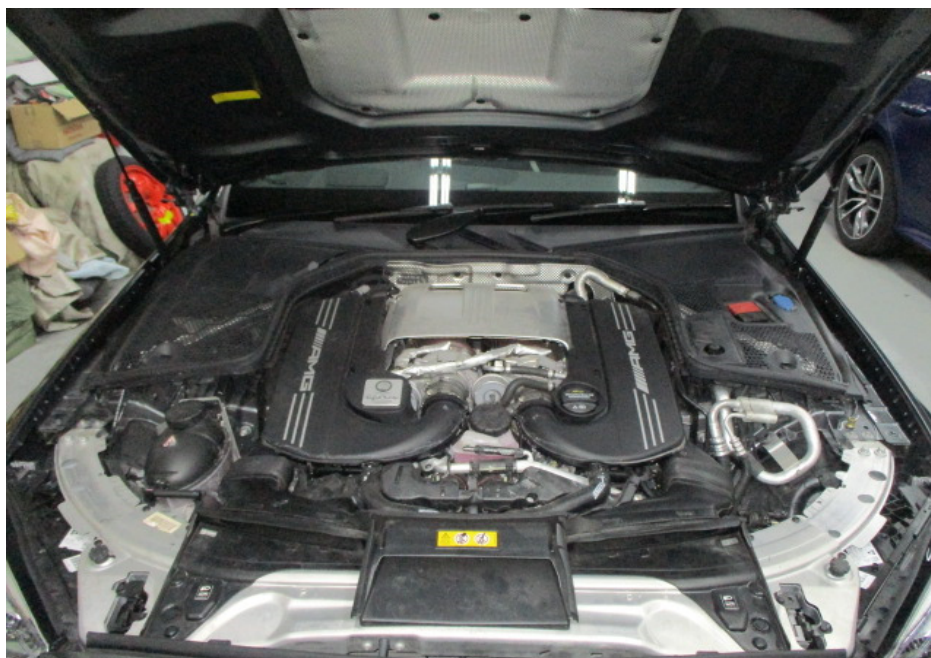
**Photo 13** shows a general view of the engine compartment of the Motor Car at the time of my inspection. The various parts and components inside the engine compartment were all observed to be intact and properly fitted. There was also no sign(s) or indication(s) of fluid leak and/or fluid stain found inside the engine compartment.

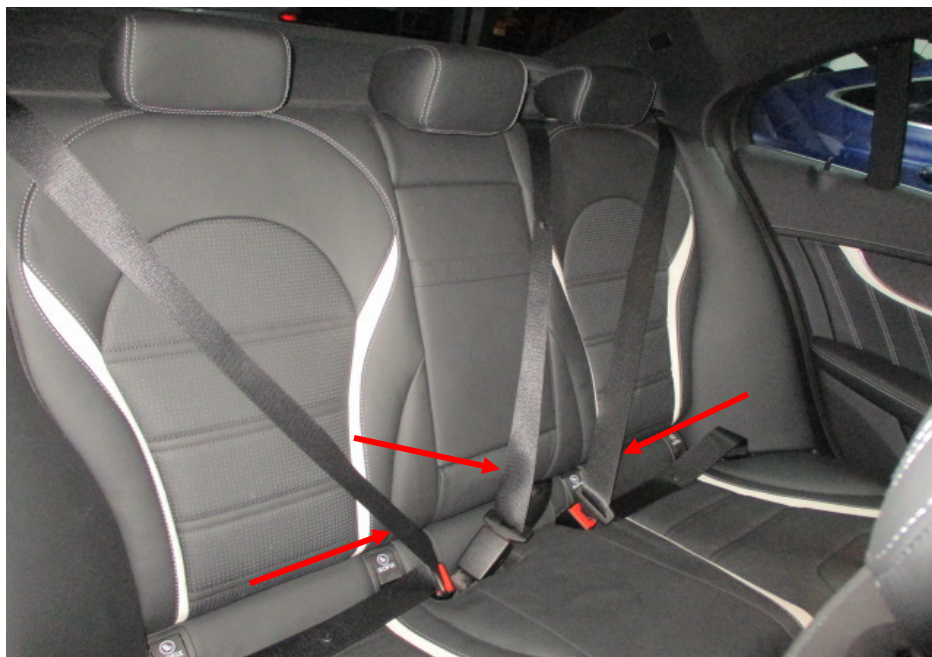
**Photo 14** shows the rear seats of the Motor Car. All the seats of the Motor Car were secured via seat rails to the floorboard. They were also fitted with a retractable seat belt reel and a pre-tensioner. The seat belts (arrowed) were tested and were able to be fastened into the respective pre-tensions that were fitted on the side of each individual seat.

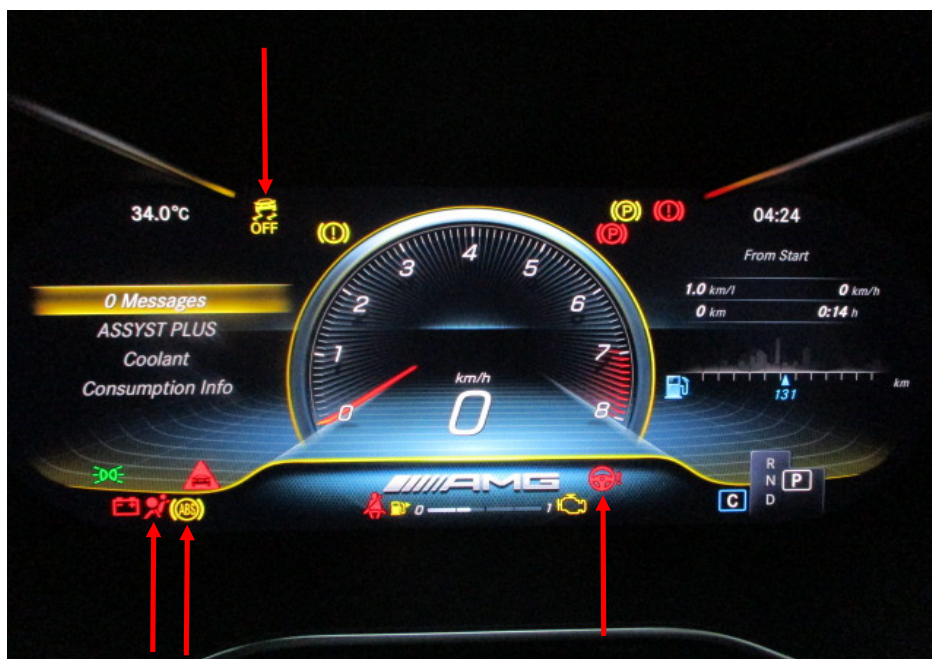
**Photo 15** shows the warning lights for the various electronic safety features appearing on the instrument panel of the Motor Car during its self-test when the engine is cranked, in particular the ABS, SRS, EPS and TCS lights (arrowed).

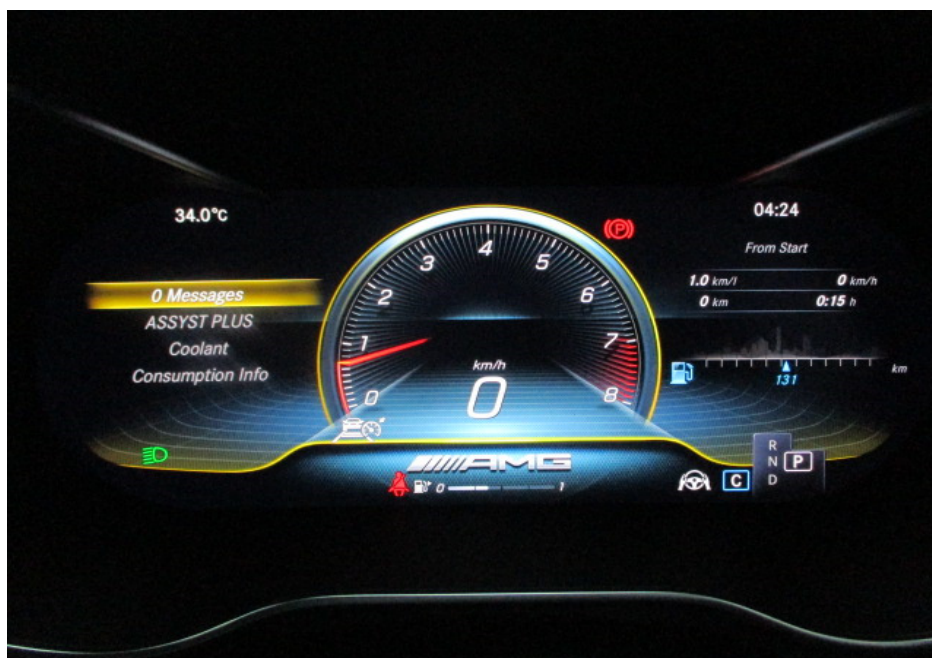
**Photo 16** shows the respective warning lights no longer illuminated, indicating that there is no fault detected to the ABS, SRS, EPS and TCS systems of the Motor Car during the self-test. These electronic systems were hence in working condition at the time of my inspection.

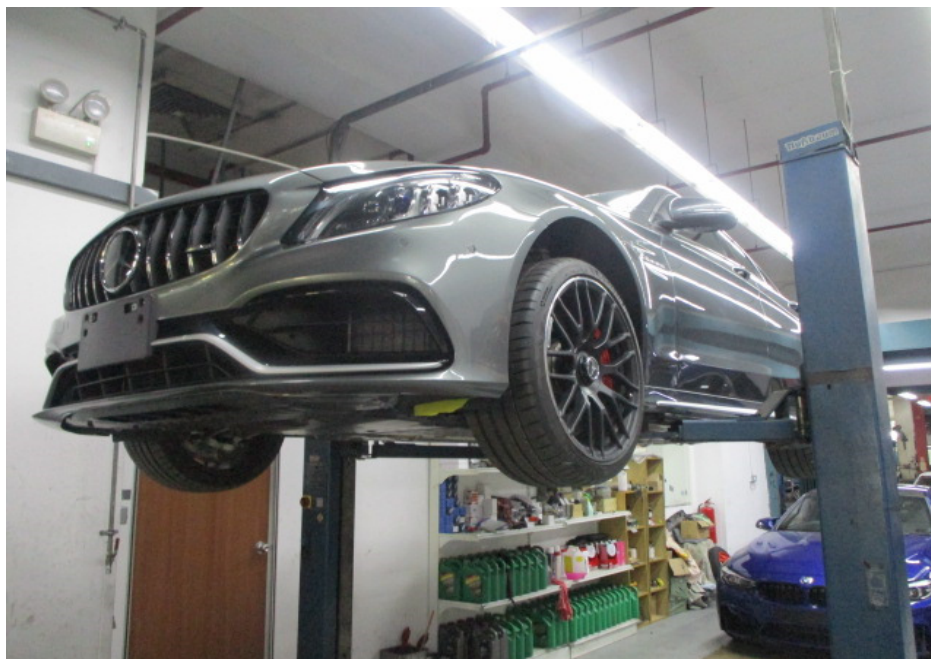
**Photo 17** shows the Motor Car hoisted up for checks on its undercarriage. There was no sign(s) or indication(s) of fluid leakage and/or fluid stain(s) on the underside of the Motor Car. The undercarriage components of the Motor Car were also all observed to be intact and secured in an appropriate manner.

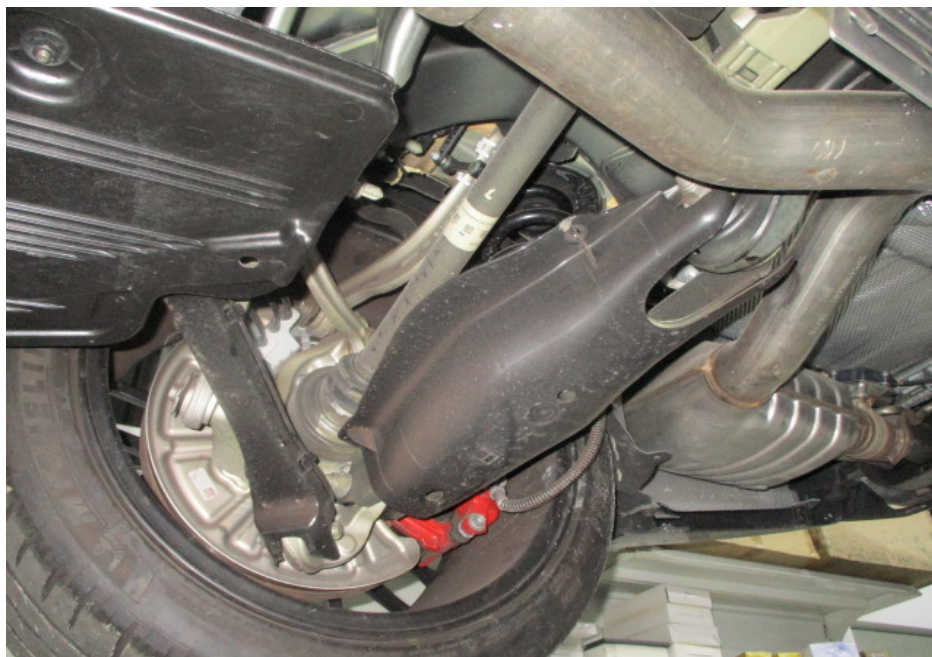
**Photo 18** shows a general view of the control arms and linkages at the rear right wheel of the Motor Car. I did not observe any fluid leak and/or fluid stain on the underside of the Motor Car. All of the Motor Car's undercarriage components were observed to be intact and secured in an appropriate manner.

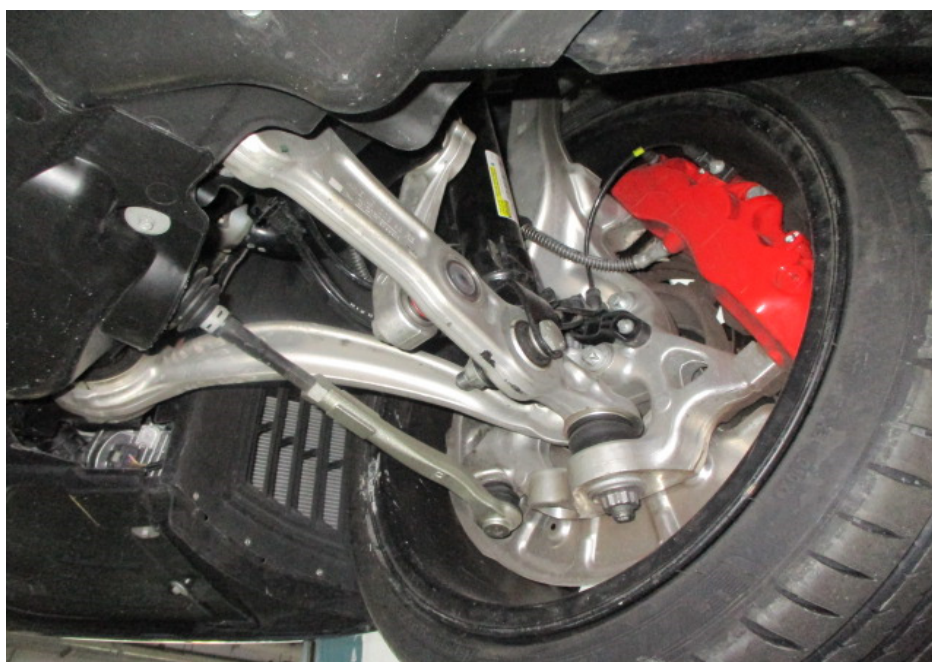
**Photo 19** shows the various undercarriage components at the front right wheel of the Motor Car. The mechanical components, control arms and linkages were all found to be intact and secured in an appropriate manner.

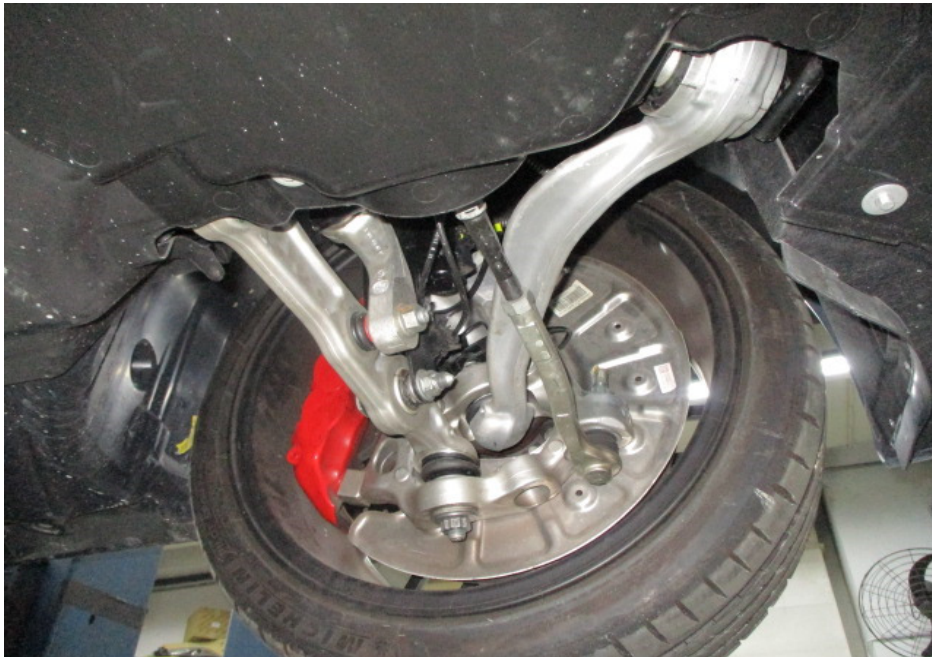
**Photo 20** shows the various undercarriage components at the front left wheel of the Motor Car. The mechanical components, control arms and linkages were all found to be intact and secured in an appropriate manner. I also did not observe any fluid leak and/or fluid stain on the underside of the Motor Car.

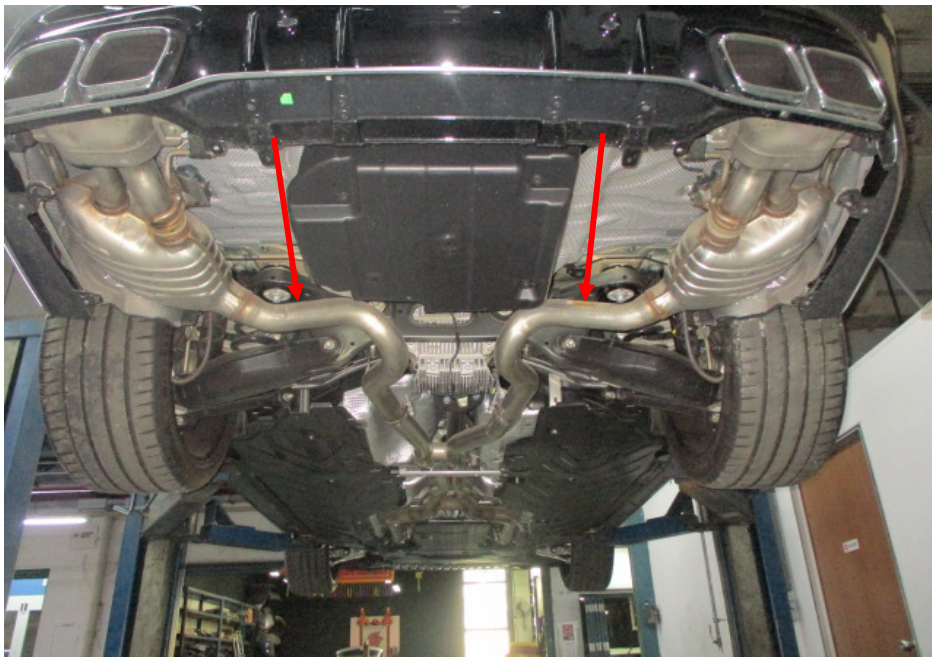
**Photo 21** shows the Motor Car's exhaust system. My examination of the Motor Car's exhaust system revealed no sign(s) or indication(s) of any cut or weld marks along its exhaust pipes (arrowed), rear mufflers and on its catalytic converters.

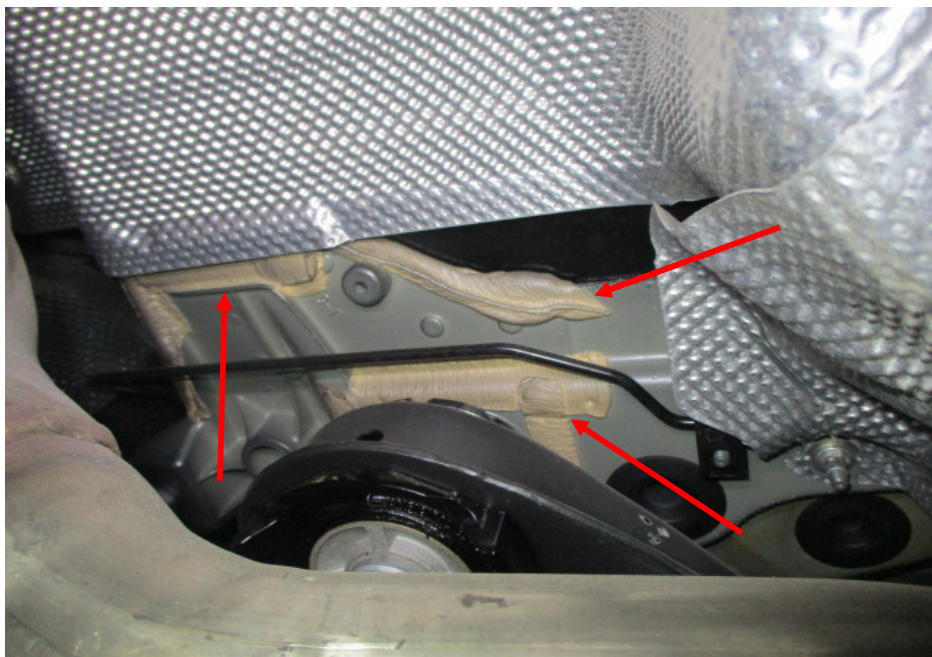
**Photo 22** shows the chassis/structural body at the underside rear left of the Motor Car. I did not find any weld marks other than original spot weld marks on the chassis/structural body of the Motor Car. The original factory sealant (arrowed) at the joints along the chassis/structural body was also untouched, indicating no work was done on the chassis/structural body of the Motor Car and that the chassis/structural body was originally fitted.

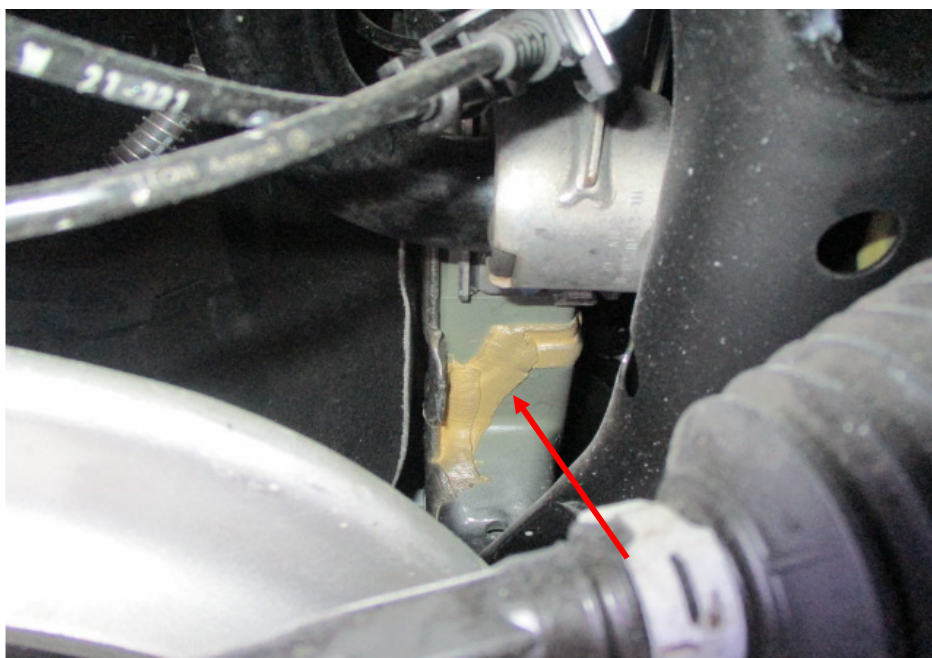
**Photo 23** shows the chassis/structural body at the underside front right of the Motor Car. The original factory sealant (arrowed) at the joints along the chassis/structural body was observed to be untouched. In general, I had found no work was carried out on the chassis/structural body of the Motor Car. The chassis/structural body of the Motor Ca was originally fitted.

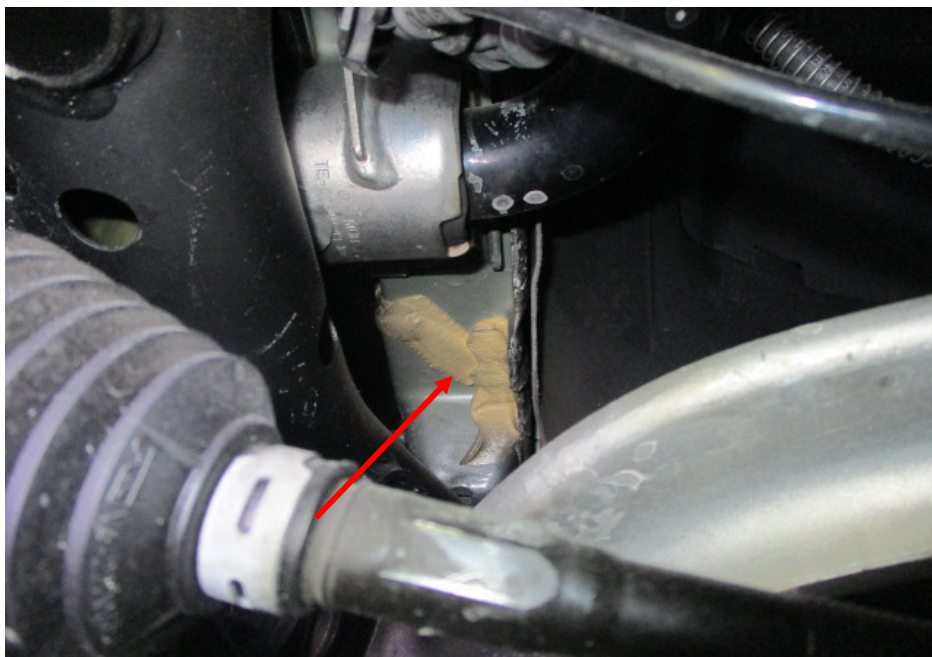
**Photo 24** shows the chassis/structural body at the underside front left of the Motor Car. The original factory sealant (arrowed) at the joints along the chassis/structural body was observed to be untouched. In general, I had found no work was carried out on the chassis/structural body of the Motor Car. The chassis/structural body of the Motor Ca was originally fitted.

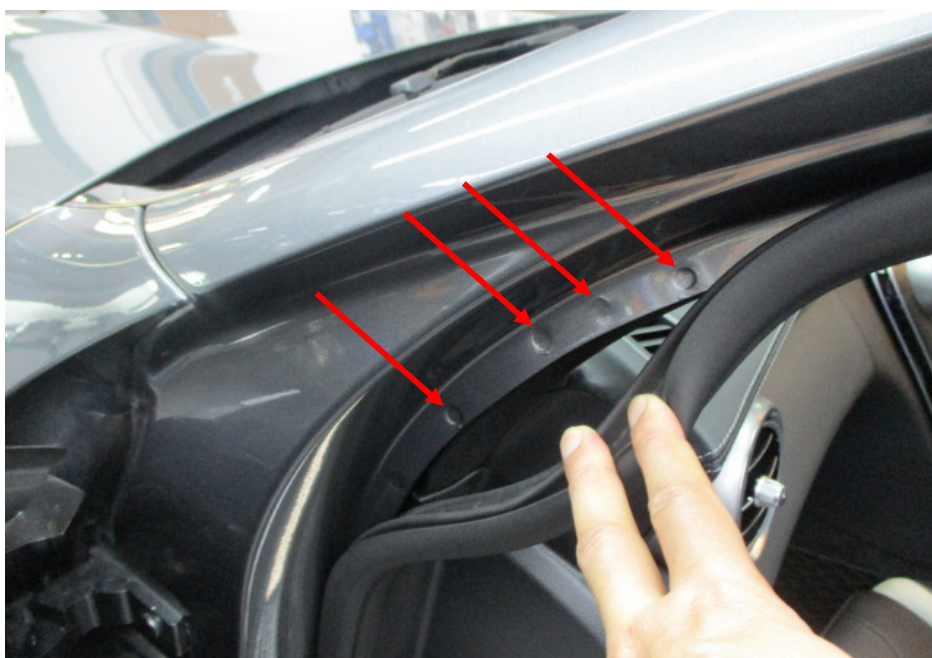
**Photo 25** shows the left side "A" pillar of the Motor Car. I did not find any weld marks other than original spot weld marks (arrowed) on the left side "A" pillar of the Motor Car which, indicates that there was no re-welding works carried out. In general, I had found all the non-detachable body panels of the Motor Car to be originally fitted at the time of my inspection.

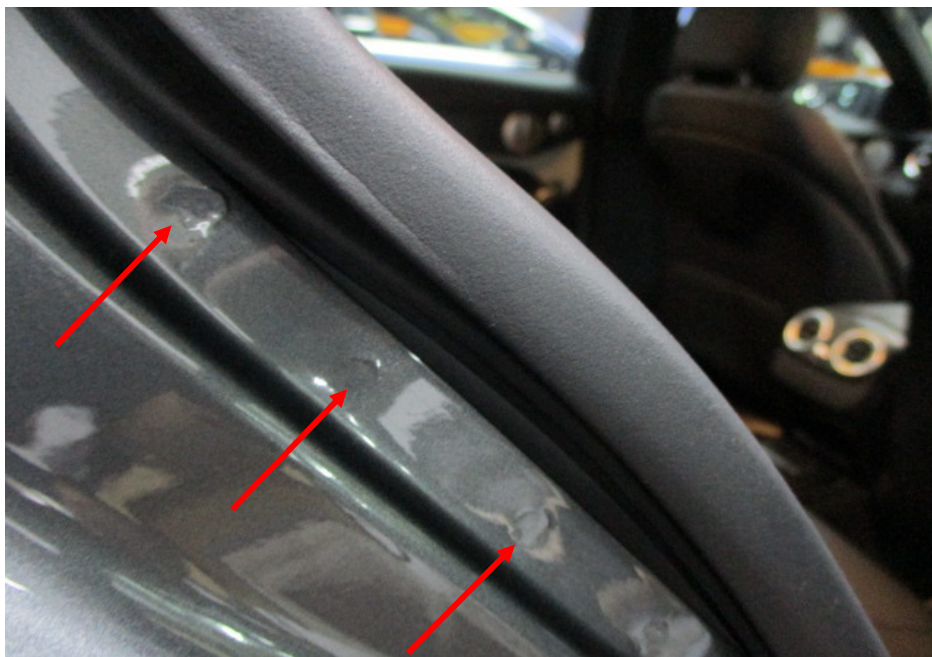
**Photo 26** shows the right side "C" pillar of the Motor Car. I did not find any weld marks other than original spot weld marks (arrowed) on the right side "C" pillar of the Motor Car which, indicates that there was no re-welding works carried out. In general, I had found all the non-detachable body panels of the Motor Car to be originally fitted at the time of my inspection.
