Your Ref: BMW M4 Coupe
(chassis number WBS4Y92080AG10908)
Our Ref : CI/TP21005778/D

INSPECTION REPORT OF AN UNREGISTERD BMW M4 COUPE MOTOR CAR WITH CHASSIS NUMBER WBS4Y92080AG10908

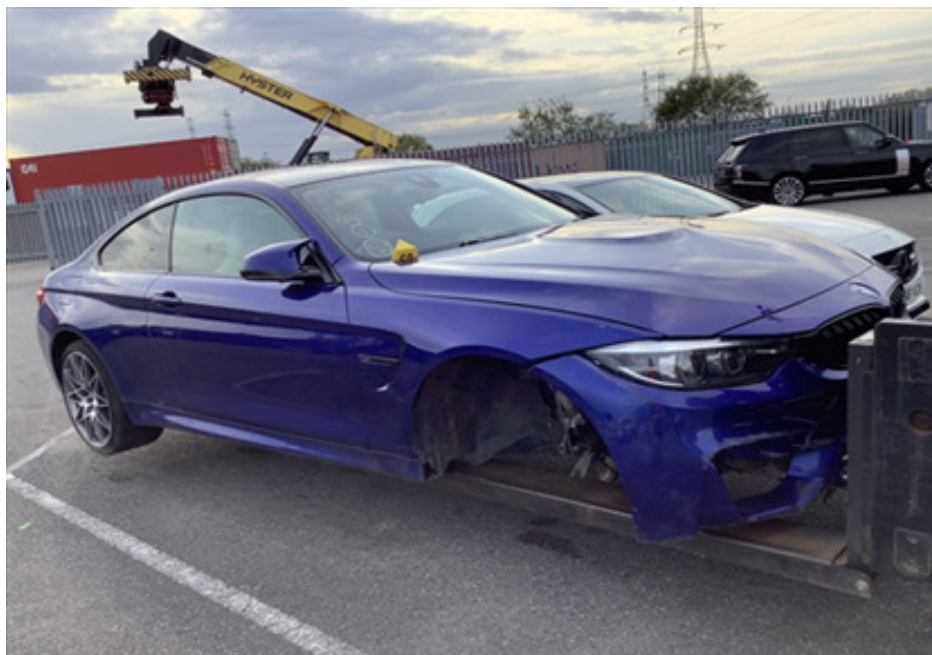
3. From the photographs provided to me, it was observed that the Motor Car had sustained damage at its front right portion. Body parts damaged include the front bumper and front bumper right lower grille. The front right wheel and front right tyre were observed to be detached/missing. Damage was also seen to the front right undercarriage parts of the Motor Car.
4. Apart for the front right portion, there was no physical damage observed to other areas of the Motor Car. The airbags were also not deployed, as seen from the photographs that were provided to me. See photo 1 – 3 below.

Photo 1 shows the front right body of the Motor Car (photograph provided to me). The Motor Car was observed to have sustained damages at its front right portion. Body parts damaged include the front bumper and front bumper right lower grille. The front right wheel and front right tyre were observed to be detached/missing. Damage was also seen to the front right undercarriage parts of the Motor Car.

22. The body parts and undercarriage parts at the front right portion of the Motor Car were visually examined and it was noted that the repair/restoration works carried out to the damaged area of the Motor Car (refer to photograph 1 above) were reasonably adequate and in order.

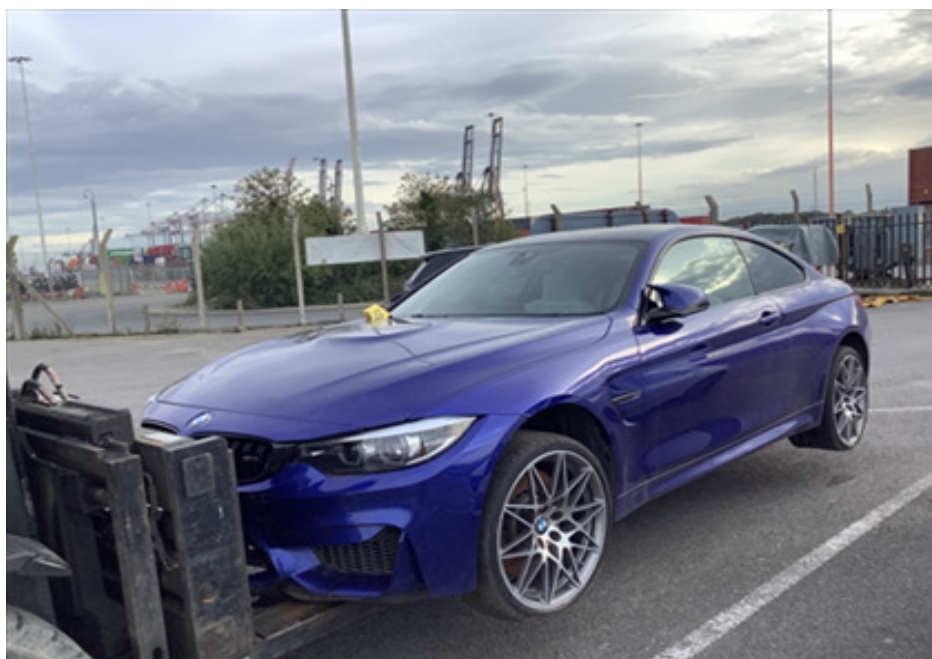
Photo 2 shows the front left body of the Motor Car (photograph provided to me). Apart for the front right portion, there was no physical damage observed to other areas of the Motor Car. The airbags were also not deployed, as seen from the photographs that were provided to me.

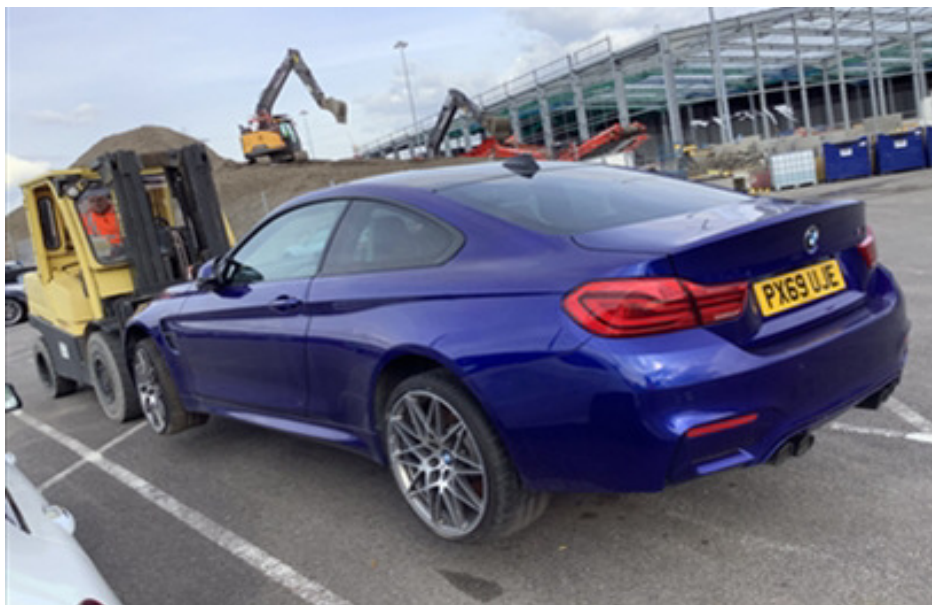
Photo 3 shows the rear left body of the Motor Car (photograph provided to me). Apart for the front right portion, there was no physical damage observed to other areas of the Motor Car.

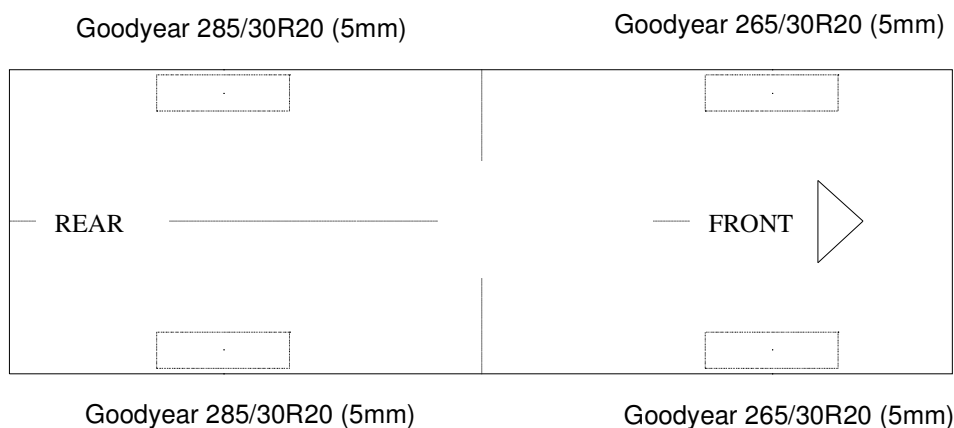
8. It was fitted with 20inch sport wheel rims that were wrapped with tyres that were observed to be of serviceable condition. The tyres were also sufficiently inflated for vehicular operation. The tyre brand, tyre size and approximate remaining tread depth of the 4 tyres of the Motor Car were recorded as follows: -

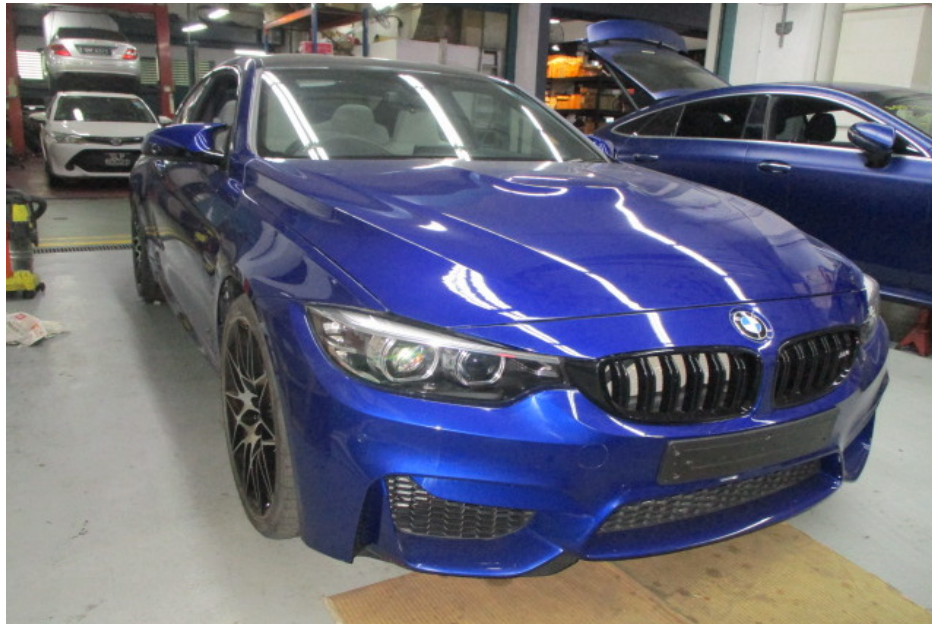
Photo 4 shows a general view of the front right body of the Motor Car at the time of my inspection. The Motor Car was observed to be in a relatively good general condition with no loose exterior fittings observed. The body parts and undercarriage parts (refer to photograph 15 below) at the front right portion of the Motor Car were visually examined and it was observed that the repair/restoration works carried out to the damaged area of the Motor Car (refer to photograph 1 above) were reasonably adequate and in order.

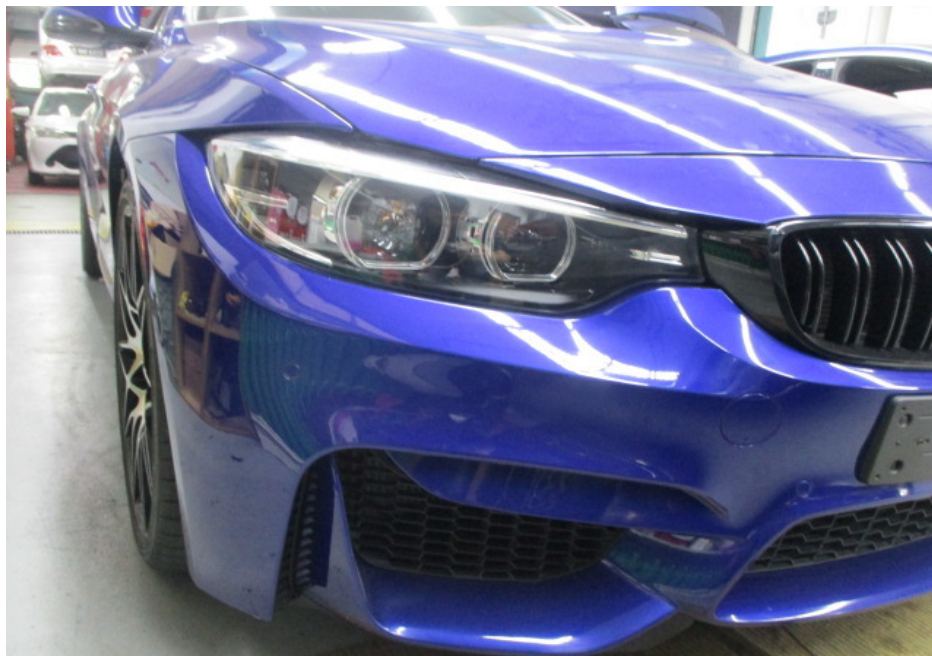
Photo 5 shows a closer view of the front bumper and front bumper right lower grille of the Motor Car. The body parts at the front right portion of the Motor Car were visually examined and it was observed that the repair/restoration works carried out to the damaged area of the Motor Car (refer to photograph 1) were reasonably adequate and in order.

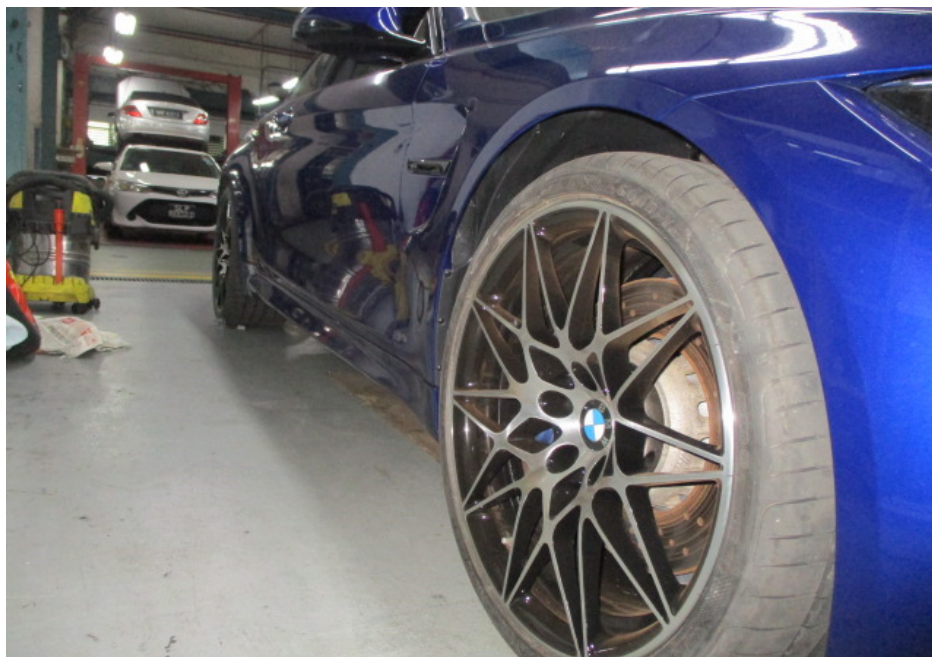
Photo 6 shows a closer view of the front right wheel rim and front right tyre of the Motor Car. The body parts and undercarriage parts (refer to photograph 15 below) at the front right portion of the Motor Car were visually examined and it was observed that the repair/restoration works carried out to the damaged area of the Motor Car (refer to photograph 1 above) were reasonably adequate and in order.

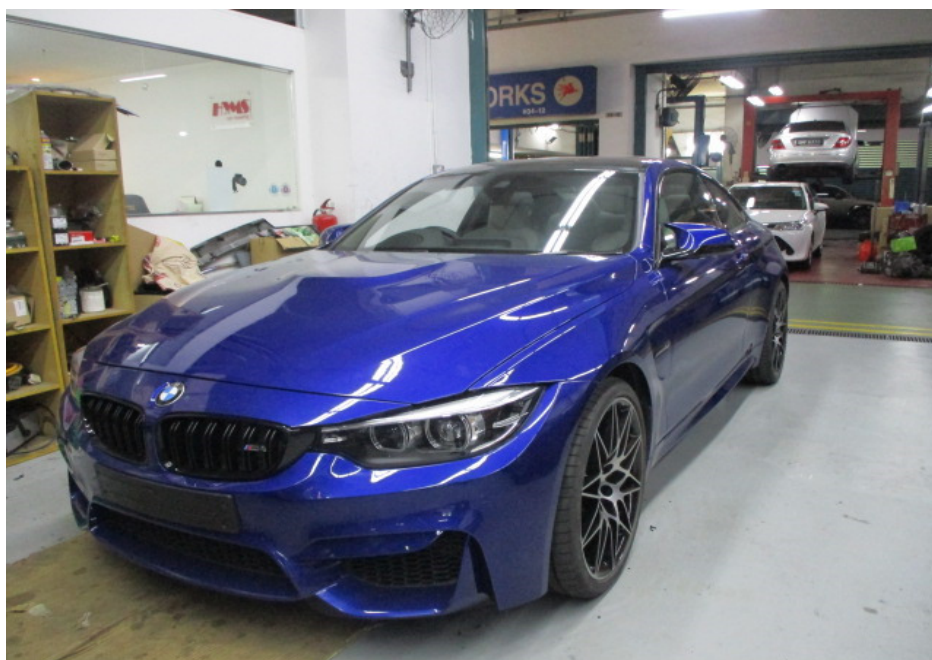
Photo 7 shows a general view of the front left body of the Motor Car at the time of my inspection. The Motor Car was observed to be in a relatively good general condition with no loose exterior fittings observed. The mileage of the Motor Car recorded at the time of my inspection was 3,938km.

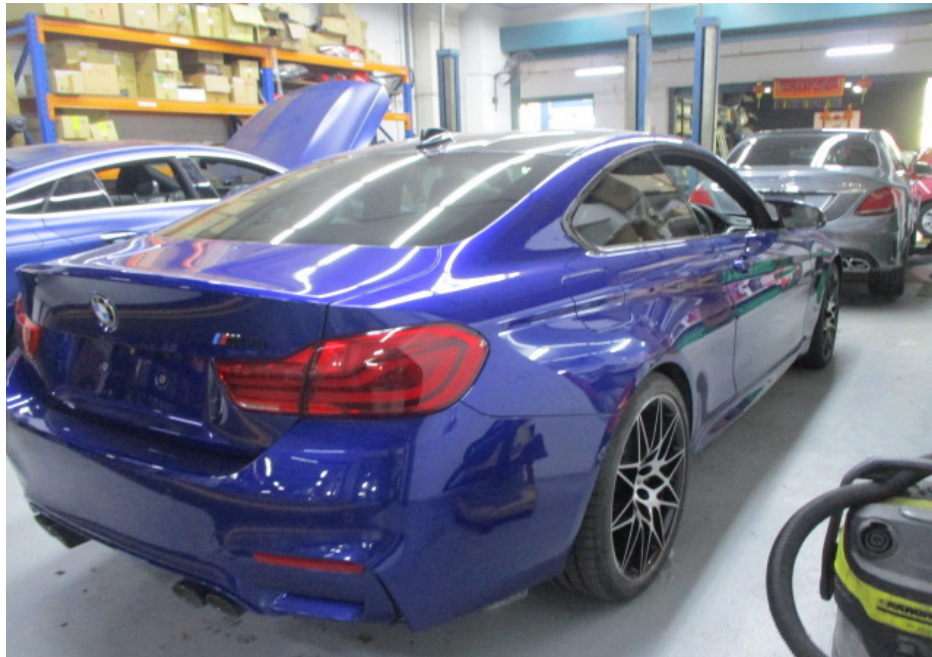
Photo 8 shows a general view of the rear right body of the Motor Car at the time of my inspection. The Motor Car was observed to be in a relatively good general condition with no loose exterior fittings observed. The mileage of the Motor Car recorded at the time of my inspection was 3,938km.

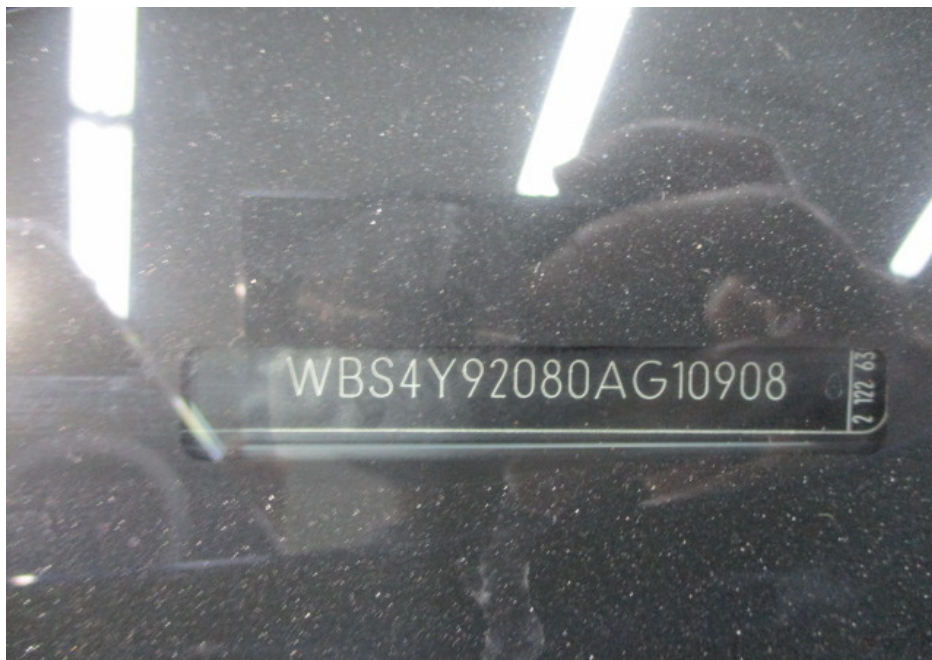
Photo 9 shows the chassis number of the Motor Car. The chassis number recorded was WBS4Y92080AG10908.

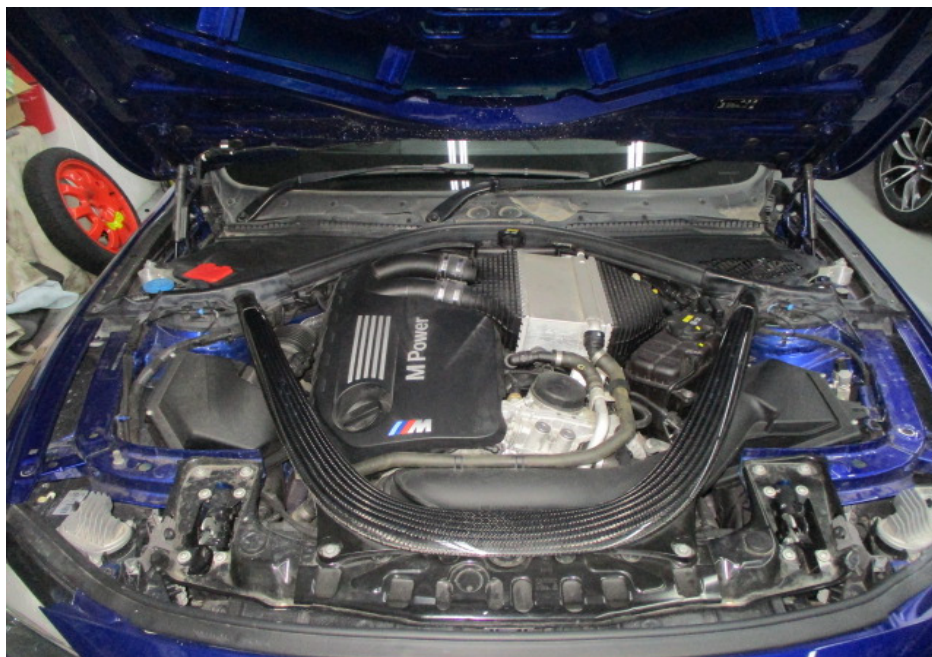
14. My examination of the engine compartment of the Motor Car revealed that the various parts and components inside the engine compartment were all intact and properly fitted. The engine oil, brake fluid and engine coolant were all found to be of sufficient level for operating purposes. Visually, there was also no contamination found to these fluids.

Photo 10 shows a general view of the engine compartment of the Motor Car at the time of my inspection. The various parts and components inside the engine compartment were all observed to be intact and properly fitted. There was also no sign(s) or indication(s) of fluid leak and/or fluid stain found inside the engine compartment.

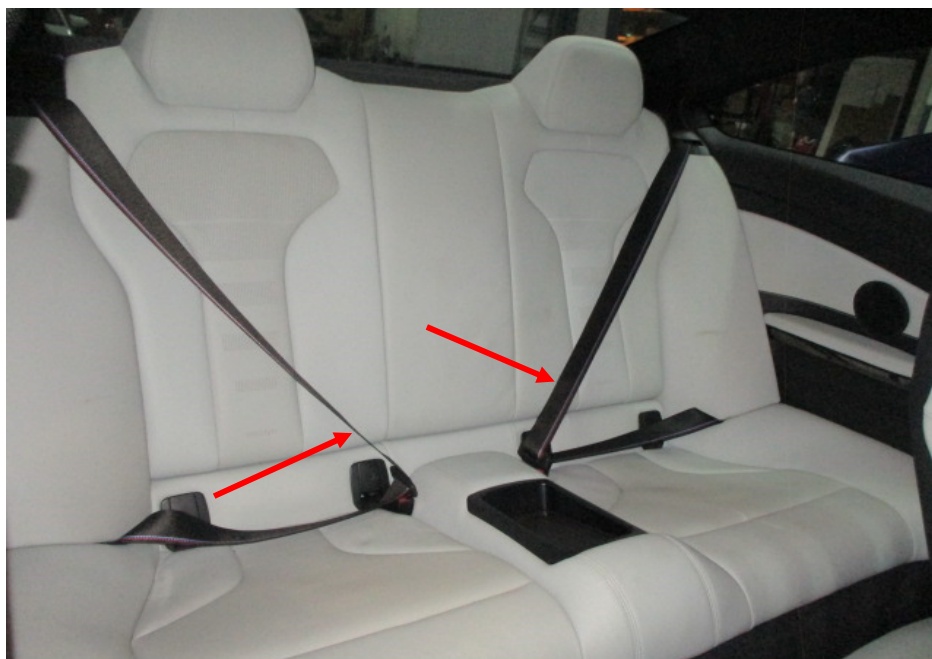
12. The seats of the Motor Car were found to be secured to the floorboard of the Motor Car via seat rails bolted onto the floorboard. Retractable seat belt reels and pre-tensioners were fitted on all seats of the Motor Car. The seat belts were tested and were able to be fastened securely into the respective pre-tensioners that were fixed to the side of all the seats.

Photo 11 shows the rear seats of the Motor Car. All the seats of the Motor Car were secured via seat rails to the floorboard. They were also fitted with a retractable seat belt reel and a pre-tensioner. The seat belts (arrowed) were tested and were able to be fastened into the respective pre-tensions that were fitted on the side of each individual seat.

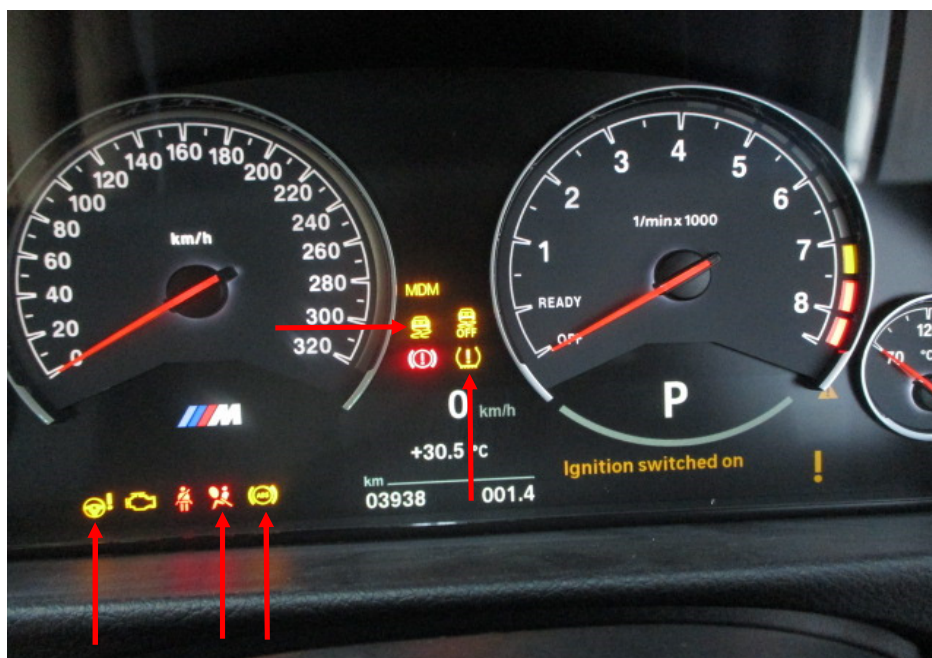
Photo 12 shows the warning lights for the various electronic safety features appearing on the instrument panel of the Motor Car during its self-test when the engine is cranked, in particular the ABS, SRS, IAS, TPM and DSC lights (arrowed).

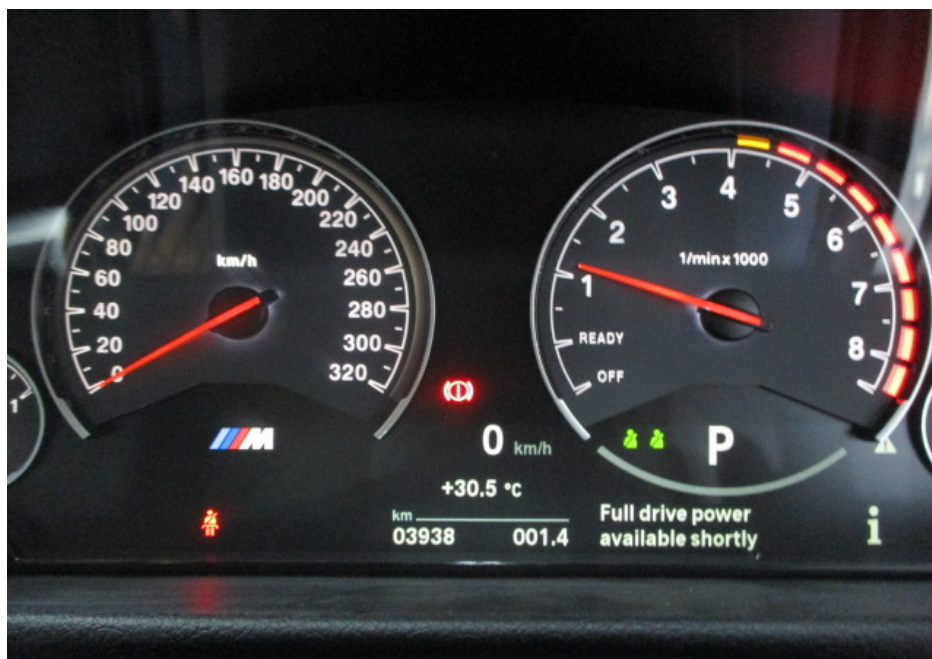
13. The Motor Car's automatic self-test of the functionality of its various electronic safety features like the Anti-Lock Brake System (ABS), Supplemental Restraint System (SRS), Integral Active Steering (IAS), Tyre Pressure Monitor (TPM) and Dynamic Stability Control (DSC) during cranking of the engine had indicated that these electronic systems were in working condition. This was determined from the respective warning lights disappearing from the instrument panel after the self-test.

Photo 13 shows the respective warning lights no longer illuminated, indicating that there is no fault detected to the ABS, SRS, IAS, TPM and DSC systems of the Motor Car during the self-test. These electronic systems were hence in working condition at the time of my inspection.

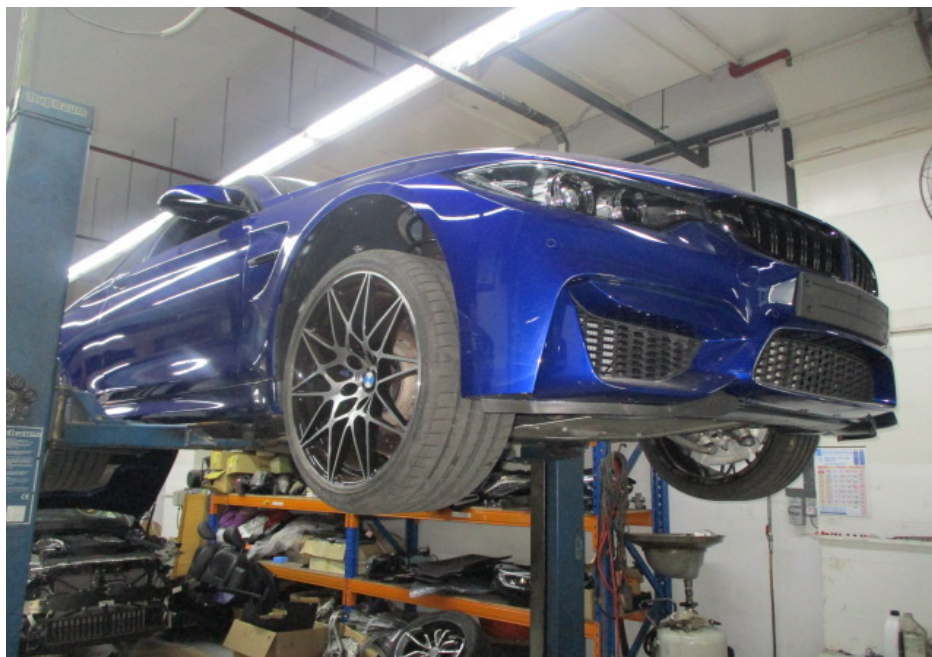
15. My checks on the underside of the Motor Car revealed no sign(s) or indication(s) of fluid leakage and/or fluid stain(s). The engine block and automatic transmission assembly were both secured properly. All undercarriage components of the Motor Car were also observed to be intact and secured in an appropriate manner.

Photo 14 shows the Motor Car hoisted up for checks on its undercarriage. There was no sign(s) or indication(s) of fluid leakage and/or fluid stain(s) on the underside of the Motor Car. The undercarriage components of the Motor Car were also all observed to be intact and secured in an appropriate manner.

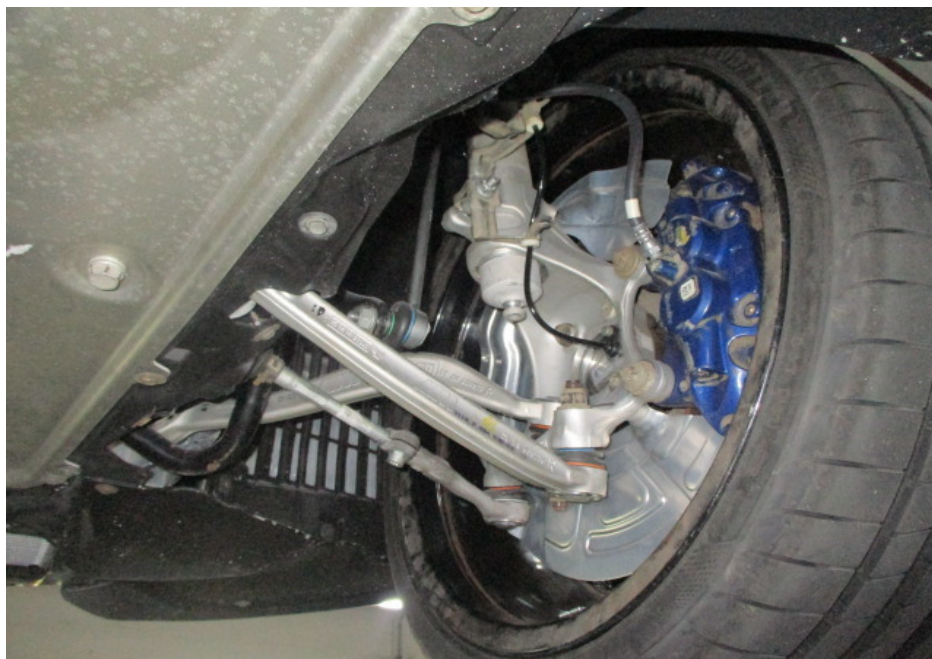
Photo 15 shows the various undercarriage components at the front right wheel of the Motor Car. The mechanical components, control arms and linkages were all found to be intact and secured in an appropriate manner. I also did not observe any fluid leak and/or fluid stain on the underside of the Motor Car.

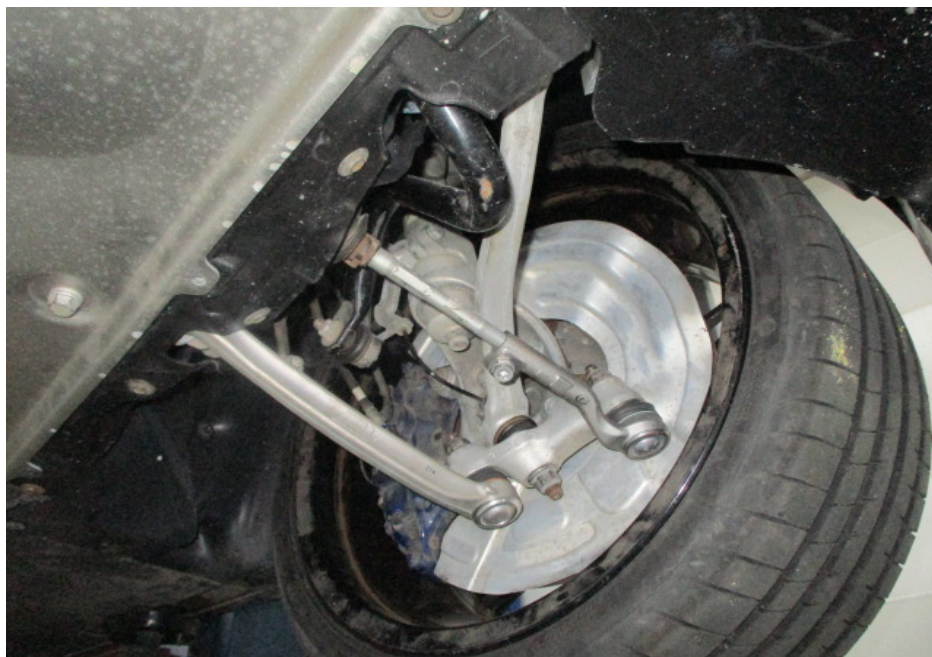
Photo 16 shows the various undercarriage components at the front left wheel of the Motor Car. The mechanical components, control arms and linkages were all found to be intact and secured in an appropriate manner.

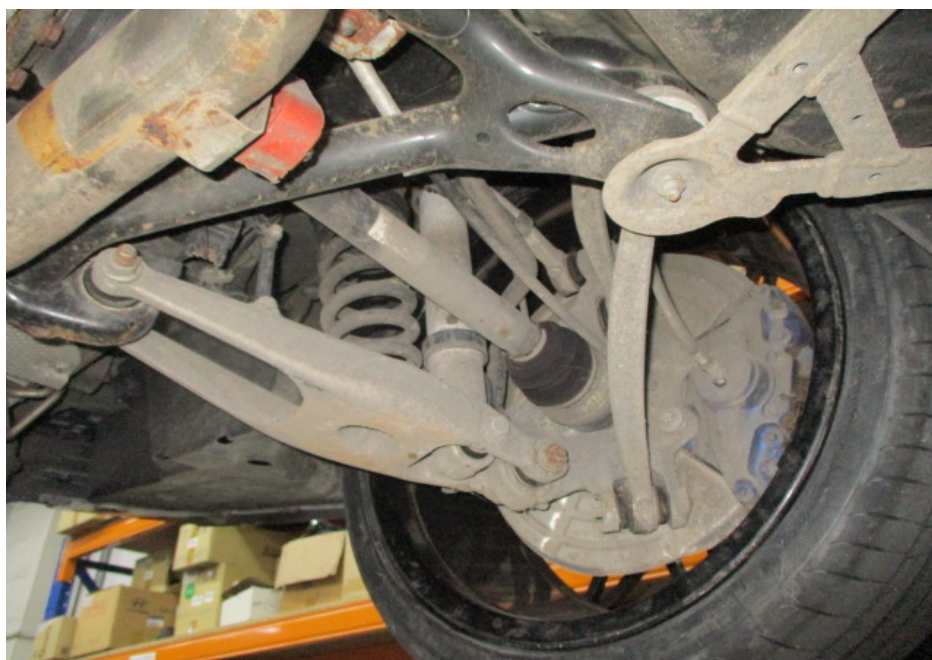
Photo 17 shows a general view of the control arms and linkages at the rear left wheel of the Motor Car. I did not observe any fluid leak and/or fluid stain on the underside of the Motor Car. All of the Motor Car's undercarriage components were observed to be intact and secured in an appropriate manner.

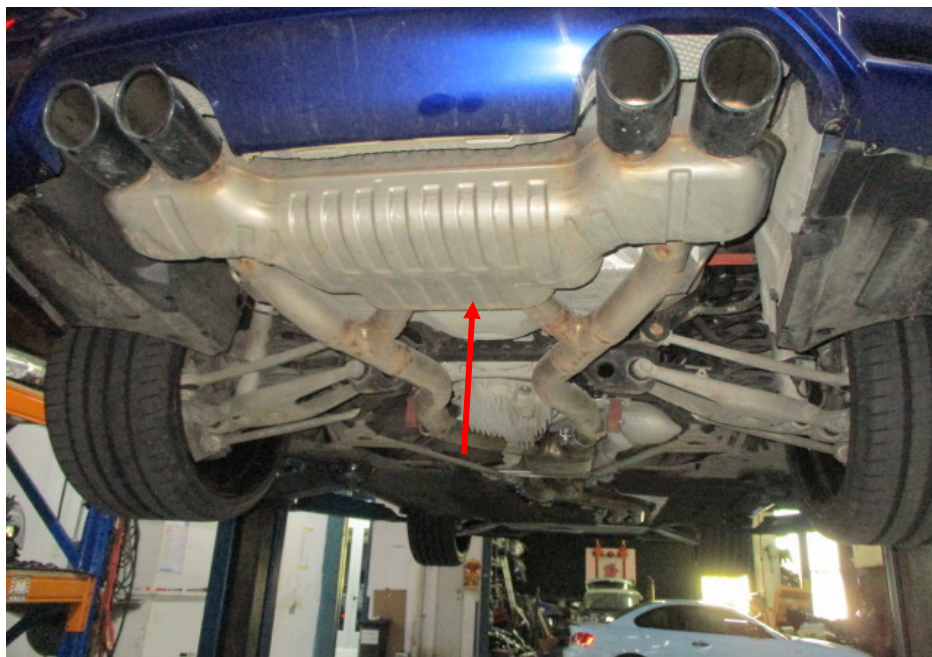
Photo 18 shows the Motor Car's rear muffler (arrowed). My examination of the Motor Car's exhaust system revealed no sign(s) or indication(s) of any cut or weld marks along its exhaust pipes and on its catalytic converters.

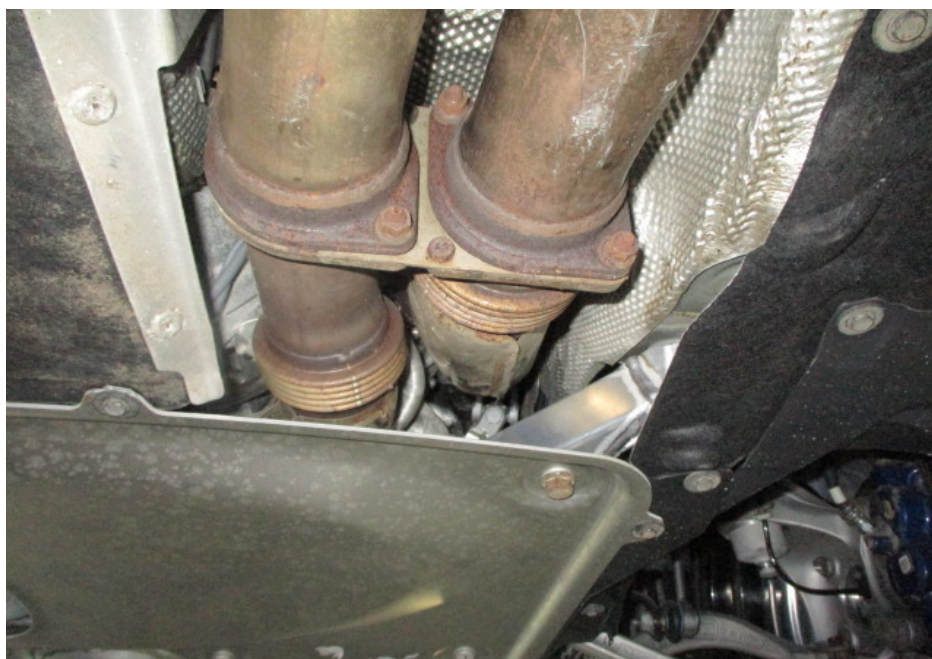
Photo 19 shows the Motor Car's catalytic converters. My examination of the Motor Car's exhaust system revealed no sign(s) or indication(s) of any cut or weld marks along its exhaust pipes and on its rear muffler.

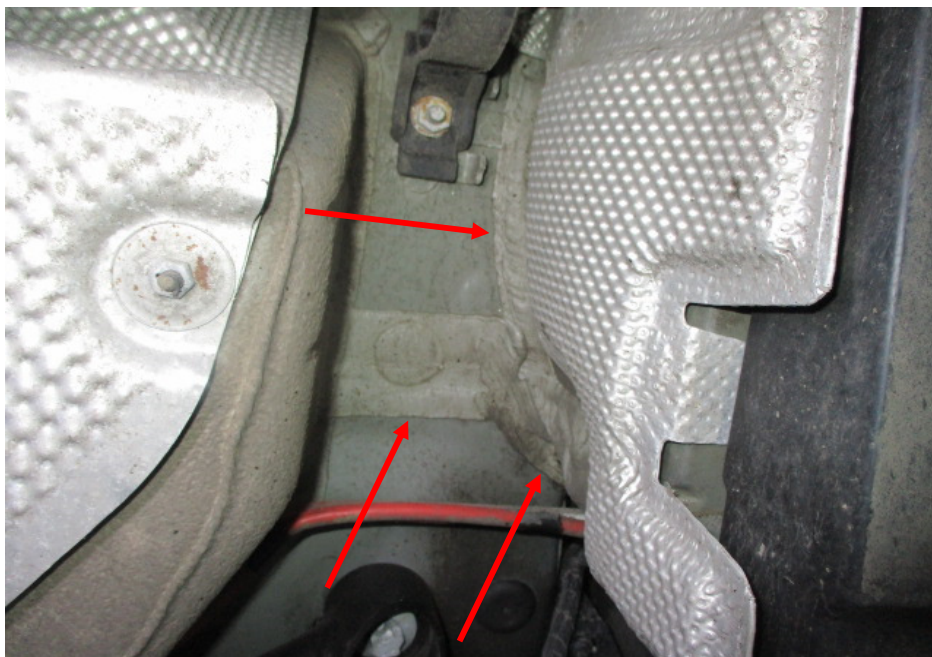
11. Visually, I did not find any weld marks, other than the original spot weld marks, on the chassis/structural body of the Motor Car. The original factory sealant at the joints along the chassis/structural body was also untouched, again indicating that no replacement of the chassis/structural body was carried out; and that the chassis/structural body was originally fitted.

Photo 20 shows the chassis/structural body at the underside rear right of the Motor Car. I did not find any weld marks other than original spot weld marks on the chassis/structural body of the Motor Car. The original factory sealant (arrowed) at the joints along the chassis/structural body was also untouched, indicating no work was done on the chassis/structural body of the Motor Car and that the chassis/structural body was originally fitted.

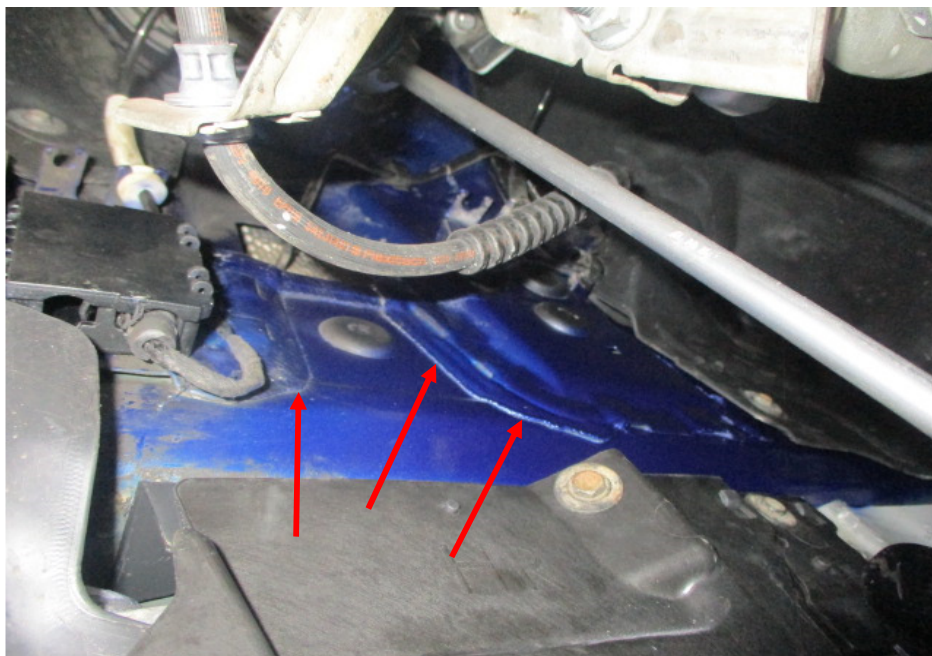
Photo 21 shows the chassis/structural body at the underside front right of the Motor Car. The original factory sealant (arrowed) at the joints along the chassis/structural body was observed to be untouched. In general, I had found no work was carried out on the chassis/structural body of the Motor Car. The chassis/structural body of the Motor Ca was originally fitted.

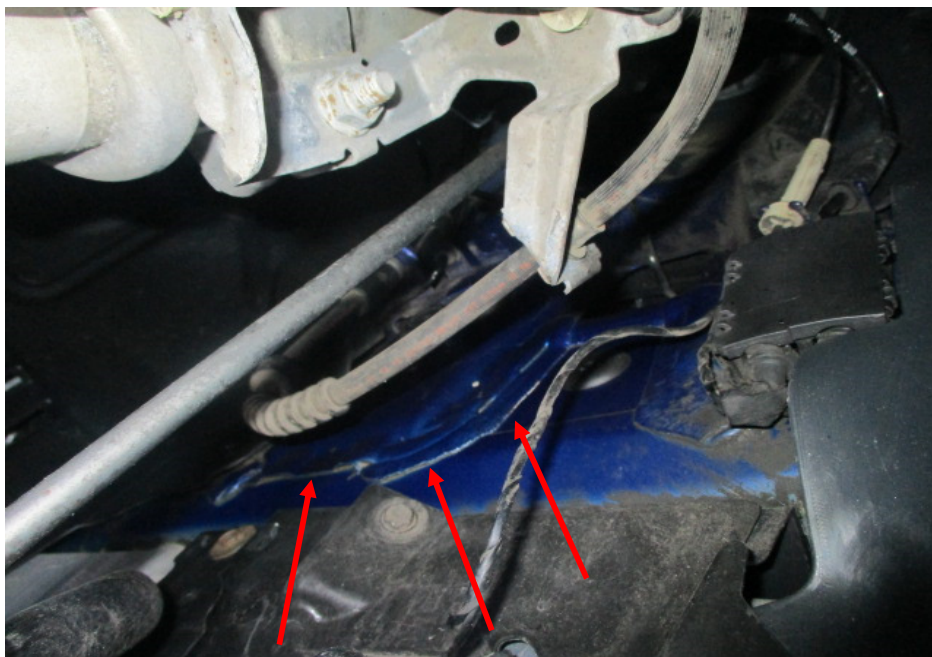
Photo 22 shows the chassis/structural body at the underside front left of the Motor Car. I did not find any weld marks other than original spot weld marks on the chassis/structural body of the Motor Car. The original factory sealant (arrowed) at the joints along the chassis/structural body was also untouched, indicating no work was done on the chassis/structural body of the Motor Car and that the chassis/structural body was originally fitted.

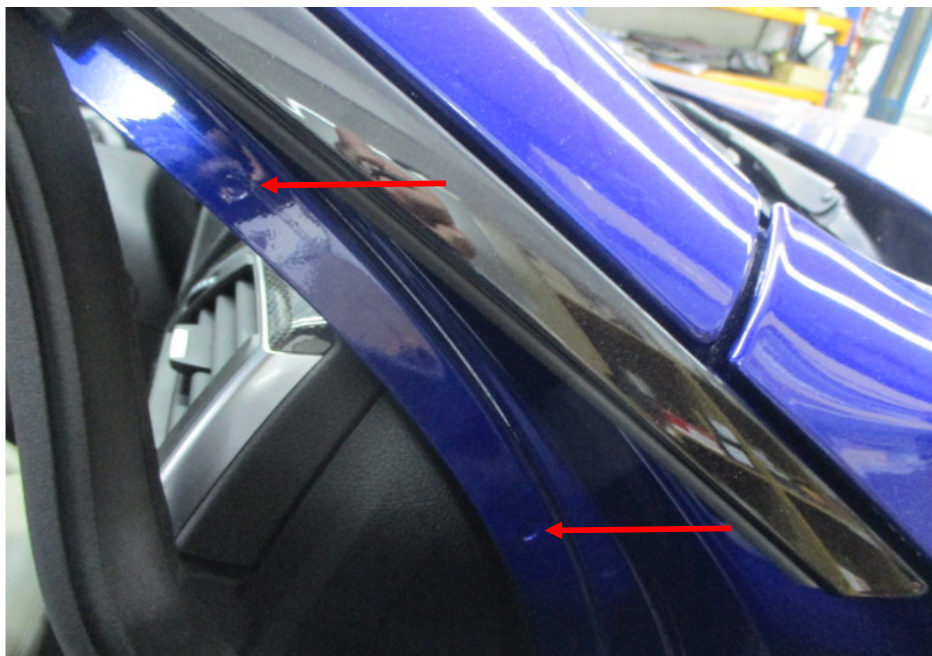
Photo 23 shows the right side "A" pillar of the Motor Car. I did not find any weld marks other than original spot weld marks (arrowed) on the right side "A" pillar of the Motor Car which, indicates that there was no re-welding works carried out. In general, I had found all the non-detachable body panels of the Motor Car to be originally fitted at the time of my inspection.

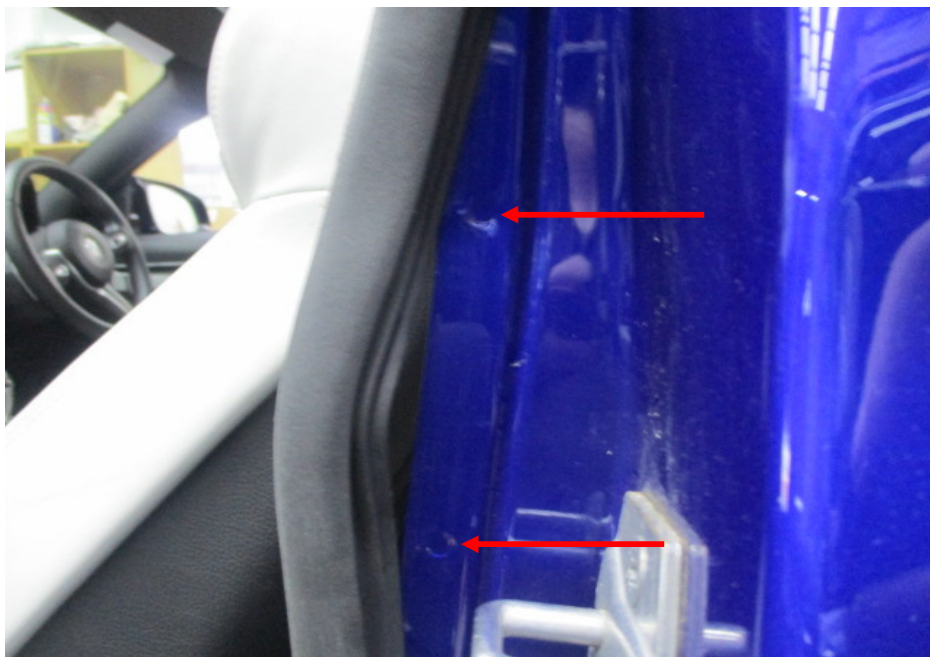
Photo 24 shows the left side rear body panel of the Motor Car. I did not find any weld marks other than original spot weld marks (arrowed) on the left side rear body panel of the Motor Car which, indicates that there was no re-welding works carried out. In general, I had found all the non-detachable body panels of the Motor Car to be originally fitted at the time of my inspection.
