Your Ref: S1M03A1Q
Our Ref : CS4/ASM21005793/P

25th May 2021

TECHNICAL INVESTIGATION REPORT OF FIRE INCIDENT INVOLVING THE INSURED VEHICLE SMY 4982D ON 11th May 2021

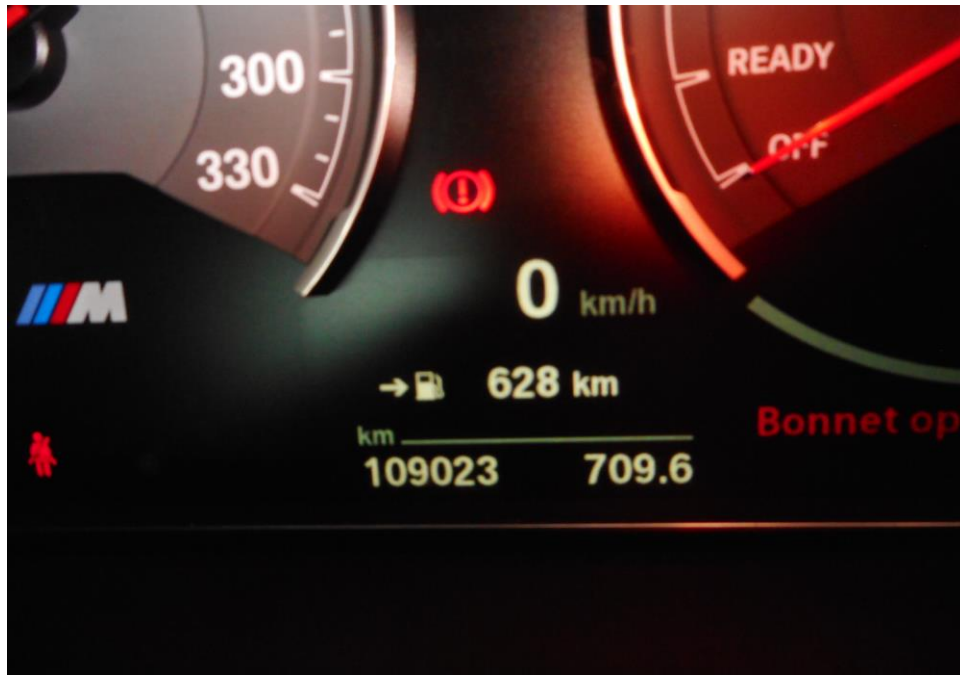
Photo 1 shows the mileage of the Insured Vehicle recorded at the time inspection at 109,023KM

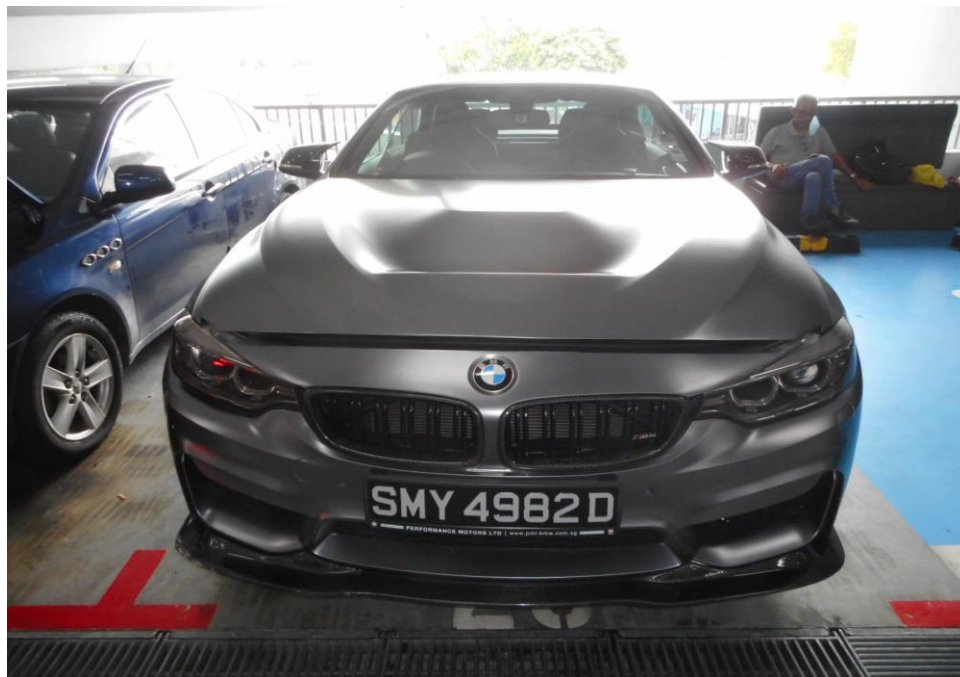
Photo 2 shows the general view of the front portion of the Insured Vehicle at the time of our inspection. The fire damage to the Insured Vehicle was confined to its interior portion. Its exterior is observed to be unaffected by the fire.

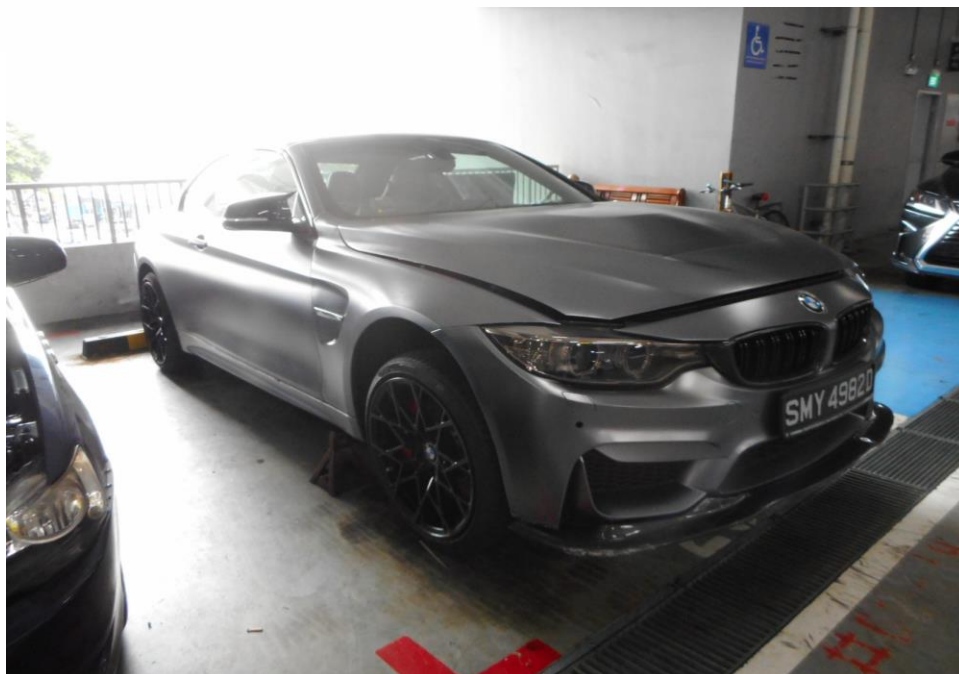
Photo 3 shows the general view of the right portion of the Insured Vehicle at the time of our inspection. The fire damage to the Insured Vehicle was confined to its interior portion. Its exterior is observed to be unaffected by the fire.

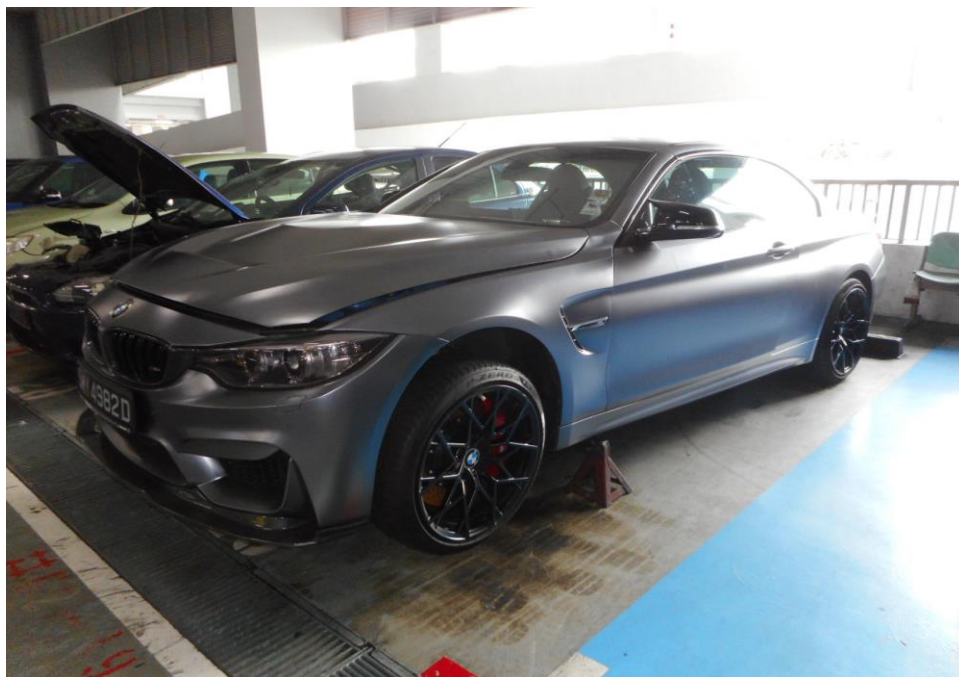
Photo 4 shows the general view of the left portion of the Insured Vehicle at the time of our inspection. The fire damage to the Insured Vehicle was confined to its interior portion. Its exterior is observed to be unaffected by the fire.

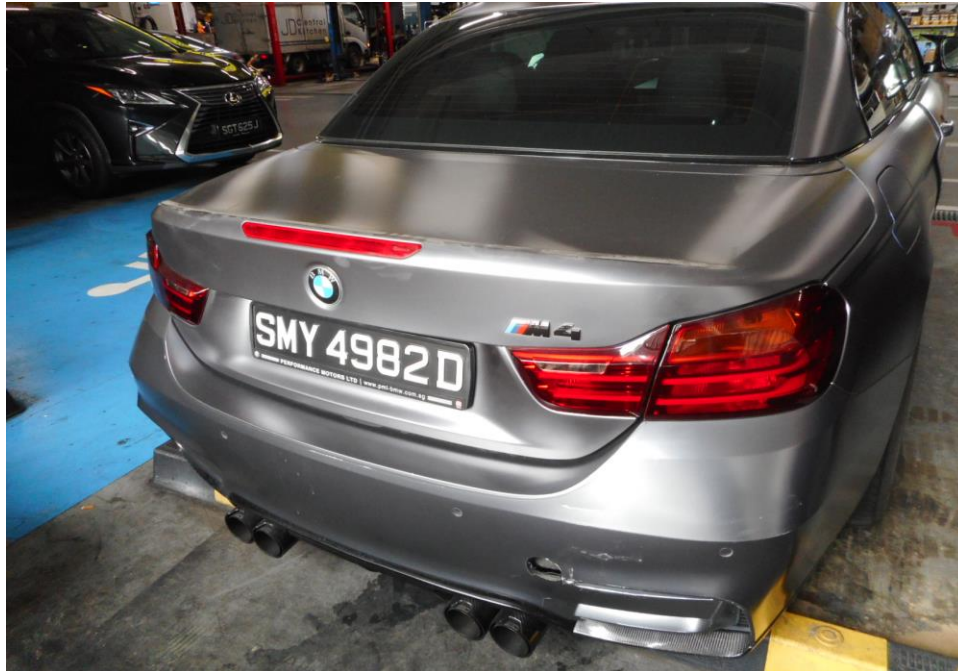
Photo 5 shows the general view of the rear portion of the Insured Vehicle at the time of our inspection. The fire damage to the Insured Vehicle was confined to its interior portion. Its exterior is observed to be unaffected by the fire.

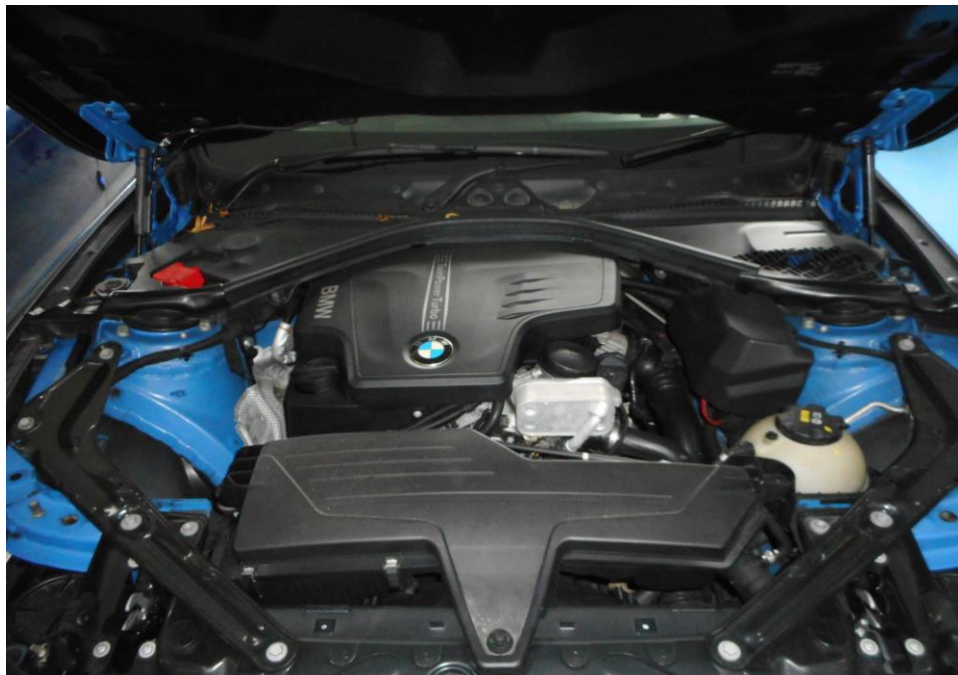
Photo 6 shows the general view of the engine portion of the Insured Vehicle at the time of our inspection. The fire damage to the Insured Vehicle was confined to its interior portion. Its engine compartment is observed to be unaffected by the fire.

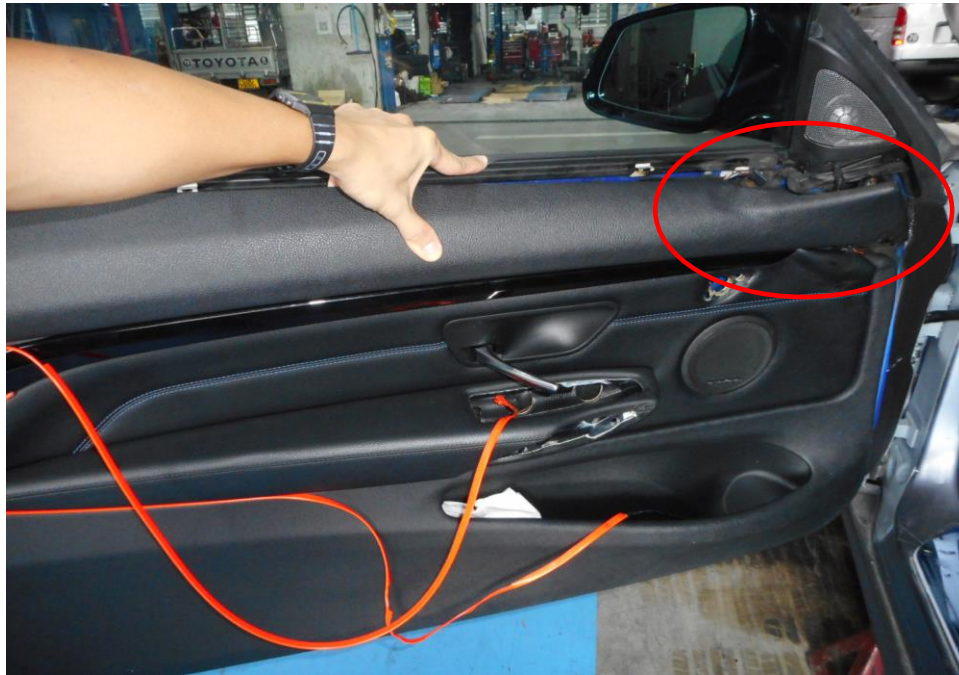
Photo 7 shows the general view of the front left interior door panel of the Insured Vehicle at the time of our inspection. The door panel had suffered heat and smoke damages (circled) as a result of the fire.

8. Based on the circumstances for this particular case, the fire appears to have originated from the interior portion of the Insured Vehicle, somewhere in the front left door panel. This can be determined basing on the area where the extent of fire damage was most severe, the circumstances of the fires' origin at the material time of incident and also the burn marks and melting of material that were found at the front left door panel.

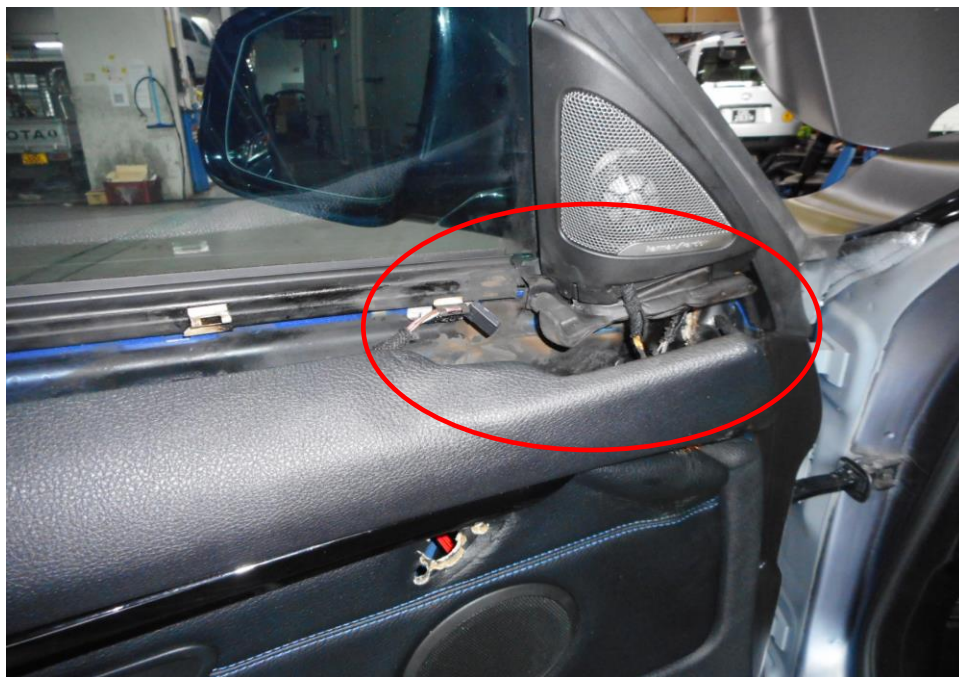
Photo 8 shows the close up view of the front left interior door panel of the Insured Vehicle at the time of our inspection. The door panel had suffered heat and smoke damages (circled) as a result of the fire.

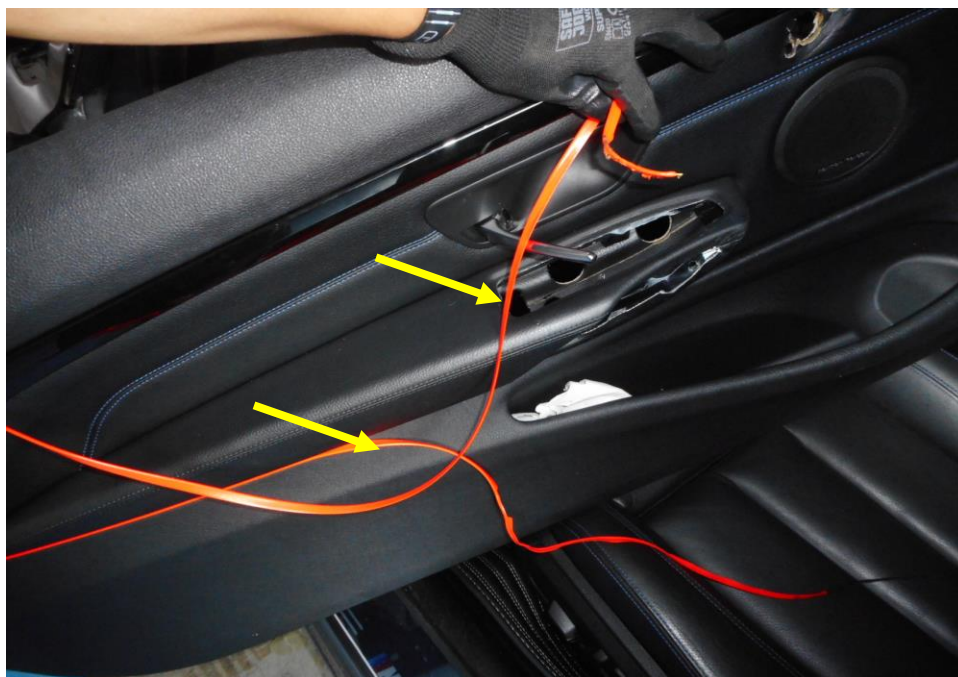
Photo 9 shows the front left interior door panel of the Insured Vehicle an additional fitted LED light strips (arrowed) on the Insured Vehicle, which was observed to be affected by the fire.

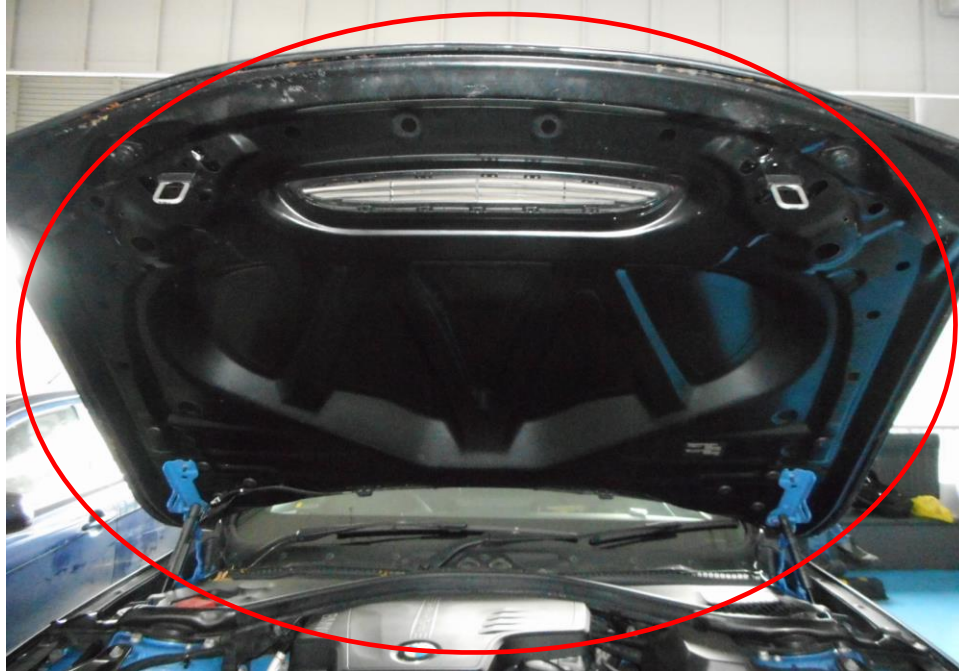
Photo 10 shows an aftermarket bonnet (circled) on the Insured Vehicle, which was observed to be unaffected by the fire.

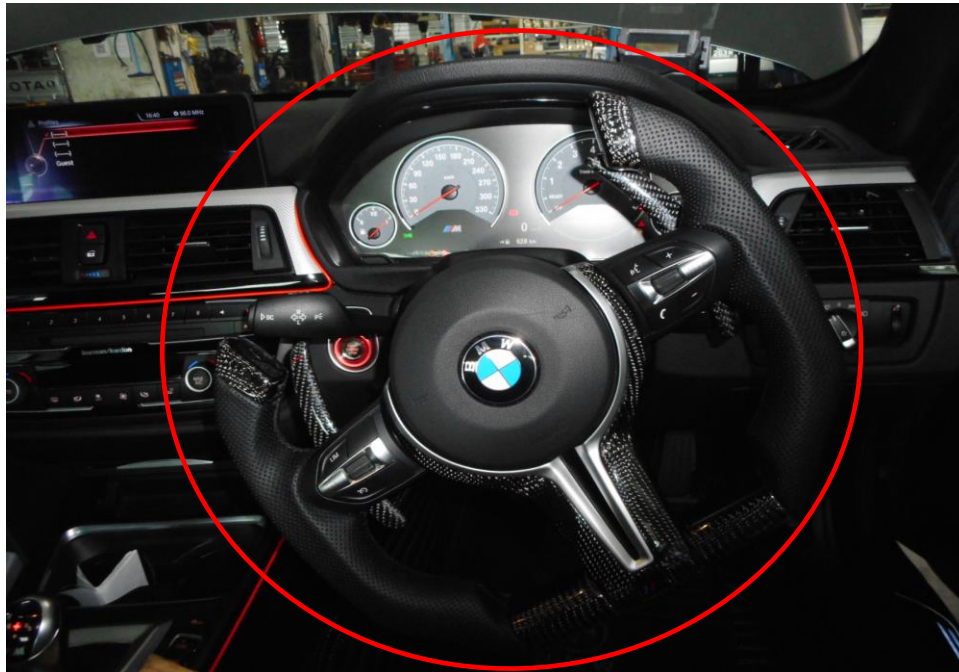
Photo 11 shows an aftermarket steering wheel (circled) on the Insured Vehicle, which was observed to be unaffected by the fire.

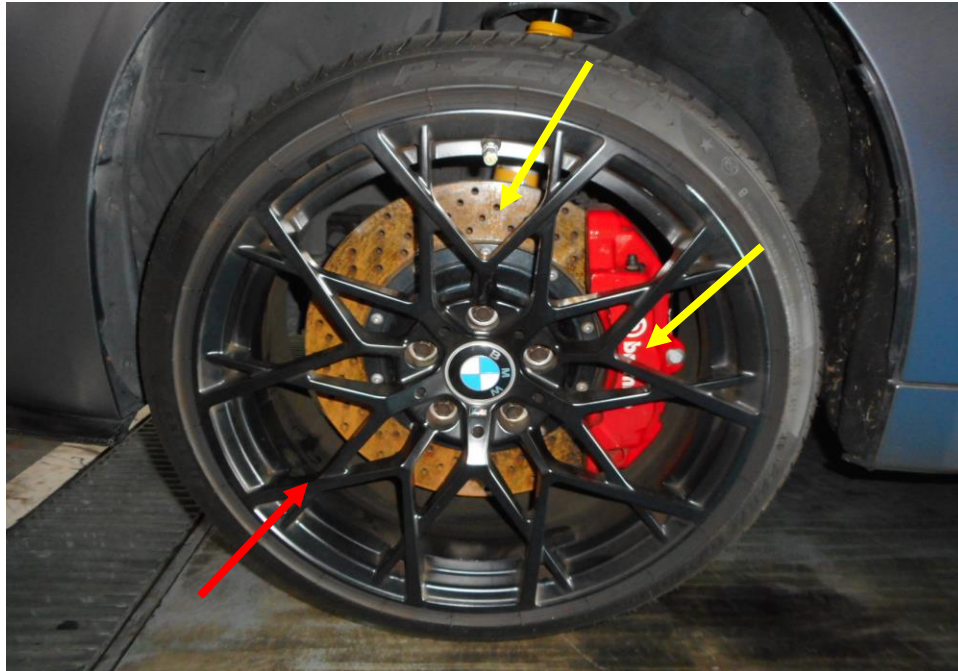
Photo 12 shows an aftermarket rim (red arrow) and upgraded brake caplier and disc brake (yellow arrow) on the Insured Vehicle, which was observed to be unaffected by the fire.

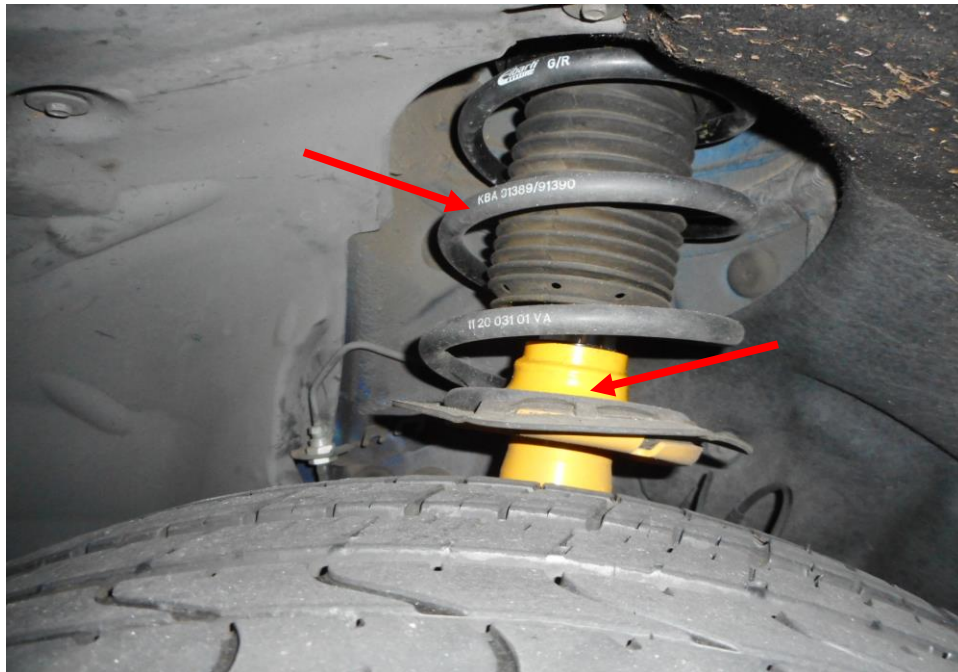
Photo 13 shows an aftermarket suspension (red arrow) on the Insured Vehicle, which was observed to be unaffected by the fire.

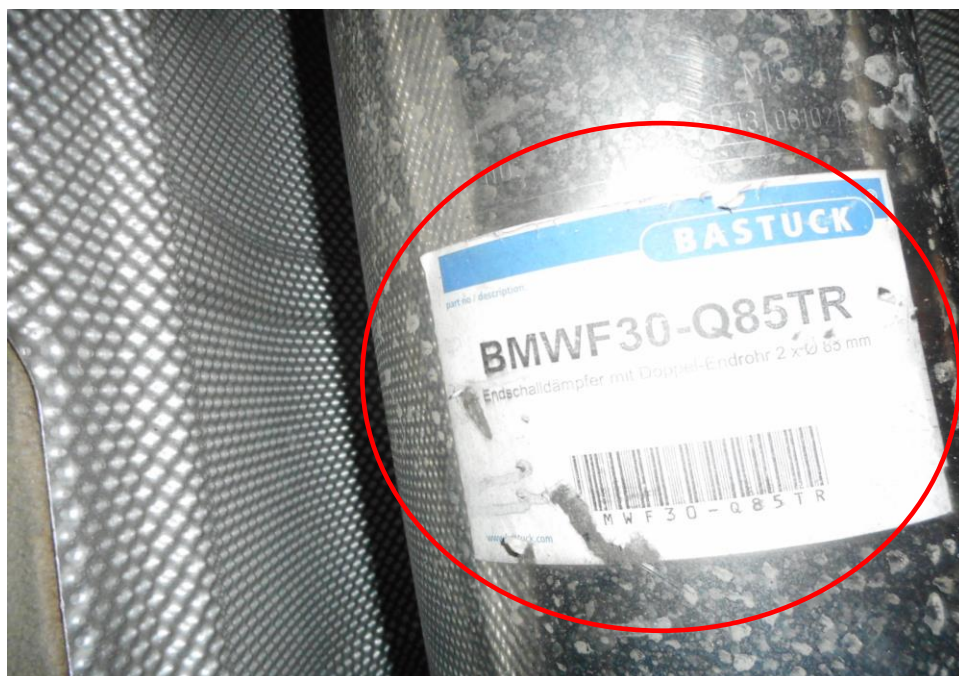
Photo 14 shows a set of aftermarket exhaust system (circled) on the Insured Vehicle, which was observed to be unaffected by the fire.

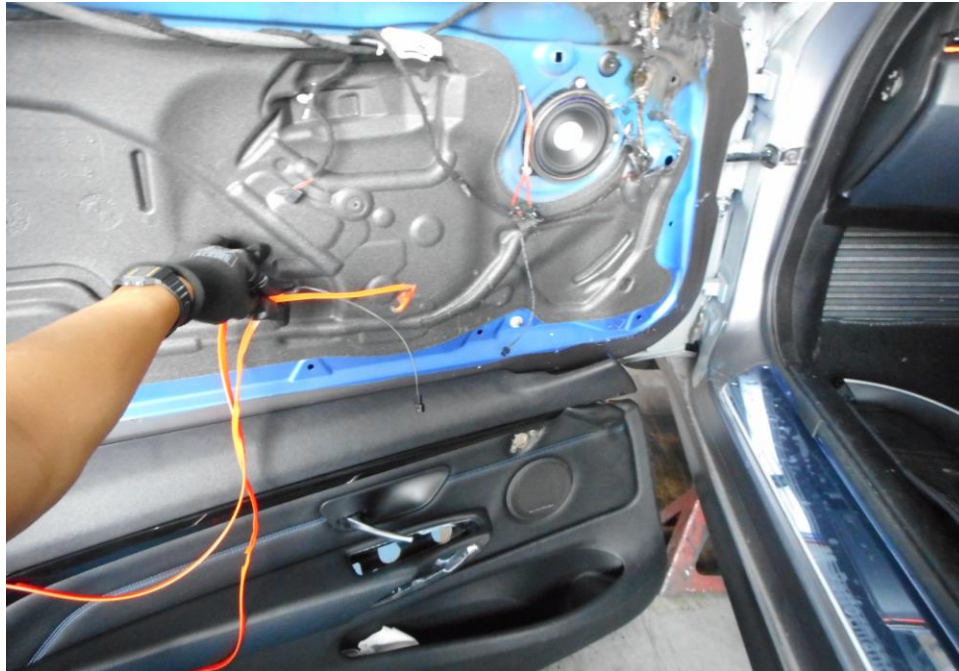
9. Upon closer observations, we have removed the front left door panel and found that the additionally fitted LED light strip wirings and its electrical components in the front left door panel were observed to be where the fire had started, we had found traces of greenish residue on the additional fitted wirings leading from the LED light strips to its electrical components. The wirings and electrical components were not original wirings fitted from manufacturer. The presence of greenish residue indicates internal heating of copper wires, a sign of an electrical short circuit occurring. The greenish residue is normally left behind from the oxidation as a result of chemical reaction involving the copper wires. This physical evidence would then appear to suggest that the cause of fire to the Insured Vehicle could have possibly been due to electrical in nature. See photo 15-20 below.

Photo 15 shows the general inside view of the front left door panel of the Insured Vehicle at the time of our inspection. Observed that the electrical components around then surrounding had sustain heat & smoke damage.

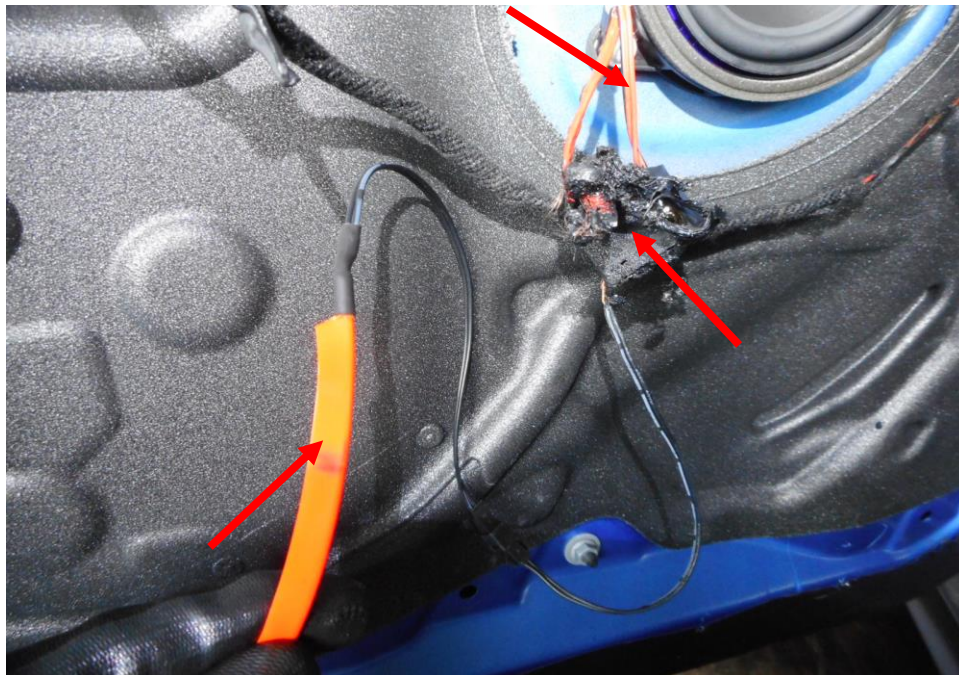
Photo 16 shows the general view of the wirings in the front left door panel of the Insured Vehicle at the time of our inspection. Observed that the fire had likely started from the additionally fitted LED light strips wiring harness connected to its electrical components (arrowed) as there was greenish residue on the surface. The presence of greenish residue indicates internal heating of copper wires, a sign of an electrical short circuit occurring. The greenish residue is normally left behind from oxidation as a result of chemical reaction involving the copper wires. The fire damage had also melted the electrical components that it was connected to. These wirings and electrical components were not original wirings fitted from manufacturer.

24. The possibility of the fire being due to electrical in nature would then seem more likely given that engine overheating and external factors would both seem unlikely. The fire being due to electrical nature is also supported by the condition of the wirings that were found leading from the additionally LED light strips and its electrical components that was fitted on the front left door panel of the Insured Vehicle. There wirings and electrical components were not original wirings fitted from manufacturer on the Insured Vehicle, which was earlier discussed in paragraph 9 above.

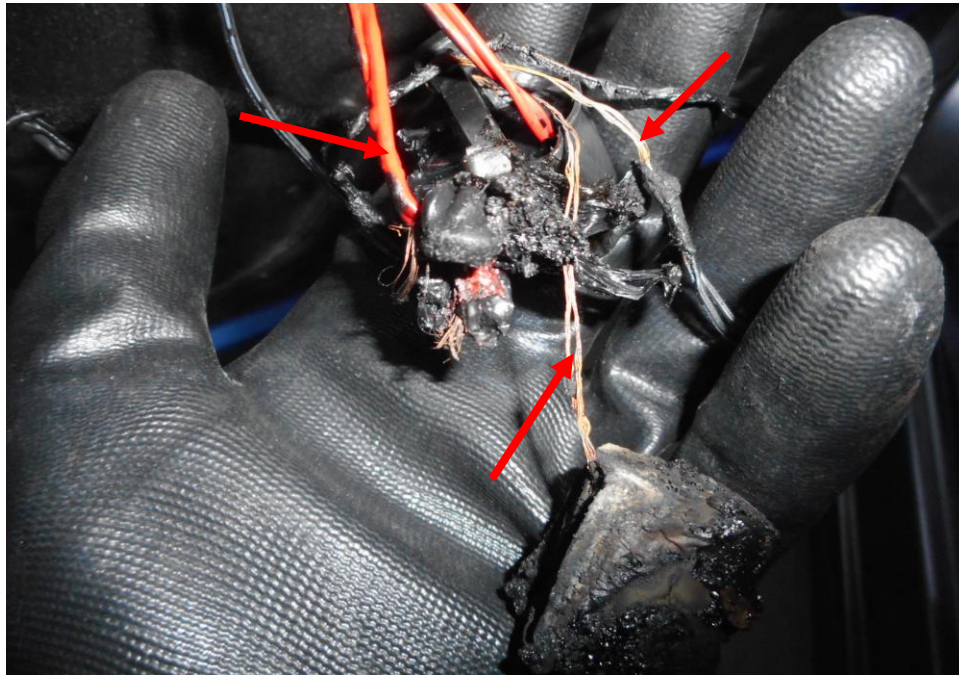
Photo 17 shows a close up view of the additionally fitted LED light strips wiring harness connected to its electrical components (arrowed) as there was greenish residue on the surface. The presence of greenish residue indicates internal heating of copper wires, a sign of an electrical short circuit occurring. The greenish residue is normally left behind from oxidation as a result of chemical reaction involving the copper wires. The fire damage had also melted the electrical components that it was connected to. This is likely where the fire had started from. These wirings and electrical components were not original wirings fitted from manufacturer.

26. Having investigated and technically analysed the damages of burnt nature to the Insured Vehicle, we are of the view that the cause of fire to the Insured Vehicle was of electrical nature. For this particular case, the fire had originated from the wirings of the additionally fitted LED light strips to its electrical components which are installed at the front left interior door panel, both are non-original manufacturer components.

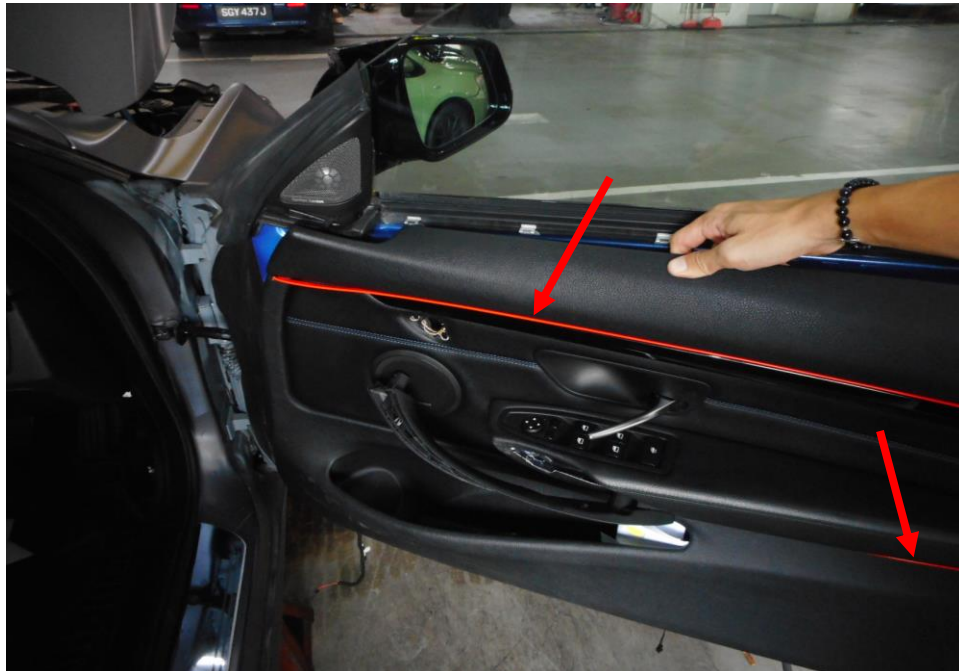
Photo 18 shows the right side door panel general view of the additionally fitted LED light strips wiring harness installed on the door panel (arrowed). These components were not affected by the fire. These wirings and electrical components were not original wirings fitted from manufacturer.

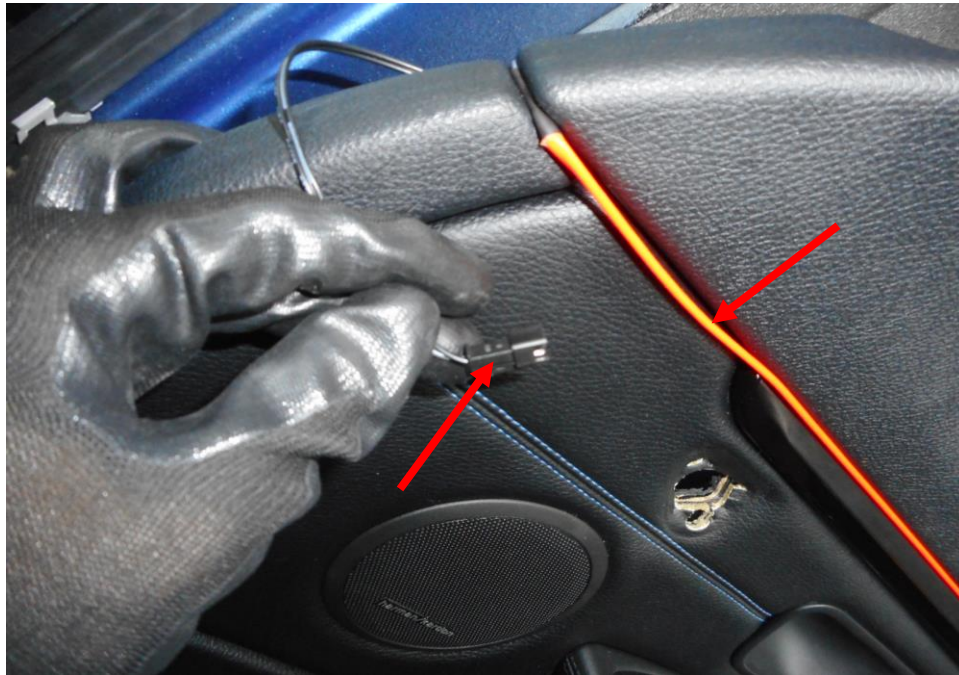
Photo 19 shows the right side door panel close up view of the additionally fitted LED light strips wiring harness with its electrical components installed on the door panel (arrowed). These components were not affected by the fire. These wirings and electrical components were not original wirings fitted from manufacturer.

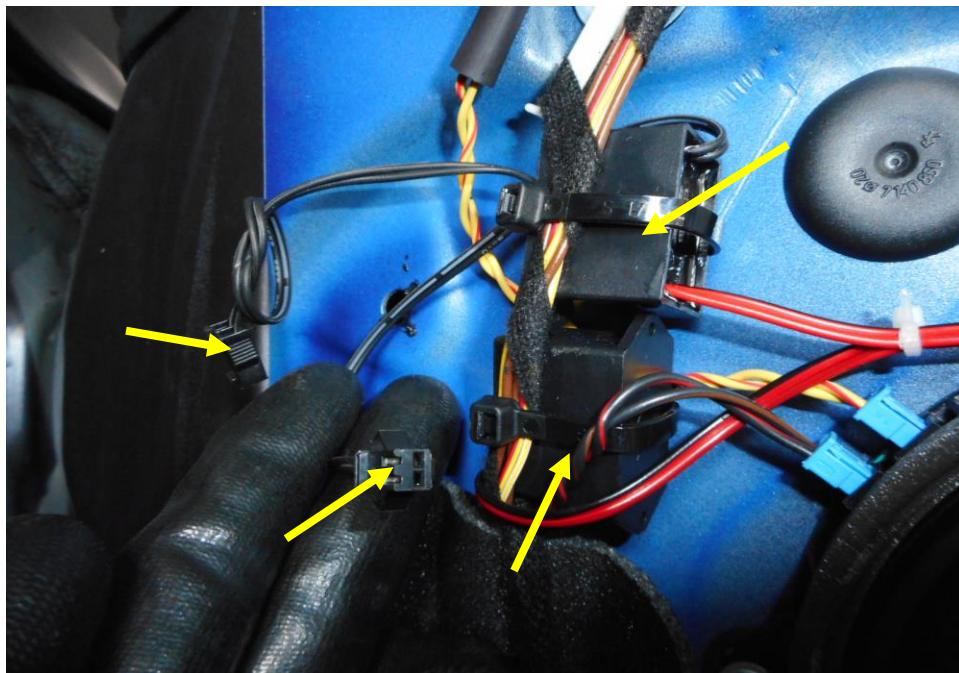
Photo 20 shows the right side door panel close up view of the additionally fitted LED light strips wiring harness with its electrical components installed on the door panel (arrowed). These components were not affected by the fire. These wirings and electrical components were not original wirings fitted from manufacturer.

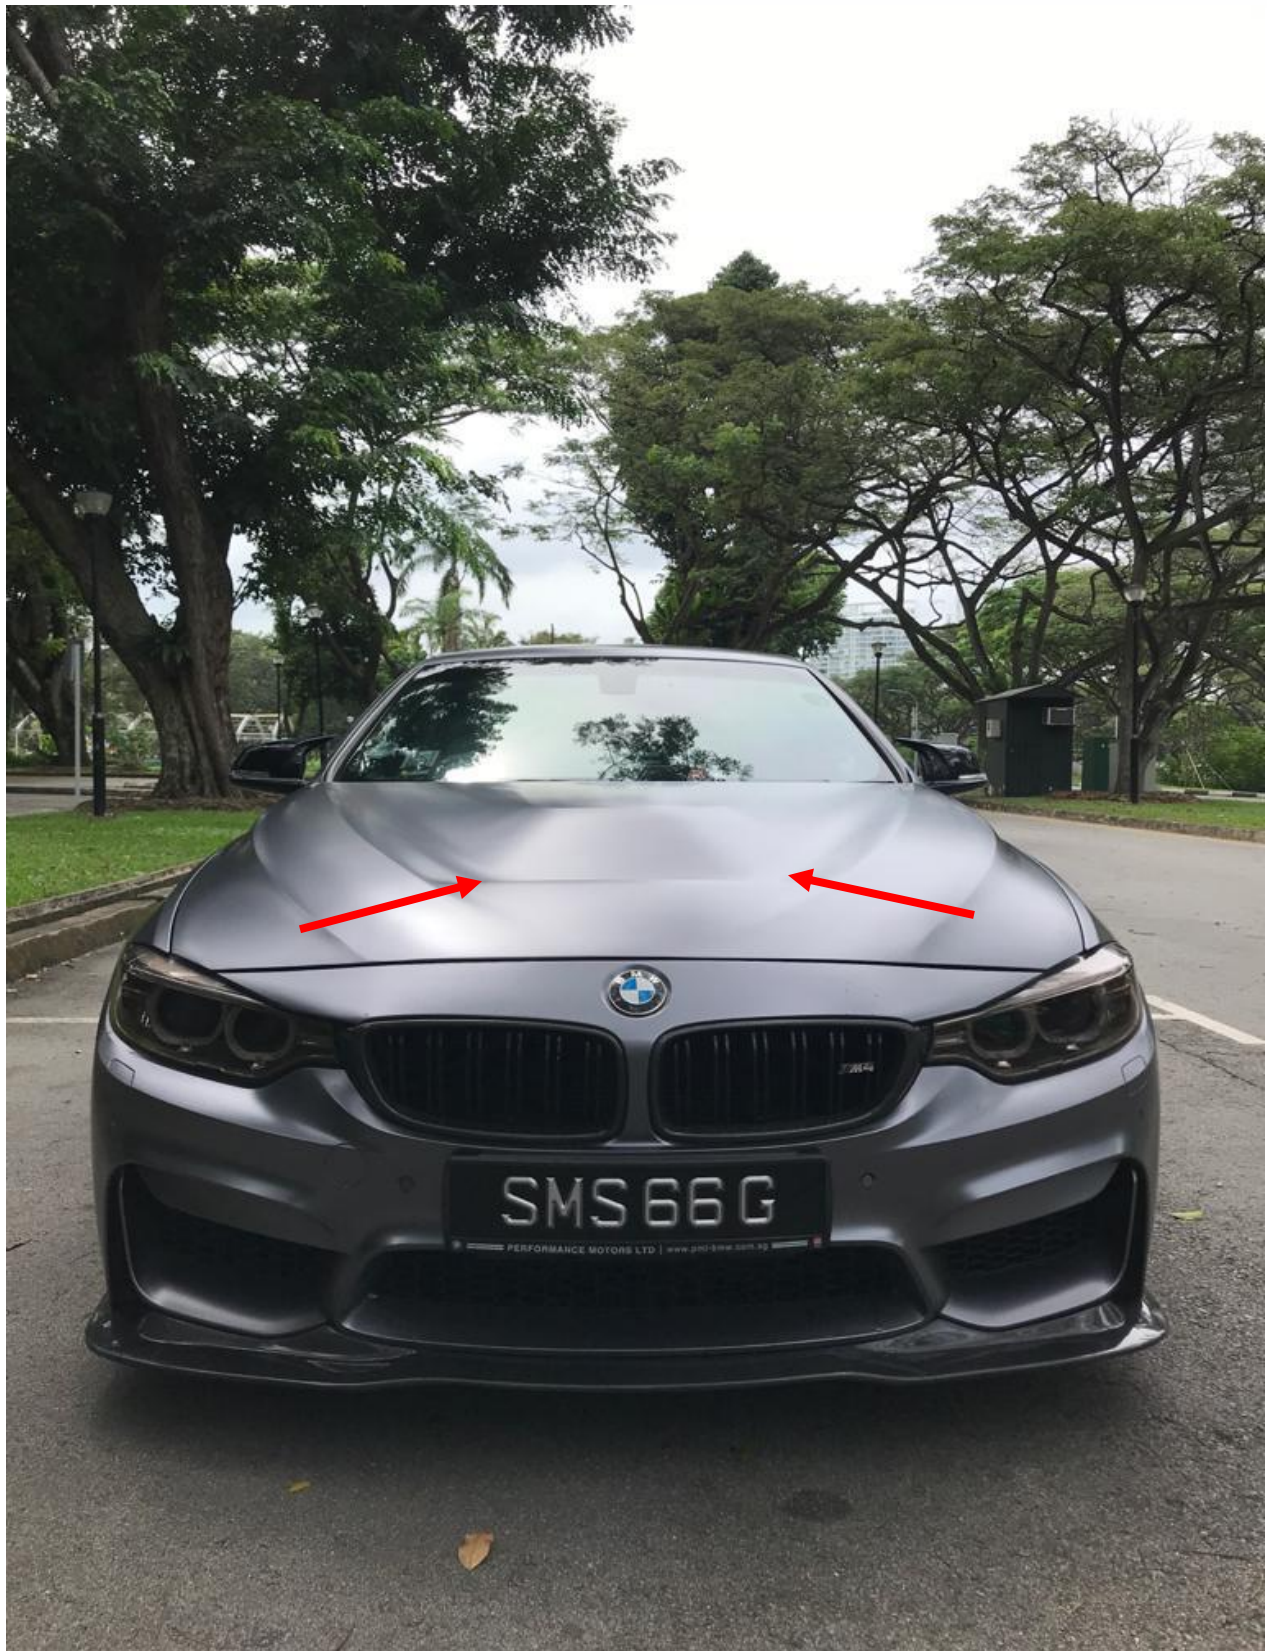
Photo 21 shows the general front view of the Insured Vehicle, which was observed to be number plated with the previous owner's plate number of SMS 66G. The aftermarket bonnet (arrowed) was also installed on the Insured Vehicle at the material time.

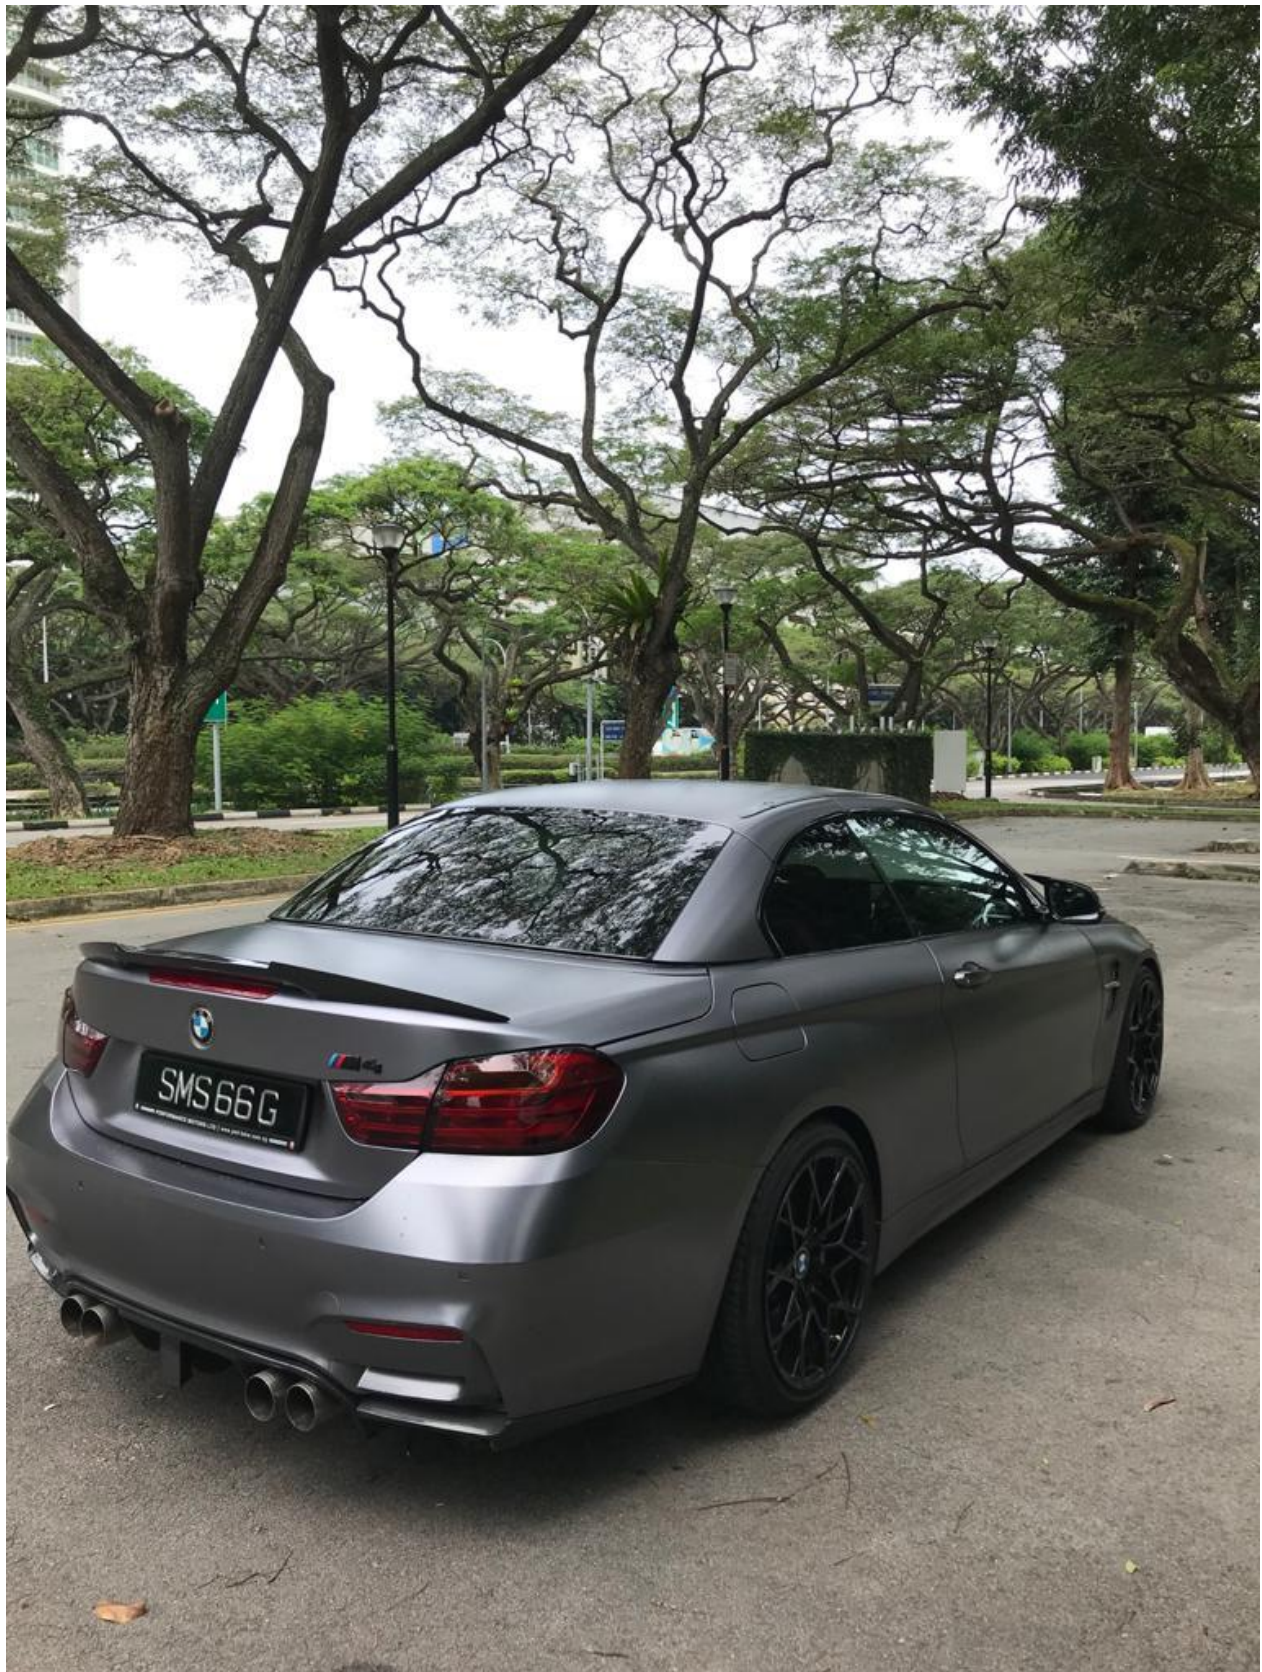
Photo 22 shows the general rear and right view of the Insured Vehicle, which was observed to be number plated with the previous owner's plate number of SMS 66G.

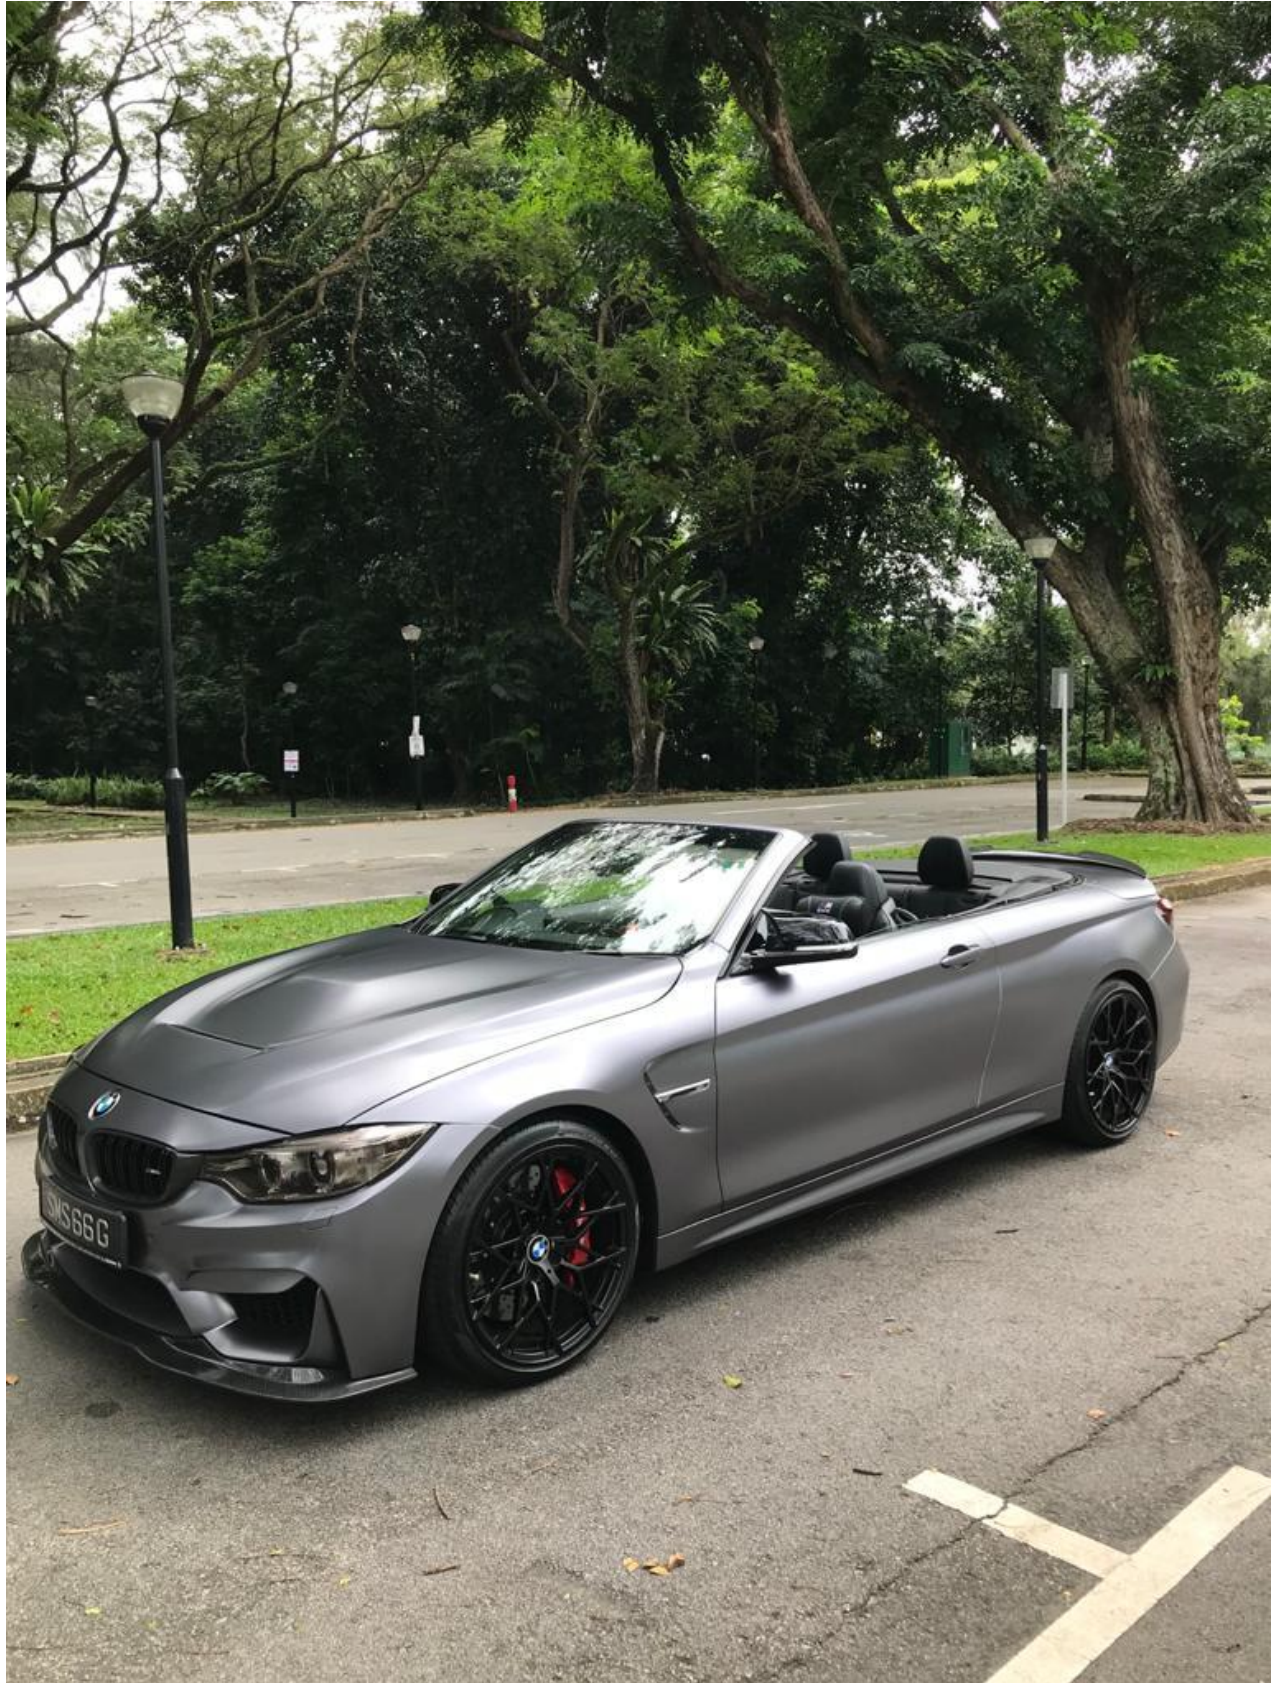
Photo 23 shows the general left view of the Insured Vehicle, which was observed to be number plated with the pervious owner's plate number of SMS 66G.
