Your Ref: S1M03A1Q
Our Ref : CS4/ASM21005793/P

25th May 2021

TECHNICAL INVESTIGATION REPORT OF FIRE INCIDENT INVOLVING THE INSURED VEHICLE SMY 4982D ON 11th May 2021

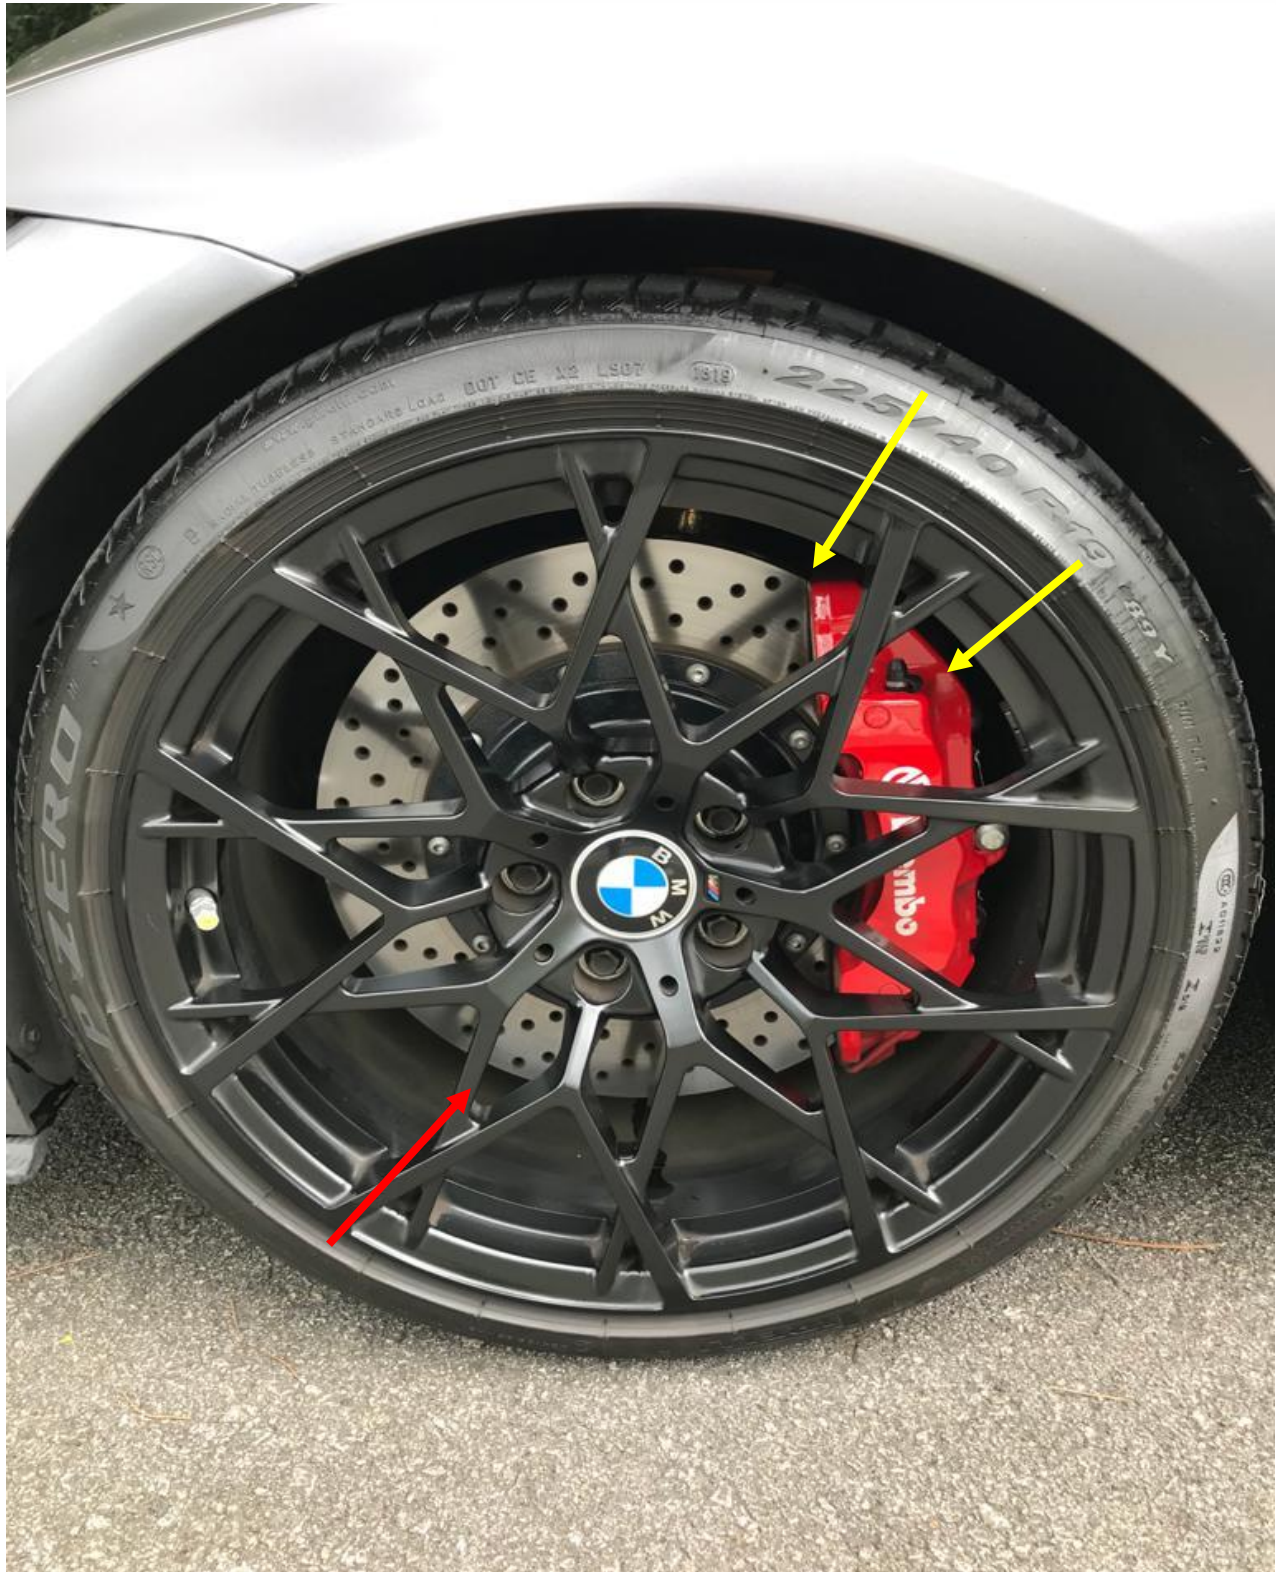
Photo 24 shows an aftermarket rim (red arrow) and upgraded brake caplier and disc brake (yellow arrow) on the Insured Vehicle at the material time.

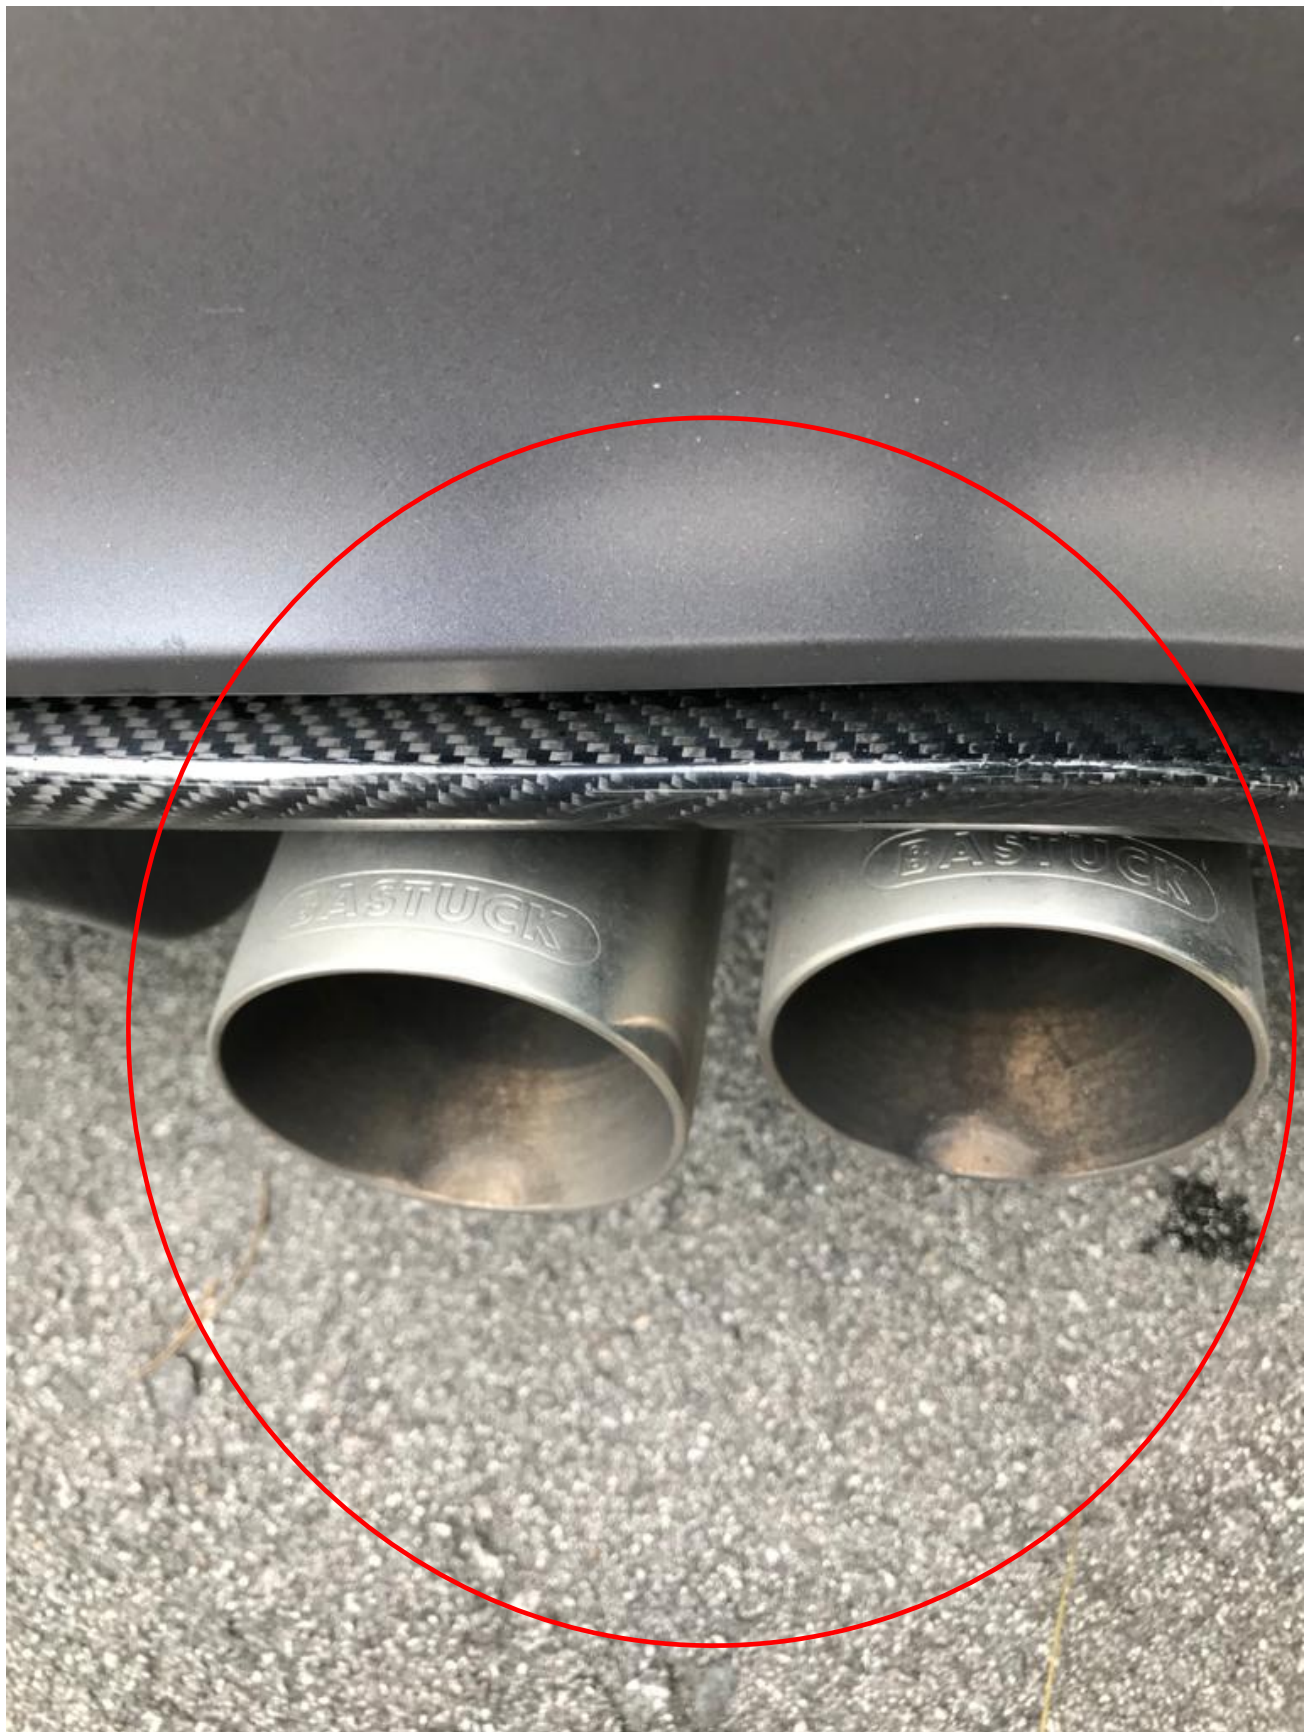
Photo 25 shows an aftermarket exhaust system (circled) on the Insured Vehicle at the material time.

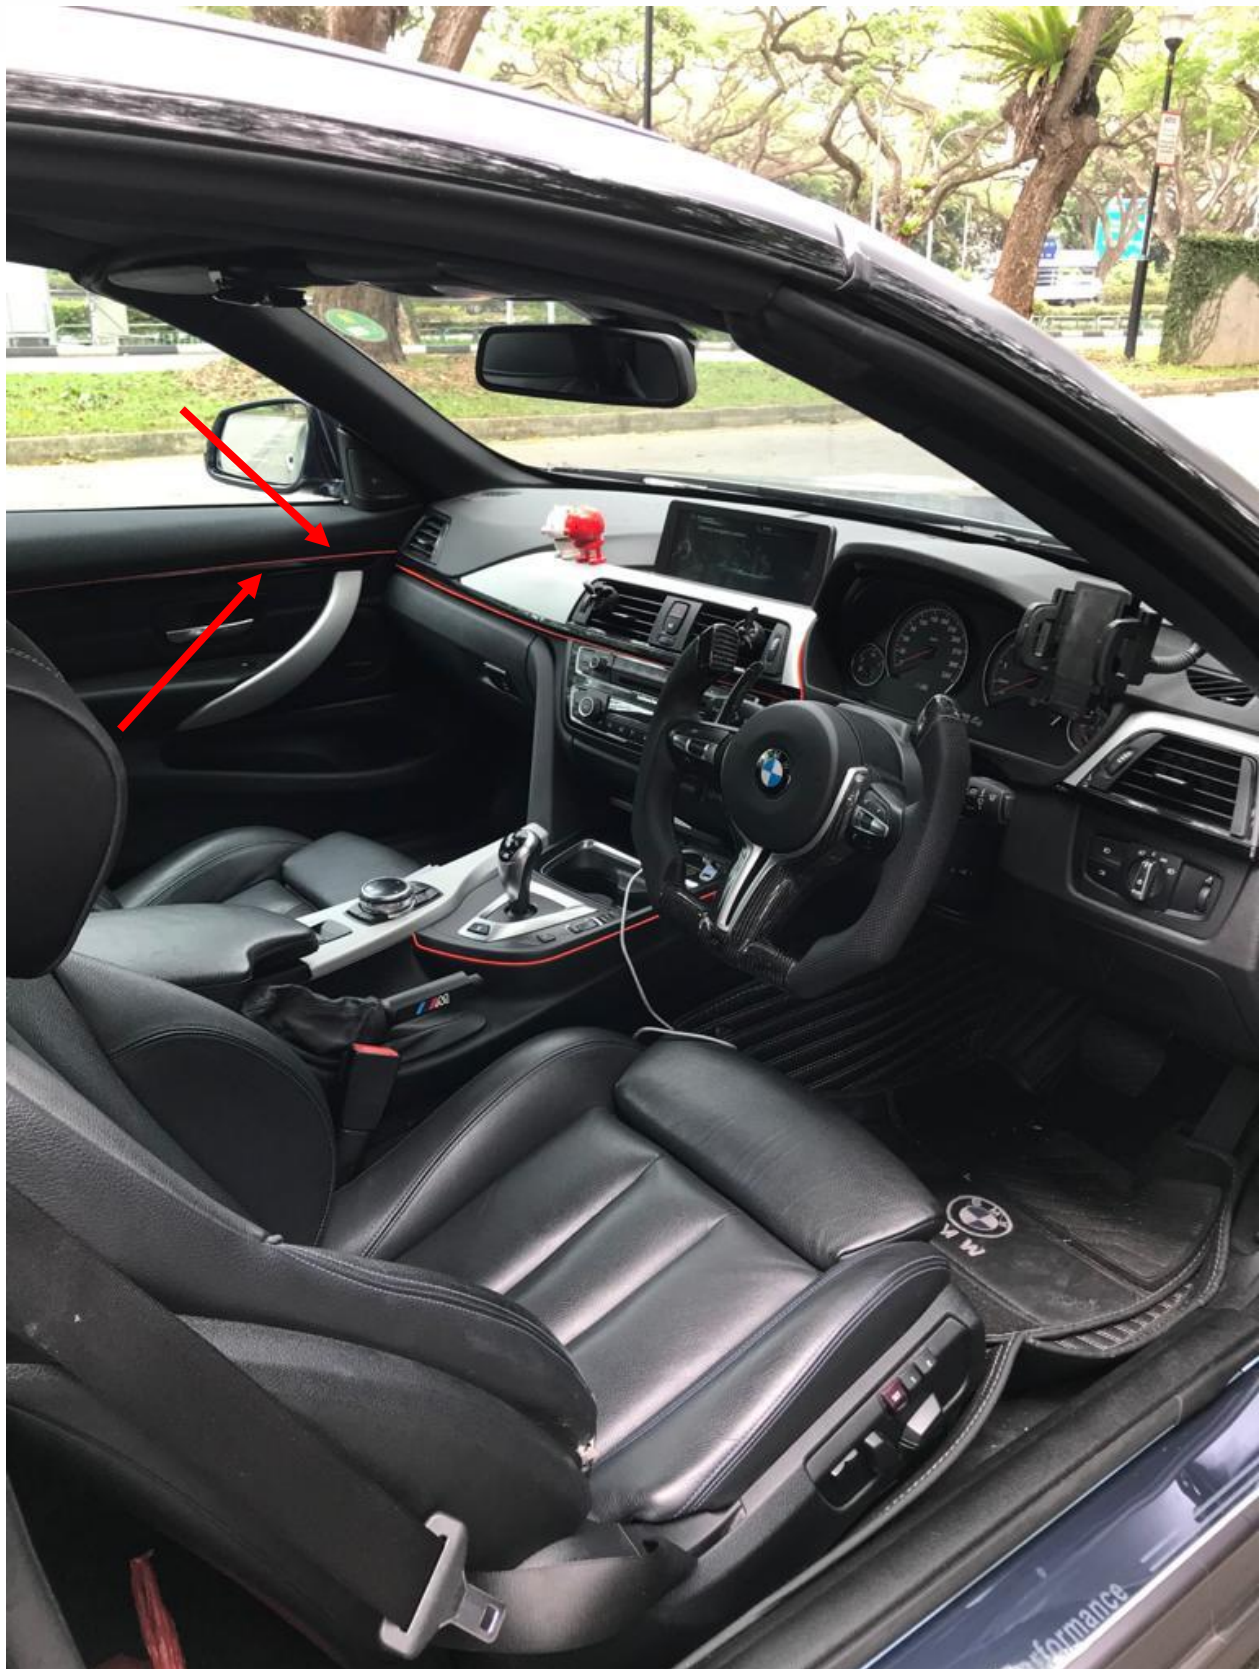
Photo 28 shows additional LED light strips that was already fitted at the front left door panel (arrowed) of the Insured Vehicle at the material time.

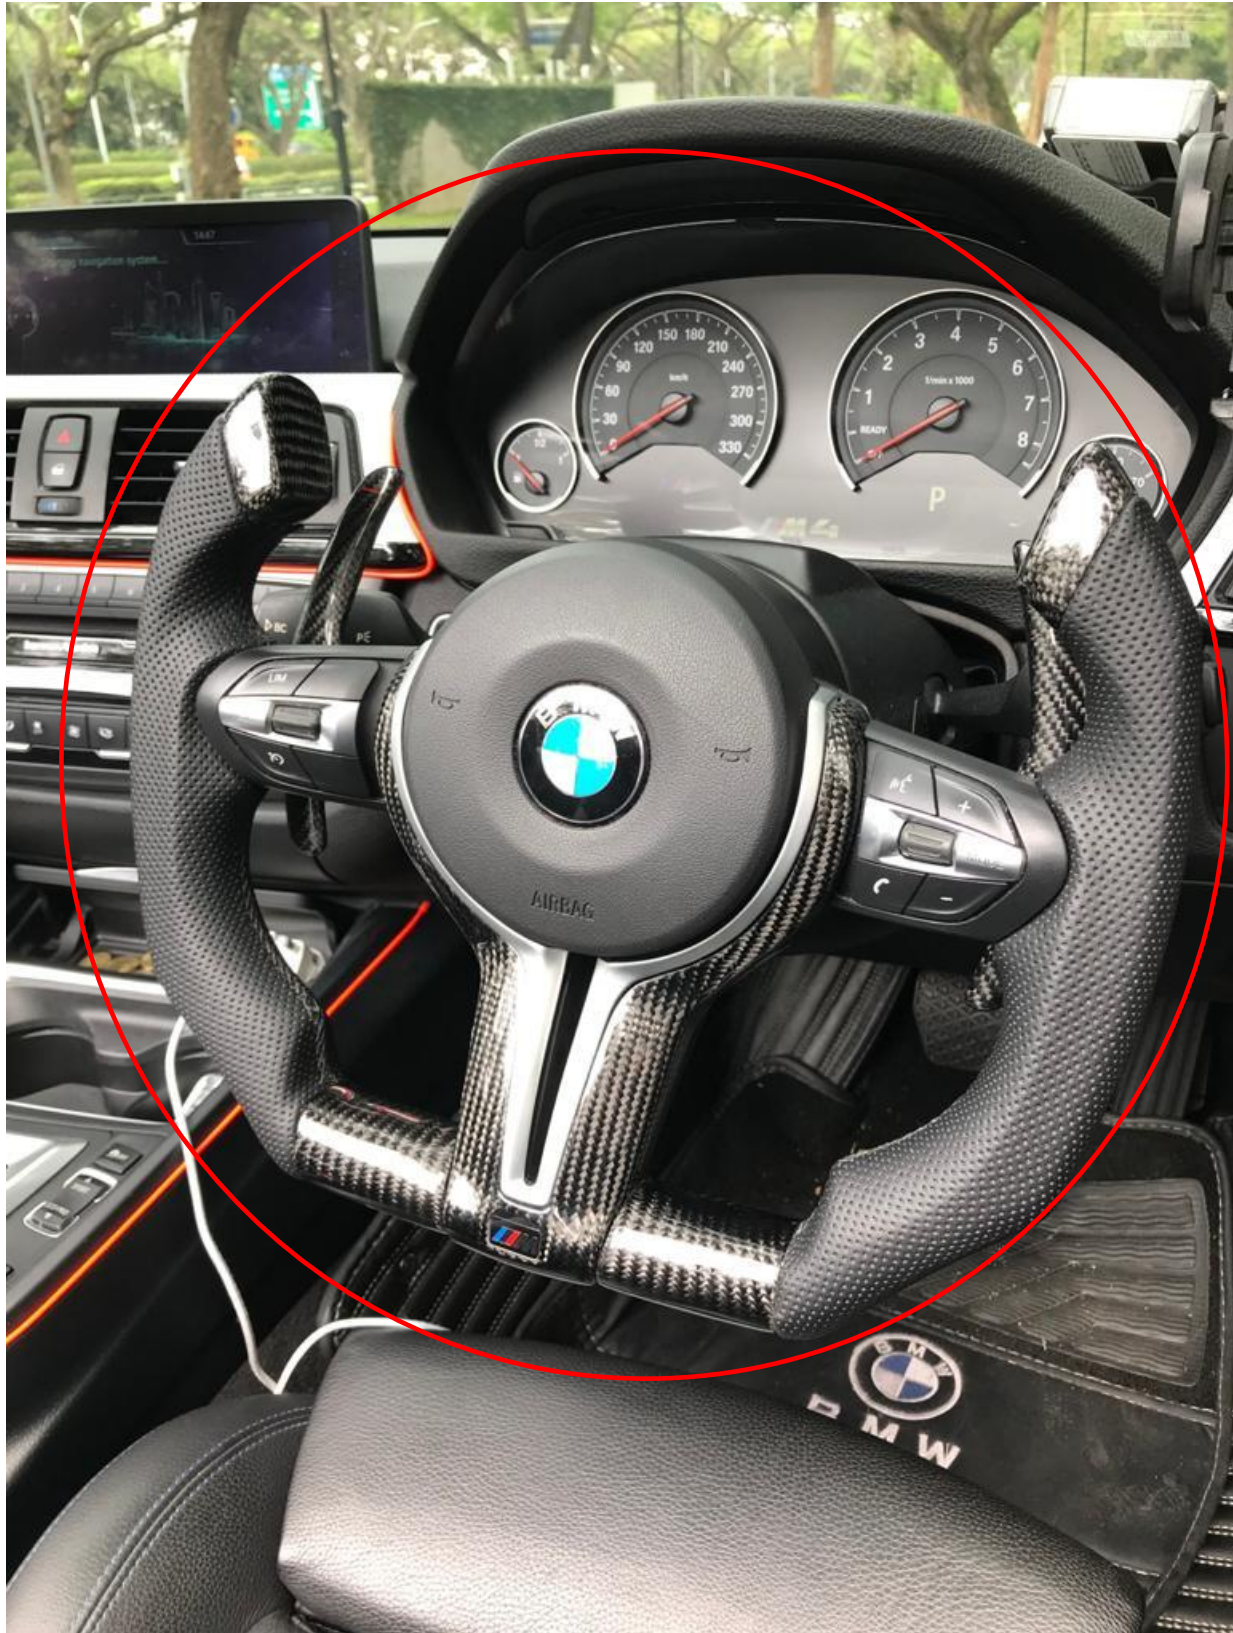
Photo 29 shows an aftermarket steering wheel (circled) on the Insured Vehicle at the material time.

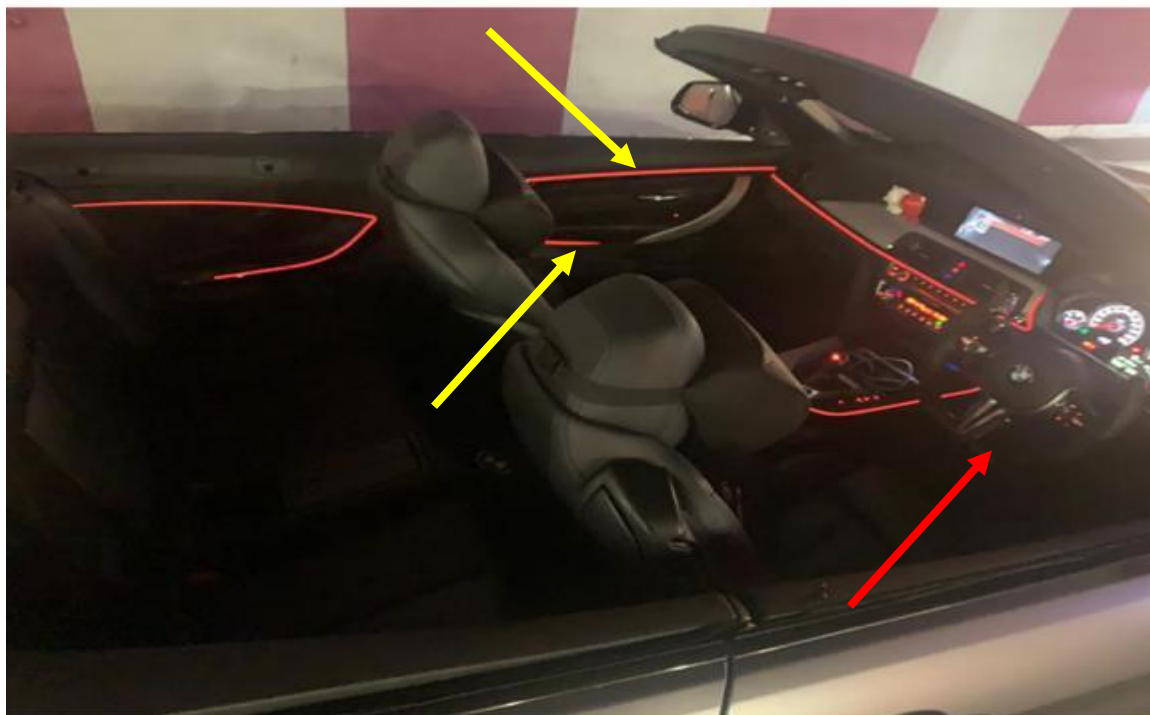
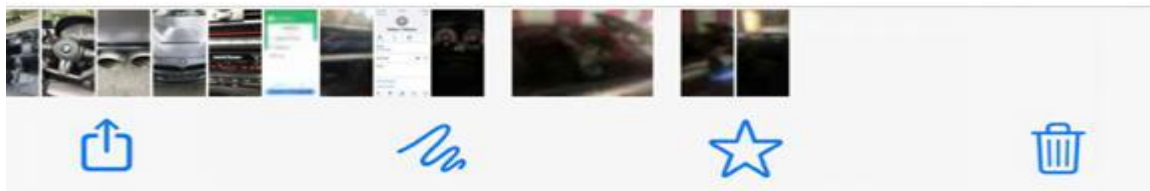
Photo 30 shows additional LED light strips at the front left door panel (yellow arrow) and the aftermarket steering wheel (red arrow) fitted on the Insured Vehicle. This photo is dated 27 January 2021 (circled) which is before the Insured Vehicle was purchase by Mr Harrison's wife.

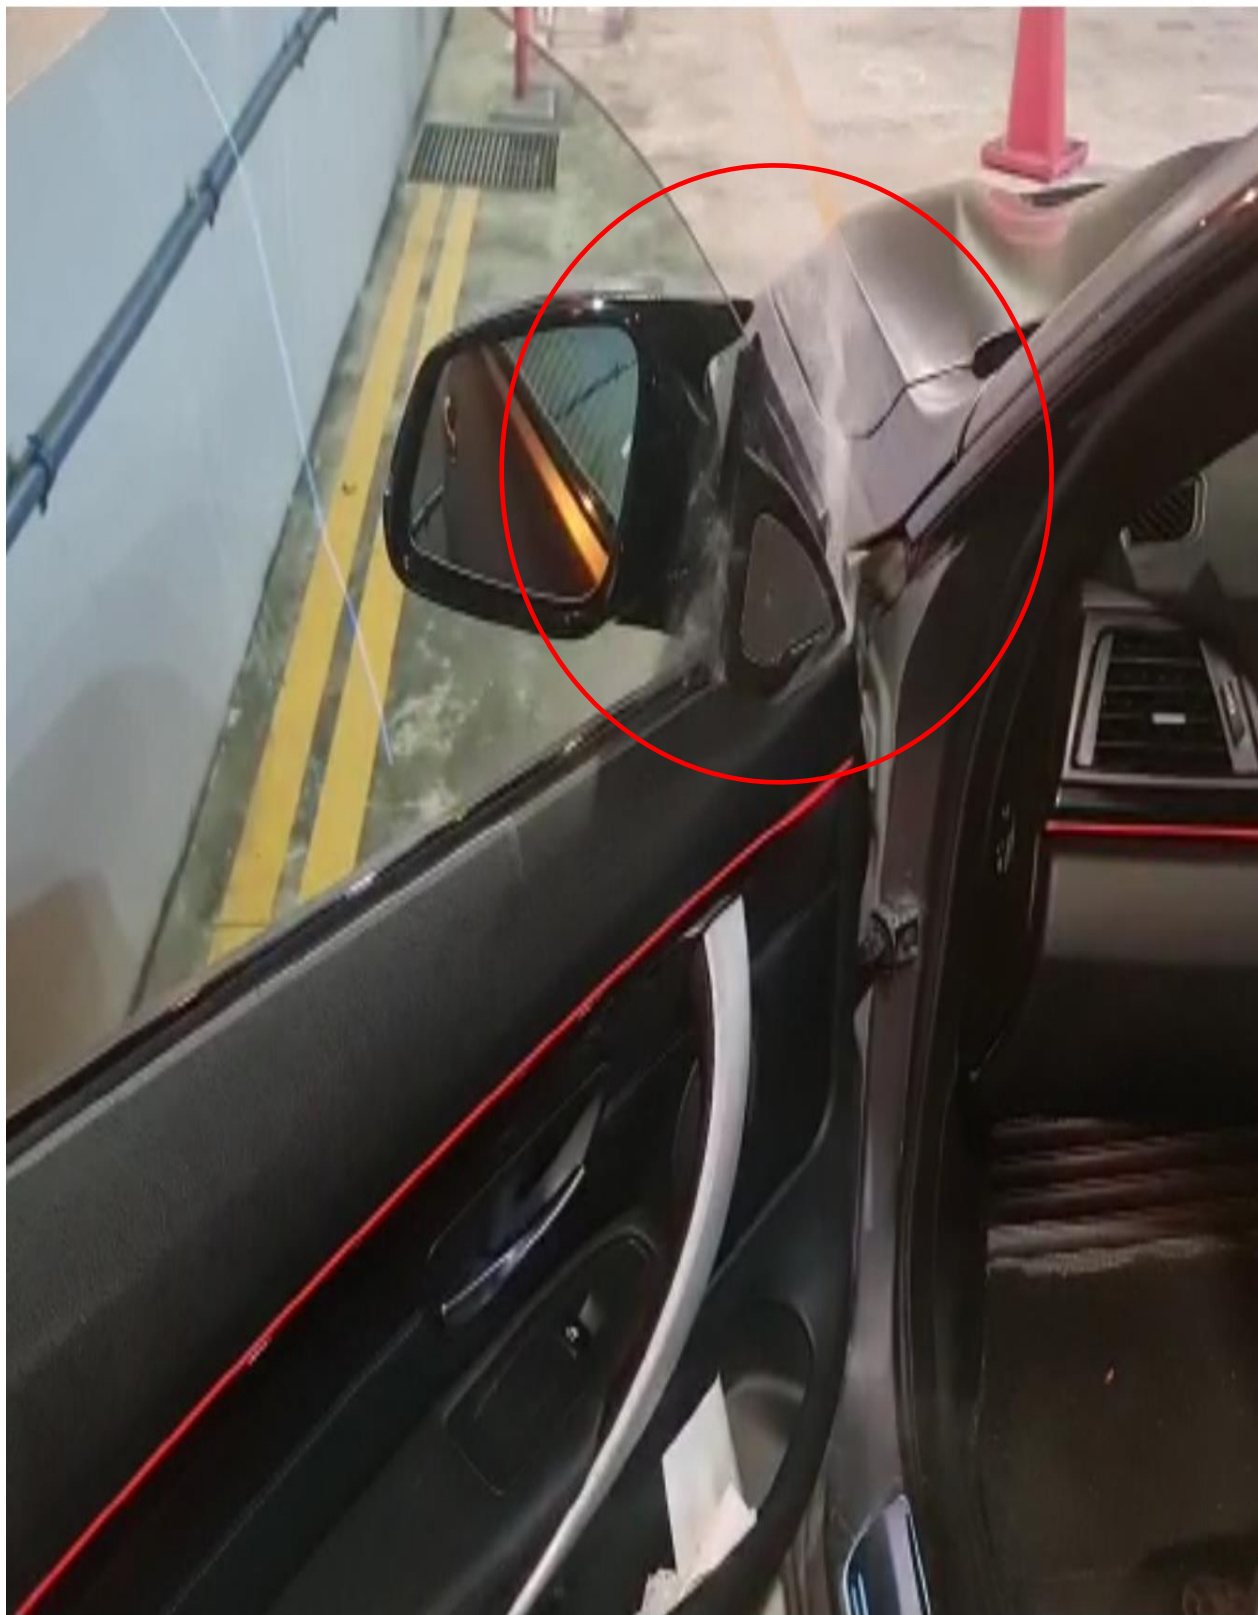
Photo 36 shows the front left door panel, where the fire had started on Insured Vehicle. Observed is smoke emitting out of the front left door panel (circled). In general, the information that could be gathered from this photograph had corresponded to the events that were related to us by Mr Harrison, location when the fire broke out.

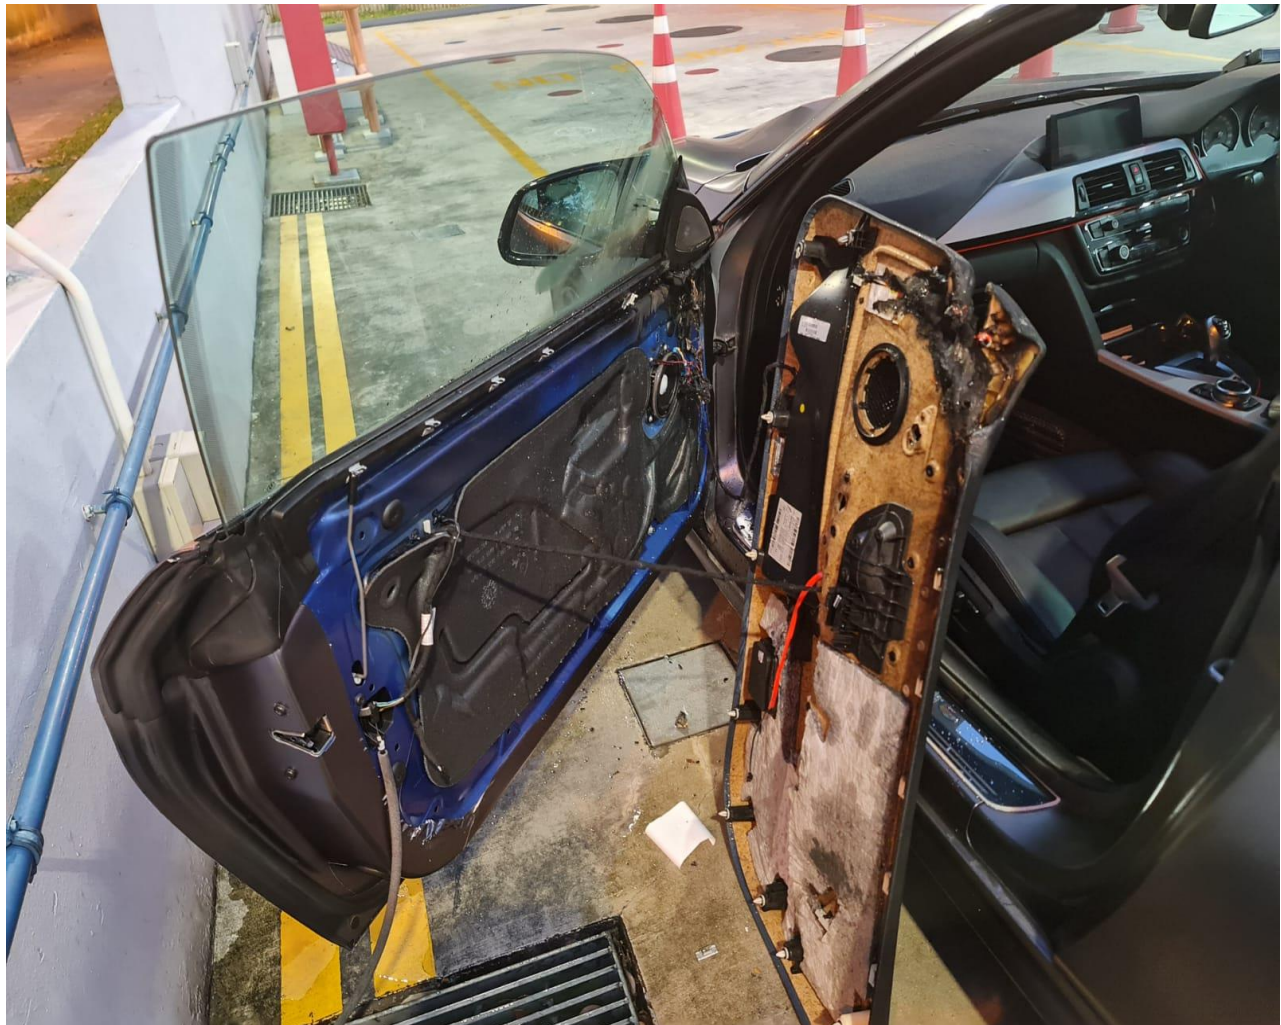
Photo 37 shows after the front left door panel was removed and the fire had been put on Insured Vehicle. In general, the information that could be gathered from this photograph had corresponded to the events that were related to us by Mr Harrison, location when the fire broke out.
