Our Reference : KAAS/6201/3564/TP/04.21
Date : 21 April 2021

VEHICLE APPRAISAL REPORT

Registration No.	: SMK3564H	Chassis Frame No.	: GB71085174
Make / Model	: Honda Freed Hybrid 1.5G (A)	Engine No. (Logcard)	: LEB5622719
Year of Manufacture/Reg	: 2018	Odometer Reading	: 173,256KM
Colour	: White		
Class / Type	: MPV

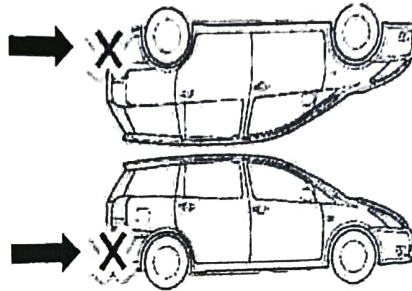
Damages sustained were consistent with the subject vehicle being involved in a collision with another vehicle and the impact was delivered

Squarely to the Rear

portion of the vehicle.

The general area of damages is at the
(Please refer to the parts list and photographs as attached for more information)

Rear portion
