Your Ref : 2940273368SG
Our Ref : CC4/AIG21006059/P

23rd June 2021

**AUTOMOBILE TECHNICAL INVESTIGATION REPORT OF ACCIDENT
INVOLVING SKT 1933R AND SMZ 1535B ON 14 MAY 2021**

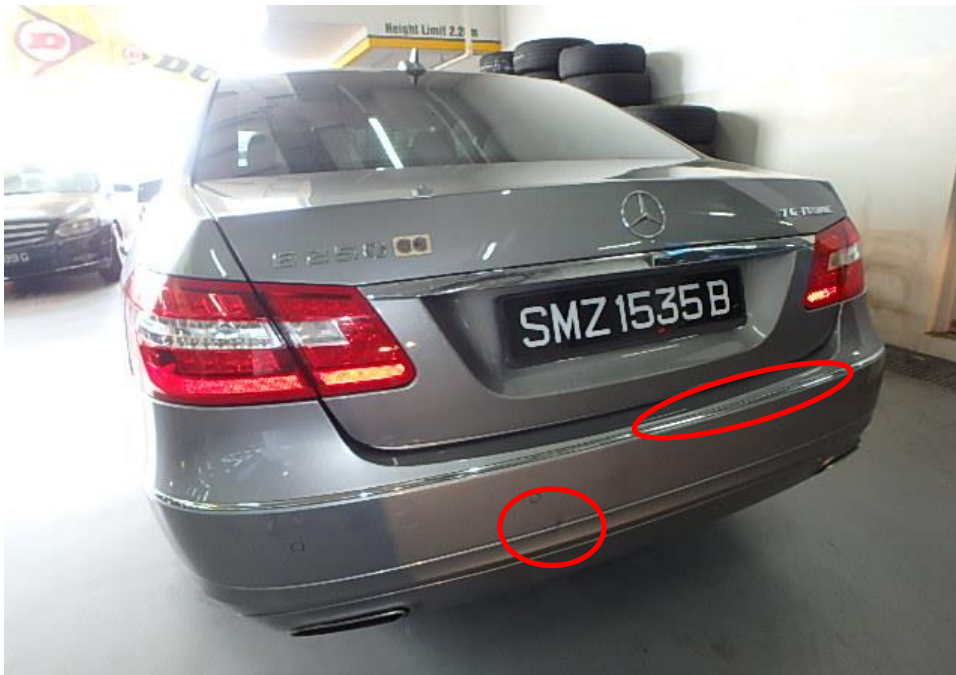
8. From the Vehicle Damage Inspection Report of Third Party by LKK Auto Consultants Pte. Ltd., we note that the Third Party had sustained damage onto its rear bumper portion. The main body part(s) listed as damaged in the report was the rear bumper and this was depicted in the photographs that were attached in the aforesaid report.
9. Examination of these photographs showed the rear bumper had been damaged. It was also noted that there were paint crack marks and dents on the rear bumper of Third Party. However there was neither a dislodgement nor misalignment of the rear bumper at the rear portion of Third Party See photos 1 – 4 below.

Photo 1 shows the general view of the rear portion of Third Party at the time of inspection. The rear bumper had been damaged. It was also noted that there were paint crack marks and dents (circled) on the rear bumper of Third Party.

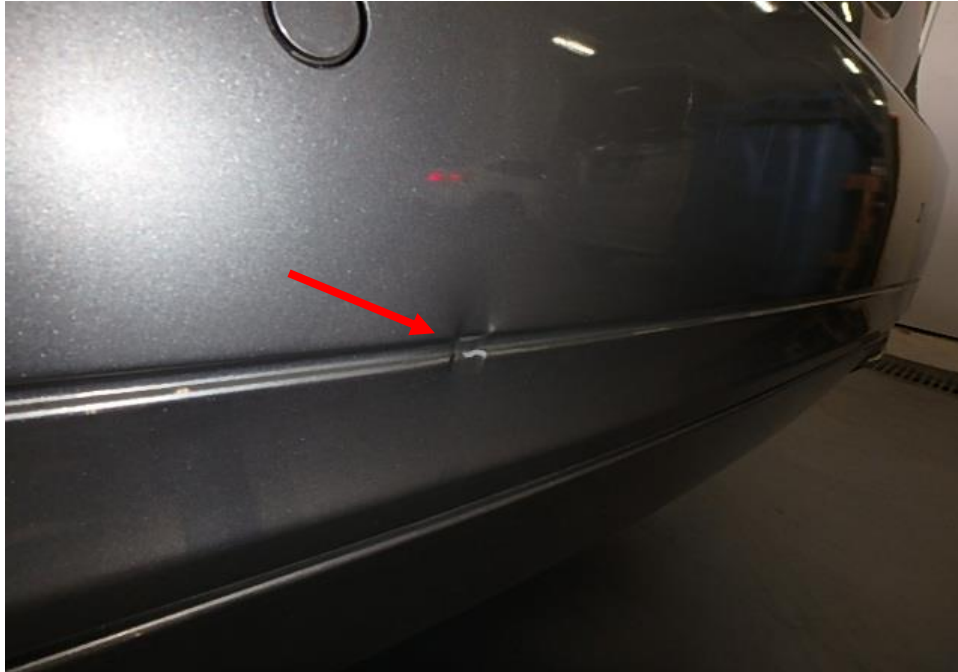
Photo 2 shows a close up view of the rear portion of the Third Party. We noted that there were dent marks on the rear bumper (arrowed).

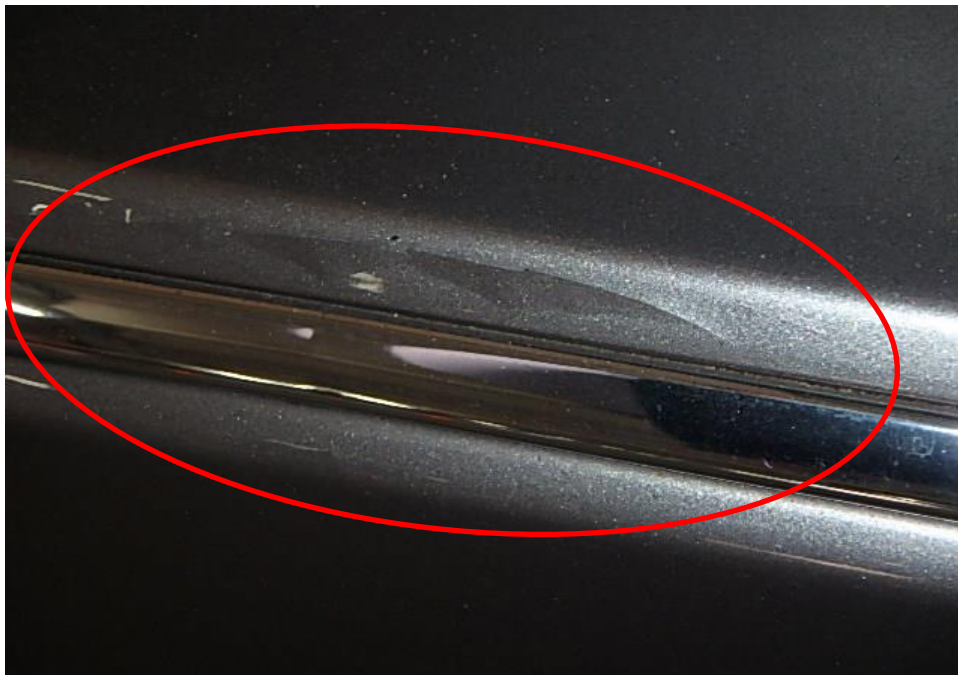
Photo 3 shows a close up view of the rear portion of the Third Party. We noted that there were paint crack marks on the rear bumper (circled).

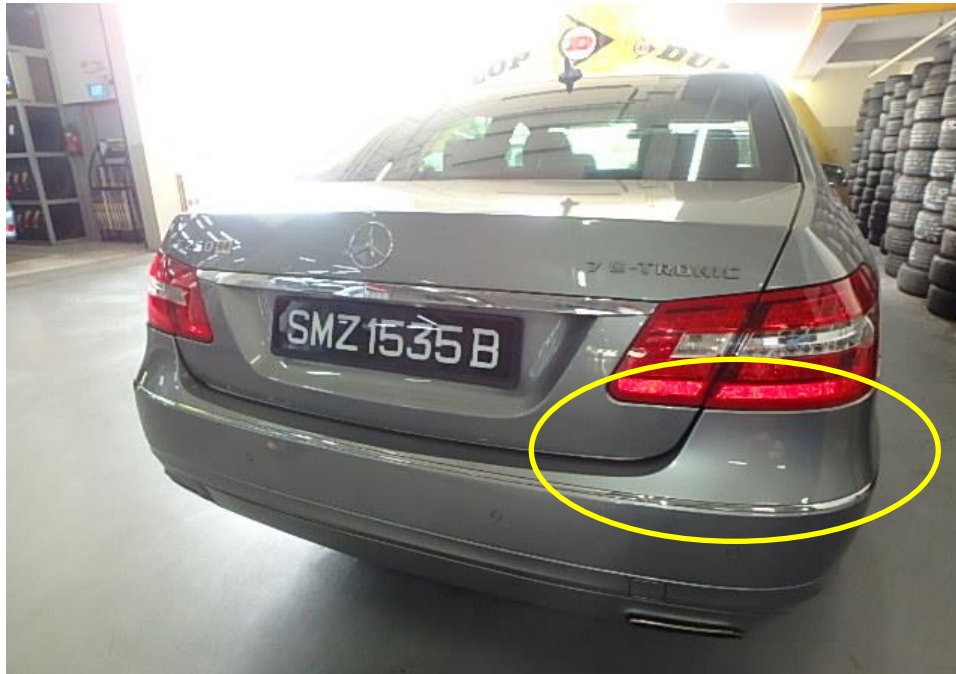
Photo 4 shows a close up view of the rear portion of the Third Party. We note that there was neither dislodgement nor misalignment of the rear bumper at the rear portion (circled) of Third Party.

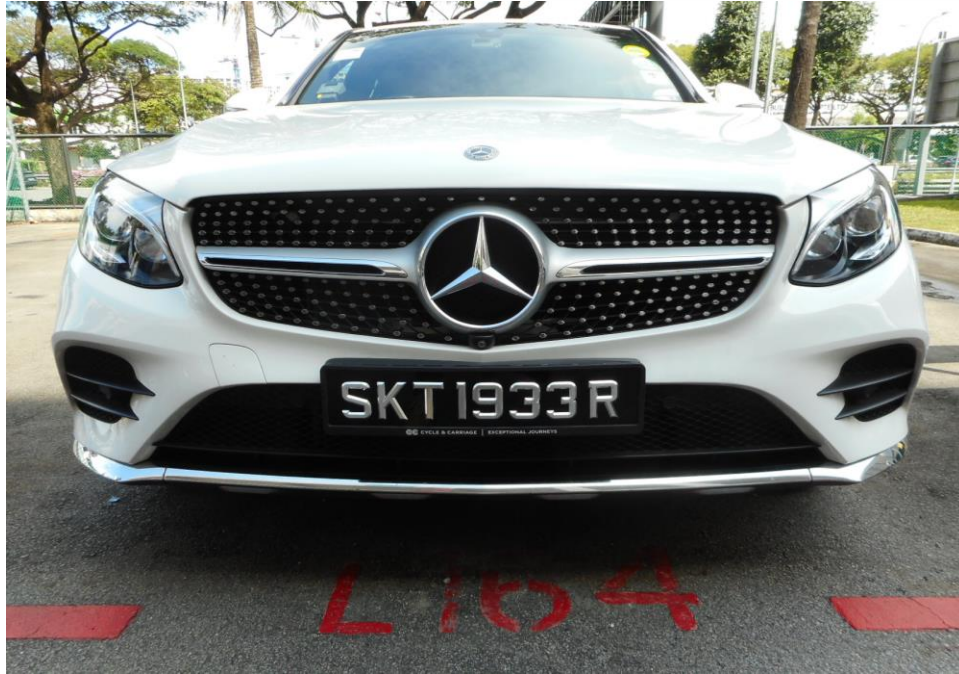
Photo 5 shows the general view of the front portion of Insured at the time of our inspection.

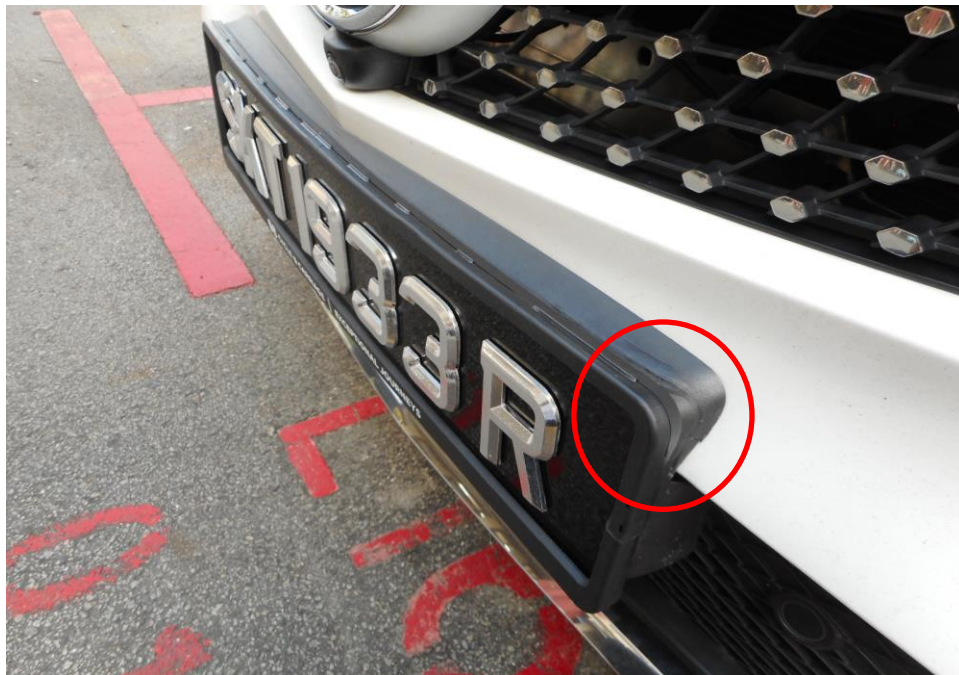
10. The Insured was physically inspected on 16 June 2021 at the premises of LKK Auto Consultants, at 51 Ubi Avenue 1, #01-25 Paya Ubi Industrial Park, 408933. The mileage recorded was 55,813km.
11. Based on the circumstances of the accident as iterated by Mary, we are of the opinion that the point of contact of Insured would be at its rear portion since Insured was behind Third Party at the mentioned point of collision. At the time of our inspection, Insured was observed to have sustained crack marks to its front number plate holder at its front bumper.
12. Insured driver Mr Gilbert had mentioned that prior to the height measurement inspection with us, his vehicle was involved in a head to rear collision with another vehicle that had caused the crack marks to its front number plate holder and the matter was settled privately that the other party. See photos 5 - 7 below.

Photo 6 shows a close up view of the Insured front portion. We observed crack marks on the front number plate holder (circled).

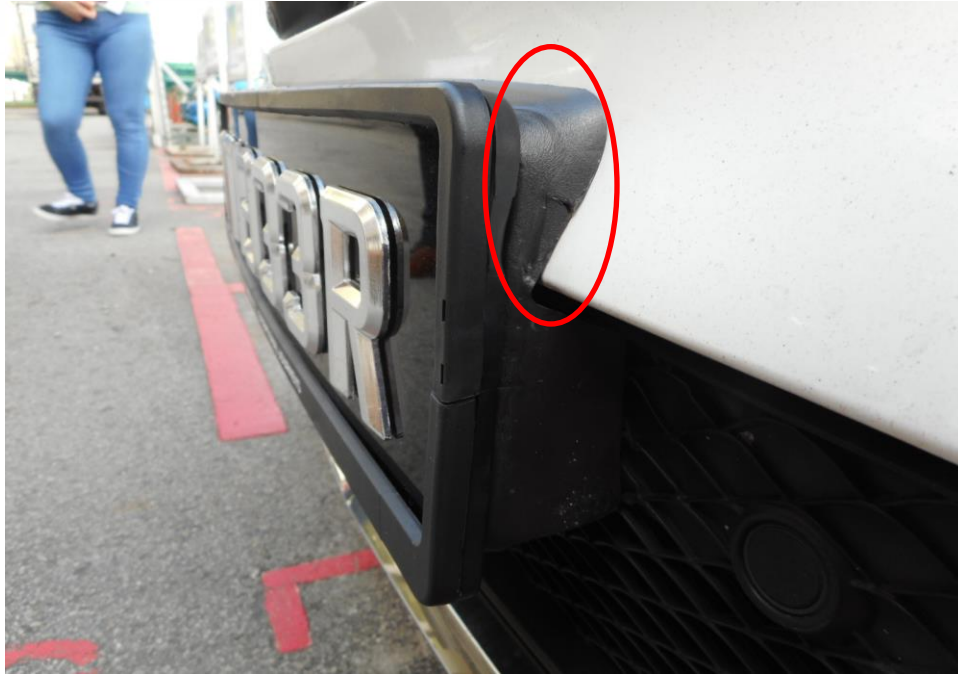
Photo 7 shows a close up view of the Insured front portion. We observed crack marks on the front number plate holder of the front bumper (circled).

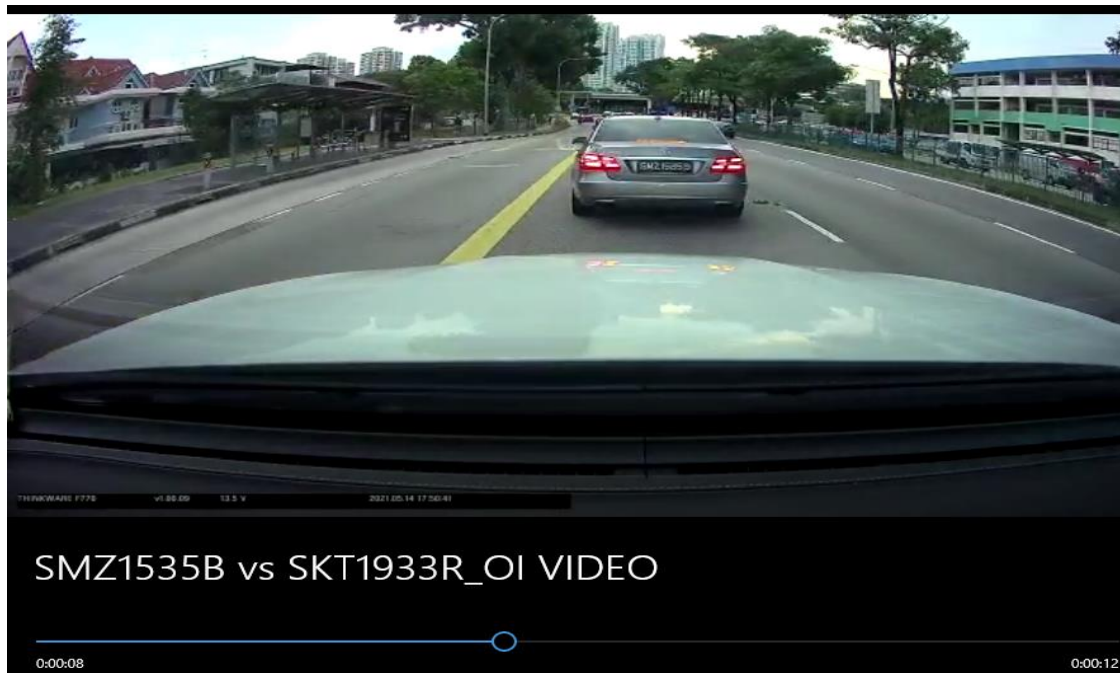
Screenshot 1 shows at the 8 second mark of the video recording, we had noted that Insured was travelling behind Third Party when Third Party had jammed brake.

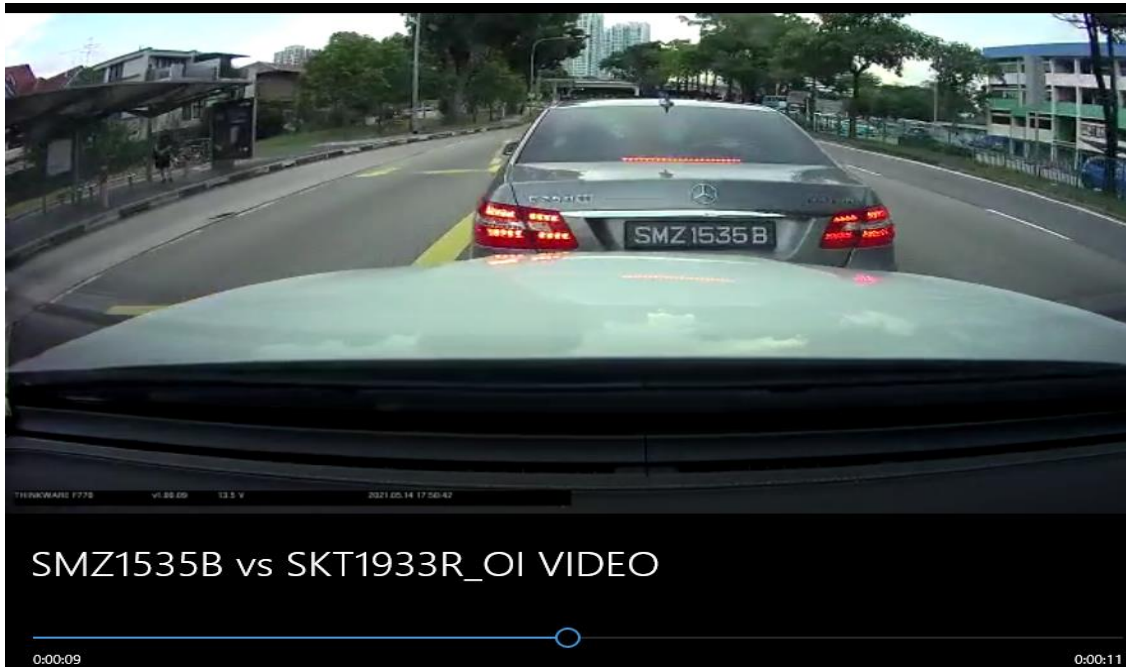
Screenshot 2 shows at the 9 second mark Insured's vehicle Auto collision system had activated and the vehicle had braked into the rear of Third Party and this is where the said collision might have taken place. However one would have to view the recordings to see and hear the movements and audio warnings.

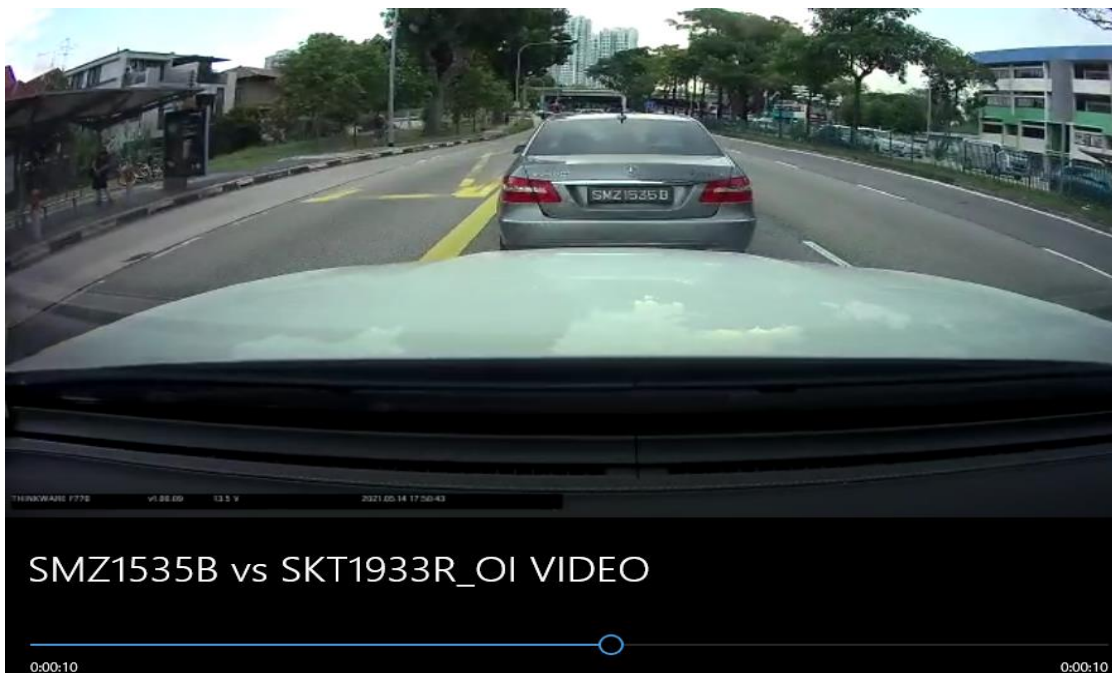
Screenshot 3 shows at the 10 second mark Third Party had started to move off afterwards. However one would have to view the recordings to see and hear the movements and audio warnings.

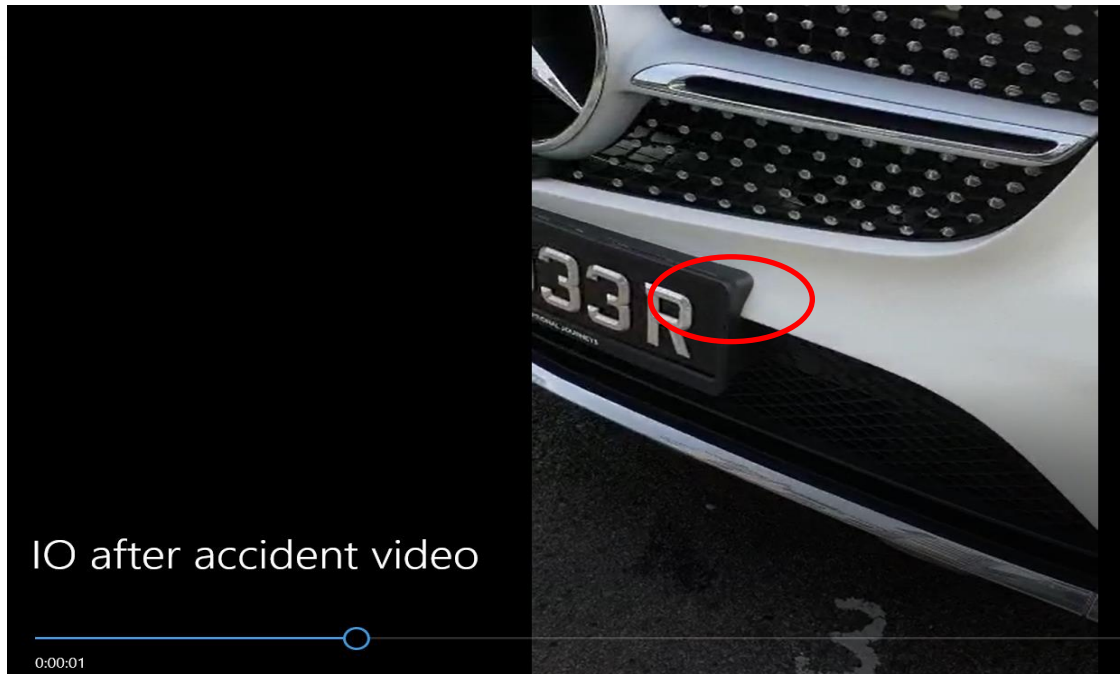
15. Insured had also send provided us with a with a video recording showing the front number plate holder was intact did not sustain any damage after the said collision. The length (duration) indicated in the video recordings was 9 seconds. At the 1 second mark, we observed that the front number plate holder of the Insured Vehicle to be intact and did not sustain any damaged to it. However, one would have to view the recordings to see movements. See screenshot 4 below.

Screenshot 4 shows at the 1 second mark, we observed that the front number plate holder (circled) of the Insured Vehicle to be intact and did not sustain any damaged to it. However, one would have to view the recordings to see and the movements. See screenshot 6 below.

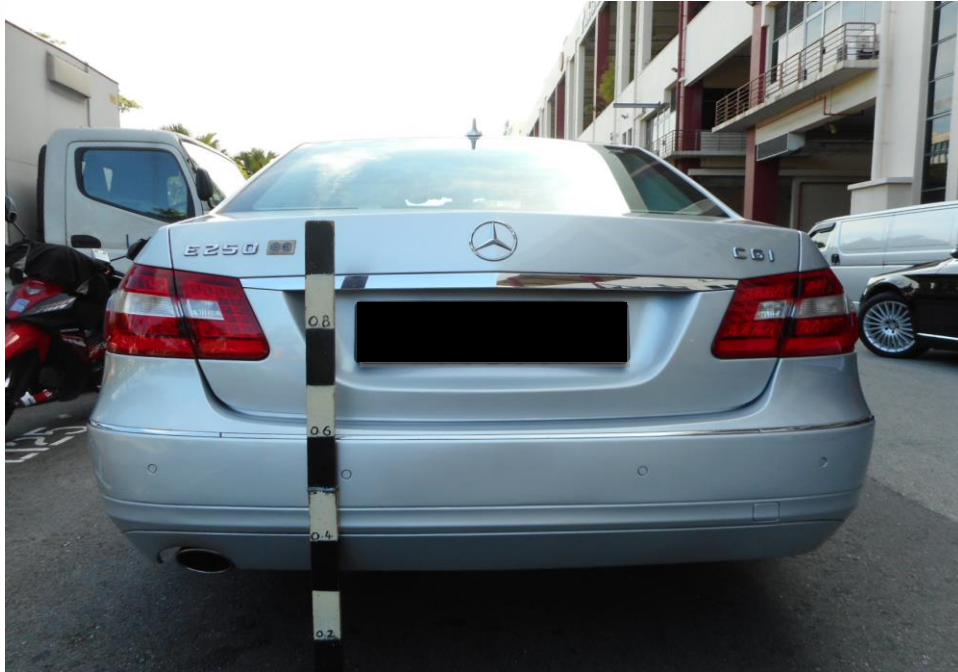
Photo 8 shows the general view of the height measurement being conducted on the rear portion of Third Party. The height above ground level of where the damages were found to the rear bumper of the Third Party was at 58cm and 46cm.

- a) the height above ground level of the range of damages (which included the dents and crack marks on the rear portion rear bumper of Third Party) was measured to be approximately at 58cm to 46cm;
- b) the height above ground level of the crack marks that we observed on the front portion front number plate holder of Insured was measured to be between 48cm to 53cm respectively;
- c) The height measurements appear to suggest that there was no possible contact between the rear portion of Third Party and the front portion of Insured. The damage observed on the rear portion of Third Party was not a result of this contact and does not correspond to the damage observed on the front portion of the Insured.

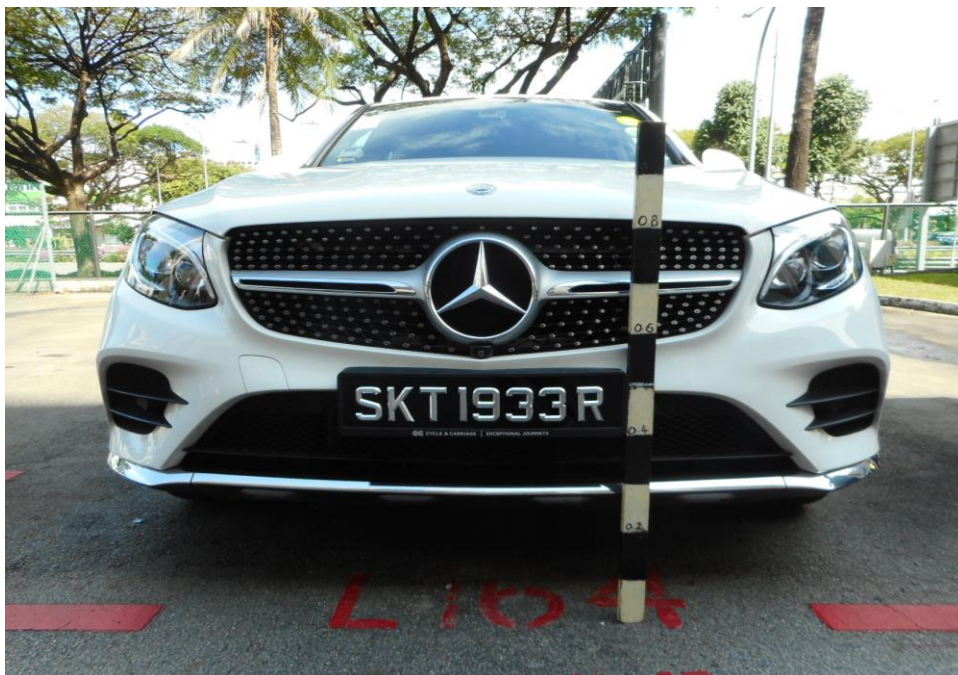
Photo 9 shows a general view of the height measurement being conducted on the front portion of Insured. The crack marks found on the front number plate holder was measured to be between 48cm to 53cm above ground level.

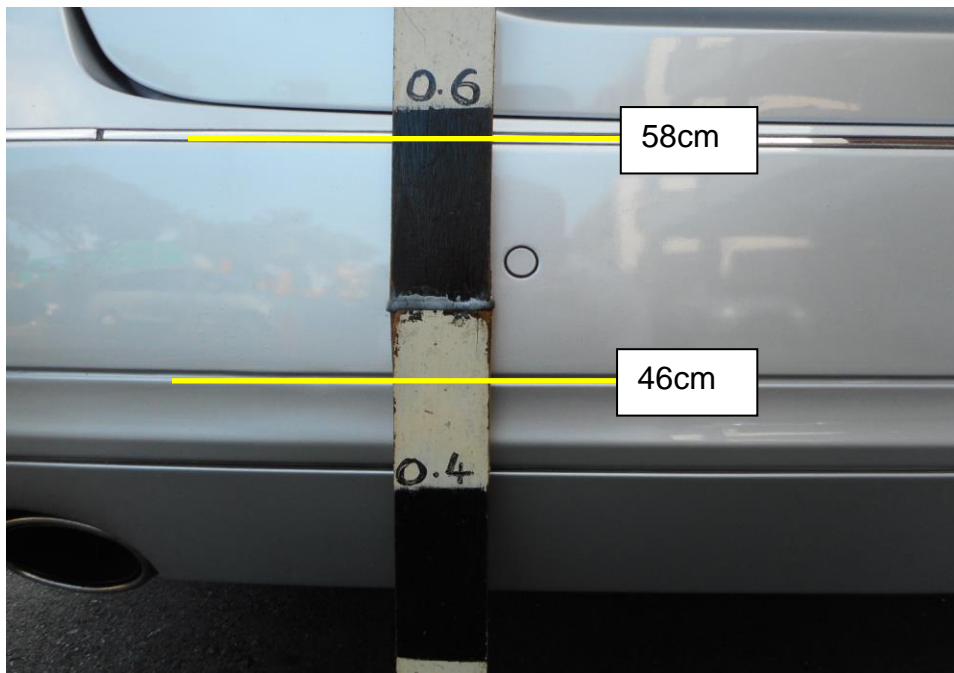
Photo 10 shows the close up view of the height measurement being conducted on the rear portion of Third Party. The height above ground level of where the damages were found to the rear bumper of the Third Party was at 58cm and 46cm.

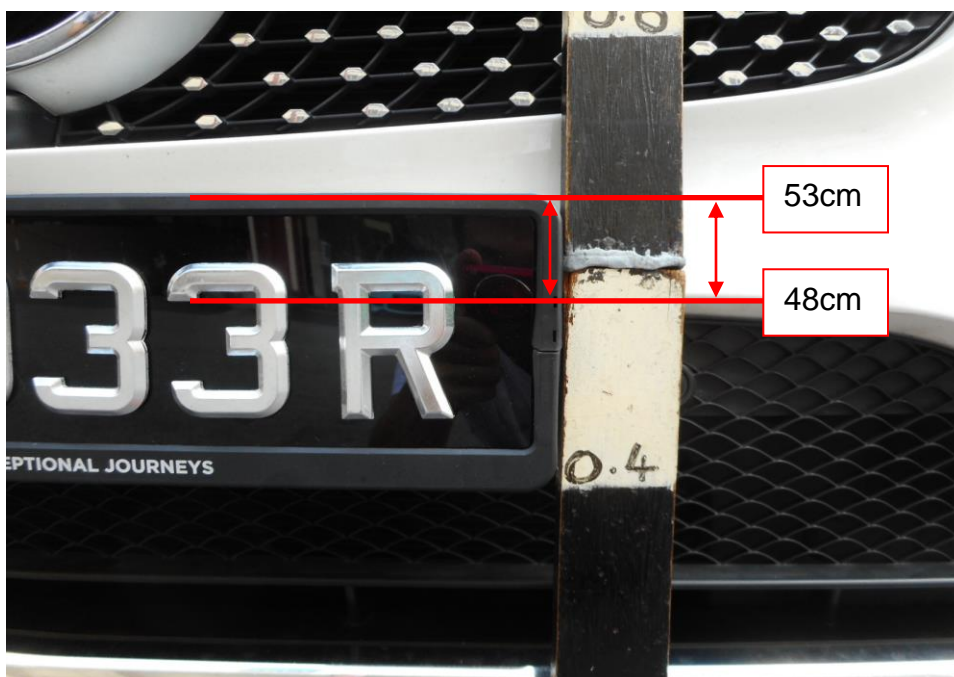
Photo 11 shows the close up view of the height measurement being conducted on the front portion of Insured. The crack marks found on the front number plate holder was measured to be between 48cm to 53cm above ground level.
