Your Ref: BMW 530i
(chassis number WBAJR32050WW84708)
Our Ref : CI/TP21006065/D

24 May 2021

**INSPECTION REPORT OF AN UNREGISTERD BMW 530i MOTOR CAR WITH
CHASSIS NUMBER WBAJR32050WW84708**

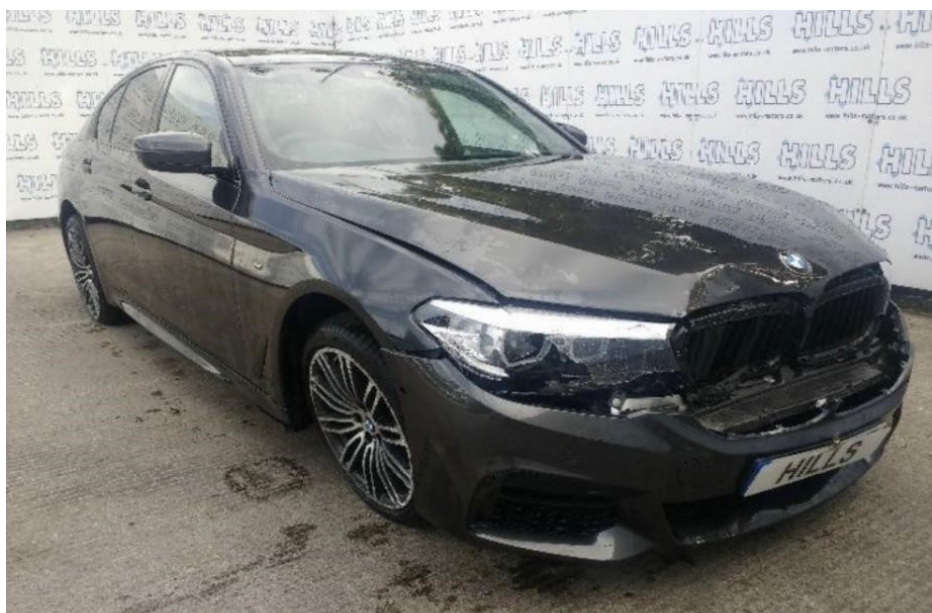
Photo 1 shows the front right body of the Motor Car (photograph provided to me). The Motor Car was observed to have sustained damage at its frontal portion. The front bumper, front grilles, front bonnet, front right fender and front right headlamp were amongst the body parts that were observed to have been damaged. The orientation of the front right wheel suggests to me that the front right undercarriage parts of the Motor Car were also damaged.

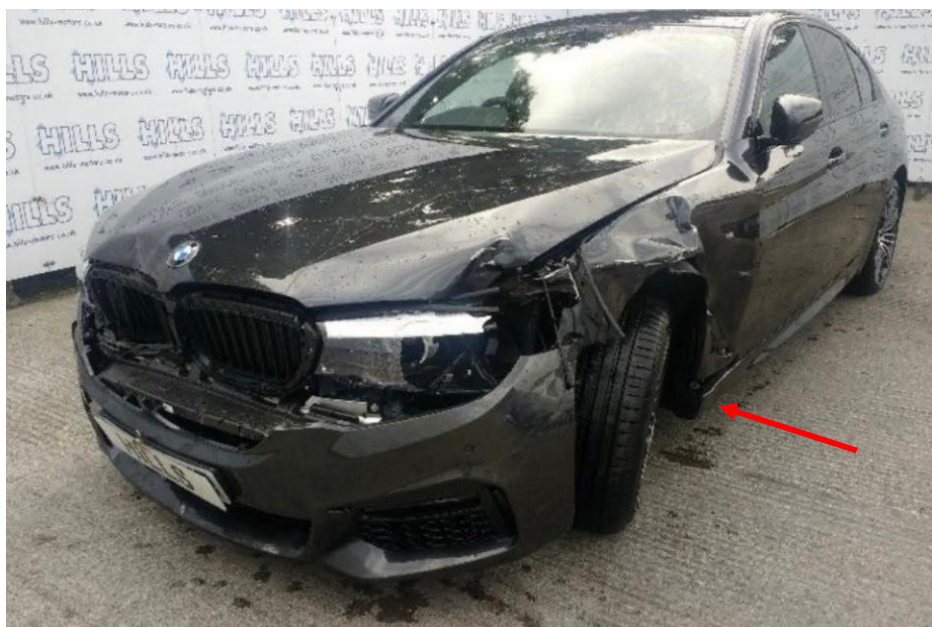
Photo 2 shows the front left body of the Motor Car (photograph provided to me). The Motor Car was observed to have sustained damage at its frontal portion. The front bumper, front bumper reinforcement, front bumper sponge, front bonnet, front left fender, front left headlamp and left side rocker panel garnish (arrowed) were amongst the body parts that were observed to have been damaged. The orientation of the front left wheel suggests to me that the front left undercarriage parts of the Motor Car were also damaged.

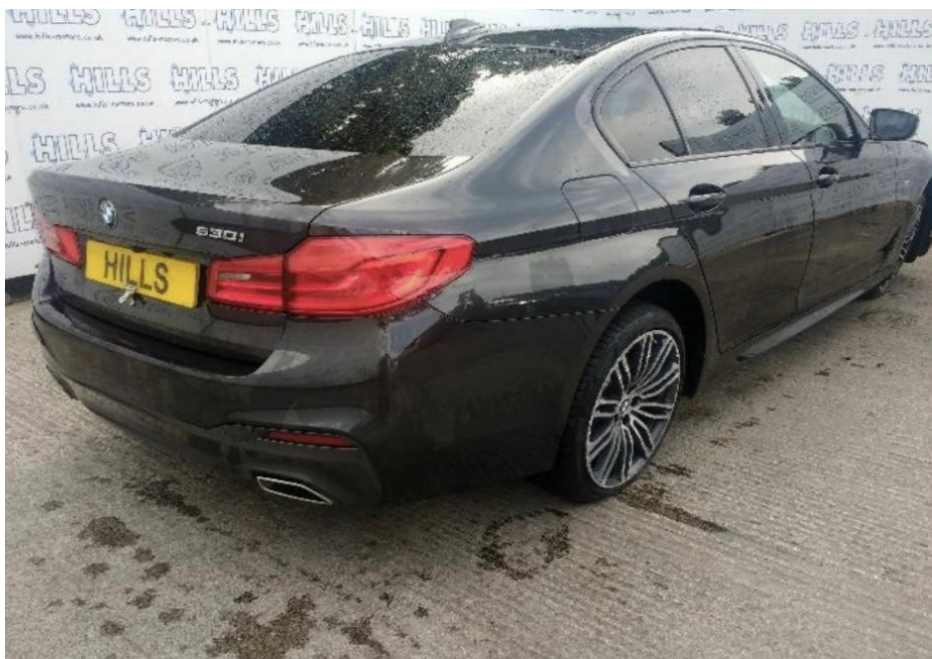
Photo 3 shows the rear right body of the Motor Car (photograph provided to me). Apart for the frontal portion, there was no physical damage seen to other areas of the Motor Car.

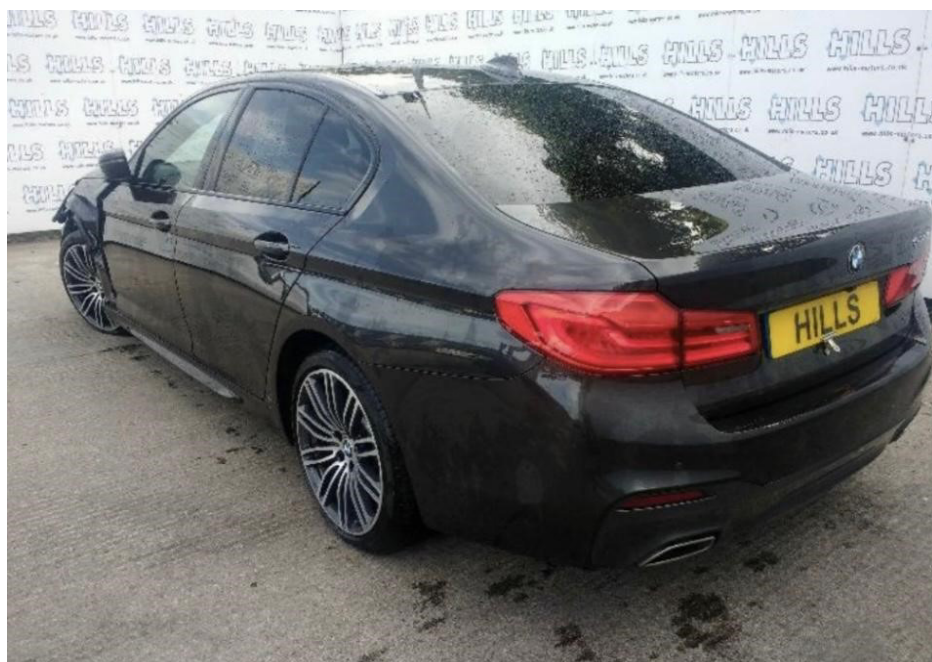
Photo 4 shows the rear left body of the Motor Car (photograph provided to me). Apart for the frontal portion, there was no physical damage seen to other areas of the Motor Car.

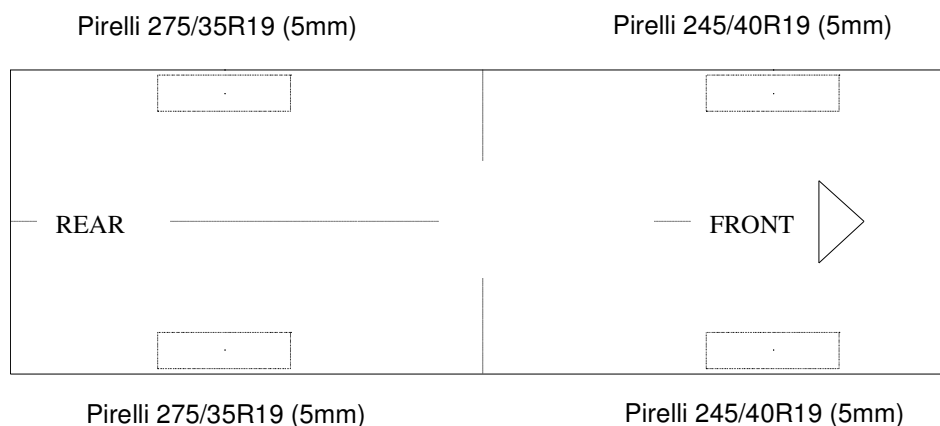
8. It was fitted with 19inch sport wheel rims that were wrapped with tyres that were observed to be of serviceable condition. The tyres were also sufficiently inflated for vehicular operation. The tyre brand, tyre size and approximate remaining tread depth of the 4 tyres of the Motor Car were recorded as follows: -

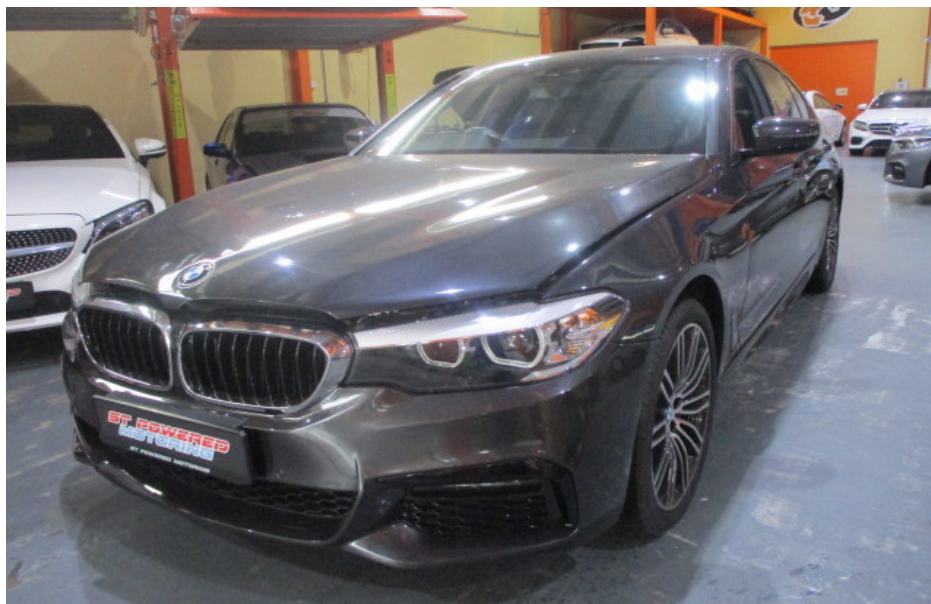
Photo 5 shows a general view of the front left body of the Motor Car at the time of my inspection. The Motor Car was observed to be in a relatively good general condition with no loose exterior fittings observed. The body parts at the frontal portion of the Motor Car were visually examined and it was observed that the repair/restoration works carried out to the damaged area of the Motor Car (refer to photograph 2 above) were reasonably adequate and in order.

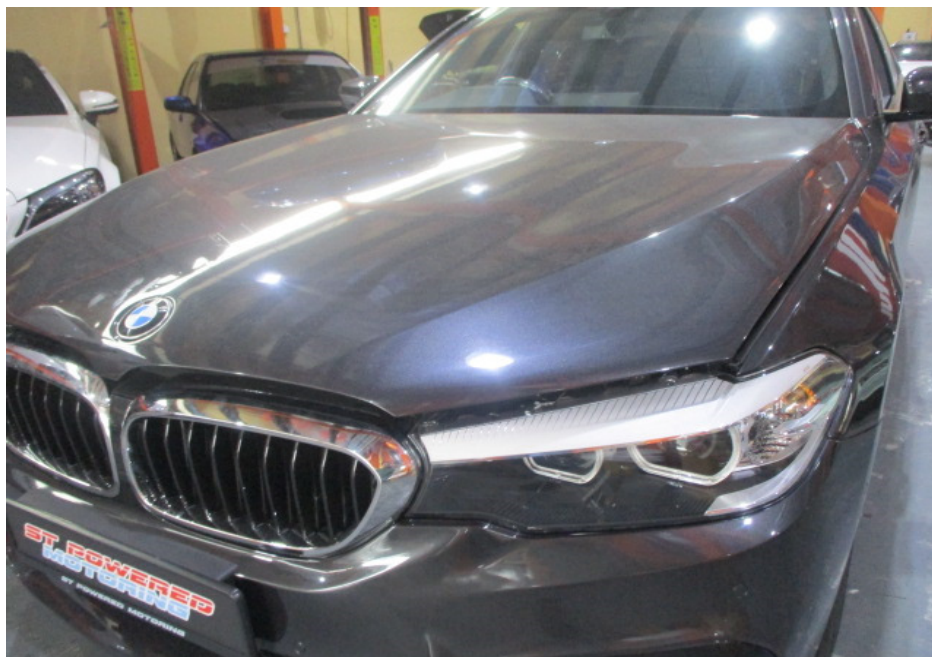
Photo 6 shows a closer view of the front bumper, front grilles, front bonnet, front left headlamp and front left fender of the Motor Car at the time of my inspection. The body parts at the frontal portion of the Motor Car were visually examined and it was observed that the repair/restoration works carried out to the damaged area of the Motor Car (refer to photograph 2 above) were reasonably adequate and in order.

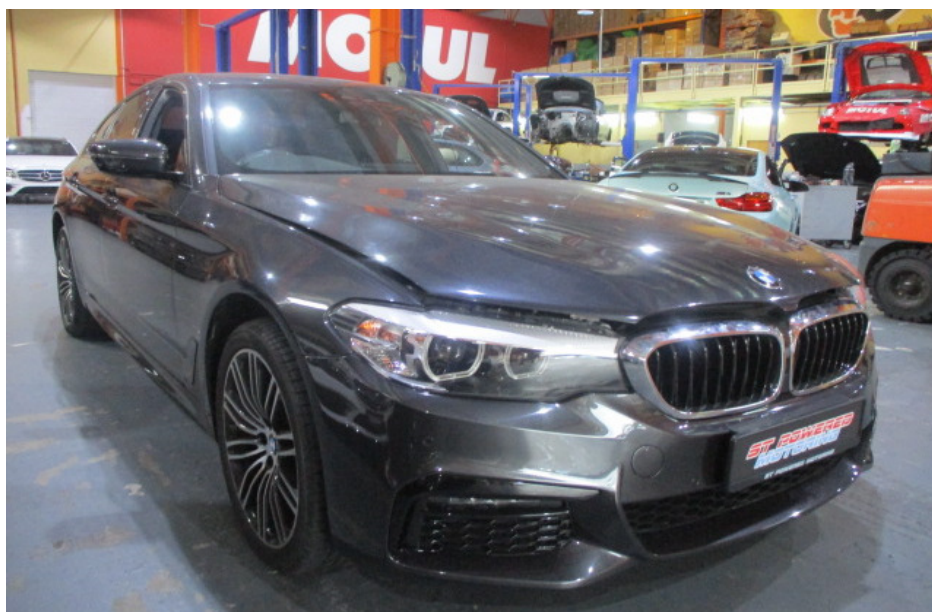
Photo 7 shows a general view of the front right body of the Motor Car at the time of my inspection. The Motor Car was observed to be in a relatively good general condition with no loose exterior fittings observed. The body parts at the frontal portion of the Motor Car were visually examined and it was observed that the repair/restoration works carried out to the damaged area of the Motor Car (refer to photograph 1 above) were reasonably adequate and in order.

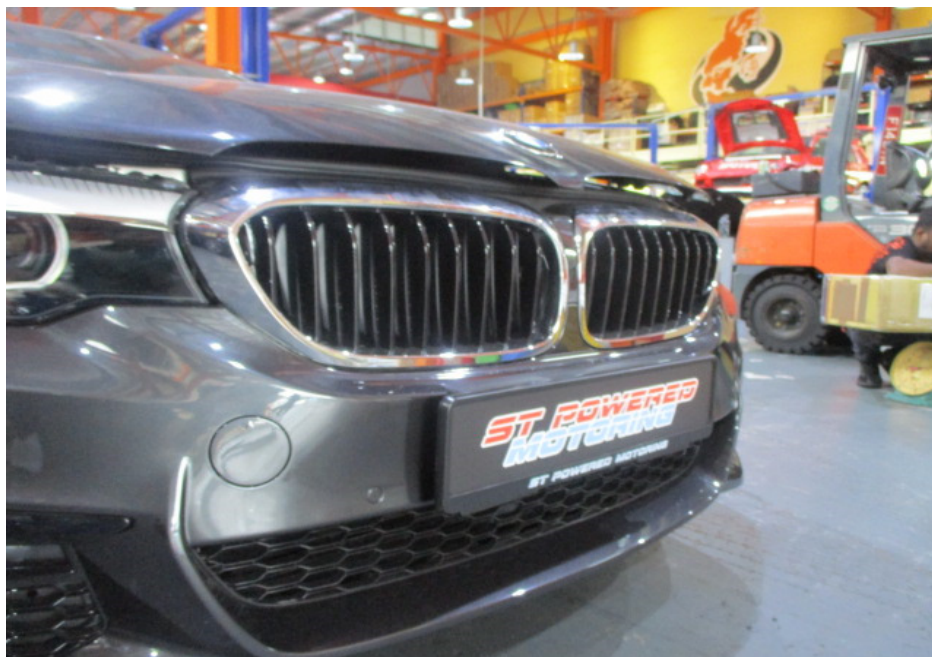
Photo 8 shows a closer view of the front bumper, front grilles, front bonnet and front right headlamp of the Motor Car at the time of my inspection. The body parts at the frontal portion of the Motor Car were visually examined and it was observed that the repair/restoration works carried out to the damaged area of the Motor Car (refer to photograph 1 above) were reasonably adequate and in order.

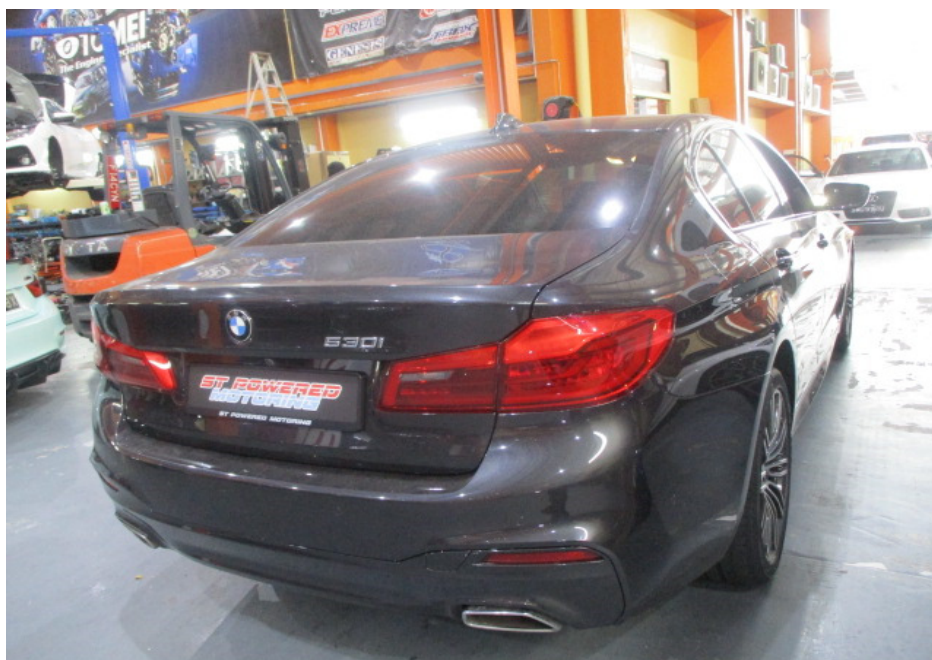
Photo 9 shows a general view of the rear right body of the Motor Car at the time of my inspection. The Motor Car was observed to be in a relatively good general condition with no loose exterior fittings observed. The mileage of the Motor Car recorded at the time of my inspection was 12,850km.

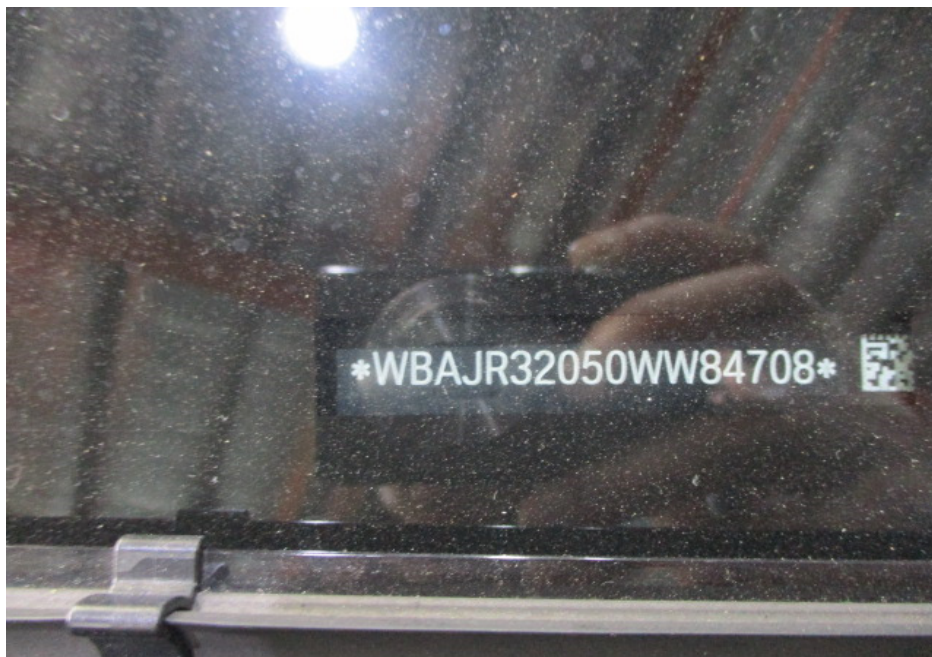
Photo 10 shows the chassis number of the Motor Car. The chassis number recorded was WBAJR32050WW84708.

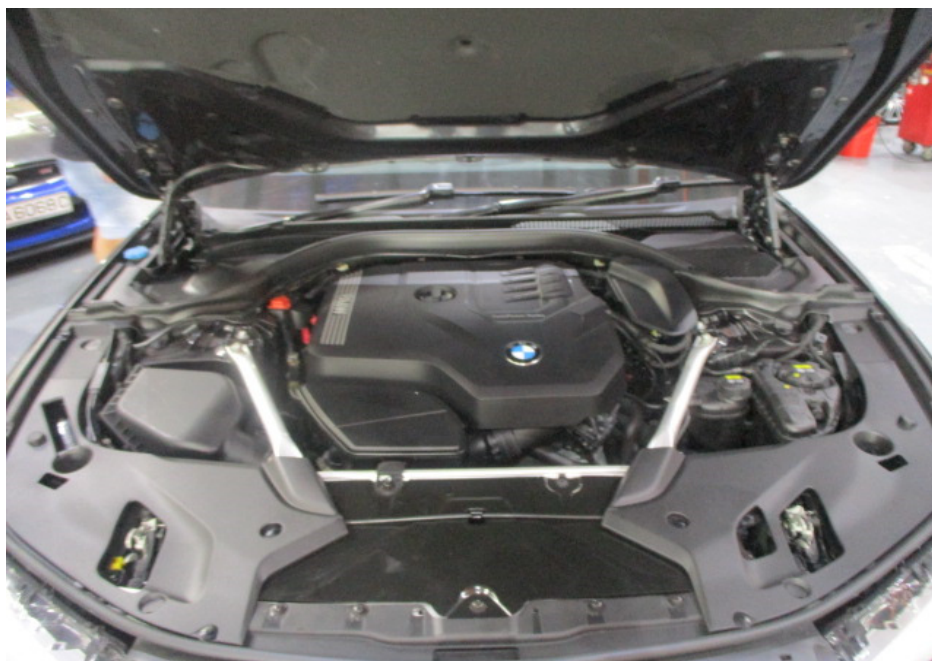
14. My examination of the engine compartment of the Motor Car revealed that the various parts and components inside the engine compartment were all intact and properly fitted. The engine oil, brake fluid and engine coolant were all found to be of sufficient level for operating purposes. Visually, there was also no contamination found to these fluids.

Photo 11 shows a general view of the engine compartment of the Motor Car at the time of my inspection. The various parts and components inside the engine compartment were all observed to be intact and properly fitted. There was also no sign(s) or indication(s) of fluid leak and/or fluid stain found inside the engine compartment.

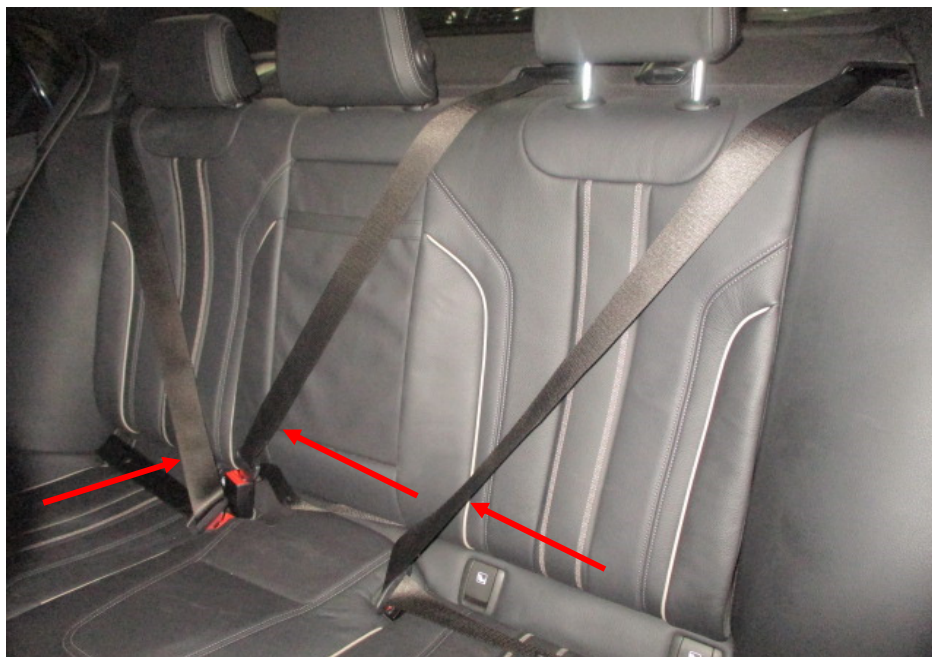
12. The seats of the Motor Car were found to be secured to the floorboard of the Motor Car via seat rails bolted onto the floorboard. Retractable seat belt reels and pre-tensioners were fitted on all seats of the Motor Car. The seat belts were tested and were able to be fastened securely into the respective pre-tensioners that were fixed to the side of all the seats.

Photo 12 shows the rear seats of the Motor Car. All the seats of the Motor Car were secured via seat rails to the floorboard. They were also fitted with a retractable seat belt reel and a pre-tensioner. The seat belts (arrowed) were tested and were able to be fastened into the respective pre-tensions that were fitted on the side of each individual seat.

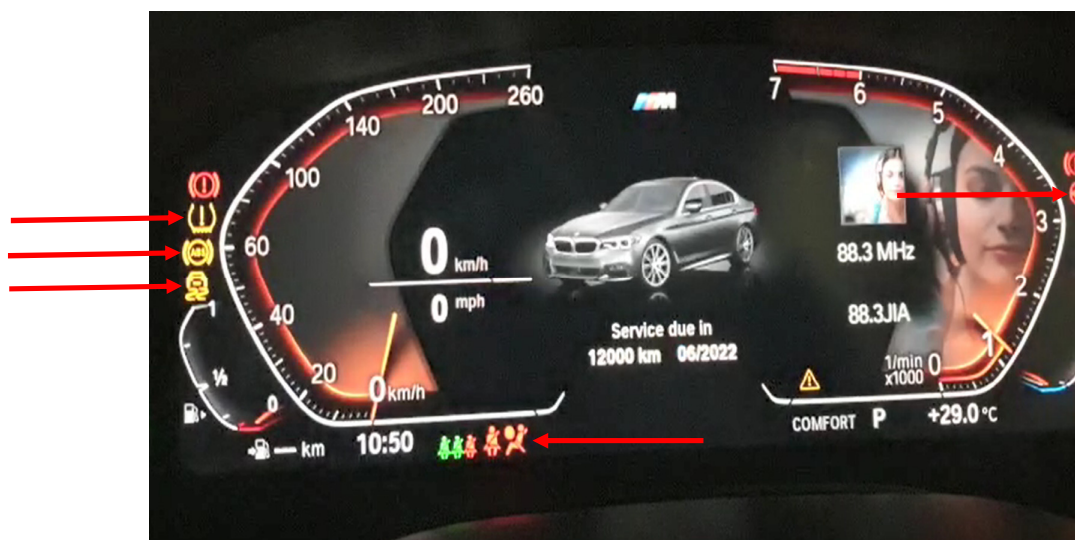
Photo 13 shows the warning lights for the various electronic safety features appearing on the instrument panel of the Motor Car during its self-test when the engine is cranked, in particular the ABS, SRS, IAS, TPM and DSC lights (arrowed).

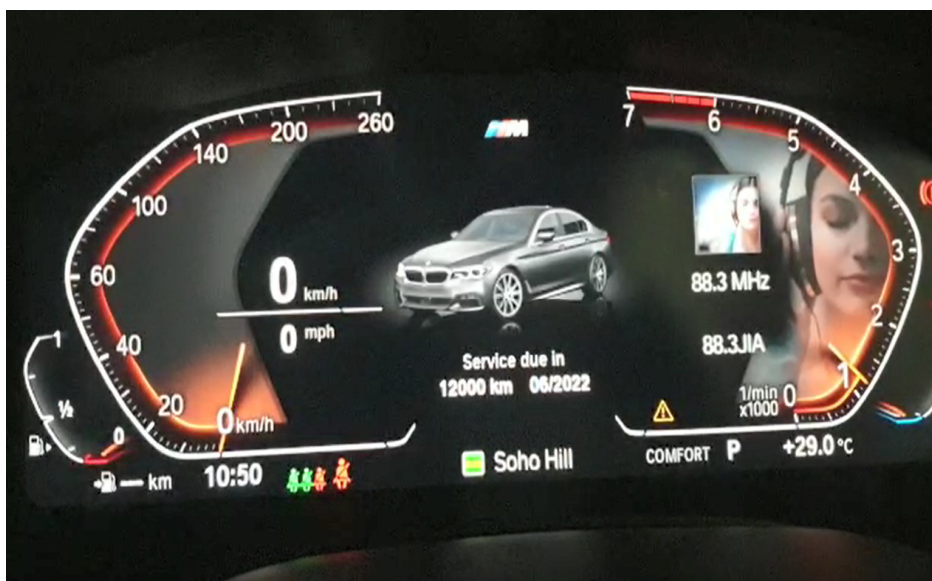
13. The Motor Car's automatic self-test of the functionality of its various electronic safety features like the Anti-Lock Brake System (ABS), Supplemental Restraint System (SRS), Integral Active Steering (IAS), Tyre Pressure Monitor (TPM) and Dynamic Stability Control (DSC) during cranking of the engine had indicated that these electronic systems were in working condition. This was determined from the respective warning lights disappearing from the instrument panel after the self-test.

Photo 14 shows the respective warning lights no longer illuminated, indicating that there is no fault detected to the ABS, SRS, IAS, TPM and DSC systems of the Motor Car during the self-test. These electronic systems were hence in working condition at the time of my inspection.

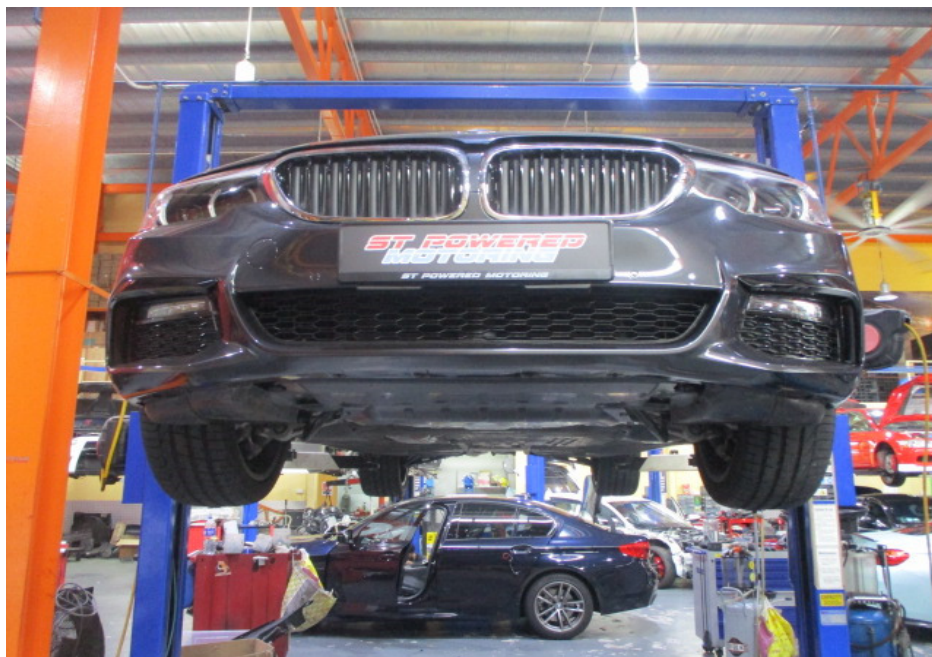
15. My checks on the underside of the Motor Car revealed no sign(s) or indication(s) of fluid leakage and/or fluid stain(s). The engine block and automatic transmission assembly were both secured properly. All undercarriage components of the Motor Car were also observed to be intact and secured in an appropriate manner.

Photo 15 shows the Motor Car hoisted up for checks on its undercarriage. There was no sign(s) or indication(s) of fluid leakage and/or fluid stain(s) on the underside of the Motor Car. The undercarriage components of the Motor Car were also all observed to be intact and secured in an appropriate manner.

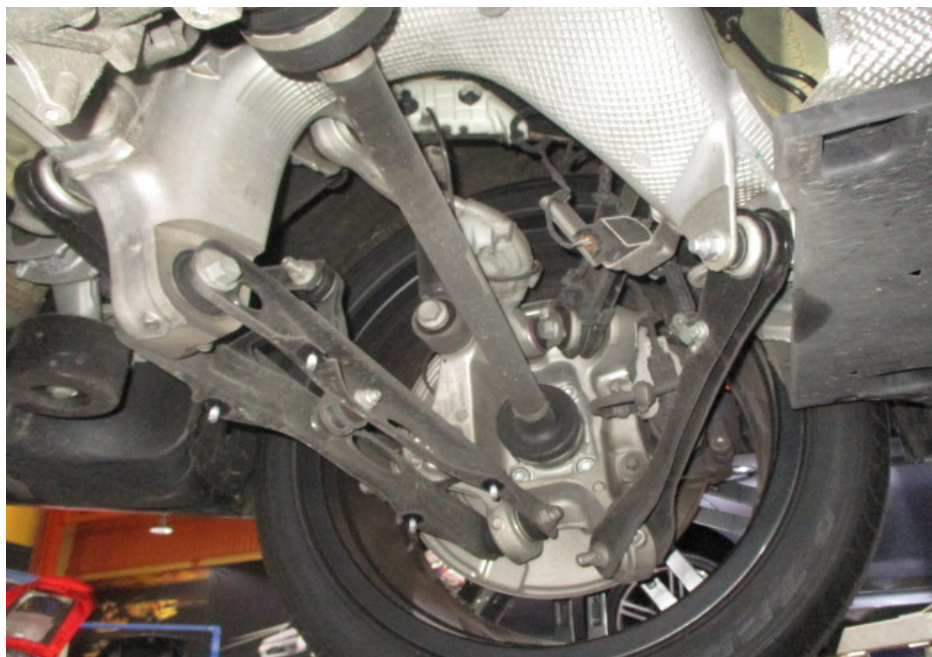
Photo 16 shows a general view of the control arms and linkages at the rear left wheel of the Motor Car. I did not observe any fluid leak and/or fluid stain on the underside of the Motor Car. All of the Motor Car's undercarriage components were observed to be intact and secured in an appropriate manner.

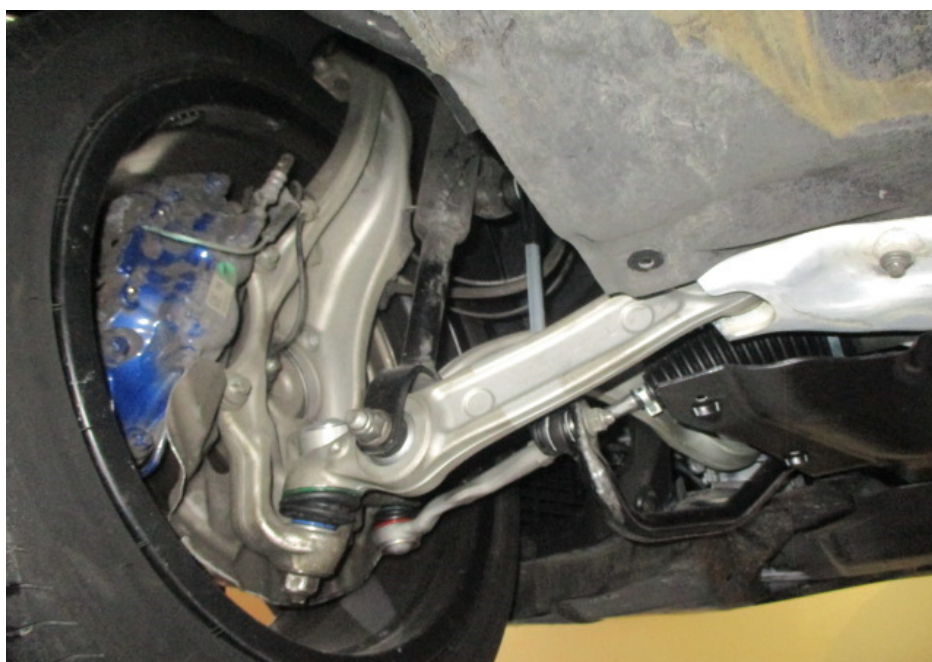
Photo 17 shows the various undercarriage components at the front left wheel of the Motor Car. The mechanical components, control arms and linkages were all found to be intact and secured in an appropriate manner.

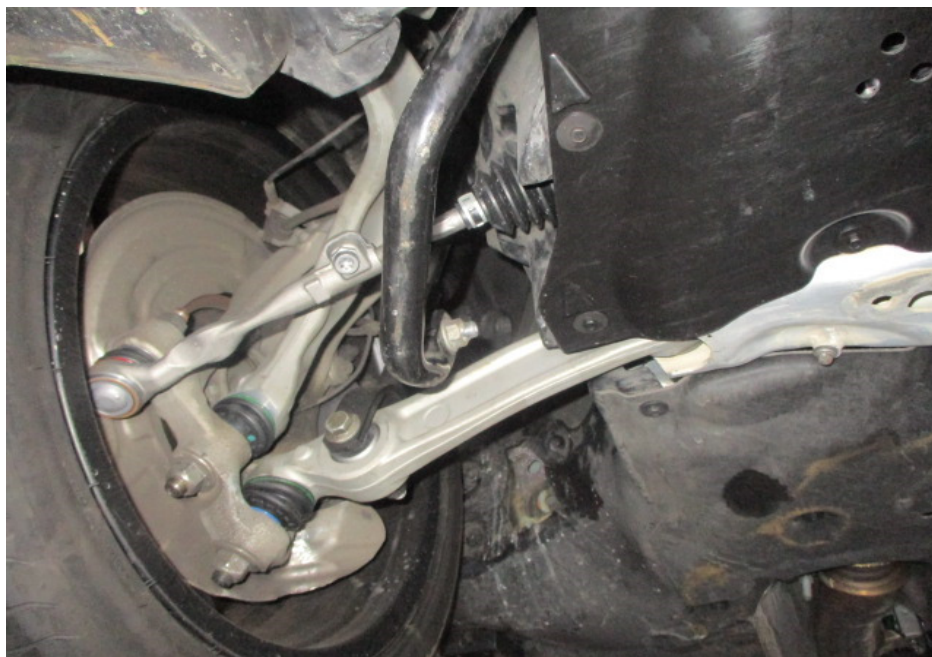
Photo 18 shows the various undercarriage components at the front right wheel of the Motor Car. The mechanical components, control arms and linkages were all found to be intact and secured in an appropriate manner. I also did not observe any fluid leak and/or fluid stain on the underside of the Motor Car.

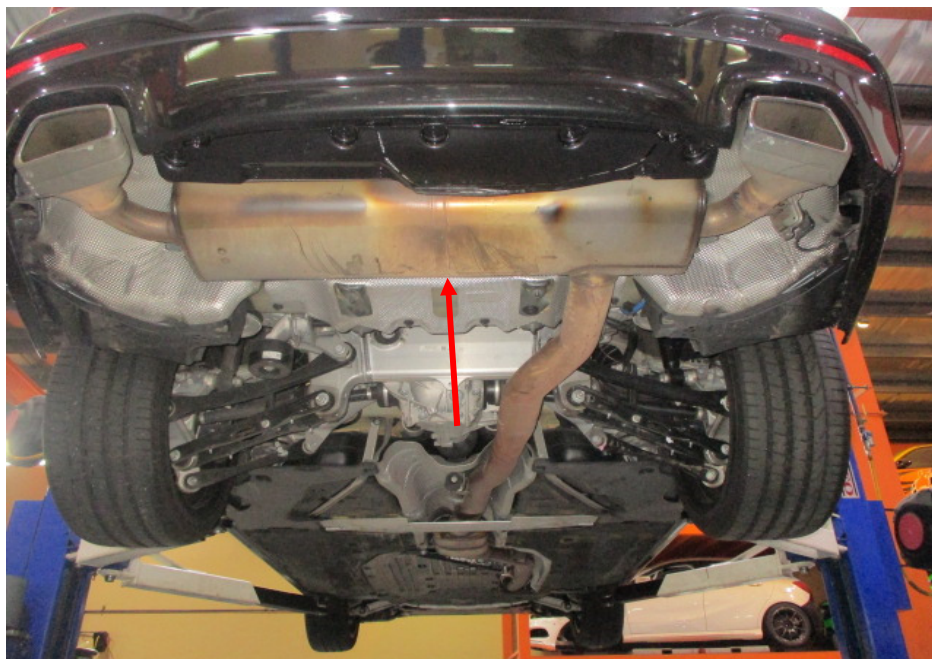
Photo 19 shows a general view of the Motor Car's exhaust system. My examination of the Motor Car's exhaust system revealed no sign(s) or indication(s) of any cut or weld marks along its catalytic converter, exhaust pipes and on its rear muffler (arrowed).

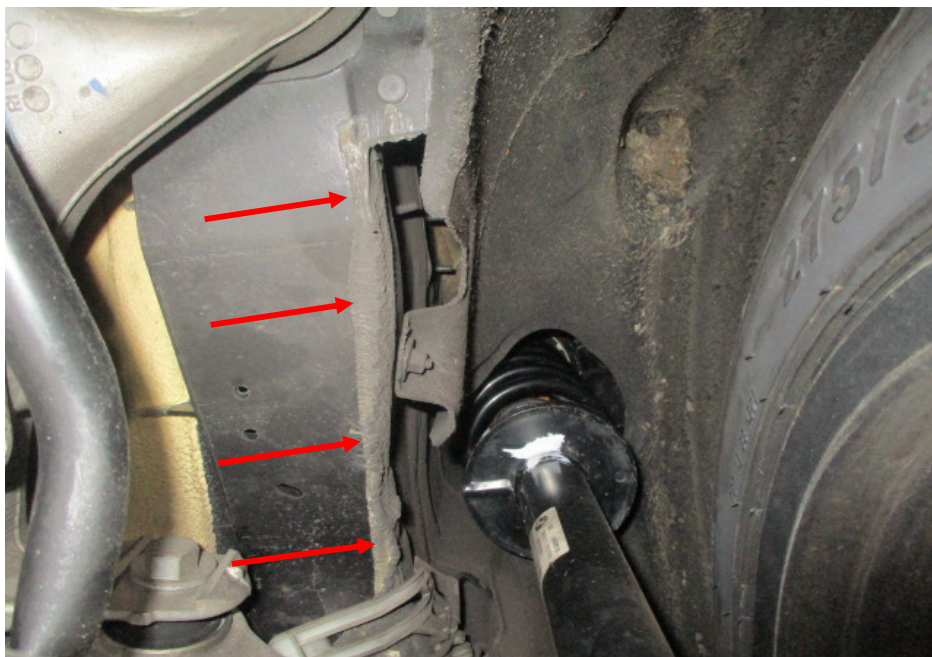
11. Visually, I did not find any weld marks, other than the original spot weld marks, on the chassis/structural body of the Motor Car. The original factory sealant at the joints along the chassis/structural body was also untouched, again indicating that no replacement of the chassis/structural body was carried out; and that the chassis/structural body was originally fitted.

Photo 20 shows the chassis/structural body at the underside rear right of the Motor Car. I did not find any weld marks other than original spot weld marks on the chassis/structural body of the Motor Car. The original factory sealant (arrowed) at the joints along the chassis/structural body was untouched, indicating no work was done on the chassis/structural body of the Motor Car and that the chassis/structural body was originally fitted.

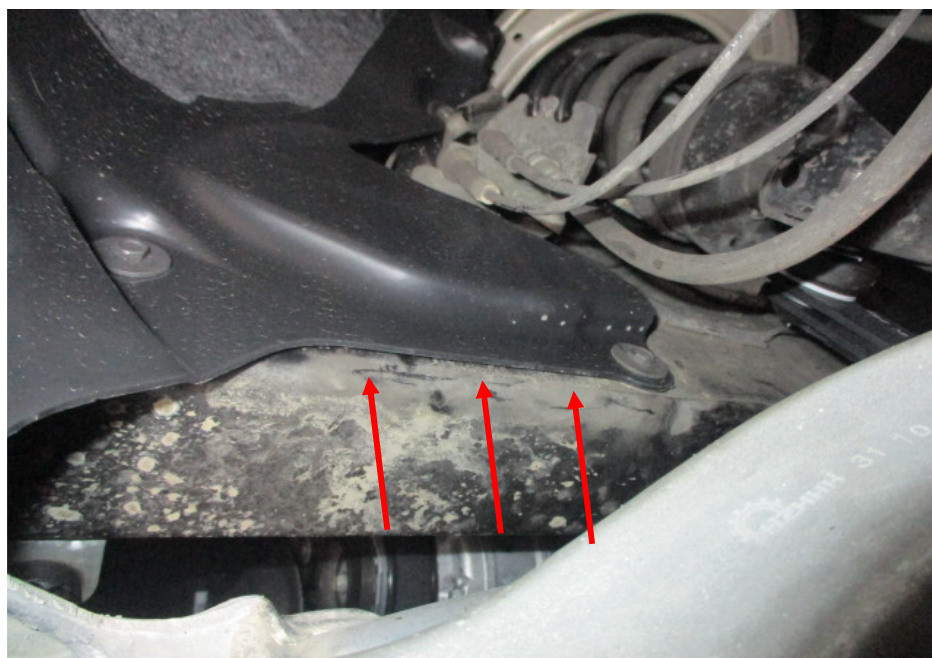
Photo 21 shows the chassis/structural body at the underside front left of the Motor Car. The original factory sealant (arrowed) at the joints along the chassis/structural body was observed to be untouched. In general, I had found no work was carried out on the chassis/structural body of the Motor Car. The chassis/structural body of the Motor Car was originally fitted.

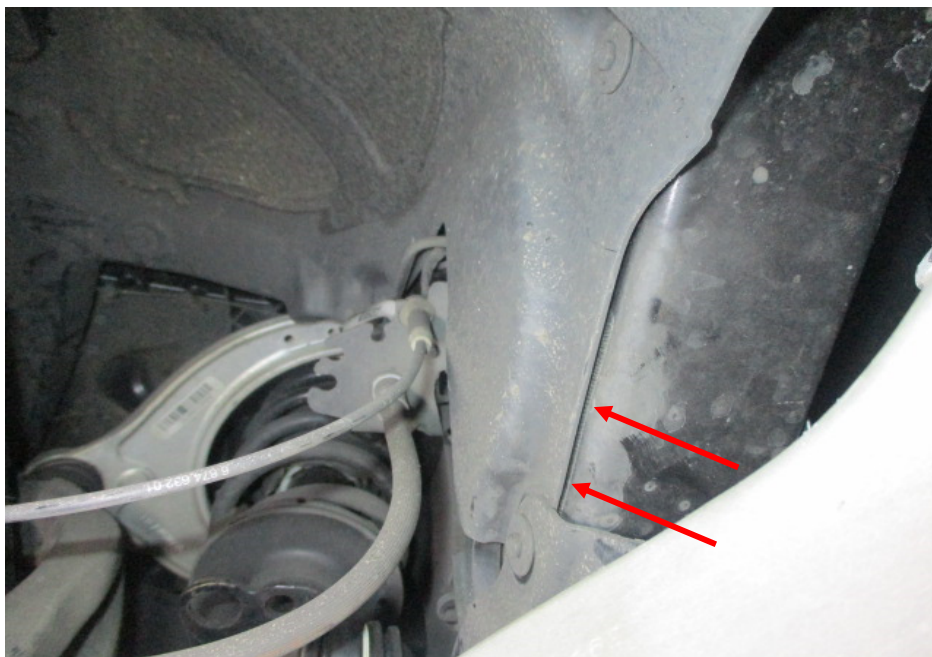
Photo 22 shows the chassis/structural body at the underside front right of the Motor Car. The original factory sealant (arrowed) at the joints along the chassis/structural body was observed to be untouched. In general, I had found no work was carried out on the chassis/structural body of the Motor Car. The chassis/structural body of the Motor Car was originally fitted.

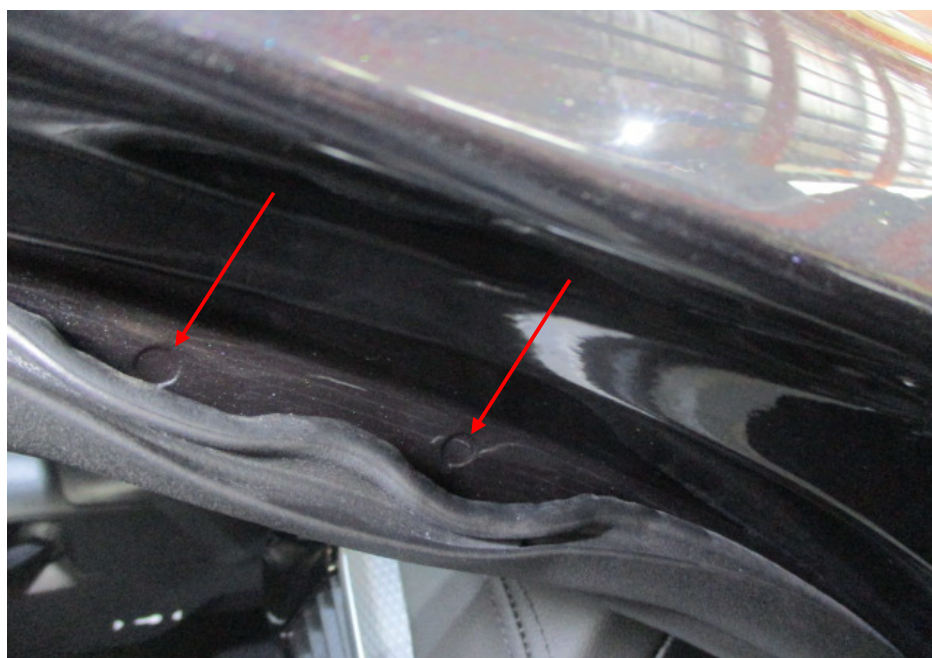
Photo 23 shows the right side "A" pillar of the Motor Car. I did not find any weld marks other than original spot weld marks (arrowed) on the right side "A" pillar of the Motor Car which, indicates that there was no re-welding works carried out. In general, I had found all the non-detachable body panels of the Motor Car to be originally fitted at the time of my inspection.

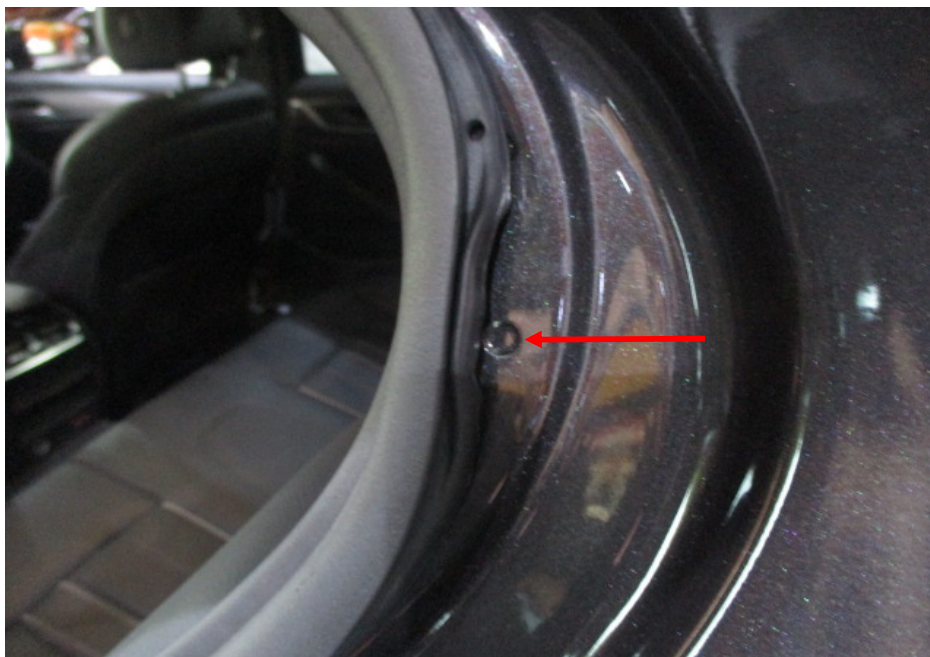
Photo 24 shows the left side "C" pillar of the Motor Car. I did not find any weld marks other than original spot weld marks (arrowed) on the left side "C" pillar of the Motor Car which, indicates that there was no re-welding works carried out. In general, I had found all the non-detachable body panels of the Motor Car to be originally fitted at the time of my inspection.
