Your Ref: Audi S5  
(chassis number WAUZZZF51KA096171)  
Our Ref : CI/TP21006066/D

24 May 2021

**INSPECTION REPORT OF AN UNREGISTERD AUDI S5 MOTOR CAR WITH CHASSIS NUMBER WAUZZZF51KA096171**

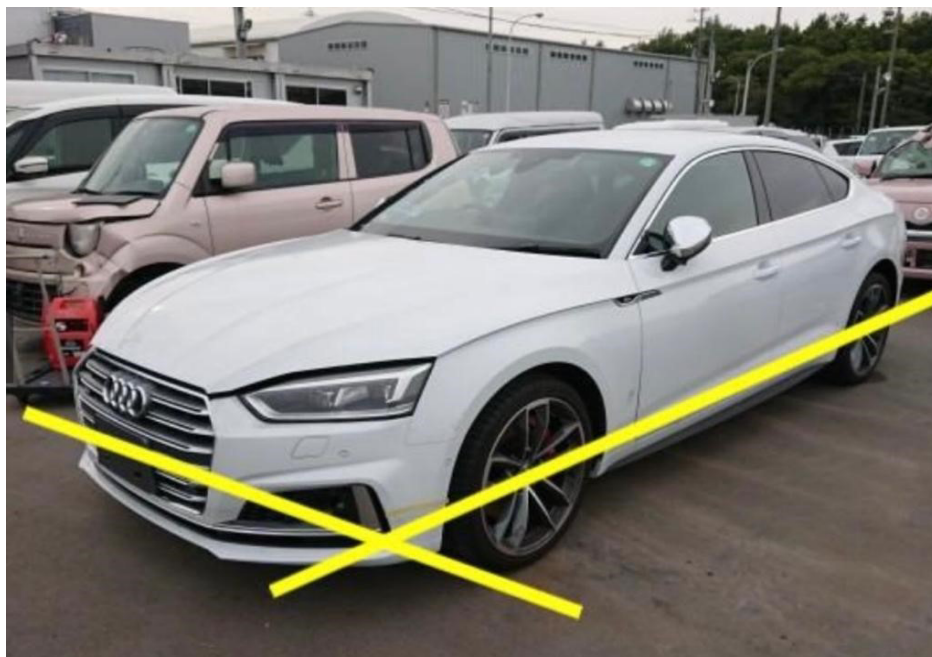
**Photo 1** shows the front left body of the Motor Car (photograph provided to me). There appears to be no visible damage to the Motor Car as seen from the photographs that were provided to me.

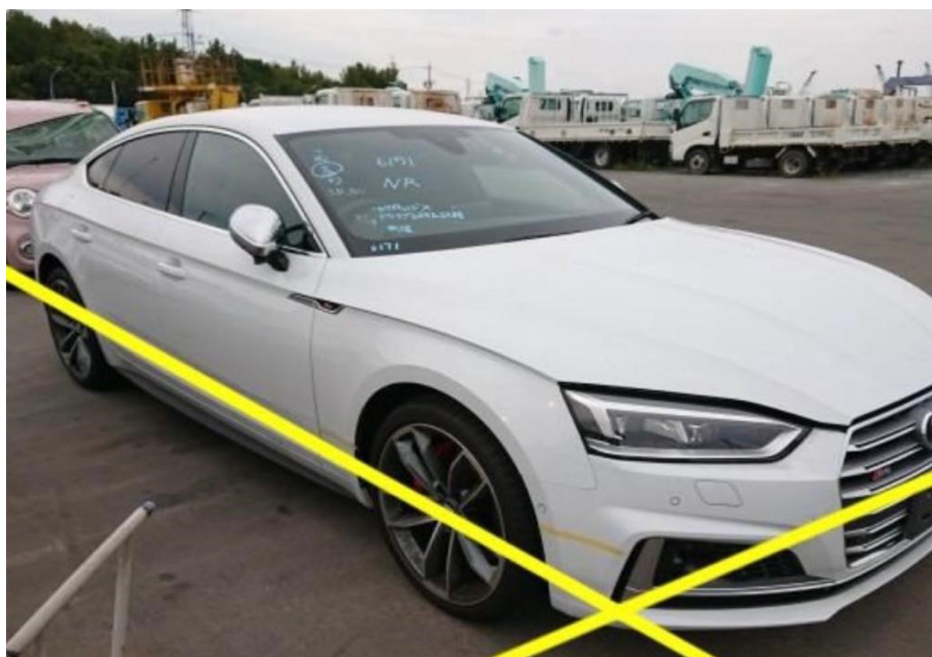
**Photo 2** shows the front right body of the Motor Car (photograph provided to me). There appears to be no visible damage to the Motor Car as seen from the photographs that were provided to me.

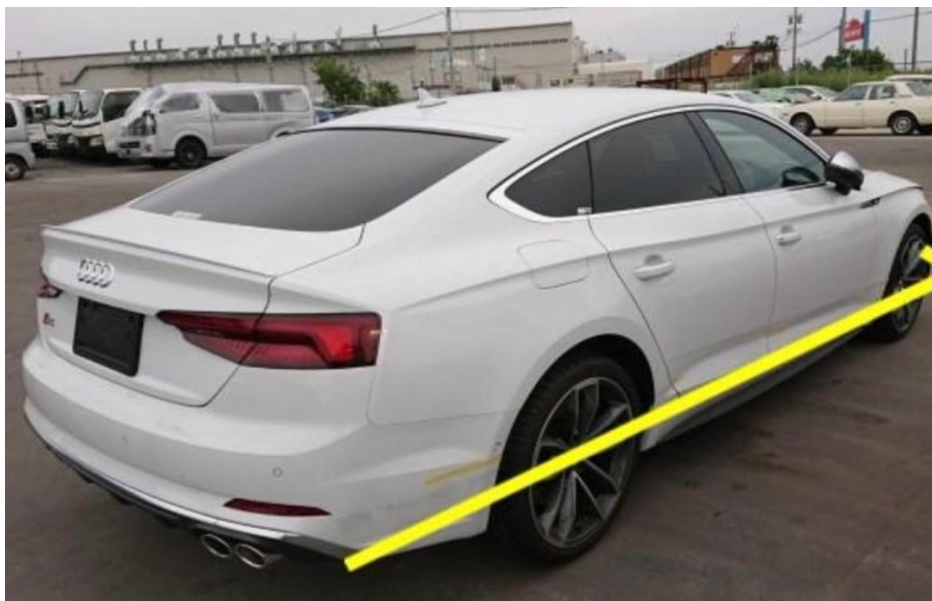
**Photo 3** shows the rear right body of the Motor Car (photograph provided to me). There appears to be no visible damage to the Motor Car as seen from the photographs that were provided to me.

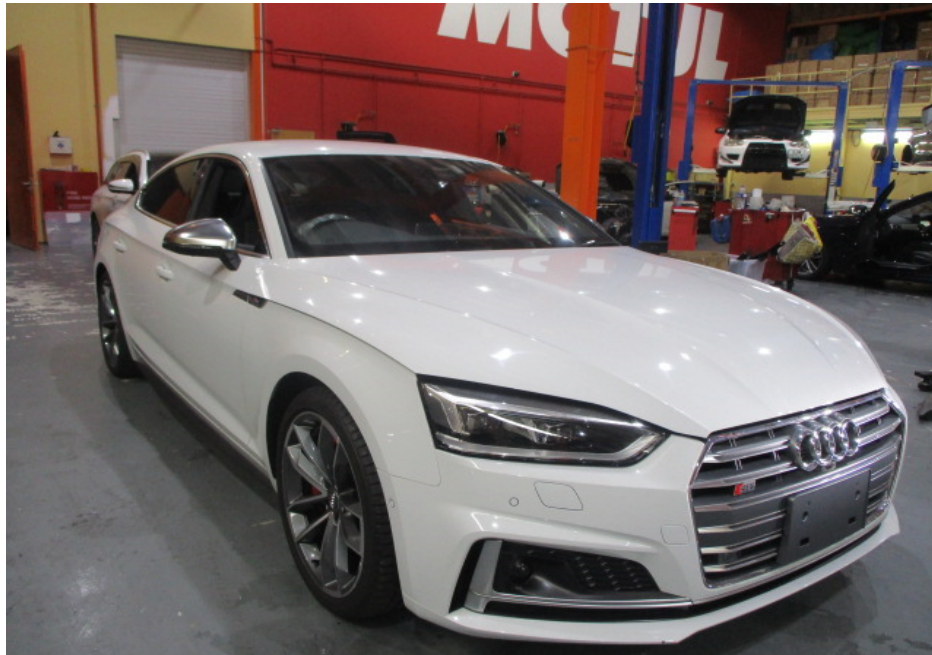
**Photo 4** shows a general view of the front right body of the Motor Car at the time of my inspection. The Motor Car was observed to be in a relatively good general condition with no loose exterior fittings observed. There was no visible damage observed to the Motor Car.

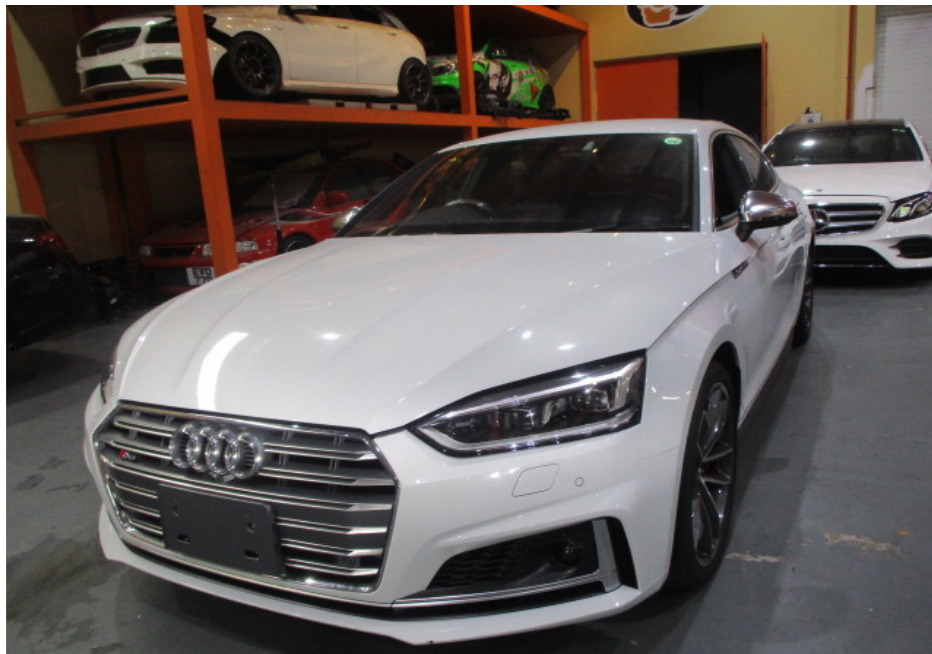
**Photo 5** shows a general view of the front left body of the Motor Car at the time of my inspection. The Motor Car was observed to be in a relatively good general condition with no loose exterior fittings observed. There was no visible damage observed to the Motor Car. The mileage of the Motor Car recorded at the time of my inspection was 2,277km.

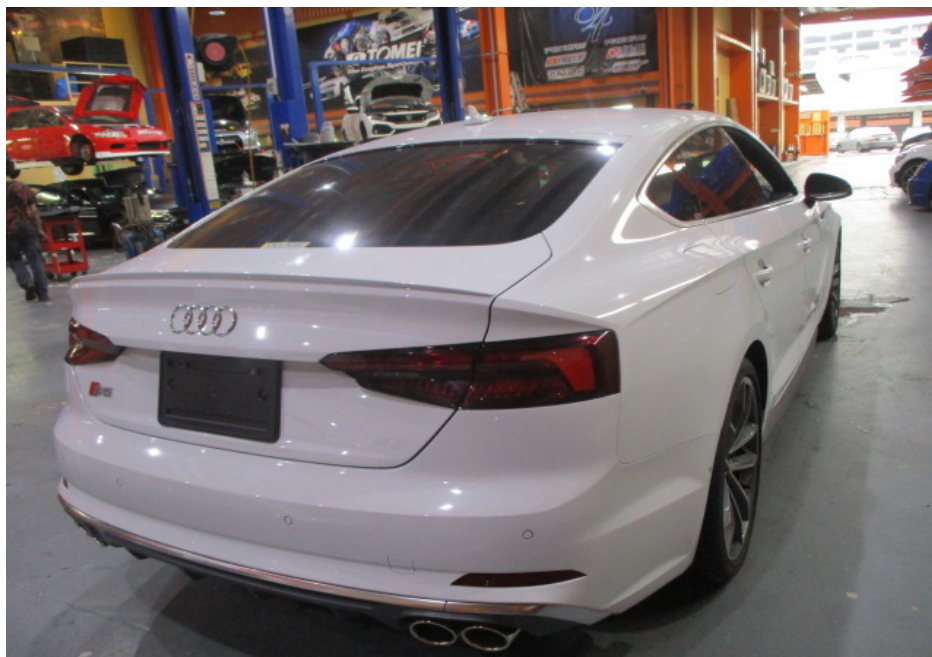
**Photo 6** shows a general view of the rear right body of the Motor Car at the time of my inspection. The Motor Car was observed to be in a relatively good general condition with no loose exterior fittings observed. There was no visible damage observed to the Motor Car. The mileage of the Motor Car recorded at the time of my inspection was 2,277km.

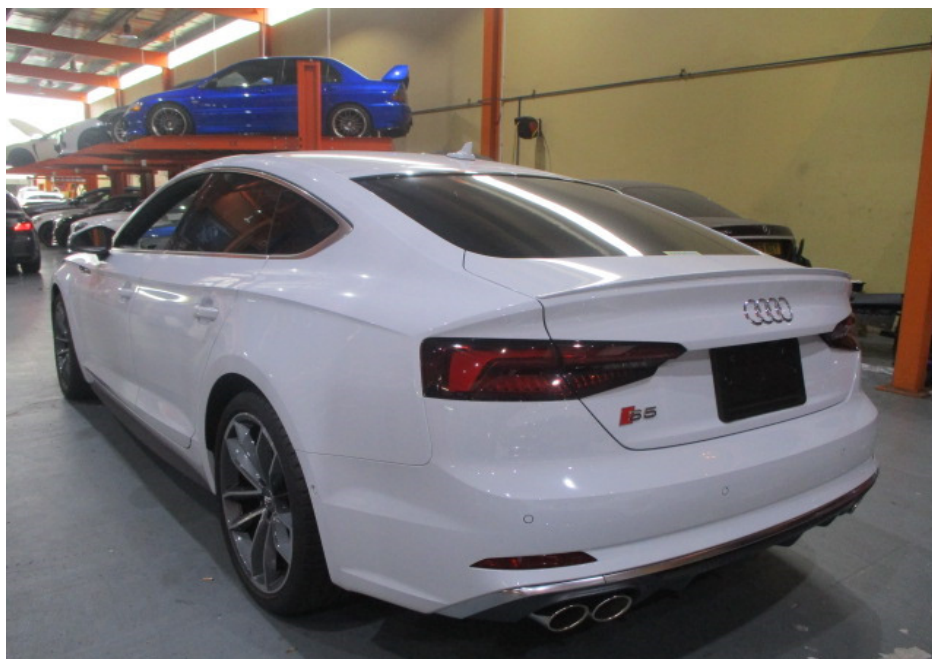
**Photo 7** shows a general view of the rear left body of the Motor Car at the time of my inspection. The Motor Car was observed to be in a relatively good general condition with no loose exterior fittings observed.

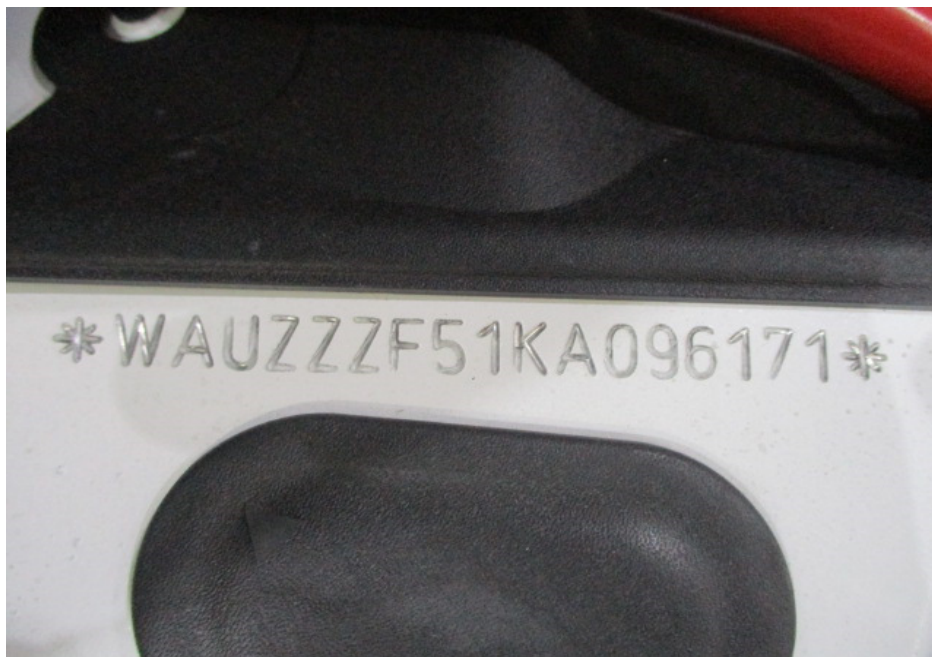
**Photo 8** shows the chassis number of the Motor Car. The chassis number recorded was WAUZZZF51KA096171.

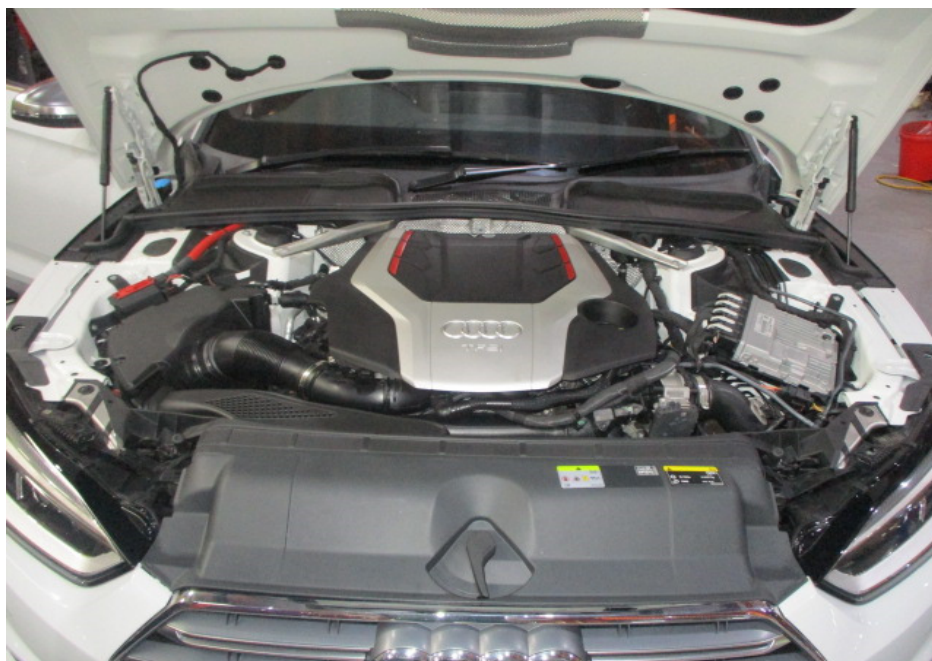
13. My examination of the engine compartment of the Motor Car revealed that the various parts and components inside the engine compartment were all intact and properly fitted. The engine oil, brake fluid and engine coolant were all found to be of sufficient level for operating purposes. Visually, there was also no contamination found to these fluids.
14. My checks on the underside of the Motor Car revealed no sign(s) or indication(s) of fluid leakage and/or fluid stain(s). The engine block and automatic transmission assembly were both secured properly. All undercarriage components of the Motor Car were also observed to be intact and secured in an appropriate manner.

**Photo 9** shows a general view of the engine compartment of the Motor Car at the time of my inspection. The various parts and components inside the engine compartment were all observed to be intact and properly fitted. There was also no sign(s) or indication(s) of fluid leak and/or fluid stain found inside the engine compartment.

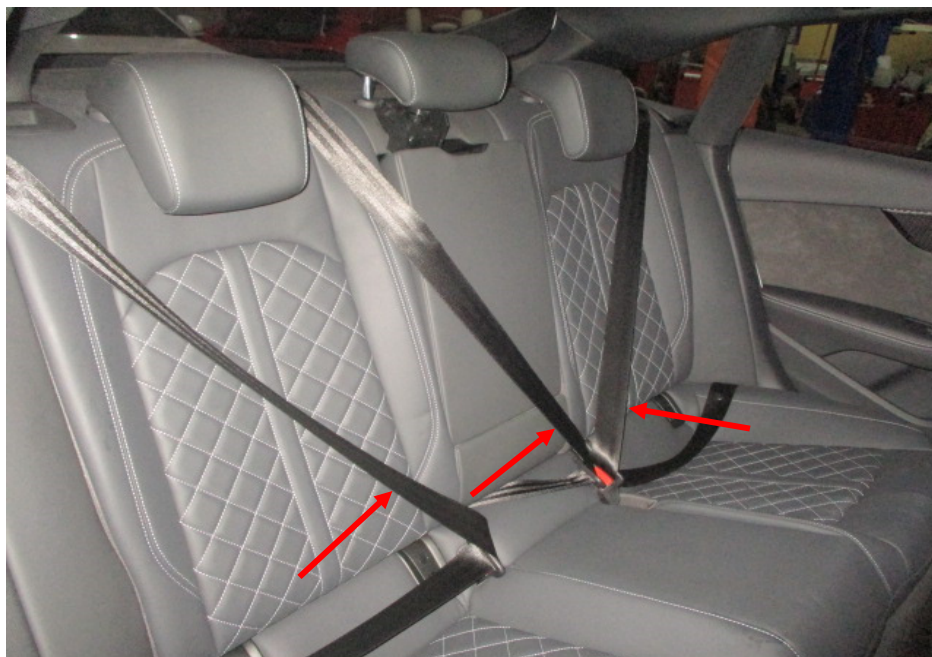
11. The seats of the Motor Car were found to be secured to the floorboard of the Motor Car via seat rails bolted onto the floorboard. Retractable seat belt reels and pre-tensioners were fitted on all seats of the Motor Car. The seat belts were tested and were able to be fastened securely into the respective pre-tensioners that were fixed to the side of all the seats.

**Photo 10** shows the rear seats of the Motor Car. All the seats of the Motor Car were secured via seat rails to the floorboard. They were also fitted with a retractable seat belt reel and a pre-tensioner. The seat belts (arrowed) were tested and were able to be fastened into the respective pre-tensions that were fitted on the side of each individual seat.

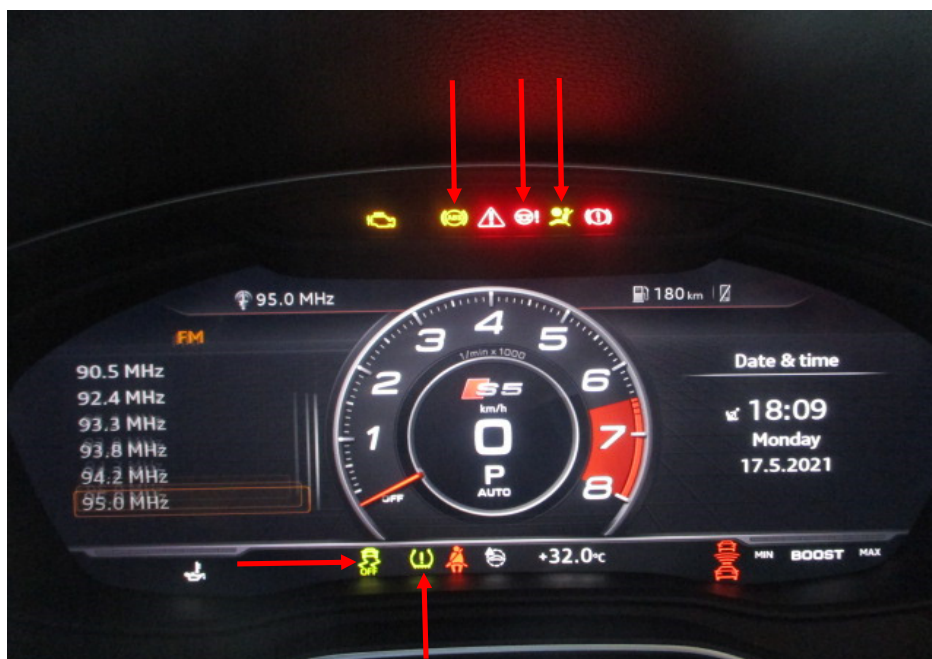
**Photo 11** shows the warning lights for the various electronic safety features appearing on the instrument panel of the Motor Car during its self-test when the engine is cranked, in particular the ABS, SRS, EPS, TPM and ESC lights (arrowed).

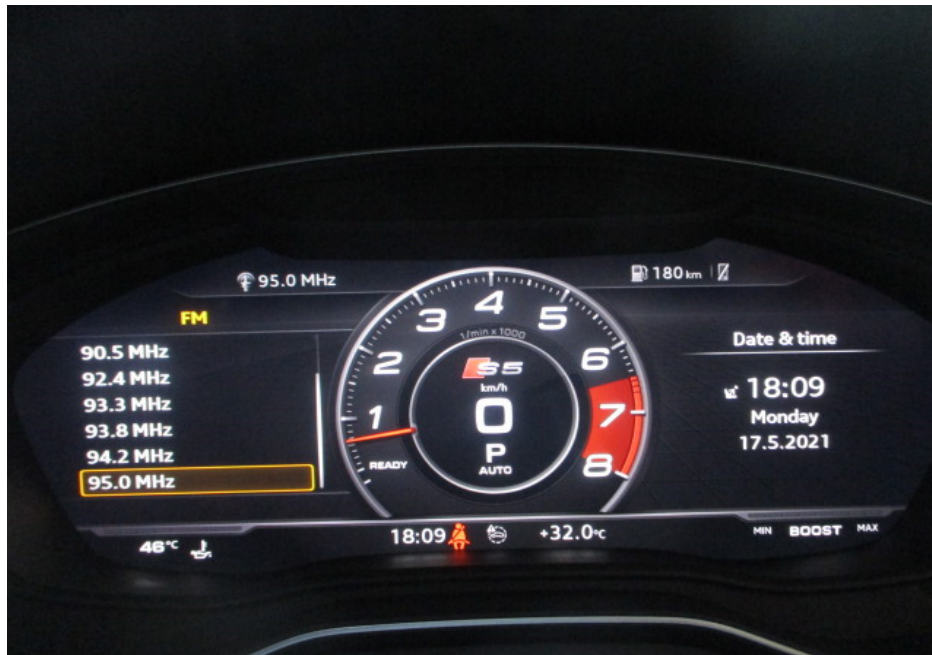
12. The Motor Car's automatic self-test of the functionality of its various electronic safety features like the Anti-Lock Brake System (ABS), Supplemental Restraint System (SRS), Electronic Power Steering (EPS), Tyre Pressure Monitor (TPM) and Electronic Stability Control (ESC) during cranking of the engine had indicated that these electronic systems were in working condition. This was determined from the respective warning lights disappearing from the instrument panel after the self-test.

**Photo 12** shows the respective warning lights no longer illuminated, indicating that there is no fault detected to the ABS, SRS, EPS, TPM and ESC systems of the Motor Car during the self-test. These electronic systems were hence in working condition at the time of my inspection.

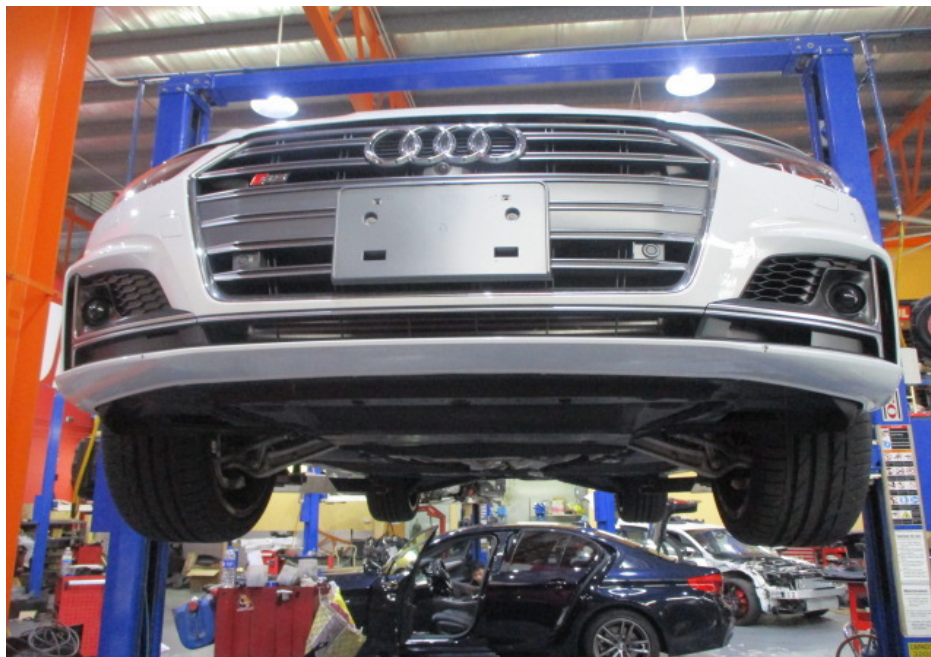
**Photo 13** shows the Motor Car hoisted up for checks on its undercarriage. There was no sign(s) or indication(s) of fluid leakage and/or fluid stain(s) on the underside of the Motor Car. The undercarriage components of the Motor Car were also all observed to be intact and secured in an appropriate manner.

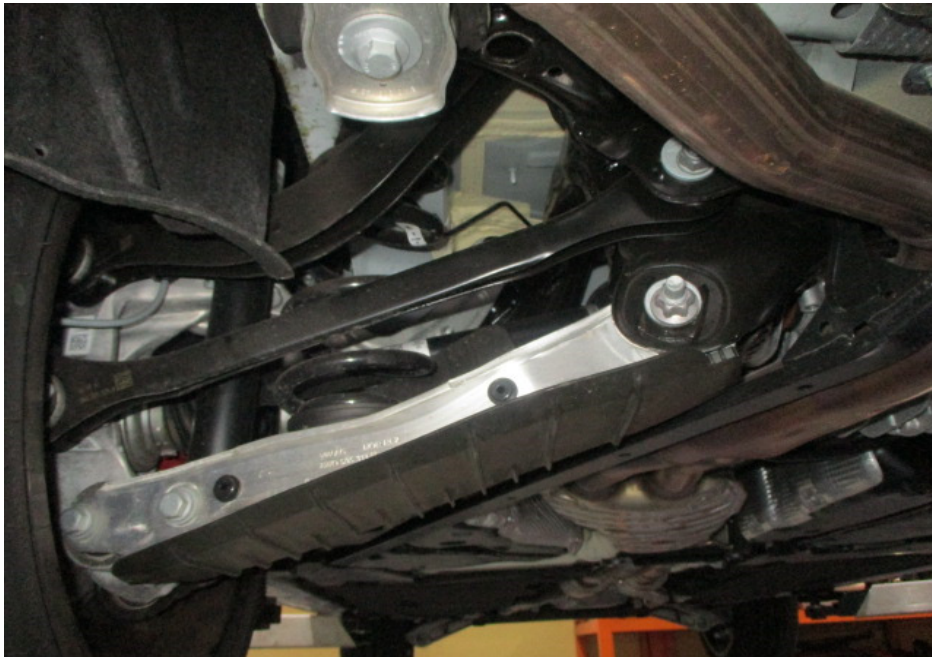
**Photo 14** shows a general view of the control arms and linkages at the rear left wheel of the Motor Car. I did not observe any fluid leak and/or fluid stain on the underside of the Motor Car. All of the Motor Car's undercarriage components were observed to be intact and secured in an appropriate manner.

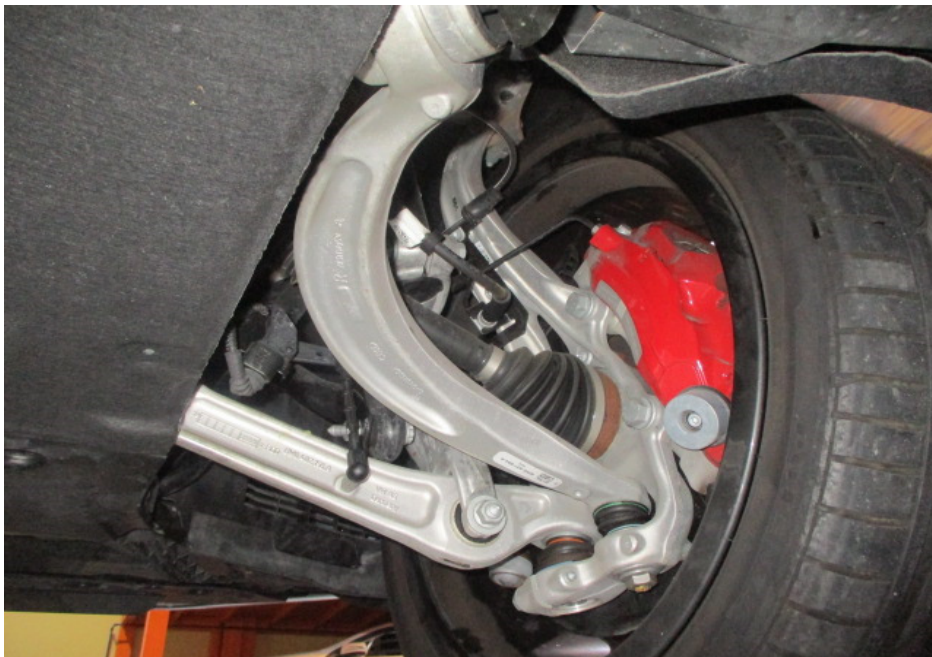
**Photo 15** shows the various undercarriage components at the front right wheel of the Motor Car. The mechanical components, control arms and linkages were all found to be intact and secured in an appropriate manner.

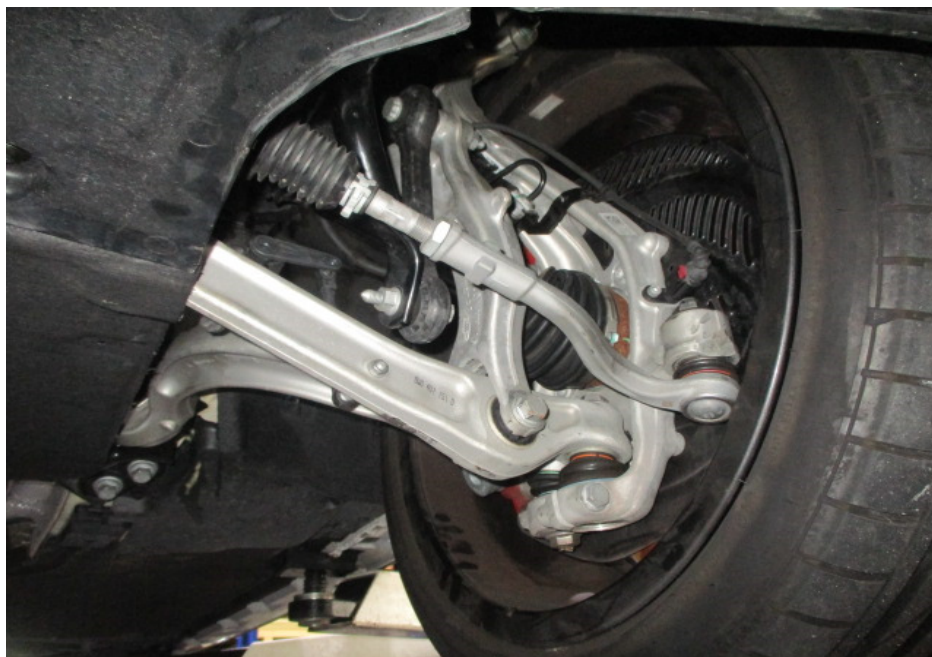
**Photo 16** shows the various undercarriage components at the front left wheel of the Motor Car. The mechanical components, control arms and linkages were all found to be intact and secured in an appropriate manner. I also did not observe any fluid leak and/or fluid stain on the underside of the Motor Car.

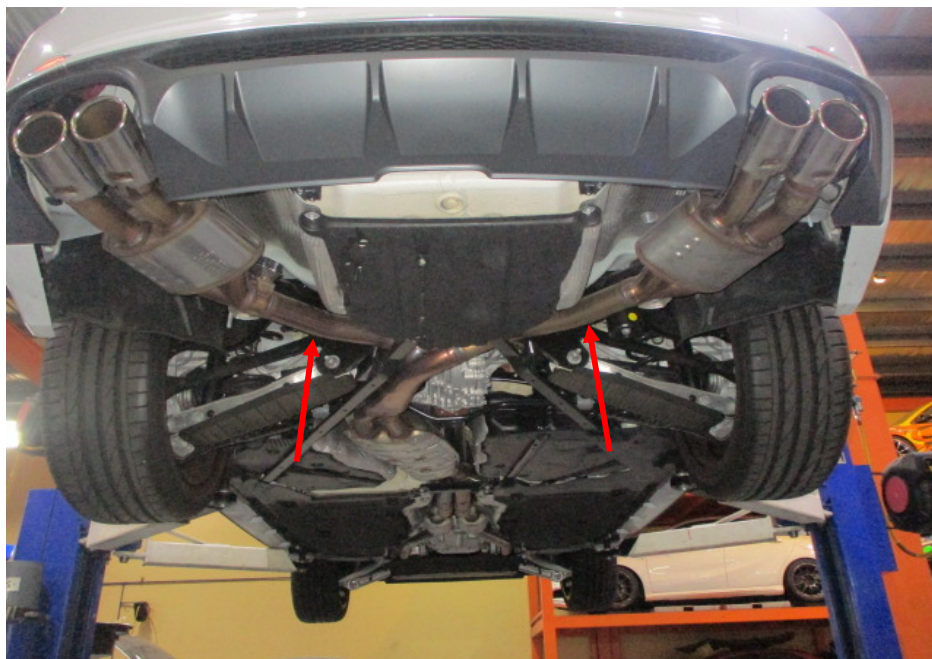
**Photo 17** shows a general view of the Motor Car's exhaust system. My examination of the Motor Car's exhaust system revealed no sign(s) or indication(s) of any cut or weld marks along its exhaust pipes (arrowed), catalytic converters and on its rear mufflers.

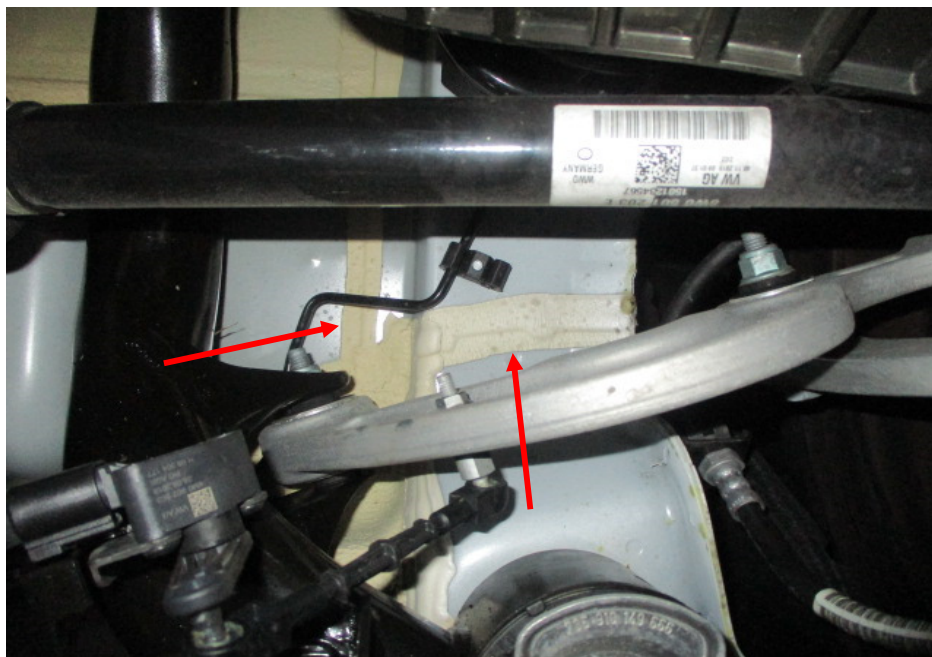
10. Visually, I did not find any weld marks, other than the original spot weld marks, on the chassis/structural body of the Motor Car. The original factory sealant at the joints along the chassis/structural body was also untouched, again indicating that no replacement of the chassis/structural body was carried out; and that the chassis/structural body was originally fitted.

**Photo 18** shows the chassis/structural body at the underside rear right of the Motor Car. I did not find any weld marks other than original spot weld marks on the chassis/structural body of the Motor Car. The original factory sealant (arrowed) at the joints along the chassis/structural body was untouched, indicating no work was done on the chassis/structural body of the Motor Car and that the chassis/structural body was originally fitted.

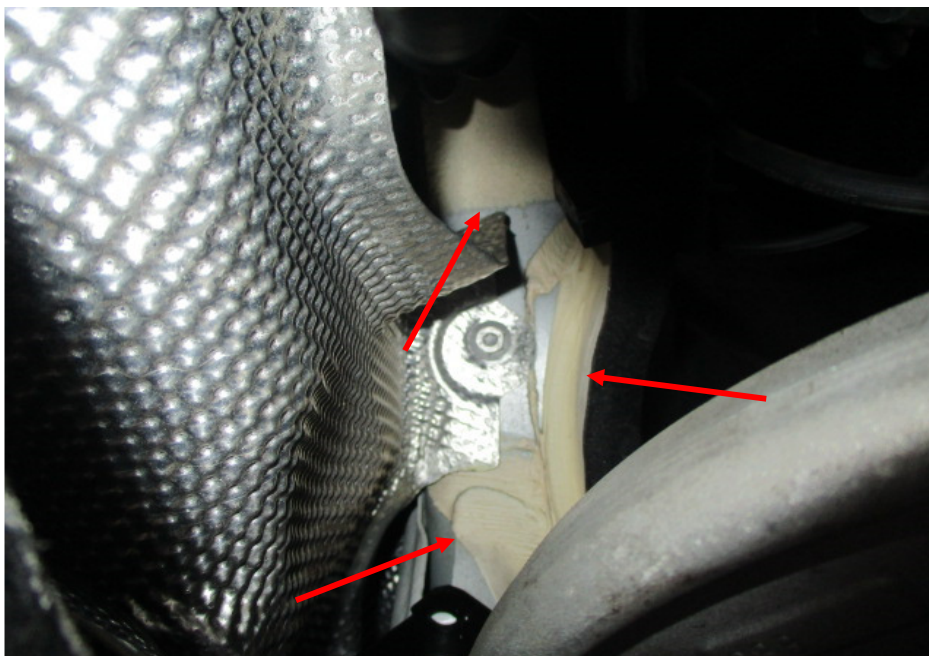
**Photo 19** shows the chassis/structural body at the underside front left of the Motor Car. The original factory sealant (arrowed) at the joints along the chassis/structural body was observed to be untouched. In general, I had found no work was carried out on the chassis/structural body of the Motor Car. The chassis/structural body of the Motor Car was originally fitted.

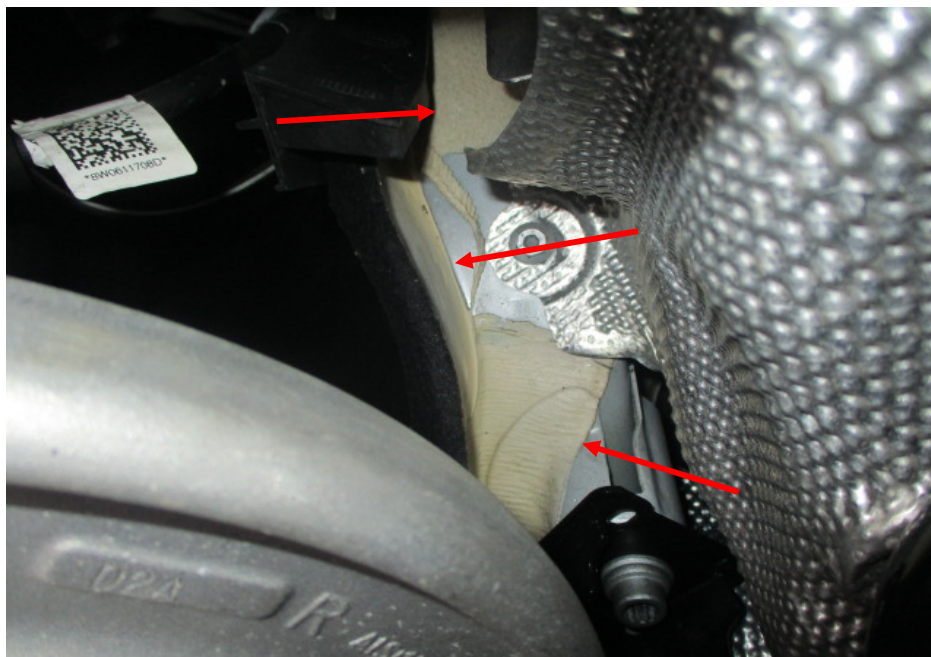
**Photo 20** shows the chassis/structural body at the underside front right of the Motor Car. The original factory sealant (arrowed) at the joints along the chassis/structural body was observed to be untouched. In general, I had found no work was carried out on the chassis/structural body of the Motor Car. The chassis/structural body of the Motor Car was originally fitted.
