## REFERENCES

| Third party vehicle | : SLZ8831L | Date of Accident | : 30/11/2020 |

| Model / Make | : Mazda 3 | Pre-accident damage | : NIL |

## DESCRIPTION OF DAMAGE

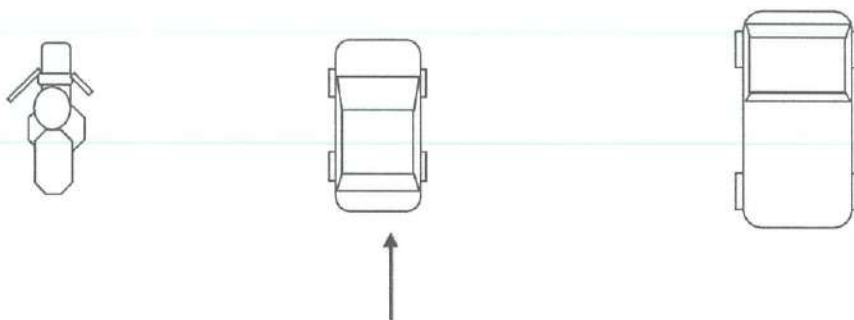
At the time of inspection, this vehicle sustained damages to the **Rear portion**.

Rear bumper, tailgate, rear end panel dented. Rear windscreen glass shattered, Taillamp, tailgate reflector base crack etc.

We have not authorised repair. Under normal circumstances, estimated **11** working days are required to repair the vehicle.
