FR7889R

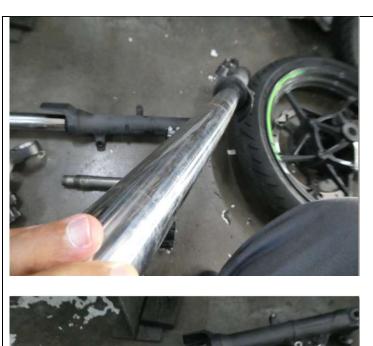
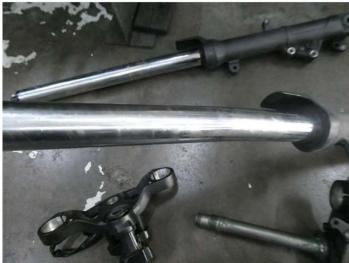
Inspection Photo:	Description:	Price:
	The LH fork & RH fork – Bent. Pls refer to	
	the below dismantle photos. The	
	damage of fork caused unbalancing of	
	motorbike and non-repairable.	
The same of the sa		
RH Fork		
-/
