Your Ref: S0M02YB0
Our Ref : CS4/ASM21006178/N

7 June 2021

TECHNICAL INVESTIGATION REPORT OF FIRE INCIDENT INVOLVING THE INSURED VEHICLE SLX 1888E ON 6 DECEMBER 2020

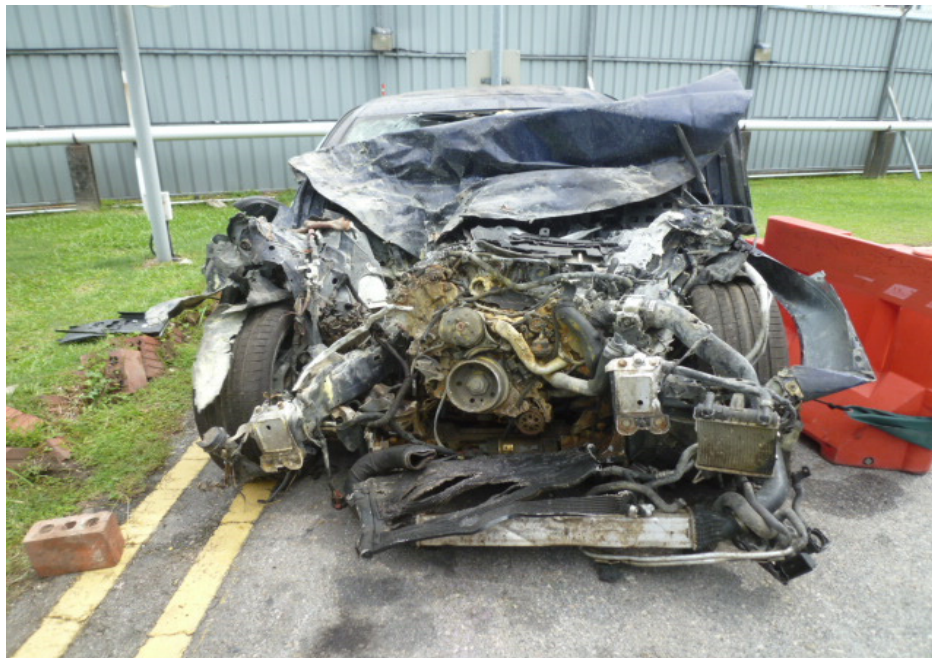
1. We refer to your letter dated 27 May 2021 and the instructions therein.
2. Our analysis, comments and opinions with respect to the cause of fire to the insured vehicle SLX 1888E (herein referred to as "**Insured Vehicle**") are set out below.

Photo 1 shows the general view of the frontal portion of the Insured Vehicle at the time of our inspection. The Insured Vehicle was observed to have sustained serious fire damage at the engine compartment. The Insured Vehicle had also sustained a direct impact of significant force onto its front side. Its front wheels, front support panel, front bumper and front bumper reinforcement were amongst the body parts that were bent/ buckled as a result of the impact force.

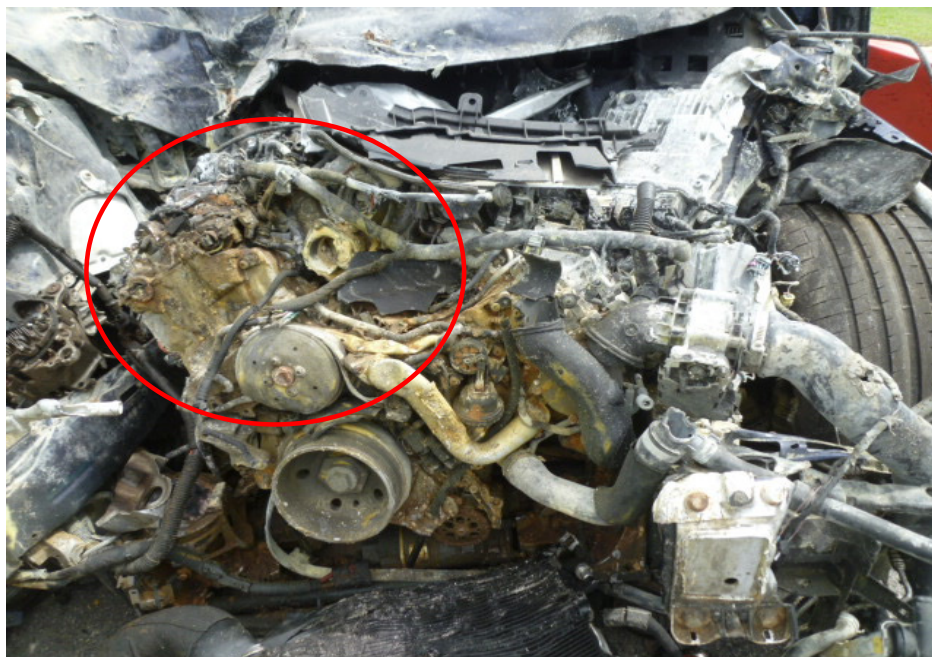
Photo 2 shows the general view of the engine compartment of the Insured Vehicle at the time of our inspection. The Insured Vehicle was observed to have sustained serious fire damage at the engine compartment (circled).

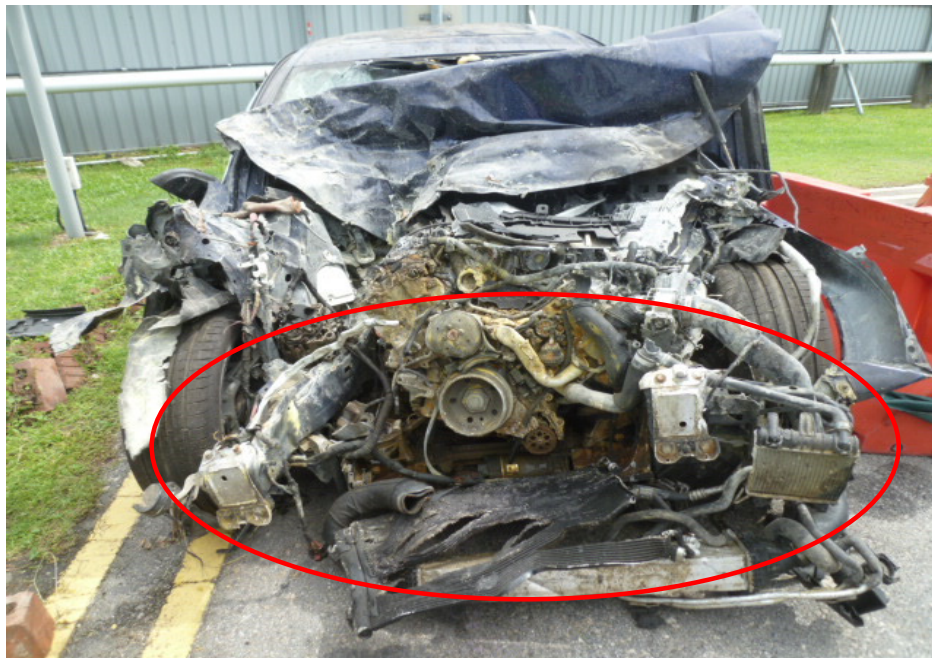
Photo 3 shows the frontal portion of the Insured Vehicle. Impact damage was observed at its front side (circled). Its front wheels, front support panel, front bumper and front bumper reinforcement were amongst the body parts that were bent/ buckled as a result of the impact force.

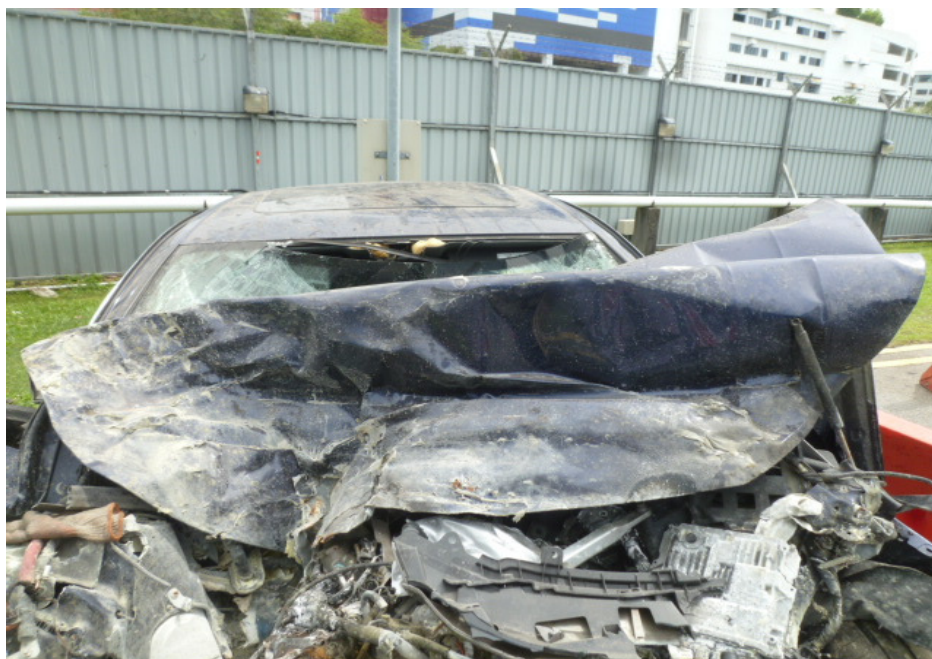
Photo 4 shows the front bonnet of the Insured Vehicle. Its front bonnet was amongst the body parts that was bent/ buckled as a result of the impact force.

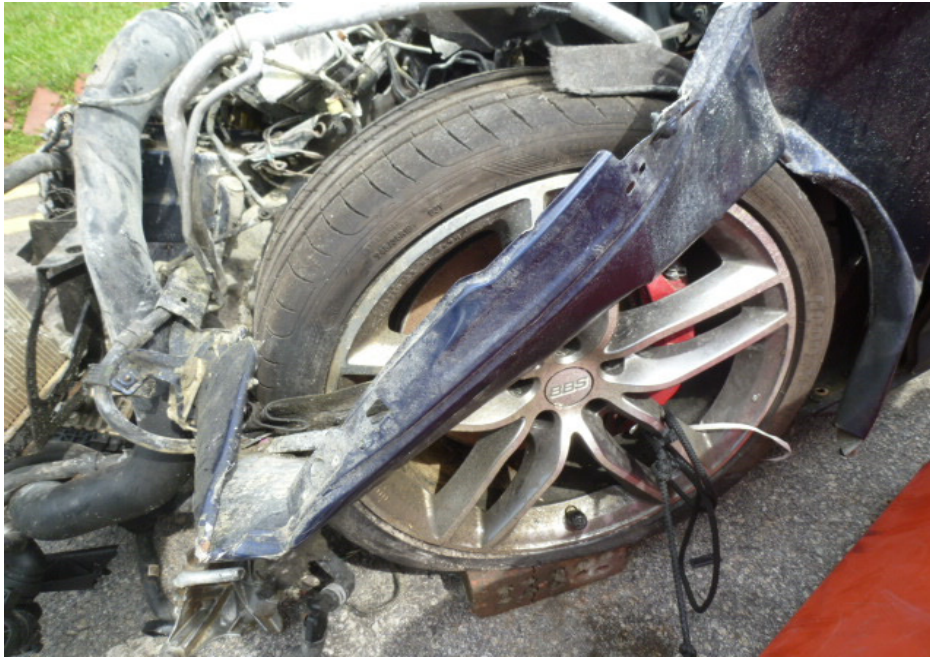
7. At the time of physical inspection of the Insured Vehicle, we had found several aftermarket 19- inch alloy rims. All these fitted components were not the standard type for the Insured Vehicle. See photo 5 below.

Photo 5 shows the non-standard rim found to be fitted on the Insured Vehicle at the time of our inspection. The 19- inch alloy rims fitted on the Insured Vehicle were not the standard type for the Insured Vehicle.

24. We found the Insured Vehicle to be fitted with 19- inch alloy rims. The tyre rims fitted do not require prior approval from LTA.
25. Although the aftermarket alloy rims fitted on the Insured Vehicle were not the standard type for the Insured Vehicle, we are of the view that these parts did not cause and/or contribute to the fire incident.

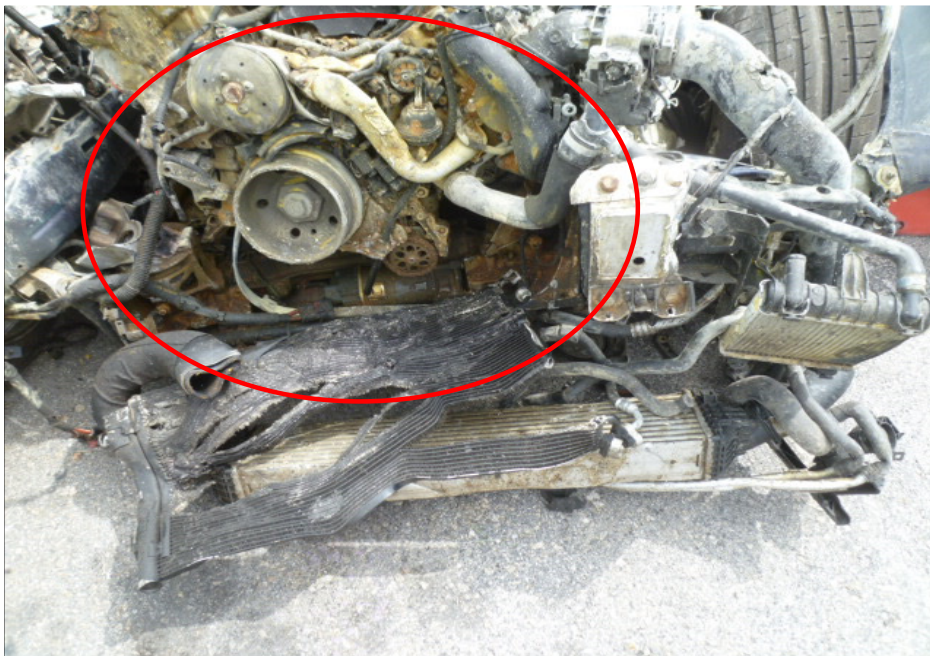
16. For this particular case, the front side of the Insured Vehicle had sustained an impact of significant force. This can be determined from the physical damage to the Insured Vehicle where the body parts around the front side were pushed inwards, in a direction towards the engine bay of the Insured Vehicle. The impact force had penetrated the front bumper reinforcement, front bumper support panel and beyond, pushing the radiator towards the engine bay. This was caused when the Insured Vehicle had collided into the rear of the Motor Bus. See photo 6 below.

Photo 6 shows the front side of the Insured Vehicle. The impact force from the collision with the Motor Bus had penetrated the front bumper reinforcement, causing a significant dent on the front bumper support panel and beyond, pushing the radiator towards the engine bay (circled).

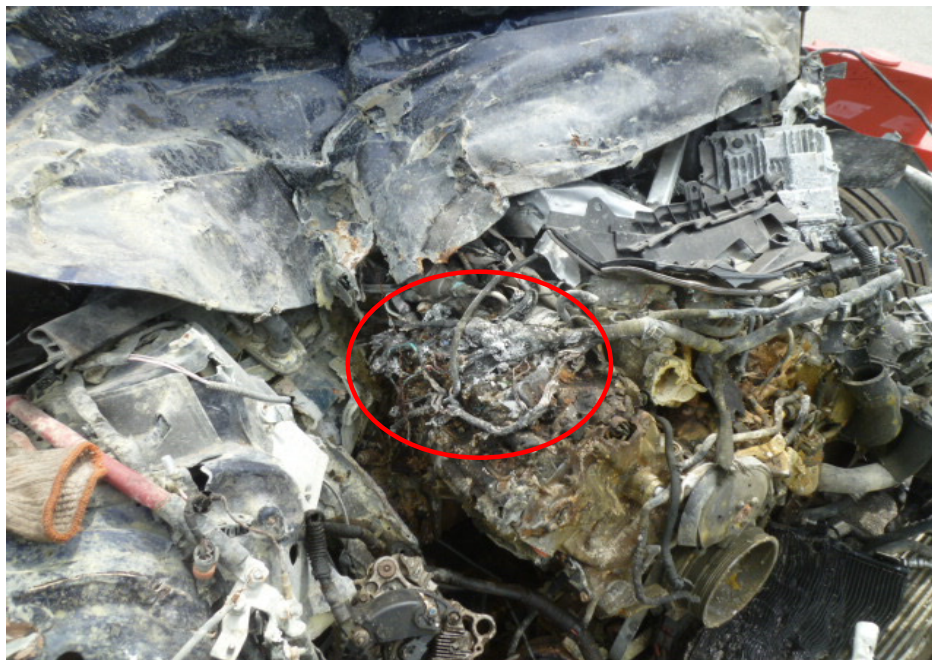
19. Upon closer examination of the Insured Vehicle, we had found greenish residue on several stretches of original factory fitted wirings from the rear of the engine compartment (before the firewall panel) leading to the electrical components along the dashboard. The presence of greenish residue indicates internal heating of copper wires, a sign of an electrical short circuit occurring. The greenish residue is normally left behind from oxidation as a result of chemical reaction involving the copper wires. This physical evidence would then appear to suggest that the cause of fire to the Insured Vehicle could have possibly been due to electrical in nature. See photos 7 - 9 below.

Photo 7 shows the engine compartment of the Insured Vehicle. We found greenish residue on some of the wirings around the rear centre portion of the engine compartment of the Insured Vehicle (circled).

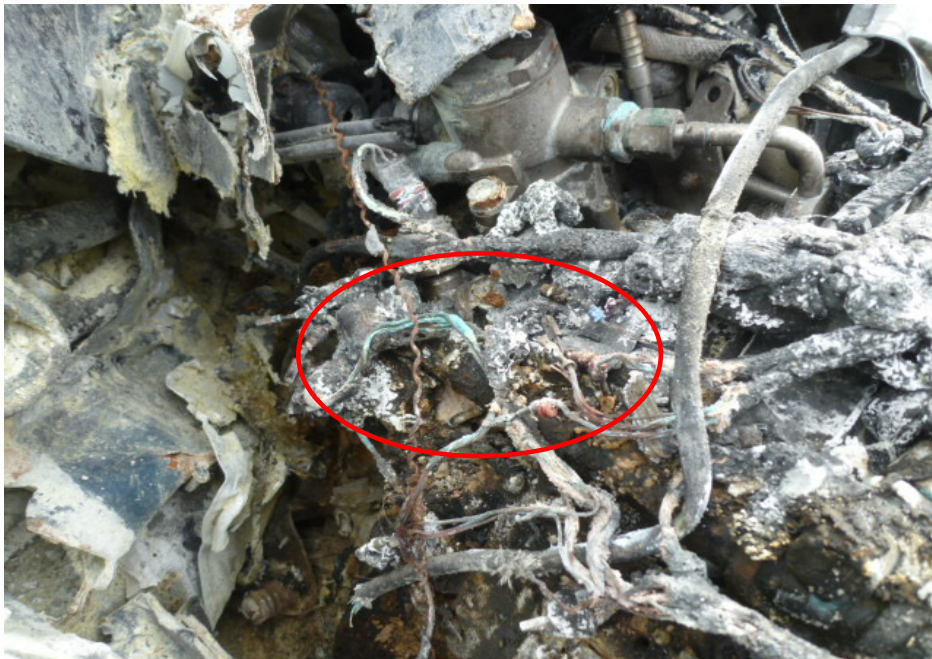
Photo 8 shows a closer view of the wirings with greenish residue found on some of the wirings around the rear centre portion of the engine compartment of the Insured Vehicle (circled). The presence of such greenish residue suggest occurrence of an electrical short circuit.

22. Having investigated and technically analysed the damages of burnt nature to the Insured Vehicle, we are of the view that the cause of fire to the Insured Vehicle was of electrical in nature, where live wire(s) around the impact area could have become detached and came into contact with the metal body of the Insured Vehicle, creating sparks, which ignited the fire.

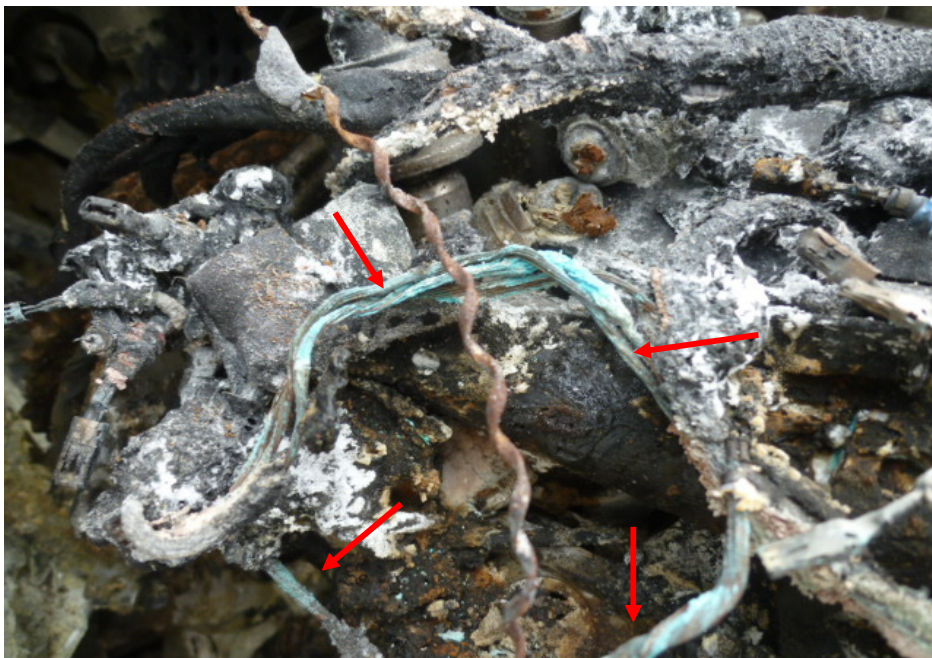
Photo 9 shows a close up view of the wirings with greenish residue found around the rear centre portion of the engine compartment of the Insured Vehicle (red arrows). The presence of such greenish residue suggest occurrence of an electrical short circuit.

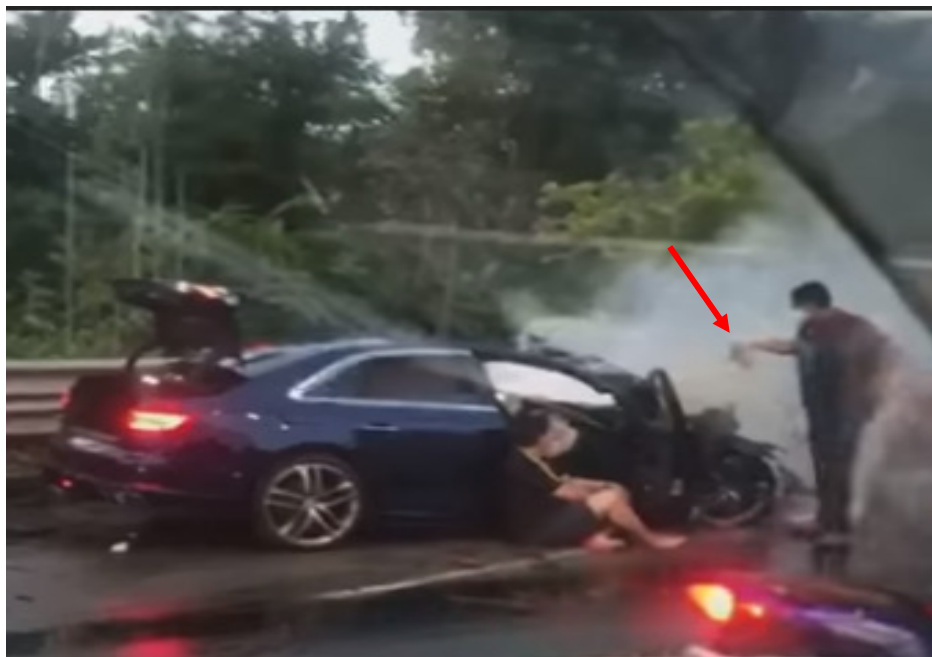
Photo 10 shows the Insured Vehicle on fire after rear- ending the Motor Bus and before the arrival of the SCDF. In general, the information that could be gathered from this photograph had corresponded to the events that were related to us by Mr Raffid, which is the fire started from the front bonnet almost immediately after the collision and that he used a small fire extinguisher from the Insured Vehicle to put out the fire (arrowed).

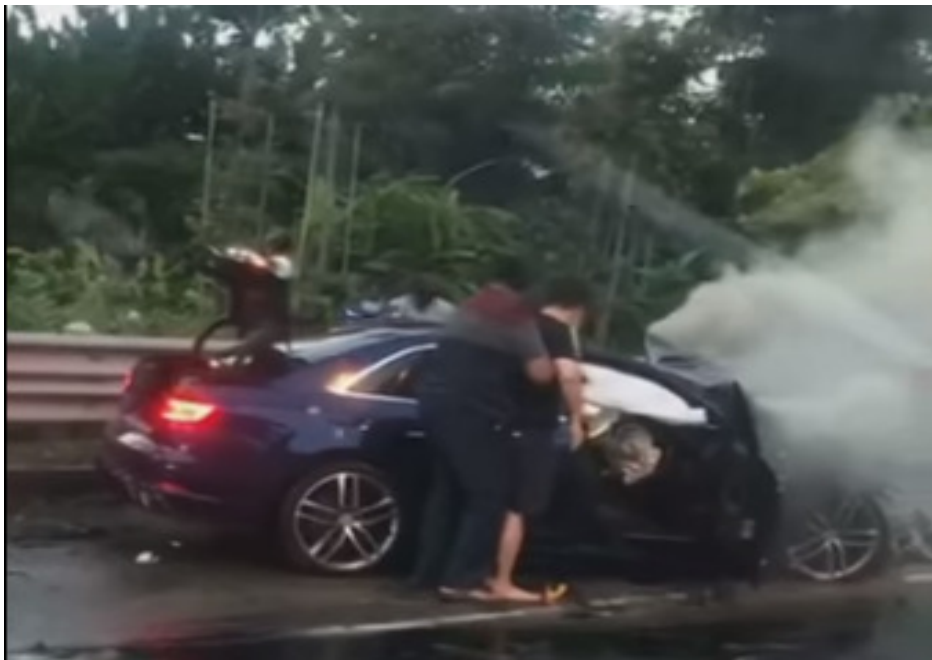
Photo 11 shows Mr Raffid helping Mr Goh up after putting out the fire to the Insured Vehicle.

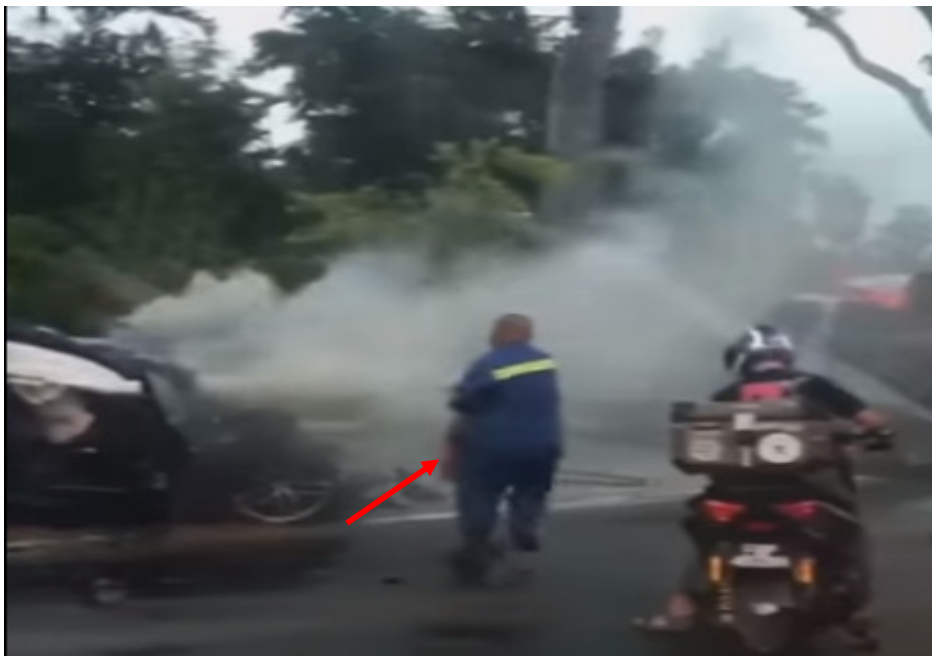
Photo 12 shows other passers-by making sure the fire to the Insured Vehicle was extinguished (arrowed).

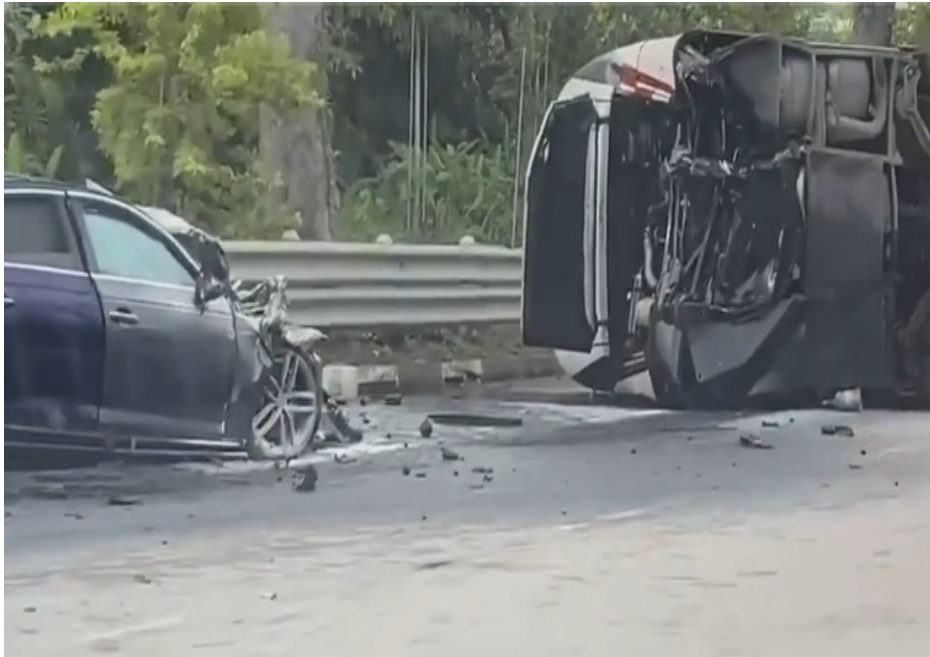
Photo 13 shows both vehicles after the fire was put out.

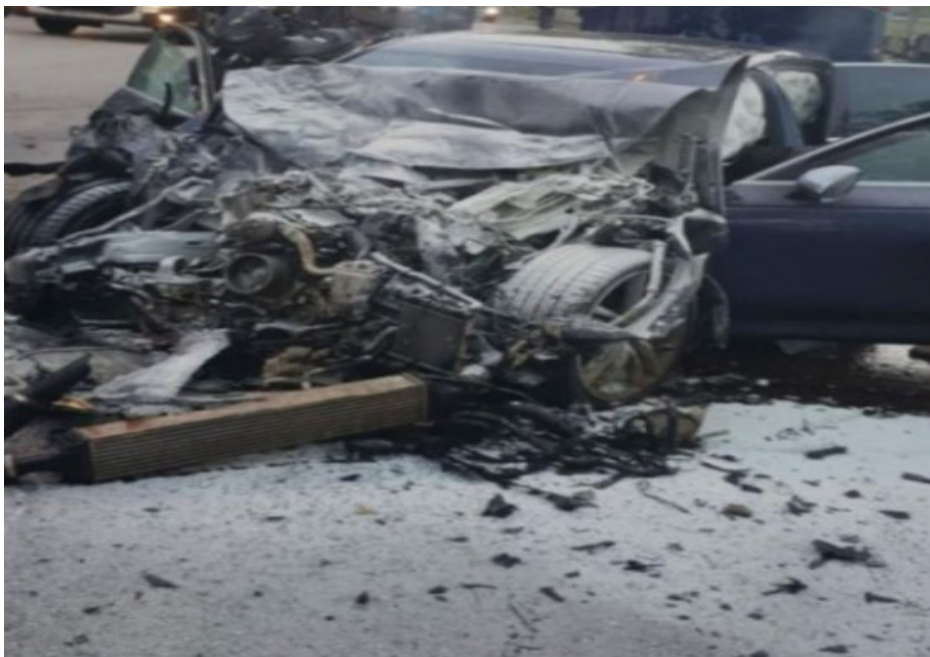
Photo 14 shows the Insured Vehicle after the fire was put out. In general, the information that could be gathered from this photograph had corresponded to the events that were related to us by Mr Raffid, which is the fire started from the front bonnet almost immediately after the collision.
