Your Ref: Toyota Alphard  
(chassis number AGH300213270)  
Our Ref : CI/TP21006209/D

29 May 2021

**INSPECTION REPORT OF AN UNREGISTERD TOYOTA ALPHARD MOTOR CAR WITH CHASSIS NUMBER AGH300213270**

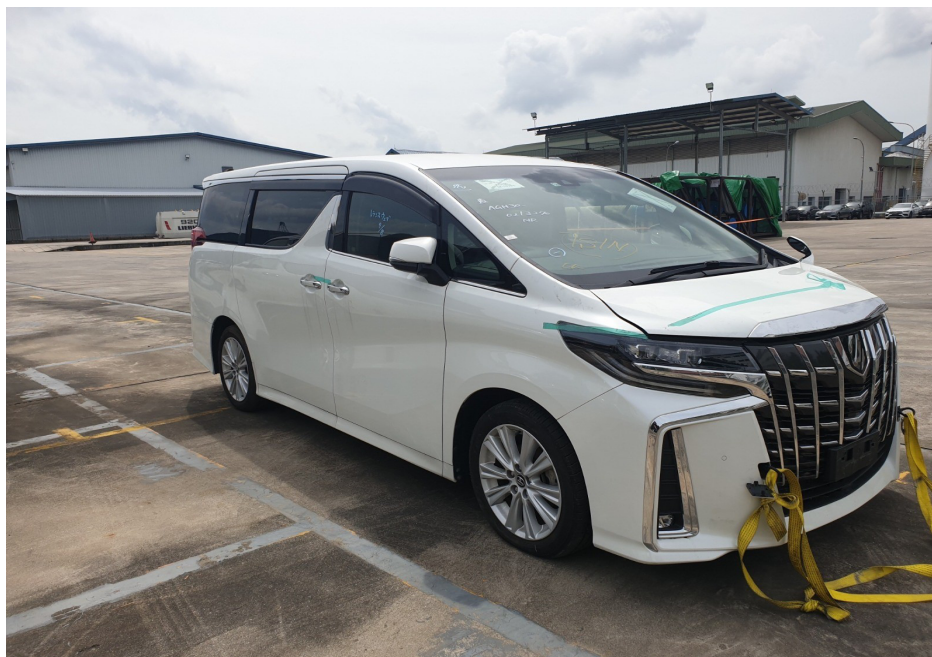
**Photo 1** shows a general view of the front right body of the Motor Car (photograph provided to me). There was no physical damage seen to the Motor Car from the photographs that were provided to me.

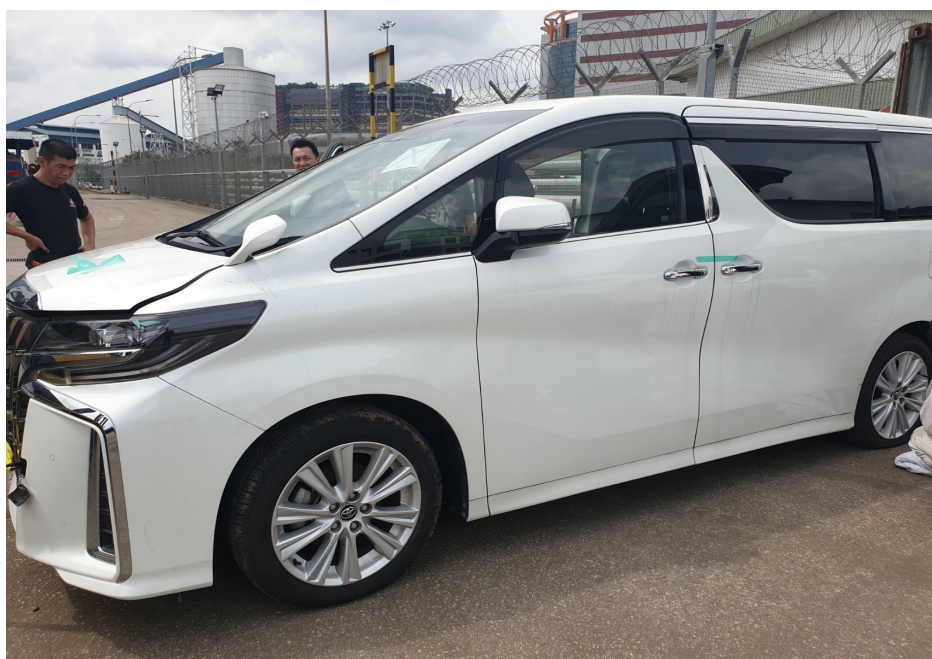
**Photo 2** shows the front left body of the Motor Car (photograph provided to me). There was no physical damage seen to the Motor Car from the photographs that were provided to me.

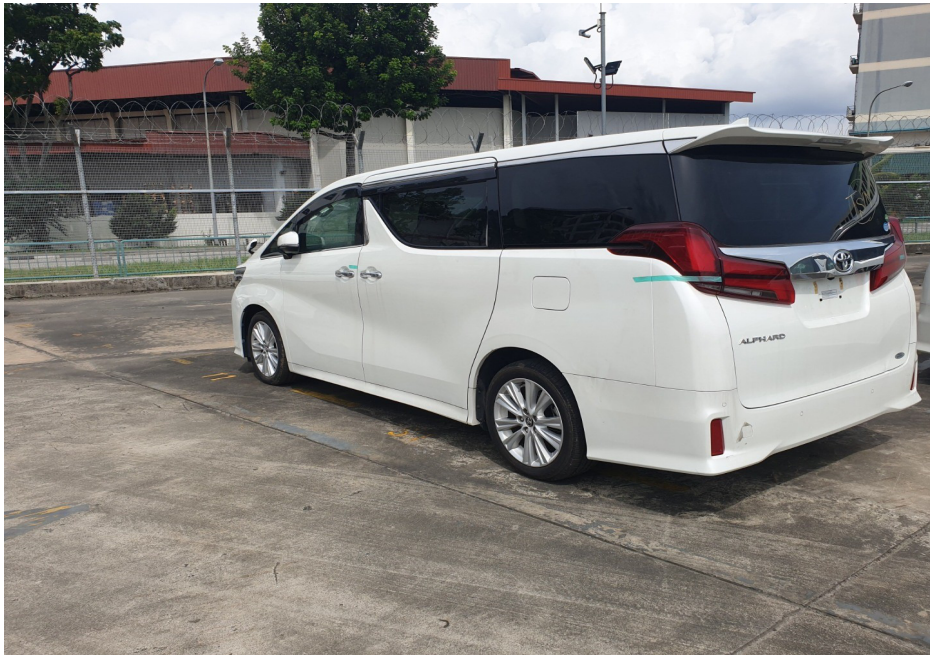
**Photo 3** shows a general view of the left body of the Motor Car (photograph provided to me). There was no physical damage seen to the Motor Car from the photographs that were provided to me.

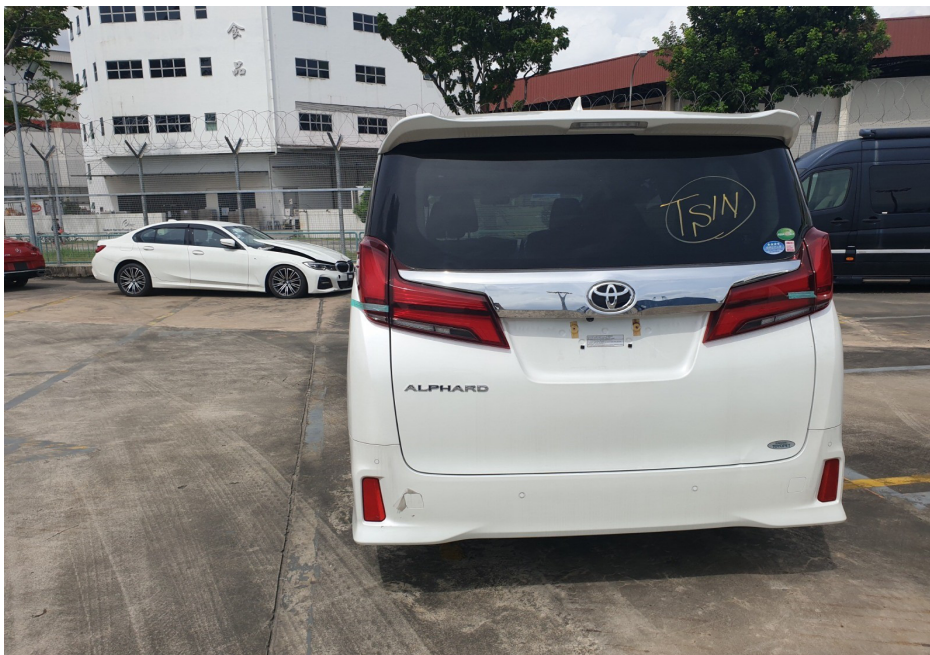
**Photo 4** shows a general view of the rear body of the Motor Car (photograph provided to me). There was no physical damage seen to the Motor Car from the photographs that were provided to me.

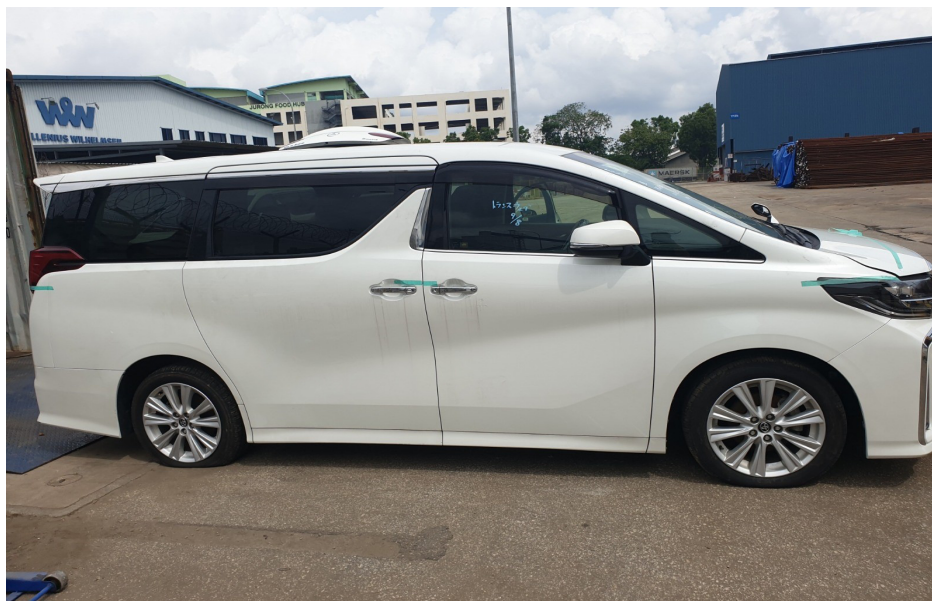
**Photo 5** shows the right body of the Motor Car (photograph provided to me). There was no physical damage seen to the Motor Car from the photographs that were provided to me.

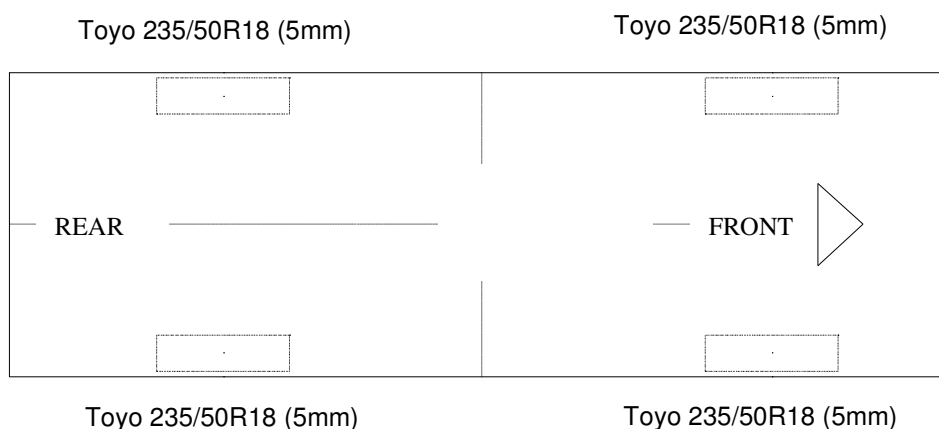
7. It was fitted with 18inch sport wheel rims that were wrapped with tyres that were observed to be of serviceable condition. The tyres were also sufficiently inflated for vehicular operation. The tyre brand, tyre size and approximate remaining tread depth of the 4 tyres of the Motor Car were recorded as follows: -

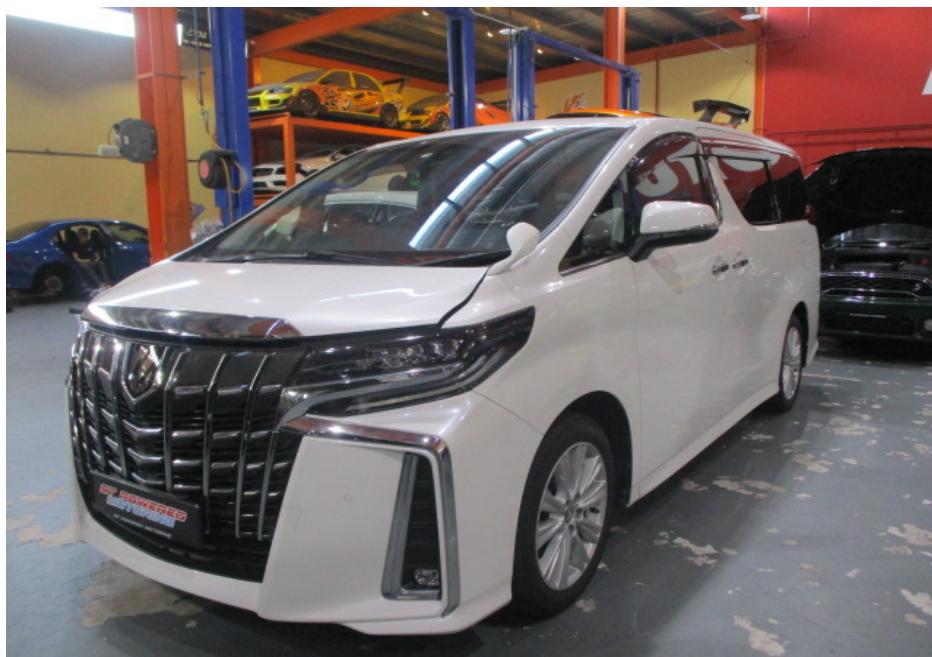
**Photo 6** shows a general view of the front left body of the Motor Car at the time of my inspection. The Motor Car was observed to be in a relatively good general condition with no loose exterior fittings observed. The mileage of the Motor Car recorded at the time of my inspection was 16,068km.

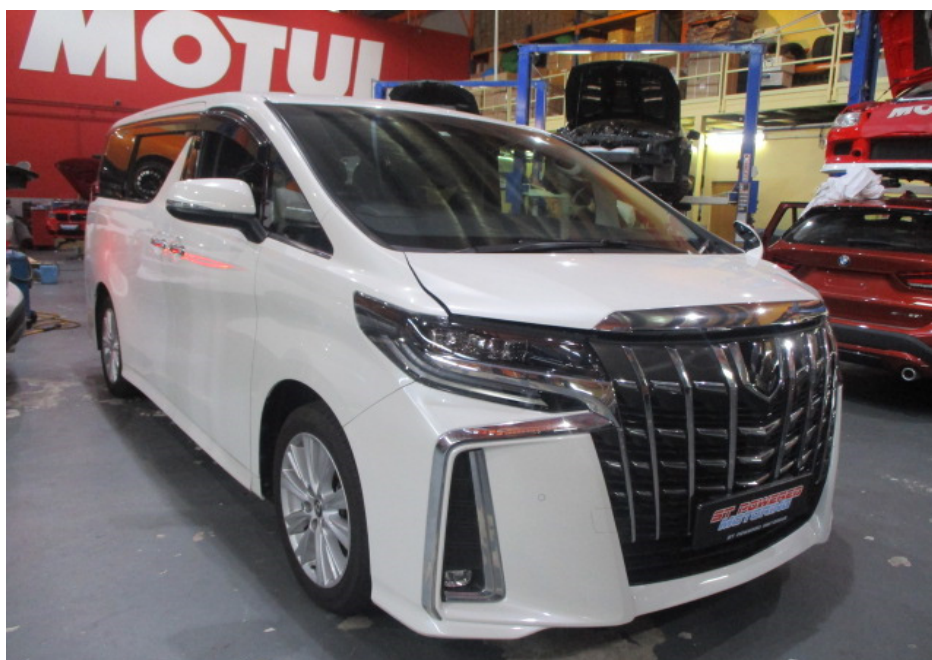
**Photo 7** shows a general view of the front right body of the Motor Car at the time of my inspection. The Motor Car was observed to be in a relatively good general condition with no loose exterior fittings observed.

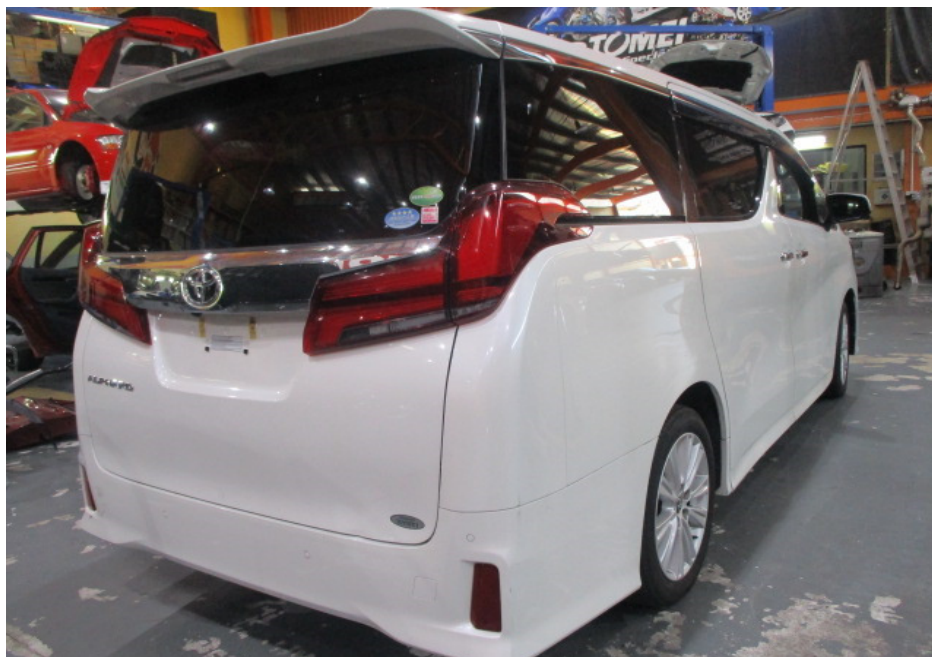
**Photo 8** shows a general view of the rear right body of the Motor Car at the time of my inspection. The Motor Car was observed to be in a relatively good general condition with no loose exterior fittings observed. The mileage of the Motor Car recorded at the time of my inspection was 16,068km.

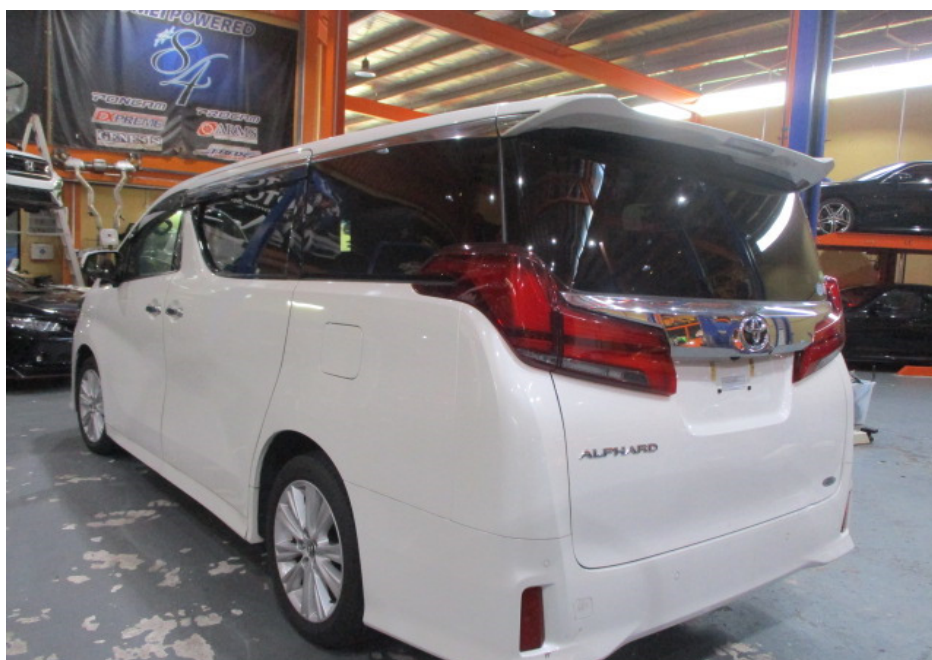
**Photo 9** shows a general view of the rear left body of the Motor Car at the time of my inspection. The Motor Car was observed to be in a relatively good general condition with no loose exterior fittings observed.

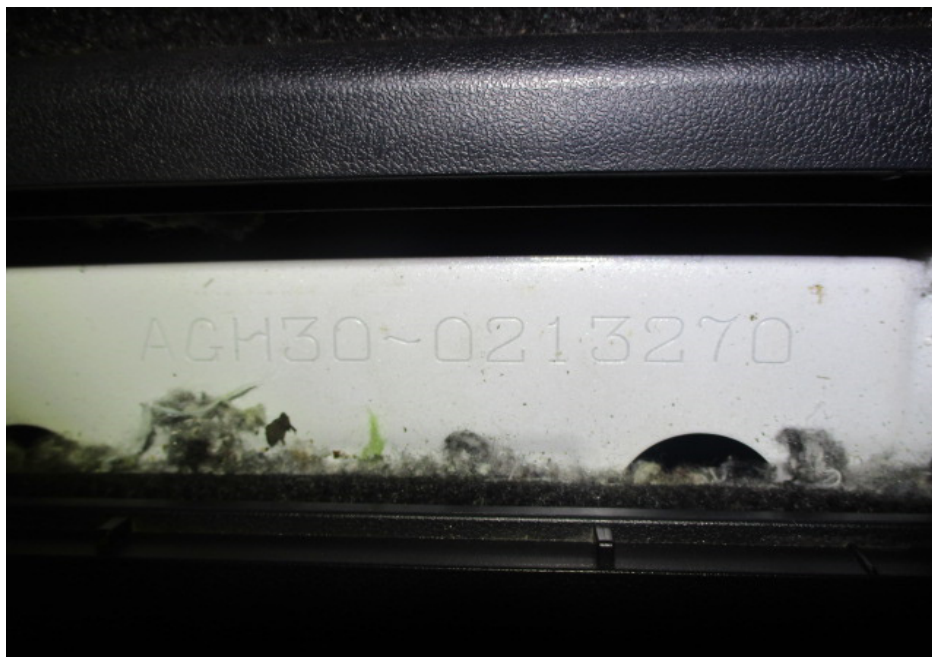
**Photo 10** shows the chassis number of the Motor Car. The chassis number recorded was AGH300213270.

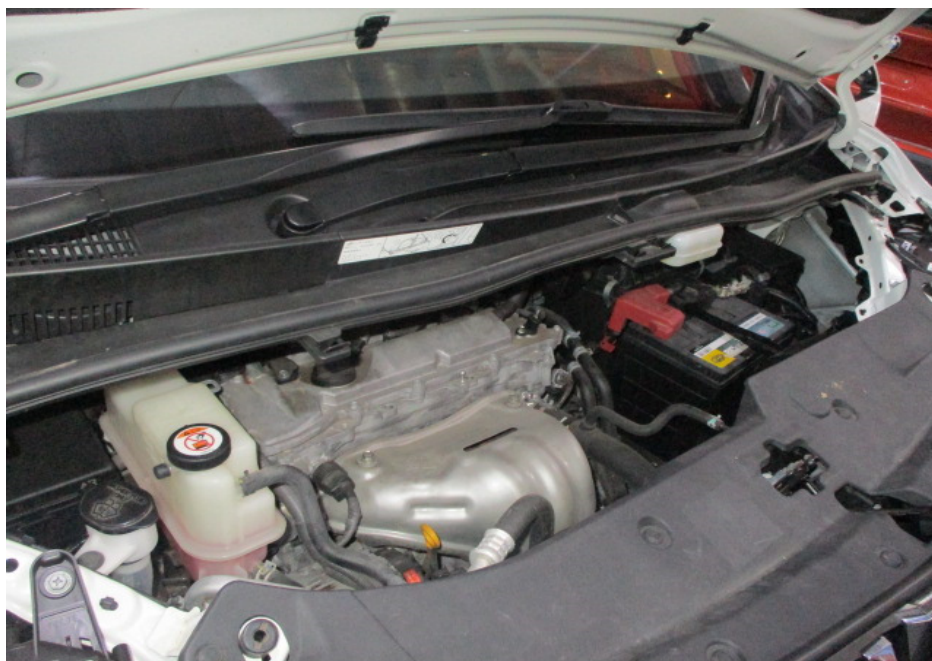
13. My examination of the engine compartment of the Motor Car revealed that the various parts and components inside the engine compartment were all intact and properly fitted. The engine oil, brake fluid and engine coolant were all found to be of sufficient level for operating purposes. Visually, there was also no contamination found to these fluids.
14. My checks on the underside of the Motor Car revealed no sign(s) or indication(s) of fluid leakage and/or fluid stain(s). The engine block and automatic transmission assembly were both secured properly. All undercarriage components of the Motor Car were also observed to be intact and secured in an appropriate manner.

**Photo 11** shows a general view of the engine compartment of the Motor Car at the time of my inspection. The various parts and components inside the engine compartment were all observed to be intact and properly fitted. There was also no sign(s) or indication(s) of fluid leak and/or fluid stain found inside the engine compartment.

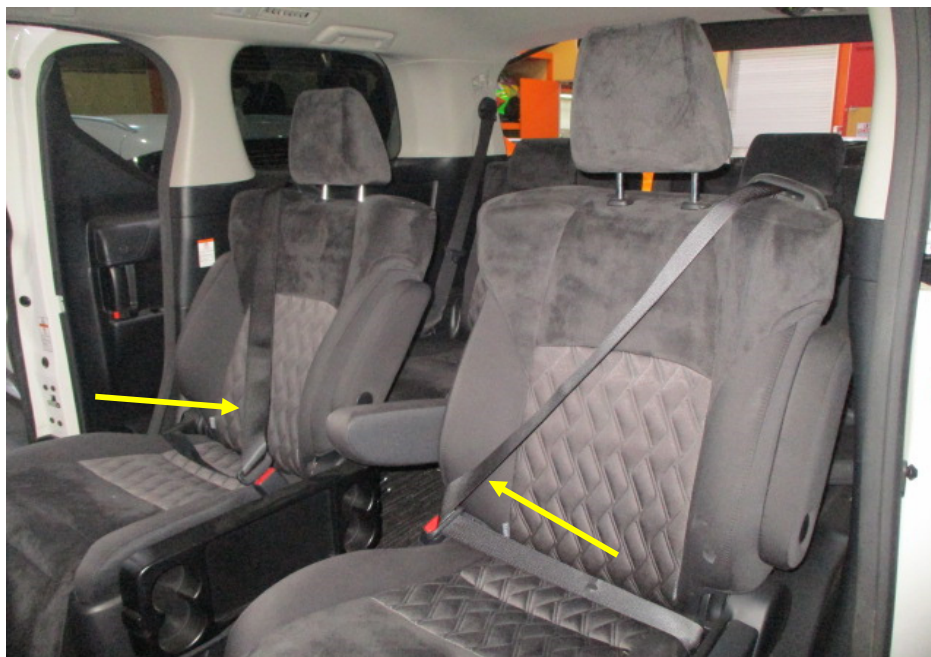
11. The seats of the Motor Car were found to be secured to the floorboard of the Motor Car via seat rails bolted onto the floorboard. Retractable seat belt reels and pre-tensioners were fitted on all seats of the Motor Car. The seat belt reels were tested and were able to be fastened securely into the respective pre-tensioners that were fixed to the side of all the seats.

**Photo 12** shows the rear seats at the 1<sup>st</sup> row of the Motor Car. All the seats of the Motor Car were secured via seat rails to the floorboard. They were also fitted with a retractable seat belt reel and a pre-tensioner. The seat belts (arrowed) were tested and were able to be fastened into the respective pre-tensions that were fitted on the side of each individual seat.

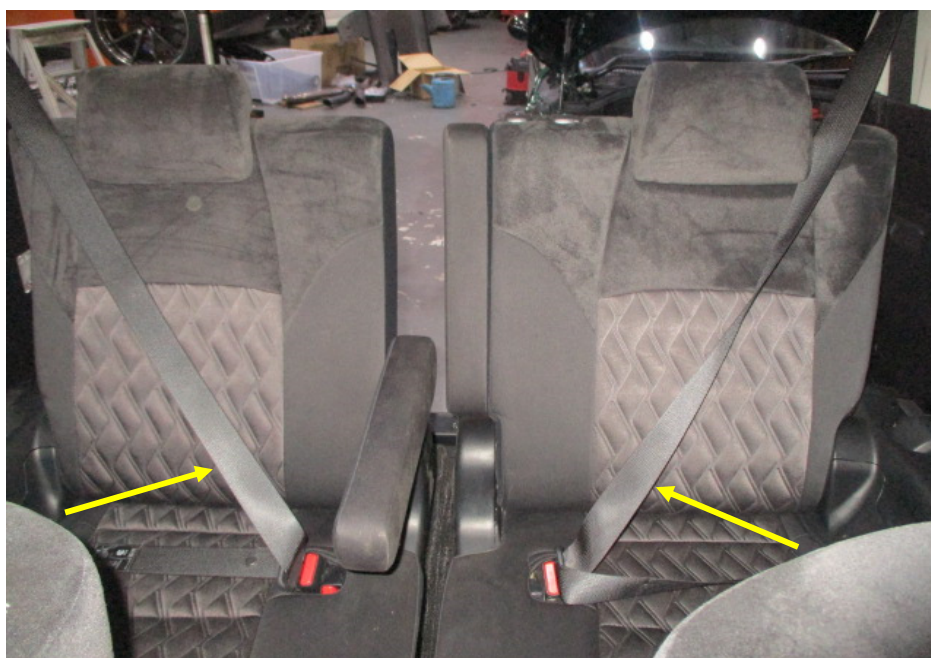
**Photo 13** shows the rear seats at the 2<sup>nd</sup> row of the Motor Car. All the seats of the Motor Car were secured via seat rails to the floorboard. They were also fitted with a retractable seat belt reel and a pre-tensioner. The seat belts (arrowed) were tested and were able to be fastened into the respective pre-tensions that were fitted on the side of each individual seat.

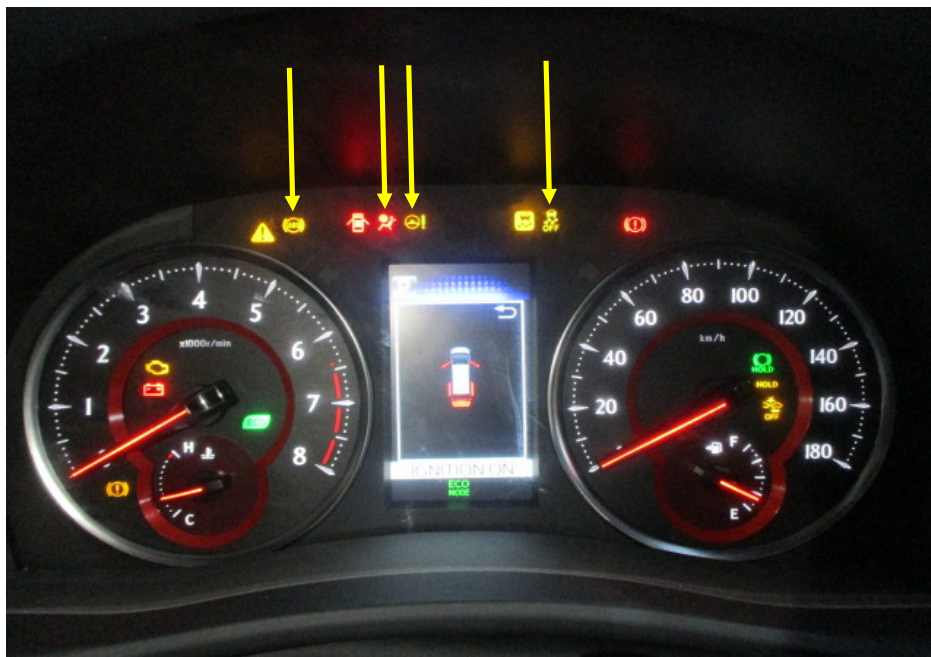
12. The Motor Car's automatic self-test of the functionality of its various electronic safety features like the Anti-Lock Brake System (ABS), Supplemental Restraint System (SRS), Electric Power Steering (EPS), Vehicle Stability Control (VSC) during cranking of the engine had indicated that these electronic systems were in working condition. This was determined from the respective warning lights disappearing from the instrument panel after the self-test.

**Photo 14** shows the warning lights for the various electronic safety features appearing on the instrument panel of the Motor Car during its self-test when the engine is cranked, in particular the lights for the ABS, SRS, EPS and VSC systems (arrowed).

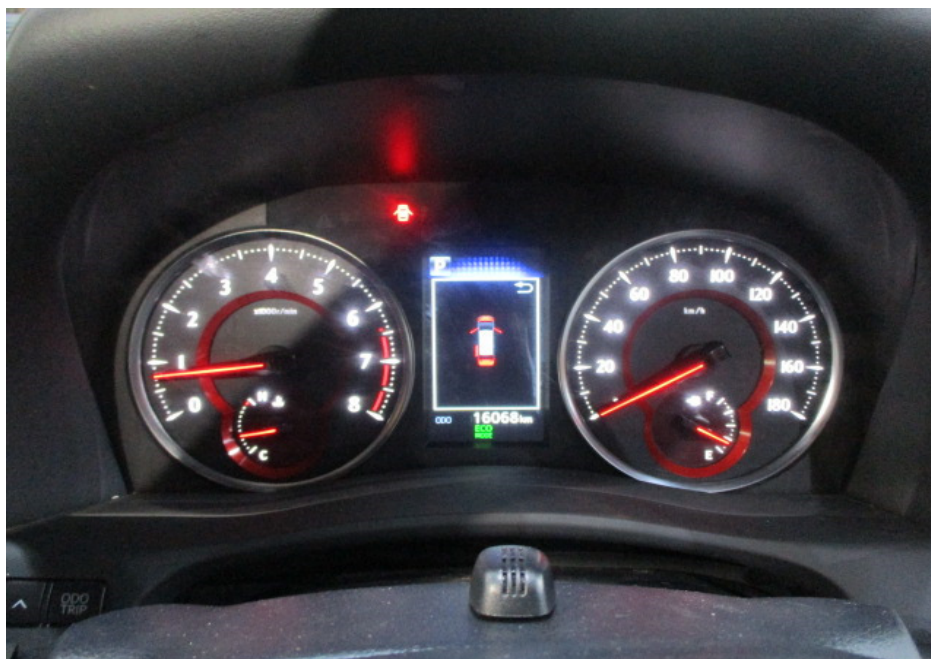
**Photo 15** shows the respective warning lights no longer illuminated, indicating that there is no fault detected to the ABS, SRS, EPS and VSC systems of the Motor Car during the self-test. These electronic systems were hence in working condition at the time of my inspection.

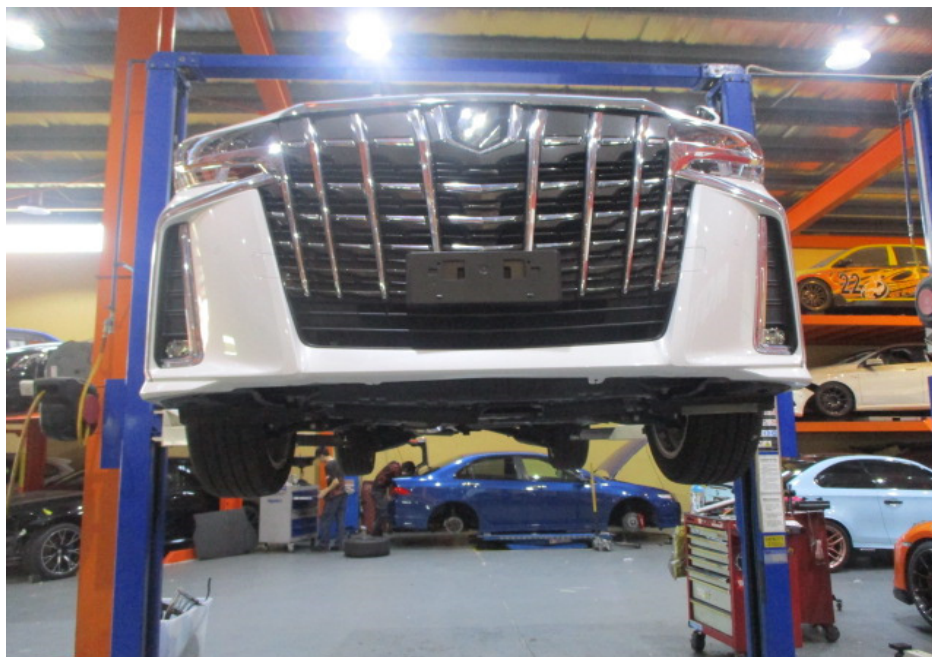
**Photo 16** shows the Motor Car hoisted up for checks on its undercarriage. There was no sign(s) or indication(s) of fluid leakage and/or fluid stain(s) on the underside of the Motor Car. The undercarriage components of the Motor Car were also all observed to be intact and secured in an appropriate manner.

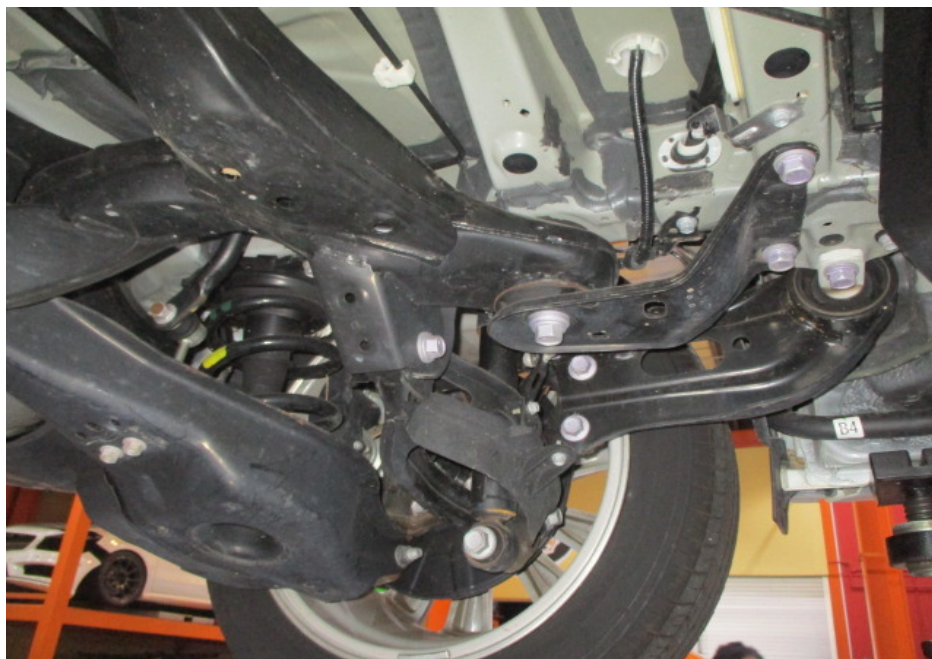
**Photo 17** shows a general view of the control arms and linkages at the rear left wheel of the Motor Car. I did not observe any fluid leak and/or fluid stain on the underside of the Motor Car. All of the Motor Car's undercarriage components were observed to be intact and secured in an appropriate manner.

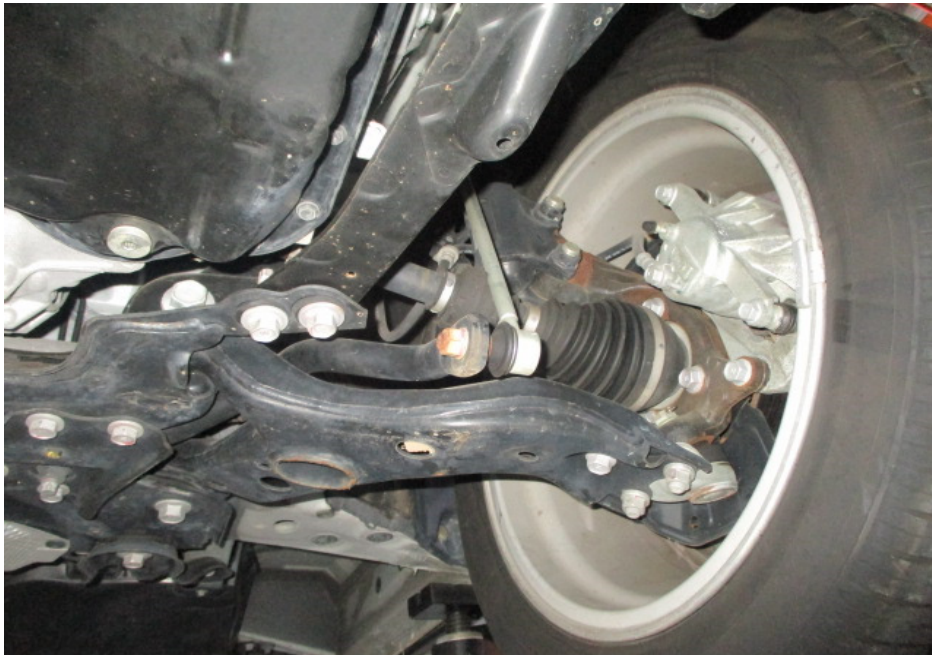
**Photo 18** shows the various undercarriage components at the front left wheel of the Motor Car. The mechanical components, control arms and linkages were all found to be intact and secured in an appropriate manner.

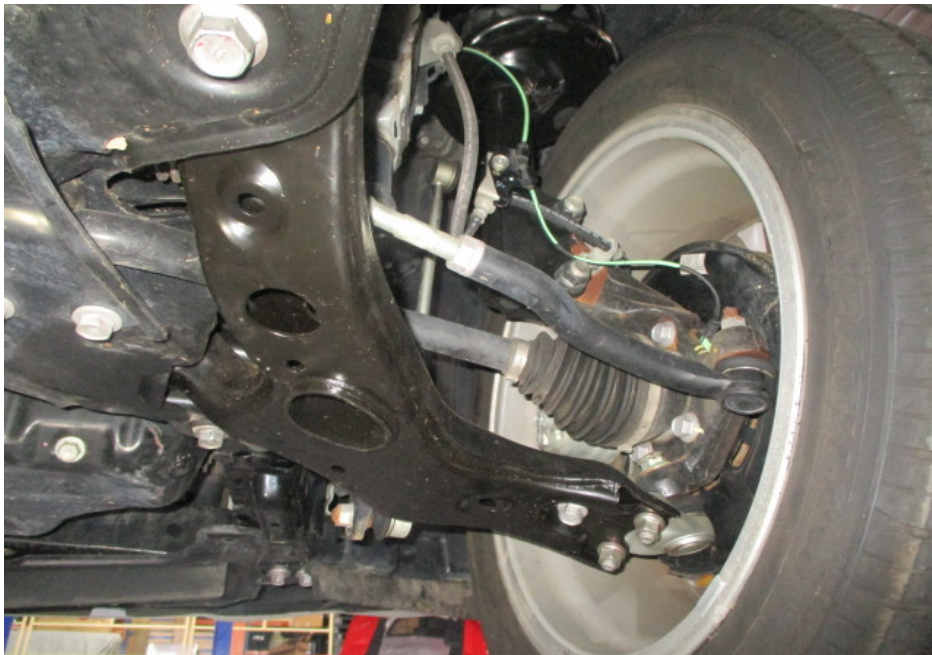
**Photo 19** shows the various undercarriage components at the front right wheel of the Motor Car. The mechanical components, control arms and linkages were all found to be intact and secured in an appropriate manner. I also did not observe any fluid leak and/or fluid stain on the underside of the Motor Car.

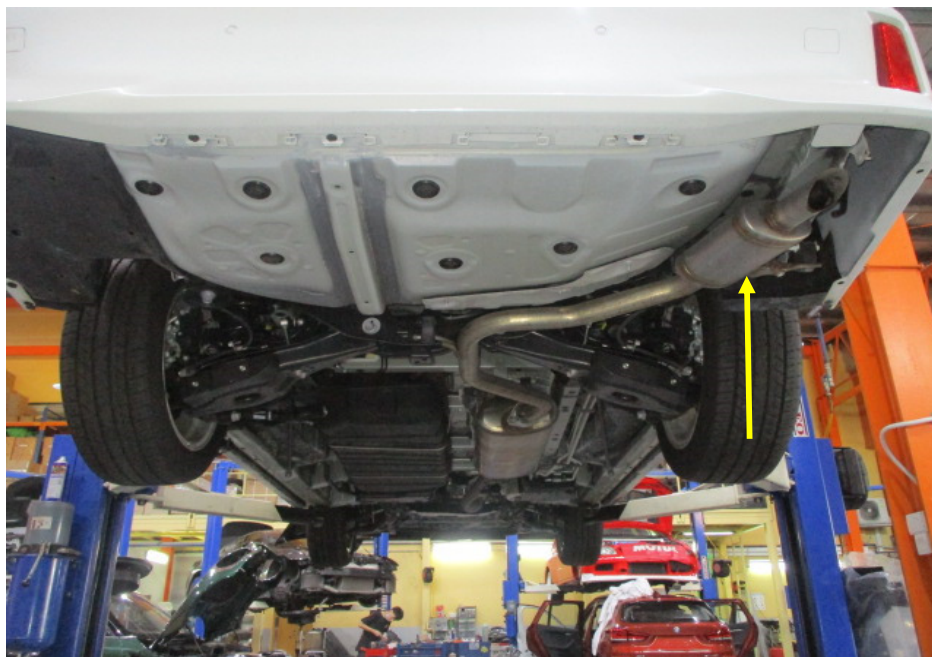
**Photo 20** shows a general view of the Motor Car's exhaust system. My examination of the Motor Car's exhaust system revealed no sign(s) or indication(s) of any cut or weld marks along its exhaust pipes, rear muffler (arrowed), centre resonator box and on its catalytic converter.

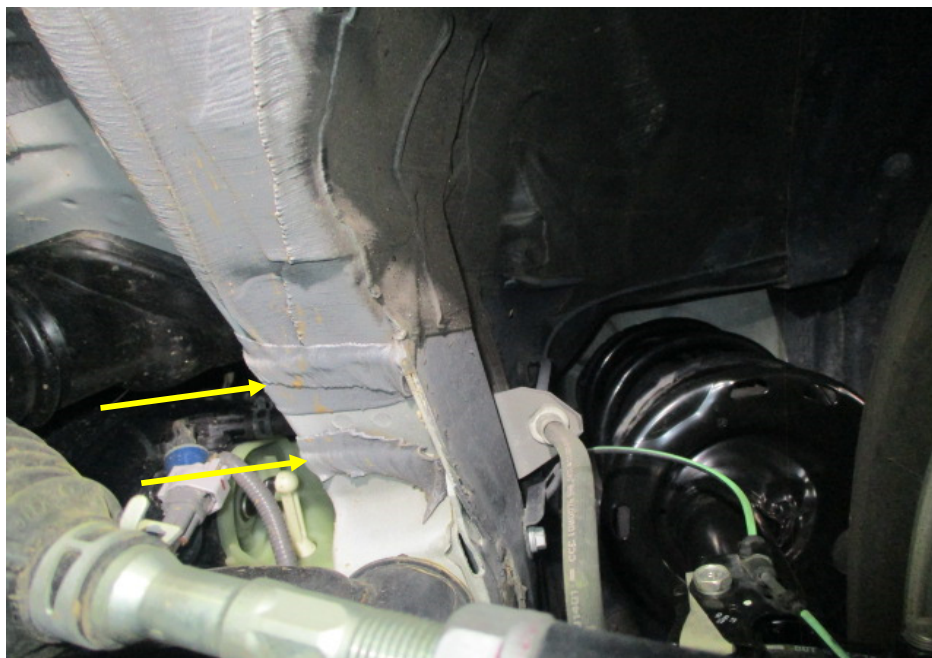
10. Visually, I did not find any weld marks, other than the original spot weld marks, on the chassis/structural body of the Motor Car. The original factory sealant at the joints along the chassis/structural body was also untouched, again indicating that no replacement of the chassis/structural body was carried out; and that the chassis/structural body was originally fitted.

**Photo 21** shows the chassis/structural body at the underside front right of the Motor Car. I did not find any weld marks other than original spot weld marks on the chassis/structural body of the Motor Car. The original factory sealant (arrowed) at the joints along the chassis/structural body was untouched, indicating no work was done on the chassis/structural body of the Motor Car and that the chassis/structural body was originally fitted.

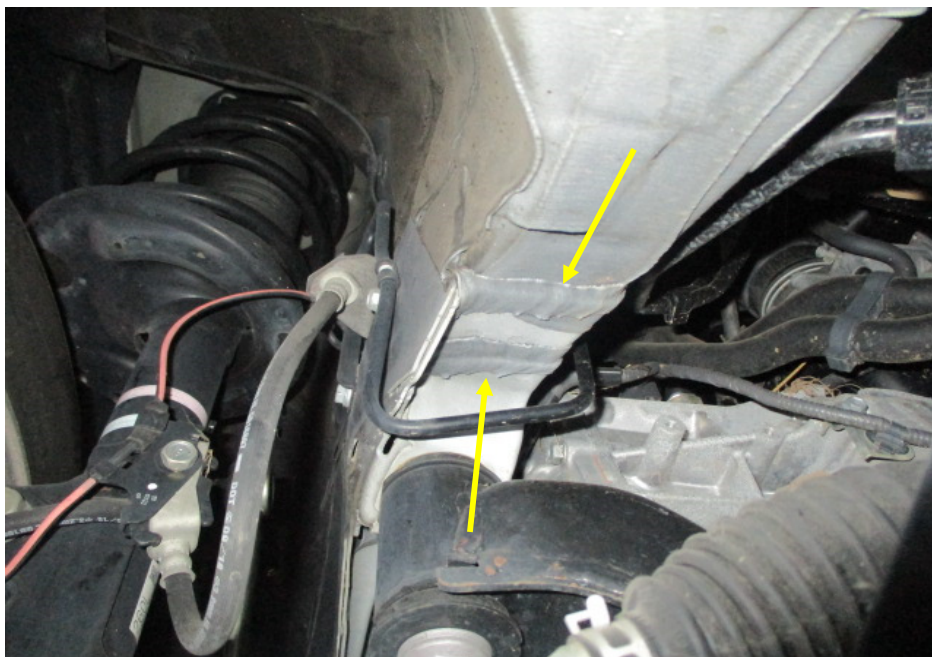
**Photo 22** shows the chassis/structural body at the underside front left of the Motor Car. The original factory sealant (arrowed) at the joints along the chassis/structural body was observed to be untouched. In general, I had found no work was carried out on the chassis/structural body of the Motor Car. The chassis/structural body of the Motor Car was originally fitted.

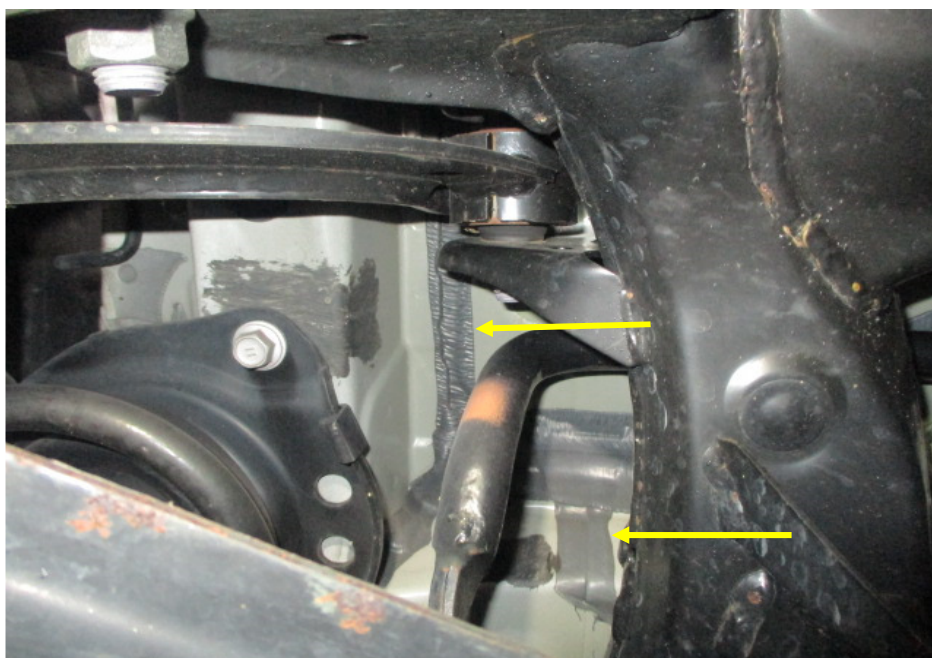
**Photo 23** shows the chassis/structural body at the underside rear right of the Motor Car. The original factory sealant (arrowed) at the joints along the chassis/structural body was observed to be untouched. In general, I had found no work was carried out on the chassis/structural body of the Motor Car. The chassis/structural body of the Motor Car was originally fitted.

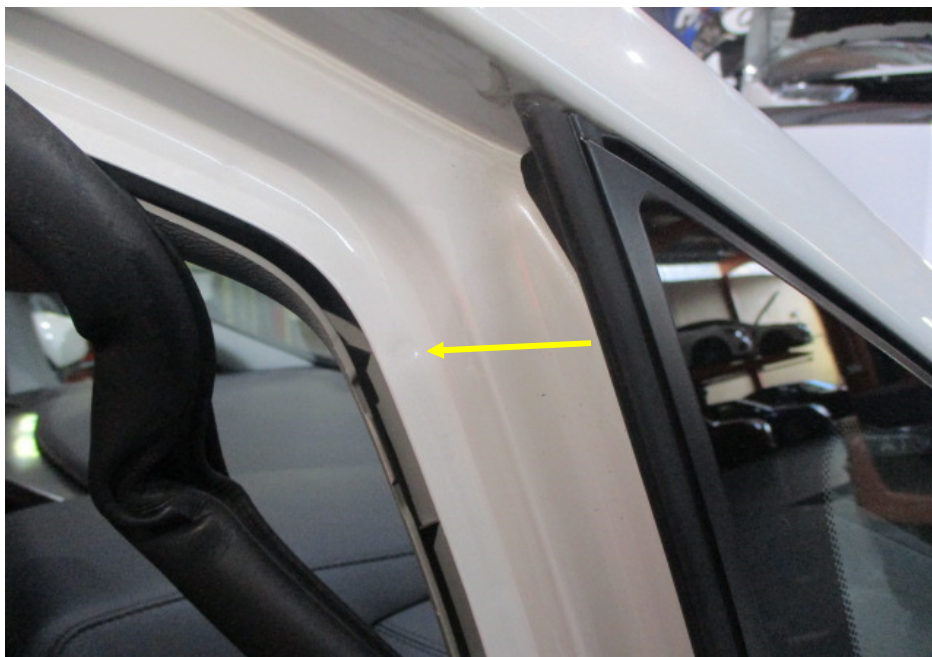
**Photo 24** shows the right side “A” pillar of the Motor Car. I did not find any weld marks other than original spot weld marks (arrowed) on the right side “A” pillar of the Motor Car, which indicates that there was no re-welding works carried out. In general, I had found all the non-detachable body panels of the Motor Car to be originally fitted at the time of my inspection.

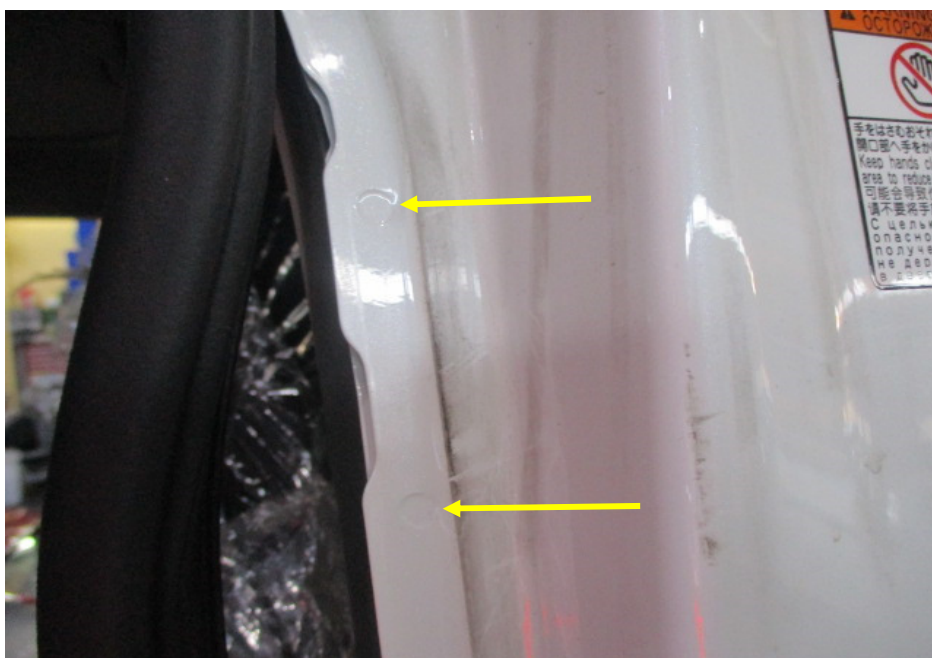
**Photo 25** shows the right side “B” pillar of the Motor Car. I did not find any weld marks other than original spot weld marks (arrowed) on the right side “B” pillar of the Motor Car, which indicates that there was no re-welding works carried out. In general, I had found all the non-detachable body panels of the Motor Car to be originally fitted at the time of my inspection.

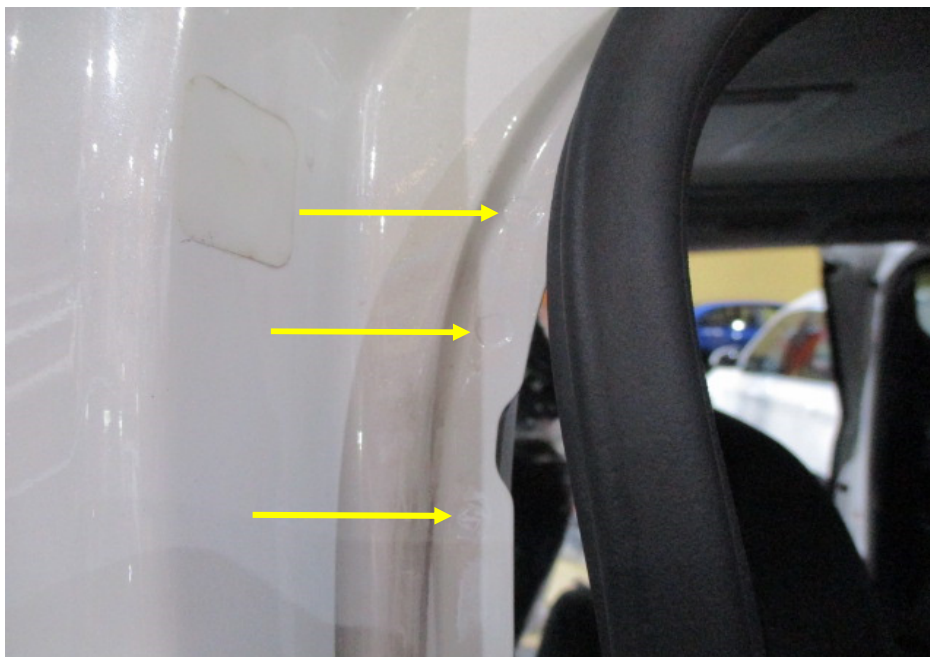
**Photo 26** shows the left side "B" pillar of the Motor Car. I did not find any weld marks other than original spot weld marks (arrowed) on the left side "B" pillar of the Motor Car, which indicates that there was no re-welding works carried out. In general, I had found all the non-detachable body panels of the Motor Car to be originally fitted at the time of my inspection.
