Your Ref: BMW X1  
(chassis number WBAJG32020ER66574)  
Our Ref : CI/TP21006210/D

29 May 2021

**INSPECTION REPORT OF AN UNREGISTERD BMW X1 MOTOR CAR WITH  
CHASSIS NUMBER WBAJG32020ER66574**

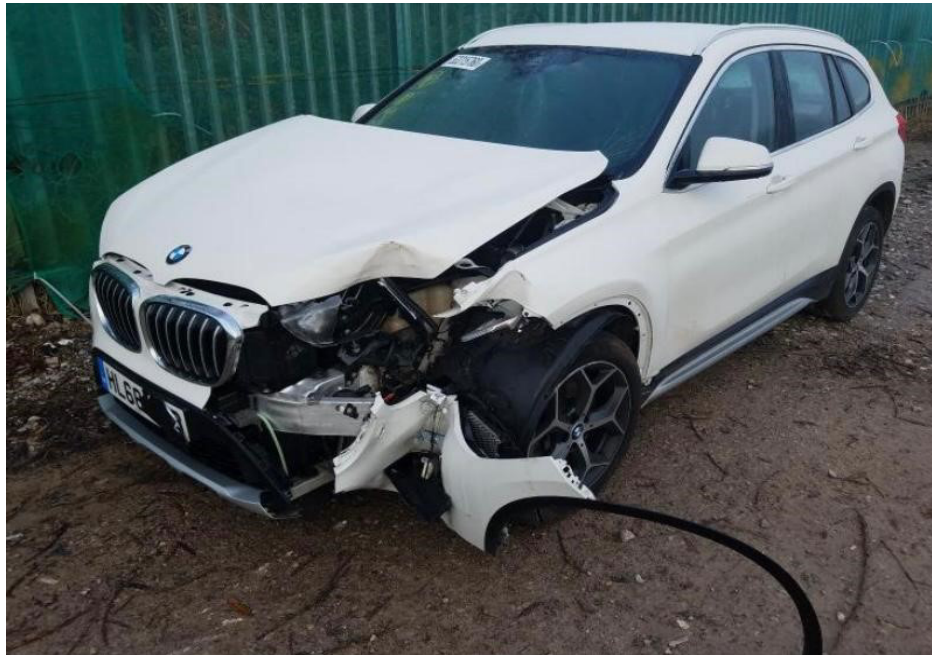
3. From the photographs provided to me, it was observed that the Motor Car had sustained damages at its front left portion. Body parts damaged include the front bumper, front bumper centre lower grille, front bumper centre lower garnish, front bumper left lower grille, front bumper reinforcement, front left fog lamp, front left radiator grille, front left headlamp, front left headlamp control units, front bonnet, front bonnet hinges, front left fender, front left fender inner shield and front left fender wheel arc garnish amongst others.
4. Apart for the front left portion, there was no physical damage observed to other areas of the Motor Car. The airbags were also not deployed, as seen from the photographs that were provided to me. See photo 1 – 4 below.

**Photo 1** shows the front left body of the Motor Car (photograph provided to me). The Motor Car was observed to have sustained damages at its front left portion. Body parts damaged include the front bumper, front bumper centre lower grille, front bumper centre lower garnish, front bumper left lower grille, front bumper reinforcement, front left fog lamp, front left radiator grille, front left headlamp, front bonnet, front bonnet hinges, front left fender, front left fender inner shield and front left fender wheel arc garnish amongst others.

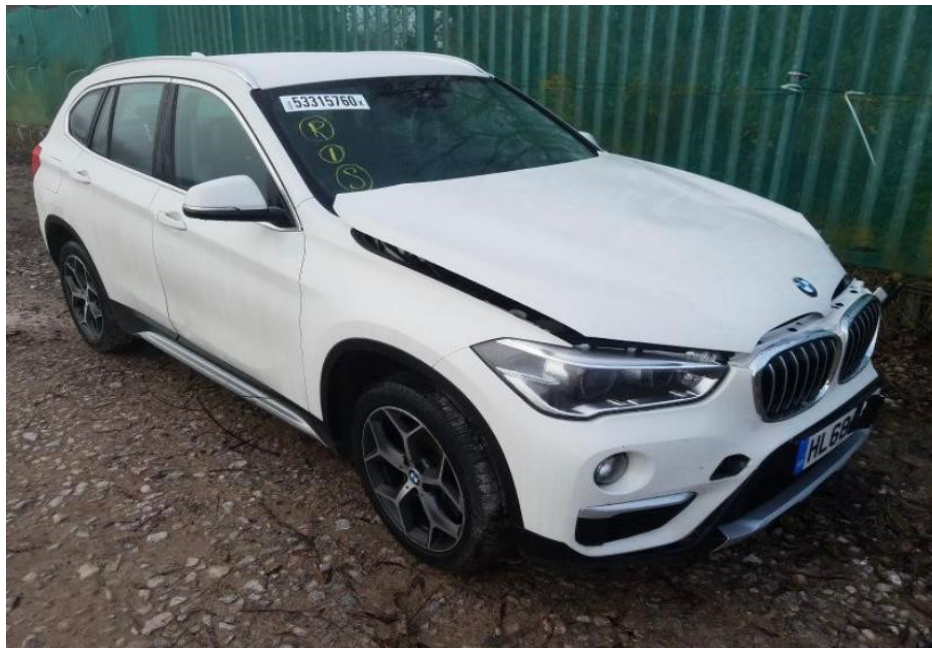
**Photo 2** shows the front right body of the Motor Car (photograph provided to me). Apart for the front left portion, there was no physical damage observed to other areas of the Motor Car. The airbags were also not deployed, as seen from the photographs that were provided to me.

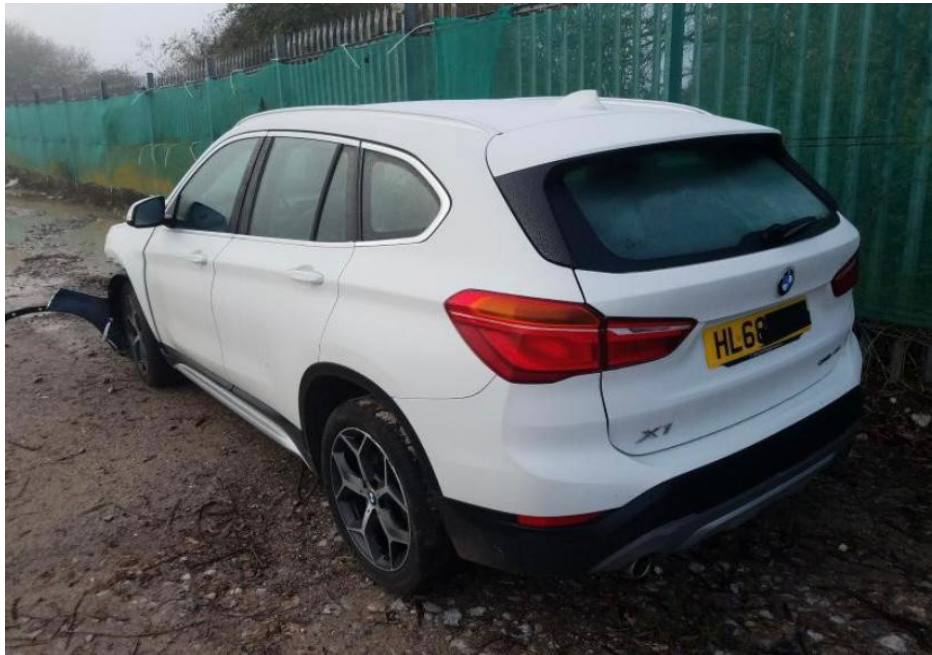
**Photo 3** shows the rear left body of the Motor Car (photograph provided to me). Apart for the front left portion, there was no physical damage observed to other areas of the Motor Car.

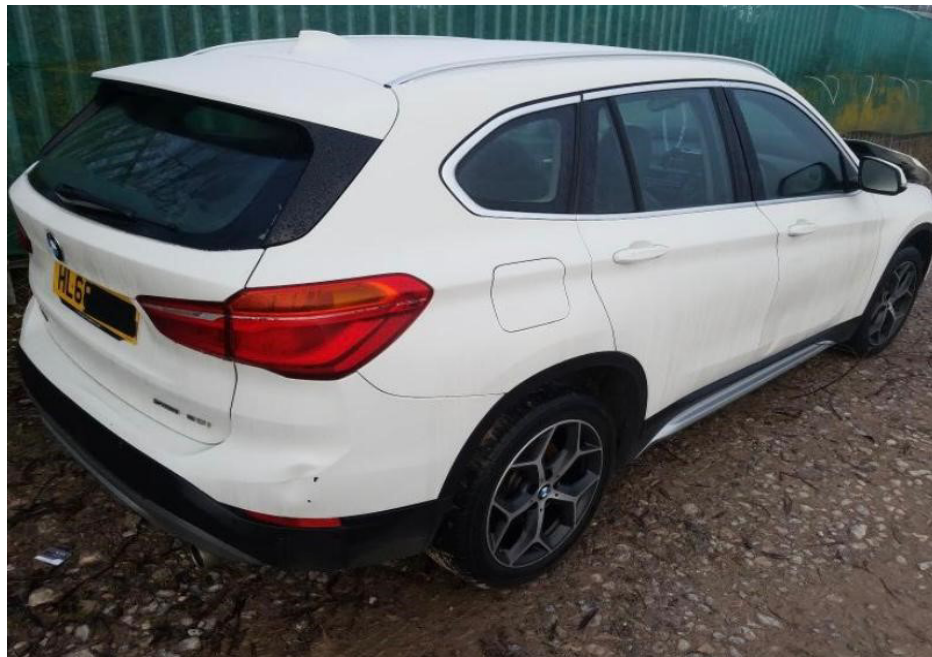
**Photo 4** shows the rear right body of the Motor Car (photograph provided to me). Apart for the front left portion, there was no physical damage observed to other areas of the Motor Car. The airbags were also not deployed, as seen from the photographs that were provided to me.

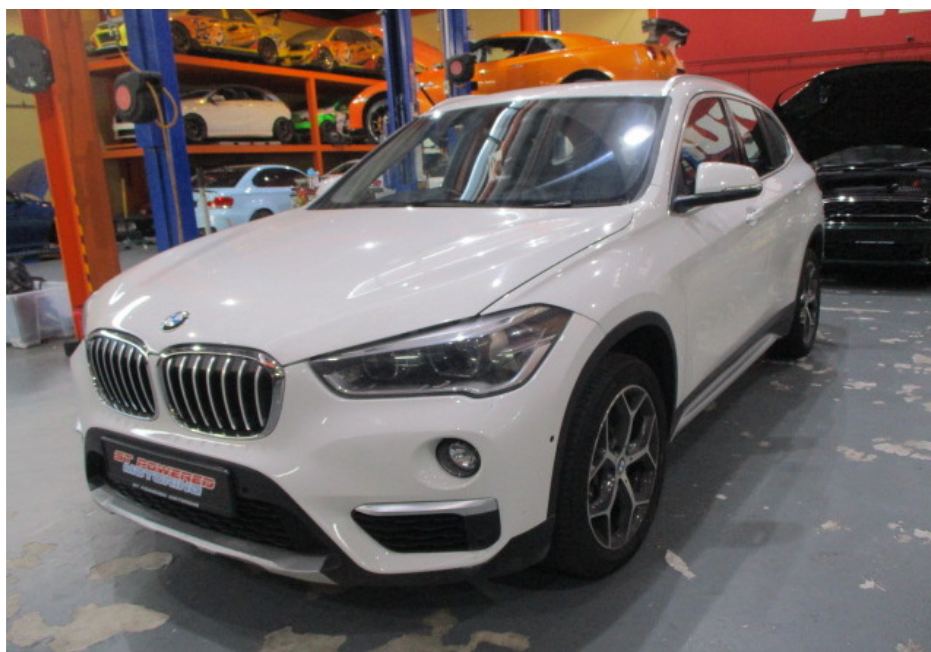
22. The body parts at the front left portion of the Motor Car were visually examined and it was noted that the repair/restoration works carried out to the damaged area of the Motor Car (refer to photograph 1 above) were reasonably adequate and in order.

**Photo 5** shows a general view of the front left body of the Motor Car at the time of my inspection. The Motor Car was observed to be in a relatively good general condition with no loose exterior fittings observed. The body parts at the front left portion of the Motor Car were visually examined and it was observed that the repair/restoration works carried out to the damaged area of the Motor Car (refer to photograph 1 above) were reasonably adequate and in order.

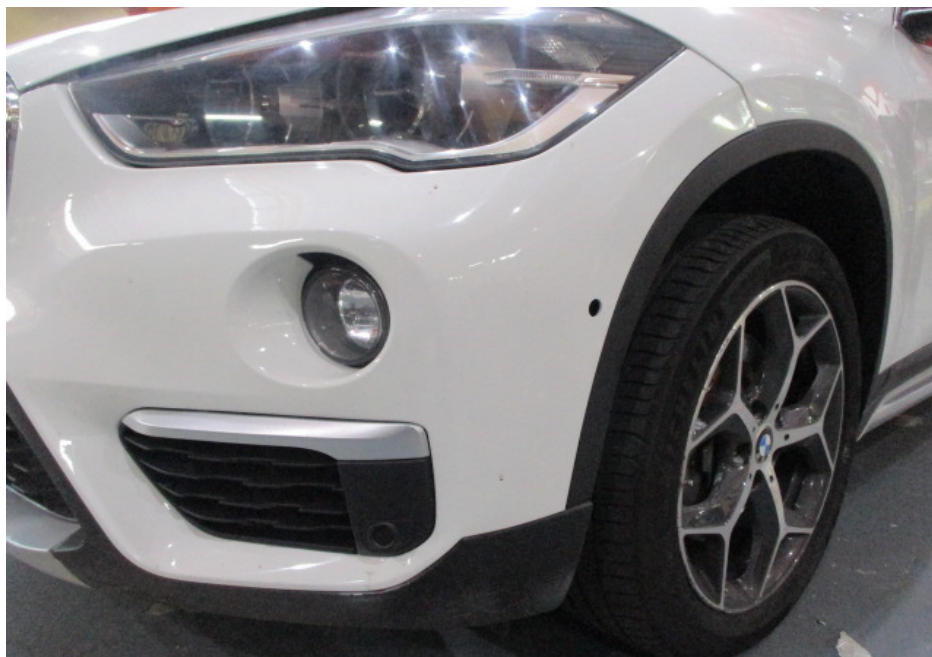
**Photo 6** shows a closer view of the front bumper, front bumper left lower grille, front left headlamp, front left fog lamp and front left fender wheel arc garnish of the Motor Car at the time of my inspection. The body parts at the front left portion of the Motor Car were visually examined and it was observed that the repair/restoration works carried out to the damaged area of the Motor Car (refer to photograph 1 above) were reasonably adequate and in order.

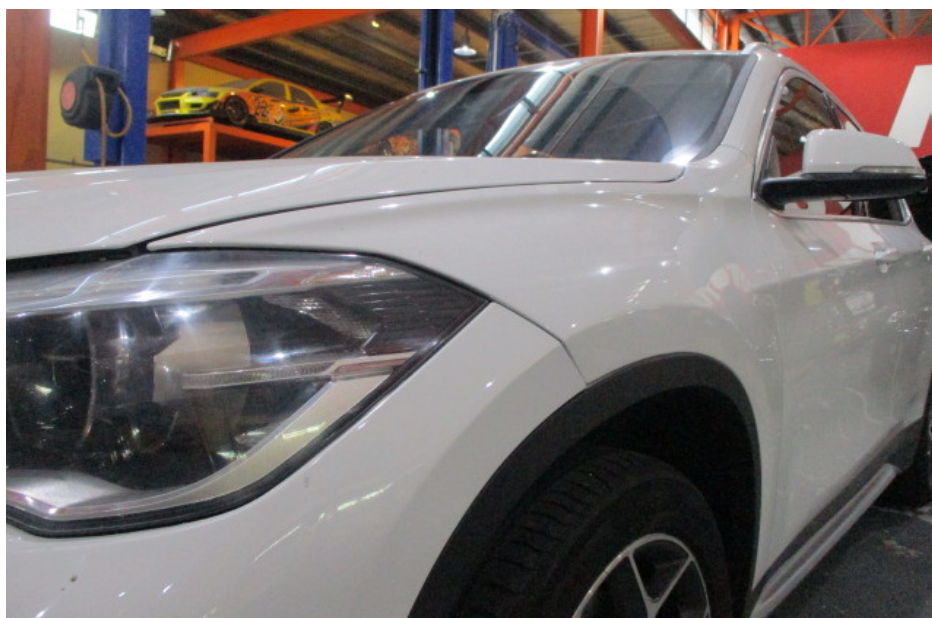
**Photo 7** shows a closer view of the front left headlamp, front bonnet, front left fender and front left fender wheel arc garnish of the Motor Car at the time of my inspection. The body parts at the front left portion of the Motor Car were visually examined and it was observed that the repair/restoration works carried out to the damaged area of the Motor Car (refer to photograph 1 above) were reasonably adequate and in order.

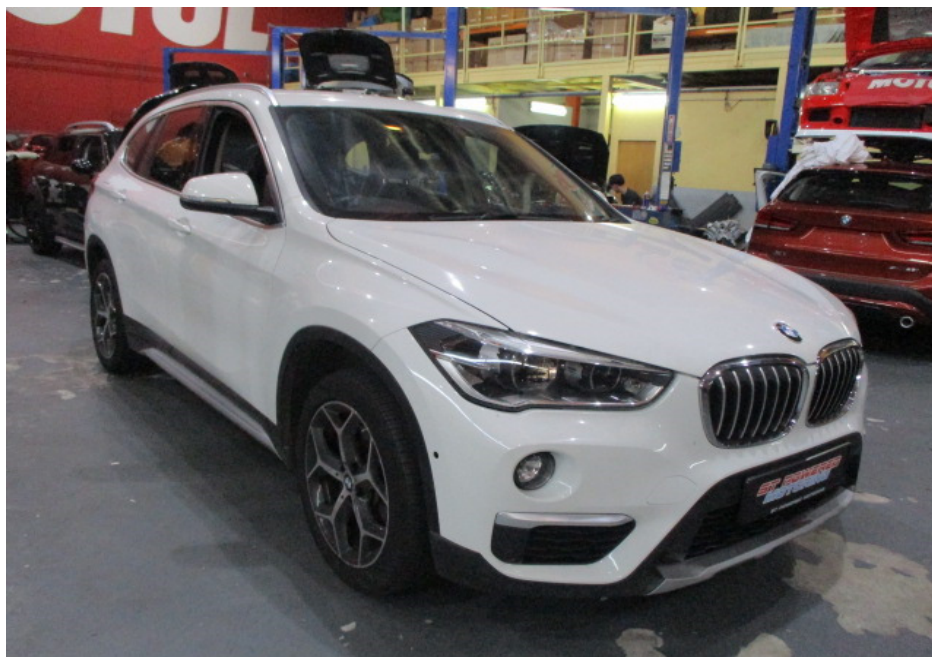
**Photo 8** shows a general view of the front right body of the Motor Car at the time of my inspection. The Motor Car was observed to be in a relatively good general condition with no loose exterior fittings observed. The body parts at the front left portion of the Motor Car were visually examined and it was observed that the repair/restoration works carried out to the damaged area of the Motor Car (refer to photograph 1 above) were reasonably adequate and in order.

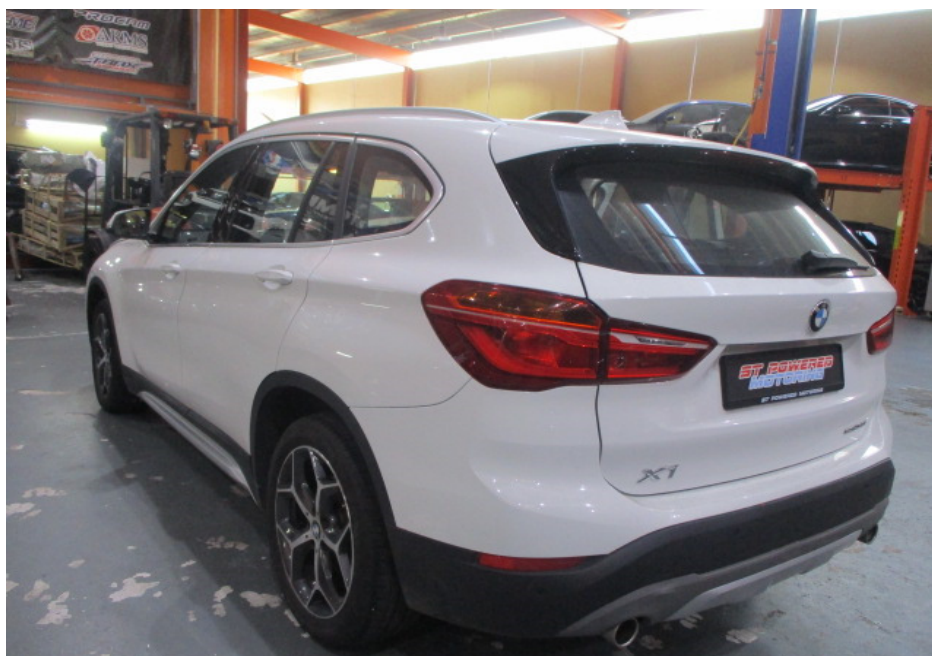
**Photo 9** shows a general view of the rear left body of the Motor Car at the time of my inspection. The Motor Car was observed to be in a relatively good general condition with no loose exterior fittings observed. The mileage of the Motor Car recorded at the time of my inspection was 8,185km.

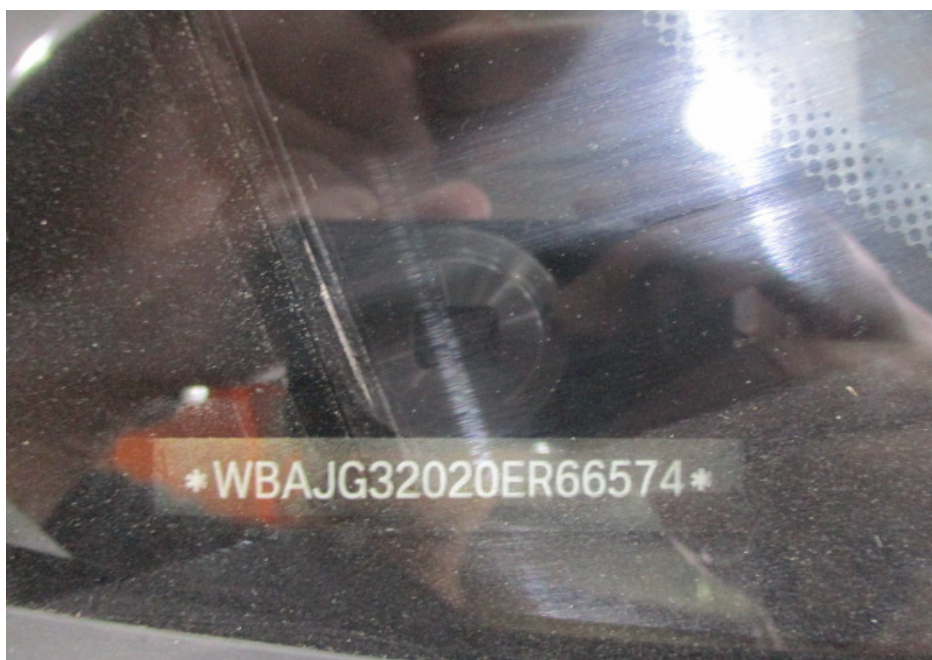
**Photo 10** shows the chassis number of the Motor Car. The chassis number recorded was WBAJG32020ER66574.

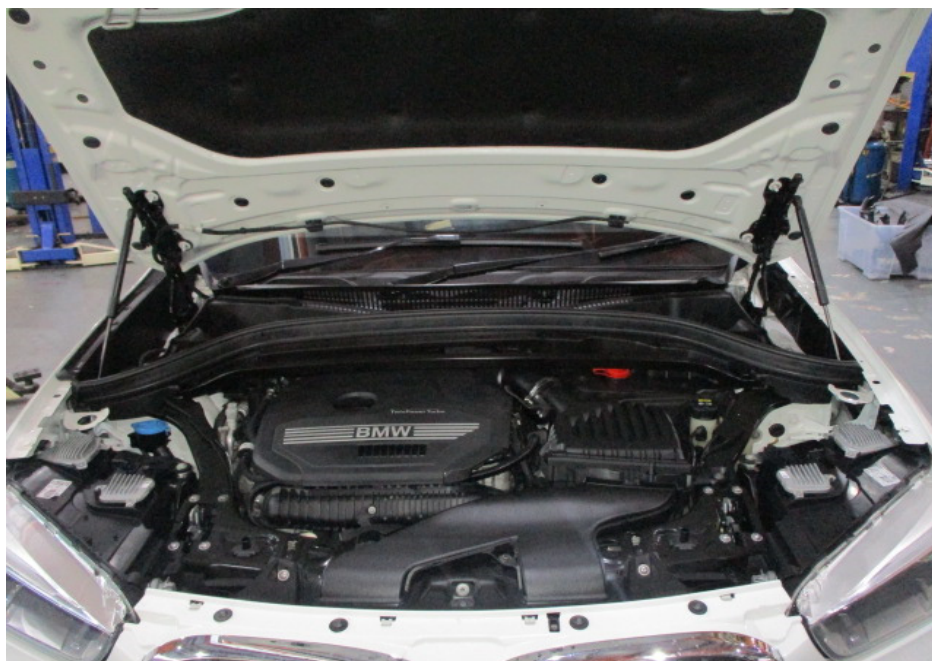
**Photo 11** shows a general view of the engine compartment of the Motor Car at the time of my inspection. The various parts and components inside the engine compartment were all observed to be intact and properly fitted. There was also no sign(s) or indication(s) of fluid leak and/or fluid stain found inside the engine compartment.

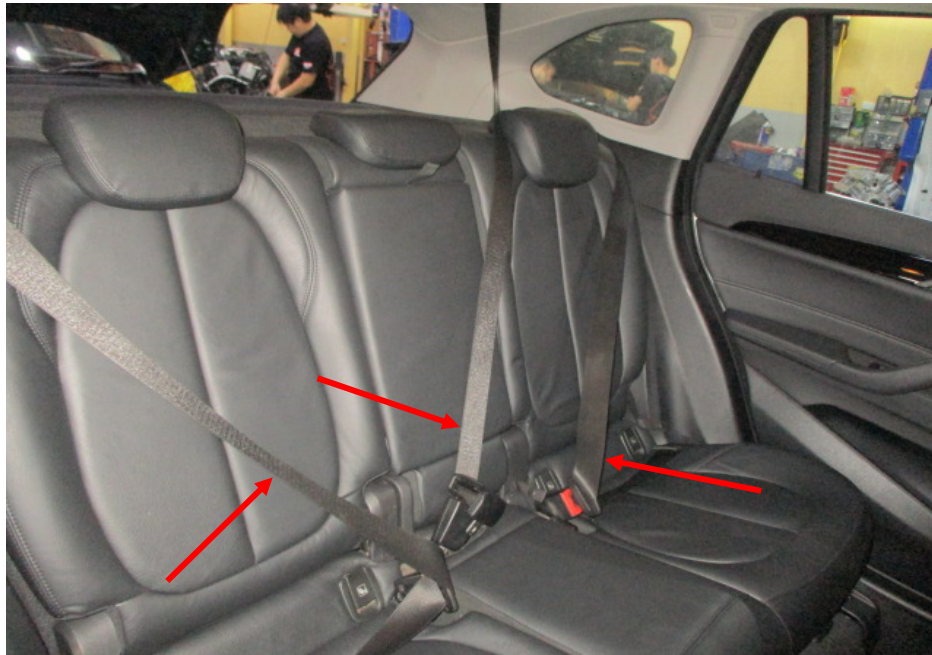
**Photo 12** shows the rear seats of the Motor Car. All the seats of the Motor Car were secured via seat rails to the floorboard. They were also fitted with a retractable seat belt reel and a pre-tensioner. The seat belts (arrowed) were tested and were able to be fastened into the respective pre-tensions that were fitted on the side of each individual seat.

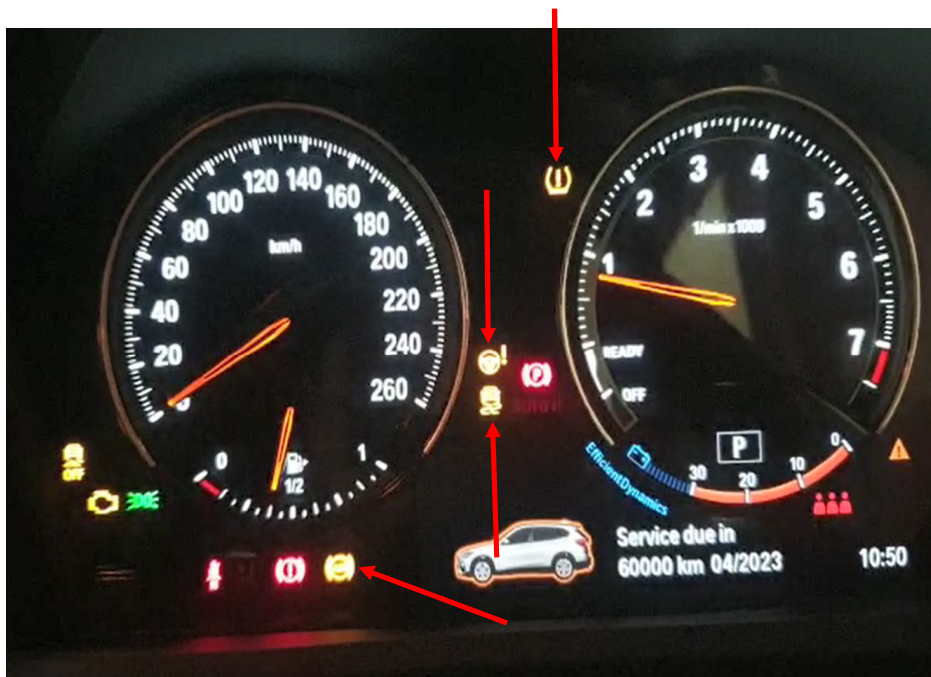
**Photo 13** shows the warning lights for the various electronic safety features appearing on the instrument panel of the Motor Car during its self-test when the engine is cranked, in particular the ABS, SRS, IAS, TPM and DSC lights (arrowed).

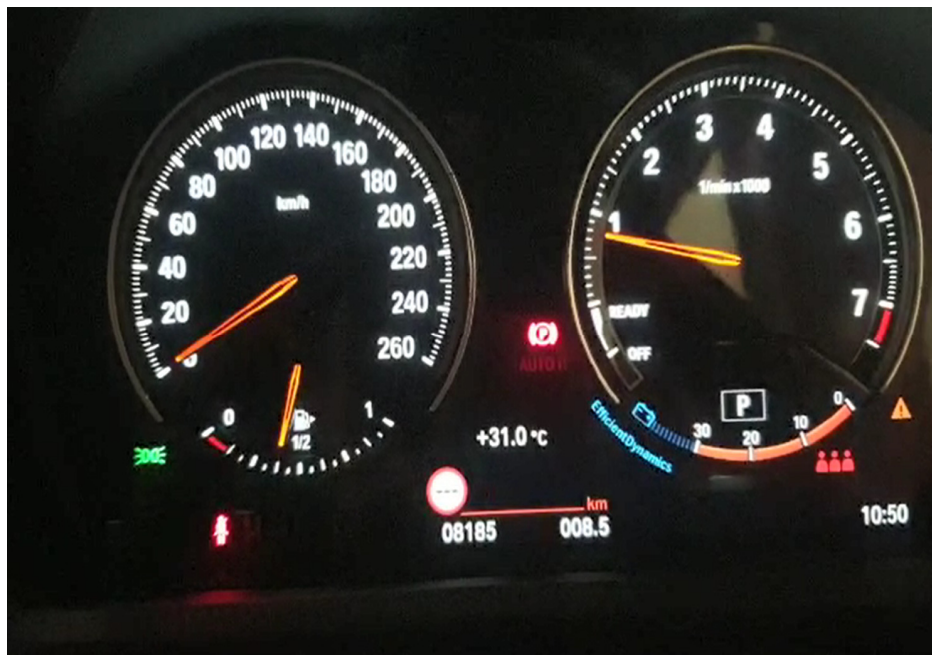
**Photo 14** shows the respective warning lights no longer illuminated, indicating that there is no fault detected to the ABS, SRS, IAS, TPM and DSC systems of the Motor Car during the self-test. These electronic systems were hence in working condition at the time of my inspection.

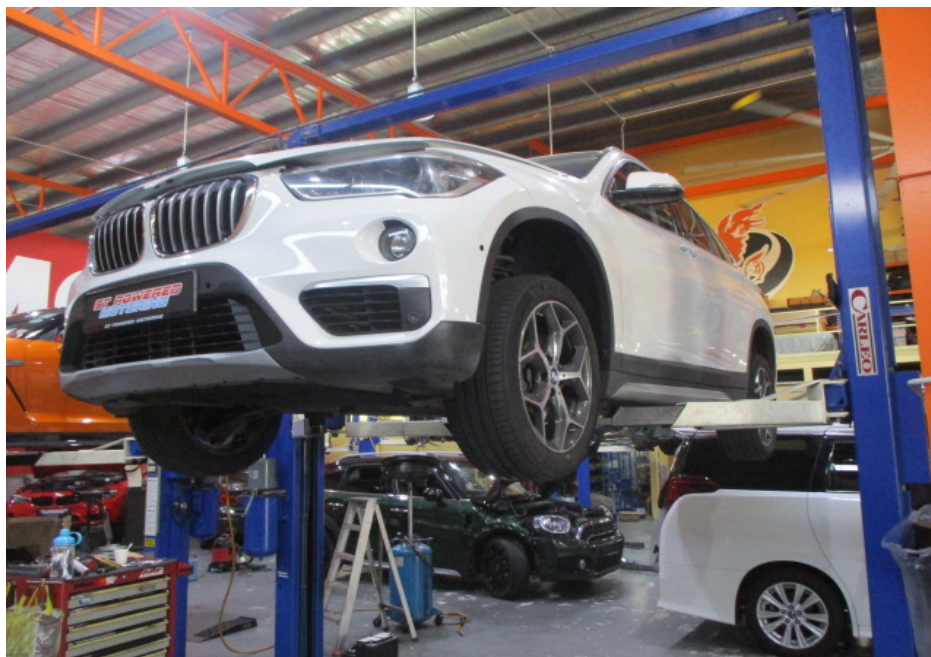
**Photo 15** shows the Motor Car hoisted up for checks on its undercarriage. There was no sign(s) or indication(s) of fluid leakage and/or fluid stain(s) on the underside of the Motor Car. The undercarriage components of the Motor Car were also all observed to be intact and secured in an appropriate manner.

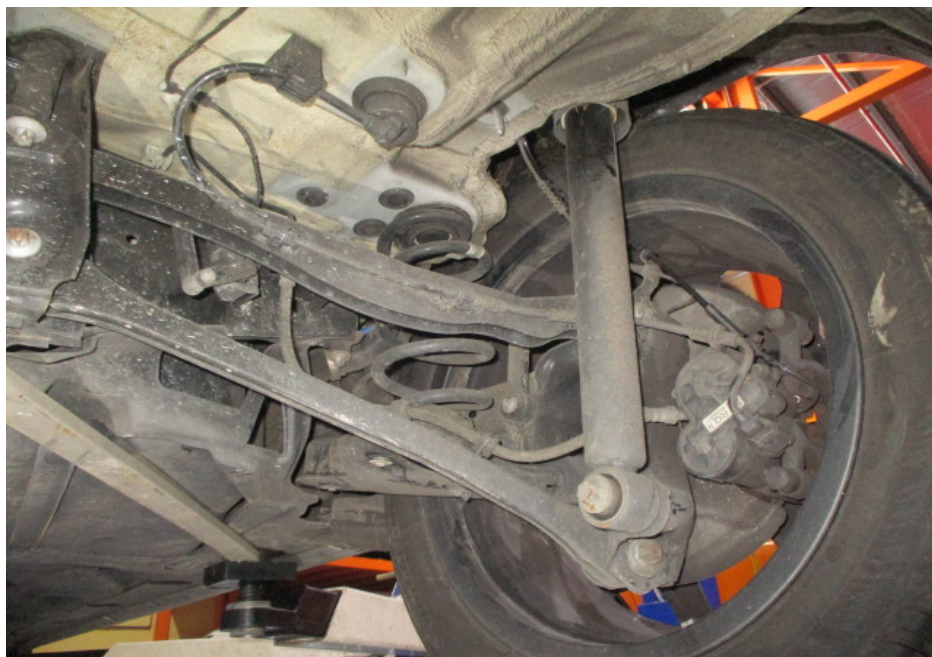
**Photo 16** shows a general view of the control arms and linkages at the rear right wheel of the Motor Car. I did not observe any fluid leak and/or fluid stain on the underside of the Motor Car. All of the Motor Car's undercarriage components were observed to be intact and secured in an appropriate manner.

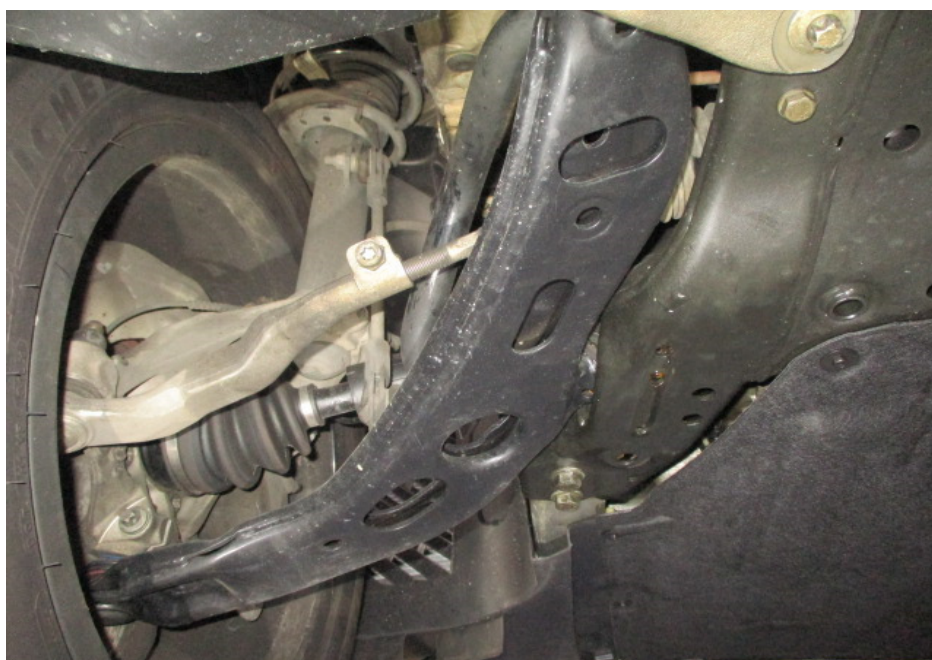
**Photo 17** shows the various undercarriage components at the front left wheel of the Motor Car. The mechanical components, control arms and linkages were all found to be intact and secured in an appropriate manner.

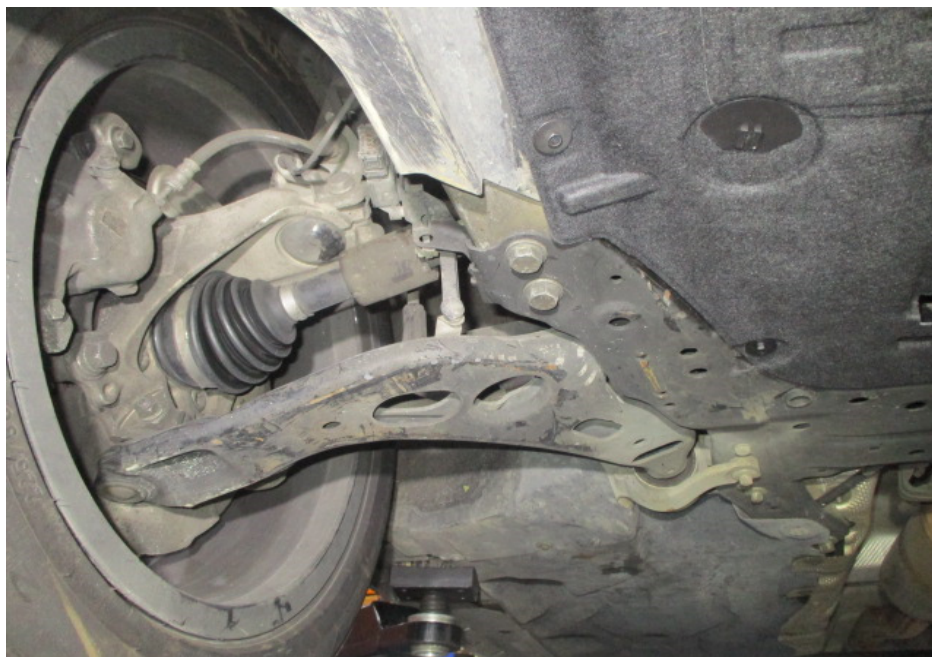
**Photo 18** shows the various undercarriage components at the front right wheel of the Motor Car. The mechanical components, control arms and linkages were all found to be intact and secured in an appropriate manner. I also did not observe any fluid leak and/or fluid stain on the underside of the Motor Car.

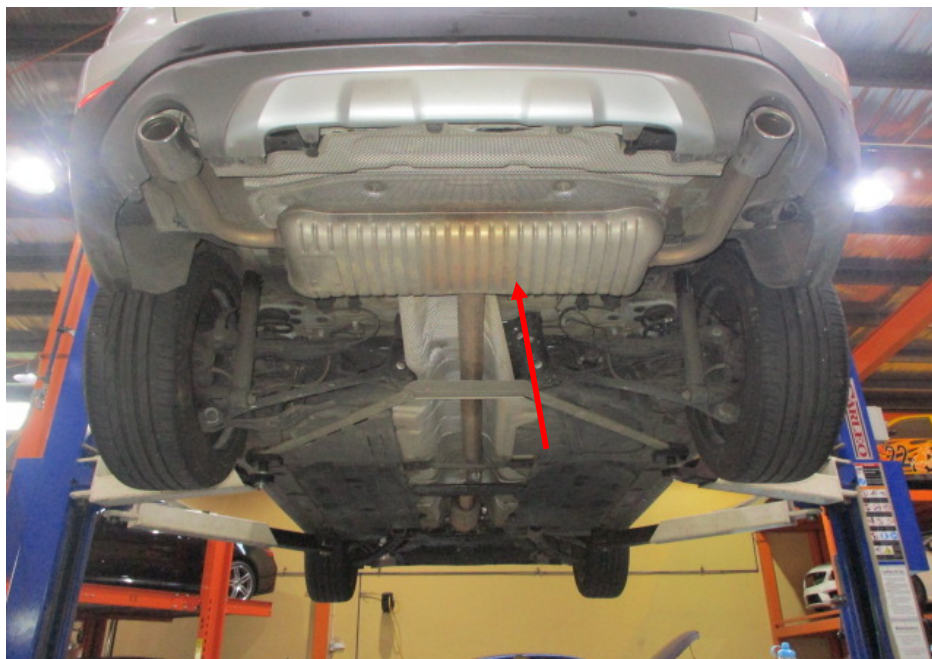
**Photo 19** shows a general view of the Motor Car's exhaust system. My examination of the Motor Car's exhaust system revealed no sign(s) or indication(s) of any cut or weld marks along its exhaust pipes, on its rear muffler (arrowed) and on its catalytic converter.

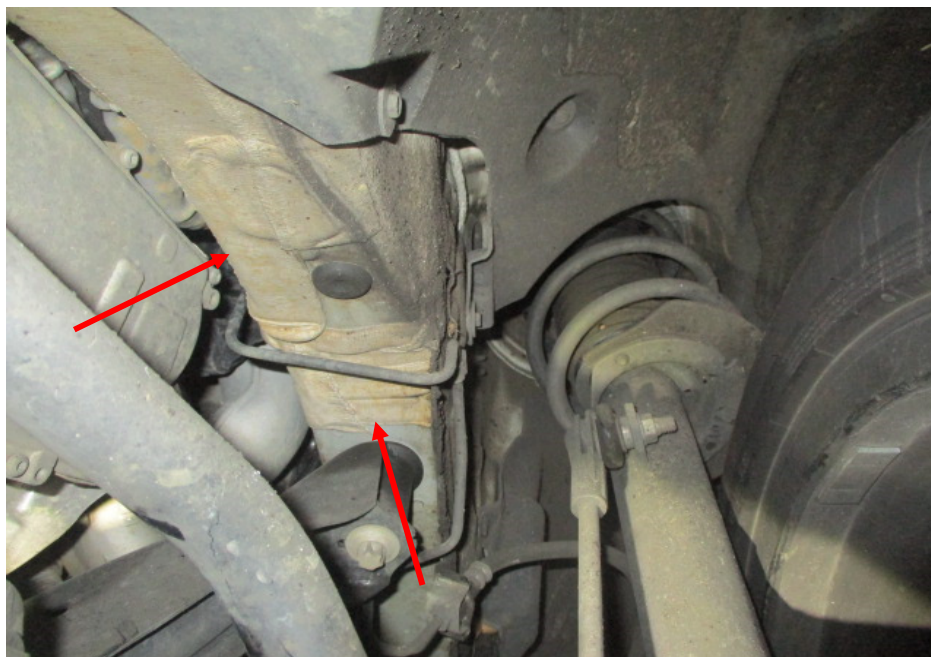
**Photo 20** shows the chassis/structural body at the underside front right of the Motor Car. I did not find any weld marks other than original spot weld marks on the chassis/structural body of the Motor Car. The original factory sealant (arrowed) at the joints along the chassis/structural body was untouched, indicating no work was done on the chassis/structural body of the Motor Car and that the chassis/structural body was originally fitted.

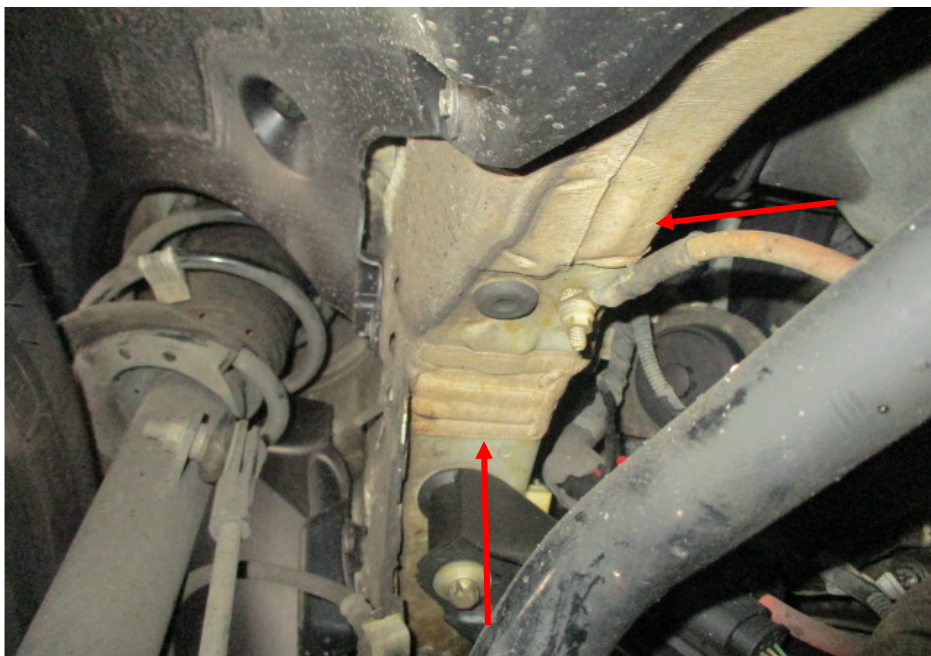
**Photo 21** shows the chassis/structural body at the underside front left of the Motor Car. The original factory sealant (arrowed) at the joints along the chassis/structural body was observed to be untouched. In general, I had found no work was carried out on the chassis/structural body of the Motor Car. The chassis/structural body of the Motor Car was originally fitted.

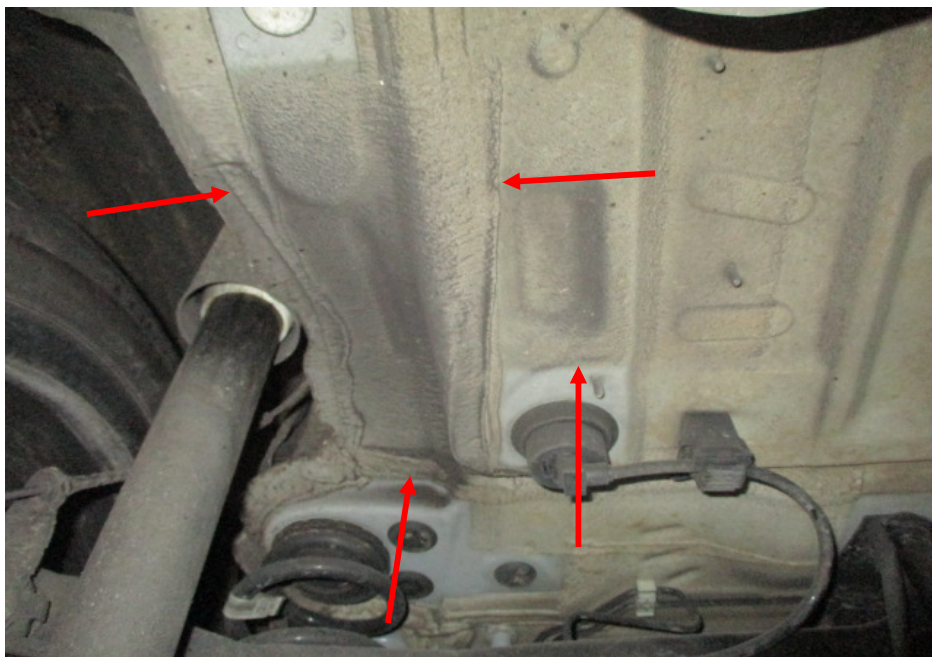
**Photo 22** shows the chassis/structural body at the underside rear left of the Motor Car. The original factory sealant (arrowed) at the joints along the chassis/structural body was observed to be untouched. In general, I had found no work was carried out on the chassis/structural body of the Motor Car. The chassis/structural body of the Motor Car was originally fitted.

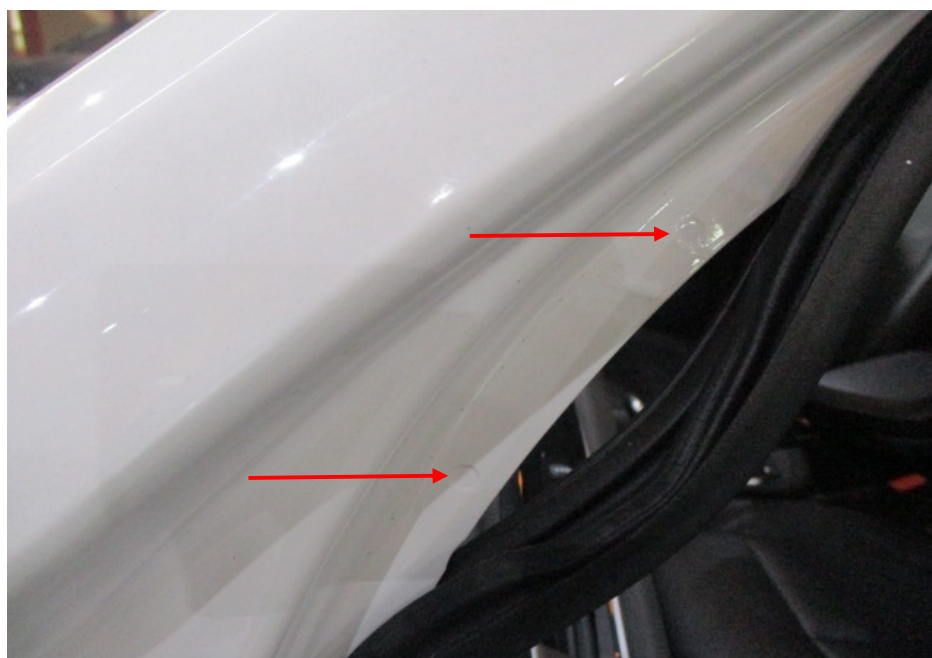
**Photo 23** shows the left side "A" pillar of the Motor Car. I did not find any weld marks other than original spot weld marks (arrowed) on the left side "A" pillar of the Motor Car which, indicates that there was no re-welding works carried out. In general, I had found all the non-detachable body panels of the Motor Car to be originally fitted at the time of my inspection.

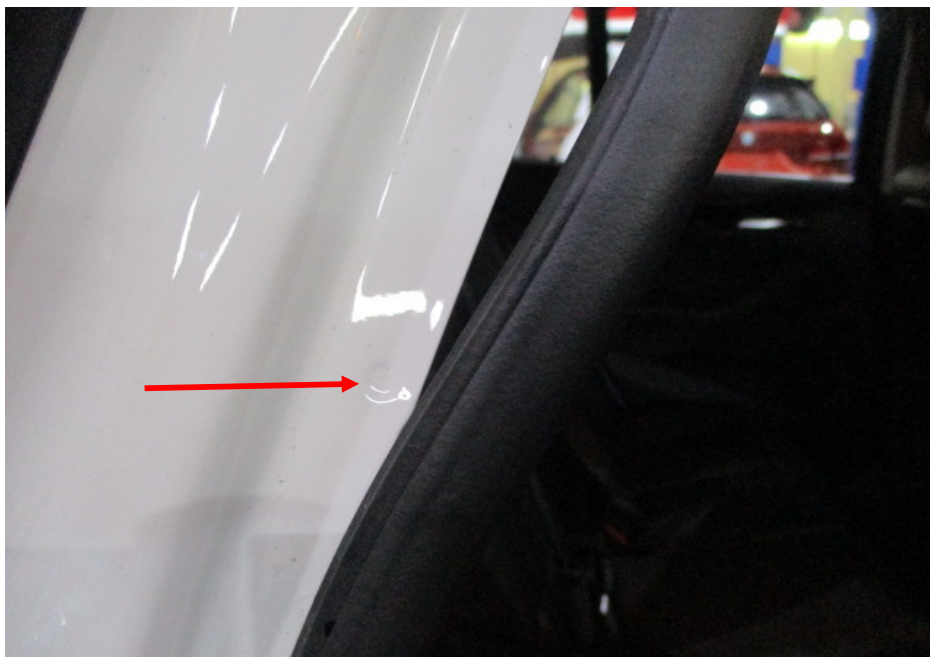
**Photo 24** shows the right side "C" pillar of the Motor Car. I did not find any weld marks other than original spot weld marks (arrowed) on the right side "C" pillar of the Motor Car which, indicates that there was no re-welding works carried out. In general, I had found all the non-detachable body panels of the Motor Car to be originally fitted at the time of my inspection.
