Your Ref: Mini Copper  
(chassis number WMWYU120403J22950)  
Our Ref : CI/TP21006214/D

01 June 2021

**INSPECTION REPORT OF AN UNREGISTERD MINI COPPER MOTOR CAR  
WITH CHASSIS NUMBER WMWYU120403J22950**

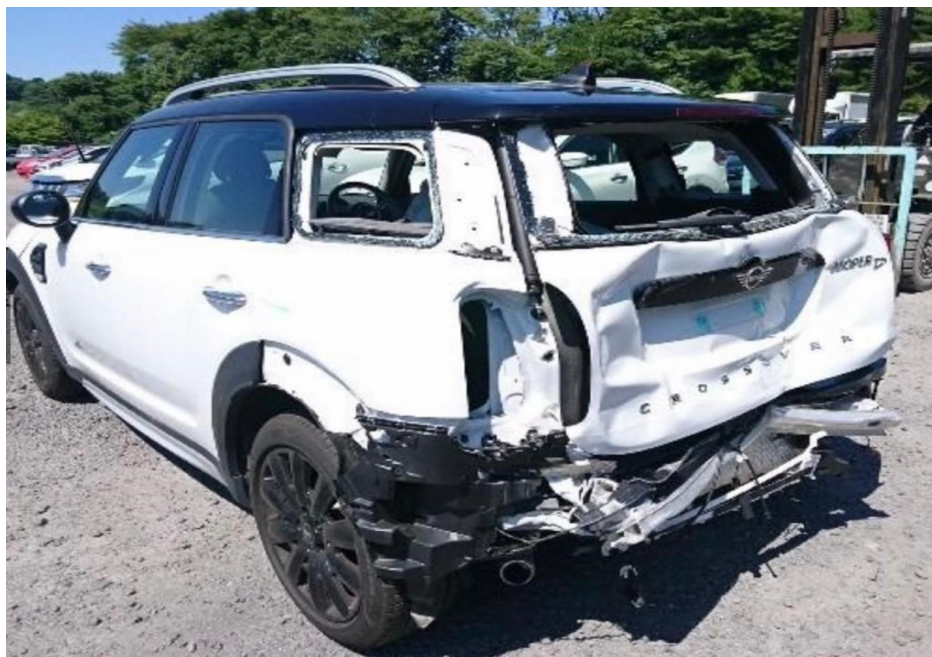
4. With regard to the Motor Car's rear portion, I had observed that the rear bumper and all its related attachments and rear left taillamp were missing/dislodged. Physical damage was also seen to the rear bumper reinforcement, rear exhaust muffler, rear tailgate, rear tailgate top garnish, rear windscreen, rear left fender, rear left fender glass, rear left fender wheel arc garnish, rear end panel and rear right fender wheel arc garnish amongst others. The airbags of the Motor Car were not activated as seen from the photographs that were provided to me. See photo 1 – 4 below.

**Photo 1** shows the rear left body of the Motor Car (photograph provided to me). The Motor Car was observed to have sustained damage at its rear portion. The front bumper and all its related attachments and rear left taillamp were missing/dislodged. Physical damage was seen to the rear bumper reinforcement, rear exhaust muffler, rear left fender, rear left fender glass, rear left fender wheel arc garnish and rear end panel amongst others.

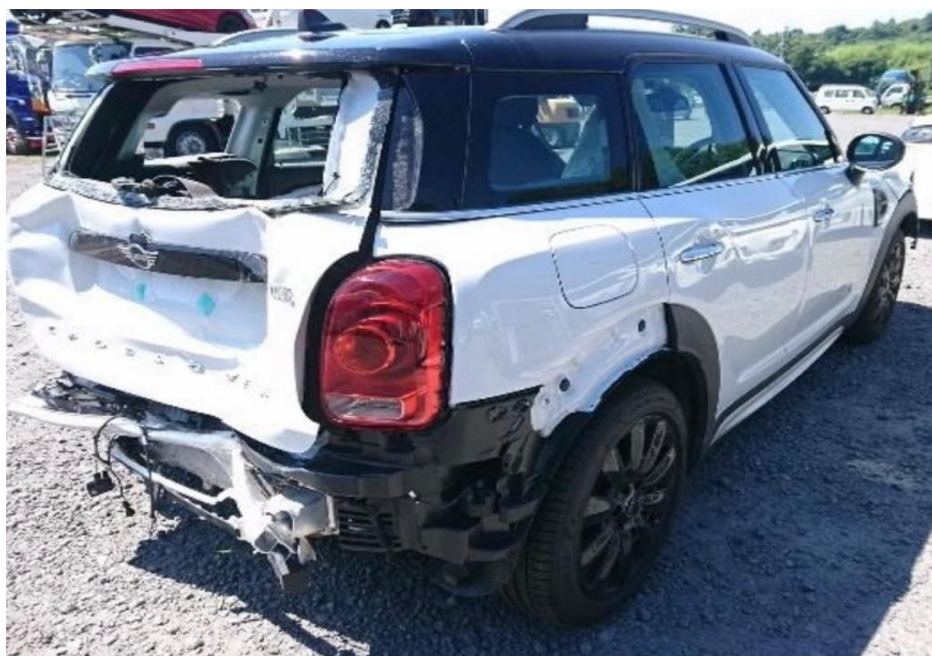
**Photo 2** shows the rear right body of the Motor Car (photograph provided to me). The Motor Car was observed to have sustained damage at its rear portion. Physical damage was seen to the rear tailgate, rear tailgate top garnish, rear windscreen and rear right fender wheel arc garnish amongst others.

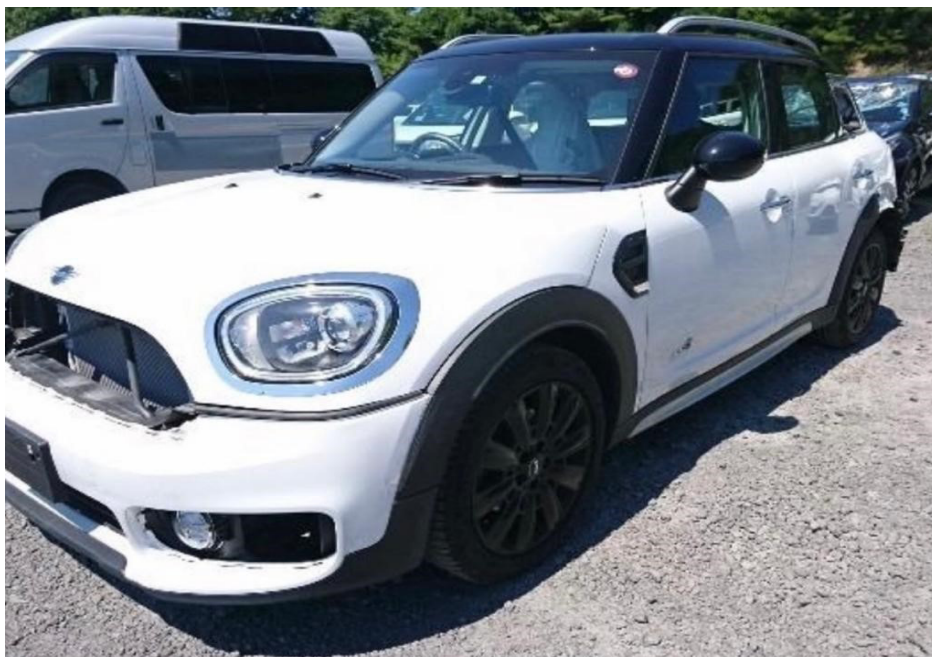
3. From the photographs provided to me, it was observed that the Motor Car had sustained damages at its frontal portion and rear portion. Body parts damaged at the frontal portion include the front bumper, front bumper right lower garnish and front right fender wheel arch garnish amongst others. The front right fog lamp garnish, front left fog lamp garnish and front radiator grille were observed to be missing/dislodged.

**Photo 3** shows the front left body of the Motor Car (photograph provided to me). Apart for the rear portion, the Motor Car had also sustained damage at its frontal portion. The front left fog lamp garnish and front radiator grille were observed to be missing/dislodged.

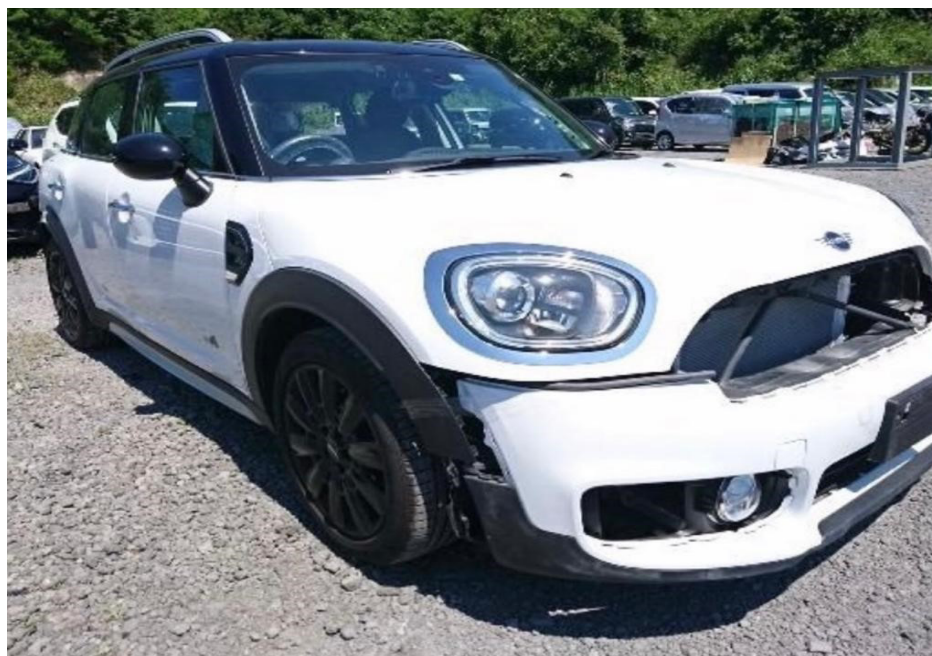
**Photo 4** shows the front right body of the Motor Car (photograph provided to me). Apart for the rear portion, the Motor Car had also sustained damage at its frontal portion. The front right fog lamp garnish and front radiator grille were observed to be missing/dislodged. Physical damage was also seen to the front bumper, front right bumper right lower garnish and front right fender wheel arc garnish amongst others.

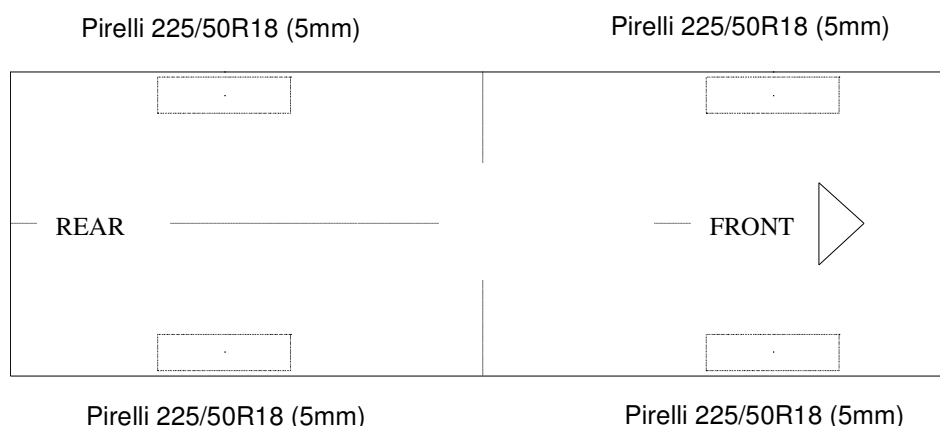
8. It was fitted with 18inch sport wheel rims that were wrapped with tyres that were observed to be of serviceable condition. The tyres were also sufficiently inflated for vehicular operation. The tyre brand, tyre size and approximate remaining tread depth of the 4 tyres of the Motor Car were recorded as follows: -

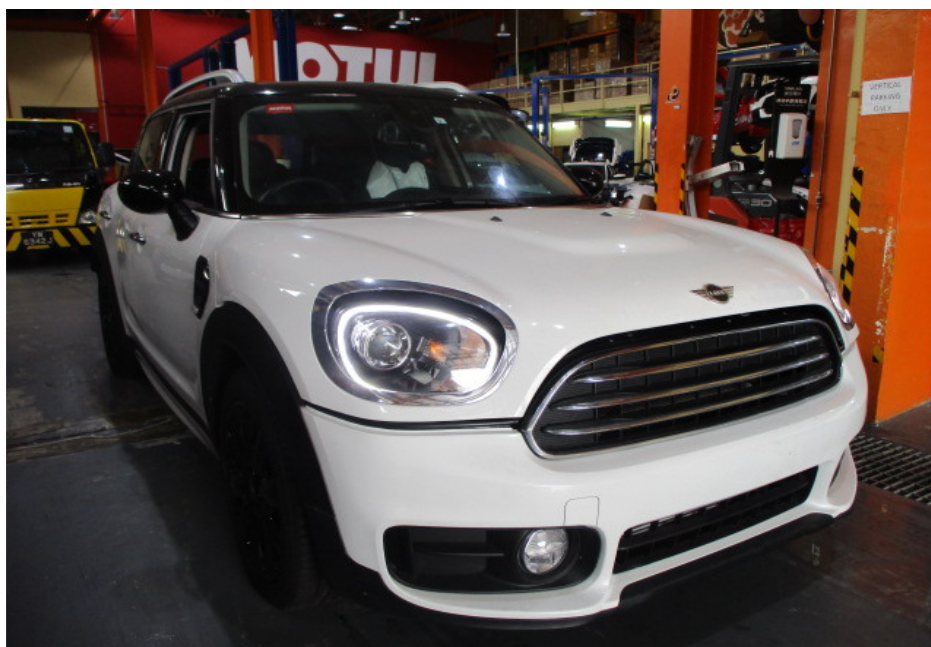
**Photo 5** shows a general view of the front right body of the Motor Car at the time of my inspection. The Motor Car was observed to be in a relatively good general condition with no loose exterior fittings observed. The body parts at the frontal portion of the Motor Car were visually examined and it was observed that the repair/restoration works carried out to the damaged area of the Motor Car (refer to photograph 3 & 4 above) were reasonably adequate and in order.

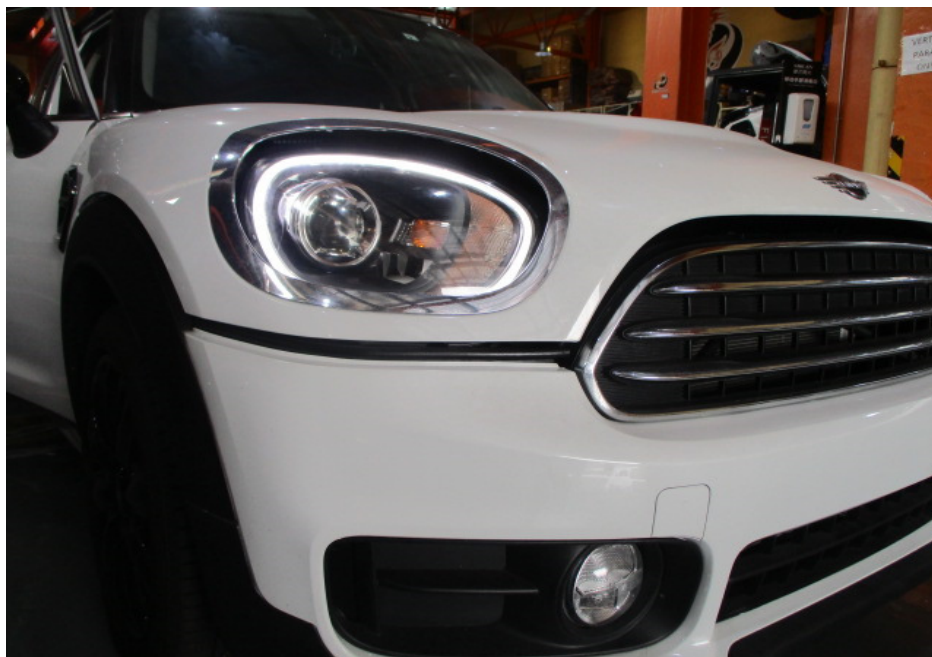
**Photo 6** shows a closer view of the front bumper, front right fog lamp garnish, front radiator grille and front right fender wheel arc garnish of the Motor Car. The body parts at the frontal portion of the Motor Car were visually examined and it was observed that the repair/restoration works carried out to the damaged area of the Motor Car (refer to photograph 4 above) were reasonably adequate and in order.

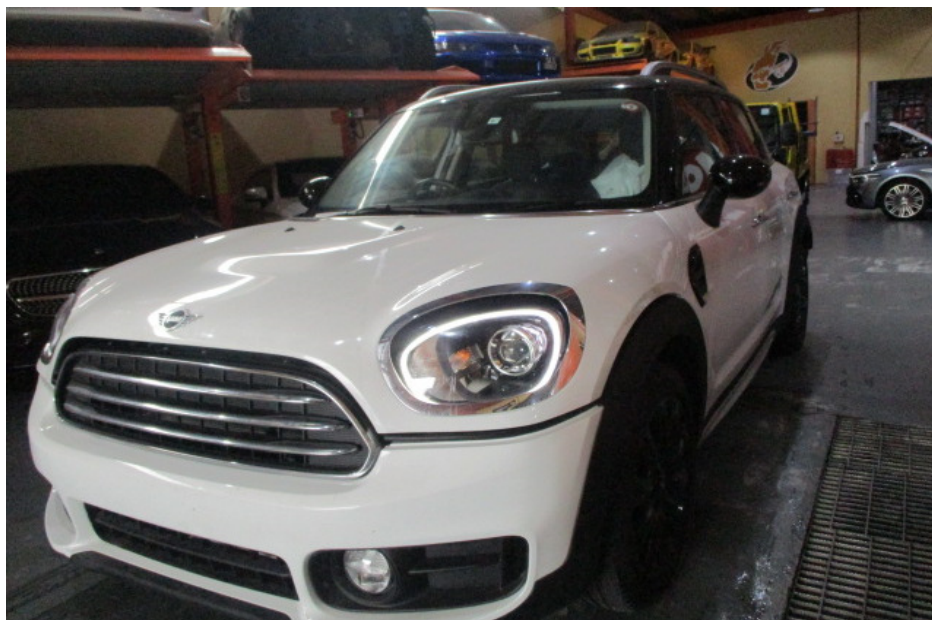
**Photo 7** shows a general view of the front left body of the Motor Car at the time of my inspection. The Motor Car was observed to be in a relatively good general condition with no loose exterior fittings observed. The body parts at the frontal portion of the Motor Car were visually examined and it was observed that the repair/restoration works carried out to the damaged area of the Motor Car (refer to photograph 3 & 4 above) were reasonably adequate and in order.

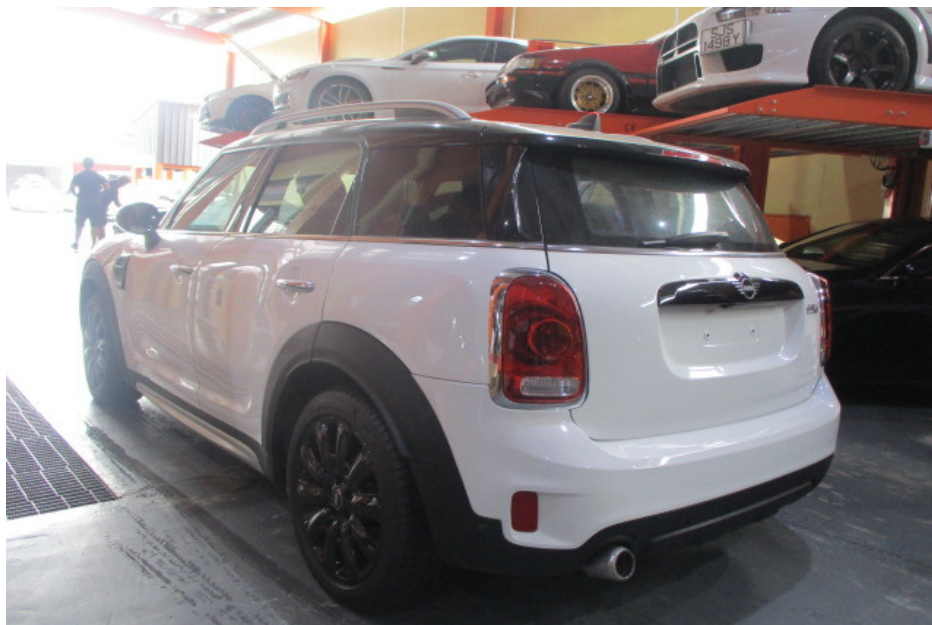
**Photo 8** shows a general view of the rear left body of the Motor Car at the time of my inspection. The Motor Car was observed to be in a relatively good general condition with no loose exterior fittings observed. The body parts at the rear portion of the Motor Car were visually examined and it was observed that the repair/restoration works carried out to the damaged area of the Motor Car (refer to photograph 1 & 2 above) were reasonably adequate and in order.

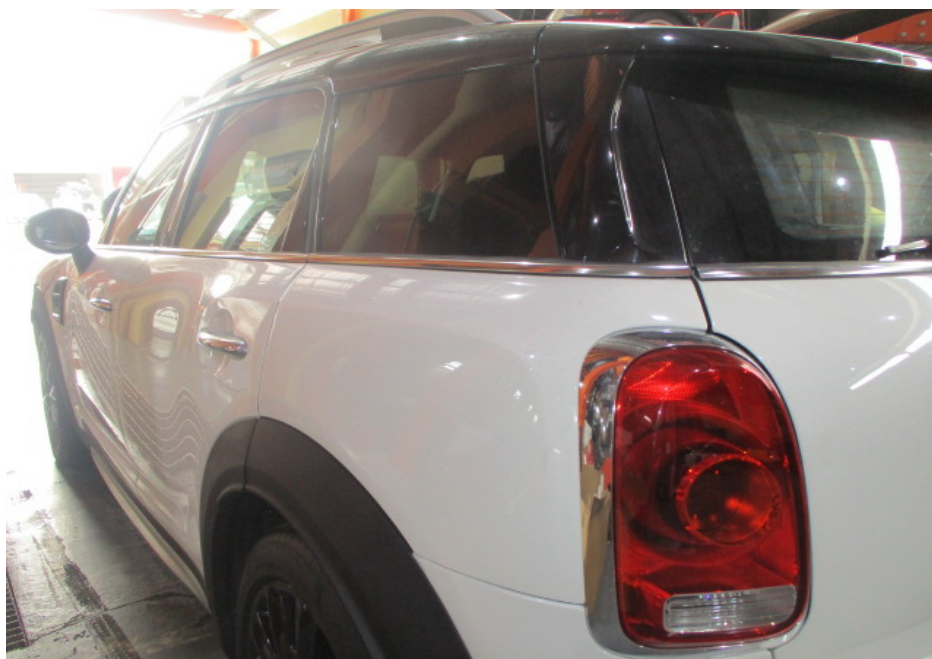
**Photo 9** shows a closer view of the rear left taillamp, rear left fender, rear left fender glass and rear left fender wheel arc garnish of the Motor Car. The body parts at the rear portion of the Motor Car were visually examined and it was observed that the repair/restoration works carried out to the damaged area of the Motor Car (refer to photograph 1 above) were reasonably adequate and in order.

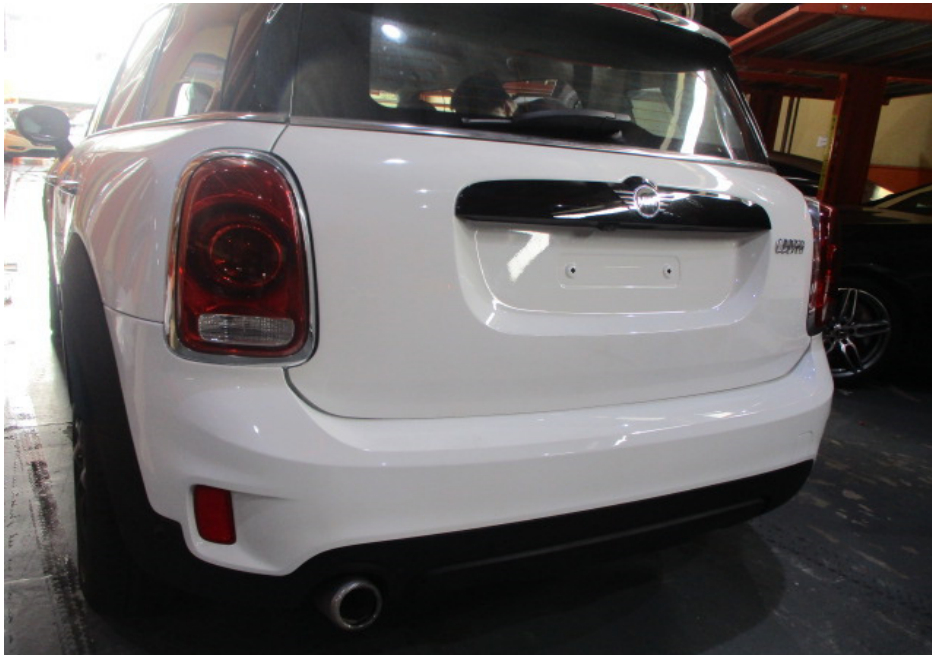
**Photo 10** shows a closer view of the rear bumper, rear bumper left reflector, rear tailgate, rear tailgate top garnish and rear left taillamp of the Motor Car. The body parts at the rear portion of the Motor Car were visually examined and it was observed that the repair/restoration works carried out to the damaged area of the Motor Car (refer to photograph 1 & 2 above) were reasonably adequate and in order.

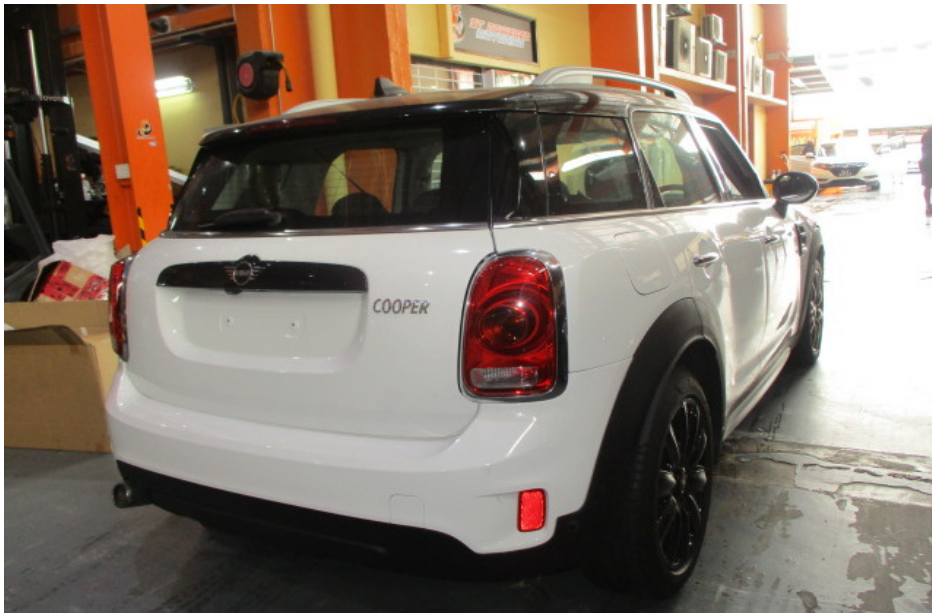
**Photo 11** shows a general view of the rear right body of the Motor Car at the time of my inspection. The Motor Car was observed to be in a relatively good general condition with no loose exterior fittings observed. The body parts at the rear portion of the Motor Car were visually examined and it was observed that the repair/restoration works carried out to the damaged area of the Motor Car (refer to photograph 1 & 2 above) were reasonably adequate and in order.

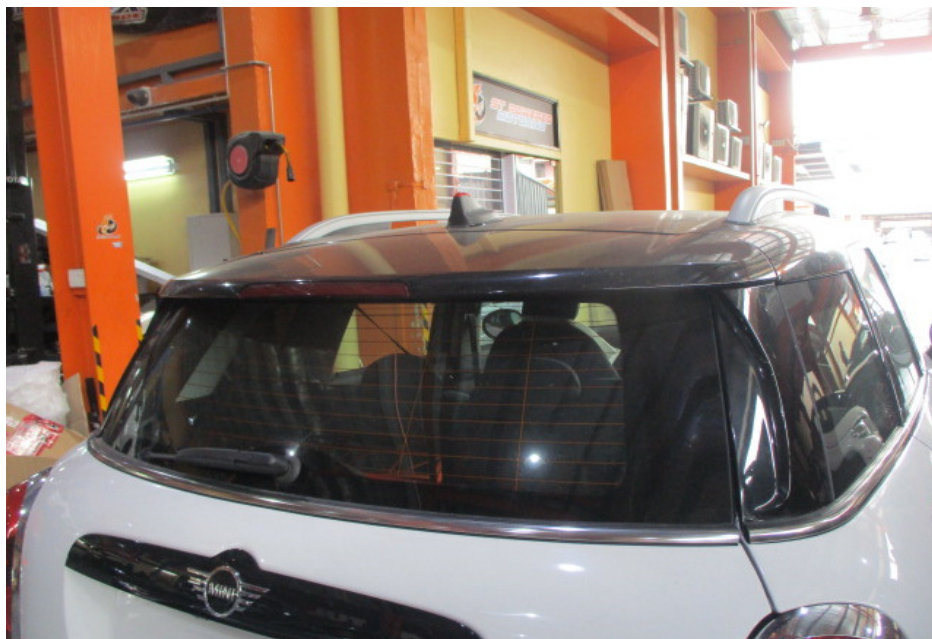
**Photo 12** shows a closer view of the rear tailgate, rear tailgate top garnish and rear windscreen of the Motor Car. The body parts at the rear portion of the Motor Car were visually examined and it was observed that the repair/restoration works carried out to the damaged area of the Motor Car (refer to photograph 1 & 2 above) were reasonably adequate and in order.

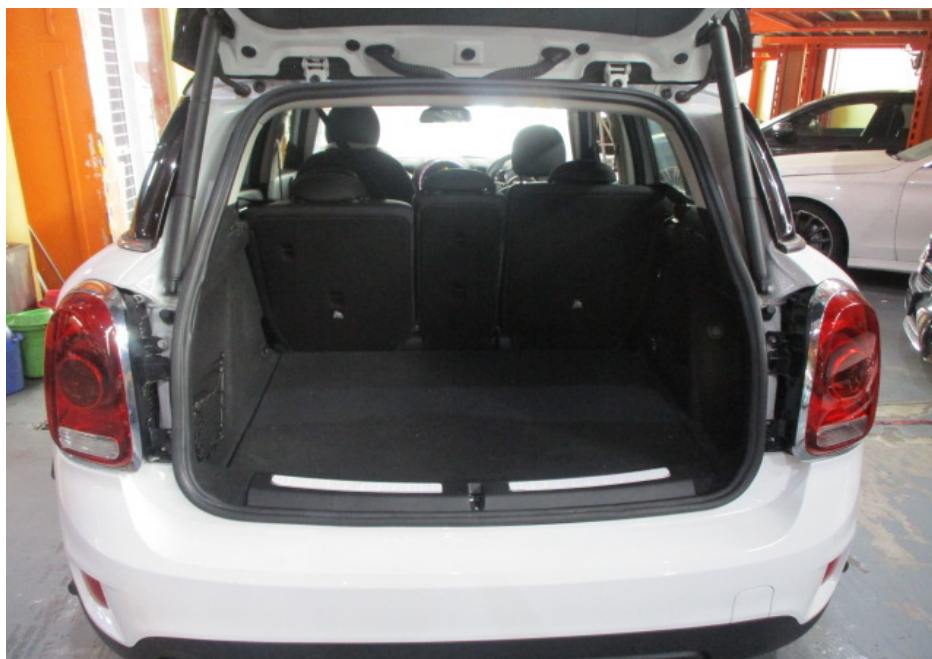
**Photo 13** shows the rear boot compartment of the Motor Car at the time of my inspection. All inner trims, hinges and upholstery etc were observed to be properly fitted. The body parts at the rear portion of the Motor Car were visually examined and the repair/restoration works carried out to the damaged area of the Motor Car (refer to photograph 1 & 2 above) were found to be reasonably adequate and in order.

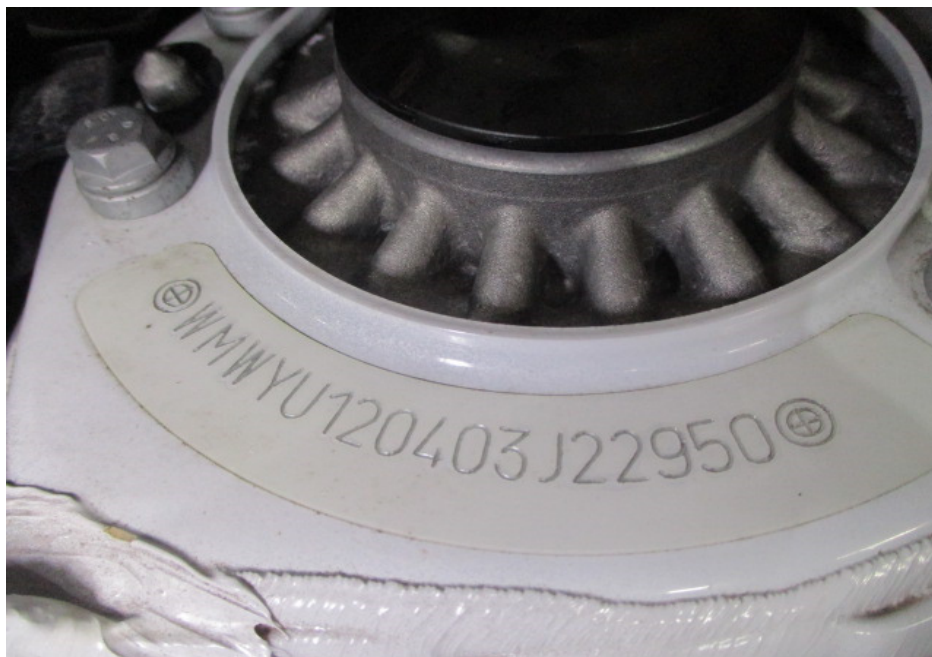
**Photo 14** shows the chassis number of the Motor Car. The chassis number recorded was WMWYU120403J22950.

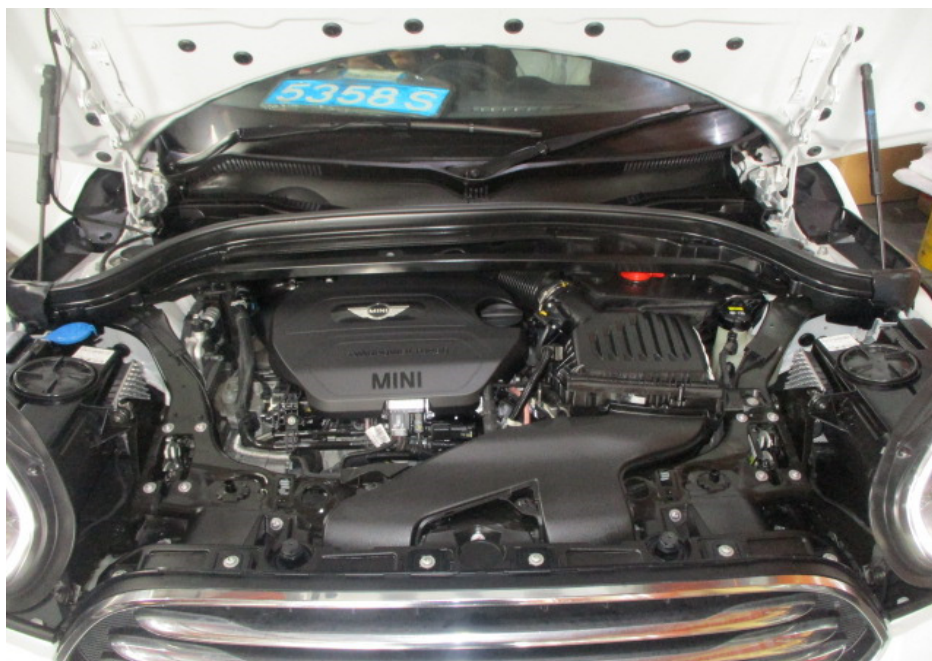
14. My examination of the engine compartment of the Motor Car revealed that the various parts and components inside the engine compartment were all intact and properly fitted. The engine oil, brake fluid and engine coolant were all found to be of sufficient level for operating purposes. Visually, there was also no contamination found to these fluids.

**Photo 15** shows a general view of the engine compartment of the Motor Car at the time of my inspection. The various parts and components inside the engine compartment were all observed to be intact and properly fitted. There was also no sign(s) or indication(s) of fluid leak and/or fluid stain found inside the engine compartment.

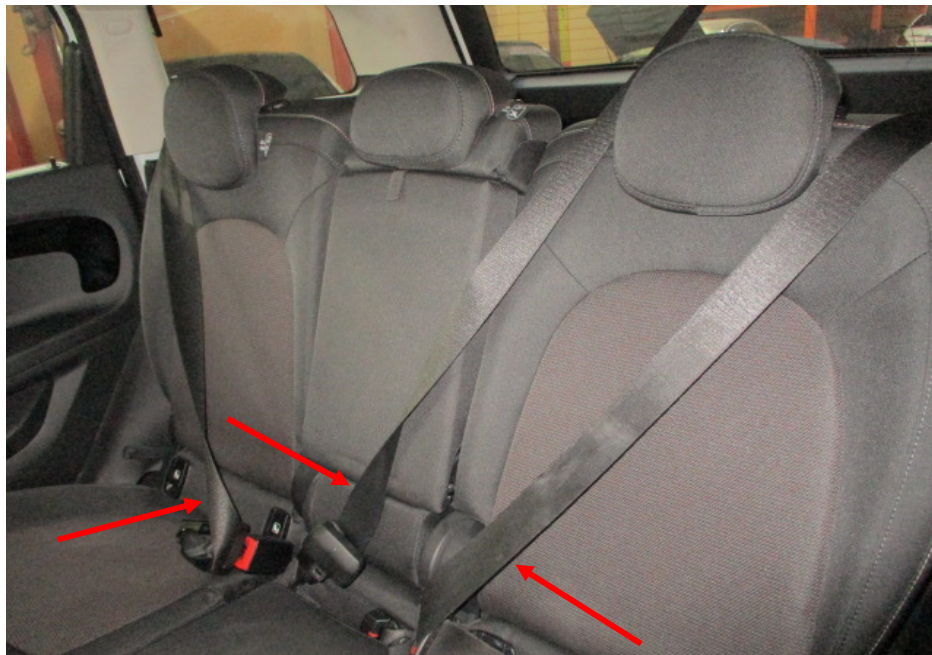
12. The seats of the Motor Car were found to be secured to the floorboard of the Motor Car via seat rails bolted onto the floorboard. Retractable seat belt reels and pre-tensioners were fitted on all seats of the Motor Car. The seat belts were tested and were able to be fastened securely into the respective pre-tensioners that were fixed to the side of all the seats.

**Photo 16** shows the rear seats of the Motor Car. All the seats of the Motor Car were secured via seat rails to the floorboard. They were also fitted with a retractable seat belt reel and a pre-tensioner. The seat belts (arrowed) were tested and were able to be fastened into the respective pre-tensions that were fitted on the side of each individual seat.

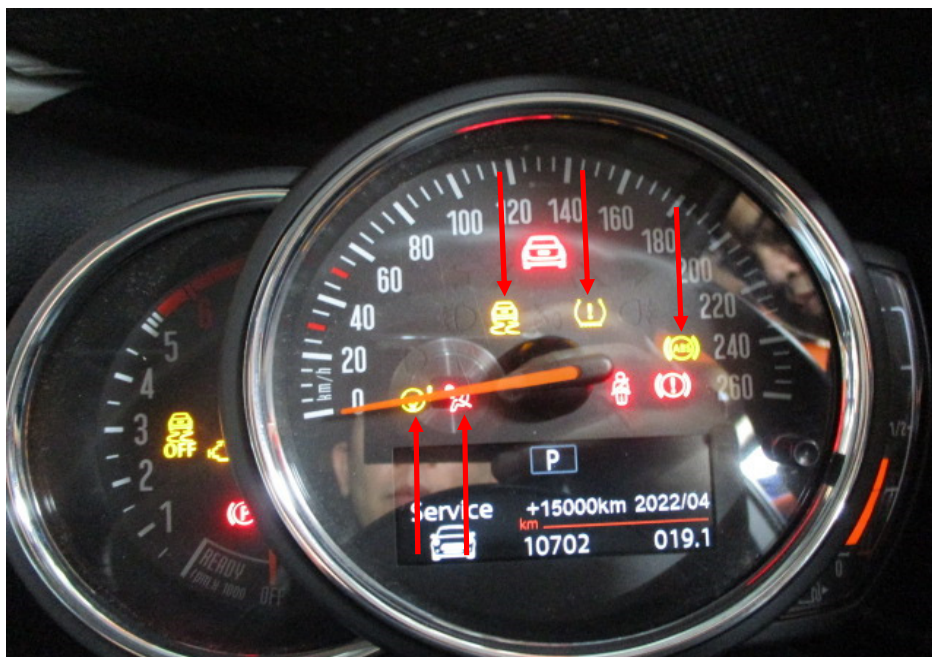
**Photo 17** shows the warning lights for the various electronic safety features appearing on the instrument panel of the Motor Car during its self-test when the engine is cranked, in particular the ABS, SRS, PAS, TPM and DSC lights (arrowed).

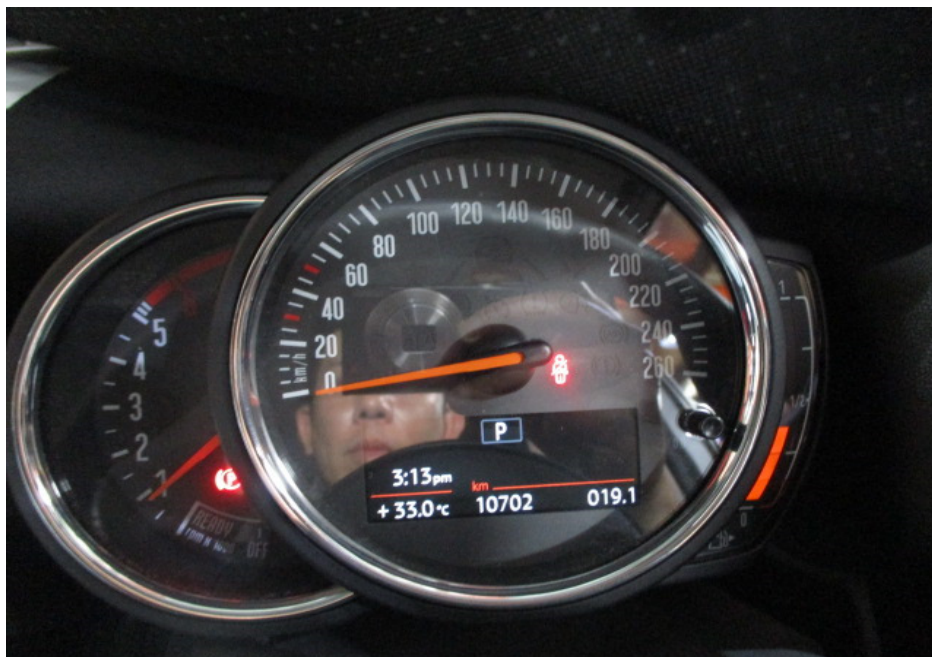
13. The Motor Car's automatic self-test of the functionality of its various electronic safety features like the Anti-Lock Brake System (ABS), Supplemental Restraint System (SRS), Power Assisted Steering (PAS), Tyre Pressure Monitor (TPM) and Dynamic Stability Control (DSC) during cranking of the engine had indicated that these electronic systems were in working condition. This was determined from the respective warning lights disappearing from the instrument panel after the self-test.

**Photo 18** shows the respective warning lights no longer illuminated, indicating that there is no fault detected to the ABS, SRS, PAS, TPM and DSC systems of the Motor Car during the self-test. These electronic systems were hence in working condition at the time of my inspection.

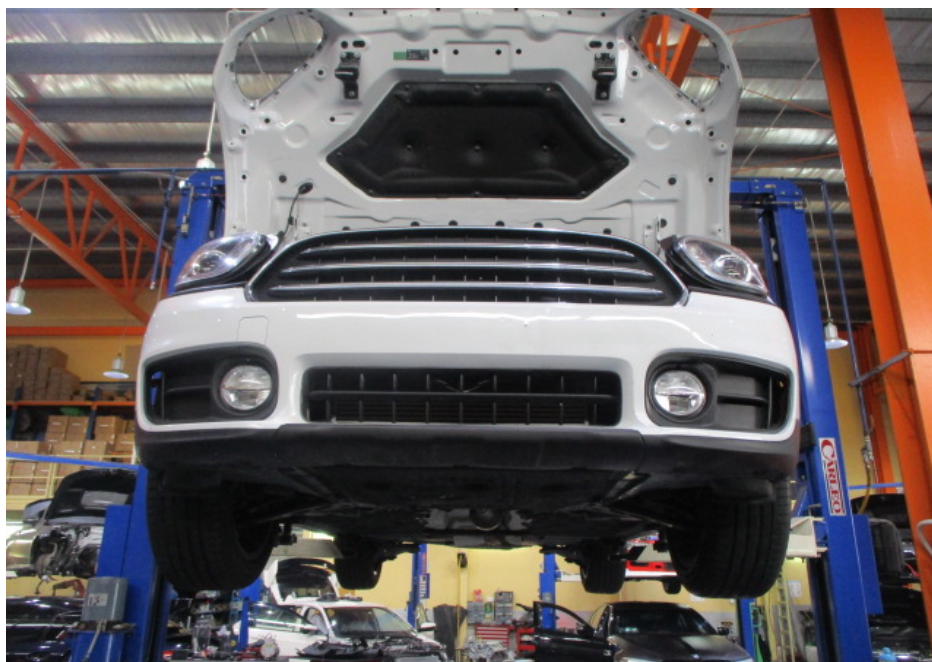
15. My checks on the underside of the Motor Car revealed no sign(s) or indication(s) of fluid leakage and/or fluid stain(s). The engine block and automatic transmission assembly were both secured properly. All undercarriage components of the Motor Car were also observed to be intact and secured in an appropriate manner.

**Photo 19** shows the Motor Car hoisted up for checks on its undercarriage. There was no sign(s) or indication(s) of fluid leakage and/or fluid stain(s) on the underside of the Motor Car. The undercarriage components of the Motor Car were also all observed to be intact and secured in an appropriate manner.

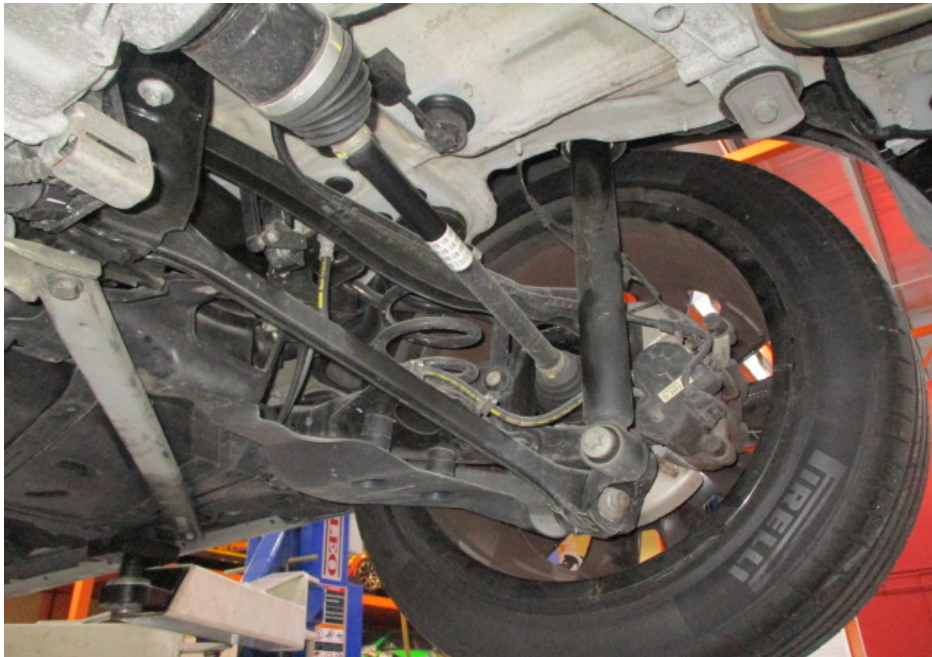
**Photo 20** shows a general view of the control arms and linkages at the rear right wheel of the Motor Car. I did not observe any fluid leak and/or fluid stain on the underside of the Motor Car. All of the Motor Car's undercarriage components were observed to be intact and secured in an appropriate manner.

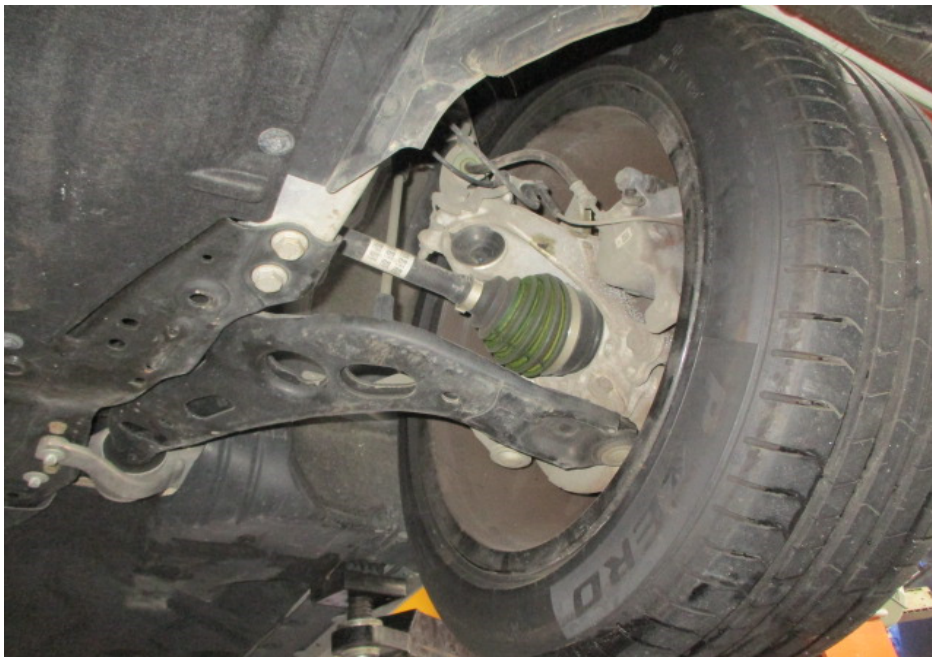
**Photo 21** shows the various undercarriage components at the front left wheel of the Motor Car. The mechanical components, control arms and linkages were all found to be intact and secured in an appropriate manner.

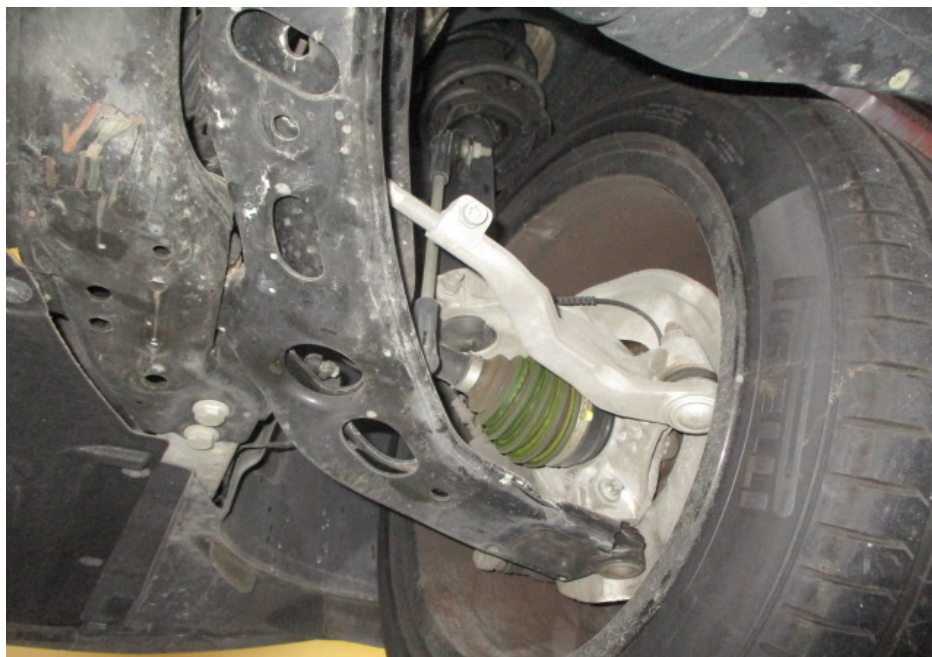
**Photo 22** shows the various undercarriage components at the front right wheel of the Motor Car. The mechanical components, control arms and linkages were all found to be intact and secured in an appropriate manner. I also did not observe any fluid leak and/or fluid stain on the underside of the Motor Car.

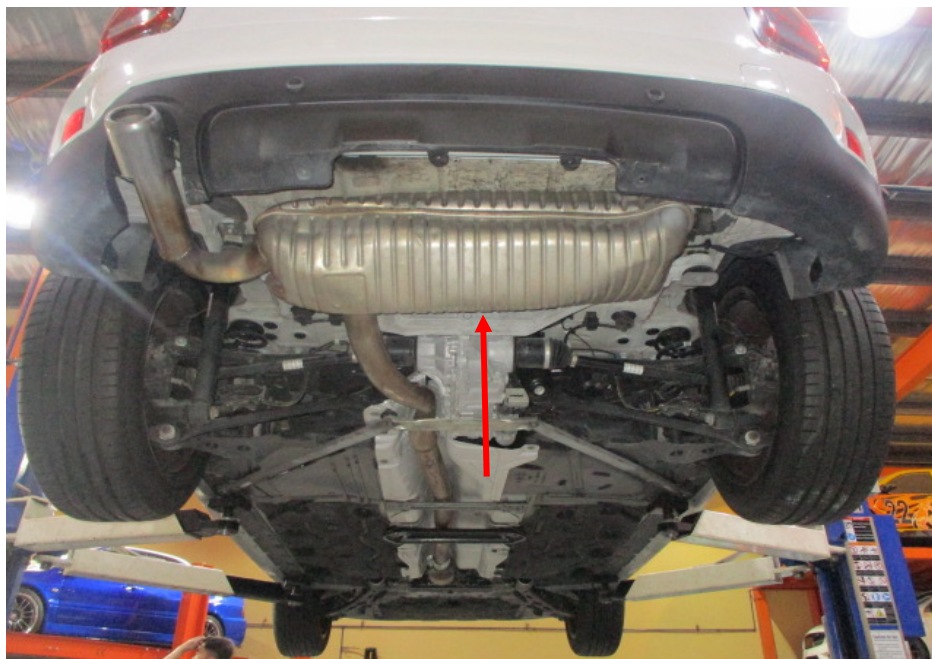
**Photo 23** shows a general view of the Motor Car's exhaust system. My examination of the Motor Car's exhaust system revealed no sign(s) or indication(s) of any cut or weld marks along its exhaust pipes, rear muffler (arrowed) and on its catalytic converter.

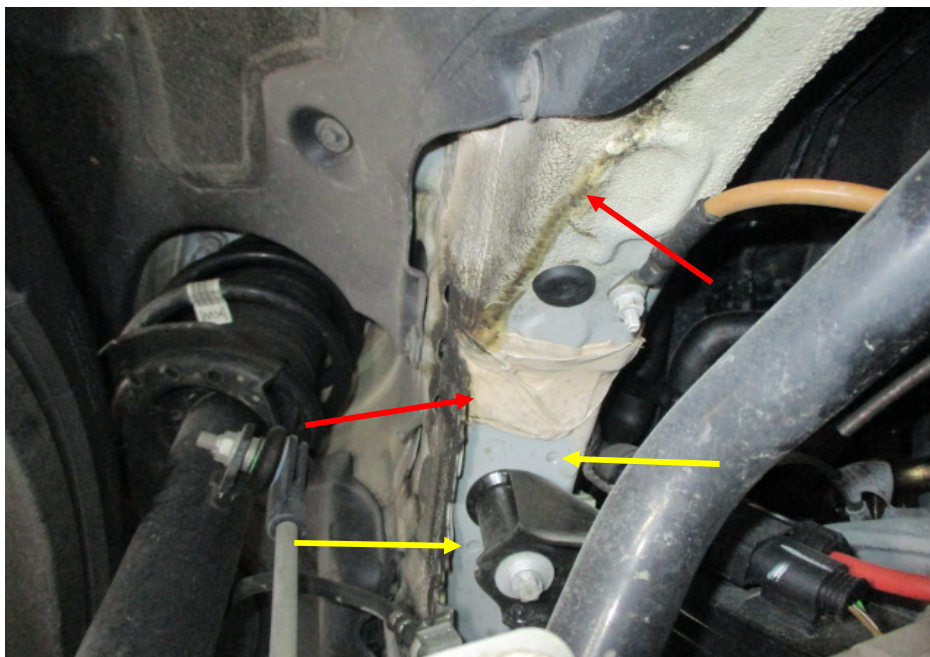
11. Visually, I did not find any weld marks, other than the original spot weld marks, on the chassis/structural body of the Motor Car. The original factory sealant at the joints along the chassis/structural body was also untouched, again indicating that no replacement of the chassis/structural body was carried out; and that the chassis/structural body was originally fitted.

**Photo 24** shows the chassis/structural body at the underside front left of the Motor Car. I did not find any weld marks other than original spot weld marks (yellow arrow) on the chassis/structural body of the Motor Car. The original factory sealant (red arrow) at the joints along the chassis/structural body was untouched, indicating no work was carried out on the chassis/structural body of the Motor Car and that the chassis/structural body was originally fitted.

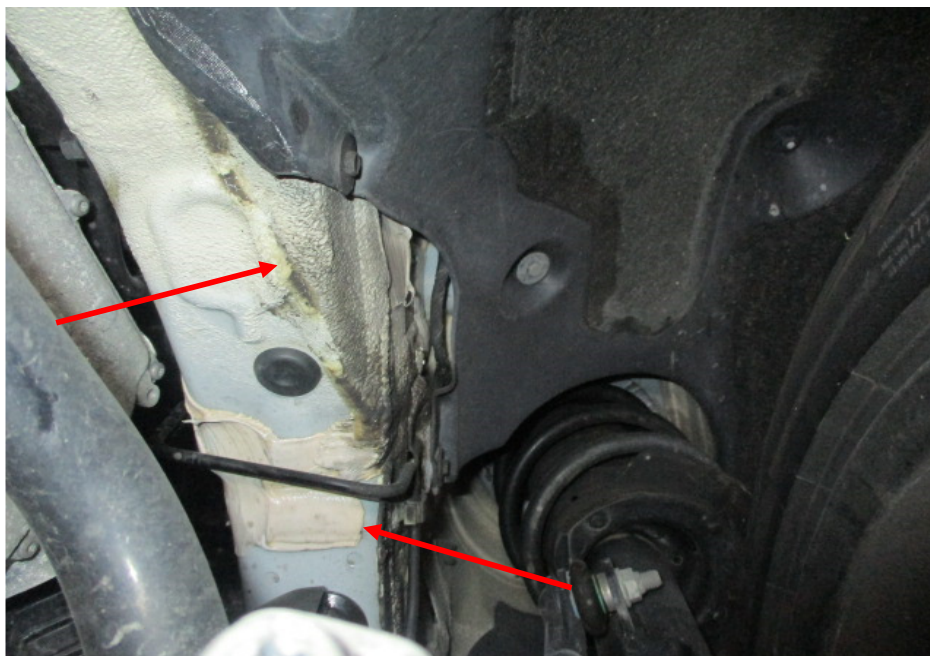
**Photo 25** shows the chassis/structural body at the underside front right of the Motor Car. The original factory sealant (arrowed) at the joints along the chassis/structural body was observed to be untouched. In general, I had found no work was carried out on the chassis/structural body of the Motor Car. The chassis/structural body of the Motor Car was originally fitted.

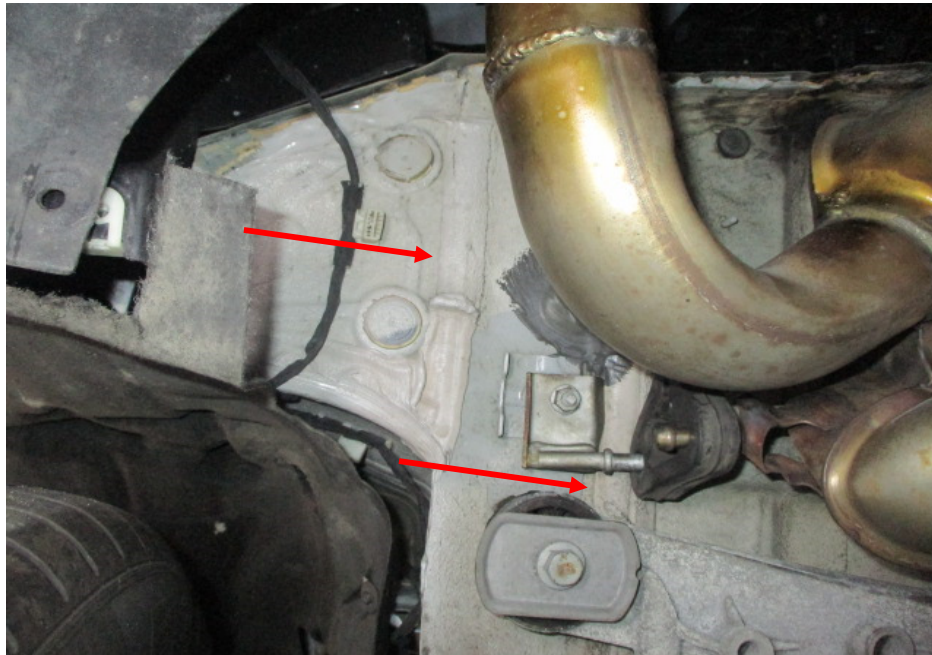
10. Checks on the non-detachable body panels like the rear fenders, floorboard, roof panel, pillars and rocker panels amongst others, revealed that these body panels were spot welded onto the chassis/structural body of the Motor Car. The original factory sealant at the joints of the non-detachable body panels was all untouched indicating no replacement of the non-detachable body panels was carried out; and that these body panels were all originally fitted.

**Photo 26** shows the floorboard at the underside rear left of the Motor Car. The original factory sealant (arrowed) at the joints along the floorboard was observed to be untouched. In general, I had found all the non-detachable body panels of the Motor Car to be originally fitted at the time of my inspection.

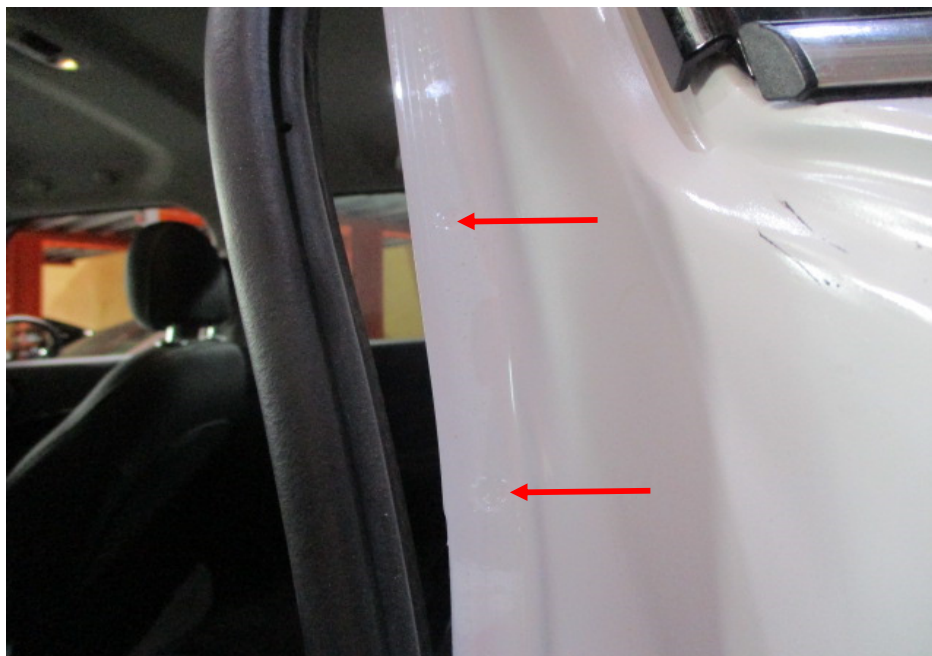
**Photo 27** shows the left side "C" pillar of the Motor Car. I did not find any weld marks other than original spot weld marks (arrowed) on the left side "C" pillar of the Motor Car which, indicates that there was no re-welding works carried out. In general, I had found all the non-detachable body panels of the Motor Car to be originally fitted at the time of my inspection.

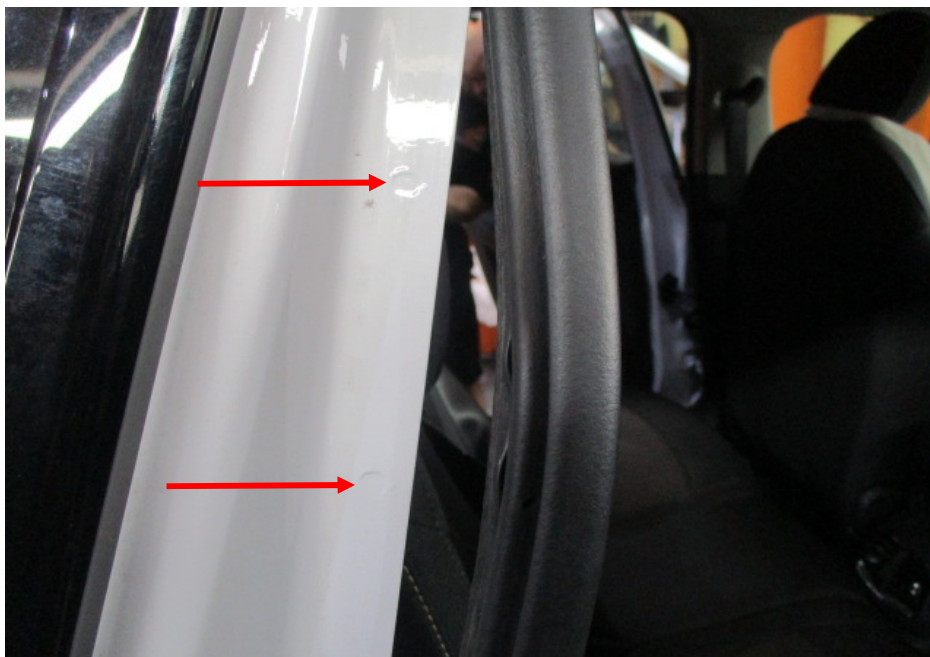
**Photo 28** shows the right side "C" pillar of the Motor Car. I did not find any weld marks other than original spot weld marks (arrowed) on the right side "C" pillar of the Motor Car which, indicates that there was no re-welding works carried out. In general, I had found all the non-detachable body panels of the Motor Car to be originally fitted at the time of my inspection.
