Your Ref: Mercedes Benz C200 Coupe  
(chassis number WDD2053772F920799)  
Our Ref : CI/TP21006247/D

01 June 2021

**INSPECTION REPORT OF AN UNREGISTERD MERCEDES BENZ C200  
COUPE MOTOR CAR WITH CHASSIS NUMBER WDD2053772F920799**

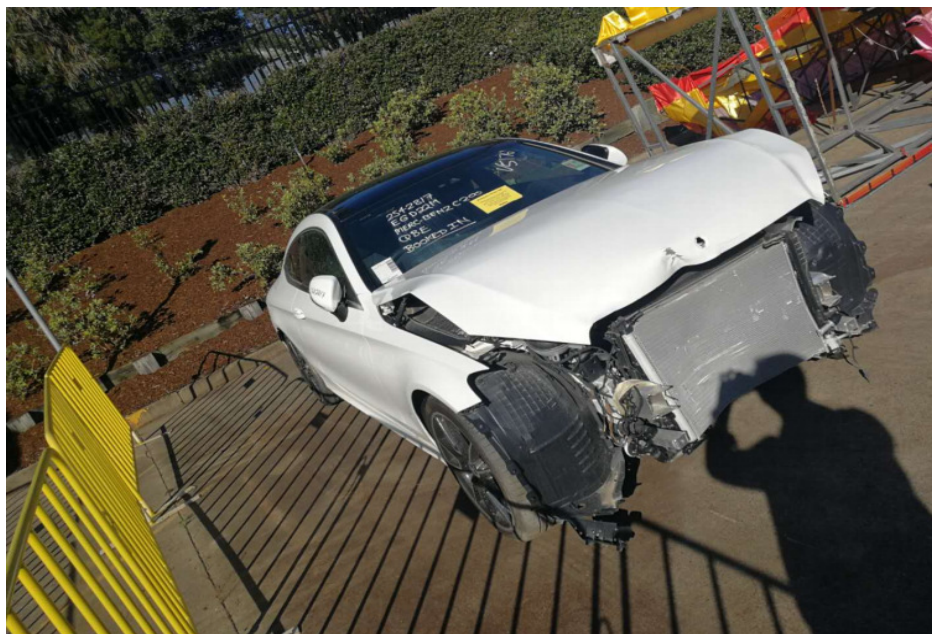
3. The photographs provided to me had showed damages at the frontal portion of the Motor Car. Physical damage was seen to the front bonnet, aircon condenser, radiator, cooling fan and air hose amongst others. The front bumper and all its related parts and attachments, front left and front right headlamps, front left and front right headlamp top panels, front top centre panel and front radiator grille amongst others were also observed to be missing/dislodged.
4. No physical damage was observed to other areas of the Motor Car. The airbags of the Motor Car were also not activated as seen from the photographs that were provided to me. See photo 1 – 4 below.

**Photo 1** shows the front right body of the Motor Car (photograph provided to me). The Motor Car was observed to have sustained damage at its frontal portion. Physical damage was seen to the front bonnet and aircon condenser amongst. The front bumper and all its related parts and attachments, front right headlamp and front radiator grille amongst others were also observed to be missing/dislodged.

22. The frontal portion of the Motor Car were visually examined, and it was observed that the repair/restoration works carried out to the damaged area of the Motor Car (refer to photograph 1 - 3 above) were reasonably adequate and in order.

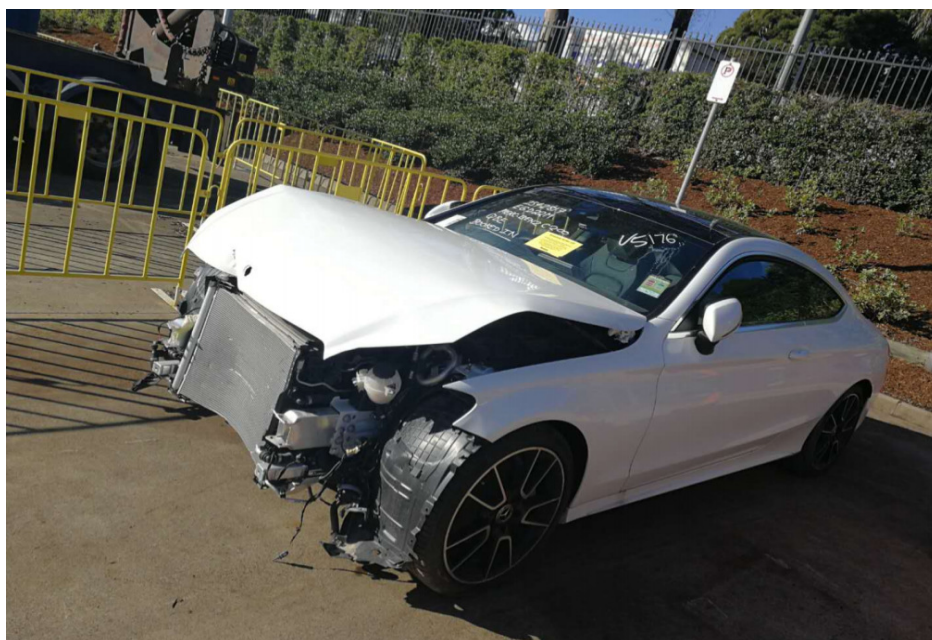
**Photo 2** shows the front left body of the Motor Car (photograph provided to me). The Motor Car was observed to have sustained damage at its frontal portion. Physical damage was seen to the front bonnet and aircon condenser amongst. The front bumper and all its related parts and attachments, front left headlamp and front radiator grille amongst others were also observed to be missing/dislodged.

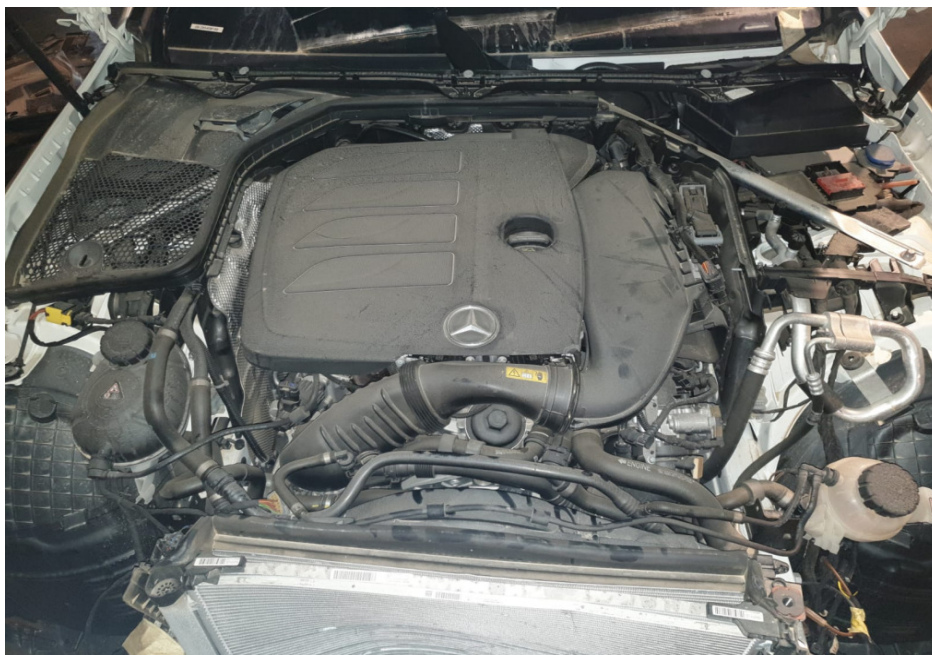
**Photo 3** shows the engine compartment of the Motor Car (photograph provided to me). Physical damage was seen to the aircon condenser, radiator, cooling fan and air hose amongst others. The front left and front right headlamp top panels and front top centre panel amongst others were also observed to be missing/dislodged.

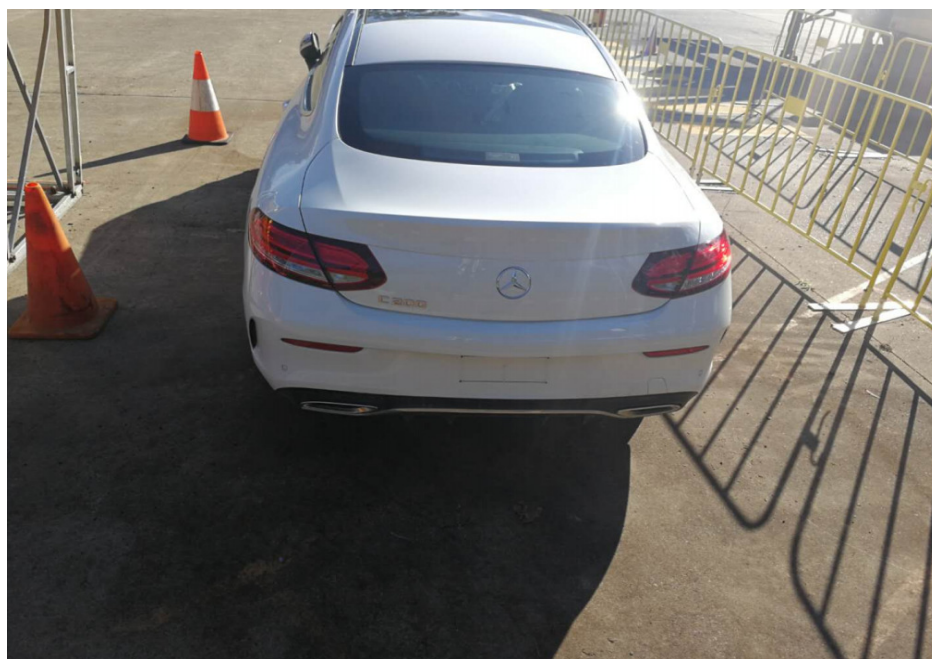
**Photo 4** shows the rear body of the Motor Car (photograph provided to me). Apart for the frontal portion, there was no physical damage seen to other areas of the Motor Car.

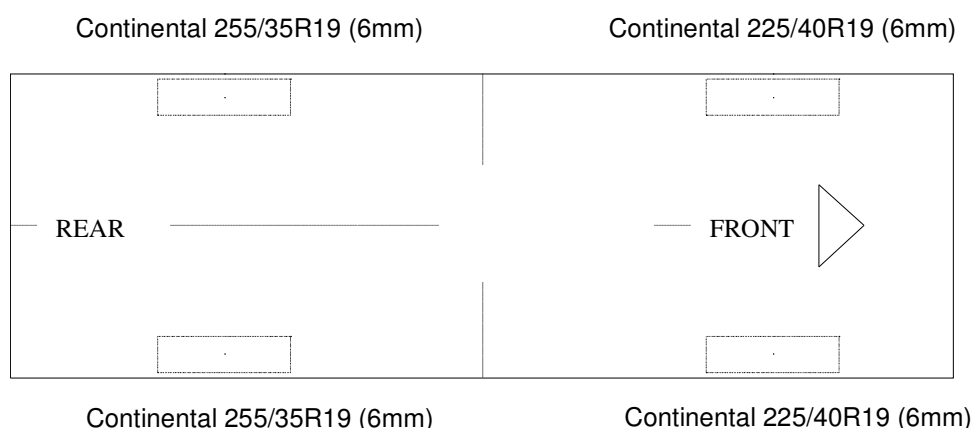
8. It was fitted with 19inch sport wheel rims that were wrapped with tyres that were observed to be of serviceable condition. The tyres were also sufficiently inflated for vehicular operation. The tyre brand, tyre size and approximate remaining tread depth of the 4 tyres of the Motor Car were recorded as follows: -

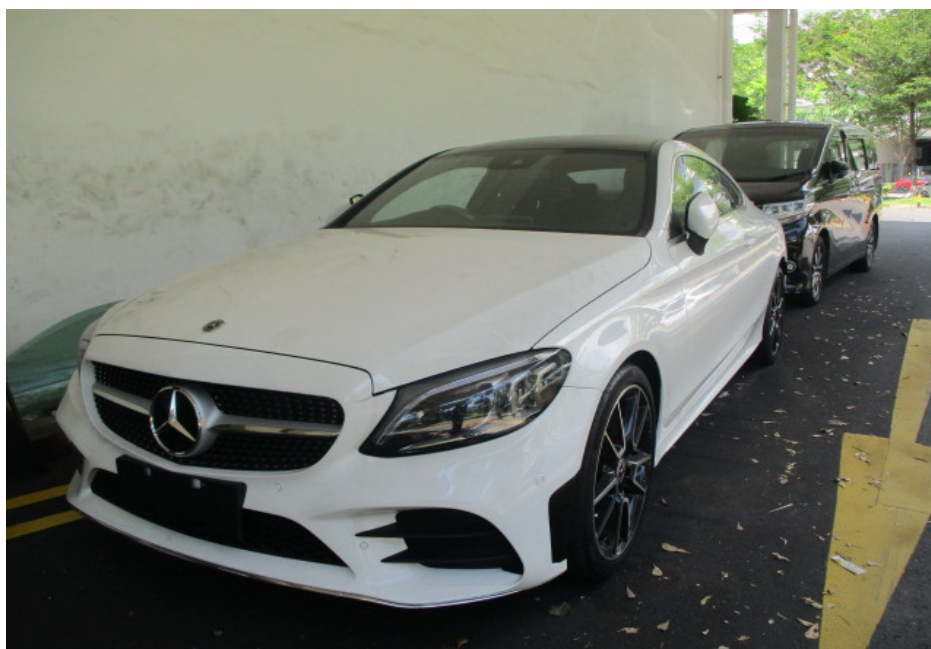
**Photo 5** shows a general view of the front left body of the Motor Car at the time of my inspection. The Motor Car was observed to be in a relatively good general condition with no loose exterior fittings observed. The frontal portion of the Motor Car were visually examined, and it was observed that the repair/restoration works carried out to the damaged area of the Motor Car (refer to photograph 1 & 2 above) were reasonably adequate and in order.

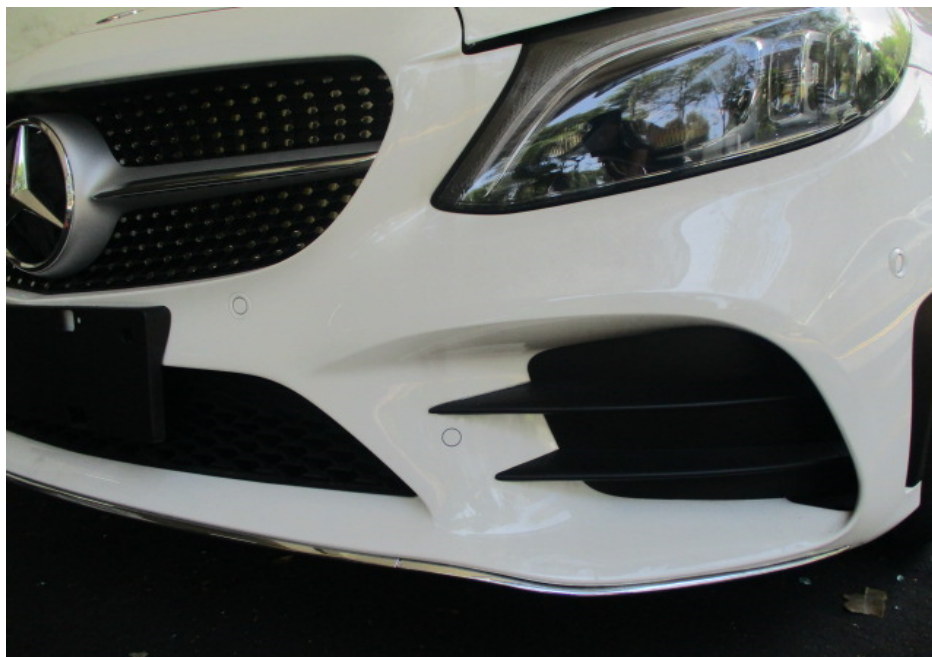
**Photo 6** shows a closer view of the Motor Car's front bumper, front bumper left lower grille and front left headlamp at the time of my inspection. The frontal portion of the Motor Car were visually examined, and it was observed that the repair/restoration works carried out to the damaged area of the Motor Car (refer to photograph 1 & 2 above) were reasonably adequate and in order.

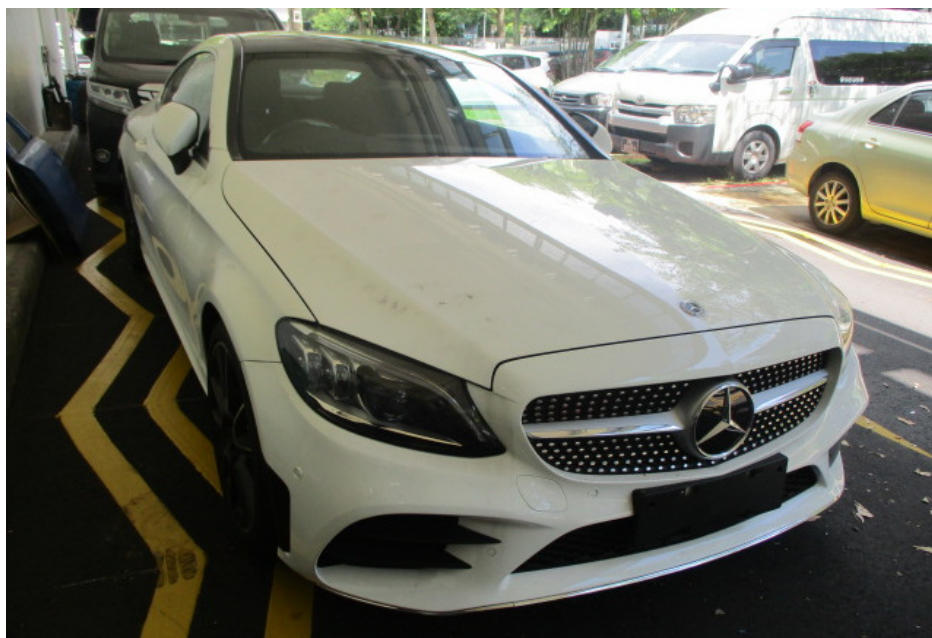
**Photo 7** shows a general view of the front right body of the Motor Car at the time of my inspection. The Motor Car was observed to be in a relatively good general condition with no loose exterior fittings observed. The frontal portion of the Motor Car were visually examined, and it was observed that the repair/restoration works carried out to the damaged area of the Motor Car (refer to photograph 1 & 2 above) were reasonably adequate and in order.

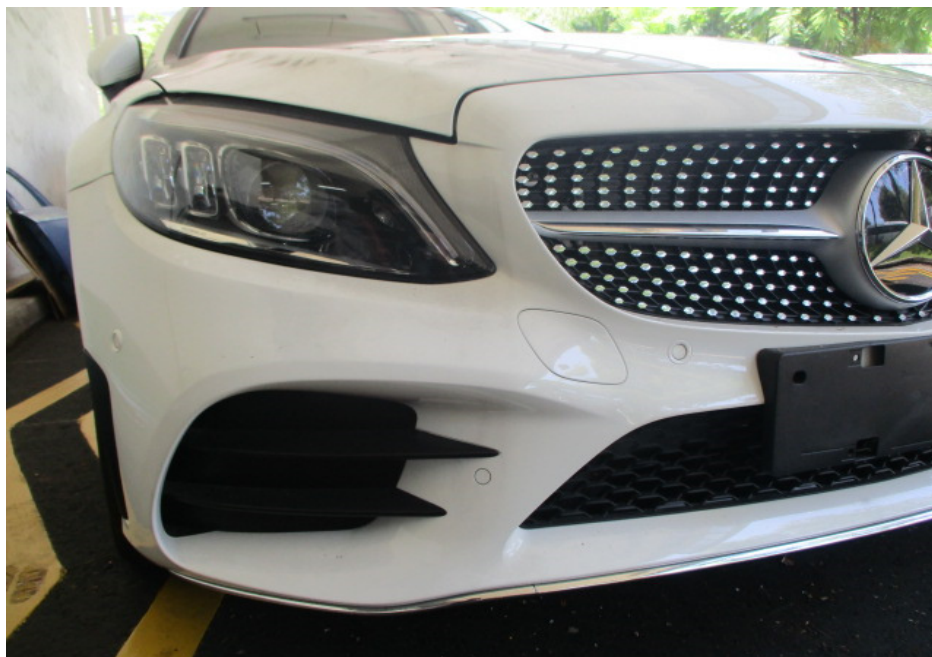
**Photo 8** shows a closer view of the Motor Car's front bumper, front bumper right lower grille, front bumper centre lower grille, front radiator grille, front right headlamp and front bonnet at the time of my inspection. The frontal portion of the Motor Car were visually examined, and it was observed that the repair/restoration works carried out to the damaged area of the Motor Car (refer to photograph 1 & 2 above) were reasonably adequate and in order.

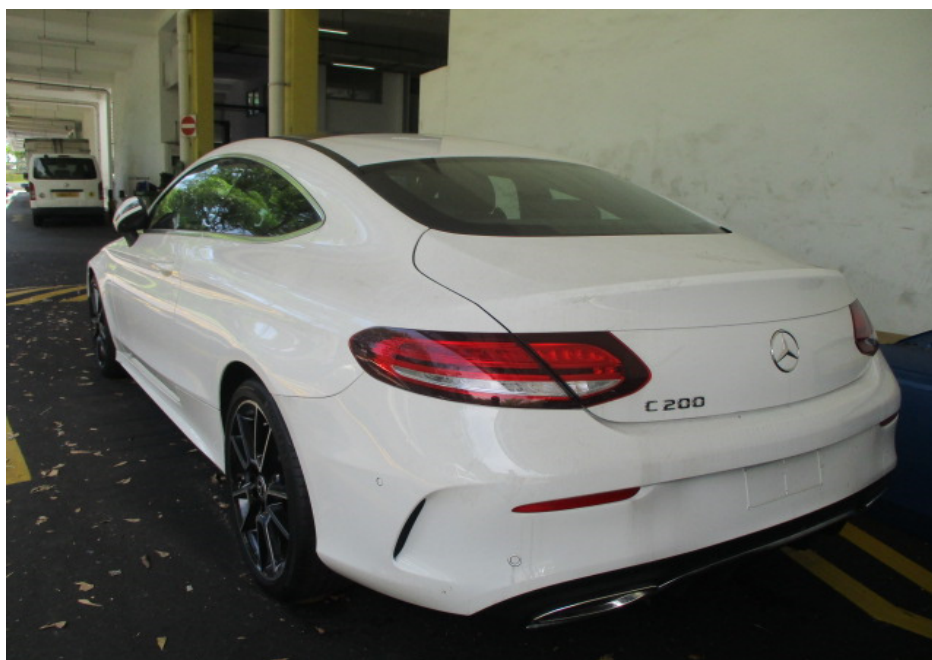
**Photo 9** shows a general view of the rear left body of the Motor Car at the time of my inspection. The Motor Car was observed to be in a relatively good general condition with no loose exterior fittings observed. The mileage of the Motor Car recorded at the time of my inspection was 718km.

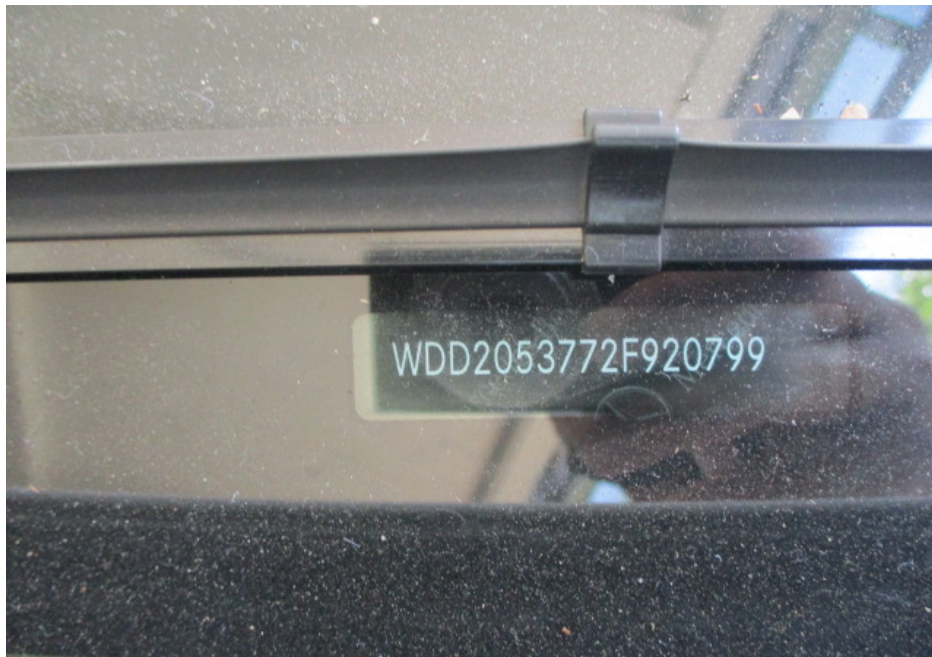
**Photo 10** shows the chassis number of the Motor Car. The chassis number recorded was WDD2053772F920799.

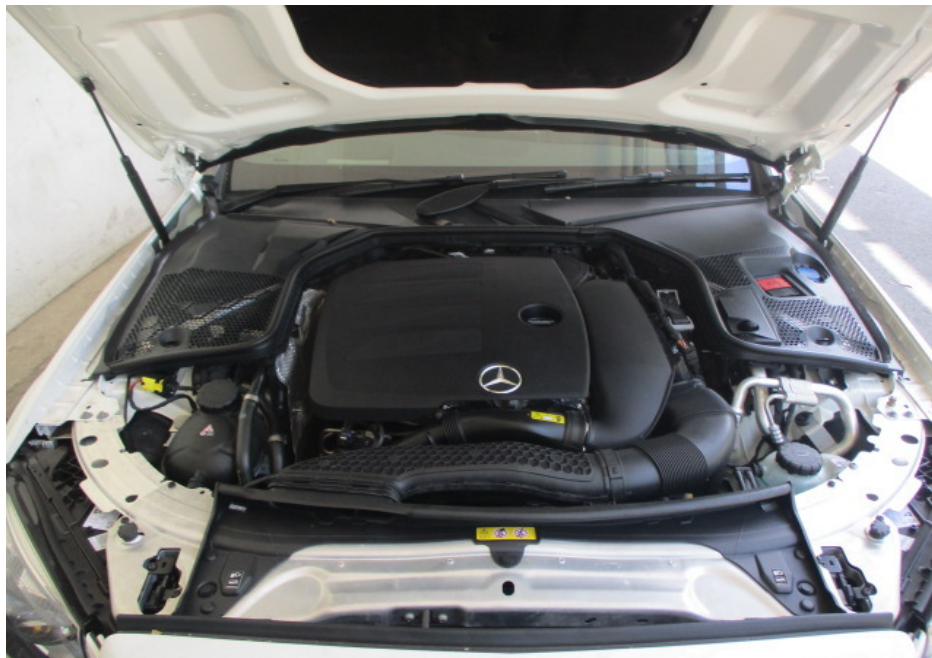
14. My examination of the engine compartment of the Motor Car revealed that the various parts and components inside the engine compartment were all intact and properly fitted. The engine oil, brake fluid and engine coolant were all found to be of sufficient level for operating purposes. Visually, there was also no contamination found to these fluids.

**Photo 11** shows a general view of the engine compartment of the Motor Car at the time of my inspection. The various parts and components inside the engine compartment were all observed to be intact and properly fitted. There was also no sign(s) or indication(s) of fluid leak and/or fluid stain found inside the engine compartment. The repair/restoration works carried out to the various parts within the engine compartment, that were damaged/dislodged/missing (refer to photograph 3 above), were reasonably adequate and in order.

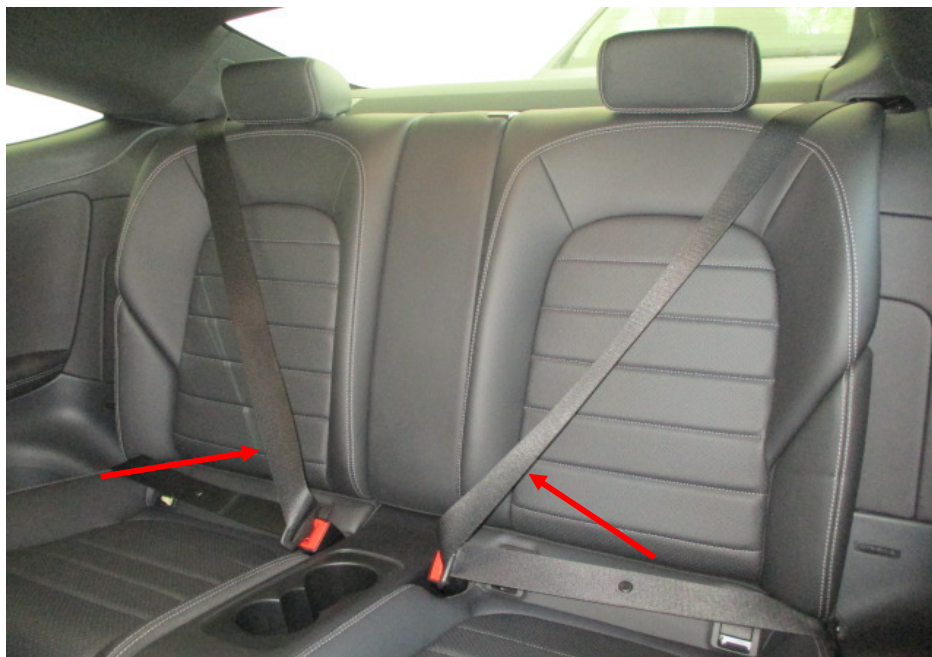
12. The seats of the Motor Car were found to be secured to the floorboard of the Motor Car via seat rails bolted onto the floorboard. Retractable seat belt reels and pre-tensioners were fitted on all seats of the Motor Car. The seat belts were tested and were able to be fastened securely into the respective pre-tensioners that were fixed to the side of all the seats.

**Photo 12** shows the rear seats of the Motor Car. All the seats of the Motor Car were secured via seat rails to the floorboard. They were also fitted with a retractable seat belt reel and a pre-tensioner. The seat belts (arrowed) were tested and were able to be fastened into the respective pre-tensions that were fitted on the side of each individual seat.

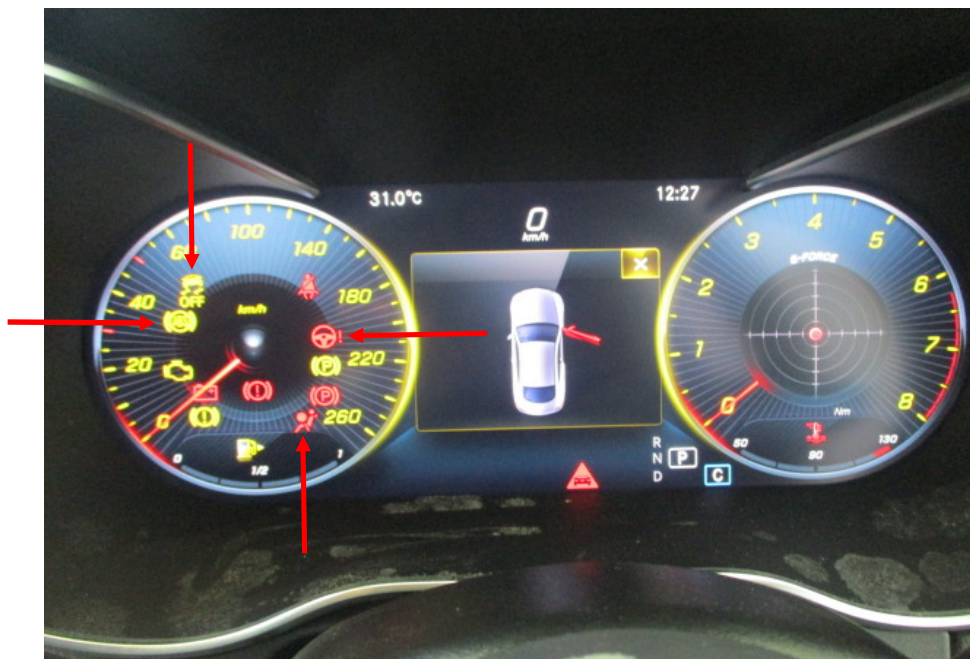
**Photo 13** shows the warning lights for the various electronic safety features appearing on the instrument panel of the Motor Car during its self-test when the engine is cranked, in particular the ABS, SRS, EPS and TCS lights (arrowed).

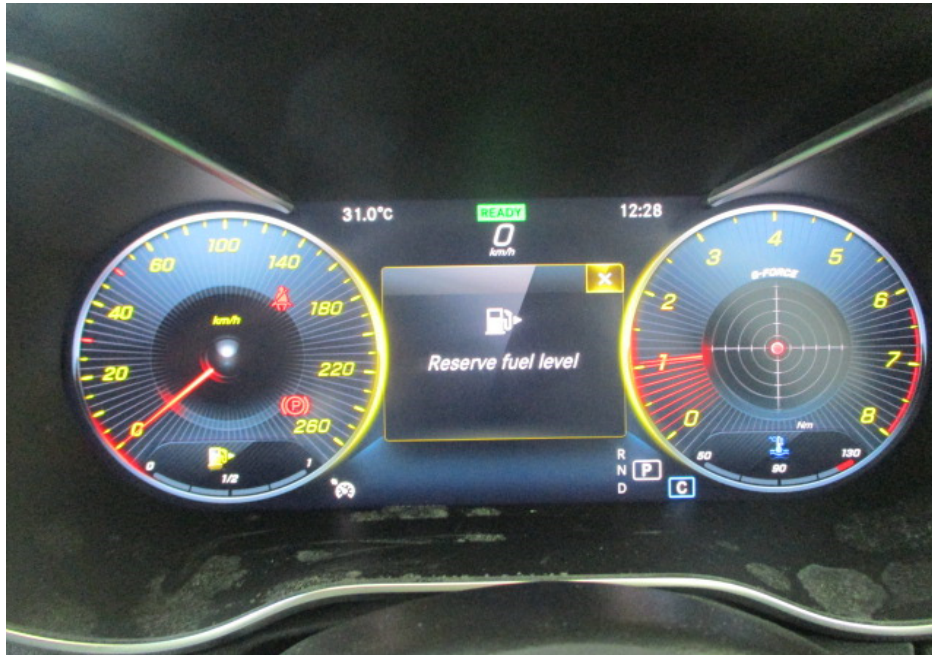
13. The Motor Car's automatic self-test of the functionality of its various electronic safety features like the Anti-Brake Lock System (ABS), Supplemental Restraint System (SRS), Electric Power Steering (EPS) and Traction Control System (TCS) during cranking of the engine had indicated that these electronic systems were in working condition. This was determined from the respective warning lights disappearing from the instrument panel after the self-test.

**Photo 14** shows the respective warning lights no longer illuminated, indicating that there is no fault detected to the ABS, SRS, EPS and TCS systems of the Motor Car during the self-test. These electronic systems were hence in working condition at the time of my inspection.

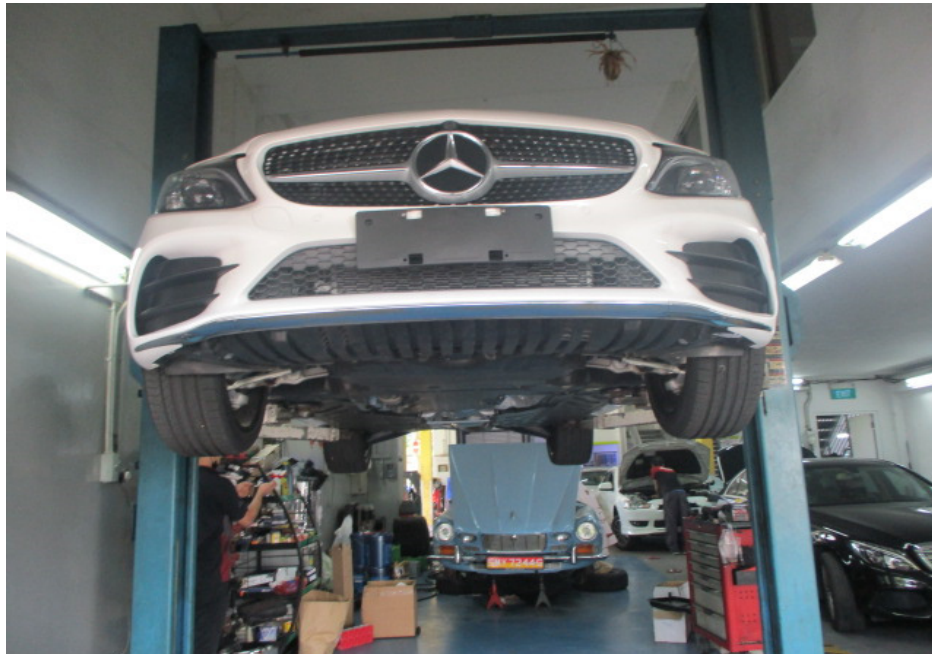
15. My checks on the underside of the Motor Car revealed no sign(s) or indication(s) of fluid leakage and/or fluid stain(s). The engine block and automatic transmission assembly were both secured properly. All undercarriage components of the Motor Car were also observed to be intact and secured in an appropriate manner.

**Photo 15** shows the Motor Car hoisted up for checks on its undercarriage. There was no sign(s) or indication(s) of fluid leakage and/or fluid stain(s) on the underside of the Motor Car. The undercarriage components of the Motor Car were also all observed to be intact and secured in an appropriate manner.

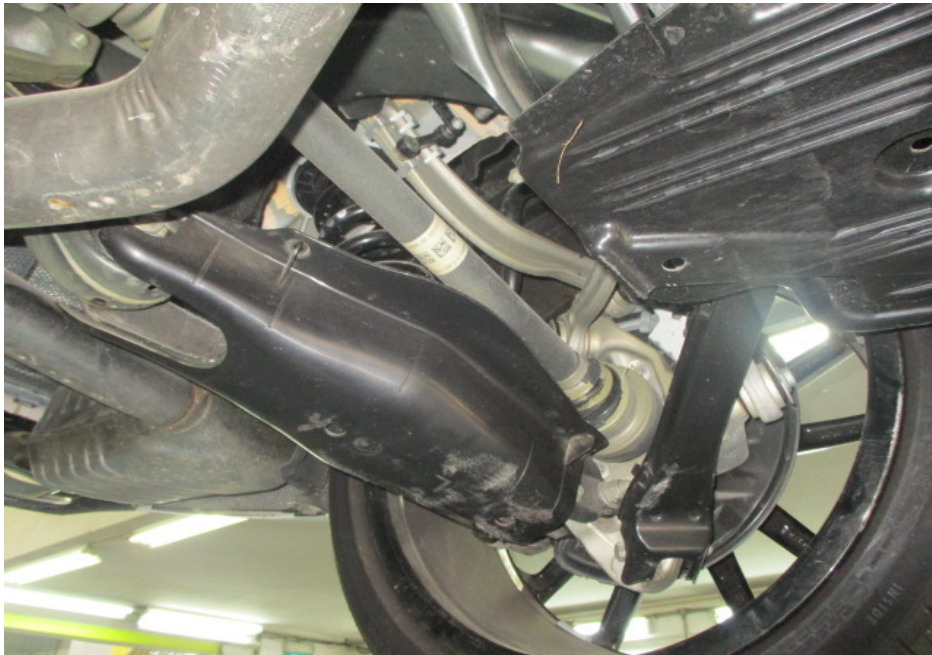
**Photo 16** shows a general view of the control arms and linkages at the rear left wheel of the Motor Car. I did not observe any fluid leak and/or fluid stain on the underside of the Motor Car. All of the Motor Car's undercarriage components were observed to be intact and secured in an appropriate manner.

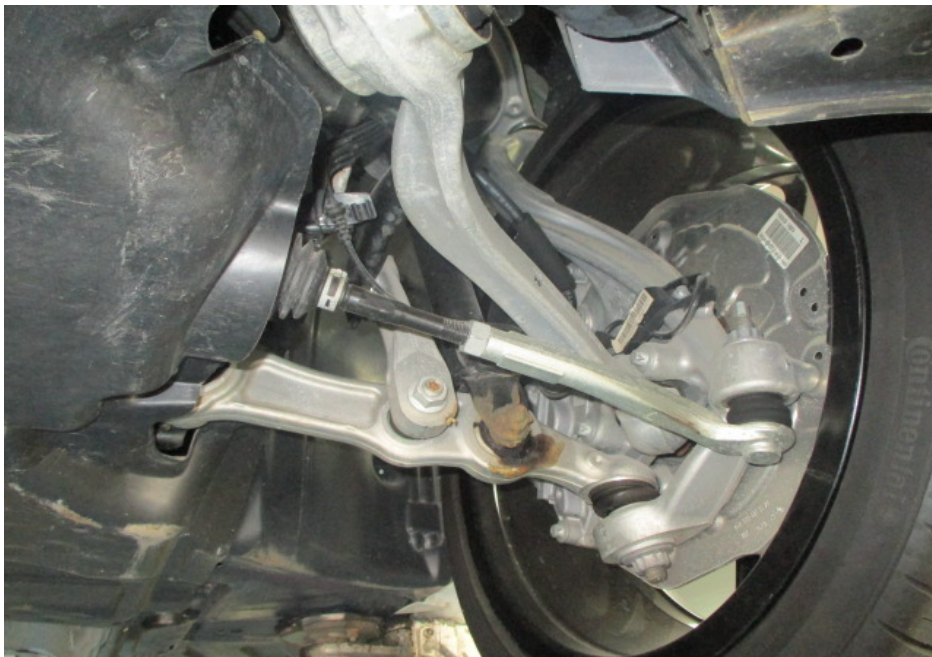
**Photo 17** shows the various undercarriage components at the front left wheel of the Motor Car. The mechanical components, control arms and linkages were all found to be intact and secured in an appropriate manner.

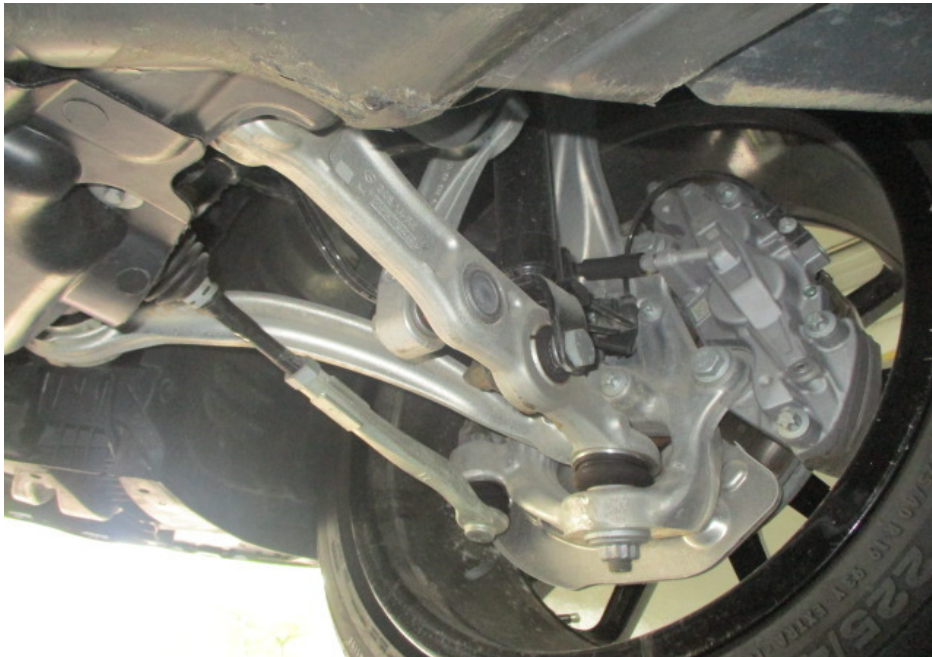
**Photo 18** shows the various undercarriage components at the front right wheel of the Motor Car. The mechanical components, control arms and linkages were all found to be intact and secured in an appropriate manner. I also did not observe any fluid leak and/or fluid stain on the underside of the Motor Car.

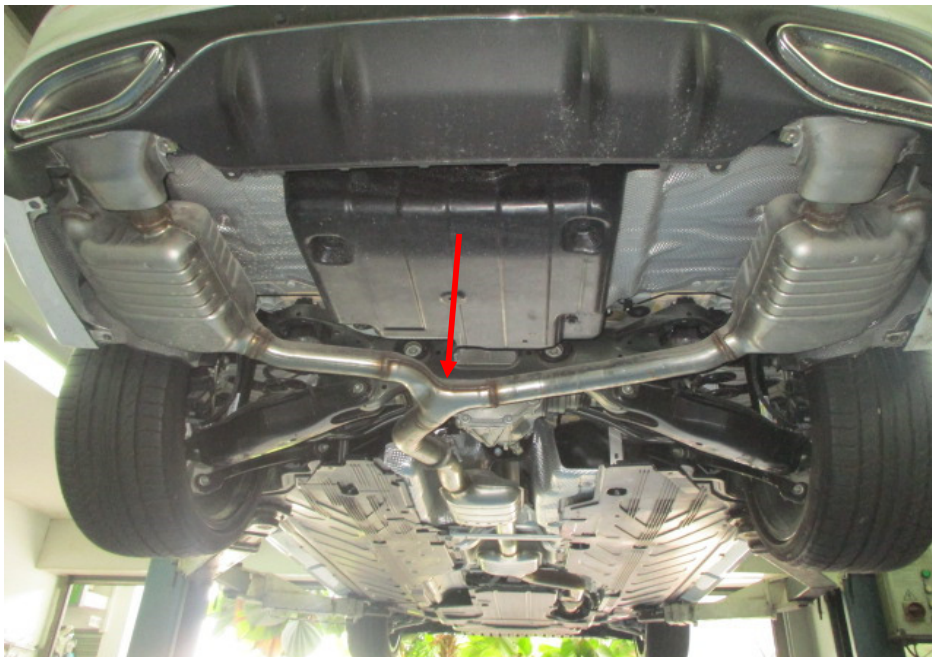
**Photo 19** shows a general view of the rear section of the Motor Car's exhaust system. My examination of the Motor Car's exhaust system revealed no sign(s) or indication(s) of any cut or weld marks along its exhaust pipes (arrowed), on its catalytic converter, centre resonator boxes and its rear mufflers.

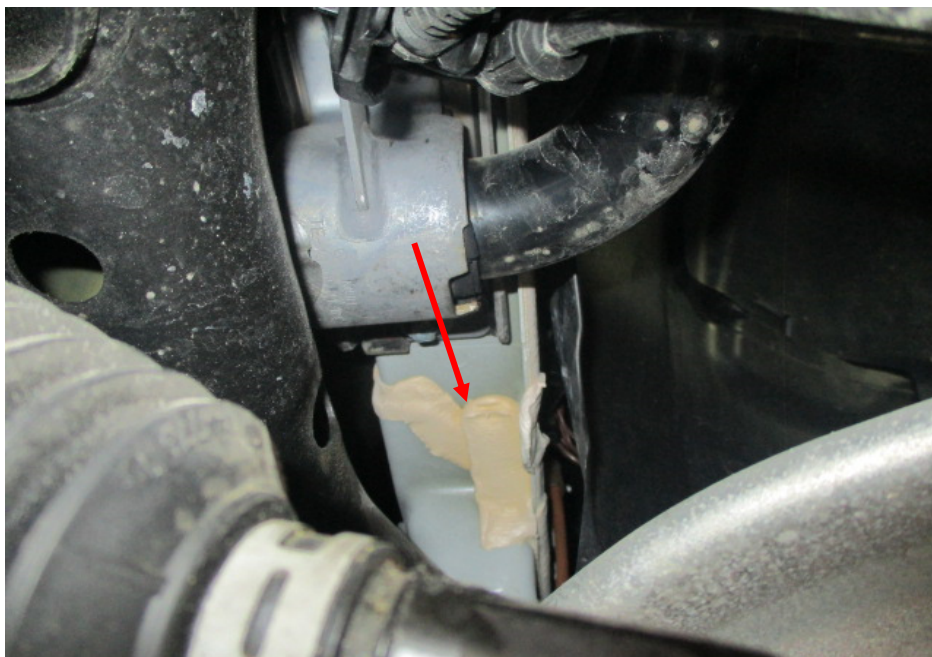
11. Visually, I did not find any weld marks, other than the original spot weld marks, on the chassis/structural body of the Motor Car. The original factory sealant at the joints along the chassis/structural body was also untouched, again indicating that no replacement of the chassis/structural body was carried out; and that the chassis/structural body was originally fitted.

**Photo 20** shows the chassis/structural body at the underside front right of the Motor Car. I did not find any weld marks other than original spot weld marks on the chassis/structural body of the Motor Car. The original factory sealant (arrowed) at the joints along the chassis/structural body was untouched, indicating no work was done on the chassis/structural body of the Motor Car and that the chassis/structural body was originally fitted.

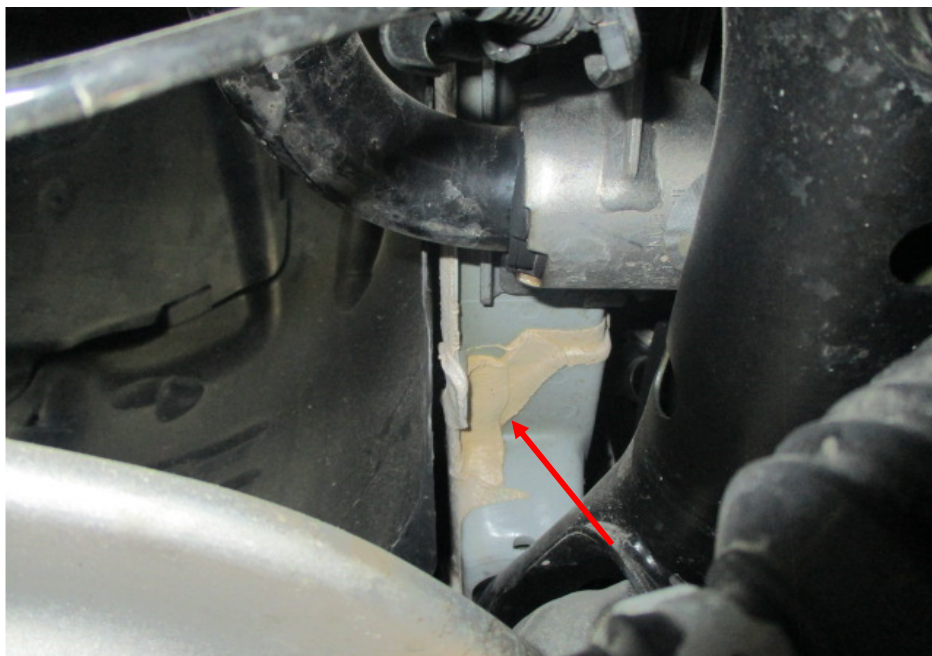
**Photo 21** shows the chassis/structural body at the underside front left of the Motor Car. The original factory sealant (arrowed) at the joints along the chassis/structural body was observed to be untouched. In general, I had found no work was carried out on the chassis/structural body of the Motor Car. The chassis/structural body of the Motor Car was originally fitted.

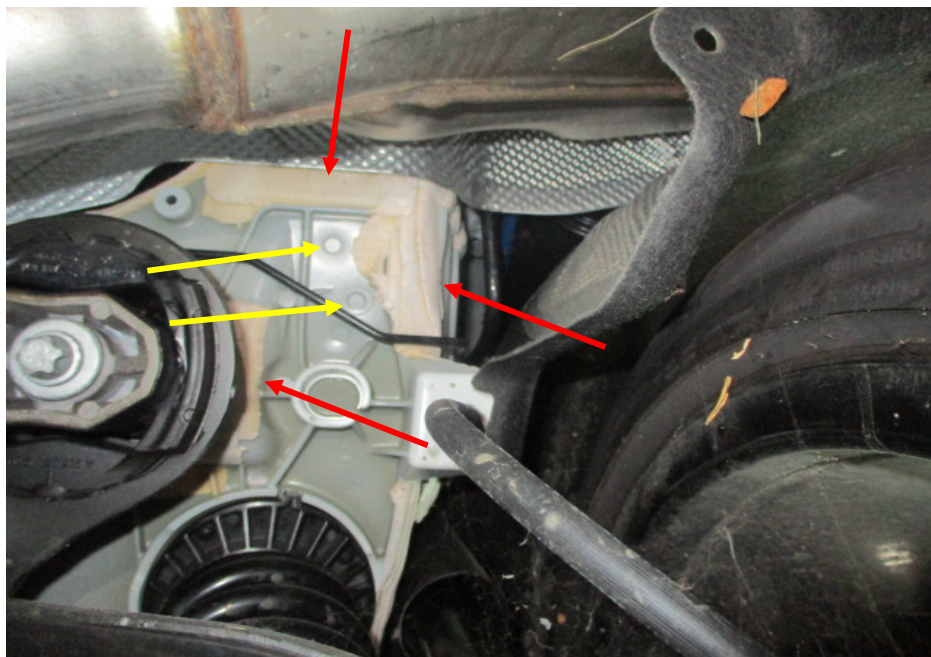
**Photo 22** shows the chassis/structural body at the underside rear right of the Motor Car. I did not find any weld marks other than original spot weld marks (yellow arrow) on the chassis/structural body of the Motor Car. The original factory sealant (red arrow) at the joints along the chassis/structural body was untouched, indicating no work was done on the chassis/structural body of the Motor Car and that the chassis/structural body was originally fitted.

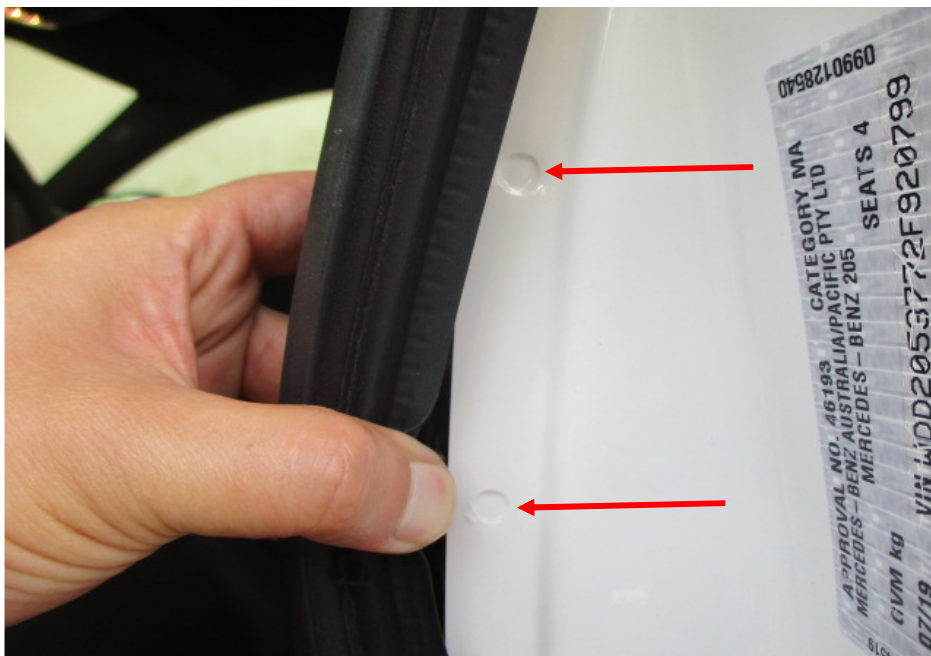
10. Checks on the non-detachable body panels like the rear fenders, floorboard, roof panel, pillars and rocker panels amongst others, revealed that these body panels were spot welded onto the chassis/structural body of the Motor Car. The original factory sealant at the joints of the non-detachable body panels was all untouched indicating no replacement of the non-detachable body panels was carried out; and that these body panels were all originally fitted.

**Photo 23** shows the left side rear body panel of the Motor Car. I did not find any weld marks other than original spot weld marks (arrowed) on the left side rear body panel of the Motor Car which, indicates that there was no re-welding works carried out. In general, I had found all the non-detachable body panels of the Motor Car to be originally fitted at the time of my inspection.

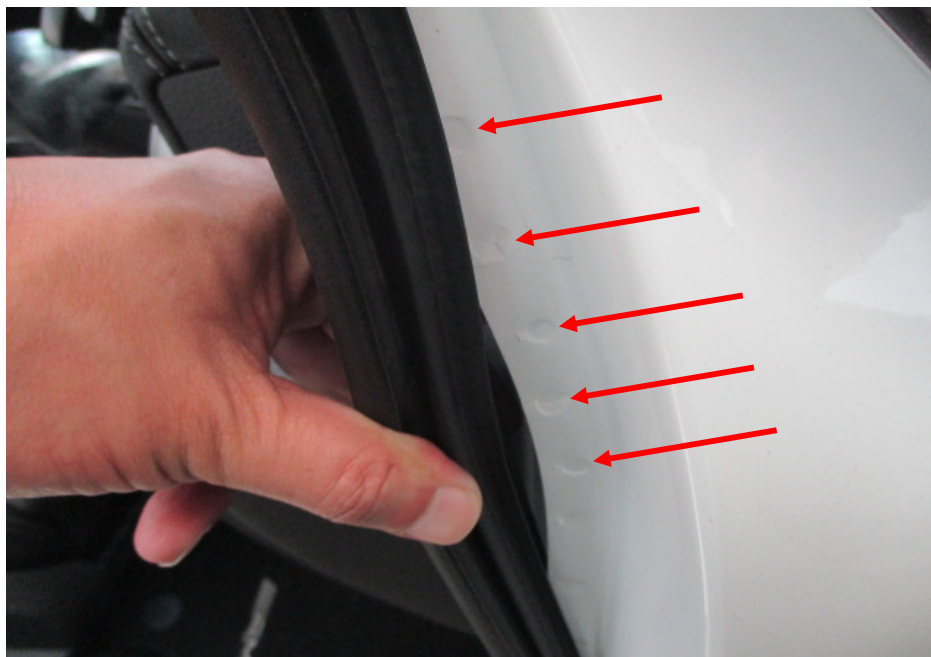
**Photo 24** shows the right side "A" pillar of the Motor Car. I did not find any weld marks other than original spot weld marks (arrowed) on the right side "A" pillar of the Motor Car which, indicates that there was no re-welding works carried out. In general, I had found all the non-detachable body panels of the Motor Car to be originally fitted at the time of my inspection.
