Your Ref: Nissan GTR  
(chassis number JN1GANR35U0400182)  
Our Ref : CI/TP21006248/D

01 June 2021

**INSPECTION REPORT OF AN UNREGISTERD NISSAN GTR MOTOR CAR  
WITH CHASSIS NUMBER JN1GANR35U0400182**

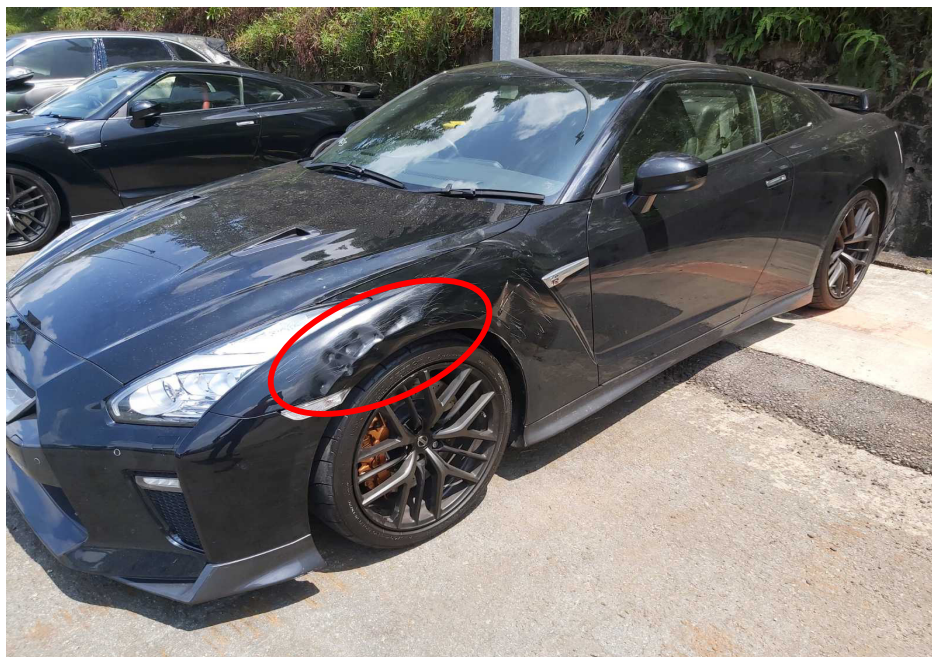
3. From the photographs provided to me, it was observed that the Motor Car had sustained damage at its front left portion. The front left fender of the Motor Car was the only body part that was damaged as seen from the photographs that were provided to me. See photo 1 – 4 below.

**Photo 1** shows the front left body of the Motor Car (photograph provided to me). The Motor Car was observed to have sustained damage at its front left portion (circled). From the photographs provided, I had observed damage to only the front left fender of the Motor Car. The airbags of the Motor Car were not activated.

21. The front left portion of the Motor Car were visually examined, and it was noted that the repair/restoration works carried out to the damaged area of the Motor Car (refer to photograph 1 & 2 above) were reasonably adequate and in order.

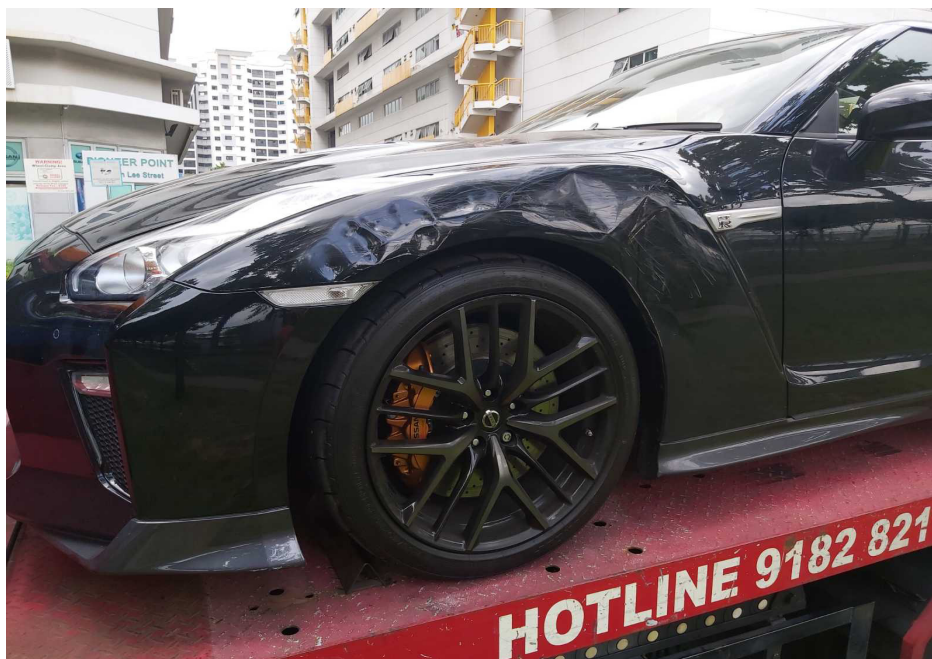
**Photo 2** shows a closer view of the damage to the front left fender of the Motor Car (photograph provided to me). There was no physical damage seen to other areas of the Motor Car apart for this damage at the front left fender.

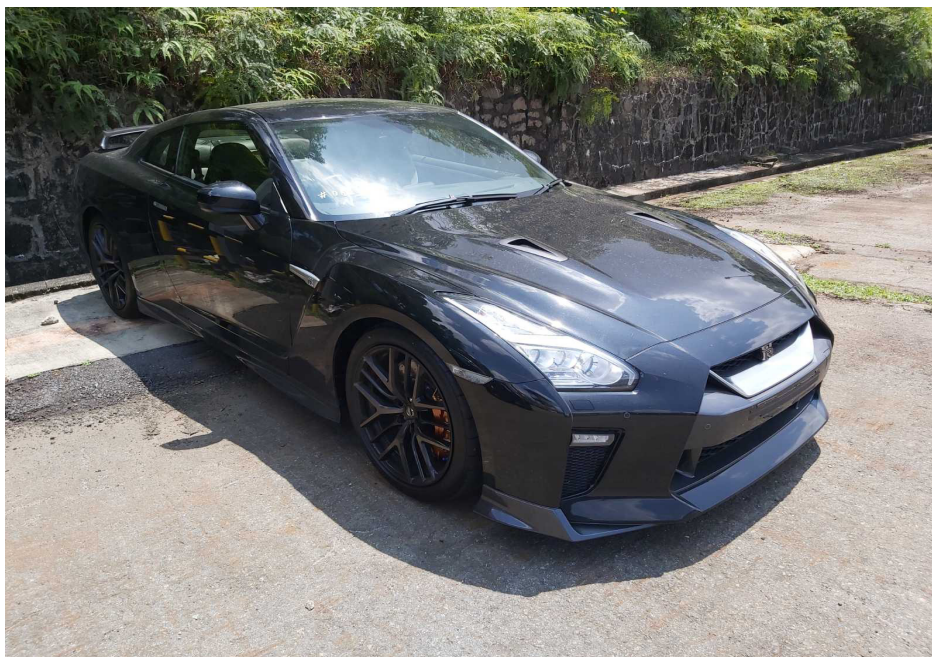
**Photo 3** shows the front right body of the Motor Car (photograph provided to me). Apart for the front left portion, there was no physical damage seen to other areas of the Motor Car. The airbags of the Motor Car were also not activated as seen from the photographs that were provided to me.

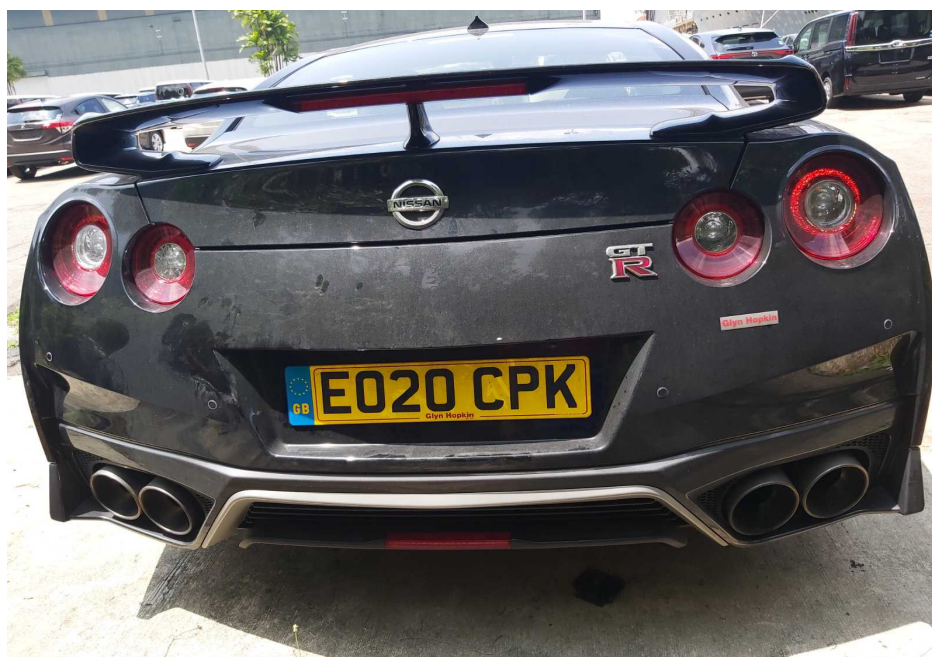
**Photo 4** shows the rear body of the Motor Car (photograph provided to me). Apart for the front left portion, there was no physical damage seen to other areas of the Motor Car.

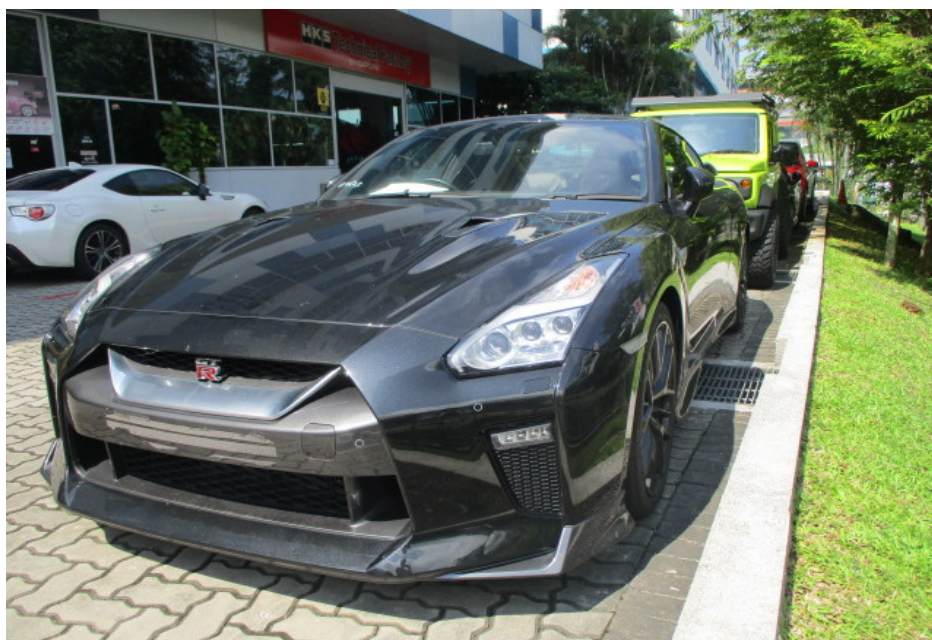
**Photo 5** shows a general view of the front left body of the Motor Car at the time of my inspection. The Motor Car was observed to be in a relatively good general condition with no loose exterior fittings observed. The front left portion of the Motor Car were visually examined, and it was observed that the repair/restoration works carried out to the damaged area of the Motor Car (refer to photograph 1 & 2 above) were reasonably adequate and in order.

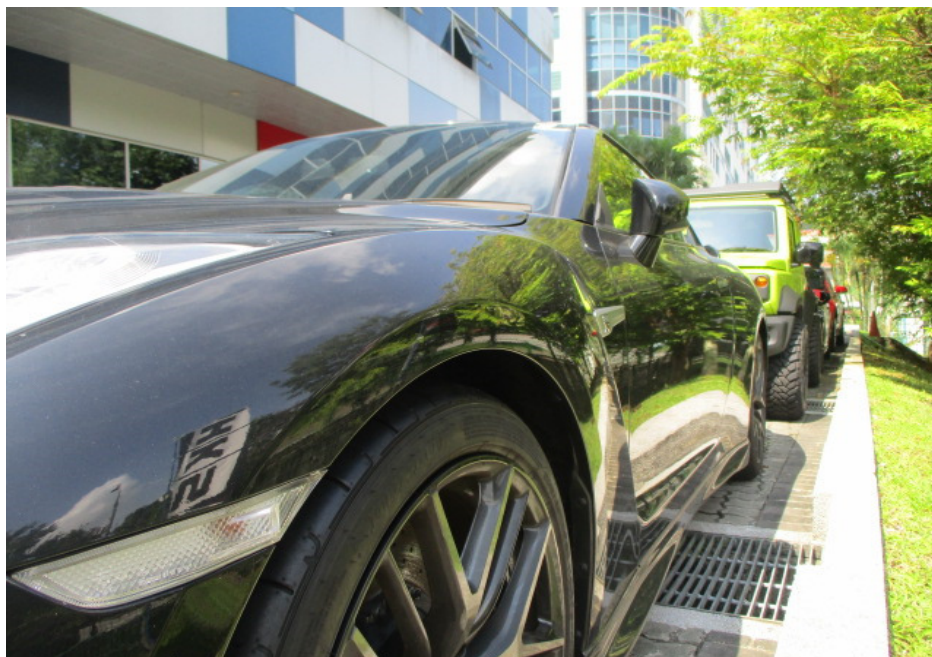
**Photo 6** shows a closer view of the Motor Car's front left fender at the time of my inspection. The front left portion of the Motor Car were visually examined, and it was observed that the repair/restoration works carried out to the damaged area of the Motor Car (refer to photograph 1 & 2 above) were reasonably adequate and in order.

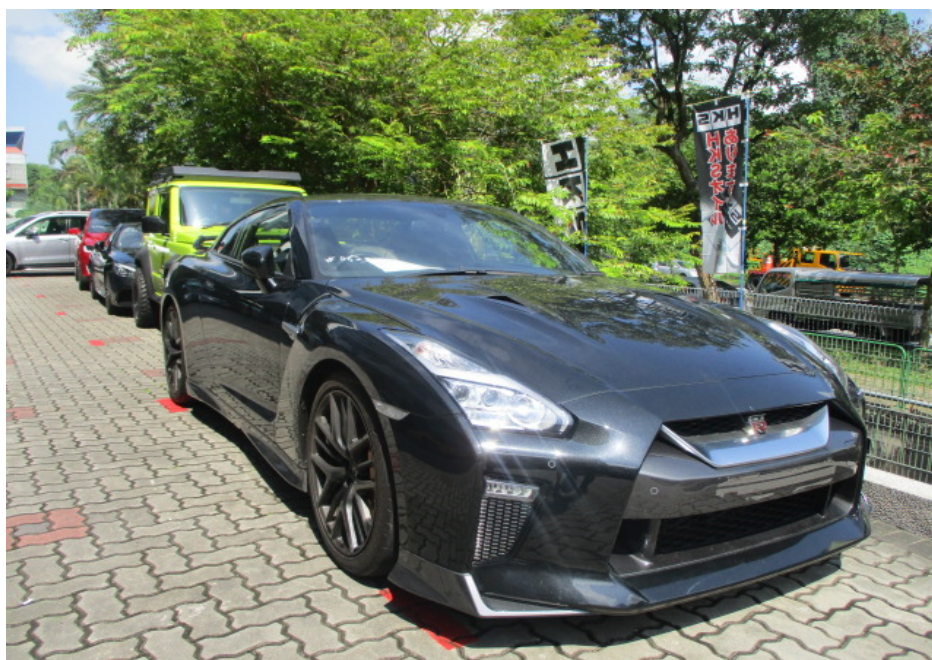
**Photo 7** shows a general view of the front right body of the Motor Car at the time of my inspection. The Motor Car was observed to be in a relatively good general condition with no loose exterior fittings observed. The mileage of the Motor Car recorded at the time of my inspection was 2,474 miles.

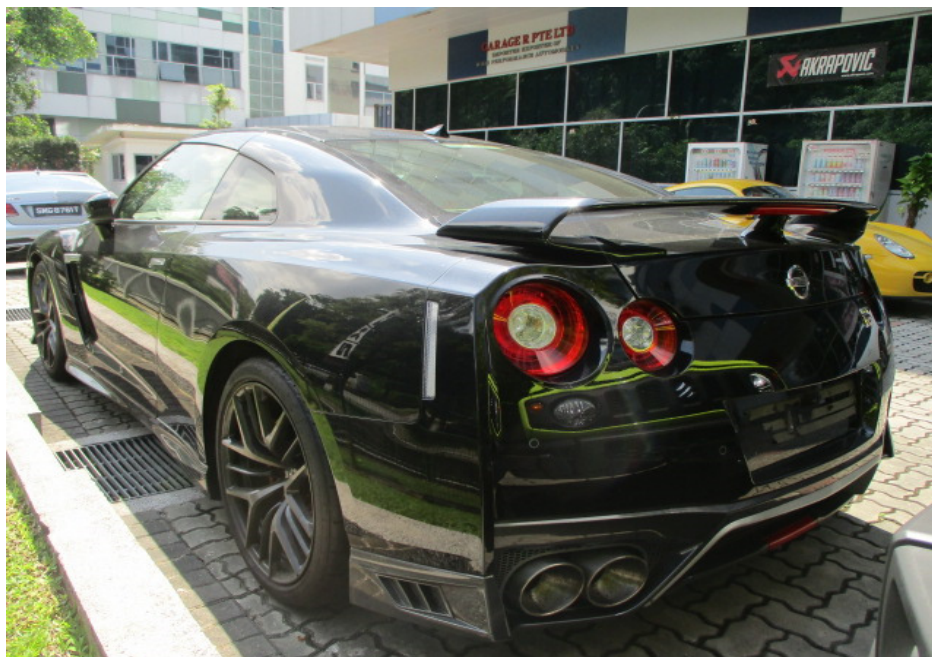
**Photo 8** shows a general view of the rear left body of the Motor Car at the time of my inspection. The Motor Car was observed to be in a relatively good general condition with no loose exterior fittings observed. The mileage of the Motor Car recorded at the time of my inspection was 2,474miles.

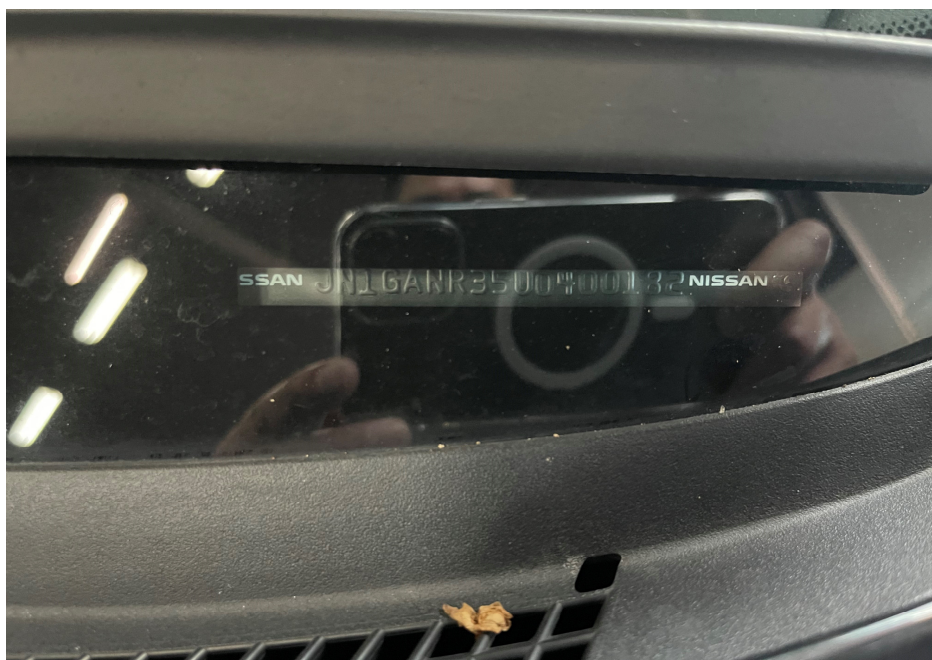
**Photo 9** shows the chassis number of the Motor Car. The chassis number recorded was JN1GANR35U0400182.

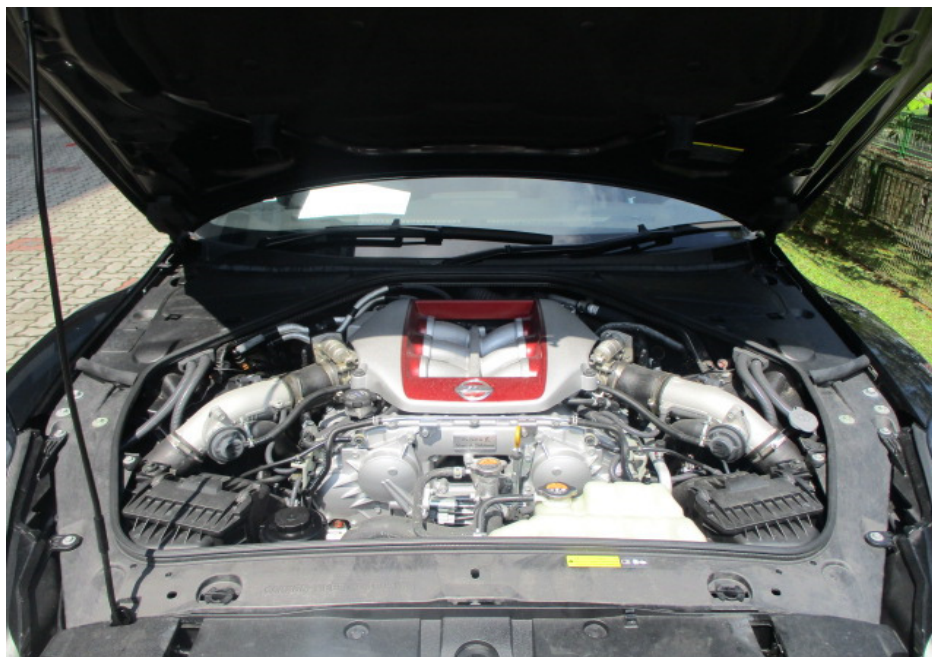
13. My examination of the engine compartment of the Motor Car revealed that the various parts and components inside the engine compartment were all intact and properly fitted. The engine oil, brake fluid and engine coolant were all found to be of sufficient level for operating purposes. Visually, there was also no contamination found to these fluids.

**Photo 10** shows a general view of the engine compartment of the Motor Car at the time of my inspection. The various parts and components inside the engine compartment were all observed to be intact and properly fitted. There was also no sign(s) or indication(s) of fluid leak and/or fluid stain found inside the engine compartment.

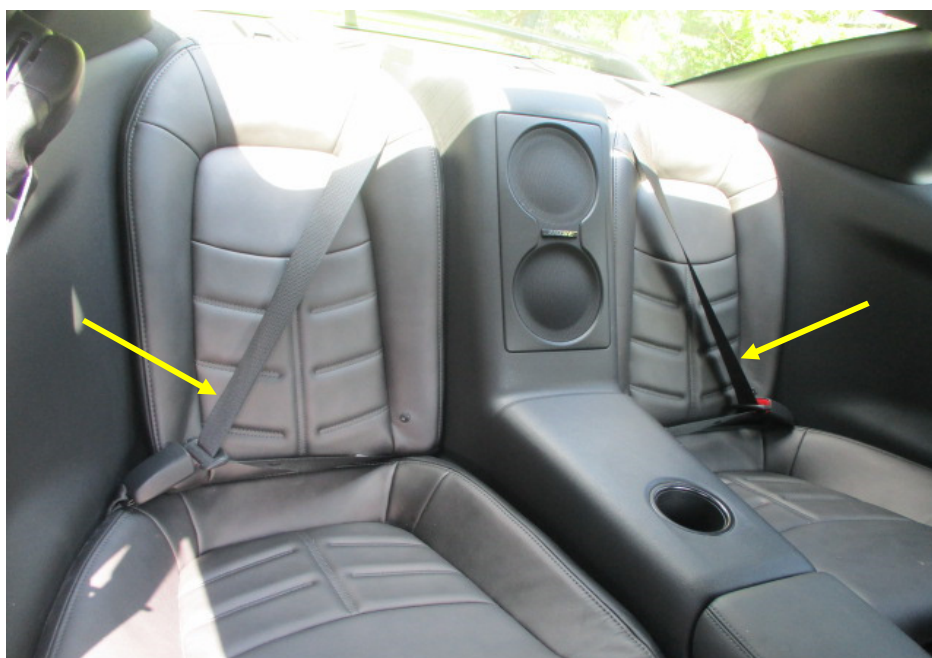
11. The seats of the Motor Car were found to be secured to the floorboard of the Motor Car via seat rails bolted onto the floorboard. Retractable seat belt reels and pre-tensioners were fitted on all seats of the Motor Car. The seat belts were tested and were able to be fastened securely into the respective pre-tensioners that were fixed to the side of all the seats.

**Photo 11** shows the rear seats of the Motor Car. All the seats of the Motor Car were secured via seat rails to the floorboard. They were also fitted with a retractable seat belt reel and a pre-tensioner. The seat belts (arrowed) were tested and were able to be fastened into the respective pre-tensions that were fitted on the side of each individual seat.

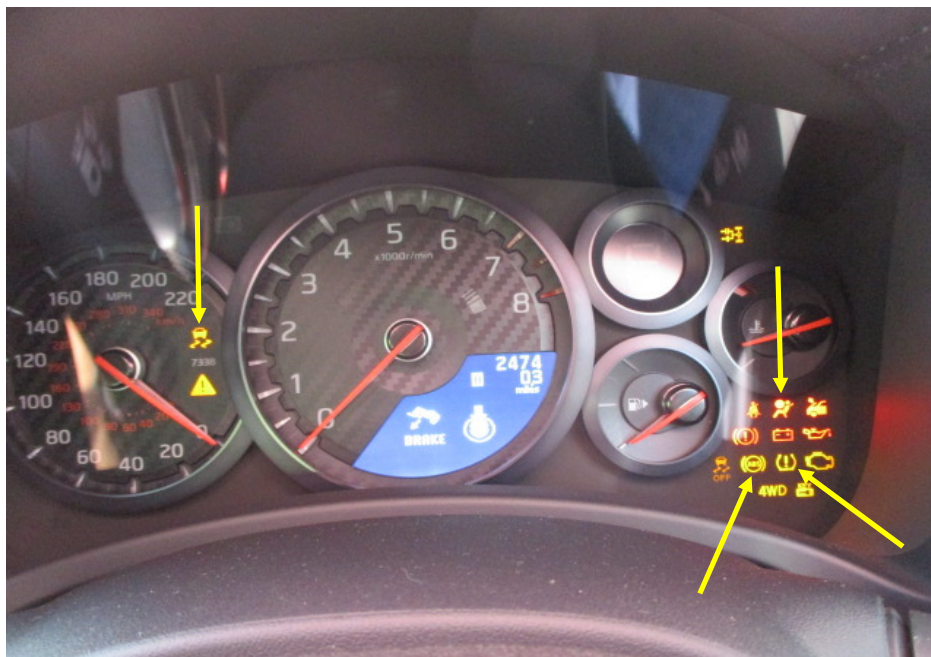
**Photo 12** shows the warning lights for the various electronic safety features appearing on the instrument panel of the Motor Car during its self-test when the engine is cranked, in particular the ABS, SRS, TPM and VDC lights (arrowed).

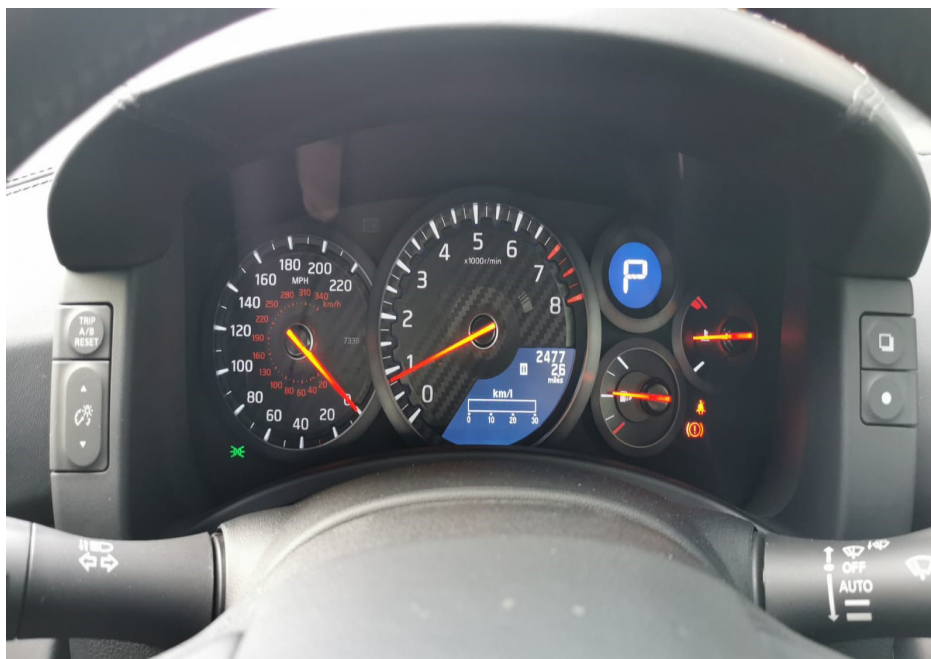
12. The Motor Car's automatic self-test of the functionality of its various electronic safety features like the Anti-Lock Brake System (ABS), Supplemental Restraint System (SRS), Tyre Pressure Monitor (TPM) and Vehicle Dynamic Control (VDC) during cranking of the engine had indicated that these electronic systems were in working condition. This was determined from the respective warning lights disappearing from the instrument panel after the self-test.

**Photo 13** shows the respective warning lights no longer illuminated, indicating that there is no fault detected to the ABS, SRS, TPM and VDC systems of the Motor Car during the self-test. These electronic systems were hence in working condition at the time of my inspection.

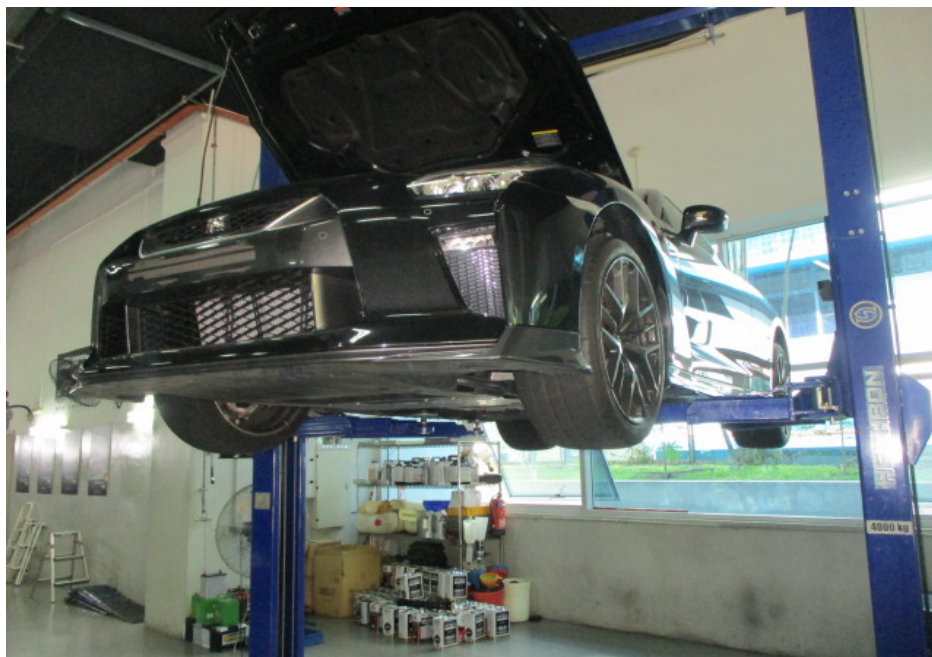
14. My checks on the underside of the Motor Car revealed no sign(s) or indication(s) of fluid leakage and/or fluid stain(s). The engine block and automatic transmission assembly were both secured properly. All undercarriage components of the Motor Car were also observed to be intact and secured in an appropriate manner.

**Photo 14** shows the Motor Car hoisted up for checks on its undercarriage. There was no sign(s) or indication(s) of fluid leakage and/or fluid stain(s) on the underside of the Motor Car. The undercarriage components of the Motor Car were also all observed to be intact and secured in an appropriate manner.

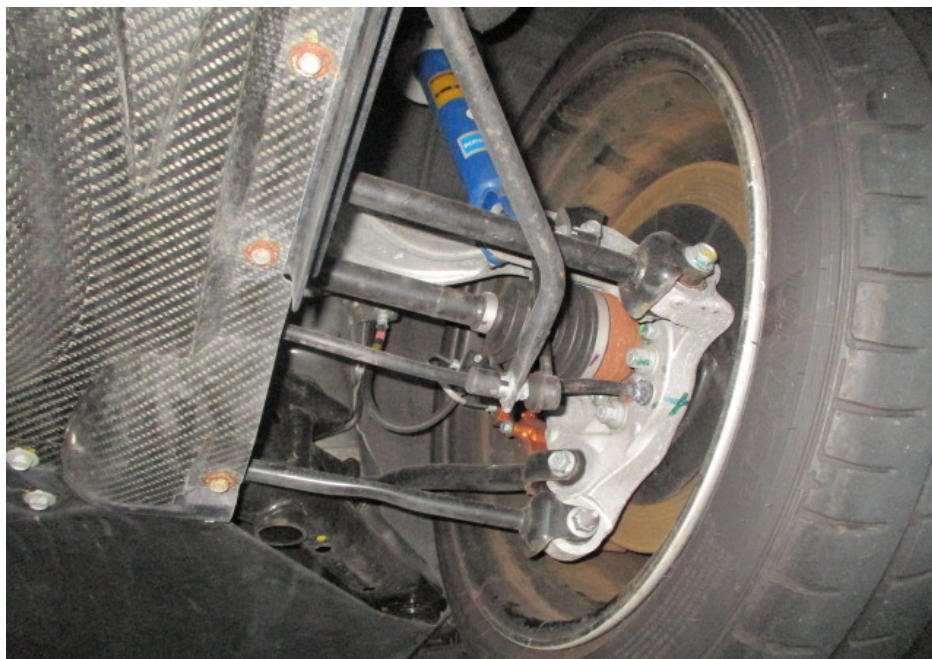
**Photo 15** shows a general view of the control arms and linkages at the rear right wheel of the Motor Car. I did not observe any fluid leak and/or fluid stain on the underside of the Motor Car. All of the Motor Car's undercarriage components were observed to be intact and secured in an appropriate manner.

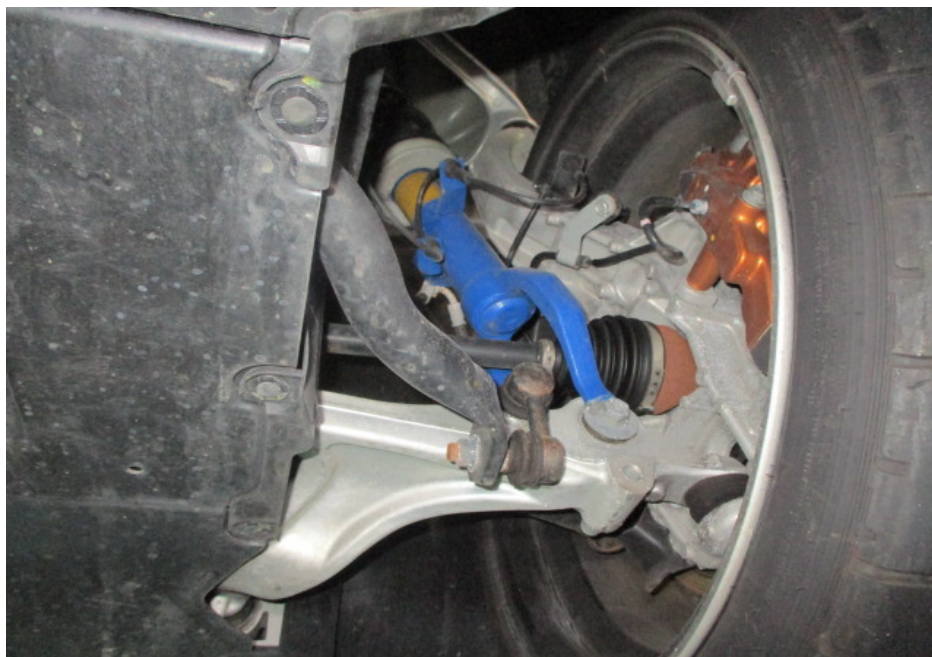
**Photo 16** shows the various undercarriage components at the front left wheel of the Motor Car. The mechanical components, control arms and linkages were all found to be intact and secured in an appropriate manner.

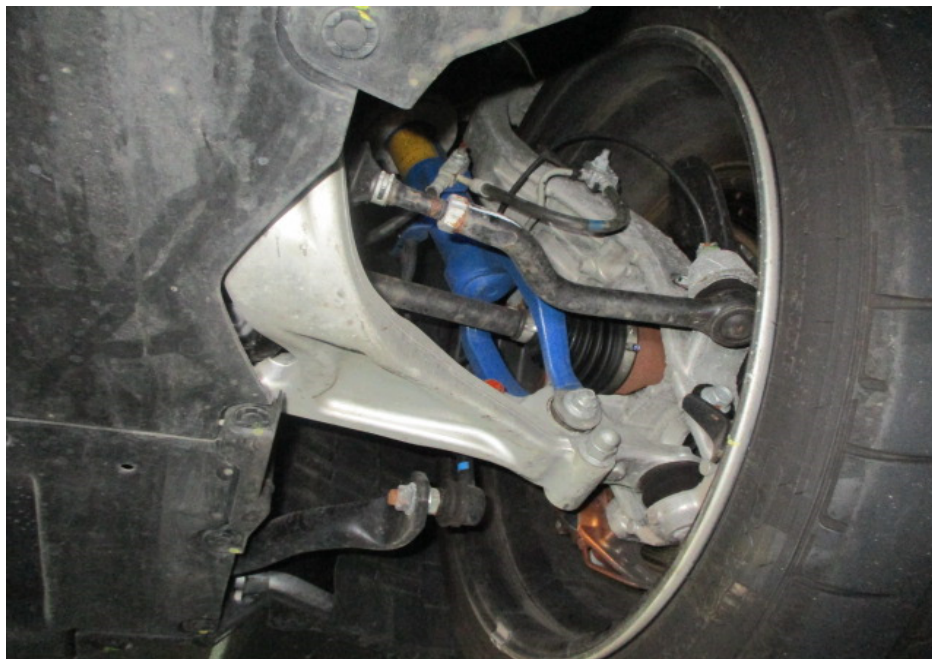
**Photo 17** shows the various undercarriage components at the front right wheel of the Motor Car. The mechanical components, control arms and linkages were all found to be intact and secured in an appropriate manner. I also did not observe any fluid leak and/or fluid stain on the underside of the Motor Car.

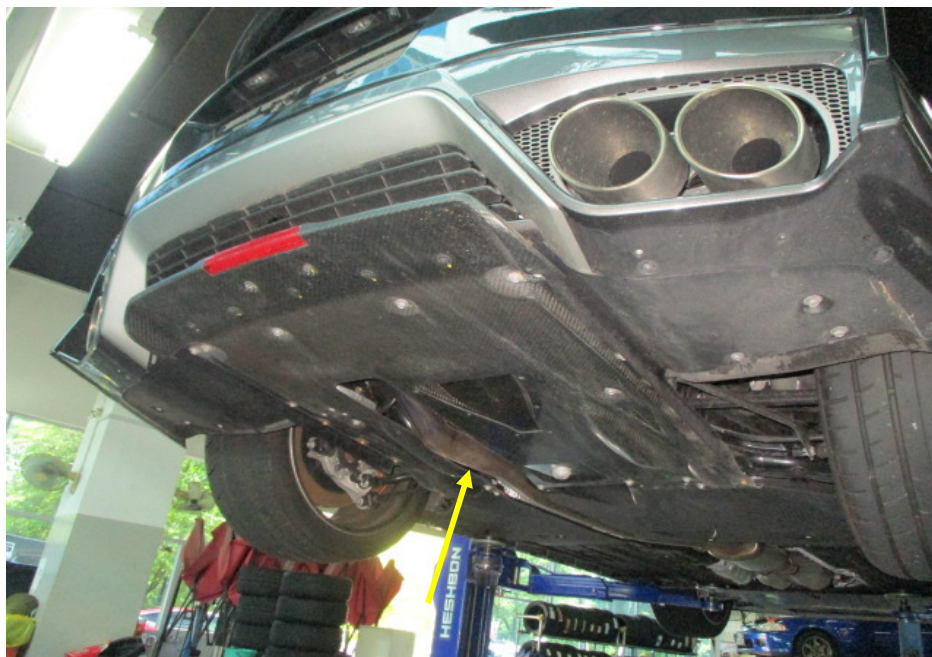
**Photo 18** shows a general view of the rear section of the Motor Car's exhaust system. My examination of the Motor Car's exhaust system revealed no sign(s) or indication(s) of any cut or weld marks along its exhaust pipes (arrowed), on its catalytic converters, centre resonator box and its rear mufflers.

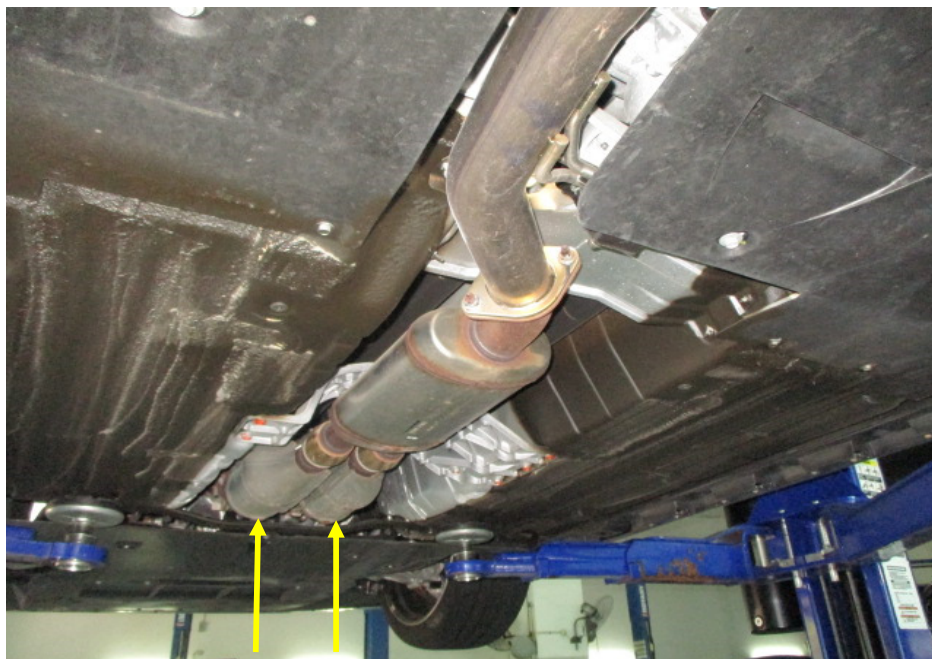
**Photo 19** shows the front section of the Motor Car's exhaust system. My examination of the Motor Car's exhaust system revealed no sign(s) or indication(s) of any cut or weld marks along its exhaust pipes, on its catalytic converters (arrowed), centre resonator box and its rear mufflers.

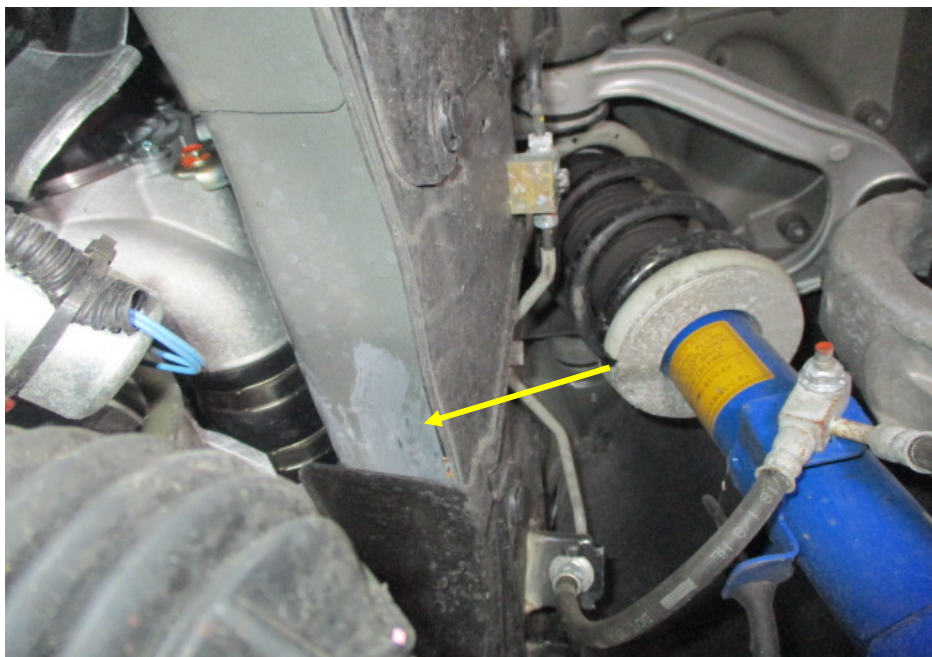
10. Visually, I did not find any weld marks, other than the original spot weld marks, on the chassis/structural body of the Motor Car. The original factory sealant at the joints along the chassis/structural body was also untouched, again indicating that no replacement of the chassis/structural body was carried out; and that the chassis/structural body was originally fitted.

**Photo 20** shows the chassis/structural body at the underside front right of the Motor Car. I did not find any weld marks other than original spot weld marks on the chassis/structural body of the Motor Car. The original factory sealant (arrowed) at the joints along the chassis/structural body was untouched, indicating no work was done on the chassis/structural body of the Motor Car and that the chassis/structural body was originally fitted.

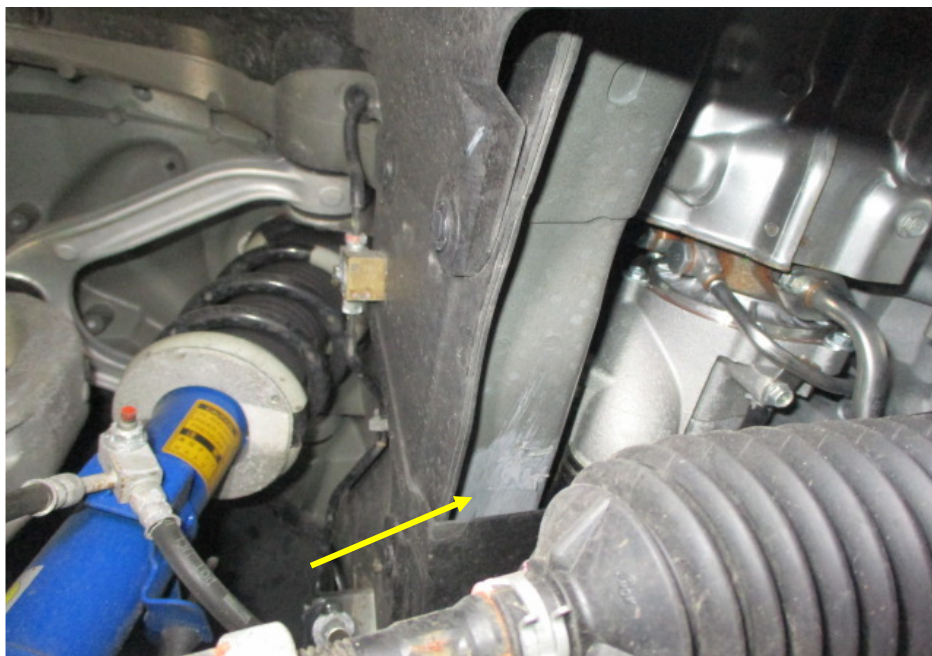
**Photo 21** shows the chassis/structural body at the underside front left of the Motor Car. The original factory sealant (arrowed) at the joints along the chassis/structural body was observed to be untouched. In general, I had found no work was carried out on the chassis/structural body of the Motor Car. The chassis/structural body of the Motor Car was originally fitted.

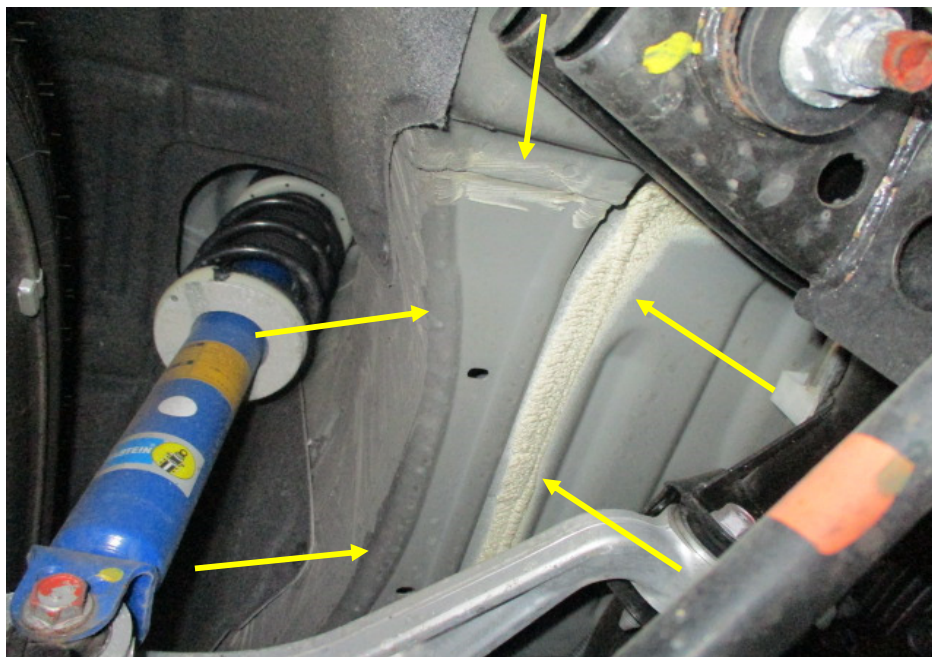
**Photo 22** shows the chassis/structural body at the underside rear left of the Motor Car. The original factory sealant (arrowed) at the joints along the chassis/structural body was observed to be untouched. In general, I had found no work was carried out on the chassis/structural body of the Motor Car. The chassis/structural body of the Motor Car was originally fitted.

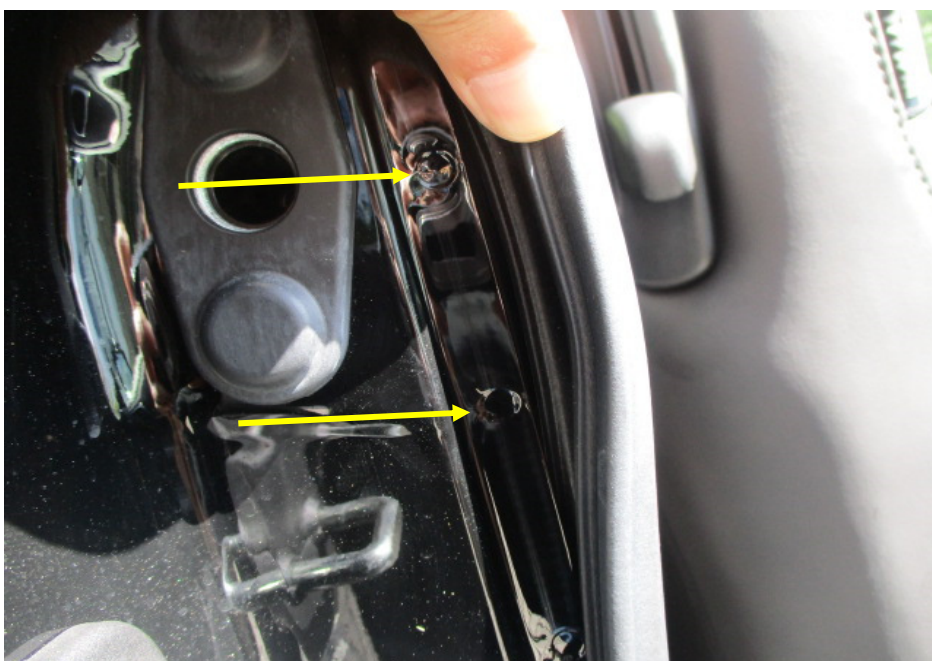
9. Checks on the non-detachable body panels like the rear fenders, floorboard, roof panel, pillars and rocker panels amongst others, revealed that these body panels were spot welded onto the chassis/structural body of the Motor Car. The original factory sealant at the joints of the non-detachable body panels was all untouched indicating no replacement of the non-detachable body panels was carried out; and that these body panels were all originally fitted.

**Photo 23** shows the right side rear body panel of the Motor Car. I did not find any weld marks other than original spot weld marks (arrowed) on the right side rear body panel of the Motor Car which, indicates that there was no re-welding works carried out. In general, I had found all the non-detachable body panels of the Motor Car to be originally fitted at the time of my inspection.

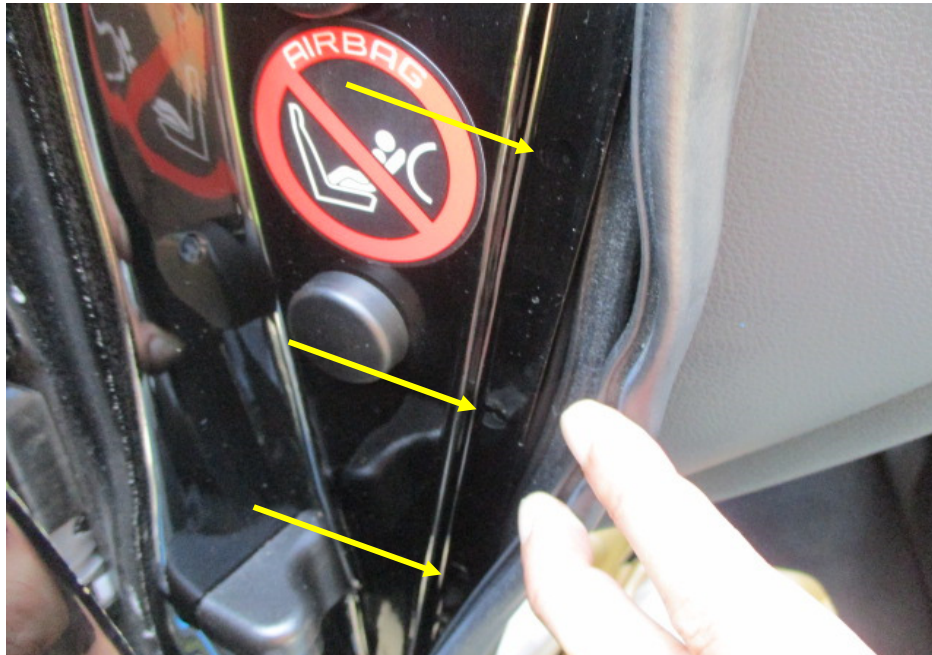
**Photo 24** shows the left side "A" pillar of the Motor Car. I did not find any weld marks other than original spot weld marks (arrowed) on the left side "A" pillar of the Motor Car which, indicates that there was no re-welding works carried out. In general, I had found all the non-detachable body panels of the Motor Car to be originally fitted at the time of my inspection.
