## VEHICLE APPRAISAL REPORT

Name of Workshop : Apex Motoring  
Place of inspection : 25 Kaki Bukit Road 4 #01-55, Synergy @ Kaki Bukit, Singapore 417800  
Date of Assignment : 20 April 2021  
Date of Accident : 18 April 2021  
Date of Inspection : 20 April 2021

| Registration No. | : SMS 4222X | Chassis Frame No. | : ZWR800421090 |
| Make / Model | : Toyota Noah Hybrid 7-Seater 1.8X CVT | Engine No. ( Logcard ) | : 2ZR2F79252 |

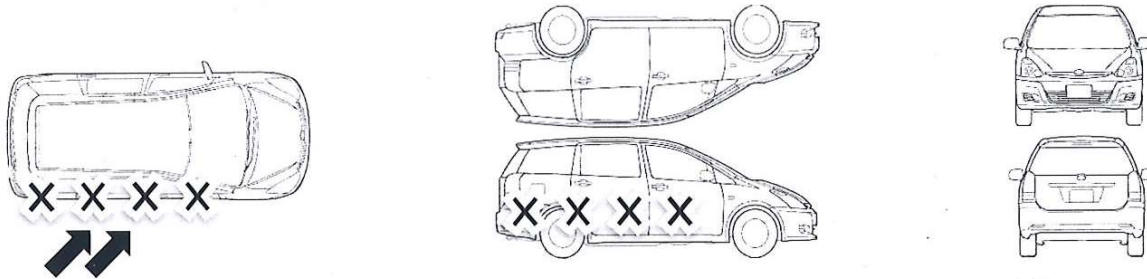
Damages sustained were consistent with the subject vehicle being involved in a collision with another vehicle and the impact was delivered **Diagonally to the RH Side from rear to front; right to left;** portion of the vehicle.

The general area of damages is at the **RH Side portion**  
( Please refer to the parts list and photographs as attached for more information )
