VEHICLE APPRAISAL REPORT

Registration No.	: SMS 4222X	Chassis Frame No.	: ZWR800421090
Make / Model	: Toyota Noah Hybrid 7-Seater 1.8X CVT	Engine No. (Logcard)	: 2ZR2F79252
Year of Manufacture/Reg	: 2019	Odometer Reading	: 83,551 KM
Colour	: Black		
Class / Type	: MPV

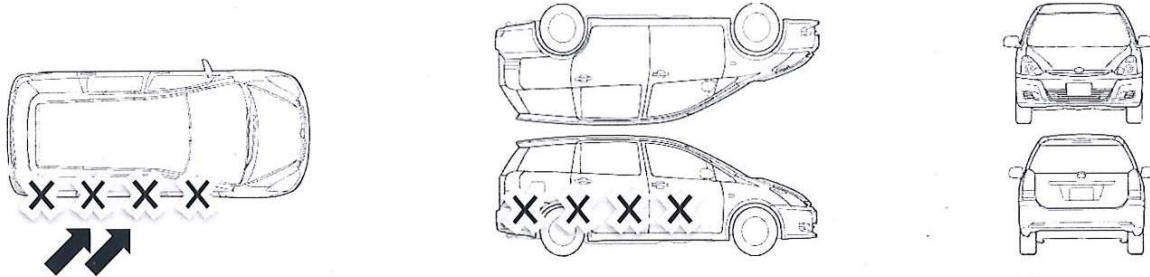
Damages sustained were consistent with the subject vehicle being involved in a collision with another vehicle and the impact was delivered **Diagonally to the RH Side from rear to front; right to left;** portion of the vehicle.

The general area of damages is at the **RH Side portion**
(Please refer to the parts list and photographs as attached for more information)
