VEHICLE DAMAGE ASSESSMENT REPORT

Ref No	: 2021/4004	Date of Report	: 23/3/2021
Claim Type	: Third Party	Date of Request	: 13/4/2021
Third party vehicle	: GBJ2585P	Date of Accident	: 22/3/2021
Insured Vehicle	:	Date of Inspection	: 13/4/2021
Your Reference No	:

Registration Plate No	: GBJ2585P	Engine Modification	: NIL
Model / Make	: Toyota Dyna	Pre-accident damage	: NIL
Colour	: Blue	General Condition	: Good
Manufacturing Year	: 2018	General Paint Work	: Good
Engine No	: 1KD2833244	Steering	: Serviceable
Engine Capacity	: 3000cc	Handbrake	: Serviceable
Chassis No	: JTFAT35Y30K211975	Footbrake	: Serviceable
Odometer No	: 17595		
Transmission	: Manual

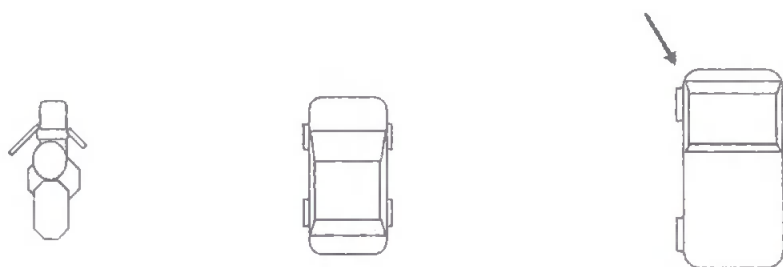
At the time of inspection, this vehicle sustained damages to the **Front Lh Portion**.

Front bumper, front grille, lh corner panel holder torn. Front lh door dented, lh headlamp grazed etc.
