You're Ref: TP/IP/25917/2021
Our Ref: CI/TPD21006321/P

24th June 2021

MECHANICAL INSPECTION REPORT OF MOTOR CAR SJT 6426S

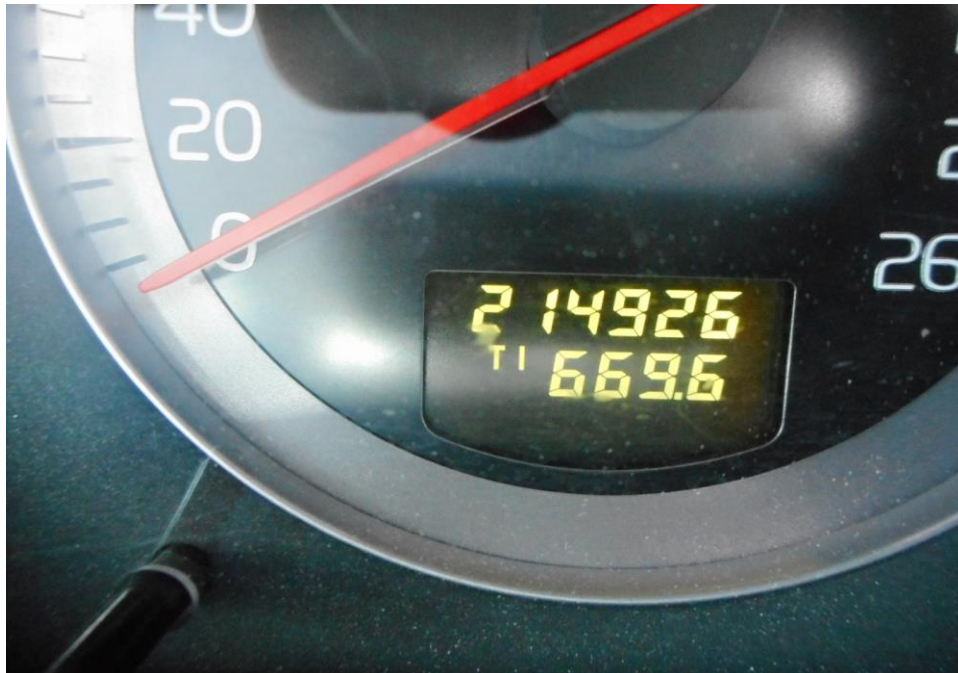
4. The mileage of the Motor Car at the time of my inspection was 214,926km.
5. The Motor Car was observed to have sustained damage at its front and rear portion. Its front bumper, front number plate and rear bumper was the body parts that were damaged as a result of the accident.

Photo 1 shows the mileage of the Motor Car at the time of my inspection. The mileage observed was 214,926km.

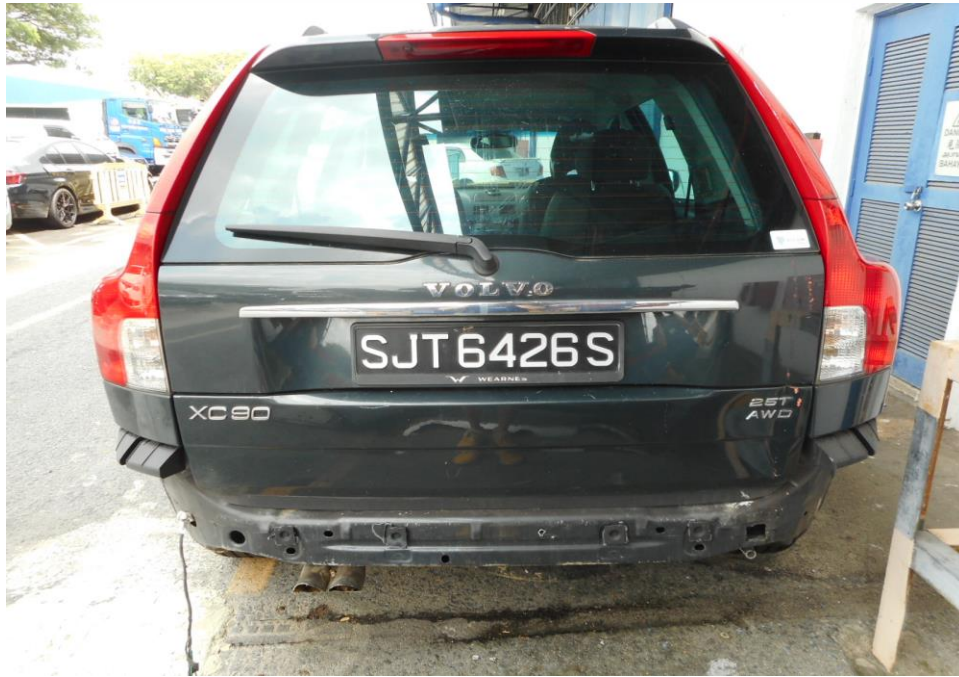
Photo 2 shows the general view of the Motor Car's rear body at the time of my inspection. The rear portion of the Motor Car was observed to have sustained damage. Its rear bumper was the body parts that were damaged as a result of the accident.

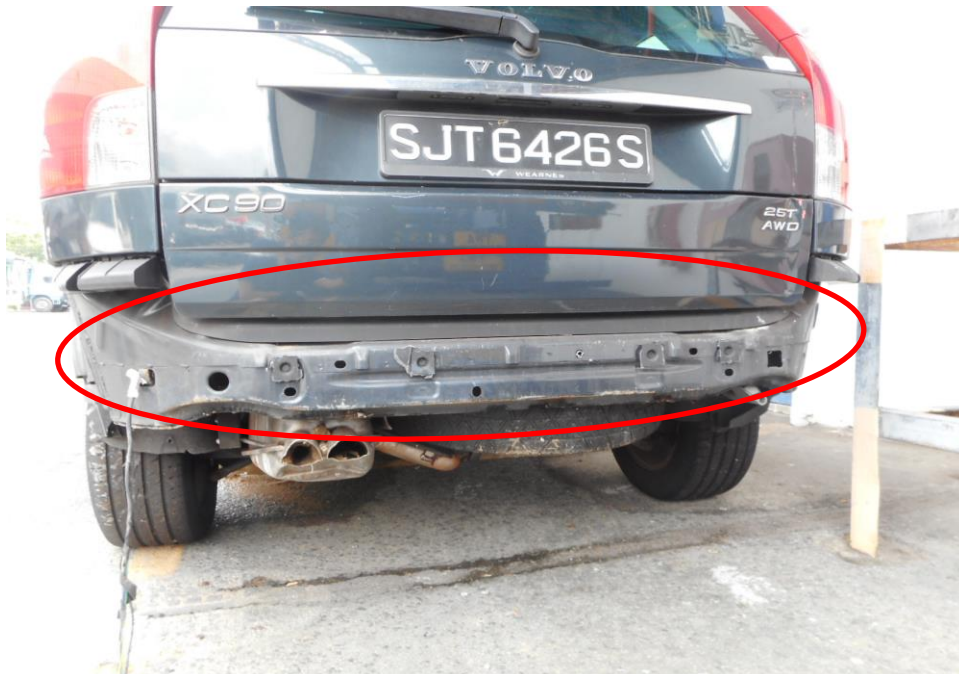
Photo 3 shows the close up view of the Motor Car's rear body at the time of my inspection. The rear portion of the Motor Car was observed to have sustained damage. Its rear bumper (circled) was the body parts that were damaged as a result of the accident.

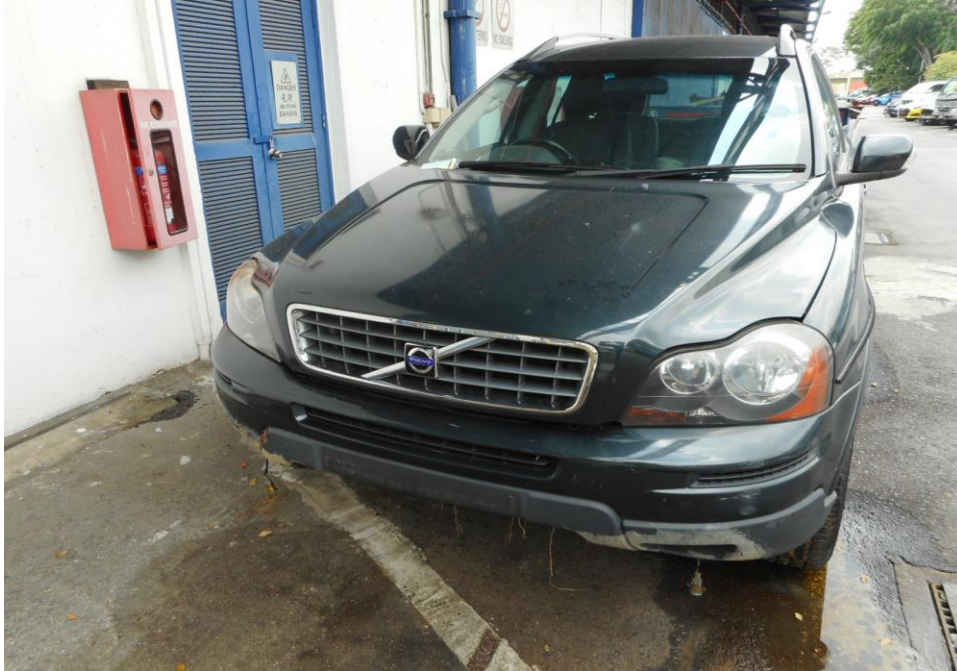
Photo 4 shows a general view of the Motor Car's front body at the time of my inspection. The front portion of the Motor Car was observed to have sustained damage. Its front bumper and number plate was the body parts that were damaged as a result of the accident.

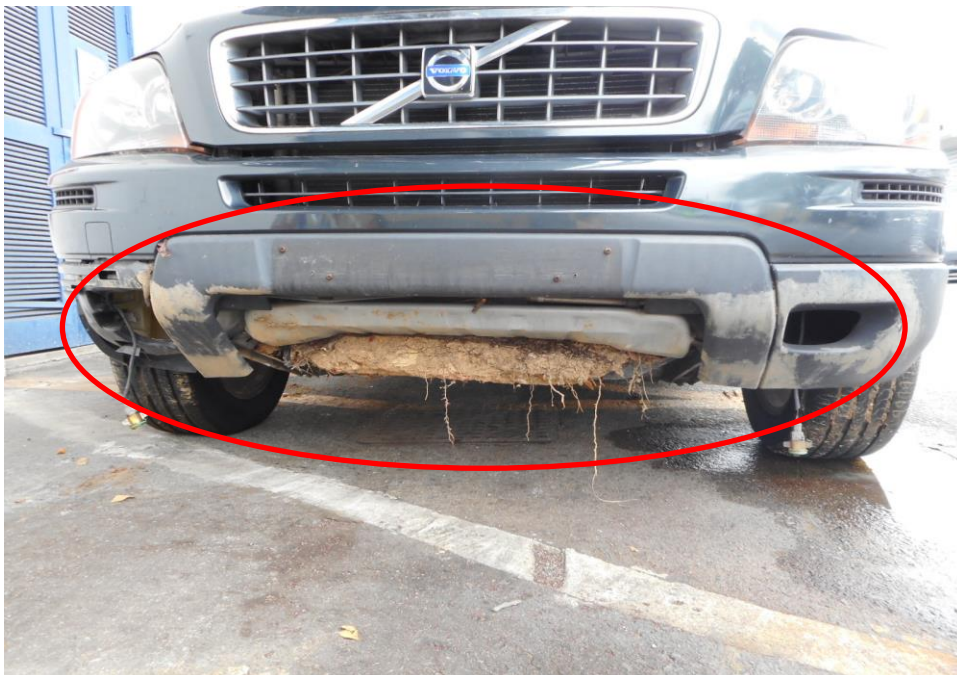
Photo 5 shows the close up view of the Motor Car's front body at the time of my inspection. The front portion of the Motor Car was observed to have sustained damage. Its front bumper and number plate (circled) was the body parts that were damaged as a result of the accident.

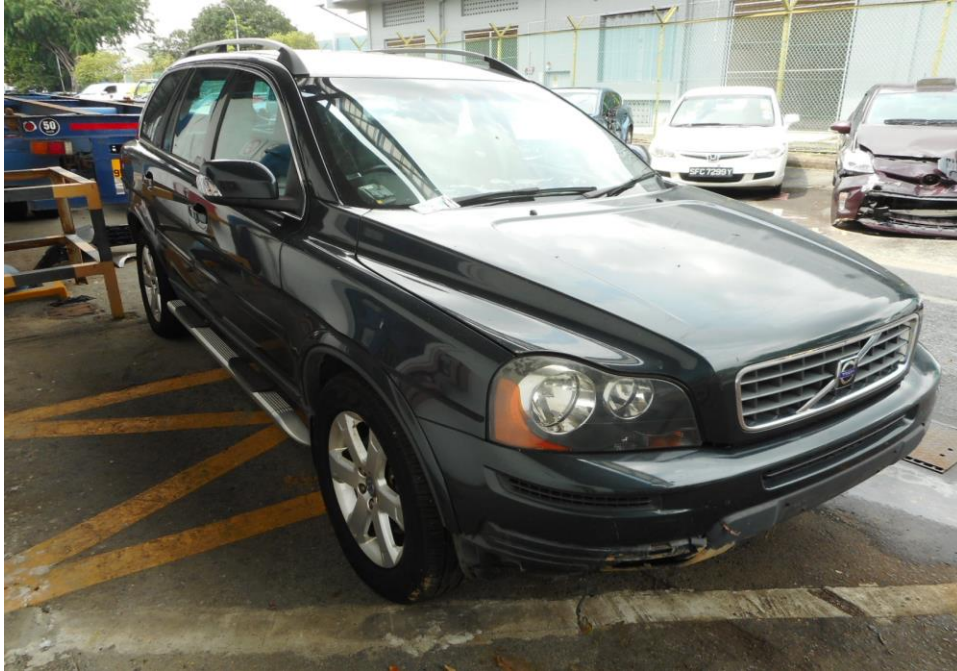
Photo 6 shows a general view of the Motor Car's right body at the time of my inspection. The right portion of the Motor Car was observed to have been unaffected by the accident.

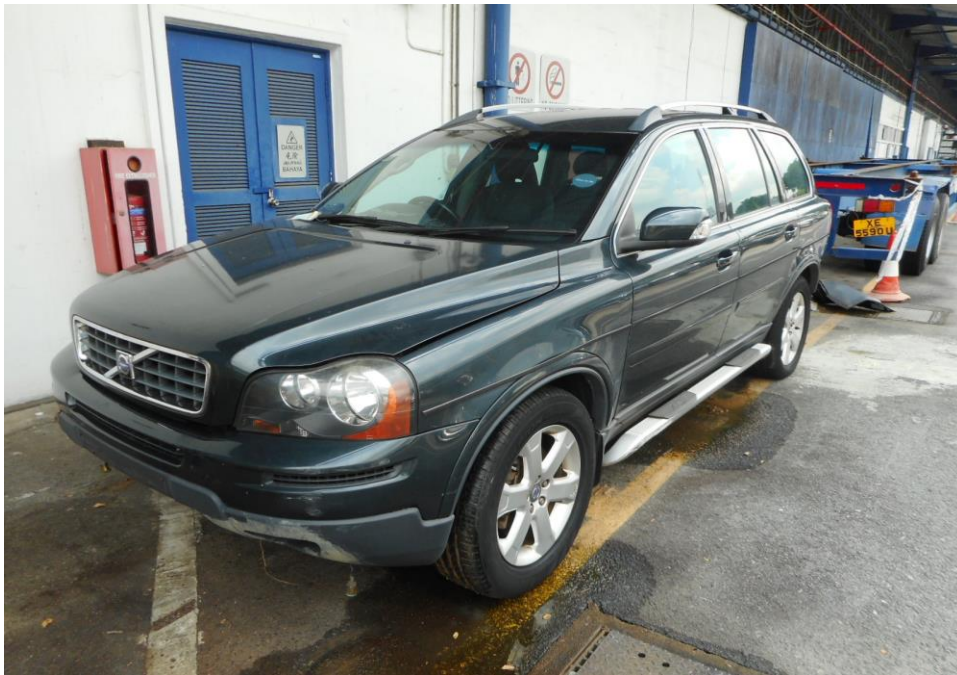
Photo 7 shows a general view of the Motor Car's left body at the time of my inspection. The left portion of the Motor Car was observed to have been unaffected by the accident.

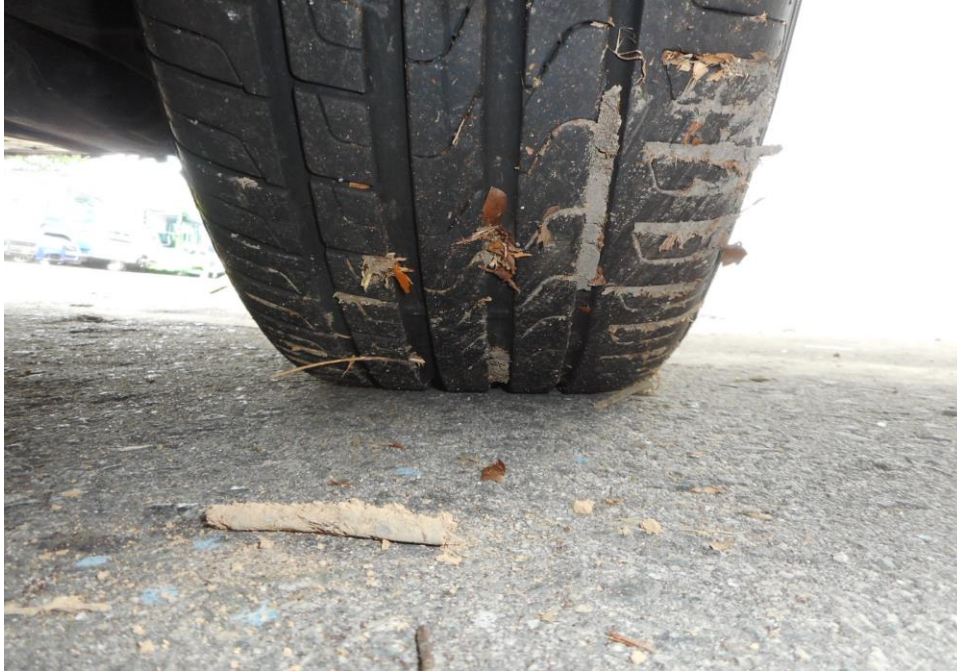
Photo 8 shows the condition of the front right tyre of the Motor Car, which was observed to be in serviceable condition with remaining tread depth of approximately 6.2mm. The tyre was sufficiently inflated for vehicular operation with no tear, cut or burst mark(s) on the outer and the inner sidewalls as well as across the tread. The 4 tyres of the Motor Car were wrapped around standard steel wheel rims without any damage.

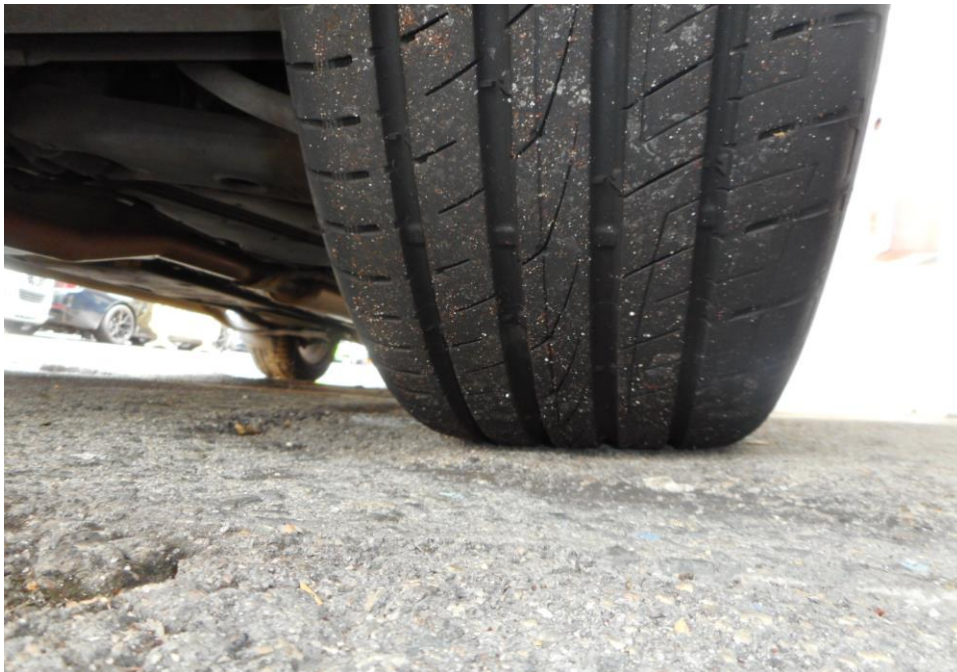
Photo 9 shows the condition of the rear right tyre of the Motor Car, which was observed to be in serviceable condition with remaining tread depth of approximately 6.3mm. The tyre was also observed to be sufficiently inflated for vehicular operation with no tear, cut or burst mark(s).

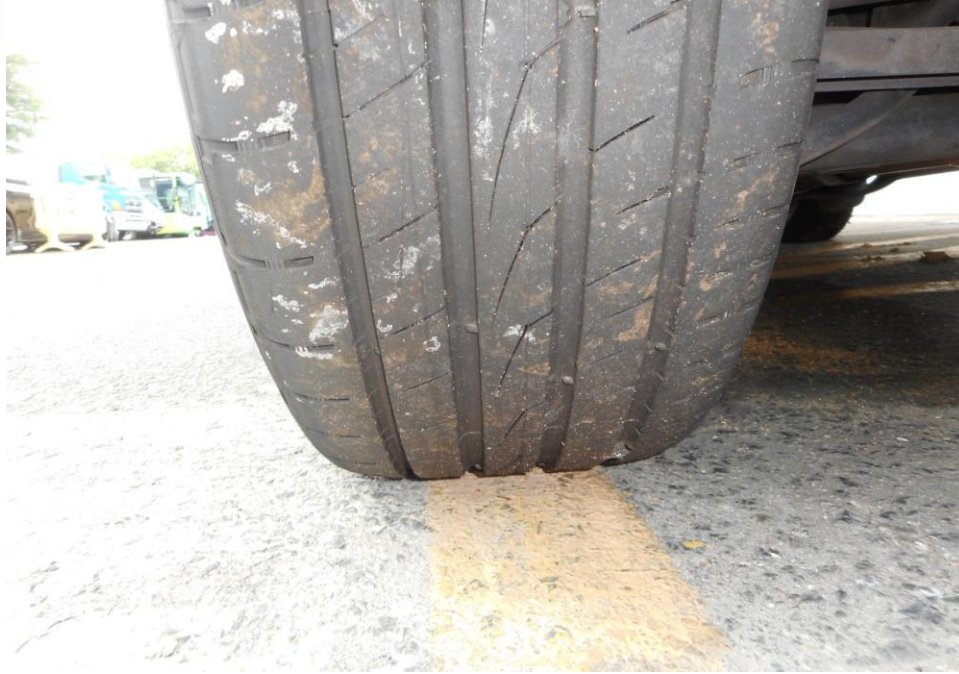
Photo 10 shows the condition of the rear left tyre of the Motor Car, which was observed to be in serviceable condition with remaining tread depth of approximately 5.8mm. The tyre, which was wrapped around steel wheel rim, was also observed to be sufficiently inflated for vehicular operation. The 4 tyres of the Motor Car were wrapped around standard steel wheel rims.

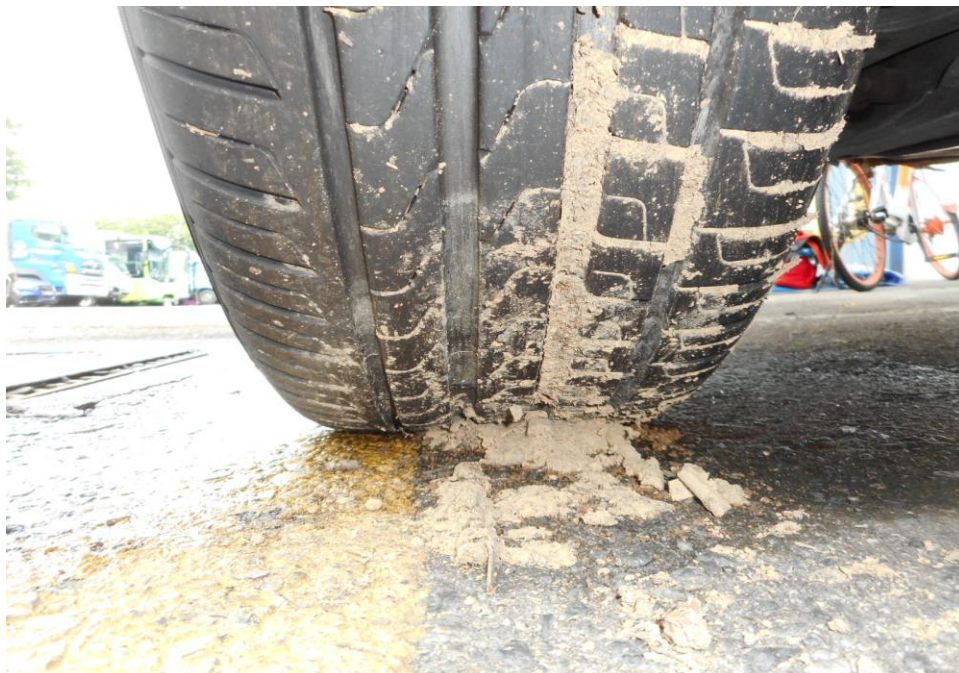
Photo 11 shows the condition of the front left tyre of the Motor Car, which was observed to be in serviceable condition with remaining tread depth of approximately 5.5mm. There was also no tear, cut or burst mark(s) on the outer and the inner sidewalls as well as across the tread of the Motor Car's 4 tyres.

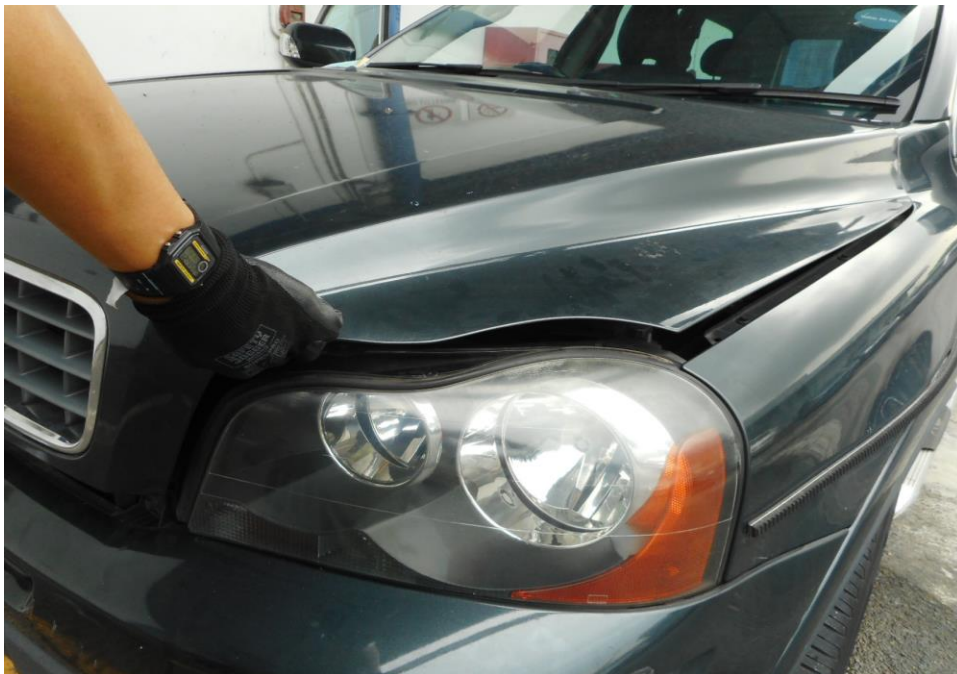
8. We were unable to raise the front bonnet of the Motor car to conduct the examination of the Motor Car's engine compartment because the accident to the Motor Car had likely damaged the lock and level mechanism of the engine compartment bonnet. (unable to open).
9. My subsequent checks on the underside of the Motor Car also revealed no sign(s) or indication(s) of fluid leak and/or fluid stain(s). Visually, the various undercarriage components of the Motor Car were all observed to be intact and without any visible damage. See photo 12 -14 below.

Photo 12 shows a general view of the front bonnet and the attempt to open the front bonnet of the Motor Car. However, the lock and level mechanism of the front bonnet was likely damaged by the accident resulting it unable to open. (Unable to open)

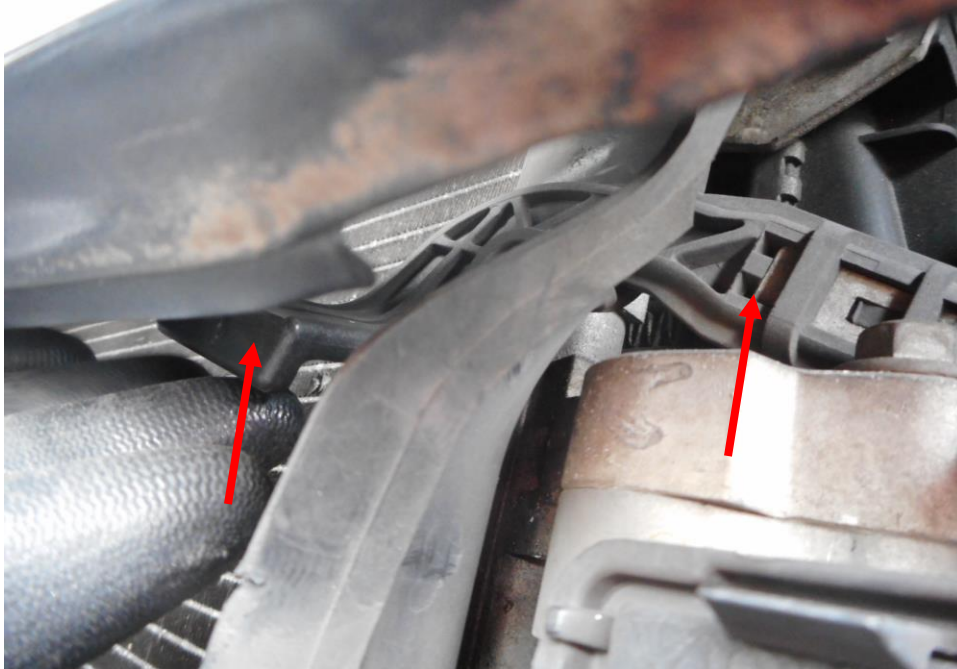
Photo 13 shows a close up view of the front bonnet and the attempt to open the front bonnet of the Motor Car. However, the lock and level mechanism (arrowed) of the front bonnet was likely damaged by the accident resulting it unable to open. (Unable to open)

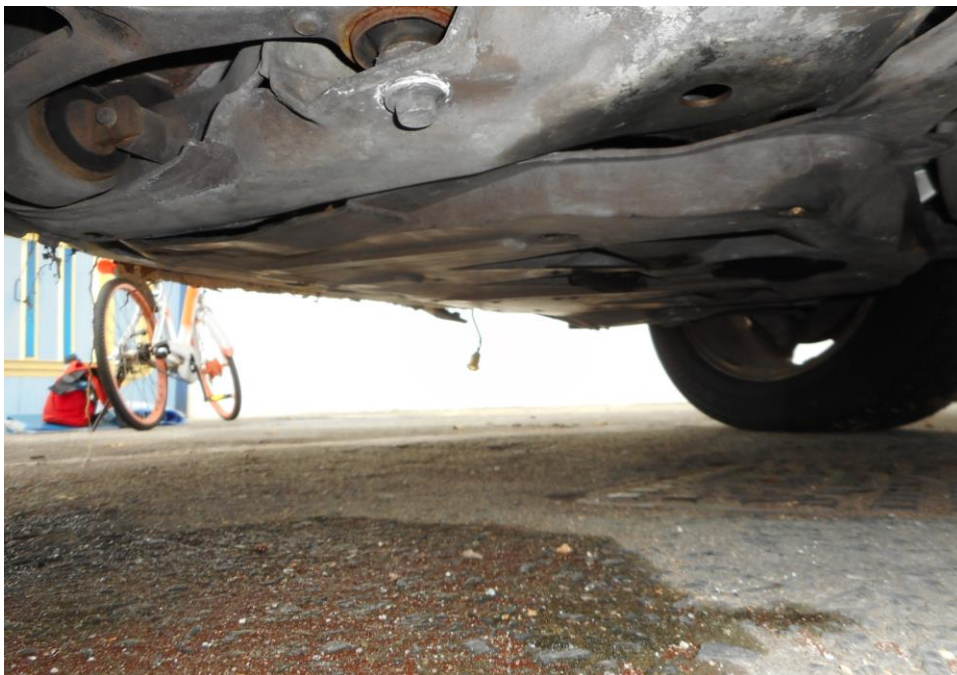
Photo 14 shows the undercarriage of the Motor Car, at the area where the engine housing and transmission housing are located. I did not find any sign(s) or indication(s) of fluid leak and/or fluid stain(s) on the underside of the Motor Car.

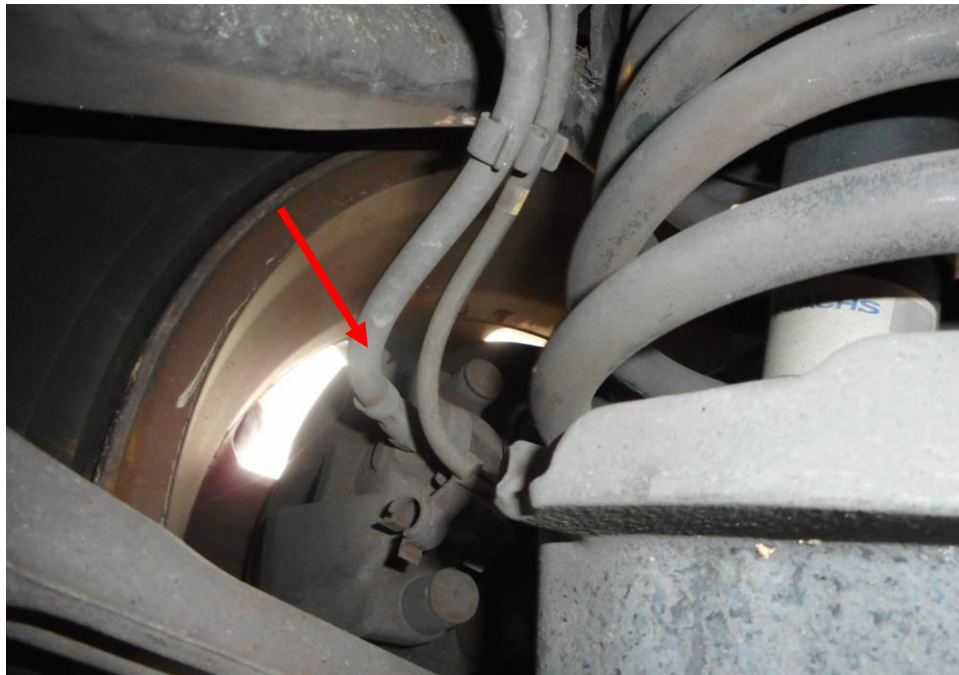
10. Static brake tests conducted on the Motor Car revealed no abnormality. The brake booster had responded well to the various tests conducted. There was also no abnormal movement of the brake pedal when it was depressed. In general, the static brake tests had suggested that there was no internal leakage of pressure/vacuum in the braking system of the Motor Car. The braking system of the Motor Car was likely to be in serviceable condition at the material time. This was taking into consideration that the brake fluid was of sufficient level, and also that there was no sign(s) of brake fluid leakage along the brake hoses and brake pipes.

Photo 15 shows the brake hose/pipe (arrowed) at the rear right wheel of the Motor Car. No leakage of brake fluid was observed. Visual examination of the various components of the braking system like the drum brake, brake booster, brake pedal etc. had revealed all to be intact and without visible damage.

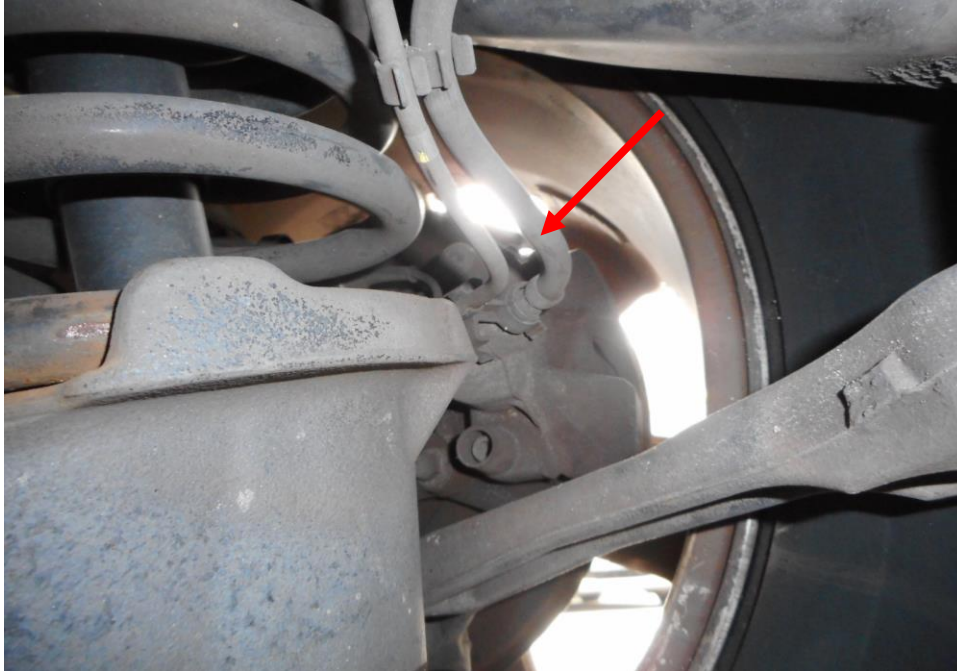
Photo 16 shows the brake hose/pipe (arrowed) at the rear left wheel of the Motor Car. I did not observe any leakage of brake fluid at the time of my inspection of the Motor Car. Static tests of the Motor Car's braking system had indicated that there was no internal leakage of pressure/vacuum. The undercarriage components of the Motor Car were also all found to be intact and without any visible damage.

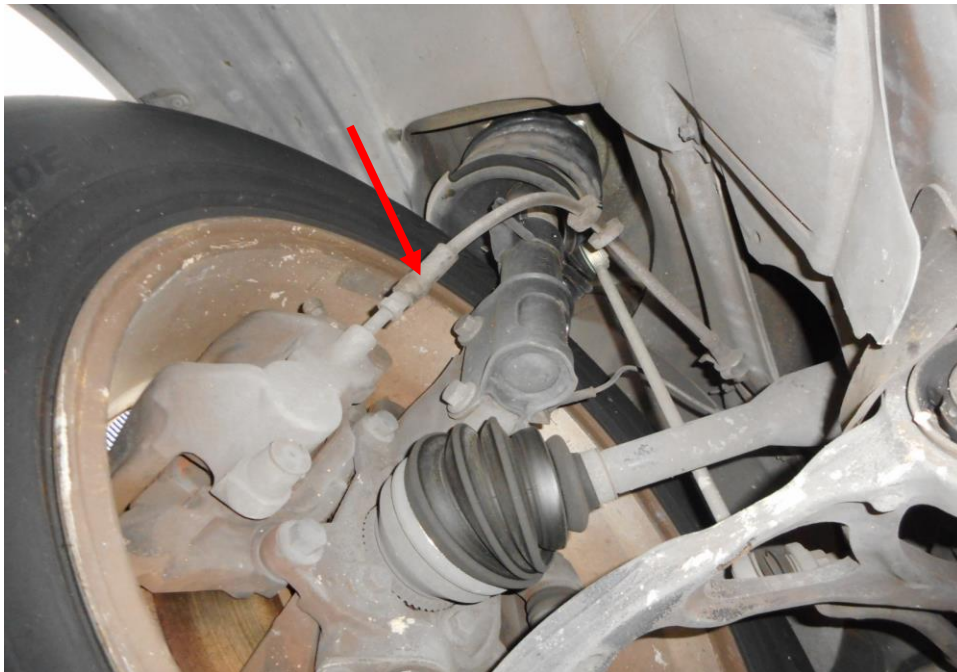
Photo 17 shows the brake hose/pipe (arrowed) at the front right wheel of the Motor Car. I did not observe any leakage of brake fluid at the time of my inspection of the Motor Car. Static tests of the Motor Car's braking system had indicated that there was no internal leakage of pressure/vacuum. The undercarriage components of the Motor Car were also all found to be intact and without any visible damage.

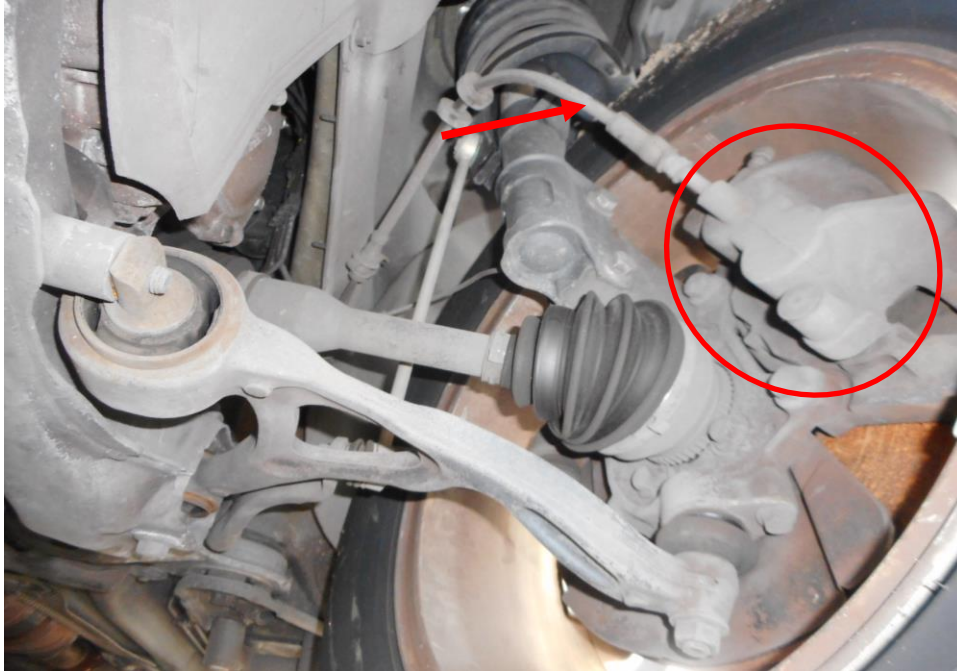
Photo 18 shows the brake hose/pipe (arrowed) at the front left wheel of the Motor Car. No leakage of brake fluid was observed. Visual examination of the various components of the braking system like the brake caliper (circled), brake booster, brake pedal etc had revealed all to be intact and without visible damage.

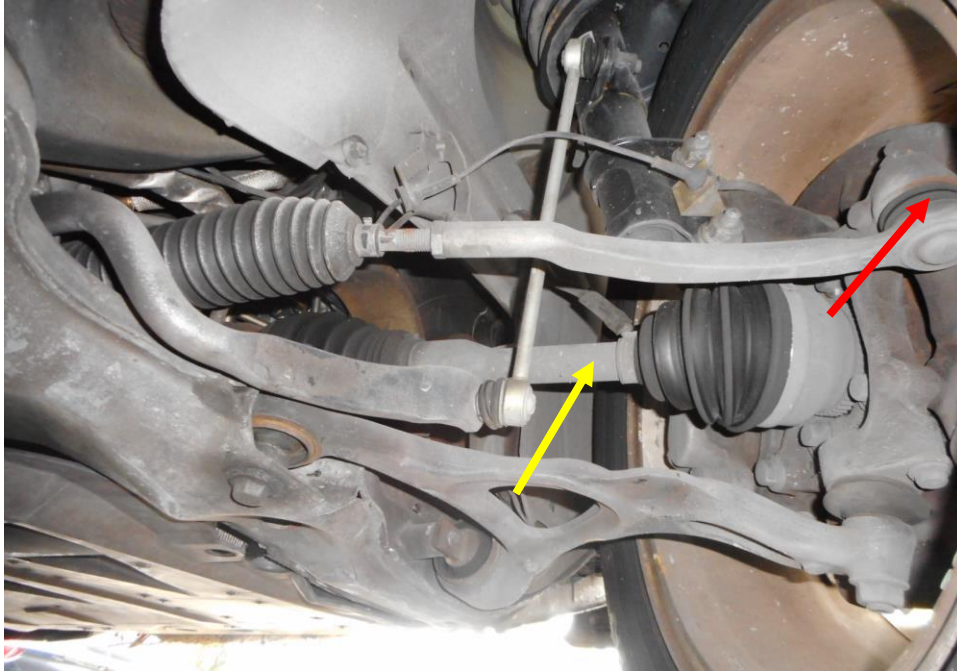
Photo 20 shows the various undercarriage components at the front right wheel of the Motor Car, in particular the steering tie rod (red arrow) and drive shaft (yellow arrow). The various steering components were all found to be intact, suggesting that the steering system of the Motor Car was likely to be in serviceable condition at the material time of accident. There was also no sign of fluid stain observed on the various undercarriage components at the front right wheel of the Motor Car.

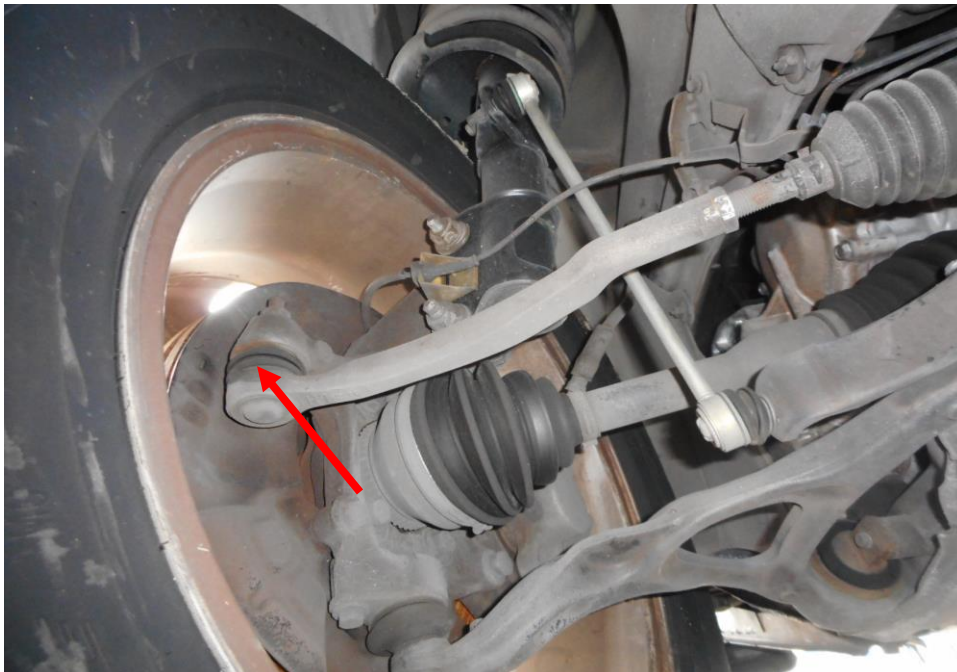
Photo 21 shows the various undercarriage components at the front left wheel of the Motor Car, which had included the steering tie rod (red arrow). The various undercarriage components of the Motor Car were all found to be intact without any visible damage.

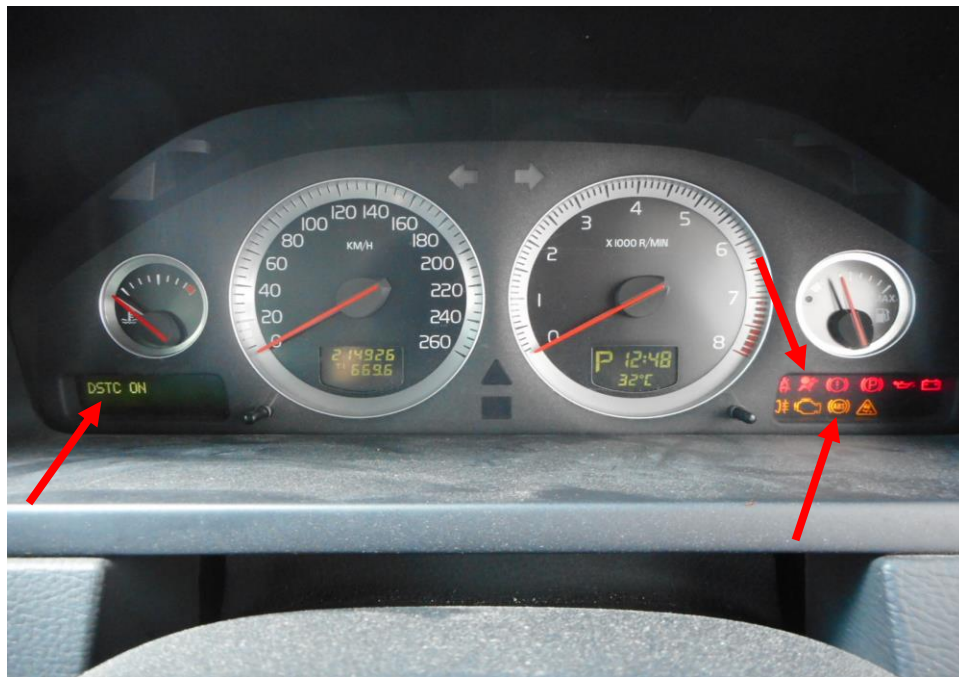
12. The Motor Car's automatic self-test of the functionality of its electronic operating systems like the Anti-Lock Brake System (ABS) Supplemental Restraint System (SRS) and Traction Control (TC) during cranking of the engine had indicated that the system were in working condition and without abnormality. This can be established from the warning lights disappearing from the instrument panel after the self-test. See photo 22 & 23 below.

Photo 22 shows the warning light for Anti-Lock Brake System (ABS), Supplemental Restraint System (SRS) and Traction Control (TC) (arrowed) appearing on the instrument panel of the Motor Car during the self-test of its various electronic operating systems when its engine was cranked.

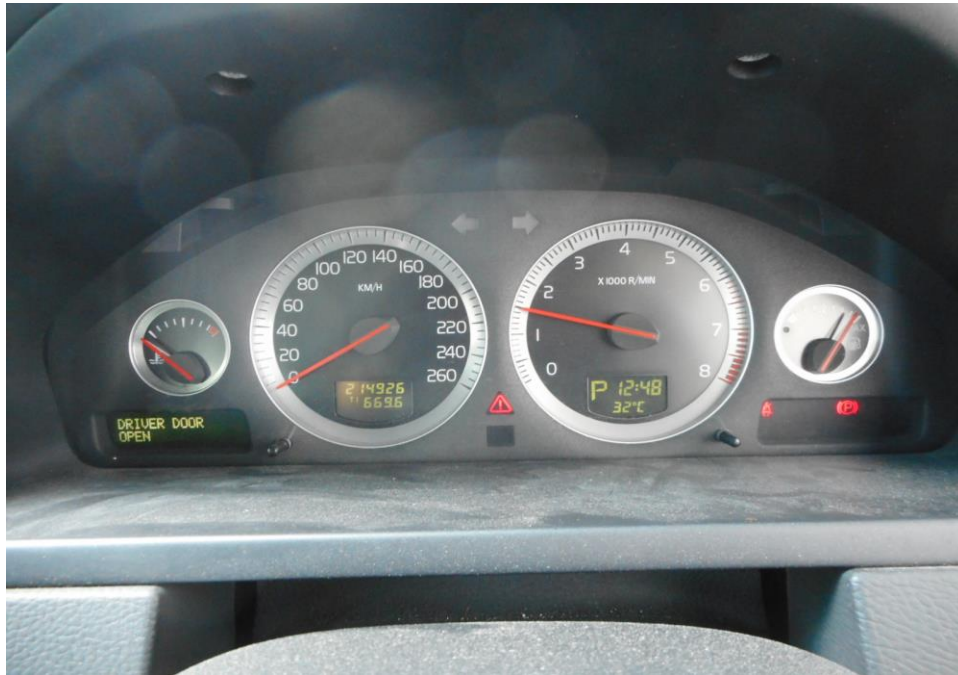
Photo 23 shows no warning lights illuminated on the instrument panel of the Motor Car after the engine was cranked. This would suggest that there was no abnormality to the electronic operating system of the Motor Car, like the ABS, SRS and TC etc.
