**Fatal Accident Investigation Team**

**MECHANICAL INSPECTION REPORT OF MOTOR CAR SKD 2076S**

1. I refer to your request on 1<sup>st</sup> June 2021 to conduct a physical inspection of a Motor Car bearing registration number SKD 2076S (herein referred to as "**Motor Car**"), which was involved in a road traffic accident on 13<sup>th</sup> May 2021.
2. The objective of the inspection is to determine if there was any possible mechanical failure to the Motor Car that may have contributed to the accident.
3. Following the request, I had carried out a physical inspection of the Motor Car on 1<sup>st</sup> June 2021 at the premises of Traffic Police vehicle pound, 517 Airport Road Singapore 539942. I now set out below my observations and comments with respect to this inspection.

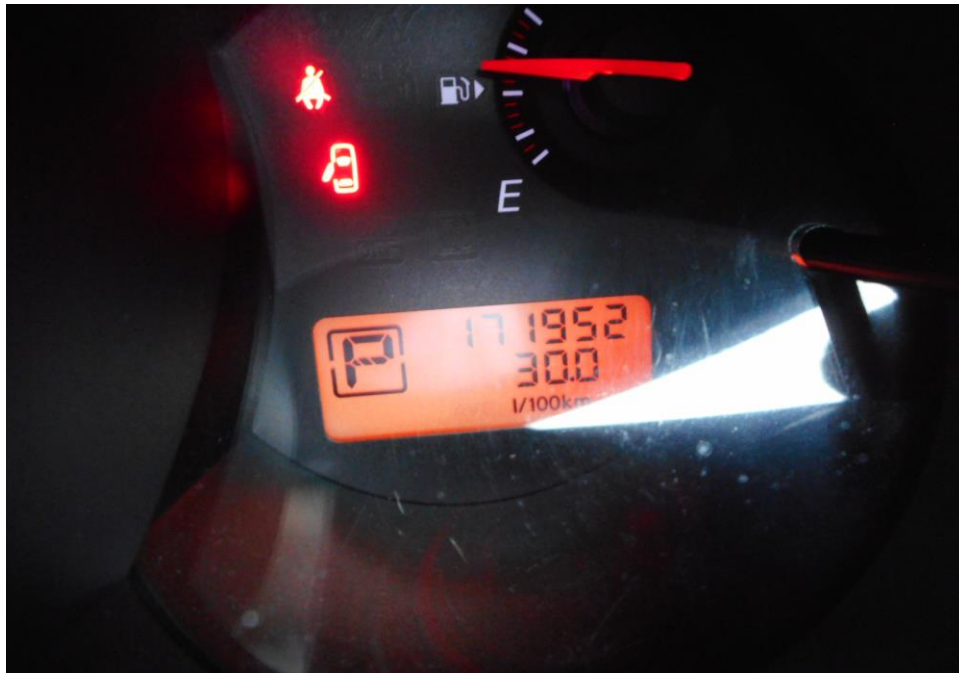
**Photo 1** shows the mileage of the Motor Car at the time of my inspection. The mileage observed was 171,952km.

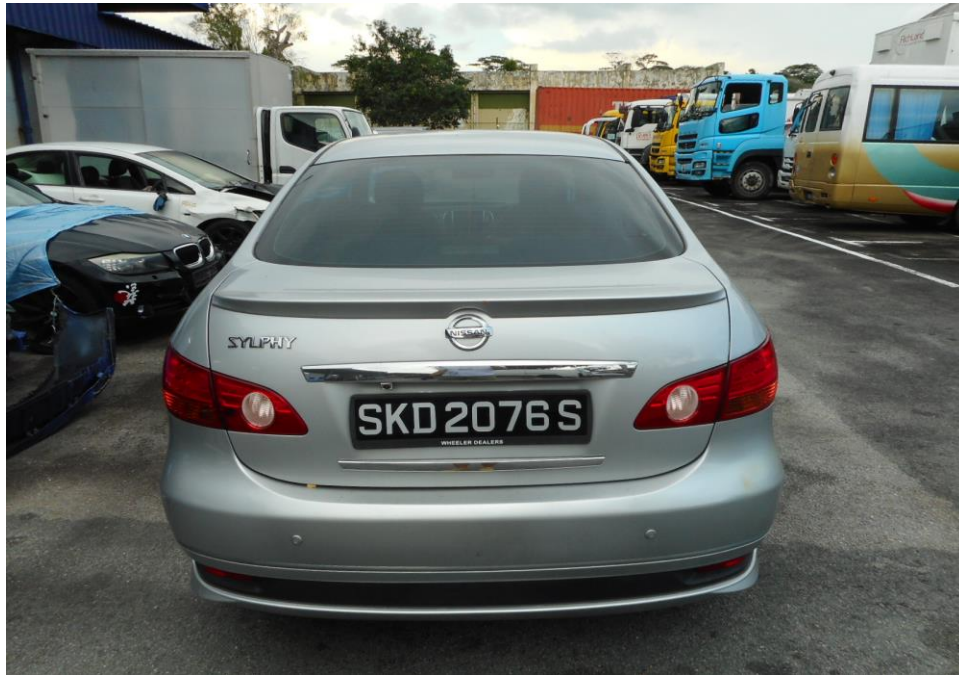
**Photo 2** shows the general view of the Motor Car's rear body at the time of my inspection. The Motor Car rear was observed to be unaffected by the accident.

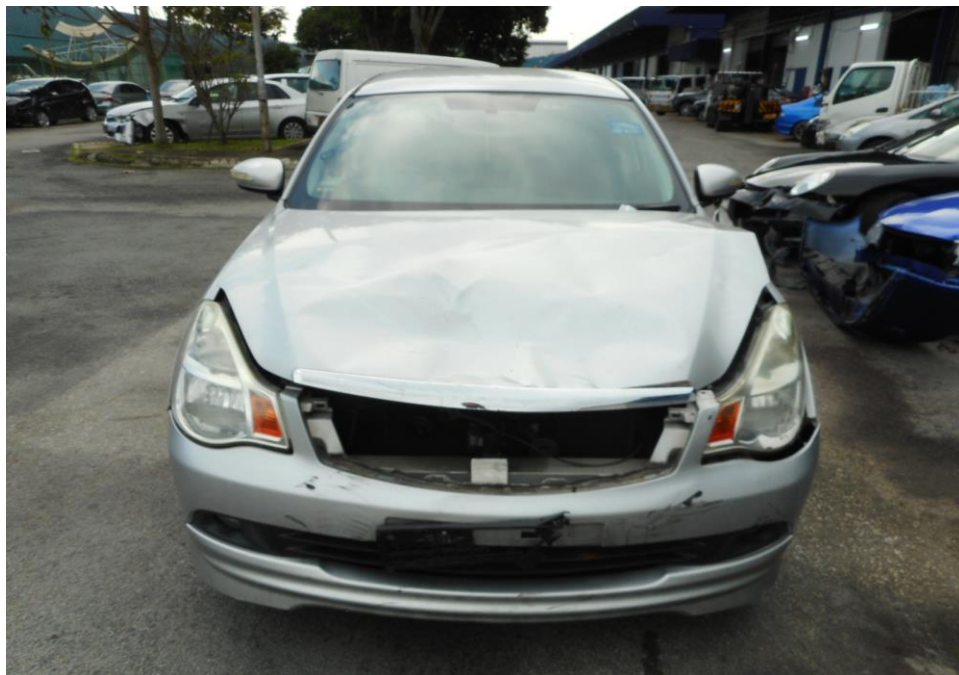
4. The mileage of the Motor Car at the time of my inspection was 171,952km.
5. The Motor Car was observed to have sustained damage at its front portion. Its front bonnet, front grille and front bumper was the body parts that were damaged as a result of the accident.

**Photo 3** shows a general view of the Motor Car's front body at the time of my inspection. The front portion of the Motor Car was observed to have sustained damage. Its front bonnet, front grille and front bumper was the body parts that were damaged as a result of the accident.

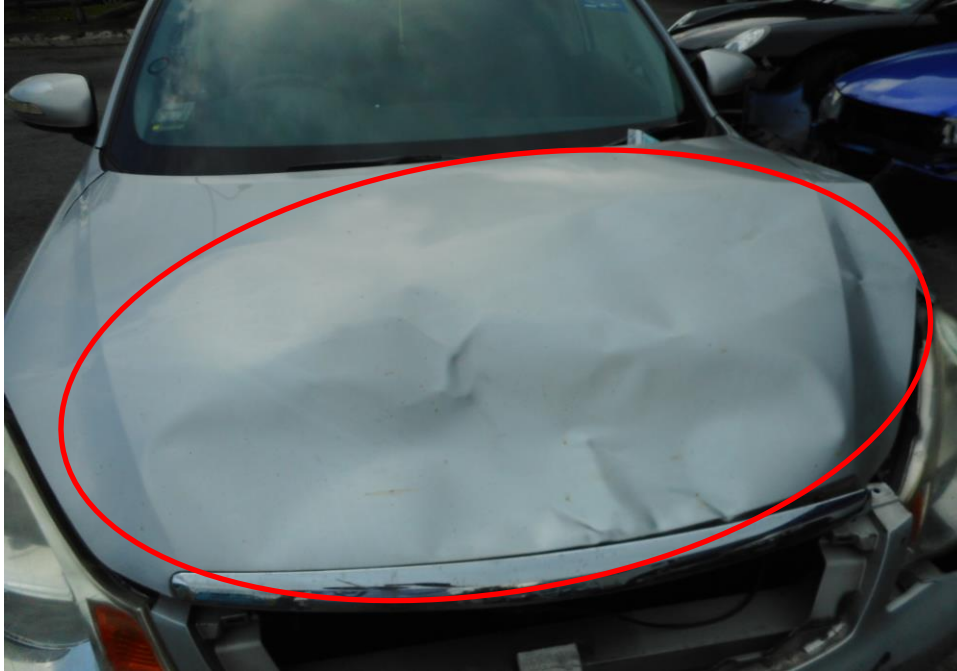
**Photo 4** shows the close up view of the Motor Car's front body at the time of my inspection. The Motor Car was observed to have sustained damage at its front bonnet (circled) as a result of the accident.

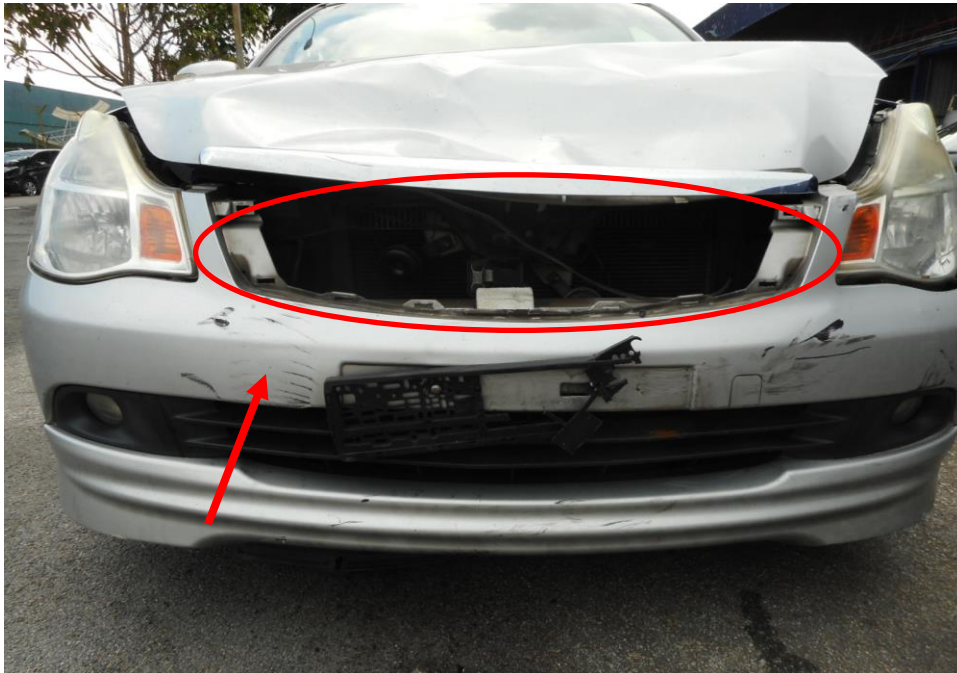
**Photo 5** shows the close up view of the Motor Car's front body at the time of my inspection. The Motor Car was observed to have sustained damage at its front grille (circled) and front bumper (arrowed) as a result of the accident.

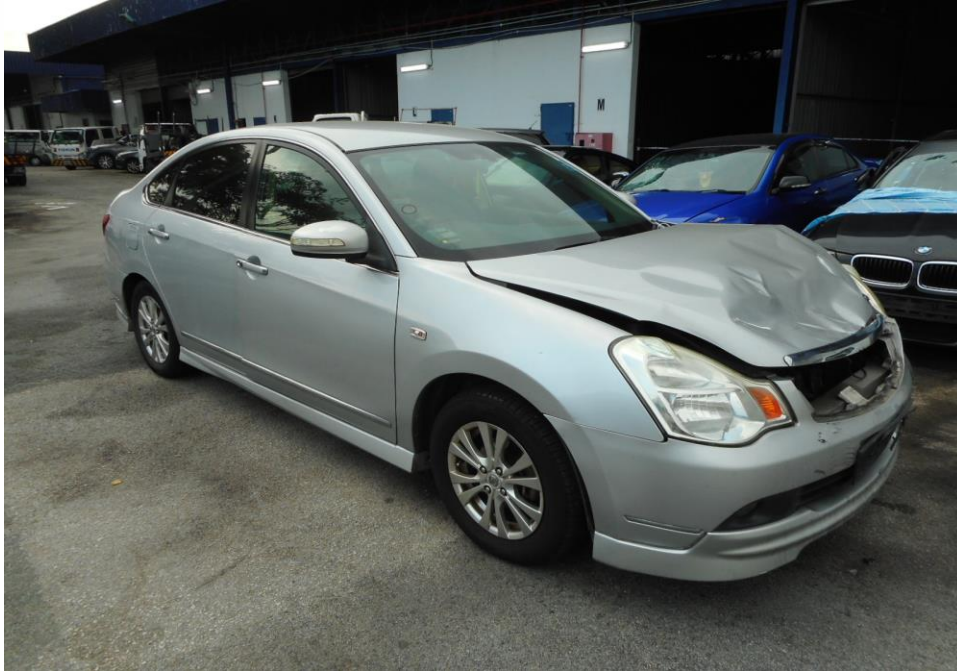
**Photo 6** shows a general view of the Motor Car's right body at the time of my inspection. The right portion of the Motor Car was observed to have been unaffected by the accident.

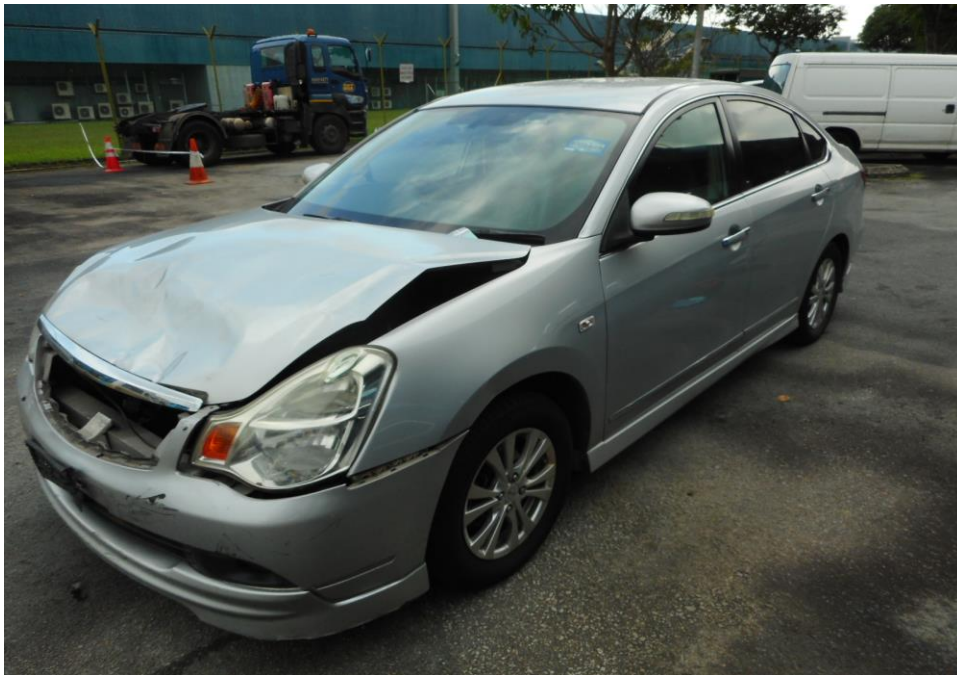
**Photo 7** shows a general view of the Motor Car's left body at the time of my inspection. The left portion of the Motor Car was observed to have been unaffected by the accident.

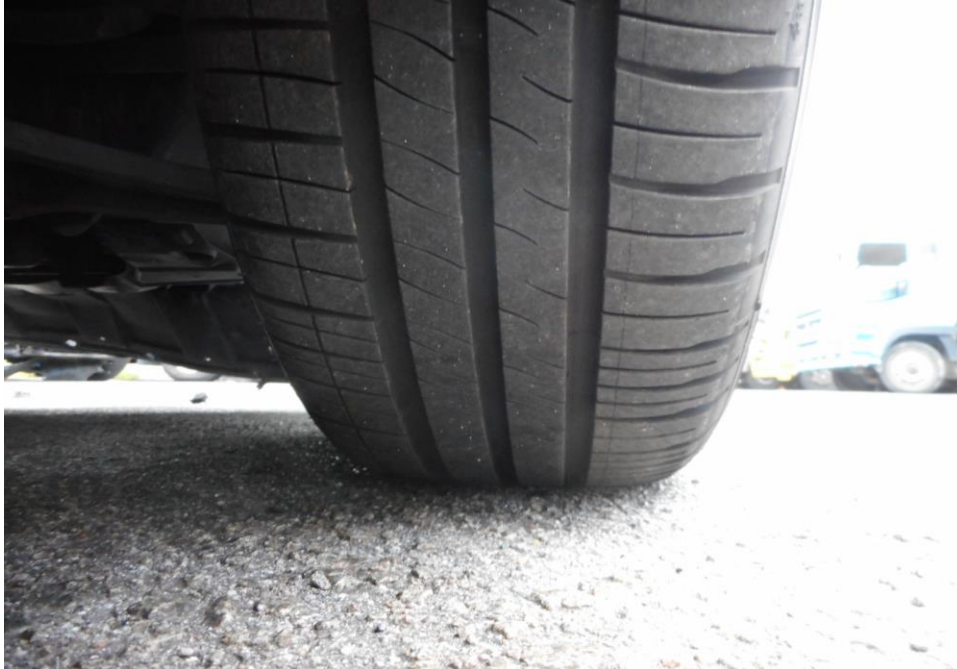
**Photo 8** shows the condition of the front right tyre of the Motor Car, which was observed to be in serviceable condition with remaining tread depth of approximately 5.6mm. The tyre was sufficiently inflated for vehicular operation with no tear, cut or burst mark(s) on the outer and the inner sidewalls as well as across the tread. The 4 tyres of the Motor Car were wrapped around standard steel wheel rims without any damage.

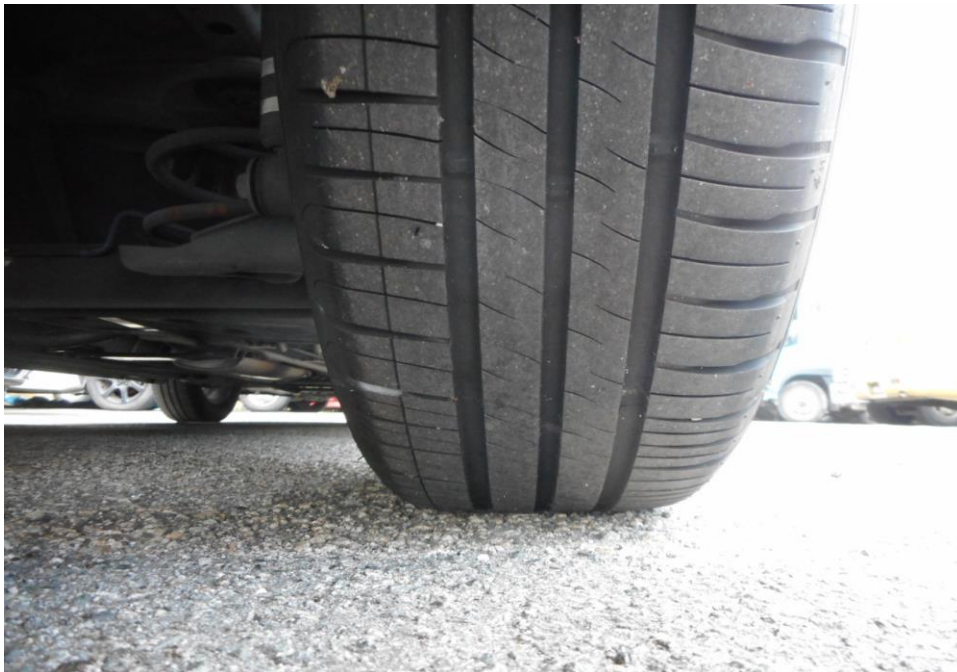
**Photo 9** shows the condition of the rear right tyre of the Motor Car, which was observed to be in serviceable condition with remaining tread depth of approximately 4.9mm. The tyre was also observed to be sufficiently inflated for vehicular operation with no tear, cut or burst mark(s).

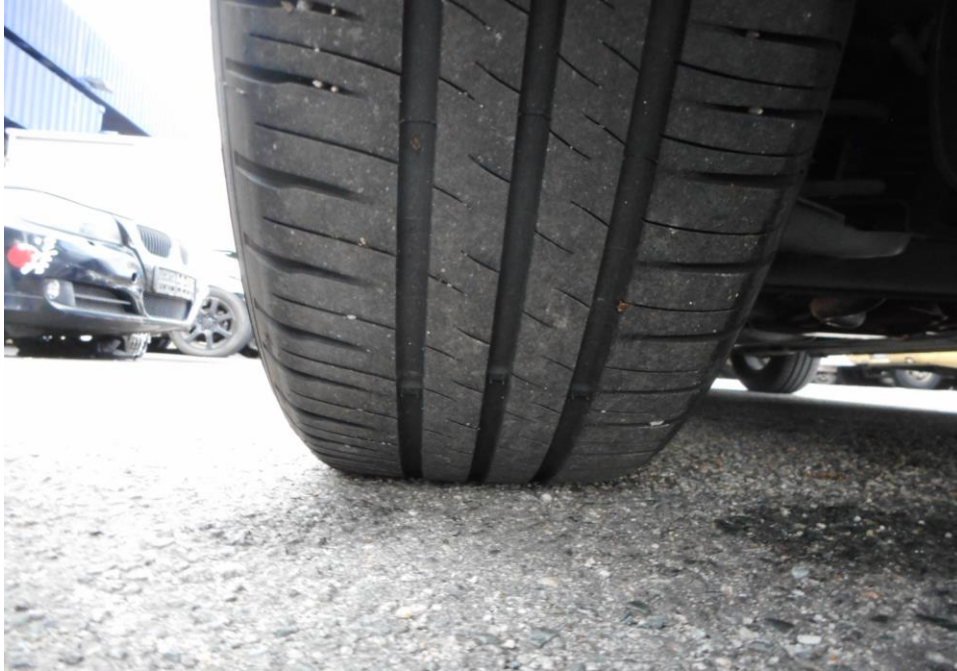
**Photo 10** shows the condition of the rear left tyre of the Motor Car, which was observed to be in serviceable condition with remaining tread depth of approximately 4.6mm. The tyre, which was wrapped around steel wheel rim, was also observed to be sufficiently inflated for vehicular operation. The 4 tyres of the Motor Car were wrapped around standard steel wheel rims.

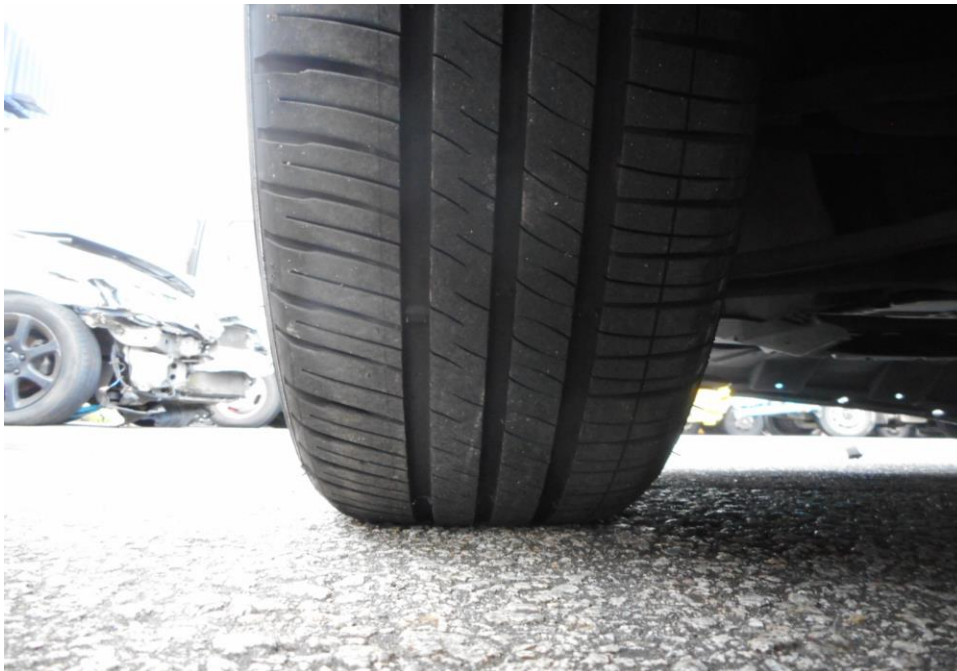
**Photo 11** shows the condition of the front left tyre of the Motor Car, which was observed to be in serviceable condition with remaining tread depth of approximately 5.2mm. There was also no tear, cut or burst mark(s) on the outer and the inner sidewalls as well as across the tread of the Motor Car's 4 tyres.

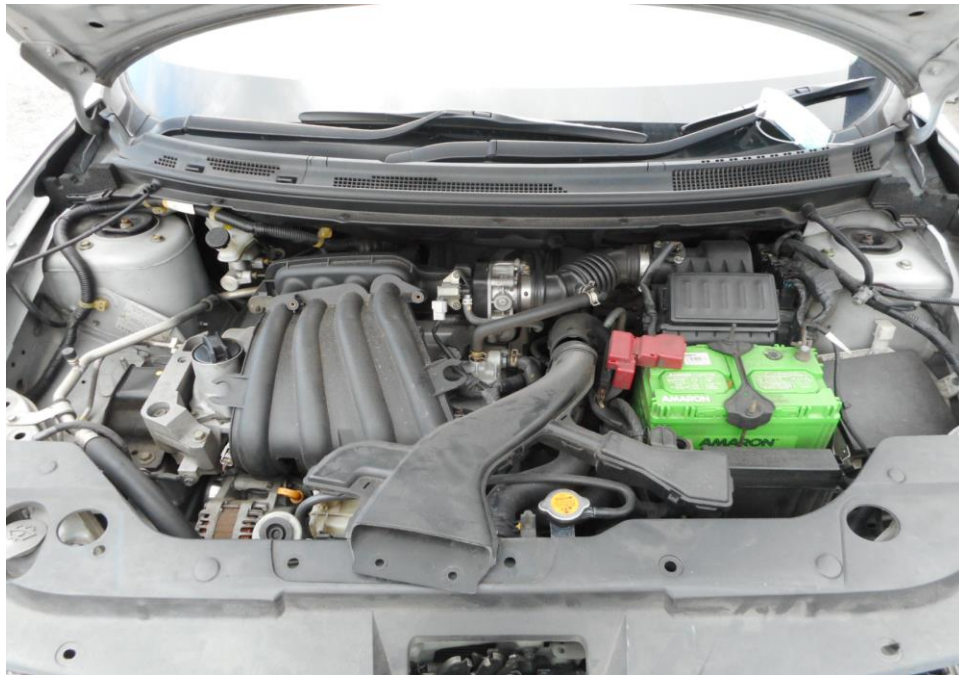
**Photo 12** shows a general view of the Motor Car's engine compartment. The various parts and components inside the engine compartment were unaffected by the accident. There was also no sign(s) or indication(s) of fluid leakage and/or fluid stain within the engine compartment.

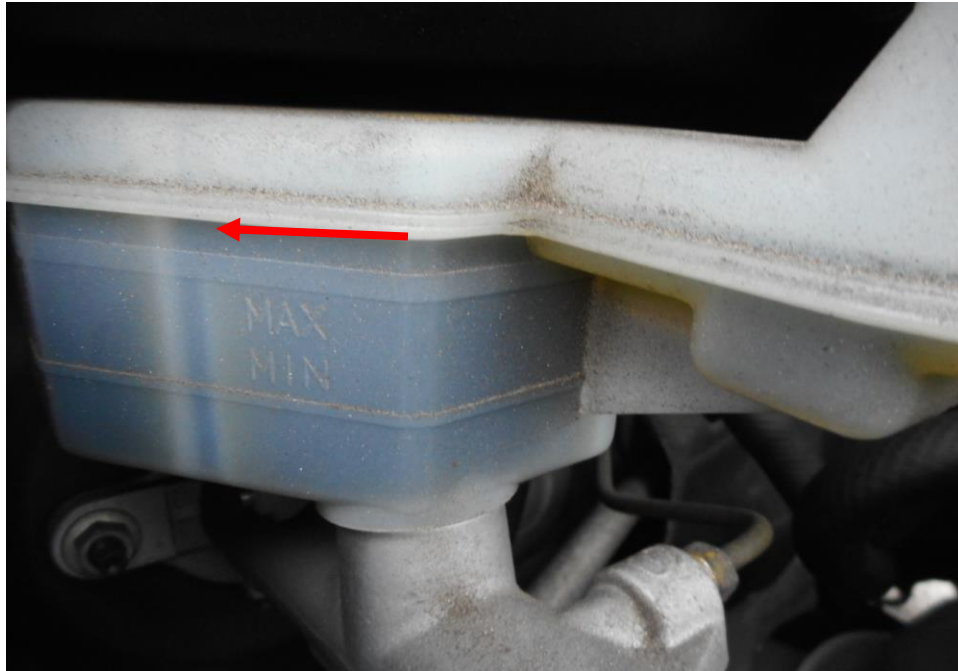
**Photo 13** shows the brake fluid reservoir of the Motor Car at the time of my inspection. The brake fluid was observed to be of sufficient level (arrowed) and without any visible contamination.

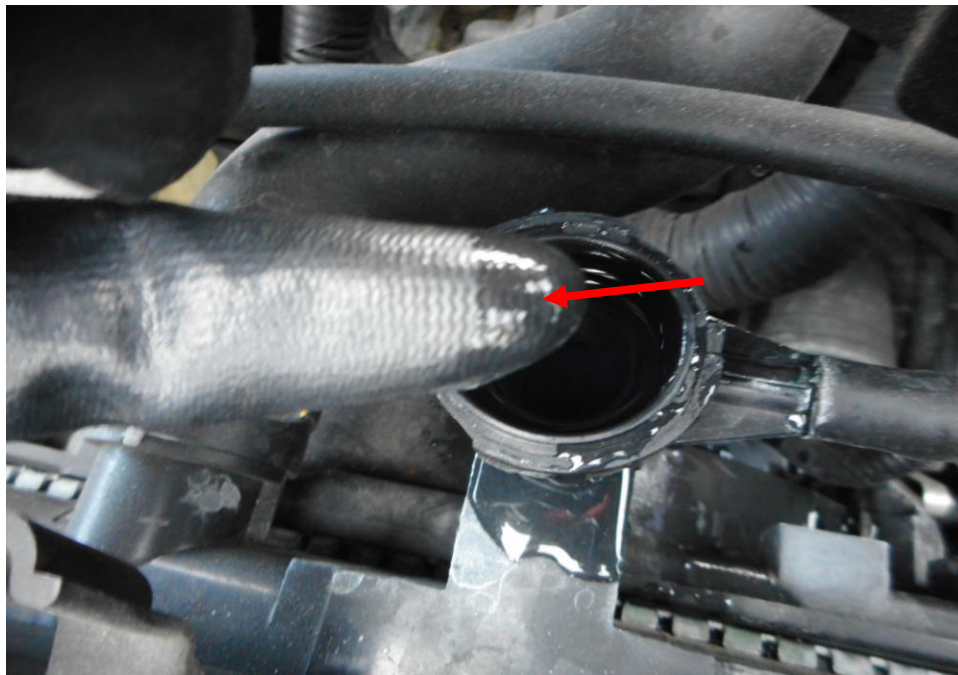
**Photo 14** shows checks being carried out to the engine coolant of the Motor Car at the time of my inspection. The engine coolant was observed to be of sufficient level (arrowed) and without any visible contamination.

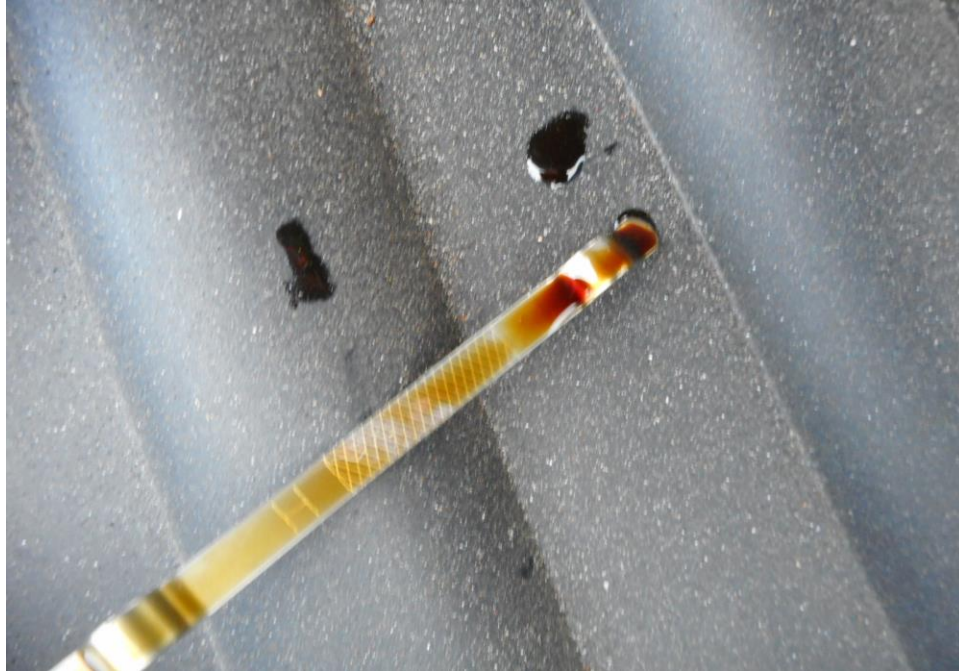
**Photo 15** shows the engine oil dip stick of the Motor Car at the time of my inspection. The engine oil was observed to be of sufficient level and without any visible contamination.

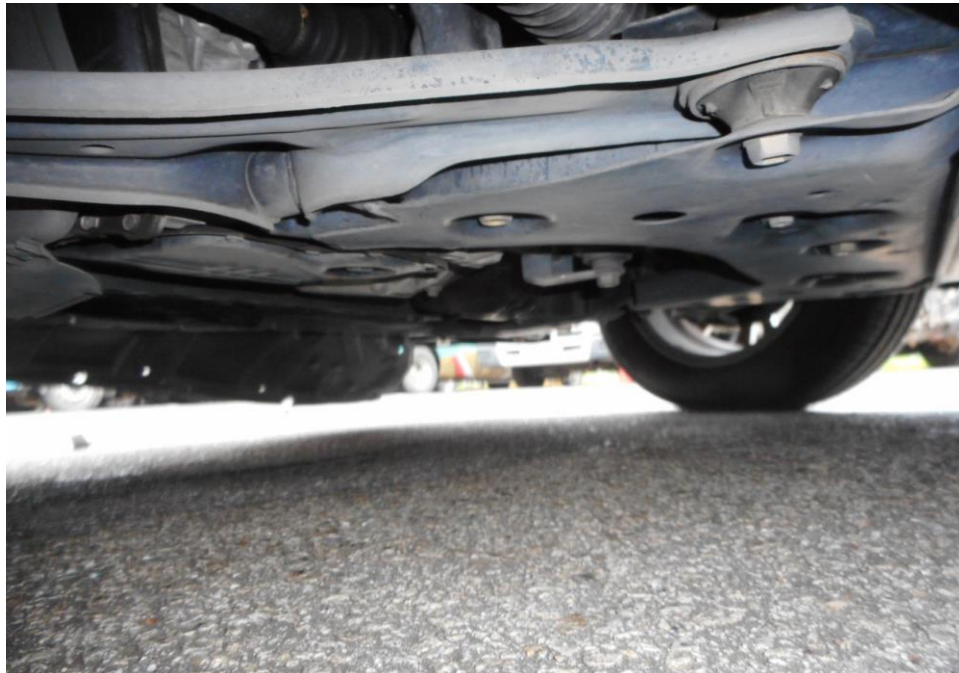
**Photo 16** shows the undercarriage of the Motor Car, at the area where the engine housing and transmission housing are located. I did not find any sign(s) or indication(s) of fluid leak and/or fluid stain(s) on the underside of the Motor Car.

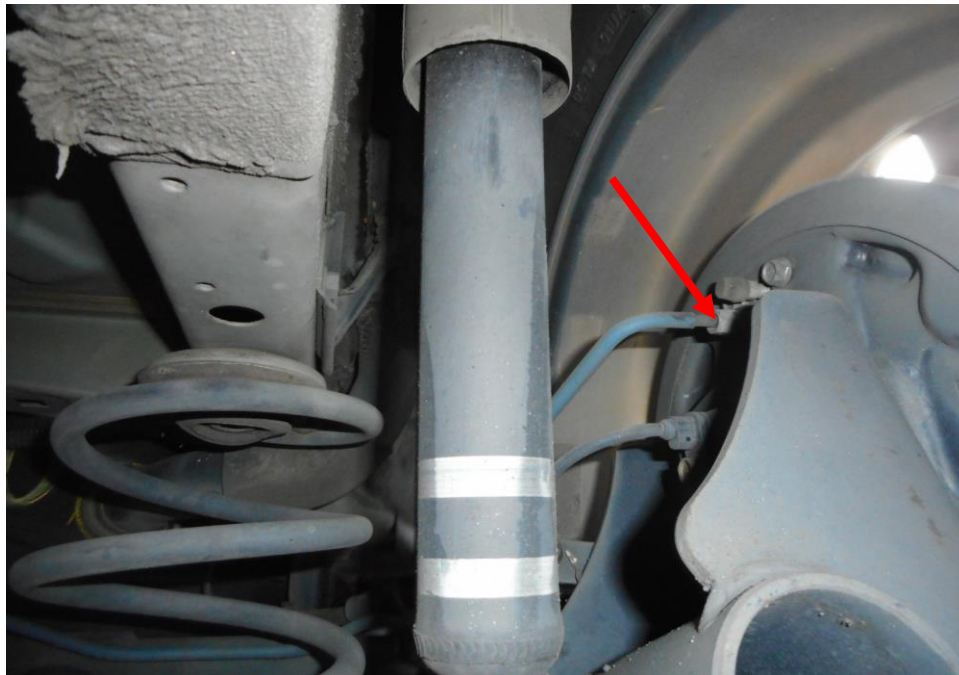
**Photo 17** shows the brake hose/pipe (arrowed) at the rear right wheel of the Motor Car. No leakage of brake fluid was observed. Visual examination of the various components of the braking system like the drum brake, brake booster, brake pedal etc. had revealed all to be intact and without visible damage.

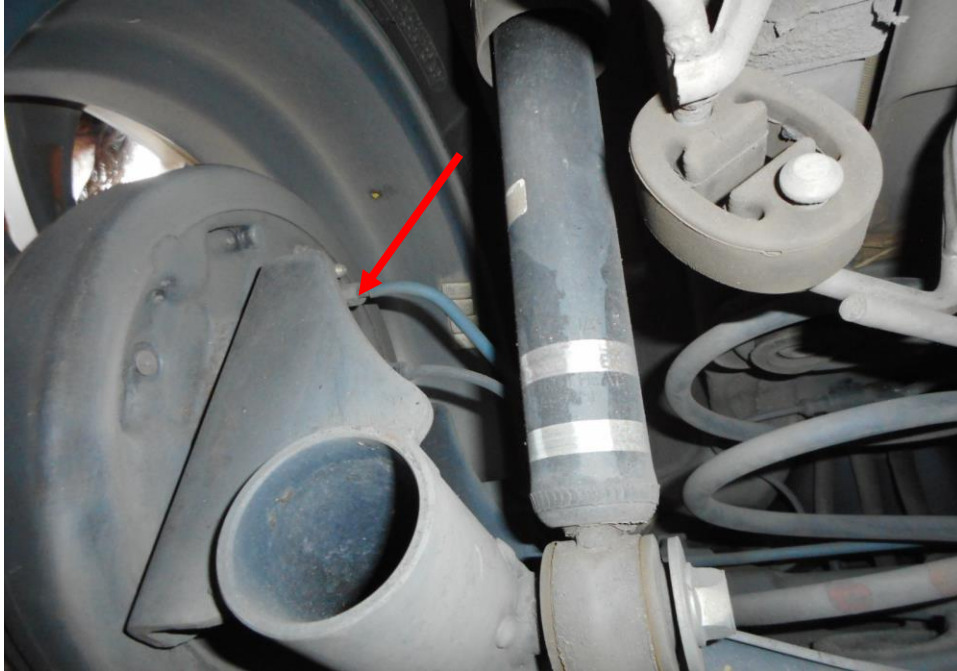
**Photo 18** shows the brake hose/pipe (arrowed) at the rear left wheel of the Motor Car. I did not observe any leakage of brake fluid at the time of my inspection of the Motor Car. Static tests of the Motor Car's braking system had indicated that there was no internal leakage of pressure/vacuum. The undercarriage components of the Motor Car were also all found to be intact and without any visible damage.

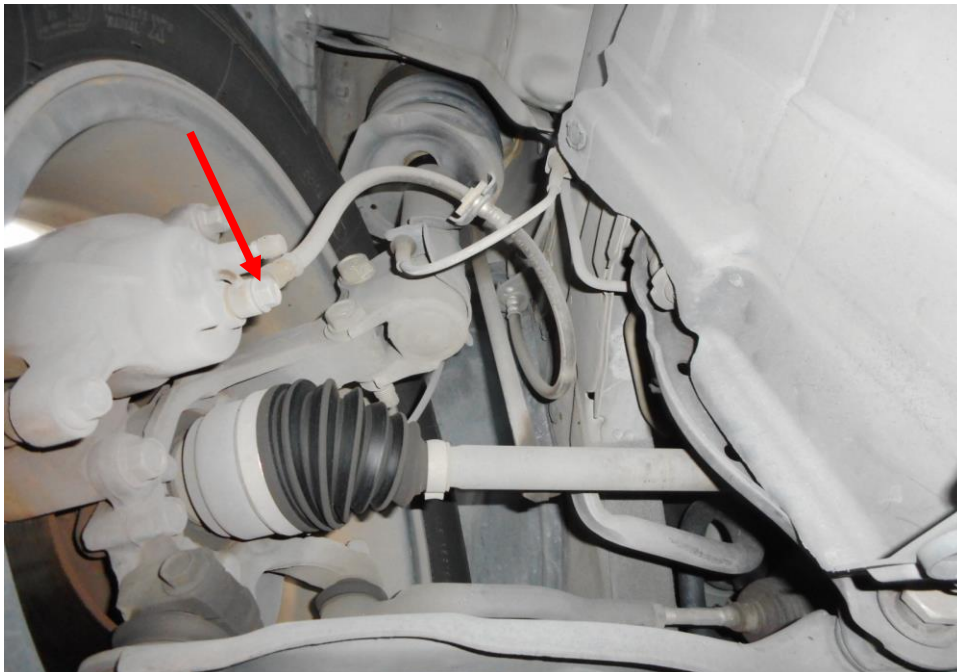
**Photo 19** shows the brake hose/pipe (arrowed) at the front right wheel of the Motor Car. I did not observe any leakage of brake fluid at the time of my inspection of the Motor Car. Static tests of the Motor Car's braking system had indicated that there was no internal leakage of pressure/vacuum. The undercarriage components of the Motor Car were also all found to be intact and without any visible damage.

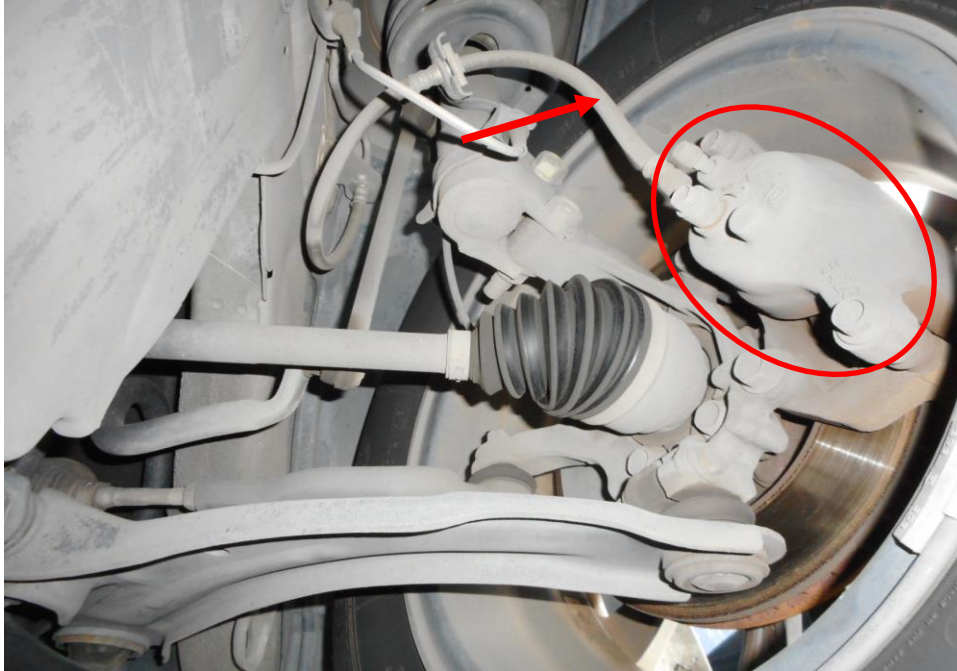
**Photo 20** shows the brake hose/pipe (arrowed) at the front left wheel of the Motor Car. No leakage of brake fluid was observed. Visual examination of the various components of the braking system like the brake caliper (circled), brake booster, brake pedal etc had revealed all to be intact and without visible damage.

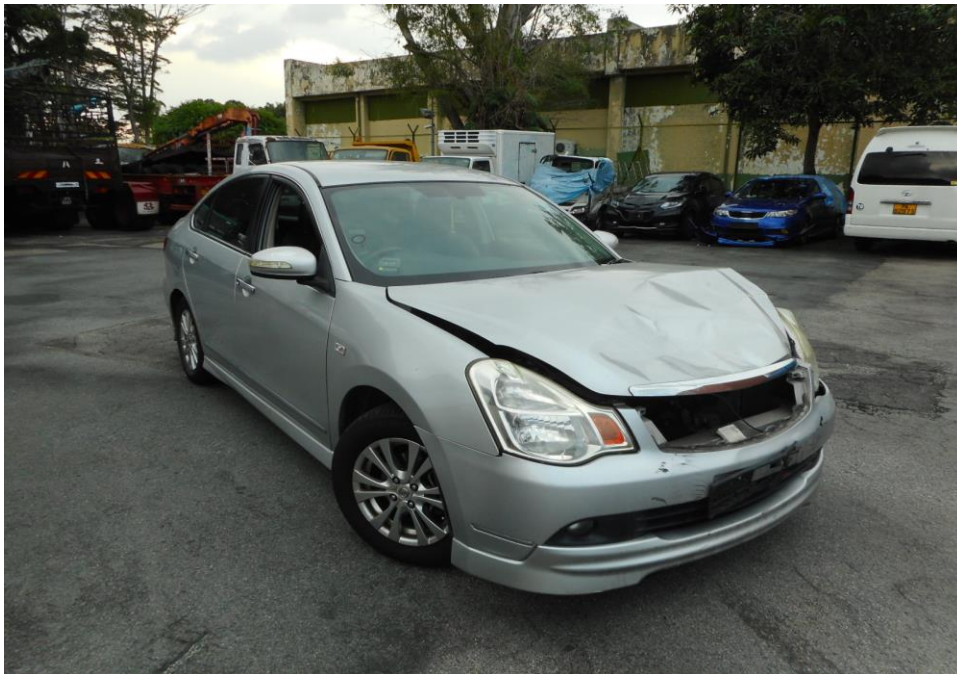
**Photo 21** shows the front right wheel of the Motor Car turned to its full left. During my steering system test, I did not experience any abnormal free play and/or resistance when I had turned the steering wheel towards the left and right. This would suggest that the steering system of the Motor Car was likely to be in serviceable condition at the material time of accident.

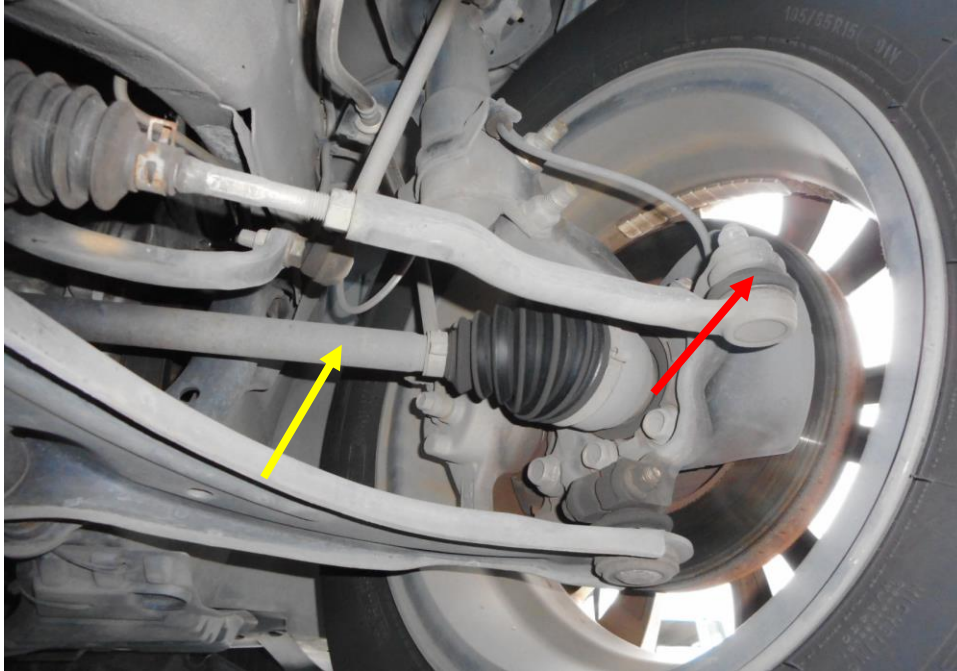
**Photo 22** shows the various undercarriage components at the front right wheel of the Motor Car, in particular the steering tie rod (red arrow) and drive shaft (yellow arrow). The various steering components were all found to be intact, suggesting that the steering system of the Motor Car was likely to be in serviceable condition at the material time of accident. There was also no sign of fluid stain observed on the various undercarriage components at the front right wheel of the Motor Car.

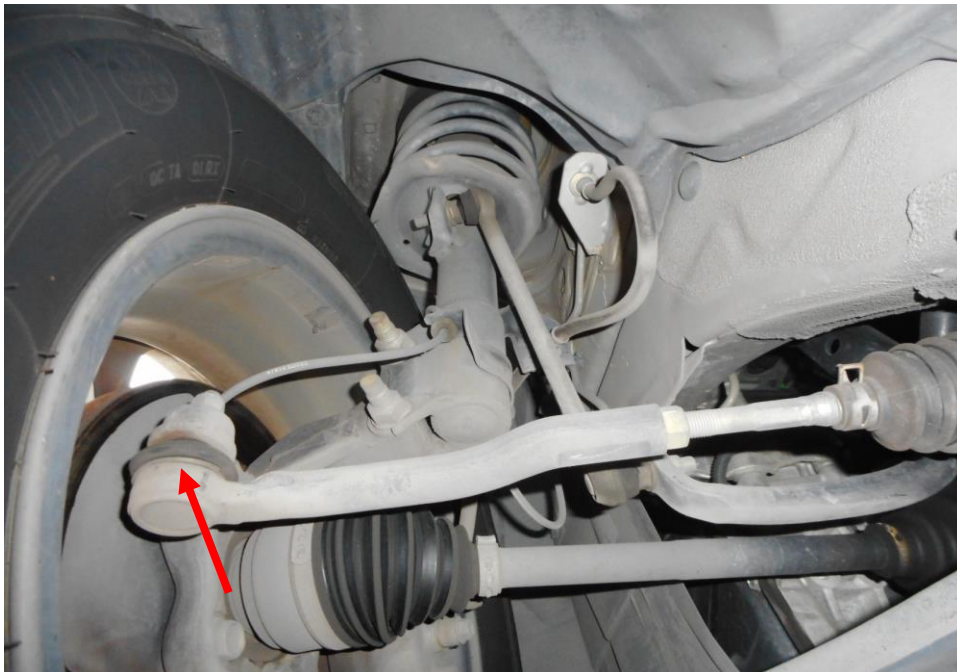
**Photo 23** shows the various undercarriage components at the front left wheel of the Motor Car, which had included the steering tie rod (red arrow). The various undercarriage components of the Motor Car were all found to be intact without any visible damage.

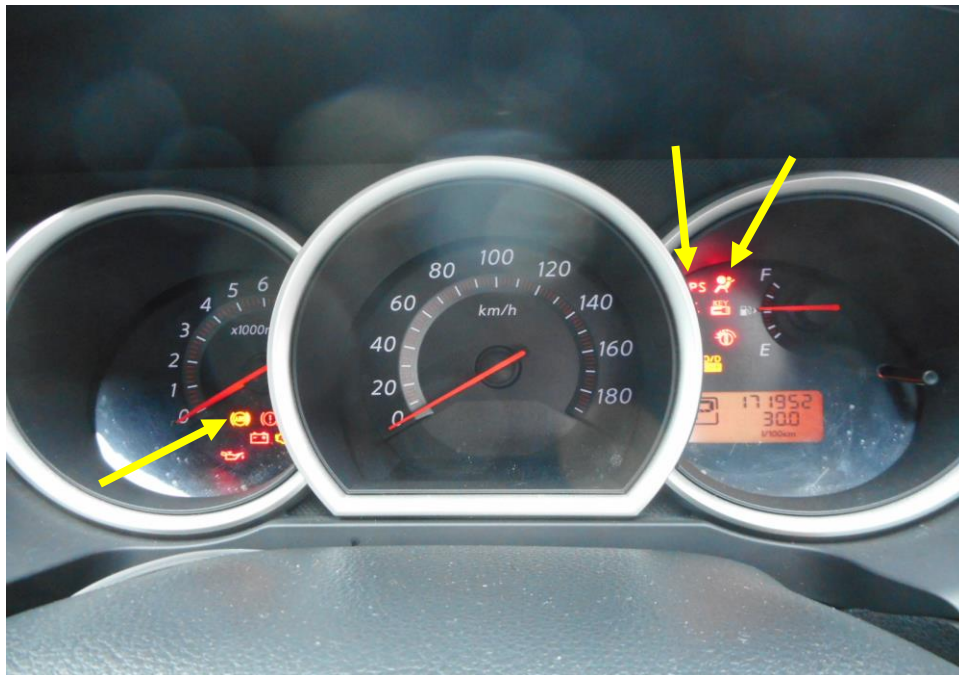
**Photo 24** shows the warning light for Anti-Lock Brake System (ABS) and Power Steering System (EPS), and Supplemental Restraint System (SRS)) (arrowed) appearing on the instrument panel of the Motor Car during the self-test of its various electronic operating systems when its engine was cranked.

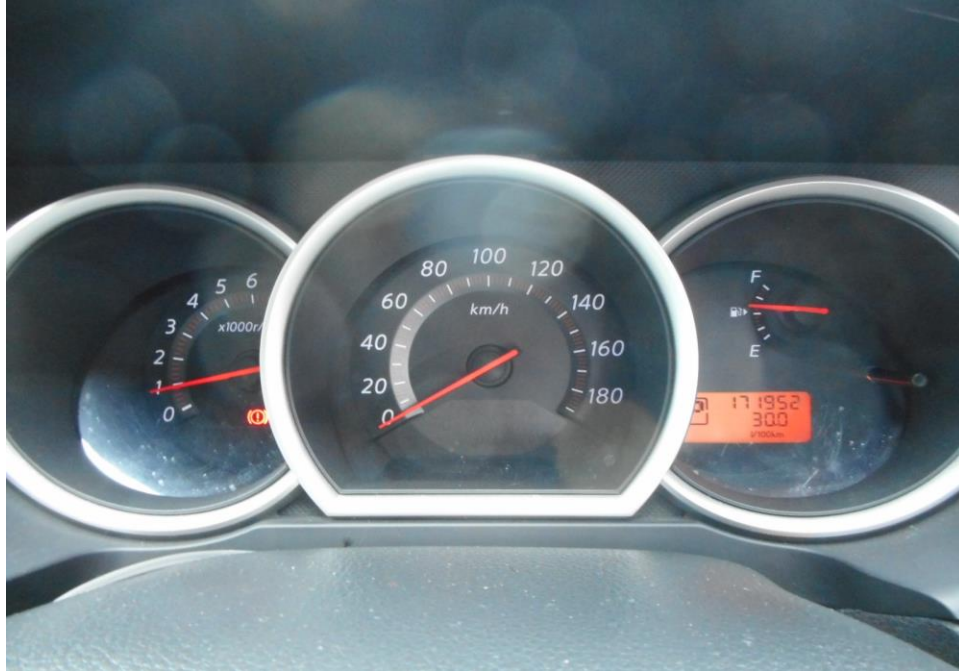
**Photo 25** shows no warning lights illuminated on the instrument panel of the Motor Car after the engine was cranked. This would suggest that there was no abnormality to the electronic operating system of the Motor Car, like the ABS, EPS, and SRS etc.
