Your Ref: BMW 523i Wagon  
(chassis number WBAJL12010BN91732)  
Our Ref : CI/TP21006361/D

06 June 2021

**INSPECTION REPORT OF AN UNREGISTERD BMW 523i WAGON MOTOR CAR WITH CHASSIS NUMBER WBAJL12010BN91732**

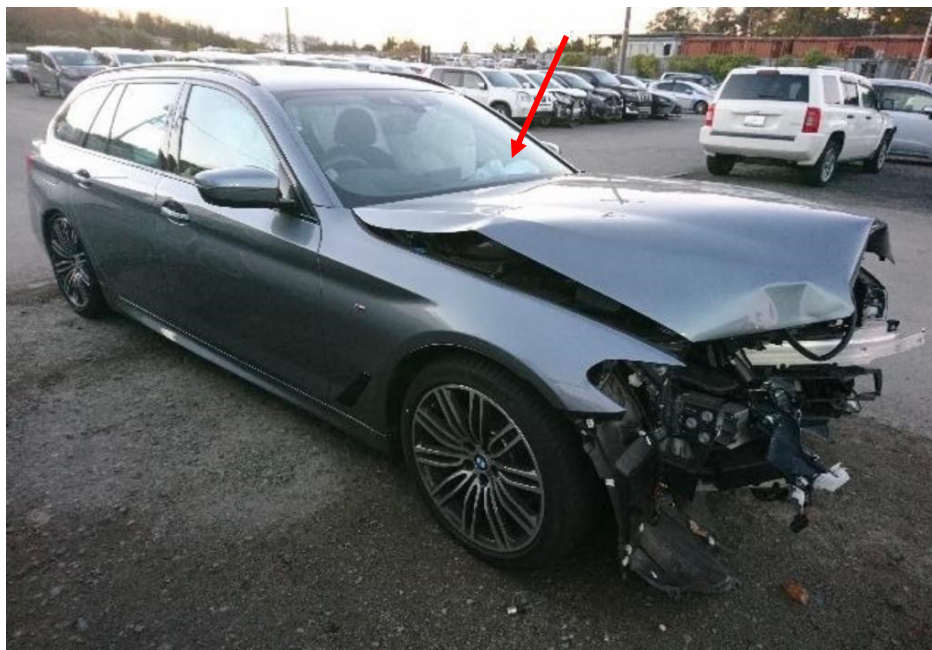
**Photo 1** shows the front right body of the Motor Car (photograph provided to me). The Motor Car was observed to have sustained damage at its frontal portion. The front bumper and all its related parts and attachments, front bumper reinforcement, front radiator grilles, front right headlamp and front bonnet were amongst the body parts that were observed to have been damaged. The front left passenger airbag (arrowed) was observed to be deployed.

22. The body parts at the frontal portion of the Motor Car were visually examined and it was noted that the repair/restoration works carried out to the damaged area of the Motor Car (refer to photograph 1 & 2 above) were reasonably adequate and in order.

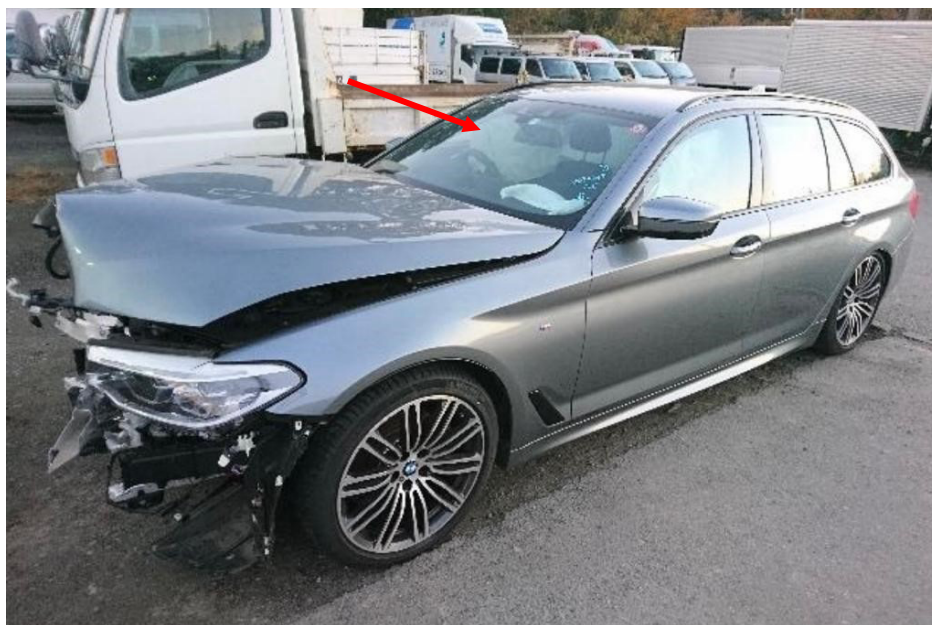
**Photo 2** shows the front left body of the Motor Car (photograph provided to me). The Motor Car was observed to have sustained damage at its frontal portion. The front bumper and all its related parts and attachments, front left headlamp, front bonnet and front left fender inner shield were amongst the body parts that were observed to have been damaged. The right side curtain airbag (arrowed) was observed to be deployed.

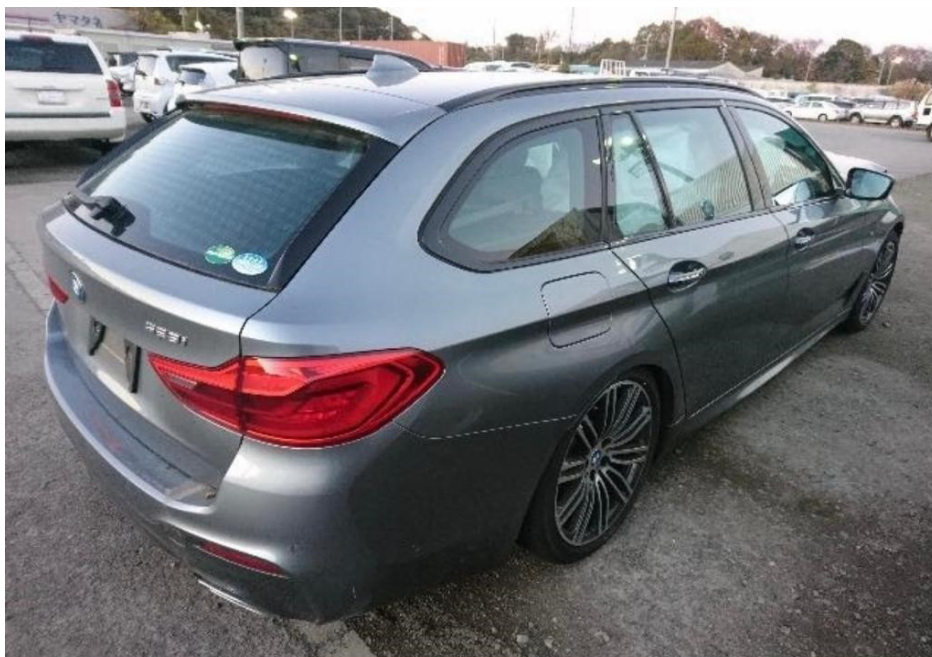
**Photo 3** shows the rear right body of the Motor Car (photograph provided to me). Apart for the frontal portion, there was no physical damage seen to other areas of the Motor Car.

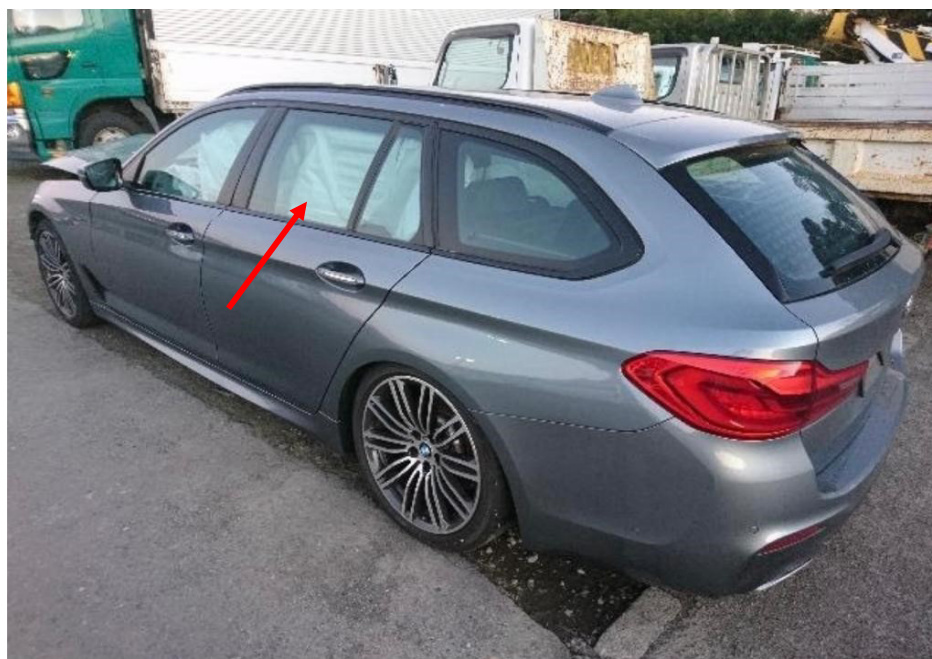
**Photo 4** shows the rear left body of the Motor Car (photograph provided to me). The left side curtain airbag (arrowed) was observed to be deployed. Apart for the frontal portion, there was no physical damage seen to other areas of the Motor Car.

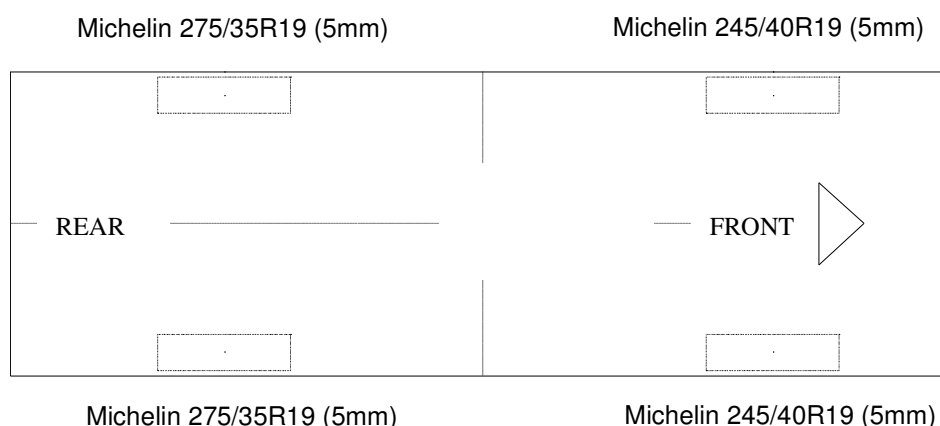
8. It was fitted with 19inch sport wheel rims that were wrapped with tyres that were observed to be of serviceable condition. The tyres were also sufficiently inflated for vehicular operation. The tyre brand, tyre size and approximate remaining tread depth of the 4 tyres of the Motor Car were recorded as follows: -

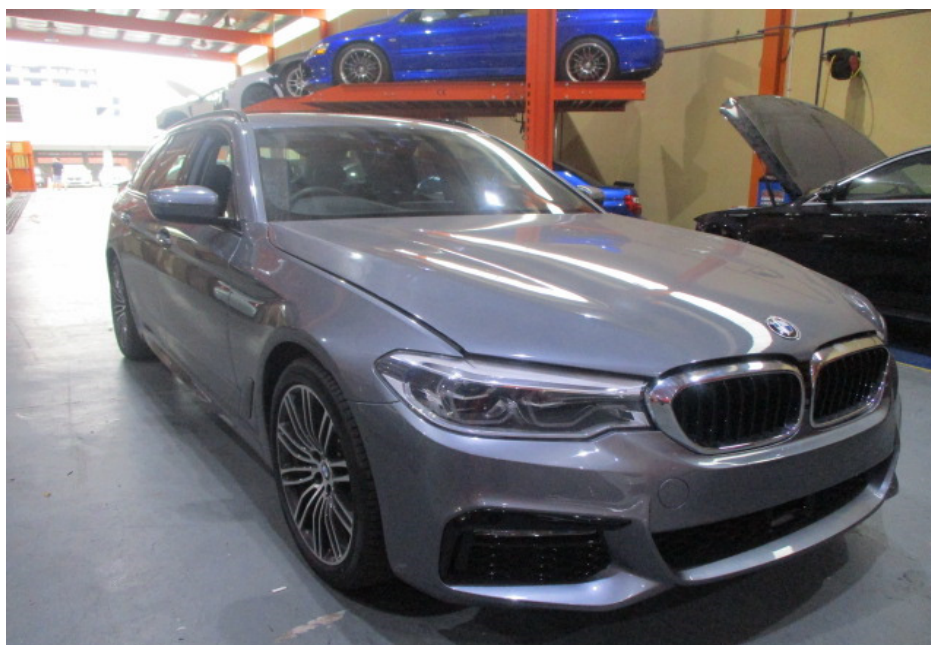
**Photo 5** shows a general view of the front right body of the Motor Car at the time of my inspection. The Motor Car was observed to be in a relatively good general condition with no loose exterior fittings observed. The body parts at the frontal portion of the Motor Car were visually examined and it was observed that the repair/restoration works carried out to the damaged area of the Motor Car (refer to photograph 1 & 2 above) were reasonably adequate and in order.

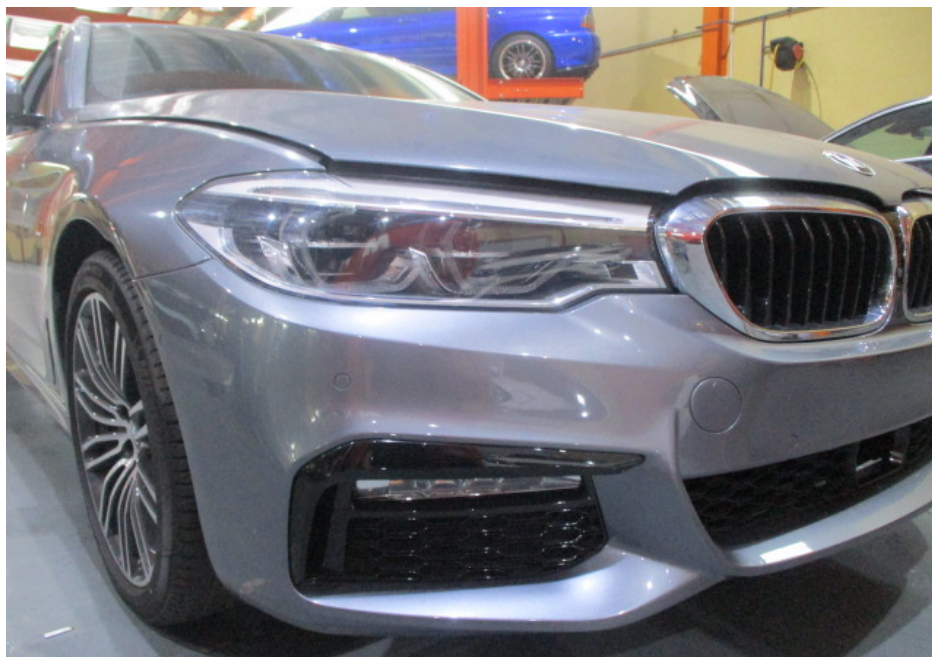
**Photo 6** shows a closer view of the front bumper, front bumper right grille, front radiator grilles, front bonnet, front right headlamp, front right day running light of the Motor Car at the time of my inspection. The body parts at the frontal portion of the Motor Car were visually examined and it was observed that the repair/restoration works carried out to the damaged area of the Motor Car (refer to photograph 1 & 2 above) were reasonably adequate and in order.

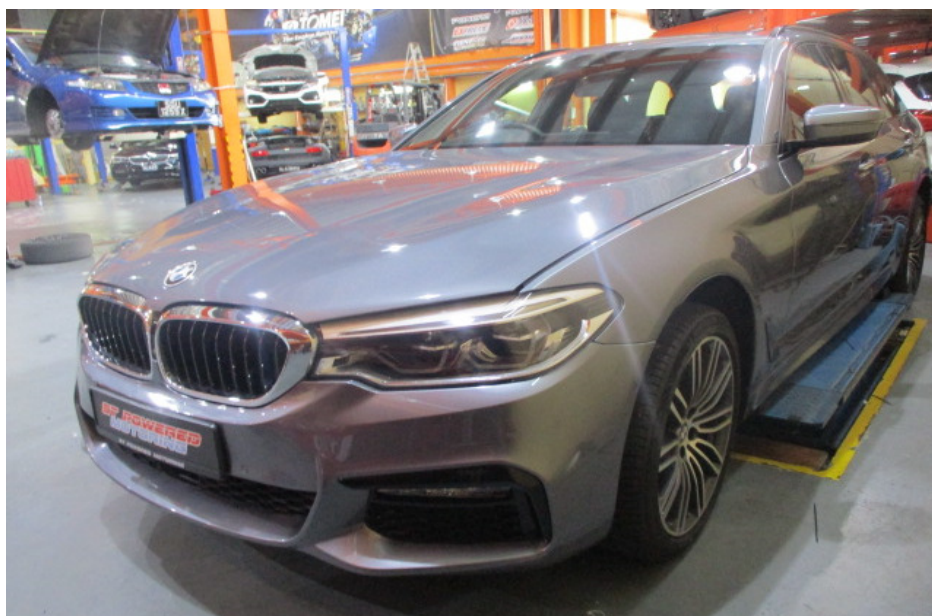
**Photo 7** shows a general view of the front left body of the Motor Car at the time of my inspection. The Motor Car was observed to be in a relatively good general condition with no loose exterior fittings observed. The body parts at the frontal portion of the Motor Car were visually examined and it was observed that the repair/restoration works carried out to the damaged area of the Motor Car (refer to photograph 1 & 2 above) were reasonably adequate and in order.

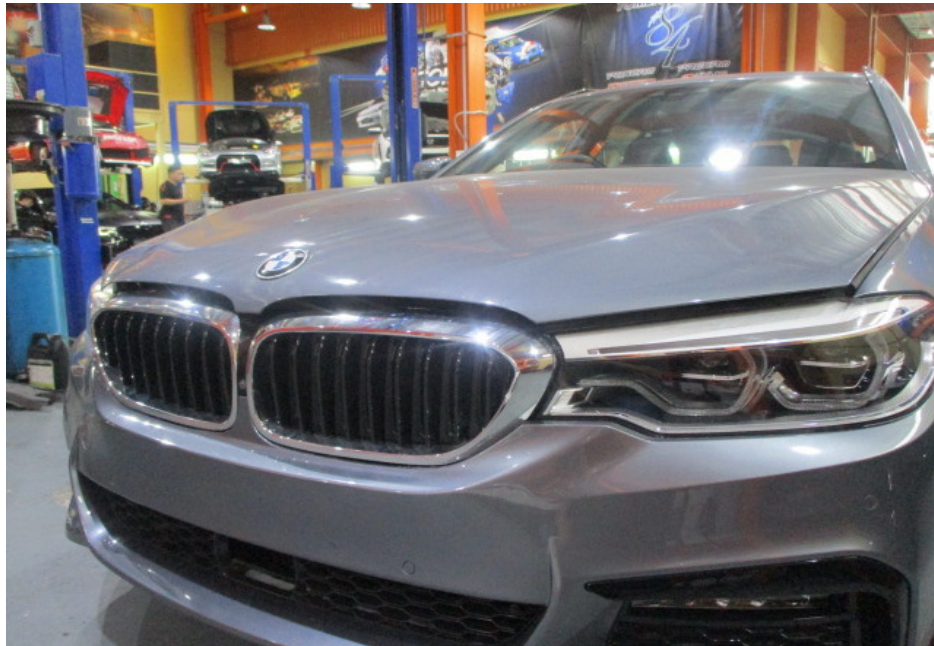
**Photo 8** shows a closer view of the front bumper, front bumper centre lower grille, front radiator grilles, front bonnet and front left headlamp of the Motor Car at the time of my inspection. The body parts at the frontal portion of the Motor Car were visually examined and it was observed that the repair/restoration works carried out to the damaged area of the Motor Car (refer to photograph 1 & 2 above) were reasonably adequate and in order.

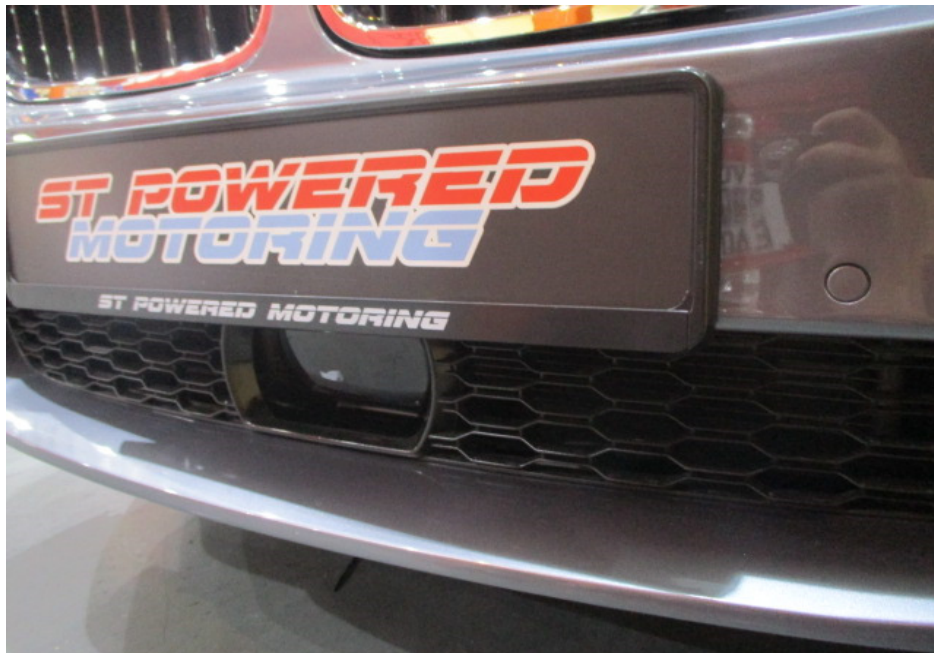
**Photo 9** shows a closer view of the front bumper centre lower grille and front radar unit of the Motor Car at the time of my inspection. The body parts at the frontal portion of the Motor Car were visually examined and it was observed that the repair/restoration works carried out to the damaged area of the Motor Car (refer to photograph 1 & 2 above) were reasonably adequate and in order.

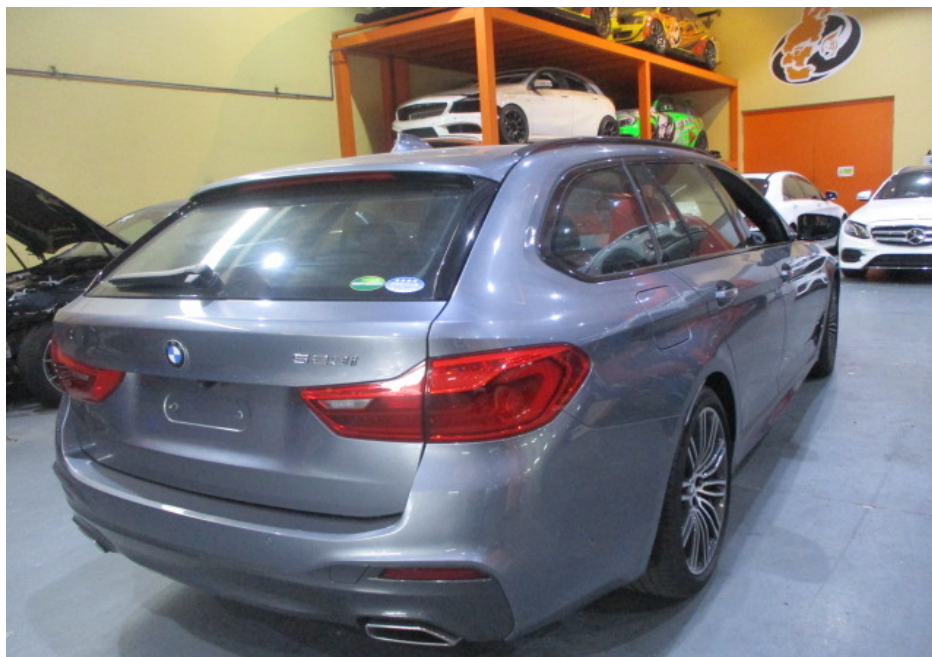
**Photo 10** shows a general view of the rear right body of the Motor Car at the time of my inspection. The Motor Car was observed to be in a relatively good general condition with no loose exterior fittings observed. The mileage of the Motor Car recorded at the time of my inspection was 1,881km.

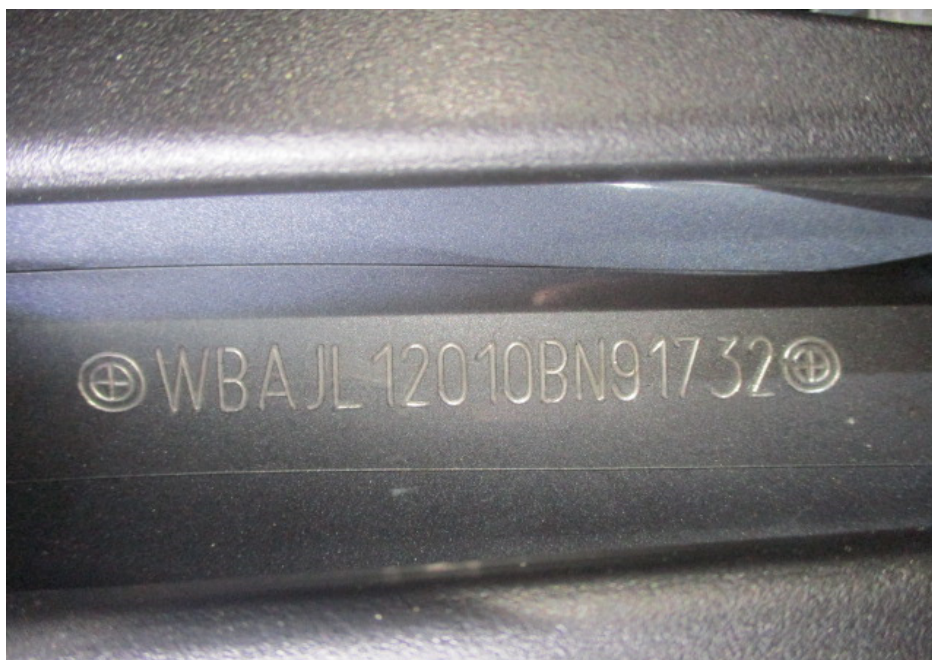
**Photo 11** shows the chassis number of the Motor Car. The chassis number recorded was WBAJL12010BN91732.

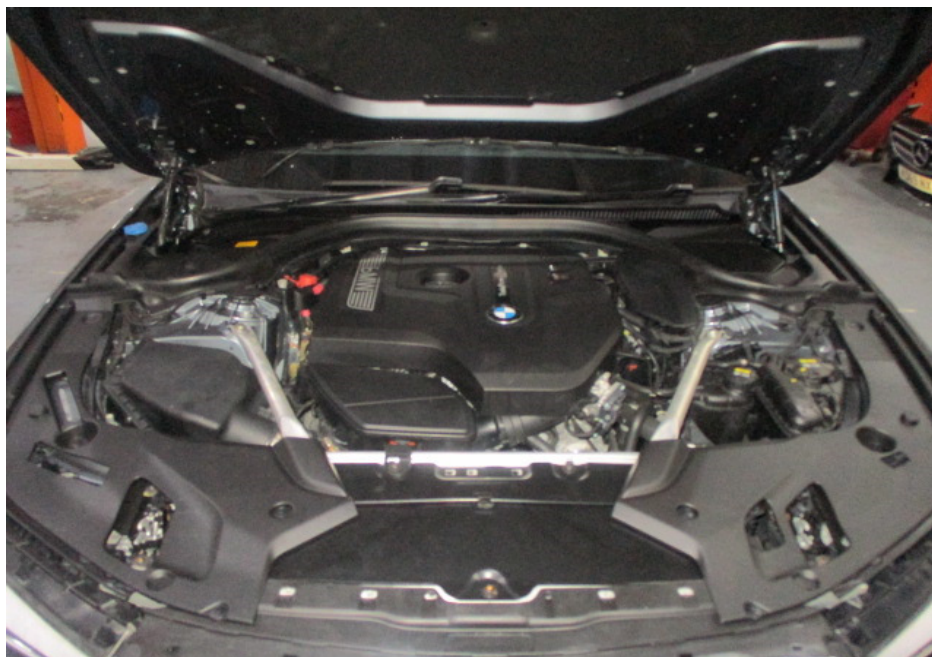
14. My examination of the engine compartment of the Motor Car revealed that the various parts and components inside the engine compartment were all intact and properly fitted. The engine oil, brake fluid and engine coolant were all found to be of sufficient level for operating purposes. Visually, there was also no contamination found to these fluids.

**Photo 12** shows a general view of the engine compartment of the Motor Car at the time of my inspection. The various parts and components inside the engine compartment were all observed to be intact and properly fitted. There was also no sign(s) or indication(s) of fluid leak and/or fluid stain found inside the engine compartment. The repair/restoration works carried out to the various parts within the engine compartment like the front headlamp top panels, front headlamp top panel garnishes, front top panel centre, front top panel centre garnish and front support panel amongst others, were reasonably adequate and in order.

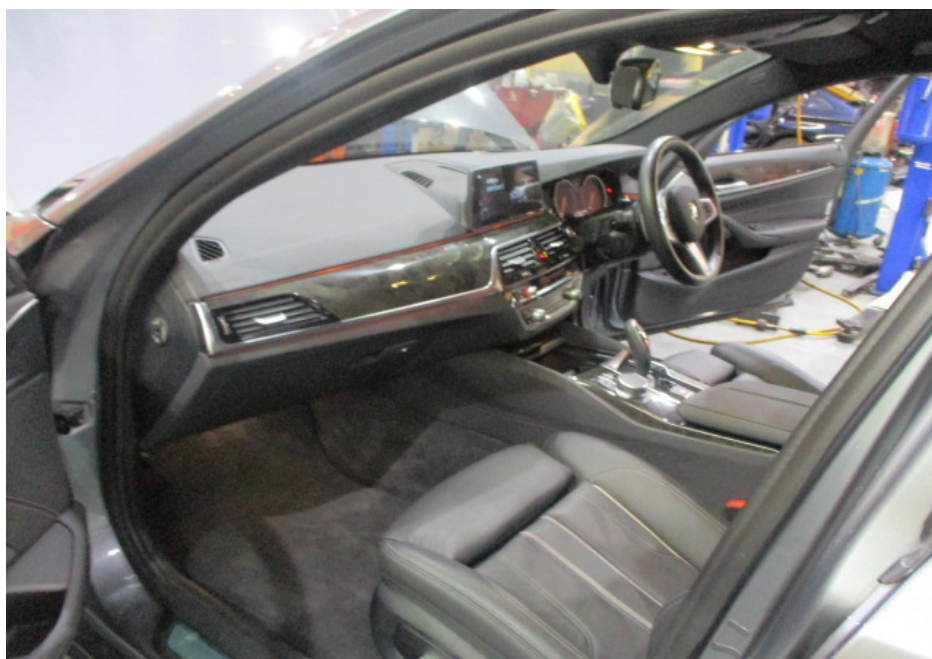
**Photo 13** shows the interior compartment of the Motor Car. The front dashboard, steering wheel, upholstery and trims etc were all observed to be intact and properly fitted.

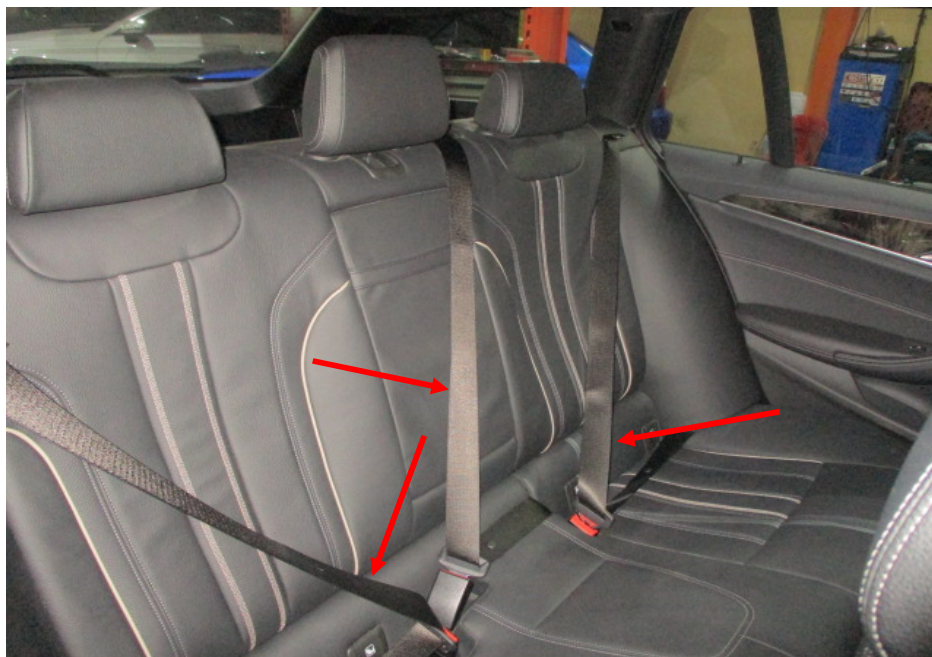
12. The seats of the Motor Car were found to be secured to the floorboard of the Motor Car via seat rails bolted onto the floorboard. Retractable seat belt reels and pre-tensioners were fitted on all seats of the Motor Car. The seat belts were tested and were able to be fastened securely into the respective pre-tensioners that were fixed to the side of all the seats.

**Photo 14** shows the rear seats of the Motor Car. All the seats of the Motor Car were secured via seat rails to the floorboard. They were also fitted with a retractable seat belt reel and a pre-tensioner. The seat belts (arrowed) were tested and were able to be fastened into the respective pre-tensions that were fitted on the side of each individual seat.

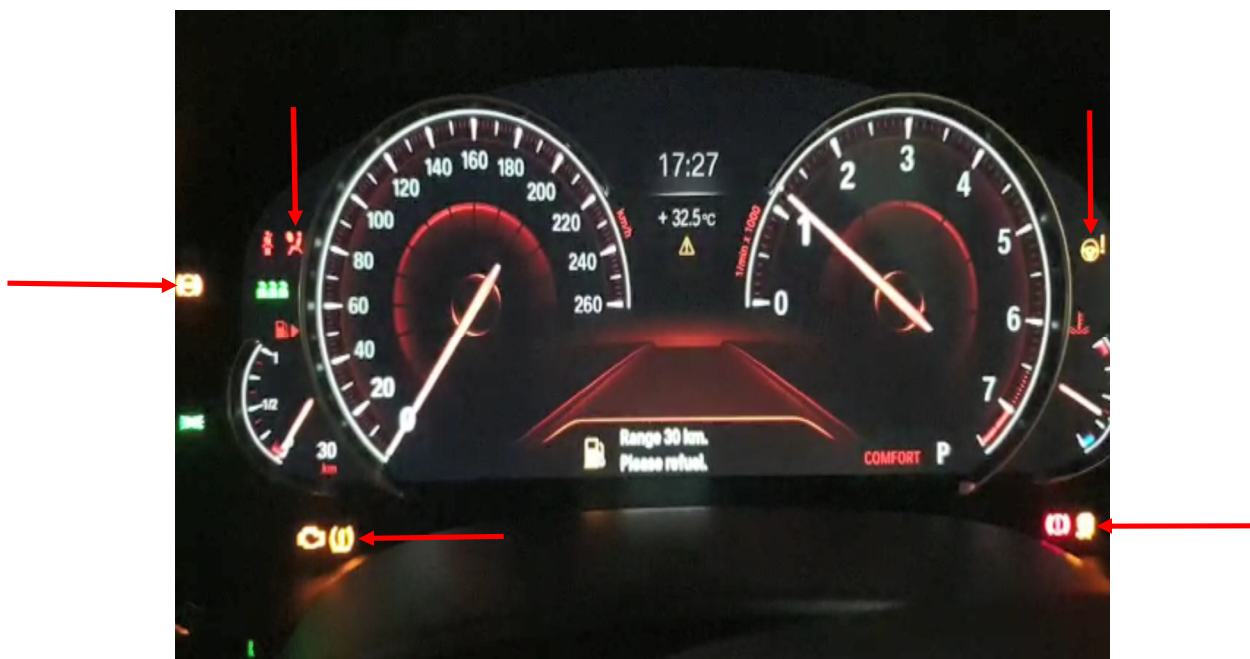
13. The Motor Car's automatic self-test of the functionality of its various electronic safety features like the Anti-Lock Brake System (ABS), Supplemental Restraint System (SRS), Integral Active Steering (IAS), Tyre Pressure Monitor (TPM) and Dynamic Stability Control (DSC) during cranking of the engine had indicated that these electronic systems were in working condition. This was determined from the respective warning lights disappearing from the instrument panel after the self-test.

**Photo 15** shows the warning lights for the various electronic safety features appearing on the instrument panel of the Motor Car during its self-test when the engine is cranked, in particular the ABS, SRS, IAS, TPM and DSC lights (arrowed).

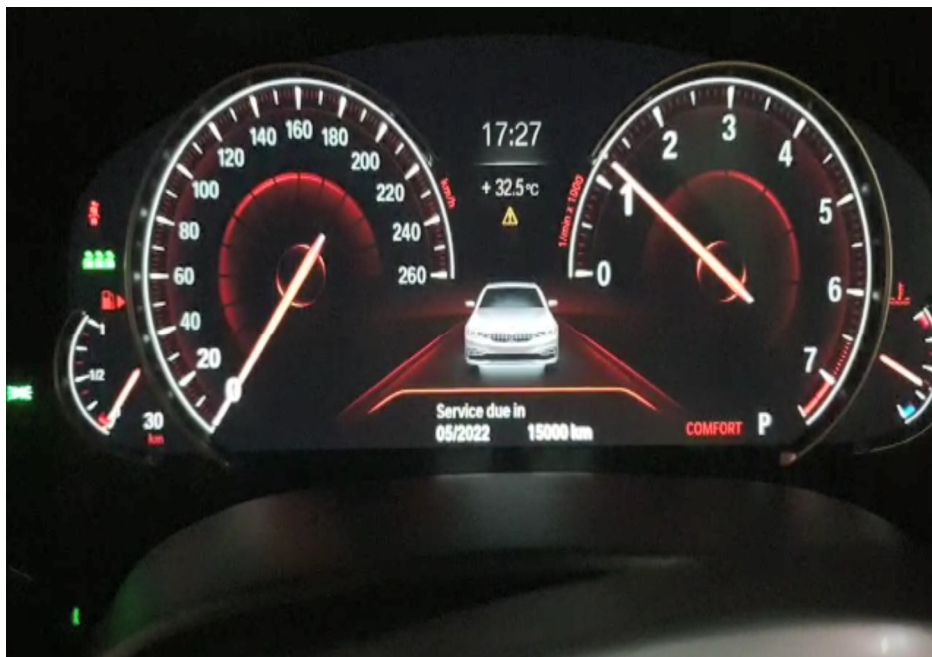
**Photo 16** shows the respective warning lights no longer illuminated, indicating that there is no fault detected to the ABS, SRS, IAS, TPM and DSC systems of the Motor Car during the self-test. These electronic systems were hence in working condition at the time of my inspection.

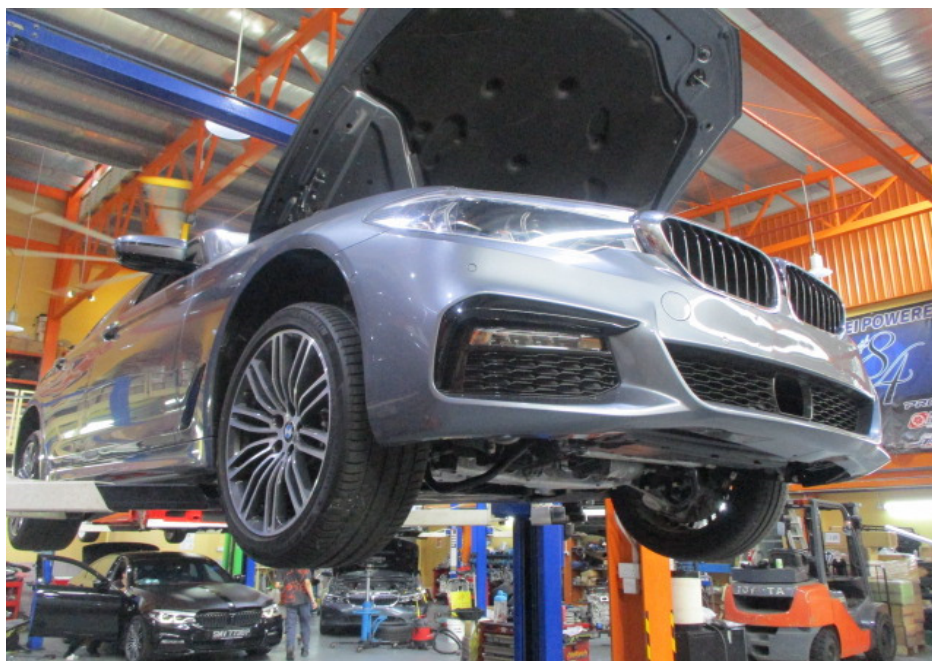
15. My checks on the underside of the Motor Car revealed no sign(s) or indication(s) of fluid leakage and/or fluid stain(s). The engine block and automatic transmission assembly were both secured properly. All undercarriage components of the Motor Car were also observed to be intact and secured in an appropriate manner.

**Photo 17** shows the Motor Car hoisted up for checks on its undercarriage. There was no sign(s) or indication(s) of fluid leakage and/or fluid stain(s) on the underside of the Motor Car. The undercarriage components of the Motor Car were also all observed to be intact and secured in an appropriate manner.

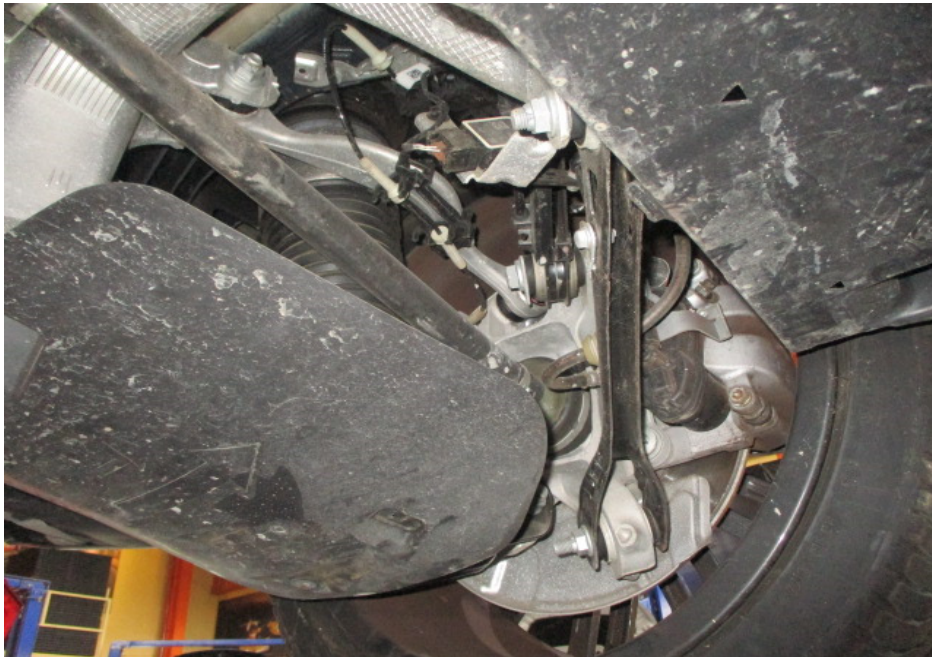
**Photo 18** shows a general view of the control arms and linkages at the rear left wheel of the Motor Car. I did not observe any fluid leak and/or fluid stain on the underside of the Motor Car. All of the Motor Car's undercarriage components were observed to be intact and secured in an appropriate manner.

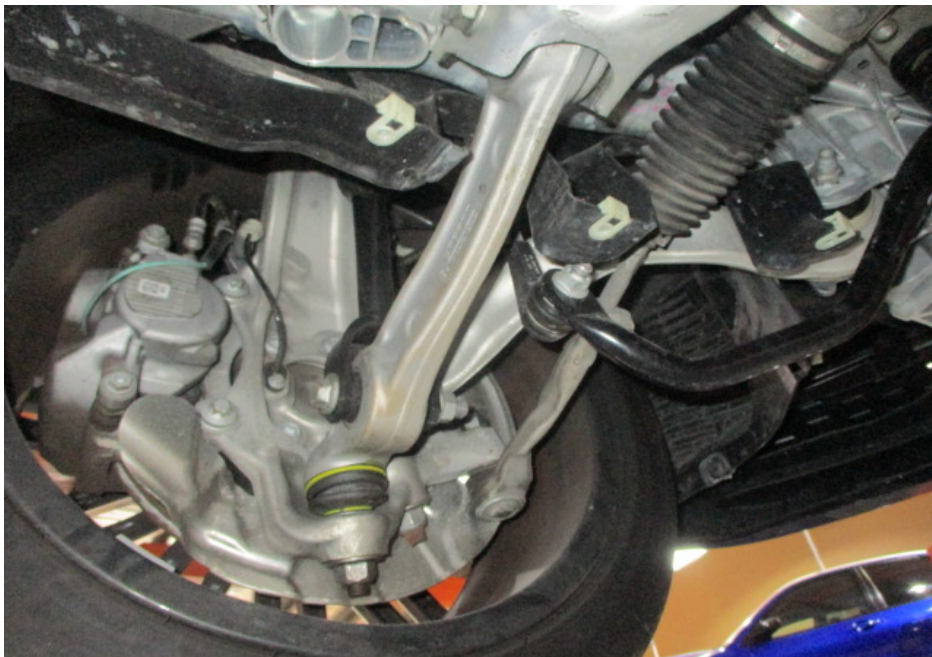
**Photo 19** shows the various undercarriage components at the front left wheel of the Motor Car. The mechanical components, control arms and linkages were all found to be intact and secured in an appropriate manner.

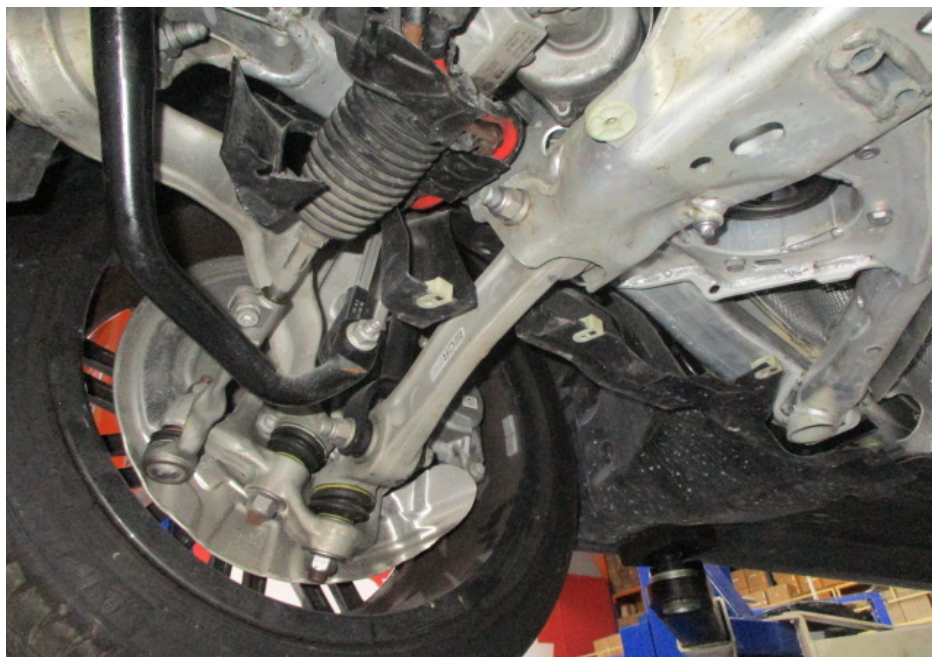
**Photo 20** shows the various undercarriage components at the front right wheel of the Motor Car. The mechanical components, control arms and linkages were all found to be intact and secured in an appropriate manner. I also did not observe any fluid leak and/or fluid stain on the underside of the Motor Car.

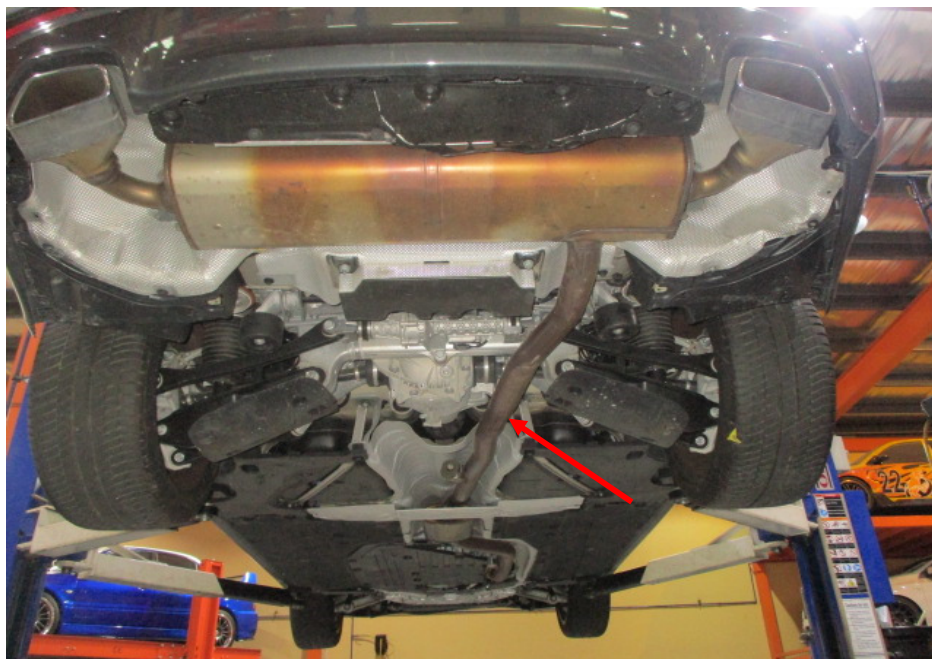
**Photo 21** shows a general view of the Motor Car's exhaust system. My examination of the Motor Car's exhaust system revealed no sign(s) or indication(s) of any cut or weld marks along its catalytic converter, centre resonator box, exhaust pipe (arrowed) and on its rear muffler.

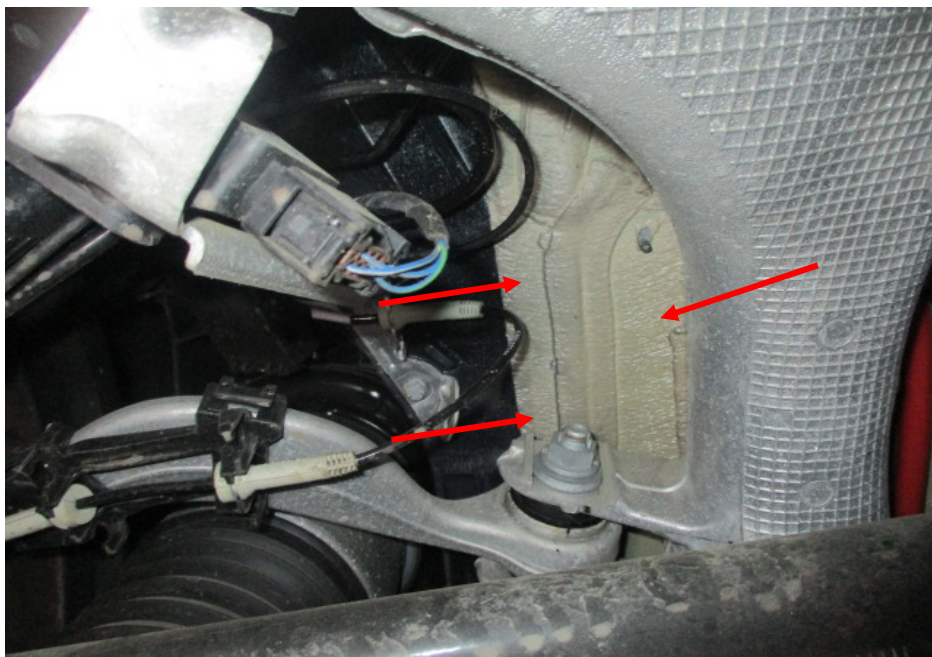
11. Visually, I did not find any weld marks, other than the original spot weld marks, on the chassis/structural body of the Motor Car. The original factory sealant at the joints along the chassis/structural body was also untouched, again indicating that no replacement of the chassis/structural body was carried out; and that the chassis/structural body was originally fitted.

**Photo 22** shows the chassis/structural body at the underside rear right of the Motor Car. I did not find any weld marks other than original spot weld marks on the chassis/structural body of the Motor Car. The original factory sealant (arrowed) at the joints along the chassis/structural body was untouched, indicating no work was done on the chassis/structural body of the Motor Car and that the chassis/structural body was originally fitted.

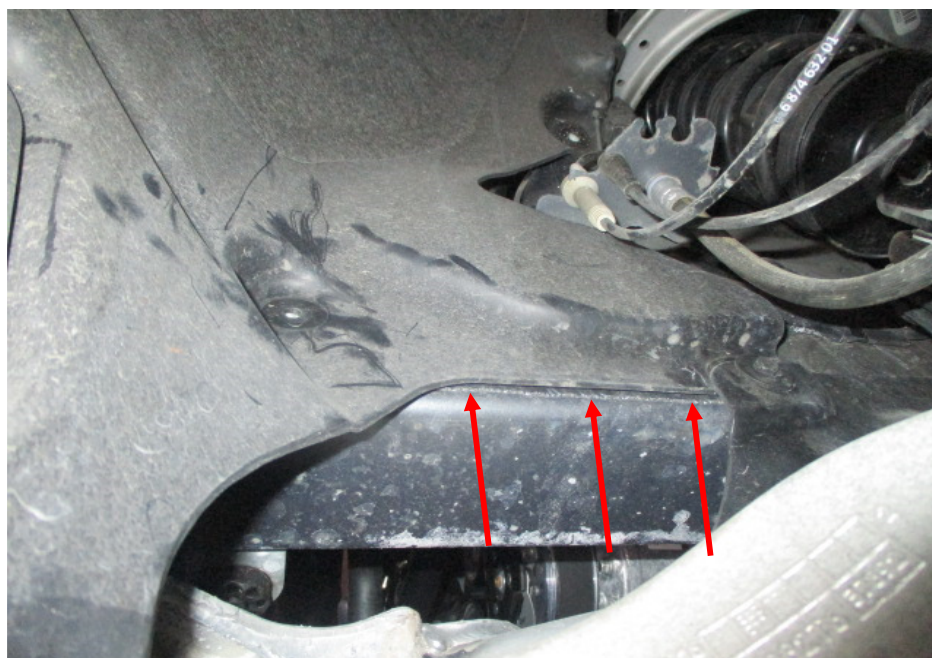
**Photo 23** shows the chassis/structural body at the underside front left of the Motor Car. The original factory sealant (arrowed) at the joints along the chassis/structural body was observed to be untouched. In general, I had found no work was carried out on the chassis/structural body of the Motor Car. The chassis/structural body of the Motor Car was originally fitted.

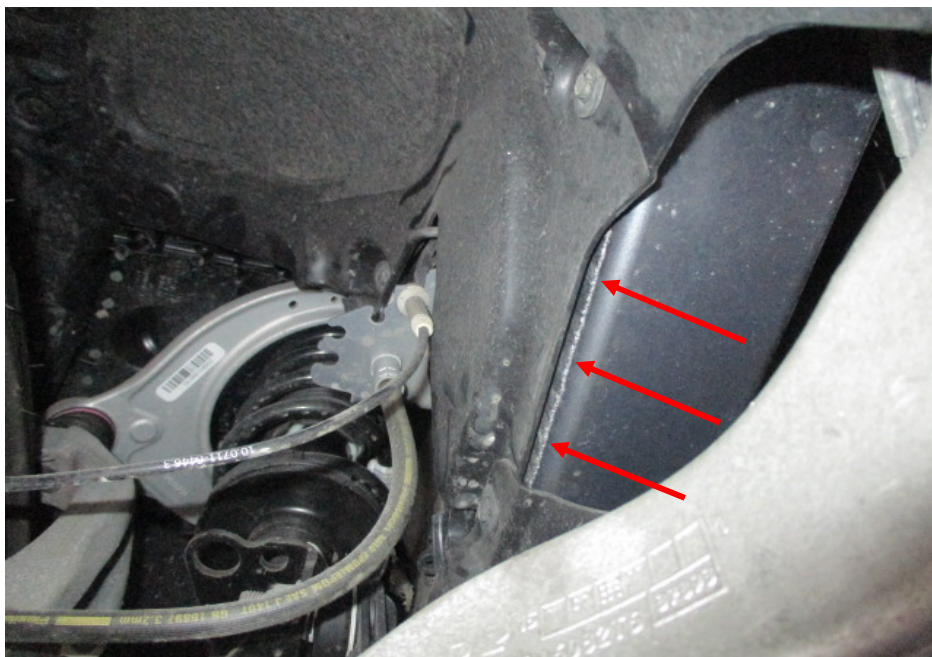
**Photo 24** shows the chassis/structural body at the underside front right of the Motor Car. The original factory sealant (arrowed) at the joints along the chassis/structural body was observed to be untouched. In general, I had found no work was carried out on the chassis/structural body of the Motor Car. The chassis/structural body of the Motor Car was originally fitted.

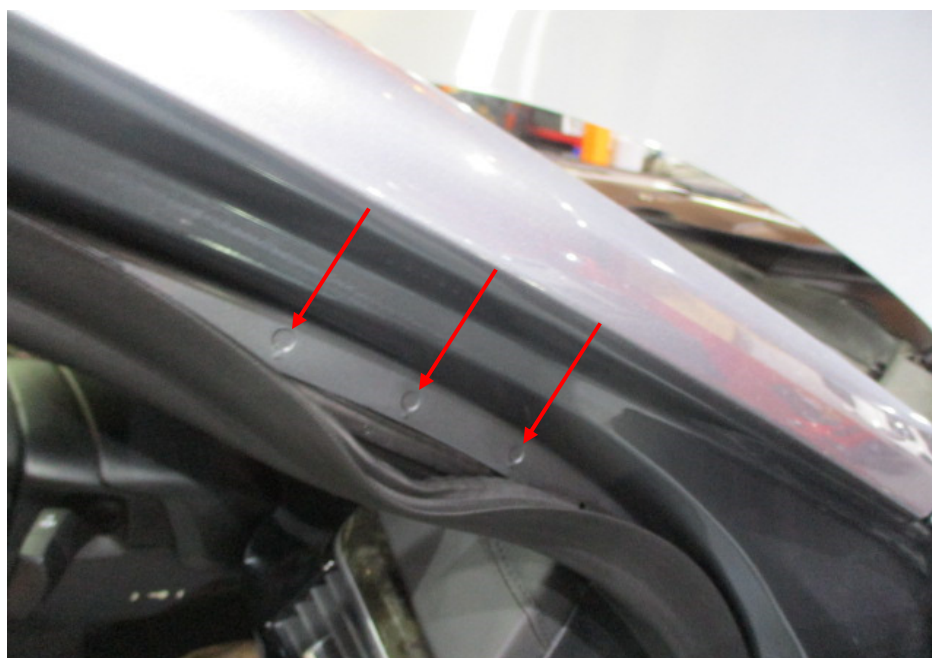
**Photo 25** shows the right side "A" pillar of the Motor Car. I did not find any weld marks other than original spot weld marks (arrowed) on the right side "A" pillar of the Motor Car which, indicates that there was no re-welding works carried out. In general, I had found all the non-detachable body panels of the Motor Car to be originally fitted at the time of my inspection.

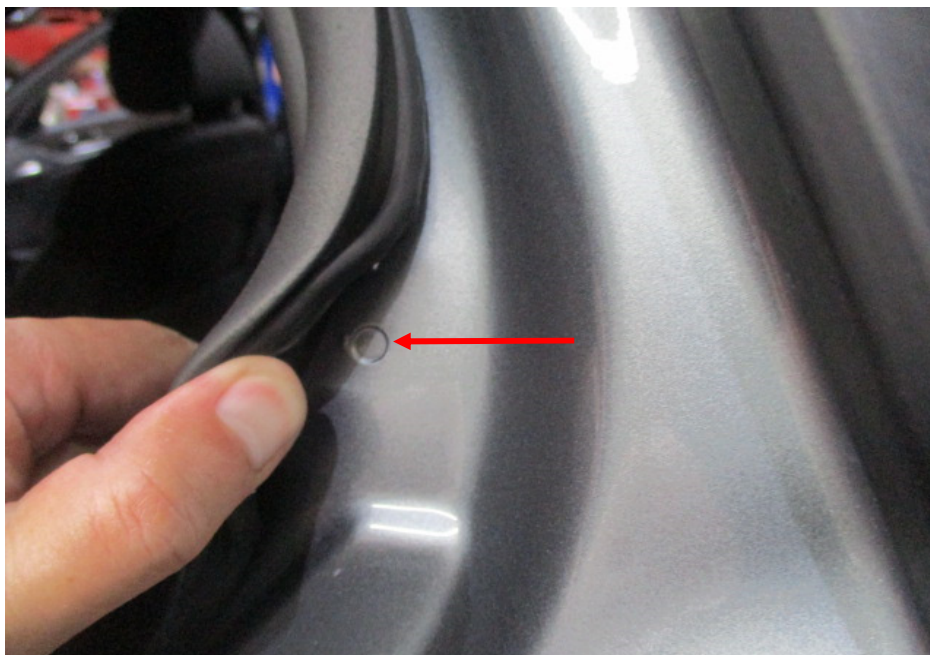
**Photo 26** shows the left side "C" pillar of the Motor Car. I did not find any weld marks other than original spot weld marks (arrowed) on the left side "C" pillar of the Motor Car which, indicates that there was no re-welding works carried out. In general, I had found all the non-detachable body panels of the Motor Car to be originally fitted at the time of my inspection.
