Your Ref : 6387540799SG
Our Ref : CC4/AIG21006445/P

2nd July 2021

**AUTOMOBILE TECHNICAL INVESTIGATION REPORT OF ACCIDENT
INVOLVING SLJ 9098P AND SMK 2953A ON 4 JUNE 2021**

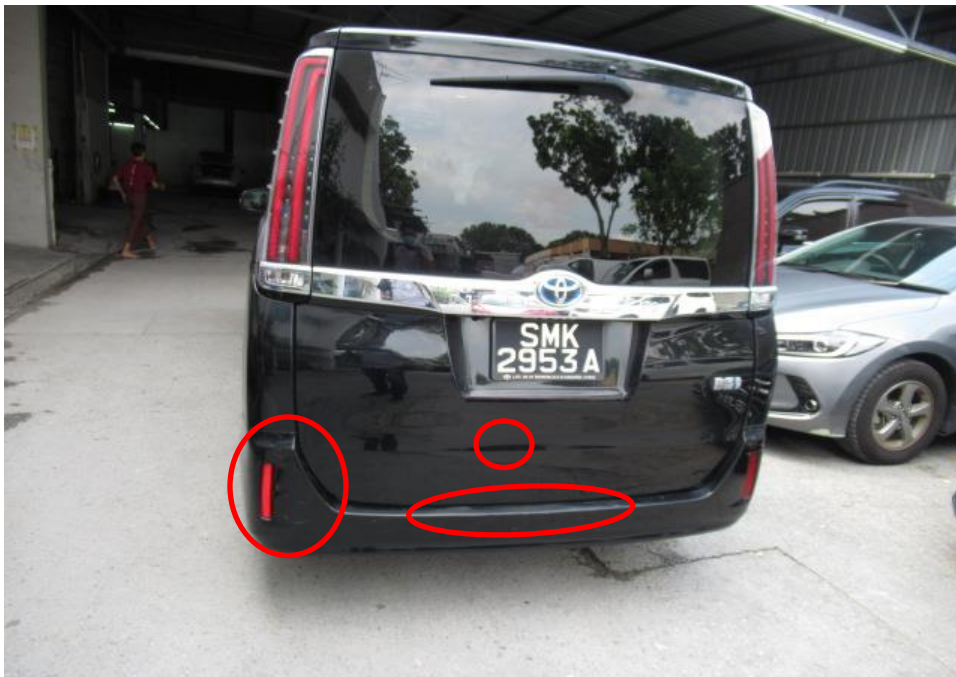
Photo 1 shows the general view of the rear portion of Toyota at the time of inspection. The rear bonnet and bumper had been damaged. It was also noted that there were paint crack marks and dents (circled) on the rear bumper of Toyota.

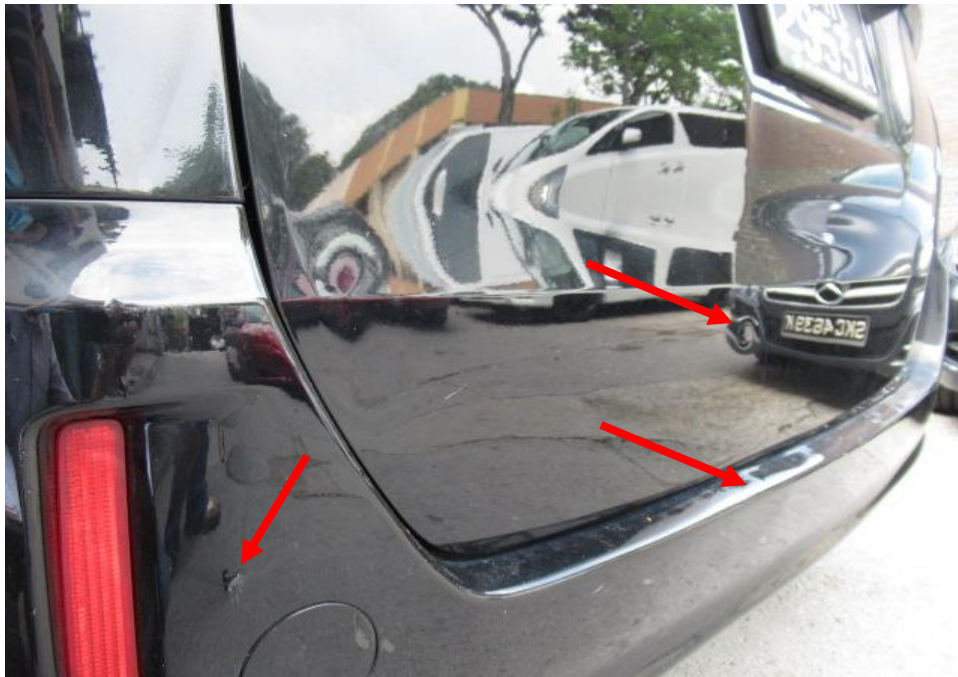
Photo 2 shows a close up view of the rear portion of the Toyota. We noted that there were dent marks on the rear bonnet and rear bumper (arrowed).

19. The damages on Toyota as compared to Mercedes is not consistent as the area of damage marks on the Toyota is of a different area as compared to the marks on Mercedes. Refer to photos 2 to 6 for Toyota and photos 9 to 15 of Mercedes above.
20. Both damages are not corresponding to their respective heights and inconsistent to their nature of contact.

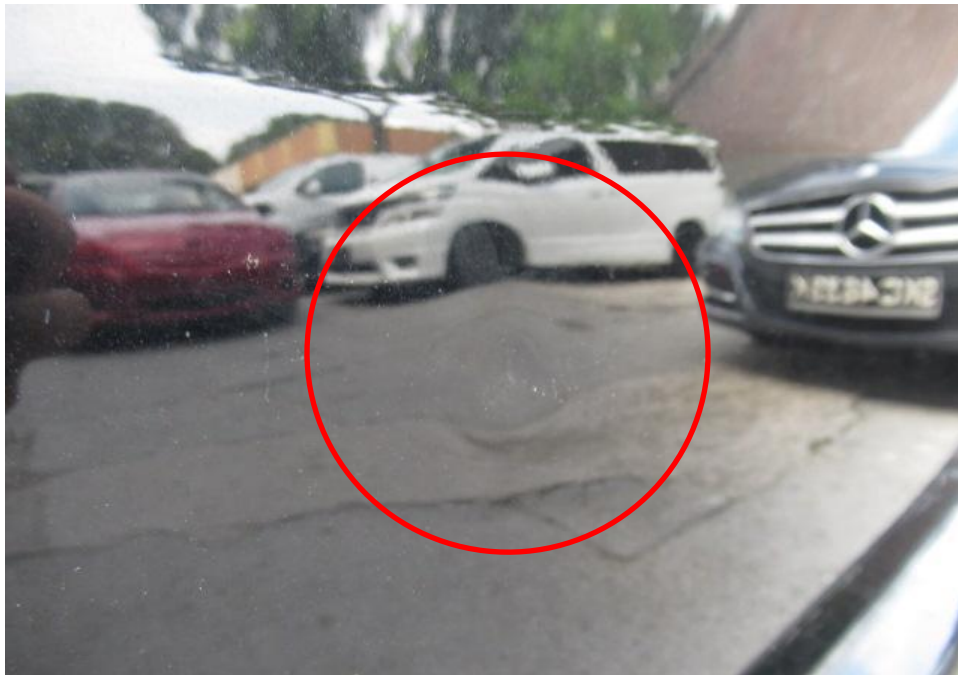
Photo 3 shows a close up view of the rear portion of the Toyota. We noted that there were dent marks on the rear bonnet (circled).

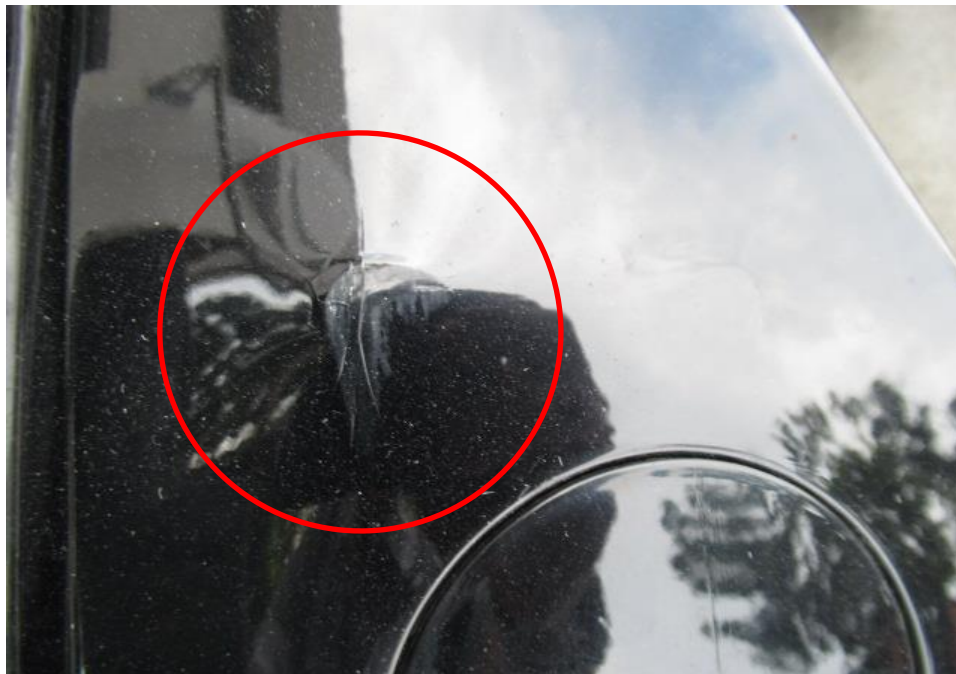
Photo 4 shows a close up view of the rear portion of the Toyota. We noted that there were dent and paint crack marks on the rear bumper (circled).

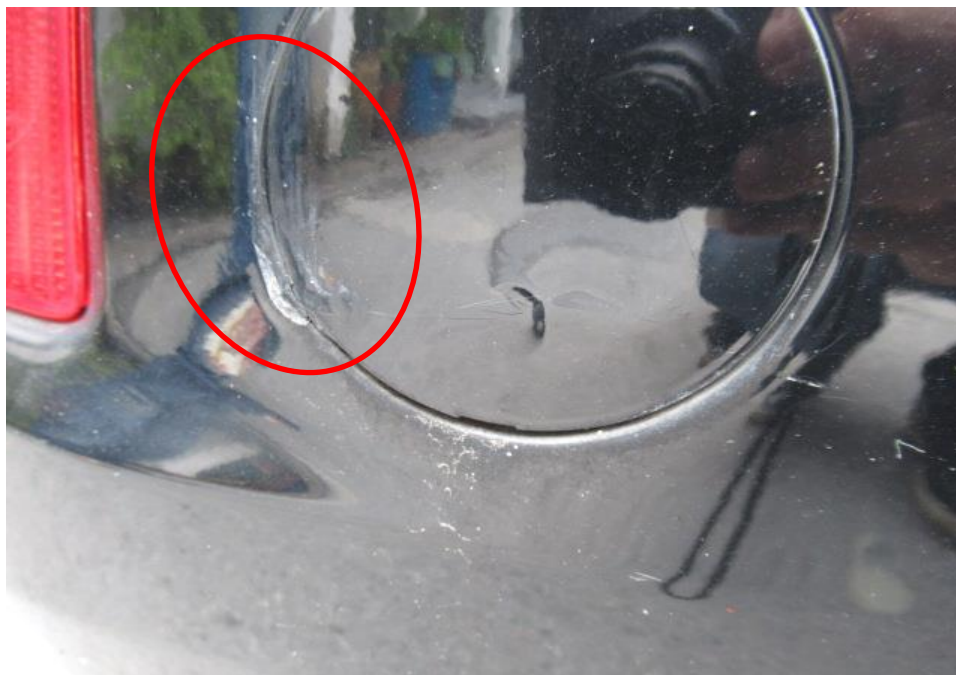
Photo 5 shows a close up view of the rear portion of the Toyota. We noted that there were paint dent and crack marks on the tow hook cap of the rear bumper (circled).

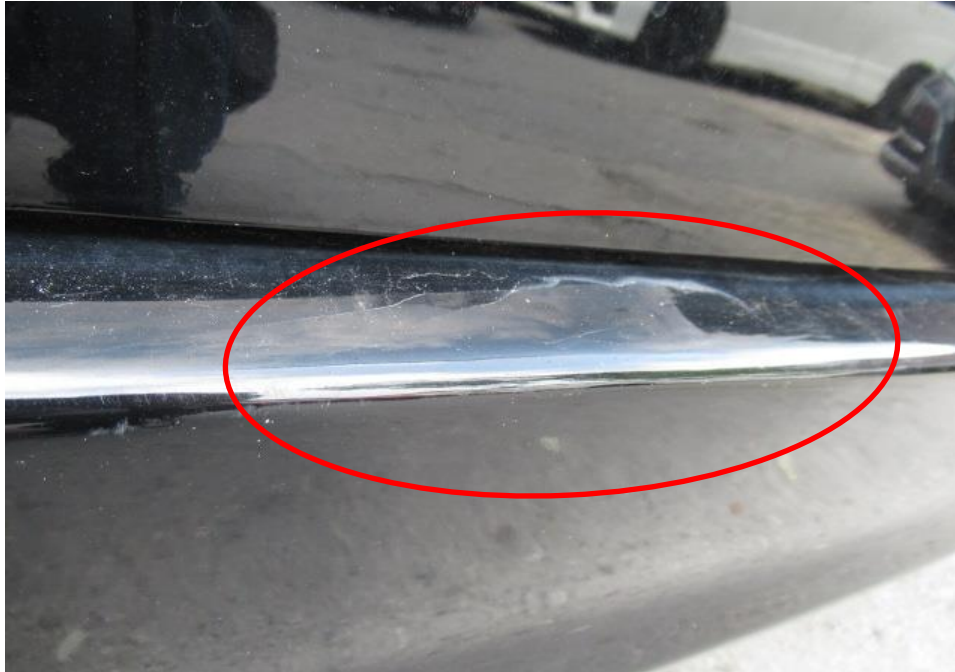
Photo 6 shows a close up view of the rear portion of the Toyota. We noted that there were paint crack marks on the rear bumper (circled).

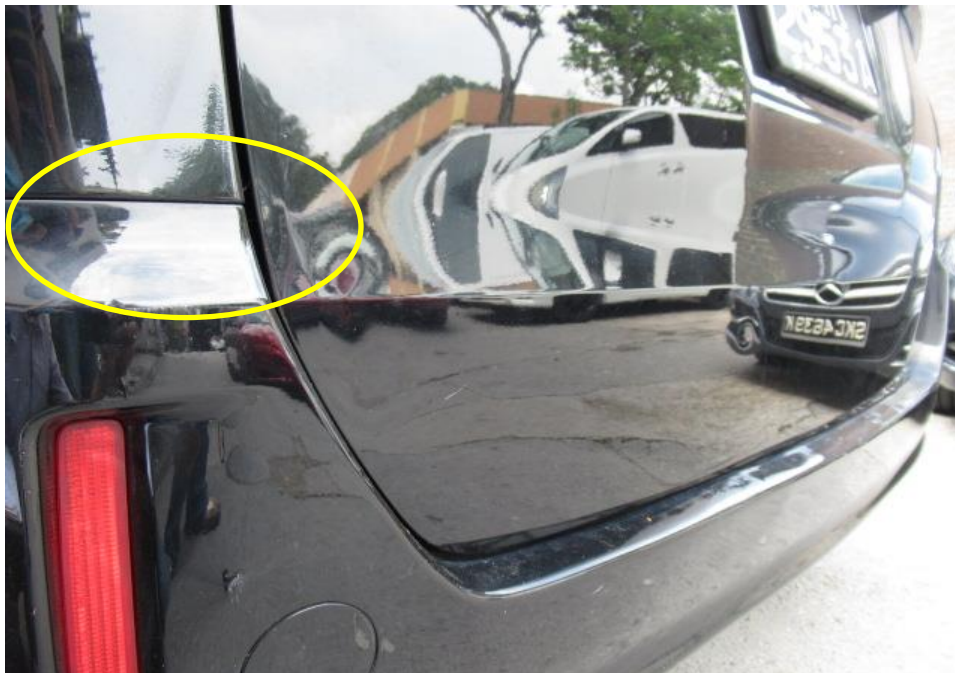
Photo 7 shows a close up view of the rear portion of the Toyota. We note that there was neither dislodgement nor misalignment of the rear bumper at the rear portion (circled) of Toyota.

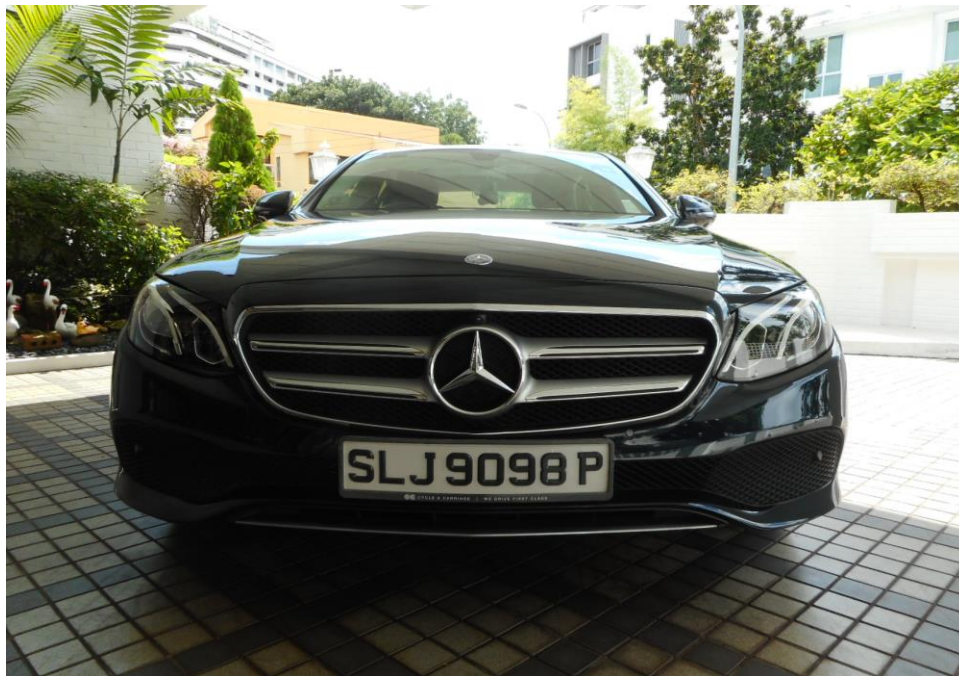
Photo 8 shows the general view of the front portion of Mercedes at the time of our inspection.

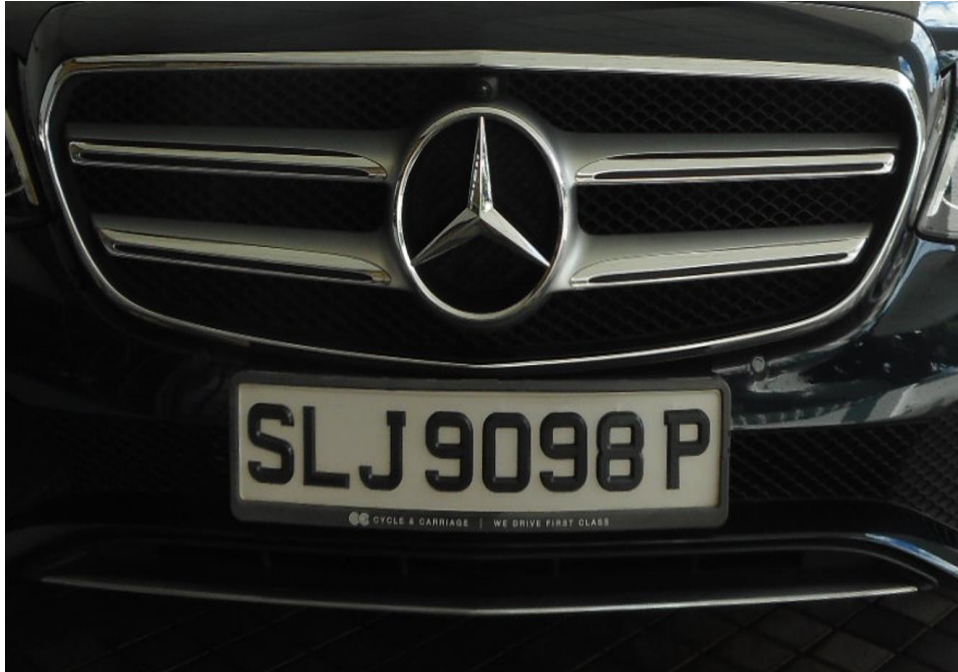
Photo 9 shows a close up view of the Mercedes front number plate. There were no cracks or dents observed.

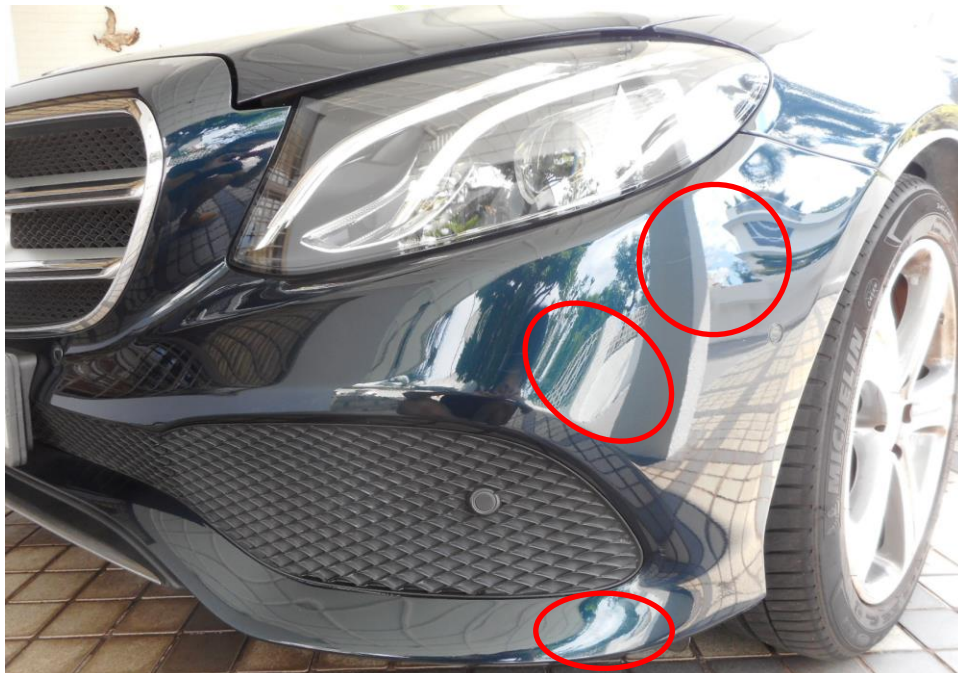
Photo 10 shows a general view of the Mercedes front portion. We observed multiple groups of scratch marks on the left corners of its front bumper (circled).

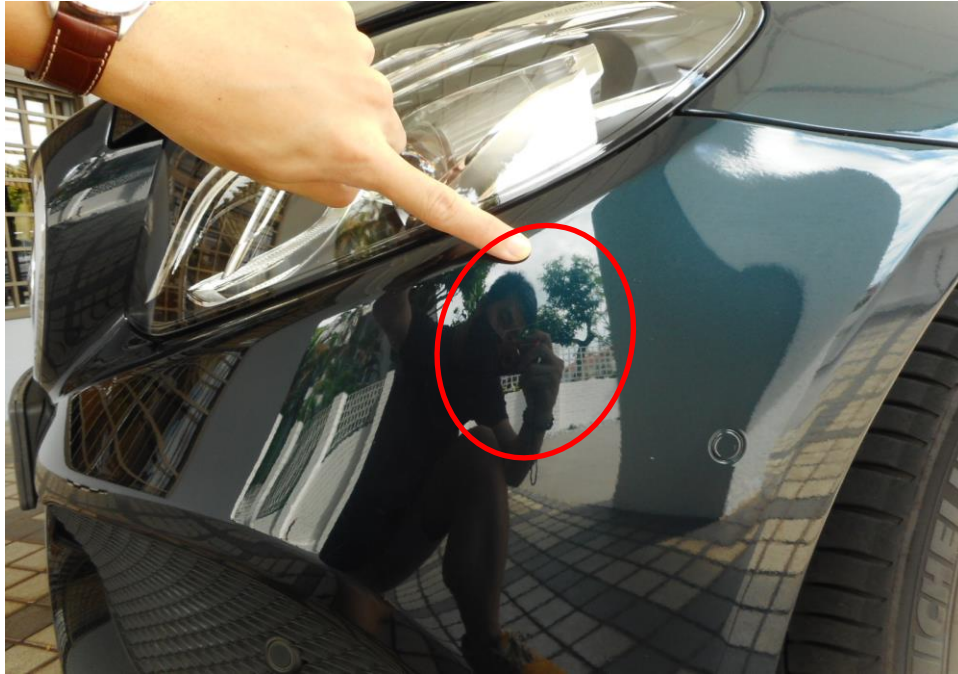
Photo 11 shows a close up view of the Mercedes front portion. We observed multiple groups of scratch marks on the left corners of its front bumper (circled).

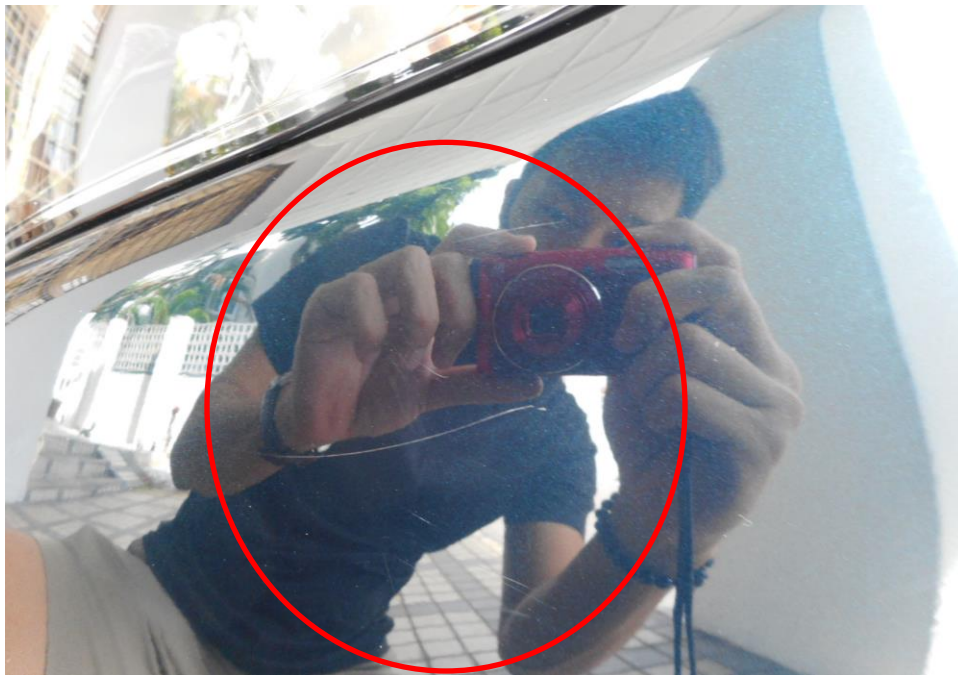
Photo 12 shows a close up view of the Mercedes front portion. We observed multiple groups of scratch marks on the left corners of its front bumper (circled).

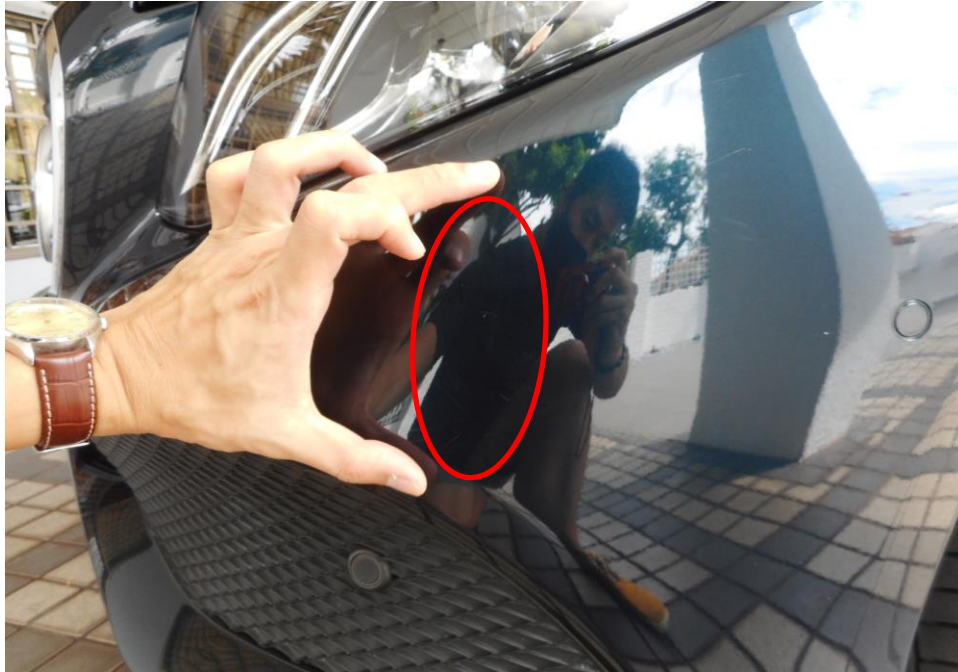
Photo 13 shows a close up view of the Mercedes front portion. We observed multiple groups of scratch marks on the left corners of its front bumper (circled).

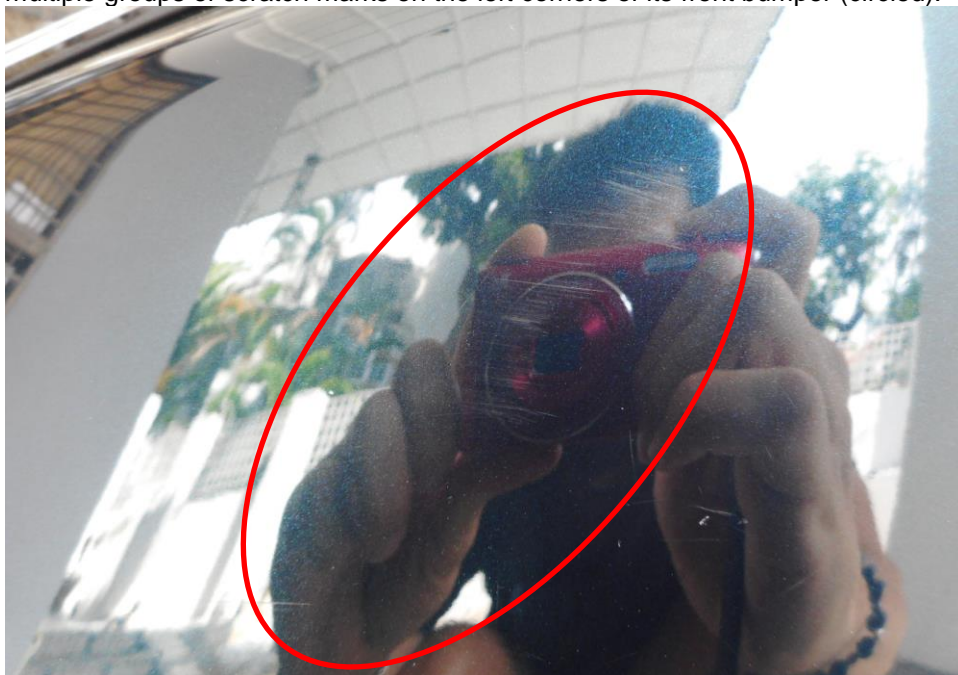
Photo 14 shows a close up view of the Mercedes front portion. We observed multiple groups of scratch marks on the left corners of its front bumper (circled).

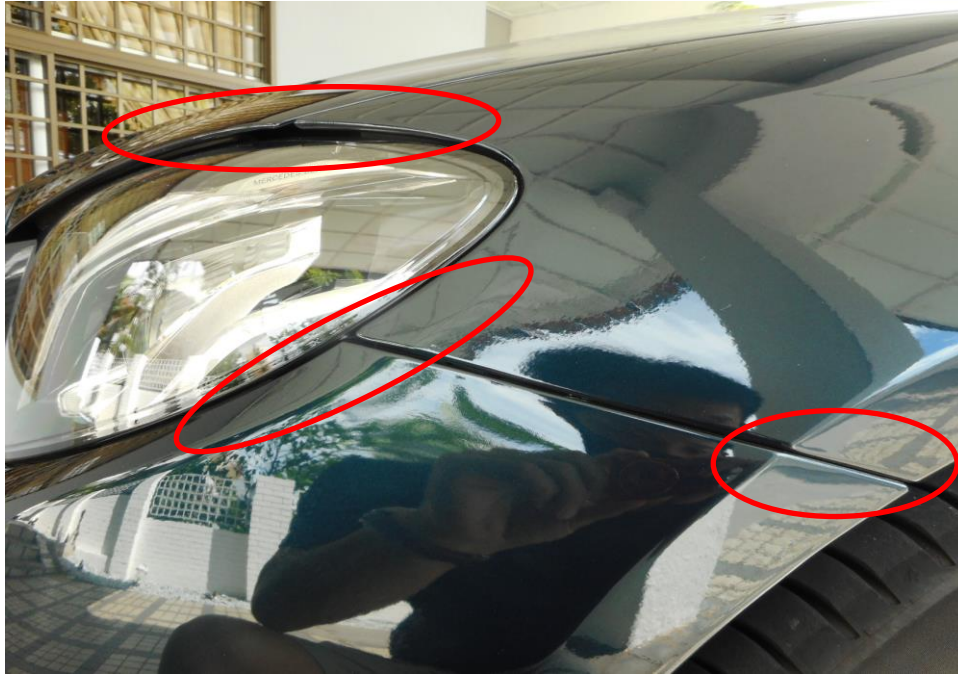
Photo 15 shows a close up view of the front portion of the Mercedes. We note that there was neither dislodgement nor misalignment of the front bumper at the front portion (circled) of Mercedes.

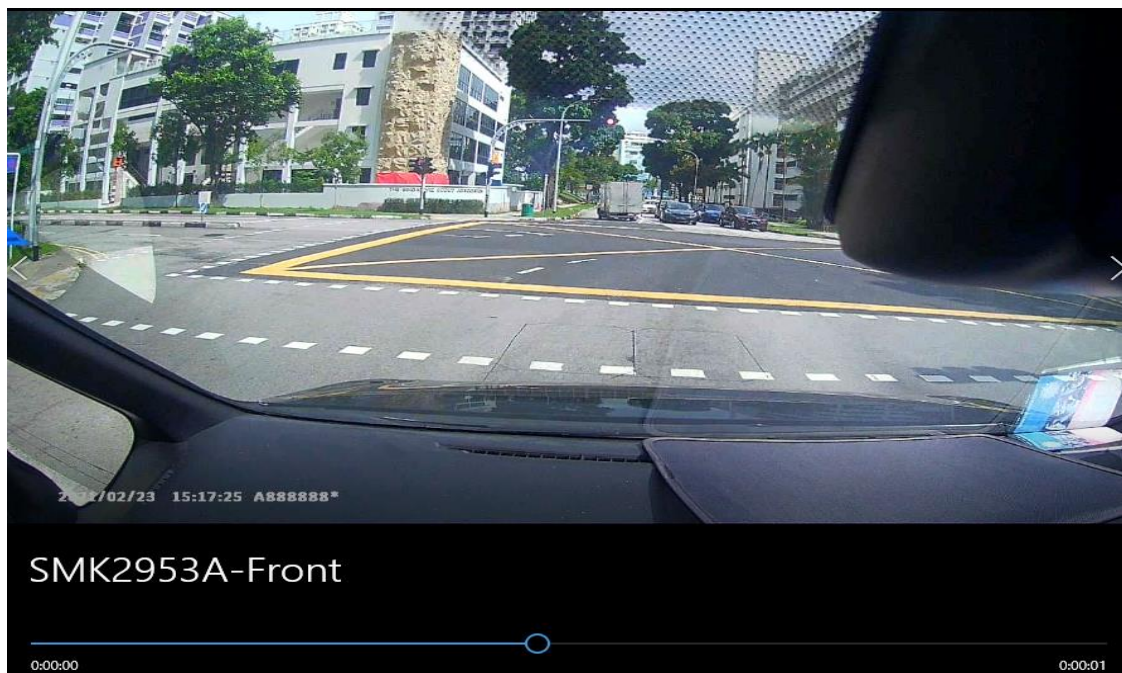
Screenshot 1 shows at the 1 second mark of the front video recording, we had noted that there was a jerking movement on the Toyota. However, we are in view that the jerk was caused by the closing of door after the driver of the Toyota had alighted the vehicle. However one would have to view the recordings to see and hear the movements and audio warnings.

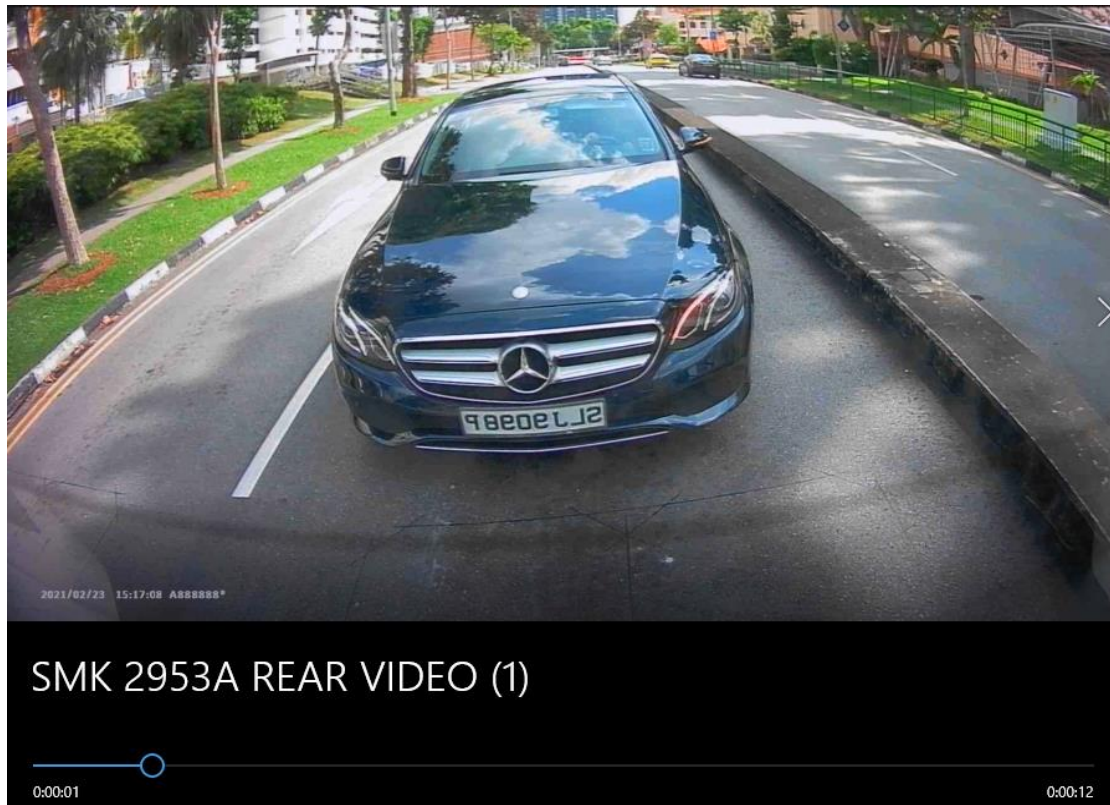
Screenshot 2 shows at the rear video recording, we had noted that Mercedes was travelling behind Toyota when the Toyota was stationary.

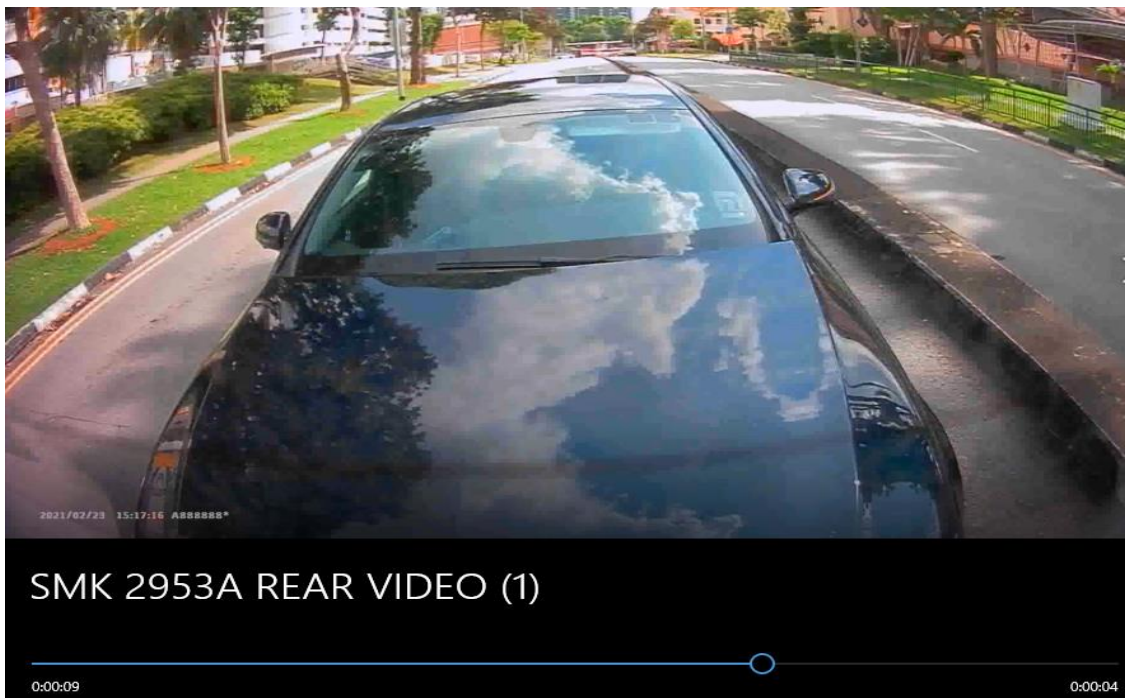
Screenshot 3 shows at the 8 to 9 second mark we noticed a jerk on the Toyota and this is where the Mercedes had driven into the rear of the Toyota and where the said collision might have taken place. However one would have to view the recordings to see and hear the movements and audio warnings.

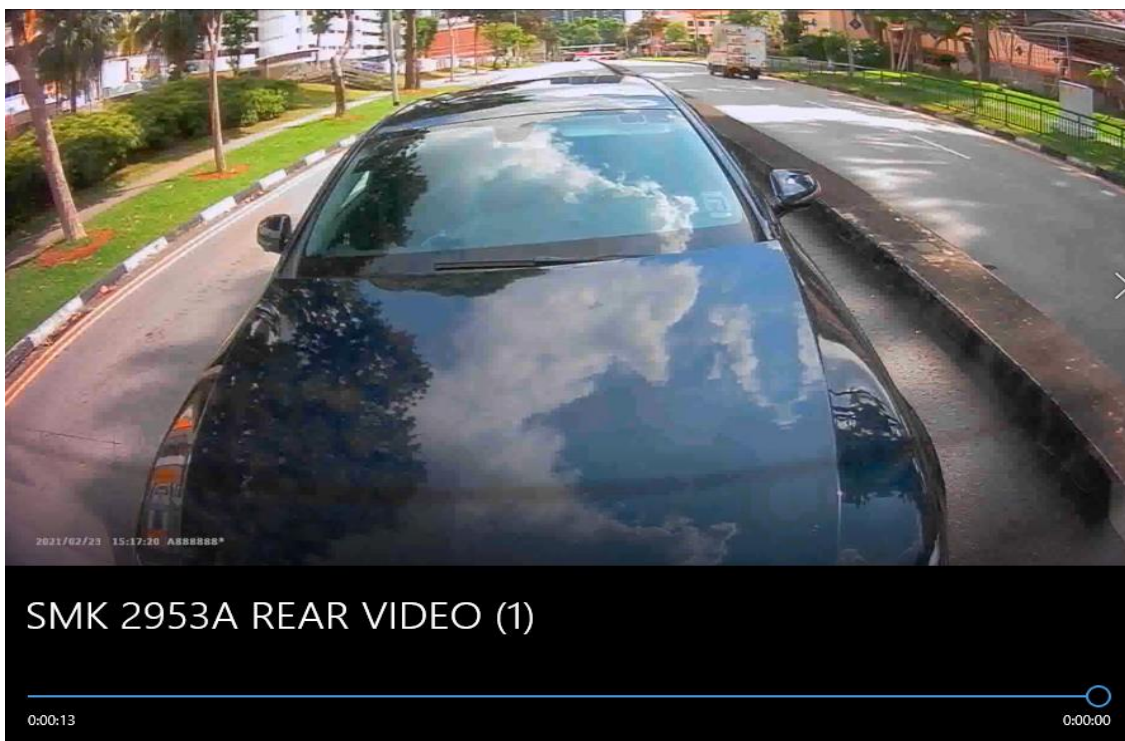
Screenshot 4 shows at the 11 to 13 second mark from the rear recordings, we noticed that the Mercedes had attempted to reverse. However one would have to view the recordings to see and hear the movements and audio warnings.

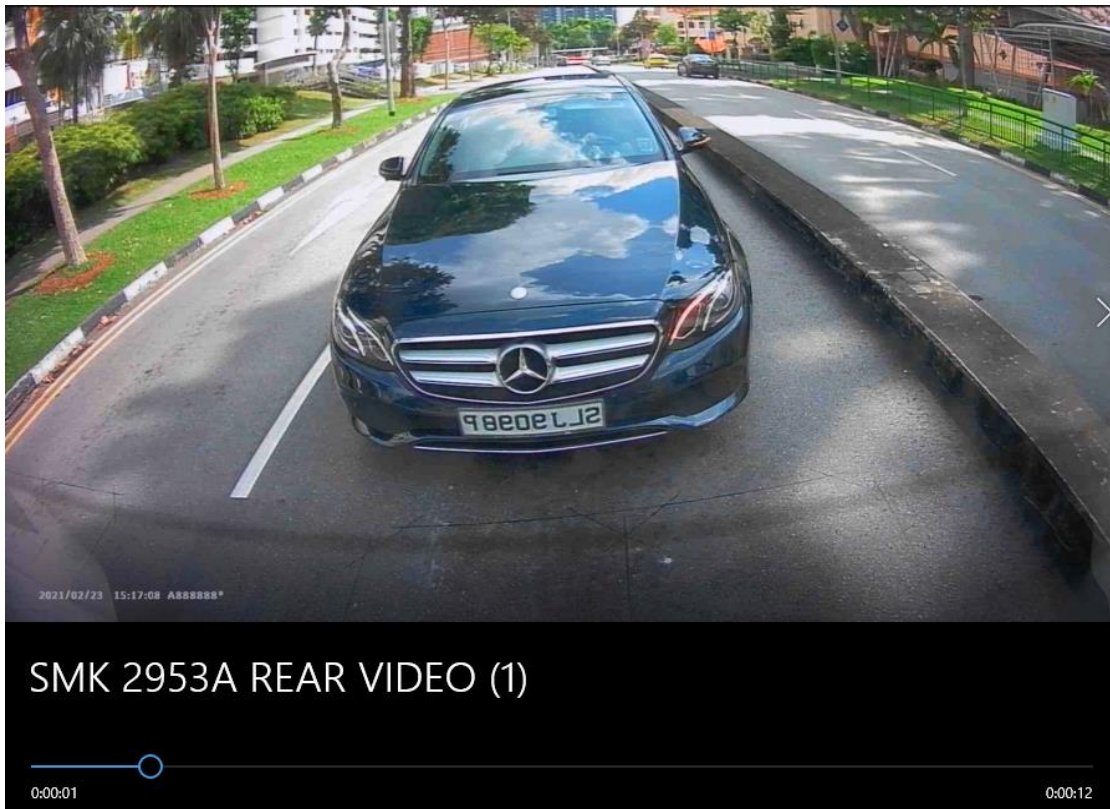
Screenshot shows the position of the Involved Motor Cars at the material time of accident. The Mercedes was observed to be directly behind the rear of the Toyota. In such a position, the front number plate of the Mercedes would have come into contact with the rear centre portion of the Toyota as the front number plate was the most protruded body part at the frontal portion of the Mercedes.

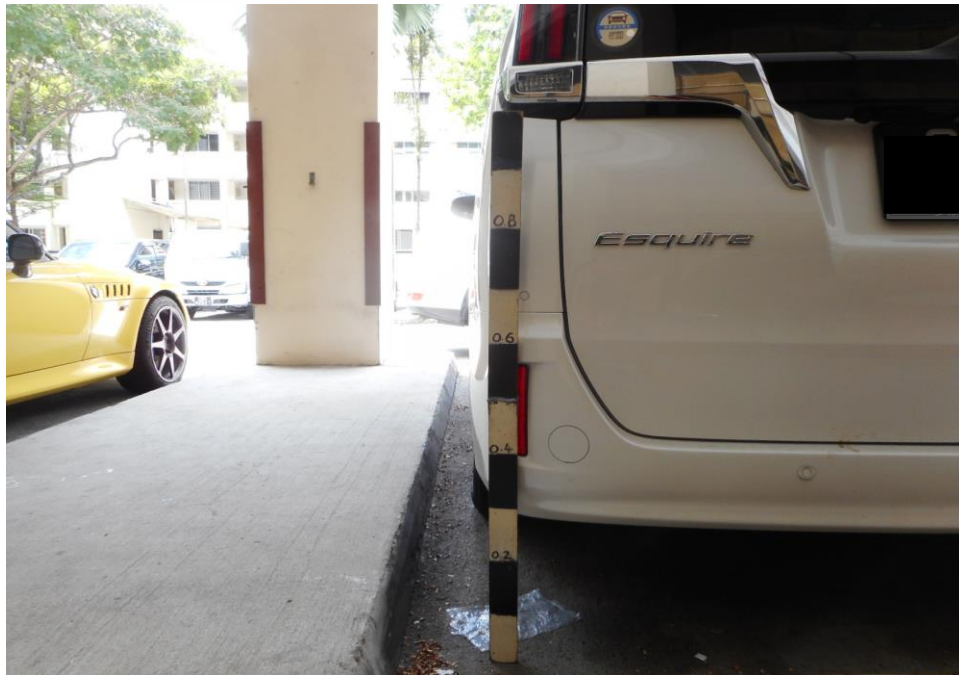
Photo 16 shows the general view of the height measurement being conducted on the rear portion of Toyota. The height above ground level of where the dent and crack marks were found to the rear bonnet and rear bumper of the Toyota was at 60cm; 47cm, 42cm and 40cm respectively.

- a) the height above ground level of the range of damages (which included the dents and crack marks on the rear portion rear bonnet and rear bumper of Toyota) was measured to be at 60cm; 47cm, 42cm and 40cm respectively.

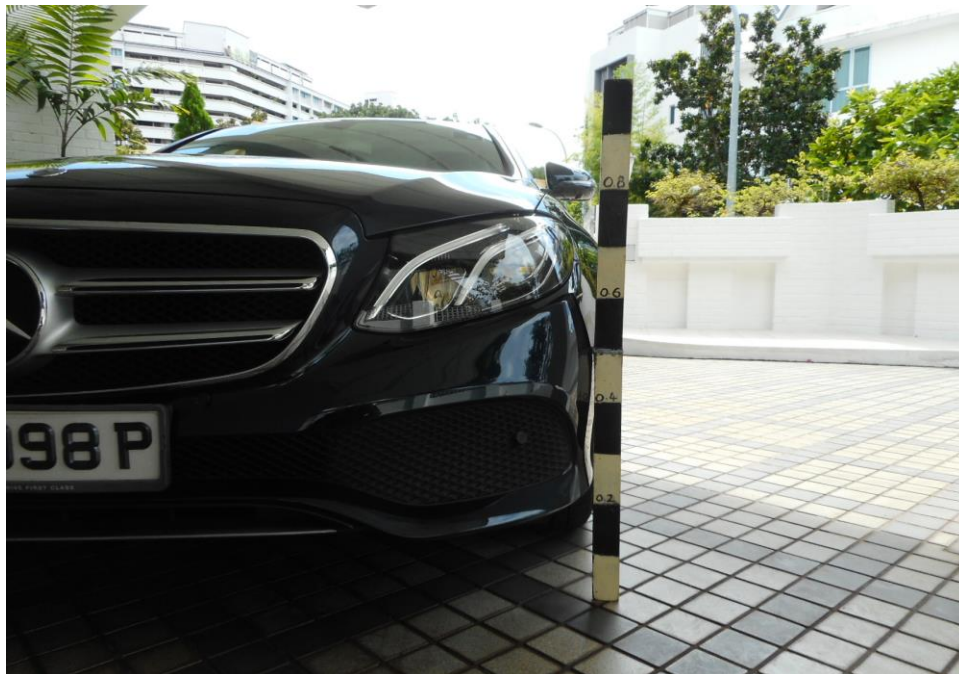
Photo 17 shows a general view of the height measurement being conducted on the front portion of Mercedes. The scratch marks found on the front bumper left corner was measured to be at 58cm to 60cm, 41cm to 56cm and 23cm to 28cm above ground level.

- c) the height above ground level of the scratch marks that we observed on the front portion front bumper left corner of the Mercedes was measured to be at 58cm to 60cm, 41cm to 56cm and 23cm to 28cm respectively;

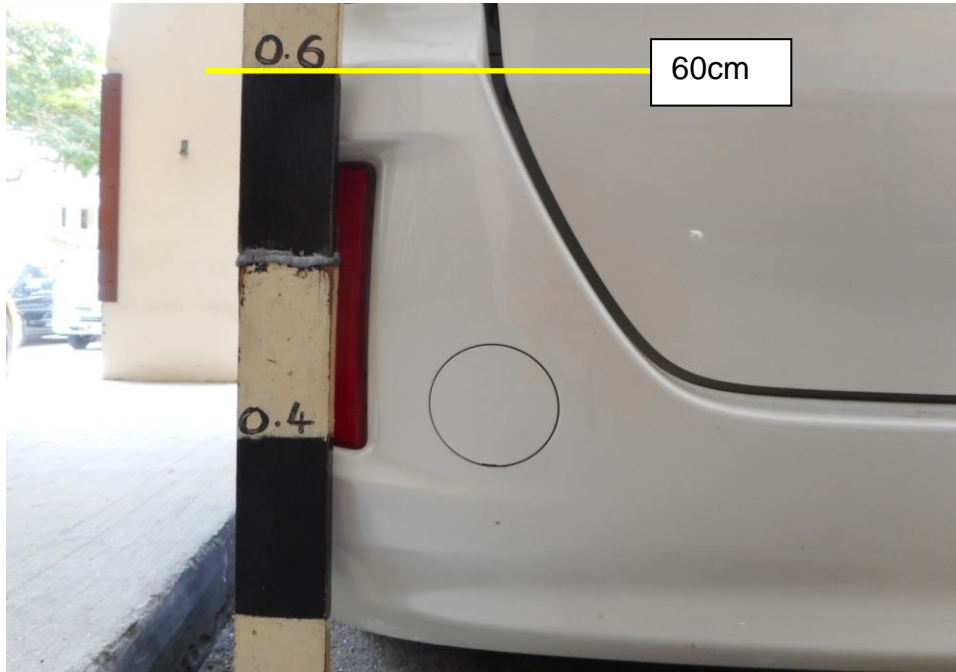
Photo 18 shows the close up view of the height measurement being conducted on the rear portion of Toyota. The height above ground level of where the dent marks were found on the rear bonnet of the Toyota was at 60cm.

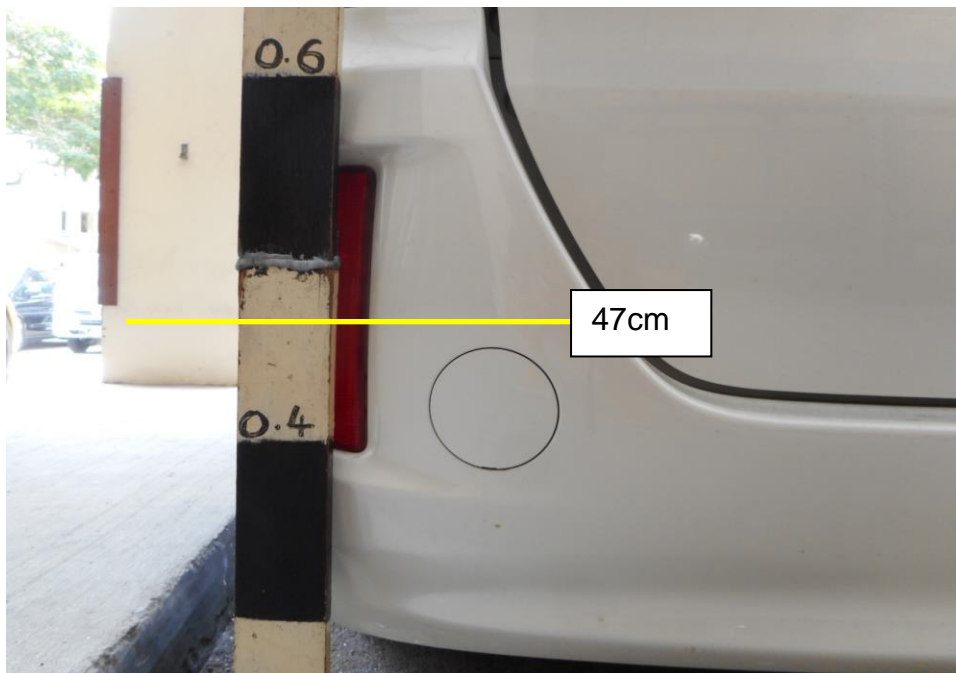
Photo 19 shows the close up view of the height measurement being conducted on the rear portion of Toyota. The height above ground level of where the dent and paint crack marks were found to the rear bumper of the Toyota was at 47cm.

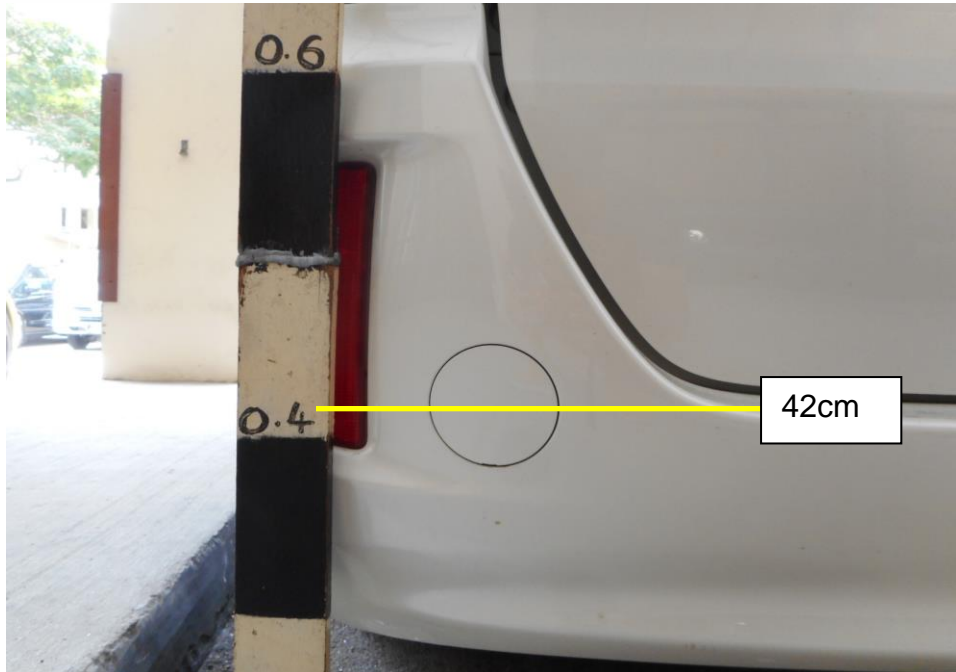
Photo 20 shows the close up view of the height measurement being conducted on the rear portion of Toyota. The height above ground level of where the paint dent crack marks were found to the rear bumper of the Toyota was at 42cm.

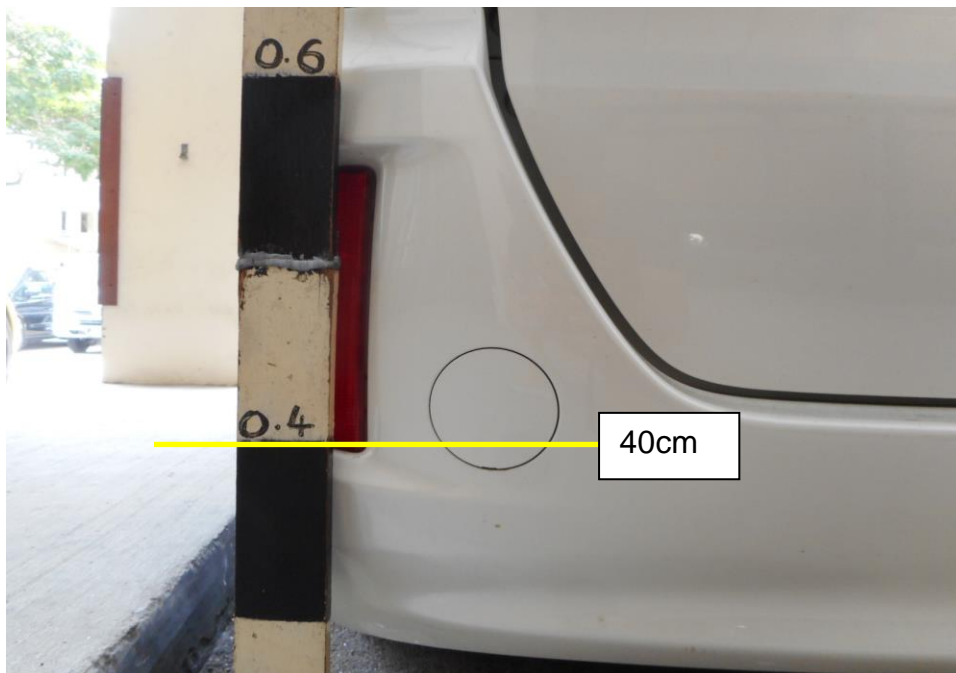
Photo 21 shows the close up view of the height measurement being conducted on the rear portion of Toyota. The height above ground level of where the paint scratch marks were found to the rear bumper tow hook cover of the Toyota was at 40cm.

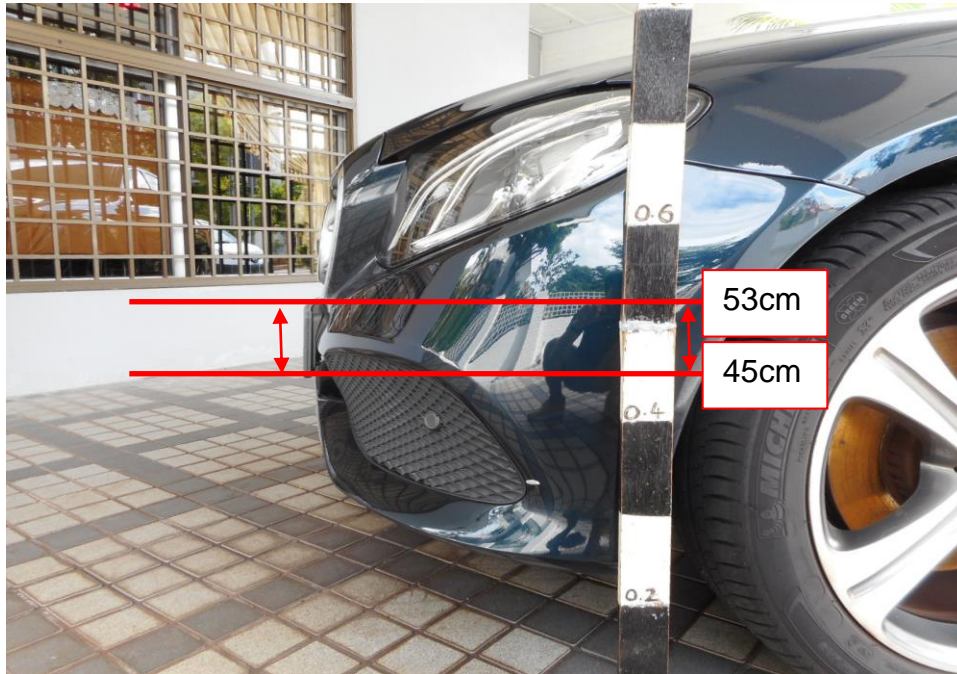
Photo 22 shows the close up view of the height measurement being conducted on the front portion of Mercedes. The front number plate was measured to be between 45cm to 53cm above ground level.

- b) the height measurements above ground level of the front number plate on the front portion front bumper of the Mercedes was measured to be at 45cm to 53cm respectively;

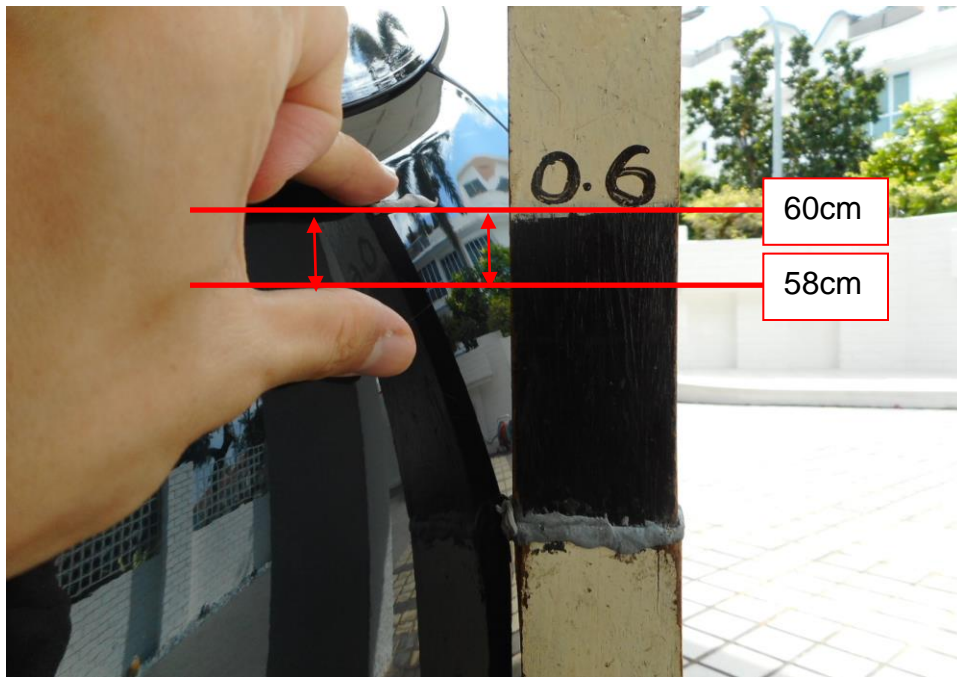
Photo 23 shows the close up view of the height measurement being conducted on the front portion of Mercedes. The scratch marks found on the front bumper left corner was measured to be between 58cm to 60cm above ground level.

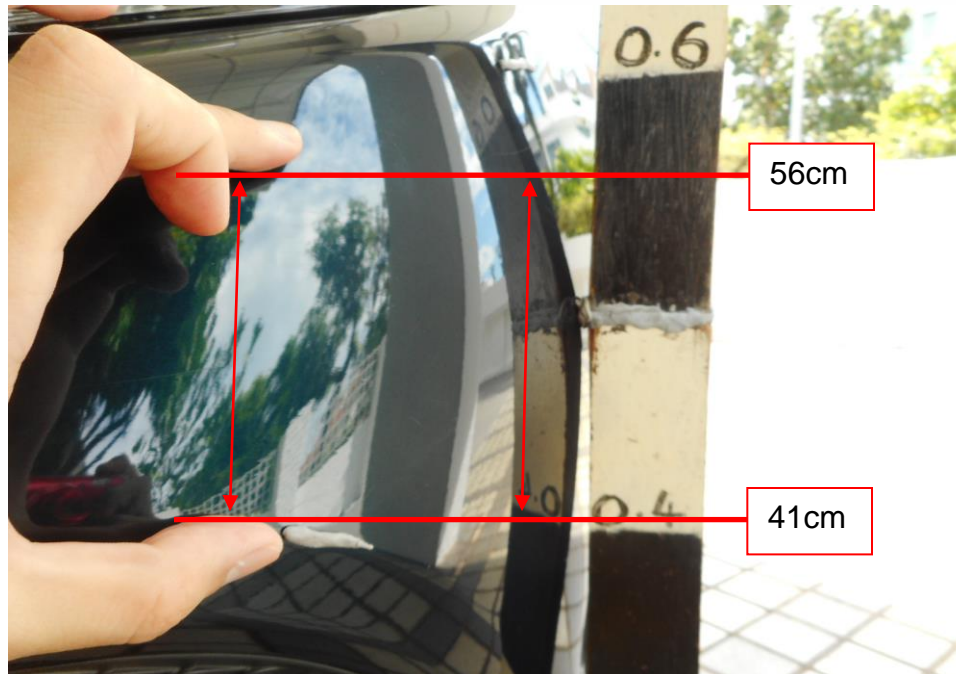
Photo 24 shows the close up view of the height measurement being conducted on the front portion of Mercedes. The scratch marks found on the front bumper left corner was measured to be between 41cm to 56cm above ground level.

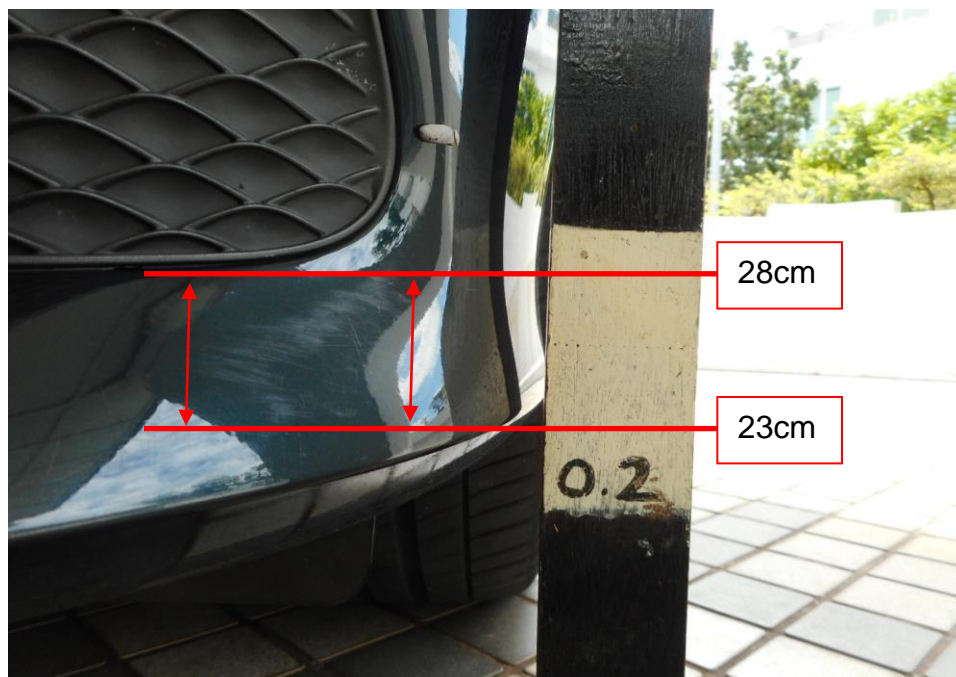
Photo 25 shows the close up view of the height measurement being conducted on the front portion of Mercedes. The scratch marks found on the front bumper left corner was measured to be between 23cm to 28cm above ground level.
