Your Ref: SGN 1005Z
Our Ref : CI/TP21006625/D

AUTOMOBILE INSPECTION REPORT OF MOTOR CAR SGN 1005Z

Vehicle Registration No.	: SGN 1005Z
Make / Model	: Honda Integra 2.0A
Chassis No	: JHMDC54506S200272
Year of Registration	: 2005 (Dec)
Mileage	: 130,744km

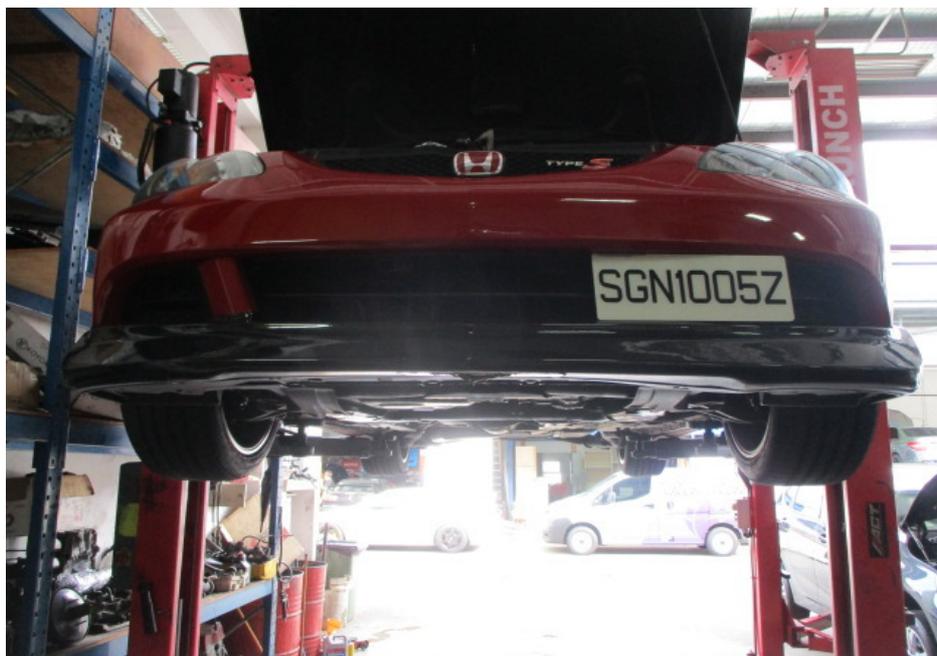
Photo 1 shows the Motor Car hoisted up at the time of my inspection. The mileage of the Motor Car recorded was 130,744km.

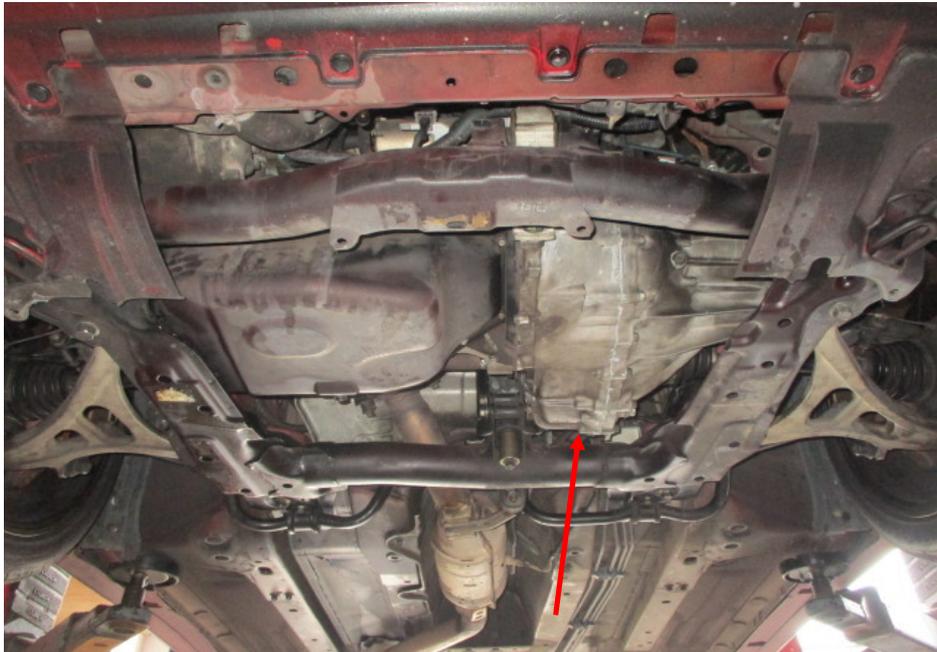
Photo 2 shows a general view of the transmission (arrowed) that was fitted on the Motor Car. The input side of the transmission is bolted to the crankshaft side of the engine block. The left and right drive shafts were observed to be securely fitted from the main shaft, located inside the transmission, to the front left wheel and front right wheel respectively. There was also no crack and/or hole observed on the transmission housing.

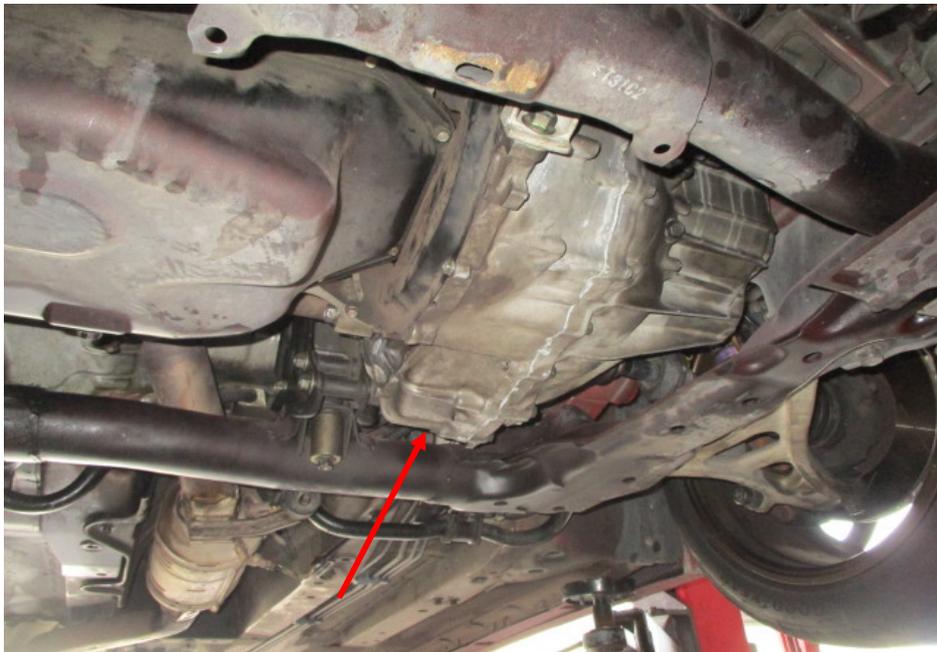
Photo 3 shows another view of the transmission (arrowed) that was fitted on the Motor Car. The input side of the transmission is bolted to the crankshaft side of the engine block. There was no crack and/or hole observed on the transmission housing.

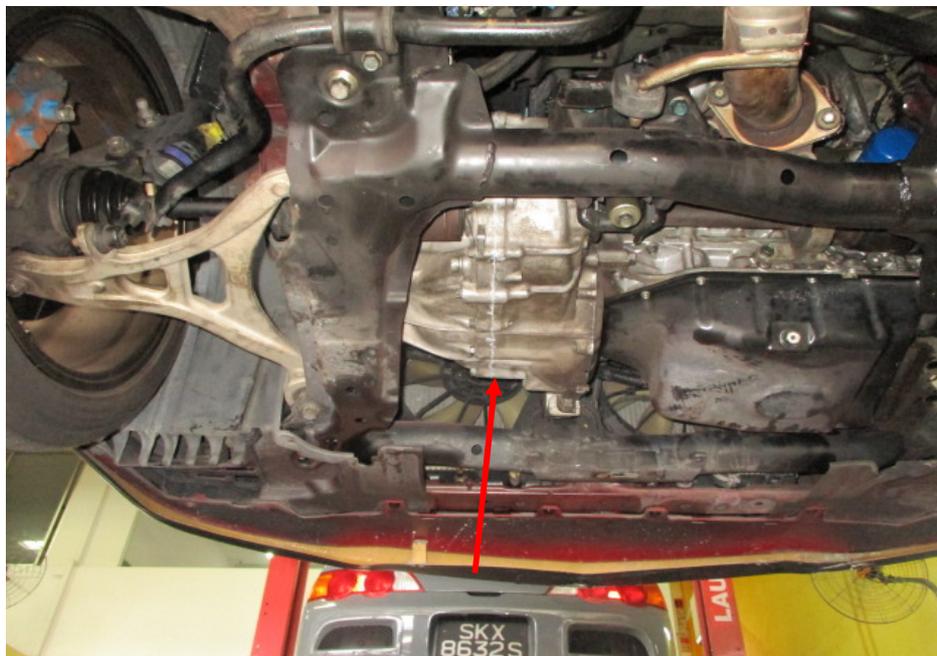
Photo 4 shows another view of the transmission (arrowed) that was fitted on the Motor Car, as viewed from the rear to front perspective of the Motor Car. There was no crack and/or hole observed on the transmission housing.

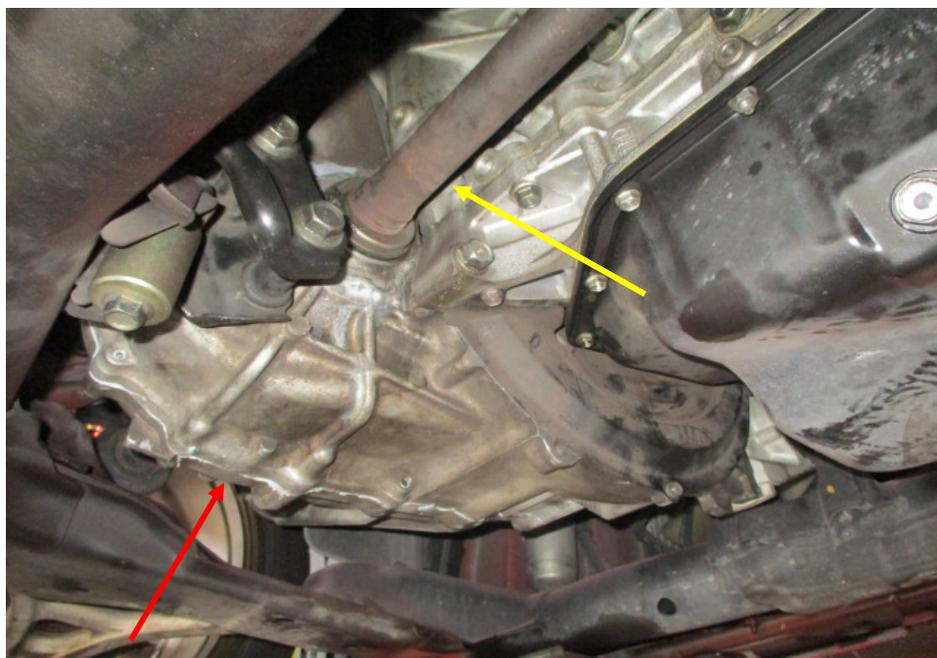
Photo 5 shows a general view of the transmission (red arrow) that was fitted on the Motor Car, as viewed from the rear right to front left perspective of the Motor Car. There was no crack and/or hole observed on the transmission housing. The left and right drive shafts were observed to be securely fitted from the main shaft, located inside the transmission, to the front left wheel and front right wheel respectively. The right drive shaft is highlighted by the yellow arrow.

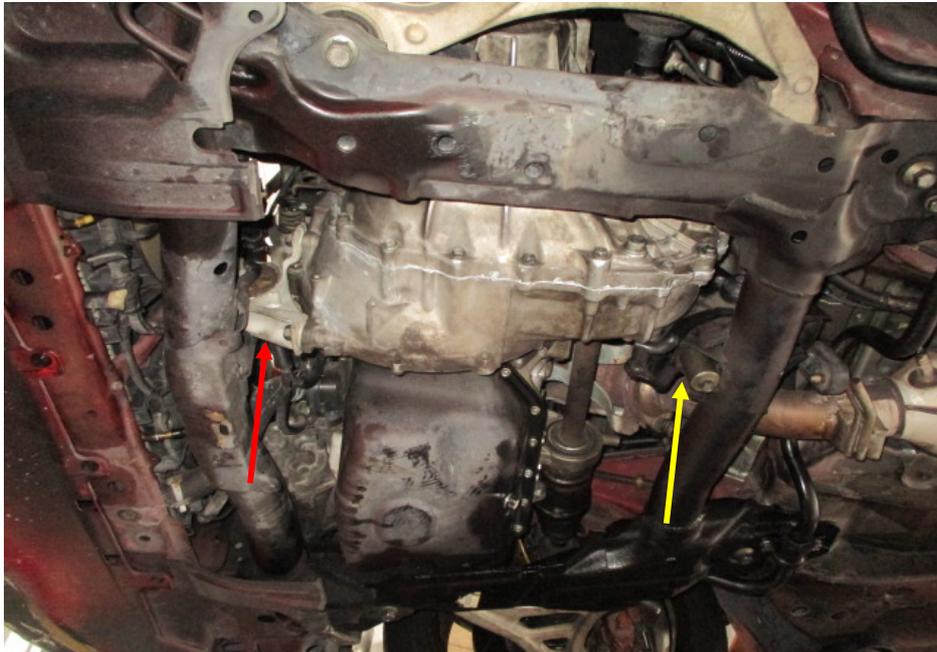
Photo 6 shows a general view of the transmission that was fitted on the Motor Car, as viewed from the left to right perspective of the Motor Car. The transmission of the Motor Car was supported by 3 brackets. One bracket at the front of the transmission, one bracket at the rear of the transmission and one bracket at the left side of the transmission. The brackets at the front (red arrow) and rear (yellow arrow) of the transmission were mounted onto the engine cross member.

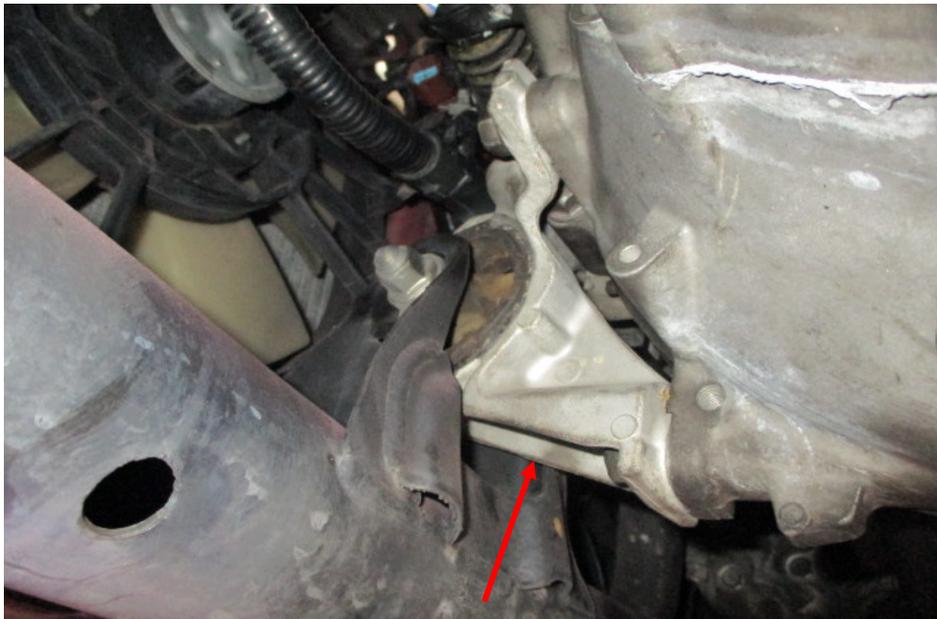
Photo 7 shows the bracket (arrowed) supporting the front of the Motor Car's transmission. This bracket was mounted onto the engine cross member. The bracket was with rubber bushing that absorbs any vibrations arising from the rotation of the transmission gears, minimising any stress to the bracket and correspondingly also minimise any stress to the engine crossmember.

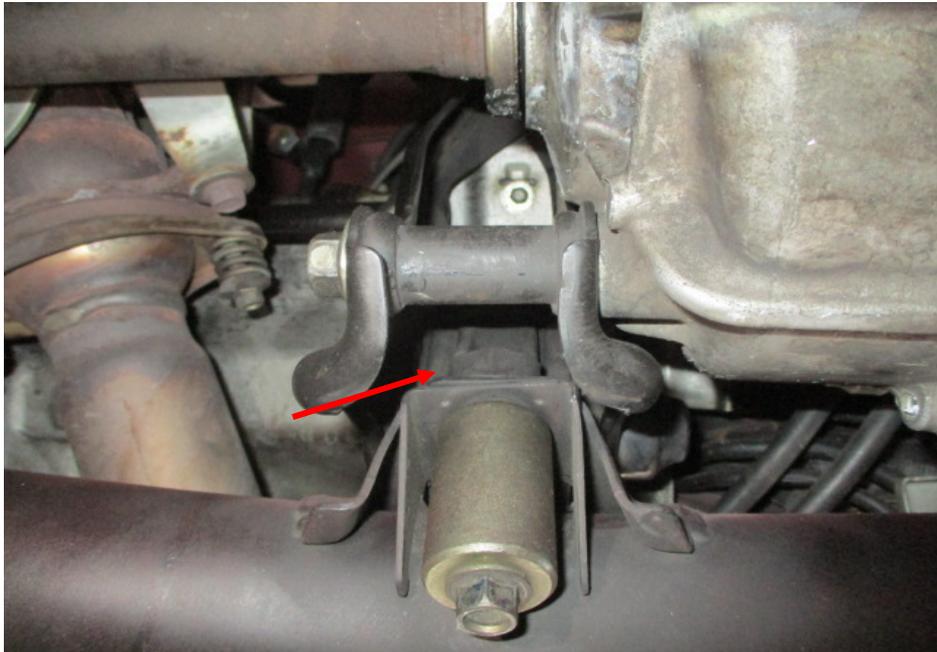
Photo 8 shows the bracket supporting the rear of the Motor Car's transmission. This bracket was mounted onto the engine cross member. The bracket was with rubber bushing (arrowed) that absorbs any vibrations arising from the rotation of the transmission gears, minimising any stress to the bracket and correspondingly also minimise any stress to the engine crossmember.

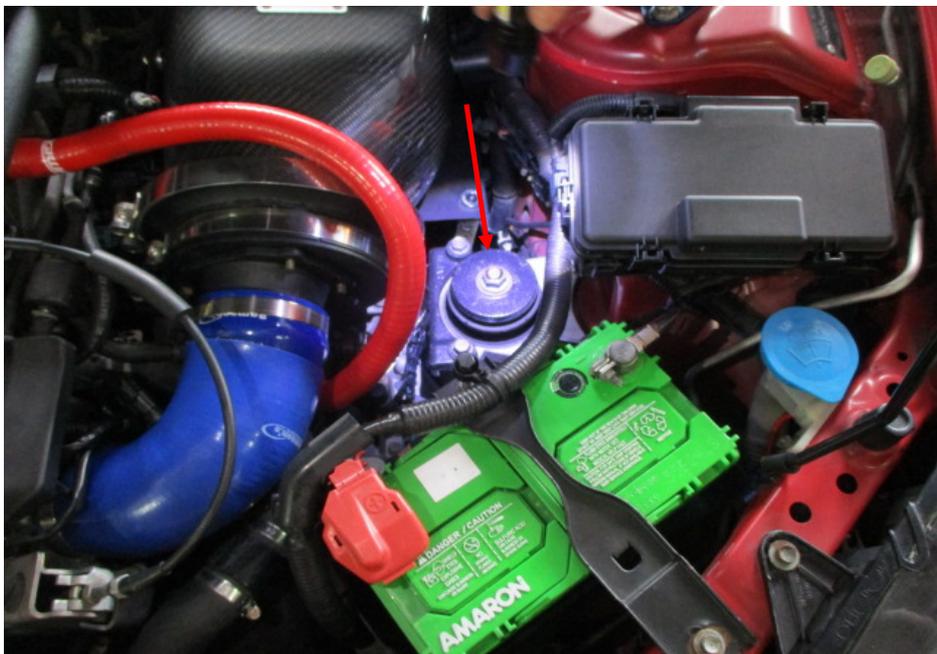
Photo 9 shows the bracket (arrowed) supporting the left side of the Motor Car's transmission. This bracket was mounted onto the left side front chassis, adjacent to the left side front wheelhouse. The bracket was with rubber bushing that absorbs any vibrations arising from the rotation of the transmission gears, minimising any stress to the bracket and correspondingly also minimise any stress to the left side front chassis member.

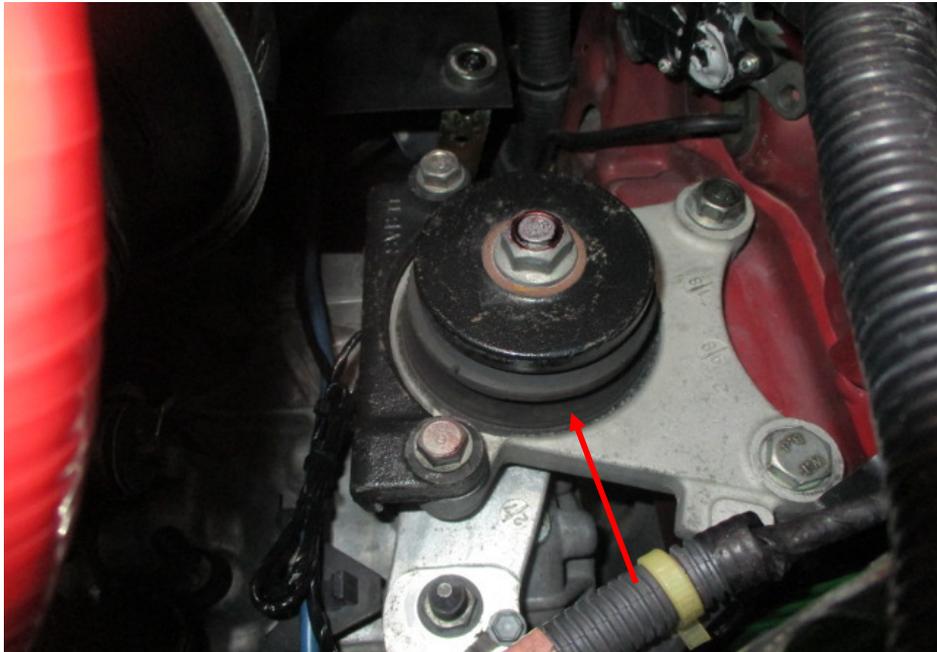
Photo 10 shows a closer view of the bracket supporting the left side of the Motor Car's transmission. This bracket was mounted onto the left side front chassis, adjacent to the left side front wheelhouse. The bracket was with rubber bushing (arrowed) that absorbs any vibrations arising from the rotation of the transmission gears, minimising any stress to the bracket and correspondingly also minimise any stress to the left side front chassis member.

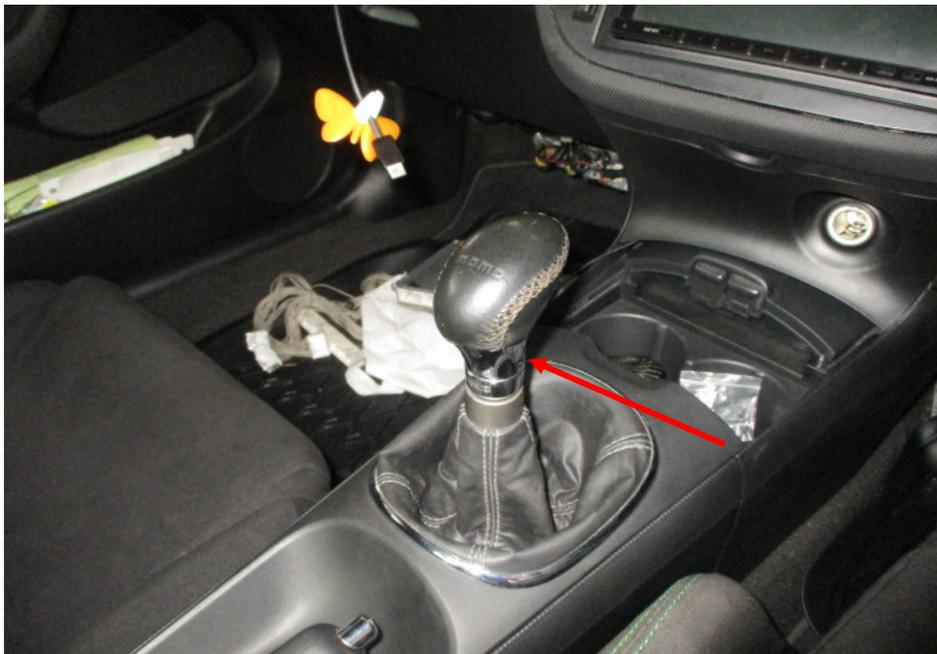
Photo 11 shows the gear shifter (arrowed) that was fitted on the Motor Car, for manually selecting the transmission gear to be engaged. The gear selector fork from the transmission of the Motor Car connects to this gear shifter.

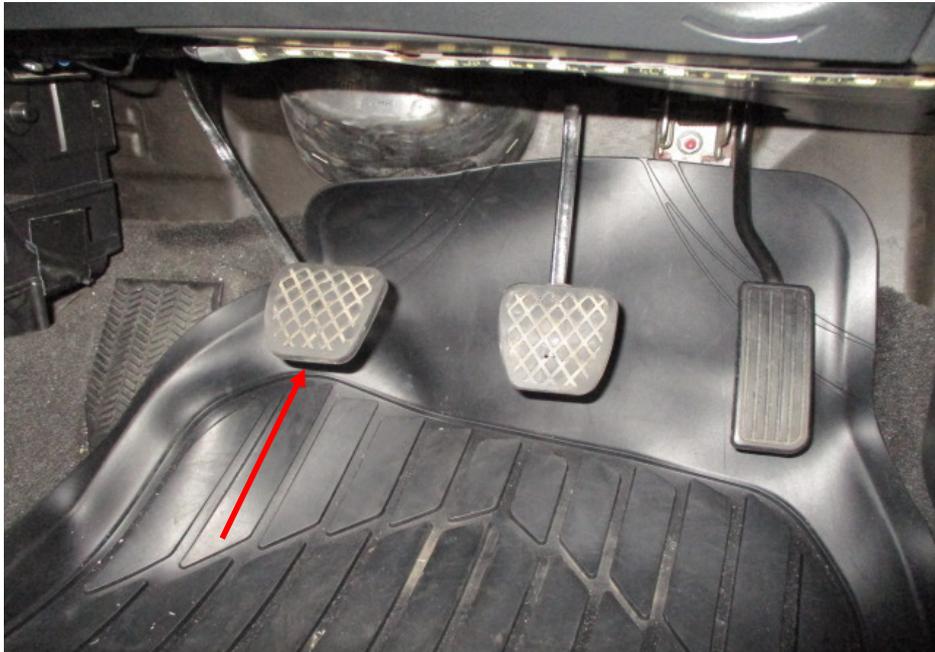
Photo 12 shows the clutch pedal (arrowed) of the Motor Car, for engaging and disengaging the transmission gears.
