Your Ref: Porsche 718 Cayman S
(chassis number WP0ZZZ98ZJK271904)
Our Ref : CI/TP21006626/D

19 June 2021

**INSPECTION REPORT OF AN UNREGISTERD PORSCHE 718 CAYMAN S
MOTOR CAR WITH CHASSIS NUMBER WP0ZZZ98ZJK271904**

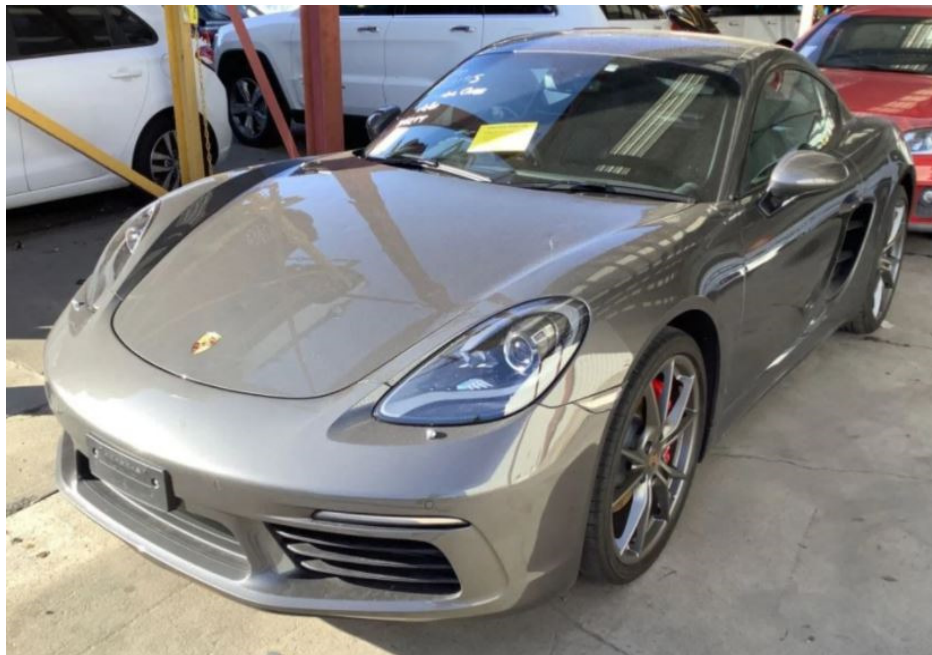
Photo 1 shows the front left body of the Motor Car prior to any repairs being carried out (photograph provided to me). The Motor Car was observed to have sustained damages of indentation nature to exterior body parts like the front bonnet. As seen from the photograph, the indentations were relatively minor on the front bonnet.

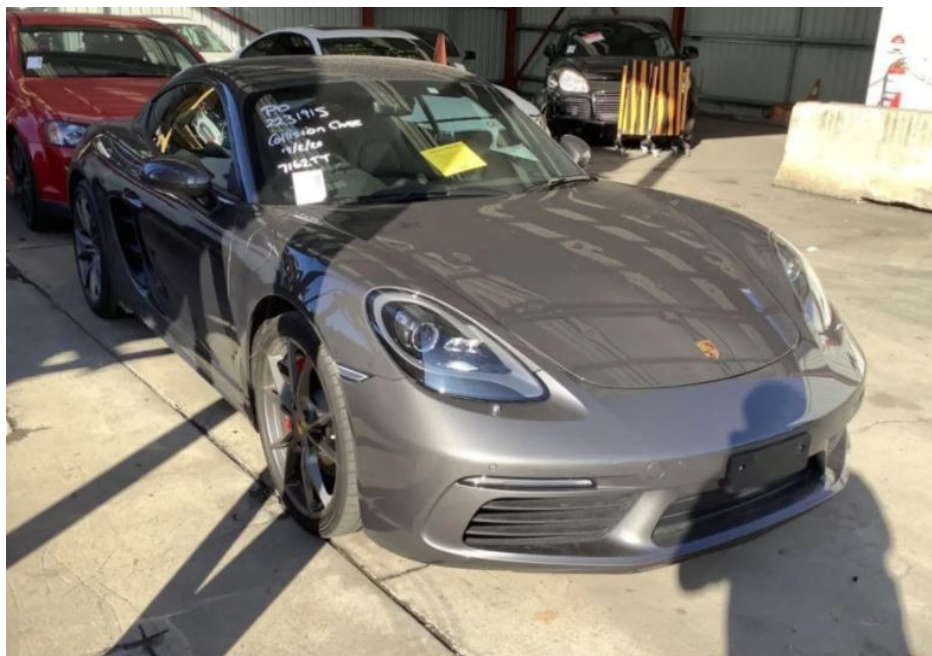
Photo 2 shows the front right body of the Motor Car prior to any repairs being carried out (photograph provided to me). The Motor Car was observed to have sustained damages of indentation nature to multiple exterior body parts like the front bonnet. As seen from the photographs provided, the indentations to the exterior body parts were relatively minor.

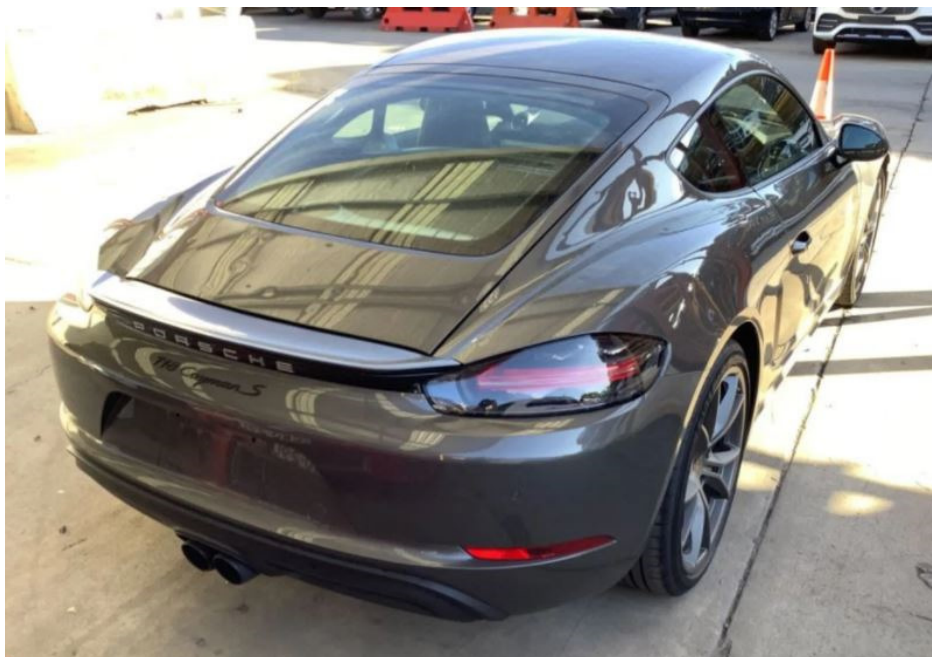
Photo 3 shows the rear right body of the Motor Car prior to any repairs being carried out (photograph provided to me). The Motor Car was observed to have sustained damages of indentation nature to multiple exterior body parts like the rear bootlid, rear right body panel and roof panel. As seen from the photographs provided, the indentations to the exterior body parts were relatively minor.

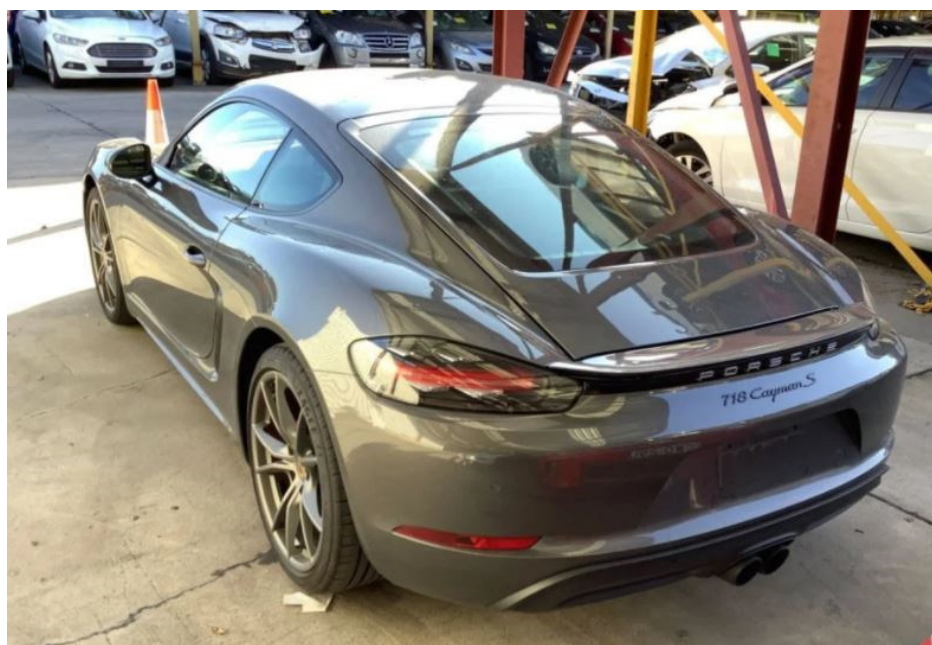
Photo 4 shows the rear left body of the Motor Car prior to any repairs being carried out (photograph provided to me). The Motor Car was observed to have sustained damages of indentation nature to exterior body parts like the front bonnet, rear bootlid and roof panel amongst others. As seen from the photographs provided, the indentations to the exterior body parts were relatively minor.

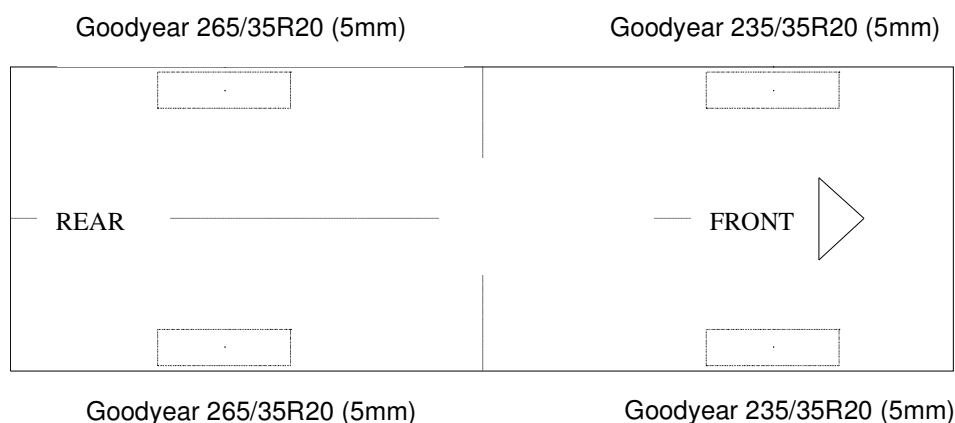
7. It was fitted with 20inch sport wheel rims that were wrapped with tyres that were observed to be of serviceable condition. The tyres were also sufficiently inflated for vehicular operation. The tyre brand, tyre size and approximate remaining tread depth of the 4 tyres of the Motor Car were recorded as follows: -

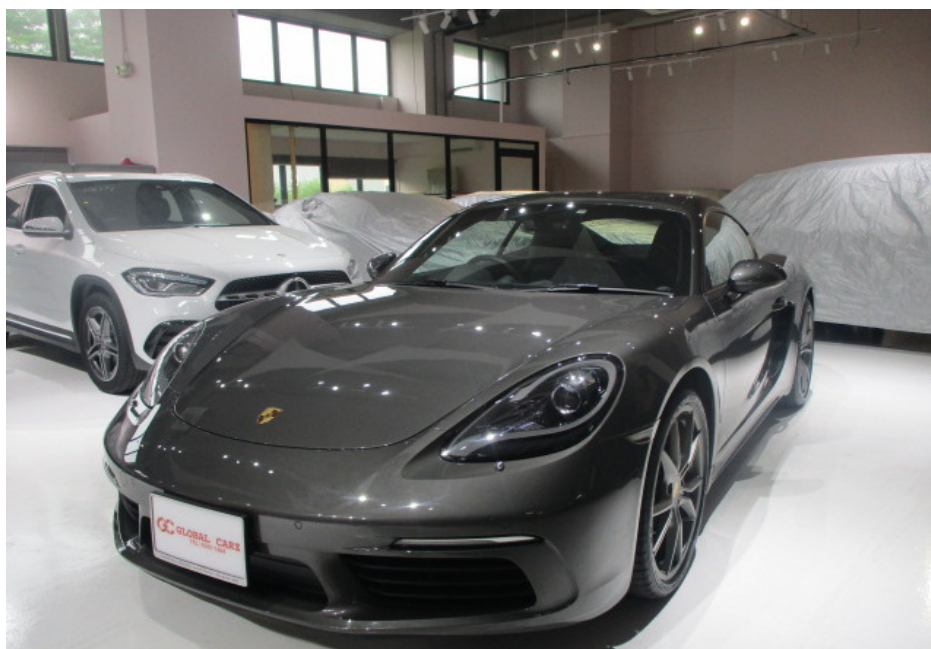
Photo 5 shows a general view of the front left body of the Motor Car at the time of my inspection. The Motor Car was observed to be in a relatively good general condition with no loose exterior fittings observed. The exterior body parts at the frontal portion of the Motor Car were visually examined, and it was observed that the repair/restoration works carried out to the damaged area of the Motor Car (refer to photograph 1 & 2 above) were reasonably adequate and in order.

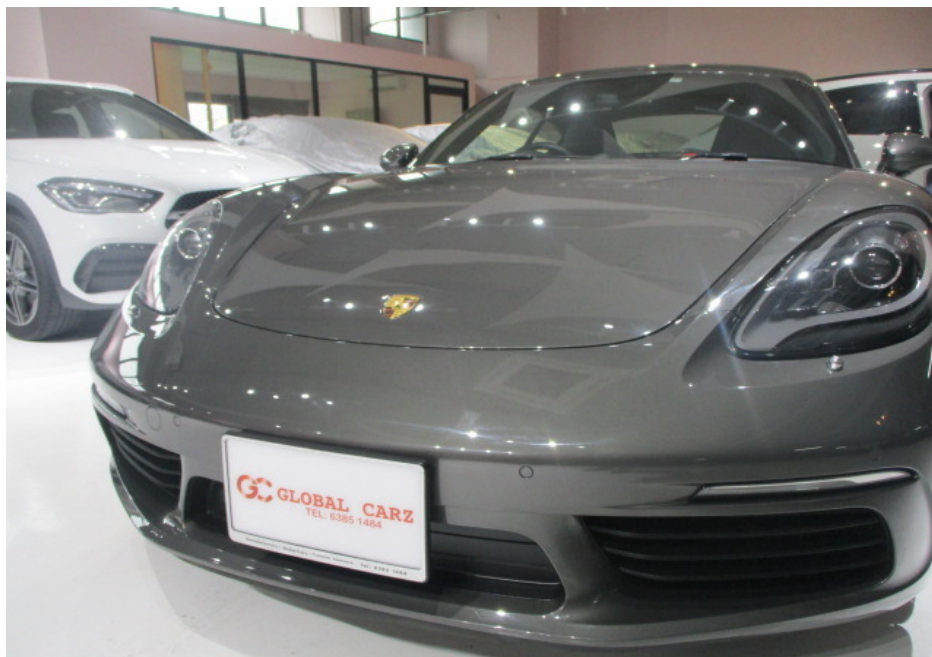
Photo 6 shows a closer view of the Motor Car's front bumper, front bonnet and front left headlamp at the time of my inspection. In general, I had found that the repair/restoration works carried out to the damaged area of the Motor Car (refer to photograph 1 & 2 above) were reasonably adequate and in order.

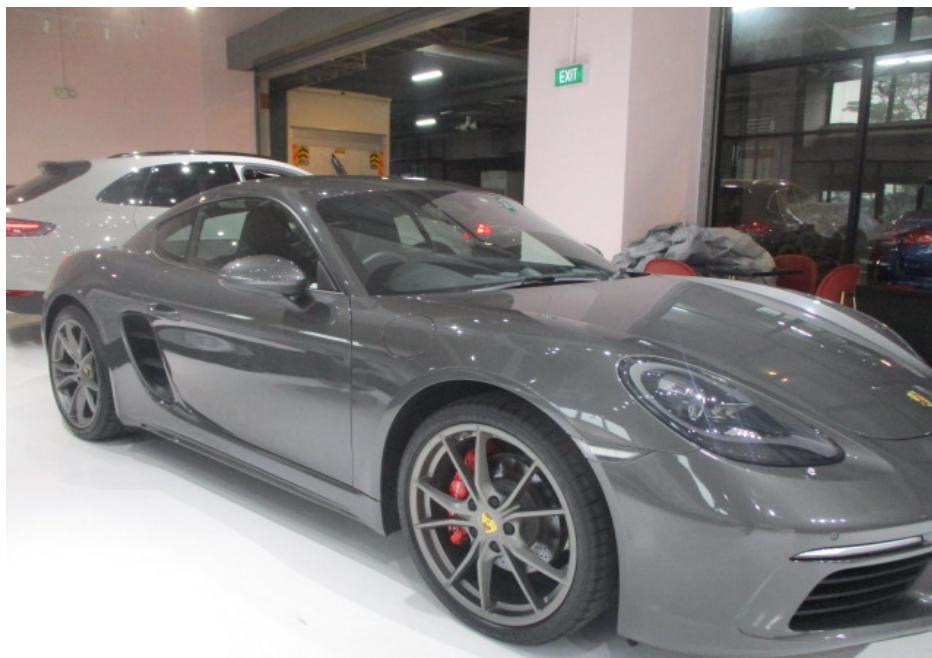
Photo 7 shows a general view of the front right body of the Motor Car at the time of my inspection. The Motor Car was observed to be in a relatively good general condition with no loose exterior fittings observed. The exterior body parts at the frontal portion of the Motor Car were visually examined, and it was observed that the repair/restoration works carried out to the damaged area of the Motor Car (refer to photograph 1 & 2 above) were reasonably adequate and in order.

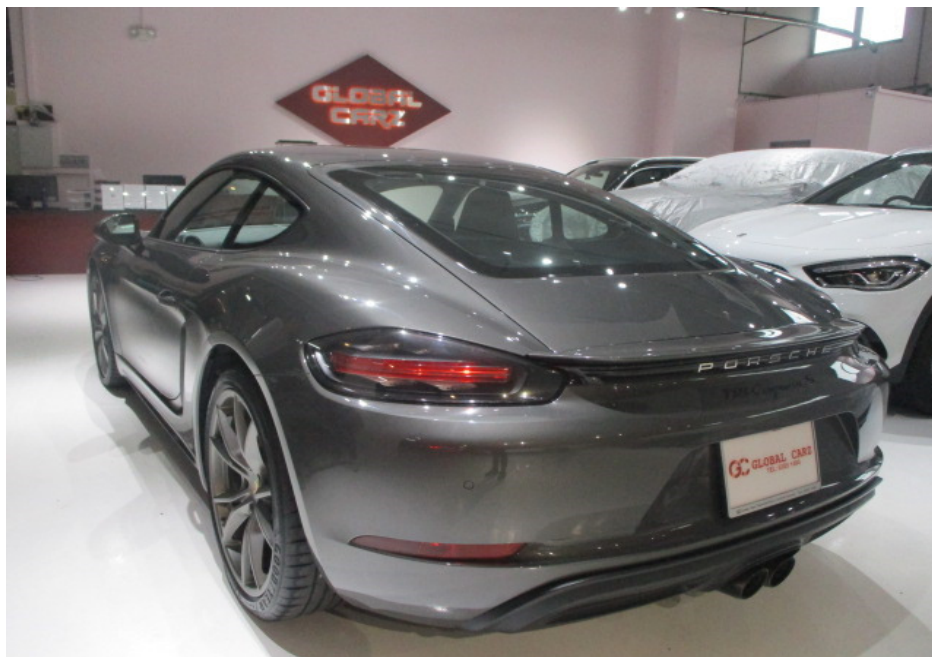
Photo 8 shows a general view of the rear left body of the Motor Car at the time of my inspection. The Motor Car was observed to be in a relatively good general condition with no loose exterior fittings observed. The exterior body parts at the rear portion of the Motor Car were visually examined, and it was observed that the repair/restoration works carried out to the damaged area of the Motor Car (refer to photograph 3 & 4 above) were reasonably adequate and in order.

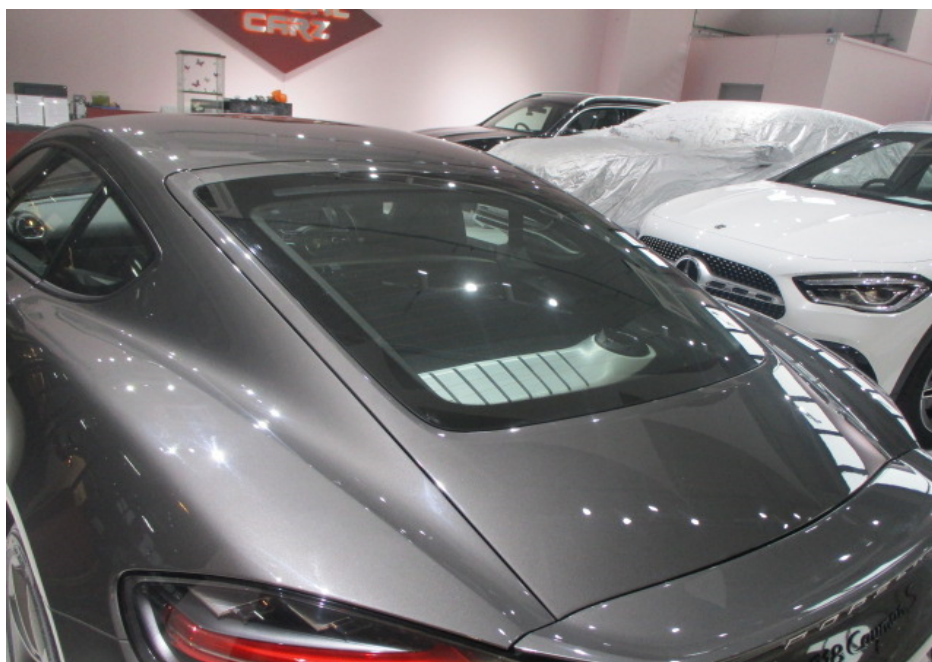
Photo 9 shows a closer view of the Motor Car's rear bootlid, rear left body panel and rear windscreen at the time of my inspection. In general, I had found that the repair/restoration works carried out to the damaged area of the Motor Car (refer to photograph 3 & 4 above) were reasonably adequate and in order.

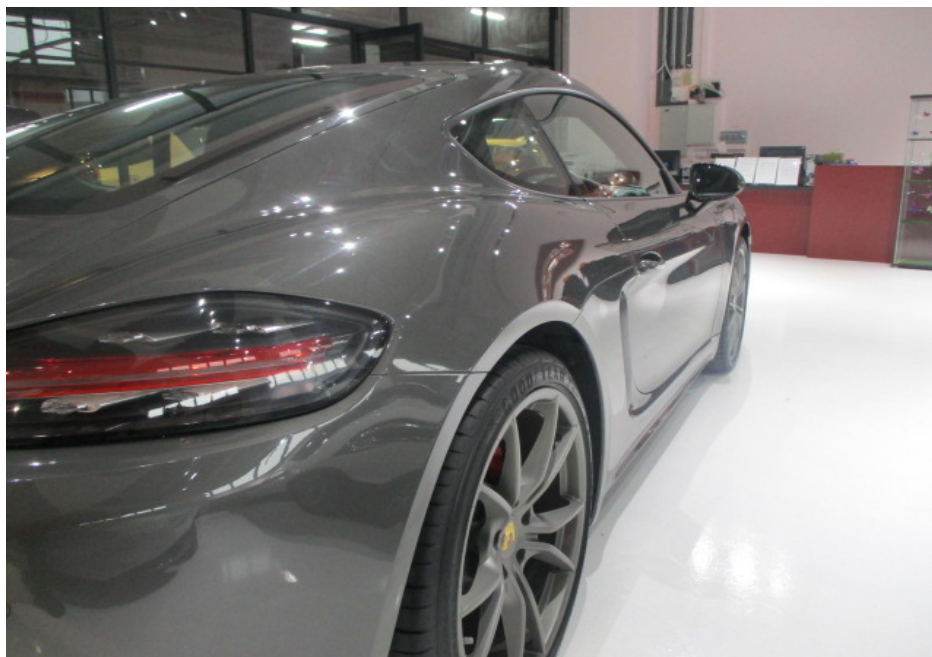
Photo 10 shows a closer view of the Motor Car's rear right taillamp and rear right body panel at the time of my inspection. In general, I had found that the repair/restoration works carried out to the damaged area of the Motor Car (refer to photograph 3 above) were reasonably adequate and in order.

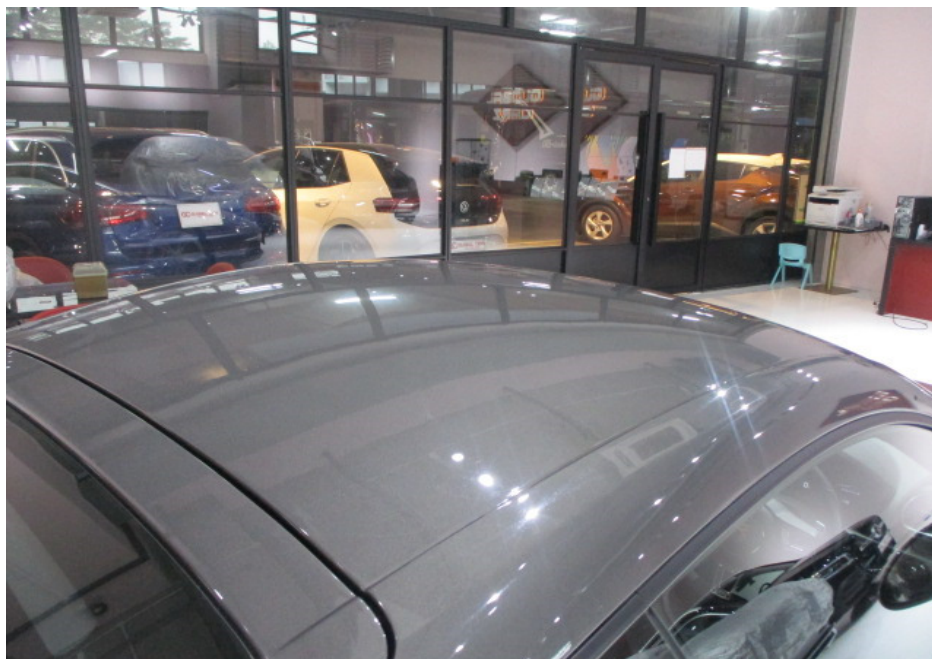
Photo 11 shows the roof panel of the Motor Car at the time of my inspection. In general, I had found that the repair/restoration works carried out to the damaged area of the Motor Car (refer to photograph 3 above) were reasonably adequate and in order.

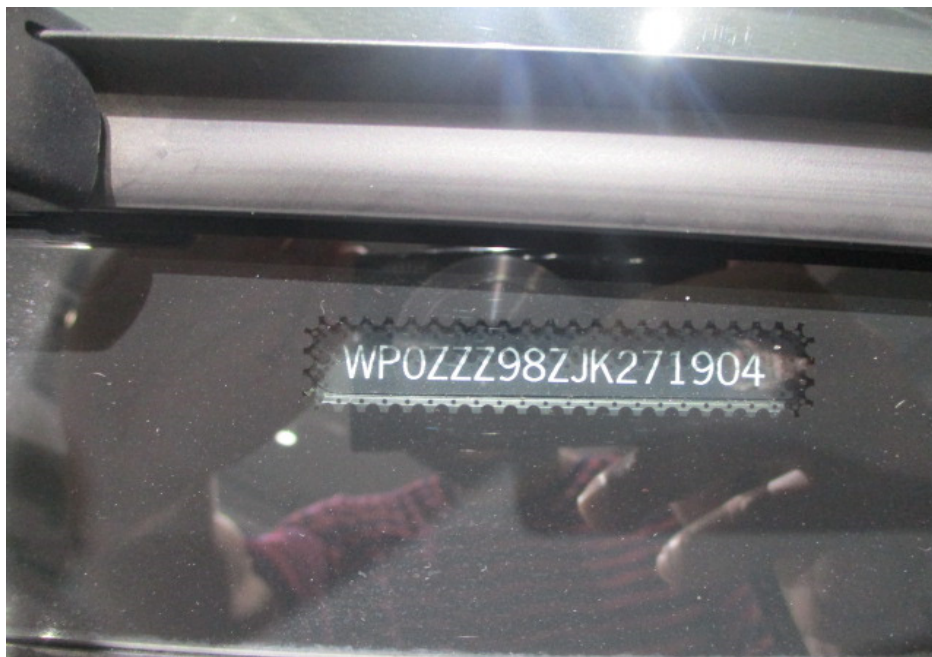
Photo 12 shows the chassis number of the Motor Car. The chassis number recorded WP0ZZZ98ZJK271904.

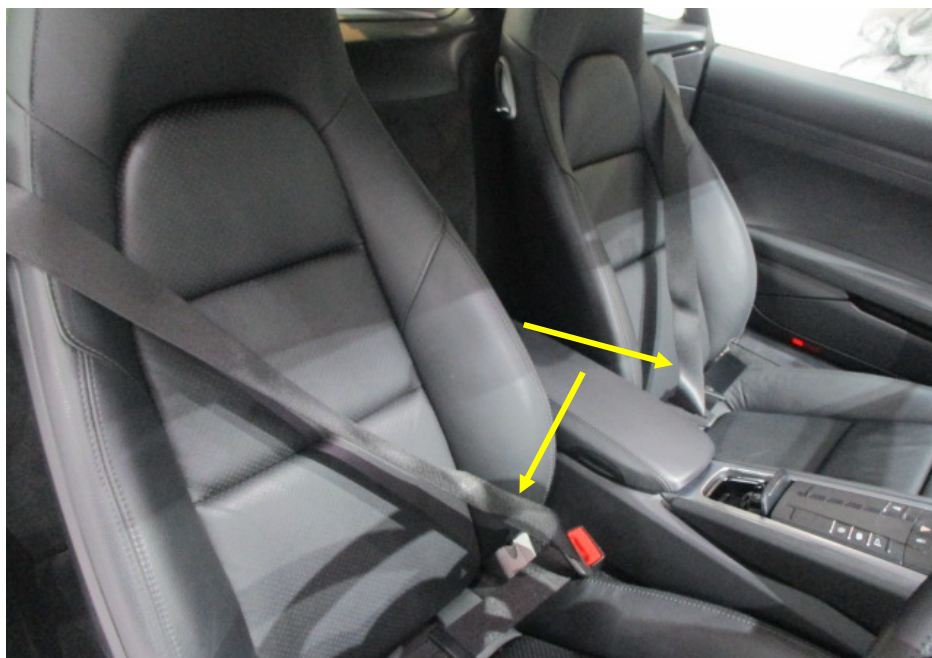
Photo 13 shows the seats of the Motor Car. All the seats of the Motor Car were secured via seat rails to the floorboard. They were also fitted with a retractable seat belt reel and a pre-tensioner. The seat belts (arrowed) were tested and were able to be fastened into the respective pre-tensions that were fitted on the side of each individual seat.

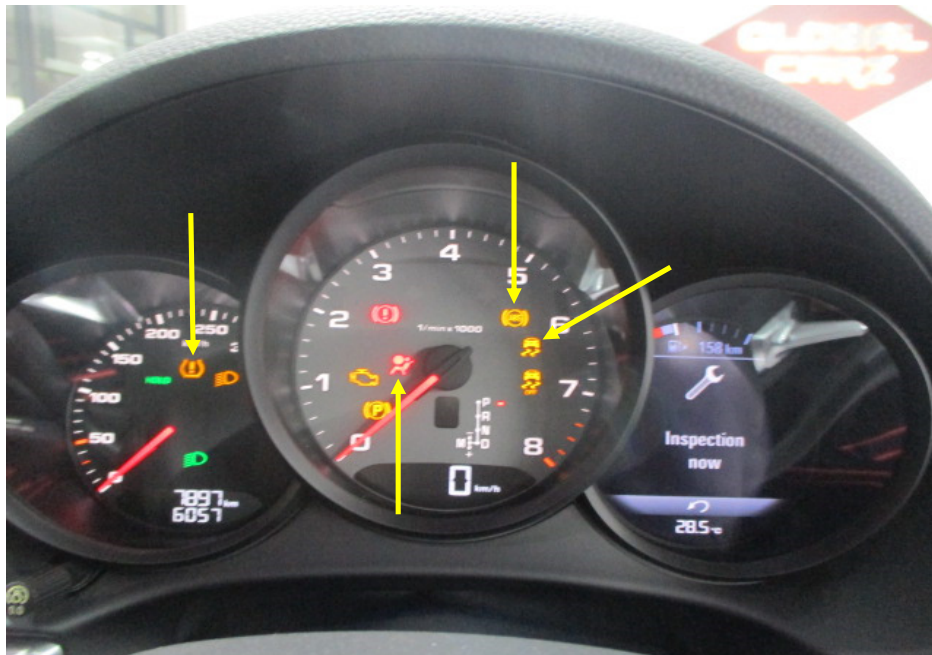
Photo 14 shows the warning lights for the various electronic safety features appearing on the instrument panel of the Motor Car during its self-test when the engine is cranked, in particular the ABS, SRS, TPM and TCS lights (arrowed).

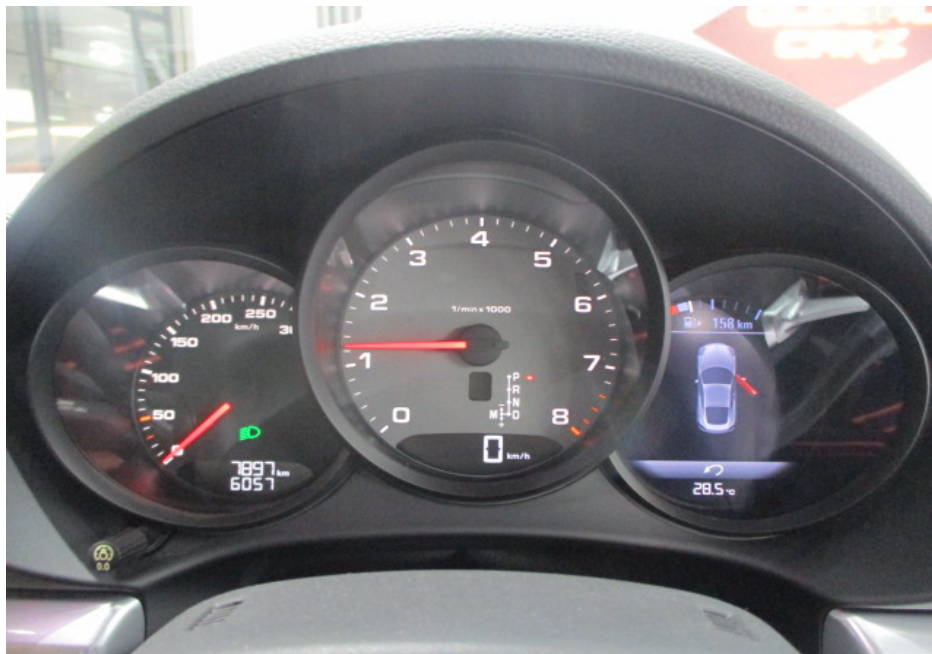
Photo 15 shows the respective warning lights no longer illuminated, indicating that there is no fault detected to the ABS, SRS, TPM and TCS systems of the Motor Car during the self-test. These electronic systems were hence in working condition at the time of my inspection.

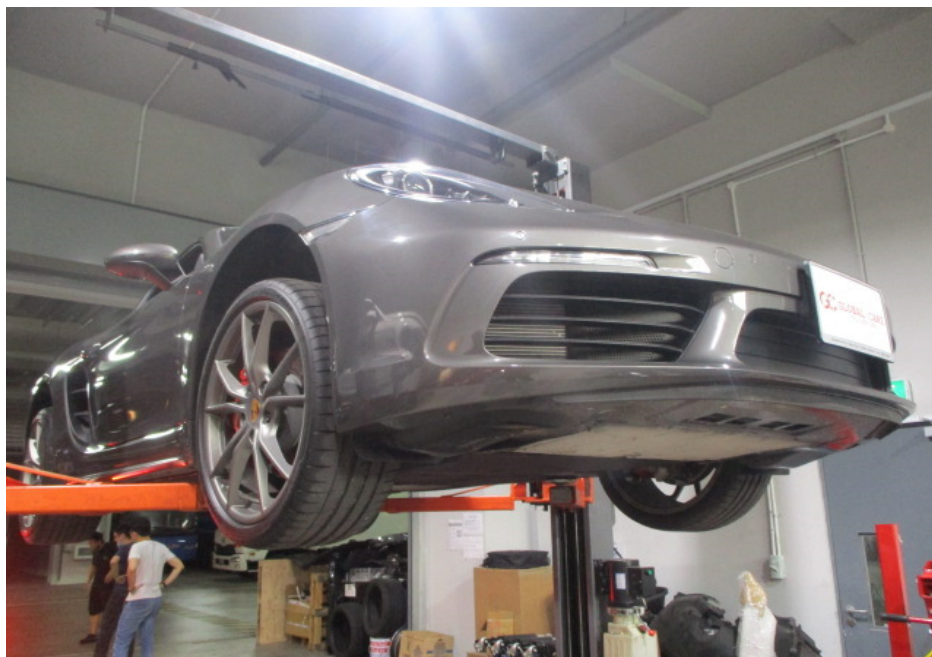
Photo 16 shows the Motor Car hoisted up for checks on its undercarriage. There was no sign(s) or indication(s) of fluid leakage and/or fluid stain(s) on the underside of the Motor Car. The undercarriage components of the Motor Car were also all observed to be intact and secured in an appropriate manner.

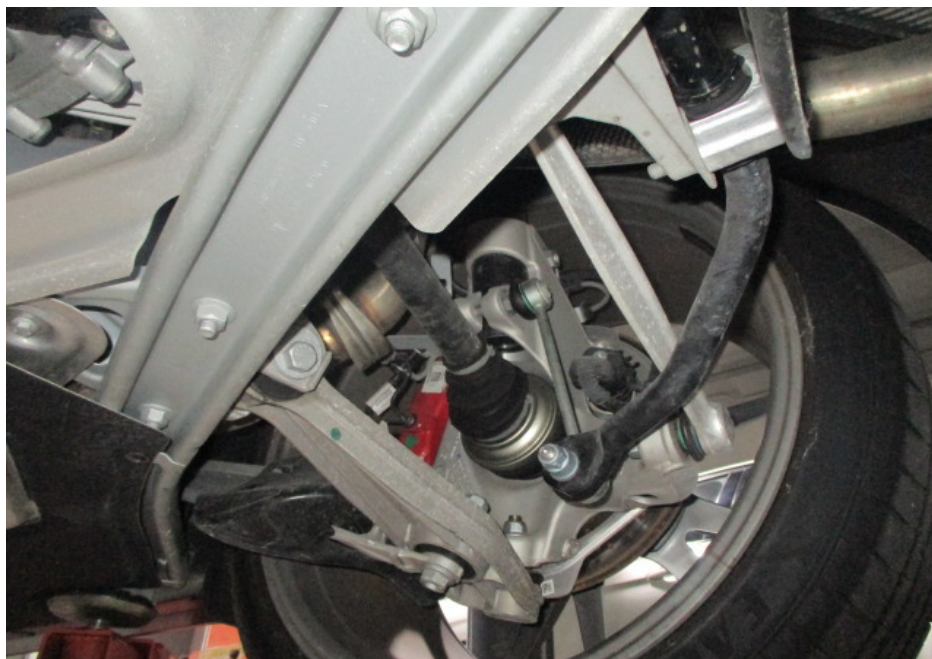
Photo 17 shows a general view of the control arms and linkages at the rear right wheel of the Motor Car. I did not observe any fluid leak and/or fluid stain on the underside of the Motor Car. All of the Motor Car's undercarriage components were observed to be intact and secured in an appropriate manner.

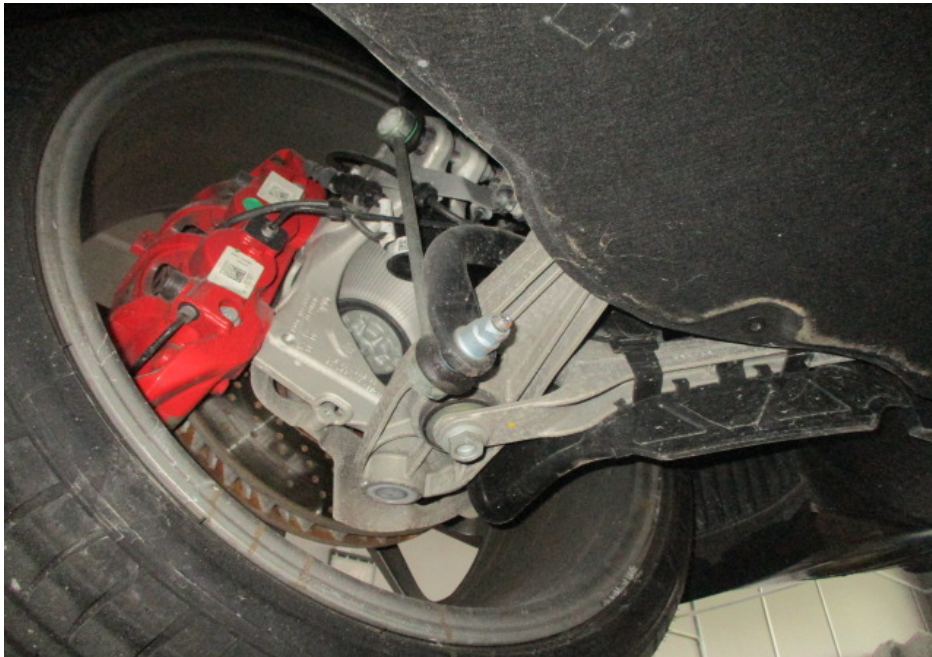
Photo 18 shows the various undercarriage components at the front left wheel of the Motor Car. The mechanical components, control arms and linkages were all found to be intact and secured in an appropriate manner.

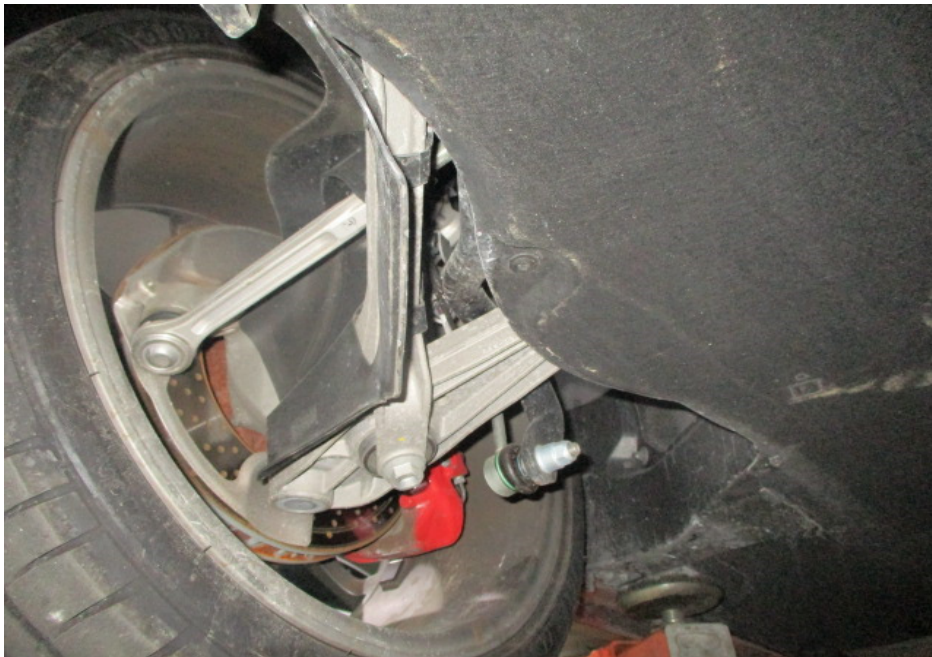
Photo 19 shows the various undercarriage components at the front right wheel of the Motor Car. The mechanical components, control arms and linkages were all found to be intact and secured in an appropriate manner. I also did not observe any fluid leak and/or fluid stain on the underside of the Motor Car.

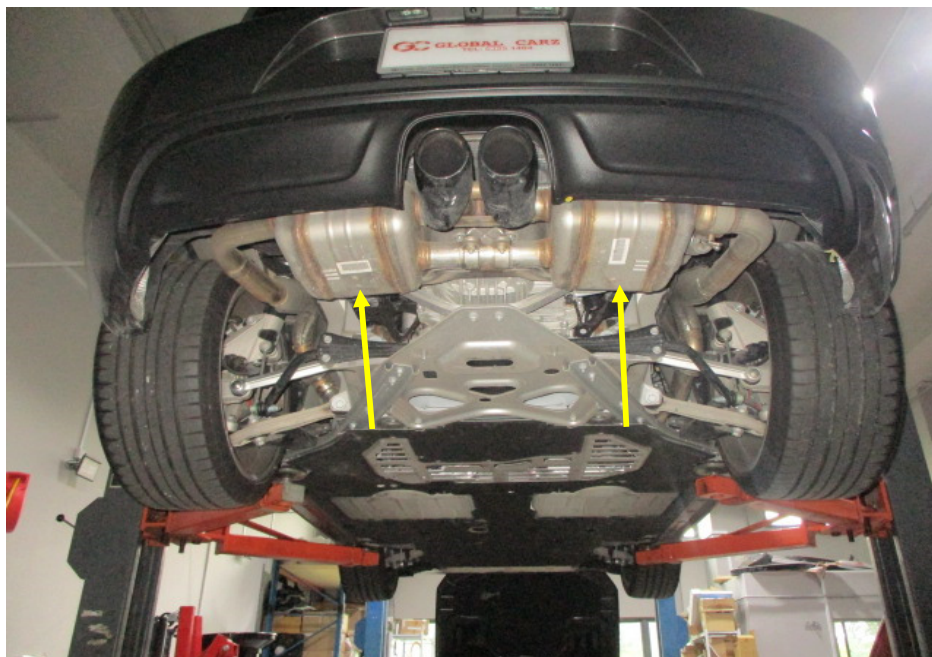
Photo 20 shows the Motor Car's rear mufflers (arrowed). My examination of the Motor Car's exhaust system revealed no sign(s) or indication(s) of any cut or weld marks along its exhaust pipes, on its catalytic converters and on its rear mufflers.

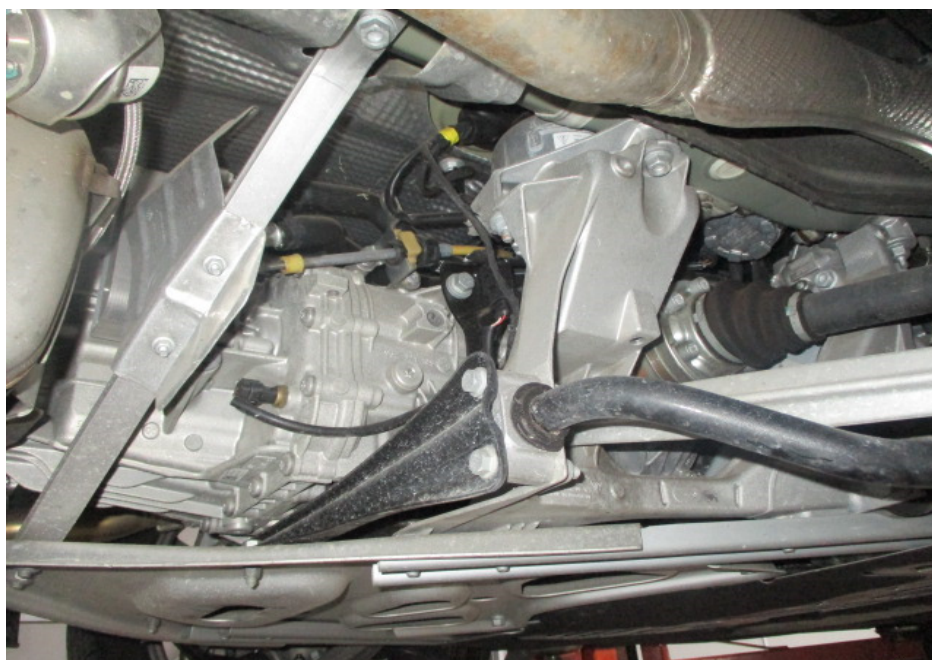
Photo 21 shows a general view of the engine compartment of the Motor Car at the time of my inspection. The engine compartment was at the rear underside of the Motor Car. The various parts and components inside the engine compartment were all observed to be intact and properly fitted. There was also no sign(s) or indication(s) of fluid leak and/or fluid stain found inside the engine compartment.

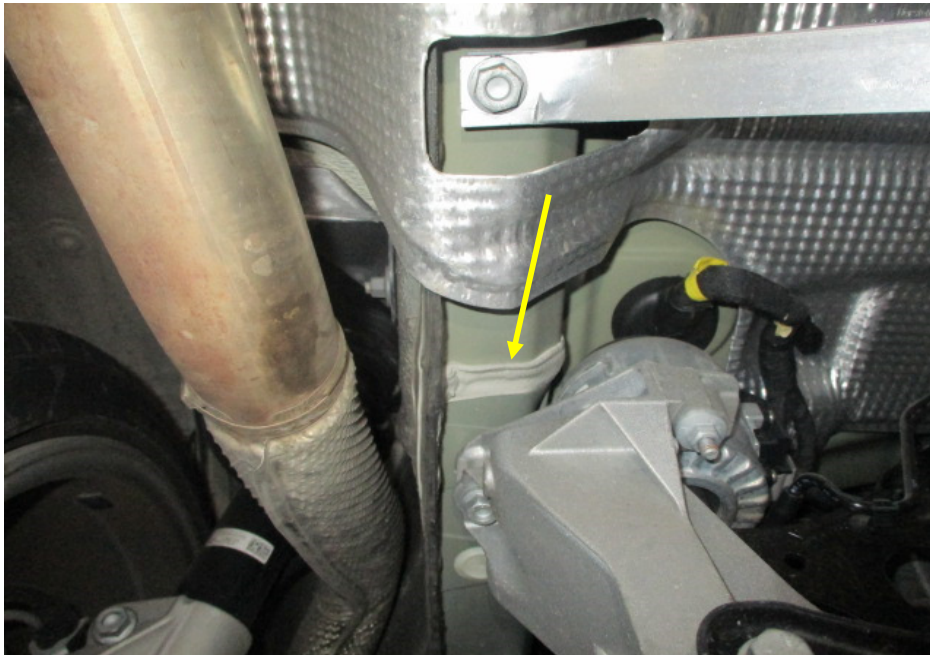
Photo 22 shows the chassis/structural body at the underside rear left of the Motor Car. I did not find any weld marks other than original spot weld marks on the chassis/structural body of the Motor Car. The original factory sealant (arrowed) at the joints along the chassis/structural body was untouched, indicating no work was done on the chassis/structural body of the Motor Car and that the chassis/structural body was originally fitted.

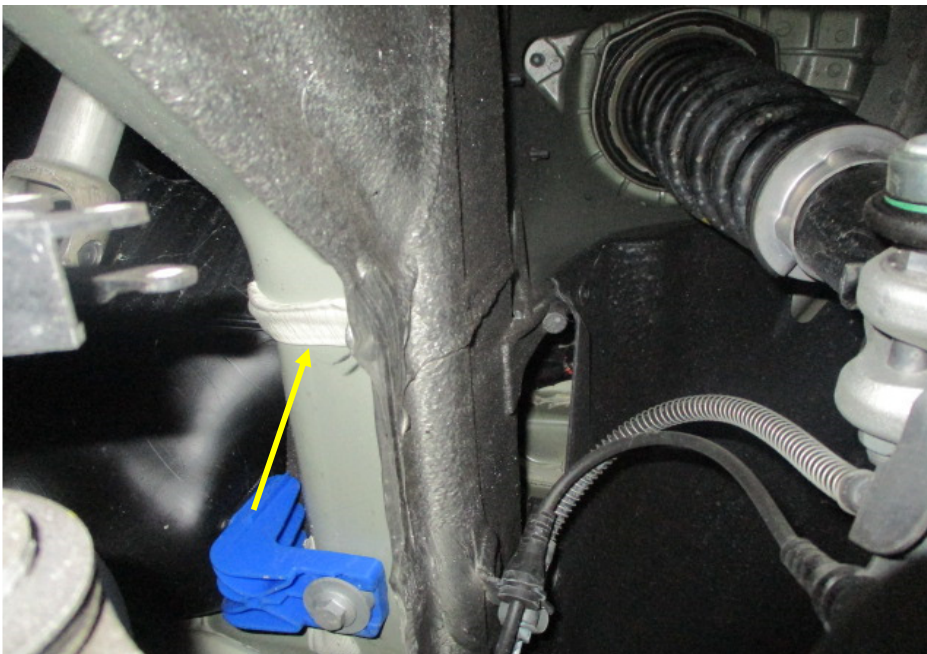
Photo 23 shows the chassis/structural body at the underside front right of the Motor Car. The original factory sealant (arrowed) at the joints along the chassis/structural body was observed to be untouched. In general, I had found no work was carried out on the chassis/structural body of the Motor Car. The chassis/structural body of the Motor Car was originally fitted.

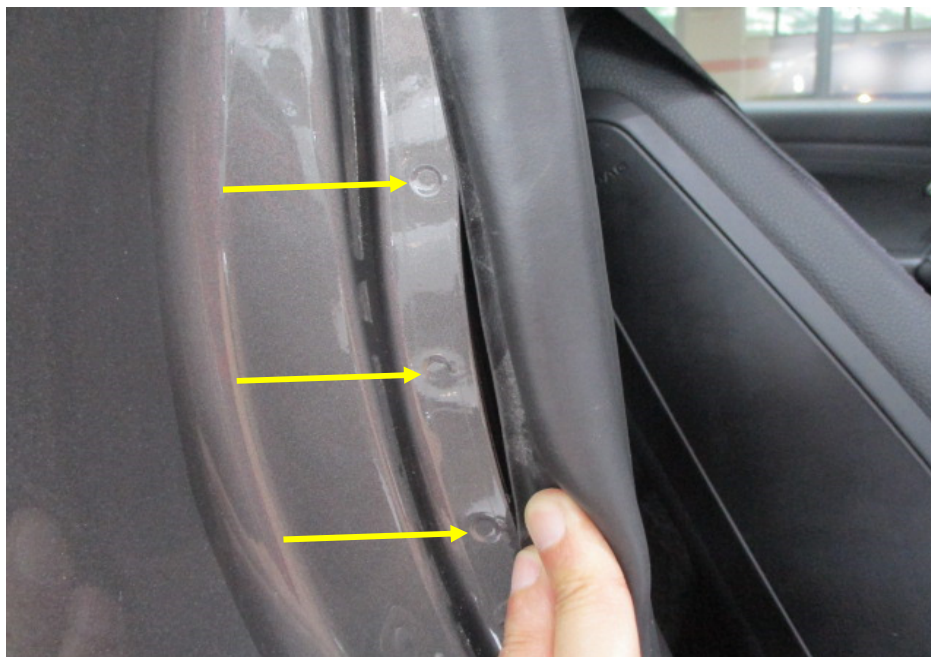
Photo 24 shows the rear right body panel of the Motor Car. I did not find any weld marks other than original spot weld marks (arrowed) on the rear right body panel of the Motor Car, which indicates that there was no re-welding works carried out. In general, I had found all the non-detachable body panels of the Motor Car to be originally fitted at the time of my inspection.
