Your Ref: Porsche Cayenne  
(chassis number WP1ZZZ9YZKDA03607)  
Our Ref : CI/TP21006627/D

11 June 2021

**INSPECTION REPORT OF AN UNREGISTERD PORSCHE CAYENNE MOTOR CAR WITH CHASSIS NUMBER WP1ZZZ9YZKDA03607**

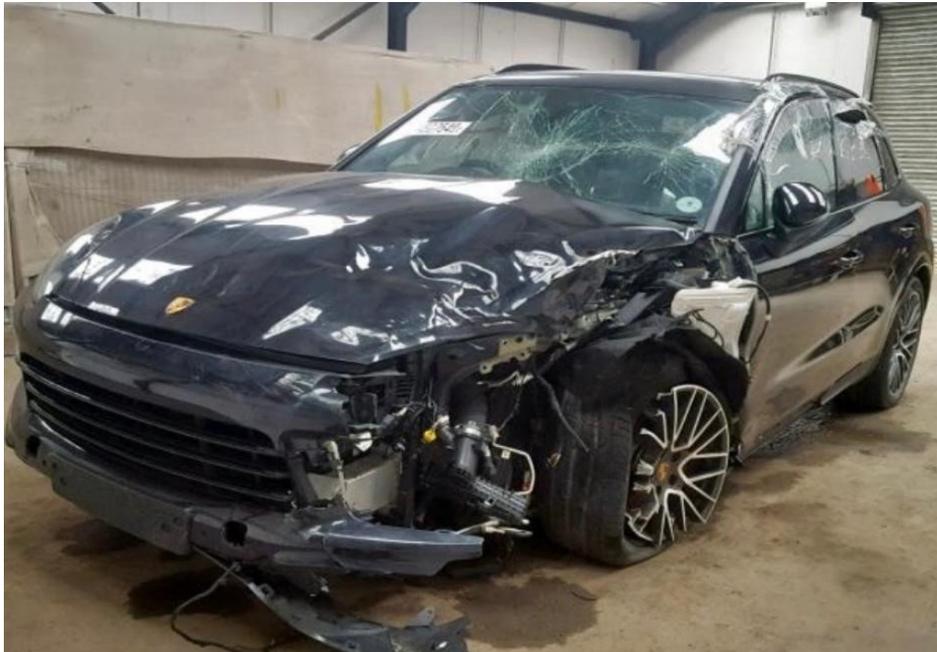
3. The photographs provided to me had showed damage to the front left portion of the Motor Car. Body parts observed to be damaged include the front bumper, front bumper left lower grille, front bumper reinforcement, front left day running light, front left headlamp, front radiator grille, front bonnet, front bonnet lock, front left fender, front left fender wheel arc garnish, front left fender inner shield, front left wheel rim, front left tyre, front left door, left side rocker panel garnish, front windscreen, front support panel and front support panel top garnish amongst others. The orientation of the front left wheel and front right wheel, as seen from the photographs, indicates to me that the front left undercarriage parts of the Motor Car were also damaged.

**Photo 1** shows the front left body of the Motor Car prior to any repairs being carried out (photograph provided to me). The Motor Car was observed to have sustained damages at its front left portion. The front bumper, front bumper left lower grille, front bumper reinforcement, front radiator grille, front left day running light, front left headlamp, front bonnet, front left fender, front left wheel rim and front windscreen were amongst the body parts that were observed to be damaged. The front left wheel and front right wheel (refer to photograph 3 below) were orientated in different directions, which suggests to me that the front left undercarriage parts of the Motor Car were also damaged.

22. The body parts at the front left portion of the Motor Car and the undercarriage parts at the front left wheel were visually examined and it was noted that the repair/restoration works carried out to the damaged area of the Motor Car (refer to photograph 1 above) were reasonably adequate and in order.

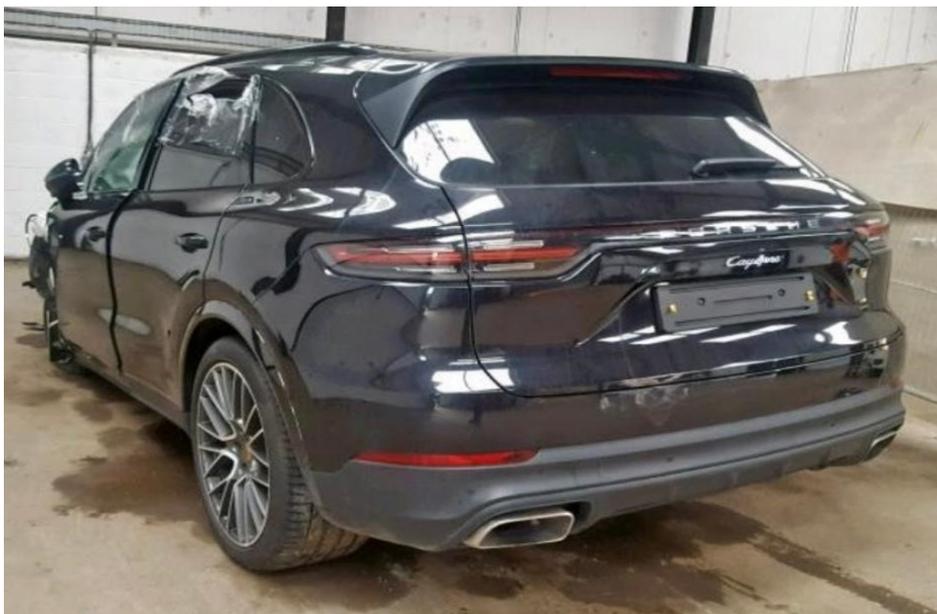
**Photo 2** shows the rear left body of the Motor Car prior to any repairs being carried out (photograph provided to me). Apart for the front left portion, there was no visible damage observed to other areas of the Motor Car.

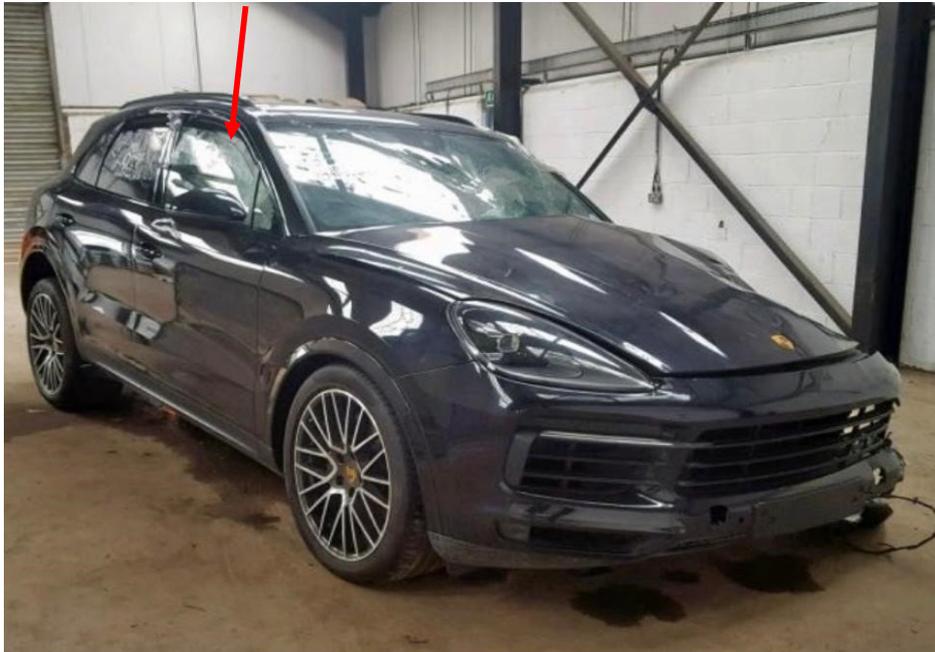
**Photo 3** shows the front right body of the Motor Car (photograph provided to me). The front right wheel was orientated straight as compared to the front left wheel, which was orientated slightly to the right (refer to photograph 1 above). This would indicate to me that there was damage to the front left undercarriage parts of the Motor Car, given that the front right portion of the Motor Car was seen to be undamaged. The right side curtain airbag (arrowed) was observed deployed.

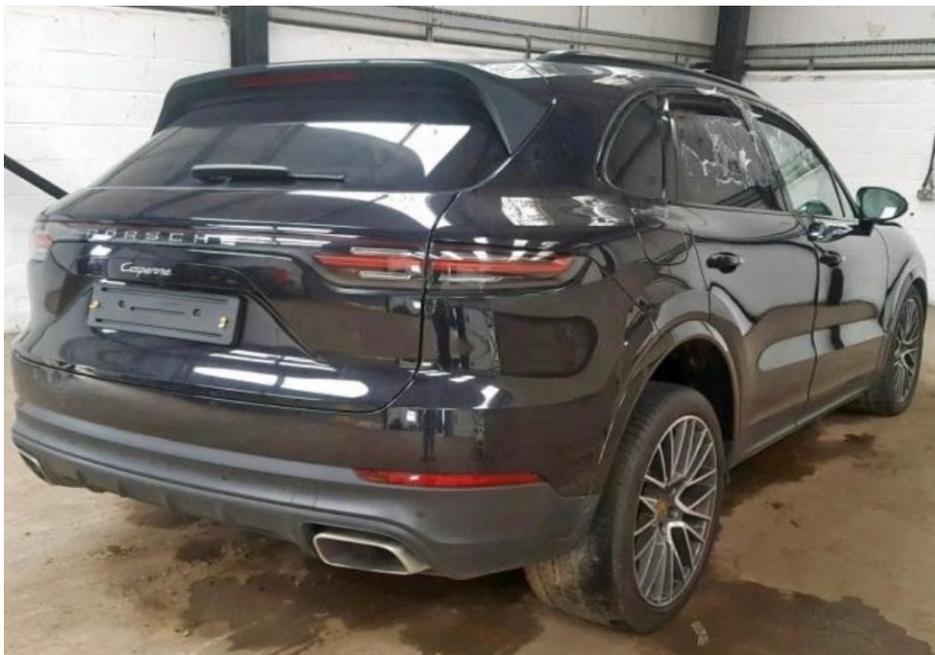
**Photo 4** shows the rear right body of the Motor Car prior to any repairs being carried out (photograph provided to me). Apart for the front left portion, there was no visible damage observed to other areas of the Motor Car.

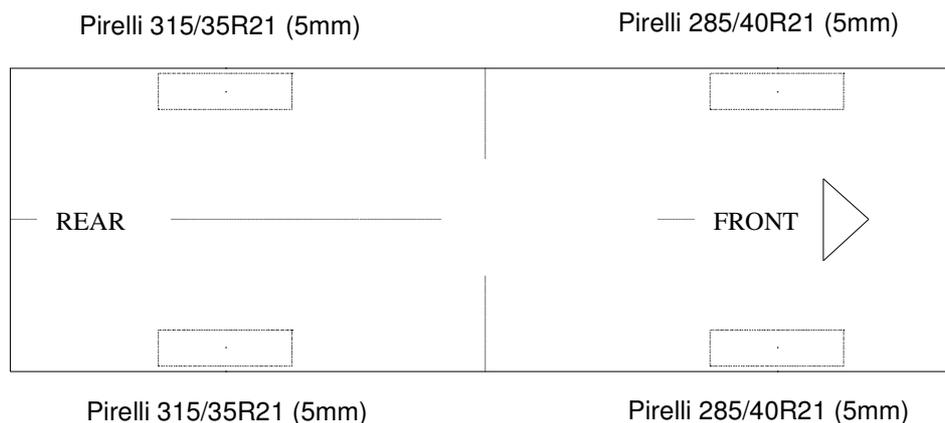
8. It was fitted with 21inch sport wheel rims that were wrapped with tyres that were observed to be of serviceable condition. The tyres were also sufficiently inflated for vehicular operation. The tyre brand, tyre size and approximate remaining tread depth of the 4 tyres of the Motor Car were recorded as follows: -

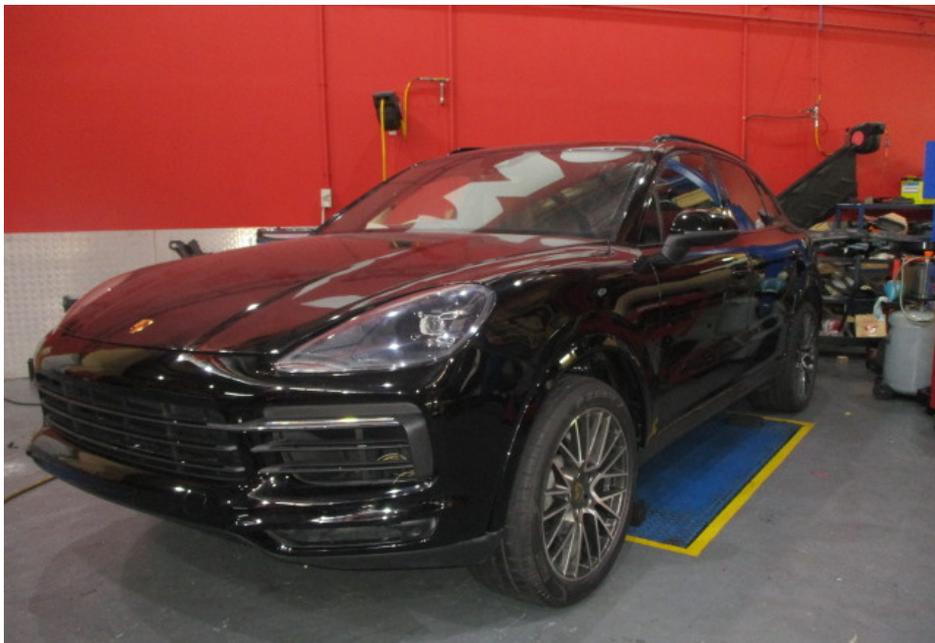
**Photo 5** shows a general view of the front left body of the Motor Car at the time of my inspection. The Motor Car was observed to be in a relatively good general condition with no loose exterior fittings observed. The body parts at the front left portion of the Motor Car were visually examined and it was observed that the repair/restoration works carried out to the damaged area of the Motor Car (refer to photograph 1 above) were reasonably adequate and in order.

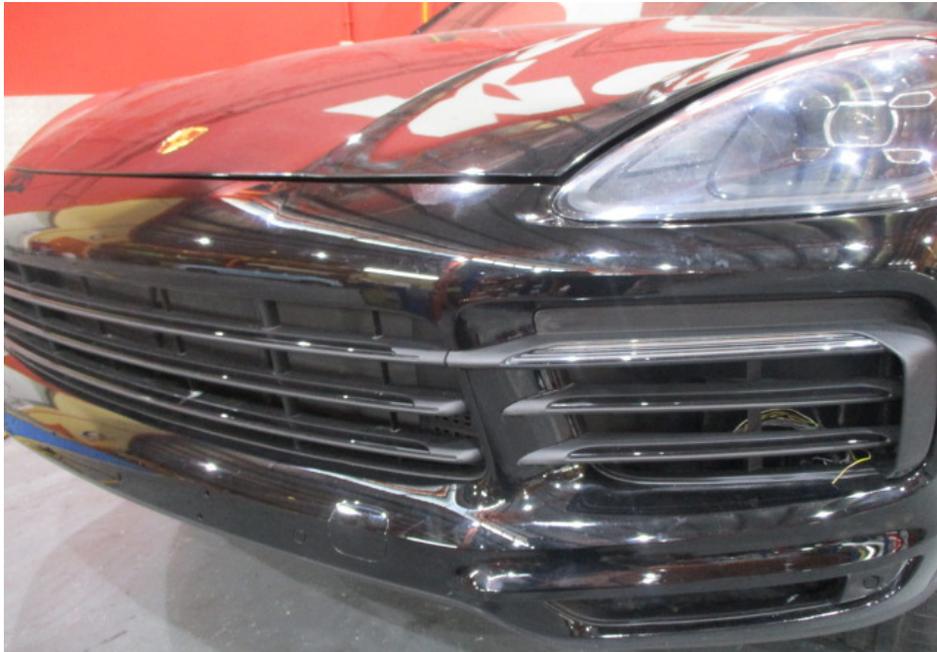
**Photo 6** shows a closer view of the Motor Car's front bumper, front bumper left lower grille, front radiator grille, front left day running light and front left headlamp. The body parts at the front left portion of the Motor Car were visually examined and it was observed that the repair/restoration works carried out to the damaged area of the Motor Car (refer to photograph 1 above) were reasonably adequate and in order.

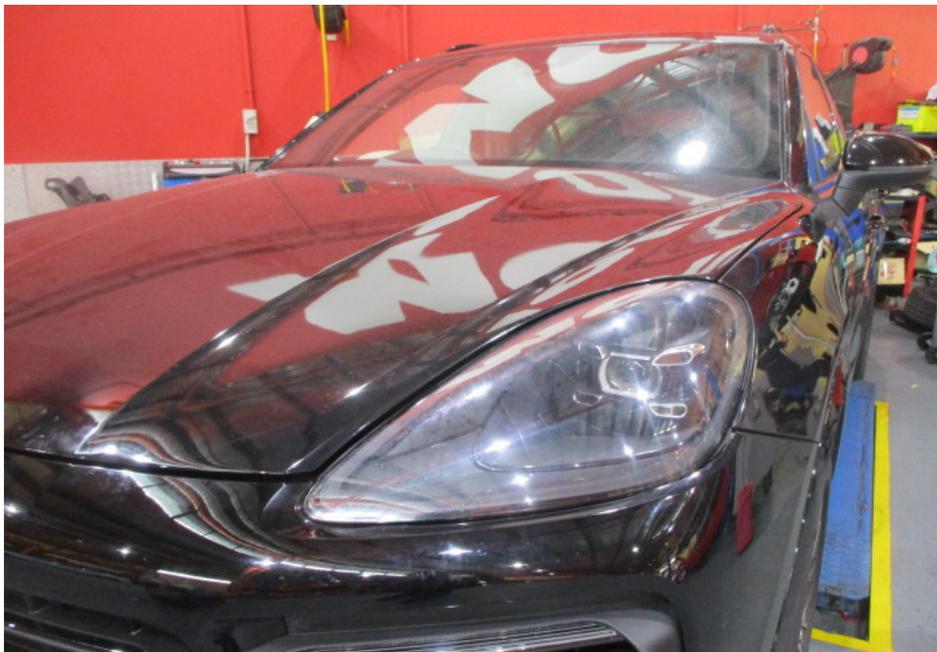
**Photo 7** shows a closer view of the Motor Car's front left headlamp and front bonnet. The body parts at the front left portion of the Motor Car were visually examined and it was observed that the repair/restoration works carried out to the damaged area of the Motor Car (refer to photograph 1 above) were reasonably adequate and in order.

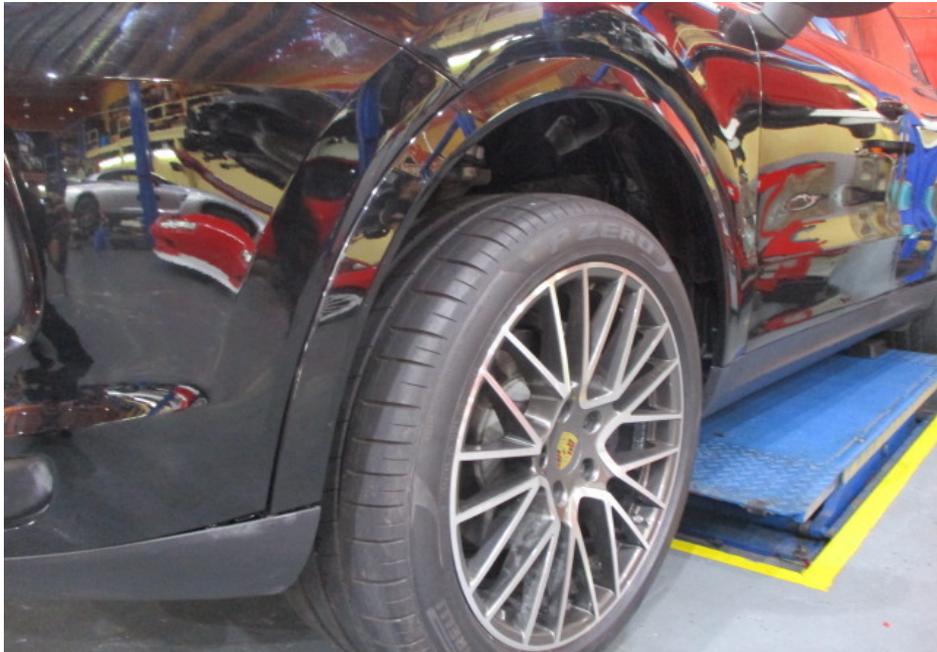
**Photo 8** shows a closer view of the Motor Car's front left wheel rim, front left tyre, front left fender wheel arc garnish and left side rocker panel garnish. The body parts at the front left portion of the Motor Car were visually examined and it was observed that the repair/restoration works carried out to the damaged area of the Motor Car (refer to photograph 1 above) were reasonably adequate and in order.

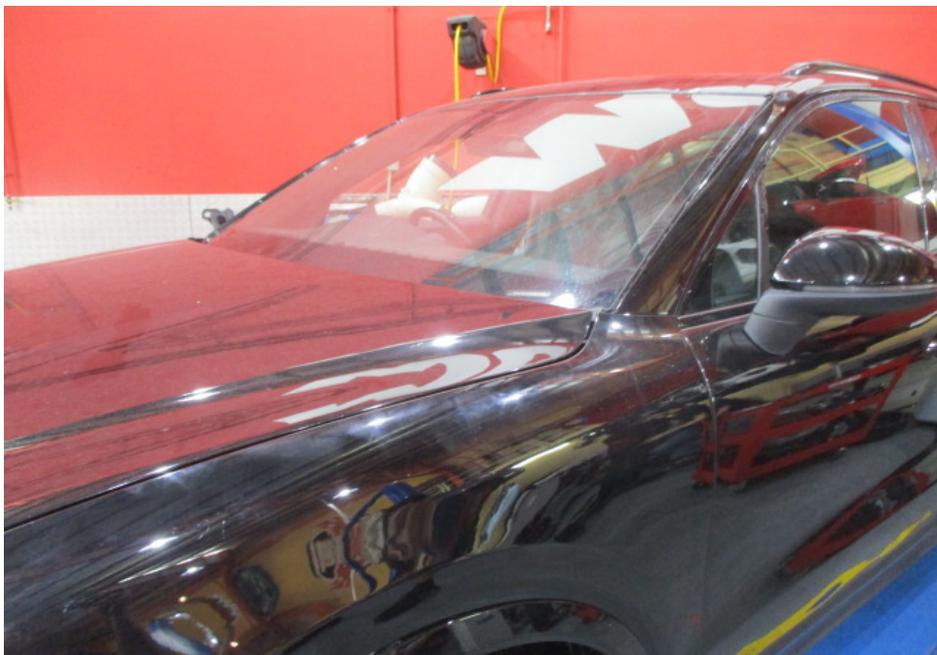
**Photo 9** shows a closer view of the Motor Car's front windscreen, front bonnet and front left fender. The body parts at the front left portion of the Motor Car were visually examined and it was observed that the repair/restoration works carried out to the damaged area of the Motor Car (refer to photograph 1 above) were reasonably adequate and in order.

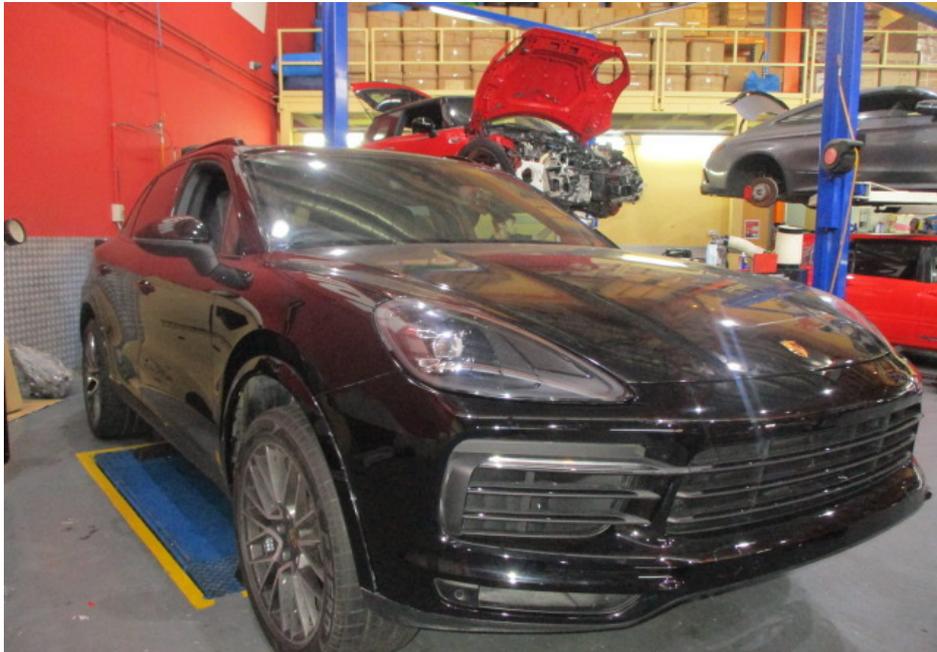
**Photo 10** shows a general view of the front right body of the Motor Car at the time of my inspection. The Motor Car was observed to be in a relatively good general condition with no loose exterior fittings observed. The mileage of the Motor Car recorded at the time of my inspection was 14,886km.

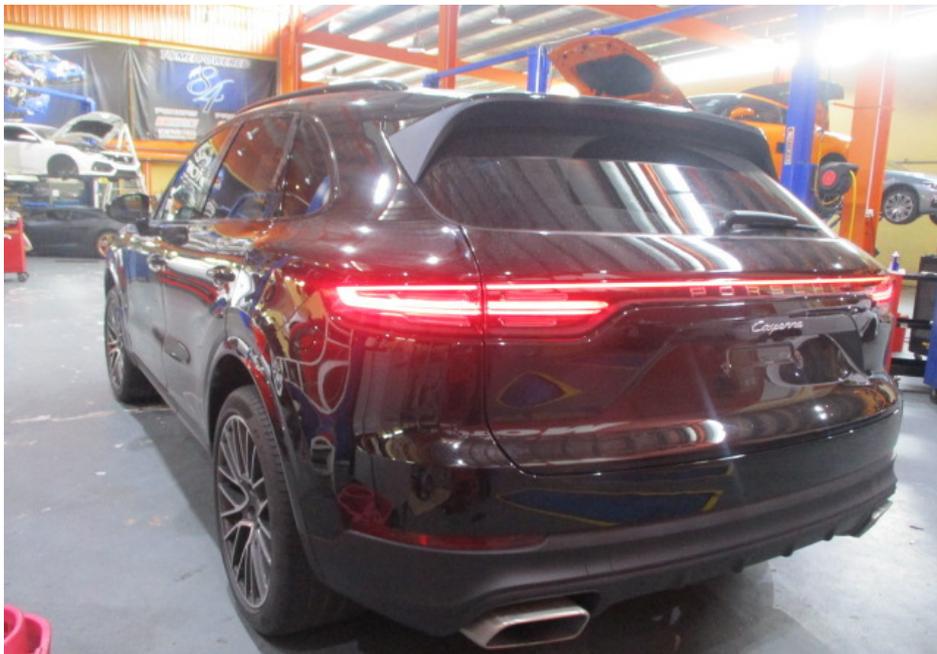
**Photo 11** shows a general view of the rear left body of the Motor Car at the time of my inspection. The Motor Car was observed to be in a relatively good general condition with no loose exterior fittings observed. The mileage of the Motor Car recorded at the time of my inspection was 14,886km.

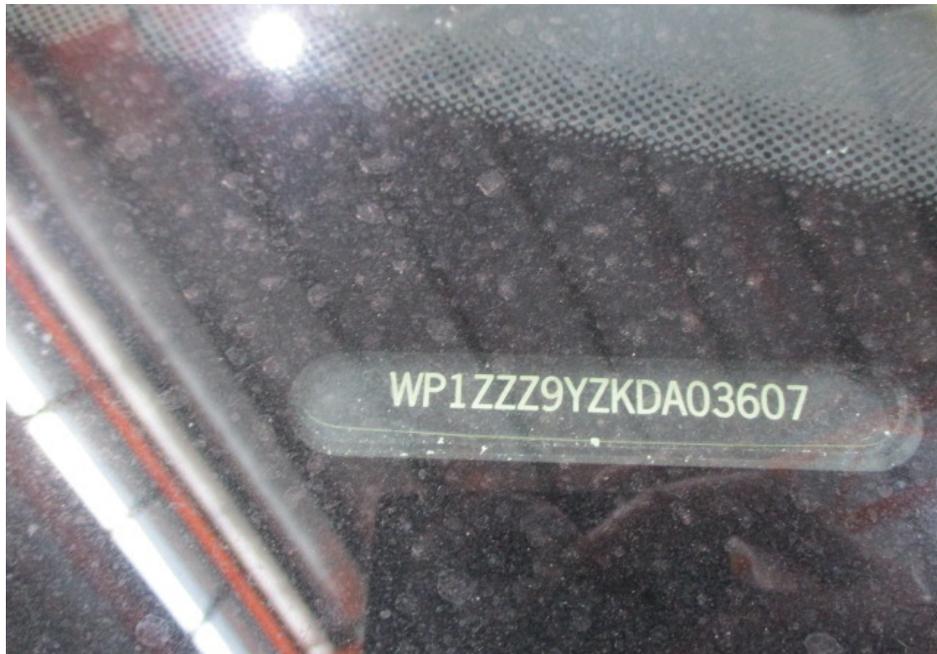
**Photo 12** shows the chassis number of the Motor Car. The chassis number recorded was WP1ZZZ9YZKDA03607.

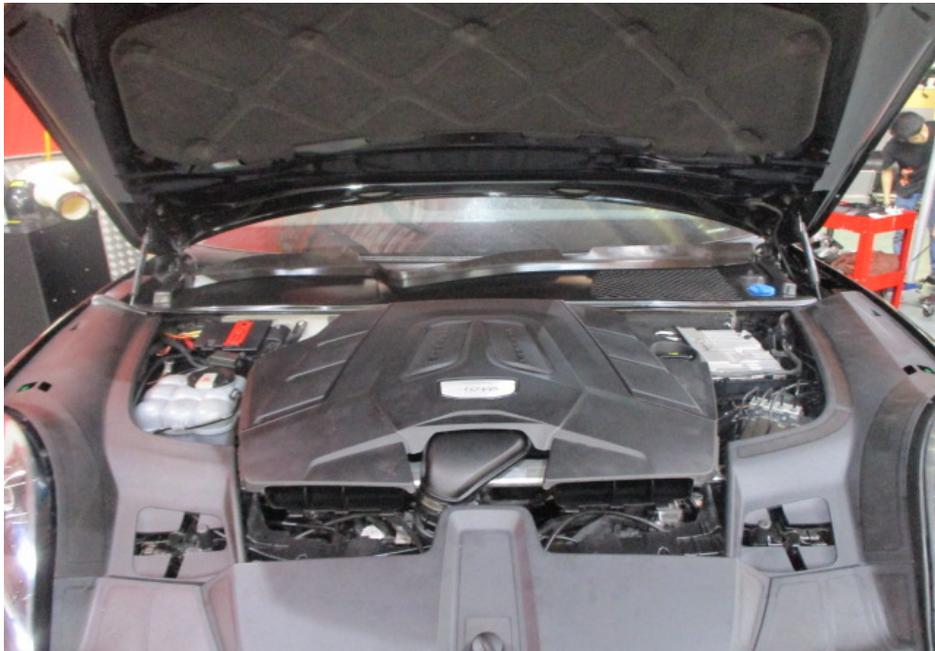
**Photo 13** shows a general view of the engine compartment of the Motor Car at the time of my inspection. The various parts and components inside the engine compartment were all observed to be intact and properly fitted. There was also no sign(s) or indication(s) of fluid leak and/or fluid stain found inside the engine compartment.

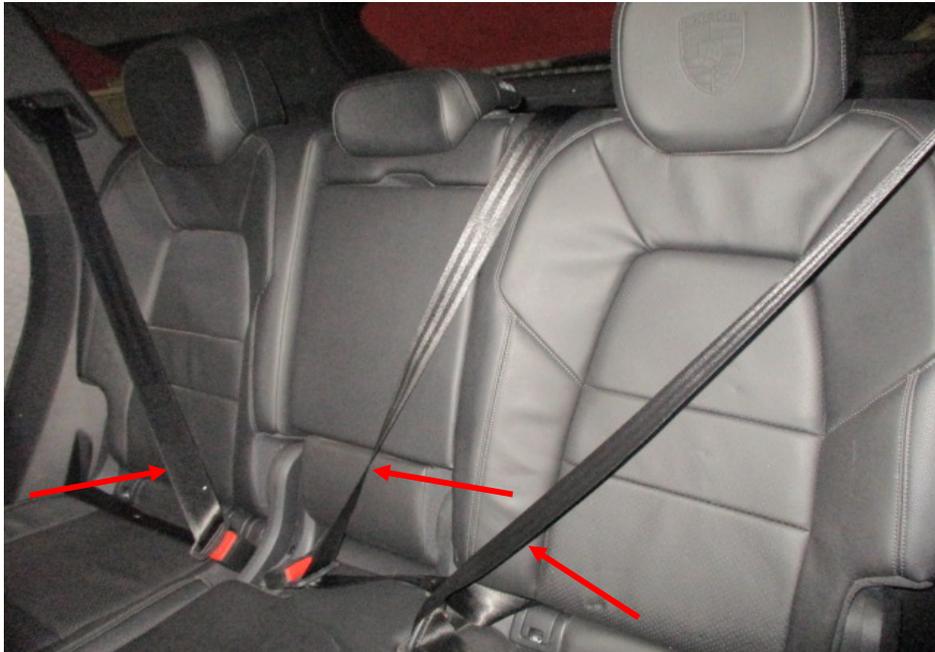
**Photo 14** shows the rear seats of the Motor Car. All the seats of the Motor Car were secured via seat rails to the floorboard. They were also fitted with a retractable seat belt reel and a pre-tensioner. The seat belts (arrowed) were tested and were able to be fastened into the respective pre-tensions that were fitted on the side of each individual seat.

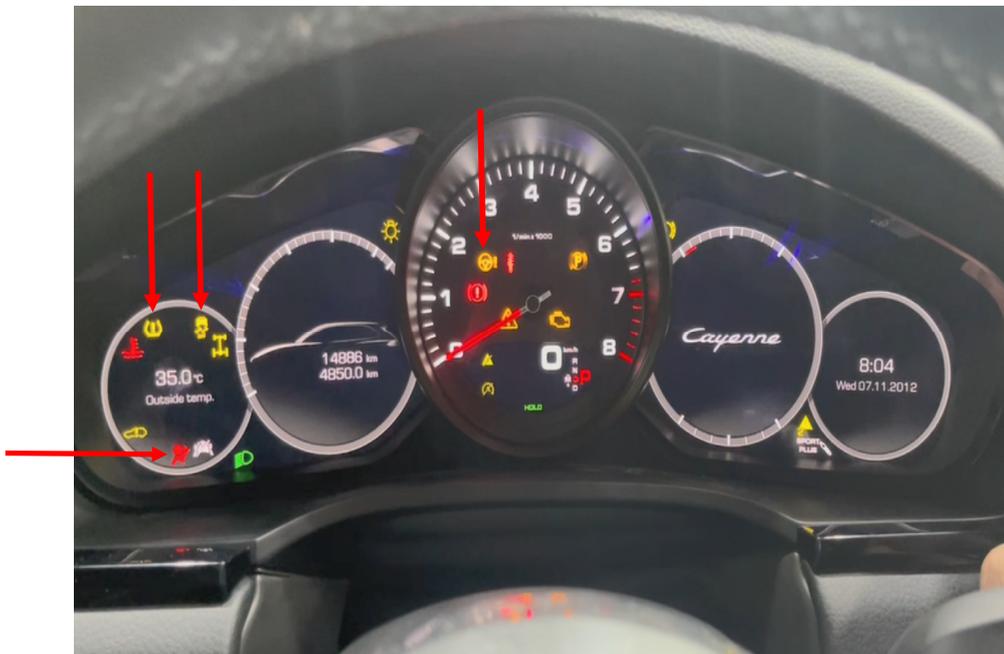
**Photo 15** shows the warning lights for the various electronic safety features appearing on the instrument panel of the Motor Car during its self-test when the engine is cranked, in particular the ABS, SRS, PSS, TPM and PSM lights (arrowed).

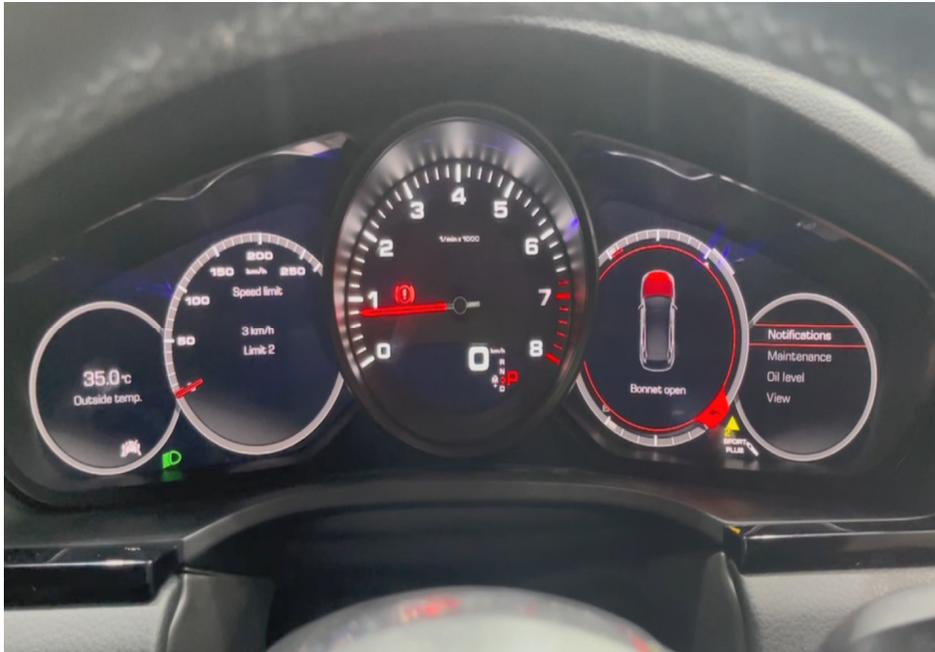
**Photo 16** shows the respective warning lights no longer illuminated, indicating that there is no fault detected to the ABS, SRS, PSS, TPM and PSM systems of the Motor Car during the self-test. These electronic systems were hence in working condition at the time of my inspection.

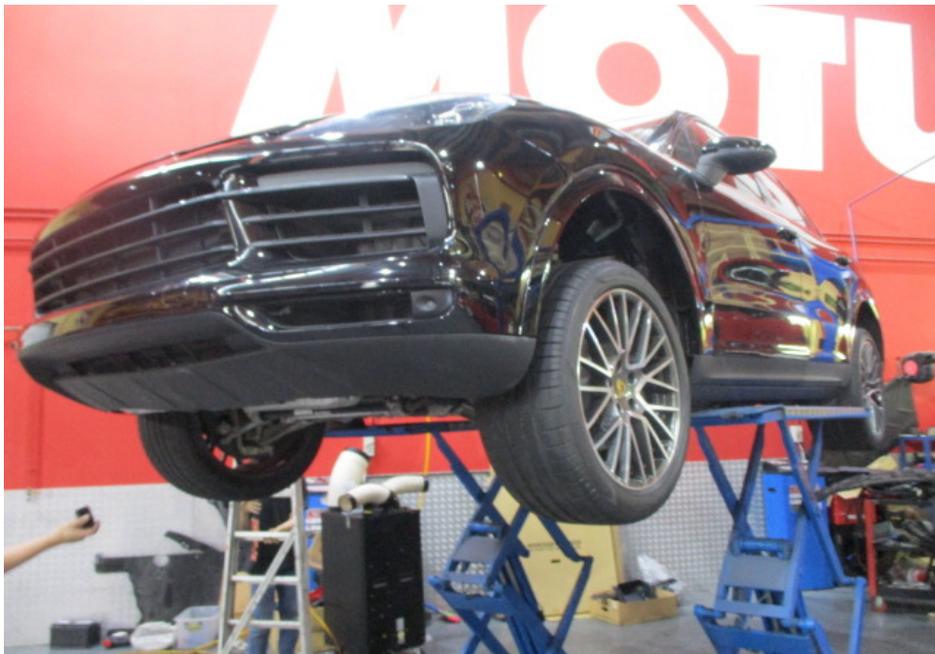
**Photo 17** shows the Motor Car hoisted up for checks on its undercarriage. There was no sign(s) or indication(s) of fluid leakage and/or fluid stain(s) on the underside of the Motor Car. The undercarriage components of the Motor Car were also all observed to be intact and secured in an appropriate manner.

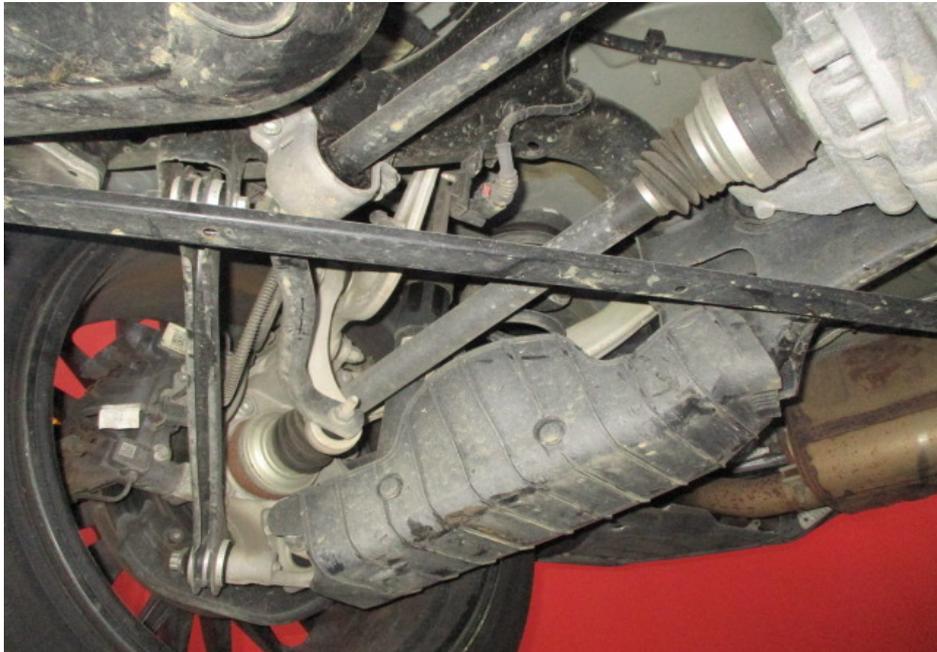
**Photo 18** shows a general view of the control arms and linkages at the rear right wheel of the Motor Car. I did not observe any fluid leak and/or fluid stain on the underside of the Motor Car. All the Motor Car's undercarriage components were observed to be intact and secured in an appropriate manner.

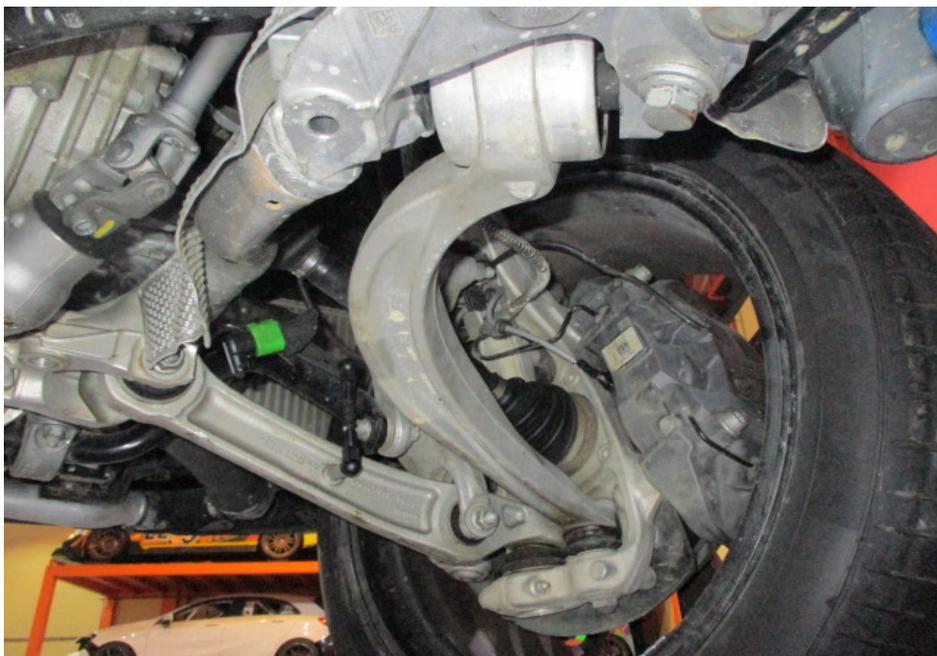
**Photo 19** shows the various undercarriage components at the front right wheel of the Motor Car. The mechanical components, control arms and linkages were all found to be intact and secured in an appropriate manner.

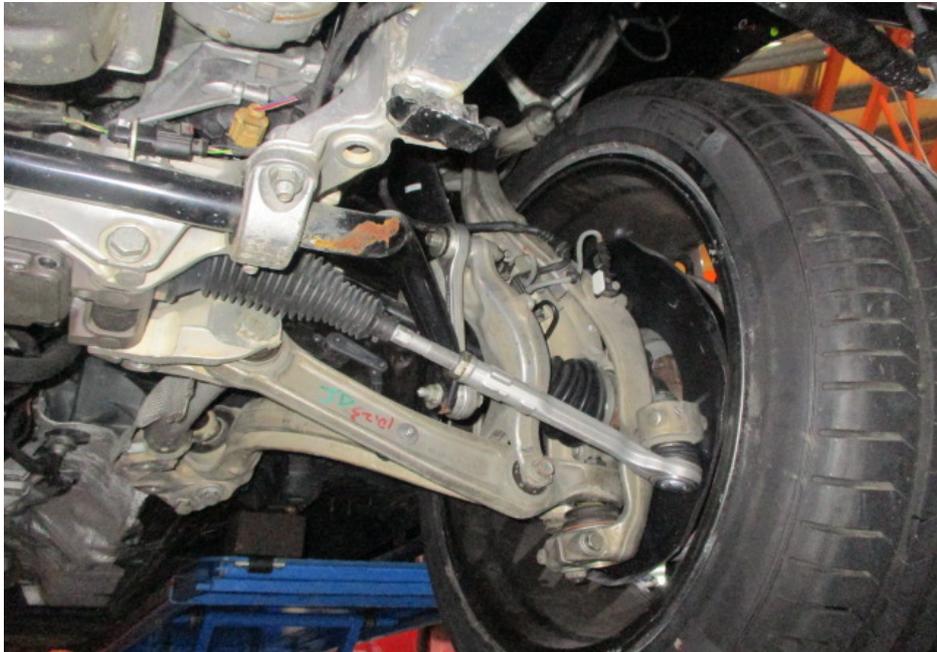
**Photo 20** shows the various undercarriage components at the front left wheel of the Motor Car. The mechanical components, control arms and linkages were all found to be intact and secured in an appropriate manner. I also did not observe any fluid leak and/or fluid stain on the underside of the Motor Car.

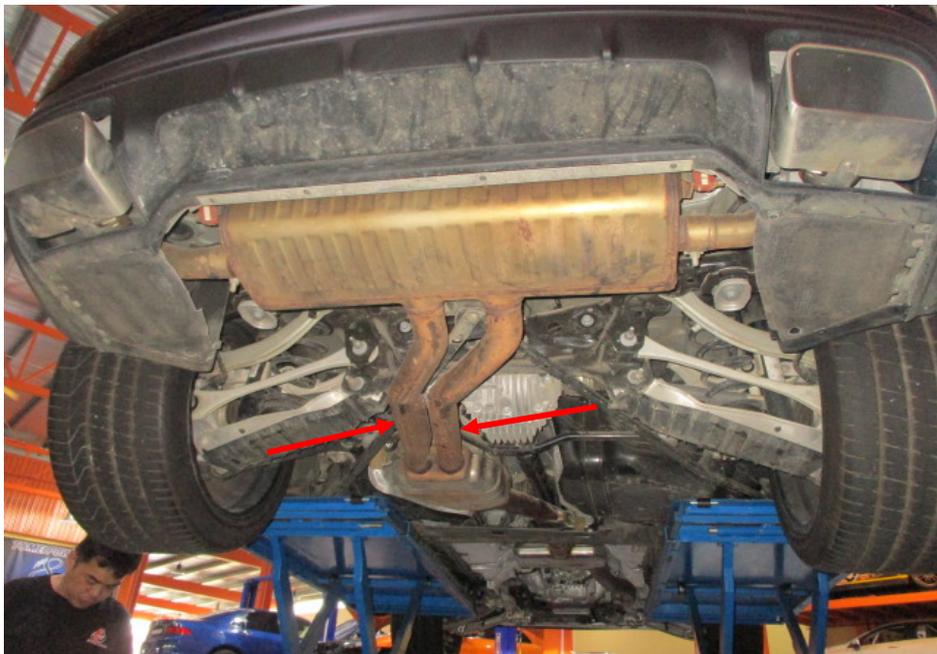
**Photo 21** shows a general view of the Motor Car's exhaust system. My examination of the Motor Car's exhaust system revealed no sign(s) or indication(s) of any cut or weld marks along its exhaust pipes (arrowed), on its catalytic converter and on its rear muffler.

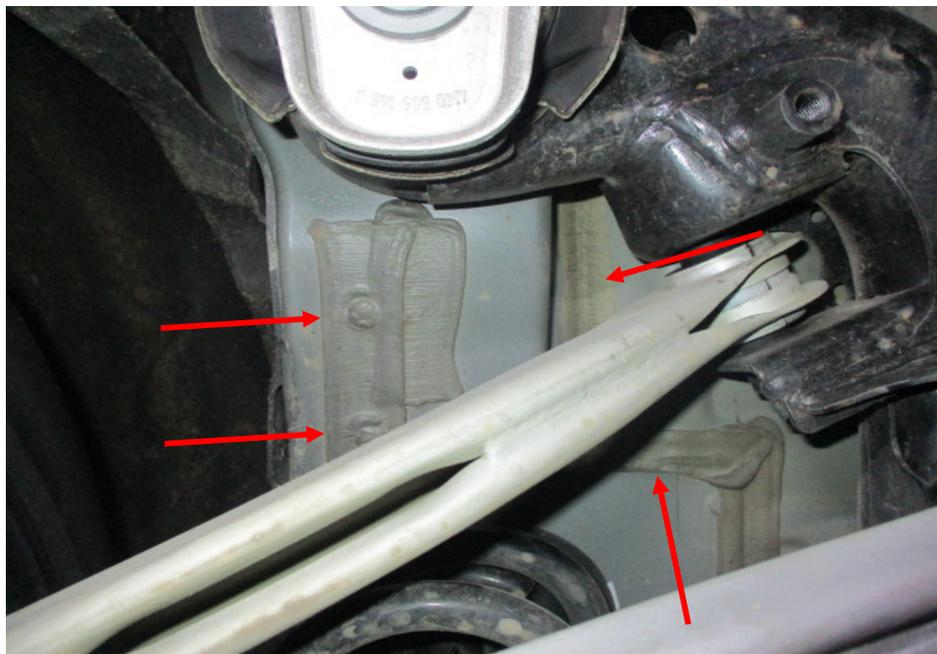
**Photo 22** shows the chassis/structural body at the underside rear left of the Motor Car. I did not find any weld marks other than original spot weld marks on the chassis/structural body of the Motor Car. The original factory sealant (arrowed) at the joints along the chassis/structural body was untouched, indicating no work was done on the chassis/structural body of the Motor Car and that the chassis/structural body was originally fitted.

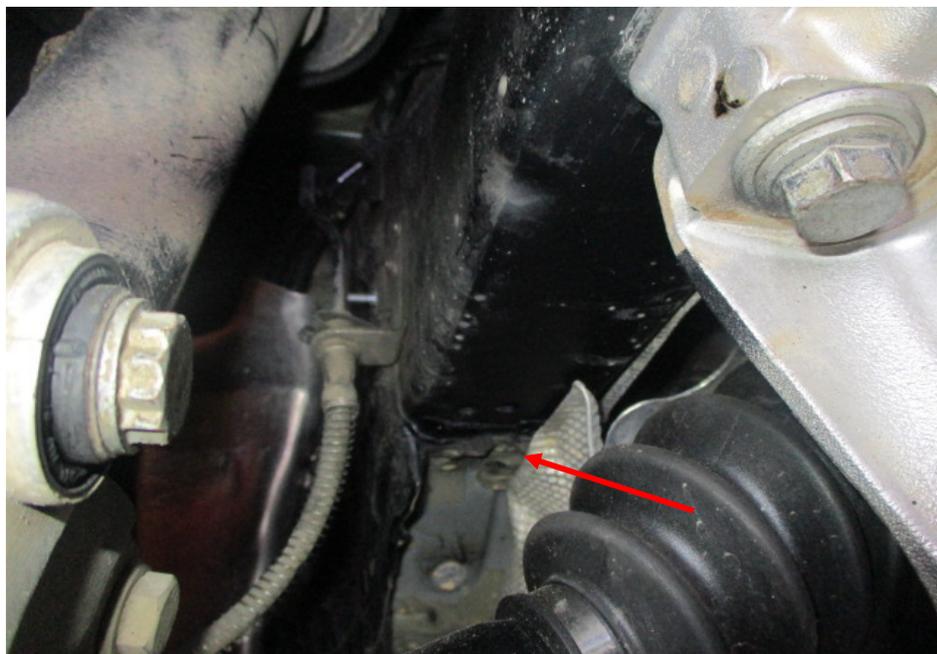
**Photo 23** shows the chassis/structural body at the underside front right of the Motor Car. The original factory sealant (arrowed) at the joints along the chassis/structural body was observed to be untouched. In general, I had found no work was carried out on the chassis/structural body of the Motor Car. The chassis/structural body of the Motor Car was originally fitted.

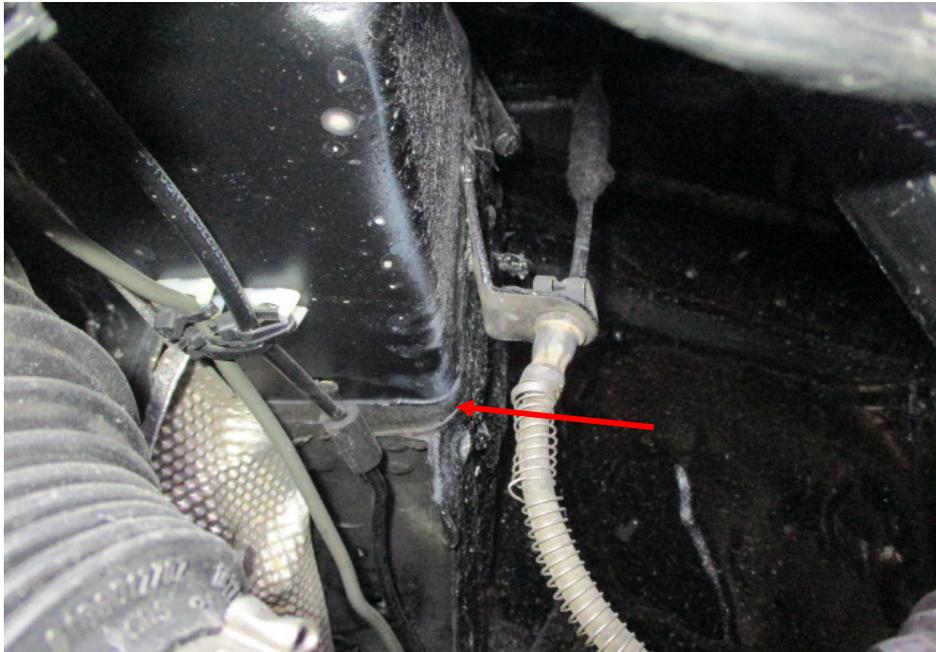
**Photo 24** shows the chassis/structural body at the underside front left of the Motor Car. The original factory sealant (arrowed) at the joints along the chassis/structural body was observed to be untouched. In general, I had found no work was carried out on the chassis/structural body of the Motor Car. The chassis/structural body of the Motor Car was originally fitted.
