Your Ref: Mercedes Benz C63s  
(chassis number WDD2053862F870162)  
Our Ref : CI/TP21006695/D

15 June 2021

**INSPECTION REPORT OF AN UNREGISTERD MERCEDES BENZ C63s  
MOTOR CAR WITH CHASSIS NUMBER WDD2053862F870162**

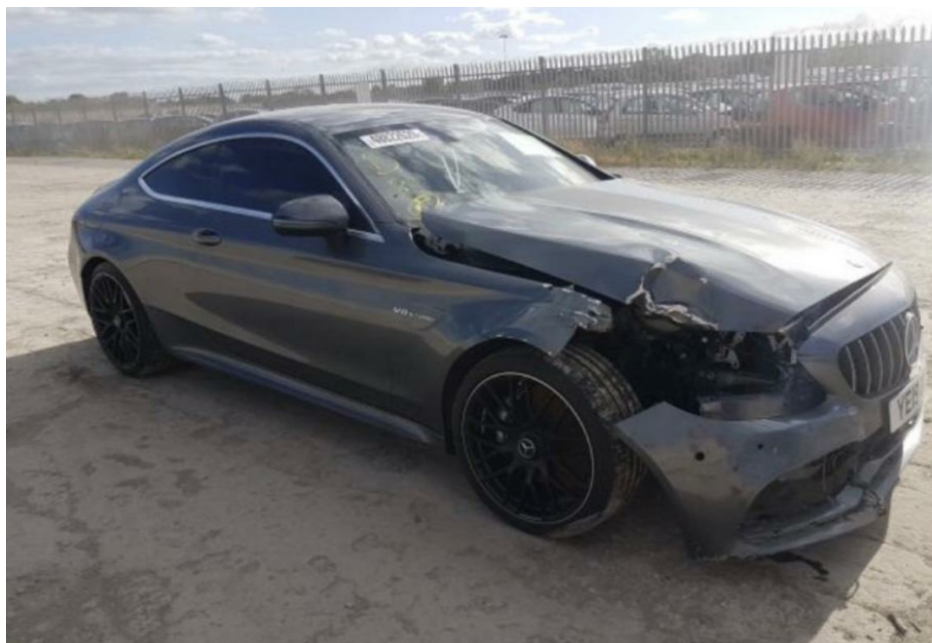
3. From the photographs provided to me, it was observed that the Motor Car had sustained damages at its front right portion. Parts damaged include the front bumper, front bumper right lower grille, front bumper centre lower grille, front bumper lower garnish, front bumper lower lip, front bumper reinforcement, front bonnet, front bonnet right hinge, front right headlamp, front right headlamp top panel, front right fender and front right fender inner shield amongst others.
4. Apart for the front right portion, there was no physical damage observed to other areas of the Motor Car. The airbags were not deployed as seen from the photographs that were provided to me. See photo 1 – 4 below.

**Photo 1** shows the front right body of the Motor Car (photograph provided to me). The Motor Car was observed to have sustained damage at its front right portion. The front bumper, front bumper right lower grille, front bumper lower garnish, front bumper lower lip, front bumper reinforcement, front right headlamp, front right fender, front right fender inner shield and front bonnet were amongst the parts that were observed to have been damaged.

22. The body parts at the front right portion of the Motor Car were visually examined and it was noted that the repair/restoration works carried out to the damaged area of the Motor Car (refer to photograph 1 above) were reasonably adequate and in order.

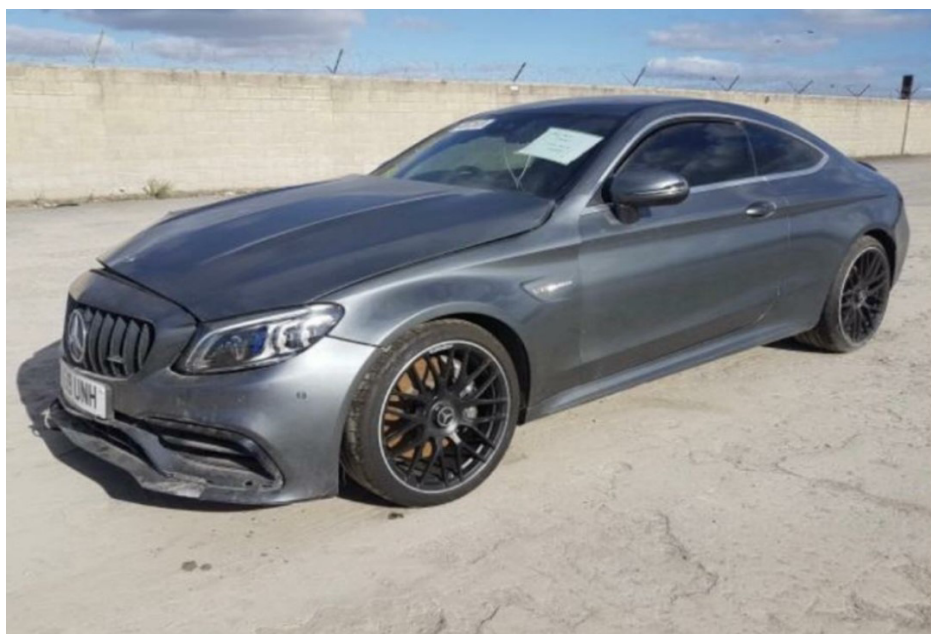
**Photo 2** shows the front left body of the Motor Car (photograph provided to me). Apart for the front right portion, there was no physical damage seen to other areas of the Motor Car. The airbags were not deployed as seen from the photographs that were provided to me. The front windscreen was also not affected. Refer to photograph 1 above, which had appeared to suggest that the front windscreen of the Motor Car was cracked/broken.

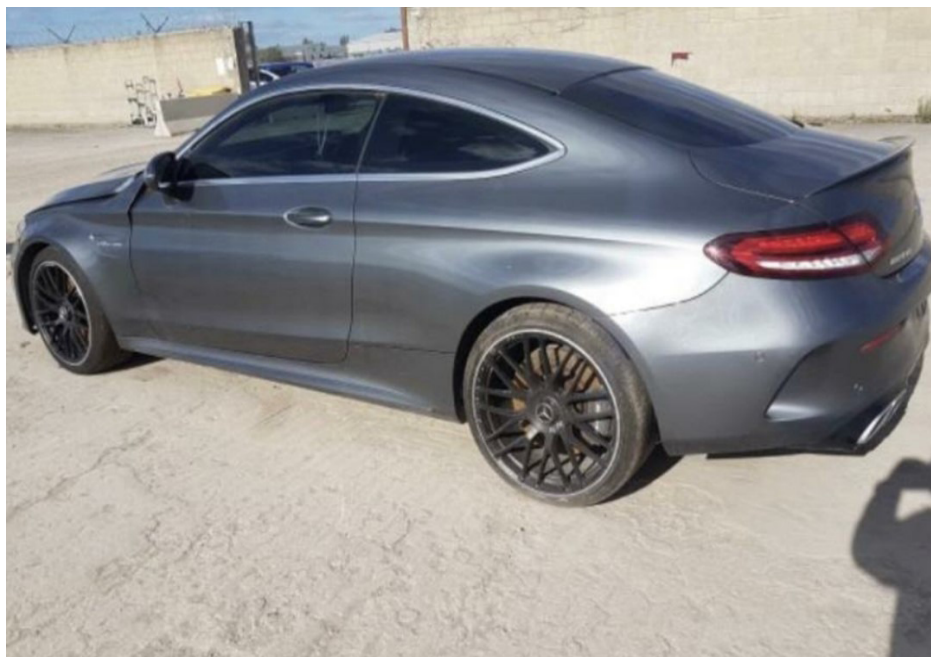
**Photo 3** shows the rear left body of the Motor Car (photograph provided to me). Apart for the front right portion, there was no physical damage seen to other areas of the Motor Car.

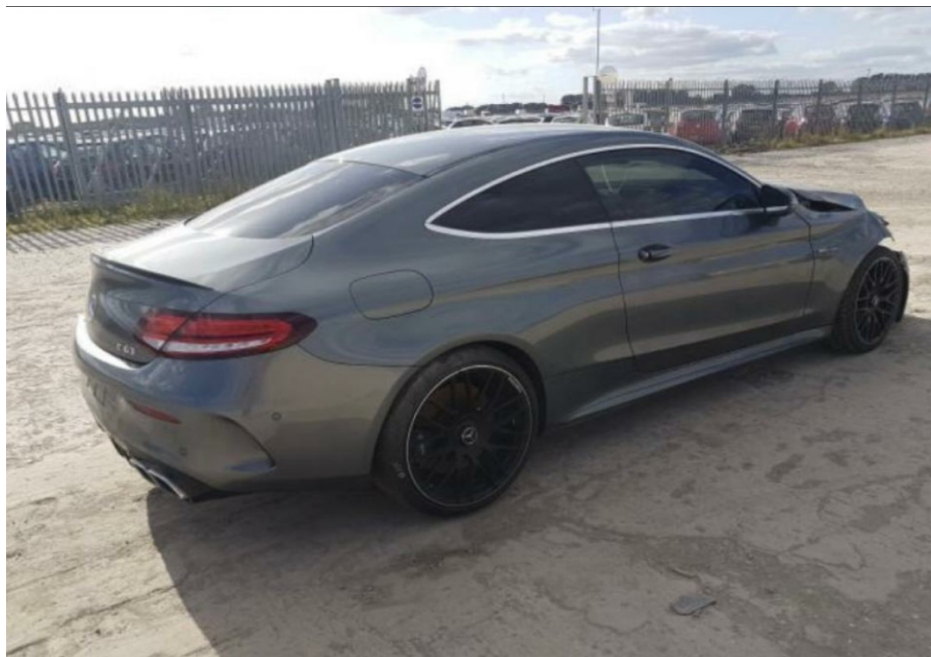
**Photo 4** shows the rear right body of the Motor Car (photograph provided to me). Apart for the front right portion, there was no physical damage seen to other areas of the Motor Car. The airbags were not deployed as seen from the photographs that were provided to me.

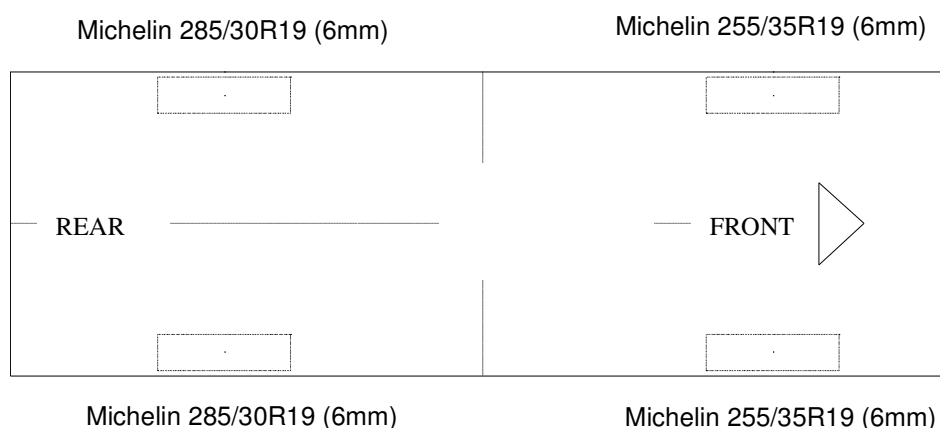
8. It was fitted with 19inch sport wheel rims that were wrapped with tyres that were observed to be of serviceable condition. The tyres were also sufficiently inflated for vehicular operation. The tyre brand, tyre size and approximate remaining tread depth of the 4 tyres of the Motor Car were recorded as follows: -

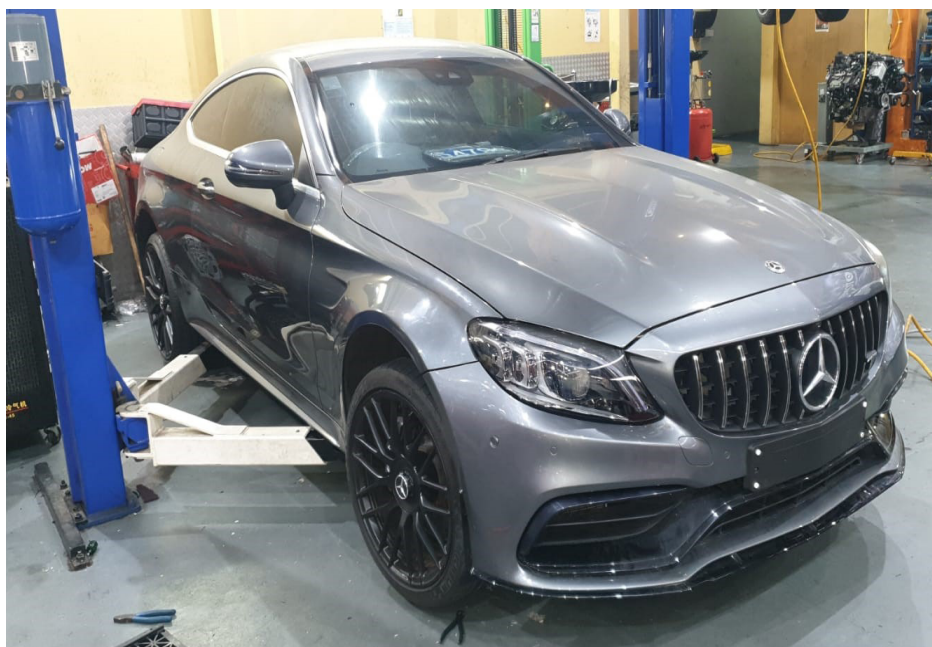
**Photo 5** shows a general view of the front right body of the Motor Car at the time of my inspection. The Motor Car was observed to be in a relatively good general condition with no loose exterior fittings observed. The body parts at the front right portion of the Motor Car were visually examined and it was observed that the repair/restoration works carried out to the damaged area of the Motor Car (refer to photograph 1 above) were reasonably adequate and in order.

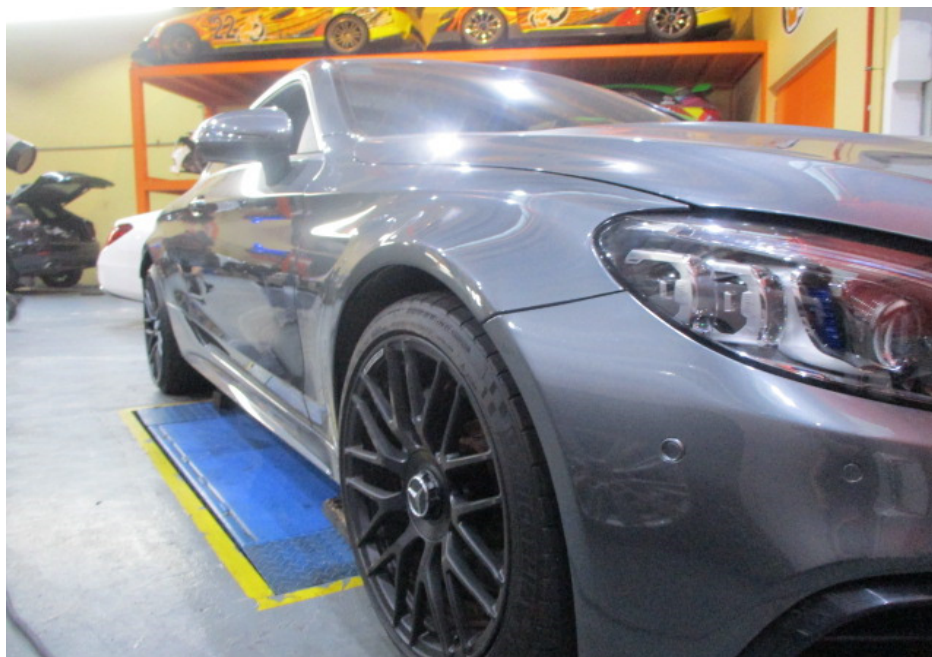
**Photo 6** shows a closer view of the front bumper, front right headlamp and front right fender of the Motor Car at the time of my inspection. The body parts at the front right portion of the Motor Car were visually examined and it was observed that the repair/restoration works carried out to the damaged area of the Motor Car (refer to photograph 1 above) were reasonably adequate and in order.

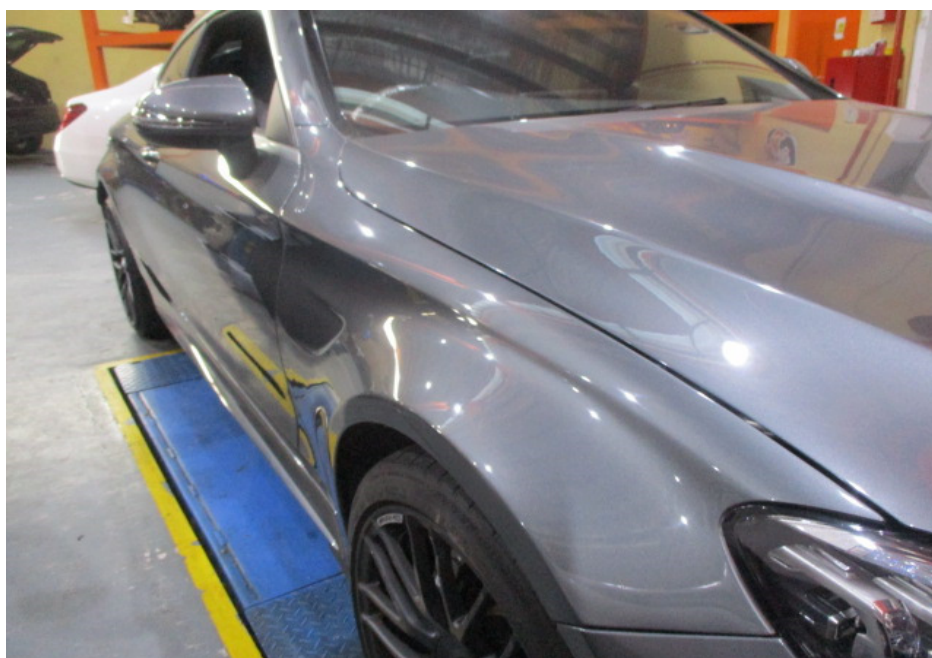
**Photo 7** shows a closer view of the front bonnet and front right fender of the Motor Car at the time of my inspection. The body parts at the front right portion of the Motor Car were visually examined and it was observed that the repair/restoration works carried out to the damaged area of the Motor Car (refer to photograph 1 above) were reasonably adequate and in order.

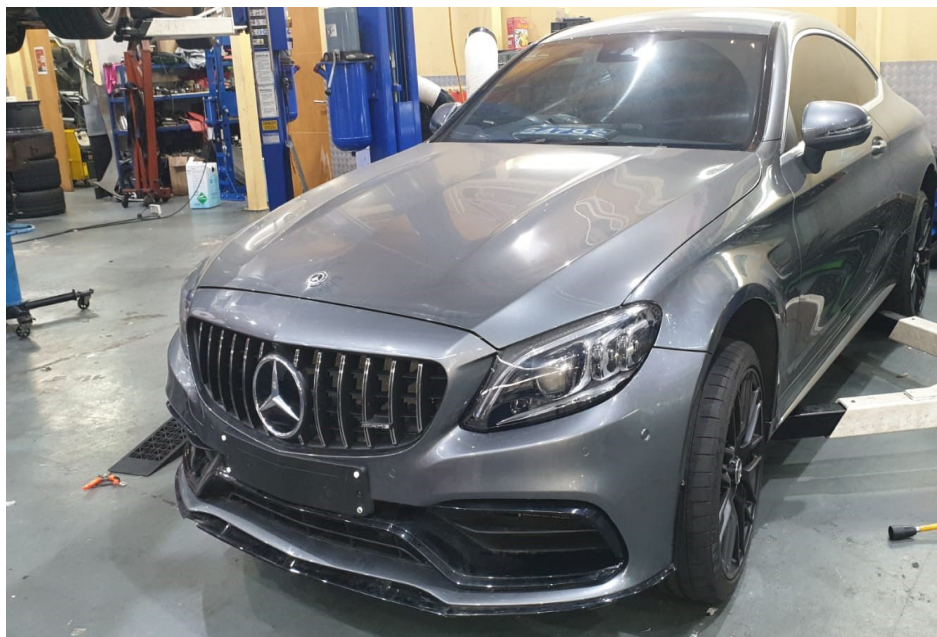
**Photo 8** shows a general view of the front left body of the Motor Car at the time of my inspection. The Motor Car was observed to be in a relatively good general condition with no loose exterior fittings observed. The mileage of the Motor Car recorded at the time of my inspection was 13,709km.

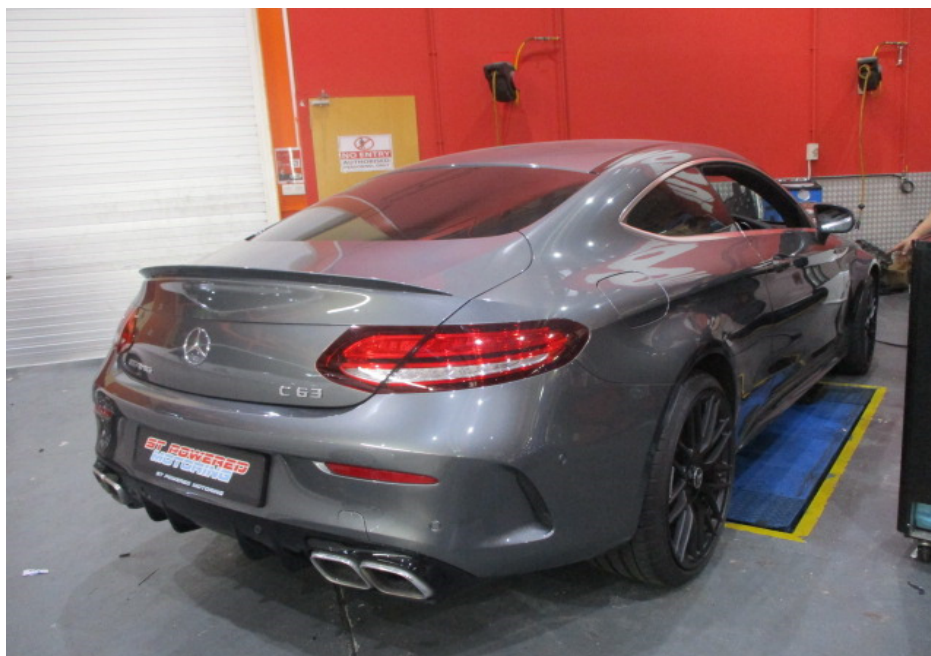
**Photo 9** shows a general view of the rear right body of the Motor Car at the time of my inspection. The Motor Car was observed to be in a relatively good general condition with no loose exterior fittings observed. The mileage of the Motor Car recorded at the time of my inspection was 13,709km.

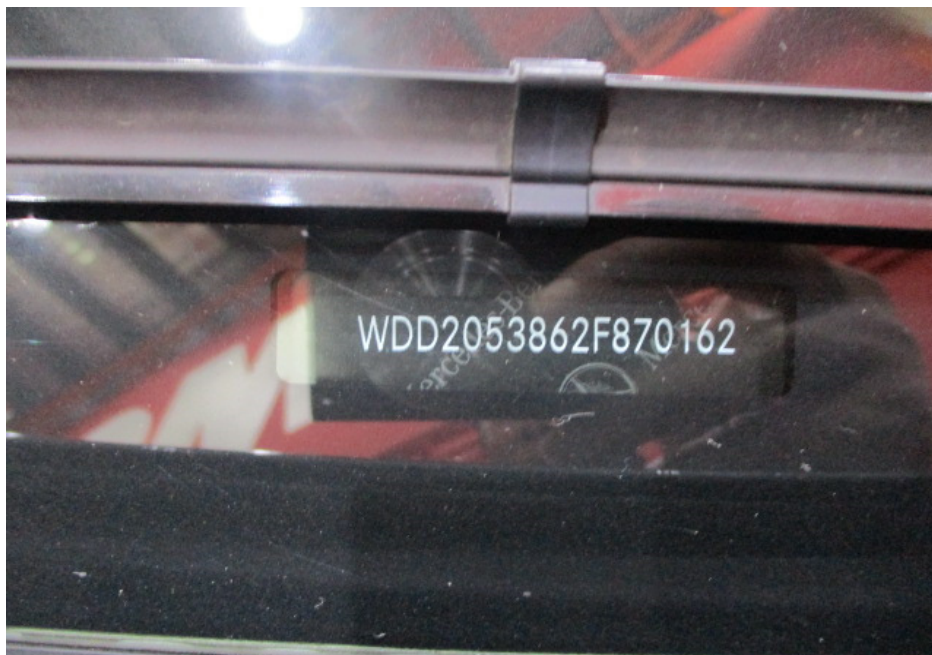
**Photo 10** shows the chassis number of the Motor Car. The chassis number recorded was WDD2053862F870162.

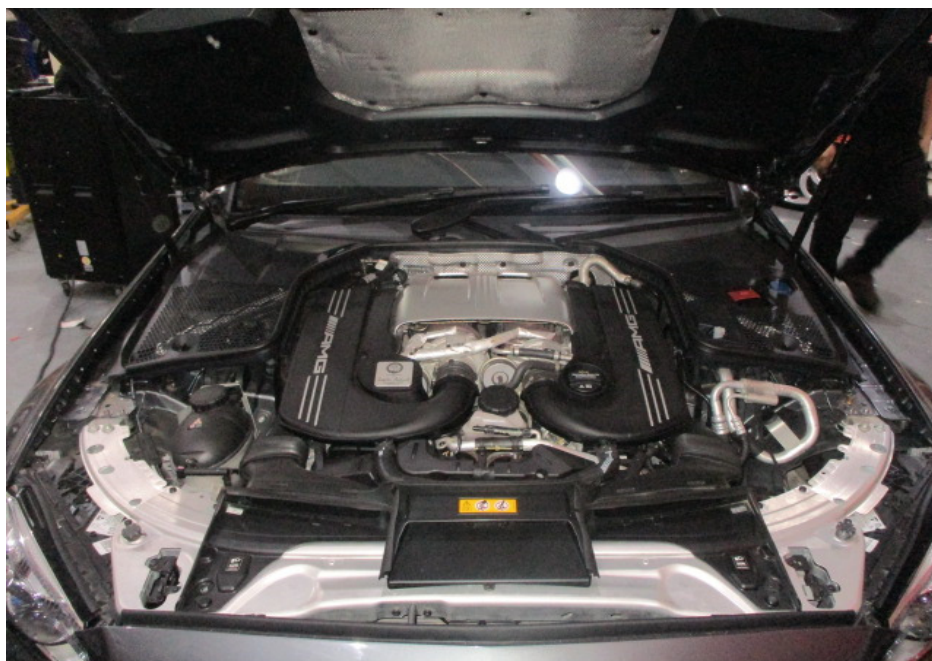
**Photo 11** shows a general view of the engine compartment of the Motor Car at the time of my inspection. The various parts and components inside the engine compartment were all observed to be intact and properly fitted. There was also no sign(s) or indication(s) of fluid leak and/or fluid stain found inside the engine compartment.

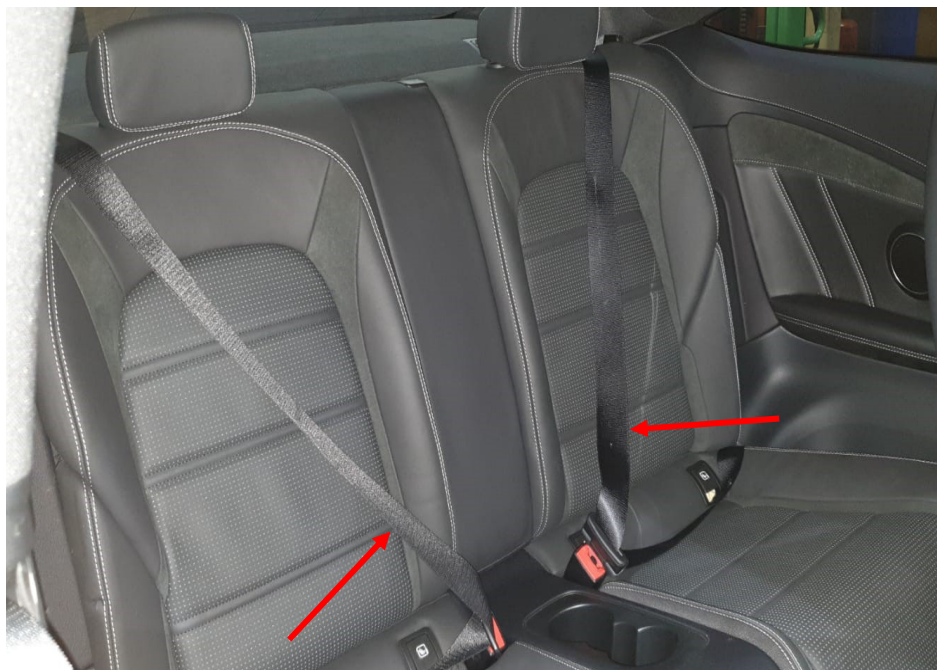
**Photo 12** shows the rear seats of the Motor Car. All the seats of the Motor Car were secured via seat rails to the floorboard. They were also fitted with a retractable seat belt reel and a pre-tensioner. The seat belts (arrowed) were tested and were able to be fastened into the respective pre-tensions that were fitted on the side of each individual seat.

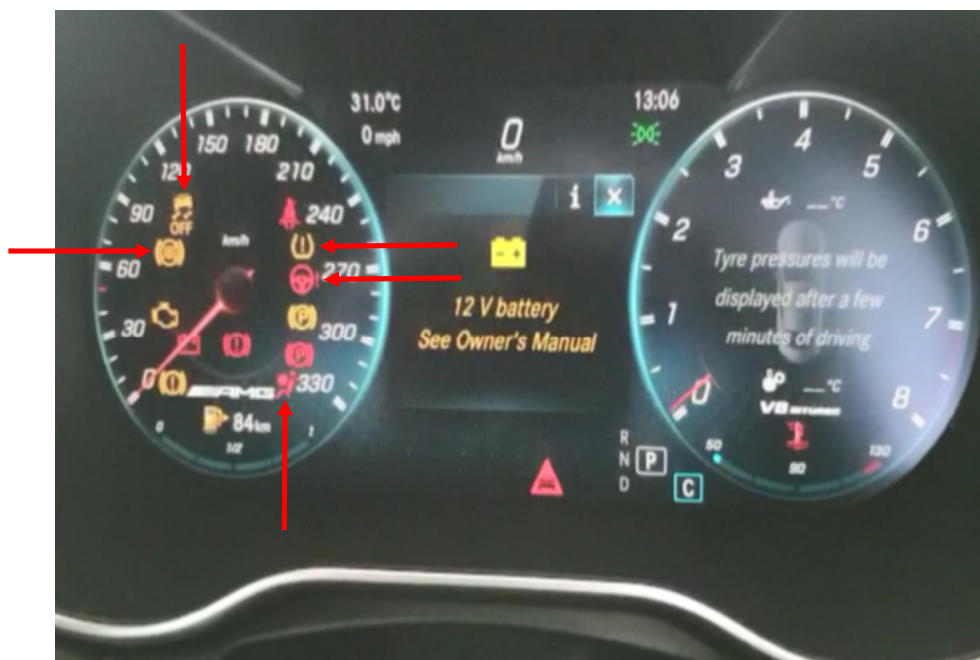
**Photo 13** shows the warning lights for the various electronic safety features appearing on the instrument panel of the Motor Car during its self-test when the engine is cranked, in particular the ABS, SRS, EPS, TPM and TCS lights (arrowed).

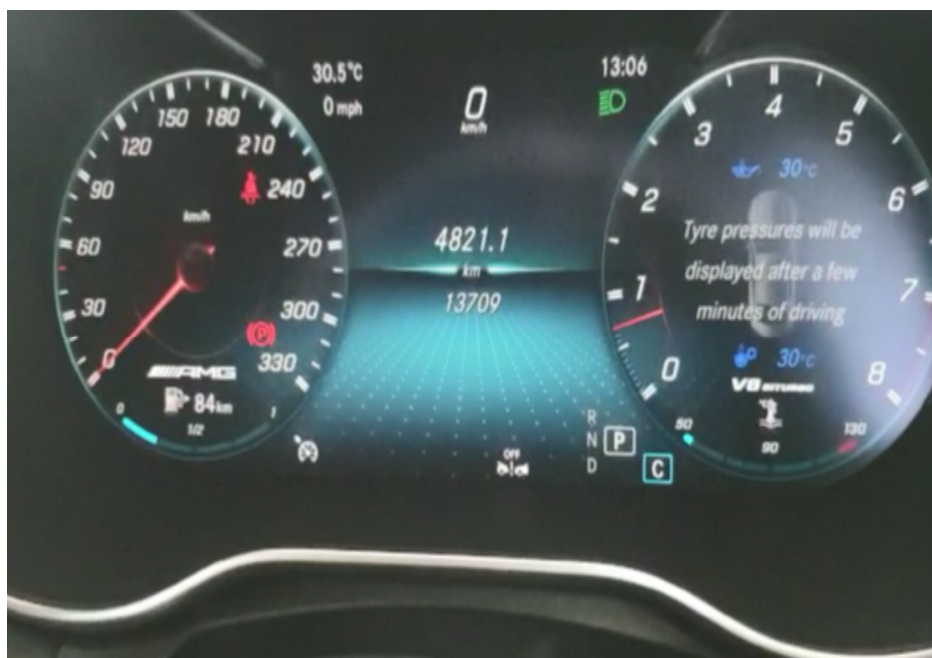
**Photo 14** shows the respective warning lights no longer illuminated, indicating that there is no fault detected to the ABS, SRS, EPS, TPM and TCS systems of the Motor Car during the self-test. These electronic systems were hence in working condition at the time of my inspection.

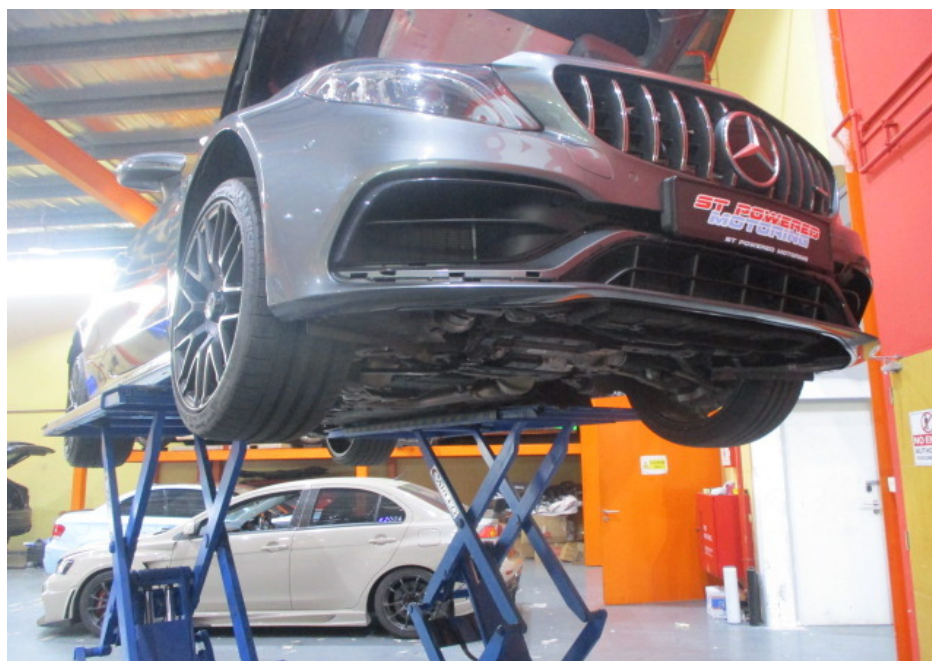
**Photo 15** shows the Motor Car hoisted up for checks on its undercarriage. There was no sign(s) or indication(s) of fluid leakage and/or fluid stain(s) on the underside of the Motor Car. The undercarriage components of the Motor Car were also all observed to be intact and secured in an appropriate manner.

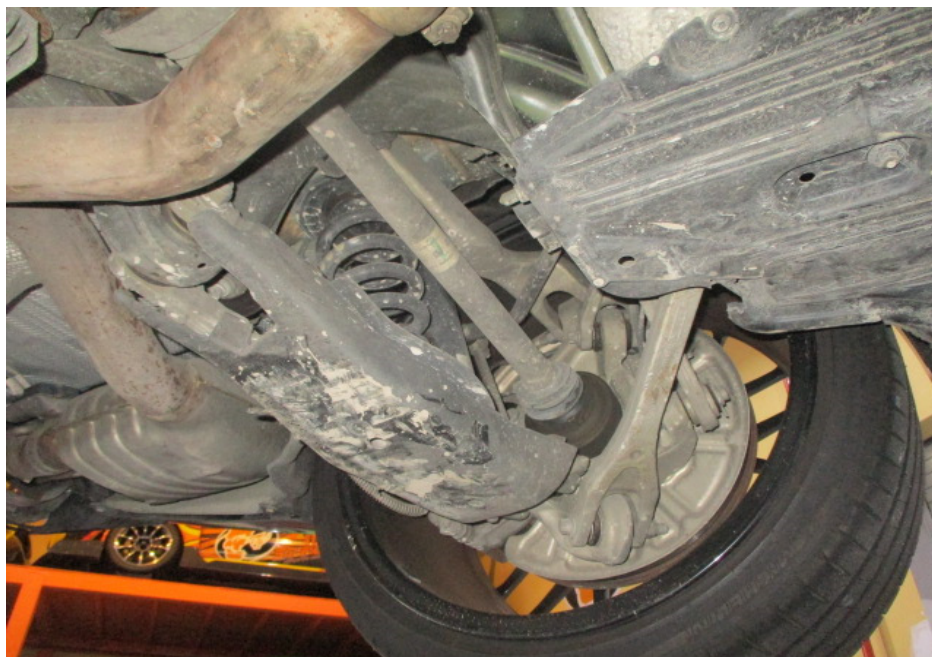
**Photo 16** shows a general view of the control arms and linkages at the rear left wheel of the Motor Car. I did not observe any fluid leak and/or fluid stain on the underside of the Motor Car. All of the Motor Car's undercarriage components were observed to be intact and secured in an appropriate manner.

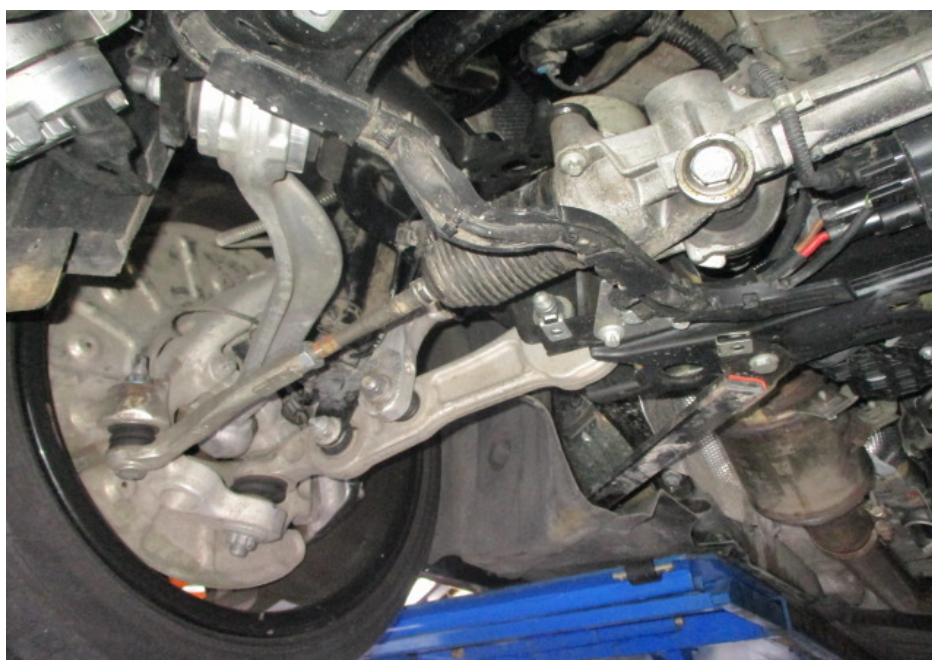
**Photo 17** shows the various undercarriage components at the front right wheel of the Motor Car. The mechanical components, control arms and linkages were all found to be intact and secured in an appropriate manner.

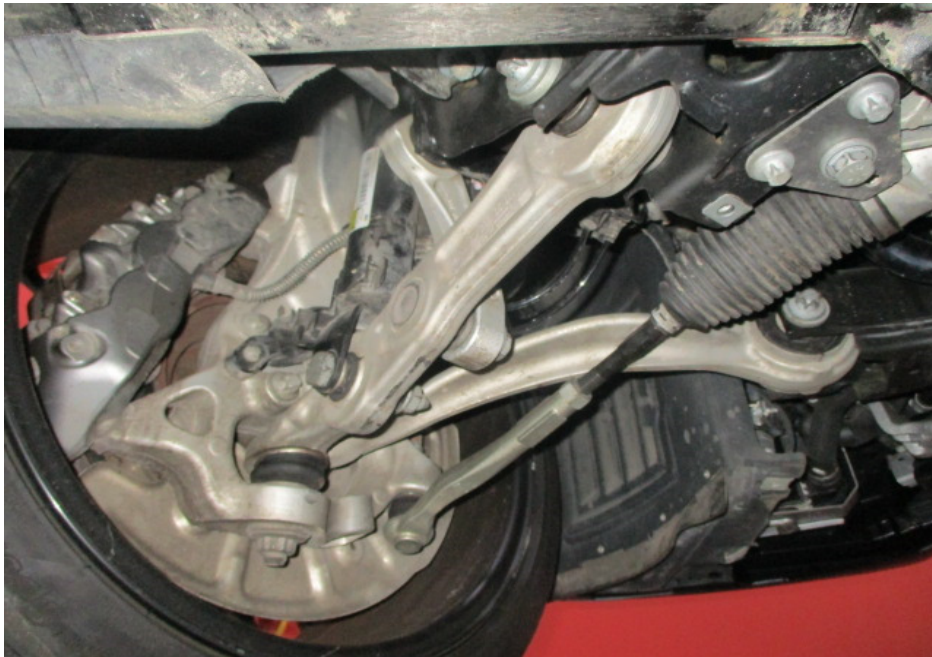
**Photo 18** shows the various undercarriage components at the front left wheel of the Motor Car. The mechanical components, control arms and linkages were all found to be intact and secured in an appropriate manner. I also did not observe any fluid leak and/or fluid stain on the underside of the Motor Car.

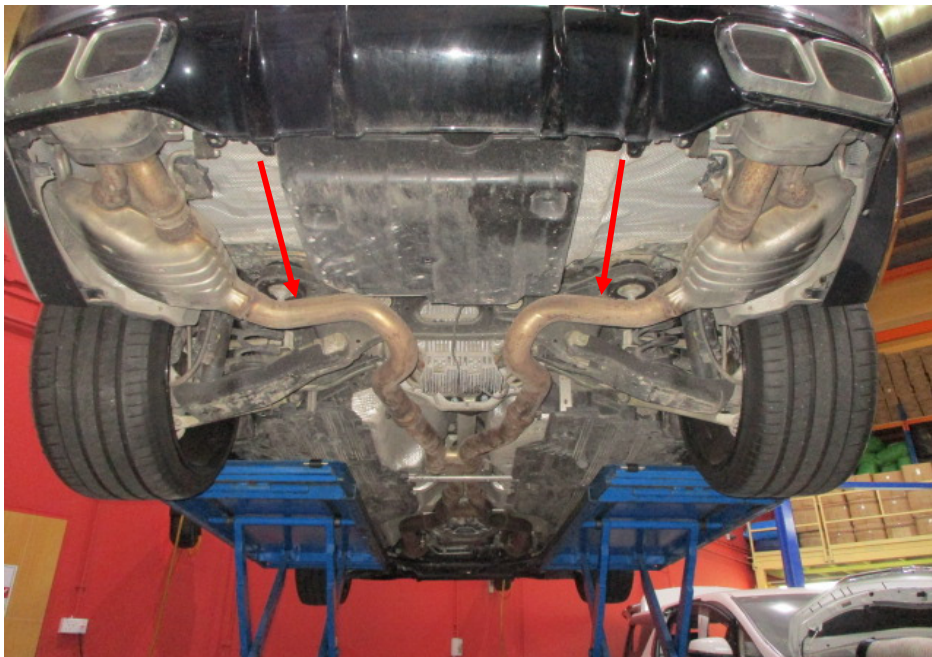
**Photo 19** shows the Motor Car's exhaust system. My examination of the Motor Car's exhaust system revealed no sign(s) or indication(s) of any cut or weld marks along its exhaust pipes (arrowed), rear mufflers and on its catalytic converters.

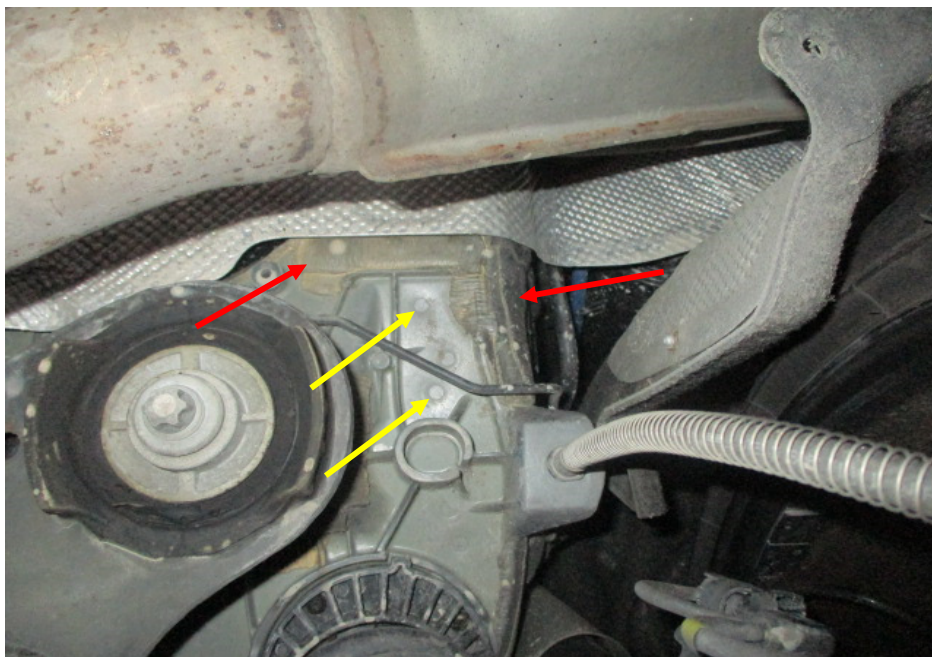
**Photo 20** shows the chassis/structural body at the underside rear right of the Motor Car. I did not find any weld marks other than original spot weld marks (yellow arrow) on the chassis/structural body of the Motor Car. The original factory sealant (red arrow) at the joints along the chassis/structural body was also untouched, indicating no work was done on the chassis/structural body of the Motor Car and that the chassis/structural body was originally fitted.

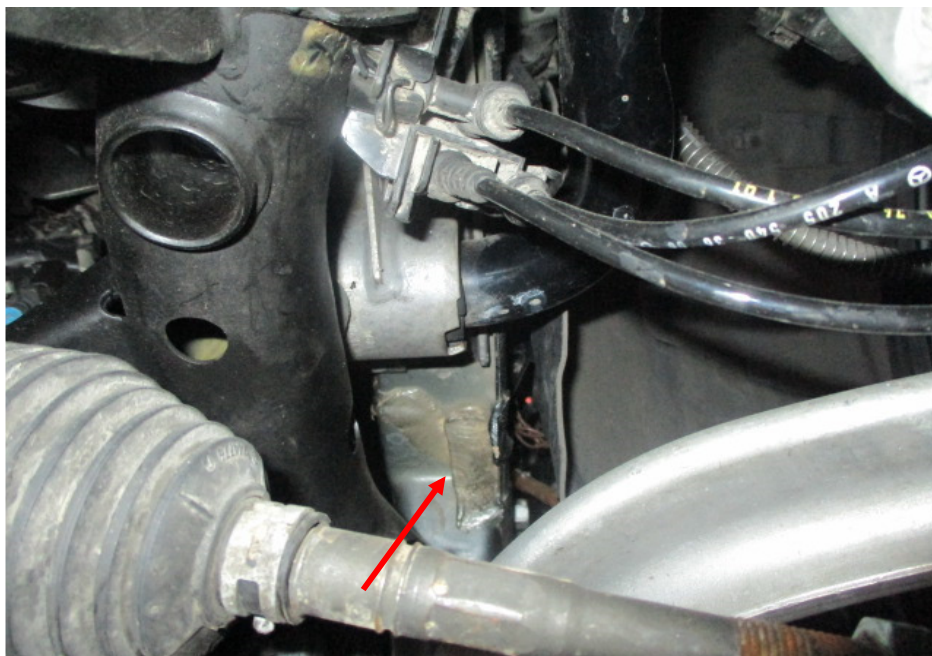
**Photo 21** shows the chassis/structural body at the underside front right of the Motor Car. The original factory sealant (arrowed) at the joints along the chassis/structural body was observed to be untouched. In general, I had found no work was carried out on the chassis/structural body of the Motor Car. The chassis/structural body of the Motor Ca was originally fitted.

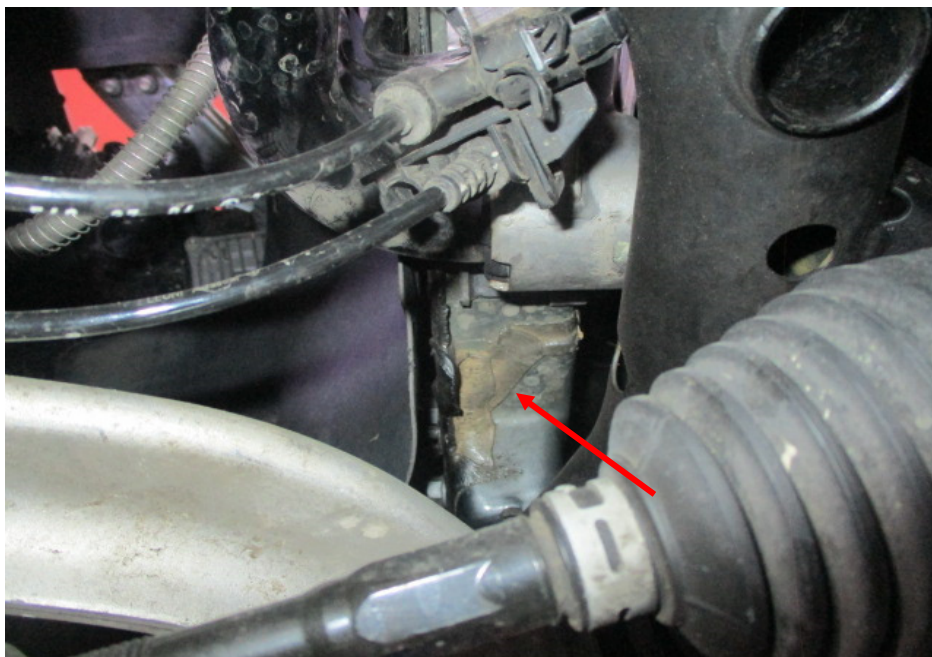
**Photo 22** shows the chassis/structural body at the underside front left of the Motor Car. The original factory sealant (arrowed) at the joints along the chassis/structural body was observed to be untouched. In general, I had found no work was carried out on the chassis/structural body of the Motor Car. The chassis/structural body of the Motor Ca was originally fitted.

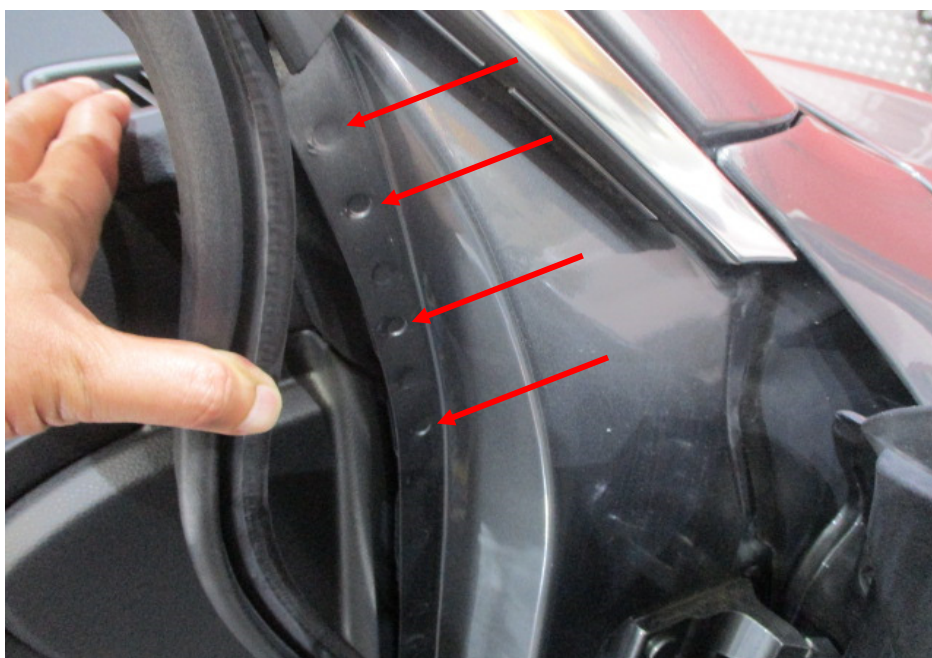
**Photo 23** shows the right side "A" pillar of the Motor Car. I did not find any weld marks other than original spot weld marks (arrowed) on the right side "A" pillar of the Motor Car which, indicates that there was no re-welding works carried out. In general, I had found all the non-detachable body panels of the Motor Car to be originally fitted at the time of my inspection.

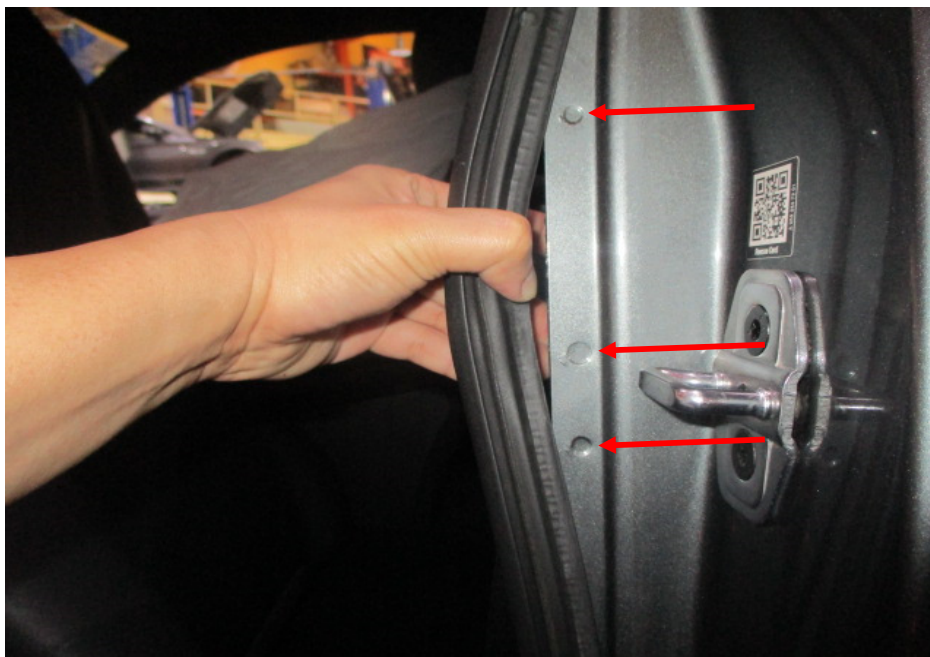
**Photo 24** shows the left side rear body panel of the Motor Car. I did not find any weld marks other than original spot weld marks (arrowed) on the left side rear body panel of the Motor Car which, indicates that there was no re-welding works carried out. In general, I had found all the non-detachable body panels of the Motor Car to be originally fitted at the time of my inspection.
