Your Ref: BMW X4 M40i  
(chassis number WBAUJ52020LP18024)  
Our Ref : CI/TP21006707/D

15 June 2021

**INSPECTION REPORT OF AN UNREGISTERD BMW X4 M40i MOTOR CAR  
WITH CHASSIS NUMBER WBAUJ52020LP18024**

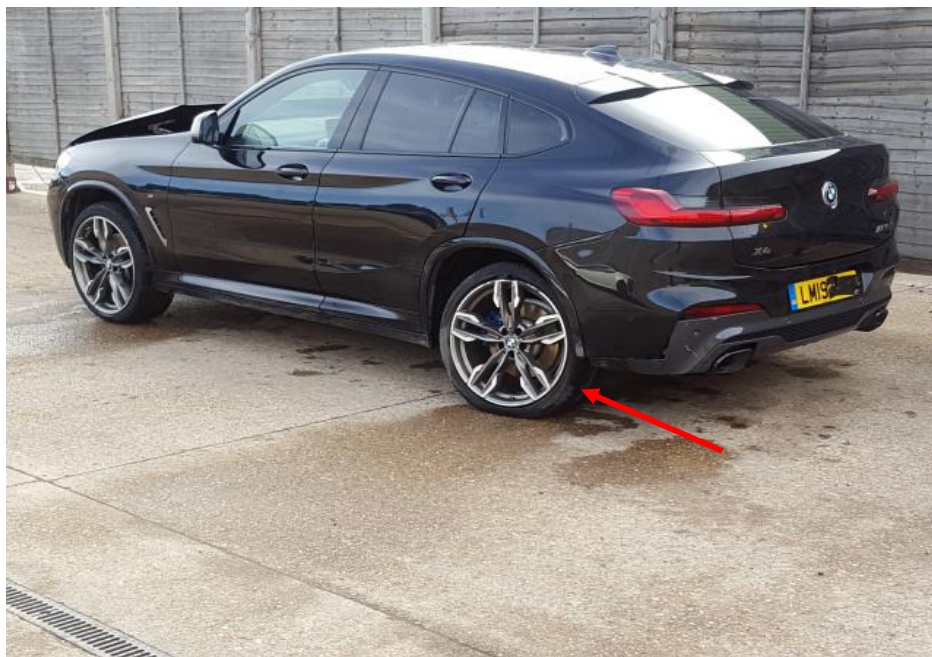
**Photo 1** shows the rear left body of the Motor Car (photograph provided to me). The rear left wheel (arrowed) was oriented in an unnatural position, which would indicate likely damage to the various undercarriage parts at the rear left wheel of the Motor Car. Parts that may be damaged include the rear left shock absorber, rear left lower arm and rear left knuckle arm amongst others. The rear left tyre was observed to be punctured.

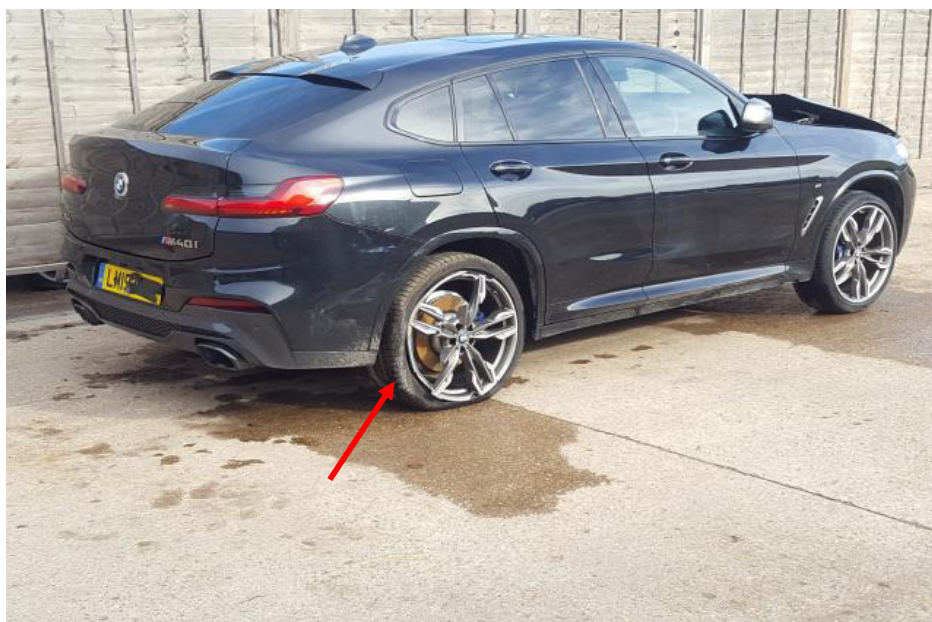
**Photo 2** shows the rear right body of the Motor Car (photograph provided to me). The rear right wheel (arrowed) was oriented in an unnatural position, which would indicate likely damage to the various undercarriage parts at the rear right wheel of the Motor Car. Parts that may be damaged include the rear right shock absorber, rear right lower arm and rear right knuckle arm amongst others. The rear right tyre was observed to be punctured.

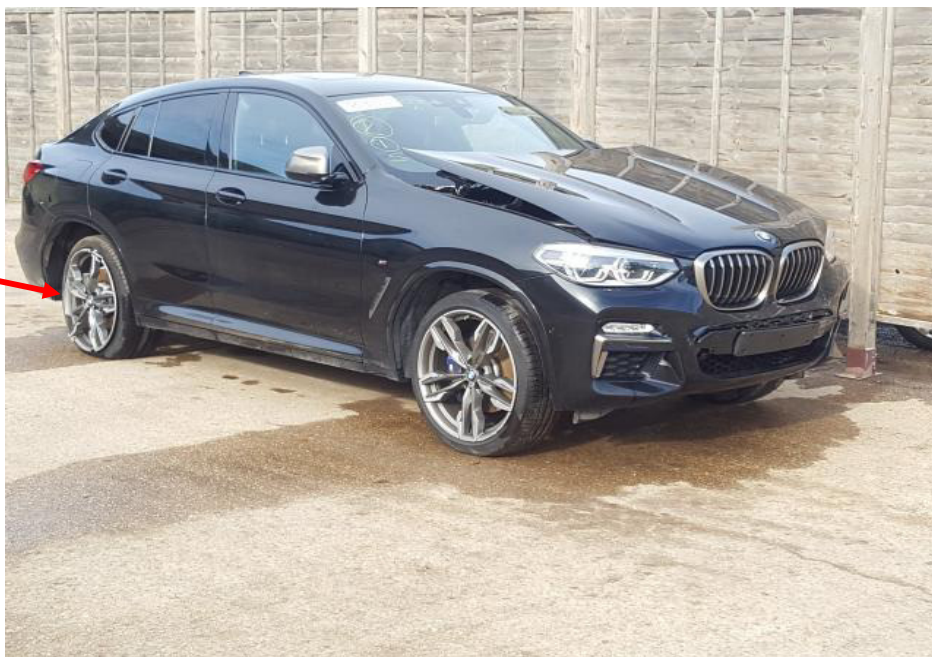
**Photo 3** shows the front right body of the Motor Car (photograph provided to me). The front bonnet of the Motor Car was also observed to be damaged where the damage profile appears to suggest that the front pedestrian protection actuators were activate. Other than the front bonnet, the rear left wheel rim and tyre and rear right wheel rim and tyre (arrowed), there was no further damage observed to the exterior body of the Motor Car.

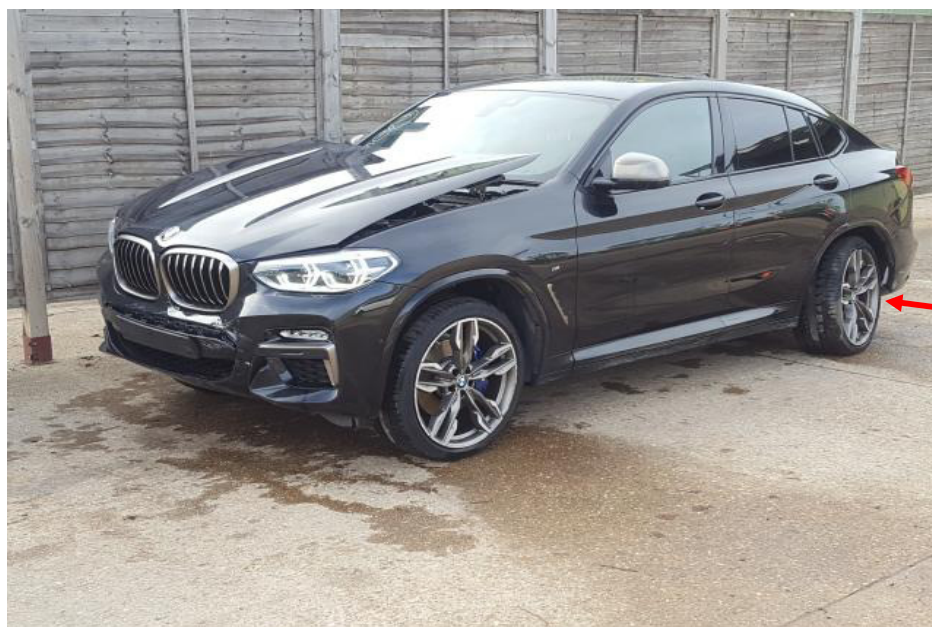
**Photo 4** shows the front left body of the Motor Car (photograph provided to me). The front bonnet of the Motor Car was also observed to be damaged where the damage profile appears to suggest that the front pedestrian protection actuators were activate. Other than the front bonnet, the rear left wheel rim and tyre (arrowed) and rear right wheel rim and tyre, there was no further damage observed to the exterior body of the Motor Car.

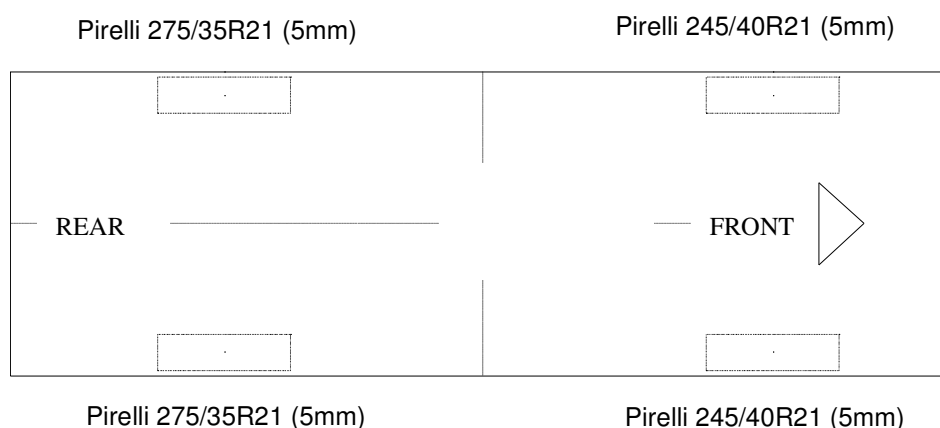
8. It was fitted with 21inch sport wheel rims that were wrapped with tyres that were observed to be of serviceable condition. The tyres were also sufficiently inflated for vehicular operation. The tyre brand, tyre size and approximate remaining tread depth of the 4 tyres of the Motor Car were recorded as follows: -

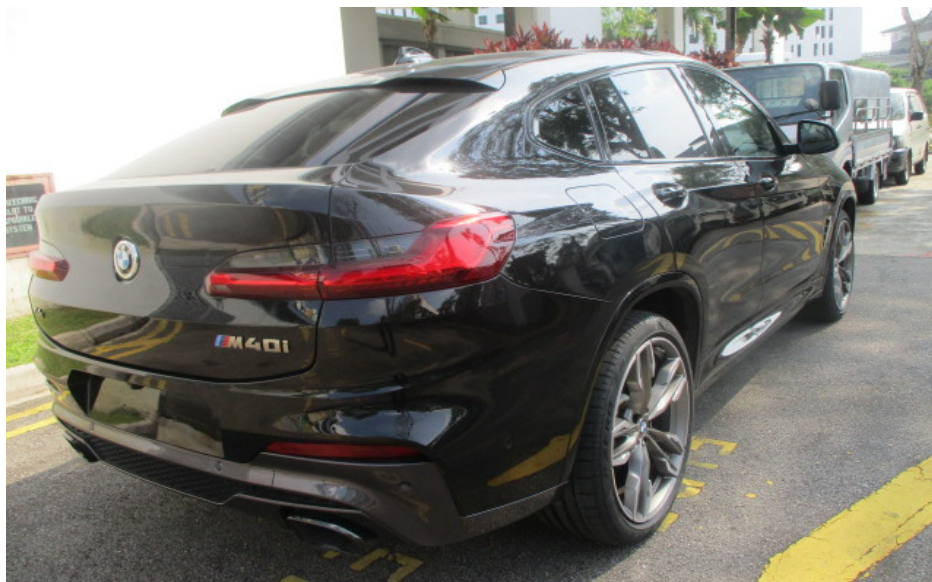
**Photo 5** shows a general view of the rear right body of the Motor Car at the time of my inspection. The Motor Car was observed to be in a relatively good general condition with no loose exterior fittings observed. The body parts at the rear portion and undercarriage parts at the rear left wheel and rear right wheel of the Motor Car were visually examined and it was observed that the repair/restoration works carried out to the damaged area of the Motor Car (refer to photograph 1 & 2 above) were reasonably adequate and in order.

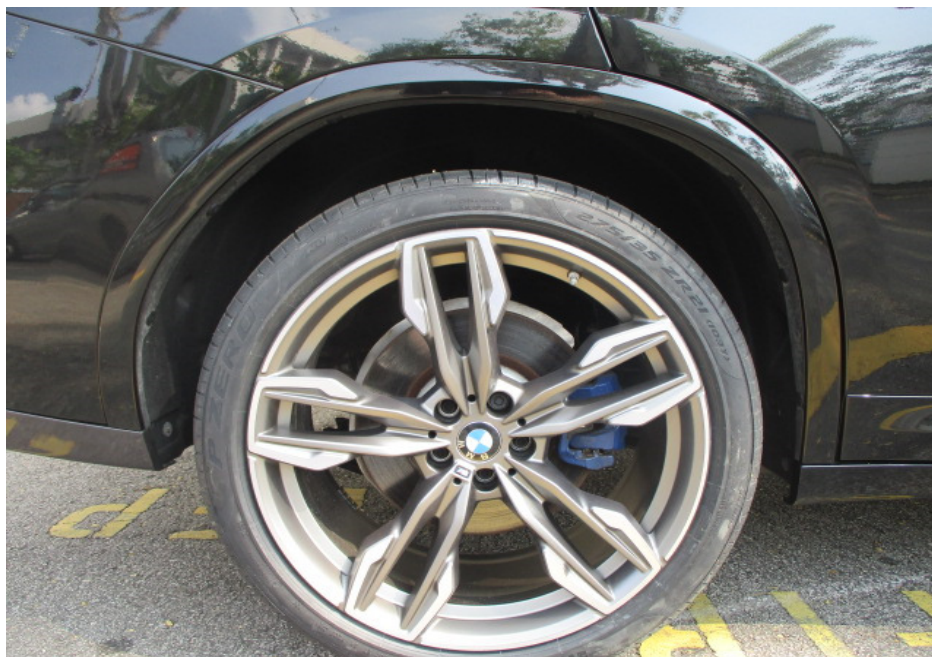
**Photo 6** shows a closer view of the rear right wheel rim of the Motor Car. The body parts at the rear portion and undercarriage parts at the rear left wheel and rear right wheel of the Motor Car were visually examined and it was observed that the repair/restoration works carried out to the damaged area of the Motor Car (refer to photograph 1 & 2 above) were reasonably adequate and in order.

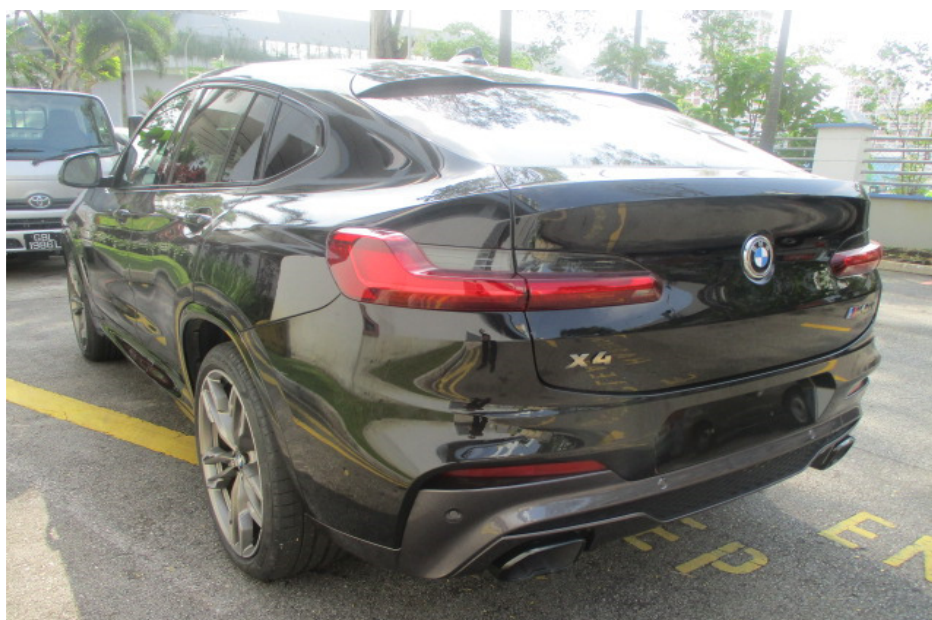
**Photo 7** shows a general view of the rear left body of the Motor Car at the time of my inspection. The Motor Car was observed to be in a relatively good general condition with no loose exterior fittings observed. The body parts at the rear portion and undercarriage parts at the rear left wheel and rear right wheel of the Motor Car were visually examined and it was observed that the repair/restoration works carried out to the damaged area of the Motor Car (refer to photograph 1 & 2 above) were reasonably adequate and in order.

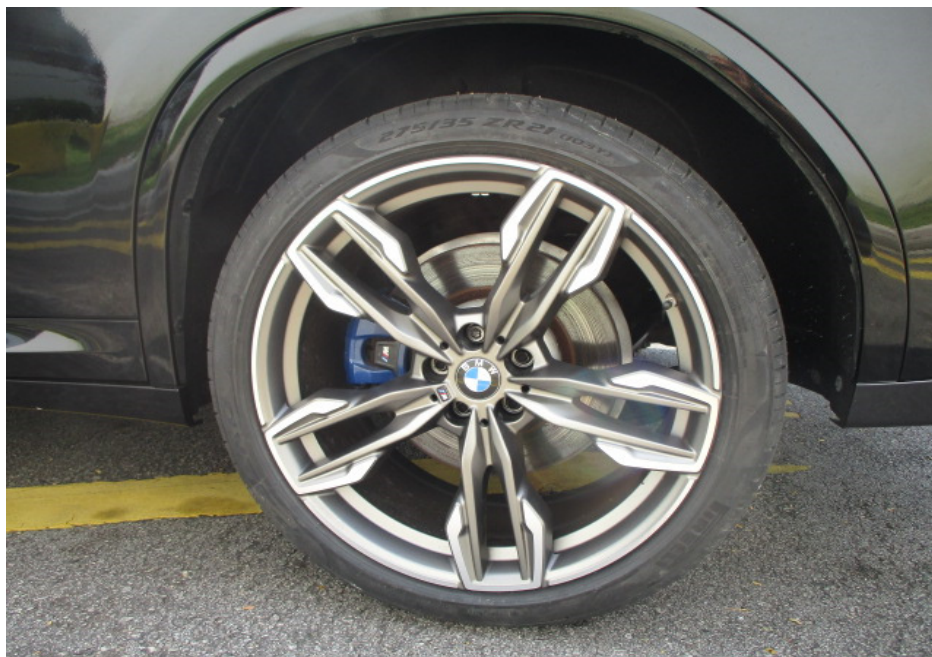
**Photo 8** shows a closer view of the rear left wheel rim of the Motor Car. The body parts at the rear portion and undercarriage parts at the rear left wheel and rear right wheel of the Motor Car were visually examined and it was observed that the repair/restoration works carried out to the damaged area of the Motor Car (refer to photograph 1 & 2 above) were reasonably adequate and in order.

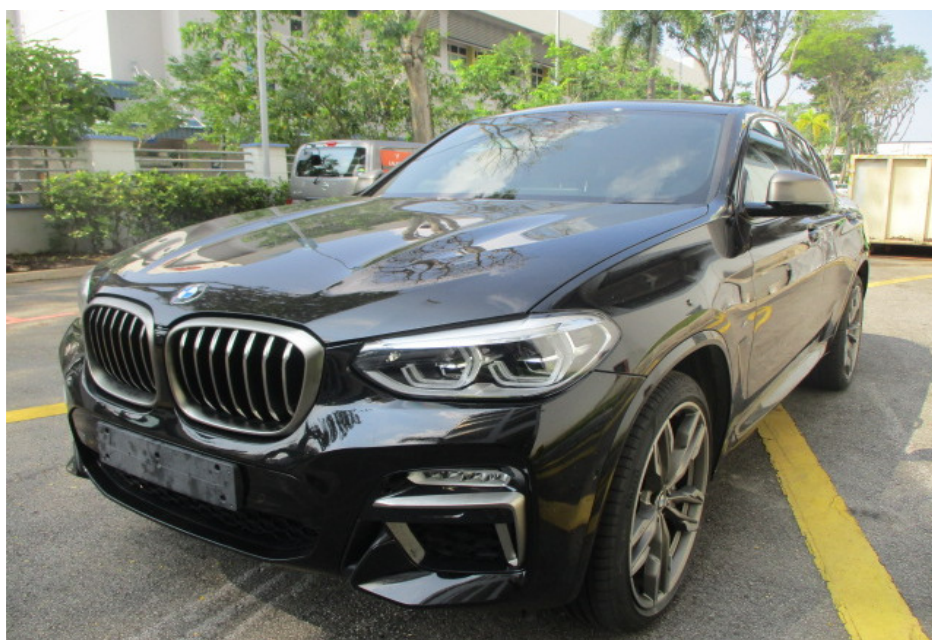
**Photo 9** shows a general view of the front left body of the Motor Car at the time of my inspection. The Motor Car was observed to be in a relatively good general condition with no loose exterior fittings observed. The body parts at the frontal portion of the Motor Car were visually examined and it was observed that the repair/restoration works carried out to the damaged area of the Motor Car (refer to photograph 3 & 4 above) were reasonably adequate and in order.

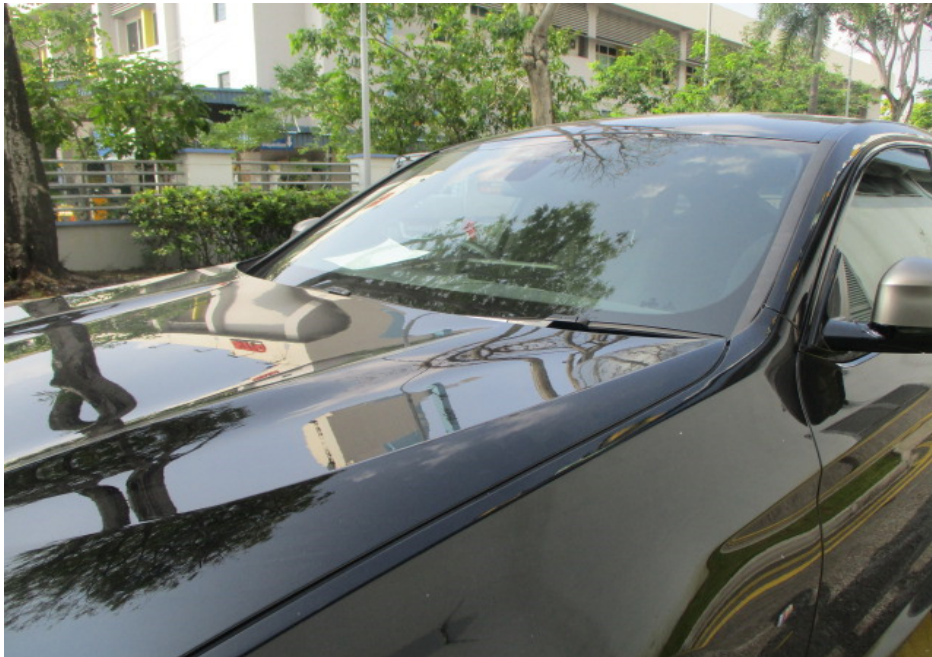
**Photo 10** shows a closer view of the Motor Car's front bonnet at the time of my inspection. The body parts at the frontal portion of the Motor Car were visually examined and it was observed that the repair/restoration works carried out to the damaged area of the Motor Car (refer to photograph 3 & 4 above) were reasonably adequate and in order.

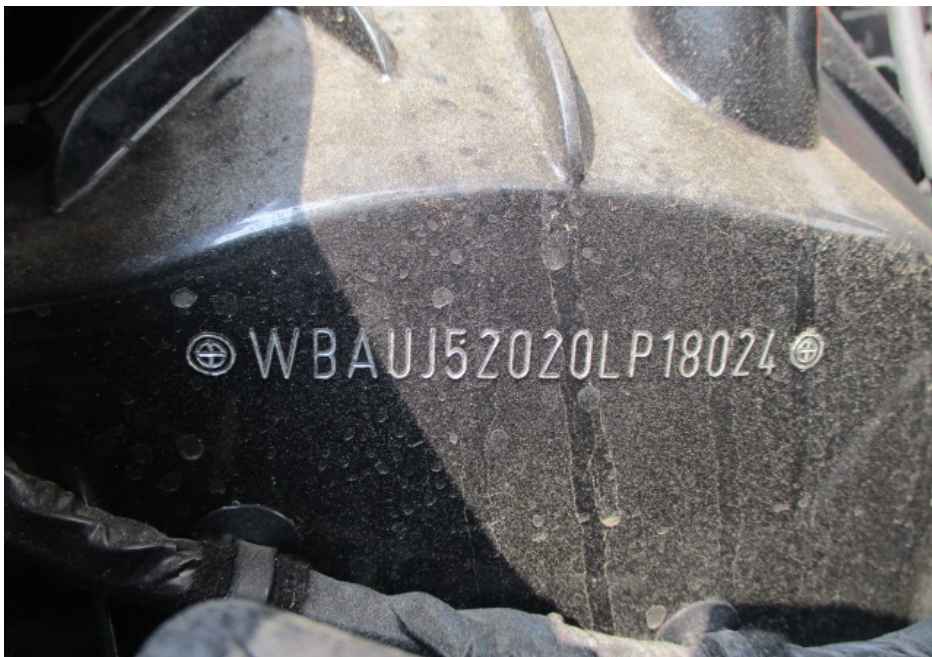
**Photo 11** shows the chassis number of the Motor Car. The chassis number recorded was WBAUJ52020LP18024.

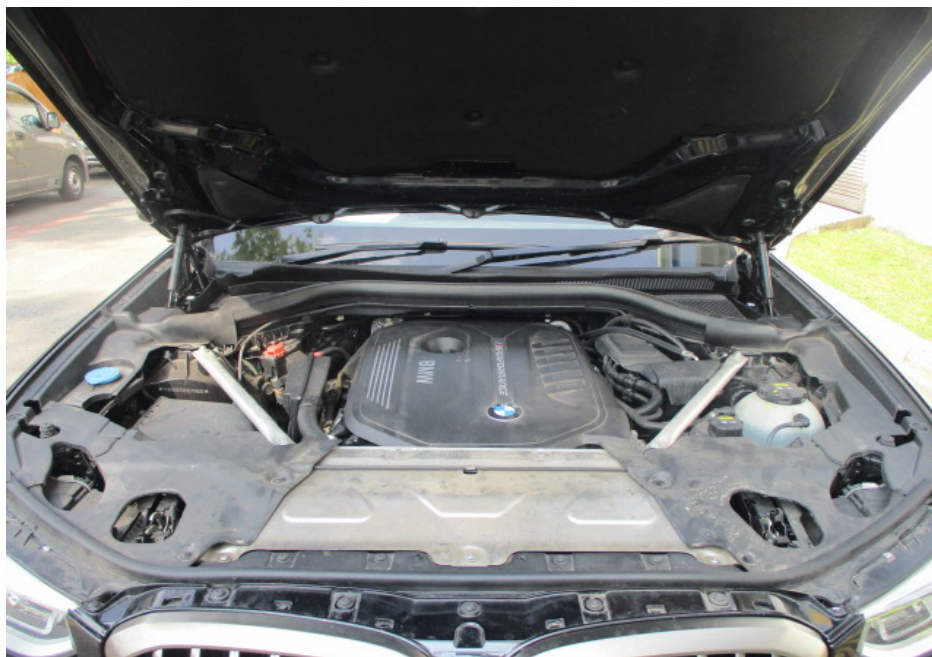
**Photo 12** shows a general view of the engine compartment of the Motor Car at the time of my inspection. The various parts and components inside the engine compartment were all observed to be intact and properly fitted. There was also no sign(s) or indication(s) of fluid leak and/or fluid stain found inside the engine compartment.

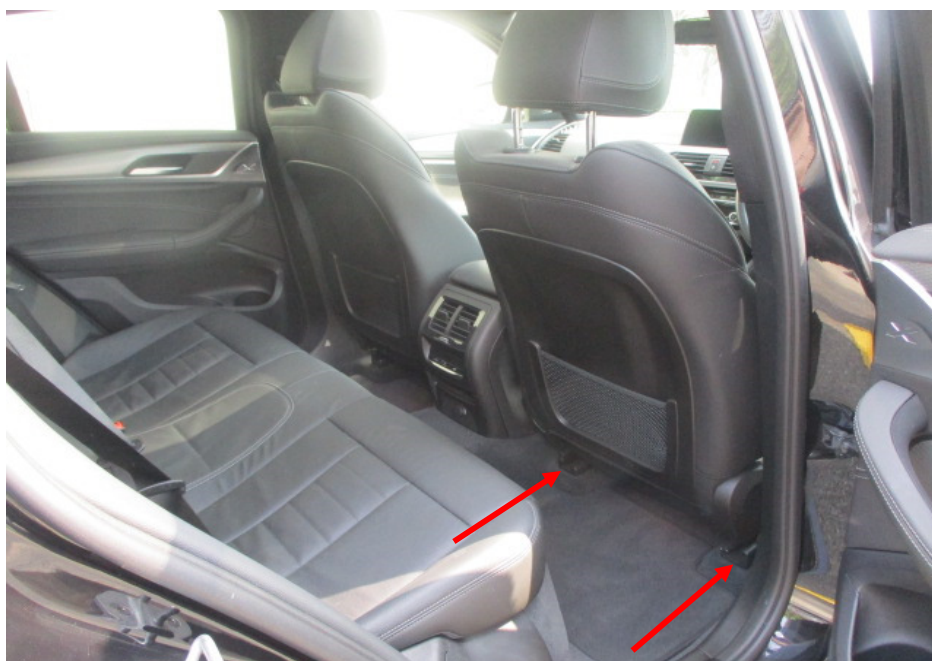
**Photo 13** shows the seats of the Motor Car. All the seats of the Motor Car were secured via seat rails (arrowed) to the floorboard. They were also fitted with a retractable seat belt reels and pre-tensioners. The seat belts were tested and were able to be fastened into the respective pre-tensions that were fitted on the side of each individual seat.

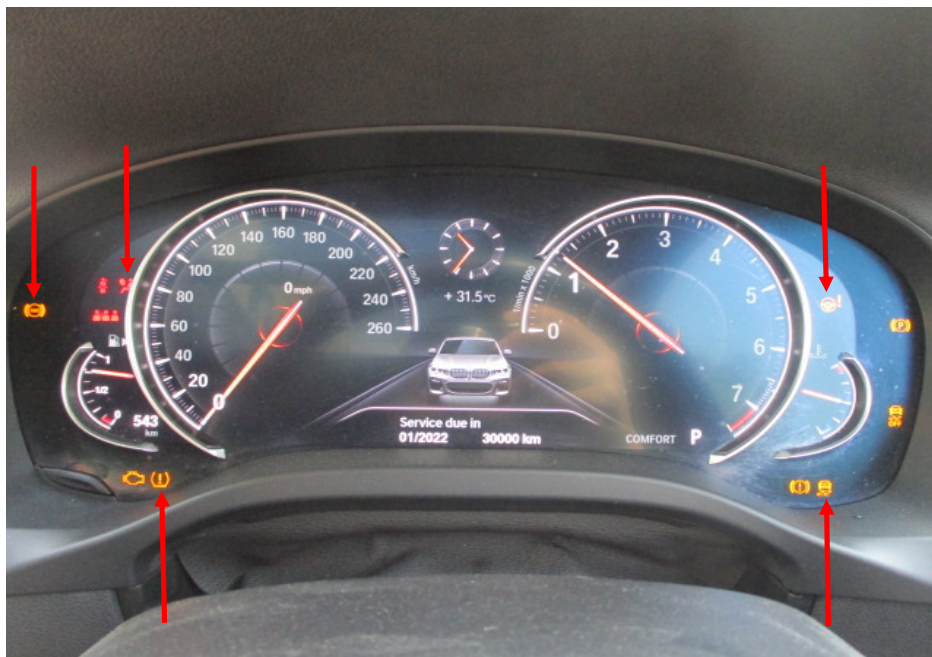
**Photo 14** shows the warning lights for the various electronic safety features appearing on the instrument panel of the Motor Car during its self-test when the engine is cranked, in particular the ABS, SRS, IAS, TPM and DSC lights (arrowed).

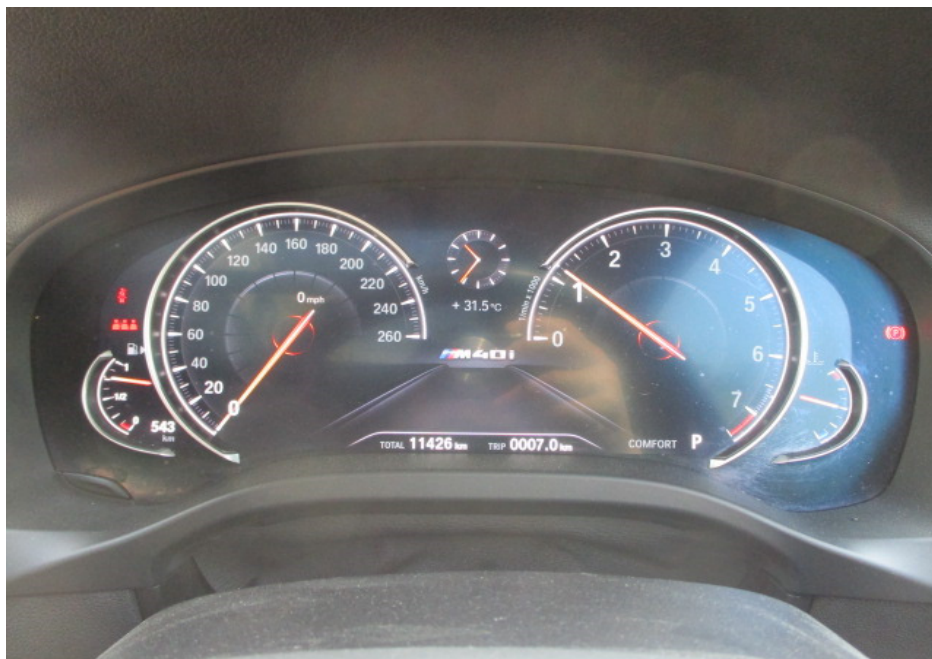
**Photo 15** shows the respective warning lights no longer illuminated, indicating that there is no fault detected to the ABS, SRS, IAS, TPM and DSC systems of the Motor Car during the self-test. These electronic systems were hence in working condition at the time of my inspection.

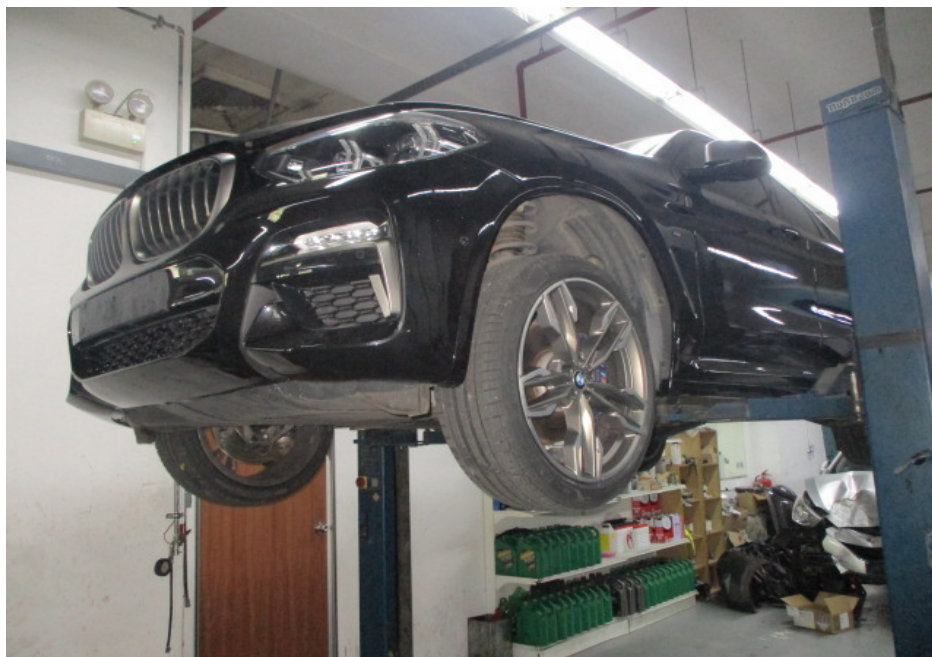
**Photo 16** shows the Motor Car hoisted up for checks on its undercarriage. There was no sign(s) or indication(s) of fluid leakage and/or fluid stain(s) on the underside of the Motor Car. The undercarriage components of the Motor Car were also all observed to be intact and secured in an appropriate manner.

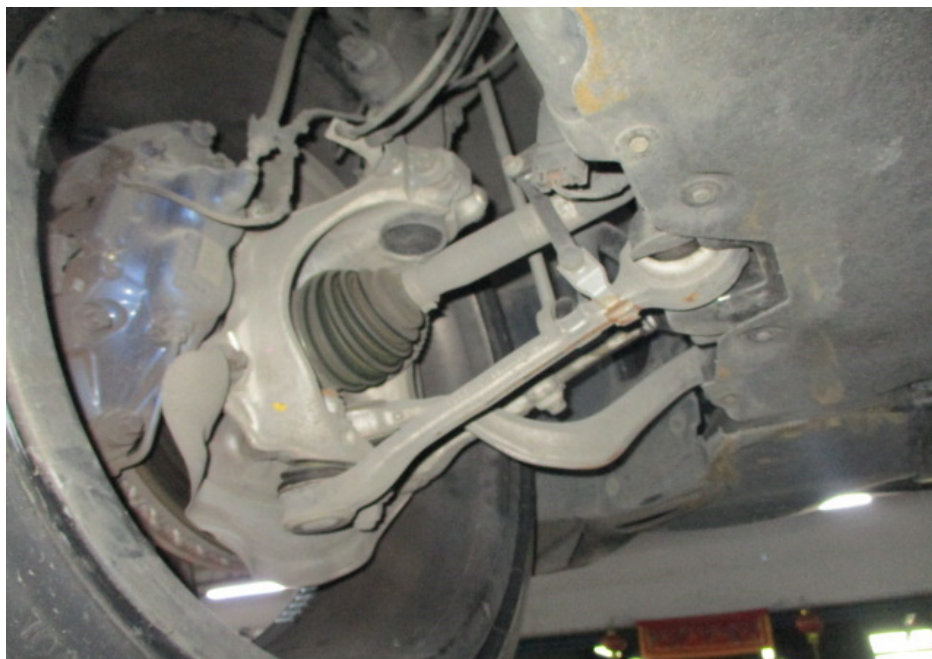
**Photo 17** shows the various undercarriage components at the front left wheel of the Motor Car. The mechanical components, control arms and linkages were all found to be intact and secured in an appropriate manner. I also did not observe any fluid leak and/or fluid stain on the underside of the Motor Car.

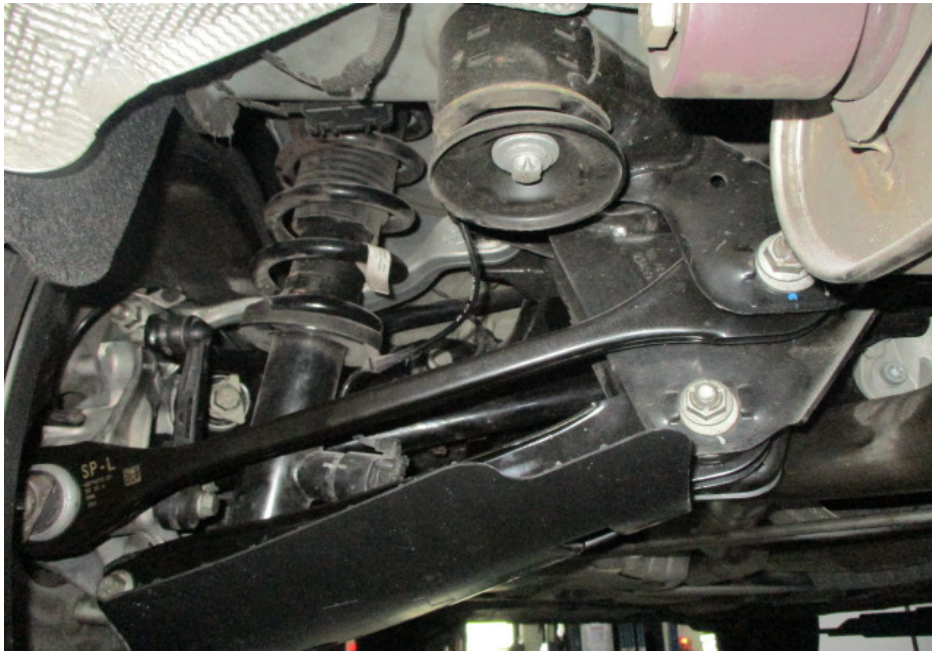
**Photo 18** shows the various undercarriage components at the rear left wheel of the Motor Car. The mechanical components, control arms and linkages were all found to be intact and secured in an appropriate manner. The undercarriage parts at the rear left wheel of the Motor Car were visually examined and it was observed that the repair/restoration works carried out were reasonably adequate and in order.

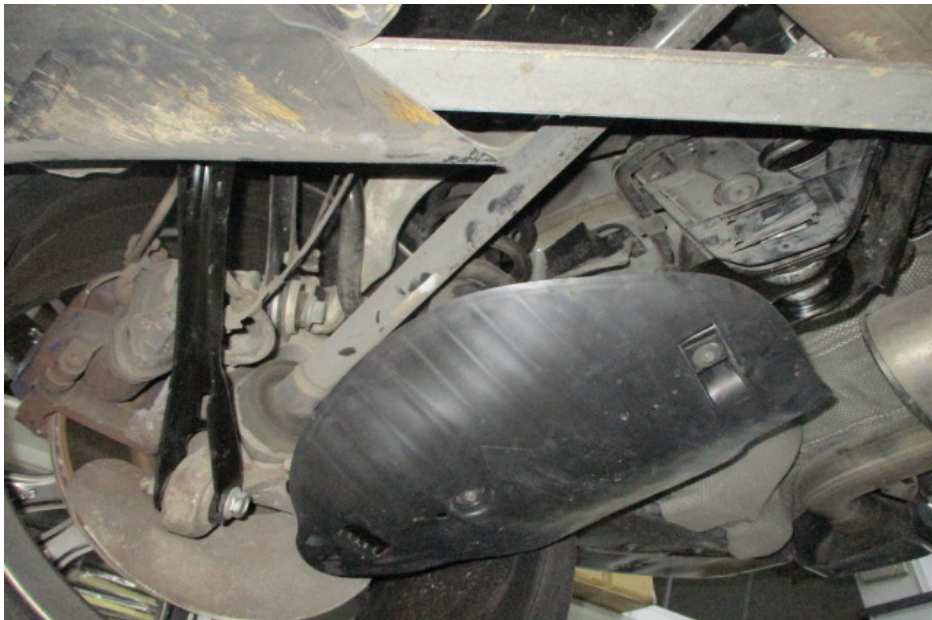
**Photo 19** shows the various undercarriage components at the rear right wheel of the Motor Car. The mechanical components, control arms and linkages were all found to be intact and secured in an appropriate manner. The undercarriage parts at the rear right wheel of the Motor Car were visually examined and it was observed that the repair/restoration works carried out were reasonably adequate and in order.

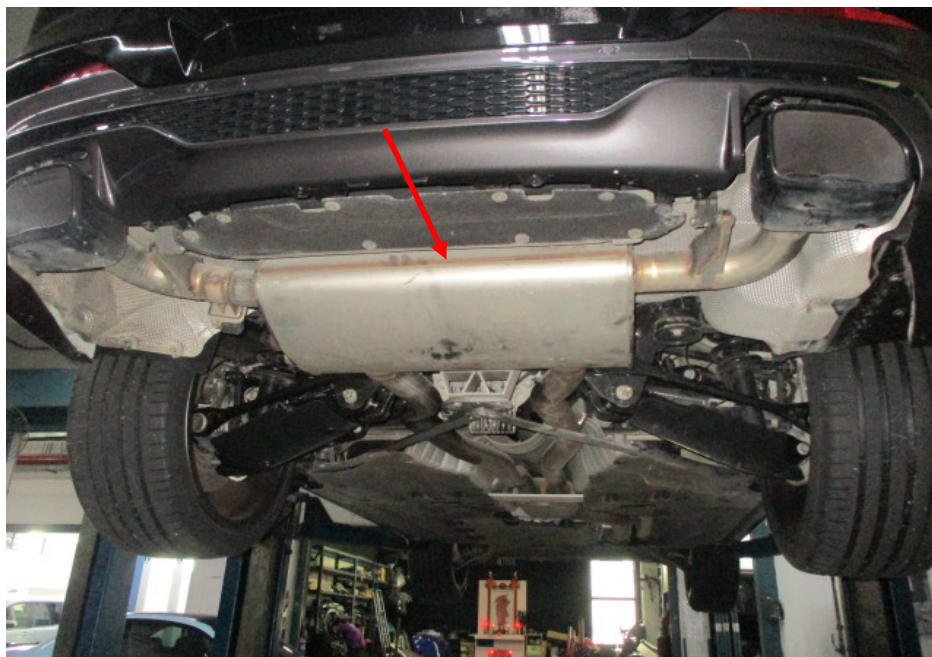
**Photo 20** shows the rear section of the Motor Car's exhaust system. My examination of the Motor Car's exhaust system revealed no sign(s) or indication(s) of any cut or weld marks along its exhaust pipes and on its centre resonator box, catalytic converter and on its rear muffler (arrowed).

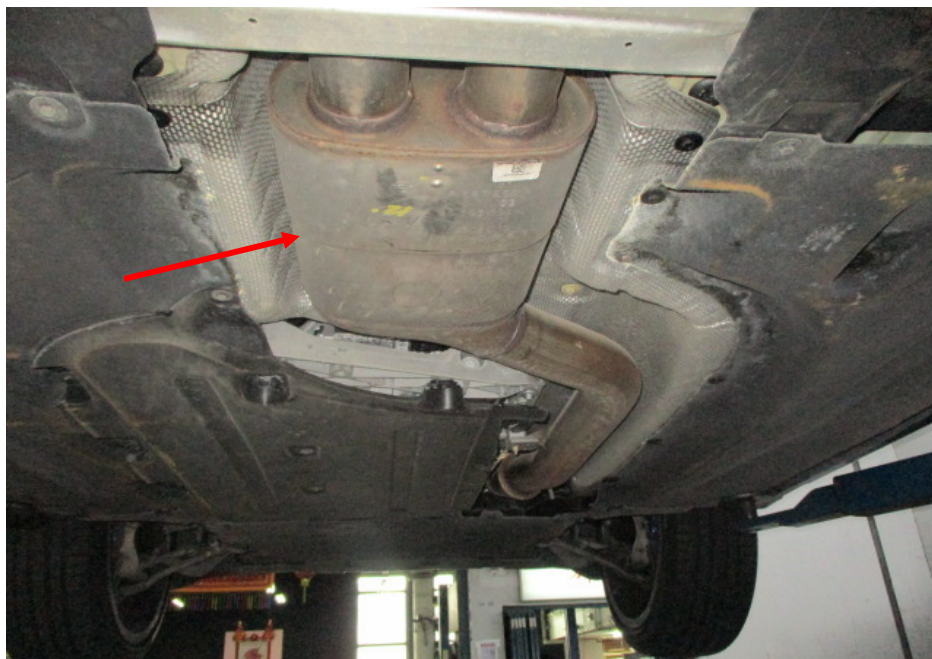
**Photo 21** shows the front section of the Motor Car's exhaust system. My examination of the Motor Car's exhaust system revealed no sign(s) or indication(s) of any cut or weld marks along its exhaust pipes and on its centre resonator box (arrowed), catalytic converter and on its rear muffler.

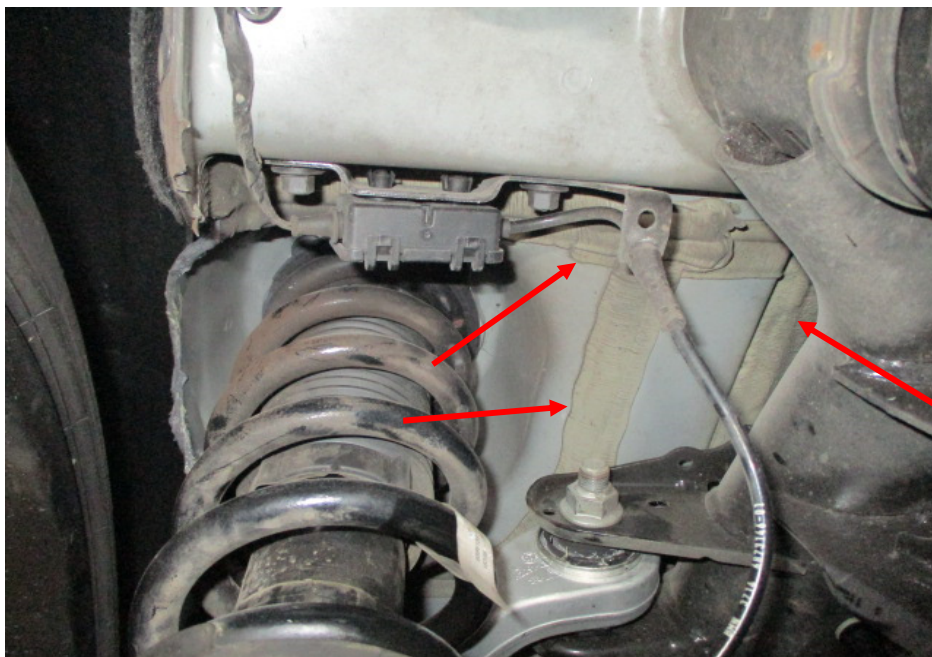
**Photo 22** shows the chassis/structural body at the underside rear left of the Motor Car. I did not find any weld marks other than original spot weld marks on the chassis/structural body of the Motor Car. The original factory sealant (arrowed) at the joints along the chassis/structural body was also untouched, indicating no work was done on the chassis/structural body of the Motor Car and that the chassis/structural body was originally fitted.

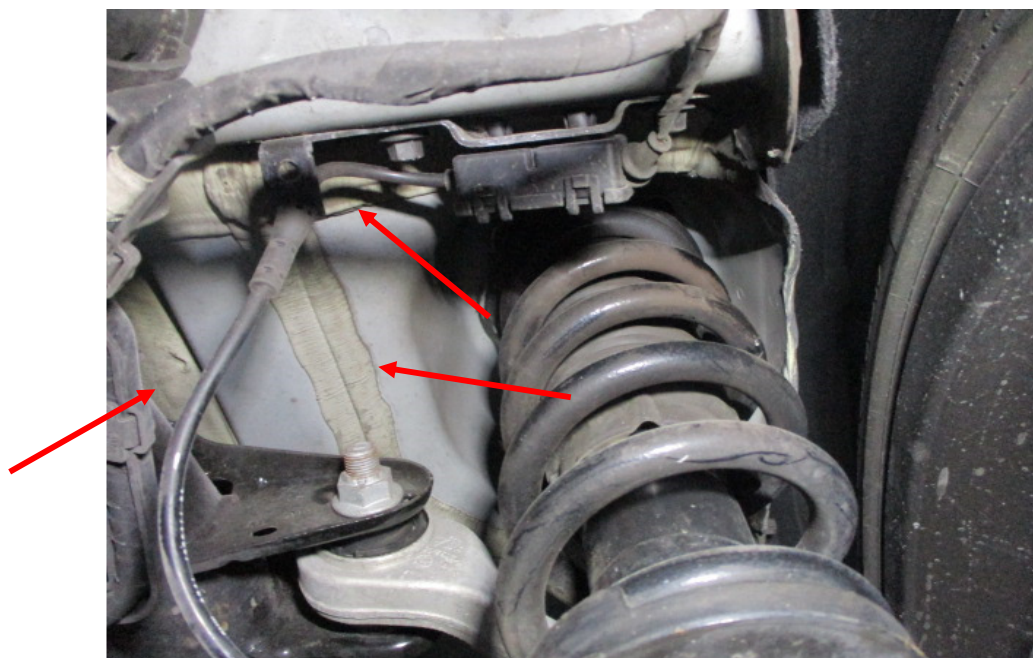
**Photo 23** shows the chassis/structural body at the underside rear right of the Motor Car. The original factory sealant (arrowed) at the joints along the chassis/structural body was observed to be untouched. In general, I had found no work was carried out on the chassis/structural body of the Motor Car. The chassis/structural body of the Motor Car was originally fitted.

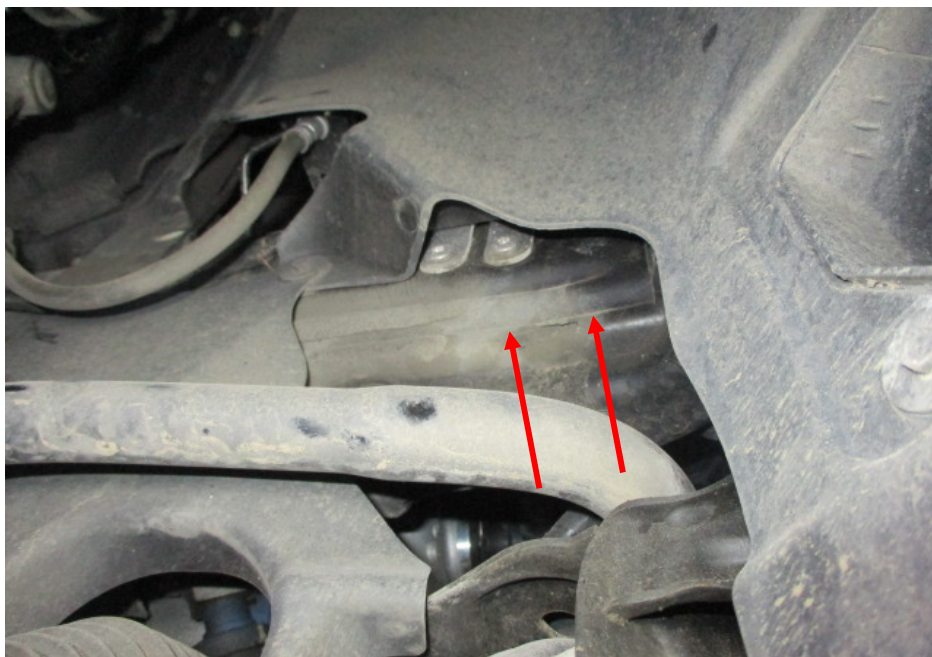
**Photo 24** shows the chassis/structural body at the underside front right of the Motor Car. I did not find any weld marks other than original spot weld marks on the chassis/structural body of the Motor Car. The original factory sealant (arrowed) at the joints along the chassis/structural body was also untouched, indicating no work was done on the chassis/structural body of the Motor Car and that the chassis/structural body was originally fitted.

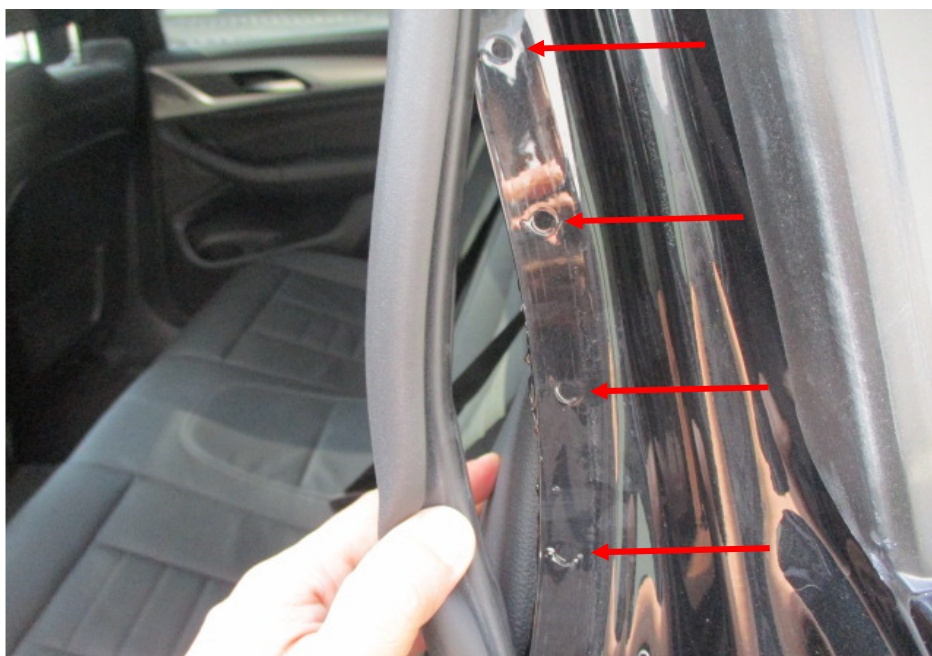
**Photo 25** shows the left side "C" pillar of the Motor Car. I did not find any weld marks other than original spot weld marks (arrowed) on the left side "C" pillar of the Motor Car which, indicates that there was no re-welding works carried out. In general, I had found all the non-detachable body panels of the Motor Car to be originally fitted at the time of my inspection.

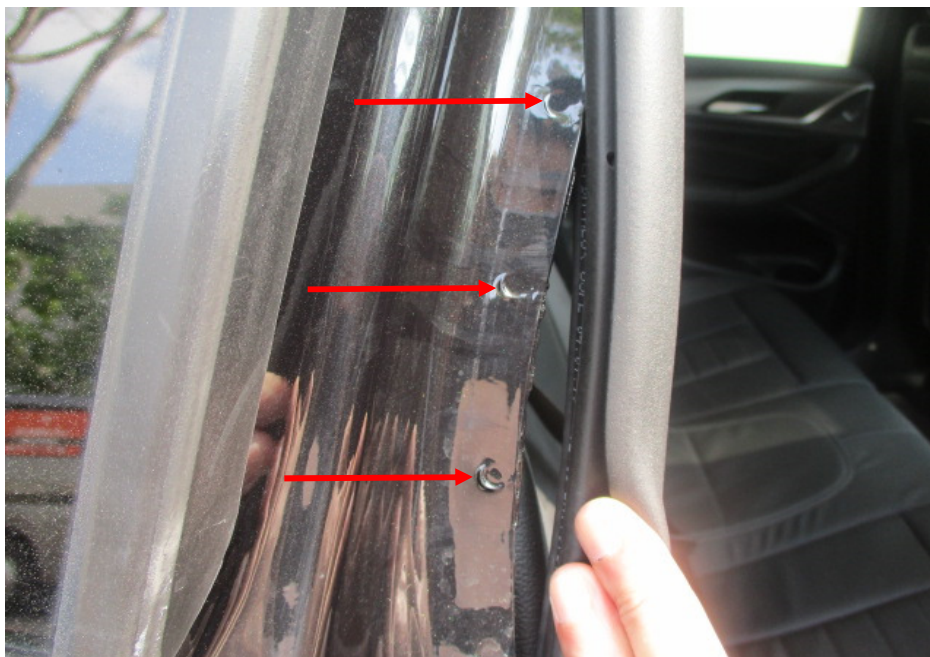
**Photo 26** shows the right side “C” pillar of the Motor Car. I did not find any weld marks other than original spot weld marks (arrowed) on the right side “C” pillar of the Motor Car which, indicates that there was no re-welding works carried out. In general, I had found all the non-detachable body panels of the Motor Car to be originally fitted at the time of my inspection.
