Your Ref: BMW 740Li
(chassis number WBA7T22060CE22268)
Our Ref : CI/TP21006730/D

18 June 2021

**INSPECTION REPORT OF AN UNREGISTERD BMW 740Li MOTOR CAR
WITH CHASSIS NUMBER WBA7T22060CE22268**

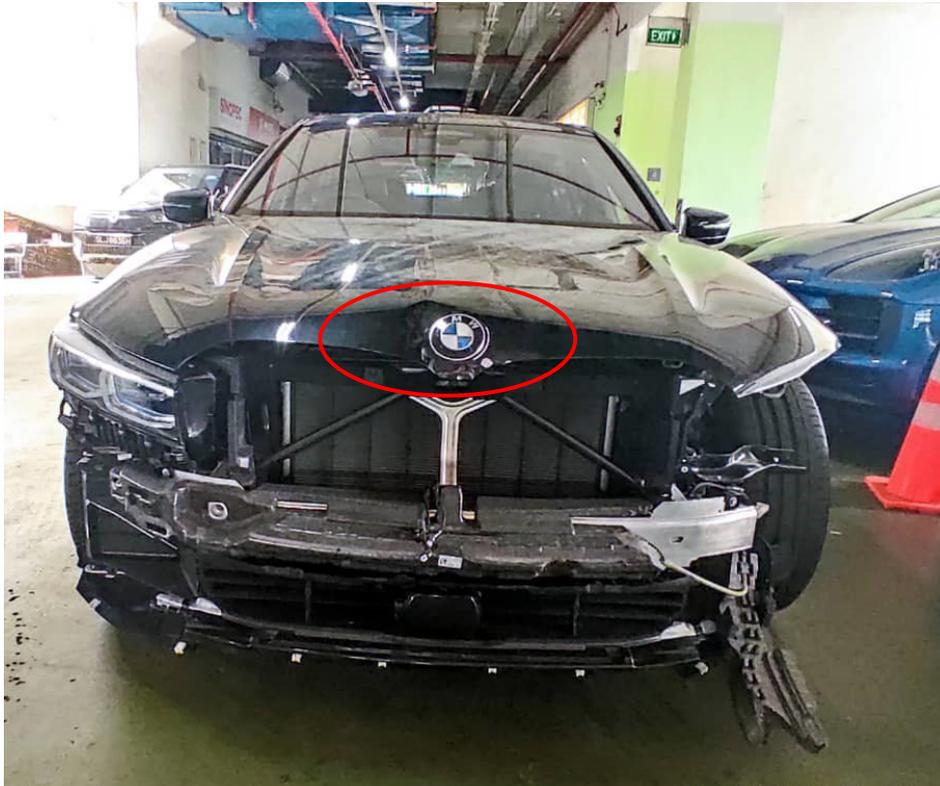
Photo 1 shows the frontal body of the Motor Car (photograph provided to me). The Motor Car's front bumper and all its related parts and attachments, front left headlamp, front radiator grilles and front left fender inner shield were observed to be missing/dislodged. The front bonnet appears to be also dented (circled).

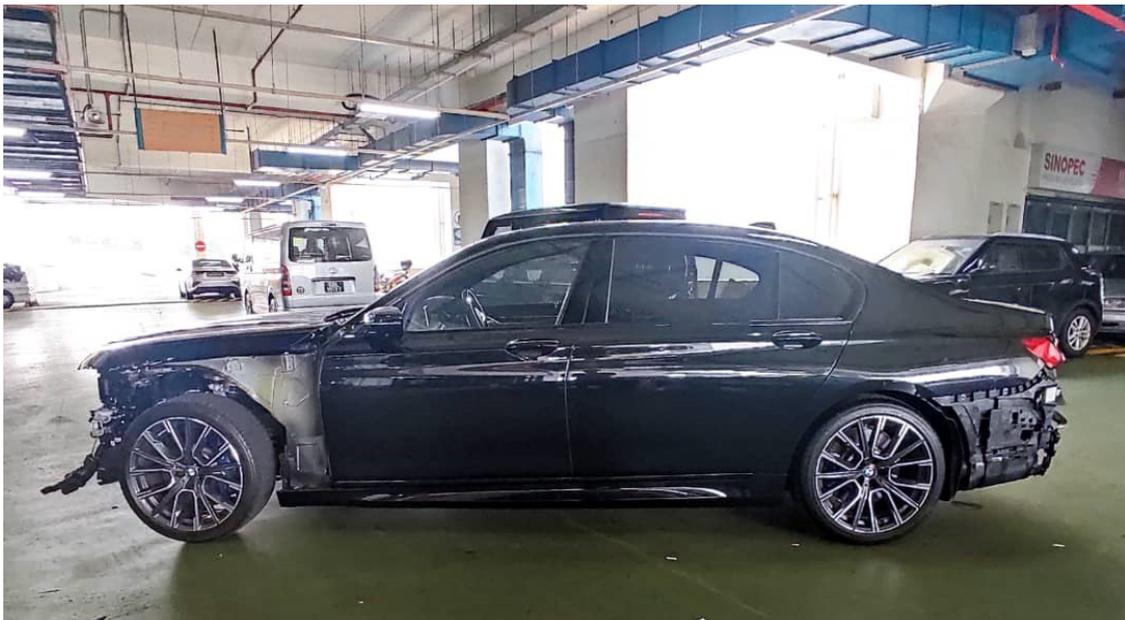
Photo 2 shows the left body of the Motor Car (photograph provided to me). The front left fender of the Motor Car was observed to be missing/dislodged. Other than this, there was no physical damage observed to the left body of the Motor Car.

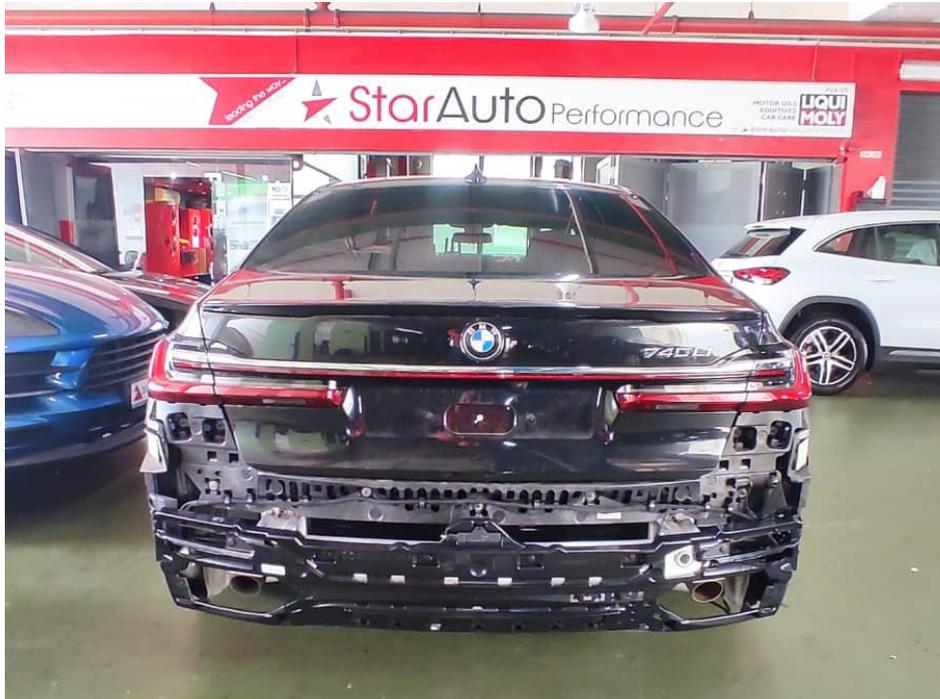
Photo 3 shows the rear body of the Motor Car (photograph provided to me). The Motor Car's rear bumper and all its related parts and attachments were observed to be missing/dislodged. Other than this, there was no physical damage observed to the rear body of the Motor Car.

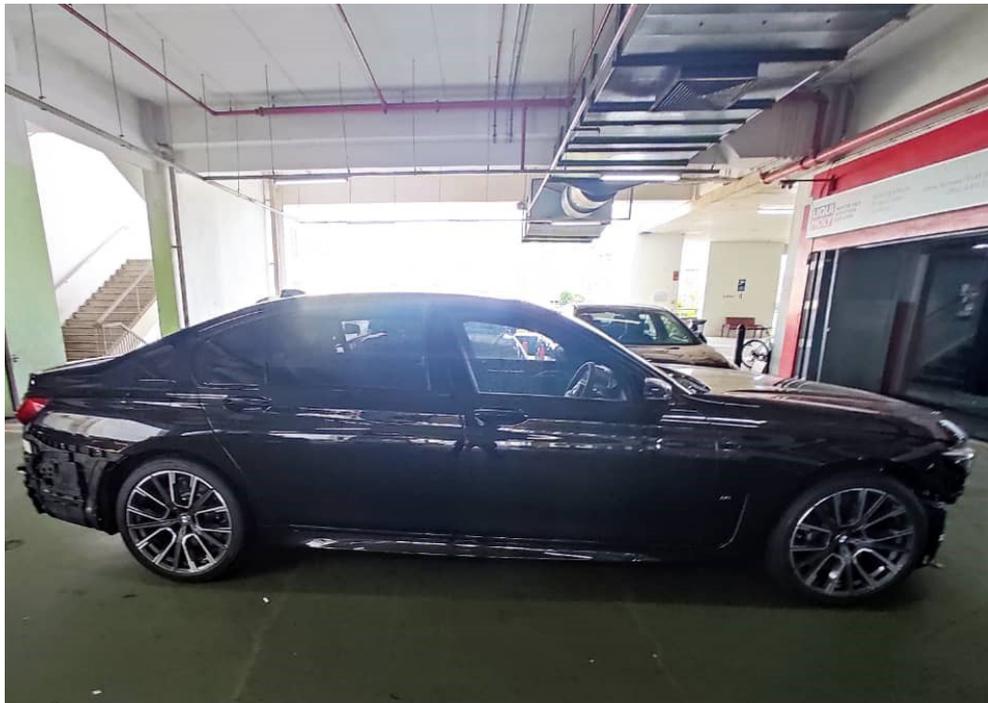
Photo 4 shows the right body of the Motor Car (photograph provided to me). No physical damage was observed to the right body of the Motor Car.

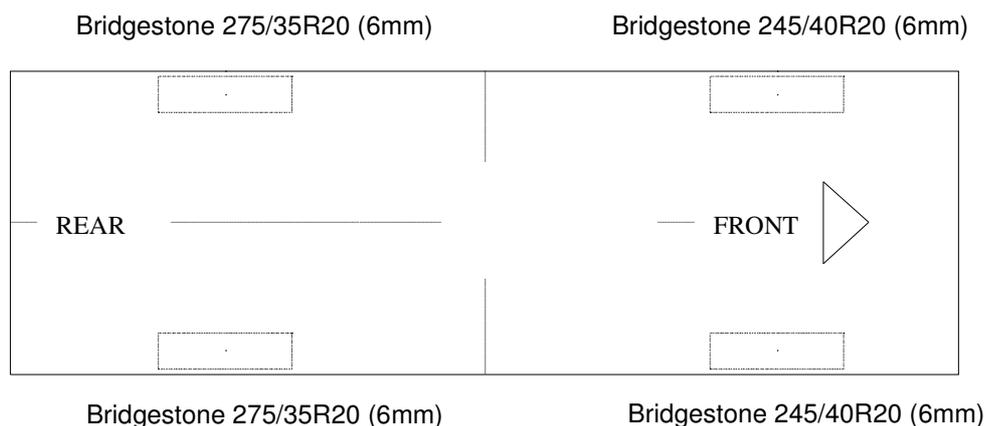
- It was fitted with 20inch sport wheel rims that were wrapped with tyres that were observed to be of serviceable condition. The tyres were also sufficiently inflated for vehicular operation. The tyre brand, tyre size and approximate remaining tread depth of the 4 tyres of the Motor Car were recorded as follows: -

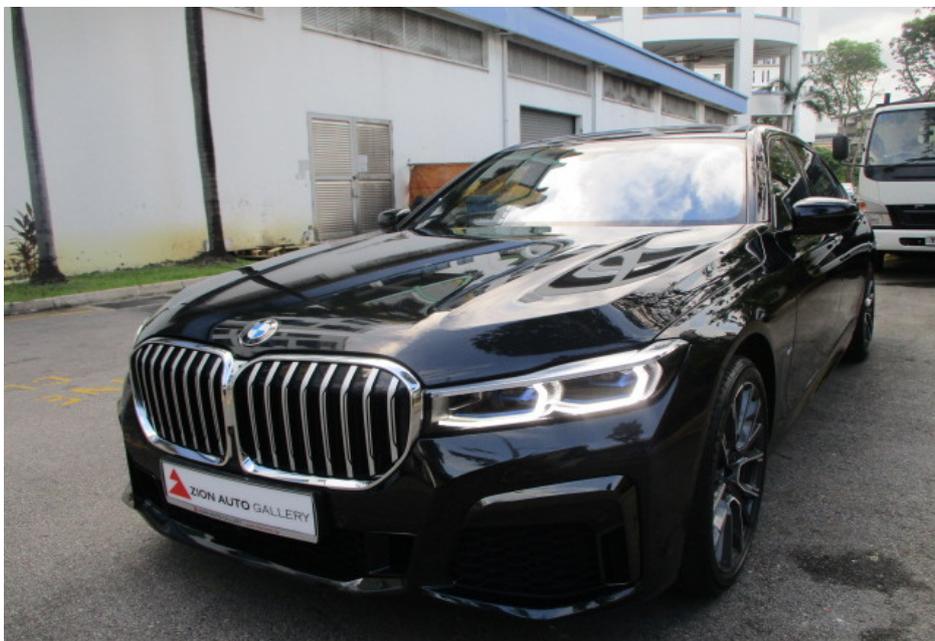
Photo 5 shows a general view of the front left body of the Motor Car at the time of my inspection. The Motor Car was observed to be in a relatively good general condition with no loose exterior fittings observed. The frontal portion of the Motor Car was visually examined, and it was observed that the repair/restoration works carried out to the damaged area of the Motor Car (refer to photograph 1) were reasonably adequate and in order.

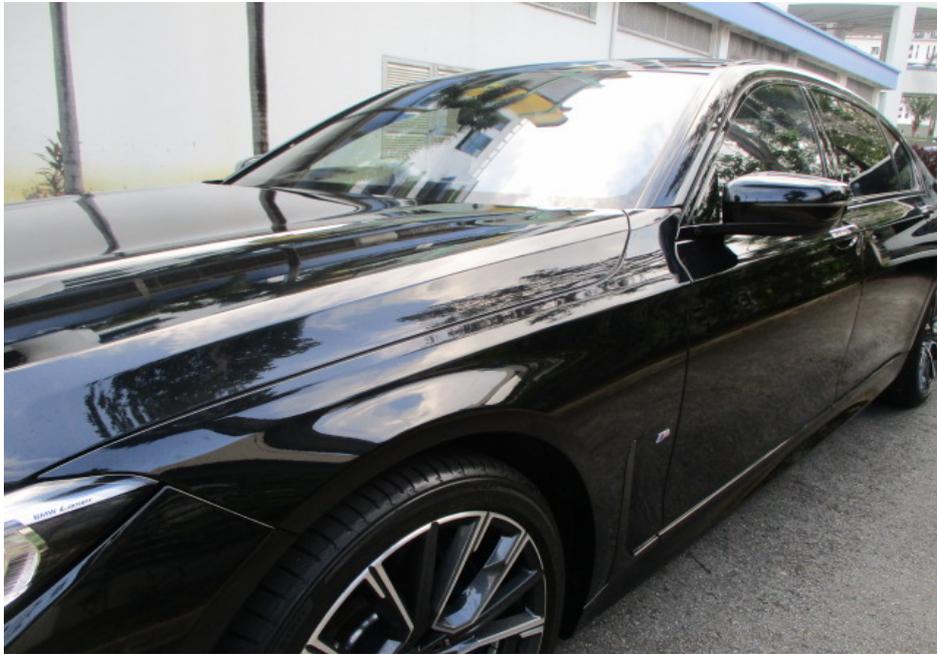
Photo 6 shows a closer view of the Motor Car's front left fender at the time of my inspection. The frontal portion of the Motor Car were visually examined, and it was observed that the repair/restoration works carried out to the damaged area of the Motor Car (refer to photograph 2 above) were reasonably adequate and in order.

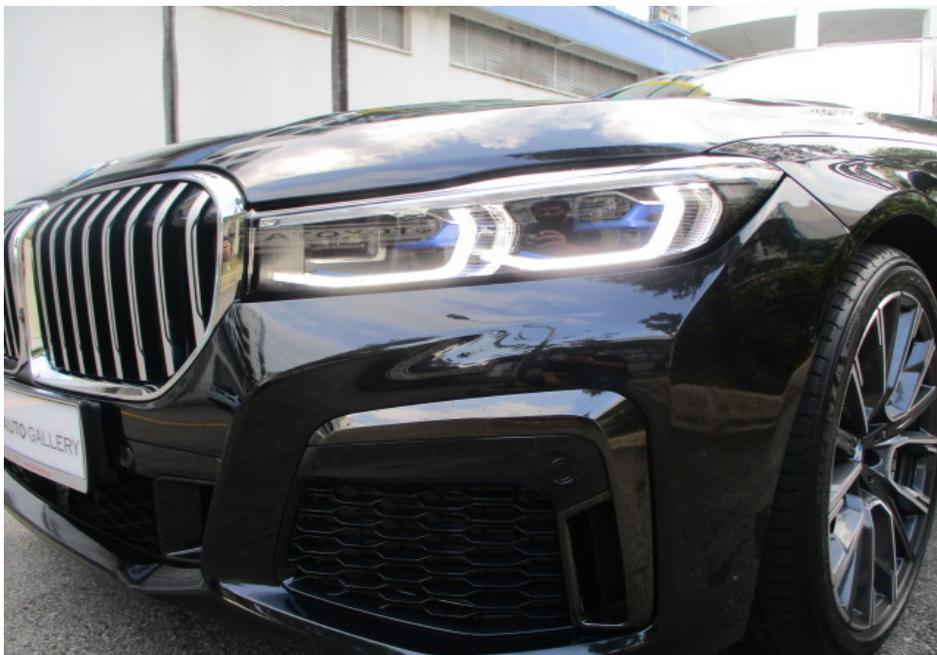
Photo 7 shows a closer view of the Motor Car's front bumper, front bumper left lower grille and front left headlamp at the time of my inspection. The frontal portion of the Motor Car was visually examined, and it was observed that the repair/restoration works carried out to the damaged area of the Motor Car (refer to photograph 1 above) were reasonably adequate and in order.

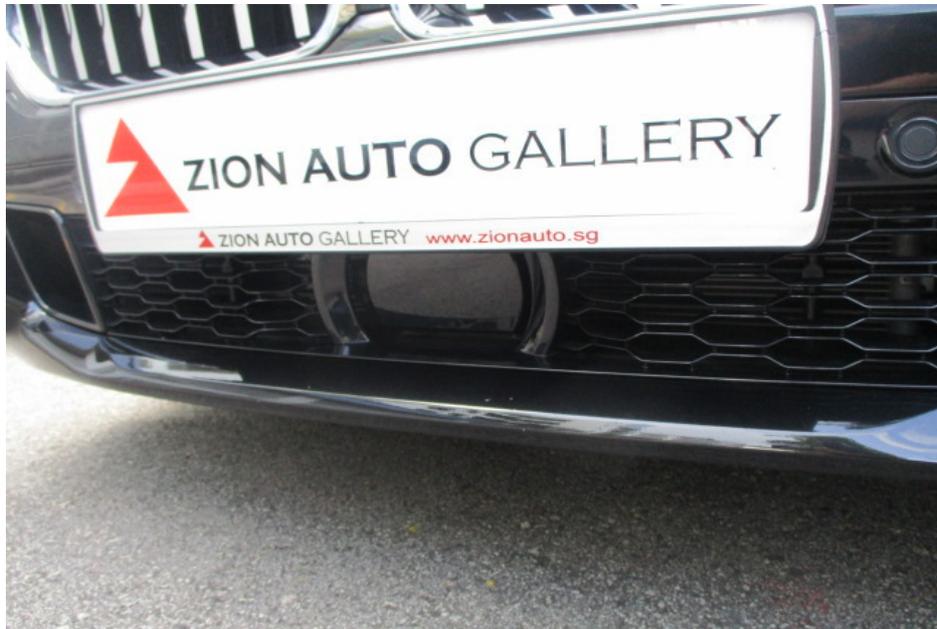
Photo 8 shows a closer view of the Motor Car's front bumper centre lower grille and front radar unit at the time of my inspection. The frontal portion of the Motor Car were visually examined, and it was observed that the repair/restoration works carried out to the damaged area of the Motor Car (refer to photograph 1 above) were reasonably adequate and in order.

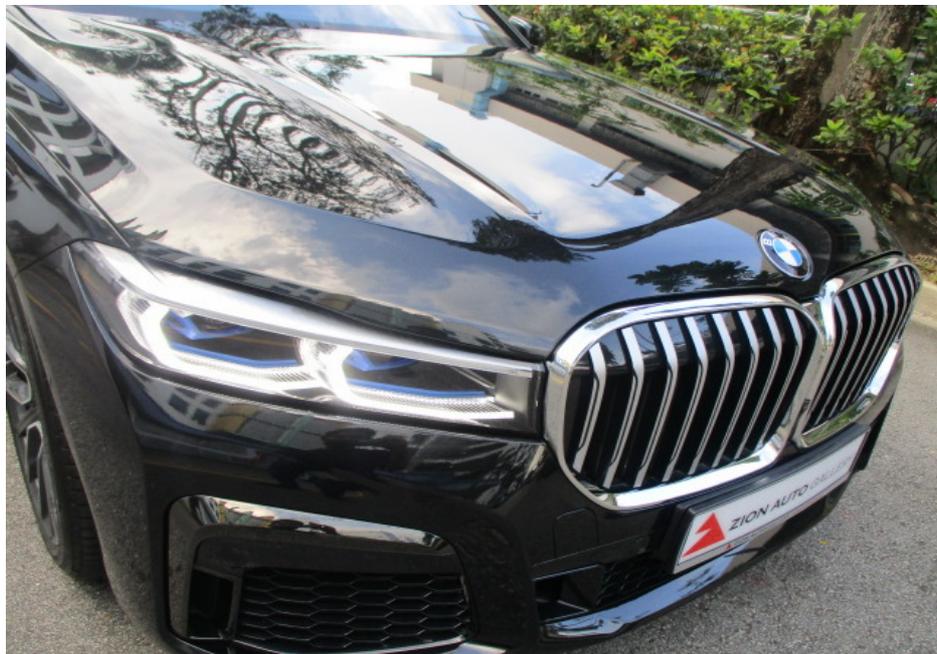
Photo 9 shows a closer view of the Motor Car's front bumper, front right lower grille, front right headlamp, front radiator grilles and front bonnet at the time of my inspection. The frontal portion of the Motor Car were visually examined, and it was observed that the repair/restoration works carried out to the damaged area of the Motor Car (refer to photograph 1 above) were reasonably adequate and in order.

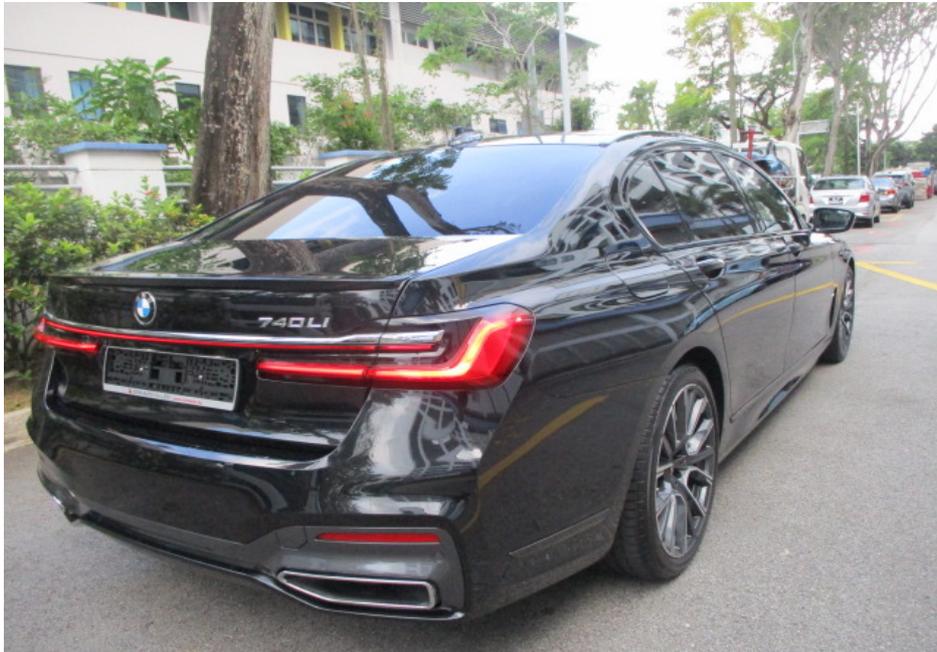
Photo 10 shows a general view of the rear right body of the Motor Car at the time of my inspection. The Motor Car was observed to be in a relatively good general condition with no loose exterior fittings observed. The rear portion of the Motor Car was visually examined, and it was observed that the repair/restoration works carried out to the damaged area of the Motor Car (refer to photograph 3) were reasonably adequate and in order.

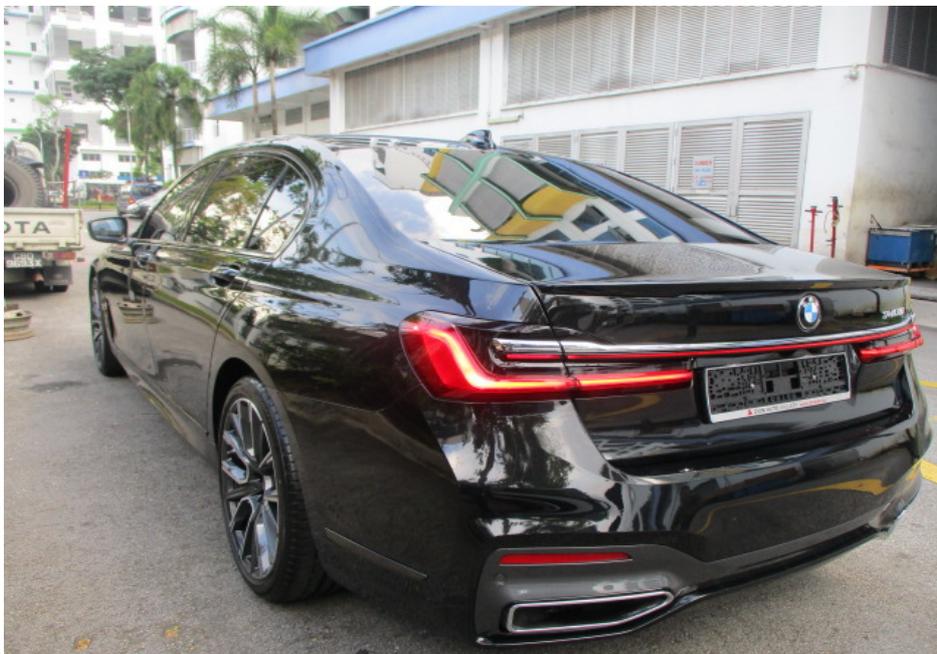
Photo 11 shows a general view of the rear left body of the Motor Car at the time of my inspection. The Motor Car was observed to be in a relatively good general condition with no loose exterior fittings observed. The mileage of the Motor Car recorded at the time of my inspection was 2,743km.

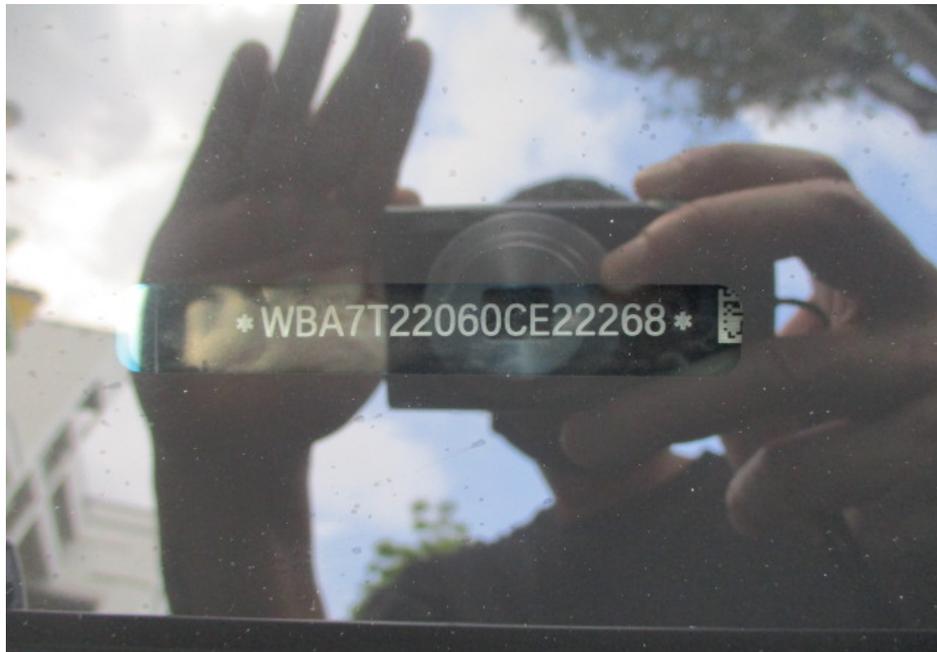
Photo 12 shows the chassis number of the Motor Car. The chassis number recorded was WBA7T22060CE22268.

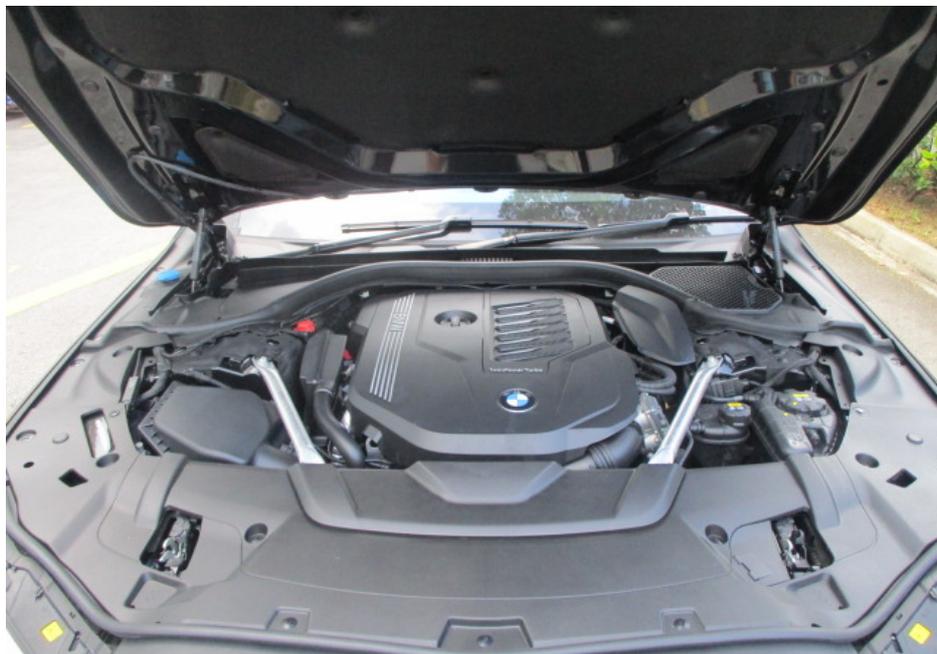
Photo 13 shows a general view of the engine compartment of the Motor Car at the time of my inspection. The various parts and components inside the engine compartment were all observed to be intact and properly fitted. There was also no sign(s) or indication(s) of fluid leak and/or fluid stain found inside the engine compartment.

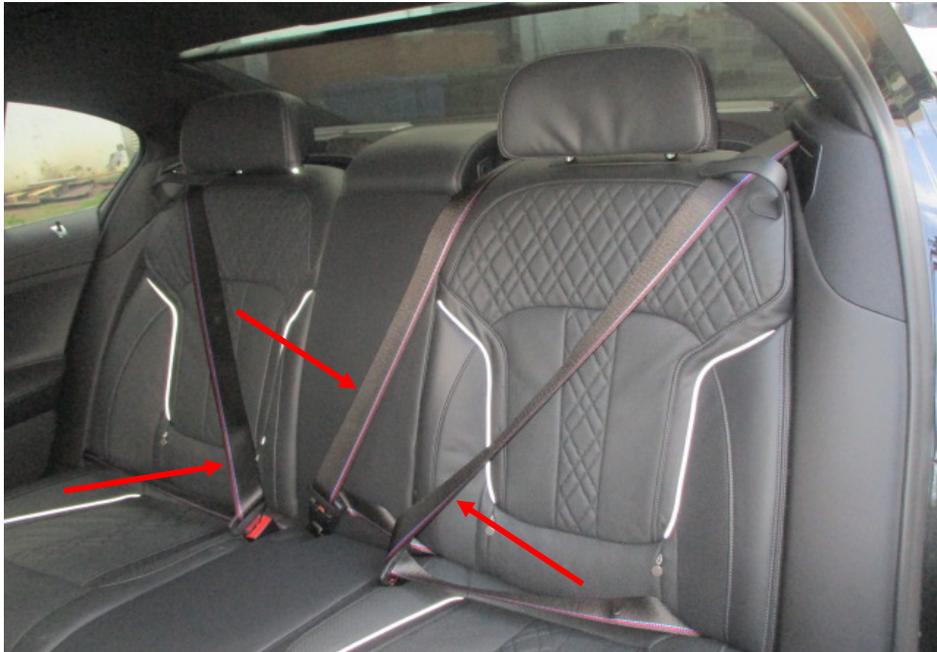
Photo 14 shows the rear seats of the Motor Car. All the seats of the Motor Car were secured via seat rails to the floorboard. They were also fitted with a retractable seat belt reel and a pre-tensioner. The seat belts (arrowed) were tested and were able to be fastened into the respective pre-tensions that were fitted on the side of each individual seat.

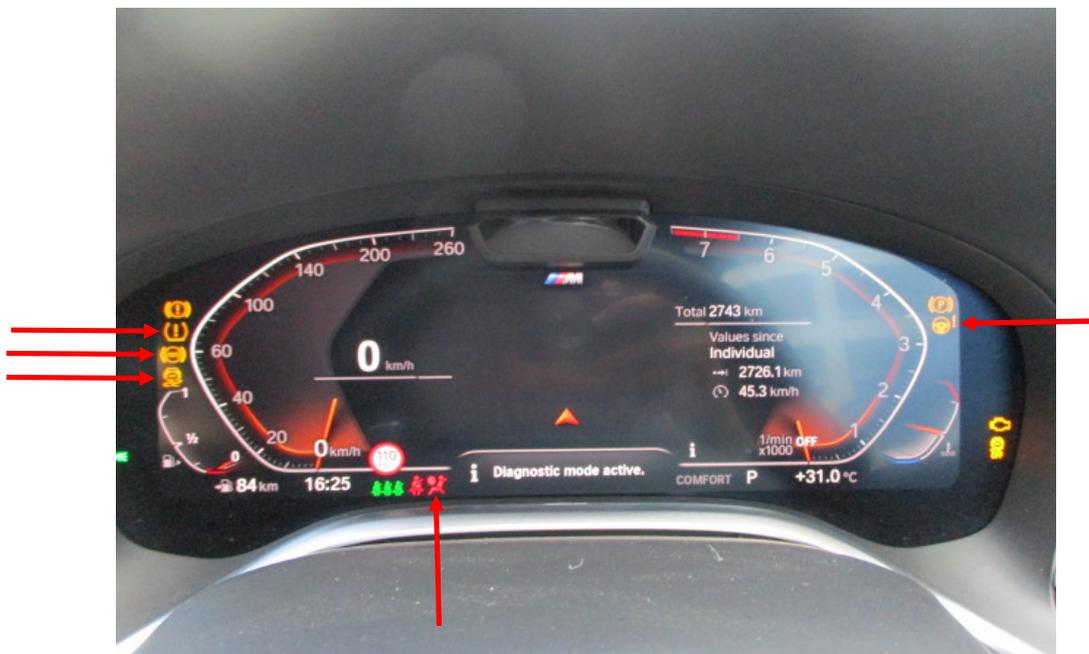
Photo 15 shows the warning lights for the various electronic safety features appearing on the instrument panel of the Motor Car during its self-test when the engine is cranked, in particular the ABS, SRS, IAS, TPM and DSC lights (arrowed).

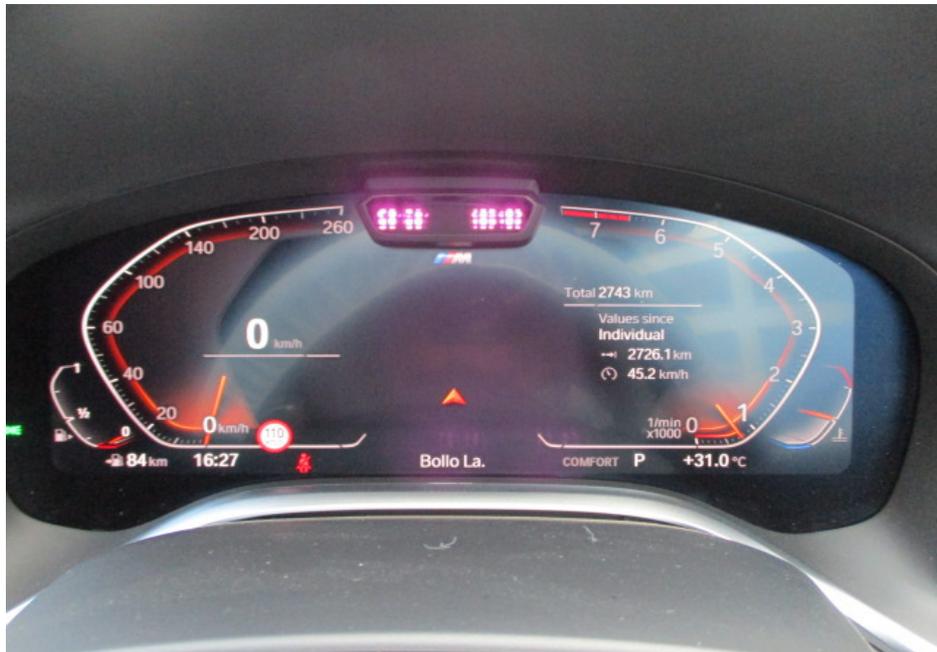
Photo 16 shows the respective warning lights no longer illuminated, indicating that there is no fault detected to the ABS, SRS, IAS, TPM and DSC systems of the Motor Car during the self-test. These electronic systems were hence in working condition at the time of my inspection.

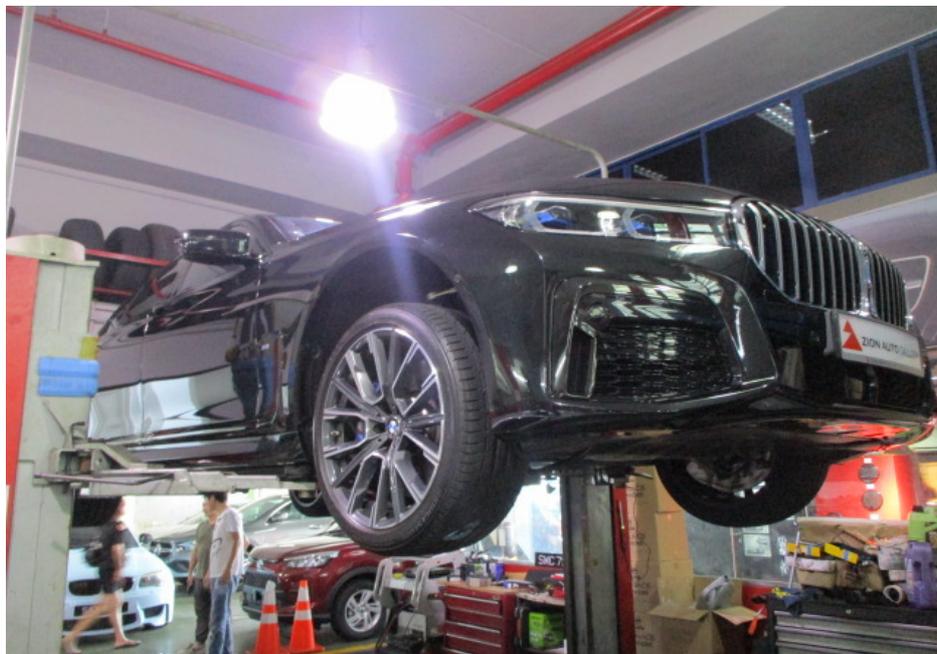
Photo 17 shows the Motor Car hoisted up for checks on its undercarriage. There was no sign(s) or indication(s) of fluid leakage and/or fluid stain(s) on the underside of the Motor Car. The undercarriage components of the Motor Car were also all observed to be intact and secured in an appropriate manner.

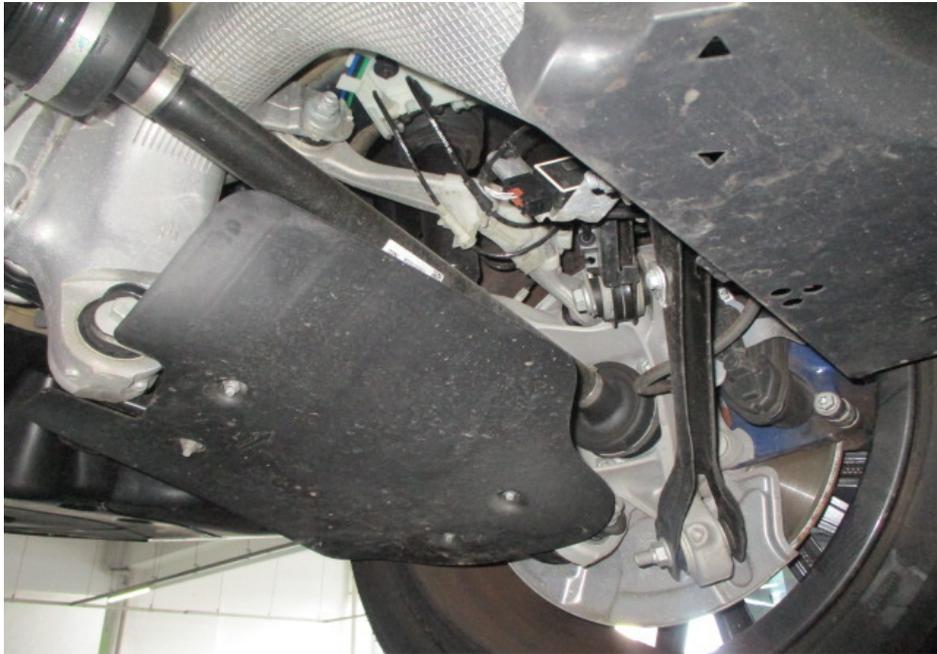
Photo 18 shows a general view of the control arms and linkages at the rear left wheel of the Motor Car. I did not observe any fluid leak and/or fluid stain on the underside of the Motor Car. All of the Motor Car's undercarriage components were observed to be intact and secured in an appropriate manner.

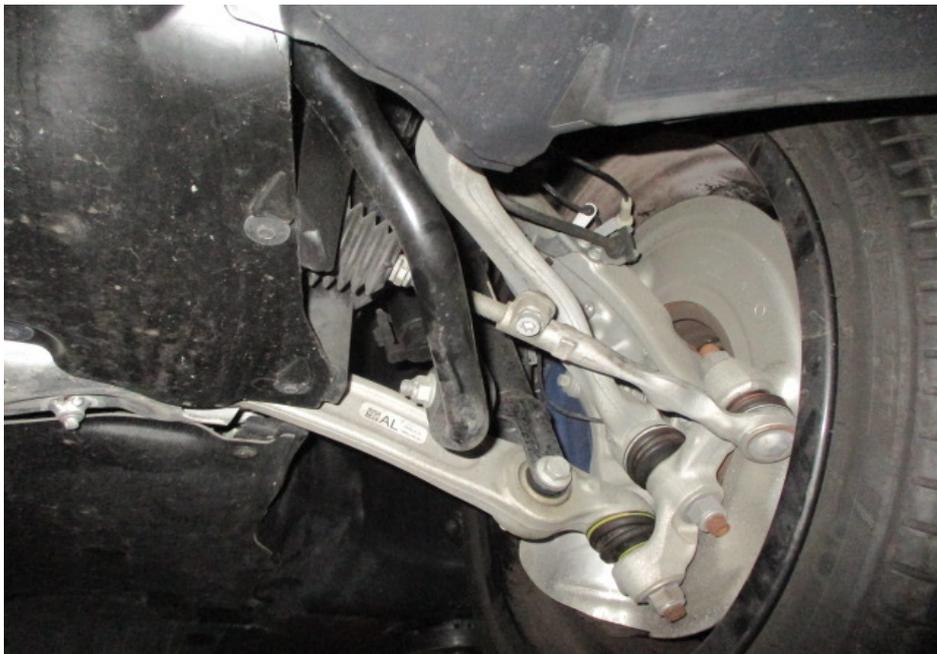
Photo 19 shows the various undercarriage components at the front left wheel of the Motor Car. The mechanical components, control arms and linkages were all found to be intact and secured in an appropriate manner.

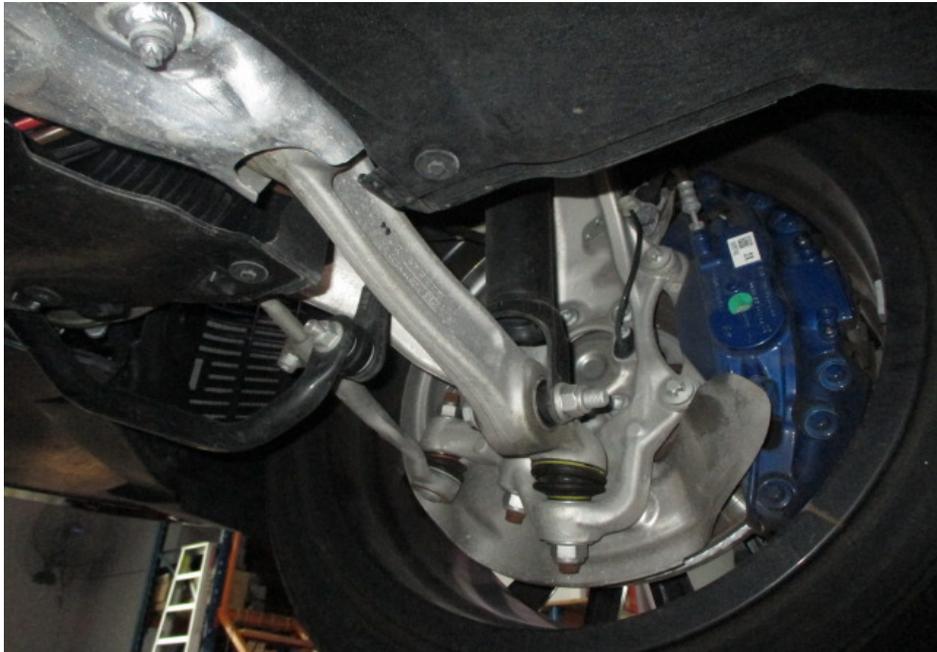
Photo 20 shows the various undercarriage components at the front right wheel of the Motor Car. The mechanical components, control arms and linkages were all found to be intact and secured in an appropriate manner. I also did not observe any fluid leak and/or fluid stain on the underside of the Motor Car.

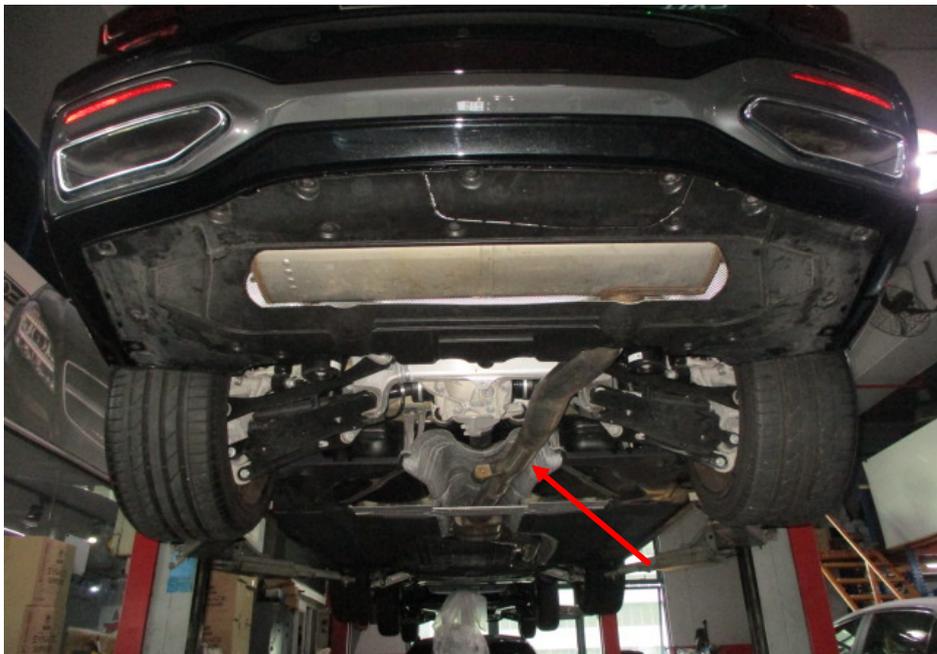
Photo 21 shows a general view of the rear section of the Motor Car's exhaust system. My examination of the Motor Car's exhaust system revealed no sign(s) or indication(s) of any cut or weld marks along its exhaust pipes (arrowed), on its catalytic converter, centre resonator box and its rear muffler.

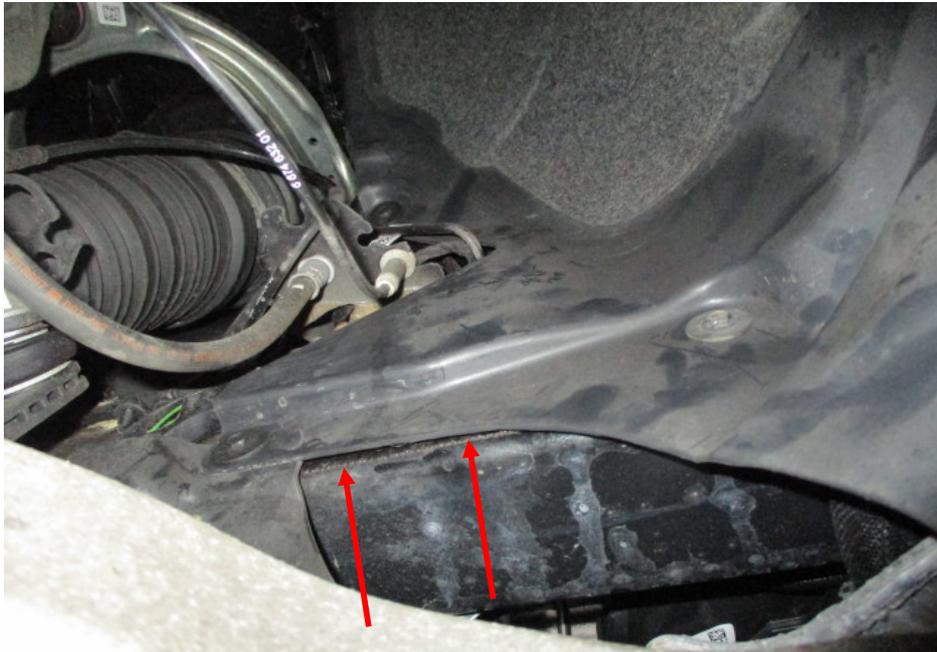
Photo 22 shows the chassis/structural body at the underside front right of the Motor Car. I did not find any weld marks other than original spot weld marks on the chassis/structural body of the Motor Car. The original factory sealant (arrowed) at the joints along the chassis/structural body was untouched, indicating no work was done on the chassis/structural body of the Motor Car and that the chassis/structural body was originally fitted.

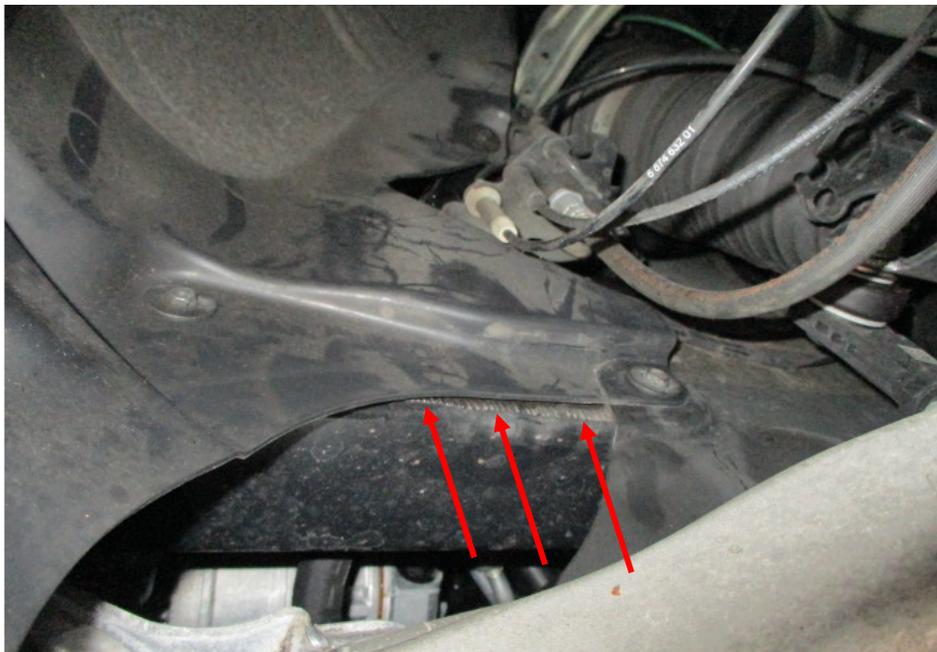
Photo 23 shows the chassis/structural body at the underside front left of the Motor Car. The original factory sealant (arrowed) at the joints along the chassis/structural body was observed to be untouched. In general, I had found no work was carried out on the chassis/structural body of the Motor Car. The chassis/structural body of the Motor Car was originally fitted.

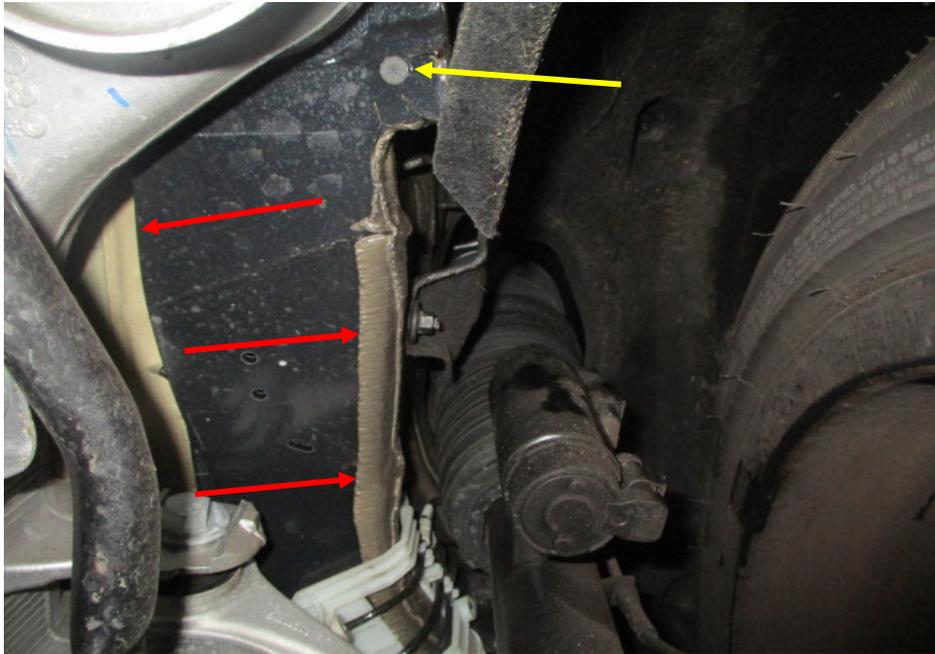
Photo 24 shows the chassis/structural body at the underside rear right of the Motor Car. I did not find any weld marks other than original spot weld marks (yellow arrow) on the chassis/structural body of the Motor Car. The original factory sealant (red arrow) at the joints along the chassis/structural body was untouched, indicating no work was done on the chassis/structural body of the Motor Car and that the chassis/structural body was originally fitted.

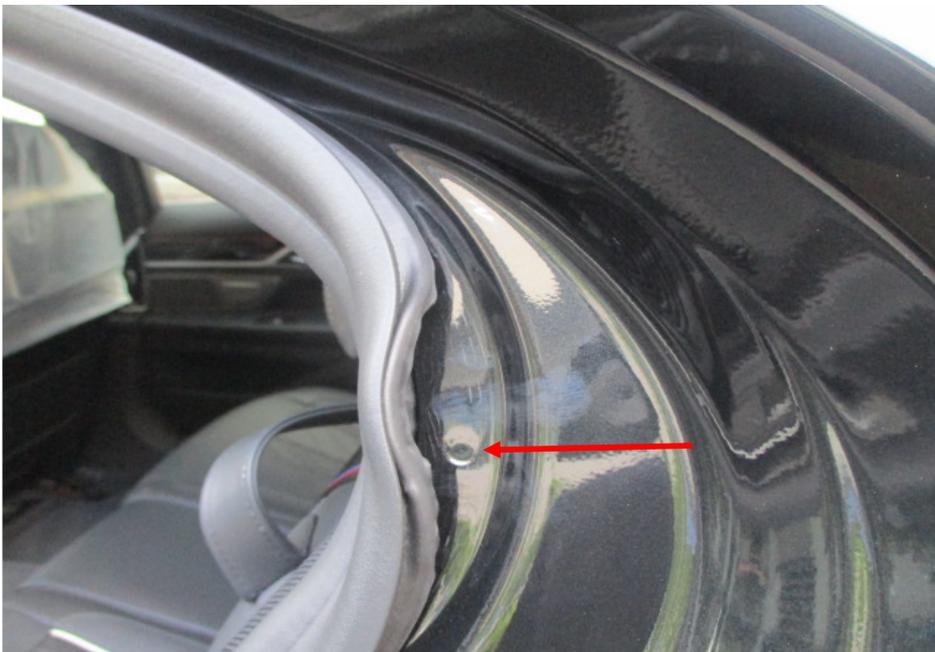
Photo 25 shows the left side "C" pillar of the Motor Car. I did not find any weld marks other than original spot weld marks (arrowed) on the left side "C" pillar of the Motor Car which, indicates that there was no re-welding works carried out. In general, I had found all the non-detachable body panels of the Motor Car to be originally fitted at the time of my inspection.

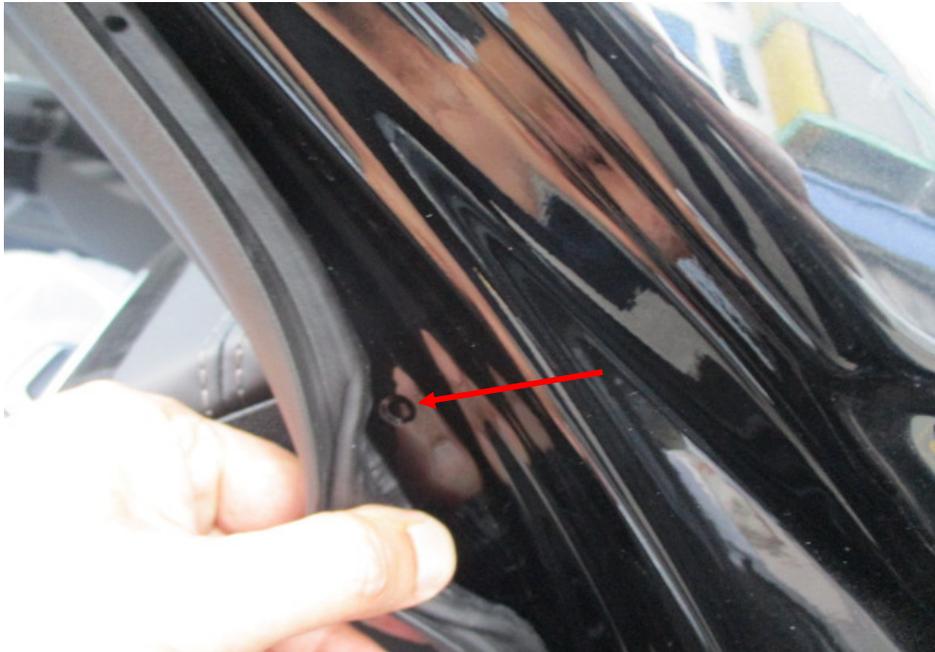
Photo 26 shows the right side “A” pillar of the Motor Car. I did not find any weld marks other than original spot weld marks (arrowed) on the right side “A” pillar of the Motor Car which, indicates that there was no re-welding works carried out. In general, I had found all the non-detachable body panels of the Motor Car to be originally fitted at the time of my inspection.
