Your Ref: Range Rover
(chassis number SALYA2AX0KA227394)
Our Ref : CI/TP21006764/D

16 June 2021

**INSPECTION REPORT OF AN UNREGISTERD RANGE ROVER MOTOR CAR
WITH CHASSIS NUMBER SALYA2AX0KA227394**

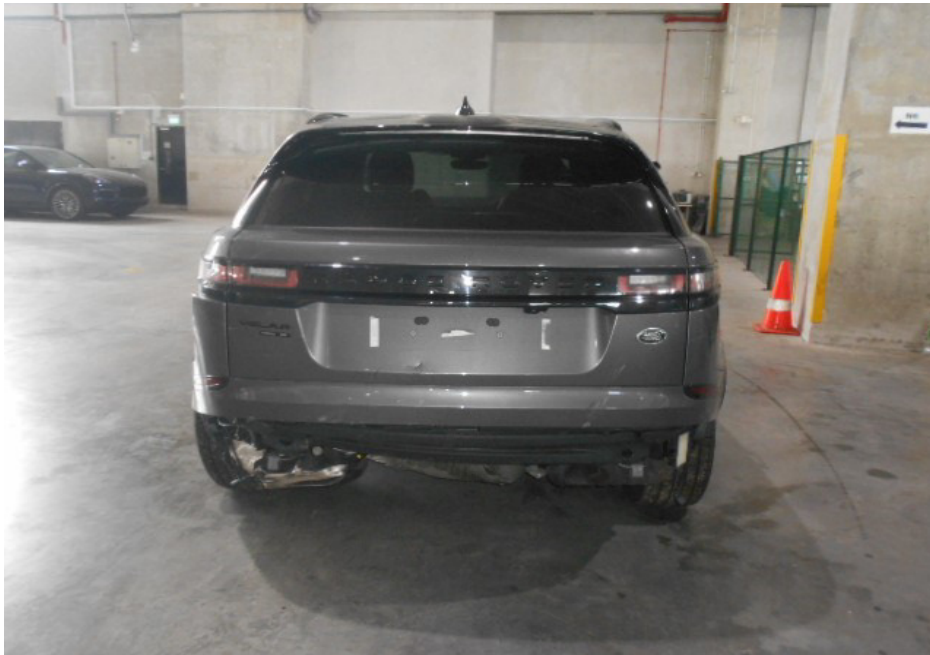
Photo 1 shows the rear body of the Motor Car (photograph provided to me). The Motor Car was observed to have sustained damage at its rear portion. The rear bumper, rear bumper lower cover, rear bumper reinforcement, rear exhaust garnishes, exhaust heat shields, reverse sensors, rear tailgate, rear end panel, rear spare tyre panel and rear left taillamp were amongst the parts that were observed to have been damaged.

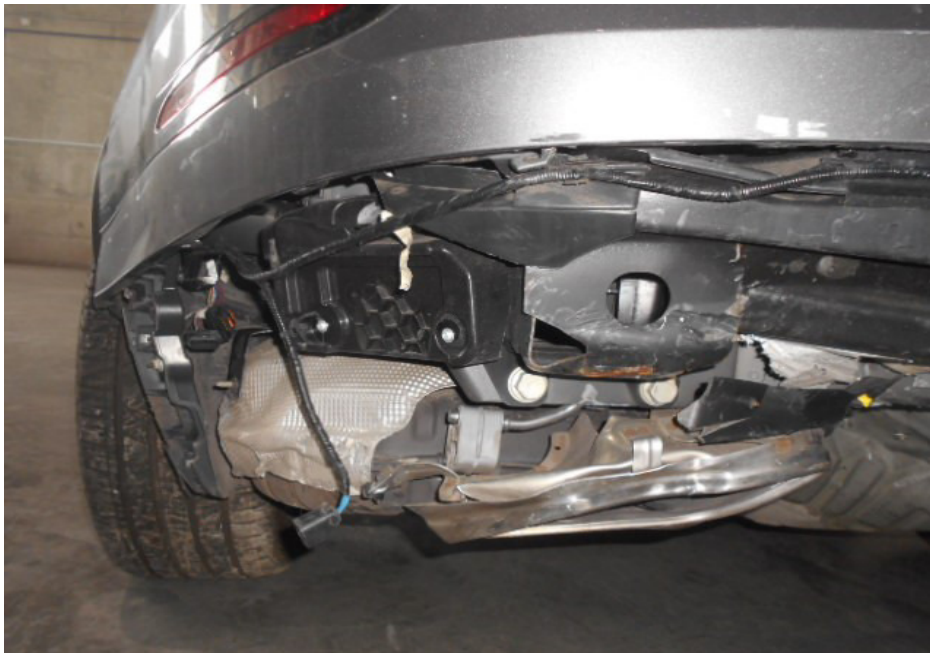
Photo 2 shows a closer view of the damage to the rear bumper, rear bumper lower cover, rear bumper reinforcement and rear left exhaust heat shield of the Motor Car (photograph provided to me).

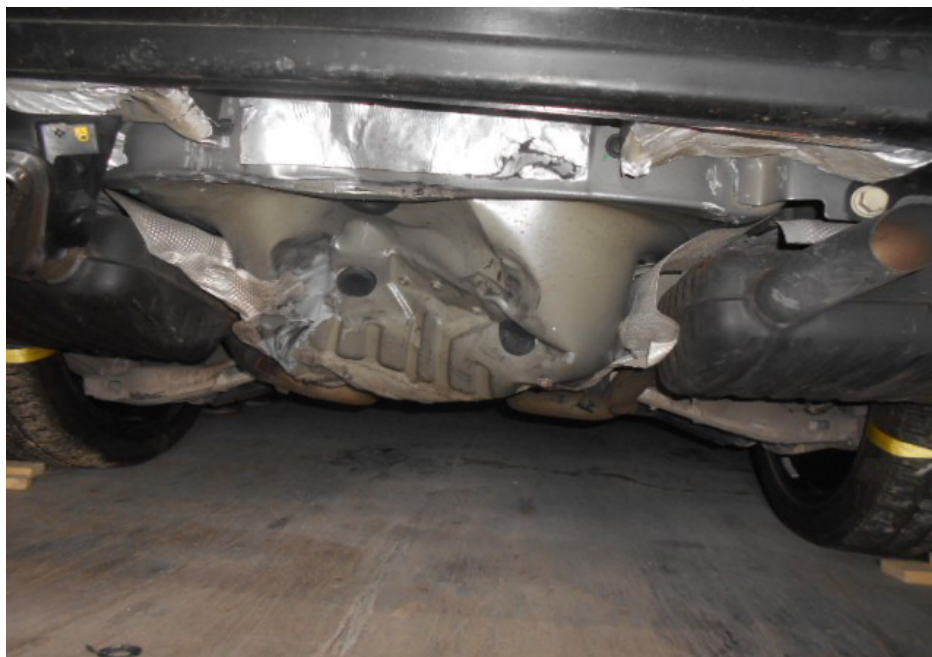
Photo 3 shows a closer view of the damage to the rear end panel, spare tyre panel and rear exhaust heat shields of the Motor Car (photograph provided to me).

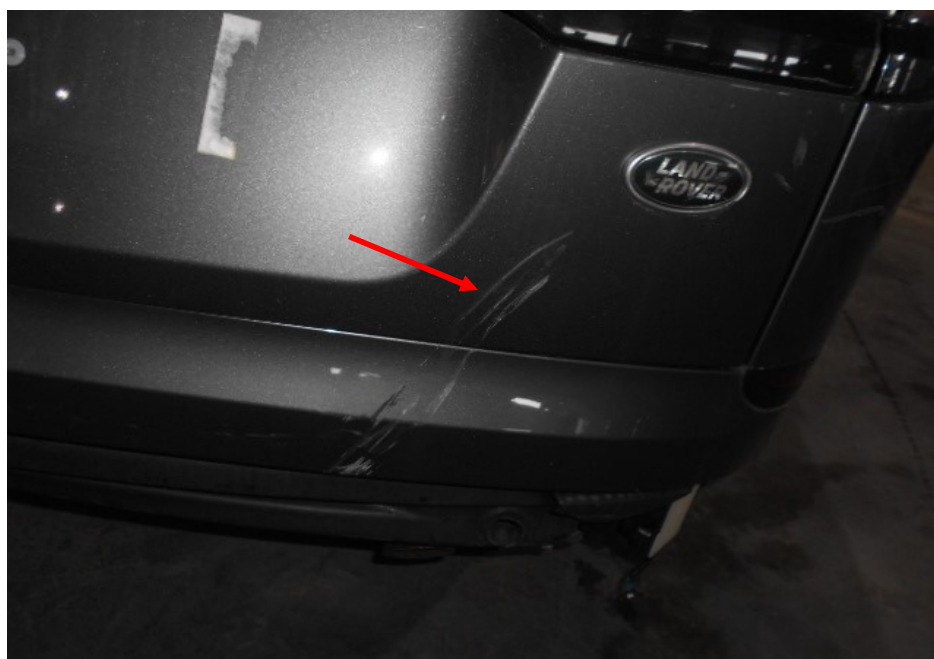
Photo 4 shows a closer view of the damage to the rear bumper and rear tailgate (arrowed) of the Motor Car (photograph provided to me).

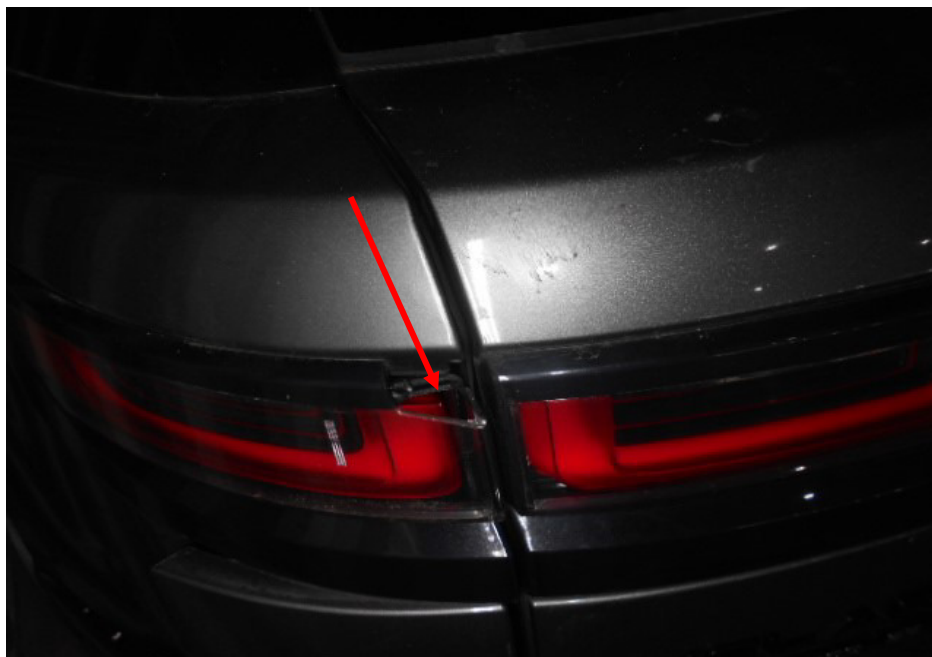
Photo 5 shows a closer view of the crack (arrowed) to the Motor Car's rear left taillamp (photograph provided to me).

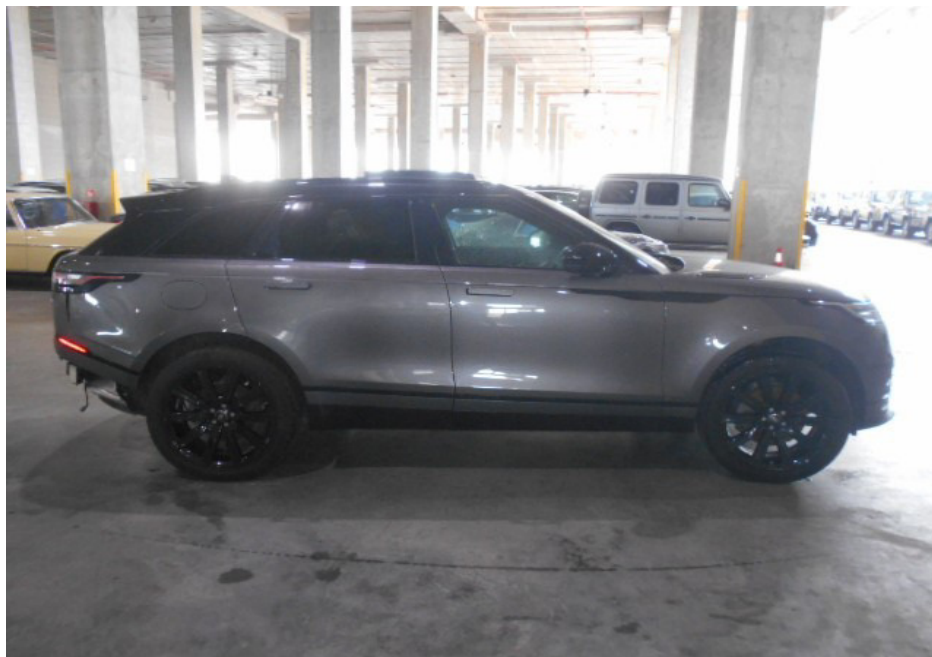
Photo 6 shows the right side body of the Motor Car (photograph provided to me). Apart for the rear portion, there was no physical damage seen to other areas of the Motor Car. The airbags of the Motor Car were also not activated as seen from the photographs that were provided to me.

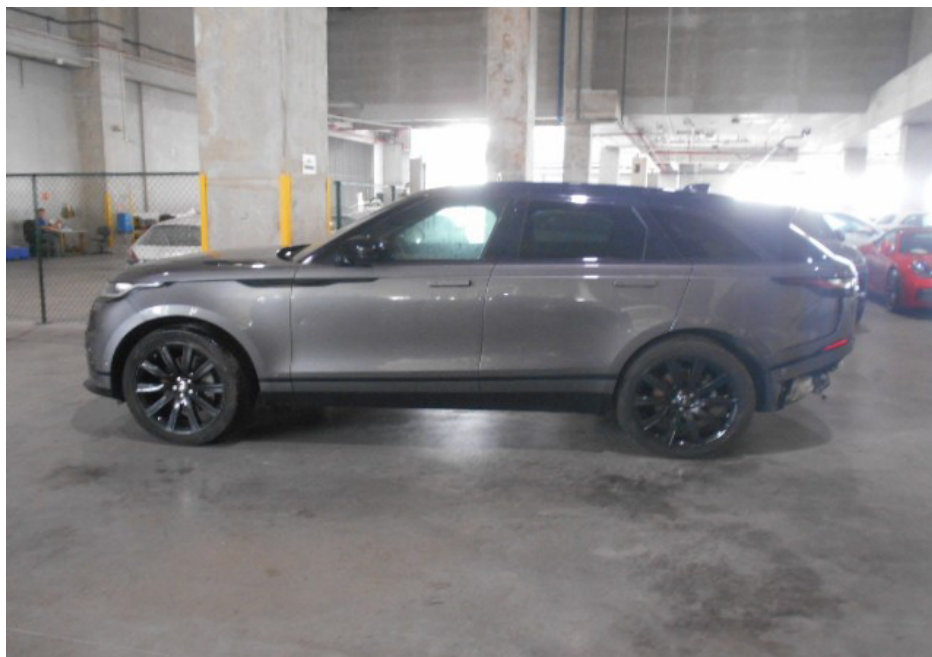
Photo 7 shows the left side body of the Motor Car (photograph provided to me). Apart for the rear portion, there was no physical damage seen to other areas of the Motor Car. The airbags of the Motor Car were also not activated as seen from the photographs that were provided to me.

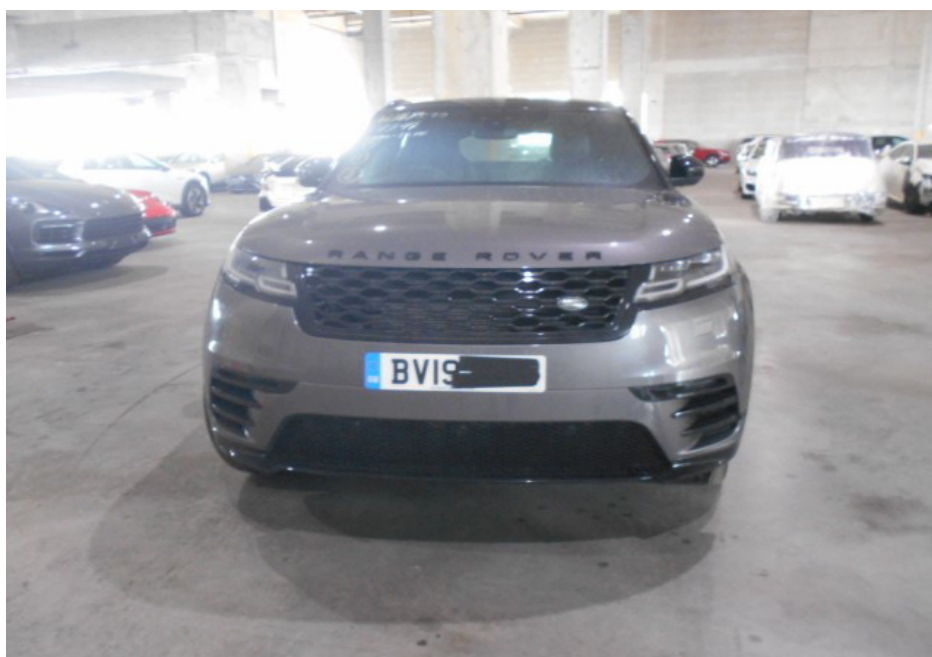
Photo 8 shows the front body of the Motor Car (photograph provided to me). Apart for the rear portion, there was no physical damage seen to other areas of the Motor Car.

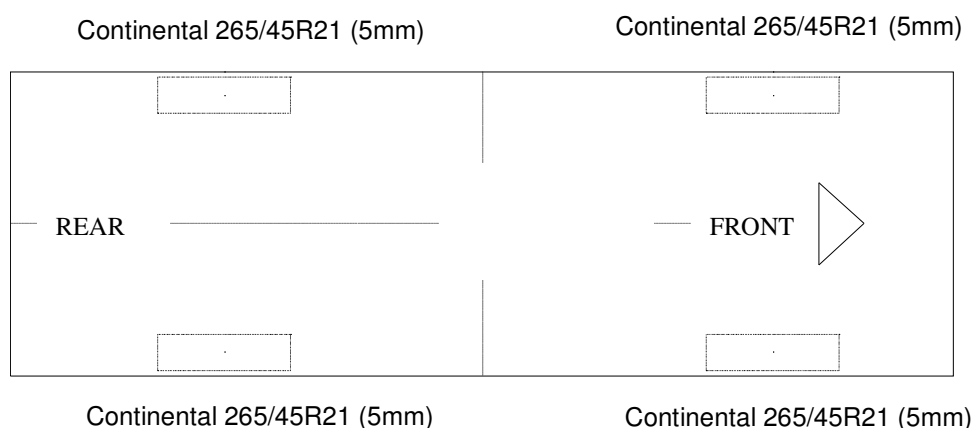
8. It was fitted with 21inch sport wheel rims that were wrapped with tyres that were observed to be of serviceable condition. The tyres were also sufficiently inflated for vehicular operation. The tyre brand, tyre size and approximate remaining tread depth of the 4 tyres of the Motor Car were recorded as follows: -

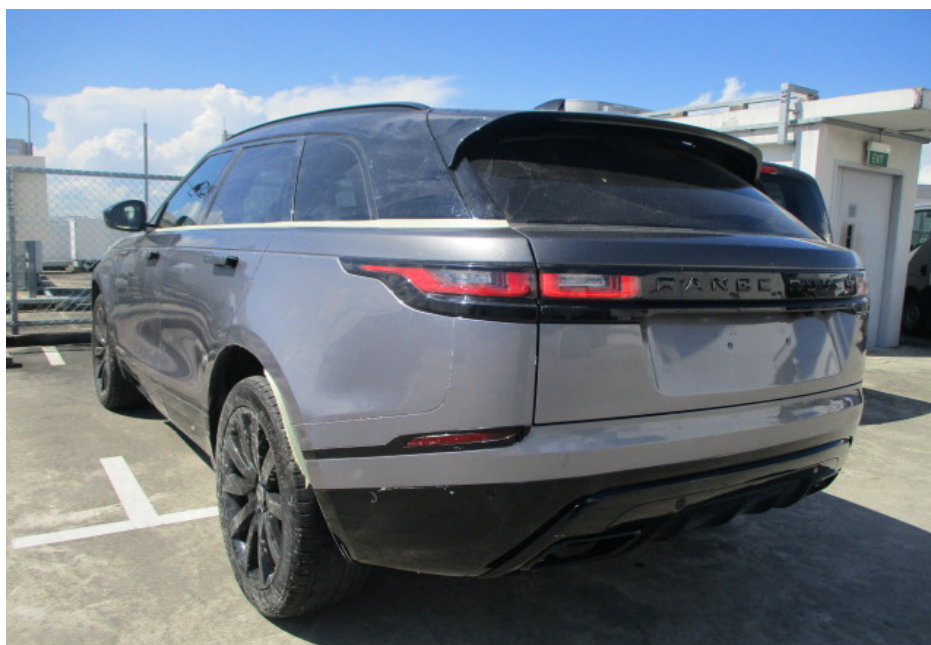
Photo 9 shows a general view of the rear left body of the Motor Car at the time of my inspection. The Motor Car was observed to be in a relatively good general condition with no loose exterior fittings observed. The body parts at the rear portion of the Motor Car were visually examined and it was observed that the repair/restoration works carried out to the damaged area of the Motor Car (refer to photograph 1 - 5 above) were reasonably adequate and in order.

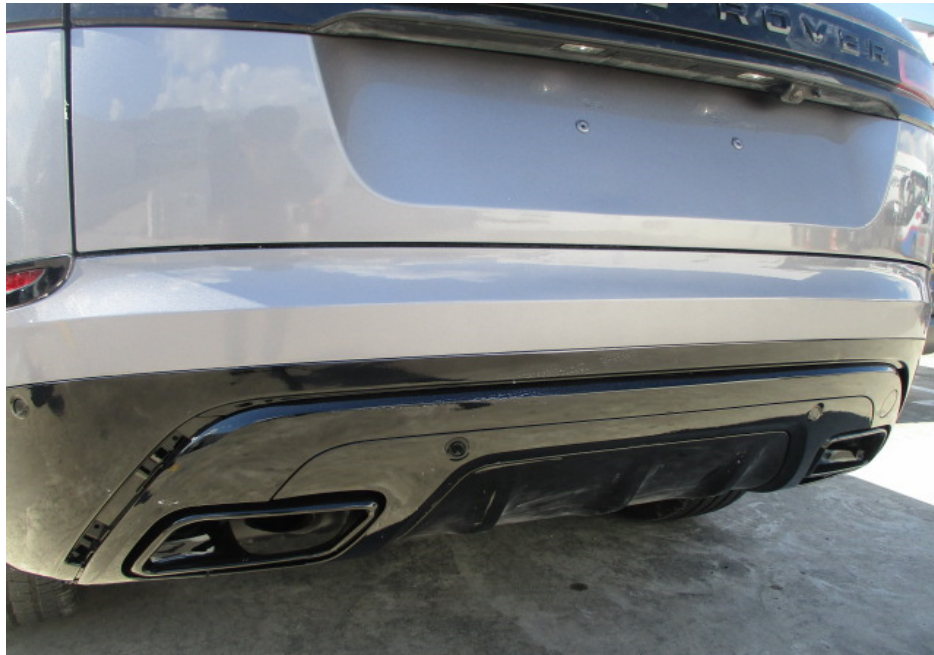
Photo 10 shows a closer view of the Motor Car's rear bumper, rear bumper lower cover, reverse sensors, rear left exhaust garnish and rear tailgate. The body parts at the rear portion of the Motor Car were visually examined and it was observed that the repair/restoration works carried out to the damaged area of the Motor Car (refer to photograph 1 - 4 above) were reasonably adequate and in order.

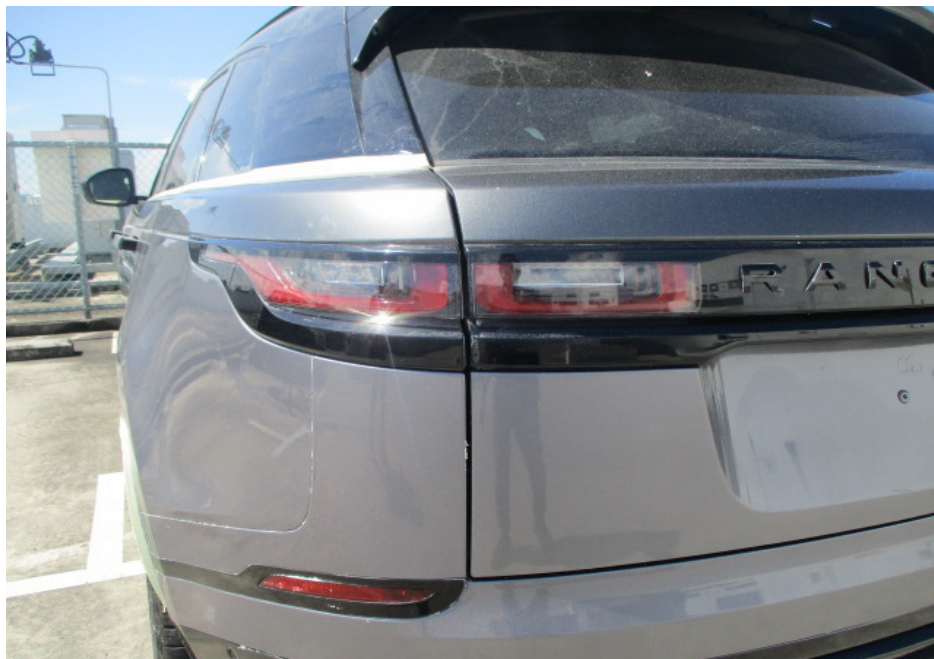
Photo 11 shows a closer view of the Motor Car's rear left taillamp. The body parts at the rear portion of the Motor Car were visually examined and it was observed that the repair/restoration works carried out to the damaged area of the Motor Car (refer to photograph 5 above) were reasonably adequate and in order.

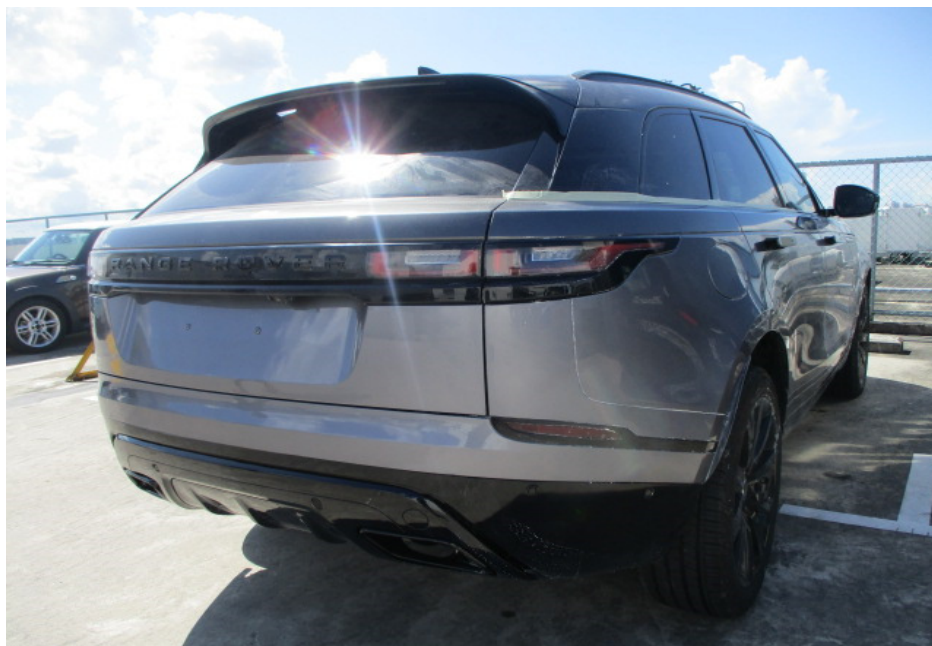
Photo 12 shows a general view of the rear right body of the Motor Car at the time of my inspection. The Motor Car was observed to be in a relatively good general condition with no loose exterior fittings observed. The body parts at the rear portion of the Motor Car were visually examined and it was observed that the repair/restoration works carried out to the damaged area of the Motor Car (refer to photograph 1 - 5 above) were reasonably adequate and in order.

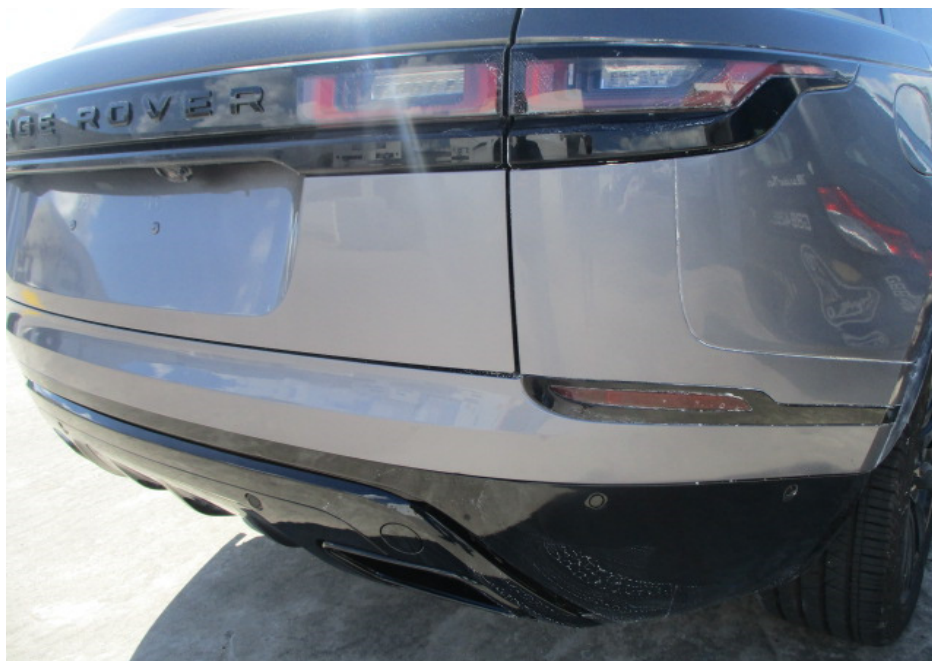
Photo 13 shows a closer view of the Motor Car's rear bumper, rear bumper lower cover, rear right exhaust garnish and rear tailgate. The body parts at the rear portion of the Motor Car were visually examined and it was observed that the repair/restoration works carried out to the damaged area of the Motor Car (refer to photograph 1 - 4 above) were reasonably adequate and in order.

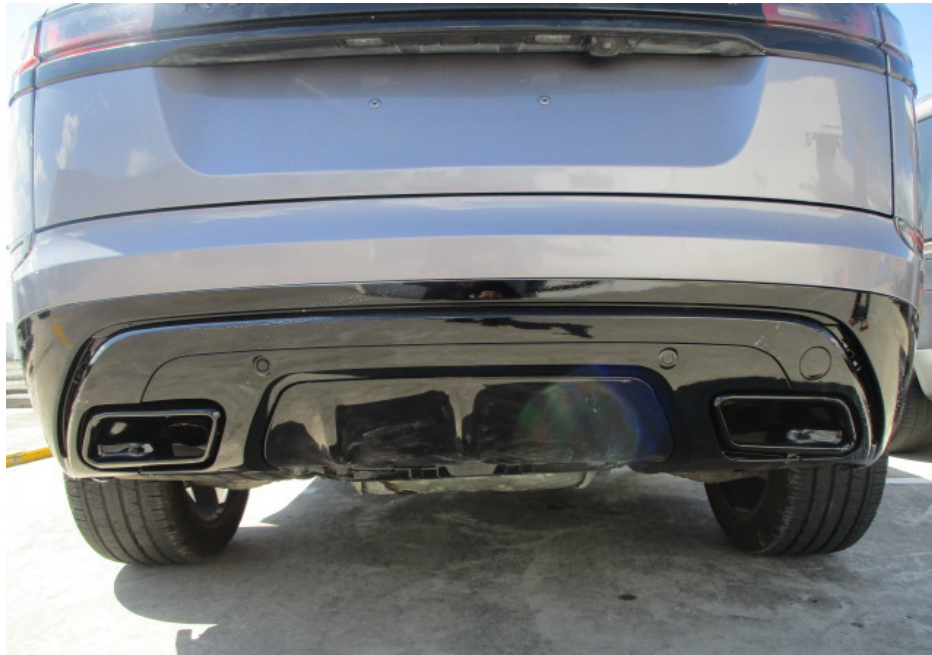
Photo 14 shows a closer view of the Motor Car's rear bumper, rear bumper lower cover, reverse sensors, rear exhaust garnishes and rear tailgate. The body parts at the rear portion of the Motor Car were visually examined and it was observed that the repair/restoration works carried out to the damaged area of the Motor Car (refer to photograph 1 - 4 above) were reasonably adequate and in order.

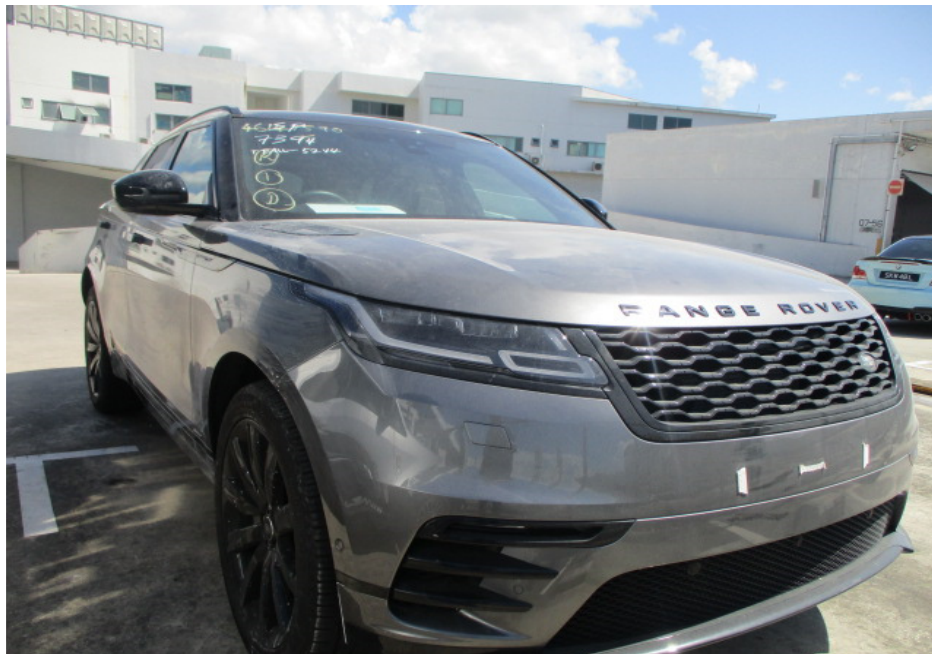
Photo 15 shows a general view of the front right body of the Motor Car at the time of my inspection. The Motor Car was observed to be in a relatively good general condition with no loose exterior fittings observed. The mileage of the Motor Car recorded at the time of my inspection was 12,041km.

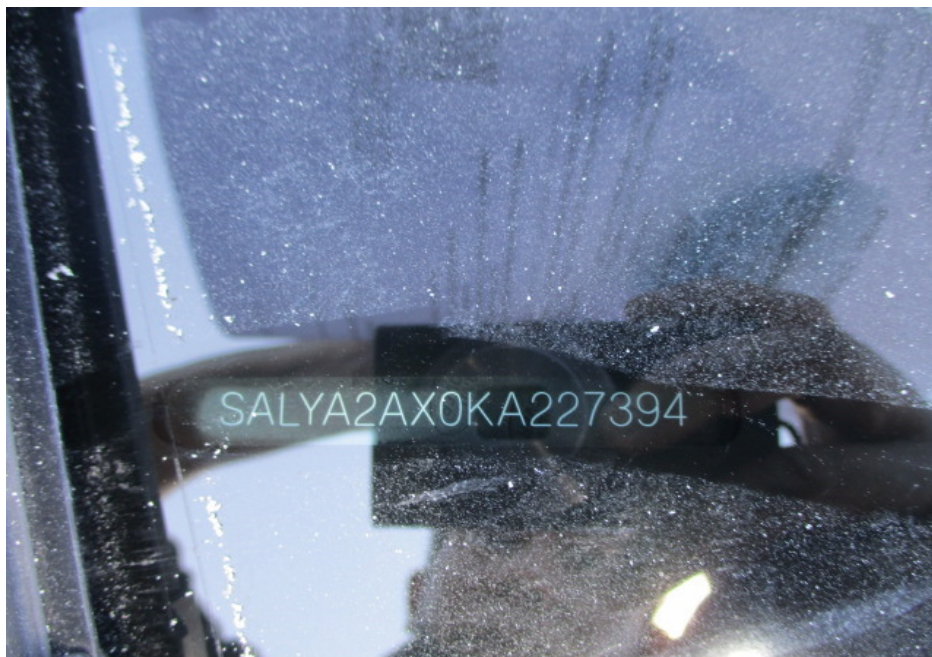
Photo 16 shows the chassis number of the Motor Car. The chassis number recorded was SALYA2AX0KA227394.

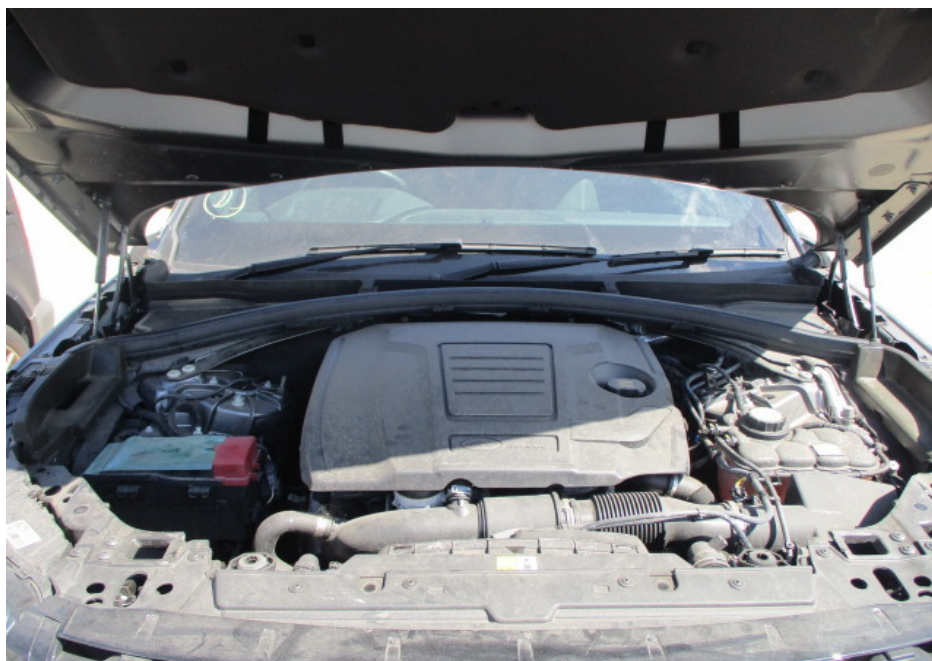
14. My examination of the engine compartment of the Motor Car revealed that the various parts and components inside the engine compartment were all intact and properly fitted. The engine oil, brake fluid and engine coolant were all found to be of sufficient level for operating purposes. Visually, there was also no contamination found to these fluids.

Photo 17 shows a general view of the engine compartment of the Motor Car at the time of my inspection. The various parts and components inside the engine compartment were all observed to be intact and properly fitted. There was also no sign(s) or indication(s) of fluid leak and/or fluid stain found inside the engine compartment.

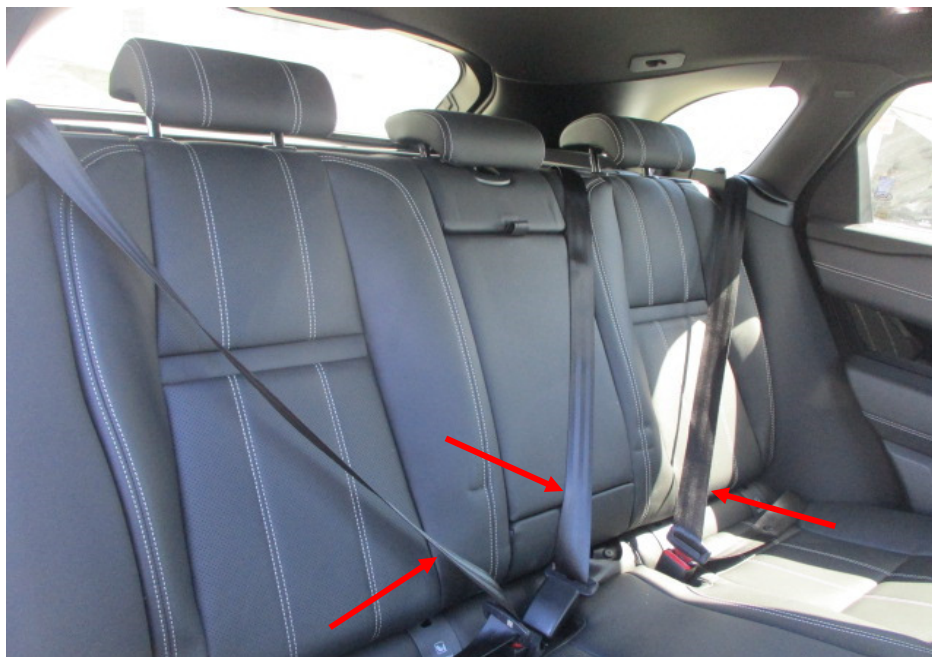
12. The seats of the Motor Car were found to be secured to the floorboard of the Motor Car via seat rails bolted onto the floorboard. Retractable seat belt reels and pre-tensioners were fitted on all seats of the Motor Car. The seat belts were tested and were able to be fastened securely into the respective pre-tensioners that were fixed to the side of all the seats.

Photo 18 shows the rear seats of the Motor Car. All the seats of the Motor Car were secured via seat rails to the floorboard. They were also fitted with a retractable seat belt reel and a pre-tensioner. The seat belts (arrowed) were tested and were able to be fastened into the respective pre-tensions that were fitted on the side of each individual seat.

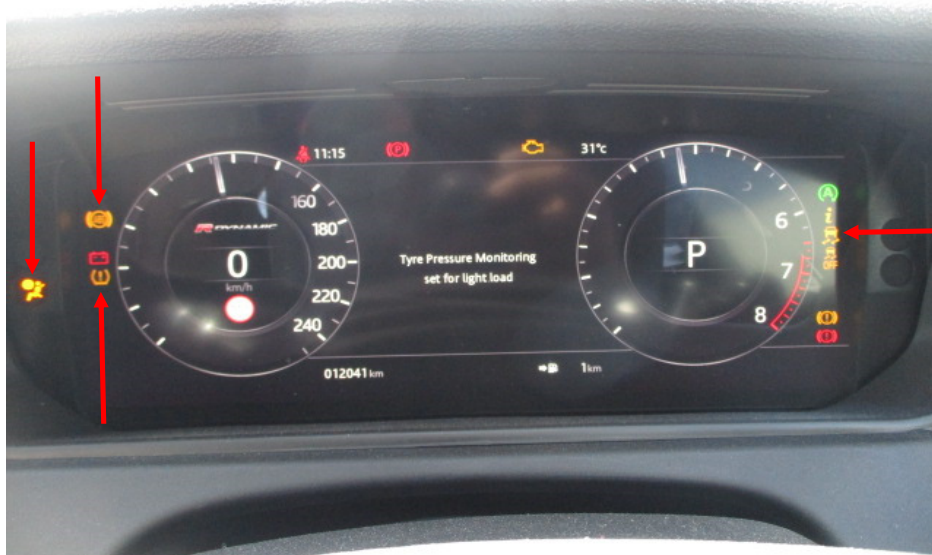
Photo 19 shows the warning lights for the various electronic safety features appearing on the instrument panel of the Motor Car during its self-test when the engine is cranked, in particular the ABS, SRS, TPM and TCS lights (arrowed).

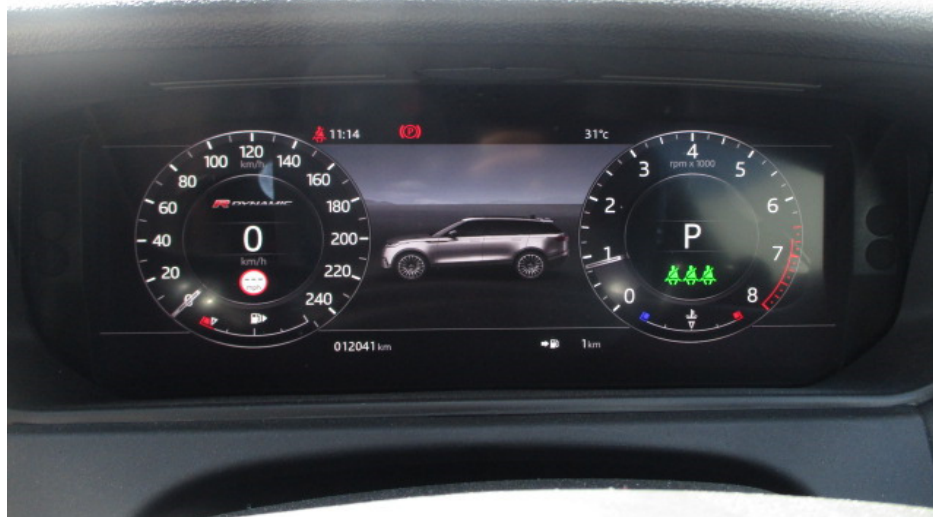
13. The Motor Car's automatic self-test of the functionality of its various electronic safety features like the Anti-Lock Brake System (ABS), Supplemental Restraint System (SRS), Tyre Pressure Monitor (TPM) and Traction Control System (TCS) during cranking of the engine had indicated that these electronic systems were in working condition. This was determined from the respective warning lights disappearing from the instrument panel after the self-test.

Photo 20 shows the respective warning lights no longer illuminated, indicating that there is no fault detected to the ABS, SRS, TPM and TCS systems of the Motor Car during the self-test. These electronic systems were hence in working condition at the time of my inspection.

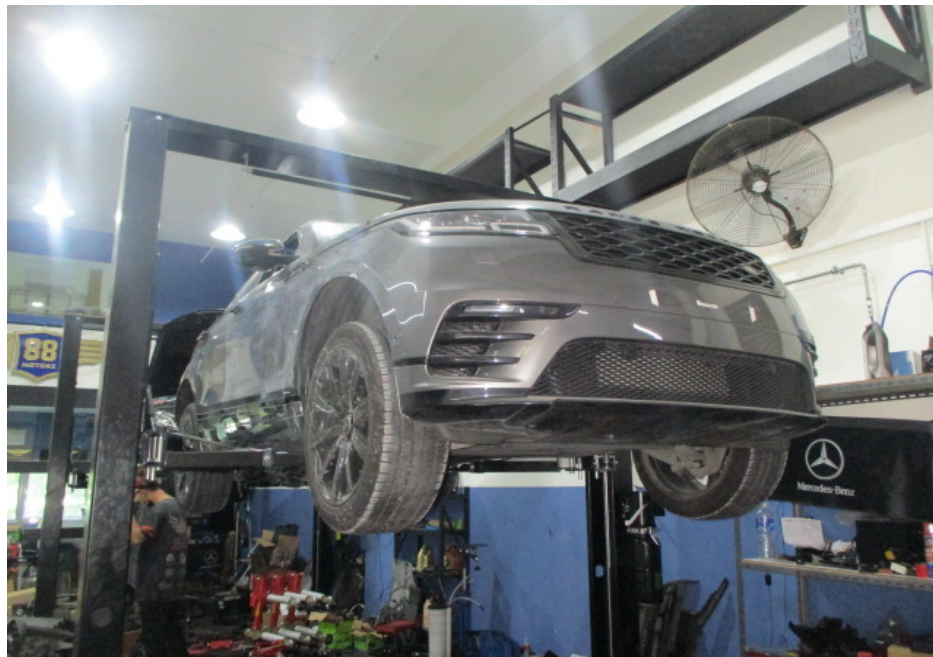
15. My checks on the underside of the Motor Car revealed no sign(s) or indication(s) of fluid leakage and/or fluid stain(s). The engine block and automatic transmission assembly were both secured properly. All undercarriage components of the Motor Car were also observed to be intact and secured in an appropriate manner.

Photo 21 shows the Motor Car hoisted up for checks on its undercarriage. There was no sign(s) or indication(s) of fluid leakage and/or fluid stain(s) on the underside of the Motor Car. The undercarriage components of the Motor Car were also all observed to be intact and secured in an appropriate manner.

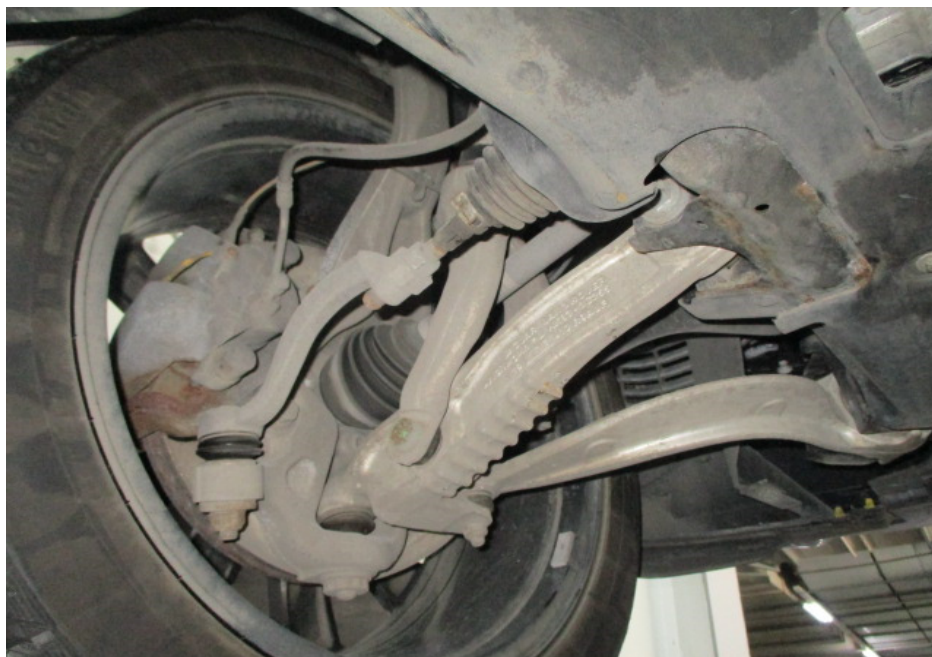
Photo 22 shows the various undercarriage components at the front left wheel of the Motor Car. The mechanical components, control arms and linkages were all found to be intact and secured in an appropriate manner. I also did not observe any fluid leak and/or fluid stain on the underside of the Motor Car.

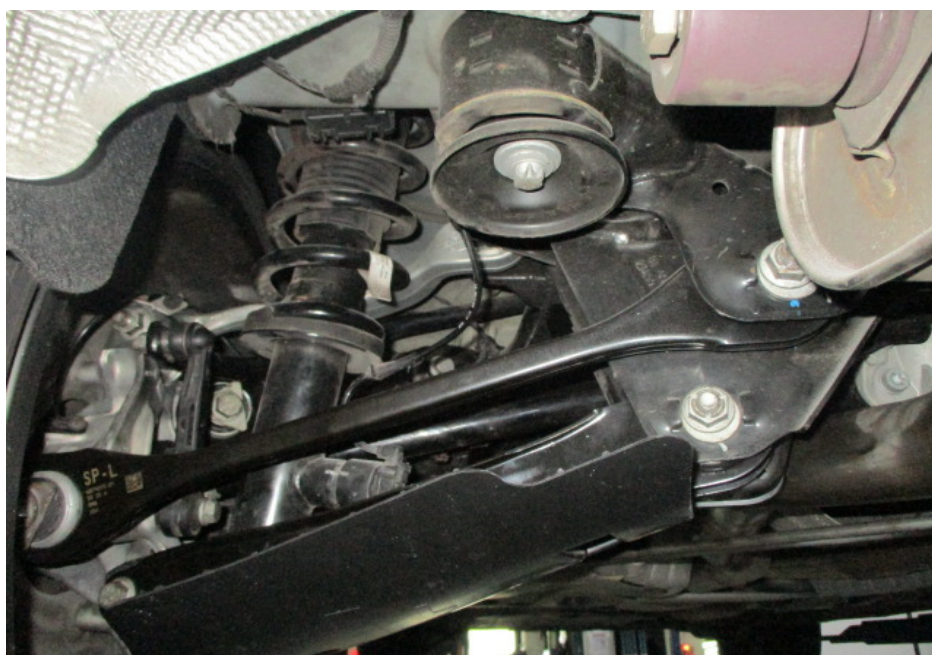
Photo 23 shows the various undercarriage components at the rear left wheel of the Motor Car. The mechanical components, control arms and linkages were all found to be intact and secured in an appropriate manner.

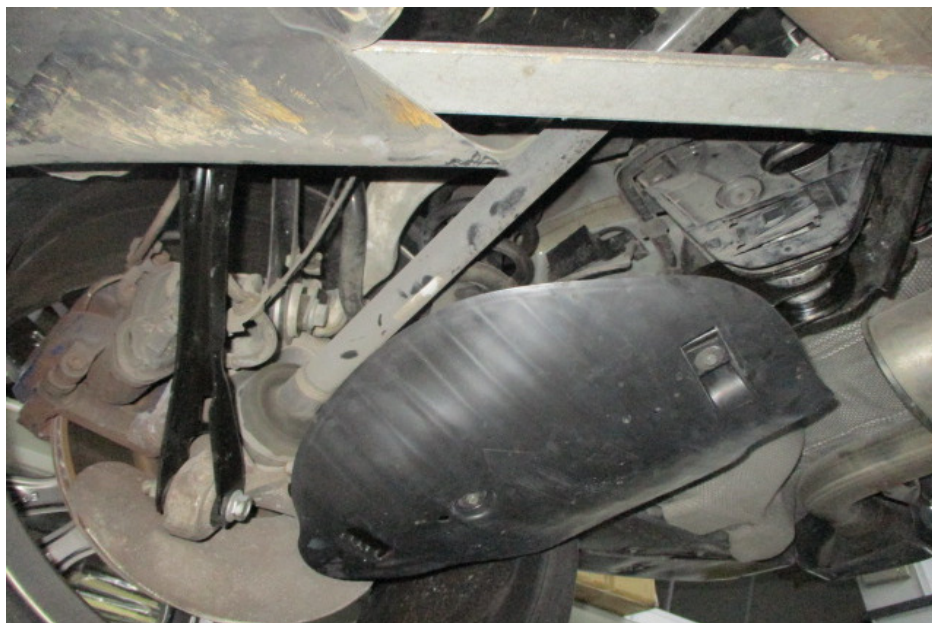
Photo 24 shows the various undercarriage components at the rear right wheel of the Motor Car. The mechanical components, control arms and linkages were all found to be intact and secured in an appropriate manner. I also did not observe any fluid leak and/or fluid stain on the underside of the Motor Car.

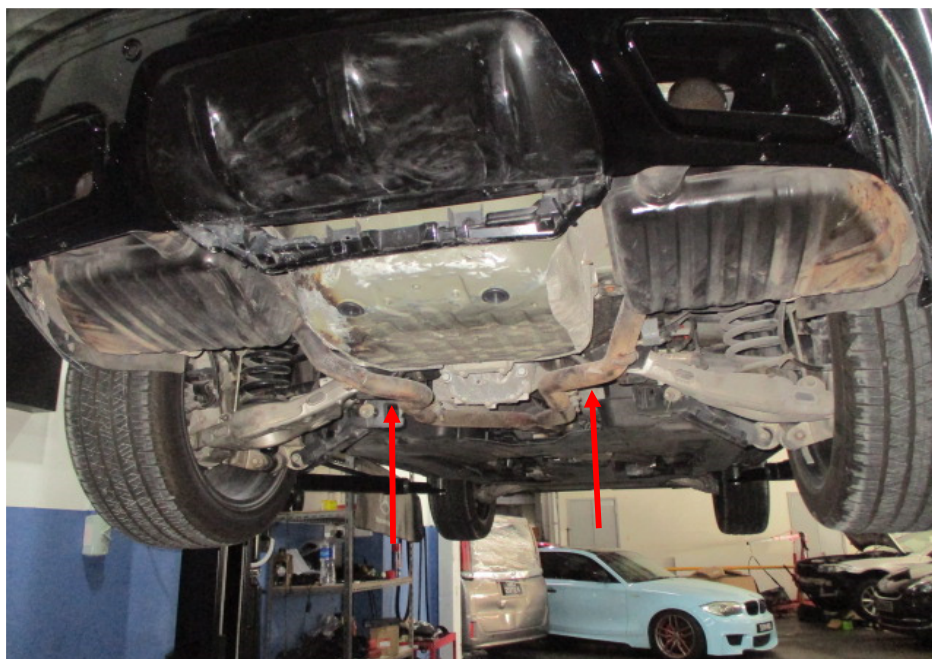
Photo 25 shows the rear section of the Motor Car's exhaust system. My examination of the Motor Car's exhaust system revealed no sign(s) or indication(s) of any cut or weld marks along its exhaust pipes (arrowed), on its centre resonator box, catalytic converter and on its rear mufflers.

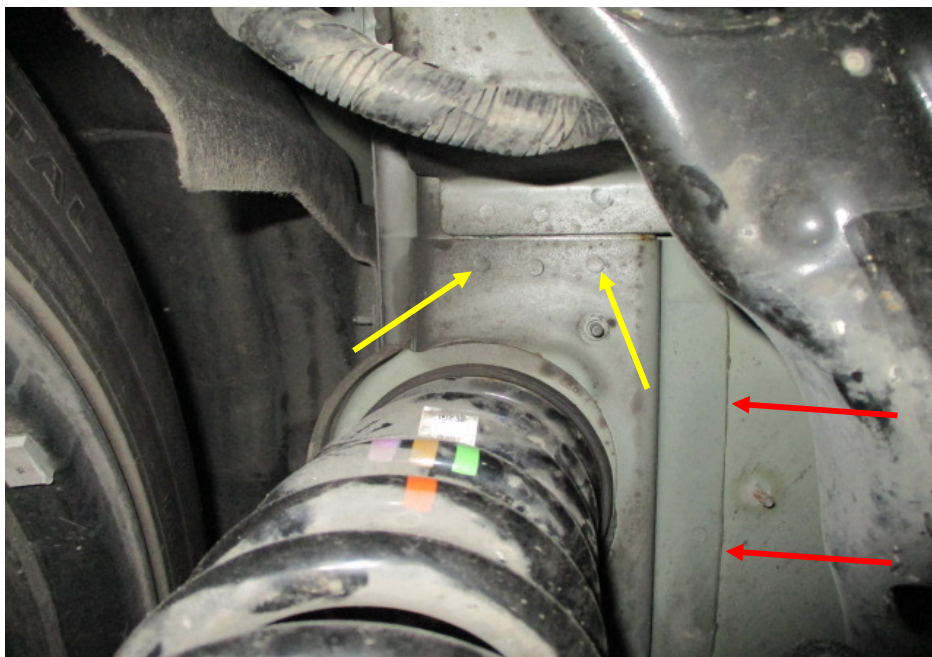
11. Visually, I did not find any weld marks, other than the original spot weld marks, on the chassis/structural body of the Motor Car. The original factory sealant at the joints along the chassis/structural body was also untouched, again indicating that no replacement of the chassis/structural body was carried out; and that the chassis/structural body was originally fitted.

Photo 26 shows the chassis/structural body at the underside rear left of the Motor Car. I did not find any weld marks other than original spot weld marks (yellow arrow) on the chassis/structural body of the Motor Car. The original factory sealant (red arrow) at the joints along the chassis/structural body was also untouched, indicating no work was done on the chassis/structural body of the Motor Car and that the chassis/structural body was originally fitted.

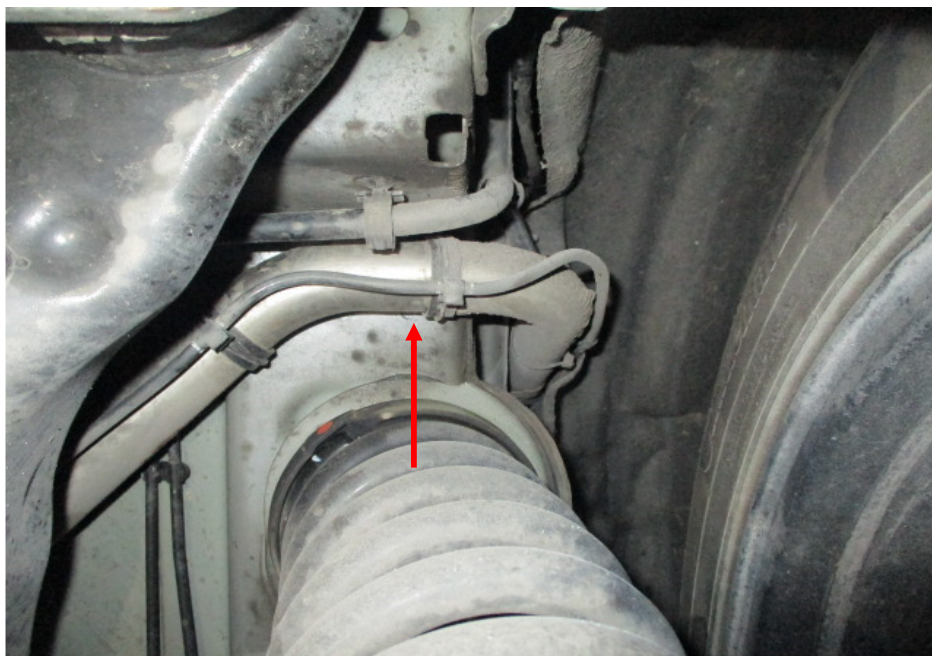
Photo 27 shows the chassis/structural body at the underside rear right of the Motor Car. I did not find any weld marks other than original spot weld marks (arrowed) on the chassis/structural body of the Motor Car, indicating no work was done on the chassis/structural body of the Motor Car and that the chassis/structural body was originally fitted.

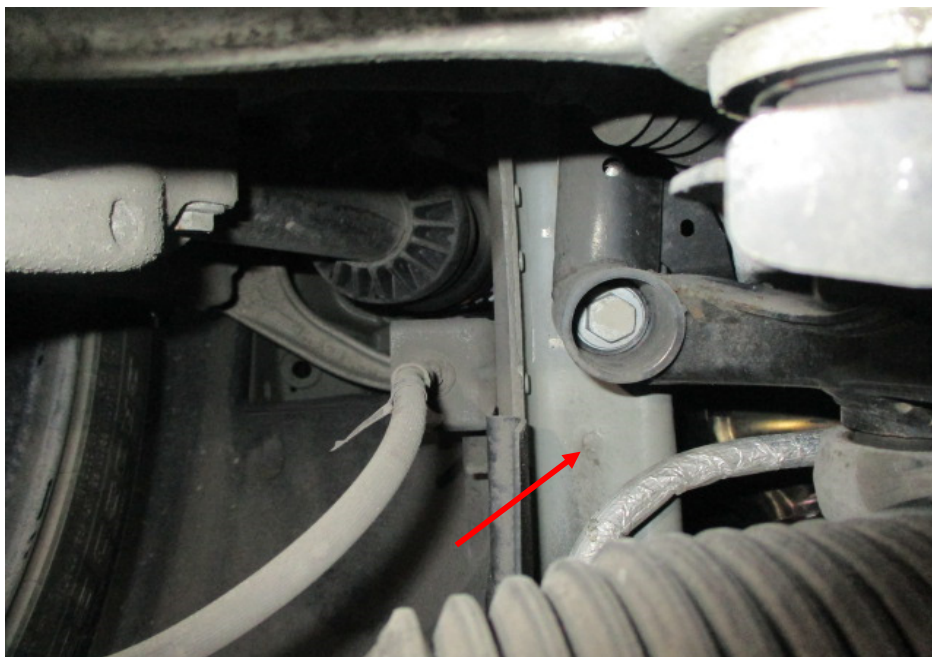
Photo 28 shows the chassis/structural body at the underside front right of the Motor Car. I did not find any weld marks other than original spot weld marks (arrowed) on the chassis/structural body of the Motor Car. The original factory sealant at the joints along the chassis/structural body was also untouched, indicating no work was done on the chassis/structural body of the Motor Car and that the chassis/structural body was originally fitted.

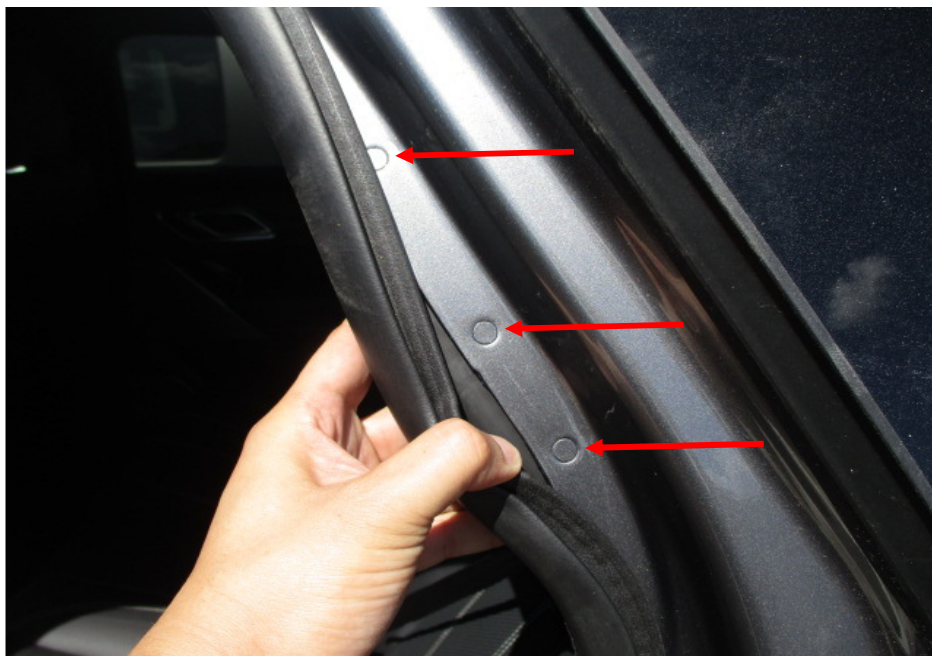
Photo 29 shows the left side "C" pillar of the Motor Car. I did not find any weld marks other than original spot weld marks (arrowed) on the left side "C" pillar of the Motor Car which, indicates that there was no re-welding works carried out. In general, I had found all the non-detachable body panels of the Motor Car to be originally fitted at the time of my inspection.

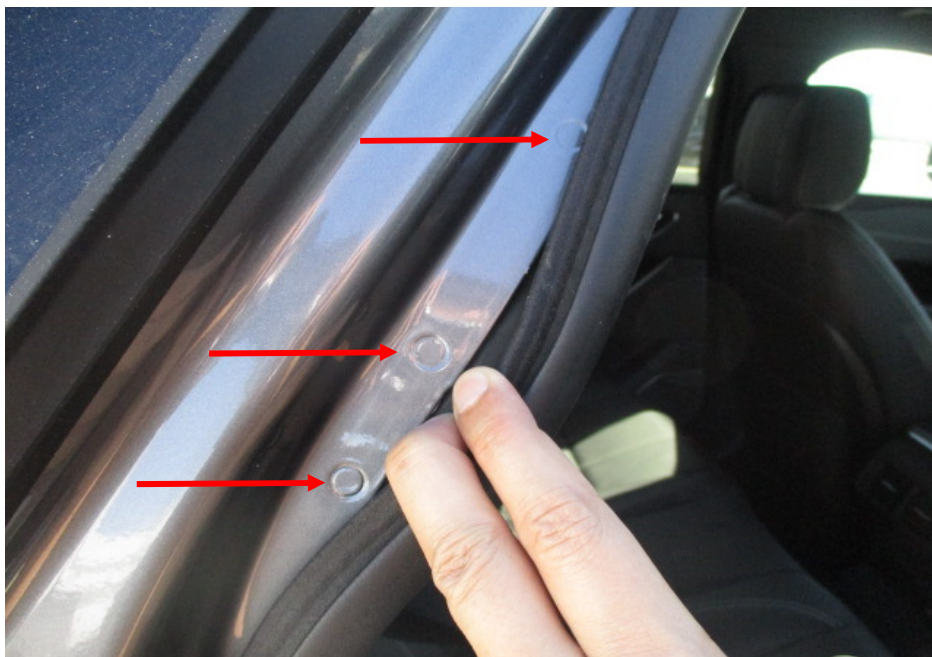
Photo 30 shows the right side "C" pillar of the Motor Car. I did not find any weld marks other than original spot weld marks (arrowed) on the right side "C" pillar of the Motor Car which, indicates that there was no re-welding works carried out. In general, I had found all the non-detachable body panels of the Motor Car to be originally fitted at the time of my inspection.
