Your Ref: BMW 330i
(chassis number WBA5R12070FH23209)
Our Ref : CI/TP21006821/D

20 June 2021

INSPECTION REPORT OF AN UNREGISTERD BMW 330i MOTOR CAR WITH CHASSIS NUMBER WBA5R12070FH23209

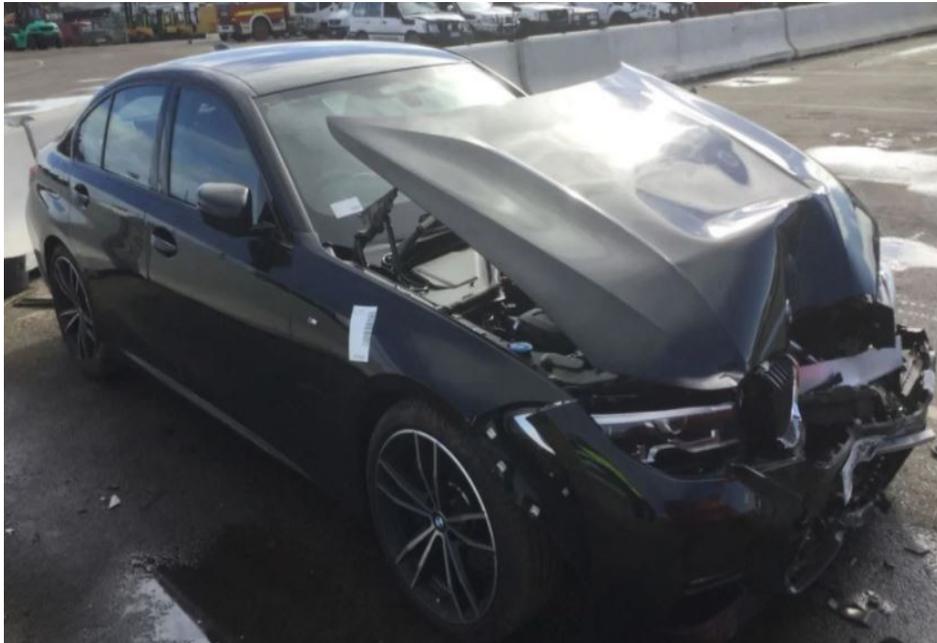
Photo 1 shows the front right body of the Motor Car prior to any repairs being carried out (photograph provided to me). The Motor Car was observed to have sustained damages at its frontal portion. The front bumper, front bumper right lower grille, front right headlamp and front bonnet were amongst the body parts that were observed to be damaged.

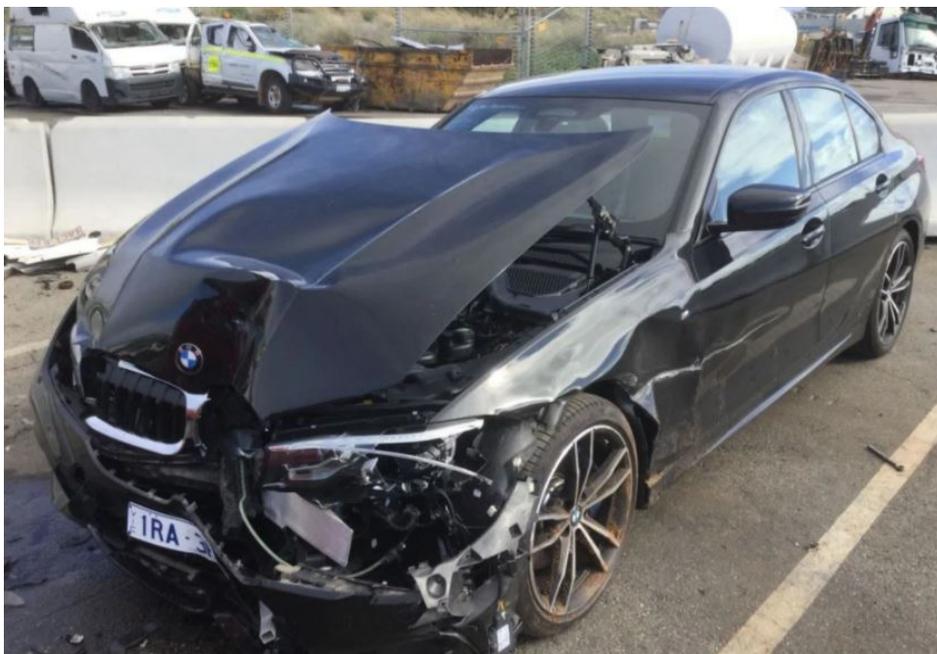
Photo 2 shows the front left body of the Motor Car prior to any repairs being carried out (photograph provided to me). The Motor Car was observed to have sustained damages at its frontal portion. The front bumper, front bumper left lower grille, front bumper centre lower grille, front bumper reinforcement, front left day running light, front left headlamp, front radiator grilles, front bonnet and front left fender were amongst the body parts that were observed to be damaged.

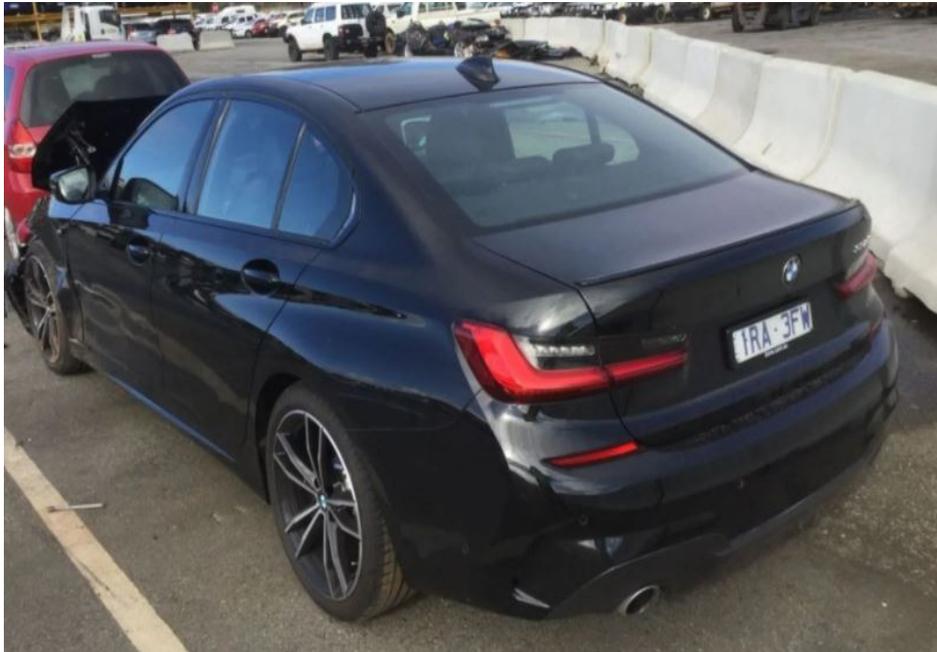
Photo 3 shows the rear left body of the Motor Car prior to any repairs being carried out (photograph provided to me). Apart for the frontal portion, there was no physical damage observed to other areas of the Motor Car. The airbags of the Motor Car were also not deployed as seen from the photographs that were provided to me.

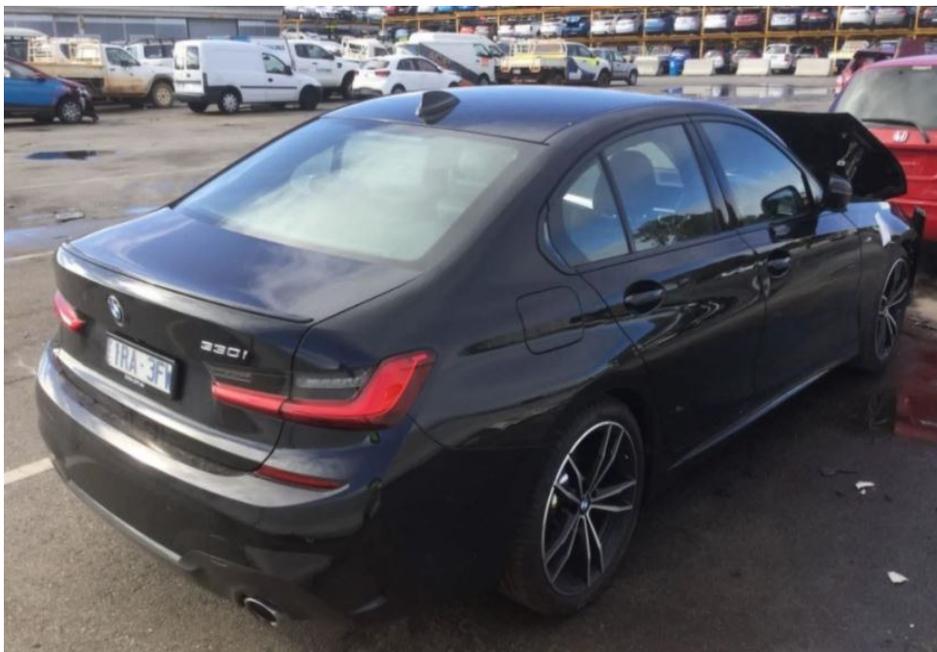
Photo 4 shows the rear right body of the Motor Car prior to any repairs being carried out (photograph provided to me). Apart for the frontal portion, there was no physical damage observed to other areas of the Motor Car. The airbags of the Motor Car were also not deployed as seen from the photographs that were provided to me.

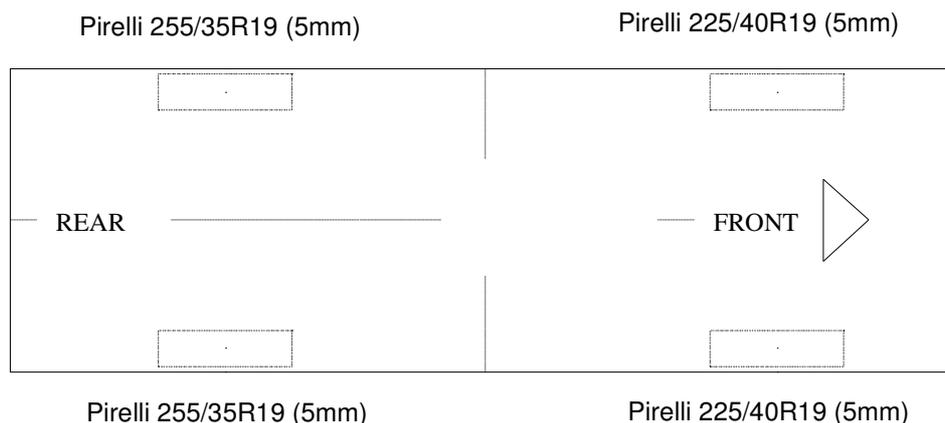
8. It was fitted with 19inch sport wheel rims that were wrapped with tyres that were observed to be of serviceable condition. The tyres were also sufficiently inflated for vehicular operation. The tyre brand, tyre size and approximate remaining tread depth of the 4 tyres of the Motor Car were recorded as follows: -

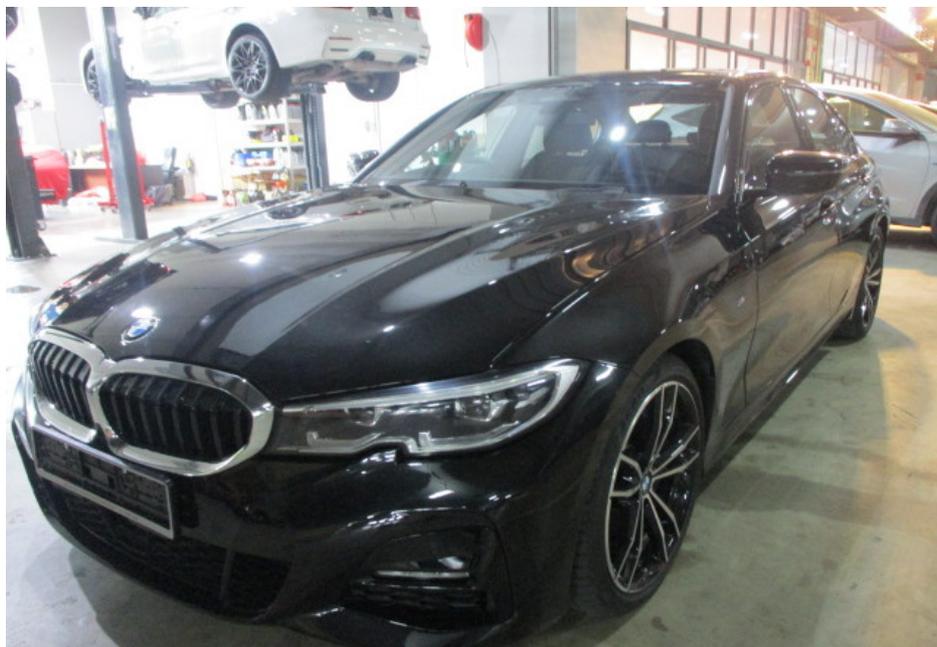
Photo 5 shows a general view of the front left body of the Motor Car at the time of my inspection. The Motor Car was observed to be in a relatively good general condition with no loose exterior fittings observed. The body parts at the frontal portion of the Motor Car were visually examined and it was observed that the repair/restoration works carried out to the damaged area of the Motor Car (refer to photograph 1 & 2 above) were reasonably adequate and in order.

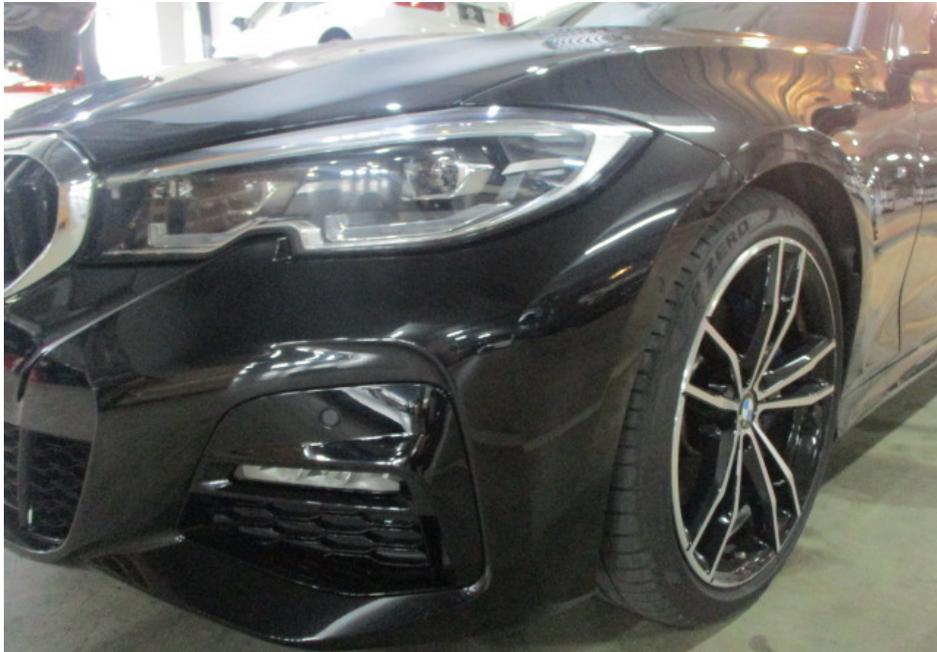
Photo 6 shows a closer view of the Motor Car's front bumper, front bumper left lower grille, front left day running light, front left headlamp and front left fender. The body parts at the frontal portion of the Motor Car were visually examined and it was observed that the repair/restoration works carried out to the damaged area of the Motor Car (refer to photograph 1 & 2 above) were reasonably adequate and in order.

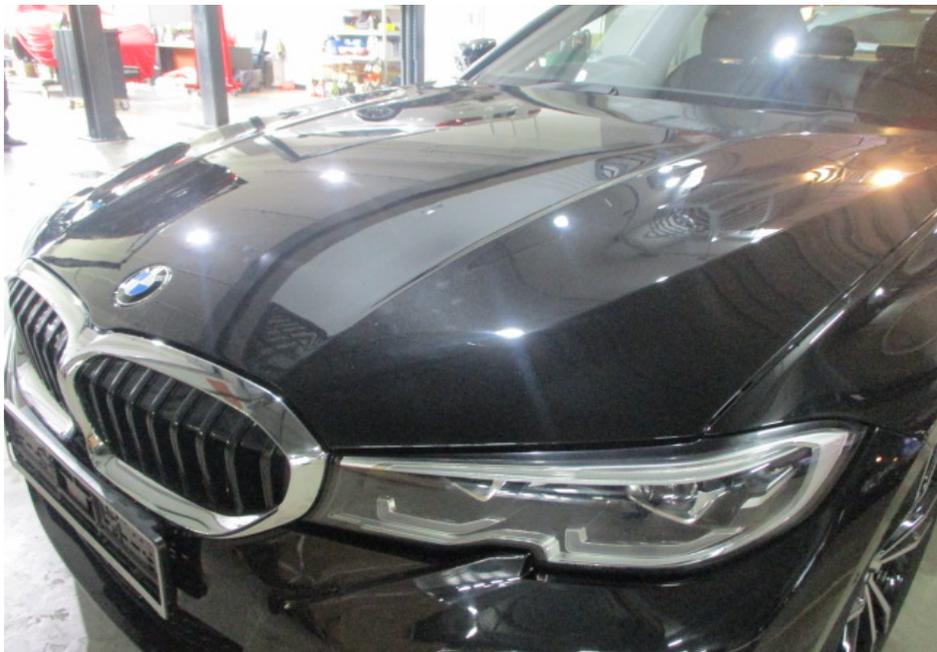
Photo 7 shows a closer view of the Motor Car's front left headlamp, front radiator grilles and front bonnet. The body parts at the frontal portion of the Motor Car were visually examined and it was observed that the repair/restoration works carried out to the damaged area of the Motor Car (refer to photograph 1 & 2 above) were reasonably adequate and in order.

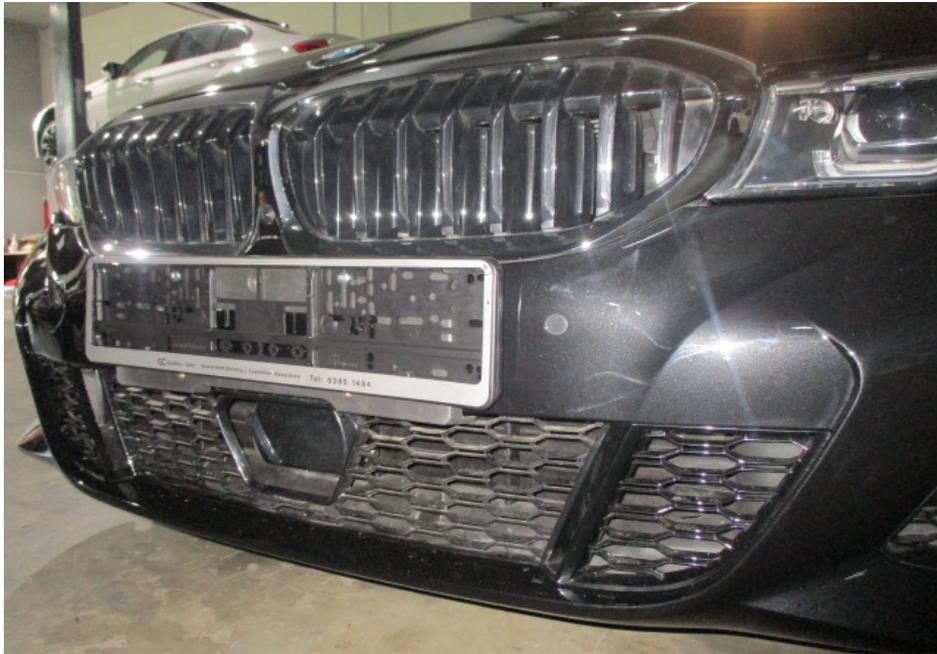
Photo 8 shows a closer view of the Motor Car's front bumper, front bumper centre lower grille, front radiator grilles and front radar unit. The body parts at the frontal portion of the Motor Car were visually examined and it was observed that the repair/restoration works carried out to the damaged area of the Motor Car (refer to photograph 1 & 2 above) were reasonably adequate and in order.

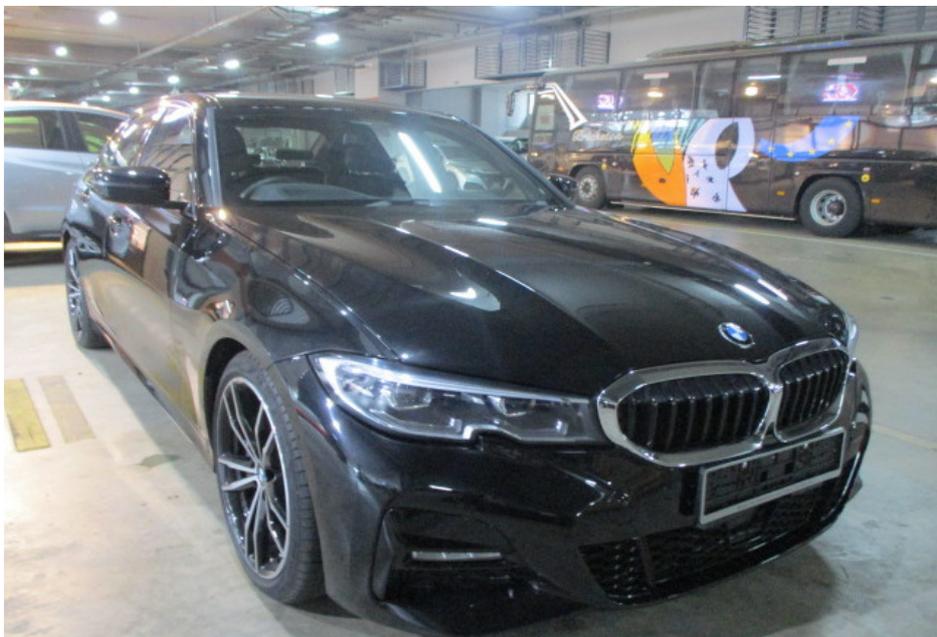
Photo 9 shows a general view of the front right body of the Motor Car at the time of my inspection. The Motor Car was observed to be in a relatively good general condition with no loose exterior fittings observed. The body parts at the frontal portion of the Motor Car were visually examined, and it was observed that the repair/restoration works carried out to the damaged area of the Motor Car (refer to photograph 1 & 2 above) were reasonably adequate and in order.

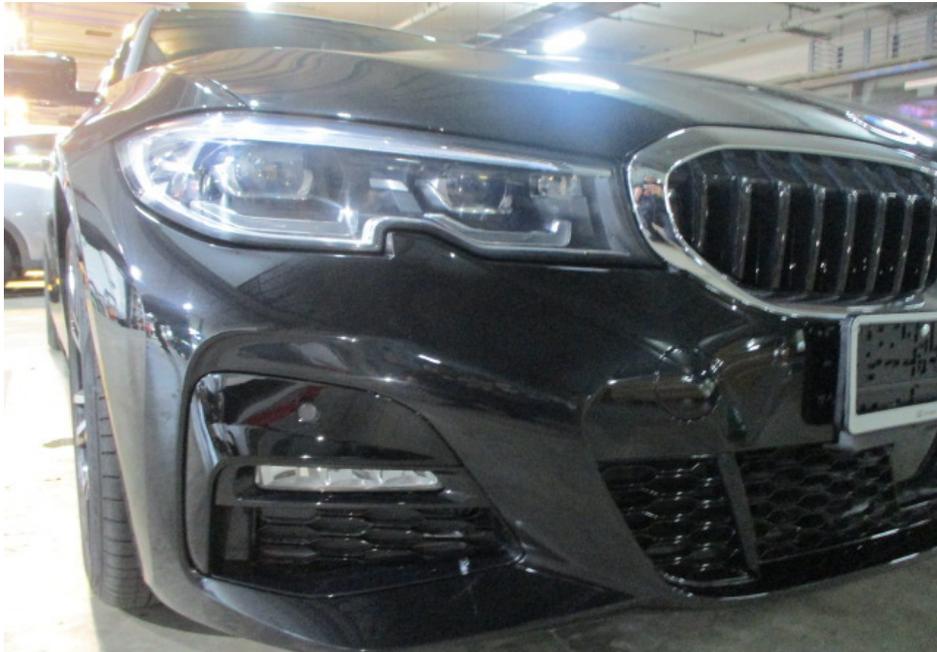
Photo 10 shows a closer view of the Motor Car's front bumper, front bumper right lower grille, front right headlamp and front right day running light. The body parts at the frontal portion of the Motor Car were visually examined and it was observed that the repair/restoration works carried out to the damaged area of the Motor Car (refer to photograph 1 & 2 above) were reasonably adequate and in order.

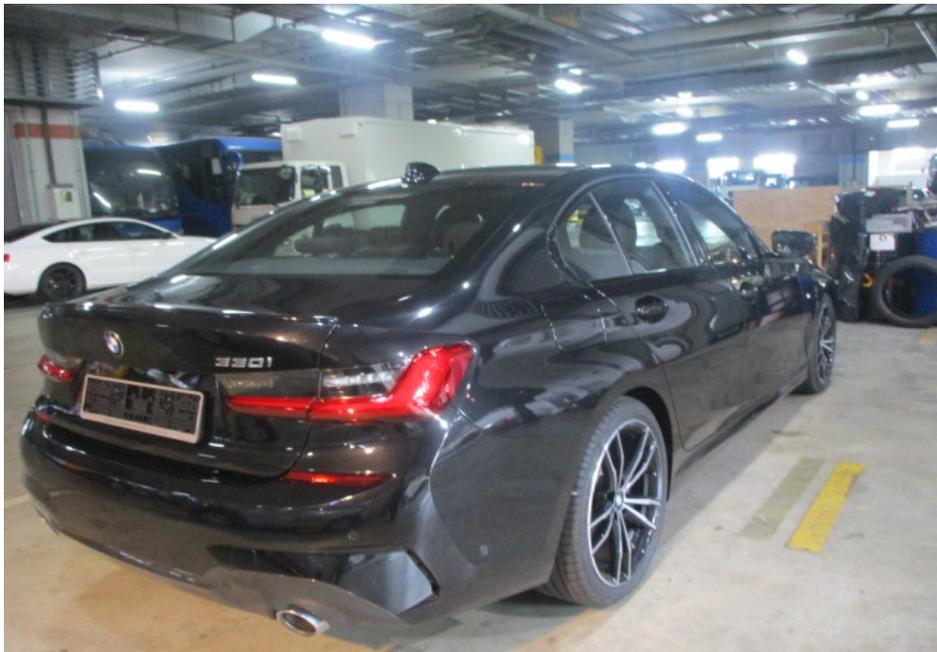
Photo 11 shows a general view of the rear right body of the Motor Car at the time of my inspection. The Motor Car was observed to be in a relatively good general condition with no loose exterior fittings observed. The mileage of the Motor Car recorded at the time of my inspection was 4,170km.

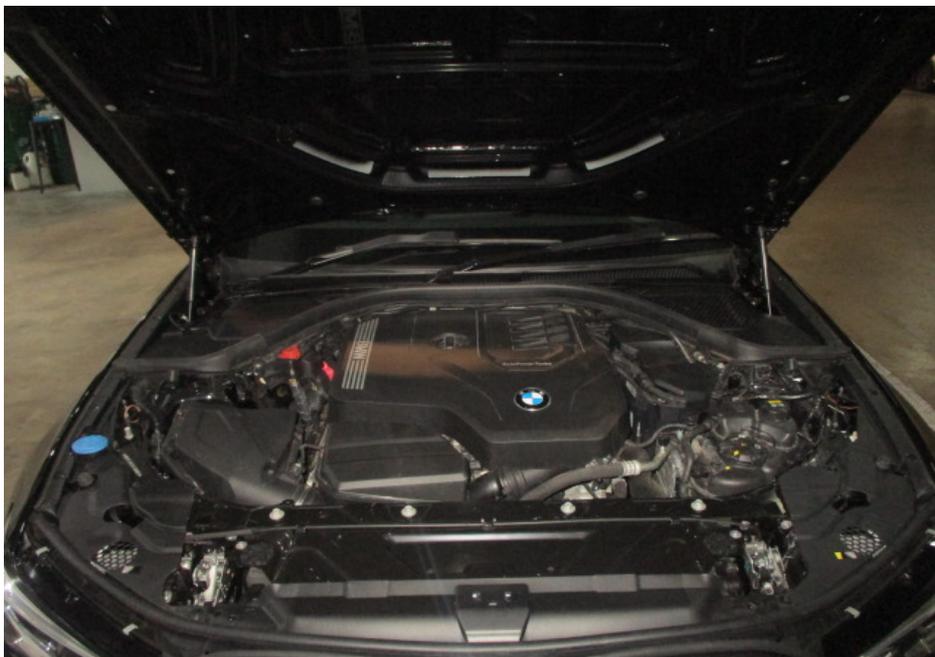
14. My examination of the engine compartment of the Motor Car revealed that the various parts and components inside the engine compartment were all intact and properly fitted. The engine oil, brake fluid and engine coolant were all found to be of sufficient level for operating purposes. Visually, there was also no contamination found to these fluids.

Photo 13 shows a general view of the engine compartment of the Motor Car at the time of my inspection. The various parts and components inside the engine compartment were all observed to be intact and properly fitted. There was also no sign(s) or indication(s) of fluid leak and/or fluid stain found inside the engine compartment.

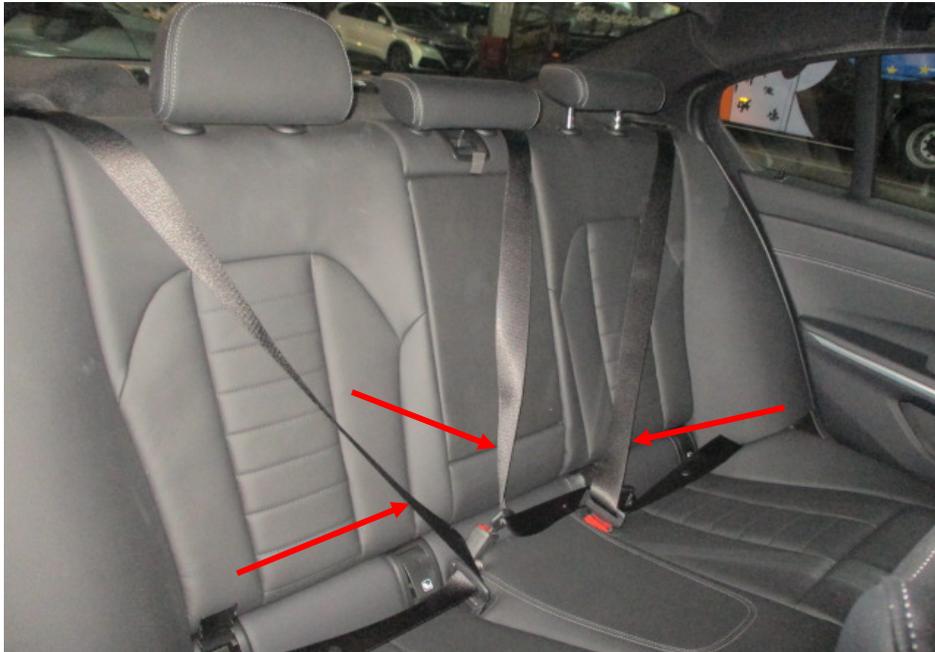
12. The seats of the Motor Car were found to be secured to the floorboard of the Motor Car via seat rails bolted onto the floorboard. Retractable seat belt reels and pre-tensioners were fitted on all seats of the Motor Car. The seat belts were tested and were able to be fastened securely into the respective pre-tensioners that were fixed to the side of all the seats.

Photo 14 shows the rear seats of the Motor Car. All the seats of the Motor Car were secured via seat rails to the floorboard. They were also fitted with a retractable seat belt reel and a pre-tensioner. The seat belts (arrowed) were tested and were able to be fastened into the respective pre-tensions that were fitted on the side of each individual seat.

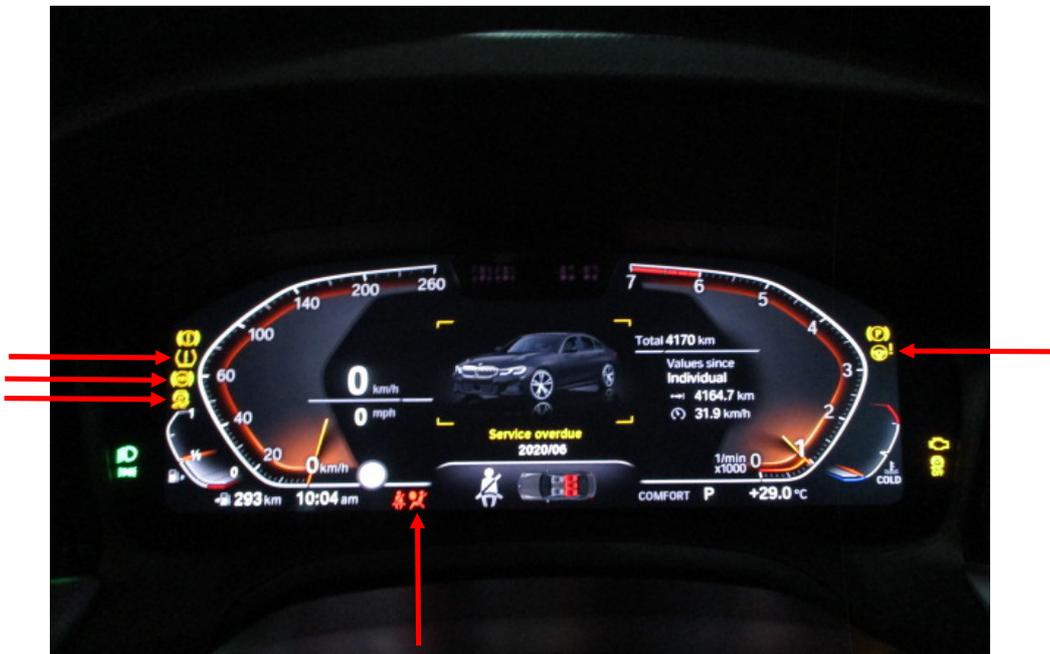
Photo 15 shows the warning lights for the various electronic safety features appearing on the instrument panel of the Motor Car during its self-test when the engine is cranked, in particular the ABS, SRS, IAS, TPM and DSC lights (arrowed).

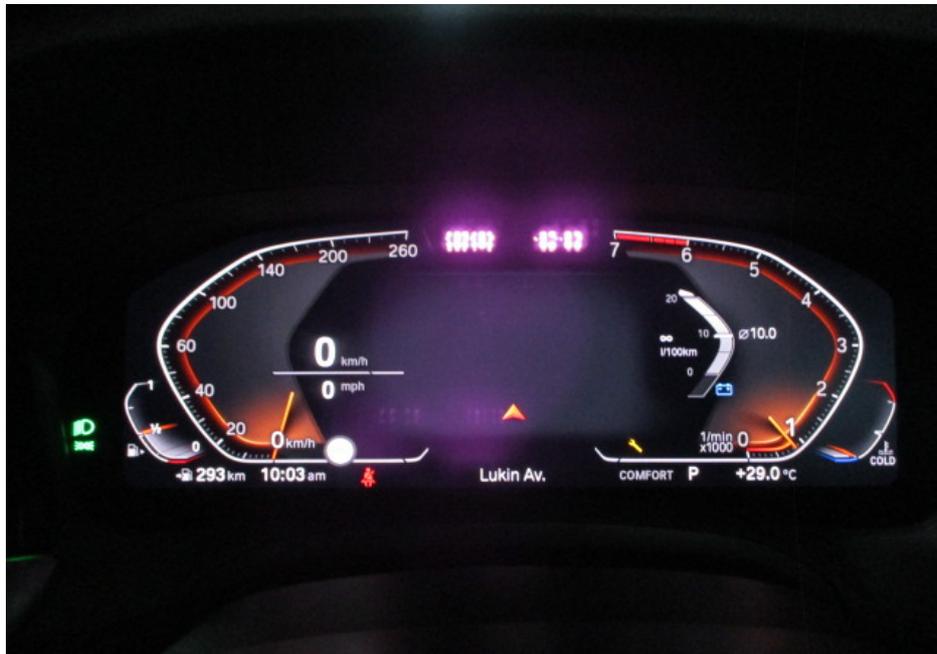
13. The Motor Car's automatic self-test of the functionality of its various electronic safety features like the Anti-Lock Brake System (ABS), Supplemental Restraint System (SRS), Integral Active Steering (IAS), Tyre Pressure Monitor (TPM) and Dynamic Stability Control (DSC) during cranking of the engine had indicated that these electronic systems were in working condition. This was determined from the respective warning lights disappearing from the instrument panel after the self-test.

Photo 16 shows the respective warning lights no longer illuminated, indicating that there is no fault detected to the ABS, SRS, IAS, TPM and DSC systems of the Motor Car during the self-test. These electronic systems were hence in working condition at the time of my inspection.

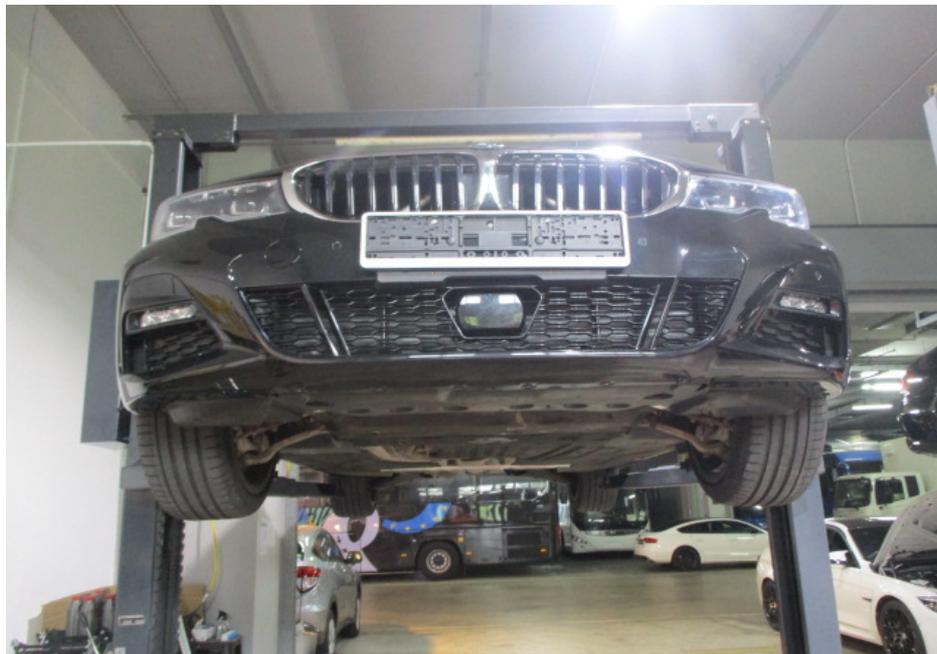
15. My checks on the underside of the Motor Car revealed no sign(s) or indication(s) of fluid leakage and/or fluid stain(s). The engine block and automatic transmission assembly were both secured properly. All undercarriage components of the Motor Car were also observed to be intact and secured in an appropriate manner.

Photo 17 shows the Motor Car hoisted up for checks on its undercarriage. There was no sign(s) or indication(s) of fluid leakage and/or fluid stain(s) on the underside of the Motor Car. The undercarriage components of the Motor Car were also all observed to be intact and secured in an appropriate manner.

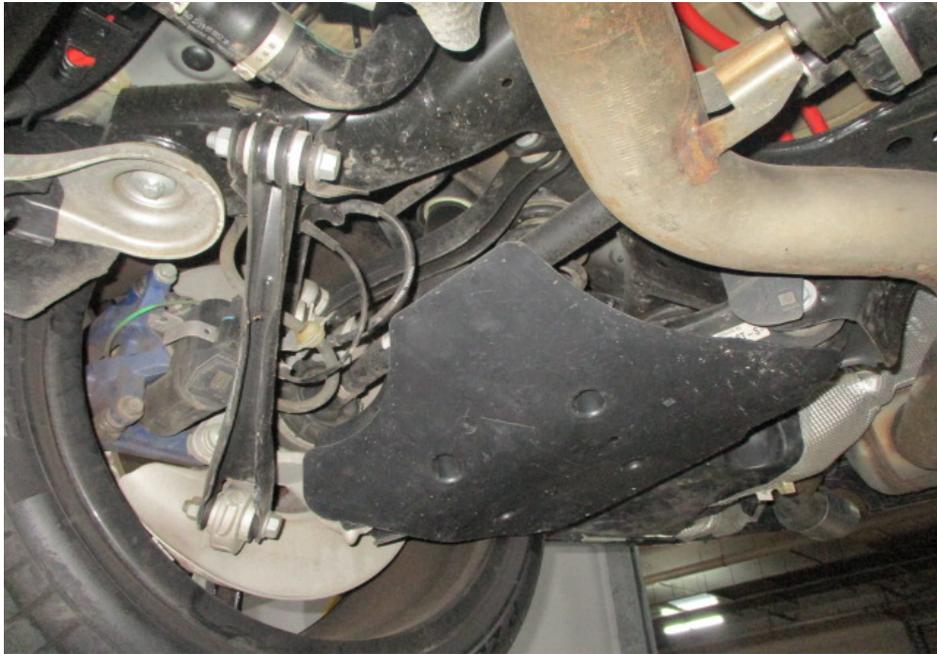
Photo 18 shows a general view of the control arms and linkages at the rear right wheel of the Motor Car. I did not observe any fluid leak and/or fluid stain on the underside of the Motor Car. All the Motor Car's undercarriage components were observed to be intact and secured in an appropriate manner.

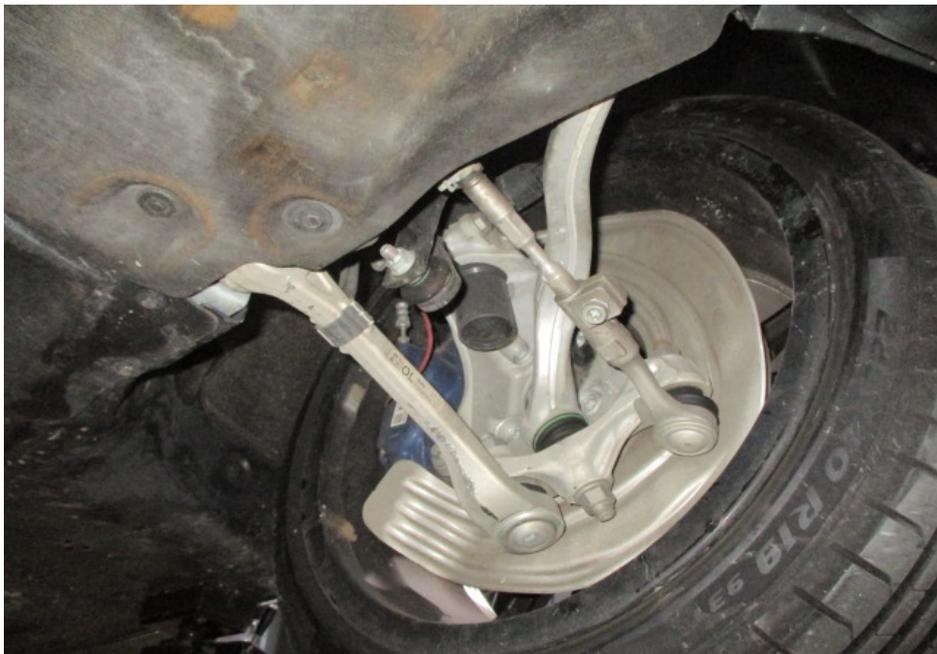
Photo 19 shows the various undercarriage components at the front left wheel of the Motor Car. The mechanical components, control arms and linkages were all found to be intact and secured in an appropriate manner.

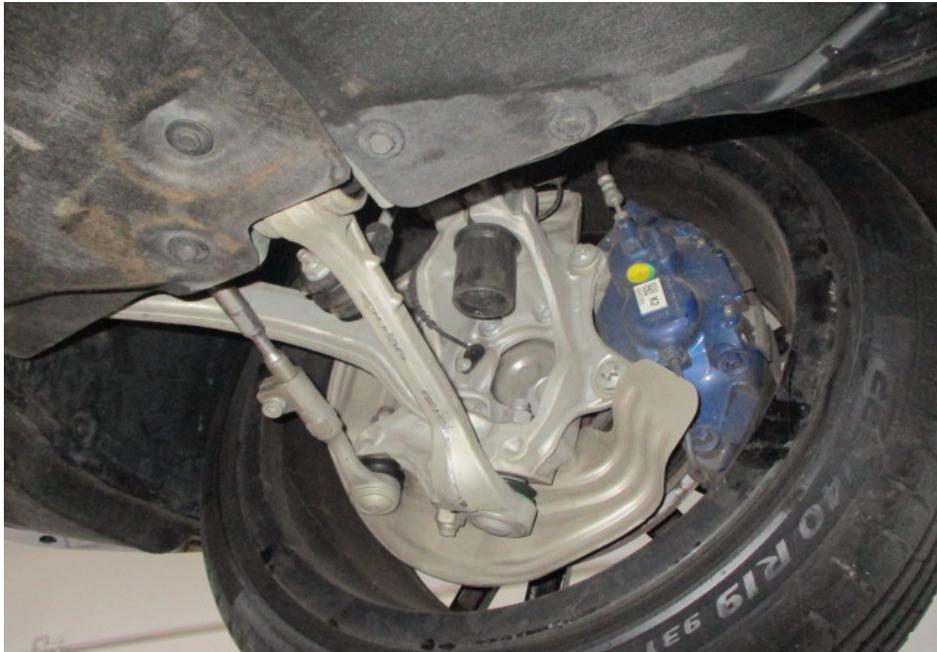
Photo 20 shows the various undercarriage components at the front right wheel of the Motor Car. The mechanical components, control arms and linkages were all found to be intact and secured in an appropriate manner. I also did not observe any fluid leak and/or fluid stain on the underside of the Motor Car.

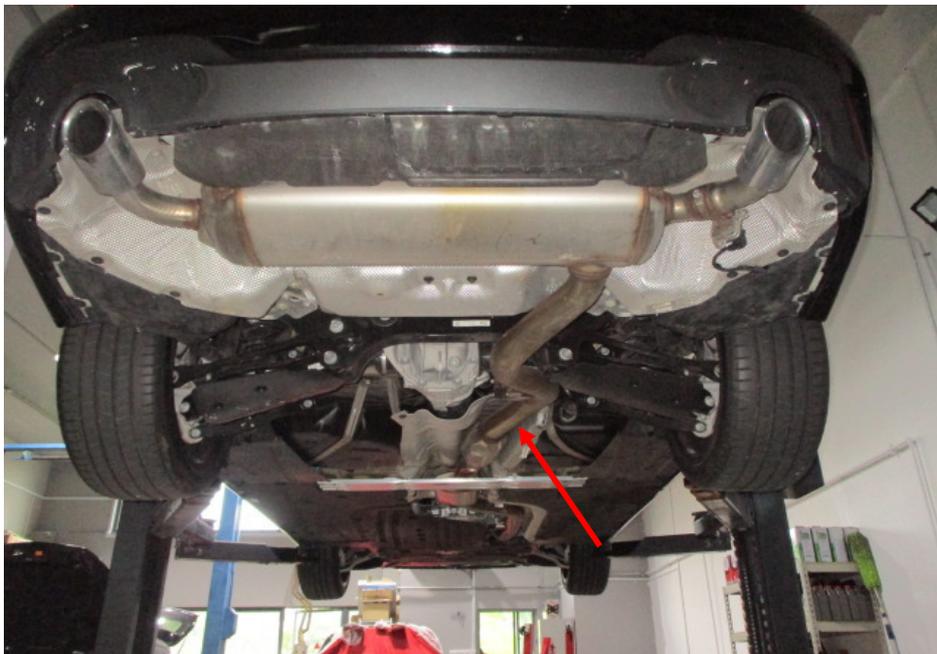
Photo 21 shows a general view of the Motor Car's exhaust system. My examination of the Motor Car's exhaust system revealed no sign(s) or indication(s) of any cut or weld marks along its exhaust pipes (arrowed), on its catalytic converter, centre resonator boxes and on its rear muffler.

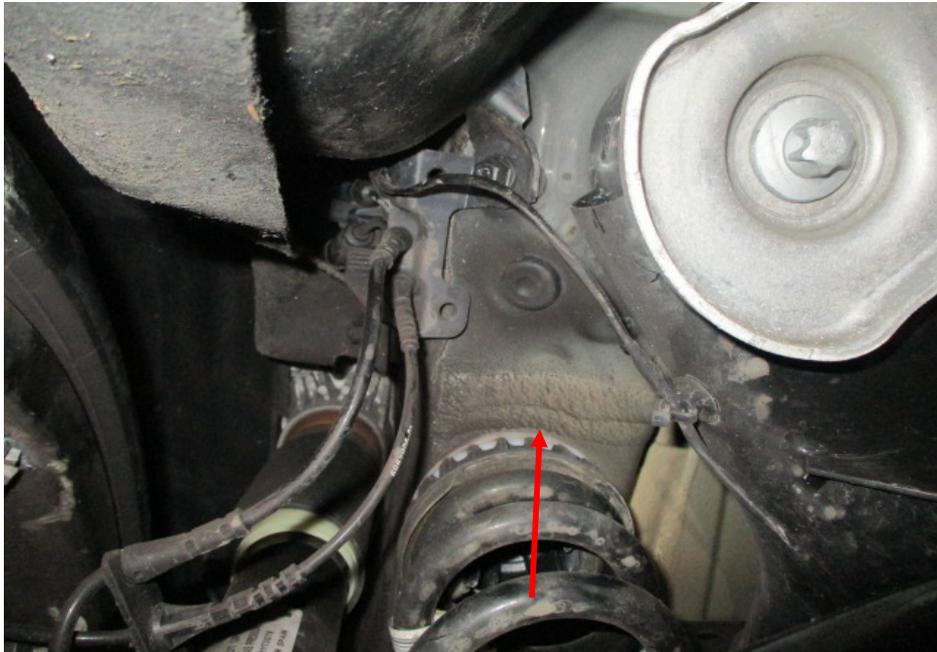
11. Visually, I did not find any weld marks, other than the original spot weld marks, on the chassis/structural body of the Motor Car. The original factory sealant at the joints along the chassis/structural body was also untouched, indicating that no replacement of the chassis/structural body was carried out; and that the chassis/structural body was originally fitted.

Photo 22 shows the chassis/structural body at the underside rear left of the Motor Car. I did not find any weld marks other than original spot weld marks on the chassis/structural body of the Motor Car. The original factory sealant (arrowed) at the joints along the chassis/structural body was untouched, indicating no work was done on the chassis/structural body of the Motor Car and that the chassis/structural body was originally fitted.

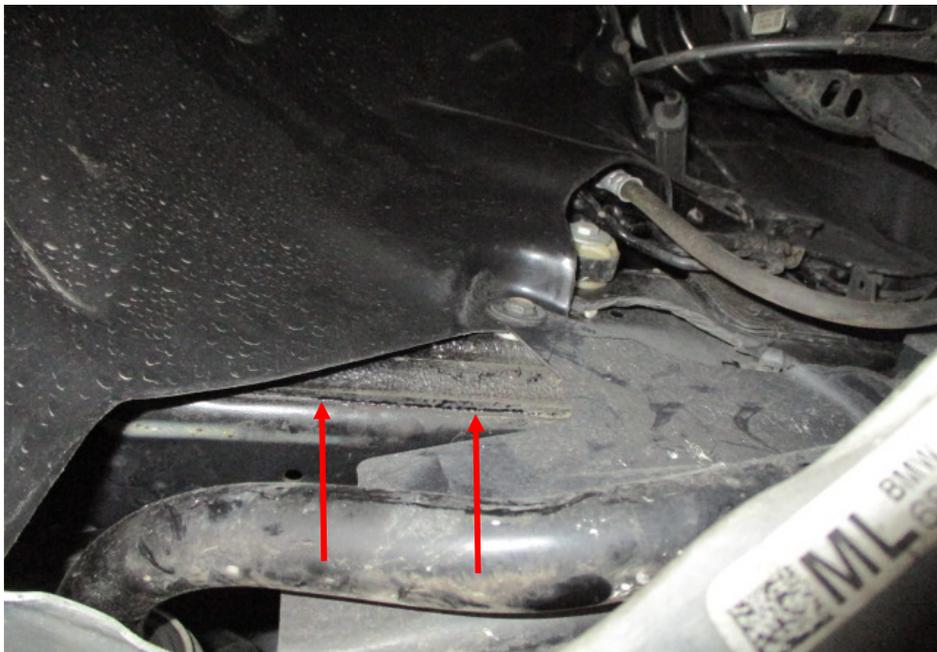
Photo 23 shows the chassis/structural body at the underside front left of the Motor Car. The original factory sealant (arrowed) at the joints along the chassis/structural body was observed to be untouched. In general, I had found no work was carried out on the chassis/structural body of the Motor Car. The chassis/structural body of the Motor Car was originally fitted.

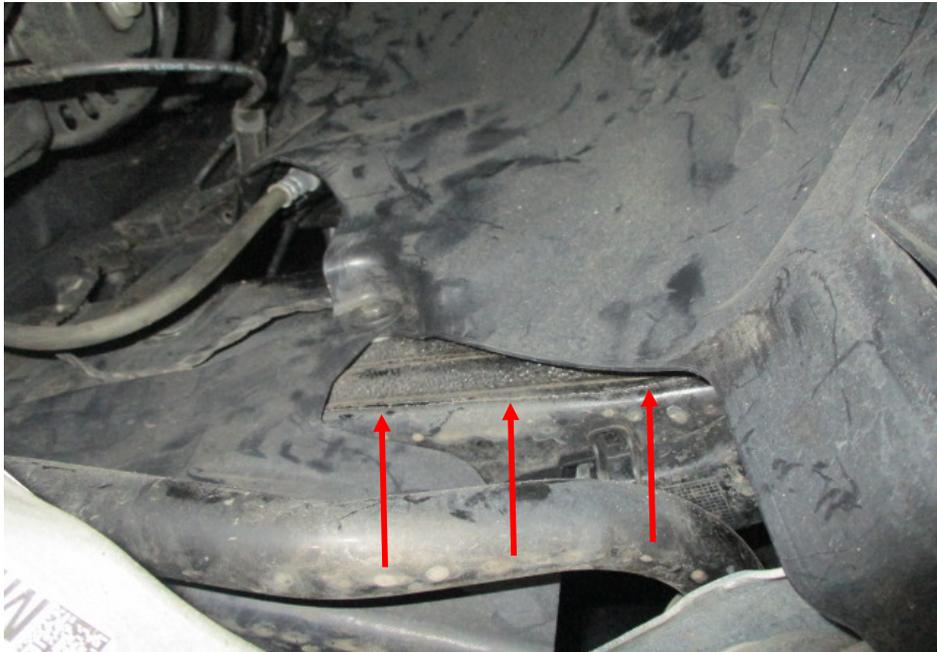
Photo 24 shows the chassis/structural body at the underside front right of the Motor Car. The original factory sealant (arrowed) at the joints along the chassis/structural body was observed to be untouched. In general, I had found no work was carried out on the chassis/structural body of the Motor Car. The chassis/structural body of the Motor Car was originally fitted.

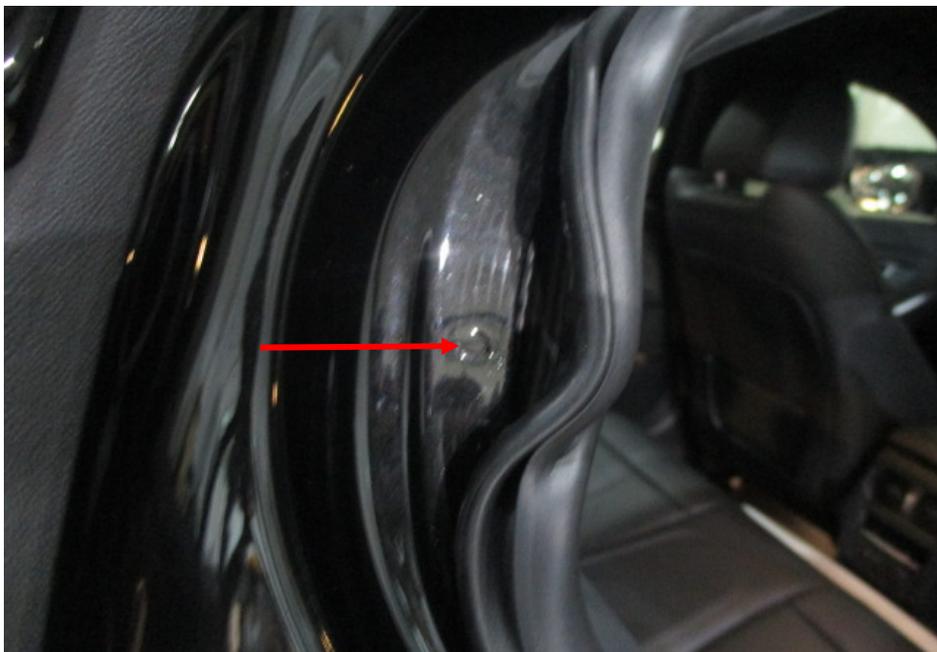
10. Checks on the non-detachable body panels like the rear fenders, floorboard, roof panel, pillars and rocker panels amongst others, revealed that these body panels were spot welded onto the chassis/structural body of the Motor Car. The original factory sealant at the joints of the non-detachable body panels was all untouched indicating no replacement of the non-detachable body panels was carried out; and that these body panels were all originally fitted.

Photo 25 shows the right side "C" pillar of the Motor Car. I did not find any weld marks other than original spot weld marks (arrowed) on the right side "C" pillar of the Motor Car which, indicates that there was no re-welding works carried out. In general, I had found all the non-detachable body panels of the Motor Car to be originally fitted at the time of my inspection.

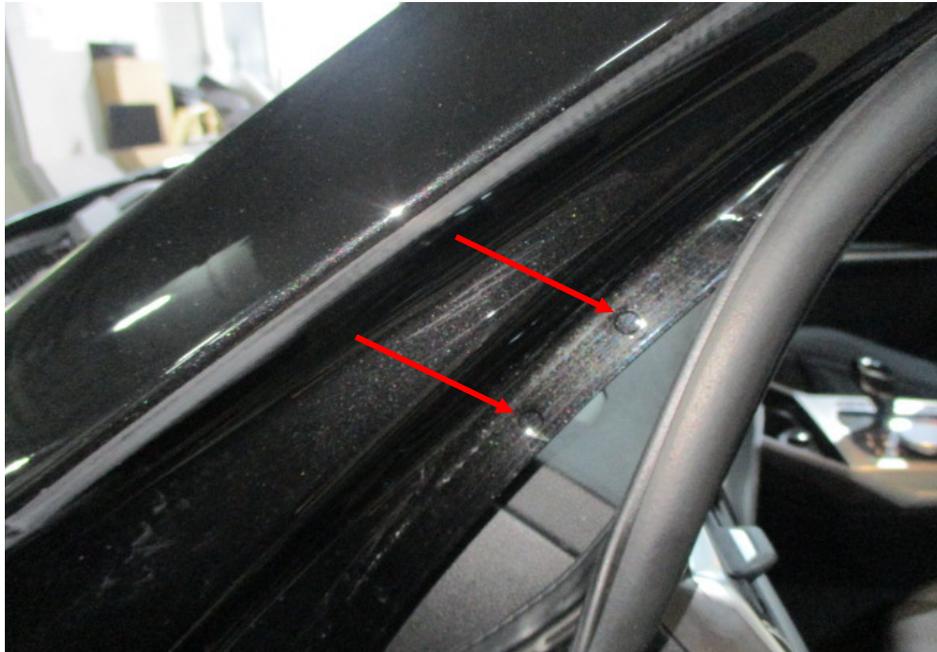
Photo 26 shows the left side "A" pillar of the Motor Car. I did not find any weld marks other than original spot weld marks (arrowed) on the left side "A" pillar of the Motor Car which, indicates that there was no re-welding works carried out. In general, I had found all the non-detachable body panels of the Motor Car to be originally fitted at the time of my inspection.
