Your Ref: BMW M3  
(chassis number WBS8M920505K98145)  
Our Ref : CI/TP21006822/D

25 June 2021

**INSPECTION REPORT OF AN UNREGISTERED BMW M3 MOTOR CAR WITH CHASSIS NUMBER WBS8M920505K98145**

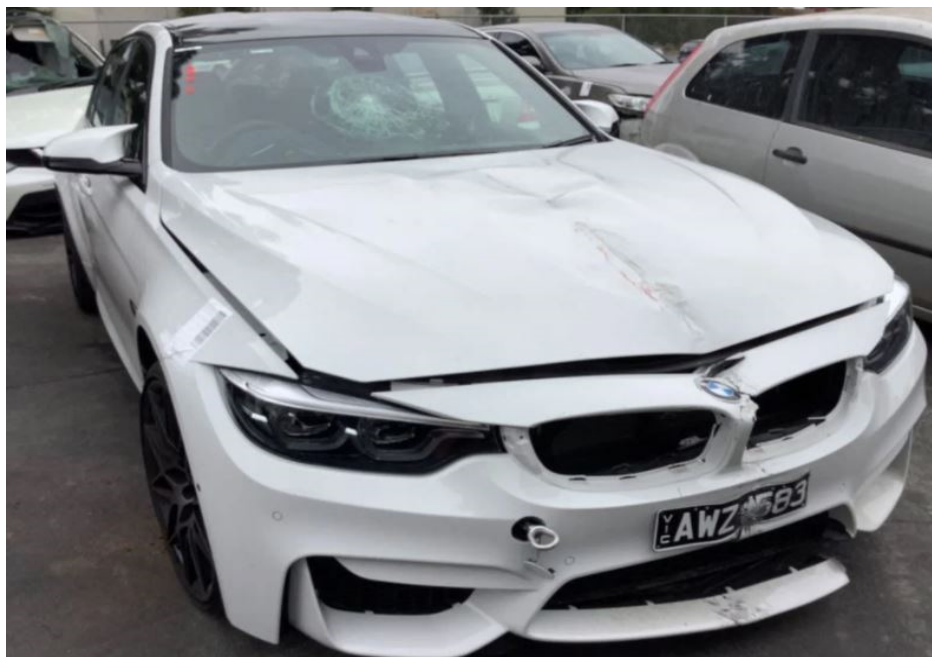
**Photo 1** shows the front right body of the Motor Car prior to any repairs being carried out (photograph provided to me). The Motor Car was observed to have sustained damages at its frontal portion. Body parts observed to be damaged include the front bumper, front bumper centre lower grille, front radiator grilles, front right headlamp and front bonnet amongst others.

22. The body parts at the frontal portion of the Motor Car were visually examined and it was noted that the repair/restoration works carried out to the damaged area of the Motor Car (refer to photograph 1 & 2 above) were reasonably adequate and in order.

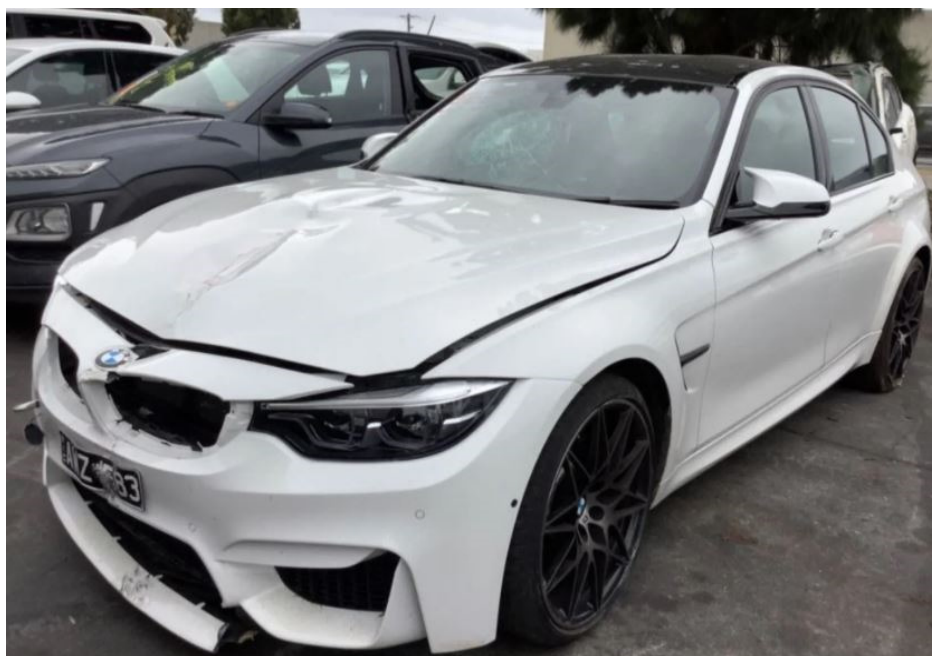
**Photo 2** shows the front left body of the Motor Car prior to any repairs being carried out (photograph provided to me). The Motor Car was observed to have sustained damages at its frontal portion. Body parts observed to be damaged include the front bumper, front bumper centre lower grille, front radiator grilles, front left headlamp and front bonnet amongst others.

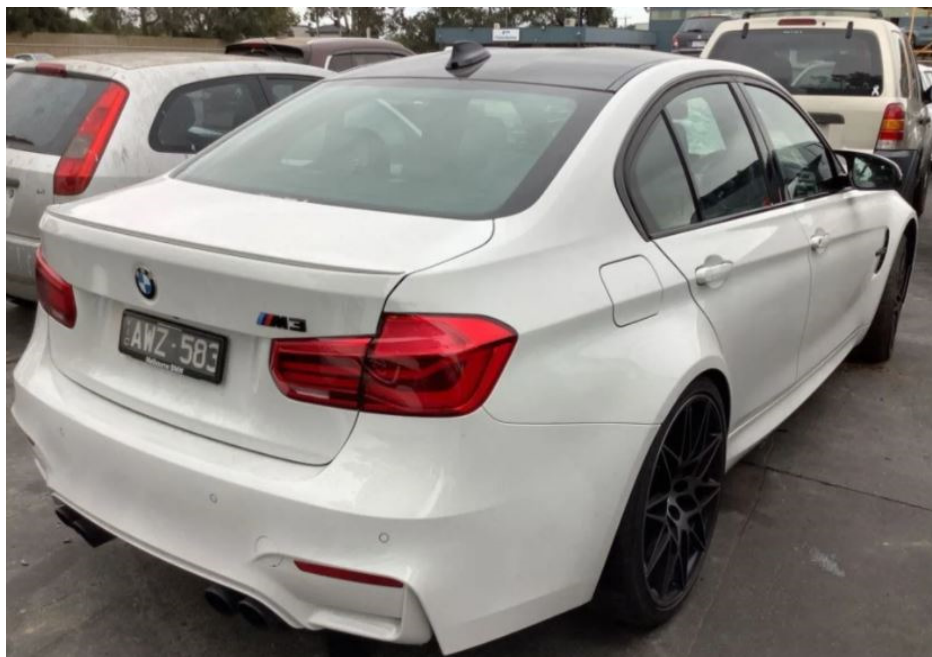
**Photo 3** shows the rear right body of the Motor Car prior to any repairs being carried out (photograph provided to me). Apart for the frontal portion, there was no physical damage observed to other areas of the Motor Car. The airbags of the Motor Car were not deployed as seen from the photographs that were provided to me.

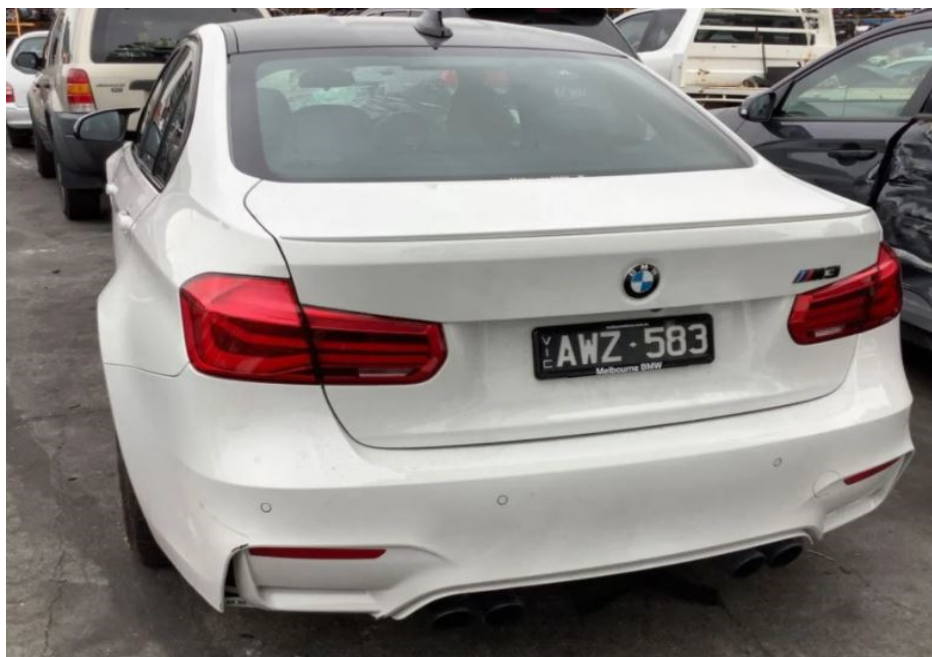
**Photo 4** shows the rear left body of the Motor Car prior to any repairs being carried out (photograph provided to me). Apart for the frontal portion, there was no physical damage observed to other areas of the Motor Car.

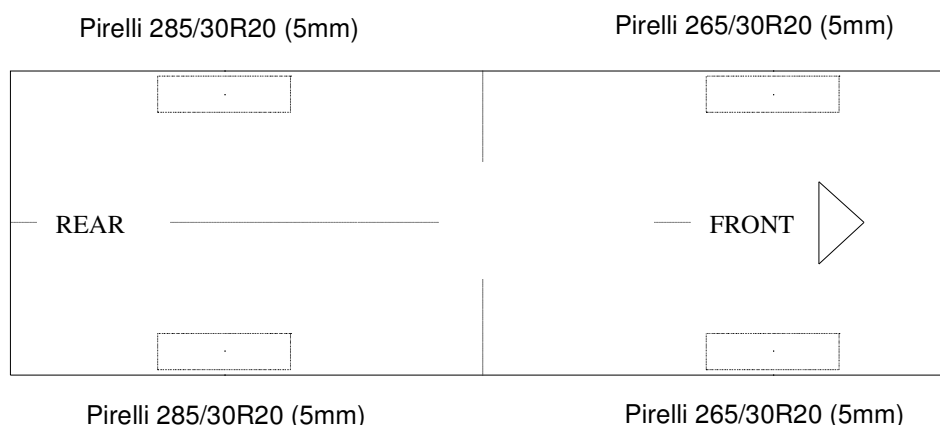
8. It was fitted with 20inch sport wheel rims that were wrapped with tyres that were observed to be of serviceable condition. The tyres were also sufficiently inflated for vehicular operation. The tyre brand, tyre size and approximate remaining tread depth of the 4 tyres of the Motor Car were recorded as follows: -

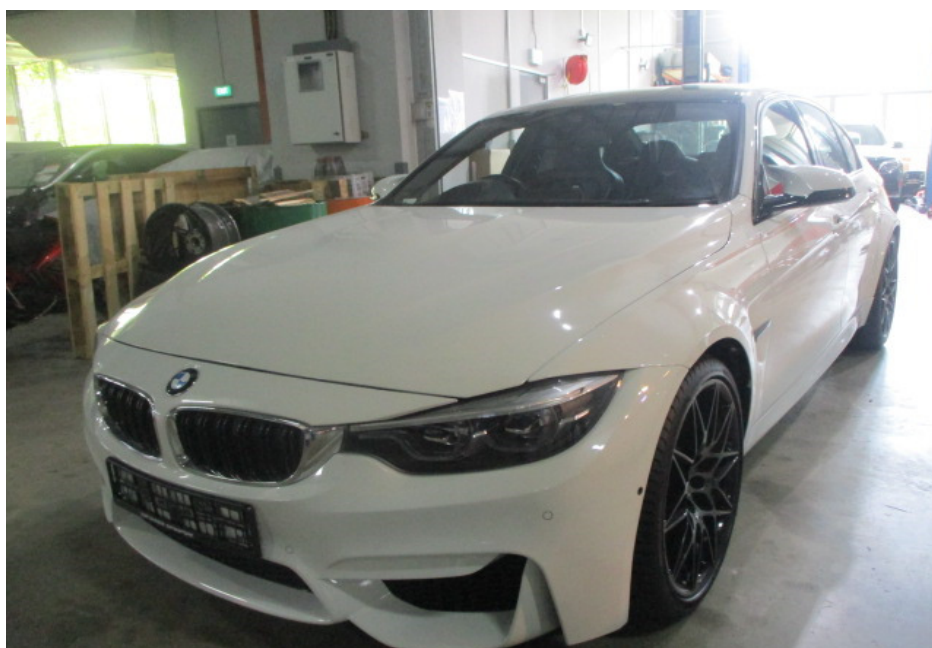
**Photo 5** shows a general view of the front left body of the Motor Car at the time of my inspection. The Motor Car was observed to be in a relatively good general condition with no loose exterior fittings observed. The body parts at the frontal portion of the Motor Car were visually examined and it was observed that the repair/restoration works carried out to the damaged area of the Motor Car (refer to photograph 1 & 2 above) were reasonably adequate and in order.

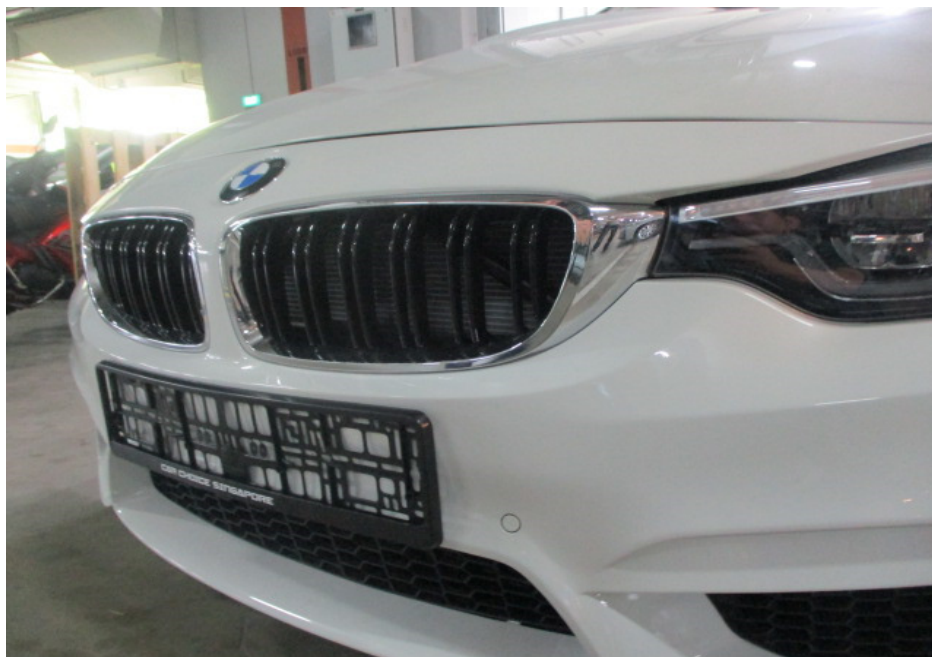
**Photo 6** shows a closer view of the Motor Car's front bumper, front bumper centre lower grille, front radiator grilles and front left headlamp. The body parts at the frontal portion of the Motor Car were visually examined and it was observed that the repair/restoration works carried out to the damaged area of the Motor Car (refer to photograph 1 & 2 above) were reasonably adequate and in order.

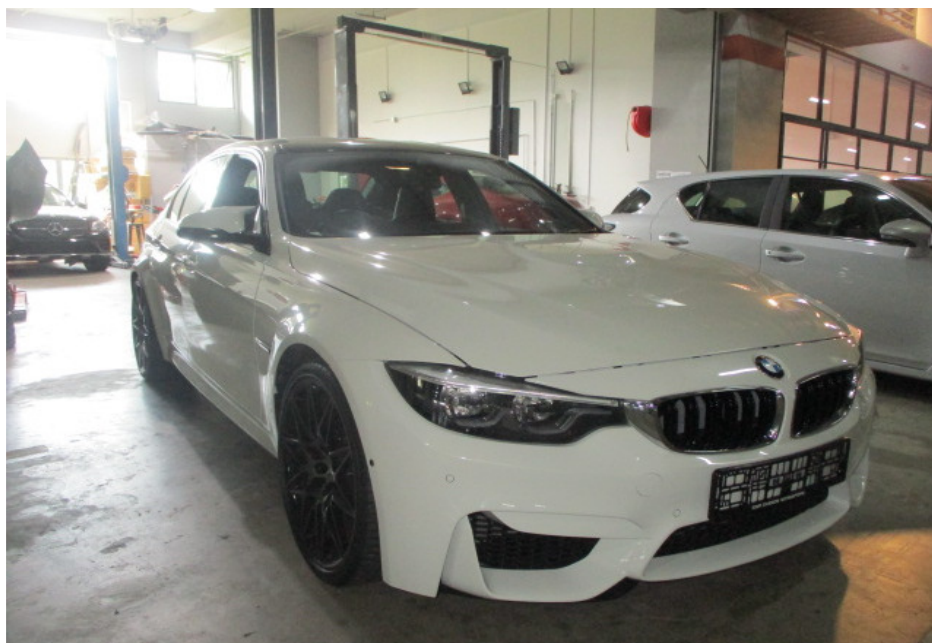
**Photo 7** shows a general view of the front right body of the Motor Car at the time of my inspection. The Motor Car was observed to be in a relatively good general condition with no loose exterior fittings observed. The body parts at the frontal portion of the Motor Car were visually examined, and it was observed that the repair/restoration works carried out to the damaged area of the Motor Car (refer to photograph 1 & 2 above) were reasonably adequate and in order.

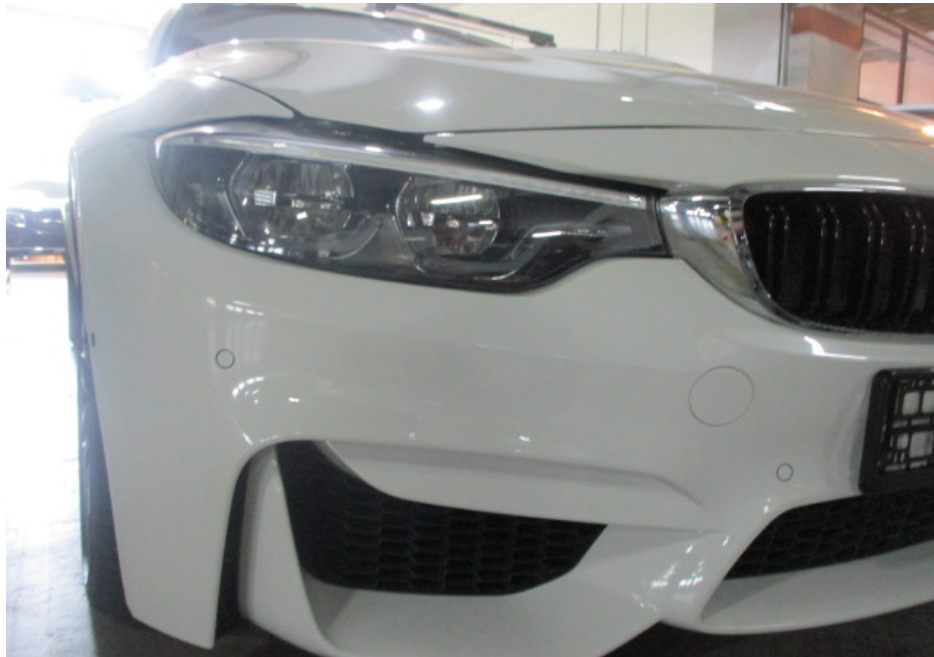
**Photo 8** shows a closer view of the Motor Car's front bumper, front bumper right lower grille and front right headlamp. The body parts at the frontal portion of the Motor Car were visually examined and it was observed that the repair/restoration works carried out to the damaged area of the Motor Car (refer to photograph 1 & 2 above) were reasonably adequate and in order.

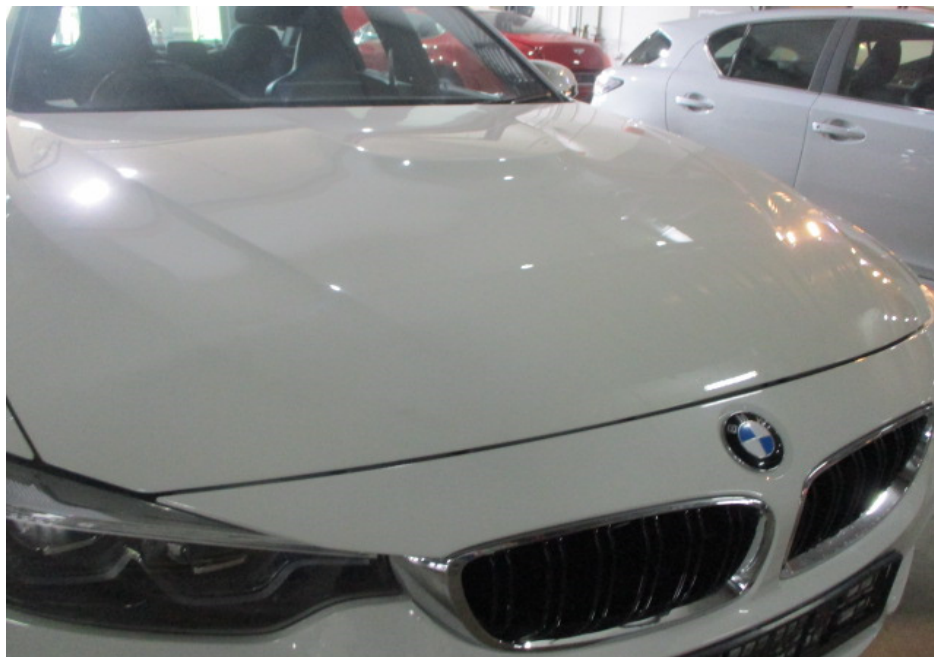
**Photo 9** shows a closer view of the Motor Car's front bonnet and front radiator grilles. The body parts at the frontal portion of the Motor Car were visually examined and it was observed that the repair/restoration works carried out to the damaged area of the Motor Car (refer to photograph 1 & 2 above) were reasonably adequate and in order.

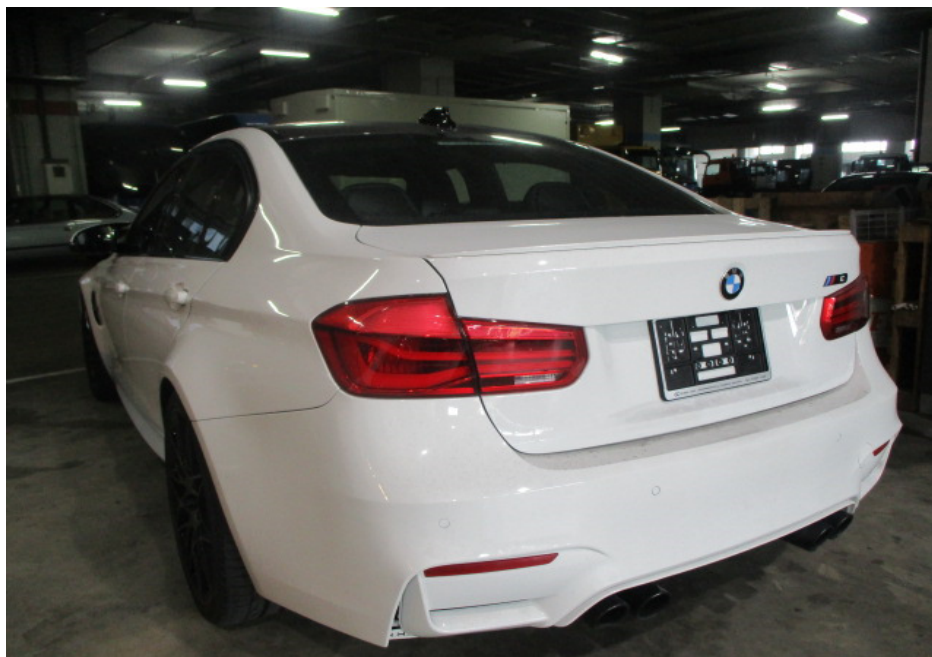
**Photo 10** shows a general view of the rear left body of the Motor Car at the time of my inspection. The Motor Car was observed to be in a relatively good general condition with no loose exterior fittings observed. The mileage of the Motor Car recorded at the time of my inspection was 16,678km.

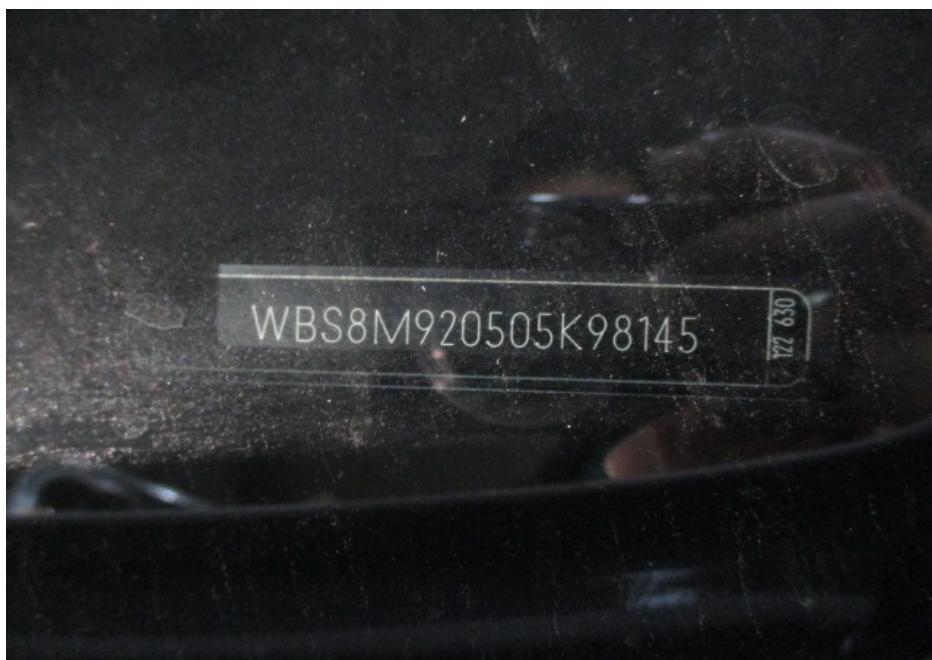
**Photo 11** shows the chassis number of the Motor Car. The chassis number recorded was WBS8M920505K98145.

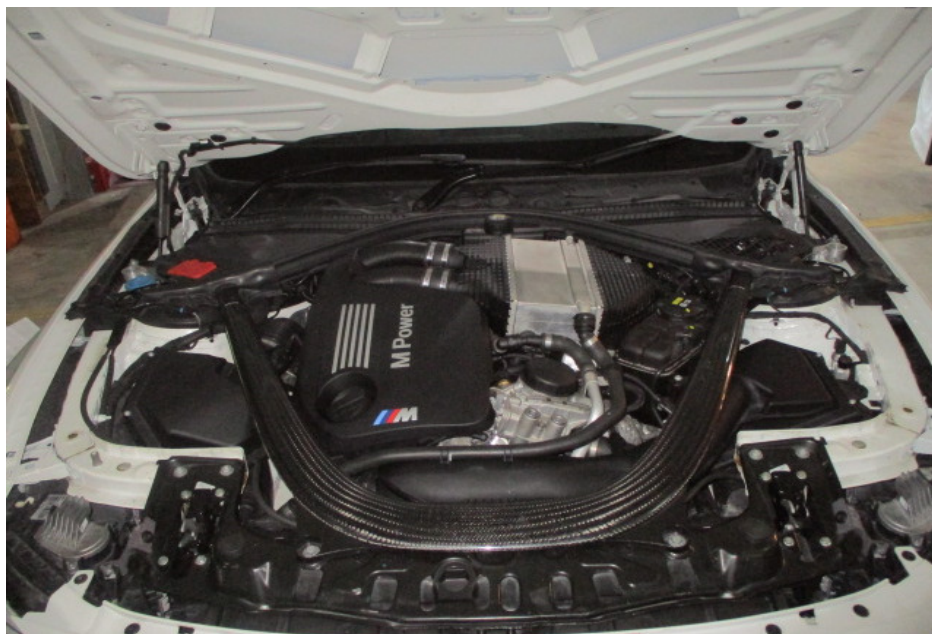
**Photo 12** shows a general view of the engine compartment of the Motor Car at the time of my inspection. The various parts and components inside the engine compartment were all observed to be intact and properly fitted. There was also no sign(s) or indication(s) of fluid leak and/or fluid stain found inside the engine compartment. The repair/restoration works carried out to the various parts within the engine compartment like the front top panel garnish, front support panel and aircon condenser amongst others, were reasonably adequate and in order.

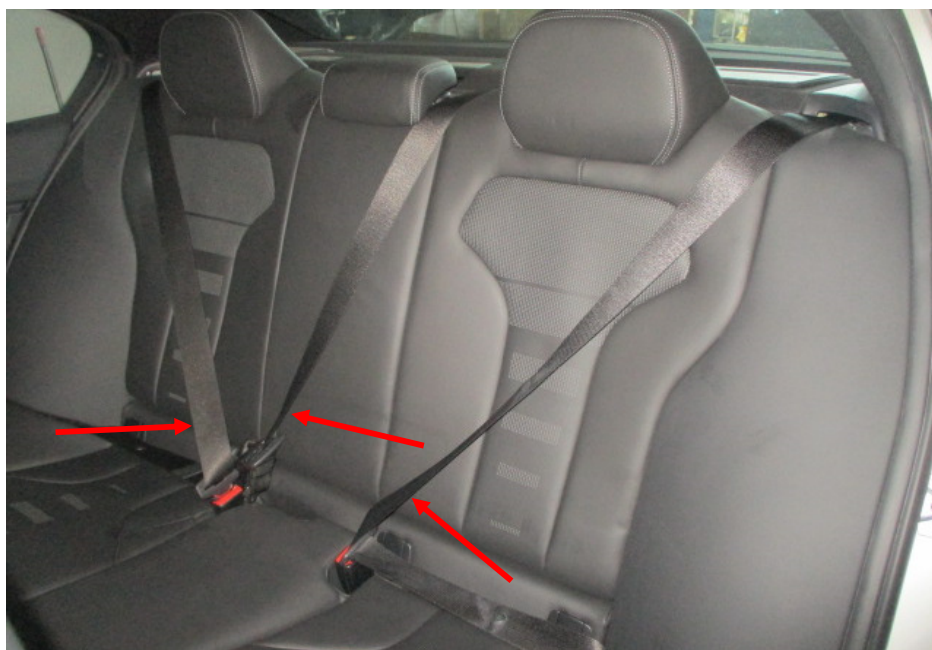
**Photo 13** shows the rear seats of the Motor Car. All the seats of the Motor Car were secured via seat rails to the floorboard. They were also fitted with a retractable seat belt reel and a pre-tensioner. The seat belts (arrowed) were tested and were able to be fastened into the respective pre-tensions that were fitted on the side of each individual seat.

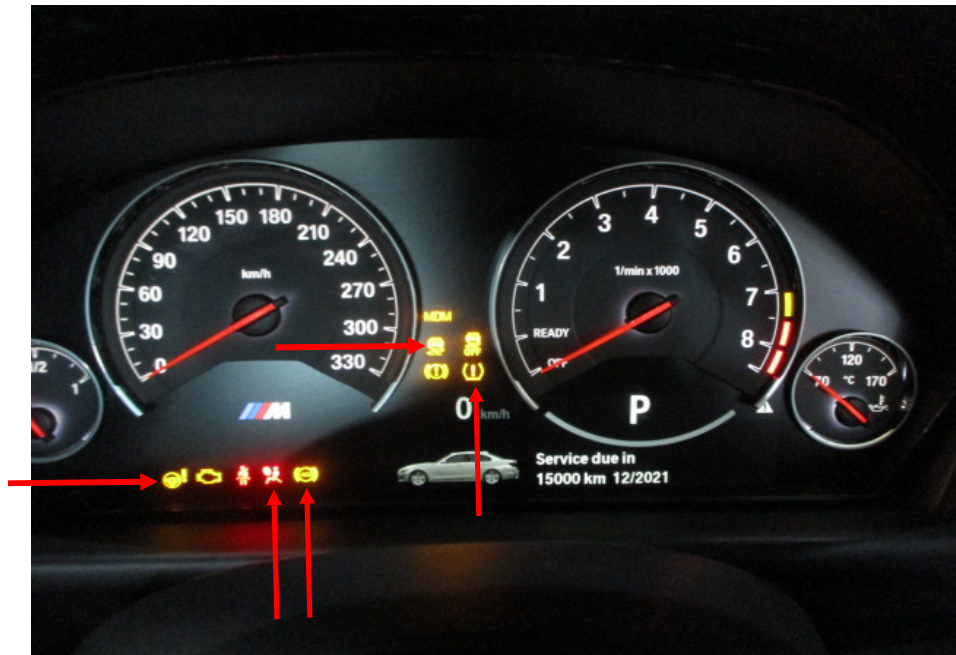
**Photo 14** shows the warning lights for the various electronic safety features appearing on the instrument panel of the Motor Car during its self-test when the engine is cranked, in particular the ABS, SRS, IAS, TPM and DSC lights (arrowed).

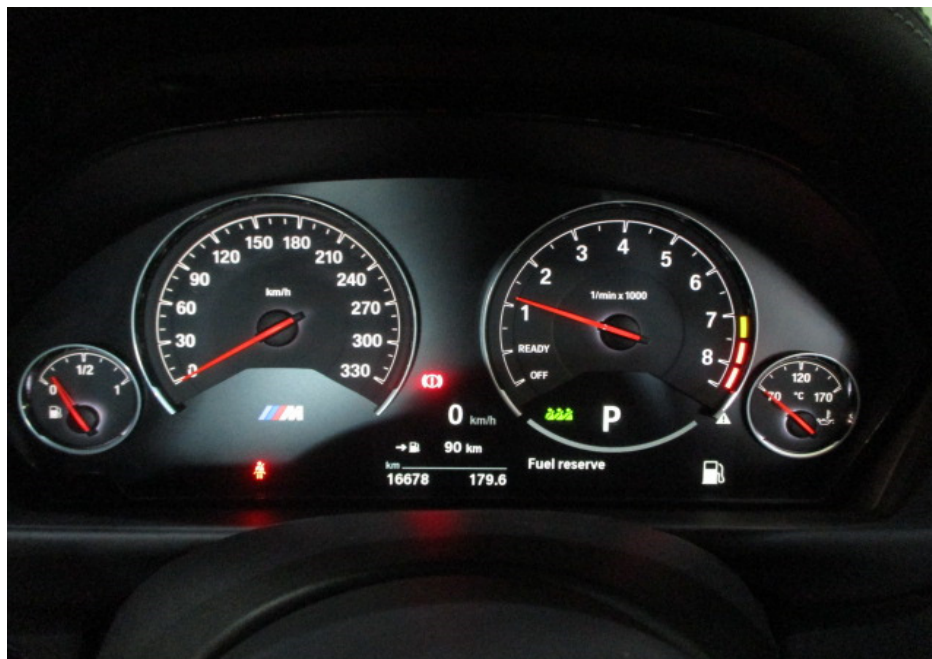
**Photo 15** shows the respective warning lights no longer illuminated, indicating that there is no fault detected to the ABS, SRS, IAS, TPM and DSC systems of the Motor Car during the self-test. These electronic systems were hence in working condition at the time of my inspection.

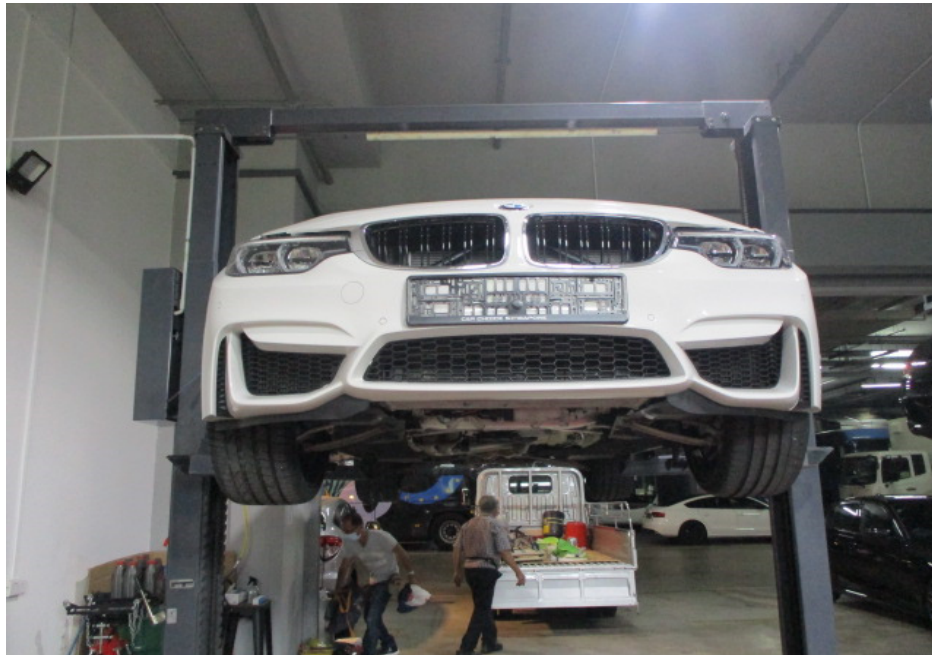
**Photo 16** shows the Motor Car hoisted up for checks on its undercarriage. There was no sign(s) or indication(s) of fluid leakage and/or fluid stain(s) on the underside of the Motor Car. The undercarriage components of the Motor Car were also all observed to be intact and secured in an appropriate manner.

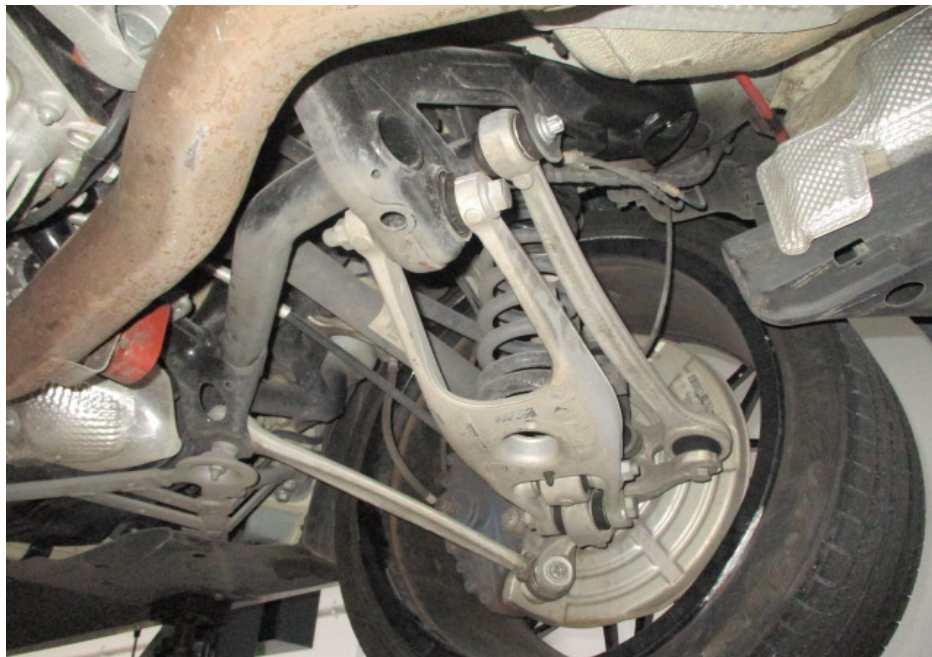
**Photo 17** shows a general view of the control arms and linkages at the rear right wheel of the Motor Car. I did not observe any fluid leak and/or fluid stain on the underside of the Motor Car. All the Motor Car's undercarriage components were observed to be intact and secured in an appropriate manner.

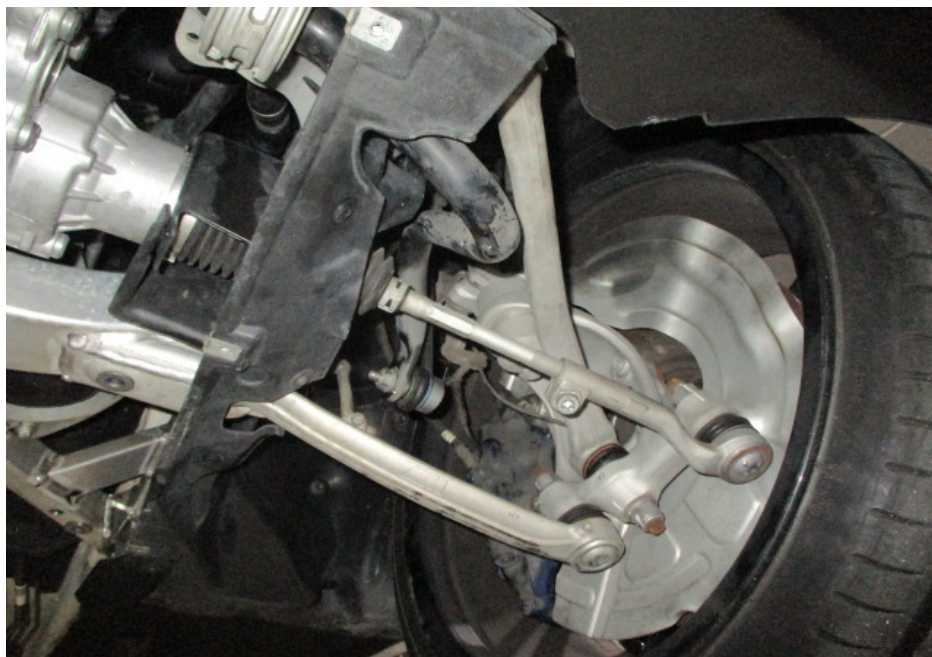
**Photo 18** shows the various undercarriage components at the front left wheel of the Motor Car. The mechanical components, control arms and linkages were all found to be intact and secured in an appropriate manner.

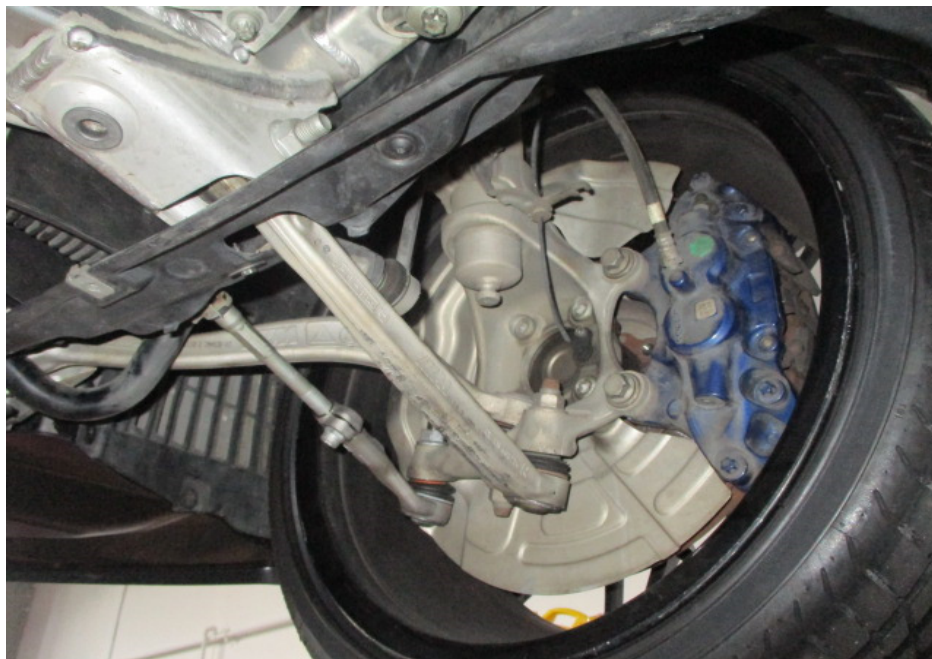
**Photo 19** shows the various undercarriage components at the front right wheel of the Motor Car. The mechanical components, control arms and linkages were all found to be intact and secured in an appropriate manner. I also did not observe any fluid leak and/or fluid stain on the underside of the Motor Car.

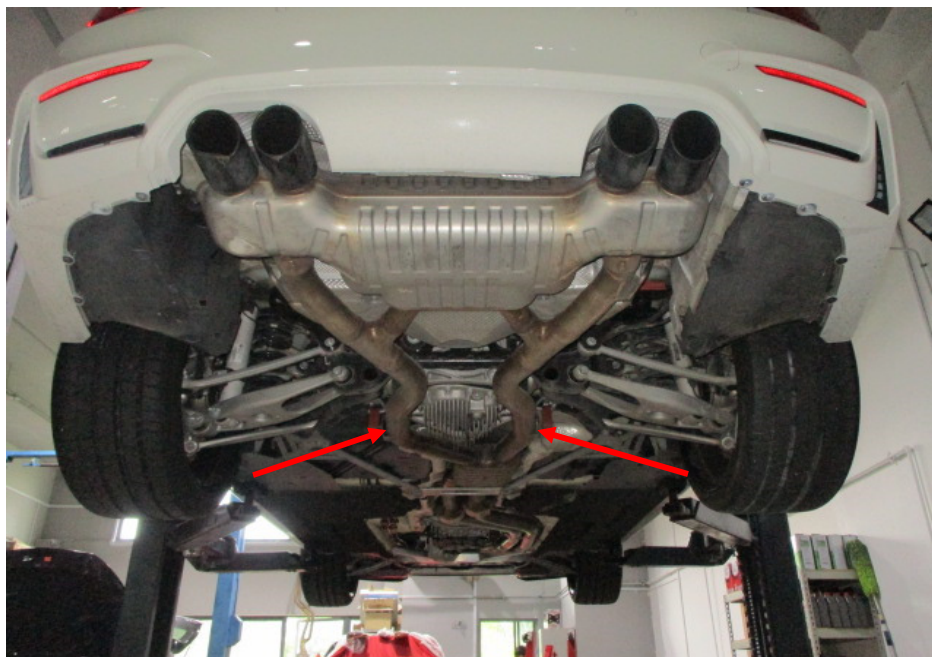
**Photo 20** shows a general view of the rear section of the Motor Car's exhaust system. My examination of the Motor Car's exhaust system revealed no sign(s) or indication(s) of any cut or weld marks along its exhaust pipes (arrowed), on its catalytic converters and on its rear mufflers.

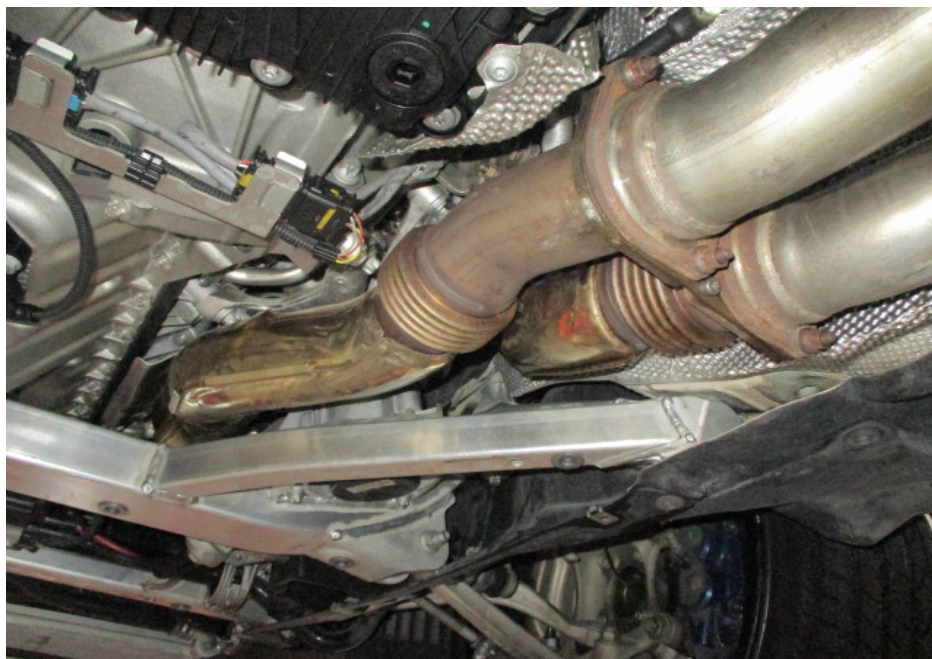
**Photo 21** shows a general view of the Motor Car's catalytic converters. My examination of the Motor Car's exhaust system revealed no sign(s) or indication(s) of any cut or weld marks along its exhaust pipes, on its catalytic converters and on its rear mufflers.

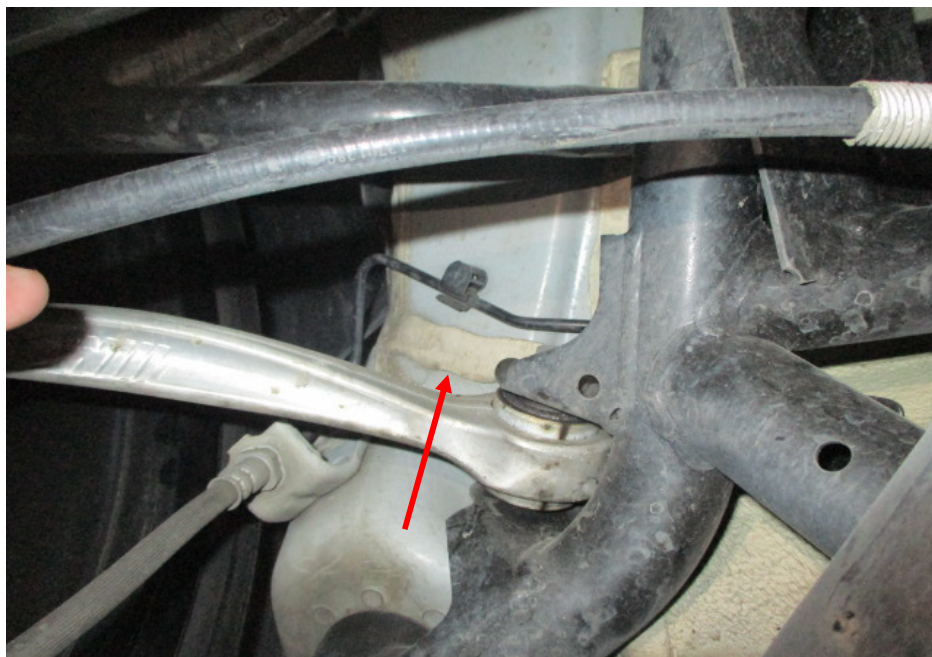
**Photo 22** shows the chassis/structural body at the underside rear left of the Motor Car. I did not find any weld marks other than original spot weld marks on the chassis/structural body of the Motor Car. The original factory sealant (arrowed) at the joints along the chassis/structural body was untouched, indicating no work was done on the chassis/structural body of the Motor Car and that the chassis/structural body was originally fitted.

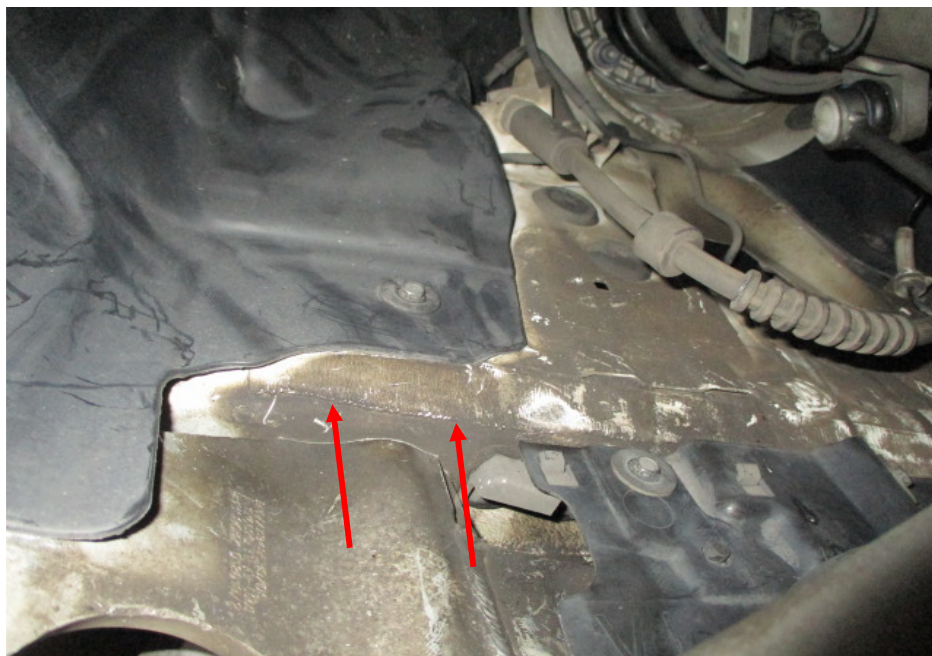
**Photo 23** shows the chassis/structural body at the underside front left of the Motor Car. The original factory sealant (arrowed) at the joints along the chassis/structural body was observed to be untouched. In general, I had found no work was carried out on the chassis/structural body of the Motor Car. The chassis/structural body of the Motor Car was originally fitted.

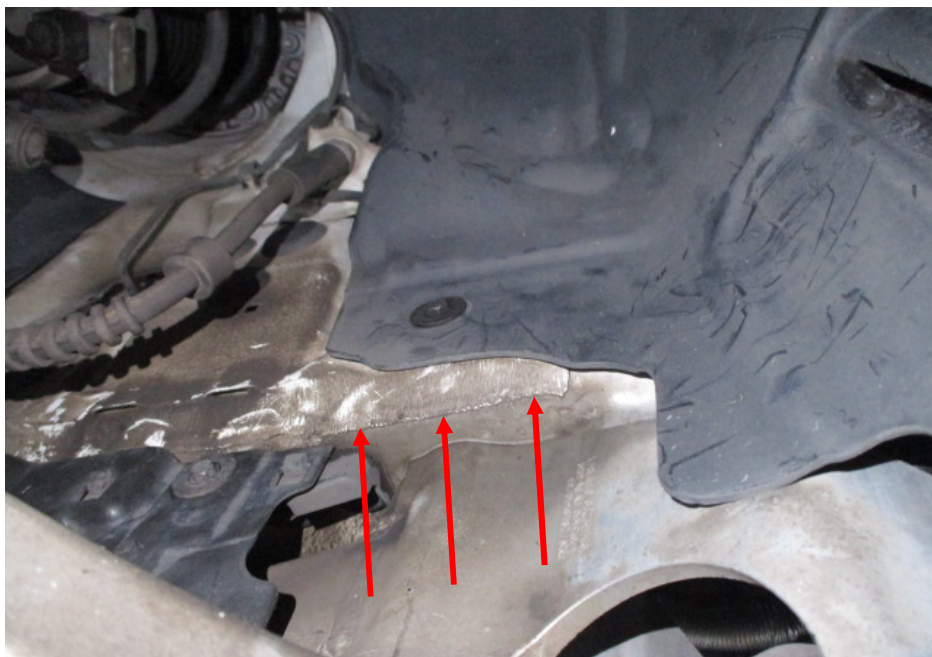
**Photo 24** shows the chassis/structural body at the underside front right of the Motor Car. The original factory sealant (arrowed) at the joints along the chassis/structural body was observed to be untouched. In general, I had found no work was carried out on the chassis/structural body of the Motor Car. The chassis/structural body of the Motor Car was originally fitted.

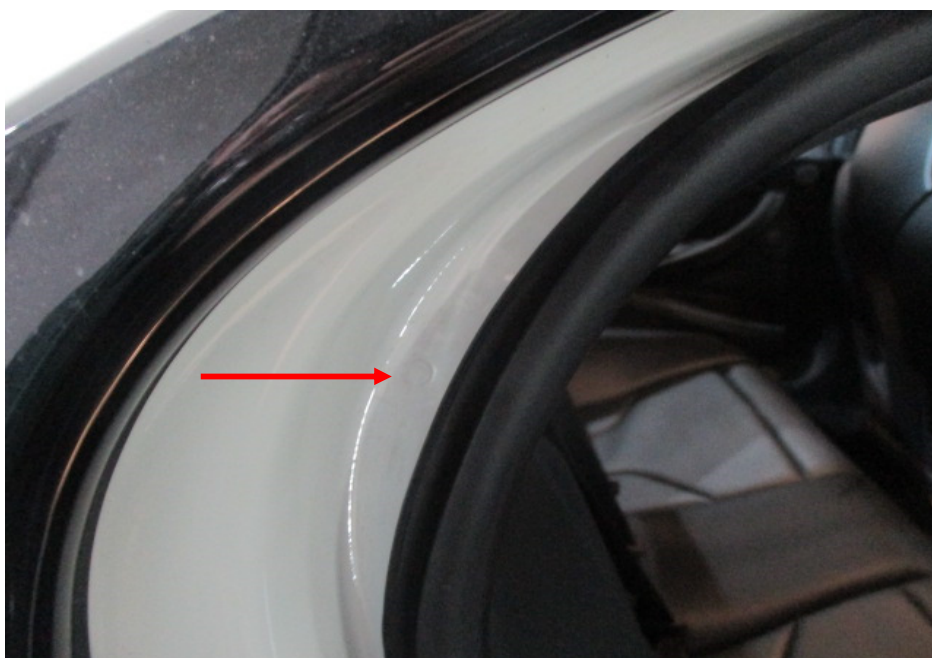
**Photo 25** shows the right side "C" pillar of the Motor Car. I did not find any weld marks other than original spot weld marks (arrowed) on the right side "C" pillar of the Motor Car which, indicates that there was no re-welding works carried out. In general, I had found all the non-detachable body panels of the Motor Car to be originally fitted at the time of my inspection.

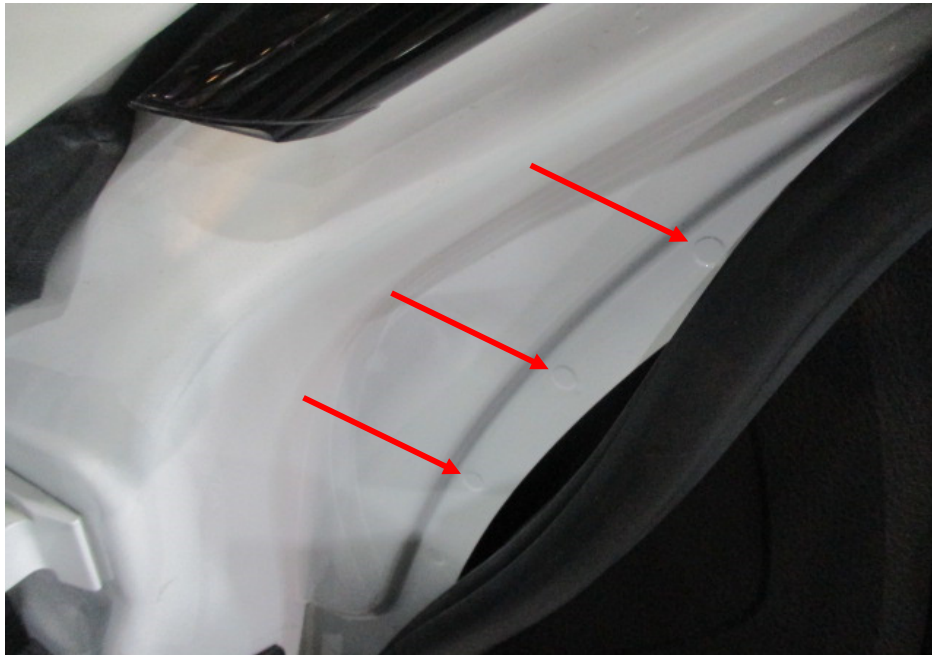
**Photo 26** shows the left side "A" pillar of the Motor Car. I did not find any weld marks other than original spot weld marks (arrowed) on the left side "A" pillar of the Motor Car which, indicates that there was no re-welding works carried out. In general, I had found all the non-detachable body panels of the Motor Car to be originally fitted at the time of my inspection.
