Your Ref: Porsche Marcan  
(chassis number WP1ZZZ95ZLLB31844)  
Our Ref : CI/TP21006823/D

10 June 2021

**INSPECTION REPORT OF AN UNREGISTERD PORSCHE MARCAN MOTOR CAR WITH CHASSIS NUMBER WP1ZZZ95ZLLB31844**

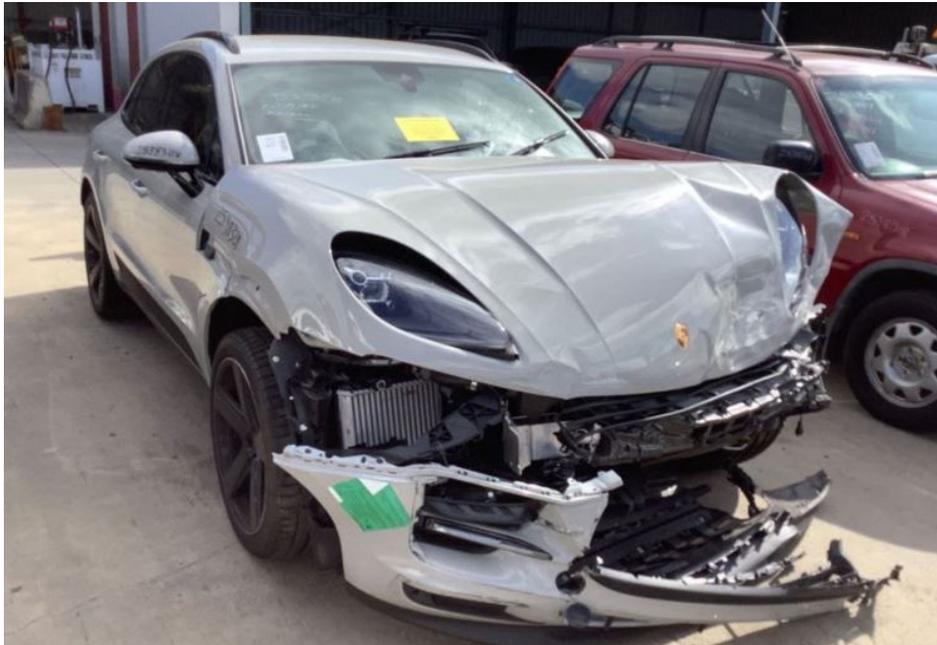
3. The photographs provided to me had showed damage to the frontal portion of the Motor Car. Body parts observed to be damaged include the front bumper, front bumper lower cover, front bumper centre lower grille, front bumper left lower grille, front bumper right lower grille, front bumper reinforcement, front radiator grille, front day running lights, front headlamps, front bonnet, front bonnet lock, front top panel garnish and front support panel amongst others. The driver's airbag, front left passenger airbag, right side curtain airbag and left side curtain airbag were deployed.
4. Apart for the frontal portion, there was no physical damage observed to other areas of the Motor Car. See photo 1 – 3 below.

**Photo 1** shows the front right body of the Motor Car prior to any repairs being carried out (photograph provided to me). The Motor Car was observed to have sustained damages at its frontal portion. The front bumper, front bumper centre lower grille, front bumper left lower grille, front bumper right lower grille, front bumper reinforcement, front radiator grille, front day running lights, front headlamps, front bonnet, front bonnet lock, front top panel garnish and front support panel amongst others were observed to be damaged.

22. The body parts at the frontal portion of the Motor Car were visually examined and it was noted that the repair/restoration works carried out to the damaged area of the Motor Car (refer to photograph 1 above) were reasonably adequate and in order.

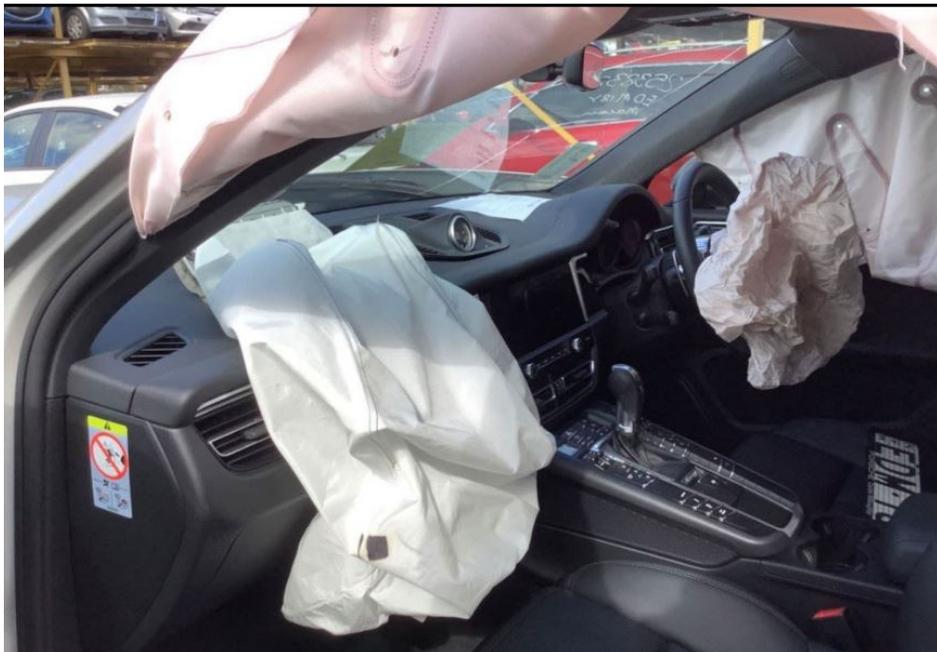
**Photo 2** shows the interior compartment of the Motor Car prior to any repairs being carried out (photograph provided to me). The driver's airbag, front left passenger airbag, right side curtain airbag and left side curtain airbag were deployed.

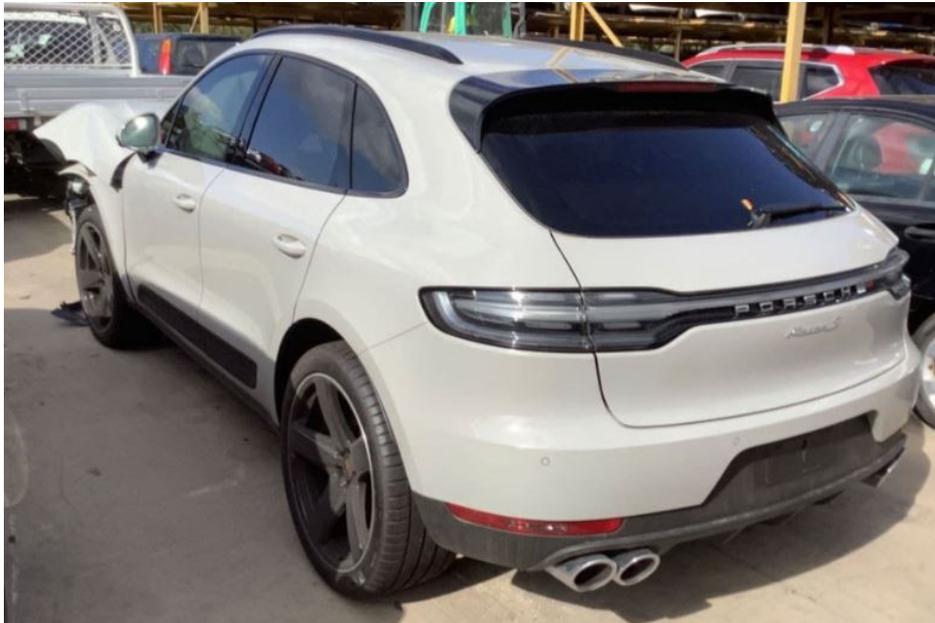
**Photo 3** shows the rear left body of the Motor Car prior to any repairs being carried out (photograph provided to me). Apart for the frontal portion, there was no physical damage observed to other areas of the Motor Car.

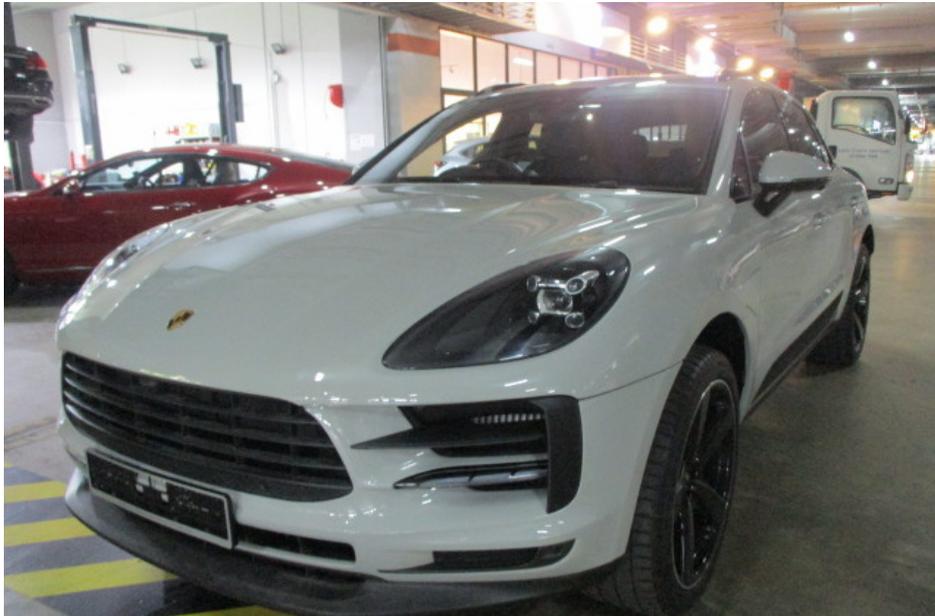
**Photo 4** shows a general view of the front left body of the Motor Car at the time of my inspection. The Motor Car was observed to be in a relatively good general condition with no loose exterior fittings observed. The body parts at the frontal portion of the Motor Car were visually examined and it was observed that the repair/restoration works carried out to the damaged area of the Motor Car (refer to photograph 1 above) were reasonably adequate and in order.

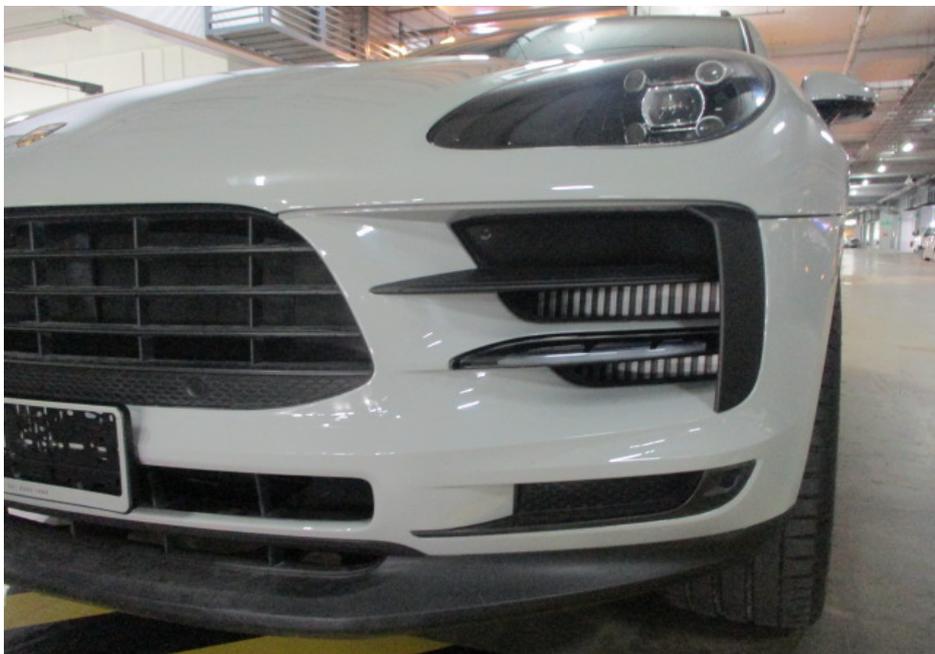
**Photo 5** shows a closer view of the Motor Car's front bumper, front bumper lower cover, front bumper left lower grille, front radiator grille, front left day running light and front left headlamp. The body parts at the frontal portion of the Motor Car were visually examined and it was observed that the repair/restoration works carried out to the damaged area of the Motor Car (refer to photograph 1 above) were reasonably adequate and in order.

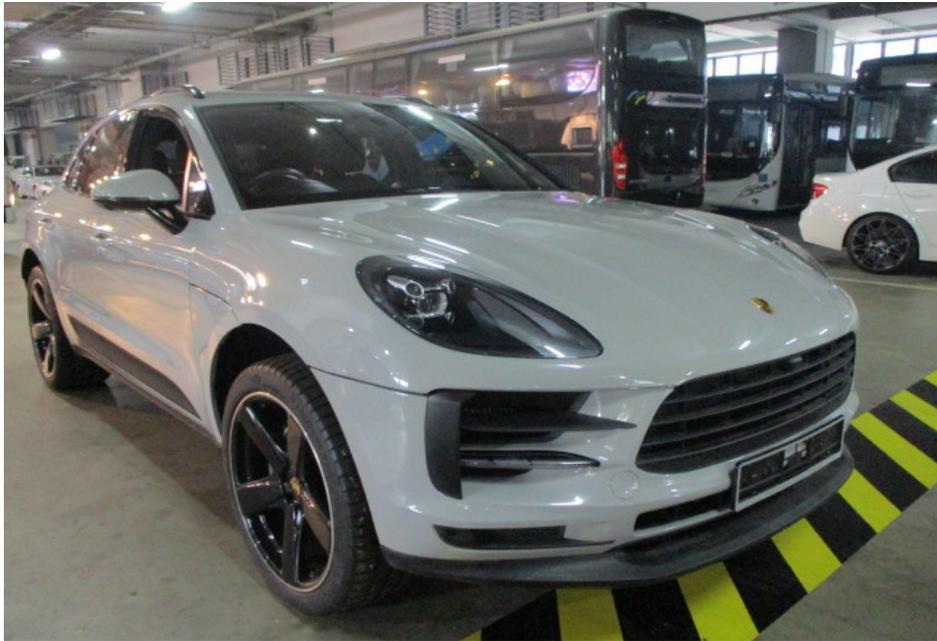
**Photo 6** shows a general view of the front right body of the Motor Car at the time of my inspection. The Motor Car was observed to be in a relatively good general condition with no loose exterior fittings observed. The body parts at the frontal portion of the Motor Car were visually examined, and it was observed that the repair/restoration works carried out to the damaged area of the Motor Car (refer to photograph 1 above) were reasonably adequate and in order.

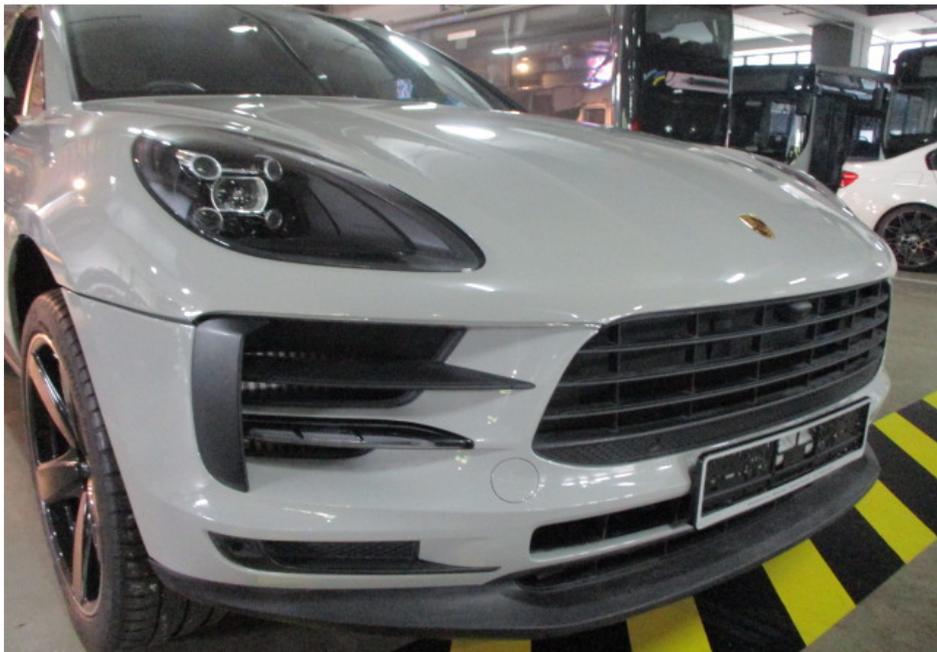
**Photo 7** shows a closer view of the Motor Car's front bumper, front bumper right lower grille, front right headlamp and front bonnet. The body parts at the frontal portion of the Motor Car were visually examined and it was observed that the repair/restoration works carried out to the damaged area of the Motor Car (refer to photograph 1 above) were reasonably adequate and in order.

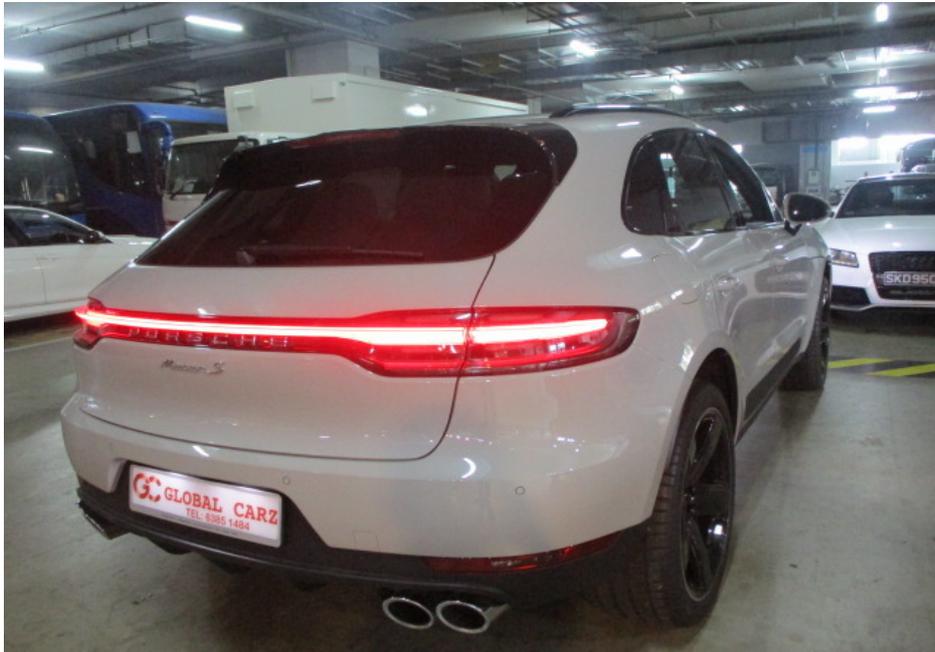
**Photo 8** shows a general view of the rear right body of the Motor Car at the time of my inspection. The Motor Car was observed to be in a relatively good general condition with no loose exterior fittings observed. The mileage of the Motor Car recorded at the time of my inspection was 3,752km.

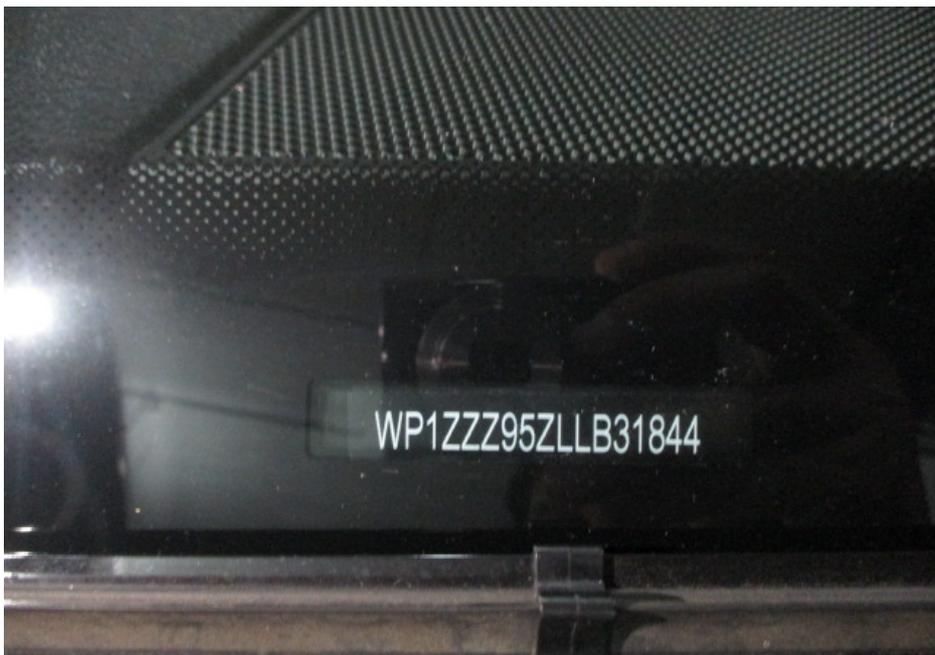
**Photo 9** shows the chassis number of the Motor Car. The chassis number recorded was WP1ZZZ95ZLLB31844.

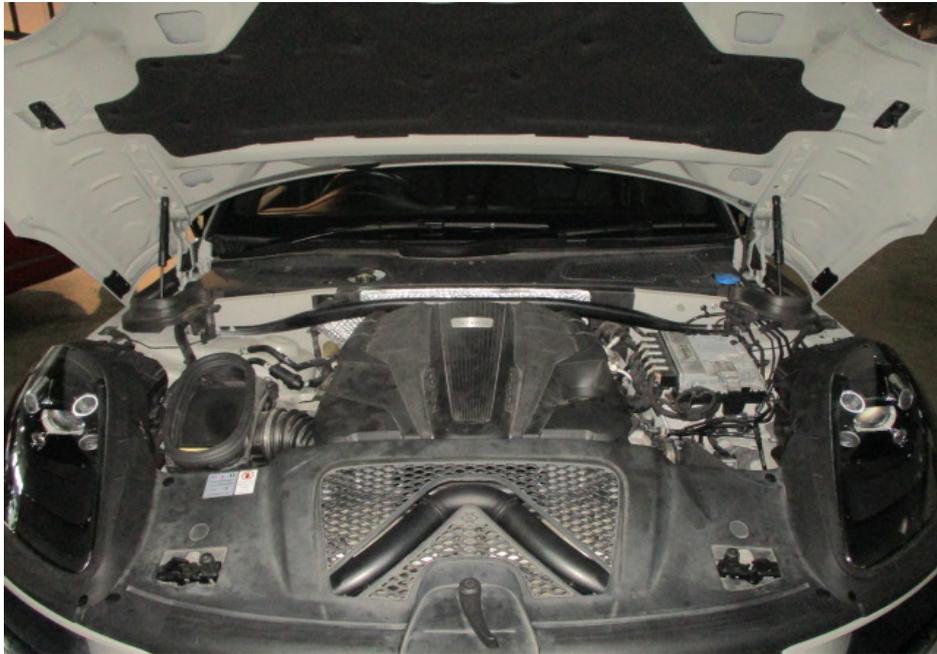
14. My examination of the engine compartment of the Motor Car revealed that the various parts and components inside the engine compartment were all intact and properly fitted. The engine oil, brake fluid and engine coolant were all found to be of sufficient level for operating purposes. Visually, there was also no contamination found to these fluids.

**Photo 10** shows a general view of the engine compartment of the Motor Car at the time of my inspection. The various parts and components inside the engine compartment were all observed to be intact and properly fitted. There was also no sign(s) or indication(s) of fluid leak and/or fluid stain found inside the engine compartment.

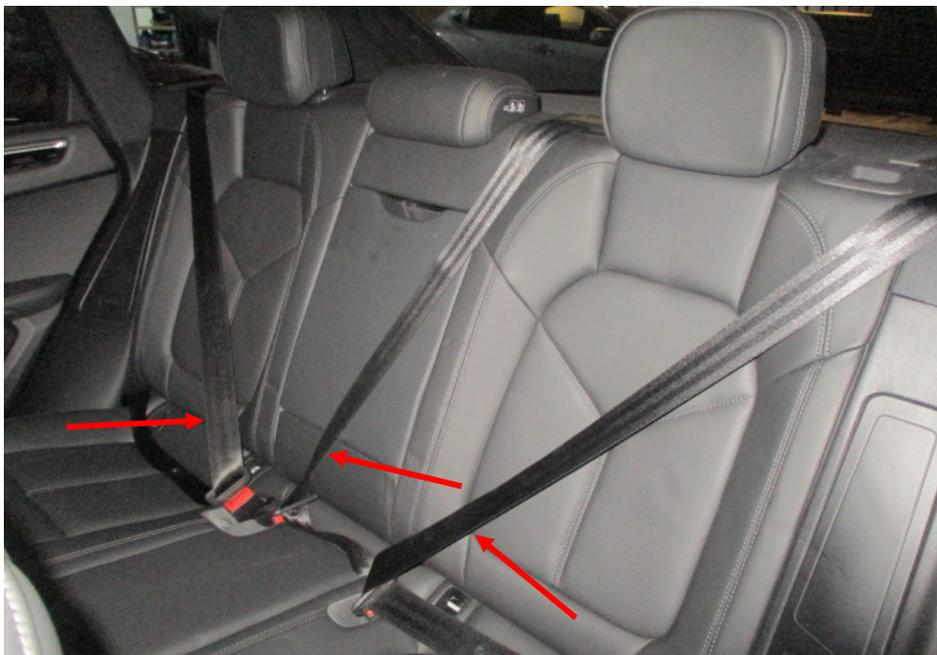
12. The seats of the Motor Car were found to be secured to the floorboard of the Motor Car via seat rails bolted onto the floorboard. Retractable seat belt reels and pre-tensioners were fitted on all seats of the Motor Car. The seat belts were tested and were able to be fastened securely into the respective pre-tensioners that were fixed to the side of all the seats.

**Photo 11** shows the rear seats of the Motor Car. All the seats of the Motor Car were secured via seat rails to the floorboard. They were also fitted with a retractable seat belt reel and a pre-tensioner. The seat belts (arrowed) were tested and were able to be fastened into the respective pre-tensions that were fitted on the side of each individual seat.

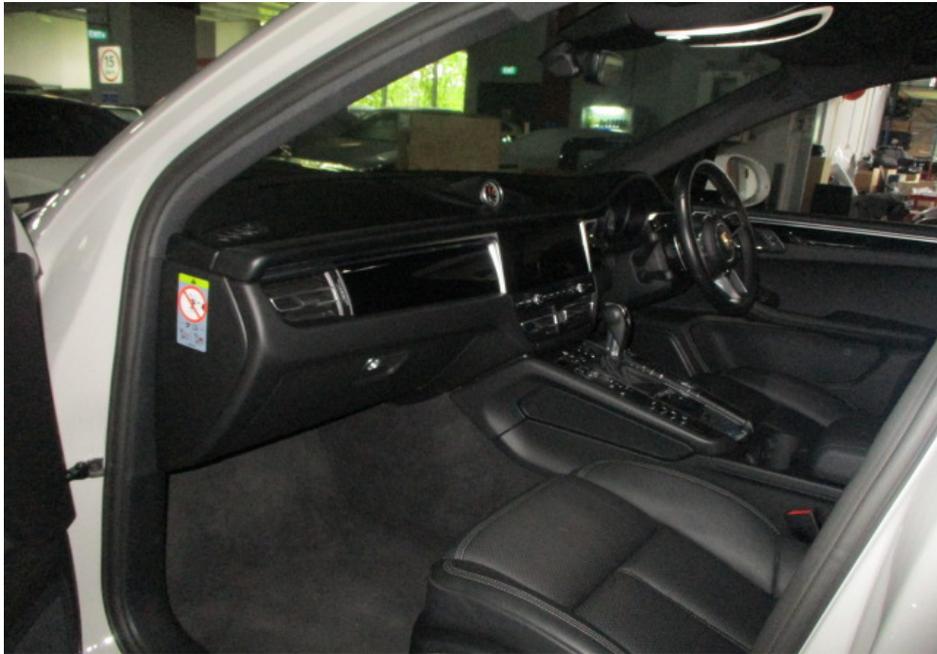
**Photo 12** shows the interior compartment of the Motor Car. The front dashboard, steering wheel, upholstery and trims etc were all observed to be intact and properly fitted.

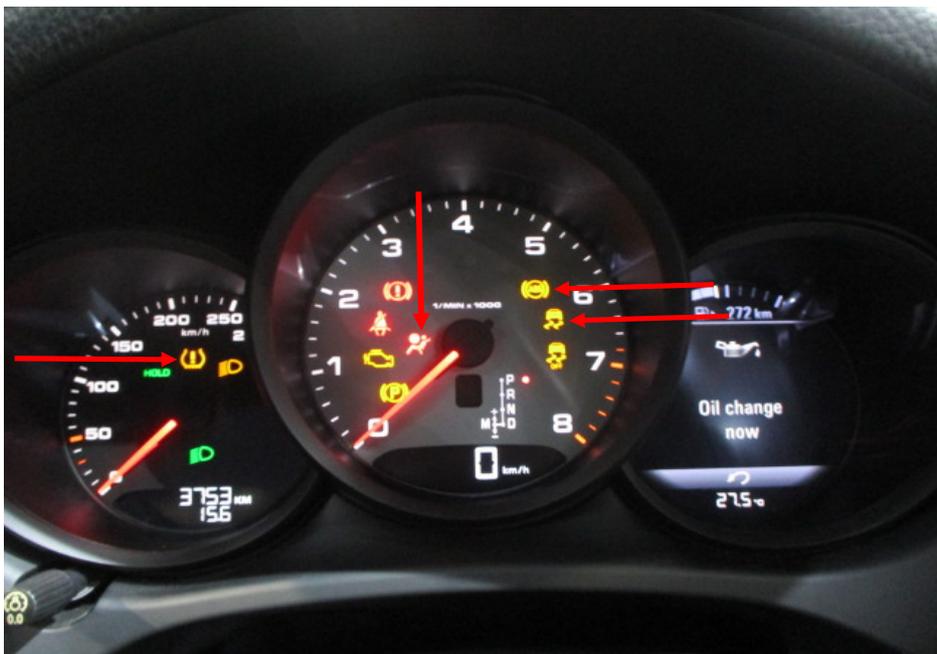
**Photo 13** shows the warning lights for the various electronic safety features appearing on the instrument panel of the Motor Car during its self-test when the engine is cranked, in particular the ABS, SRS, TPM and TCS lights (arrowed).

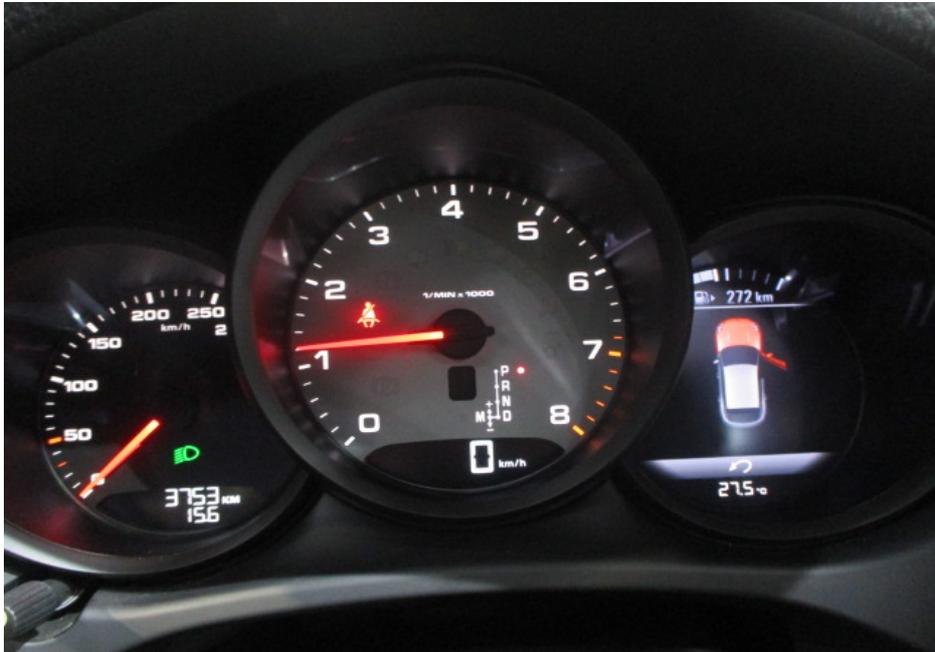
13. The Motor Car's automatic self-test of the functionality of its various electronic safety features like the Anti-Lock Brake System (ABS), Supplemental Restraint System (SRS), Tyre Pressure Monitor (TPM) and Traction Control System (TCS) during cranking of the engine had indicated that these electronic systems were in working condition. This was determined from the respective warning lights disappearing from the instrument panel after the self-test.

**Photo 14** shows the respective warning lights no longer illuminated, indicating that there is no fault detected to the ABS, SRS, TPM and TCS systems of the Motor Car during the self-test. These electronic systems were hence in working condition at the time of my inspection.

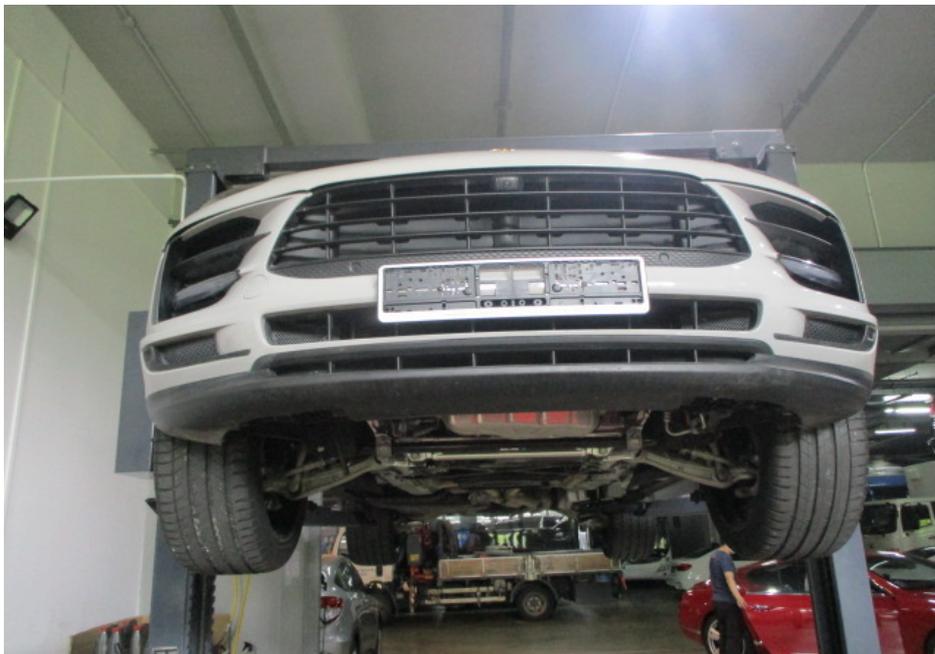
15. My checks on the underside of the Motor Car revealed no sign(s) or indication(s) of fluid leakage and/or fluid stain(s). The engine block and automatic transmission assembly were both secured properly. All undercarriage components of the Motor Car were also observed to be intact and secured in an appropriate manner.

**Photo 15** shows the Motor Car hoisted up for checks on its undercarriage. There was no sign(s) or indication(s) of fluid leakage and/or fluid stain(s) on the underside of the Motor Car. The undercarriage components of the Motor Car were also all observed to be intact and secured in an appropriate manner.

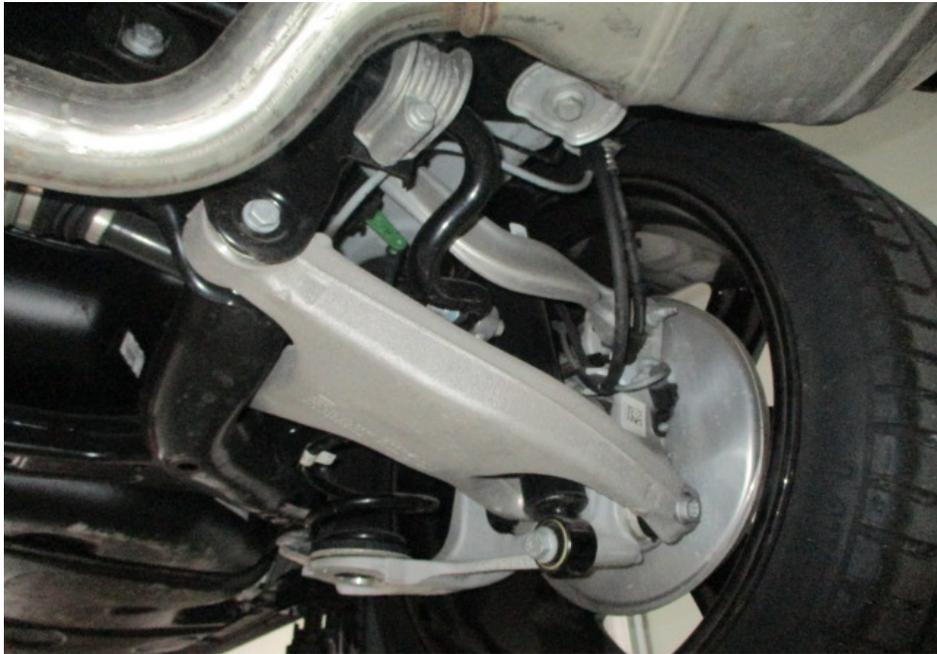
**Photo 16** shows a general view of the control arms and linkages at the rear right wheel of the Motor Car. I did not observe any fluid leak and/or fluid stain on the underside of the Motor Car. All the Motor Car's undercarriage components were observed to be intact and secured in an appropriate manner.

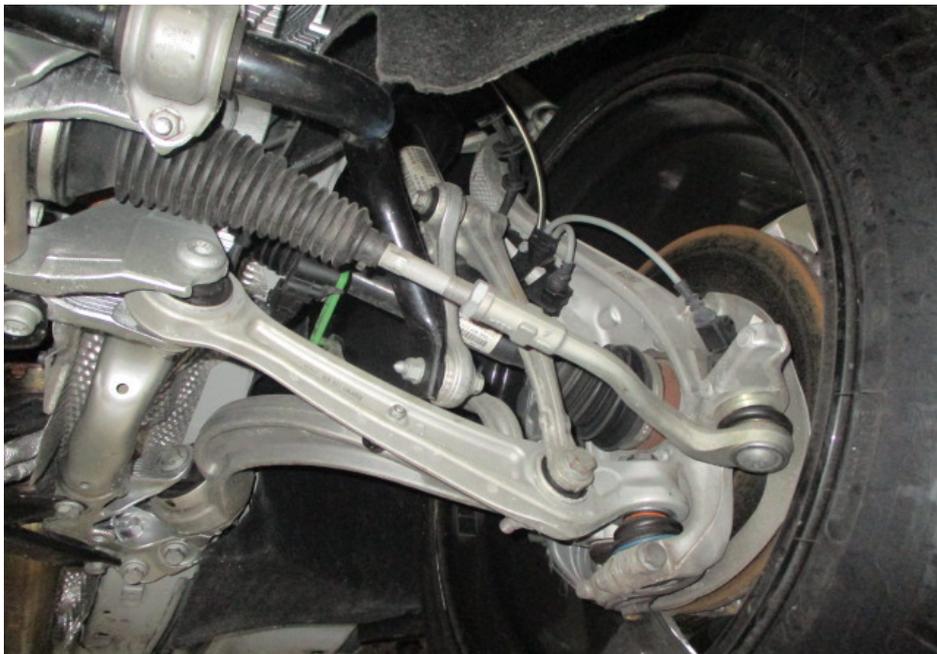
**Photo 17** shows the various undercarriage components at the front left wheel of the Motor Car. The mechanical components, control arms and linkages were all found to be intact and secured in an appropriate manner.

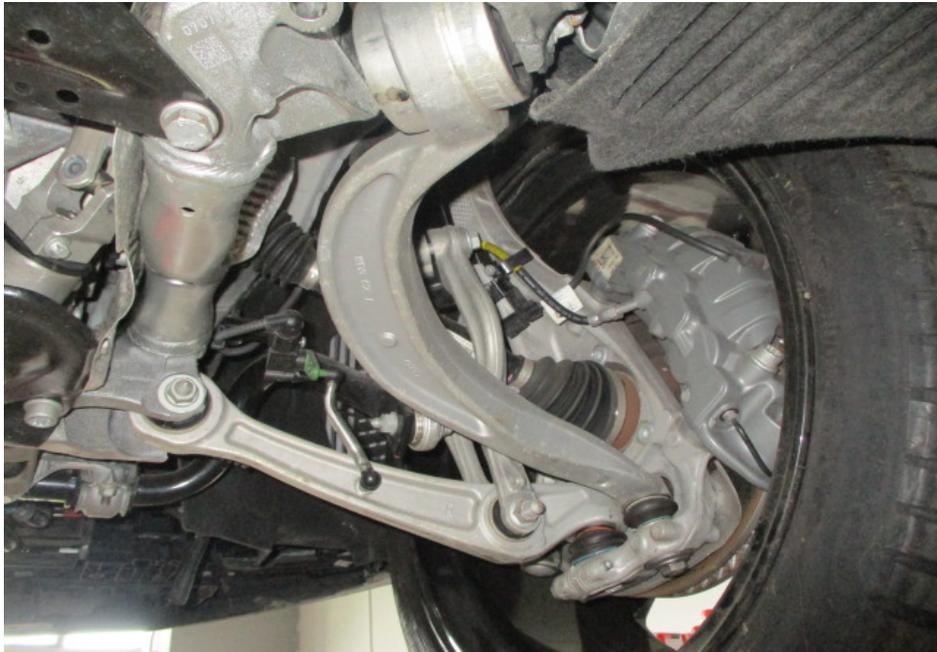
**Photo 18** shows the various undercarriage components at the front right wheel of the Motor Car. The mechanical components, control arms and linkages were all found to be intact and secured in an appropriate manner. I also did not observe any fluid leak and/or fluid stain on the underside of the Motor Car.

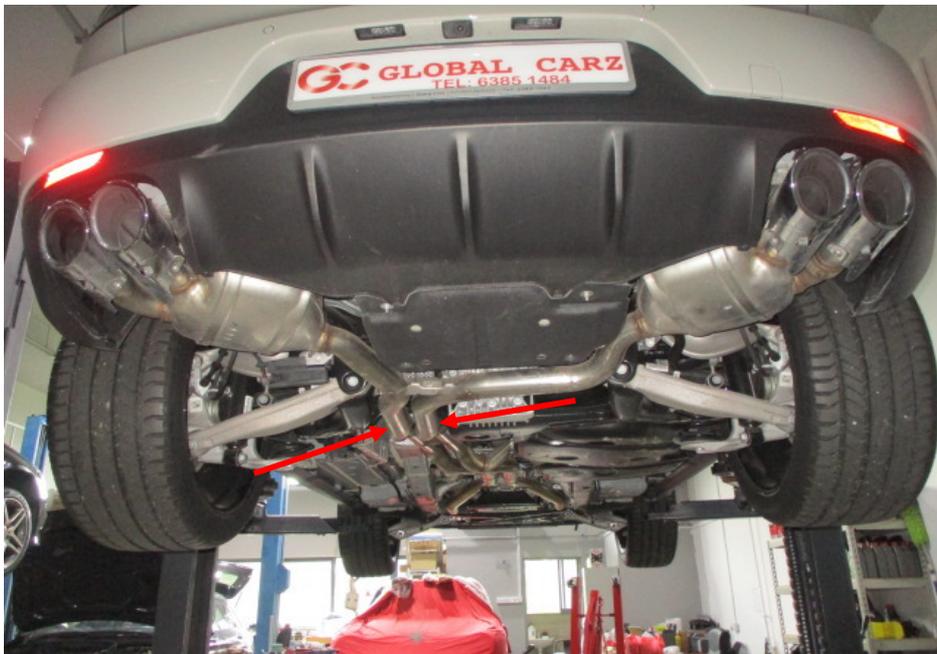
**Photo 19** shows a general view of the Motor Car's exhaust system. My examination of the Motor Car's exhaust system revealed no sign(s) or indication(s) of any cut or weld marks along its exhaust pipes (arrowed), on its catalytic converters and on its rear mufflers.

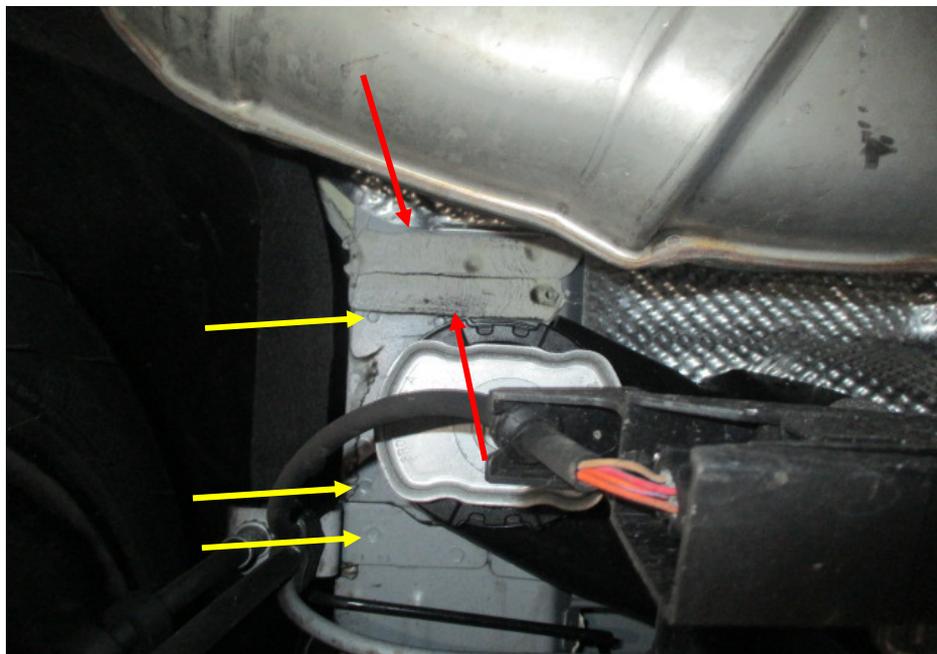
11. Visually, I did not find any weld marks, other than the original spot weld marks, on the chassis/structural body of the Motor Car. The original factory sealant at the joints along the chassis/structural body was also untouched, indicating that no replacement of the chassis/structural body was carried out; and that the chassis/structural body was originally fitted.

**Photo 20** shows the chassis/structural body at the underside rear left of the Motor Car. I did not find any weld marks other than original spot weld marks (yellow arrow) on the chassis/structural body of the Motor Car. The original factory sealant (red arrow) at the joints along the chassis/structural body was untouched, indicating no work was done on the chassis/structural body of the Motor Car and that the chassis/structural body was originally fitted.

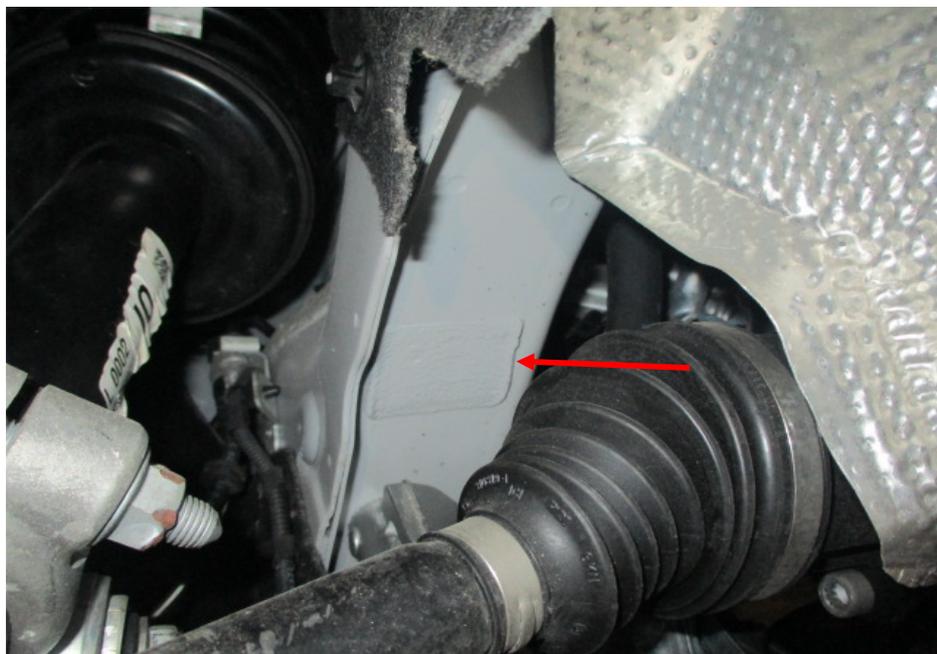
**Photo 21** shows the chassis/structural body at the underside front left of the Motor Car. The original factory sealant (arrowed) at the joints along the chassis/structural body was observed to be untouched. In general, I had found no work was carried out on the chassis/structural body of the Motor Car. The chassis/structural body of the Motor Car was originally fitted.

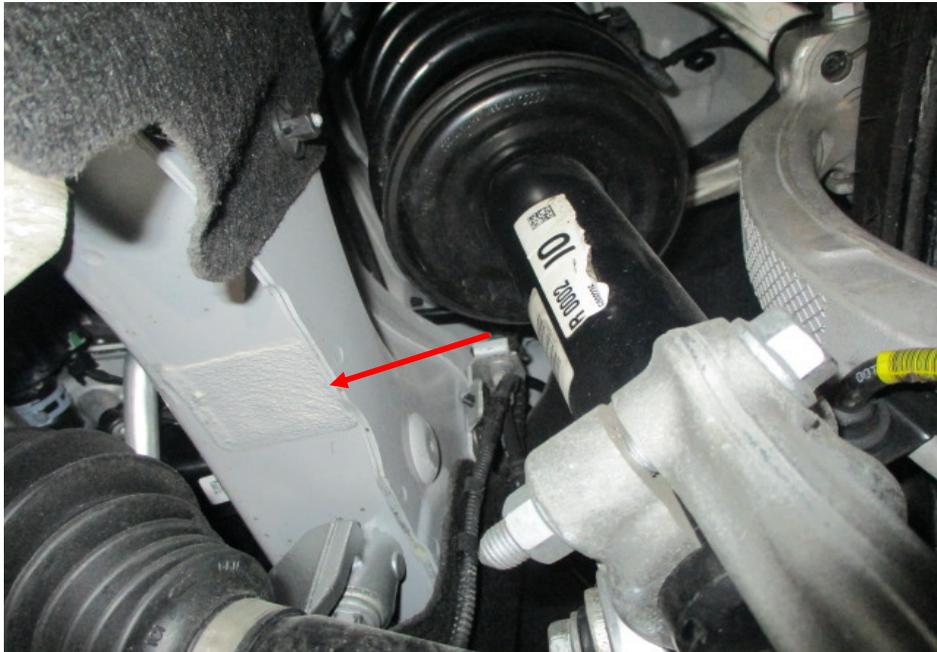
**Photo 22** shows the chassis/structural body at the underside front right of the Motor Car. The original factory sealant (arrowed) at the joints along the chassis/structural body was observed to be untouched. In general, I had found no work was carried out on the chassis/structural body of the Motor Car. The chassis/structural body of the Motor Car was originally fitted.

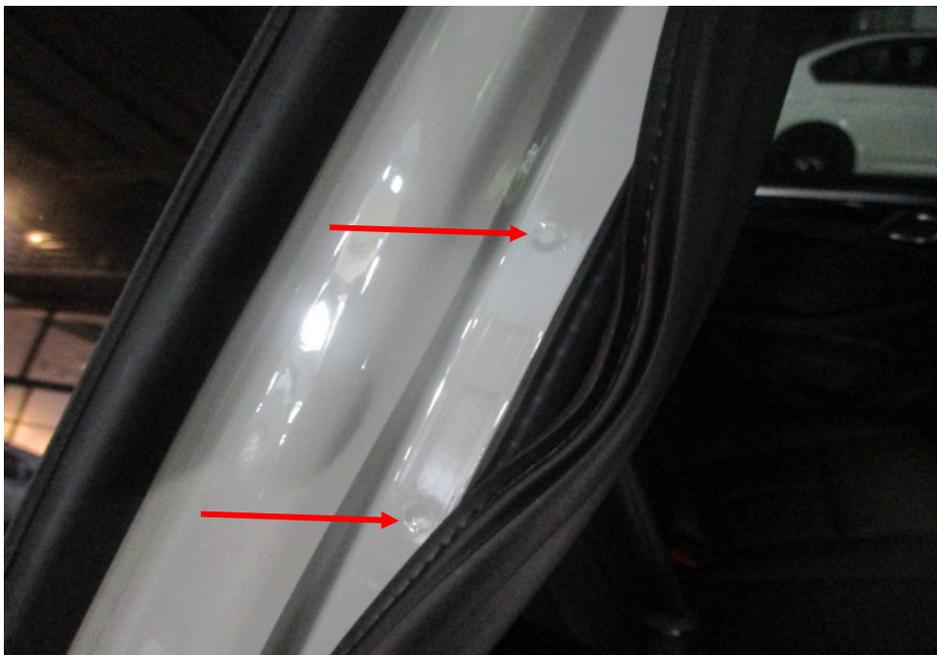
**Photo 23** shows the right side "C" pillar of the Motor Car. I did not find any weld marks other than original spot weld marks (arrowed) on the right side "C" pillar of the Motor Car which, indicates that there was no re-welding works carried out. In general, I had found all the non-detachable body panels of the Motor Car to be originally fitted at the time of my inspection.

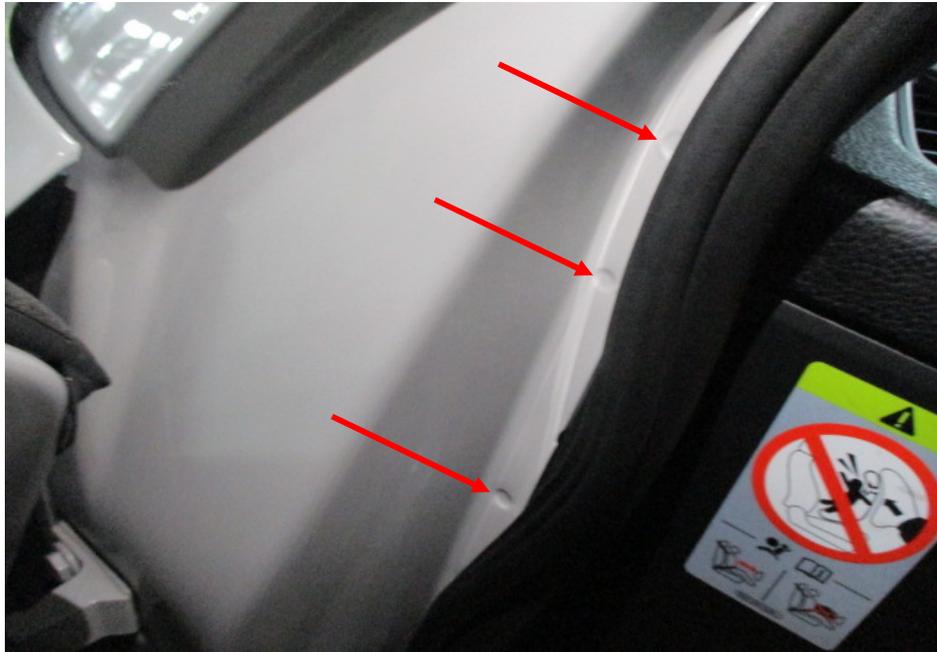
**Photo 24** shows the left side "A" pillar of the Motor Car. I did not find any weld marks other than original spot weld marks (arrowed) on the left side "A" pillar of the Motor Car which, indicates that there was no re-welding works carried out. In general, I had found all the non-detachable body panels of the Motor Car to be originally fitted at the time of my inspection.
