AUTOMOBILE INSPECTION REPORT

Our Reference No. : PAS/WM/210310/TP

Registration No. : SJW 4018 J

: HONDA FIT 1.3G A Make/Model

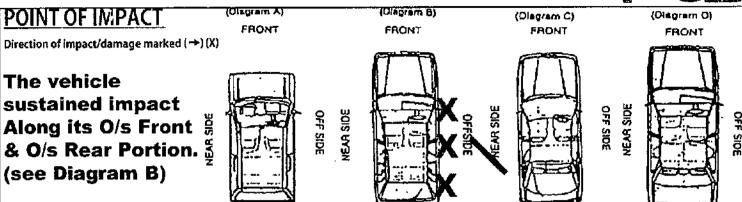
APPENDIX A

Parts damaged were: The front and rear ols door, ols centre door pillar and top rooftop panel, front ols door mirror, rear ols fender and wheel arch were dented

A static inspection was carried out on 22/02/2021 & our report is here with enclosed for your perusal. The Repairs Estimate submitted by M/s Willy Motor Company as per attached Appraisement Schedule have been revised and scrutinised thoroughly by us & in our opinion, we consider it to be fair and reasonable. The repairer has agreed to effect repairs to the owners satisfaction & to roadworthy condition on an agreed Lump Sum Repair Basis of \$8,550.00 after deducting the Policy Excess Clause of \$NA. As instructed, we have not authorised any of the repairs on your behalf.
