Your Ref: Range Rover Vogue  
(chassis number SALGA2AK8LA577244)  
Our Ref : CI/TP21006901/D

**INSPECTION REPORT OF AN UNREGISTERD RANGE ROVER VOGUE  
MOTOR CAR WITH CHASSIS NUMBER SALGA2AK8LA577244**

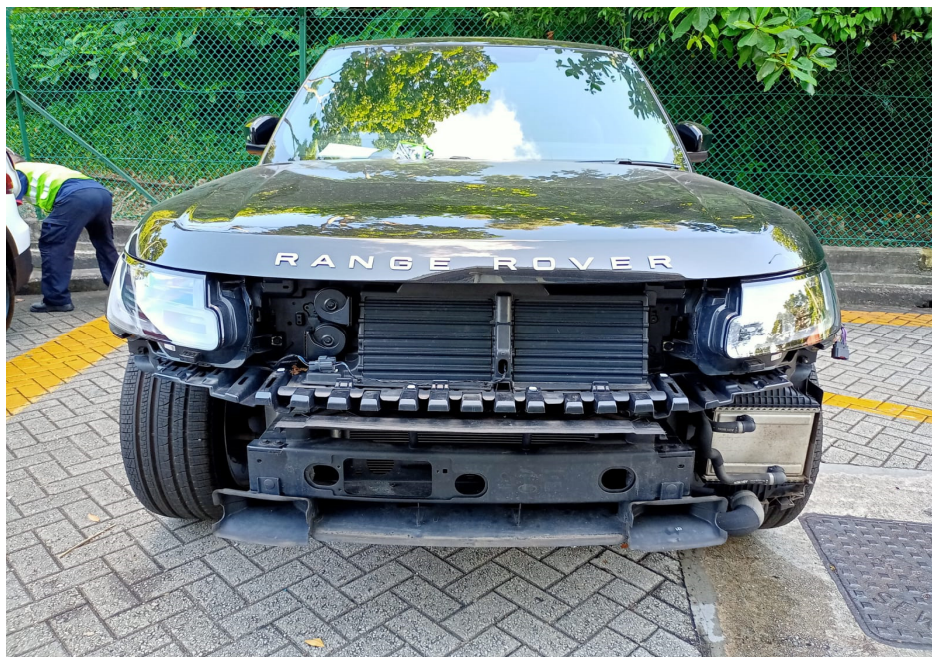
3. The photographs provided to me had showed the Motor Car's front bumper and all its related parts and attachments, damaged/dislodged/missing. No physical damage was observed to other areas of the Motor Car. The airbags were also not deployed as seen from the photographs that were provided to me. See photo 1 – 4 below.

**Photo 1** shows the frontal body of the Motor Car (photograph provided to me). The Motor Car's front bumper and all its related parts and attachments were observed to be damaged/dislodged/missing.

21. The frontal body of the Motor Car were visually examined, and it was noted that the repair/restoration works carried out to the damaged area of the Motor Car (refer to photograph 1 above) were reasonably adequate and in order.

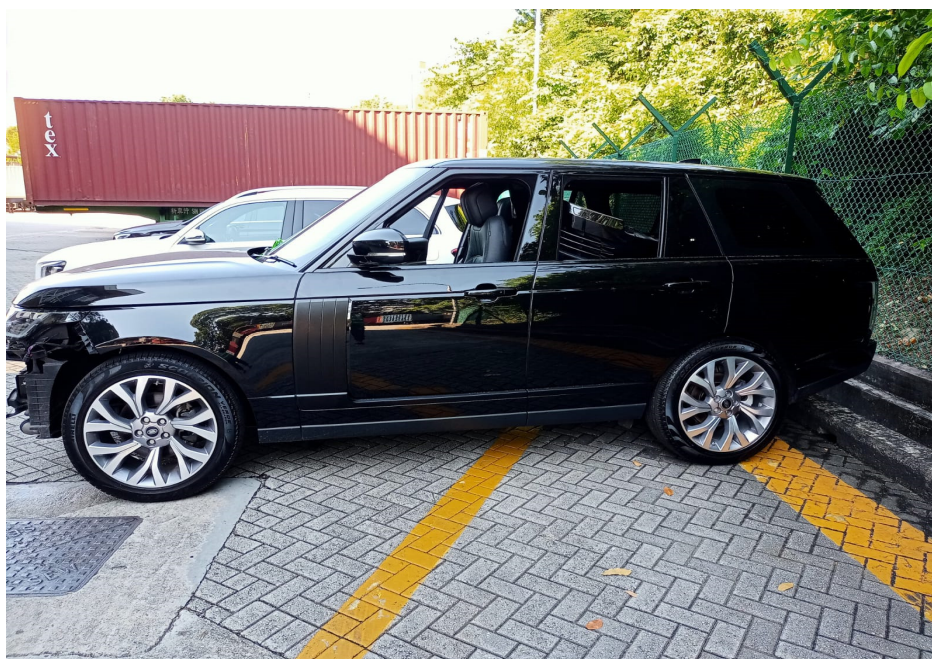
**Photo 2** shows the left body of the Motor Car (photograph provided to me). There was no physical damage seen to other areas of the Motor Car apart for the front bumper and all its related parts and attachments, which were damaged/dislodged/missing. The airbags of the Motor Car were also not deployed as seen from the photographs that were provided to me.

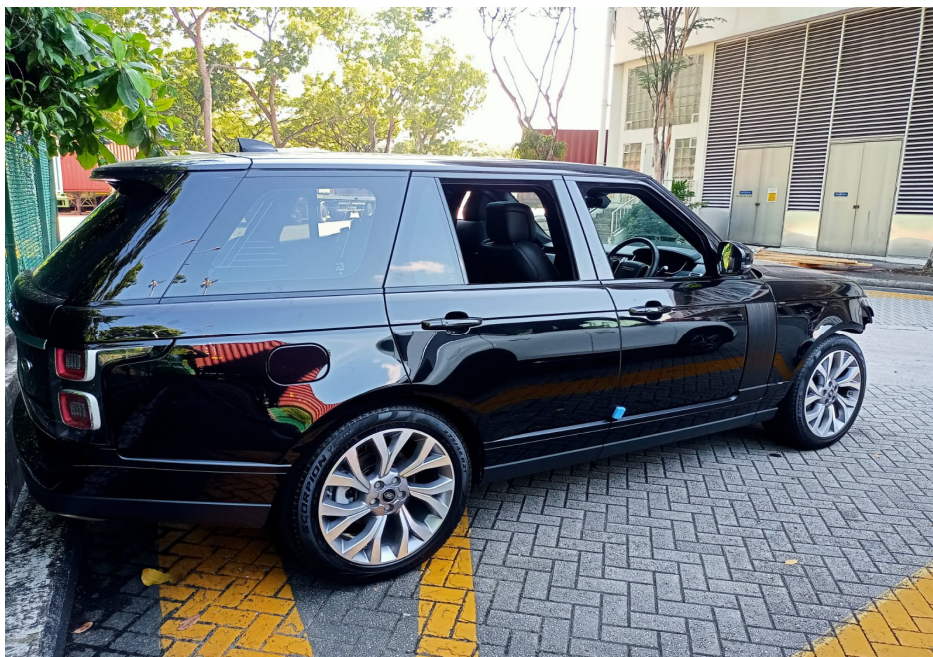
**Photo 3** shows the right body of the Motor Car (photograph provided to me). There was no physical damage seen to other areas of the Motor Car apart for the front bumper and all its related parts and attachments, which were damaged/dislodged/missing. The airbags of the Motor Car were also not deployed as seen from the photographs that were provided to me.

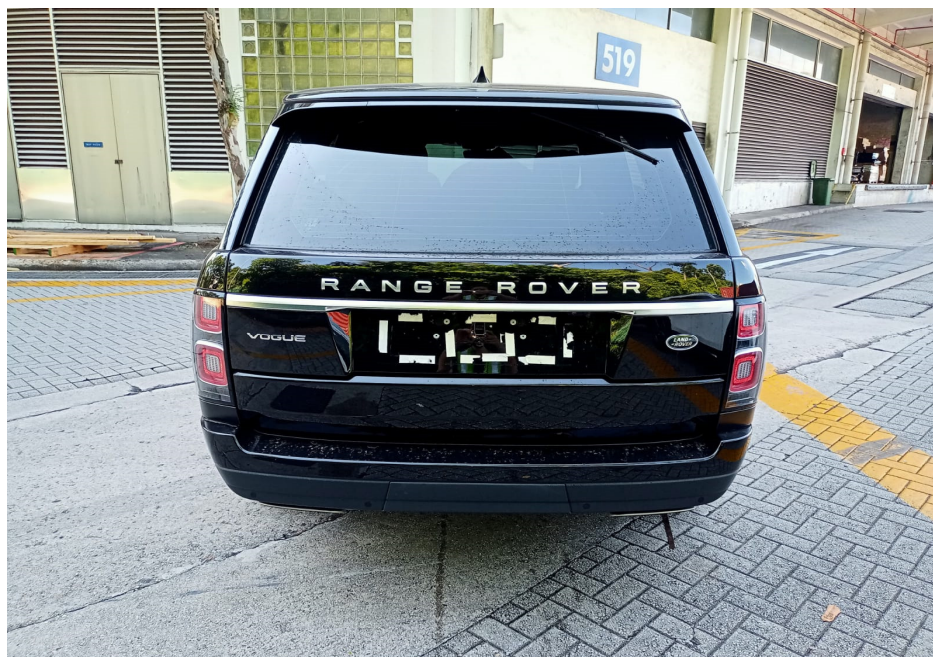
**Photo 4** shows the rear body of the Motor Car (photograph provided to me). There was no physical damage seen to other areas of the Motor Car apart for the front bumper and all its related parts and attachments, which were damaged/dislodged/missing.

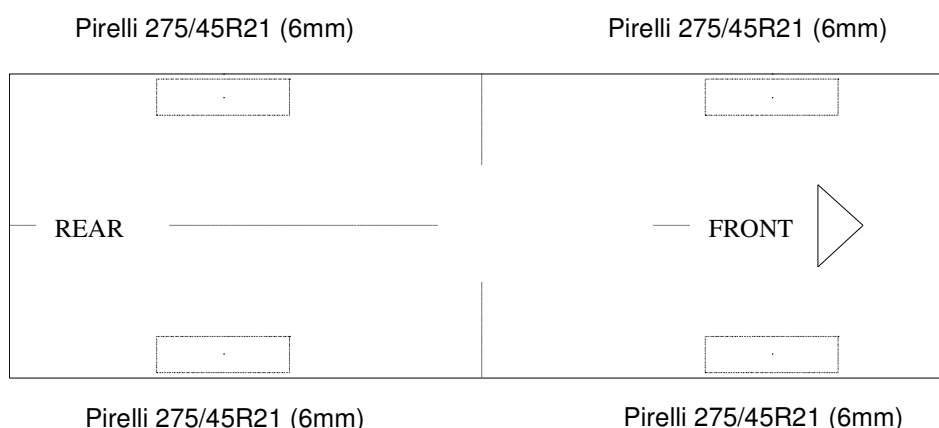
7. It was fitted with 21inch sport wheel rims that were wrapped with tyres that were observed to be of serviceable condition. The tyres were also sufficiently inflated for vehicular operation. The tyre brand, tyre size and approximate remaining tread depth of the 4 tyres of the Motor Car were recorded as follows: -

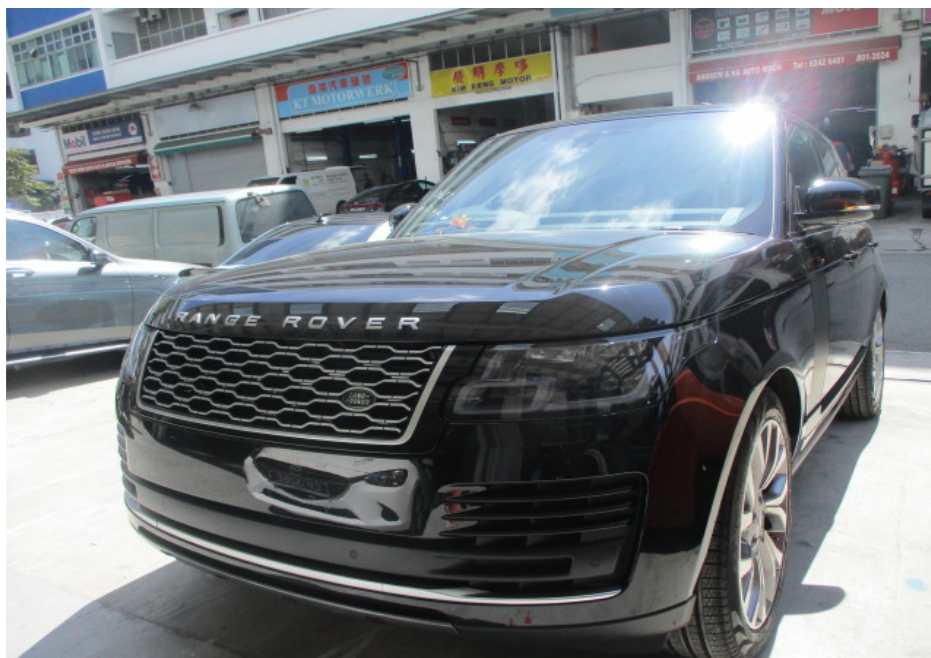
**Photo 5** shows a general view of the front left body of the Motor Car at the time of my inspection. The Motor Car was observed to be in a relatively good general condition with no loose exterior fittings observed. The frontal body of the Motor Car was visually examined, and it was observed that the repair/restoration works carried out to the damaged area of the Motor Car (refer to photograph 1 above) were reasonably adequate and in order.

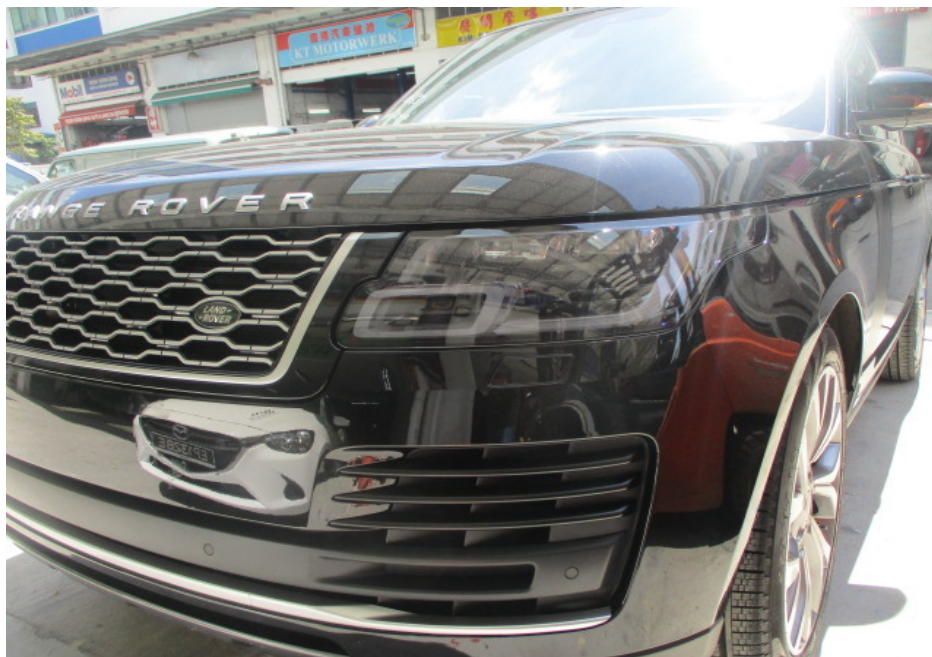
**Photo 6** shows a closer view of the Motor Car's front bumper, front bumper left lower grille, front left headlamp and front radiator grille at the time of my inspection. The frontal body of the Motor Car was visually examined, and it was observed that the repair/restoration works carried out to the damaged area of the Motor Car (refer to photograph 1 above) were reasonably adequate and in order.

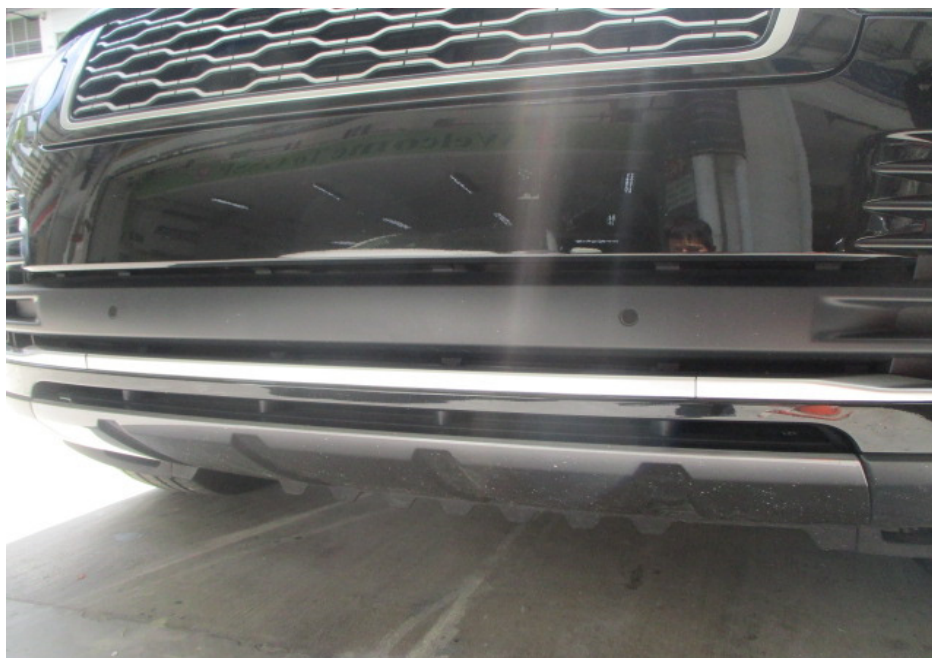
**Photo 7** shows a closer view of the Motor Car's front bumper and front bumper lower garnishes at the time of my inspection. The frontal body of the Motor Car was visually examined, and it was observed that the repair/restoration works carried out to the damaged area of the Motor Car (refer to photograph 1 above) were reasonably adequate and in order.

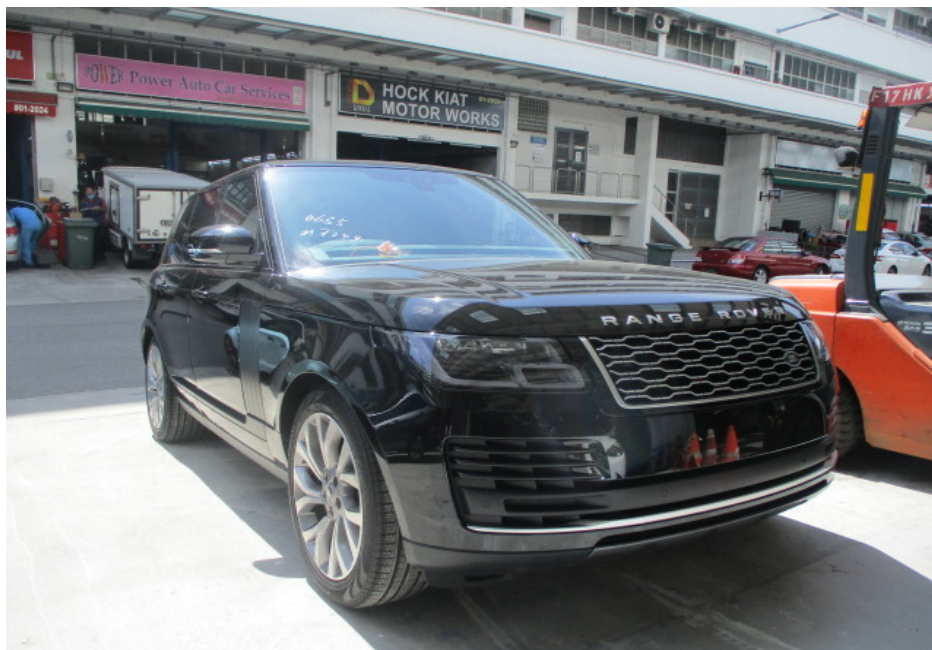
**Photo 8** shows a general view of the front right body of the Motor Car at the time of my inspection. The Motor Car was observed to be in a relatively good general condition with no loose exterior fittings observed. The frontal body of the Motor Car was visually examined, and it was observed that the repair/restoration works carried out to the damaged area of the Motor Car (refer to photograph 1 above) were reasonably adequate and in order.

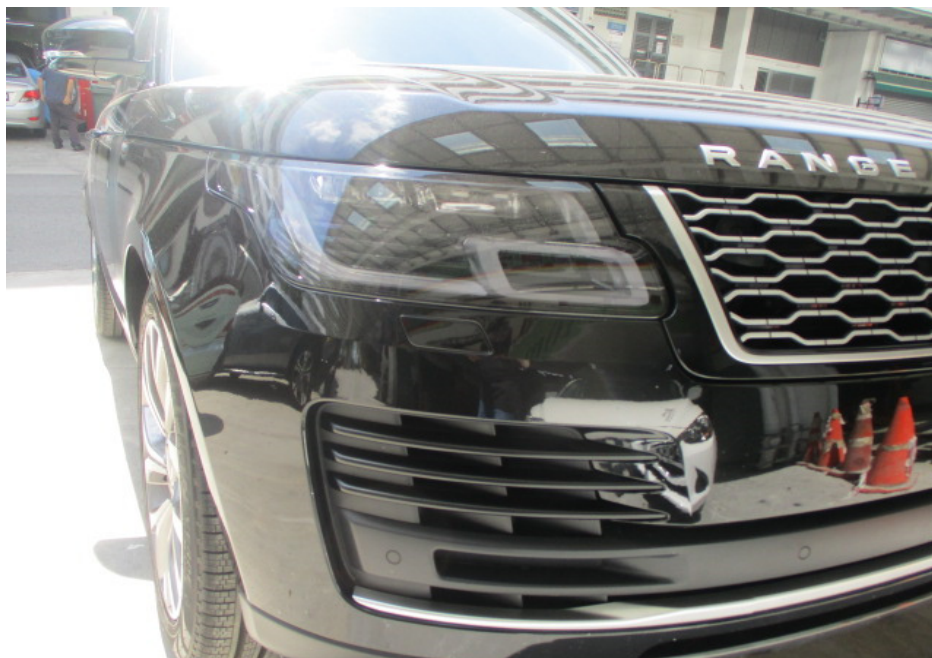
**Photo 9** shows a closer view of the Motor Car's front bumper, front bumper right lower grille and front right headlamp at the time of my inspection. The frontal body of the Motor Car was visually examined, and it was observed that the repair/restoration works carried out to the damaged area of the Motor Car (refer to photograph 1 above) were reasonably adequate and in order.

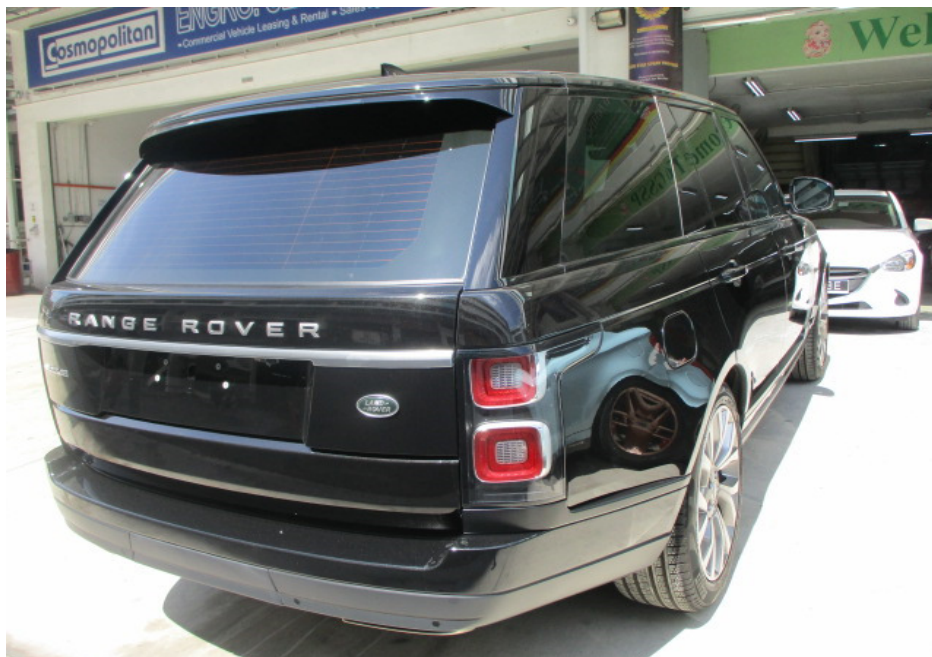
**Photo 10** shows a general view of the rear right body of the Motor Car at the time of my inspection. The Motor Car was observed to be in a relatively good general condition with no loose exterior fittings observed. The mileage of the Motor Car recorded at the time of my inspection was 9,593km.

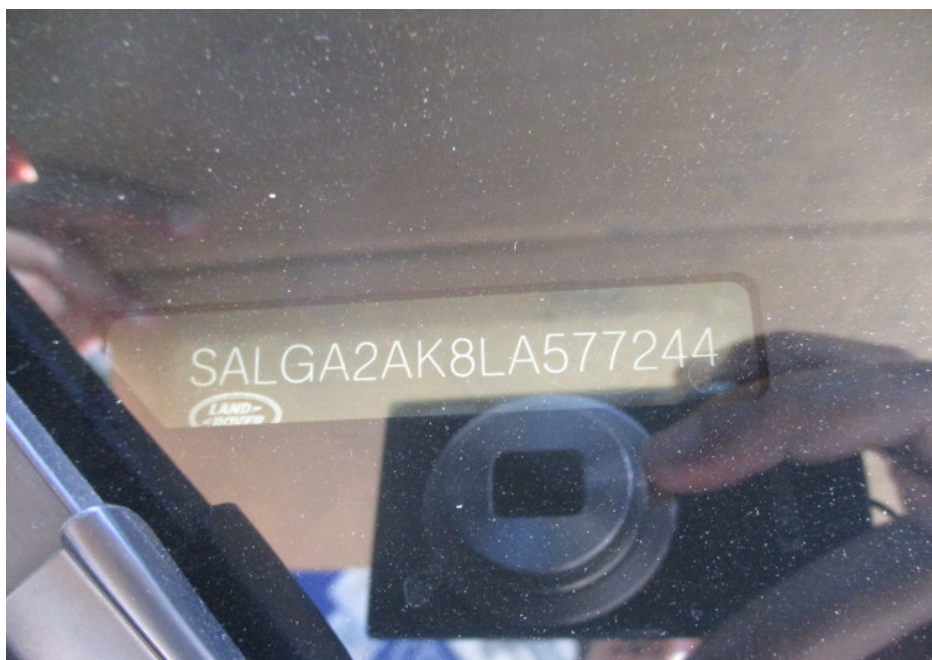
**Photo 11** shows the chassis number of the Motor Car. The chassis number recorded was SALGA2AK8LA577244.

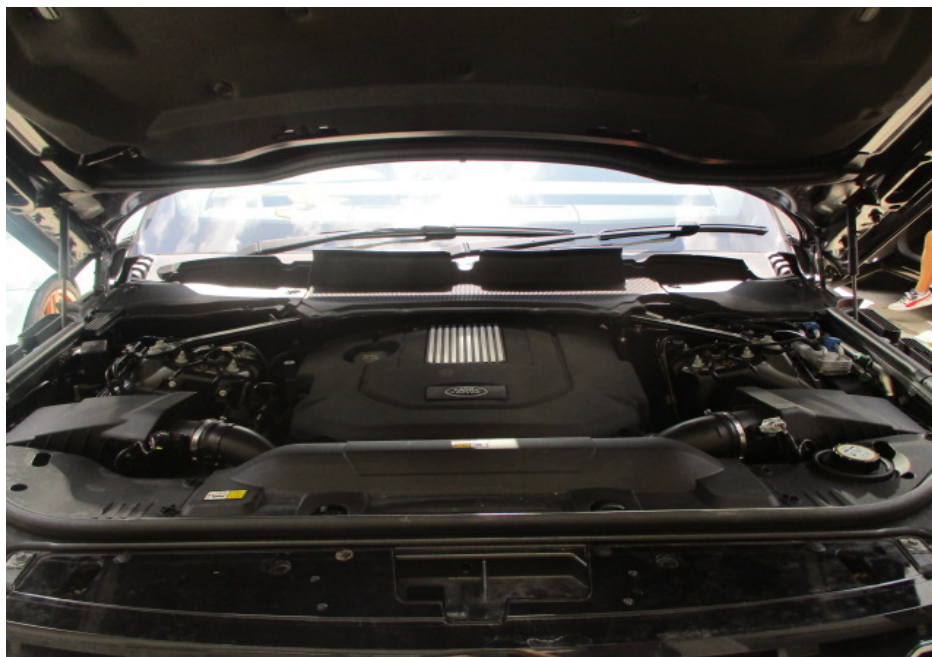
**Photo 12** shows a general view of the engine compartment of the Motor Car at the time of my inspection. The various parts and components inside the engine compartment were all observed to be intact and properly fitted. There was also no sign(s) or indication(s) of fluid leak and/or fluid stain found inside the engine compartment.

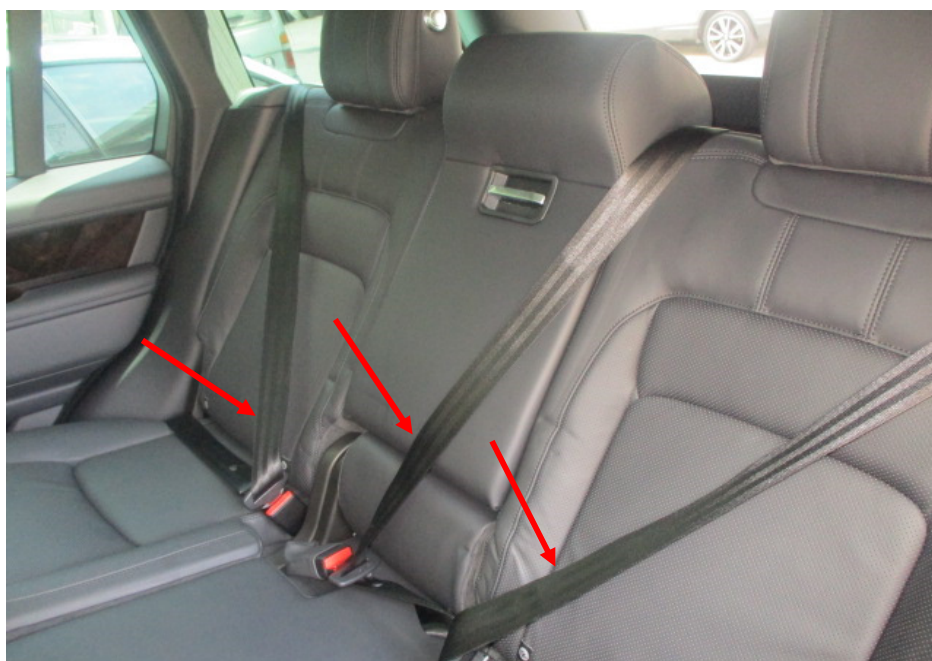
**Photo 13** shows the rear seats of the Motor Car. All the seats of the Motor Car were secured via seat rails to the floorboard. They were also fitted with a retractable seat belt reel and a pre-tensioner. The seat belts (arrowed) were tested and were able to be fastened into the respective pre-tensions that were fitted on the side of each individual seat.

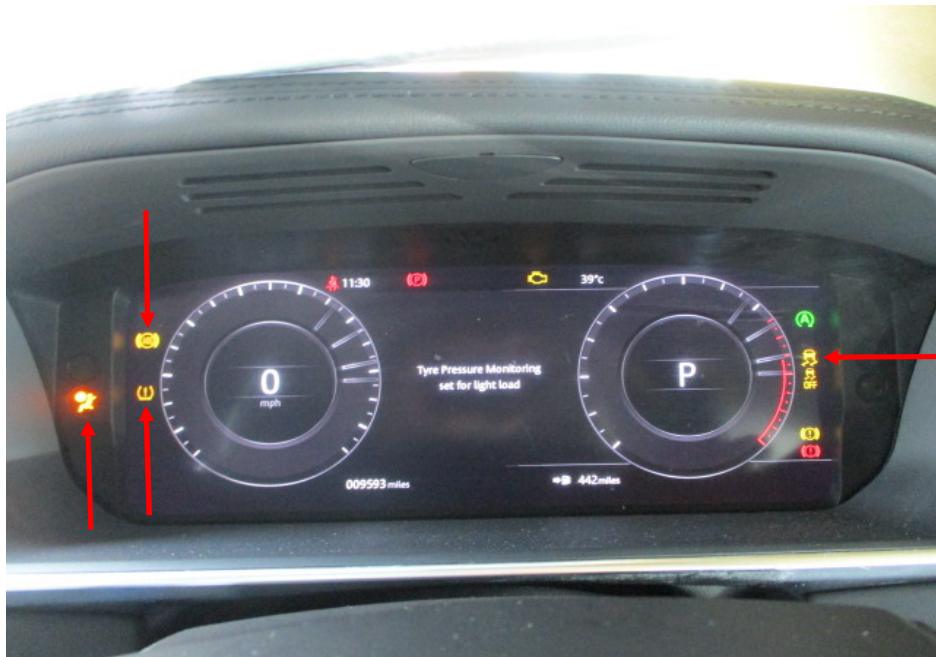
**Photo 14** shows the warning lights for the various electronic safety features appearing on the instrument panel of the Motor Car during its self-test when the engine is cranked, in particular the ABS, SRS, TPM and TCS lights (arrowed).

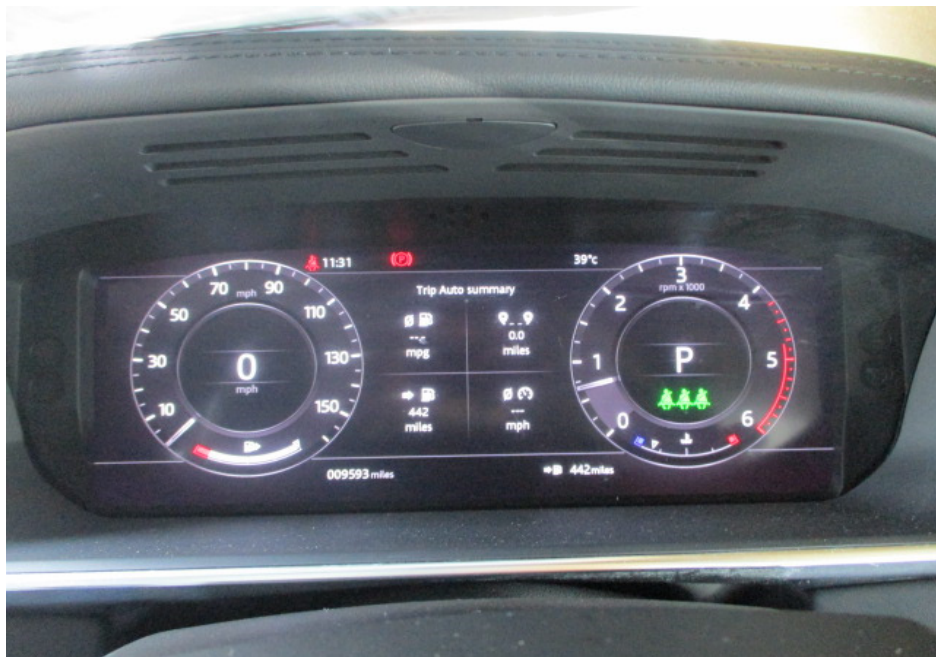
**Photo 15** shows the respective warning lights no longer illuminated, indicating that there is no fault detected to the ABS, SRS, TPM and TCS systems of the Motor Car during the self-test. These electronic systems were hence in working condition at the time of my inspection.

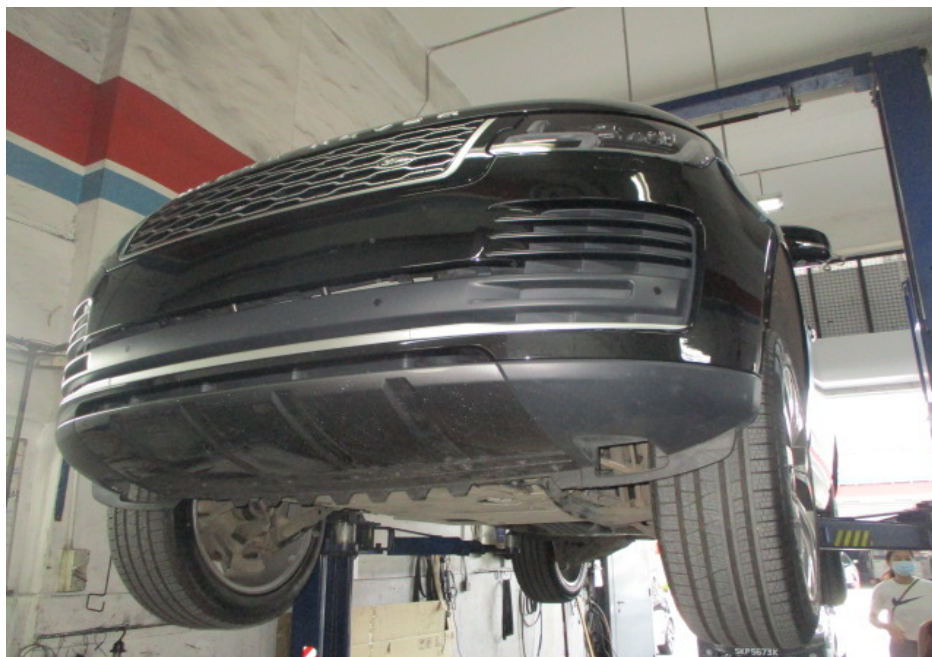
**Photo 16** shows the Motor Car hoisted up for checks on its undercarriage. There was no sign(s) or indication(s) of fluid leakage and/or fluid stain(s) on the underside of the Motor Car. The undercarriage components of the Motor Car were also all observed to be intact and secured in an appropriate manner.

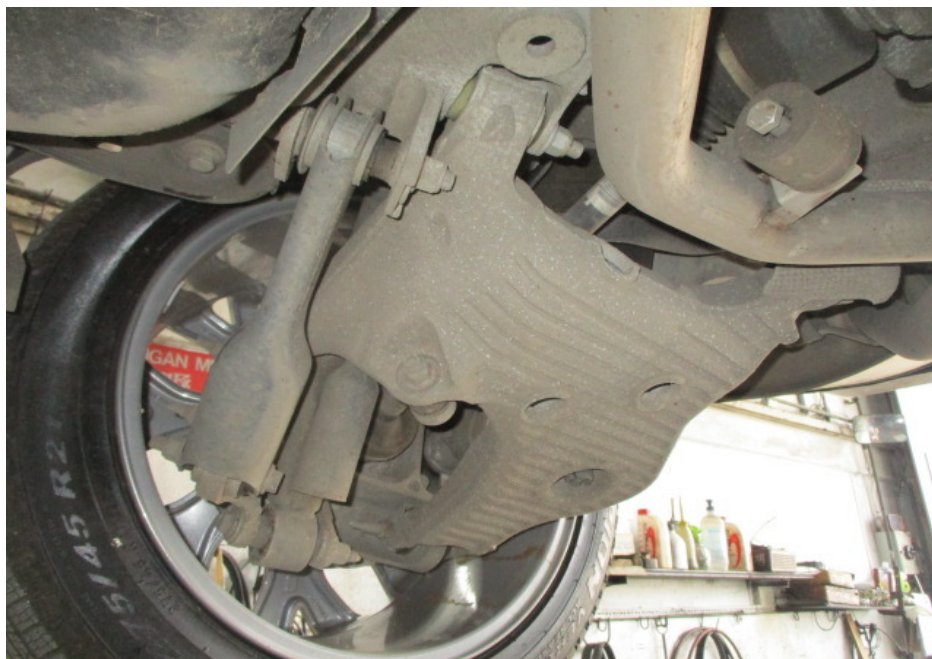
**Photo 17** shows a general view of the control arms and linkages at the rear right wheel of the Motor Car. I did not observe any fluid leak and/or fluid stain on the underside of the Motor Car. All of the Motor Car's undercarriage components were observed to be intact and secured in an appropriate manner.

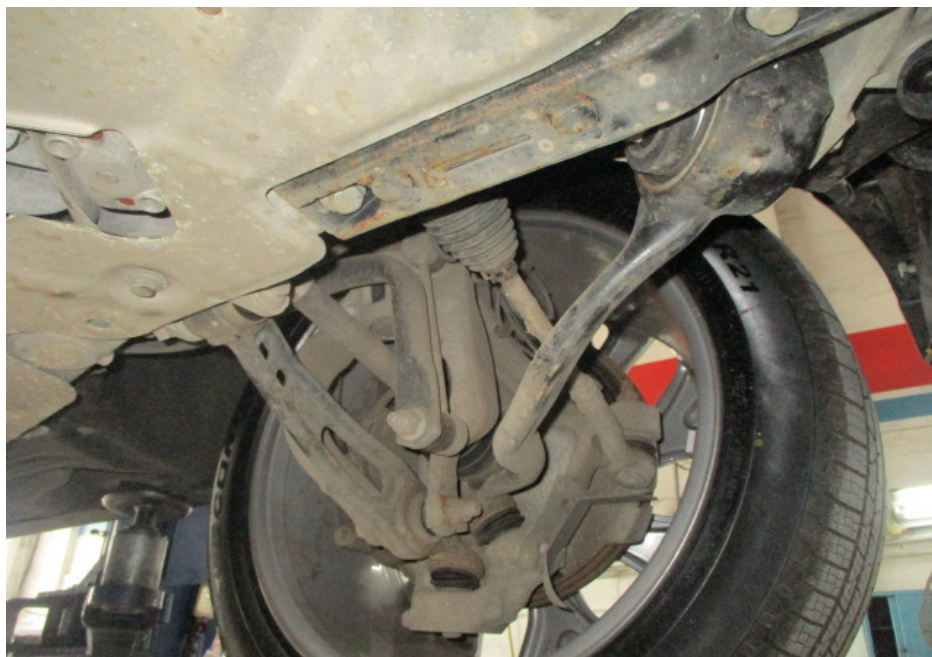
**Photo 18** shows the various undercarriage components at the front left wheel of the Motor Car. The mechanical components, control arms and linkages were all found to be intact and secured in an appropriate manner.

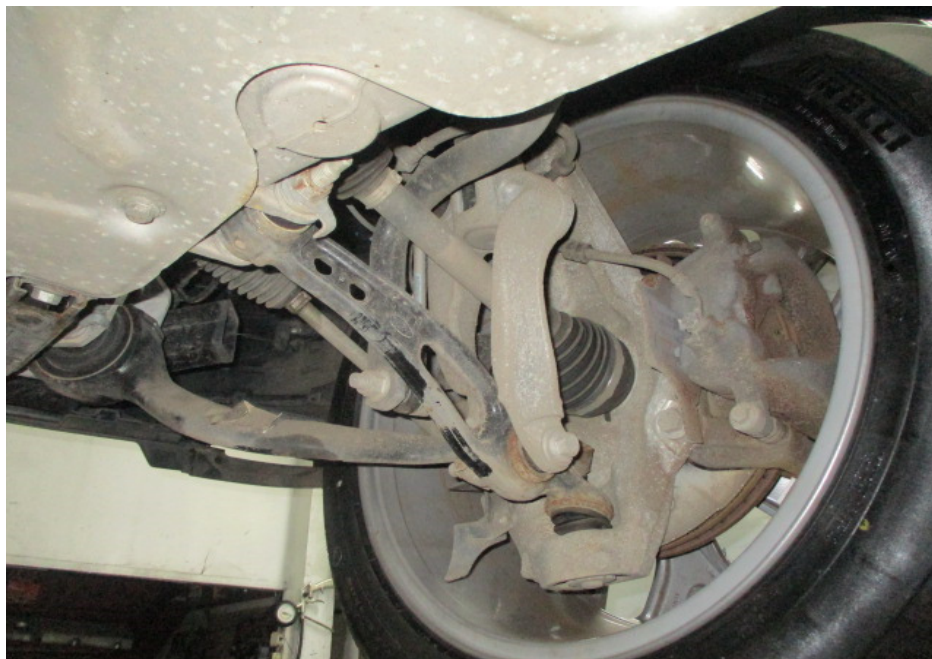
**Photo 19** shows the various undercarriage components at the front right wheel of the Motor Car. The mechanical components, control arms and linkages were all found to be intact and secured in an appropriate manner. I also did not observe any fluid leak and/or fluid stain on the underside of the Motor Car.

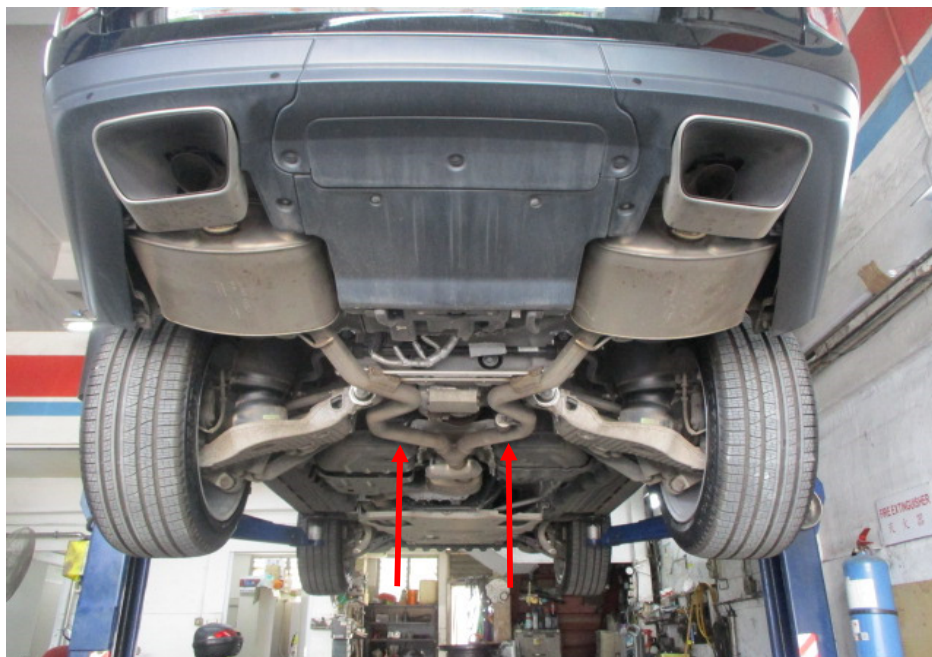
**Photo 20** shows a general view of the rear section of the Motor Car's exhaust system. My examination of the Motor Car's exhaust system revealed no sign(s) or indication(s) of any cut or weld marks along its exhaust pipes (arrowed), on its catalytic converter, centre resonator boxes and on its rear mufflers.

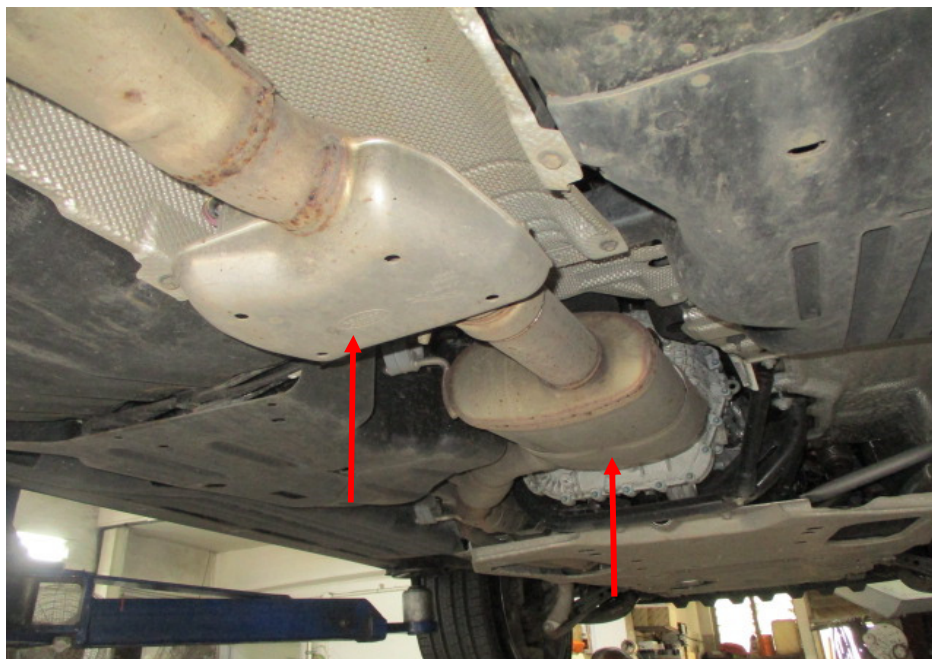
**Photo 21** shows the front section of the Motor Car's exhaust system. My examination of the Motor Car's exhaust system revealed no sign(s) or indication(s) of any cut or weld marks along its exhaust pipes, on its catalytic converters, centre resonator boxes (arrowed) and on its rear mufflers.

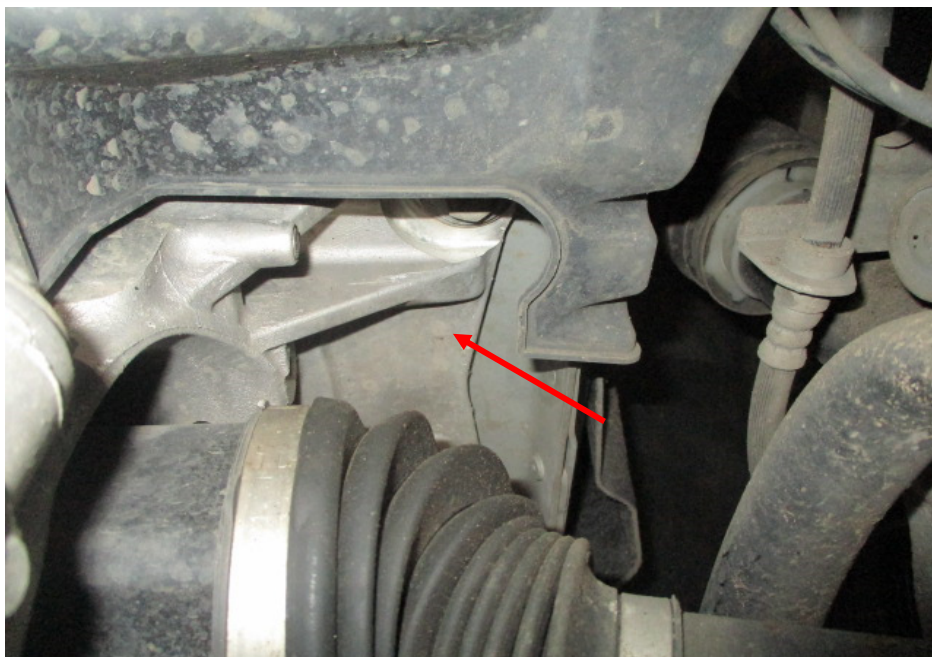
**Photo 22** shows the chassis/structural body at the underside front left of the Motor Car. I did not find any weld marks other than original spot weld marks (arrowed) on the chassis/structural body of the Motor Car. The original factory sealant at the joints along the chassis/structural body was untouched, indicating no work was done on the chassis/structural body of the Motor Car and that the chassis/structural body was originally fitted.

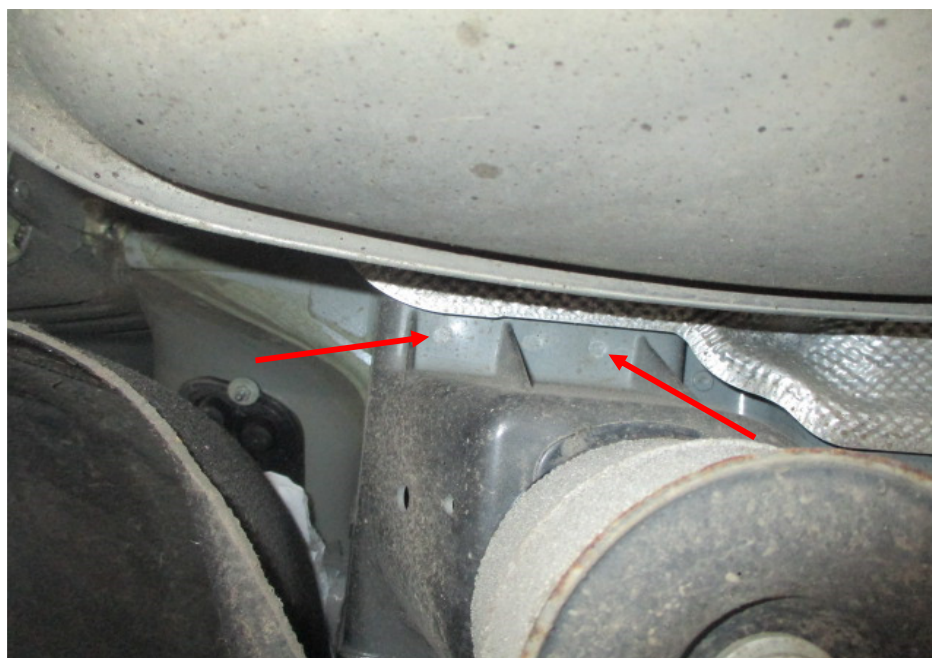
**Photo 23** shows the chassis/structural body at the underside rear left of the Motor Car. I did not find any weld marks other than original spot weld marks (arrowed) on the chassis/structural body of the Motor Car. In general, I had found no work was carried out on the chassis/structural body of the Motor Car. The chassis/structural body of the Motor Car was originally fitted.

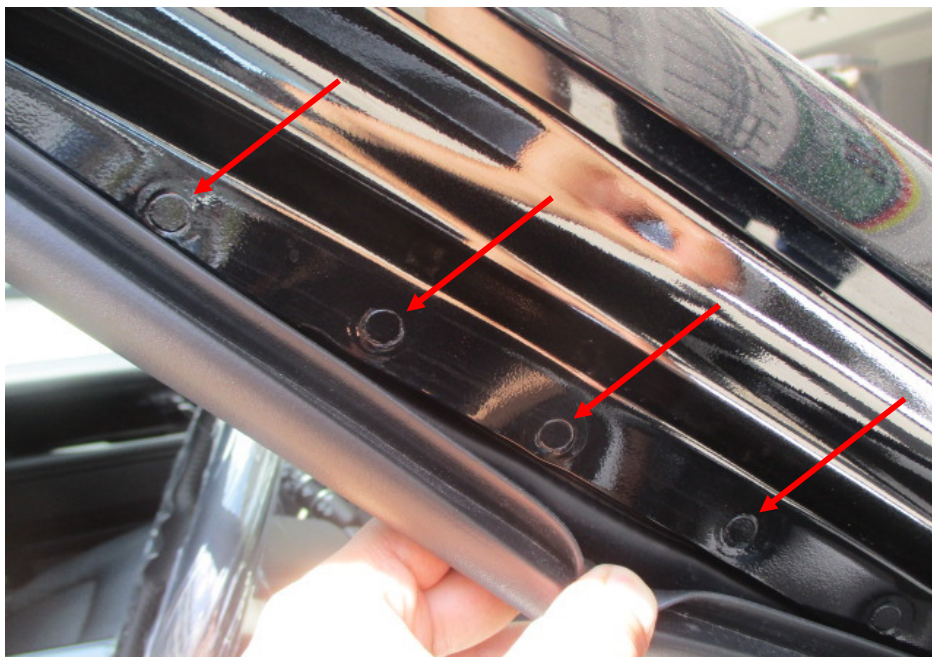
**Photo 24** shows the right side "A" pillar of the Motor Car. I did not find any weld marks other than original spot weld marks (arrowed) on the right side "A" pillar of the Motor Car which, indicates that there was no re-welding works carried out. In general, I had found all the non-detachable body panels of the Motor Car to be originally fitted at the time of my inspection.

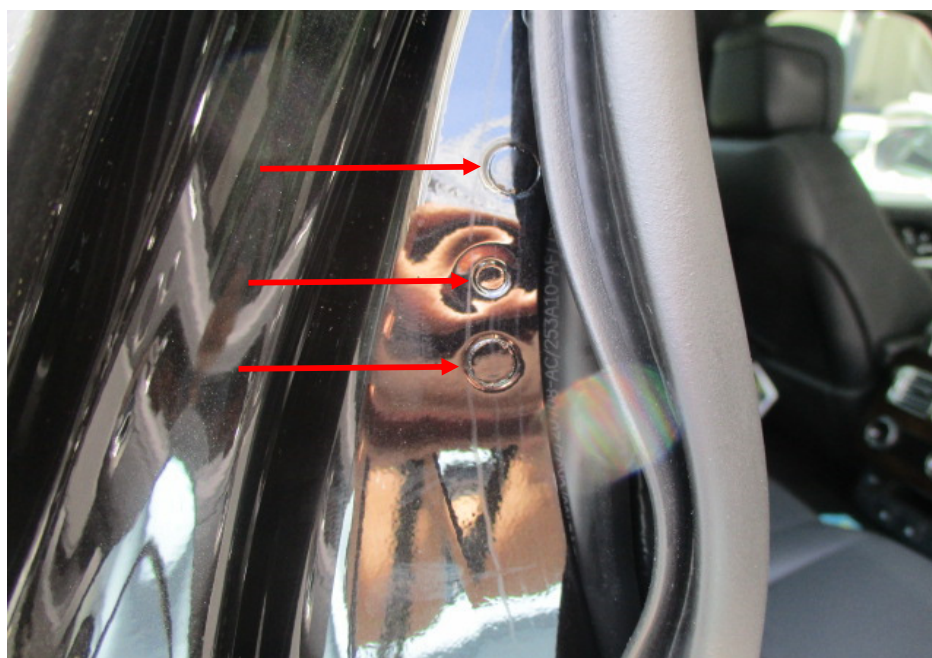
**Photo 25** shows the right side "C" pillar of the Motor Car. I did not find any weld marks other than original spot weld marks (arrowed) on the right side "C" pillar of the Motor Car which, indicates that there was no re-welding works carried out. In general, I had found all the non-detachable body panels of the Motor Car to be originally fitted at the time of my inspection.

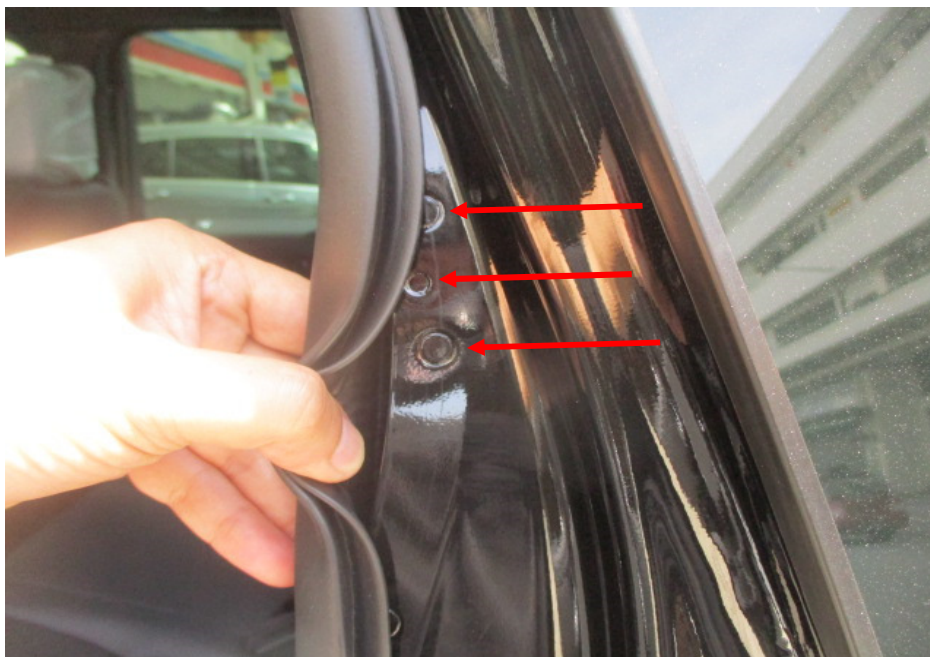
**Photo 26** shows the left side "C" pillar of the Motor Car. I did not find any weld marks other than original spot weld marks (arrowed) on the left side "C" pillar of the Motor Car which, indicates that there was no re-welding works carried out. In general, I had found all the non-detachable body panels of the Motor Car to be originally fitted at the time of my inspection.
