RESPONSE TO REPORTS

Danny Raj Muniappan JLX 215

Central Chambers Law Corp File Ref: TBA
Envista Ref: 125387-G4S3
Report Date: 19 July 2021

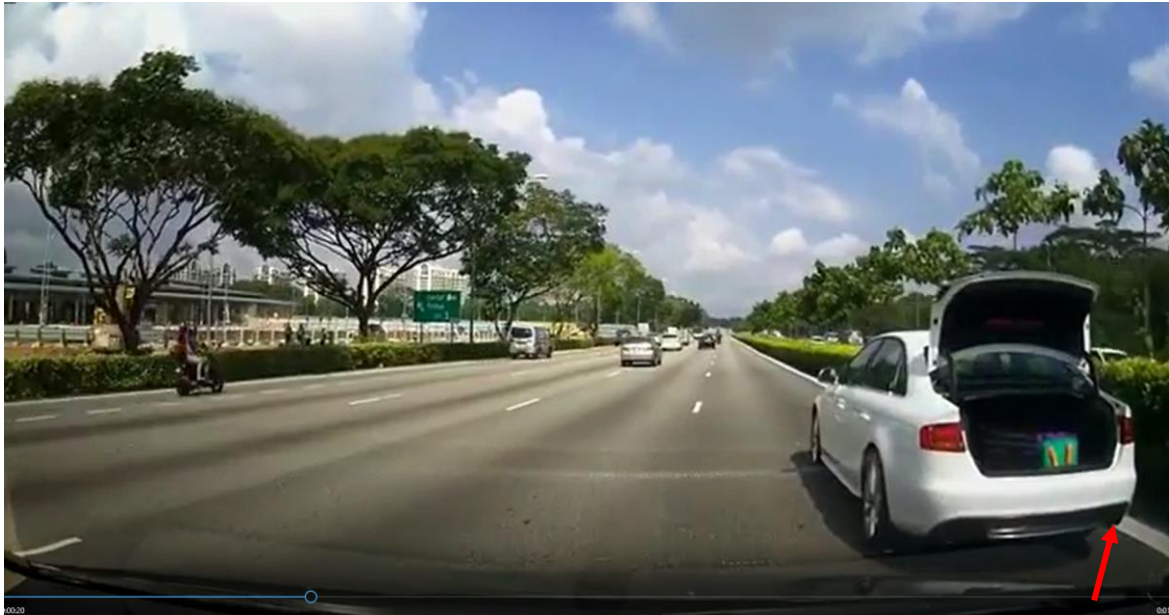
There was no reference to the warning lights until Mr. Zhiqiang felt a sudden power loss. This paragraph provides an explanation of what he did after he felt the power loss. As Mr. Zhiqiang claims that he was trying to move towards the shoulder of the road, the car would have been expected to be more on the left side of the lane, however as the arrow in photograph 1 shows, Mr. Zhiqiang had stopped the car closer to the right side of the lane. This photograph was taken from the video footage just before the impact. Envista cannot understand the process by which the car reached the right-hand lane when its driver intended it to be taken left.

1. The arrow indicates the car was stopped to the right edge of the lane
