Your Ref: TP/IP/ 26771/2021
Our Ref : CI/TPD21007264/P

2nd July 2021

MECHANICAL INSPECTION REPORT OF MOTOR VAN GP 6563K

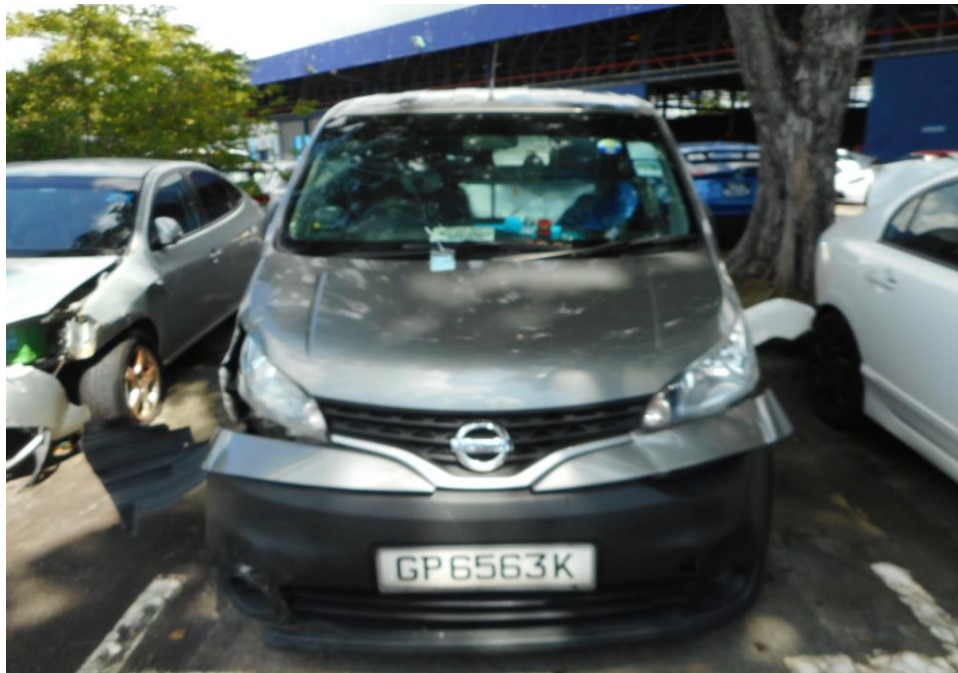
4. The mileage of the Motor Van at the time of my inspection was not recorded as the Motor Van was not started due the damaged the engine had sustained as a result of the accident.
5. The Motor Van was observed to have sustained damage at its front portion. Its front windscreen, front bonnet, front bumper, front left and right fender and various engine components were amongst the body parts that were damaged as a result of the accident.

Photo 1 shows a general view of the Motor Van's front body at the time of my inspection. The Motor Van was observed to have sustained damage at front portion. Its front windscreen, front bonnet, front bumper, front left and right fender and various engine components were amongst the body parts that were damaged as a result of the accident.

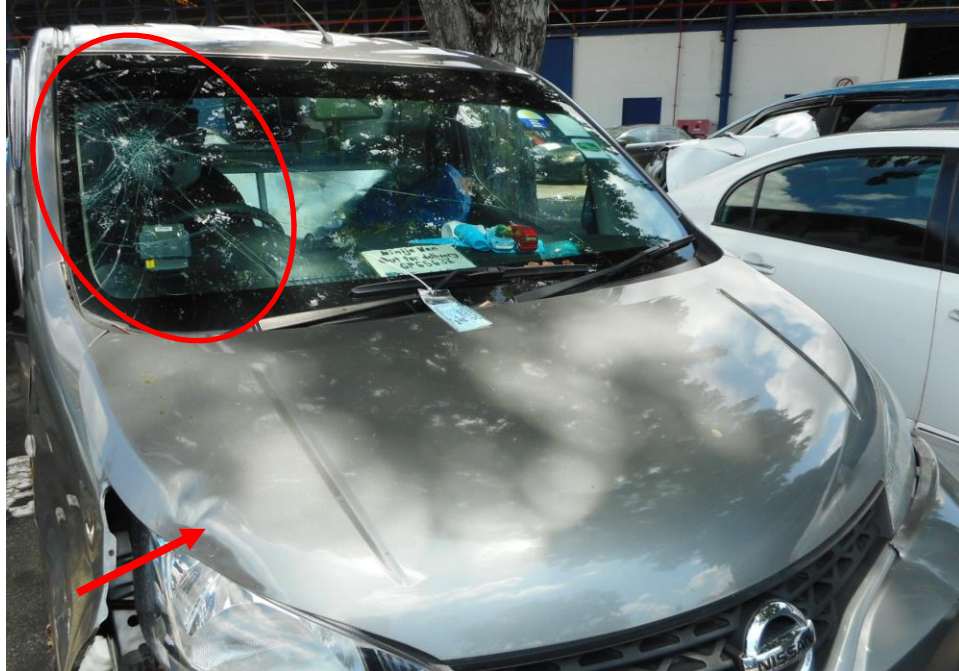
Photo 2 shows the close up view of the Motor Van's front body at the time of my inspection. The Motor Van was observed to have sustained damage at its front portion. Its front bonnet (arrowed) and front windscreen (circled) were amongst the body parts that were damaged as a result of the accident.

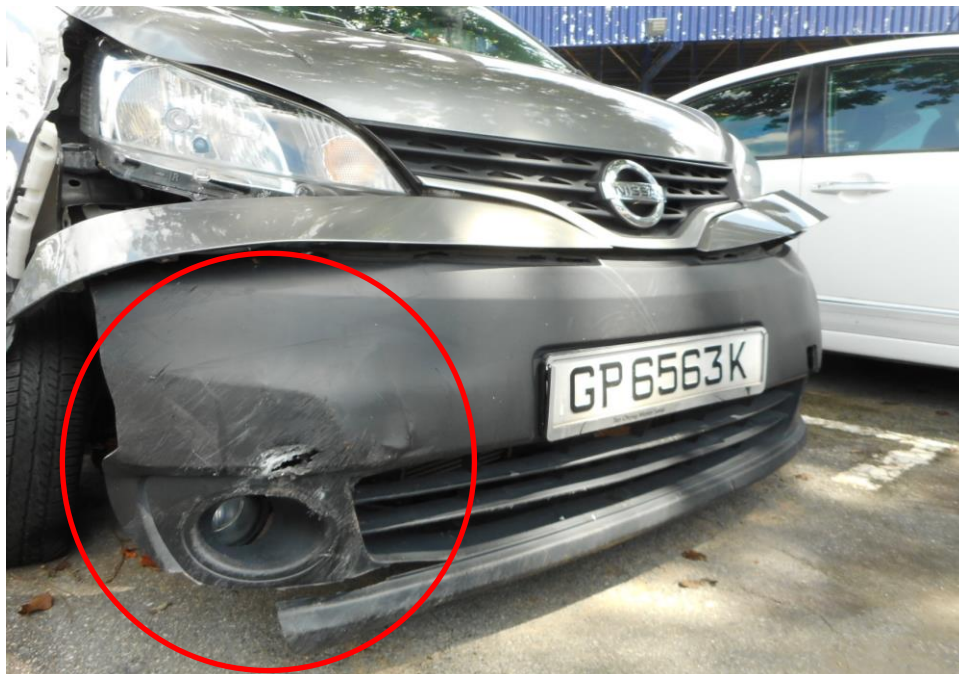
Photo 3 shows the close up view of the Motor Van's front body at the time of my inspection. The Motor Van was observed to have sustained damage at its front portion. Its front bumper (circled) were amongst the body parts that were damaged as a result of the accident.

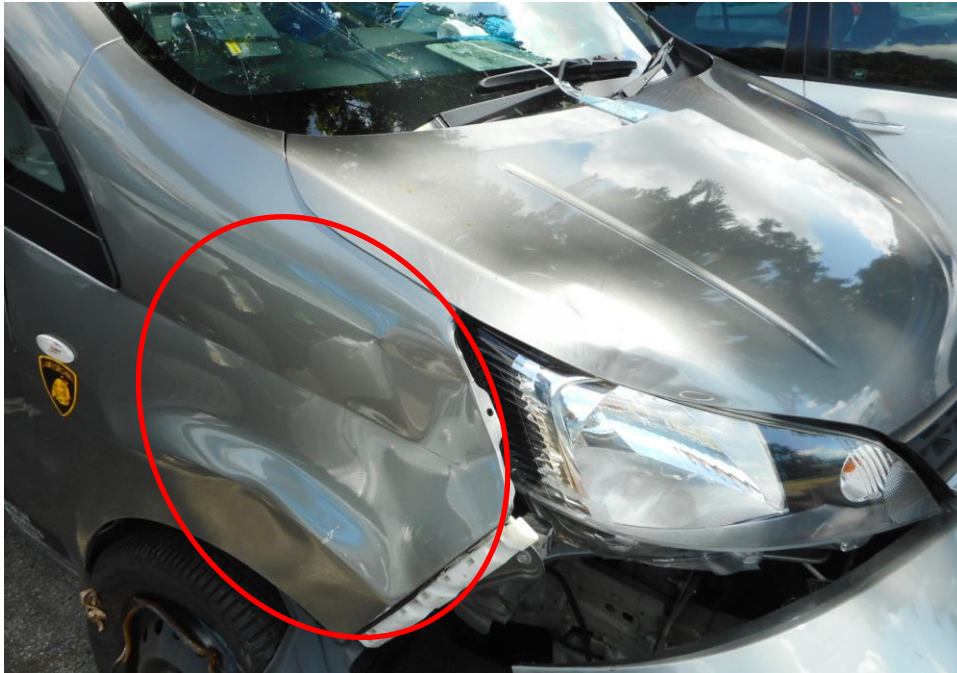
Photo 4 shows the close up view of the Motor Van's front body at the time of my inspection. The Motor Van was observed to have sustained damage at its front portion. Its front right fender (circled) were amongst the body parts that were damaged as a result of the accident.

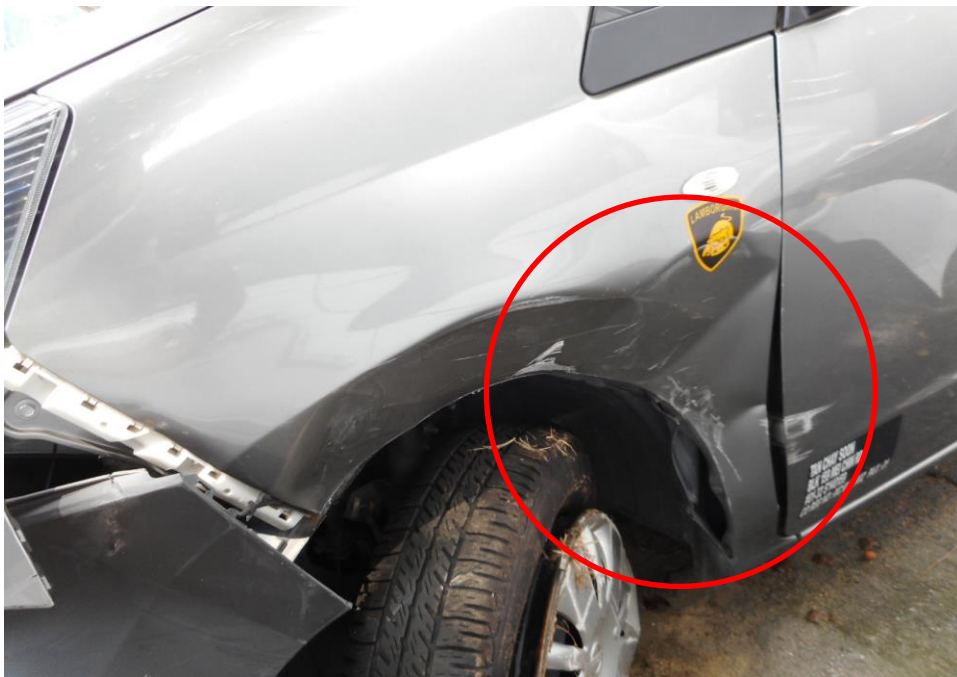
Photo 5 shows the close up view of the Motor Van's front body at the time of my inspection. The Motor Van was observed to have sustained damage at its front portion. Its front left fender (circled) were amongst the body parts that were damaged as a result of the accident.

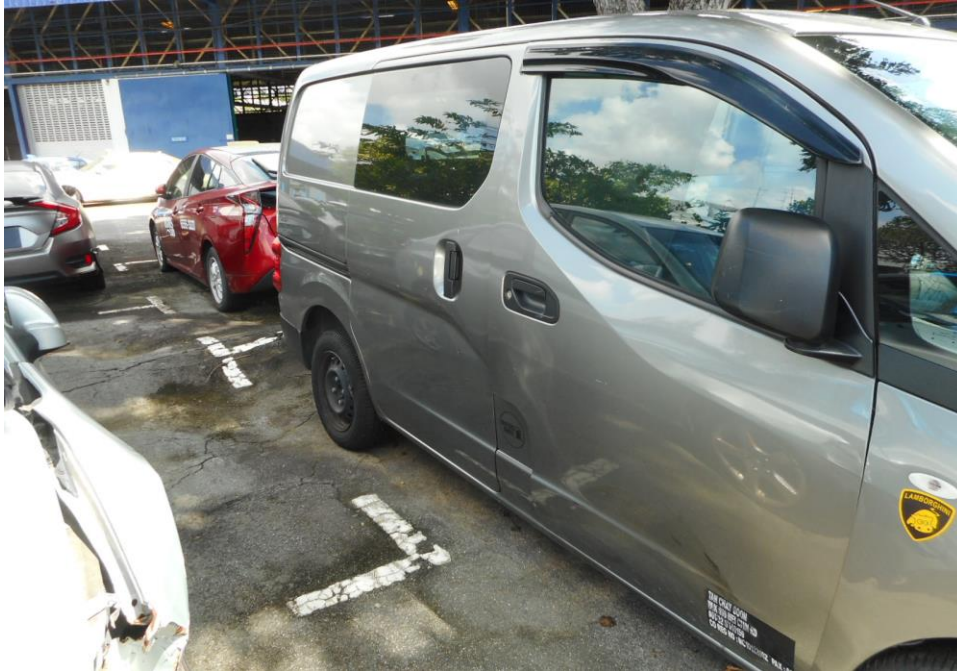
Photo 6 shows a general view of the Motor Van's right body at the time of my inspection. The right portion of the Motor Van was observed to have been unaffected by the accident.

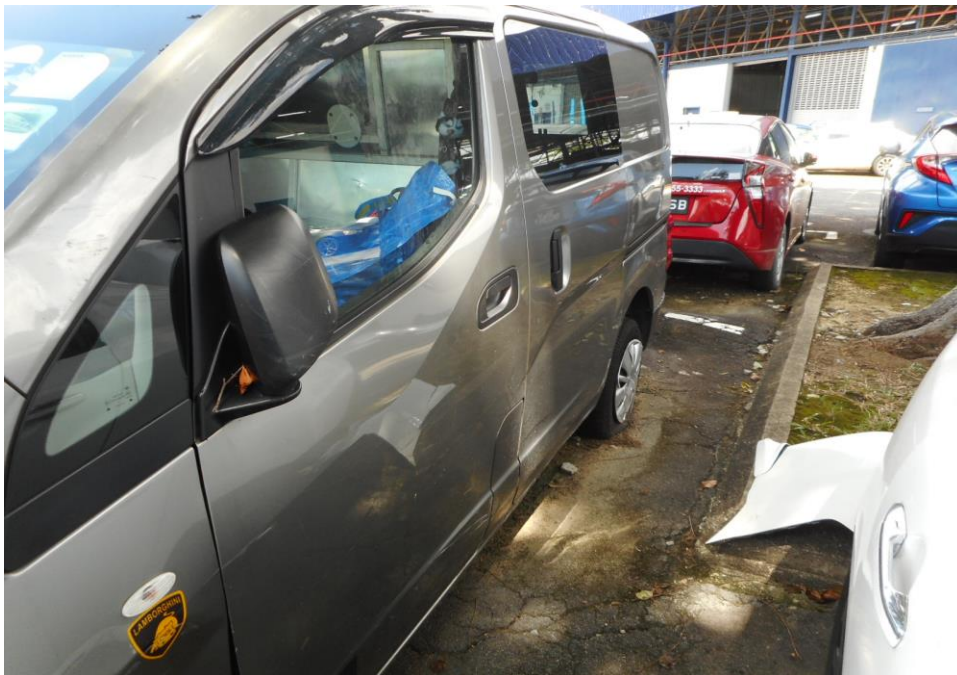
Photo 7 shows a general view of the Motor Van's left body at the time of my inspection. The left portion of the Motor Van was observed to have been unaffected by the accident.

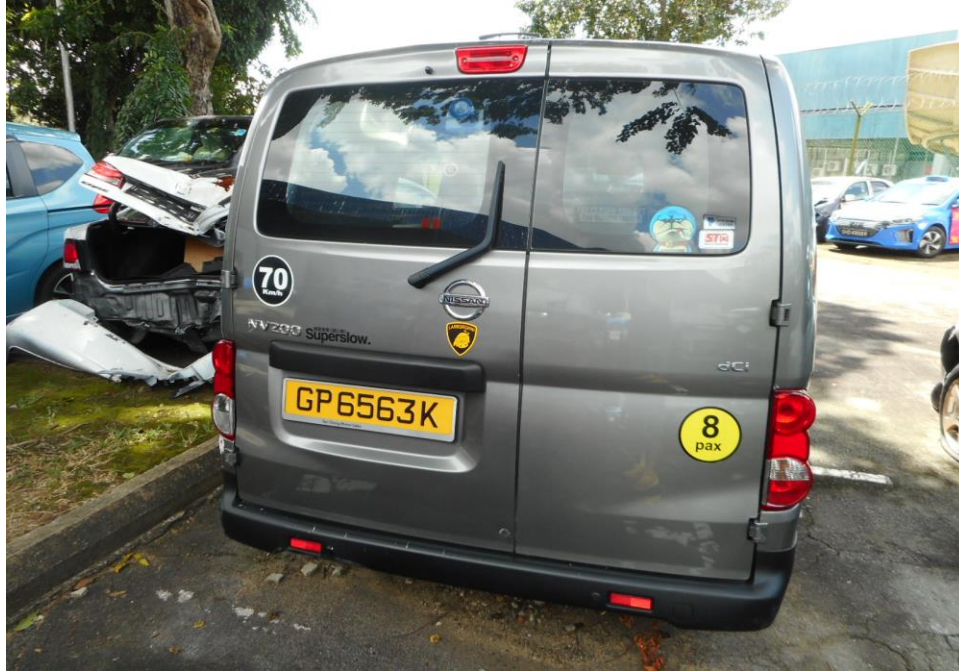
Photo 8 shows the general view of the Motor Van's rear body at the time of my inspection. The Motor Van rear was observed to be unaffected by the accident.

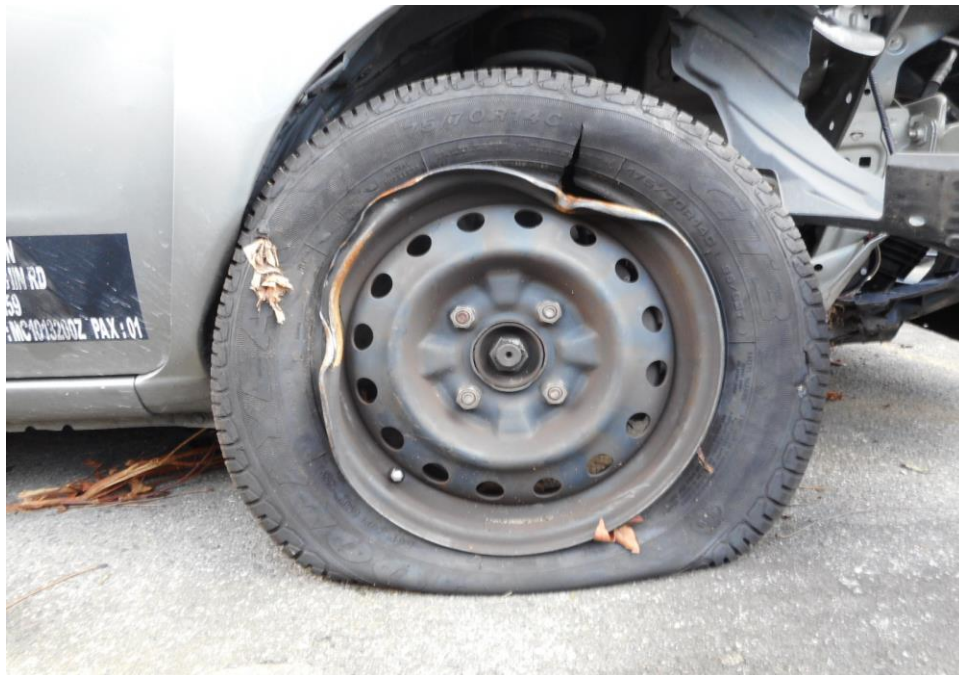
Photo 9 shows the condition of the front right tyre of the Motor Van, which was observed to be unserviceable condition with remaining tread depth of approximately 4.7mm. The tyre was observed with cut mark(s) on the outer sidewalls and there was damage observed on the wheel rims as a result of the accident.

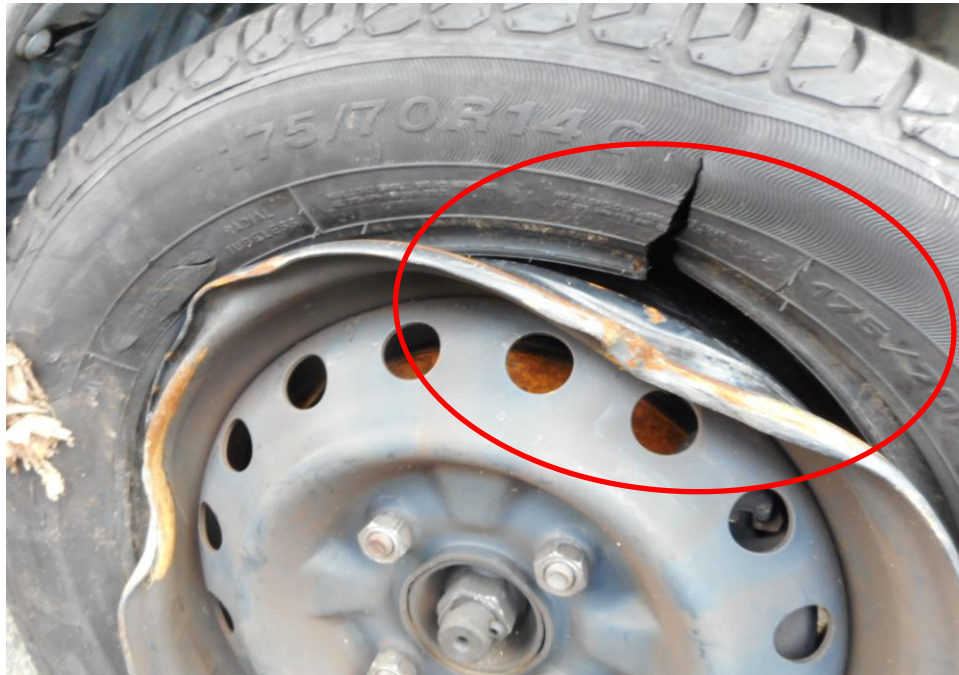
Photo 10 shows the close up view of the condition of the front right tyre of the Motor Van, which was observed to be unserviceable condition with remaining tread depth of approximately 4.7mm. The tyre was observed with cut mark(s) on the outer sidewalls and there was damage observed on the wheel rims (circled) as a result of the accident.

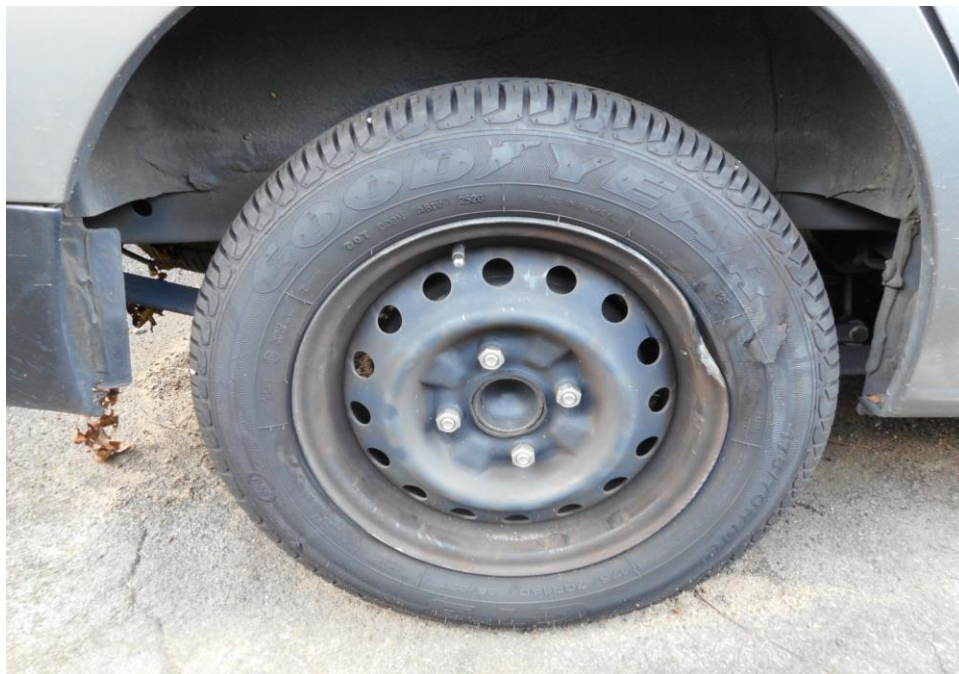
Photo 11 shows the condition of the rear right tyre of the Motor Van, which was observed to be in serviceable condition with remaining tread depth of approximately 6.5mm. The tyre was observed with cut marks and wheel rim damage as a result of the accident, however it was observed to be sufficiently inflated for vehicular operation

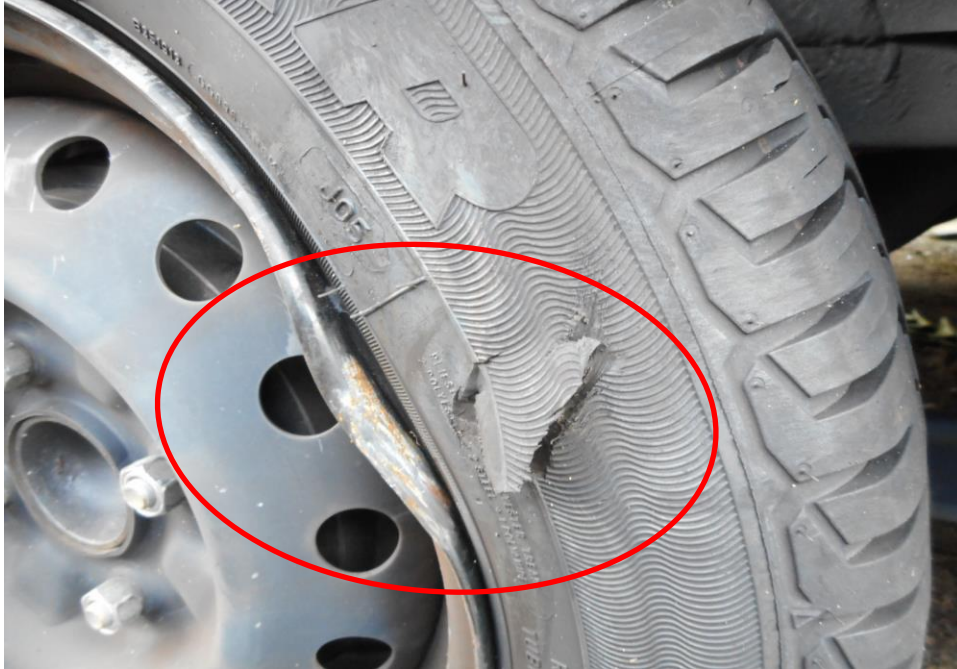
Photo 12 shows the close up view of the condition of the rear right tyre of the Motor Van, which was observed to be in serviceable condition with remaining tread depth of approximately 6.5mm. The tyre was observed with cut marks and wheel rim damage (circled) as a result of the accident, however it was observed to be sufficiently inflated for vehicular operation

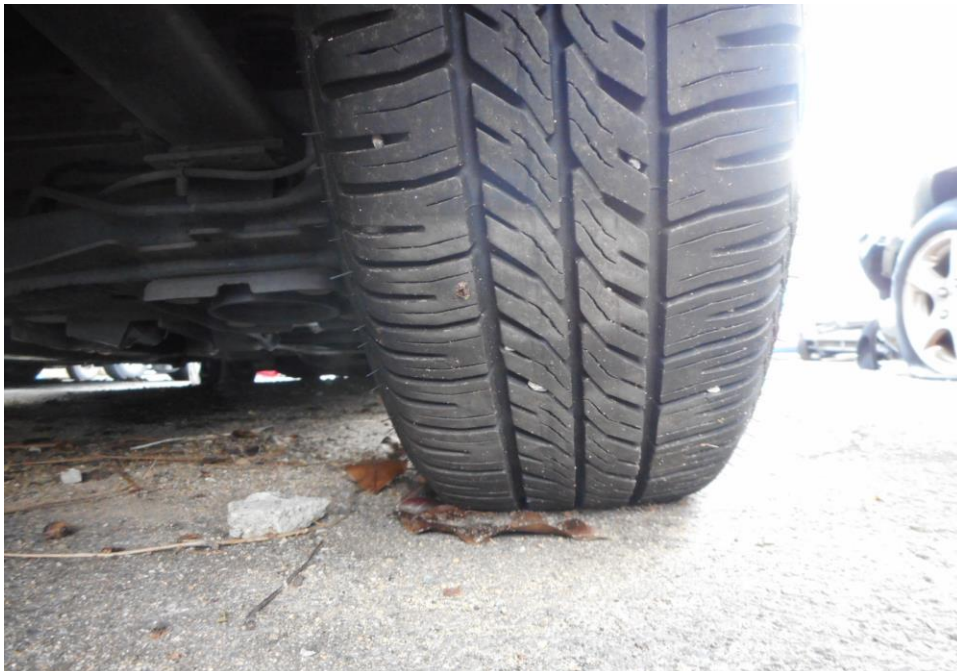
Photo 13 shows the condition of the rear right tyre of the Motor Van, which was observed to be in serviceable condition. The tyre was observed with cut marks and wheel rim damage as a result of the accident, however it was observed to be sufficiently inflated for vehicular operation

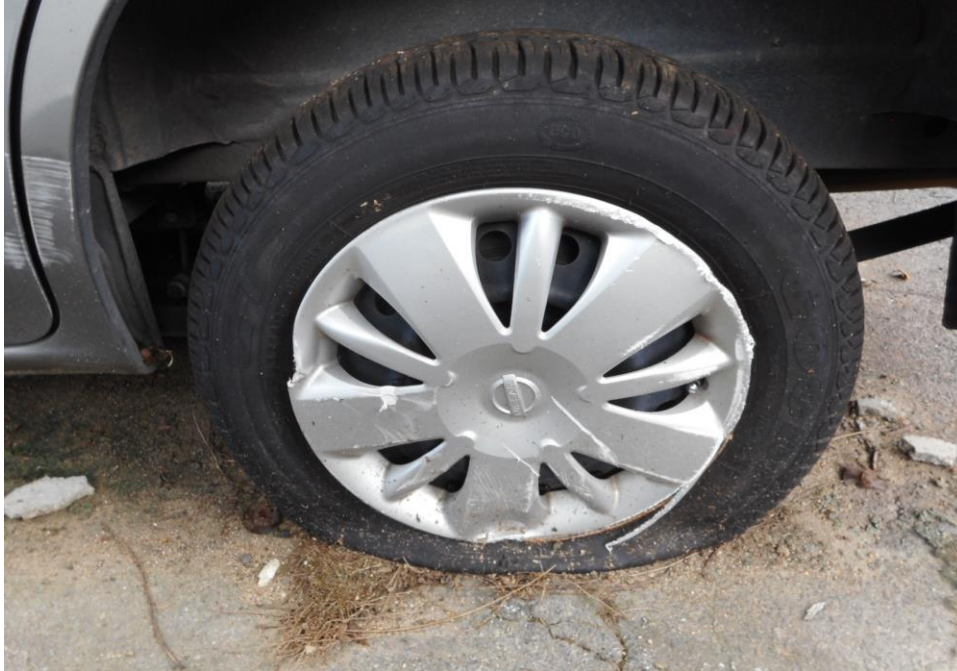
Photo 14 shows the condition of the rear left tyre of the Motor Van, which was observed to be unserviceable condition with remaining tread depth of approximately 5.7mm. The tyre was observed with cut mark(s) on the outer sidewalls and there was damage observed on the wheel rims as a result of the accident.

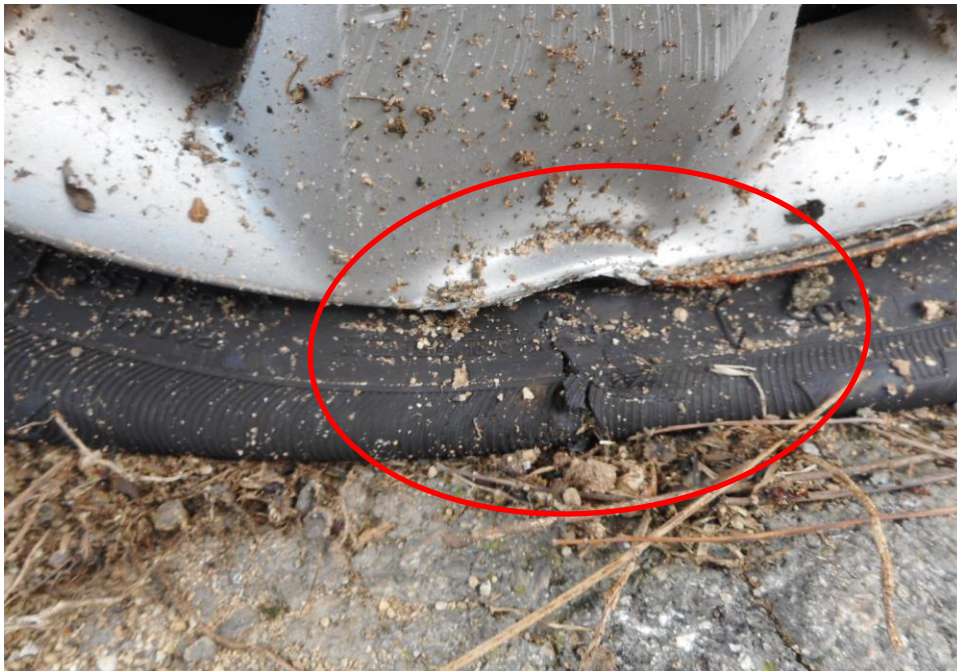
Photo 15 shows the close up view of the condition of the rear left tyre of the Motor Van, which was observed to be unserviceable condition with remaining tread depth of approximately 5.7mm. The tyre was observed with cut mark(s) on the outer sidewalls and there was damage observed on the wheel rims (circled) as a result of the accident.

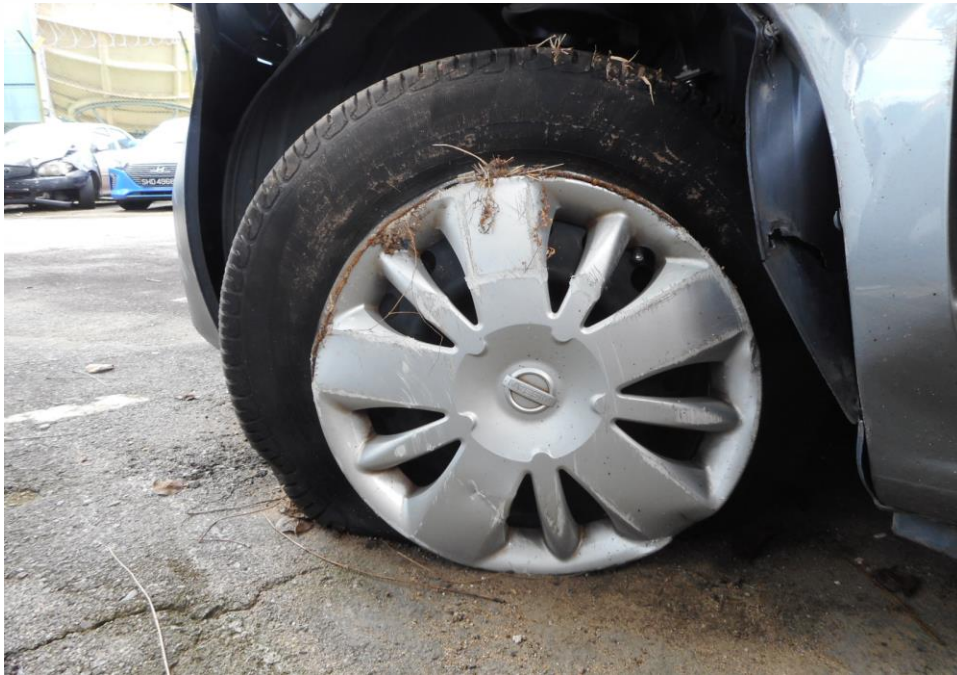
Photo 16 shows the condition of the front left tyre of the Motor Van, which was observed to be unserviceable condition with remaining tread depth of approximately 3.9mm. The tyre was observed to slip out the wheel rim and there was damage observed on the wheel rims as a result of the accident.

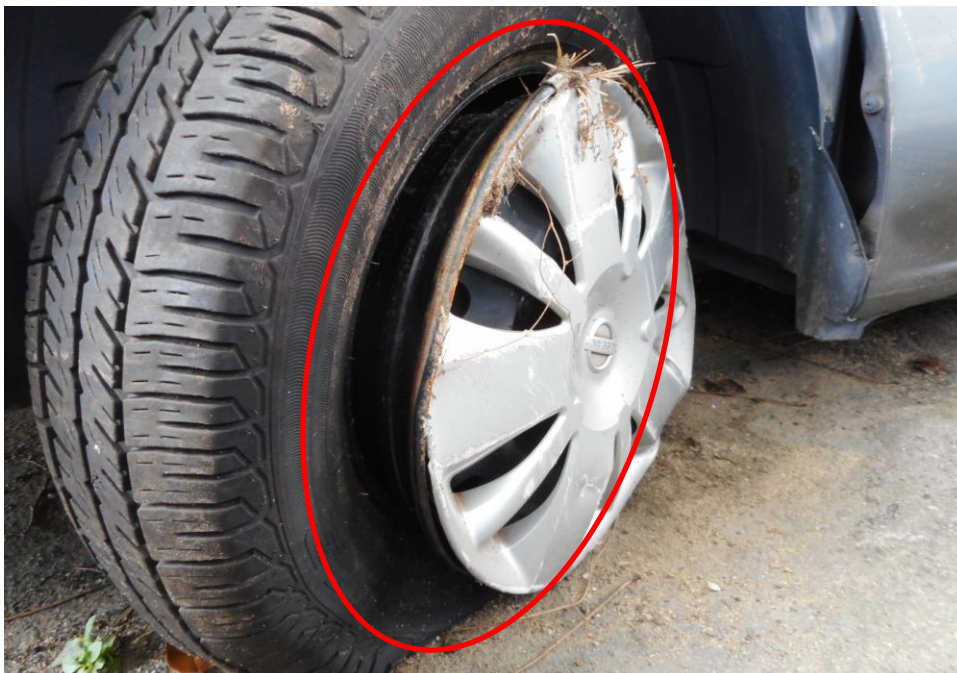
Photo 17 shows the close up view of the condition of the front left tyre of the Motor Van, which was observed to be unserviceable condition with remaining tread depth of approximately 3.9mm. The tyre was observed to slip out the wheel rim and there was damage observed on the wheel rims (circled) as a result of the accident.

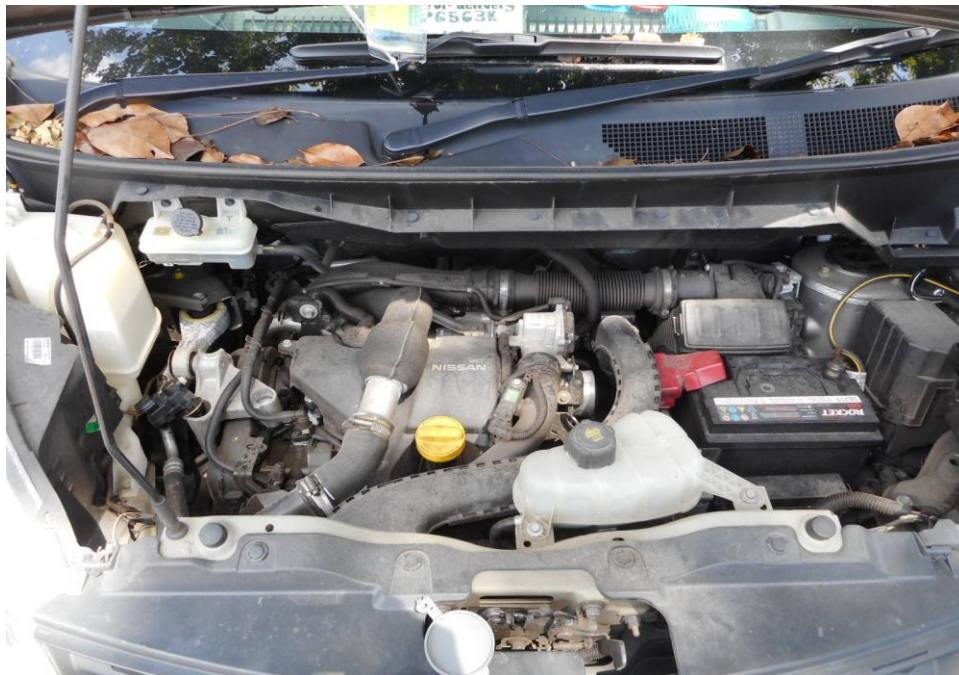
10. Further examination of the engine compartment revealed no sign(s) or indication(s) of fluid leakage and/or fluid stain within the engine compartment of the Motor Van.

Photo 18 shows a general view of the Motor Van's engine compartment. The various parts and components inside the engine compartment were unaffected by the accident. There was also no sign(s) or indication(s) of fluid leakage and/or fluid stain within the engine compartment.

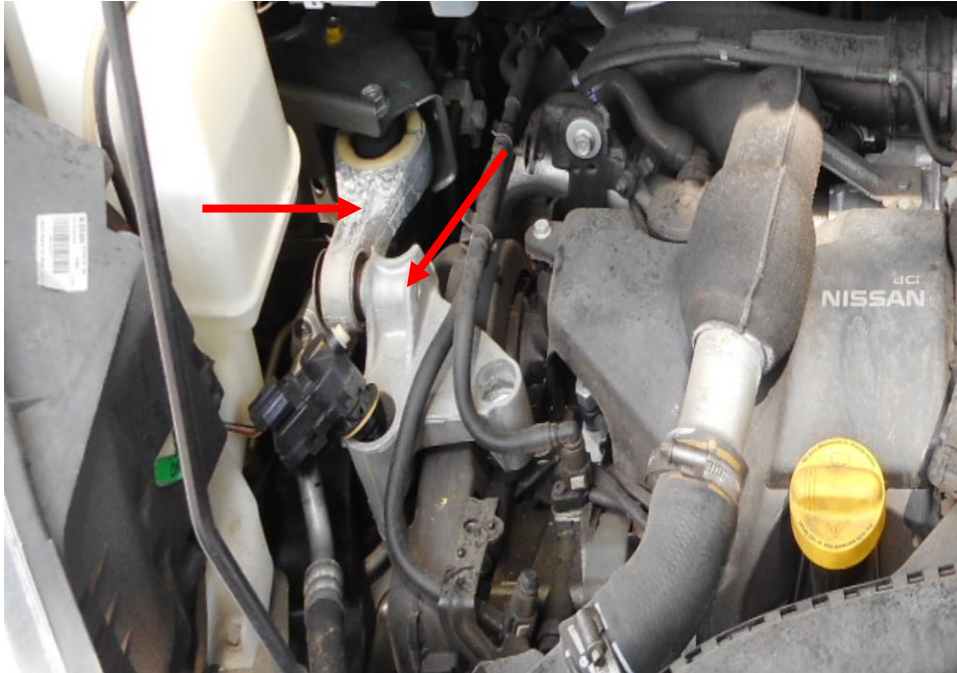
8. Upon examination of the engine compartment of the Motor Van, I had observed that the mounting of the engine was damaged as a result of the accident and caused the engine to fall to the bottom. However, all the parts and components inside the engine compartment to be intact and unaffected by the accident.

Photo 19 shows the engine mounting of the Motor Van at the time of my inspection. The mounting (arrowed) was observed to be damaged and broken off from the engine as a result of the accident and caused the engine to fall to the bottom.

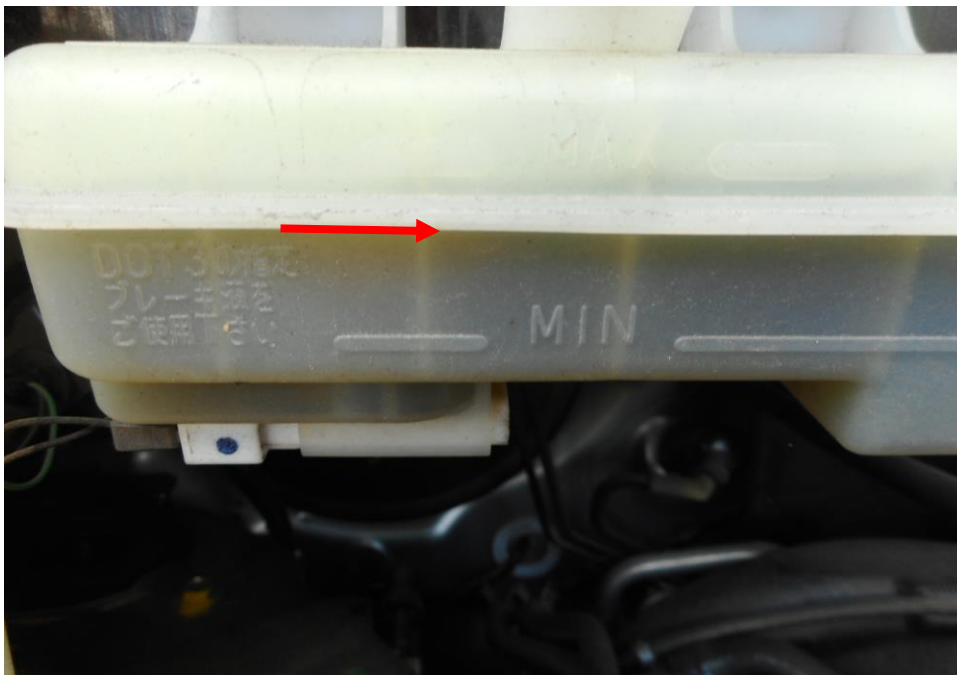
Photo 20 shows the brake fluid reservoir of the Motor Van at the time of my inspection. The brake fluid was observed to be of sufficient level (arrowed) and without any visible contamination.

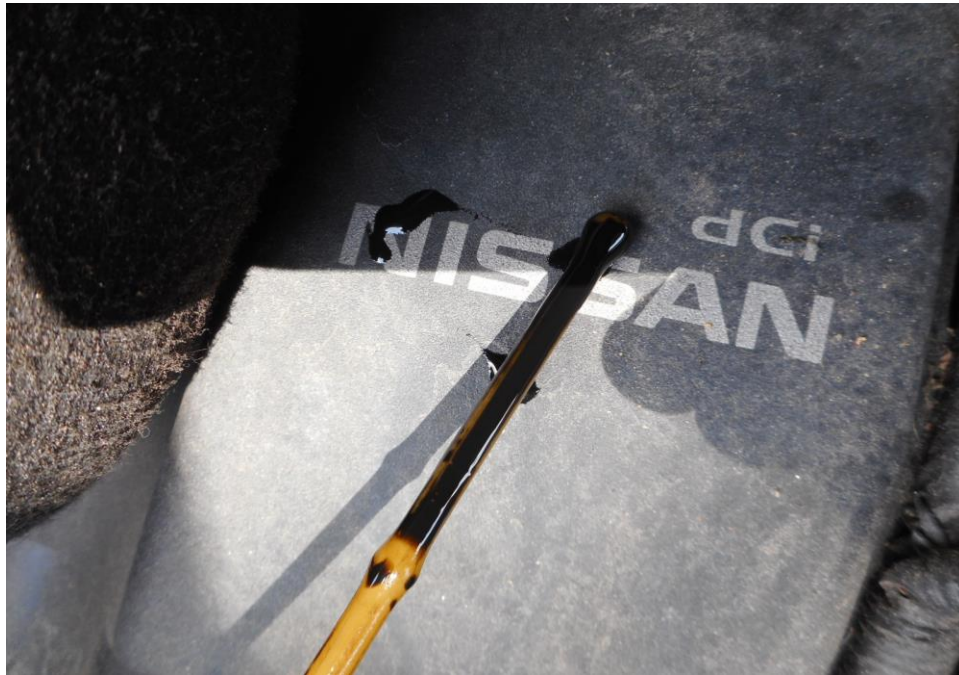
Photo 21 shows the engine oil dip stick of the Motor Van at the time of my inspection. The engine oil was observed to be of sufficient level and without any visible contamination.

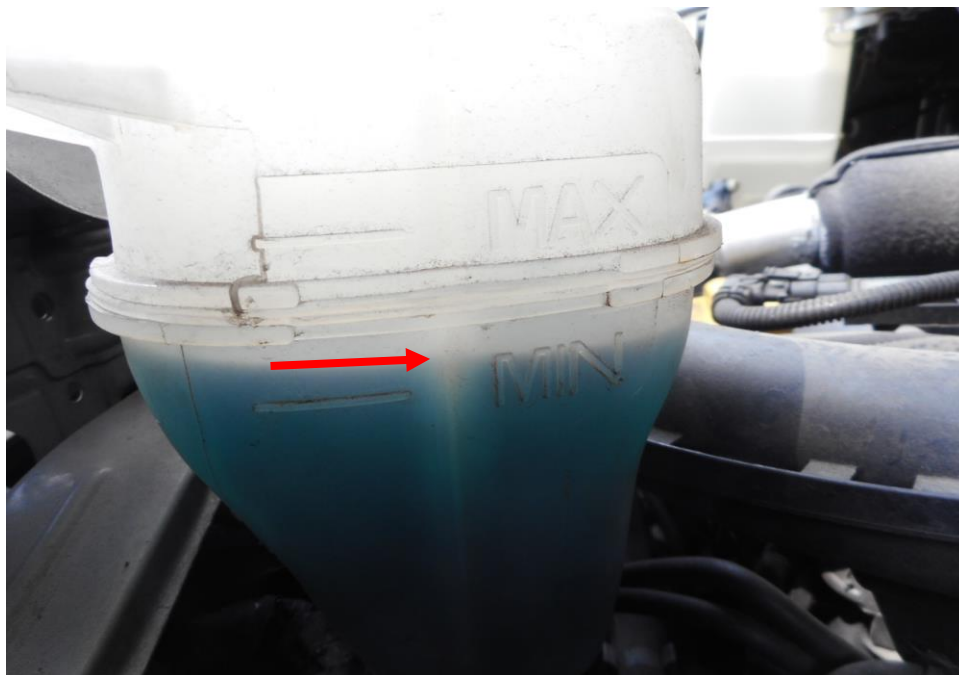
Photo 22 shows checks being carried out to the engine coolant of the Motor Van at the time of my inspection. The engine coolant was observed to be of sufficient level (arrowed) and without any visible contamination.

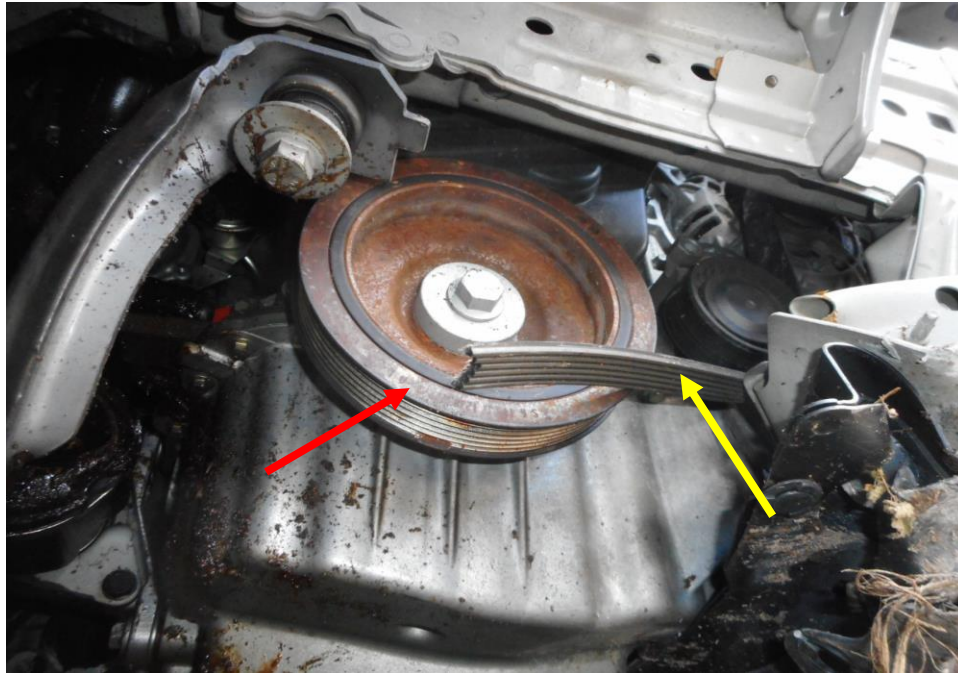
11. My subsequent checks on the underside of the Motor Van revealed that the engine crankshaft and crankshaft timing belt had sustained damaged as a result of the accident. Visually, the other various undercarriage components of the Motor Van were all observed to be intact and without any visible damage. See photo 18 – 23 below.

Photo 23 shows the underside of the Motor Van at the time of my inspection. The engine crankshaft timing bet (yellow arrow) and the engine crankshaft was damaged (red arrow) as a result of the accident.

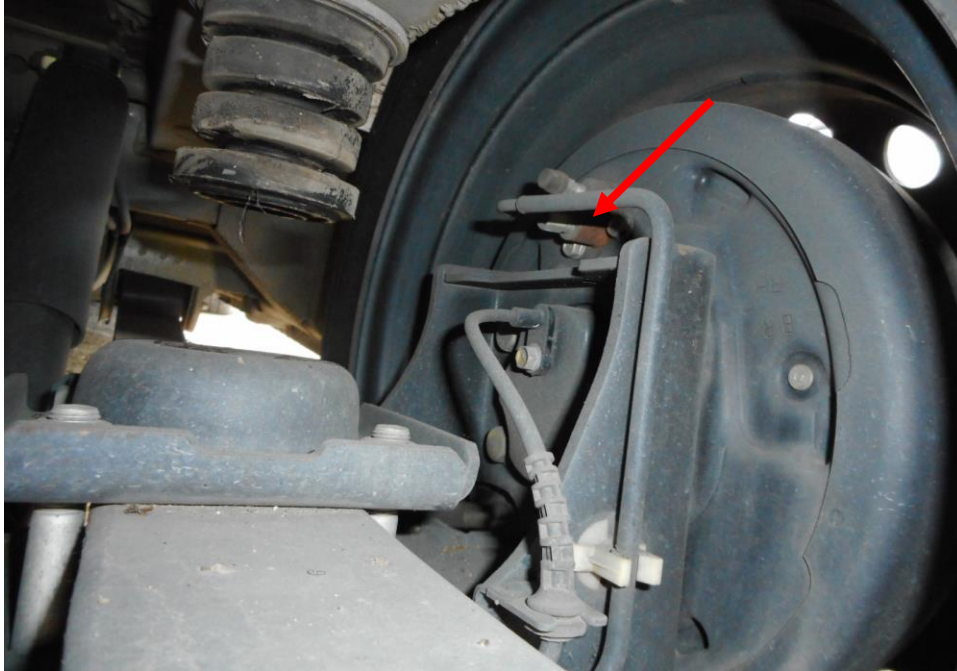
Photo 24 shows the brake hose/pipe (arrowed) at the rear right wheel of the Motor Van. No leakage of brake fluid was observed. Visual examination of the various components of the braking system like the drum brake, brake booster, brake pedal etc. had revealed all to be intact and without visible damage.

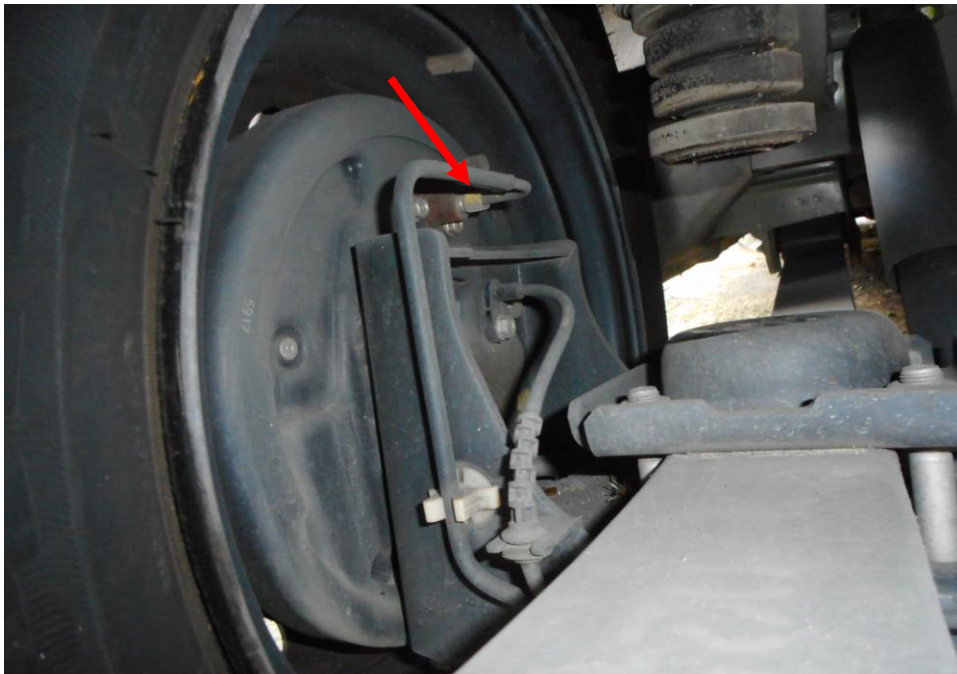
Photo 25 shows the brake hose/pipe (arrowed) at the rear left wheel of the Motor Van. I did not observe any leakage of brake fluid at the time of my inspection of the Motor Van. Static tests of the Motor Van's braking system had indicated that there was no internal leakage of pressure/vacuum. The undercarriage components of the Motor Van were also all found to be intact and without any visible damage.

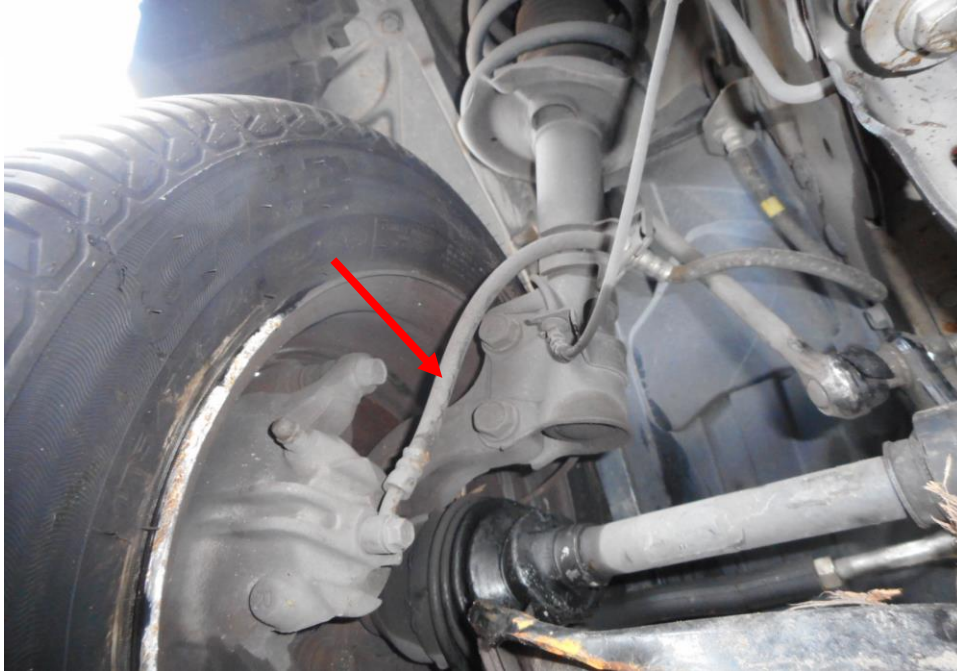
Photo 26 shows the brake hose/pipe (arrowed) at the front right wheel of the Motor Van. I did not observe any leakage of brake fluid at the time of my inspection of the Motor Van. Static tests of the Motor Van's braking system had indicated that there was no internal leakage of pressure/vacuum. The undercarriage components of the Motor Van were also all found to be intact and without any visible damage.

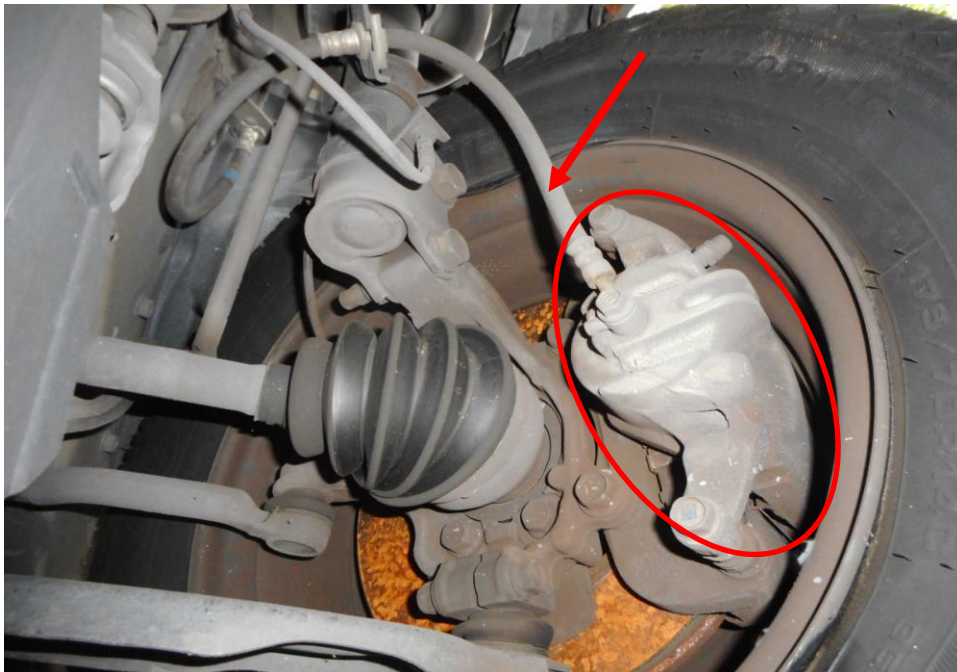
Photo 27 shows the brake hose/pipe (arrowed) at the front left wheel of the Motor Van. No leakage of brake fluid was observed. Visual examination of the various components of the braking system like the brake caliper (circled), brake booster, brake pedal etc had revealed all to be intact and without visible damage.

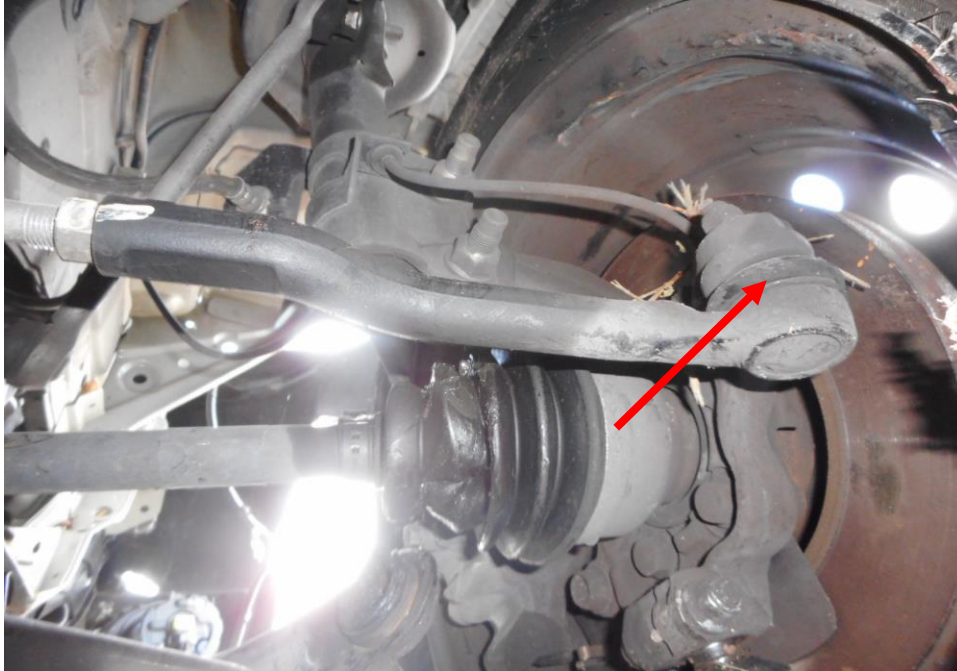
Photo 28 shows the various undercarriage components at the front right wheel of the Motor Van, in particular the steering tie rod (red arrow). The various steering components were all found to be intact, suggesting that the steering system of the Motor Van was likely to be in serviceable condition at the material time of accident. There was also no sign of fluid stain observed on the various undercarriage components at the front right wheel of the Motor Van.

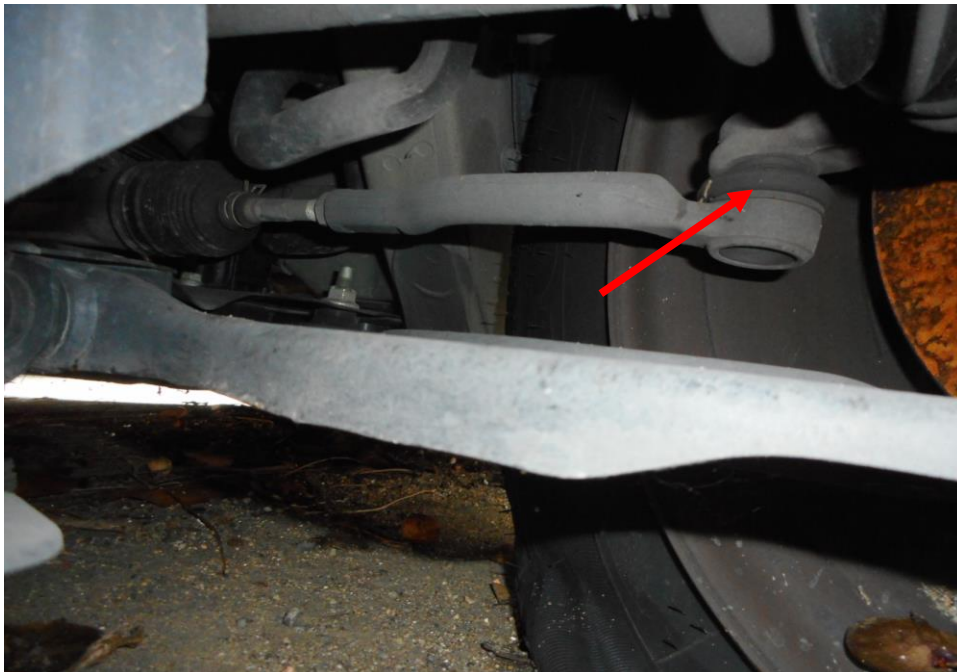
Photo 29 shows the various undercarriage components at the front left wheel of the Motor Van, in particular the steering tie rod (red arrow). The various steering components were all found to be intact, suggesting that the steering system of the Motor Van was likely to be in serviceable condition at the material time of accident. There was also no sign of fluid stain observed on the various undercarriage components at the front left wheel of the Motor Van.

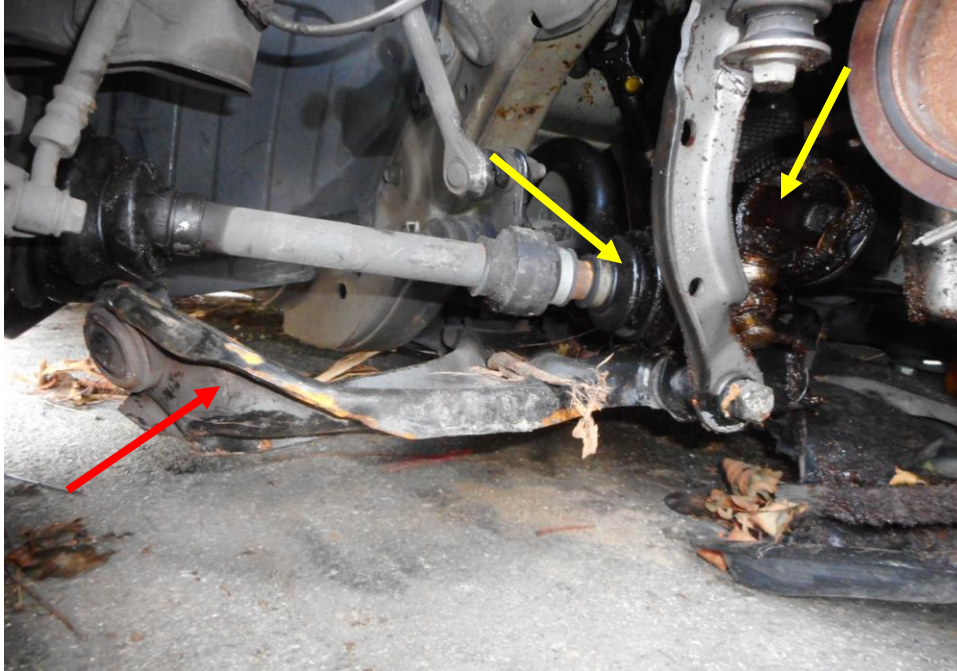
14. We have observed that the Motor Van's front right control arm and front right driveshaft was damaged as a result of the accident. See photo 24 - 30 below.

Photo 30 shows the various undercarriage components at the front right wheel of the Motor Van, we observed that the front right control arm (red arrow) and front right driveshaft (yellow arrow) had sustained damage as a result of the accident.
