You're Ref: TP/IP/28149/2021  
Our Ref: CI/TPD21007266/P

**Fatal Accident Investigation Team**

**MECHANICAL INSPECTION REPORT OF MOTOR CAR SLK 2774L**

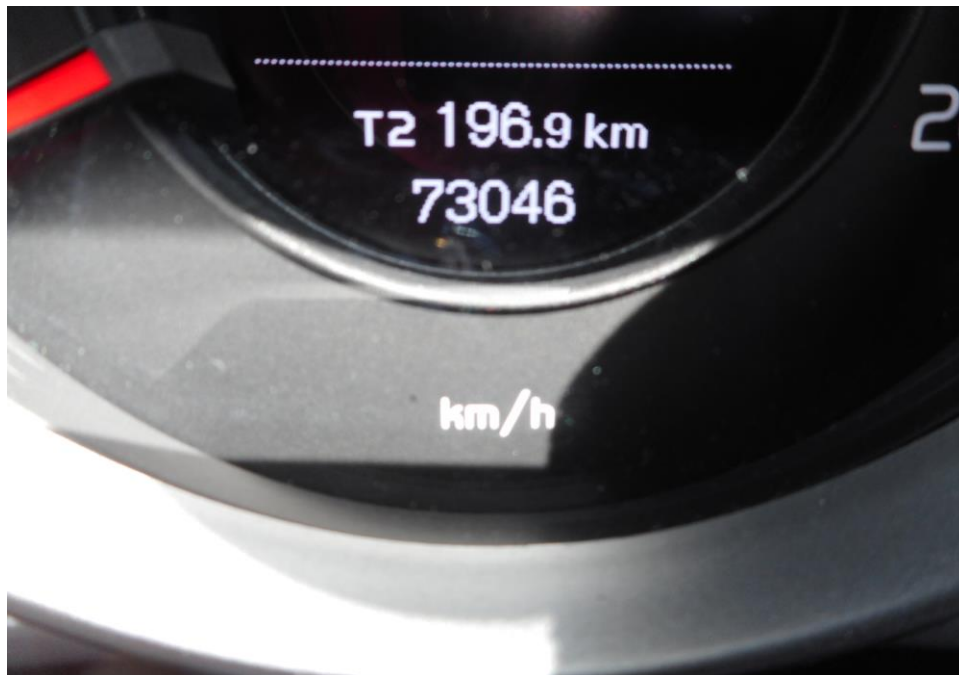
**Photo 1** shows the mileage of the Motor Car at the time of my inspection. The mileage observed was 73,046km.

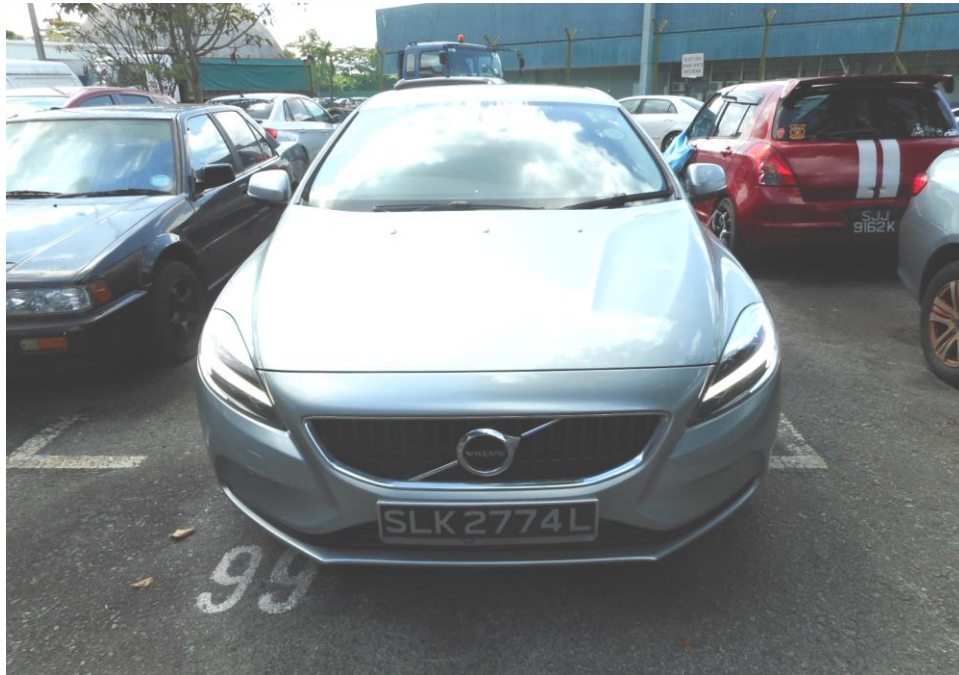
**Photo 2** shows a general view of the Motor Car's front body at the time of my inspection. The front portion of the Motor Car was observed to have sustained damage. Its front left fender was the body part that were damaged as a result of the accident.

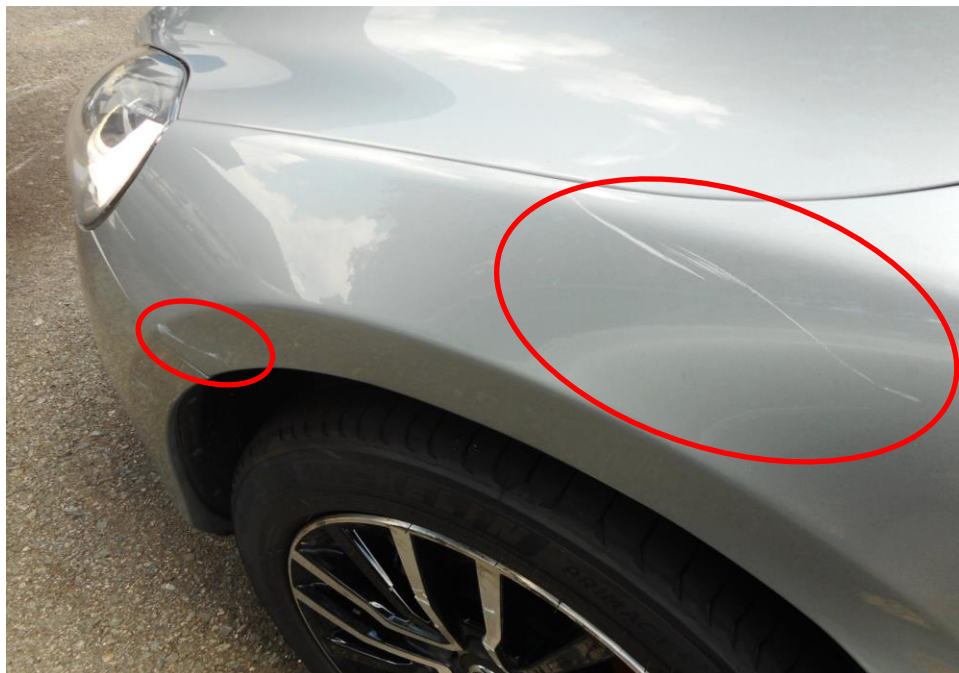
**Photo 3** shows a close up view of the Motor Car's front body at the time of my inspection. The front portion of the Motor Car was observed to have sustained damage. Its front left fender (circled) was the body part that were damaged as a result of the accident.

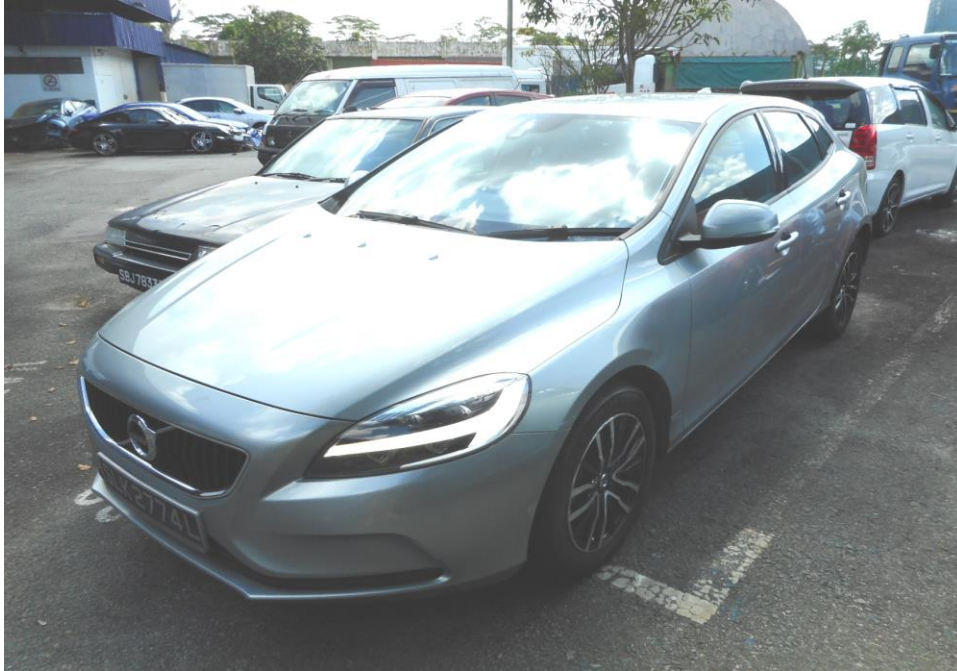
**Photo 4** shows a general view of the Motor Car's left body at the time of my inspection. The left portion of the Motor Car was observed to have been unaffected by the accident.

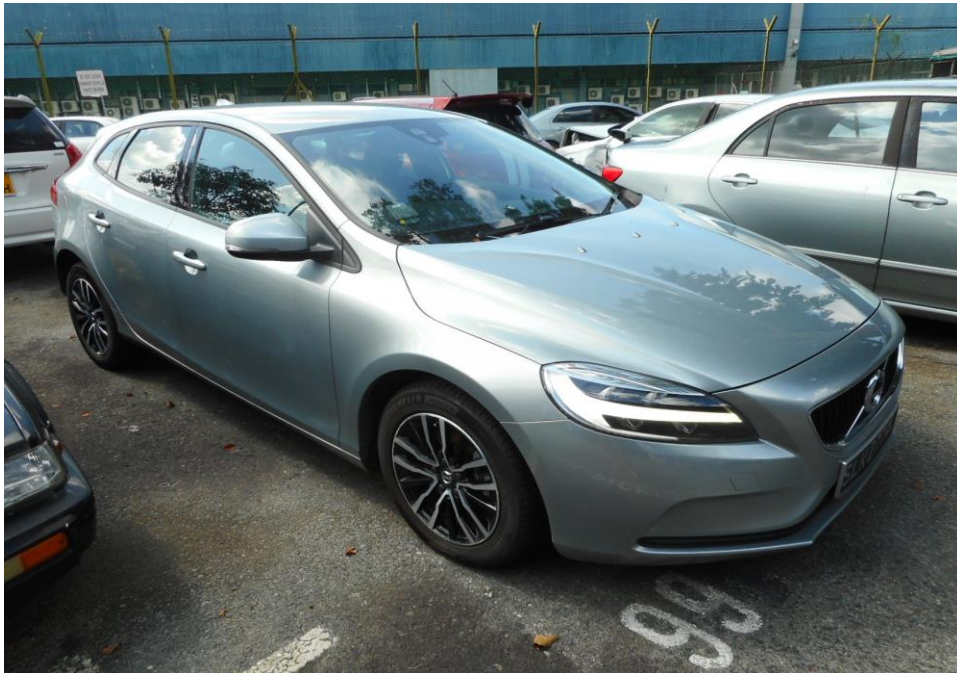
**Photo 5** shows a general view of the Motor Car's right body at the time of my inspection. The right portion of the Motor Car was observed to have been unaffected by the accident.

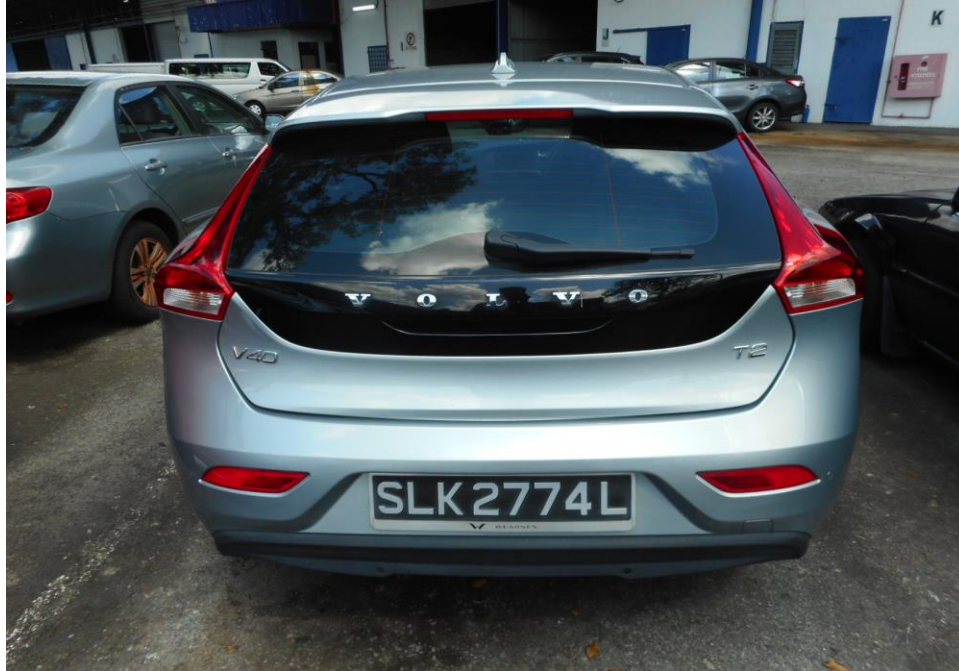
**Photo 6** shows the general view of the Motor Car's rear body at the time of my inspection. The Motor Car rear was observed to be unaffected by the accident.

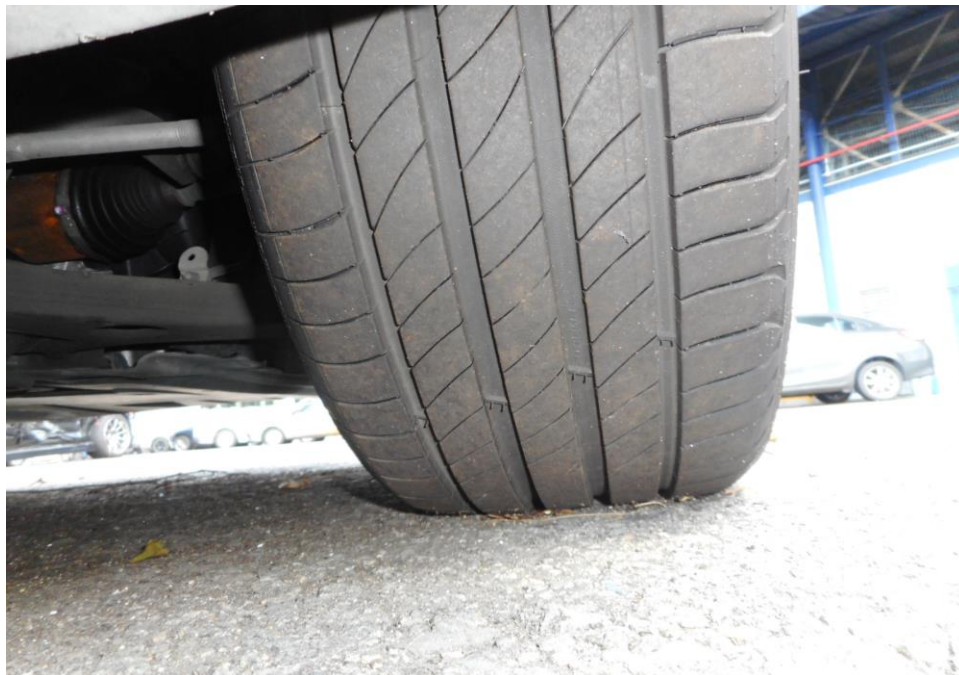
**Photo 7** shows the condition of the front right tyre of the Motor Car, which was observed to be in serviceable condition with remaining tread depth of approximately 6.2mm. The tyre was sufficiently inflated for vehicular operation with no tear, cut or burst mark(s) on the outer and the inner sidewalls as well as across the tread. The 4 tyres of the Motor Car were wrapped around standard steel wheel rims without any damage.

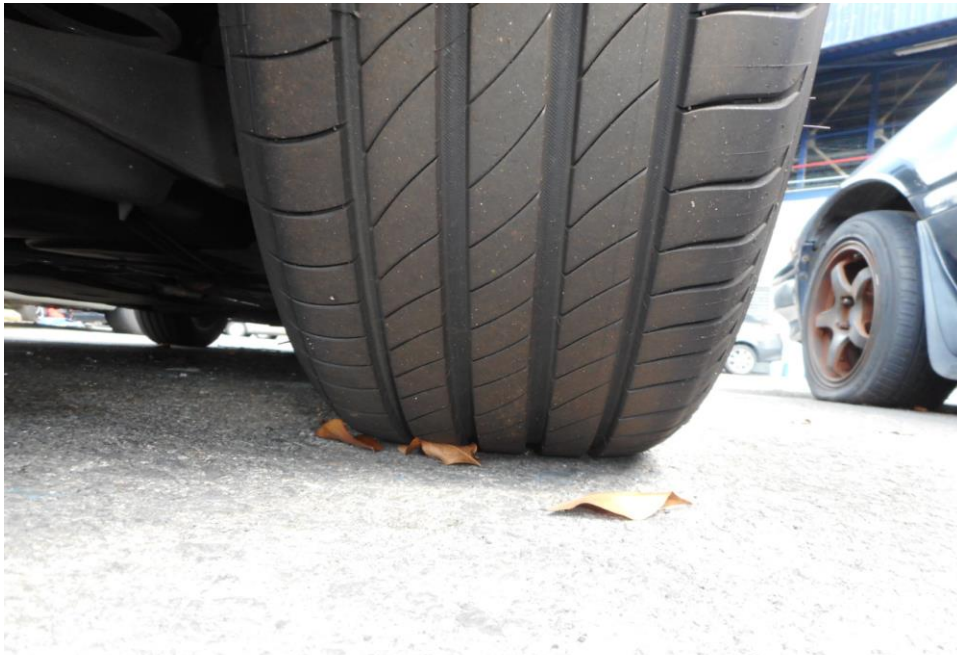
**Photo 8** shows the condition of the rear right tyre of the Motor Car, which was observed to be in serviceable condition with remaining tread depth of approximately 6.4mm. The tyre was also observed to be sufficiently inflated for vehicular operation with no tear, cut or burst mark(s).

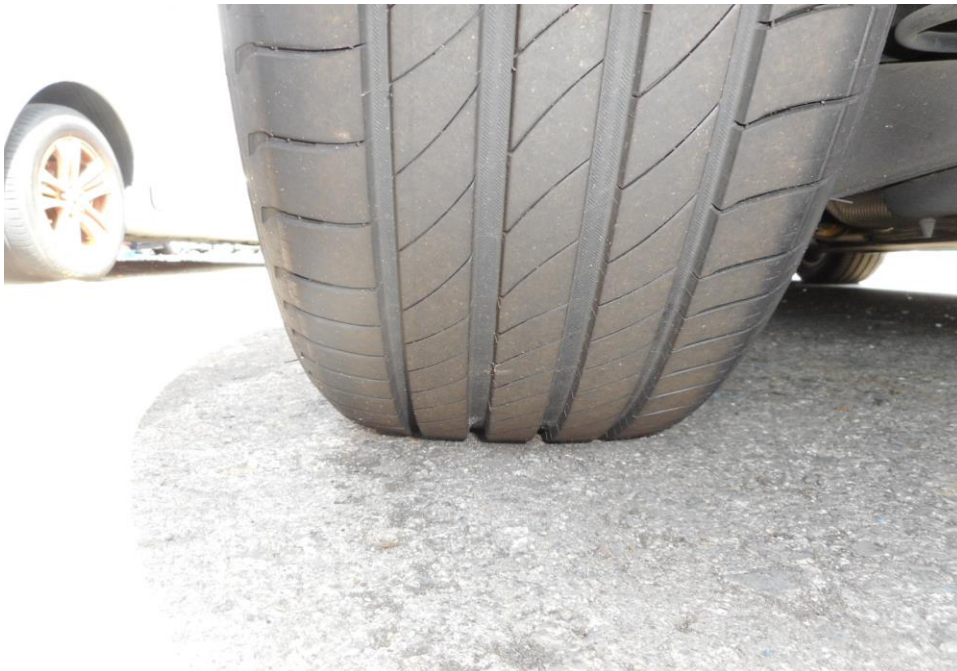
**Photo 9** shows the condition of the rear left tyre of the Motor Car, which was observed to be in serviceable condition with remaining tread depth of approximately 6.4mm. The tyre, which was wrapped around steel wheel rim, was also observed to be sufficiently inflated for vehicular operation. The 4 tyres of the Motor Car were wrapped around standard steel wheel rims.

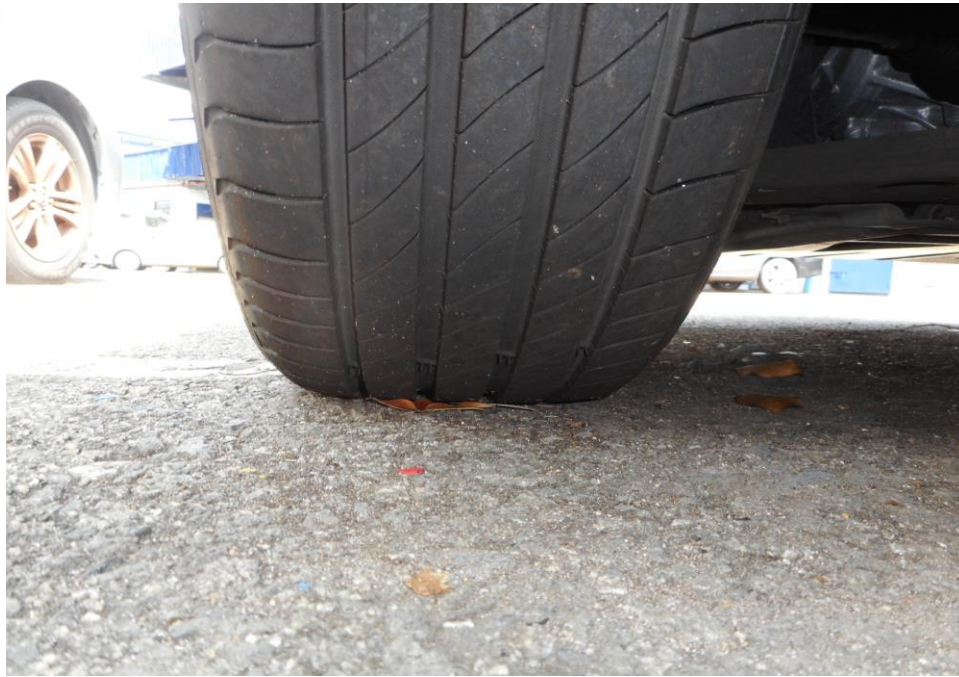
**Photo 10** shows the condition of the front left tyre of the Motor Car, which was observed to be in serviceable condition with remaining tread depth of approximately 6mm. There was also no tear, cut or burst mark(s) on the outer and the inner sidewalls as well as across the tread of the Motor Car's 4 tyres.

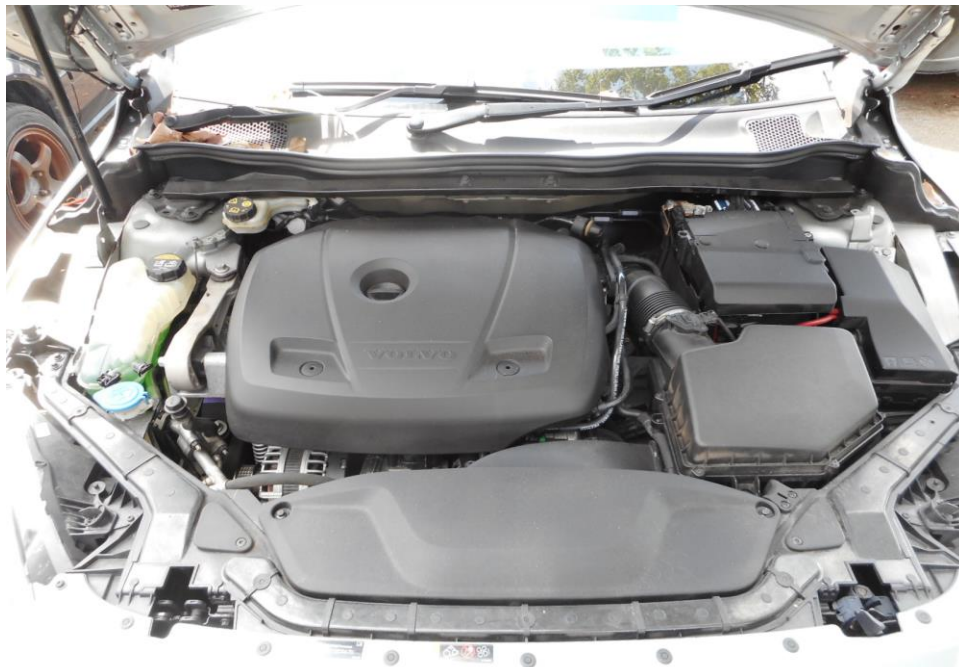
**Photo 11** shows a general view of the Motor Car's engine compartment. The various parts and components inside the engine compartment were unaffected by the accident. There was also no sign(s) or indication(s) of fluid leakage and/or fluid stain within the engine compartment.

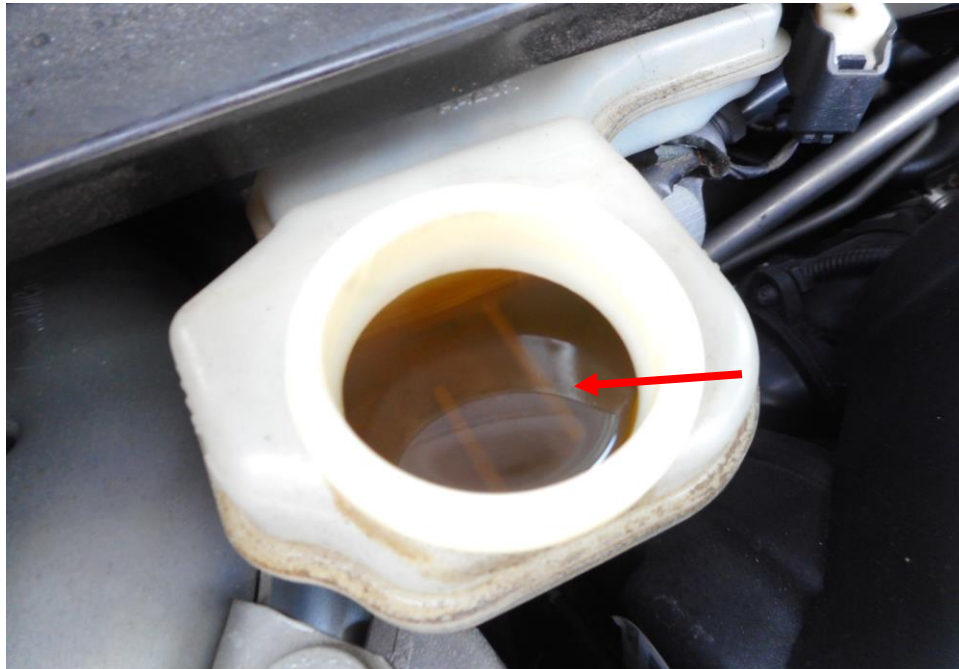
**Photo 12** shows the brake fluid reservoir of the Motor Car at the time of my inspection. The brake fluid was observed to be of sufficient level (arrowed) and without any visible contamination.

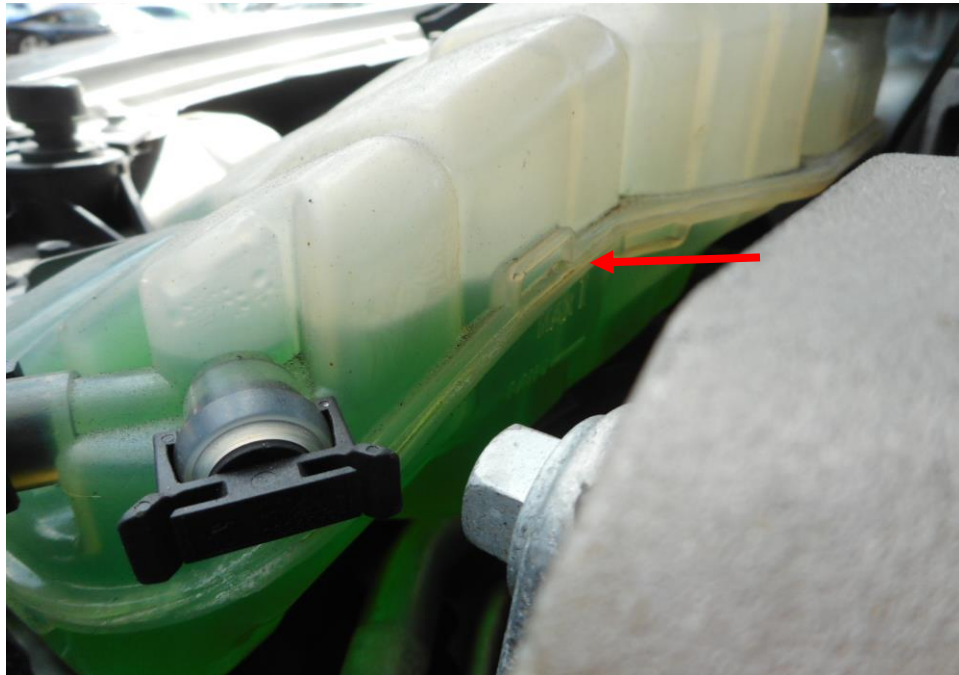
**Photo 13** shows checks being carried out to the engine coolant of the Motor Car at the time of my inspection. The engine coolant was observed to be of sufficient level (arrowed) and without any visible contamination.

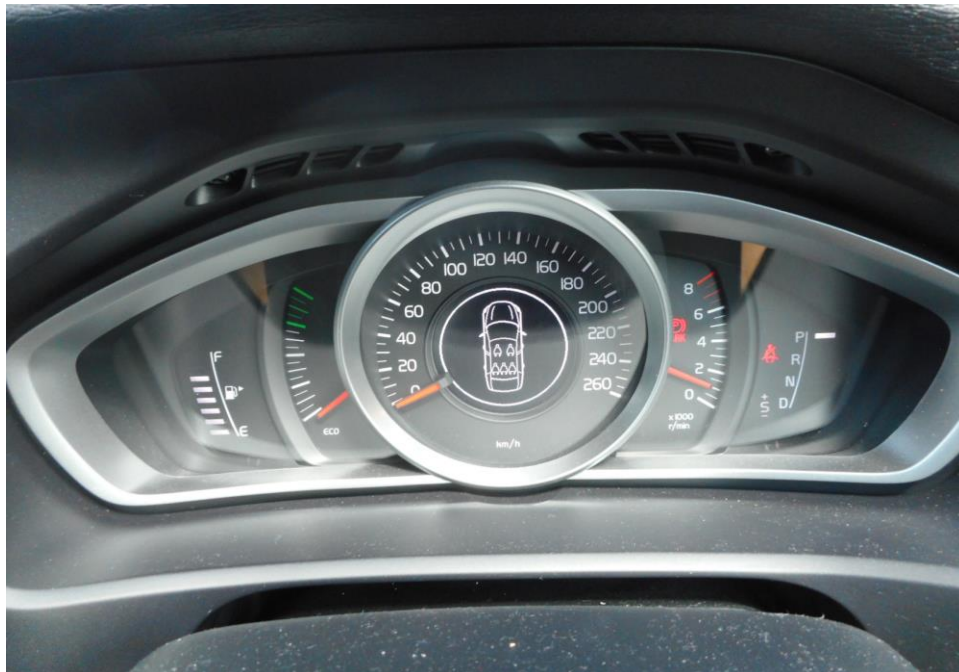
**Photo 14** shows the instrument display of the Motor Car at the time of my inspection. The engine oil was observed to be of sufficient level and without any visible contamination as there was no engine oil warning light illuminated up of the instrument display.

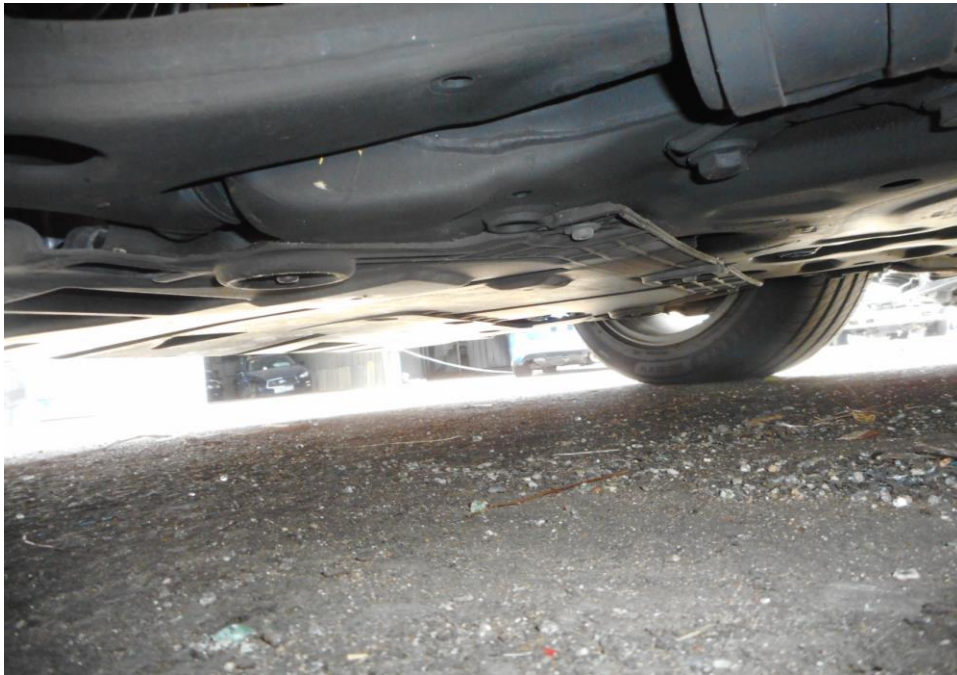
**Photo 15** shows the undercarriage of the Motor Car, at the area where the engine housing and transmission housing are located. I did not find any sign(s) or indication(s) of fluid leak and/or fluid stain(s) on the underside of the Motor Car.

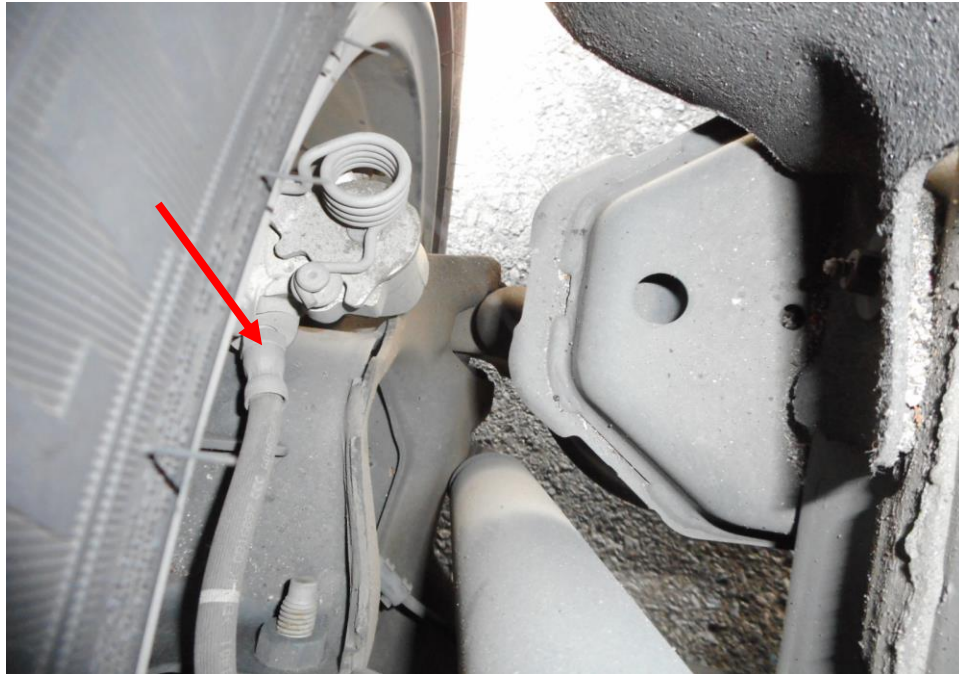
**Photo 16** shows the brake hose/pipe (arrowed) at the rear right wheel of the Motor Car. No leakage of brake fluid was observed. Visual examination of the various components of the braking system like the drum brake, brake booster, brake pedal etc. had revealed all to be intact and without visible damage.

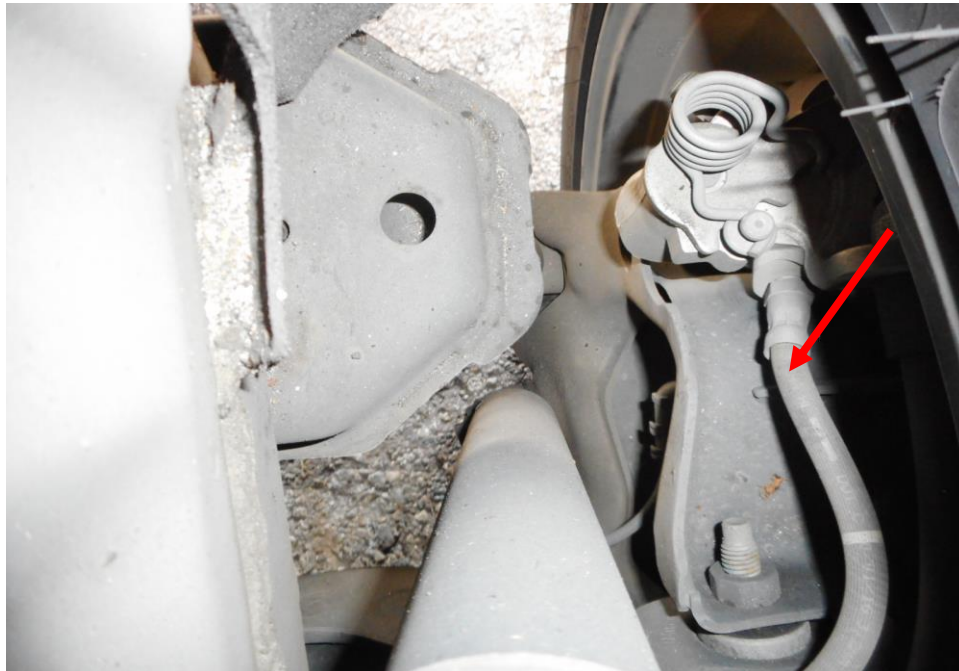
**Photo 17** shows the brake hose/pipe (arrowed) at the rear left wheel of the Motor Car. I did not observe any leakage of brake fluid at the time of my inspection of the Motor Car. Static tests of the Motor Car's braking system had indicated that there was no internal leakage of pressure/vacuum. The undercarriage components of the Motor Car were also all found to be intact and without any visible damage.

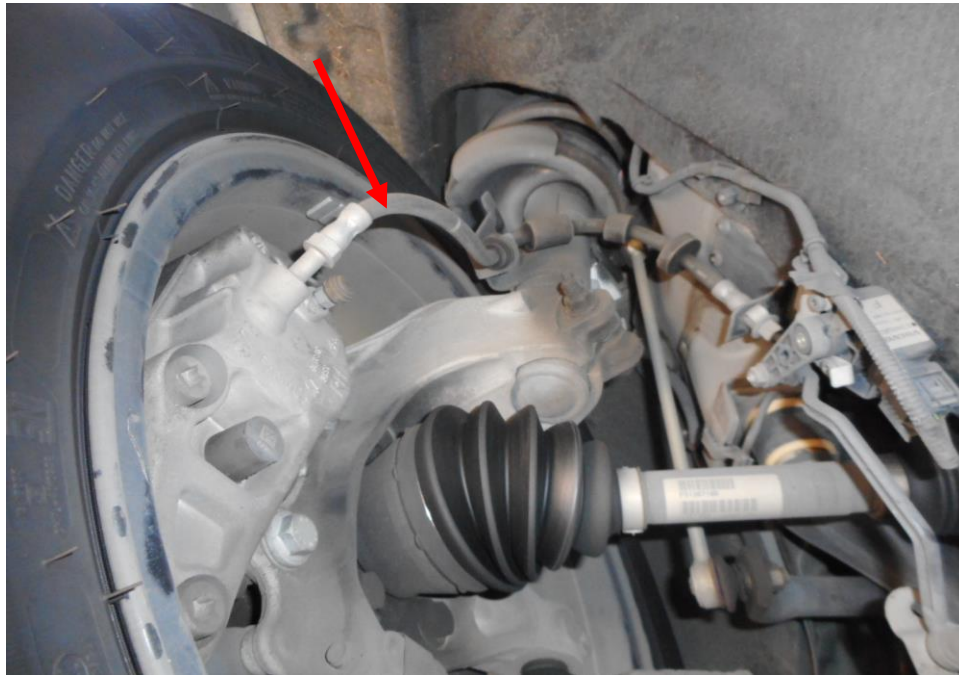
**Photo 18** shows the brake hose/pipe (arrowed) at the front right wheel of the Motor Car. I did not observe any leakage of brake fluid at the time of my inspection of the Motor Car. Static tests of the Motor Car's braking system had indicated that there was no internal leakage of pressure/vacuum. The undercarriage components of the Motor Car were also all found to be intact and without any visible damage.

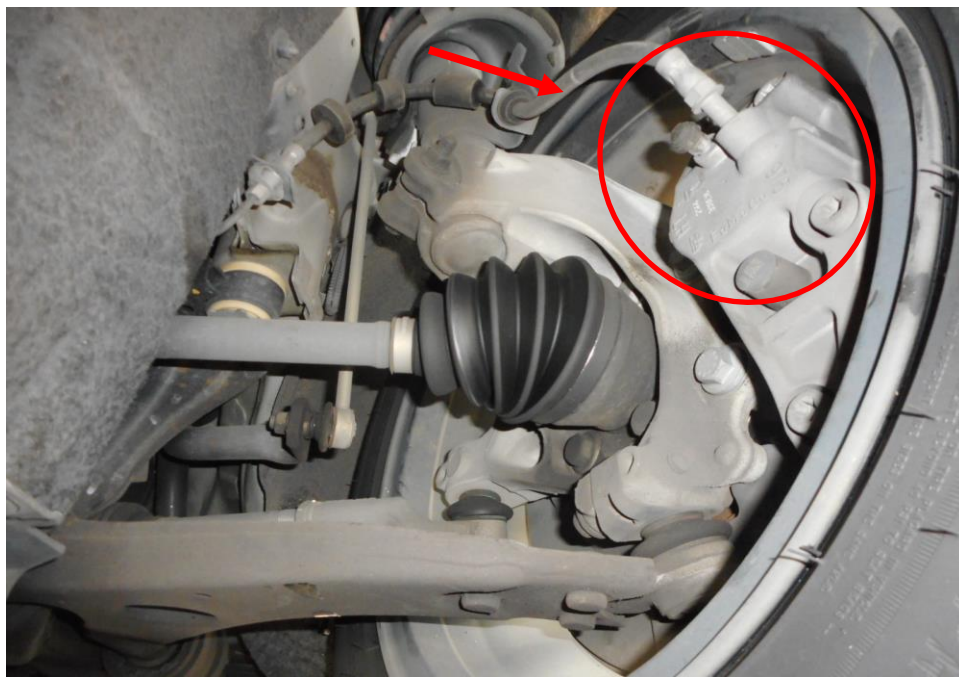
**Photo 19** shows the brake hose/pipe (arrowed) at the front left wheel of the Motor Car. No leakage of brake fluid was observed. Visual examination of the various components of the braking system like the brake caliper (circled), brake booster, brake pedal etc had revealed all to be intact and without visible damage.

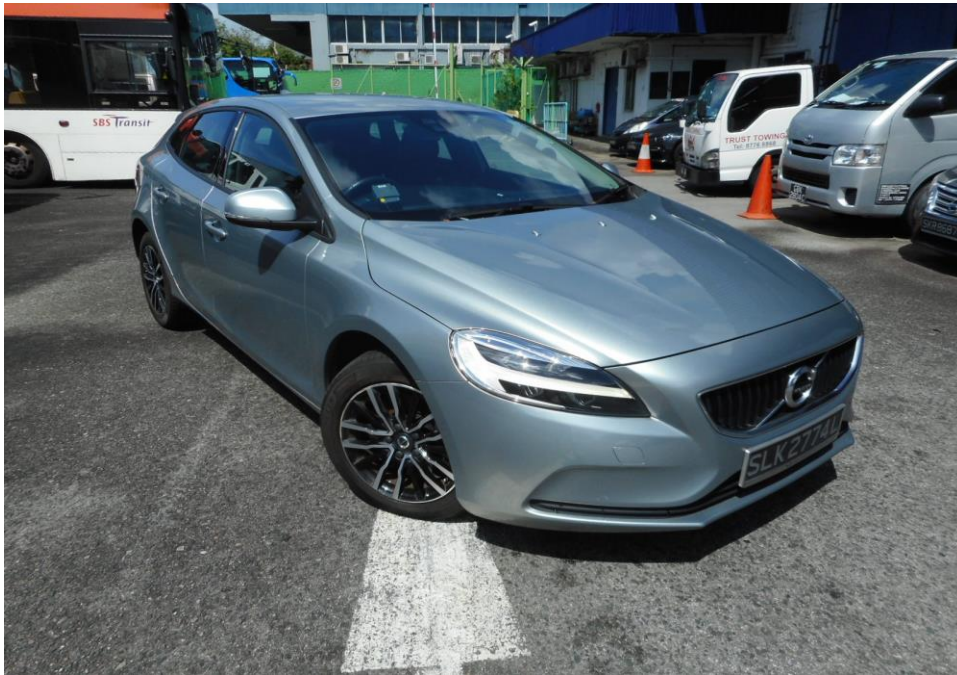
**Photo 20** shows the front right wheel of the Motor Car turned to its full left. During my steering system test, I did not experience any abnormal free play and/or resistance when I had turned the steering wheel towards the left and right. This would suggest that the steering system of the Motor Car was likely to be in serviceable condition at the material time of accident.

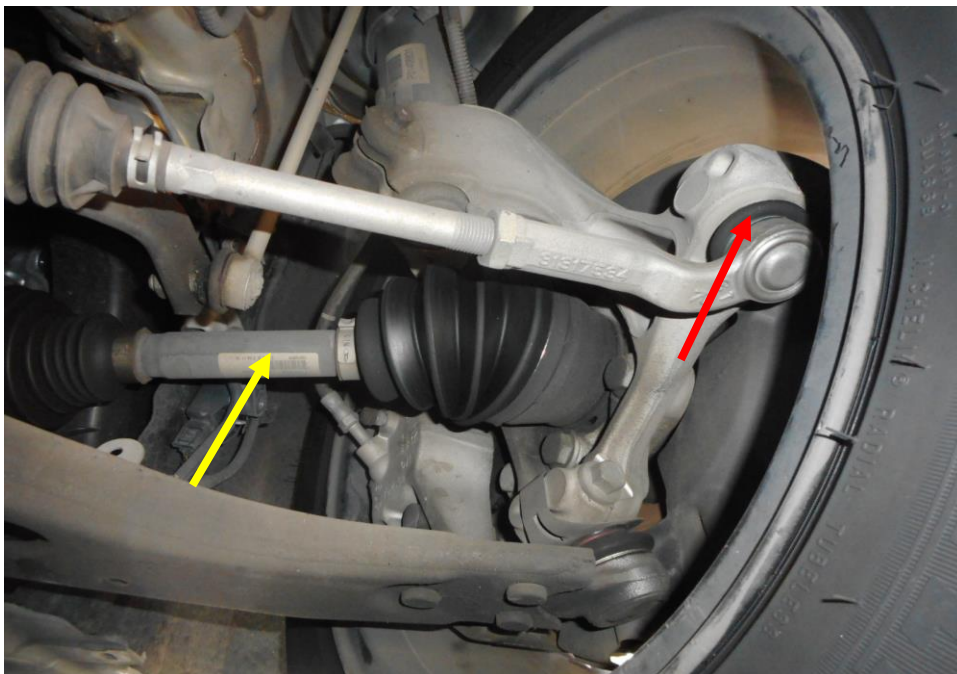
**Photo 21** shows the various undercarriage components at the front right wheel of the Motor Car, in particular the steering tie rod (red arrow) and drive shaft (yellow arrow). The various steering components were all found to be intact, suggesting that the steering system of the Motor Car was likely to be in serviceable condition at the material time of accident. There was also no sign of fluid stain observed on the various undercarriage components at the front right wheel of the Motor Car.

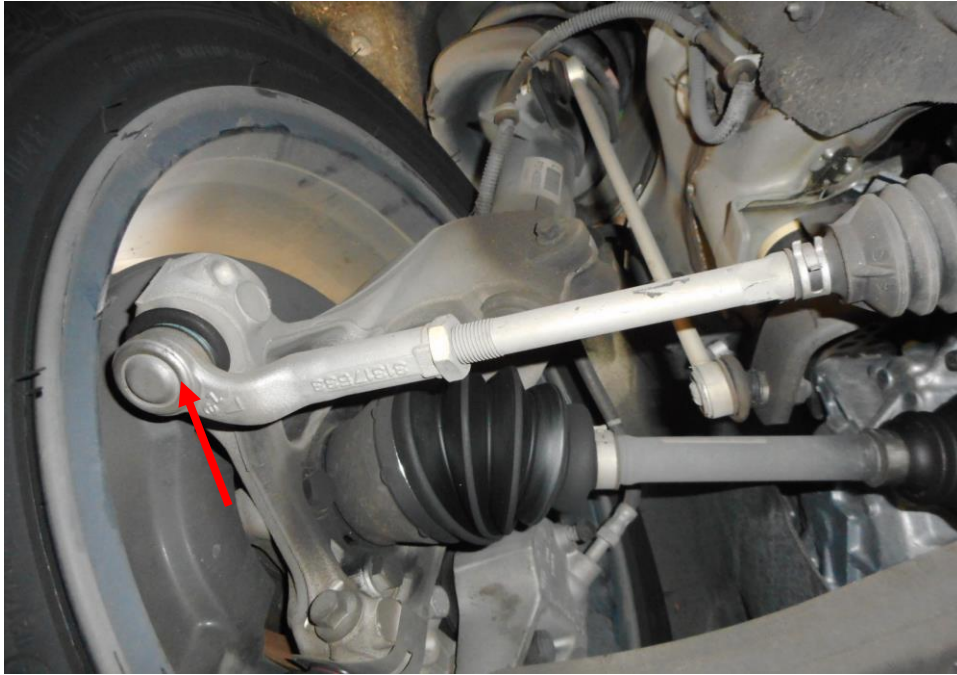
**Photo 22** shows the various undercarriage components at the front left wheel of the Motor Car, which had included the steering tie rod (red arrow). The various undercarriage components of the Motor Car were all found to be intact without any visible damage.

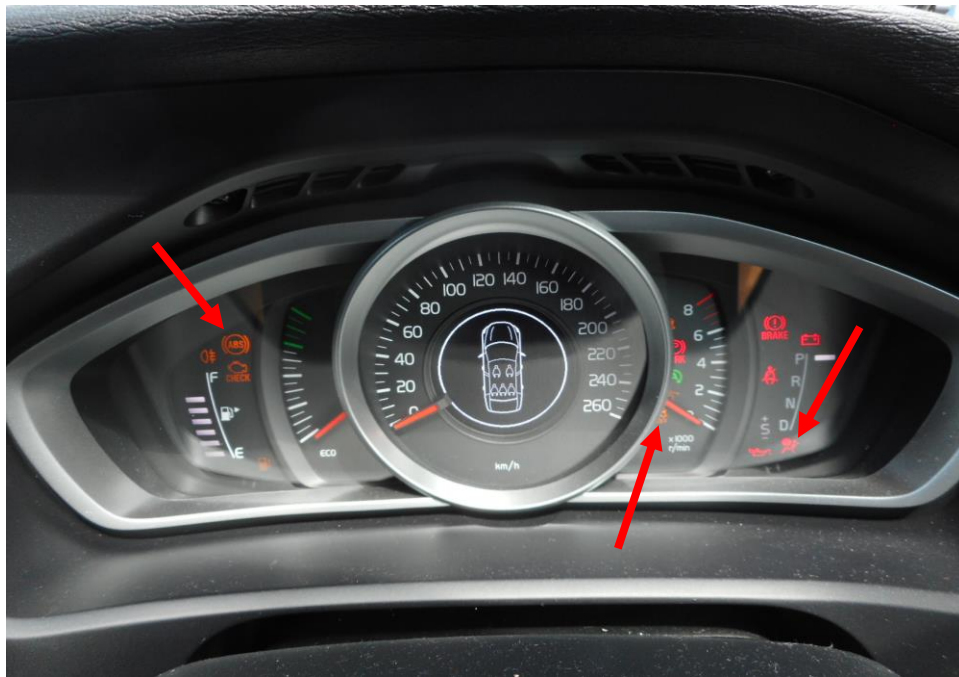
**Photo 23** shows the warning light for Anti-Lock Brake System (ABS) and Traction Control System (TCS) and Supplemental Restraint System (SRS) (arrowed) appearing on the instrument panel of the Motor Car during the self-test of its various electronic operating systems when its engine was cranked.

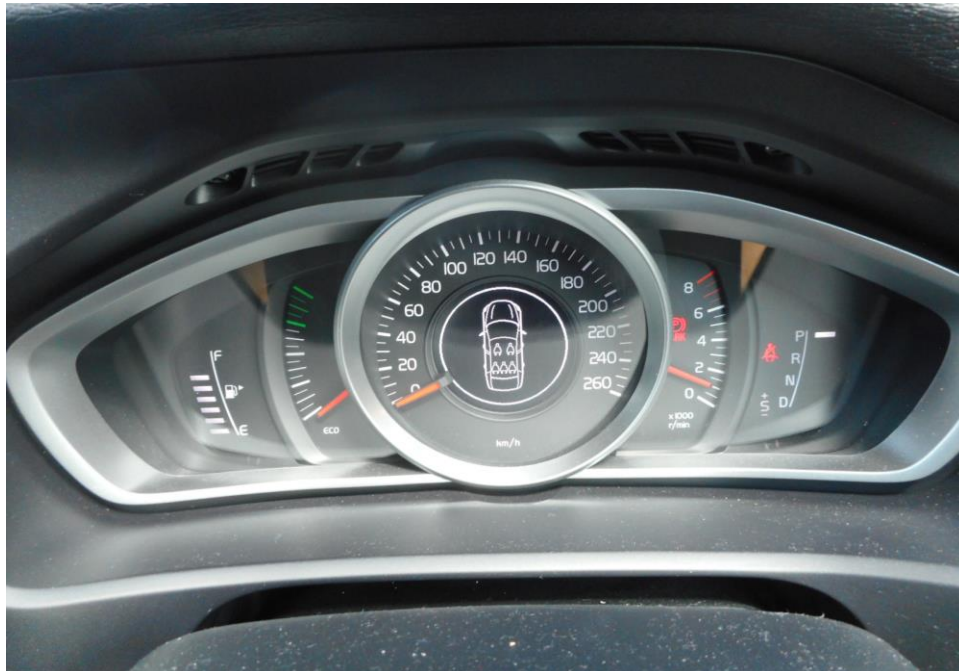
**Photo 24** shows no warning lights illuminated on the instrument panel of the Motor Car after the engine was cranked. This would suggest that there was no abnormality to the electronic operating system of the Motor Car, like the ABS, TCS and SRS etc.
