Your Ref: TP/IP/22175/2021
Our Ref : CI/TPD21007269/P

22nd July 2021

MECHANICAL INSPECTION REPORT OF MOTOR BUS, PC 3857U

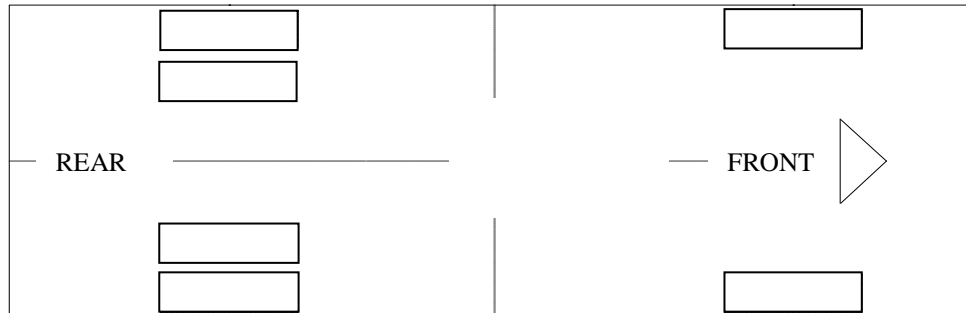
Motor Bus

Doublestar 275/70R22.5 (9.5mm)

Doublestar 275/70R22.5 (5.6mm)

Doublestar 275/70R22.5 (7.7mm)

Doublestar 275/70R22.5 (6.8mm)

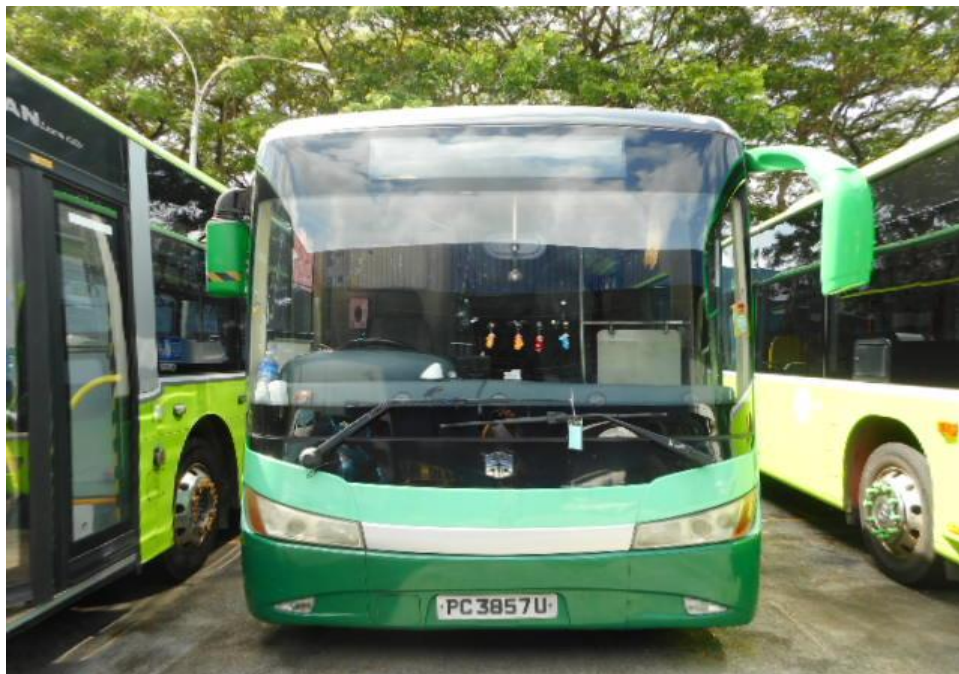
Photo 1 shows a general view of the front body of the Motor Bus at the time of my inspection. The Motor Bus was observed to be intact and unaffected by the accident.

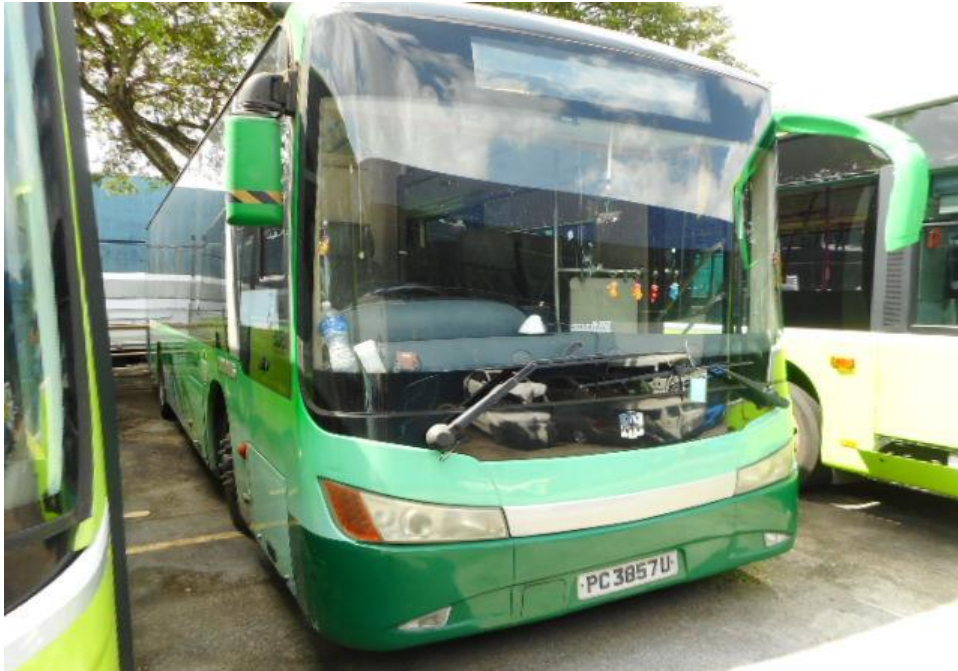
Photo 2 shows a general view of the right body of the Motor Bus at the time of my inspection. The Motor Bus was observed to be intact and unaffected by the accident.

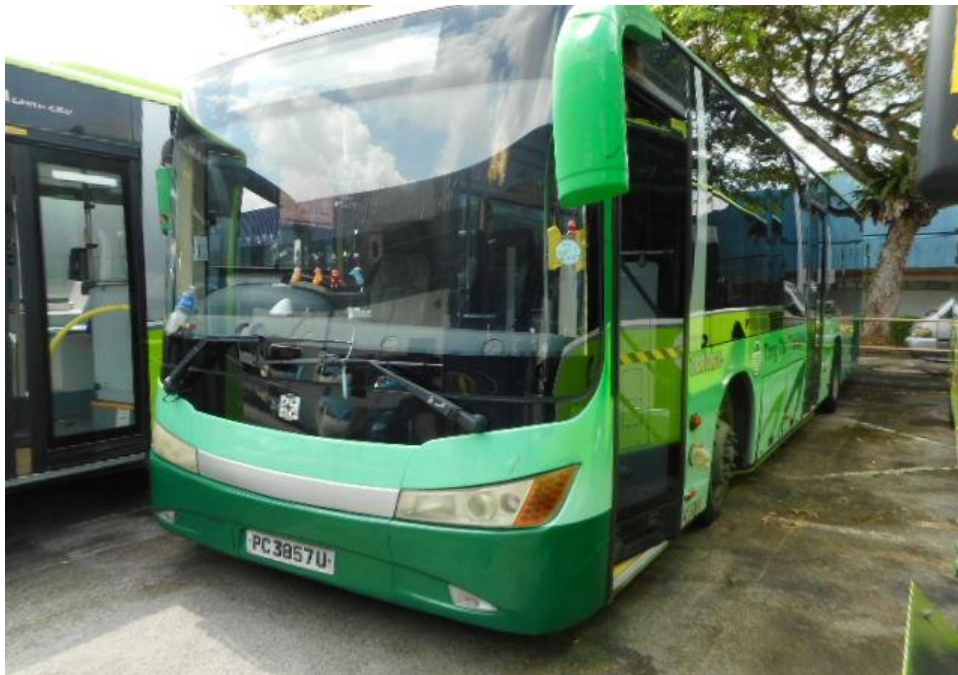
Photo 3 shows a general view of the left body of the Motor Bus at the time of my inspection. The Motor Bus was observed to be intact and unaffected by the accident.

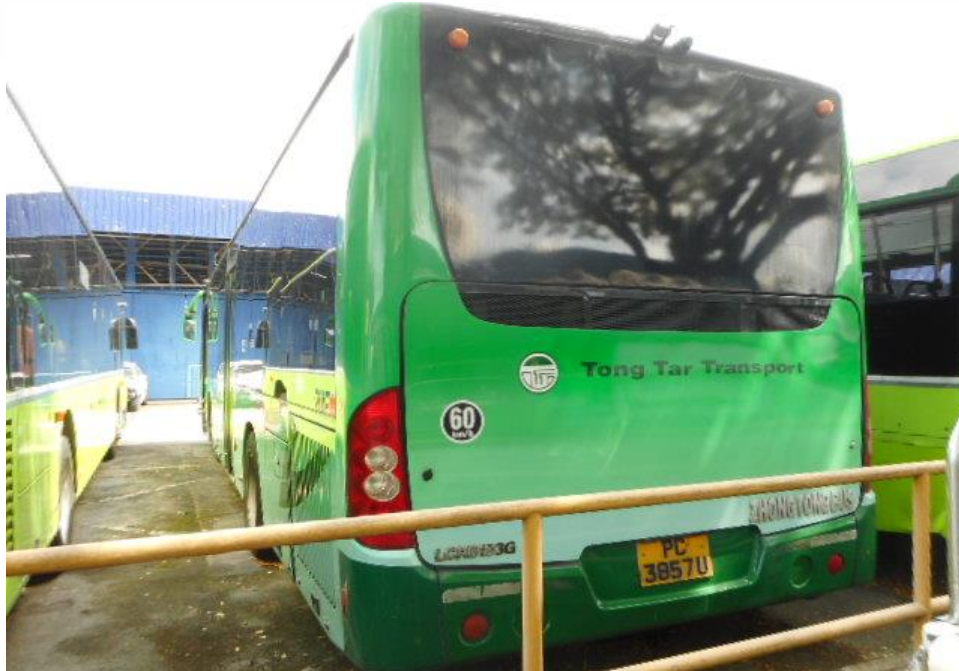
Photo 4 shows a general view of the Motor Bus's rear body at the time of my inspection. The Motor Bus was observed to be intact and unaffected by the accident.

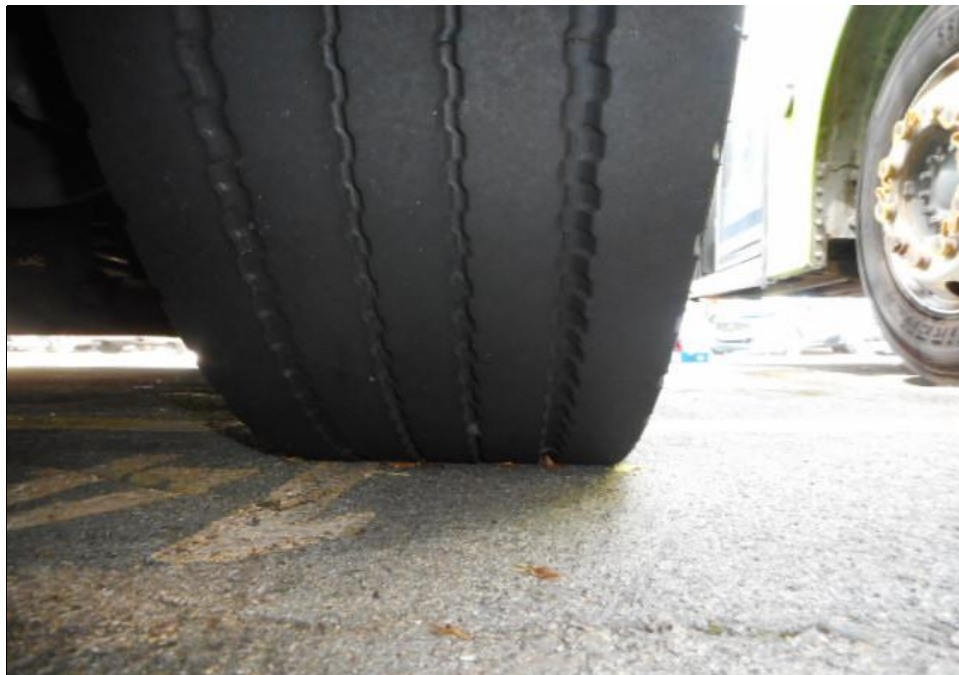
Photo 5 shows the condition of the front right tyre of the Motor Bus, which was observed to be in serviceable condition with remaining tread depth of approximately 6.8 mm. The tyre, which was wrapped around standard steel wheel rim, was also observed to be sufficiently inflated for vehicular operation. There was no tear, cut or burst mark(s) on the outer and the inner sidewalls as well as across the tread of the 6 tyres that were fitted on the Motor Bus.

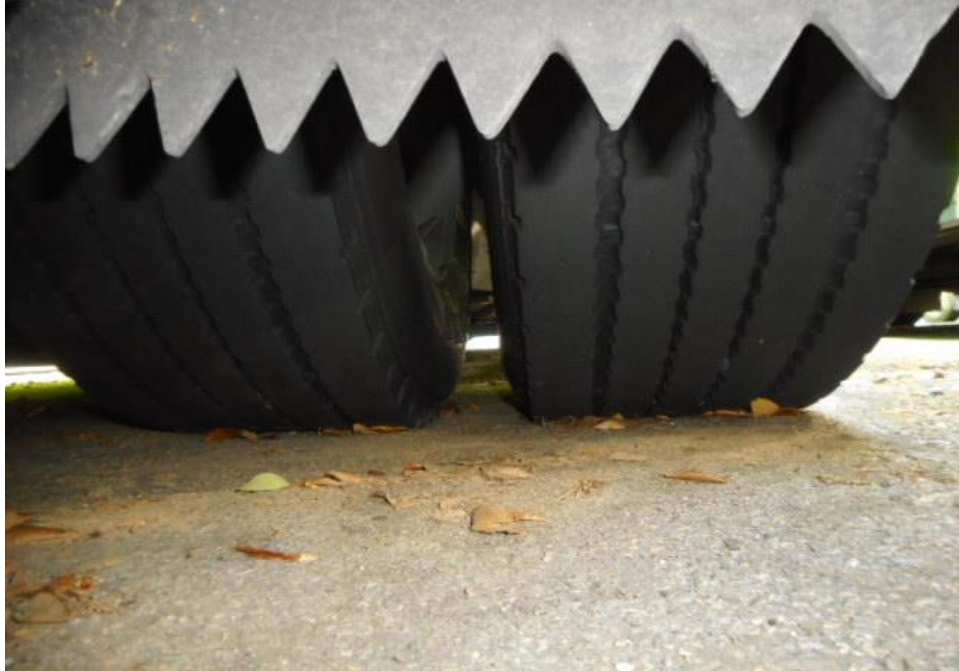
Photo 6 shows the condition of the rear right tyre of the Motor Bus, which was observed to be in serviceable condition with remaining tread depth of approximately 7.7mm. The tyre, which was wrapped around standard steel wheel rim, was also observed to be sufficiently inflated for vehicular operation.

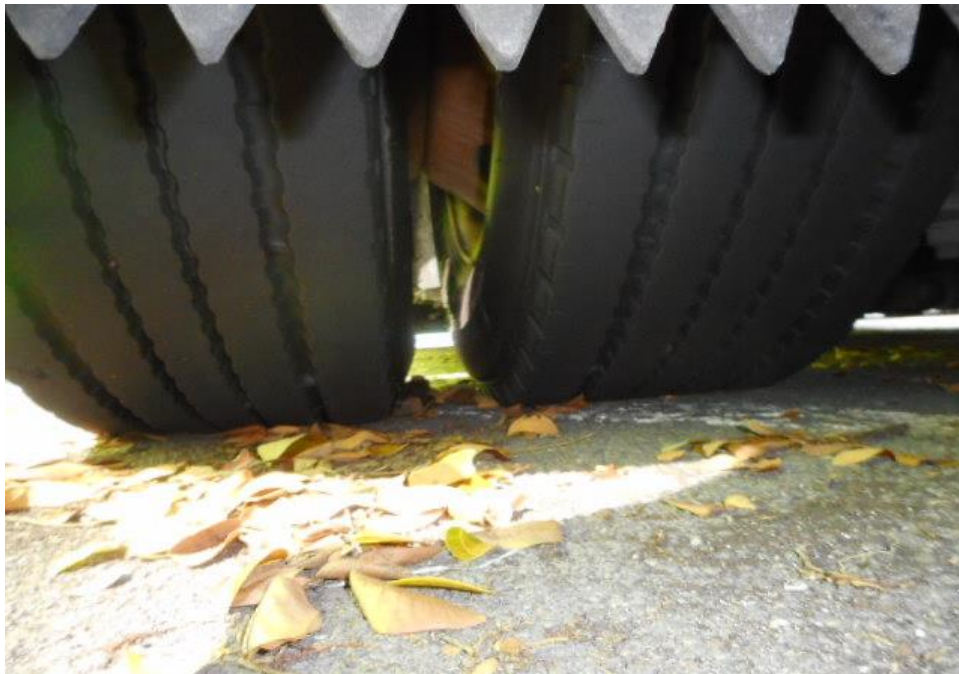
Photo 7 shows the condition of the rear left tyres of the Motor Bus, which was observed to be in serviceable condition with remaining tread depth of approximately 9.5mm. The tyres, which were wrapped around standard steel wheel rim, were also observed to be sufficiently inflated for vehicular operation. There was also no damage found on all 6 steel wheel rims of the Bus.

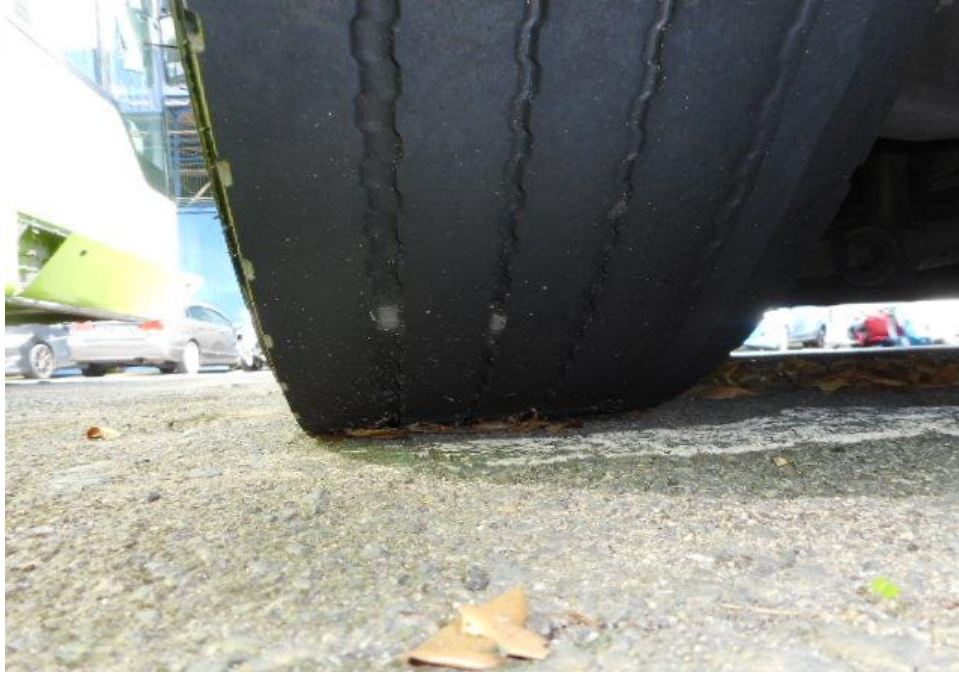
Photo 8 shows the condition of the front left tyres of the Motor Bus, which were observed to be in serviceable condition with remaining tread depth of approximately 5.6mm. There was also no tear, cut or burst mark(s) on the outer and the inner sidewalls as well as across the tread of the 6 tyres that were fitted on the Bus.

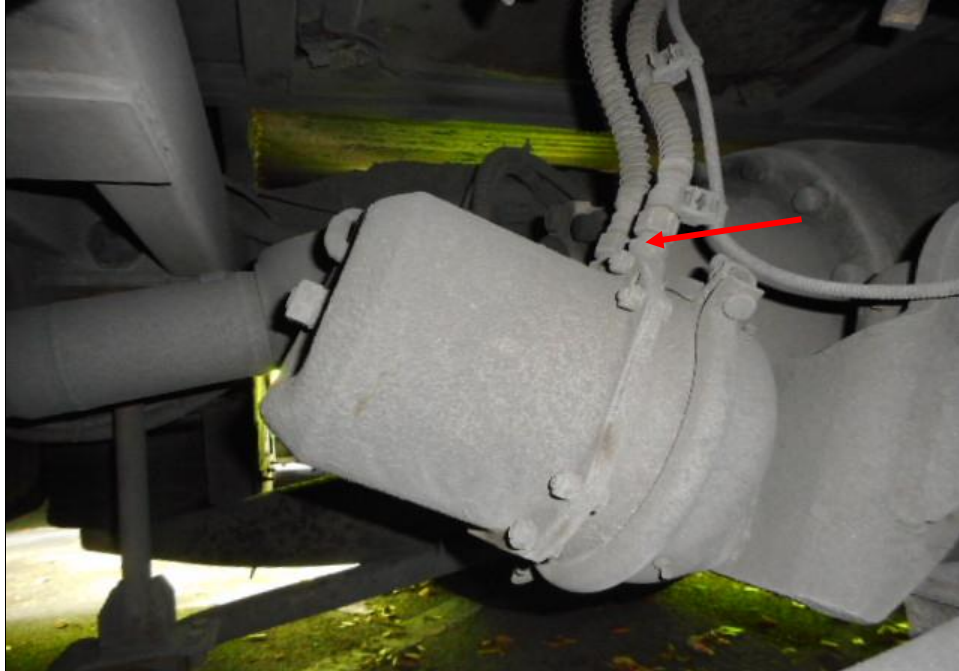
Photo 9 shows the brake pipe (arrowed) at the rear right wheel of the Motor Bus. I did not observe any leakage of brake fluid at the time of my inspection of the Motor Bus. My visual examination of the various mechanical components in the braking system, had indicated that there was no internal leakage of pressure/vacuum and there components were generally in good condition.

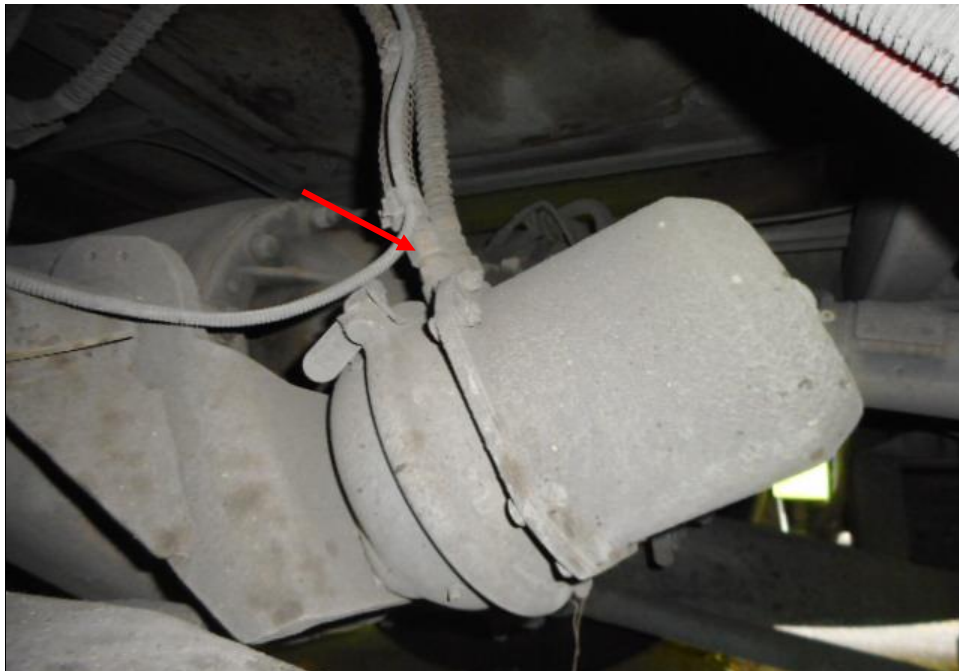
Photo 10 shows the brake pipe (arrowed) at the rear left wheel of the Motor Bus. I did not observe any leakage of brake fluid at the time of my inspection of the Motor Bus. My static tests of the Motor Bus's braking system, along with my visual examination of the various mechanical components in the braking system, had indicated that there was no internal leakage of pressure/vacuum and there components were generally in good condition.

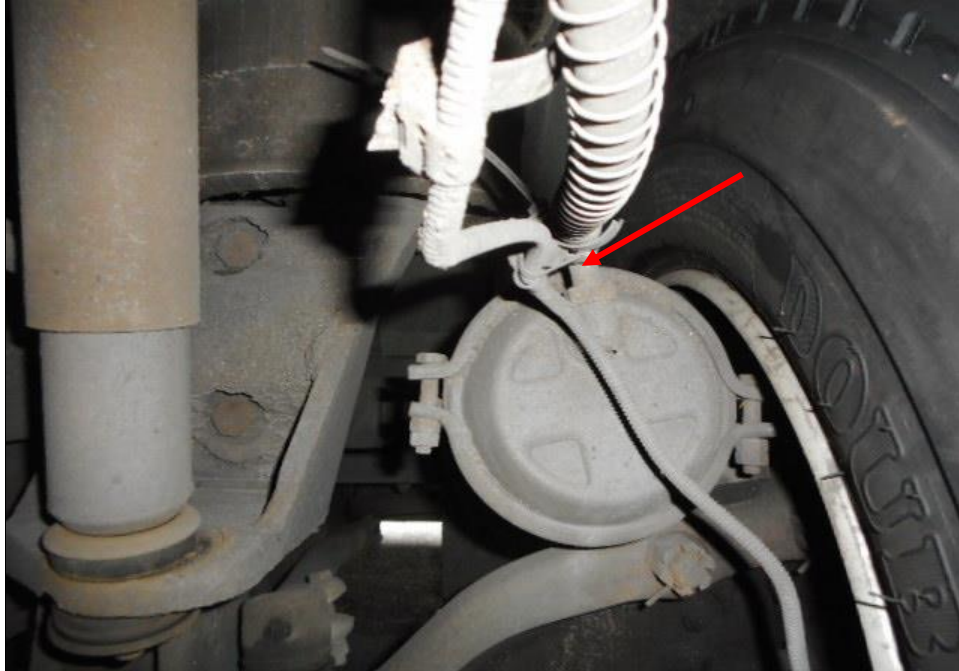
Photo 11 shows the brake pipe (arrowed) at the front right wheel of the Motor Bus. I did not observe any leakage of brake fluid at the time of my inspection of the Motor Bus. My static tests of the Motor Bus's braking system, along with my visual examination of the various mechanical components in the braking system, had indicated that there was no internal leakage of pressure/vacuum and there components were generally in good condition.

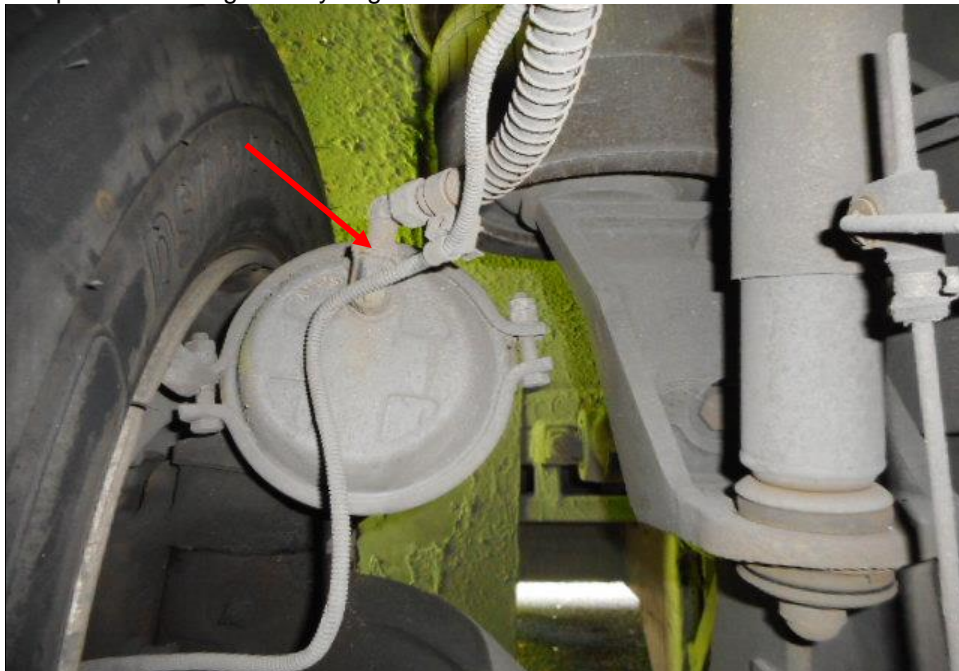
Photo 12 shows the brake pipe (arrowed) at the front left wheel of the Motor Bus. I did not observe any leakage of brake fluid at the time of my inspection of the Motor Bus. My visual examination of the various mechanical components in the braking system had indicated that there was no internal leakage of pressure/vacuum and there components were generally in good condition.

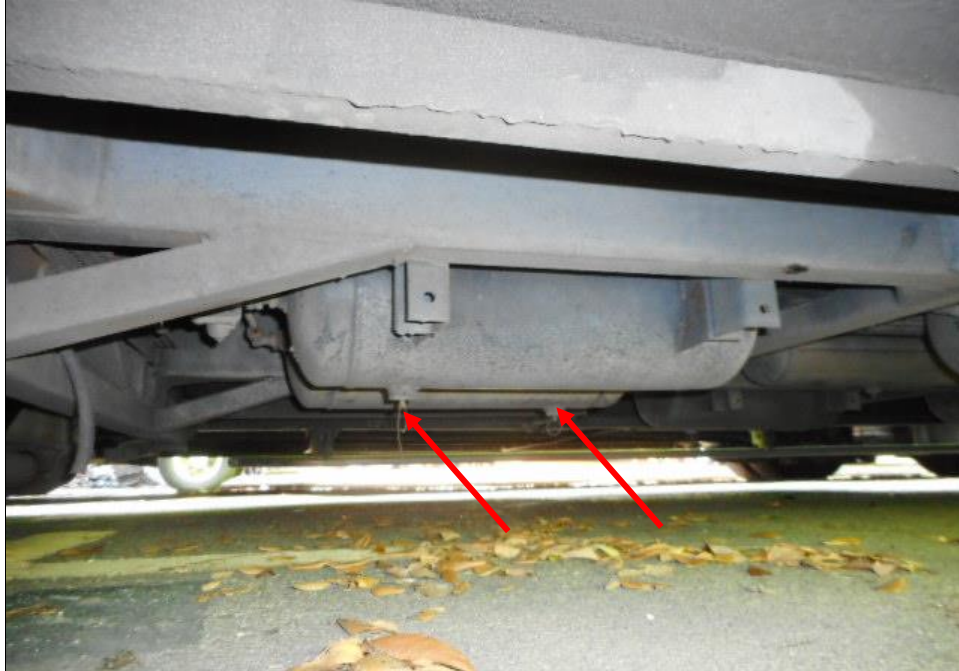
Photo 13 shows the air brake cylinders (arrowed) at the undercarriage of the Motor Bus. I did not observe any leakage of air brake fluid at the time of my inspection of the Motor Bus. My visual examination of the various mechanical components in the braking system had indicated that there was no internal leakage of pressure/vacuum and there components were generally in good condition.

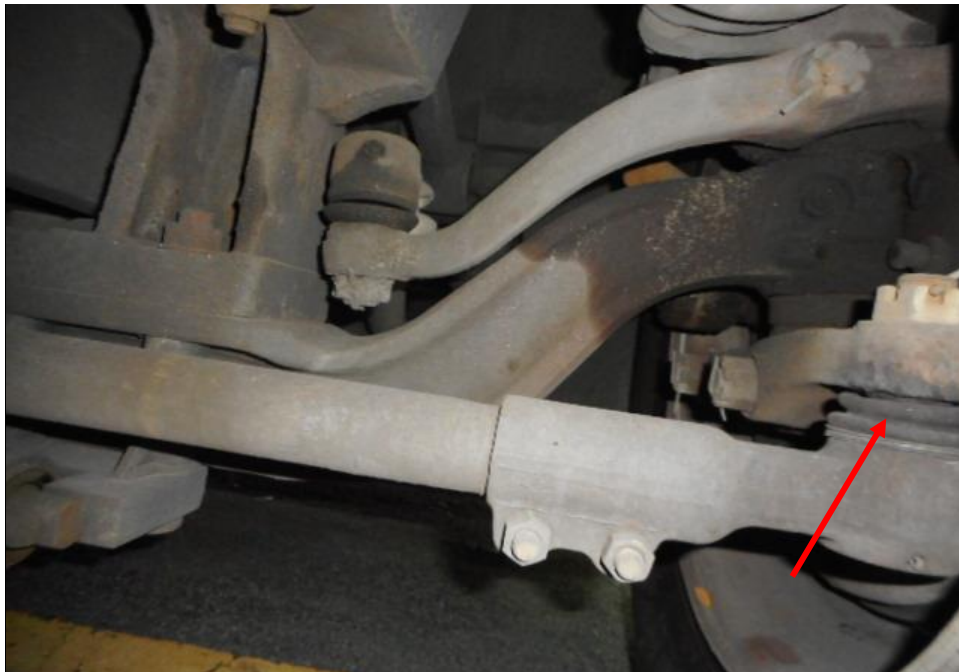
Photo 14 shows the various undercarriage components at the front right wheel of the Motor Bus, in particular the steering tie rod end (arrowed). The various steering components were all found to be intact, suggesting that the steering system of the Motor Bus was likely to be in serviceable condition at the material time of accident. There was also no sign of fluid stain(s) observed on the various undercarriage components.

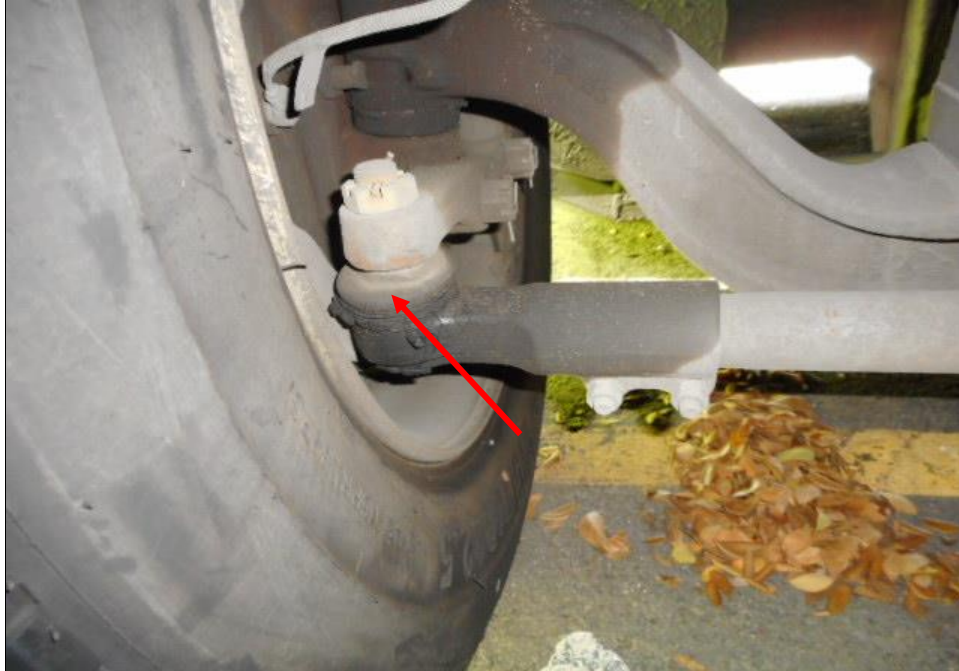
Photo 15 shows the various undercarriage components at the front left wheel of the Motor Bus, in particular the steering tie rod end (arrowed). The various undercarriage components of the Motor Bus were all found to be intact without any visible damage. There was also no sign of fluid stain(s) observed on the various undercarriage components.

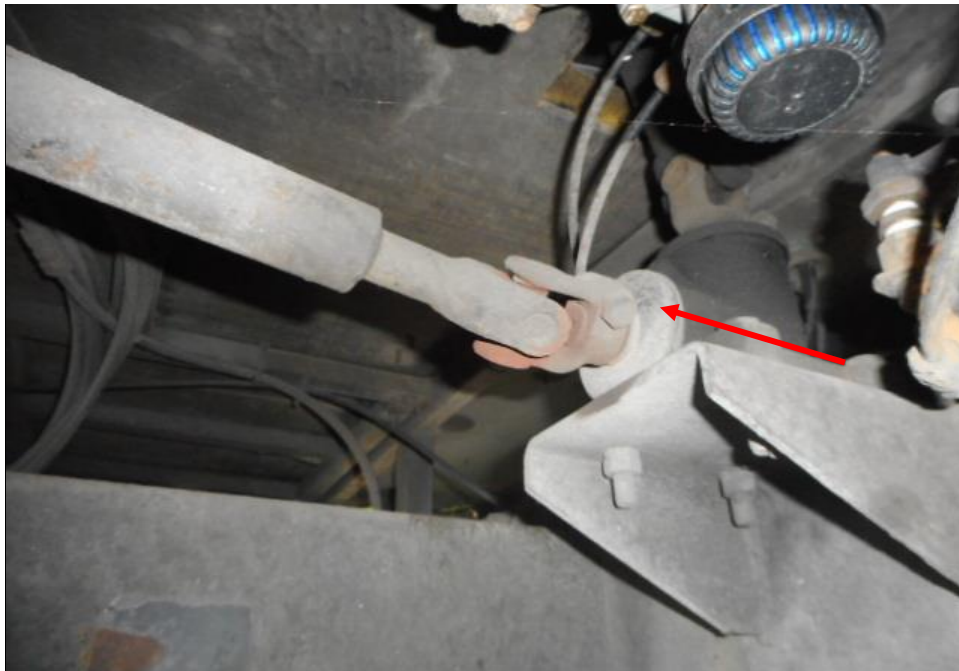
Photo 16 shows the steering box component (arrowed) at the undercarriage of the Motor Bus was found to be intact without any visible damage. There was also no sign of fluid stain(s) observed on the various undercarriage components.
