Your Ref: TP/IP/27321/2021  
Our Ref : CI/TPD21007270/P

**Fatal Accident Investigation Team**

**MECHANICAL INSPECTION REPORT OF MOTOR LORRY GBH 2727H**

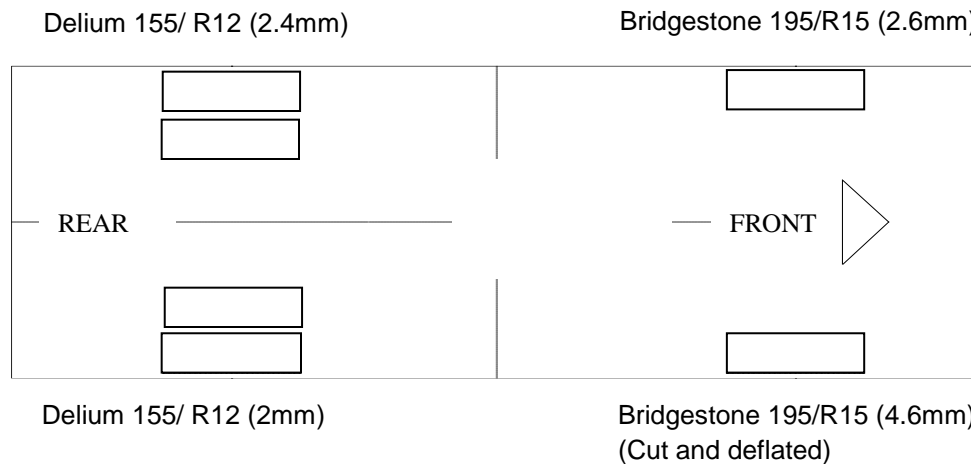
6. The front right tyre was observed to be cut on the outer sidewalls and deflated as a result of the accident. However, all the other 5 tyres of the Motor Lorry were observed to be in serviceable condition and sufficiently inflated for vehicular operation. I did not find any tear, cut or burst mark(s) on the outer and the inner sidewalls as well as across the tread of the 5 tyres. The tyre brand, tyre size and remaining tread depth of the 6 tyres of the Motor Lorry were recorded as follows:-

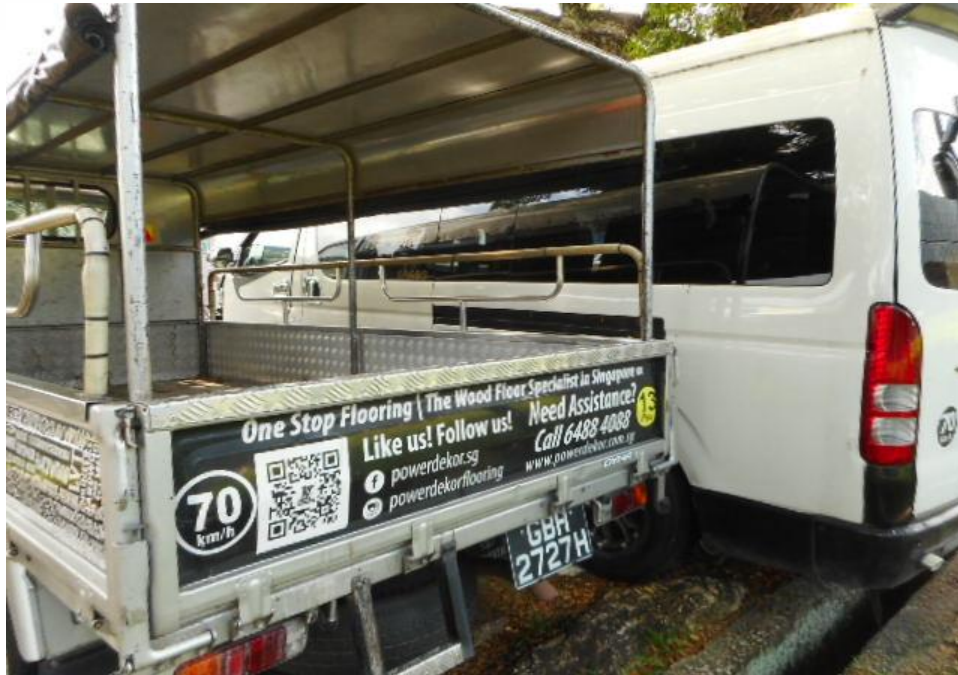
**Photo 1** shows a general view of the rear body of the Motor Lorry at the time of my inspection. The Motor Lorry was observed to be intact and unaffected by the accident.

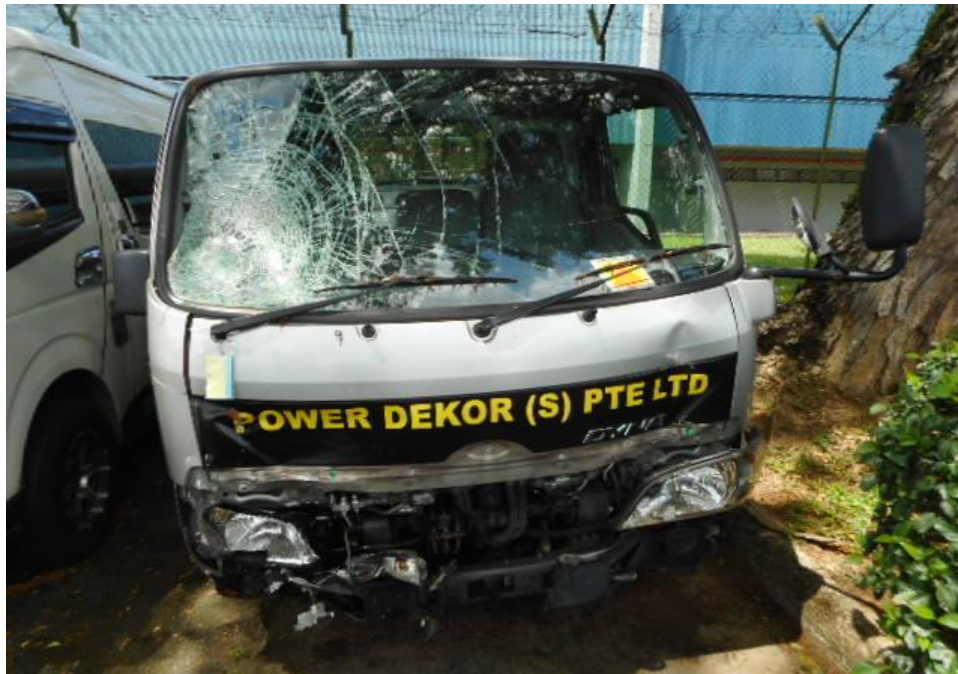
4. The mileage of the Motor Lorry at the time of my inspection was not recorded as the Motor Lorry's engine and ignition system was unable to be jumpstarted up despite multiple attempts in jumpstarting them.
5. The Motor Lorry was observed to sustained damage at its front portion. Its front windscreen, front body panel, front both headlamps and front bumper were damage at the time of my inspection as a result of the accident.

**Photo 2** shows a general view of the Motor Lorry's frontal portion at the time of my inspection. It appeared to have sustained damage at its front portion. Its front windscreen, front body panel, front both headlamps and front bumper were damaged at the time of my inspection as a result of the accident.

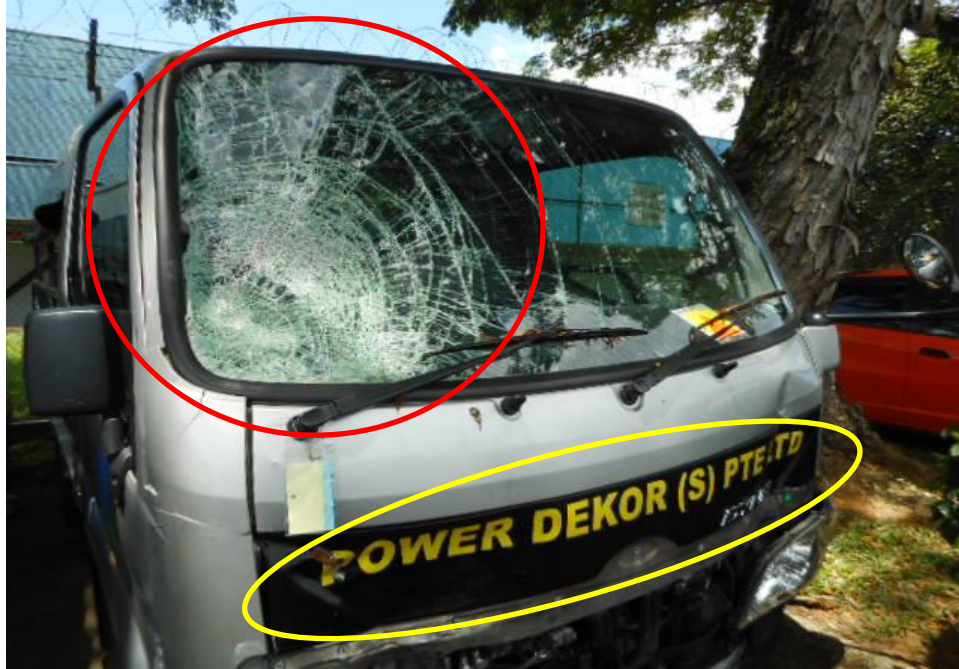
**Photo 3** shows a close up view of the Motor Lorry's front portion at the time of my inspection. Its front windscreen (red circle) and front body panel (yellow circle) was damage at the time of my inspection as a result of the accident.

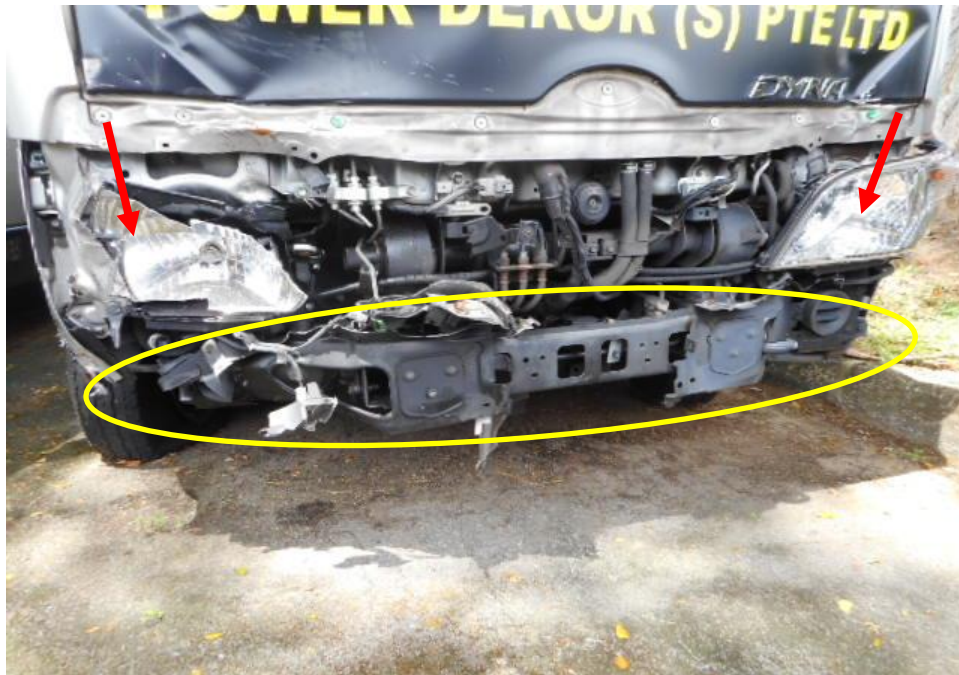
**Photo 4** shows a close up view of the Motor Lorry's front portion at the time of my inspection. Its front both headlamps (arrowed) and front bumper (circled) was damage at the time of my inspection as a result of the accident.

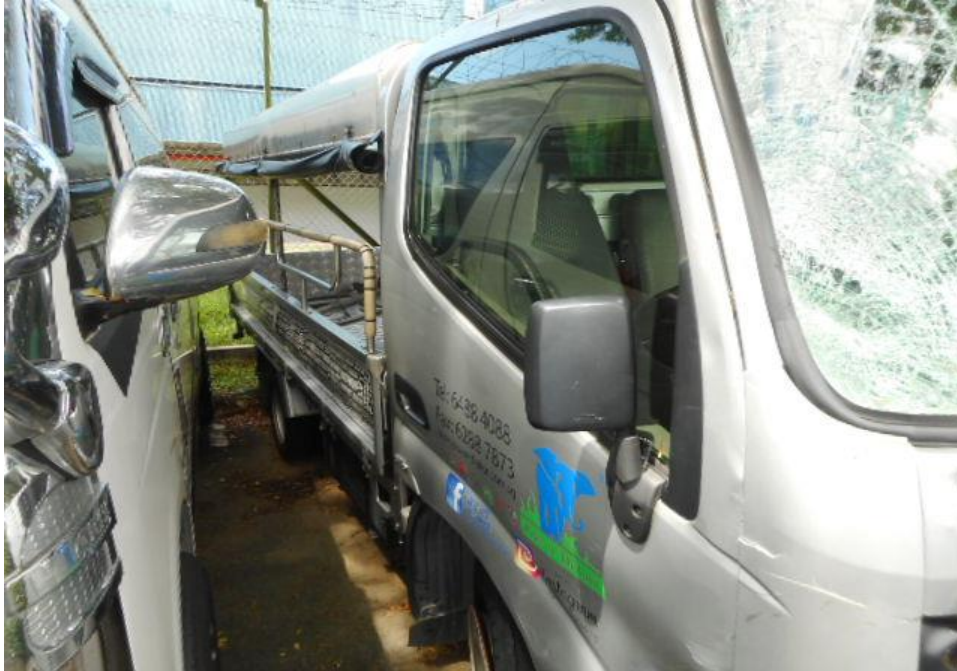
**Photo 5** shows a general view of the right body of the Motor Lorry at the time of my inspection. The Motor Lorry was observed to be intact and unaffected by the accident.

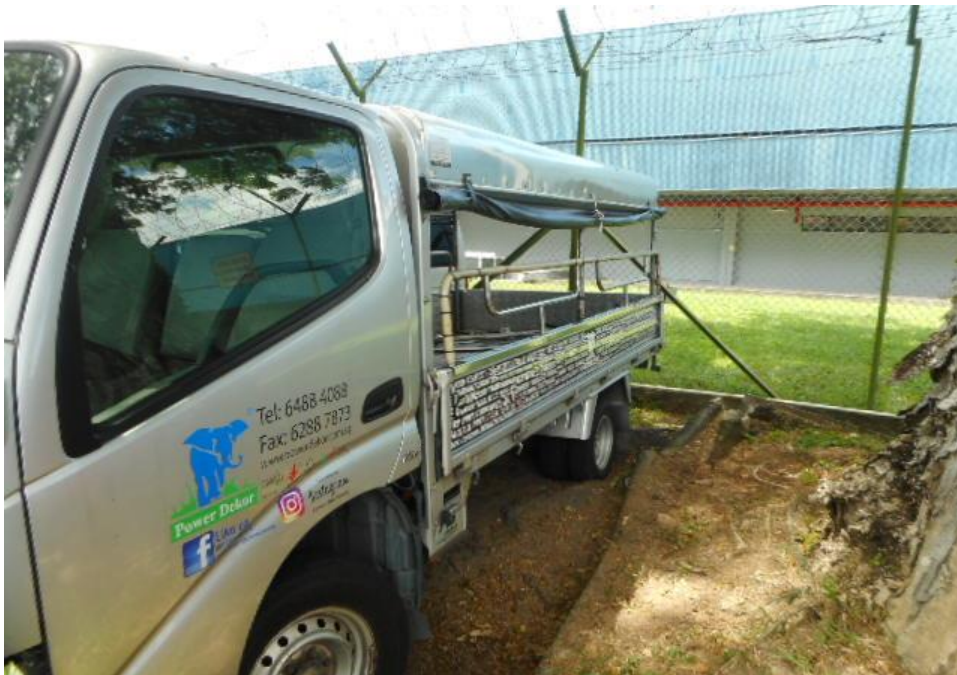
**Photo 6** shows a general view of the left body of the Motor Lorry at the time of my inspection. The Motor Lorry was observed to be intact and unaffected by the accident.

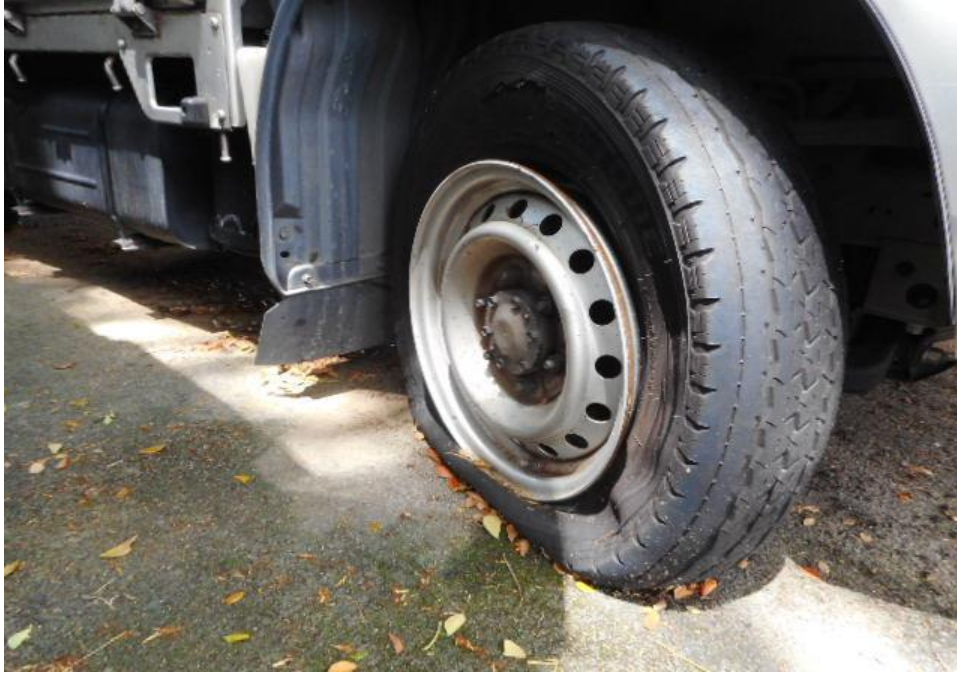
**Photo 7** shows the condition of the front right tyre of the Motor Lorry, which was observed to of unserviceable condition with remaining tread depth of approximately 4.6mm. The tyre, was observed with cut marks on the outer and slip off the wheel rim as a result of the accident.

19. The front right tyre was observed to be cut on the outer sidewalls and deflated as a result of the accident. However, the other 5 tyres fitted on the Motor Lorry were also found to be in serviceable condition. I did not find any tear, cut or burst mark(s) on the outer and the inner sidewalls as well as across the tread of the 5 tyres. The 6 tyres were observed with remaining tread depth of approximately 2mm – 4.6mm.

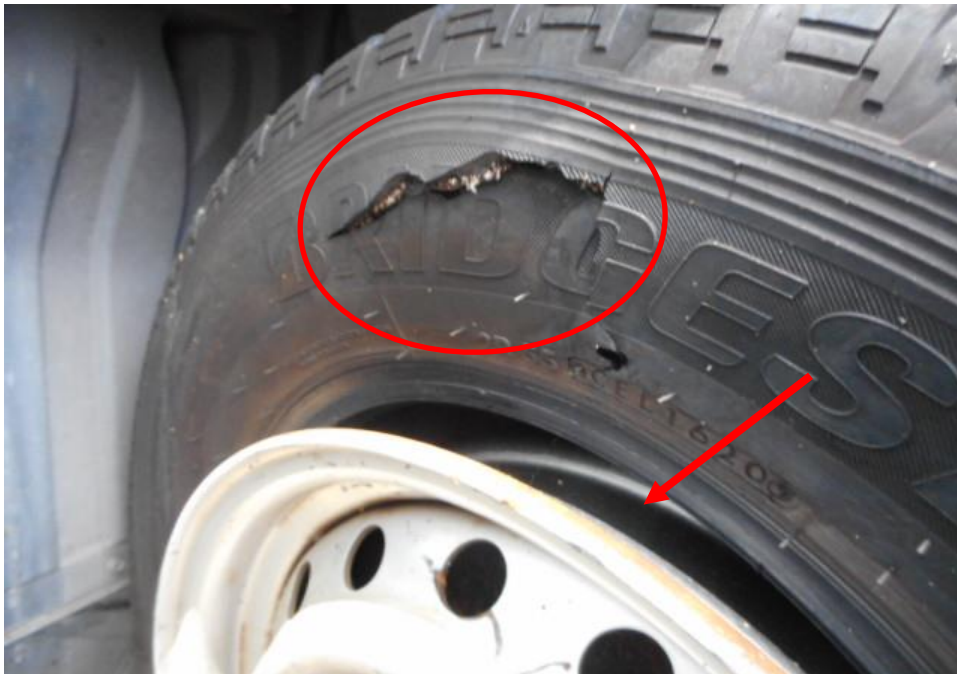
**Photo 8** shows the close up condition of the front right tyre of the Motor Lorry, which was observed to of unserviceable condition with remaining tread depth of approximately 4.6mm. The tyre, was observed with cut marks (circled) on the outer and slip off the wheel rim (arrowed) as a result of the accident.

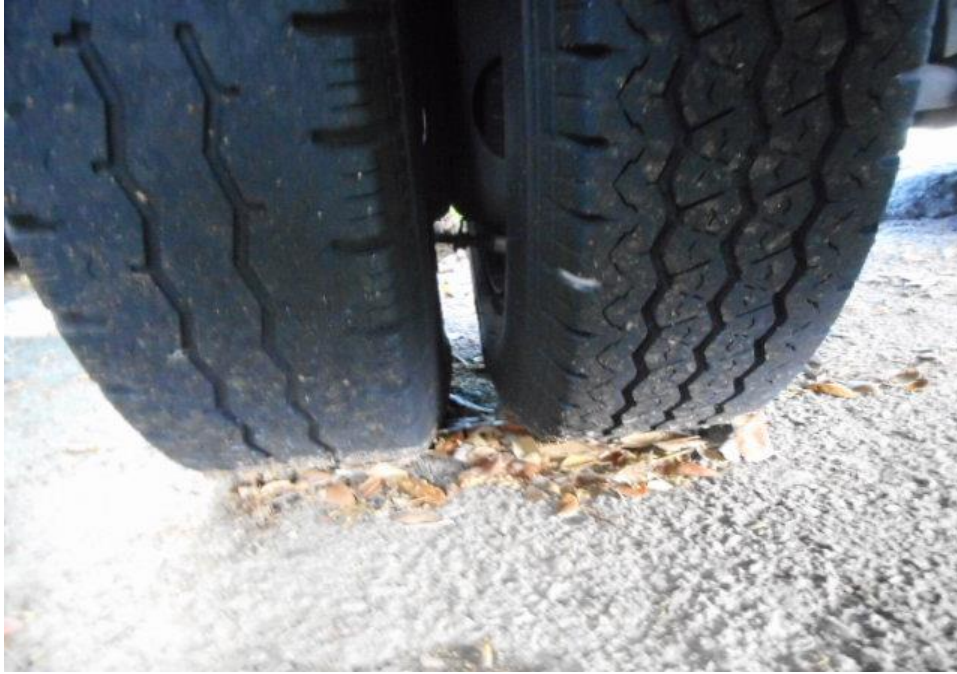
**Photo 9** shows the condition of the rear right tyre of the Motor Lorry, which was observed to be in serviceable condition with remaining tread depth of approximately 2mm. The tyre, which was wrapped around standard steel wheel rim, it was observed to be sufficiently inflated for vehicular operation.

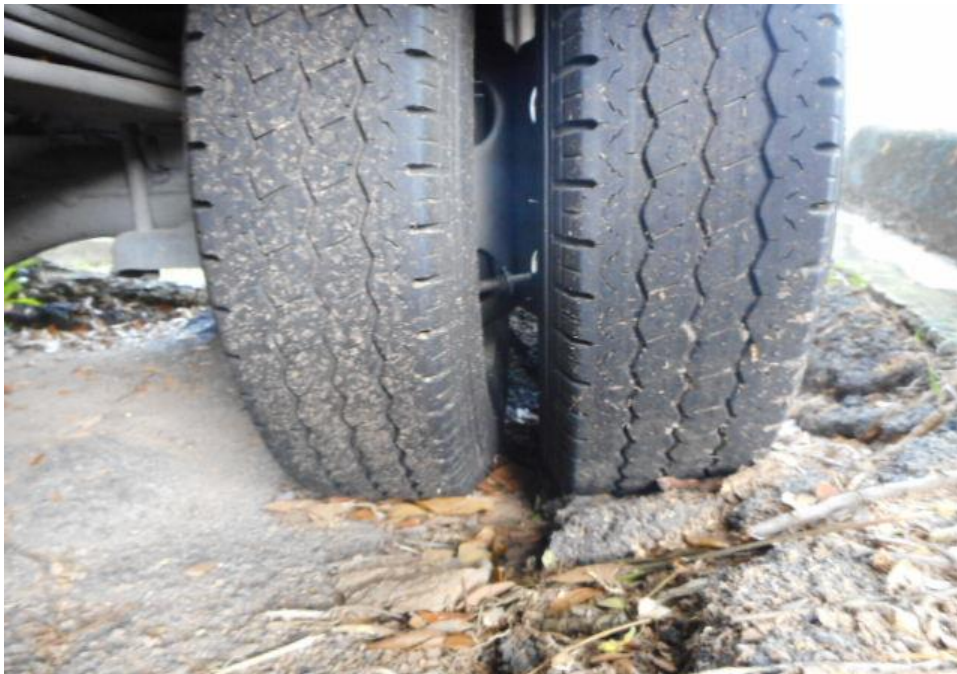
**Photo 10** shows the condition of the rear left tyres of the Motor Lorry, which was observed to be in serviceable condition with remaining tread depth of approximately 2.4mm. The tyres, which were wrapped around standard steel wheel rim, were also observed to be sufficiently inflated for vehicular operation. There was also no damage found on all 6 steel wheel rims of the Motor Lorry.

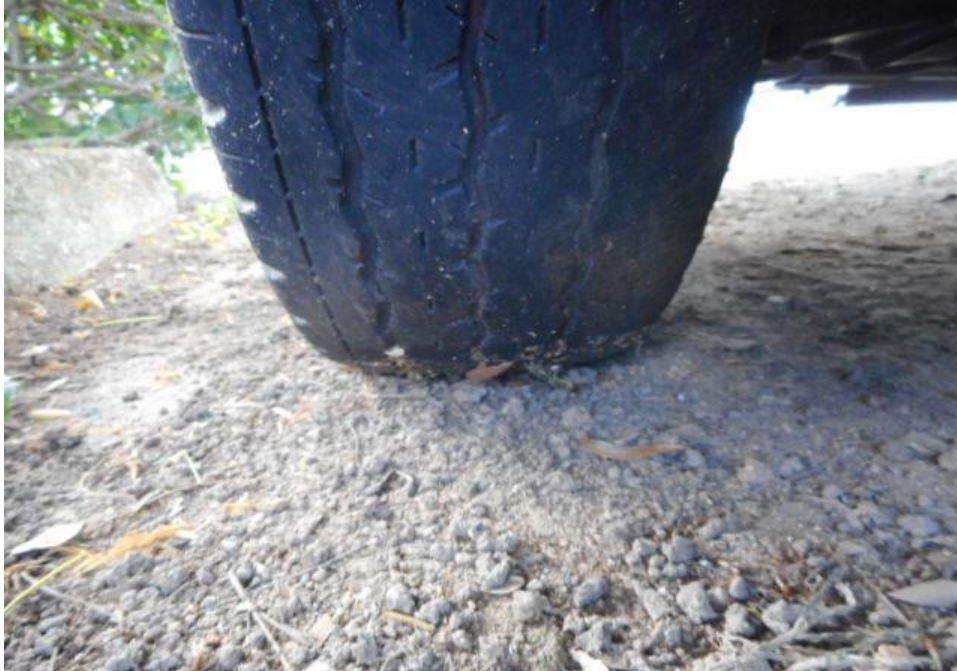
**Photo 11** shows the condition of the rear right tyres of the Motor Lorry, which were observed to be in serviceable condition with remaining, tread depth of approximately 2.6mm. There was also no tear, cut or burst mark(s) on the outer and the inner sidewalls as well as across the tread of the 6 tyres that were fitted on the Motor Lorry.

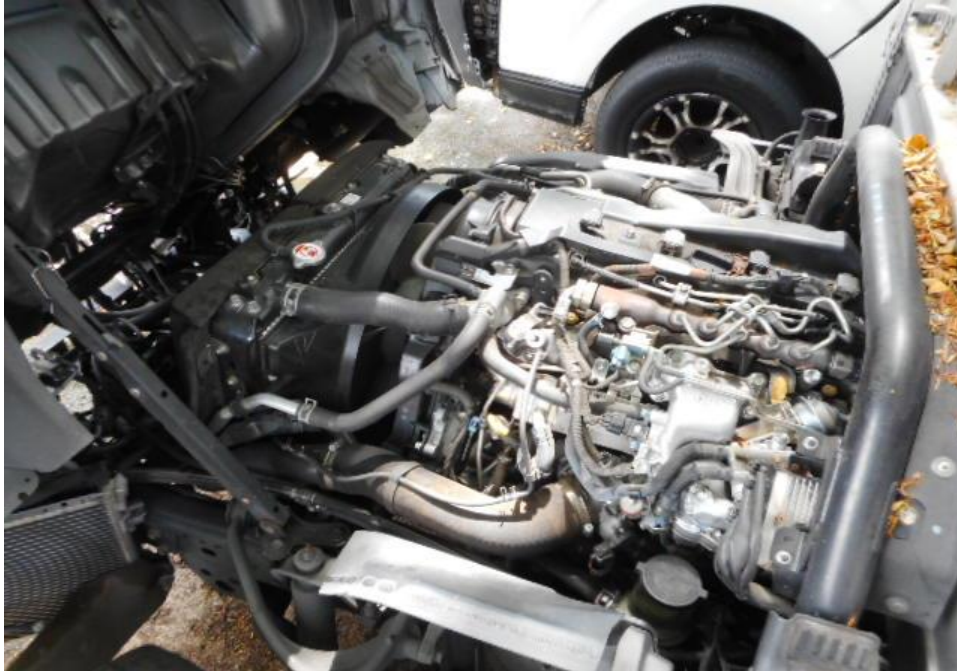
**Photo 12** shows a general view of the Motor Lorry's engine compartment, which was accessed by lifting the front cabin of the Motor Lorry. The various parts and components inside the engine compartment were unaffected by the accident. There was also no sign(s) or indication(s) of fresh fluid leakage and/or fluid stain within the engine compartment

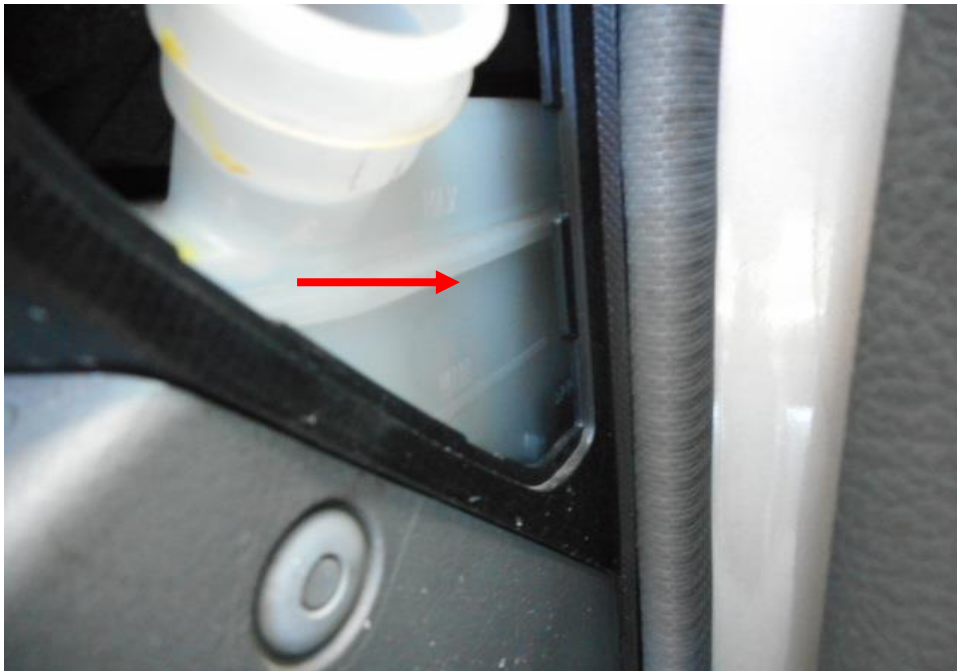
**Photo 13** shows the brake fluid reservoir of the Motor Lorry at the time of my inspection. The brake fluid was observed to be of sufficient level (arrowed) and without any visible contamination.

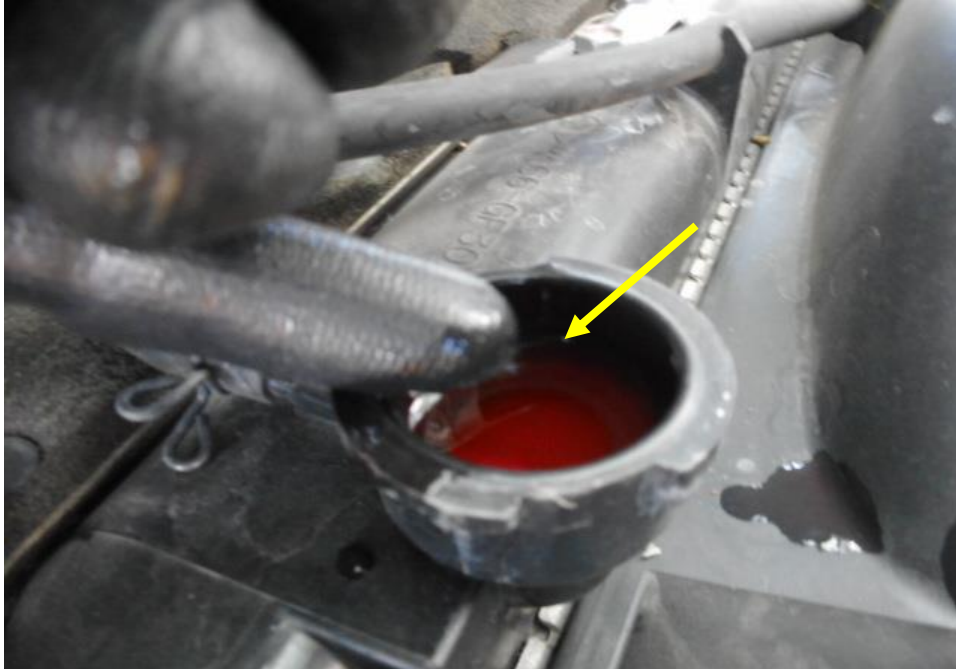
**Photo 14** shows the engine coolant reservoir of the Motor Lorry at the time of my inspection. The engine coolant was observed to be of sufficient level (arrowed) and without any visible contamination.

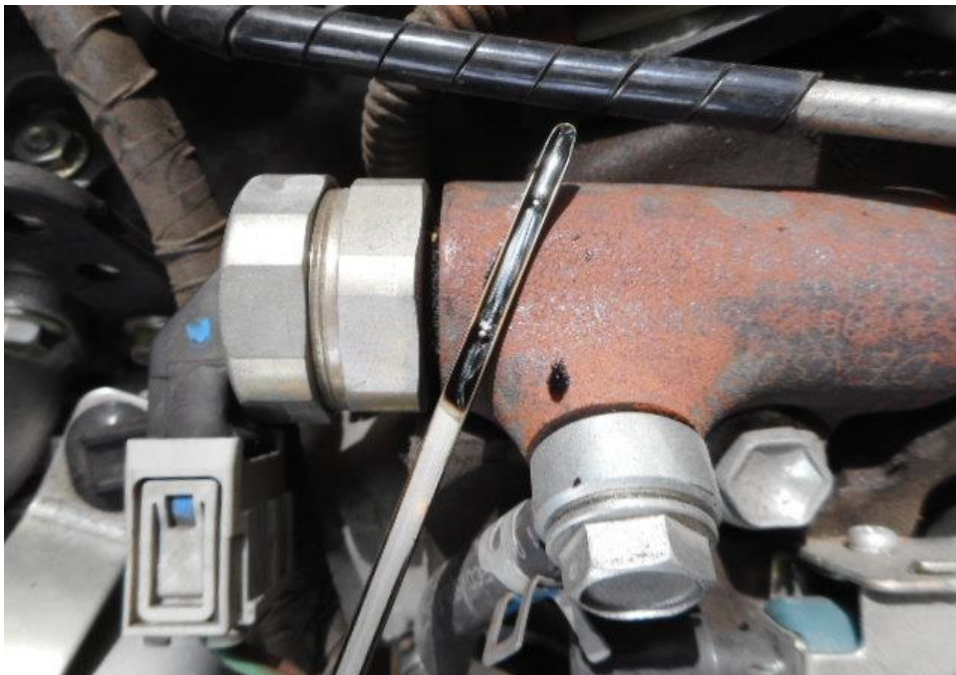
**Photo 15** shows the engine oil dip stick of the Motor Lorry at the time of my inspection. The engine oil was observed to be of sufficient level and without any visible contamination.

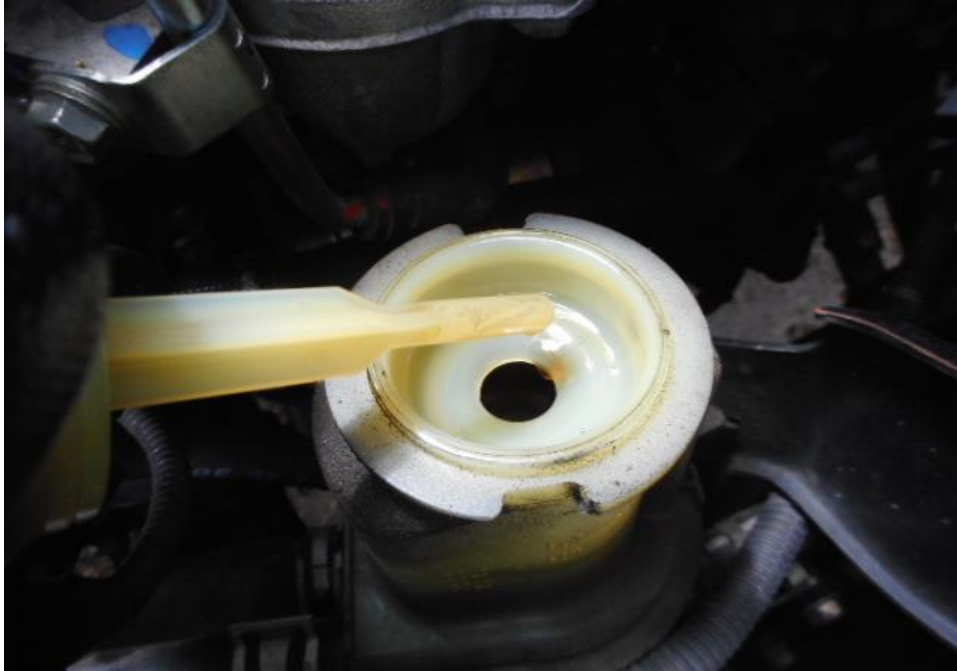
**Photo 16** shows the power steering fluid reservoir of the Motor Lorry at the time of my inspection. The power steering fluid was observed to be of sufficient level (arrowed) and without any visible contamination.

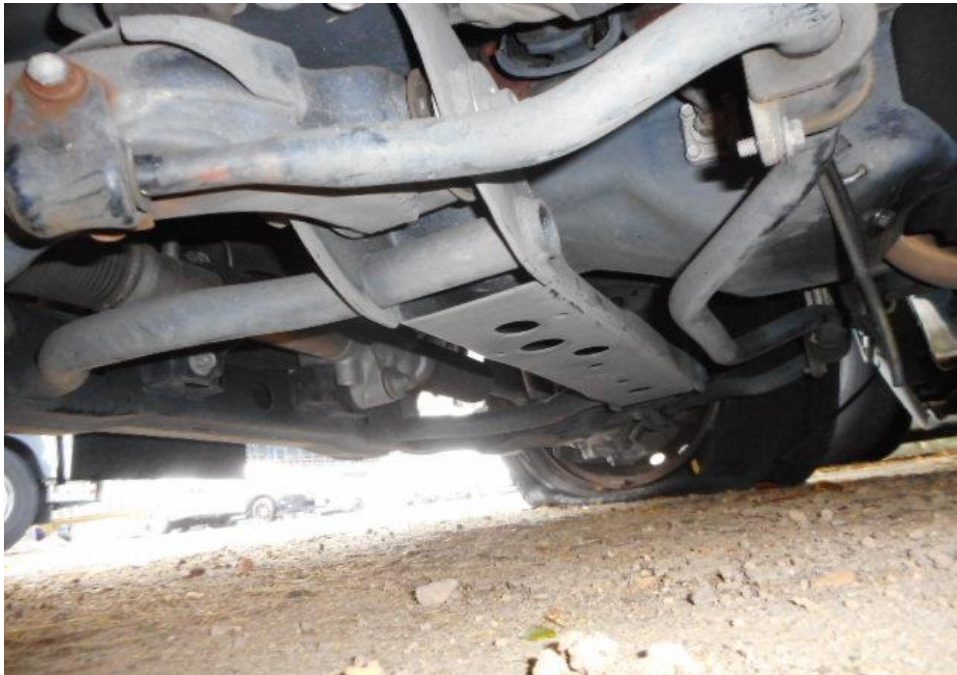
**Photo 17** shows the undercarriage of the Motor Lorry, at the area where the engine housing and transmission housing are located. I did not find any sign(s) or indication(s) of fluid leak and/or fluid stain(s) on the underside of the Motor Lorry.

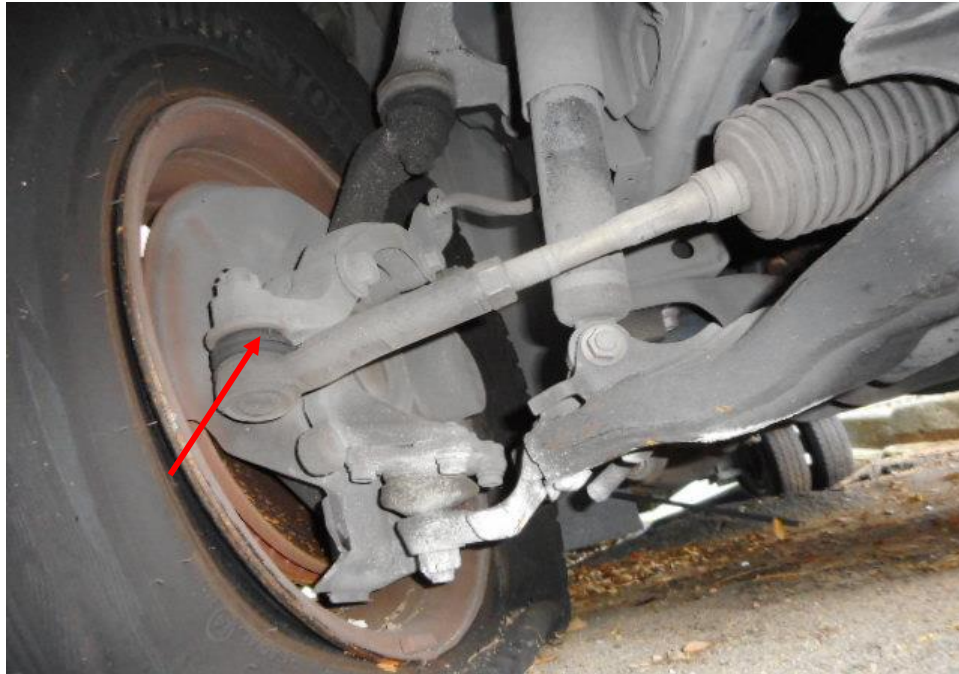
**Photo 18** shows the various undercarriage components at the front right wheel of the Motor Lorry, in particular the steering tie rod end (arrowed). The various steering components were all found to be intact, suggesting that the steering system of the Motor Lorry was likely to be in serviceable condition at the material time of accident. There was also no sign of fluid stain(s) observed on the various undercarriage components.

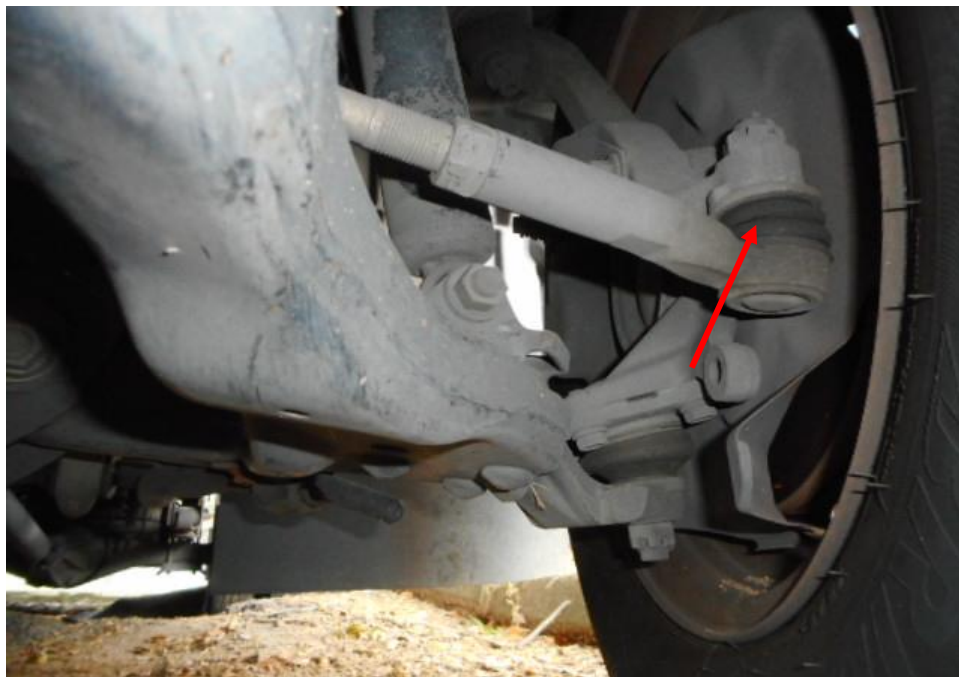
**Photo 19** shows the various undercarriage components at the front left wheel of the Motor Lorry, in particular the steering tie rod end (arrowed). The various undercarriage components of the Motor Lorry were all found to be intact without any visible damage. There was also no sign of fluid stain(s) observed on the various undercarriage components.

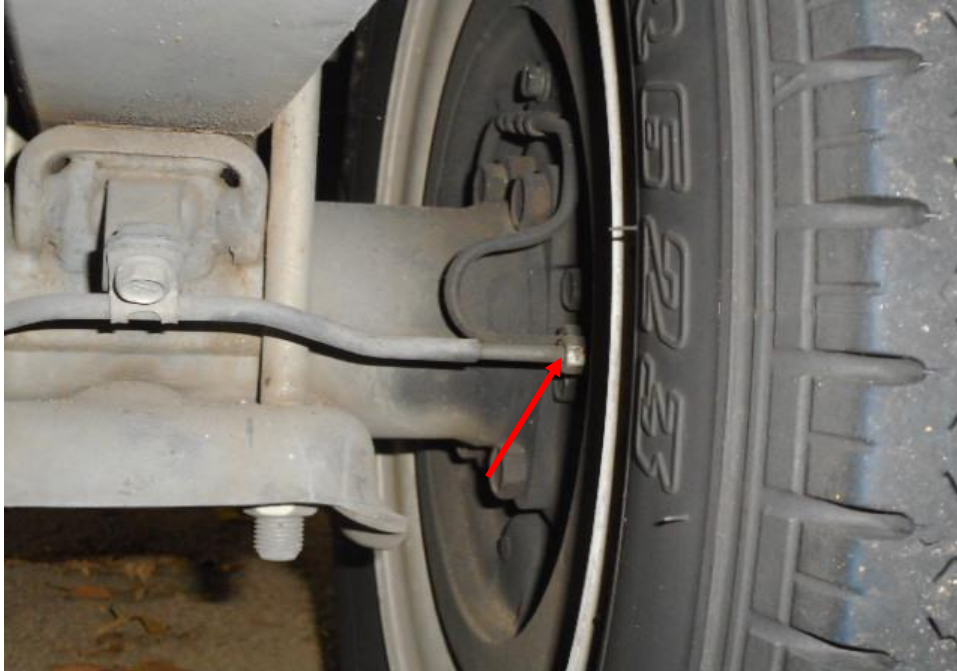
**Photo 20** shows the brake pipe (arrowed) at the rear right wheel of the Motor Lorry. I did not observe any leakage of brake fluid at the time of my inspection of the Motor Lorry. My static tests of the Motor Lorry's braking system, along with my visual examination of the various mechanical components in the braking system, had indicated that there was no internal leakage of pressure/vacuum. Hence the braking system of the Motor Lorry was likely to be in serviceable condition at the material time of accident.

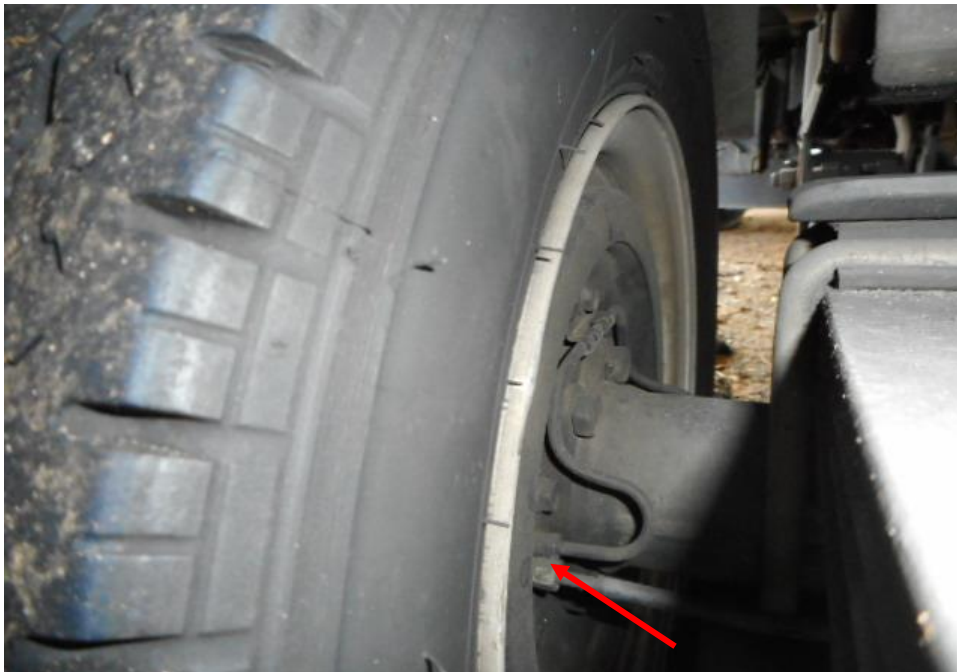
**Photo 21** shows the brake pipe (arrowed) at the rear left wheel of the Motor Lorry. I did not observe any leakage of brake fluid at the time of my inspection of the Motor Lorry. My static tests of the Motor Lorry's braking system, along with my visual examination of the various mechanical components in the braking system had indicated that there was no internal leakage of pressure/vacuum. Hence the braking system of the Motor Lorry was likely to be in serviceable condition at the material time of accident.

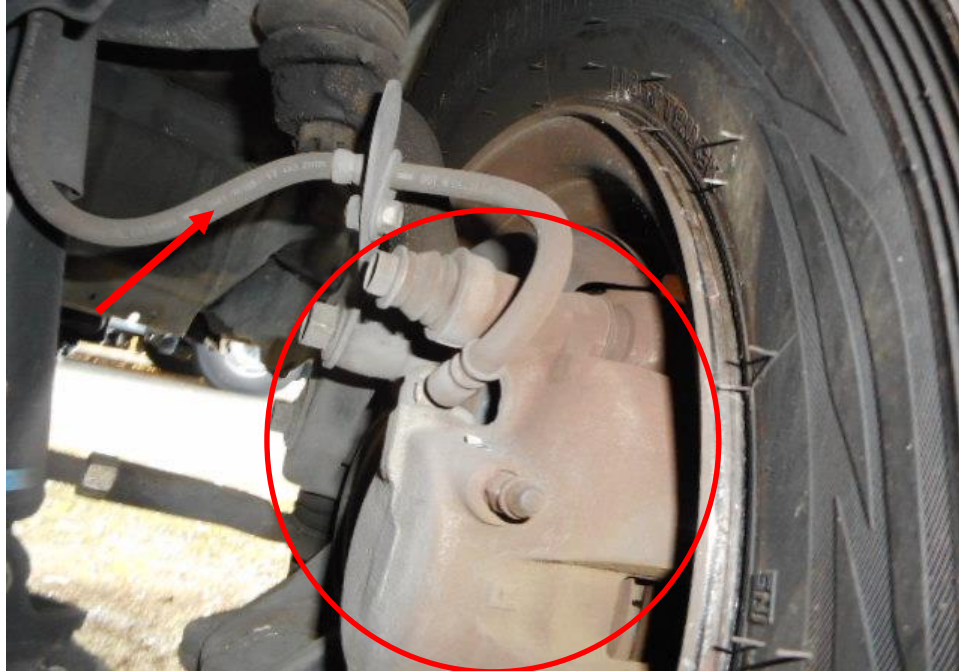
**Photo 22** shows the brake hose/pipe (arrowed) at the front right wheel of the Motor Lorry. No leakage of brake fluid was observed. Visual examination of the various components of the braking system like the brake caliper (circled), brake booster, brake pedal etc had revealed all to be intact and without visible damage at the time of accident. There was also no sign of fluid stain(s) observed on the various undercarriage components.

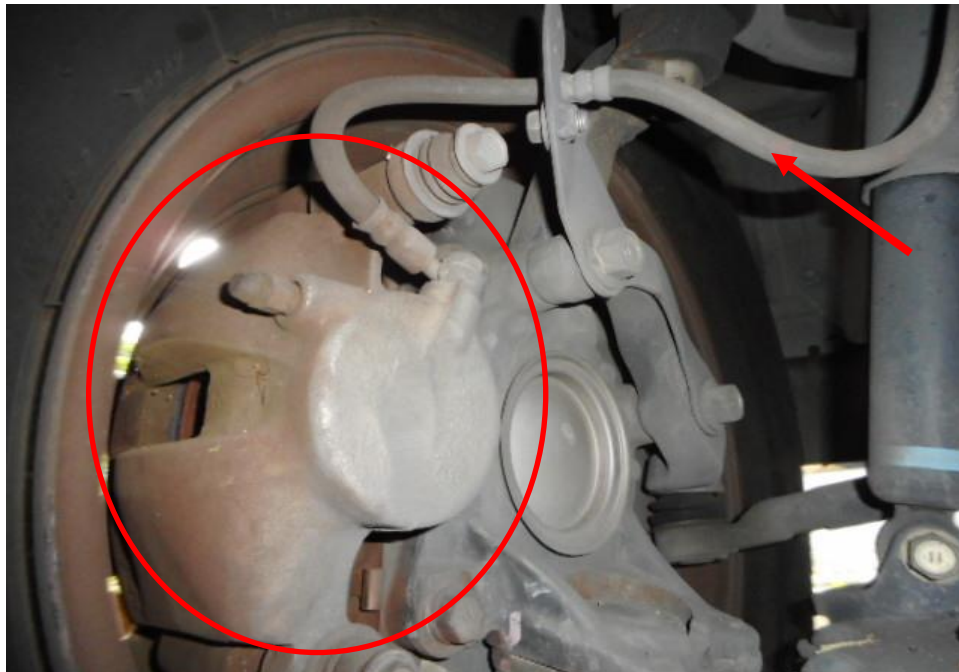
**Photo 23** shows the brake hose/pipe (arrowed) at the front left wheel of the Motor Lorry. No leakage of brake fluid was observed. Visual examination of the various components of the braking system like the brake caliper (circled), brake booster, brake pedal etc had revealed all to be intact and without visible damage at the time of accident. There was also no sign of fluid stain(s) observed on the various undercarriage components.
