Your Ref: TP/IP/19813/2021
Our Ref : CI/TPD21007272/P

Fatal Accident Investigation Team

MECHANICAL INSPECTION REPORT OF MOTOR TRUCK, XE 7733L

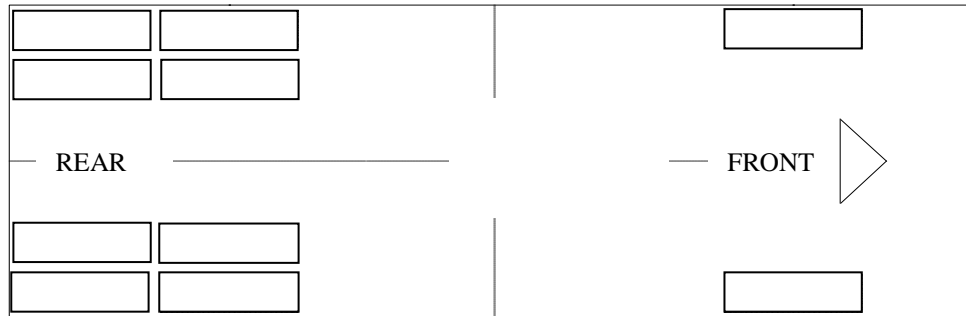
5. The 2 front tyres and 7 rear tyres of the Motor Truck were observed to be in serviceable condition and sufficiently inflated for vehicular operation. I did not find any tear, cut or burst mark(s) on the outer and the inner sidewalls as well as across the tread of the 10 tyres of the Motor Truck. However, observed that the rear left inner tyre was deflated and slipped out of the wheel rim. The tyre brand, tyre size and remaining tread depth of the 10 tyres of the Motor Truck were recorded as follows:-

Motor Truck

Lavnvigator 295/80R22.5 (6.5mm)
(Deflated)

Fireway 295/80R22.5 (12.4mm)

Lavnvigator 295/80R22.5 (6.5mm)

Fireway 295/80R22.5 (11mm)

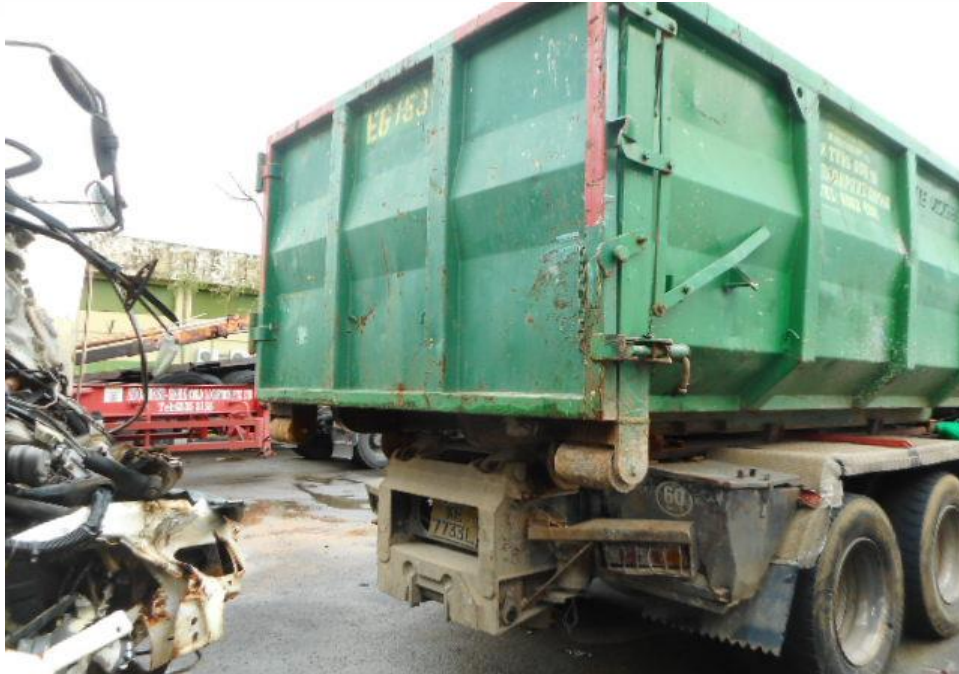
4. The Motor Truck was observed to sustained damage at its rear portion. Its rear right brake lamp were damage at the time of my inspection as a result of the accident.

Photo 1 shows a general view of the Motor Truck's rear body at the time of my inspection. The Motor Truck was observed to sustained damage at its rear portion. Its rear right brake lamp were damage at the time of my inspection as a result of the accident.

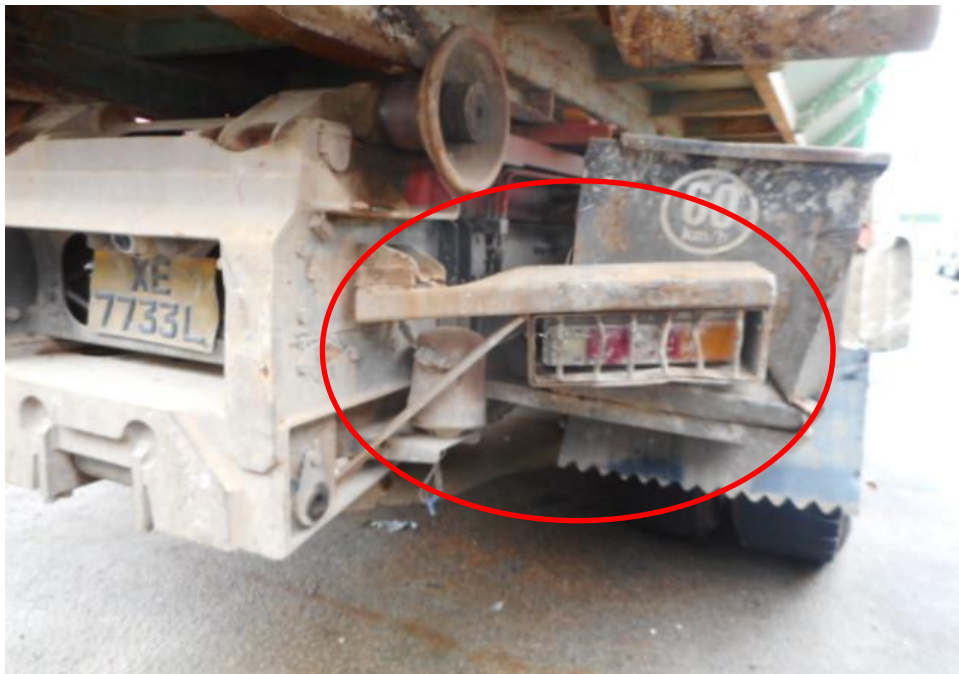
Photo 2 shows a close up view of the Motor Truck's rear body at the time of my inspection. The Motor Truck was observed to sustained damage at its rear portion. Its rear right brake lamp (circled) were damage at the time of my inspection as a result of the accident.

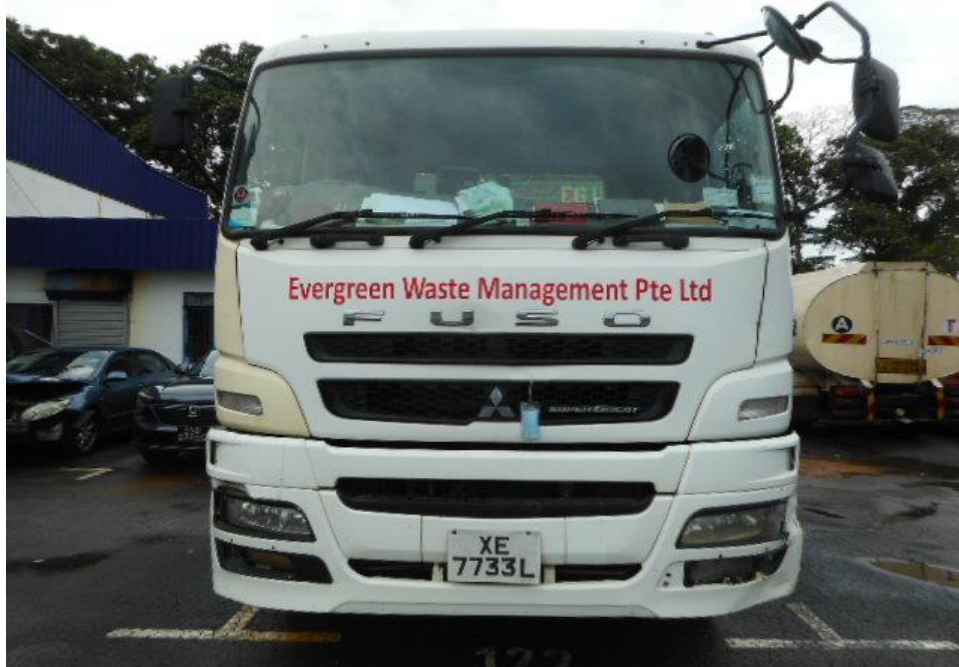
Photo 3 shows a general view of the front body of the Motor Truck at the time of my inspection. The Motor Truck was observed to be intact and unaffected by the accident.

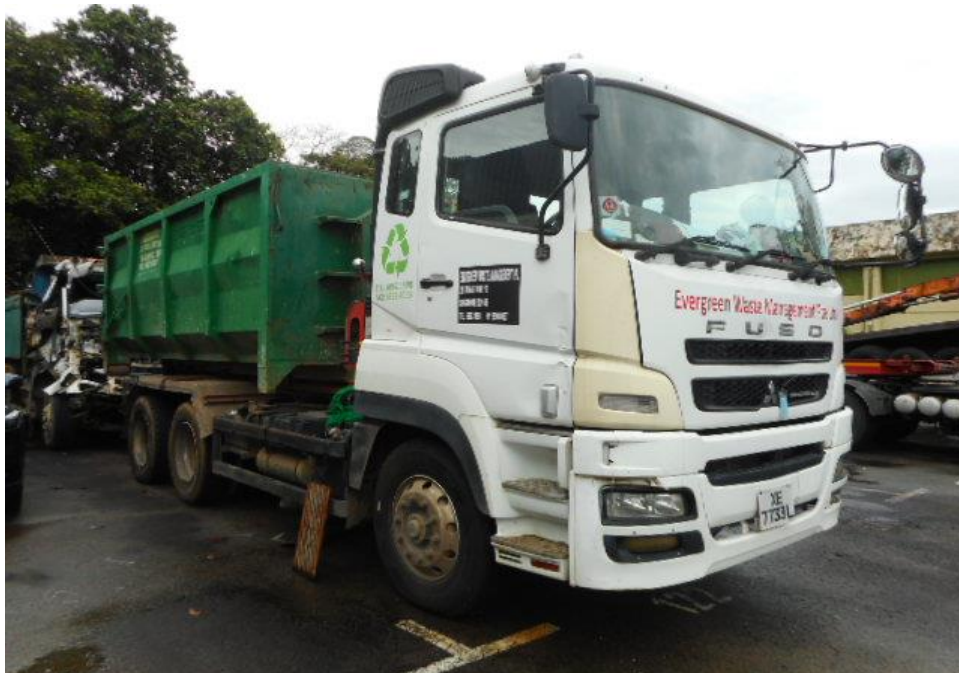
Photo 4 shows a general view of the right body of the Motor Truck at the time of my inspection. The Motor Truck was observed to be intact and unaffected by the accident.

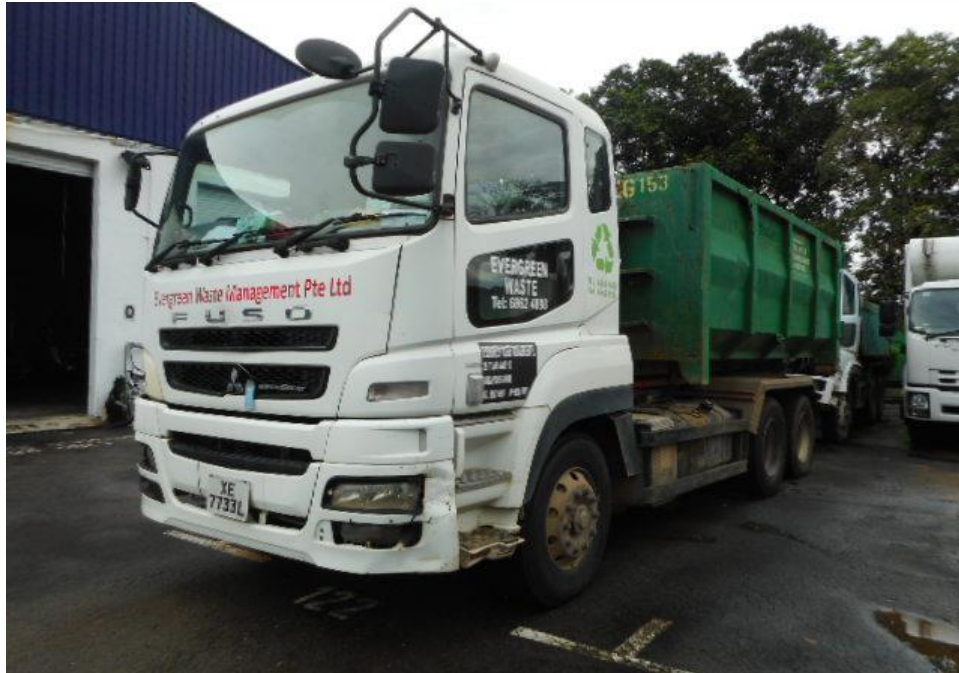
Photo 5 shows a general view of the left body of the Motor Truck at the time of my inspection. The Motor Truck was observed to be intact and unaffected by the accident.

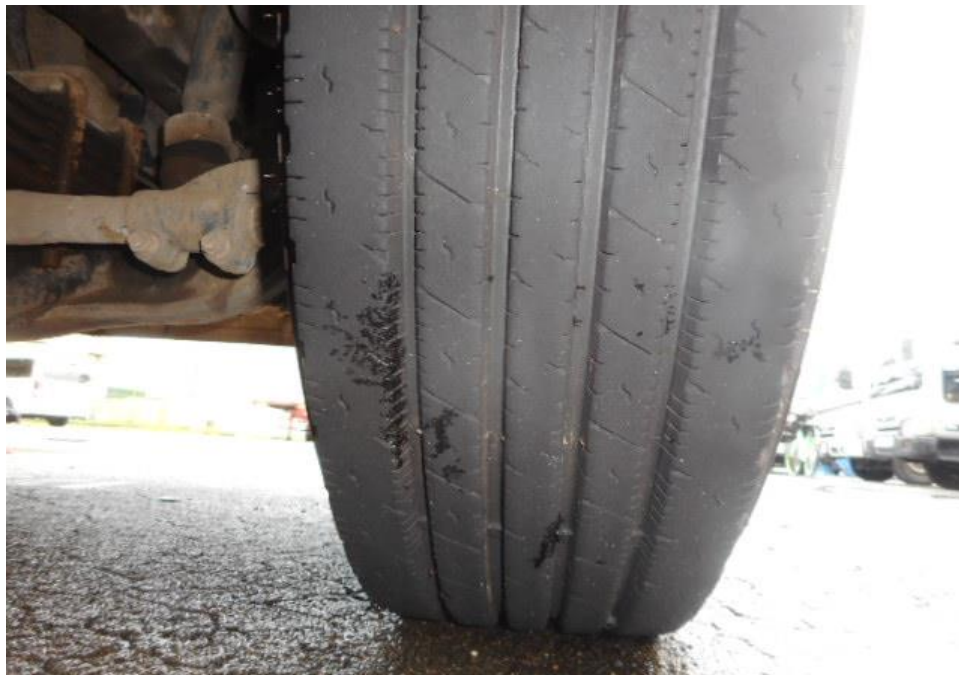
Photo 6 shows the condition of the front right tyre of the Motor Truck, which was observed to be in serviceable condition with remaining tread depth of approximately 11mm. The tyre, which was wrapped around standard steel wheel rim, was also observed to be sufficiently inflated for vehicular operation. There was no tear, cut or burst mark(s) on the outer and the inner sidewalls as well as across the tread of the 10 tyres that were fitted on the Motor Truck.

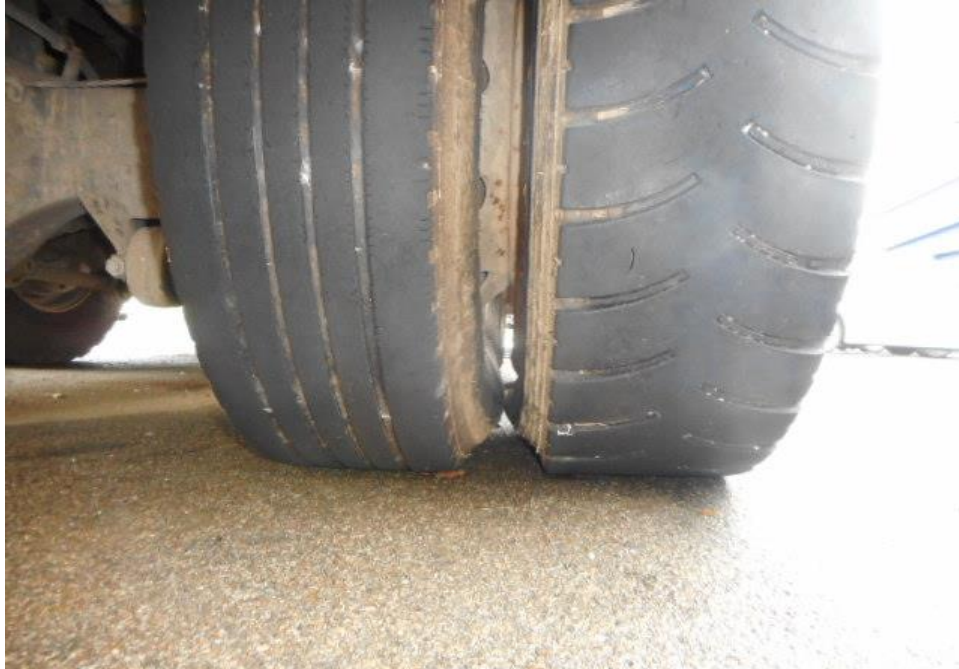
Photo 7 shows the condition of the rear right tyre of the Motor Truck, which was observed to be in serviceable condition with remaining tread depth of approximately 6.5mm. The tyre, which was wrapped around standard steel wheel rim, was also observed to be sufficiently inflated for vehicular operation.

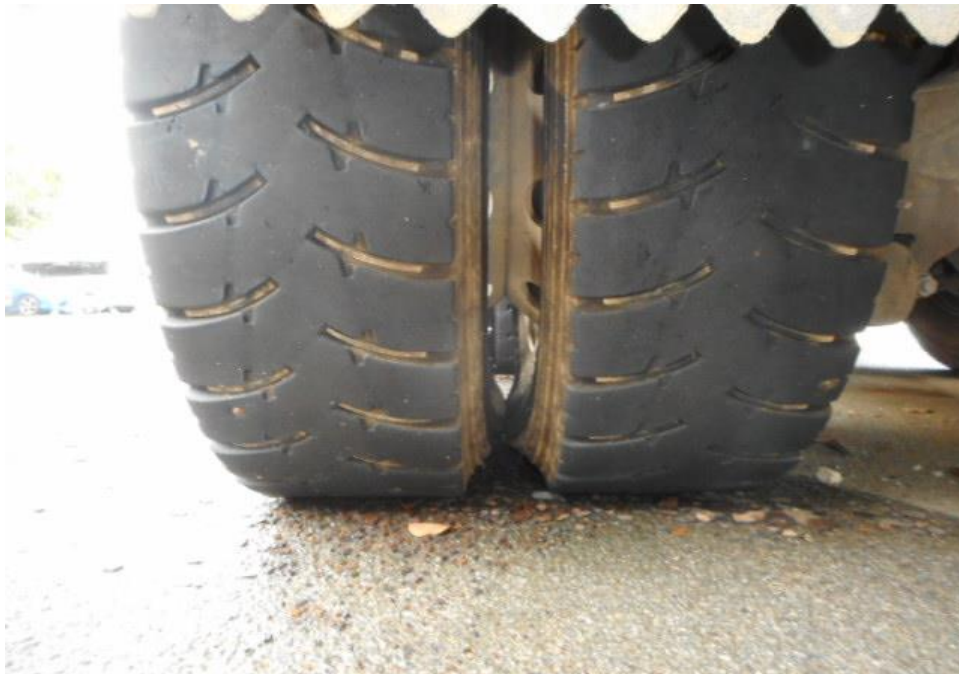
Photo 8 shows the condition of the rear right tyre of the Motor Truck, which was observed to be in serviceable condition with remaining tread depth of approximately 6.5mm. The tyre, which was wrapped around standard steel wheel rim, was also observed to be sufficiently inflated for vehicular operation.

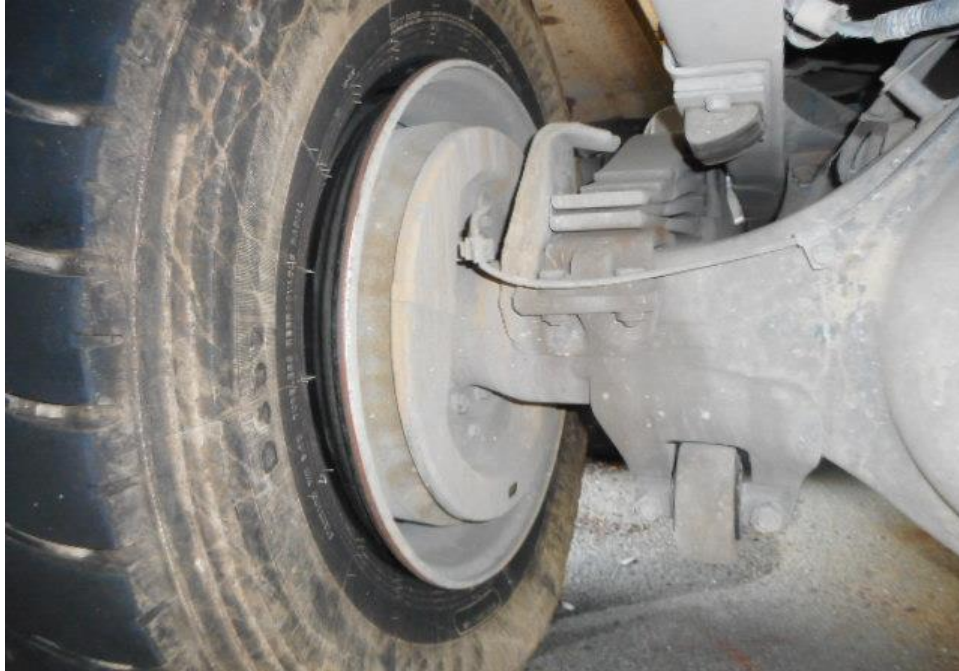
6. The 9 tyres of the Motor Truck were observed to be wrapped around standard steel wheel rims that were found to be without any damage. However, observed that the rear left inner tyre was deflated and slipped out of the wheel rim. See photo 1 – 11 below.

Photo 9 shows the close up view of the rear left inner tyre of the Motor Truck, which was observed to be deflated and slipped off the wheel rim.

12. The 2 front tyres, 7 rear tyres fitted on the Motor Truck were also found to be in serviceable condition. I did not find any tear, cut or burst mark(s) on the outer and the inner sidewalls as well as across the tread of the Motor Truck 10 tyres. The other 9 tyres of the Motor Truck were observed to be sufficiently inflated for vehicular operation with remaining tread depth of approximately 6.5mm – 12.4mm. However, at the time of inspection we observed that the rear left inner tyre was deflated and slipped out of the wheel rim.

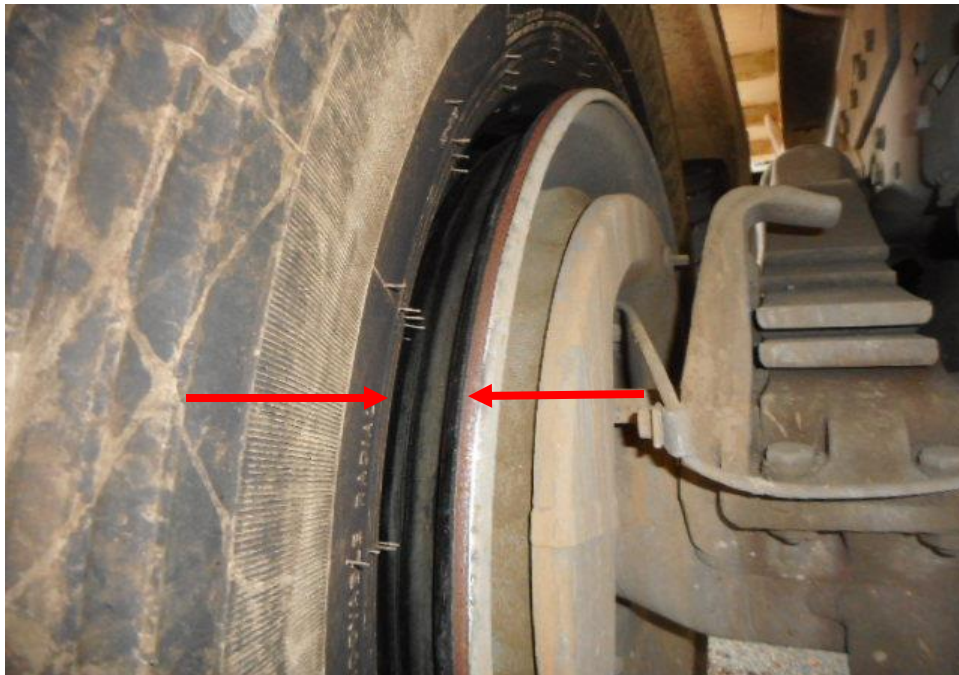
Photo 10 shows the close up view of the rear left inner tyre of the Motor Truck, which was observed to be deflated and slipped off the wheel rim (arrowed).

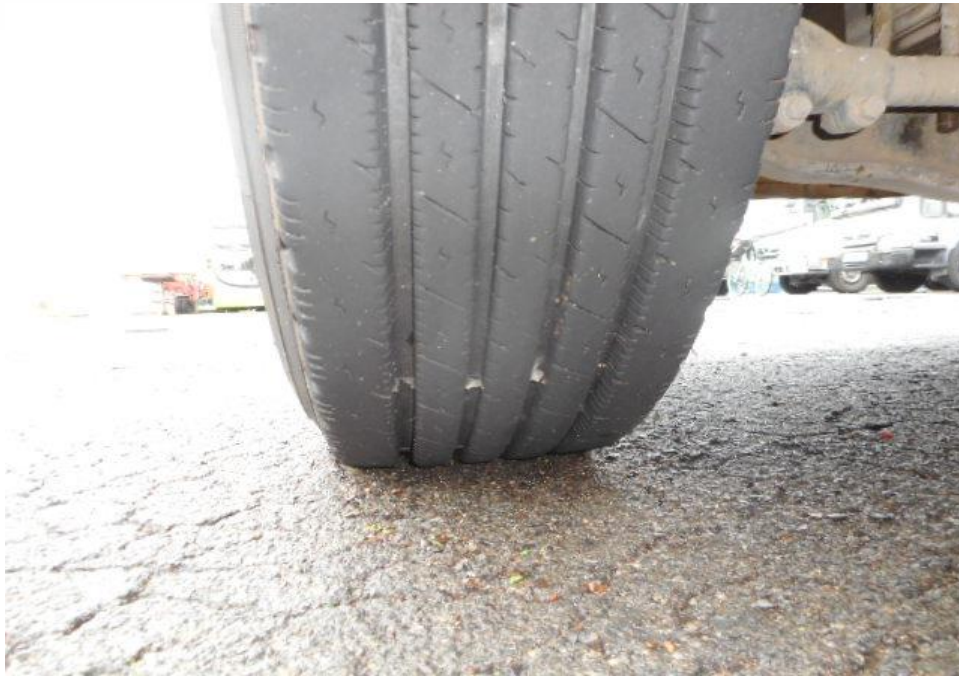
Photo 11 shows the condition of the front left tyres of the Motor Truck, which were observed to be in serviceable condition with remaining tread depth of approximately 12.4mm. There was also no tear, cut or burst mark(s) on the outer and the inner sidewalls as well as across the tread of the 10 tyres that were fitted on the Truck.

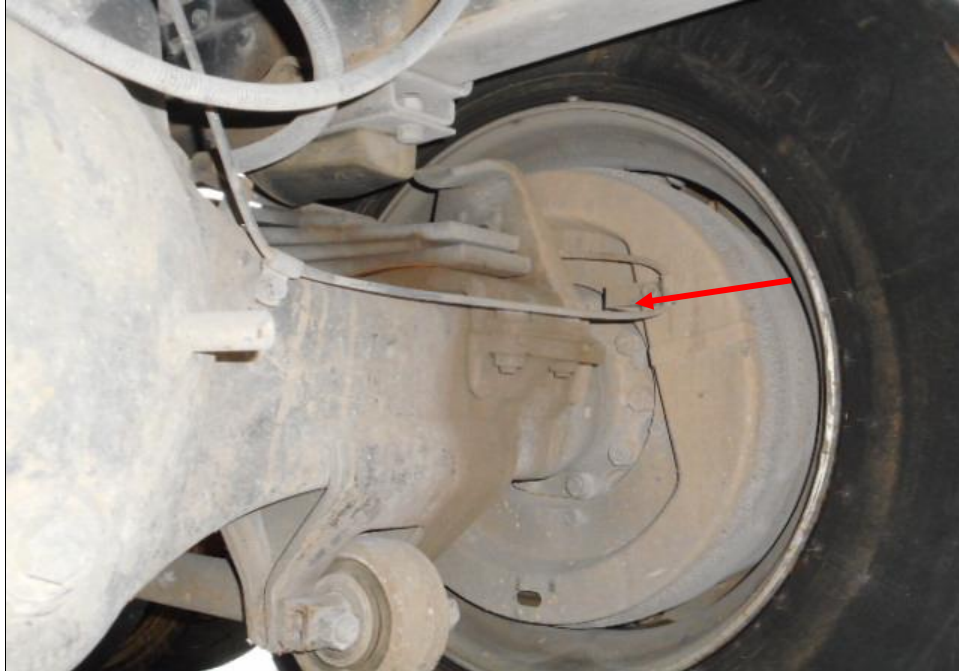
Photo 12 shows the brake pipe (arrowed) at the rear right wheel of the Motor Truck. I did not observe any leakage of brake fluid at the time of my inspection of the Motor Truck. My visual examination of the various mechanical components in the braking system, had indicated that these was no internal leakage of pressure/vacuum and these components were generally in good condition.

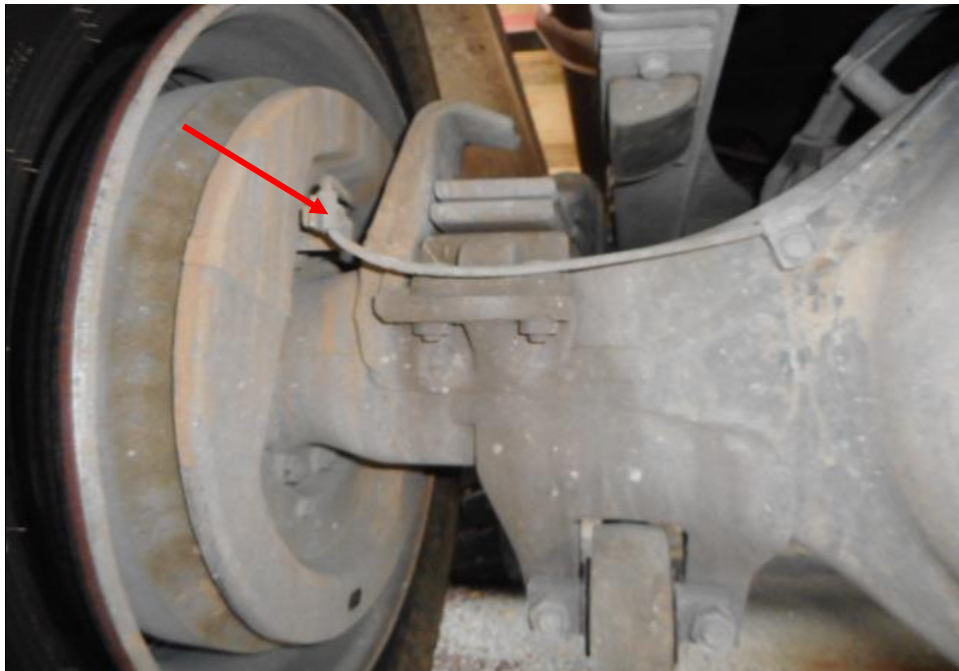
Photo 13 shows the brake pipe (arrowed) at the rear left wheel of the Motor Truck. I did not observe any leakage of brake fluid at the time of my inspection of the Motor Truck. My static tests of the Motor Truck's braking system, along with my visual examination of the various mechanical components in the braking system, had indicated that these was no internal leakage of pressure/vacuum and these components were generally in good condition.

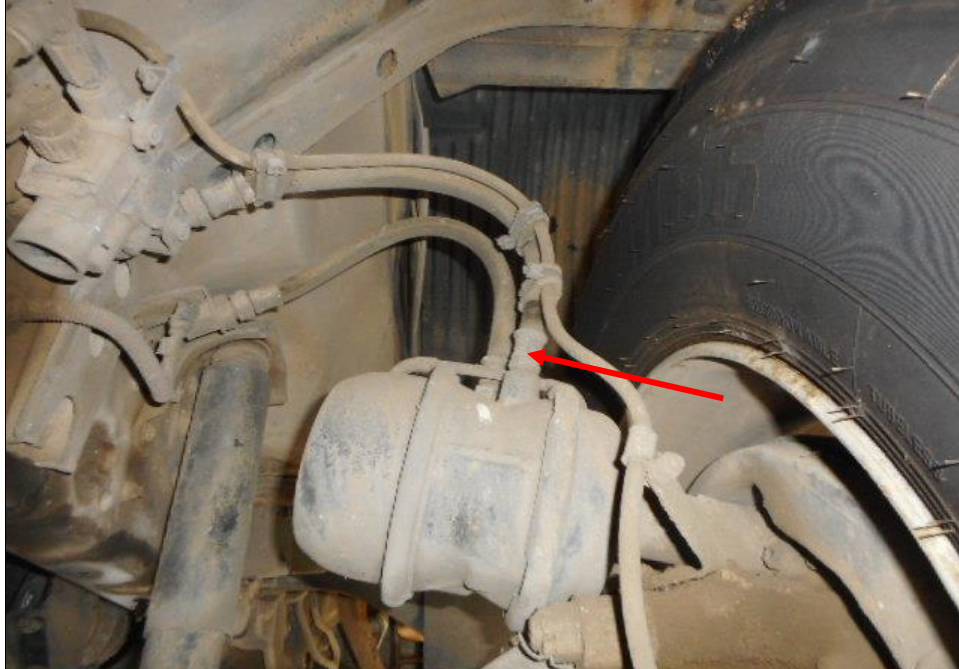
Photo 14 shows the brake pipe (arrowed) at the front right wheel of the Motor Truck. I did not observe any leakage of brake fluid at the time of my inspection of the Motor Truck. My static tests of the Motor Truck's braking system, along with my visual examination of the various mechanical components in the braking system, had indicated that there was no internal leakage of pressure/vacuum and these components were generally in good condition.

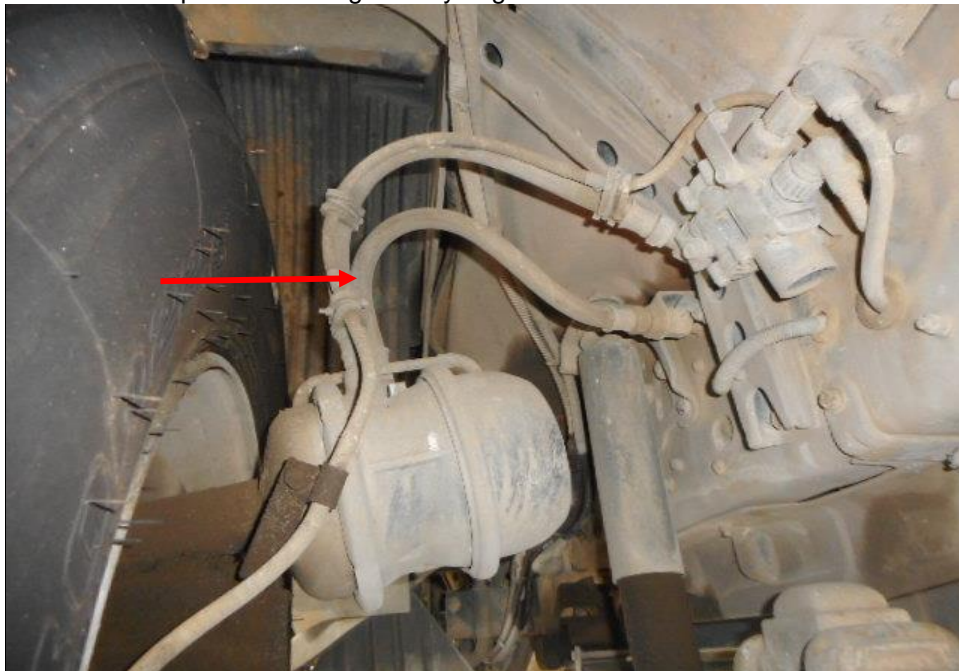
Photo 15 shows the brake pipe (arrowed) at the front left wheel of the Motor Truck. I did not observe any leakage of brake fluid at the time of my inspection of the Motor Truck. My visual examination of the various mechanical components in the braking system had indicated that there was no internal leakage of pressure/vacuum and these components were generally in good condition.

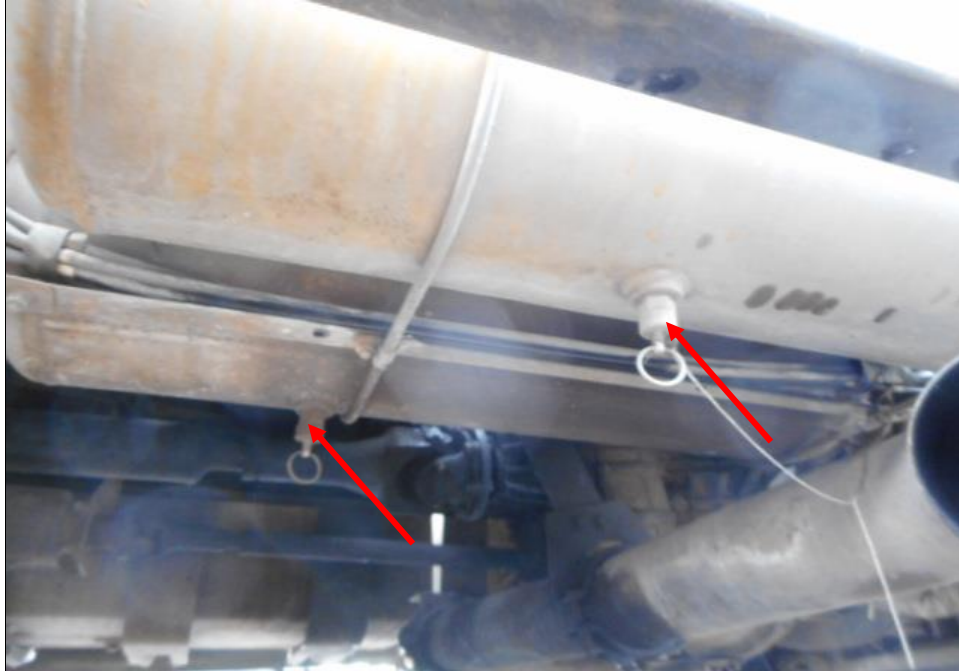
Photo 16 shows the air brake cylinders (arrowed) at the undercarriage of the Motor Truck. I did not observe any leakage of air brake fluid at the time of my inspection of the Motor Truck. My visual examination of the various mechanical components in the braking system had indicated that these was no internal leakage of pressure/vacuum and these components were generally in good condition.

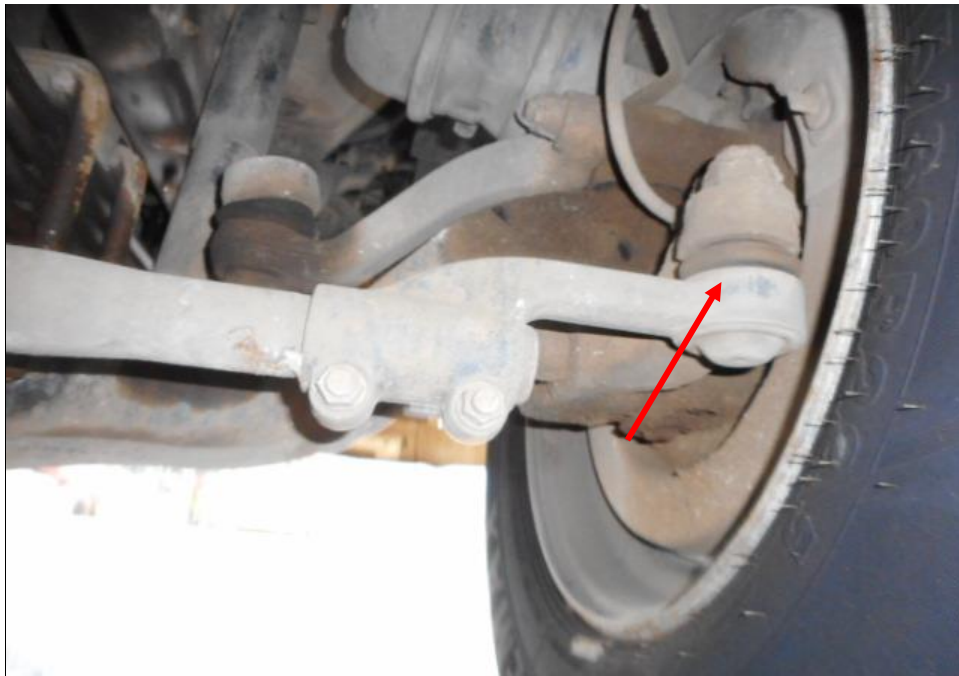
Photo 17 shows the various undercarriage components at the front right wheel of the Motor Truck, in particular the steering tie rod end (arrowed). The various steering components were all found to be intact, suggesting that the steering system of the Motor Truck was likely to be in serviceable condition at the material time of accident. There was also no sign of fluid stain(s) observed on the various undercarriage components.

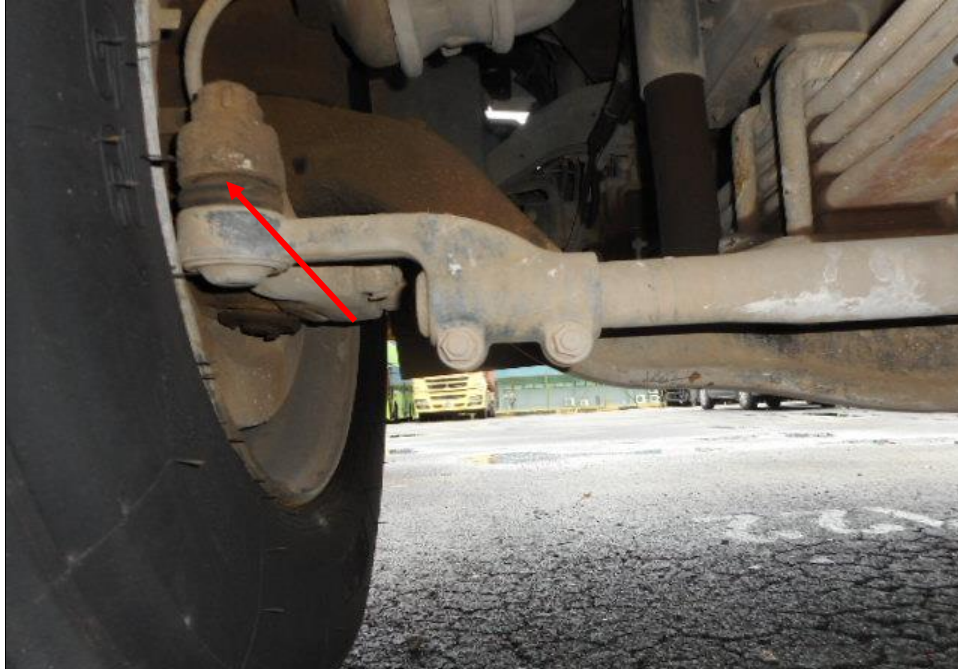
Photo 18 shows the various undercarriage components at the front left wheel of the Motor Truck, in particular the steering tie rod end (arrowed). The various undercarriage components of the Motor Truck were all found to be intact without any visible damage. There was also no sign of fluid stain(s) observed on the various undercarriage components.

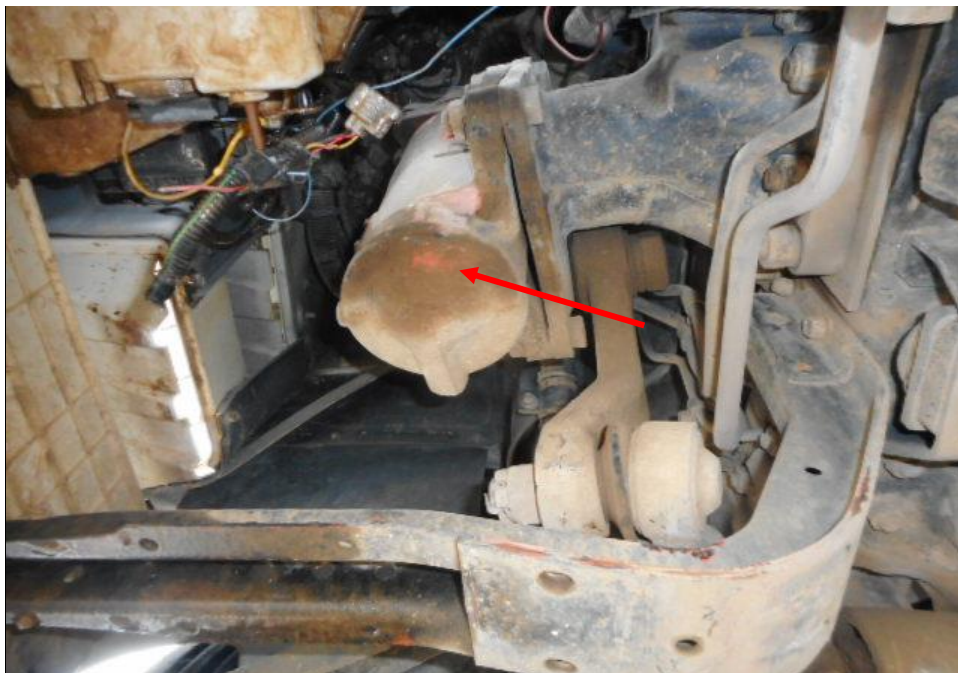
Photo 19 shows the steering box component (arrowed) at the undercarriage of the Motor Truck was found to be intact without any visible damage. There was also no sign of fluid stain(s) observed on the various undercarriage components.
