Your Ref: TP/IP/19813/2021
Our Ref: CI/TPD21007273/P

Fatal Accident Investigation Team

MECHANICAL INSPECTION REPORT OF MOTOR LORRY YP 6143B

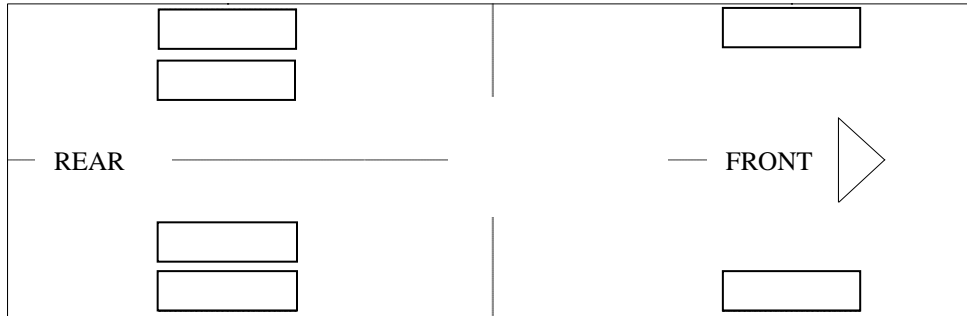
6. The condition of the Motor Lorry's 6 tyres was observed to be in serviceable condition. I did not find any tear, cut or burst mark(s) on the outer and the inner sidewalls as well as across the tread of the 6 tyres. The 6 tyres were also observed to be sufficiently inflated for vehicular operation. The tyre brand, tyre size and remaining tread depth of the 6 tyres were recorded as follows:-

Bridgestone 195/85R15 (2.5mm)

Bridgestone 195/85R15 (5.1mm)

Bridgestone 195/85R15 (4mm)

Bridgestone 195/85R15 (7.4mm)

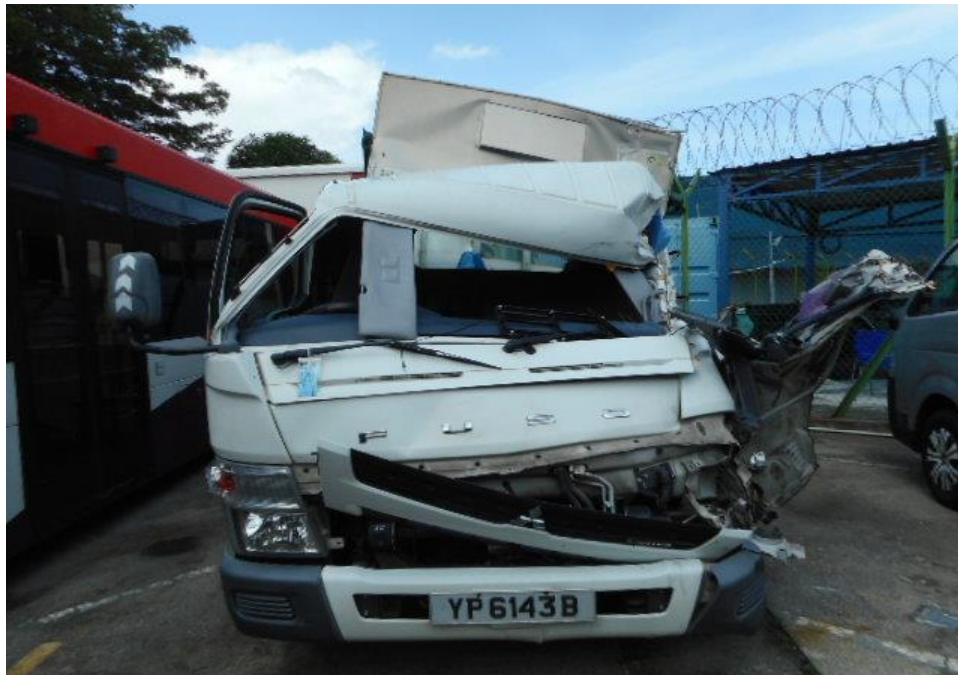
Photo 1 shows a general view of the front windscreen and body panel of the Motor Lorry at the time of our inspection. The Motor Lorry was observed sustained major damages at its front and rear cabin portion as well as its left door as a result of the accident.

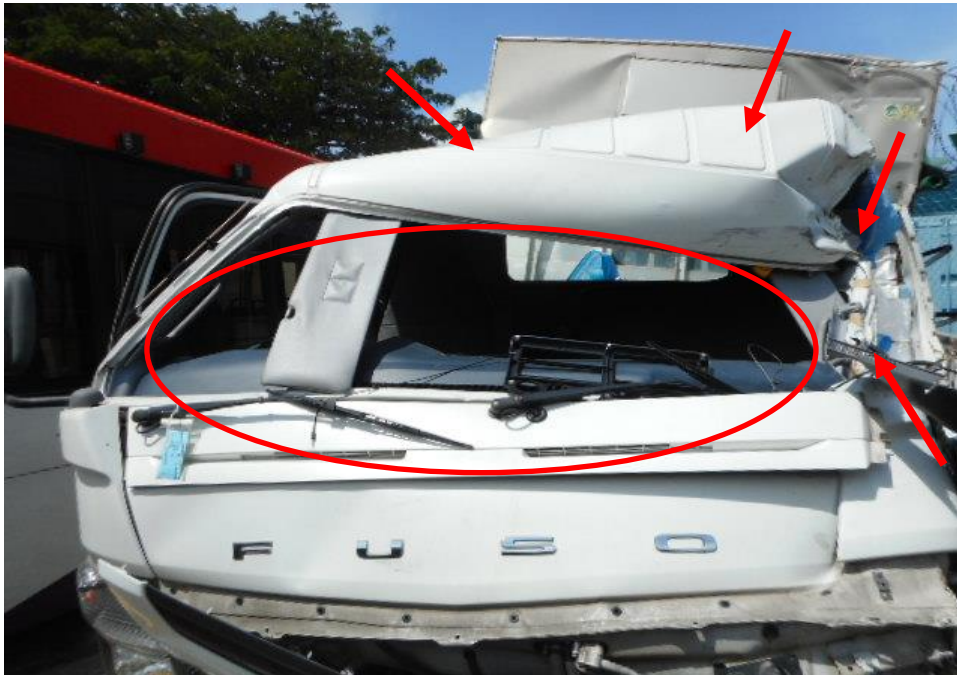
Photo 2 shows the close up view of the front portion of the Motor Lorry at the time of our inspection. The Motor Lorry was observed to have sustained major damages to its front windscreen (circled) and its front cabin (arrowed) that was crushed due to the accident's impact.

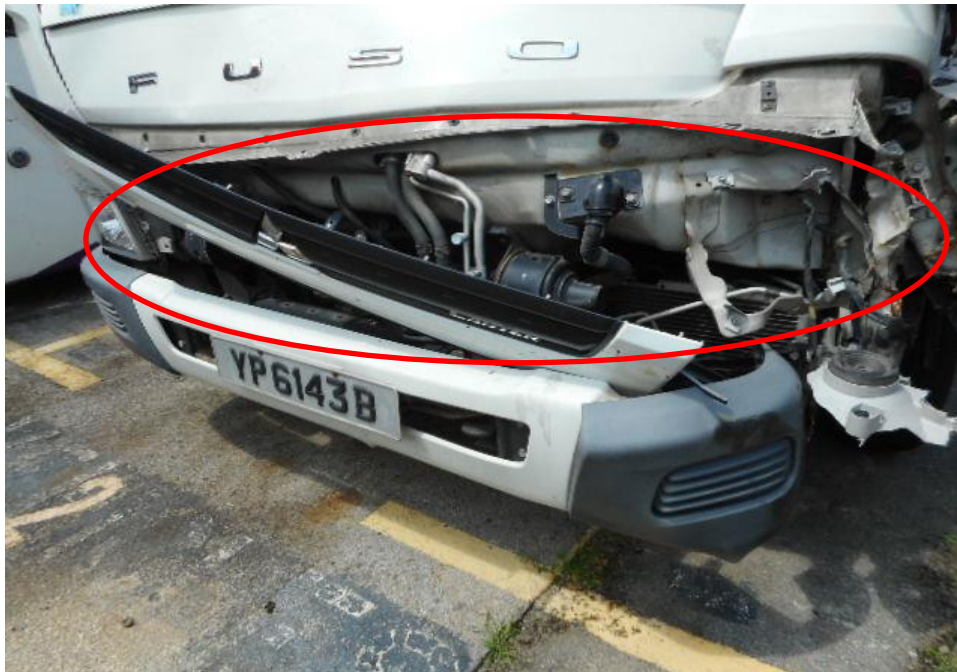
Photo 3 shows the close up view of the front portion of the Motor Lorry at the time of our inspection. The Motor Lorry was observed to have sustained major damages to its front body panel (circled) that was damaged as a result of the accident's impact.

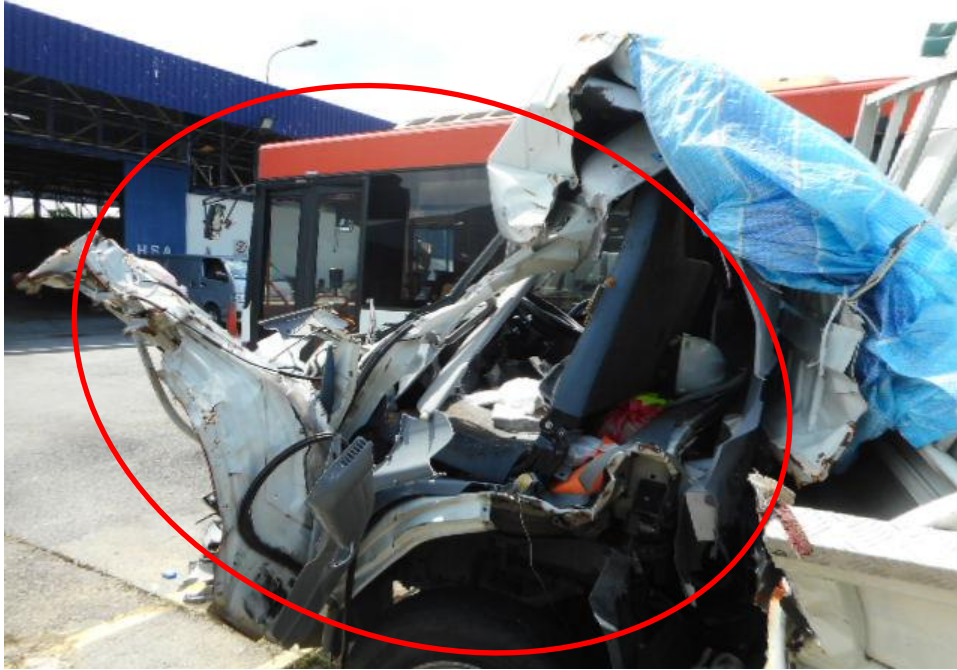
Photo 4 shows the close up view of the left door of the Motor Lorry at the time of our inspection. The Motor Lorry was observed to have sustained damages to its left door (circled) as a result of the accident's impact.

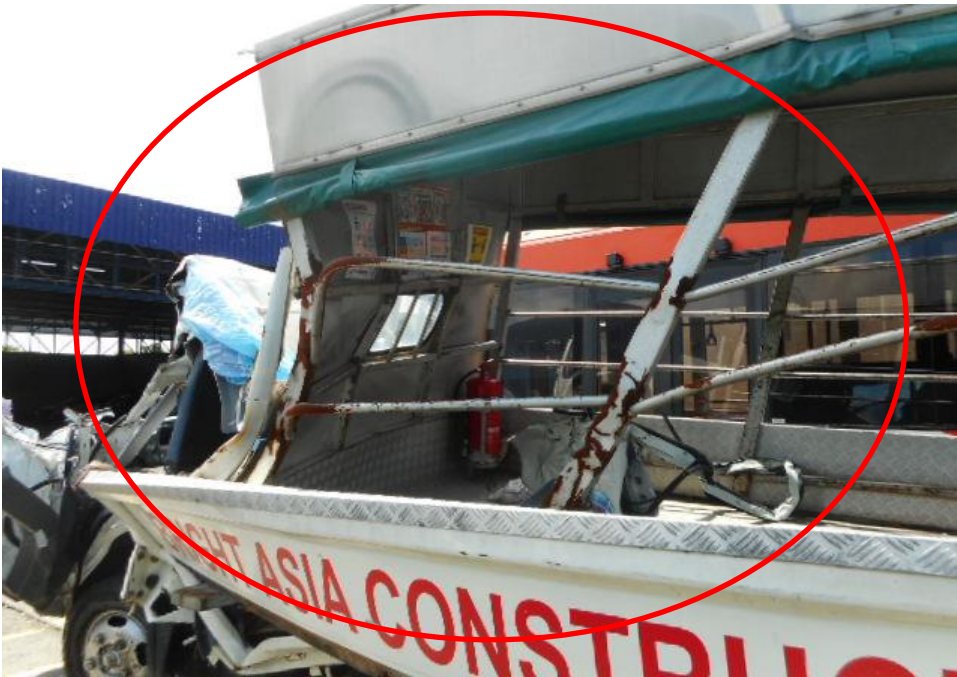
Photo 5 shows a left general view of the rear cabin portion of the Motor Lorry at the time of my inspection, its rear cabin body panel (circled) was observed to have been damaged as a result of the accident's impact.

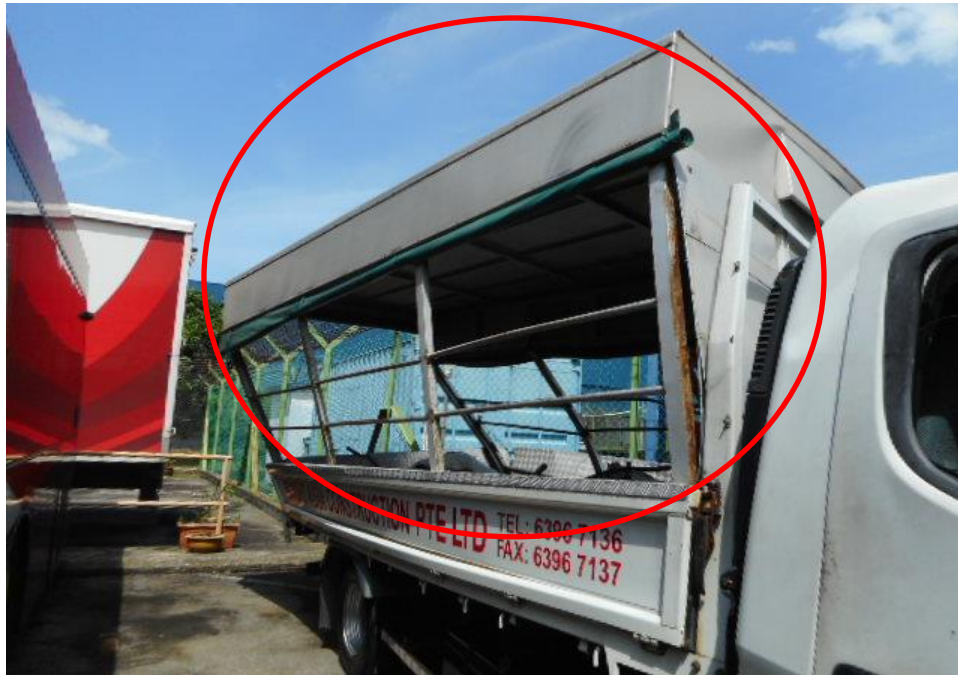
Photo 6 shows a right general view of the rear cabin portion of the Motor Lorry at the time of my inspection, its rear cabin body panel (circled) was observed to have been damaged as a result of the accident's impact.

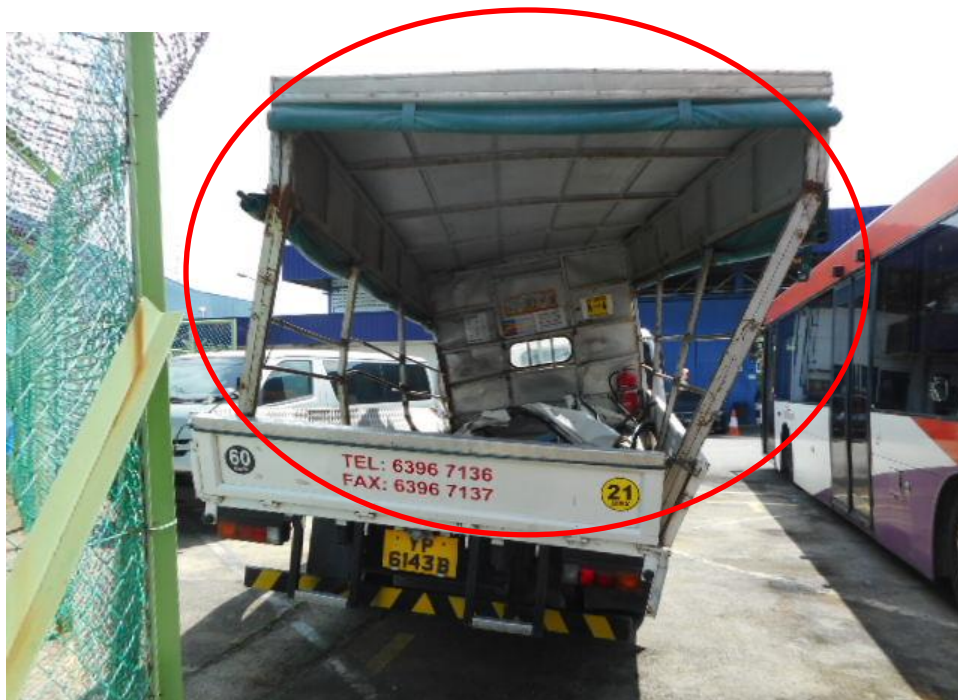
Photo 7 shows a rear general view of the rear cabin portion of the Motor Lorry at the time of my inspection, its rear cabin body panel (circled) was observed to have been damaged as a result of the accident's impact.

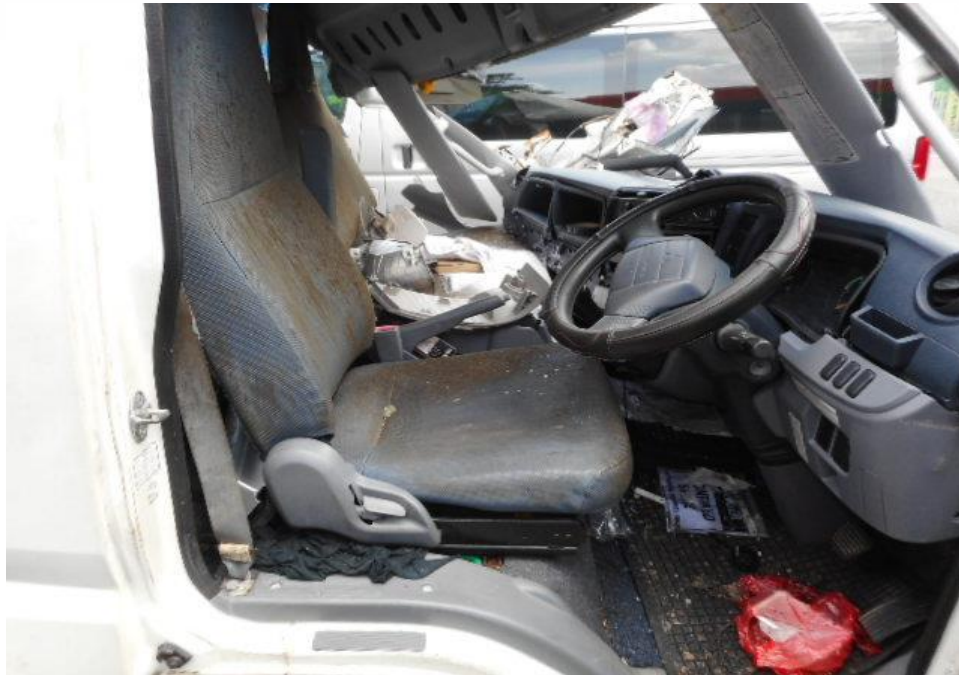
Photo 8 shows the close up view of the front interior cabin of the Motor Lorry. It was observed to have sustained extensive induced damages to the dashboard as a result of the accident.

12. The static test of the Motor Lorry electronic safety system could not be inspected as the instrument cluster was damaged due to the induce impact from the accident.

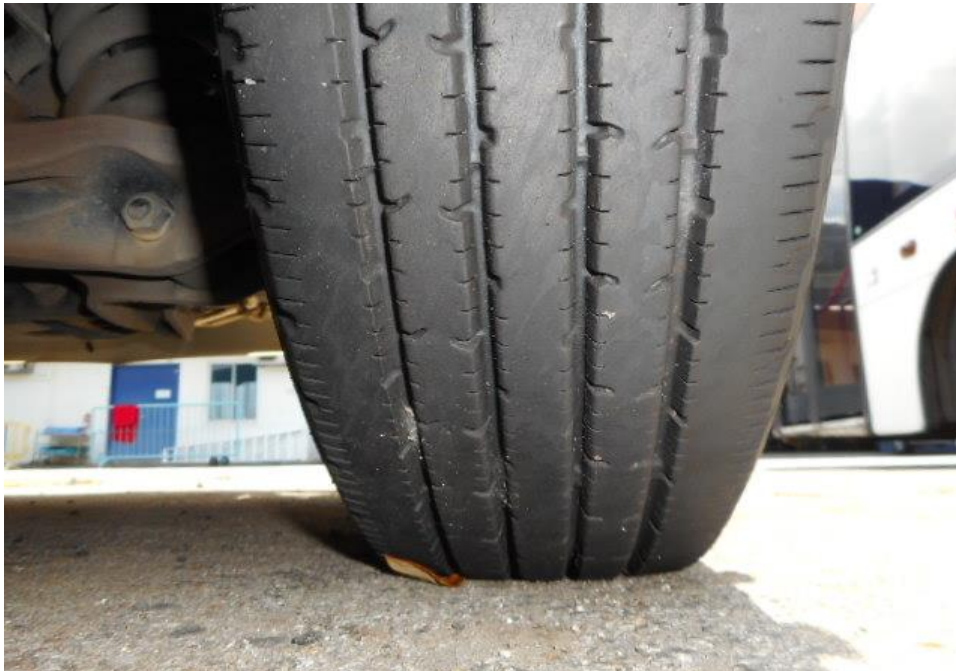
Photo 9 shows the condition of the front right tyre of the Motor Lorry, which was observed to be in serviceable condition with remaining tread depth of approximately 7.4mm. The tyre, which was wrapped around standard steel wheel rim, was also observed to be sufficiently inflated for vehicular operation.

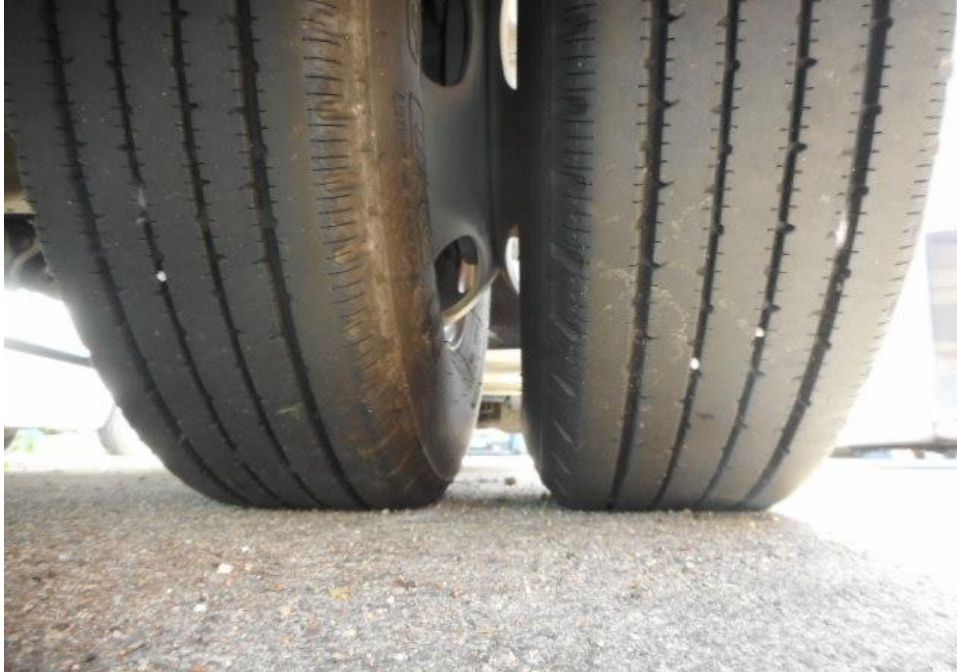
Photo 10 shows the condition of the rear right tyres of the Motor Lorry, which observed to be in serviceable condition with remaining tread depth of approximately 4mm. The tyres, which were wrapped around standard steel wheel rim, were also observed to be sufficiently inflated for vehicular operation.

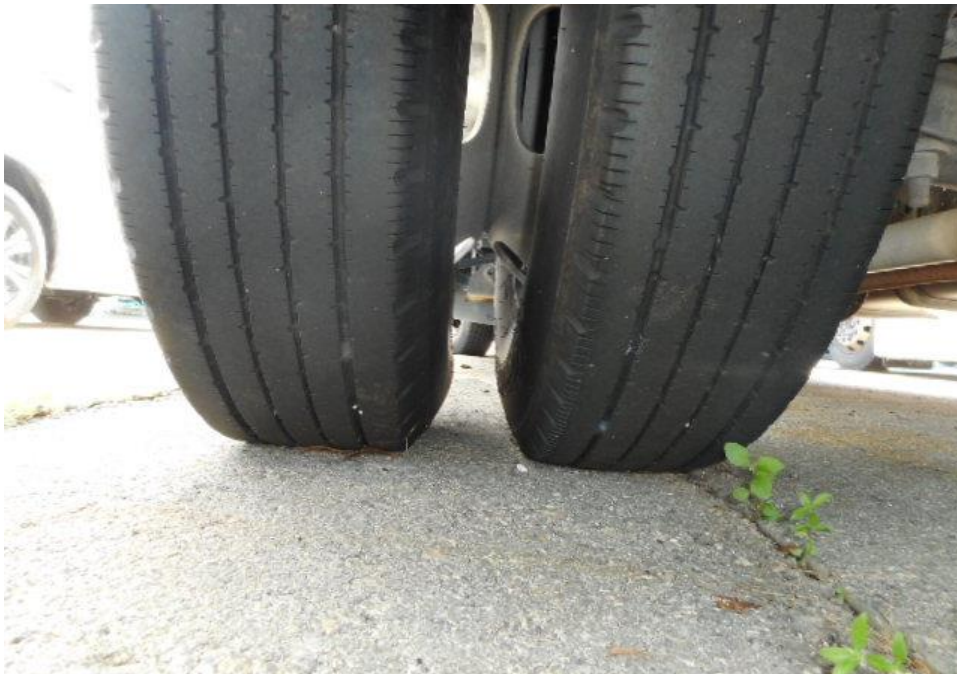
Photo 11 shows the condition of the rear left tyres of the Motor Lorry, which were observed to be in serviceable condition with remaining, tread depth of approximately 2.5mm. See above.

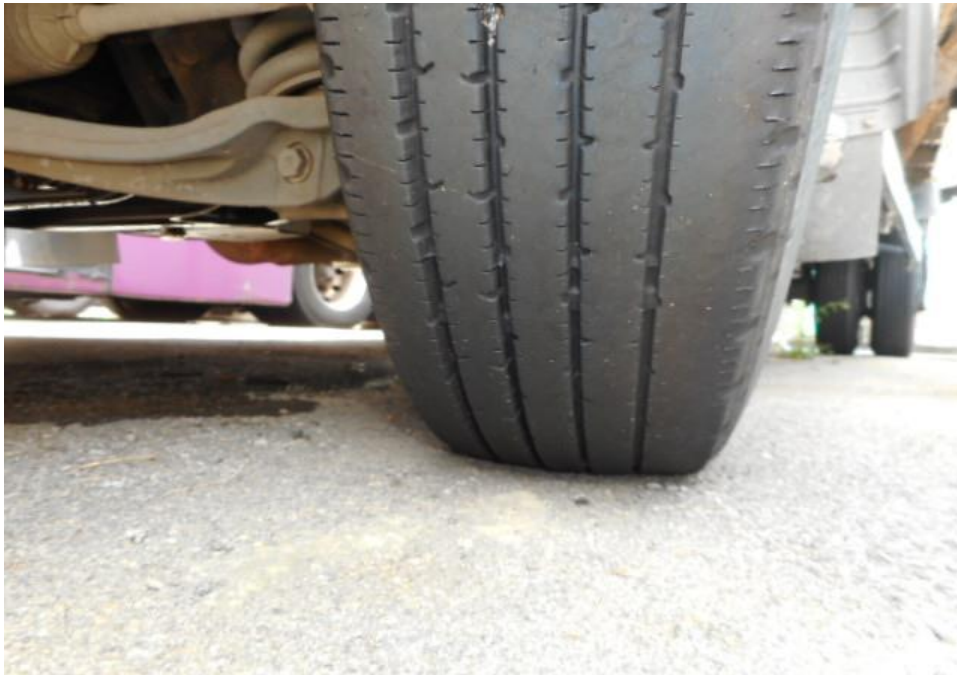
Photo 12 shows the condition of the front right tyre of the Motor Lorry, which was observed to be in serviceable condition with remaining tread depth of approximately 5.5mm. The tyre, which was wrapped around standard steel wheel rim, was also observed to be sufficiently inflated for vehicular operation.

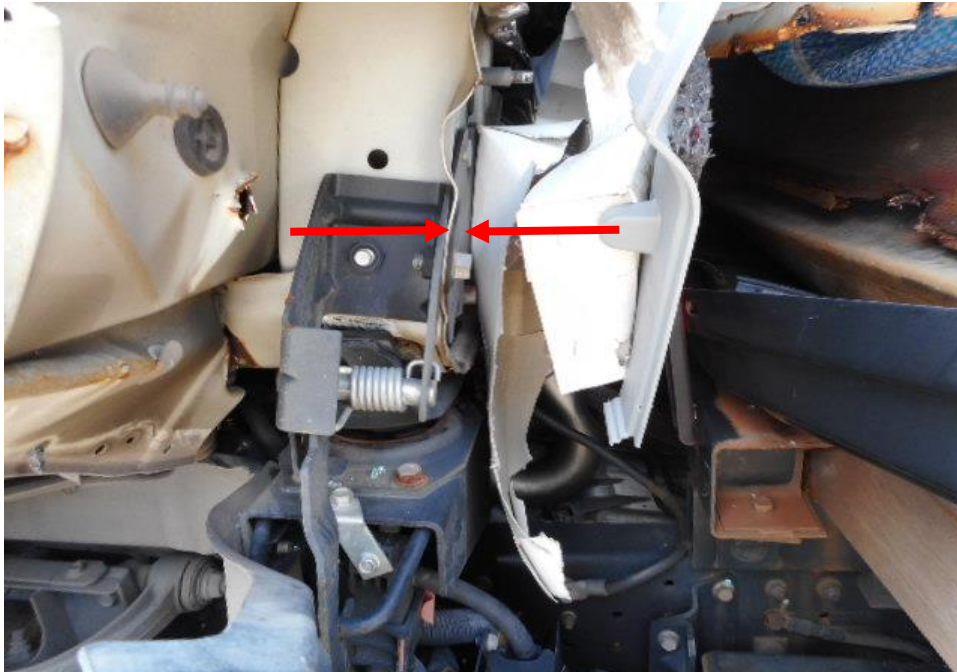
8. Upon examination of the Motor Lorry's engine compartment, we had observed that all the parts, components and fluids could not be inspected as due to the damage induced has crushed and deformed the cabin of the Motor Lorry which immobilized its opening and viewing, however we are able to observe the brake fluid of the Motor Lorry and was observed to be sufficient level without any visible contamination.
9. Our subsequent checks on the underside of the Motor Lorry also revealed no fluid stain. Visually, the various undercarriage components of the Motor Lorry were all observed to be intact and without any visible damage. See photo 13 – 15 below.

Photo 13 shows the induced damage to the cabin (arrowed) of the Motor Lorry's which immobilised the opening and viewing of the various parts and components inside the engine compartment, a result of the accident.

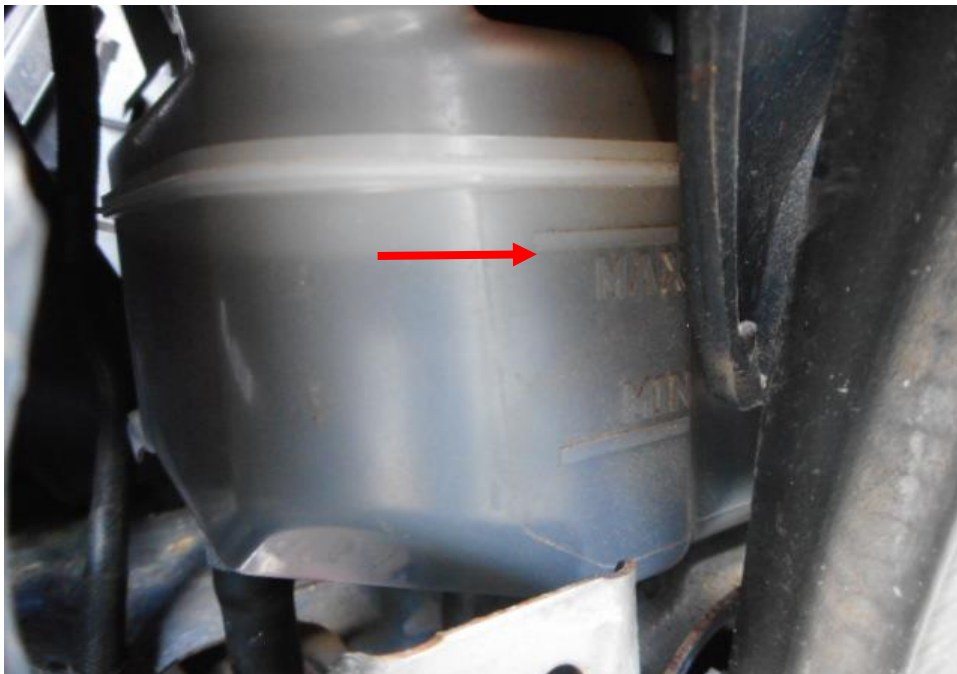
Photo 14 shows the brake fluid reservoir of the Motor Lorry at the time of our inspection. The brake fluid was observed to be of sufficient level and without any visible contamination (arrowed).

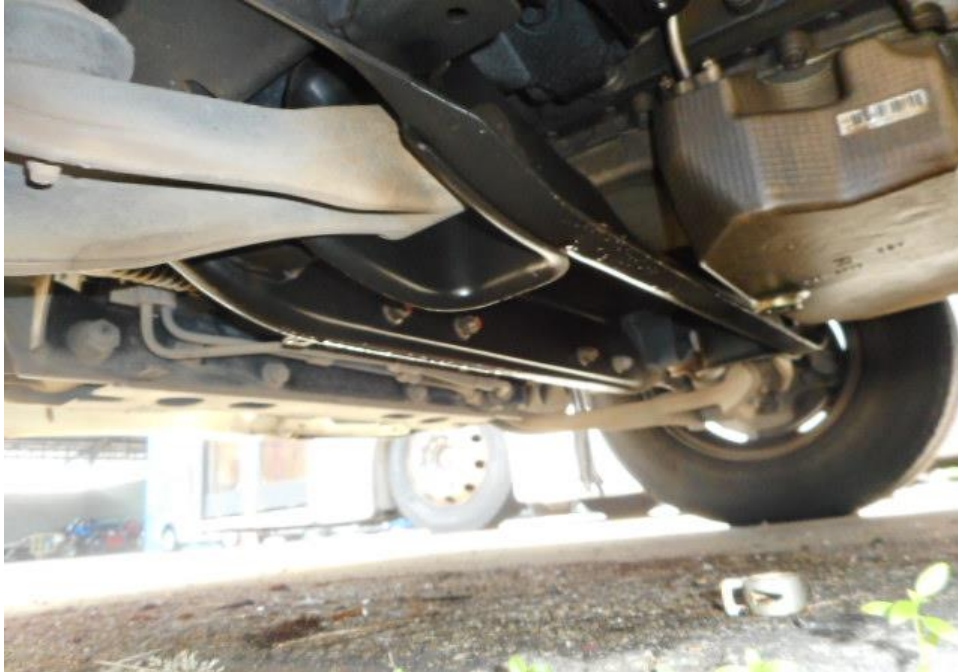
Photo 15 shows the undercarriage of the engine of the Motor Lorry at the time of our inspection. There was also sign(s) and indication(s) of old fluid stain within the engine undercarriage area.

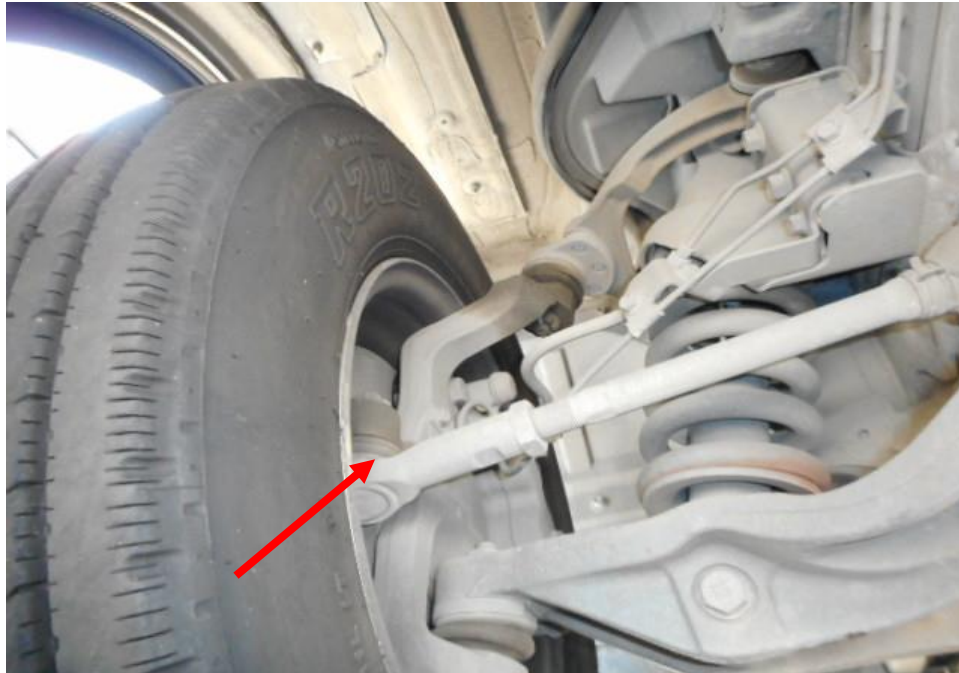
Photo 16 shows the various undercarriage components at the front right wheel of the Motor Lorry, in particular the steering tie rod end and ball joints (arrowed). The various undercarriage components of the Motor Lorry were all found to be intact without any visible damage. There was also no sign of fluid stain(s) observed on the various undercarriage components.

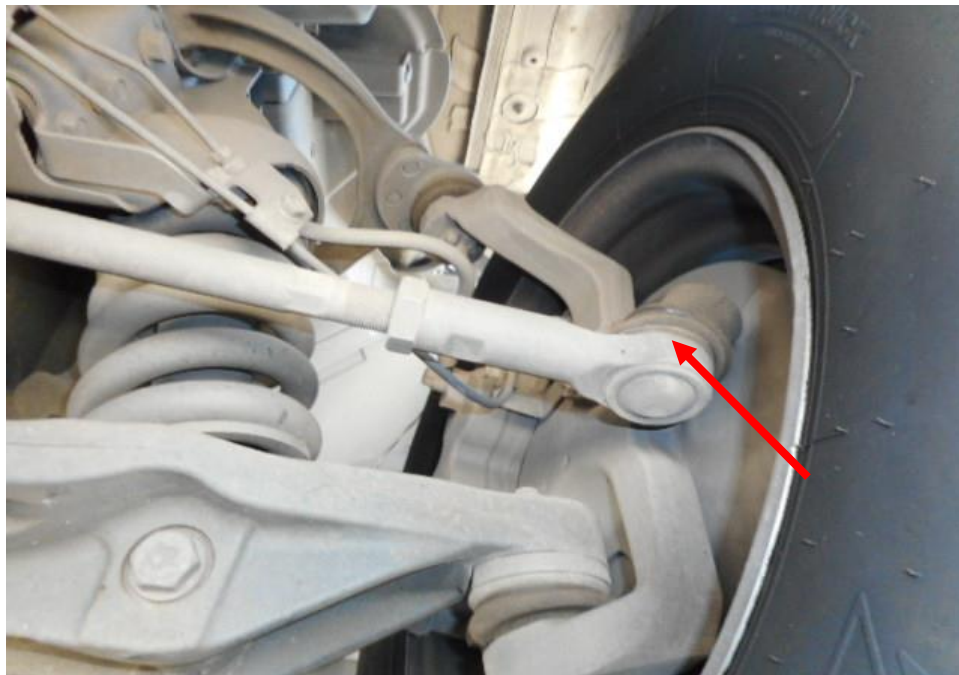
Photo 17 shows the various undercarriage components at the front left wheel of the Motor Lorry, in particular the steering tie rod end and ball joints (arrowed) were observed to be damaged.

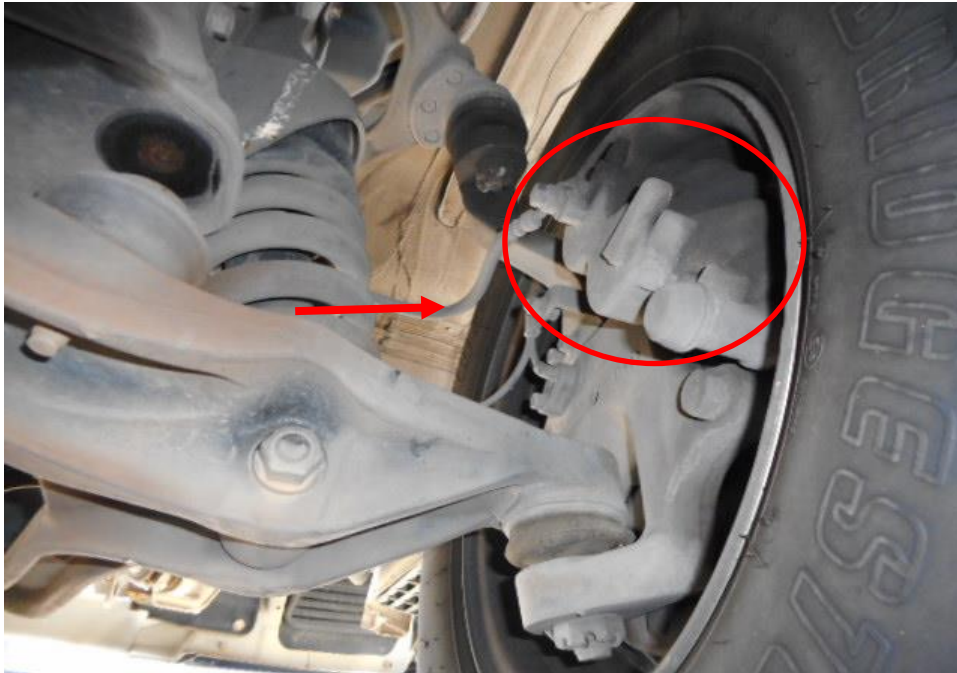
Photo 18 shows the various undercarriage components at the front right wheel of the Motor Lorry, in particular the brake hose (arrowed) and callipers (circled). The various undercarriage components of the Motor Lorry were all found to be intact without any visible damage. There was also no sign of fluid stain(s) observed on the various undercarriage components.

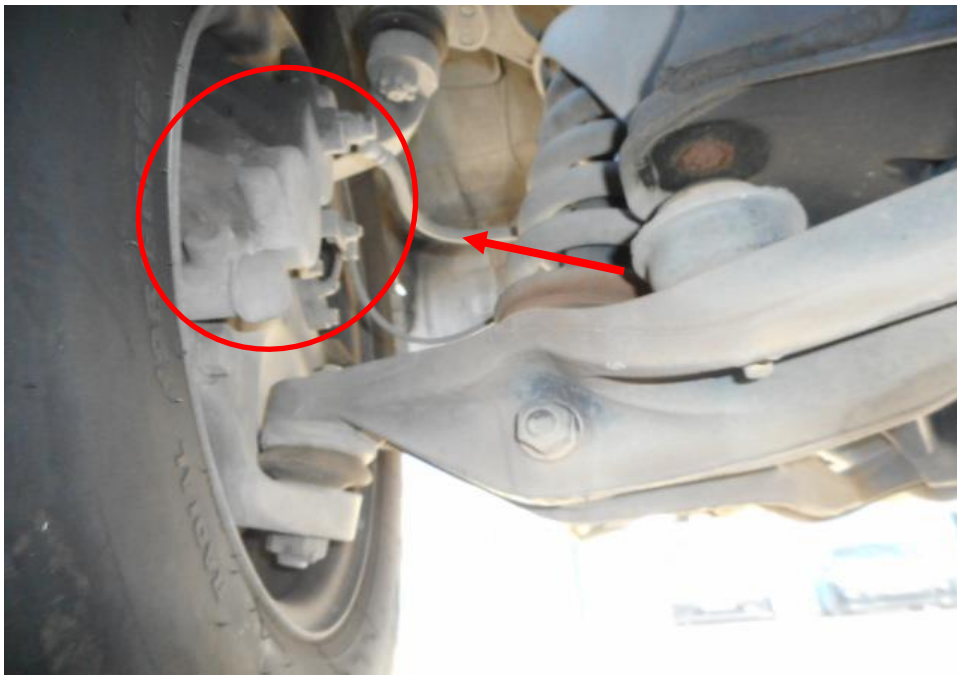
Photo 19 shows the various undercarriage components at the front left wheel of the Motor Lorry, in particular the brake hose (arrowed) and callipers (circled). The various undercarriage components of the Motor Lorry were all found to be intact without any visible damage. There was also no sign of fluid stain(s) observed on the various undercarriage components.

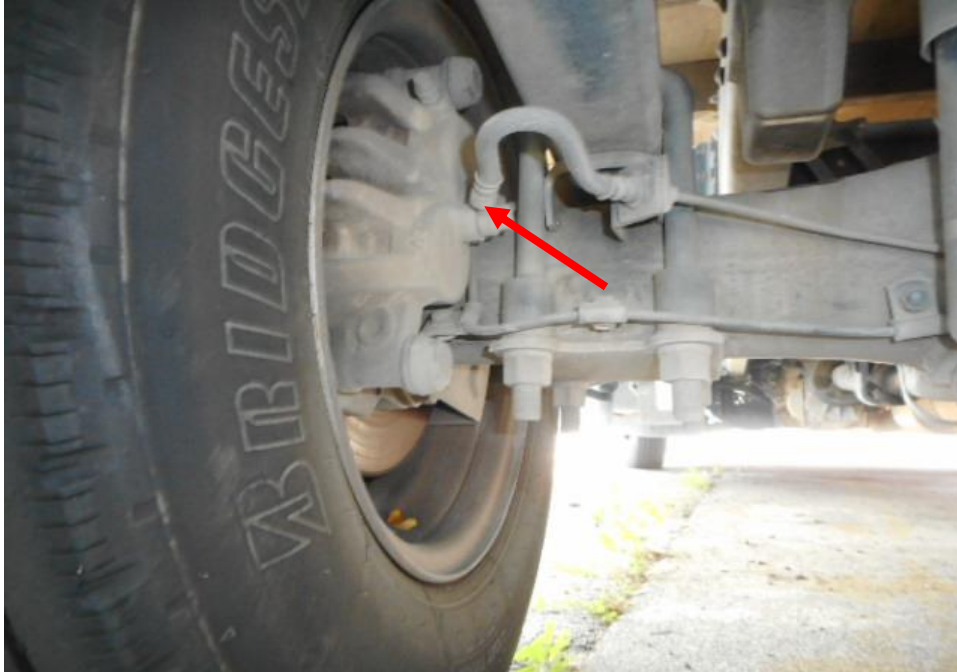
Photo 20 shows the various undercarriage components at the rear left wheel of the Motor Lorry, in particular the brake hose and drum brake (arrowed). The various undercarriage components of the Motor Lorry were all found to be intact without any visible damage. There was also no sign of fluid stain(s) observed on the various undercarriage components.

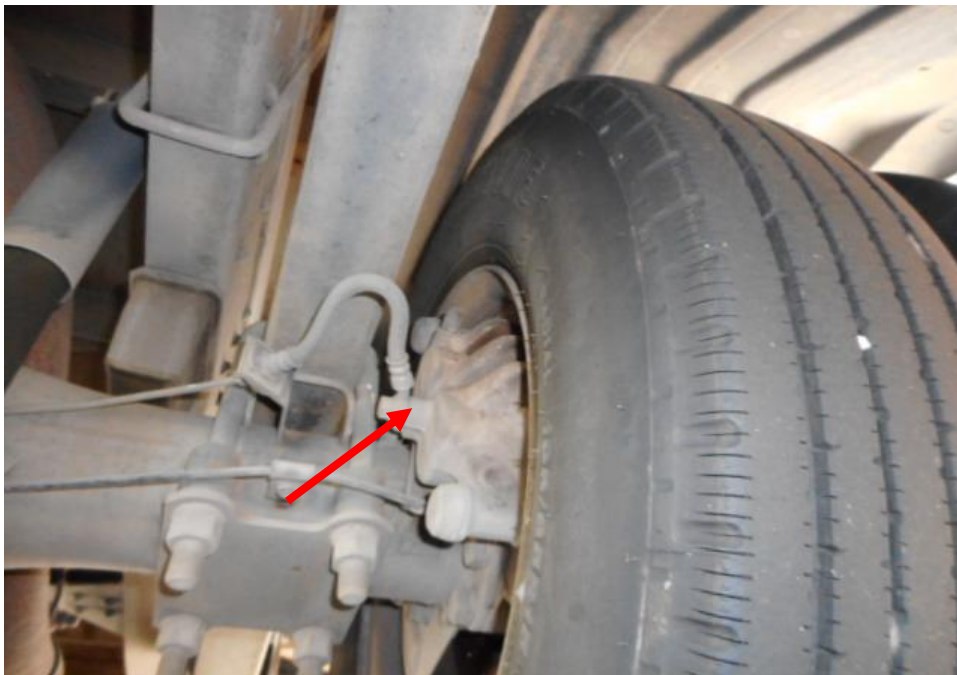
Photo 21 shows the various undercarriage components at the rear right wheel of the Motor Lorry, in particular the brake hose and drum brake (arrowed). The various undercarriage components of the Motor Lorry were all found to be intact without any visible damage. There was also no sign of fluid stain(s) observed on the various undercarriage components.
