Your Ref: TP/IP/18961/2021
Our Ref : CI/TPD21007274/P

Fatal Accident Investigation Team

MECHANICAL INSPECTION REPORT OF MOTOR CAR SLM 6734R

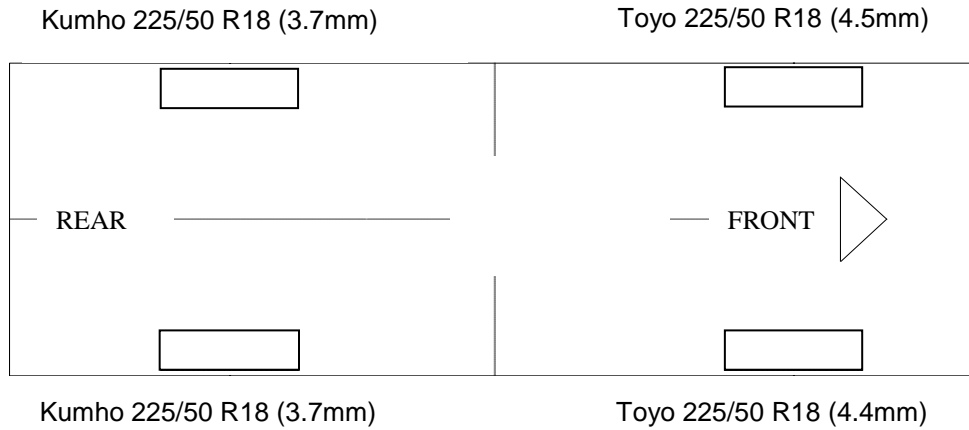
6. The 4 tyres of the Motor Car were observed to be in serviceable condition and sufficiently inflated for vehicular operation. I did not find any tear, cut or burst mark(s) on the outer and the inner sidewalls as well as across the tread of the 4 tyres. The tyre brand, tyre size and remaining tread depth of the 4 tyres of the Motor Car were recorded as follows:-

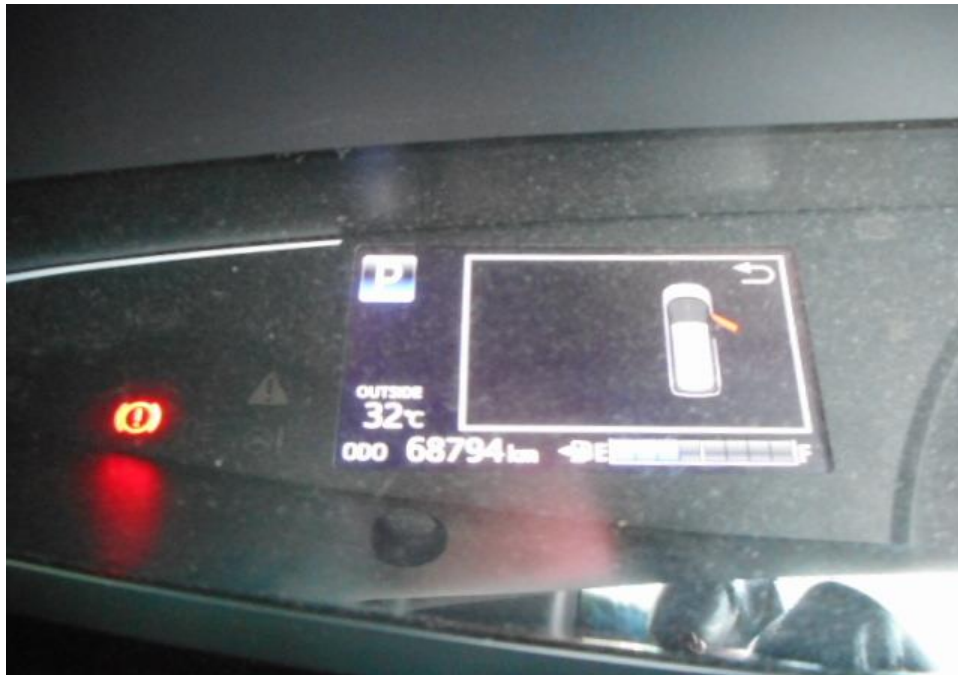
4. The mileage of the Motor Car at the time of my inspection was 687,794km.
5. There was no visible damage observed on Motor Car at the time of my inspection.

Photo 1 shows a general view of the instrument cluster of the Motor Car at the time of my inspection. The mileage of the Motor Car was 68,794km

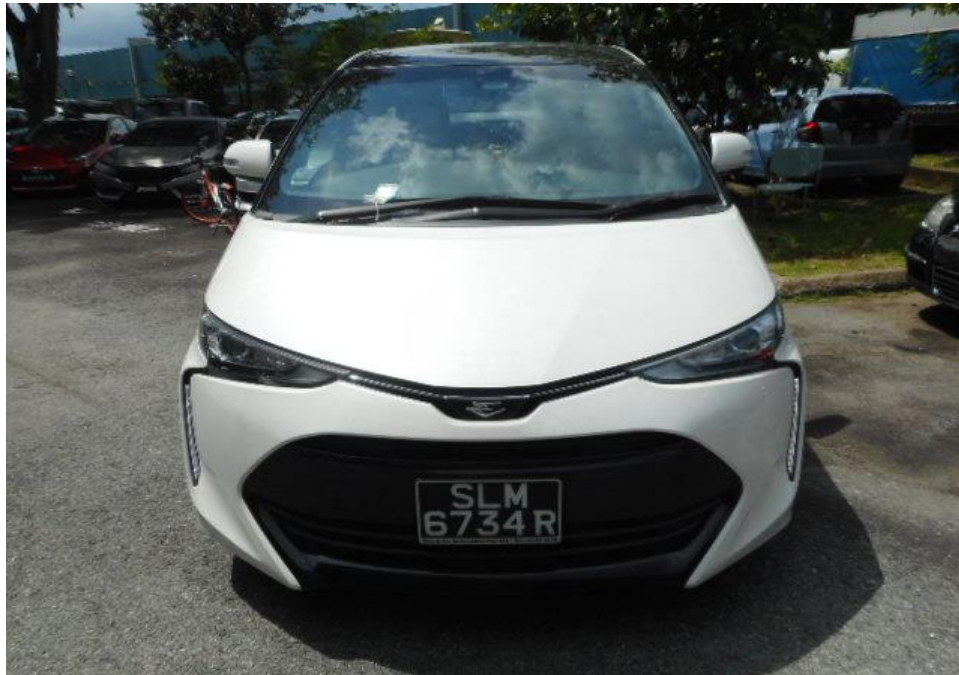
Photo 2 shows a general view of the Motor Car at the time of my inspection. The Motor Car was observed to be intact and unaffected by the accident.

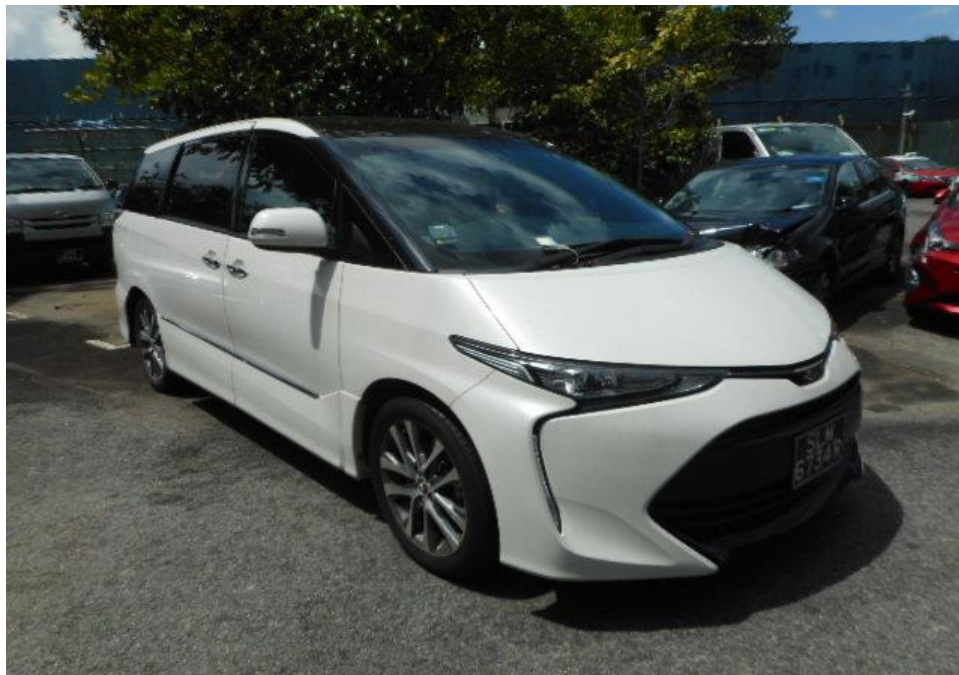
Photo 3 shows a general view of the right body of the Motor Car at the time of my inspection. The Motor Car was observed to be intact and unaffected by the accident.

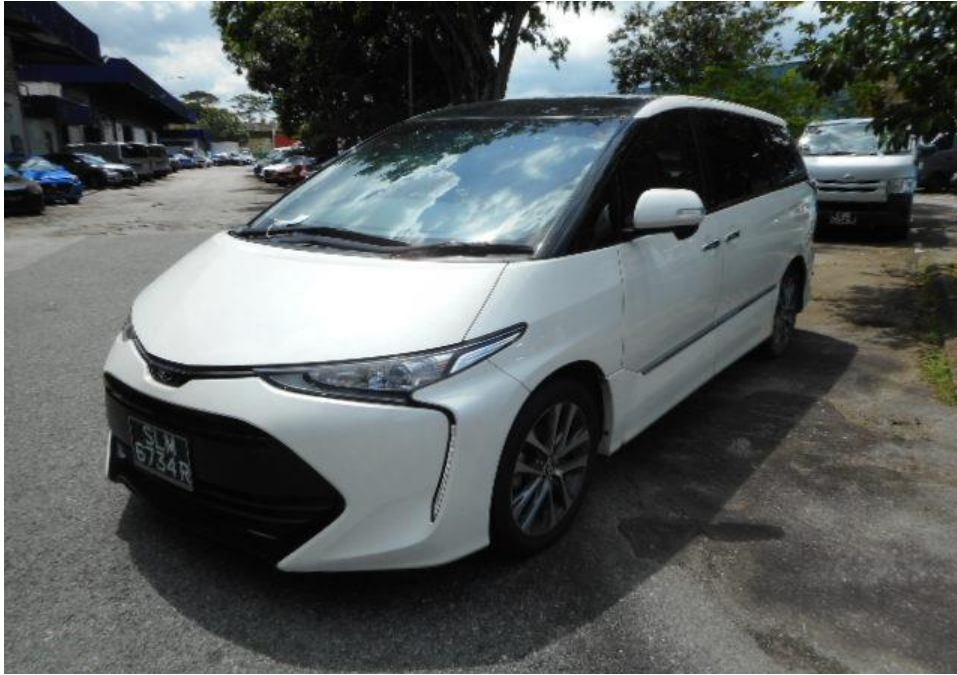
Photo 4 shows a general view of the left body of the Motor Car at the time of my inspection. The Motor Car was observed to be intact and unaffected by the accident.

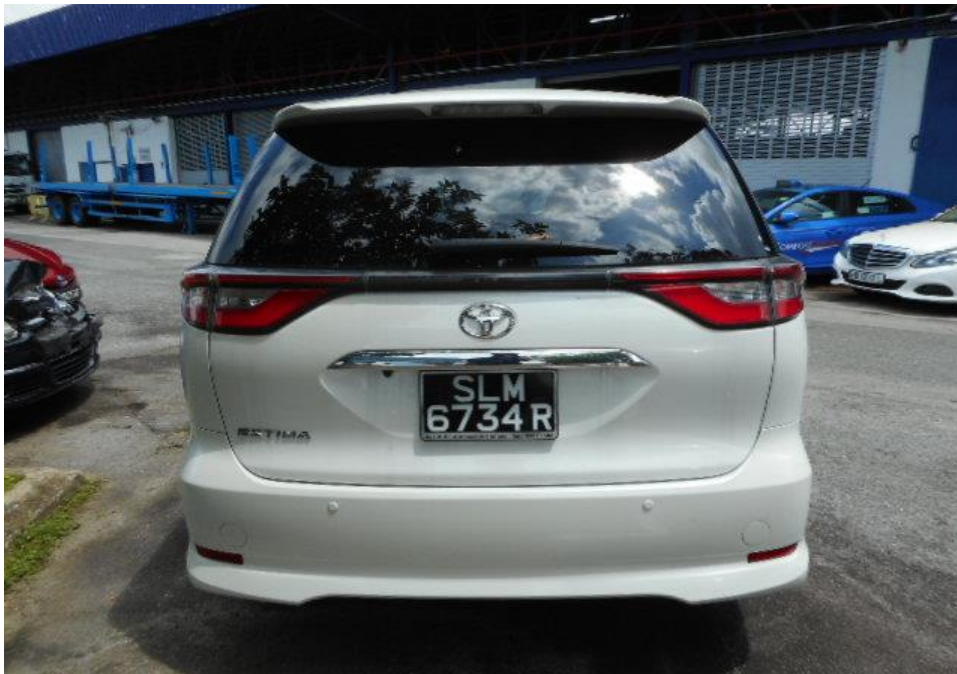
Photo 5 shows a general view of the rear body of the Motor Car at the time of my inspection. The Motor Car was observed to be intact and unaffected by the accident.

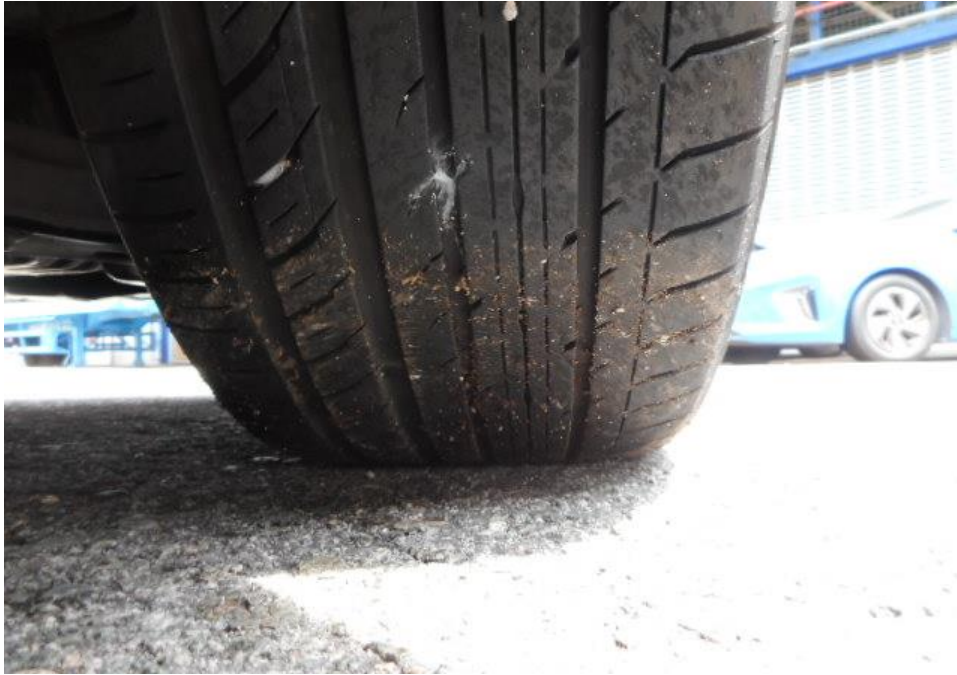
Photo 6 shows the condition of the front right tyre of the Motor Car, which was observed to be in serviceable condition with remaining tread depth of approximately 4.4mm. The tyre, which was wrapped around standard alloy wheel rim, was also observed to be sufficiently inflated for vehicular operation. There was no tear, cut or burst mark(s) on the outer and the inner sidewalls as well as across the tread of the 4 tyres that were fitted on the Motor Car.

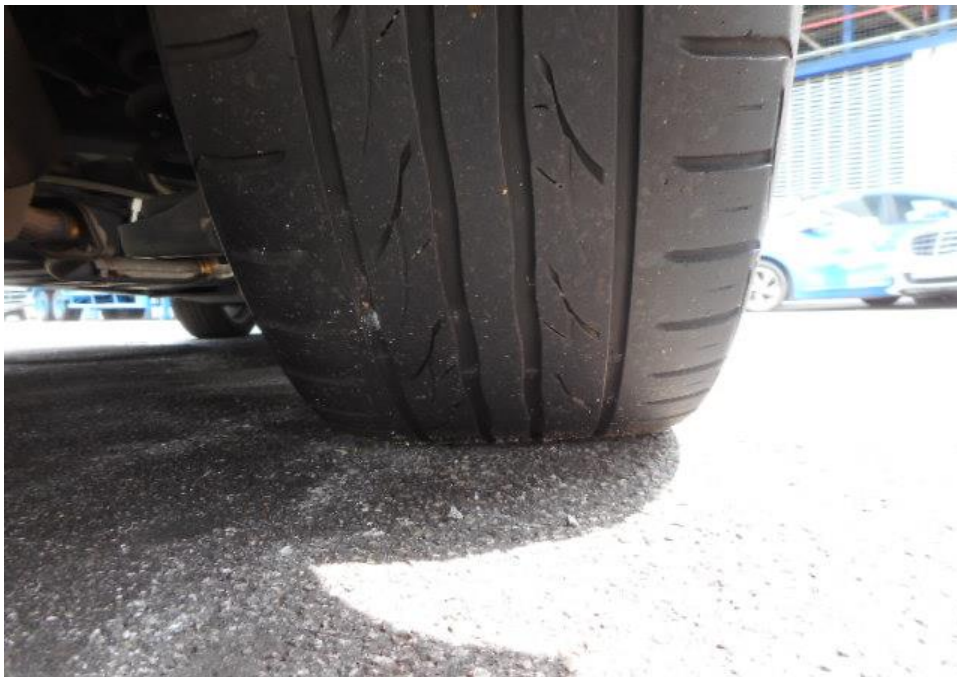
Photo 7 shows the condition of the rear right tyre of the Motor Car, which was observed to be in serviceable condition with remaining tread depth of approximately 3.7mm. The tyre, which was wrapped around standard alloy wheel rim, was also observed to be sufficiently inflated for vehicular operation.

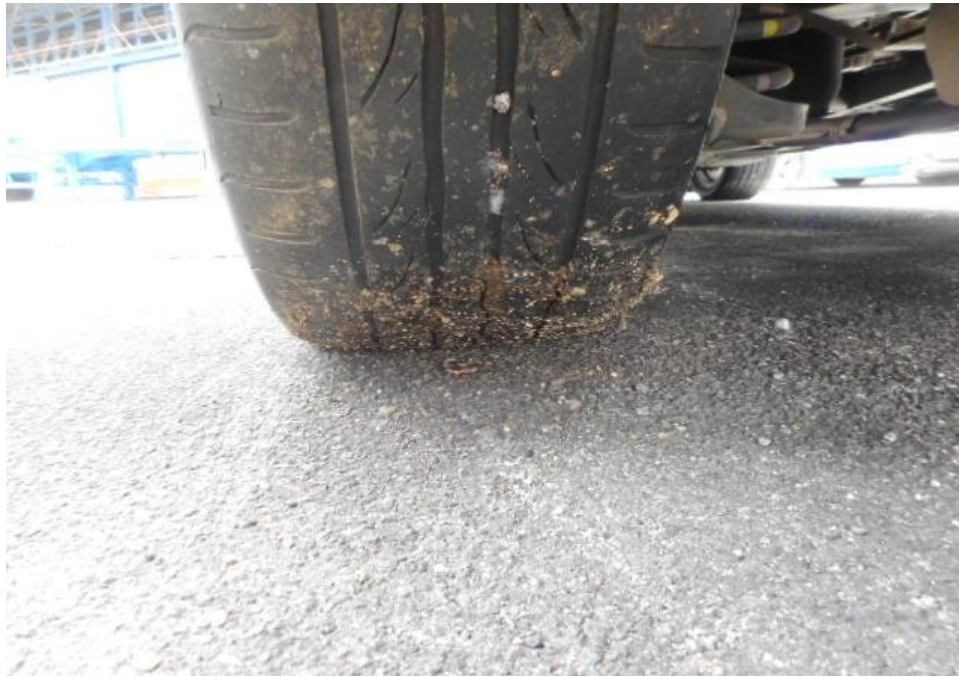
Photo 8 shows the condition of the rear left tyres of the Motor Car, which was observed to be in serviceable condition with remaining tread depth of approximately 3.7mm. The tyres, which were wrapped around standard alloy wheel rim, were also observed to be sufficiently inflated for vehicular operation. There was also no damage found on all 4 alloy wheel rims of the Motor Car.

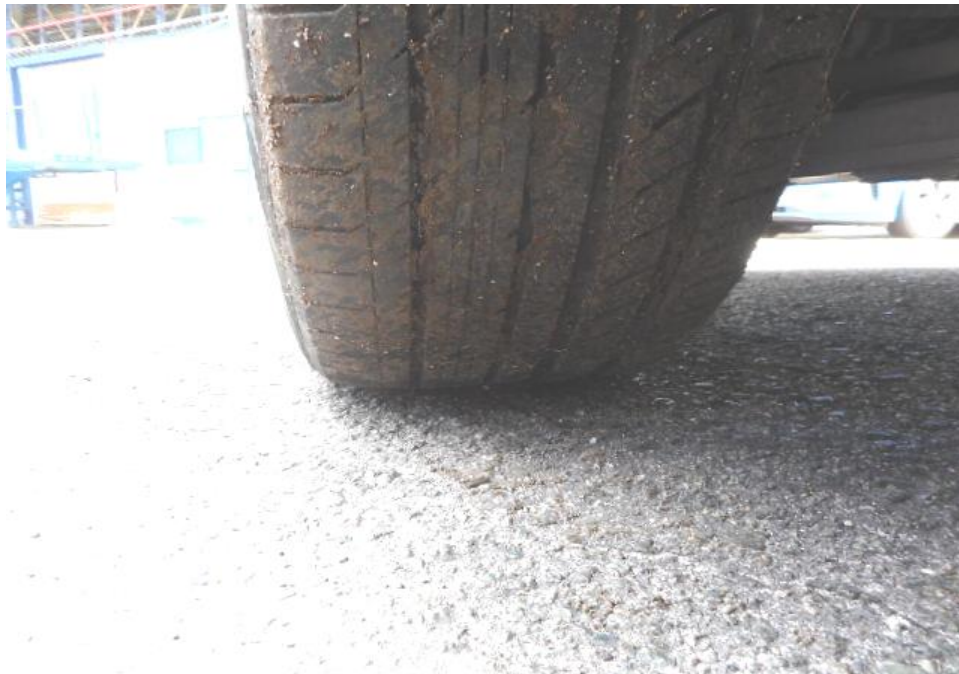
Photo 9 shows the condition of the rear right tyres of the Motor Car, which were observed to be in serviceable condition with remaining, tread depth of approximately 4.5mm. There was also no tear, cut or burst mark(s) on the outer and the inner sidewalls as well as across the tread of the 4 tyres that were fitted on the Motor Car.

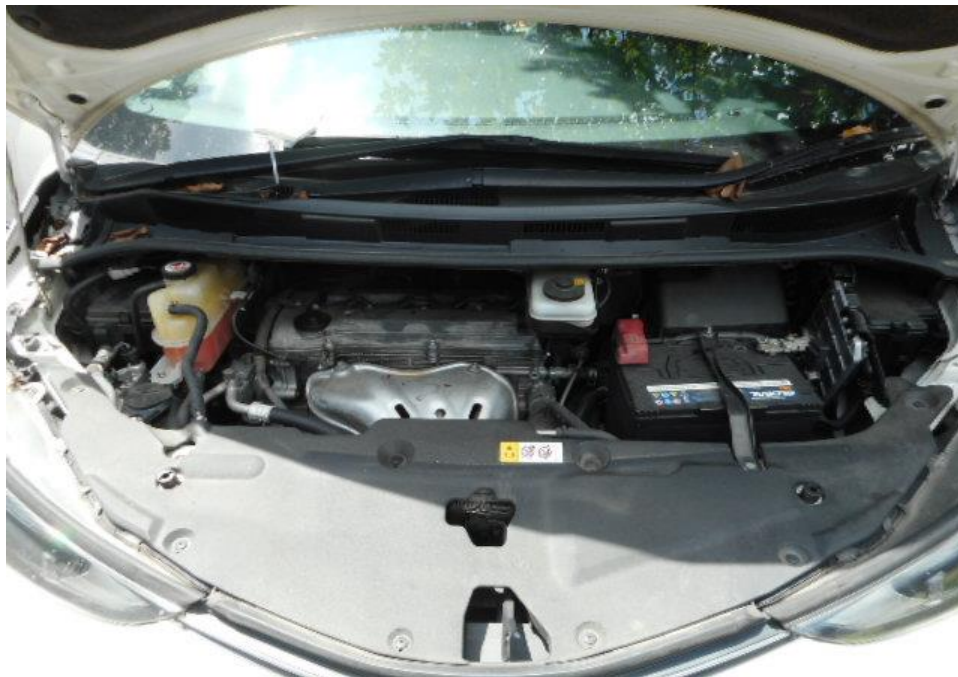
Photo 10 shows a general view of the Motor Car's engine compartment, which was accessed by lifting the front cabin of the Motor Car. The various parts and components inside the engine compartment were unaffected by the accident. There was also no sign(s) or indication(s) of fresh fluid leakage and/or fluid stain within the engine compartment

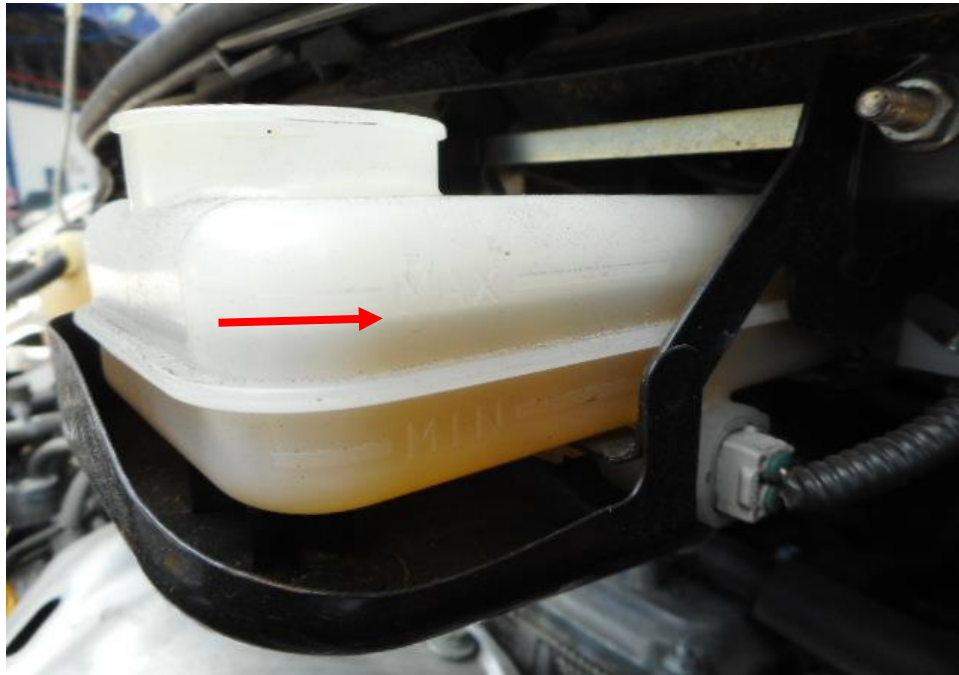
Photo 11 shows the brake fluid reservoir of the Motor Car at the time of my inspection. The brake fluid was observed to be of sufficient level (arrowed) and without any visible contamination.

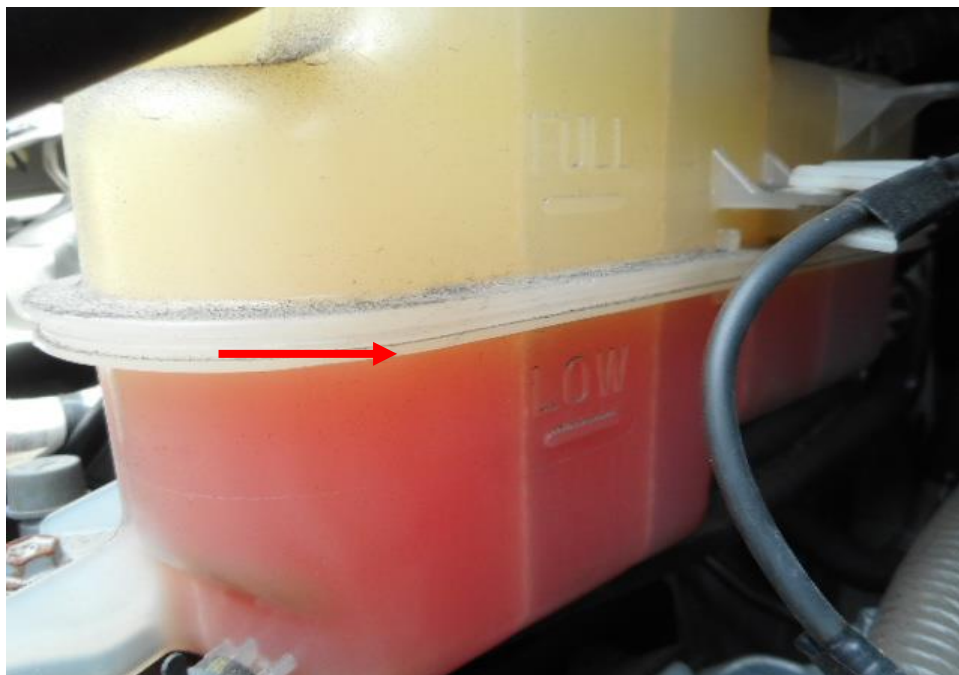
Photo 12 shows the engine coolant reservoir of the Motor Car at the time of my inspection. The engine coolant was observed to be of sufficient level (arrowed) and without any visible contamination.

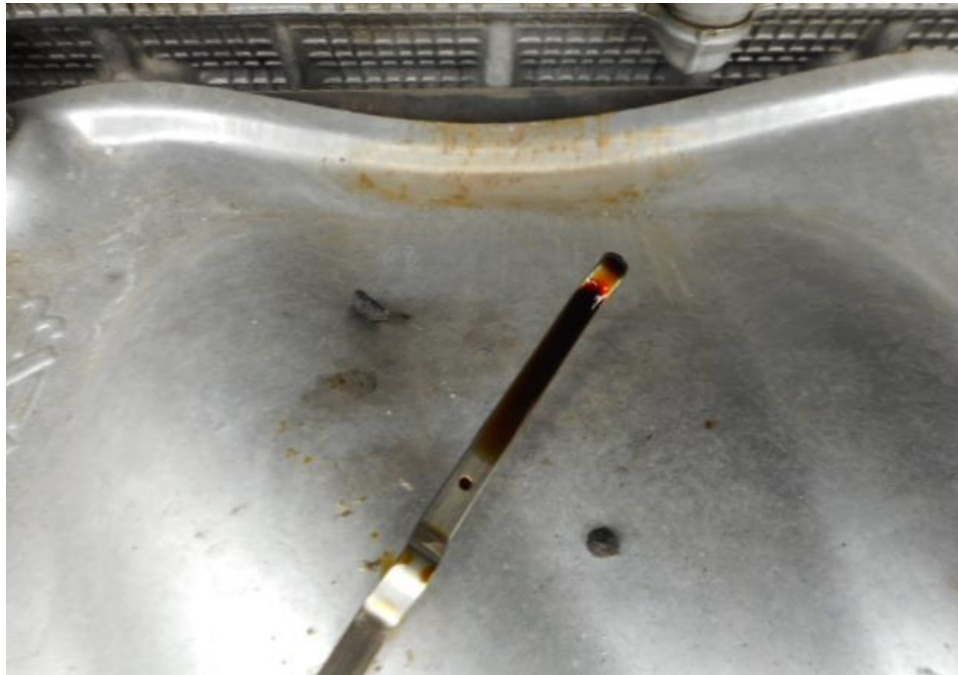
Photo 13 shows the engine oil dip stick of the Motor Car at the time of my inspection. The engine oil was observed to be of sufficient level and without any visible contamination.

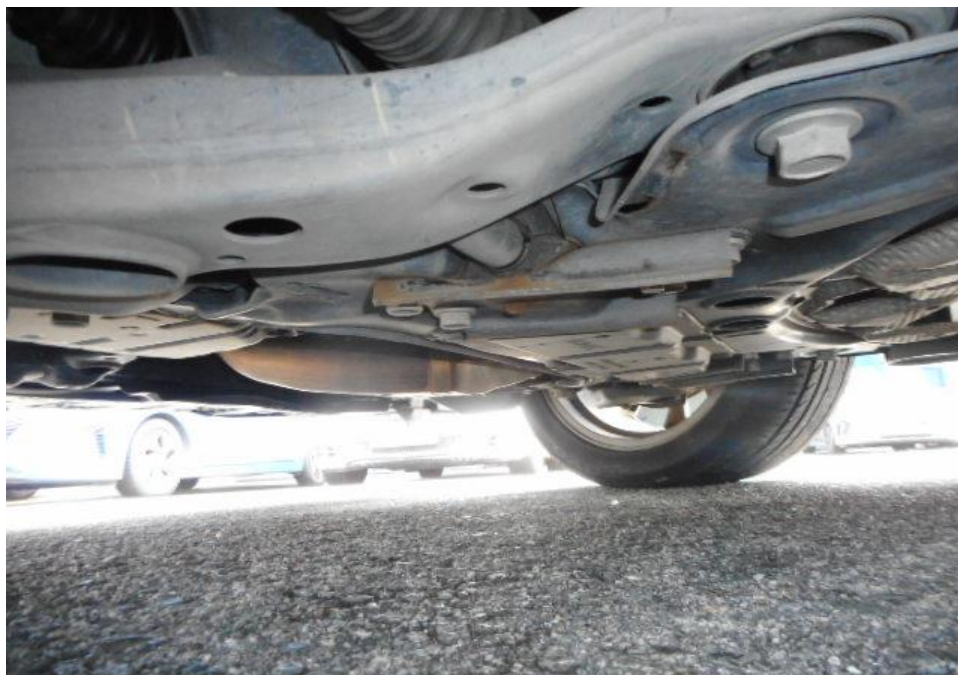
Photo 14 shows the undercarriage of the Motor Car, at the area where the engine housing and transmission housing are located. . I did not find any sign(s) or indication(s) of fluid leak and/or fluid stain(s) on the underside of the Motor Car.

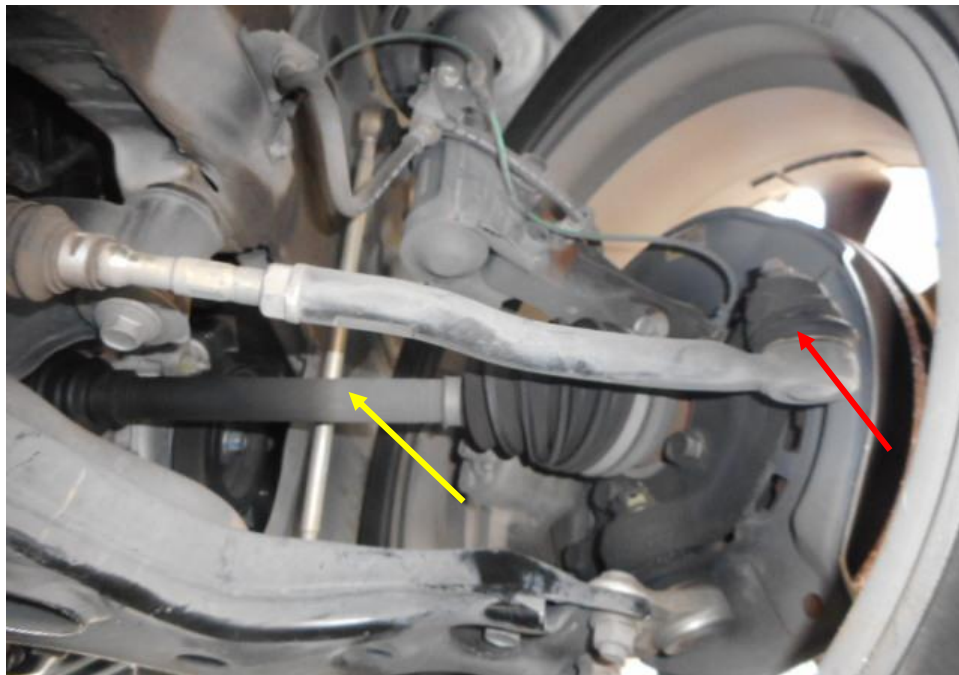
Photo 15 shows the various undercarriage components at the front right wheel of the Motor Car, in particular the steering tie rod end (red arrowed) and drive shaft (yellow arrow). The various steering components were all found to be intact, suggesting that the steering system of the Motor Car was likely to be in serviceable condition at the material time of accident. There was also no sign of fluid stain(s) observed on the various undercarriage components.

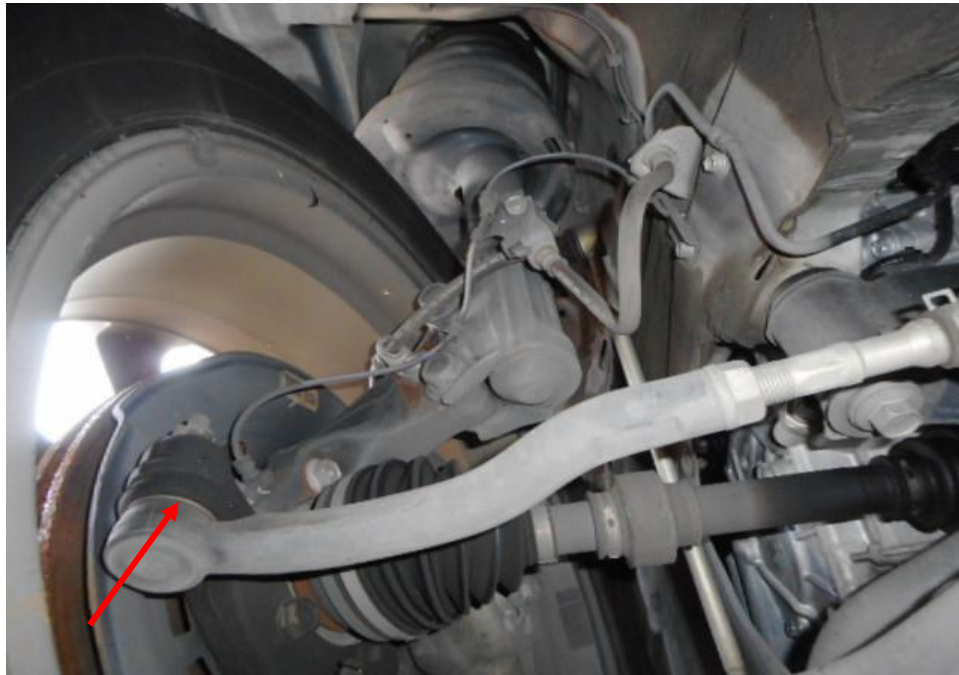
Photo 16 shows the various undercarriage components at the front left wheel of the Motor Car, in particular the steering tie rod end (arrowed). The various Undercarriage components of the Motor Car were all found to be intact without any visible damage. There was also no sign of fluid stain(s) observed on the various undercarriage components.

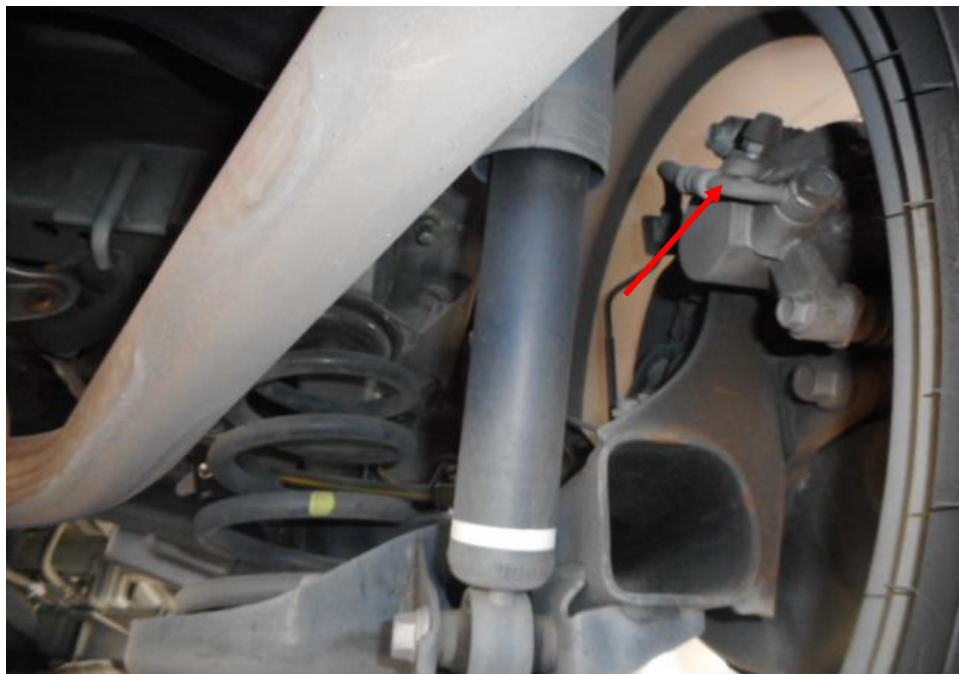
Photo 17 shows the brake pipe (arrowed) at the rear right wheel of the Motor Car. I did not observe any leakage of brake fluid at the time of my inspection of the Motor Car. My static tests of the Motor Car's braking system, along with my visual examination of the various mechanical components in the braking system, had indicated that there was no internal leakage of pressure/vacuum. Hence the braking system of the Motor Car was likely to be in serviceable condition at the material time of accident.

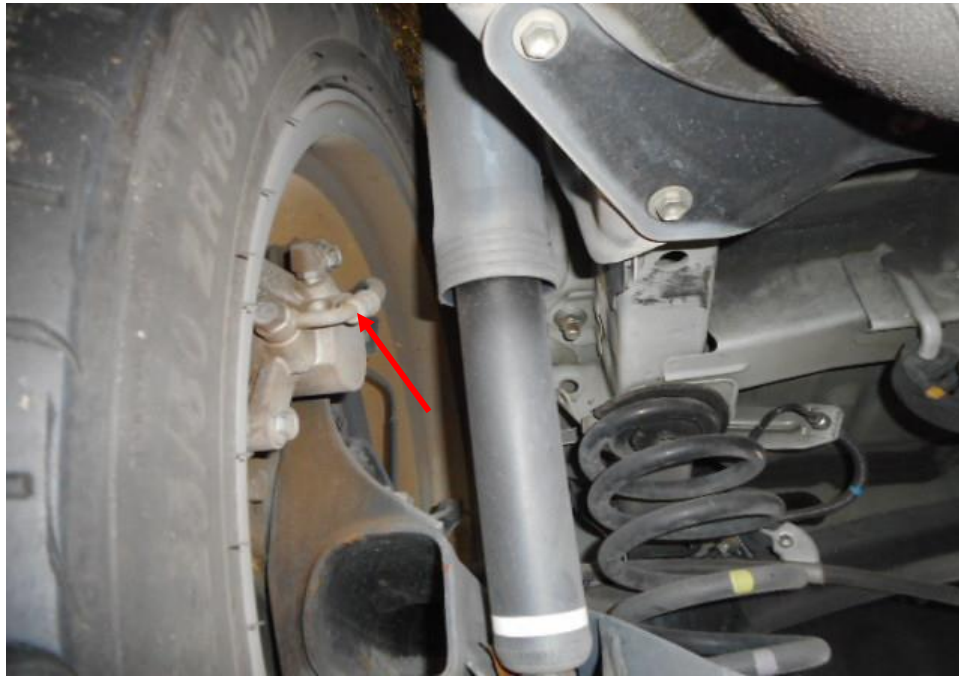
Photo 18 shows the brake pipe (arrowed) at the rear left wheel of the Motor Car. I did not observe any leakage of brake fluid at the time of my inspection of the Motor Car. My static tests of the Motor Car's braking system, along with my visual examination of the various mechanical components in the braking system had indicated that there was no internal leakage of pressure/vacuum. Hence the braking system of the Motor Car was likely to be in serviceable condition at the material time of accident.

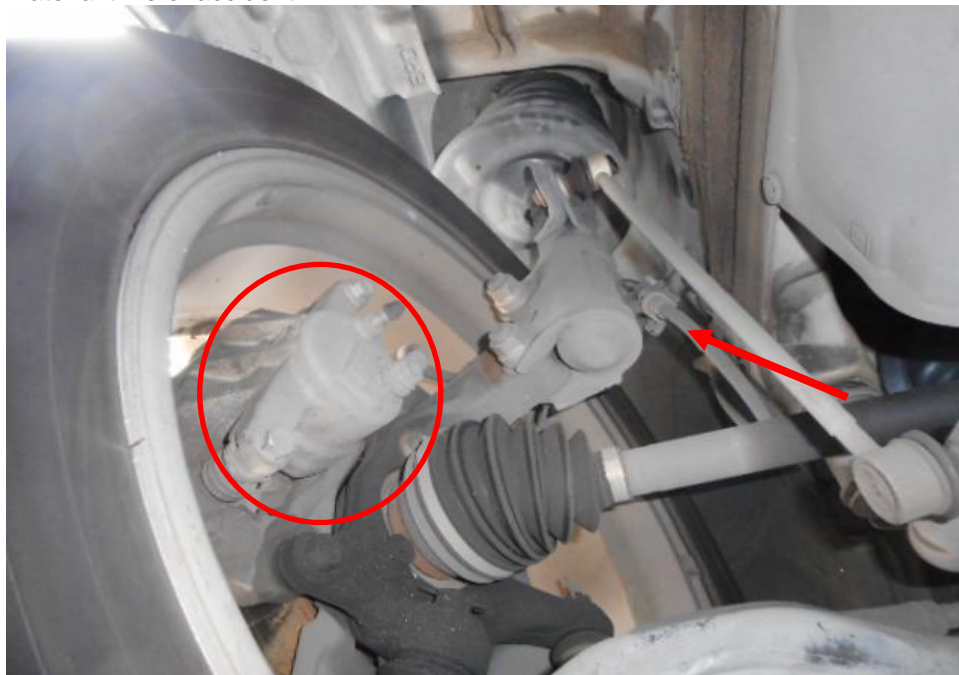
Photo 19 shows the brake hose/pipe (arrowed) at the front right wheel of the Motor Car. No leakage of brake fluid was observed. Visual examination of the various components of the braking system like the brake caliper (circled), brake booster, brake pedal etc had revealed all to be intact and without visible damage at the time of accident. There was also no sign of fluid stain(s) observed on the various undercarriage components.

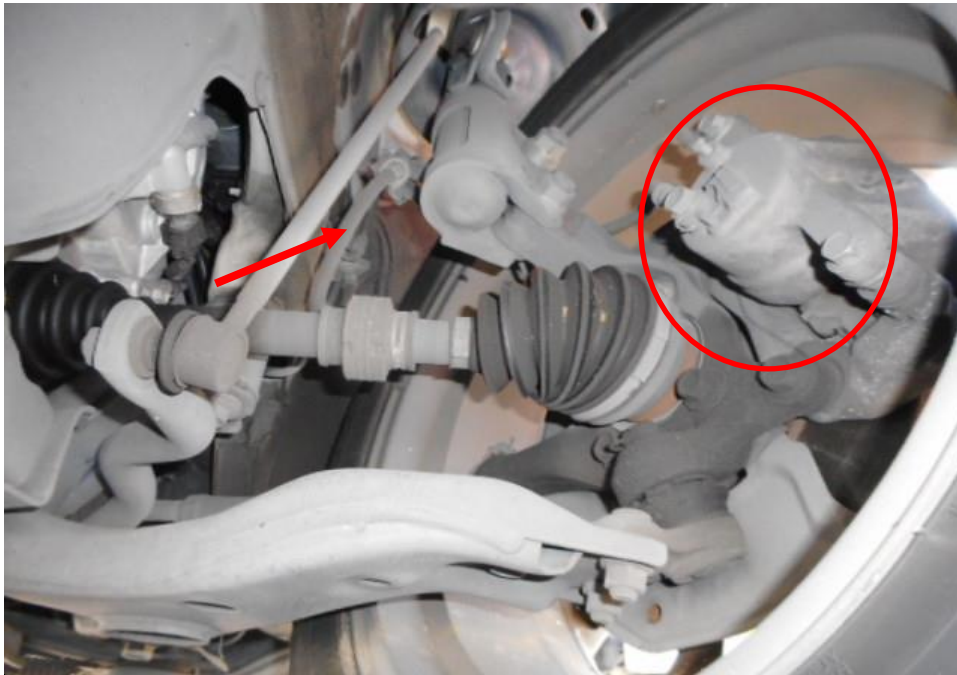
Photo 20 shows the brake hose/pipe (arrowed) at the front left wheel of the Motor Car. No leakage of brake fluid was observed. Visual examination of the various components of the braking system like the brake caliper (circled), brake booster, brake pedal etc had revealed all to be intact and without visible damage at the time of accident. There was also no sign of fluid stain(s) observed on the various undercarriage components.

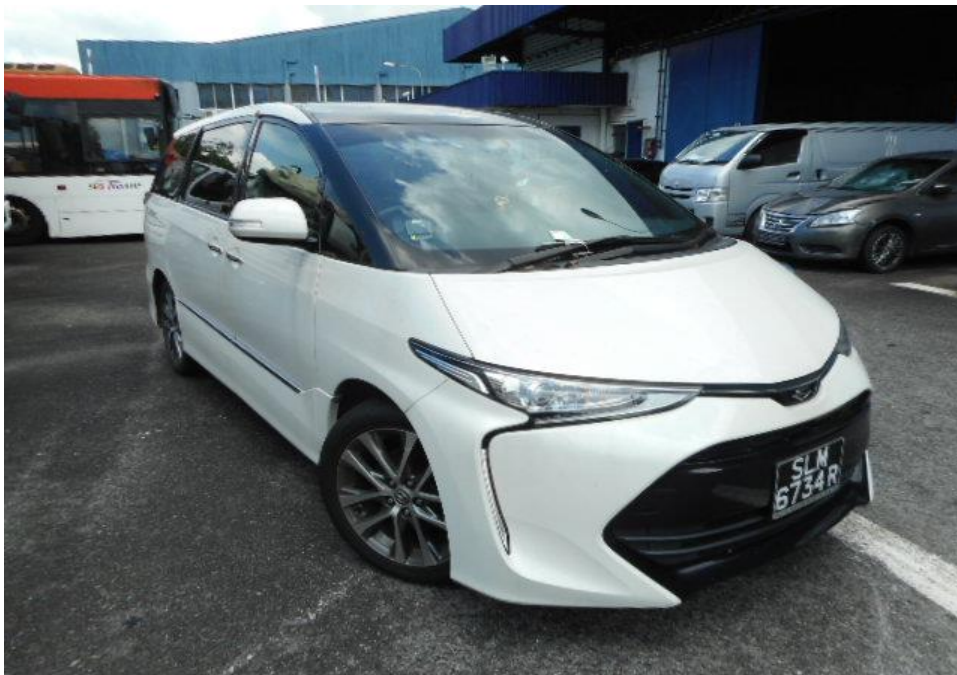
Photo 21 shows the front right wheel of the Motor Car turned to its full left. During my steering system test, I did not experience any abnormal free play and/or resistance when I had turned the steering wheel towards full left and full right. This would suggest that the steering system of the Motor Car was likely to be in serviceable condition at the material time of accident.

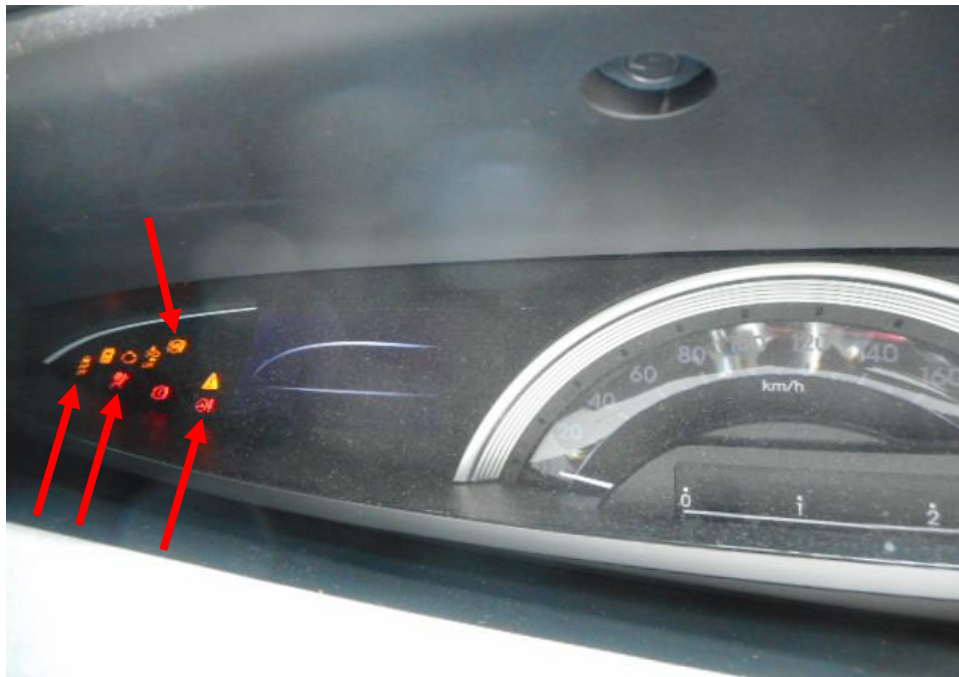
Photo 22 shows the warning light for Anti-Lock Brake System (ABS), Traction Control System (TCS), Supplemental Restraint System (SRS) and Electric Power Steering System (EPS) appearing on the instrument panel of the Motor Car during the self-test of its various electronic operating systems when its engine was cranked.

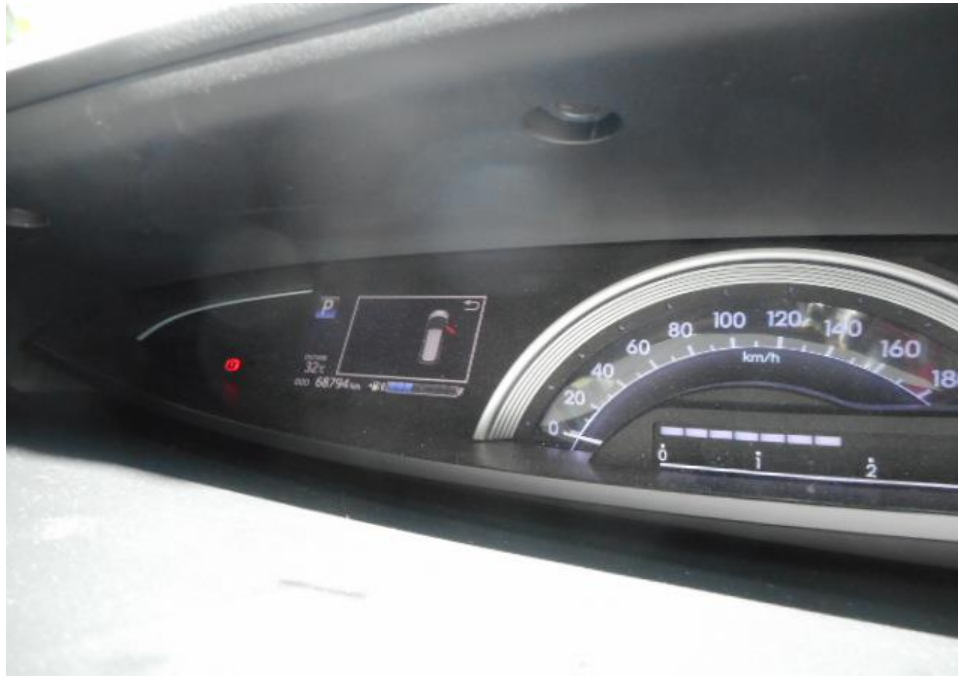
Photo 23 shows no warning lights illuminated on the instrument panel of the Motor Car after the engine was cranked. This would suggest that there was no abnormality to the various electronic operating systems of the Motor Car, like the ABS, TCS, SRS and EPS.
