Your Ref: TP/IP/23985/2021
Our Ref : CI/TPD21007275/P

Fatal Accident Investigation Team

MECHANICAL INSPECTION REPORT OF MOTOR TRUCK XD 2517H

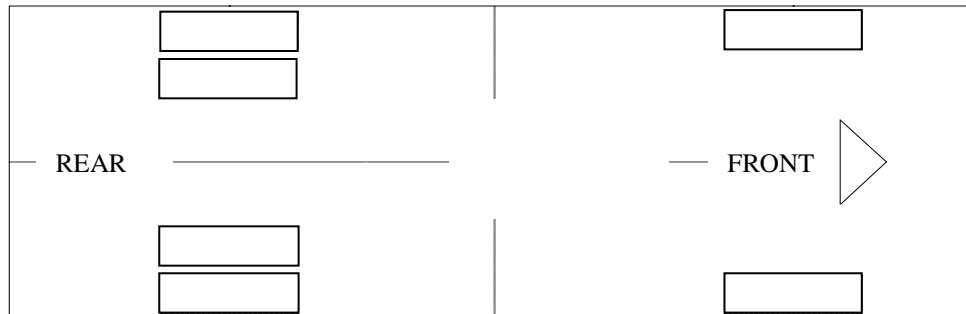
Motor Truck

Firenza 295/80R22.5 (13.7mm)

Firenza 295/80R22.5 (9.4mm)

Firenza 295/80R22.5 (12.5mm)

Firenza 295/80R22.5 (9.2mm)

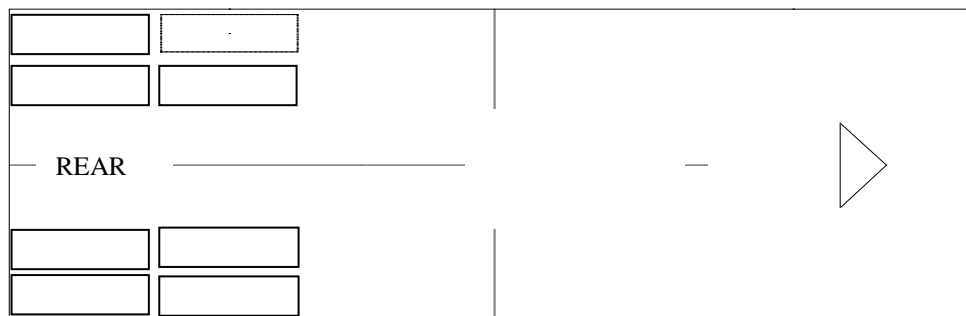
Trailer

Headway 10.00R22.5 (7.1mm)

Headway 10.00R22.5 (4.2mm)

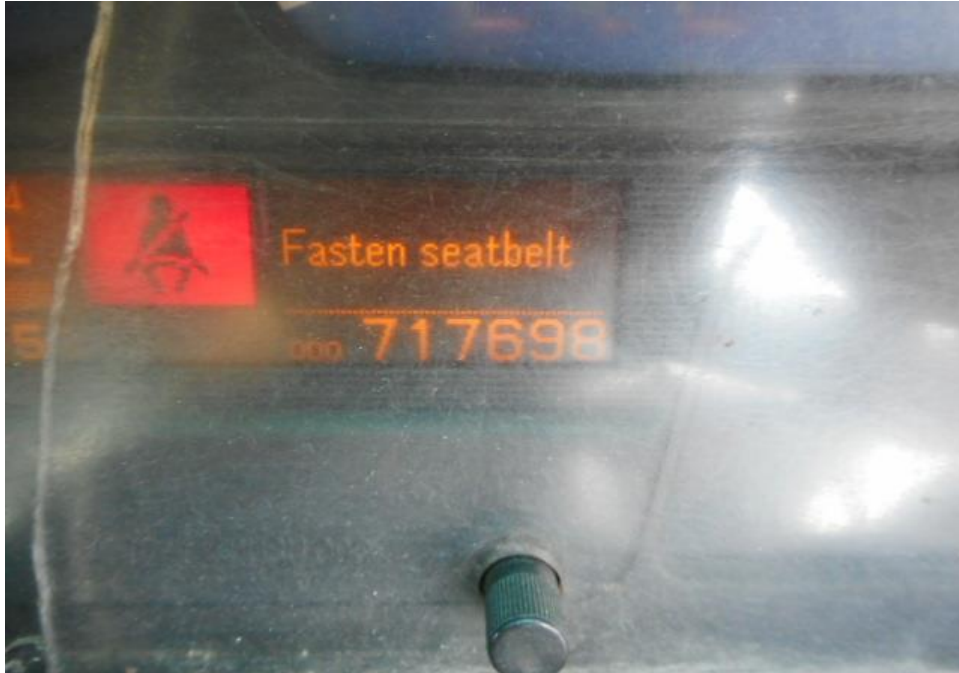
Photo 1 shows a general view of the instrument cluster of the Motor Truck at the time of my inspection. The mileage of the Motor Truck was 717,698km

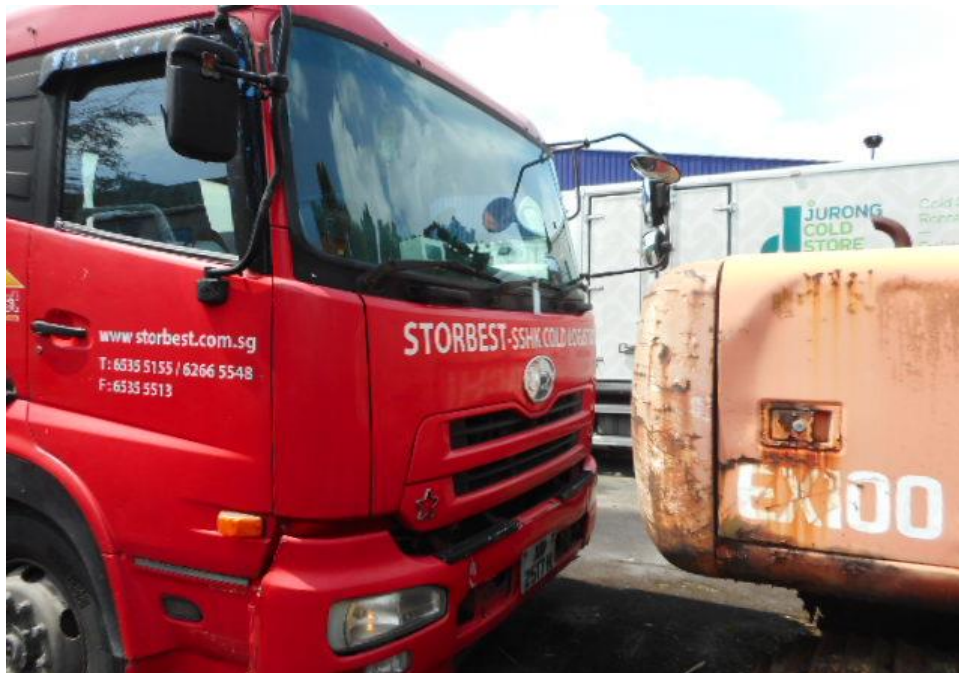
Photo 2 shows a general view of the front body of the Motor Truck at the time of my inspection. The Motor Truck was observed to be intact and unaffected by the accident.

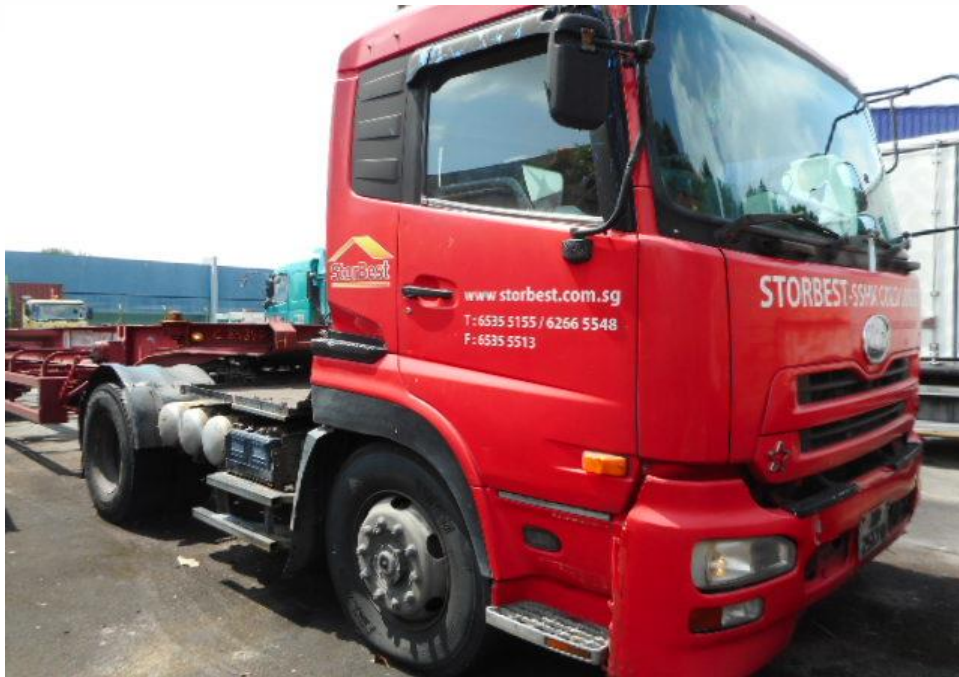
Photo 3 shows a general view of the front right body of the Motor Truck at the time of my inspection. The Motor Truck was observed to be intact and unaffected by the accident.

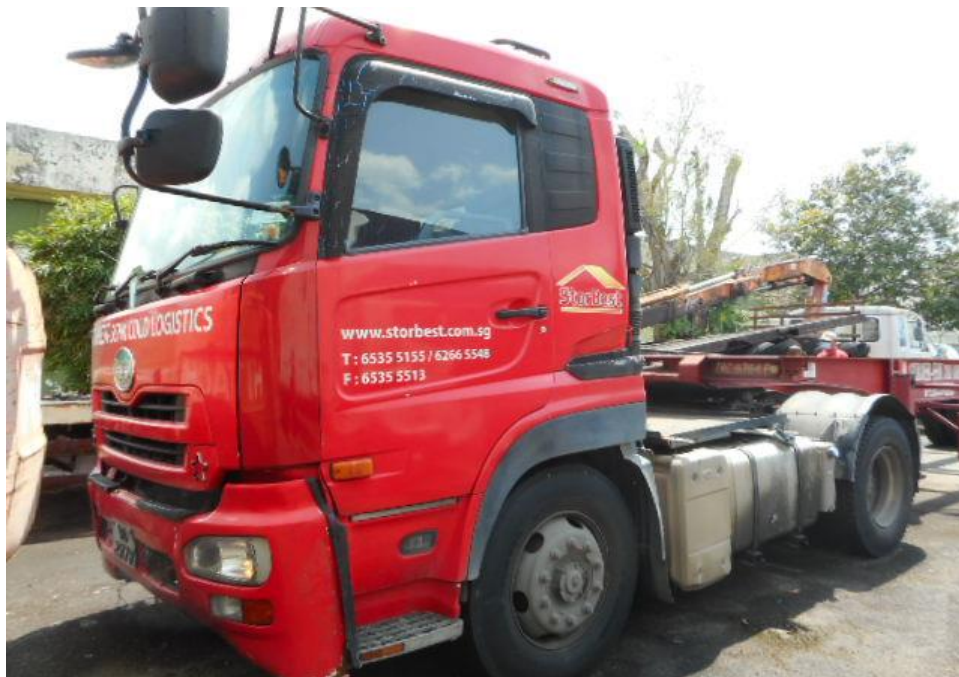
Photo 4 shows a general view of the front left body of the Motor Truck at the time of my inspection. The Motor Truck was observed to be intact and unaffected by the accident.

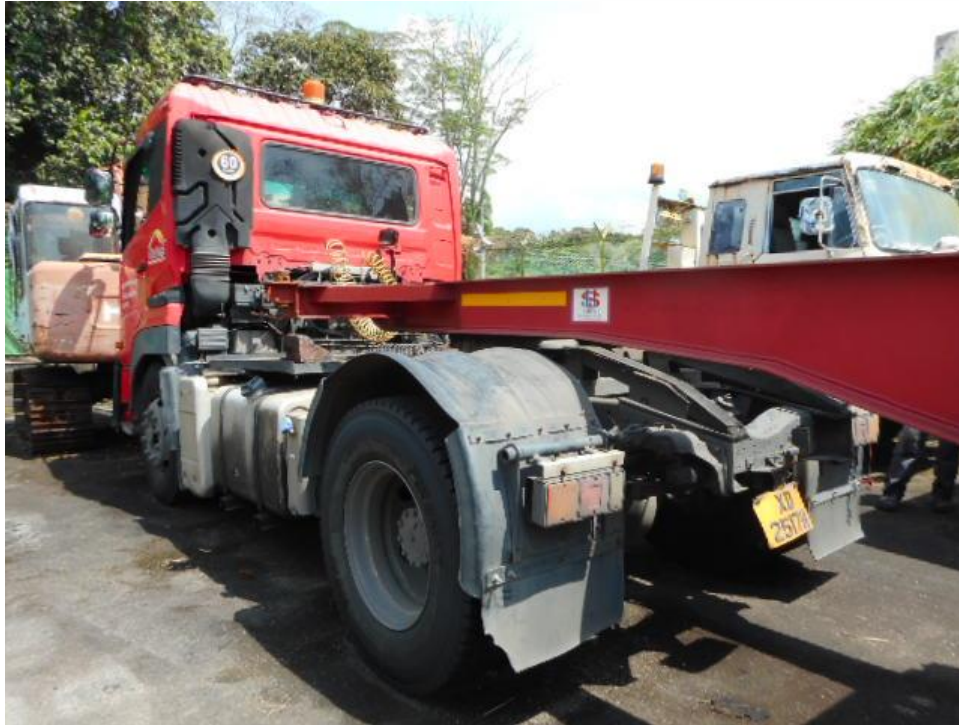
Photo 5 shows a general view of the Motor Truck's rear body at the time of my inspection. The Motor Truck was observed to be intact and unaffected by the accident.

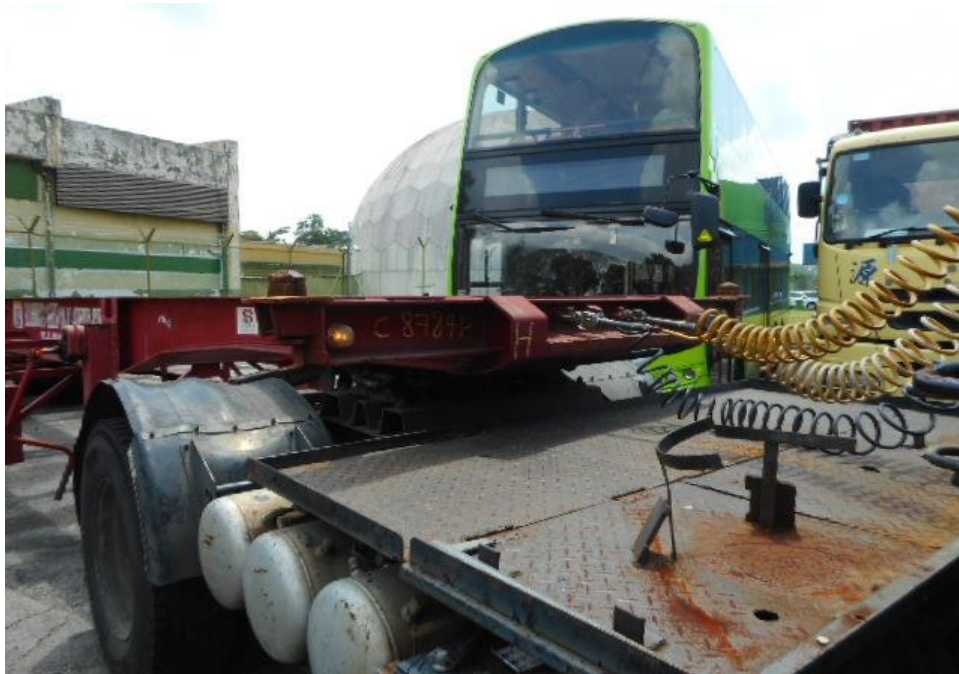
Photo 6 shows a general view of the front body of the trailer at the time of my inspection. The Motor Truck was observed to be intact and unaffected by the accident.

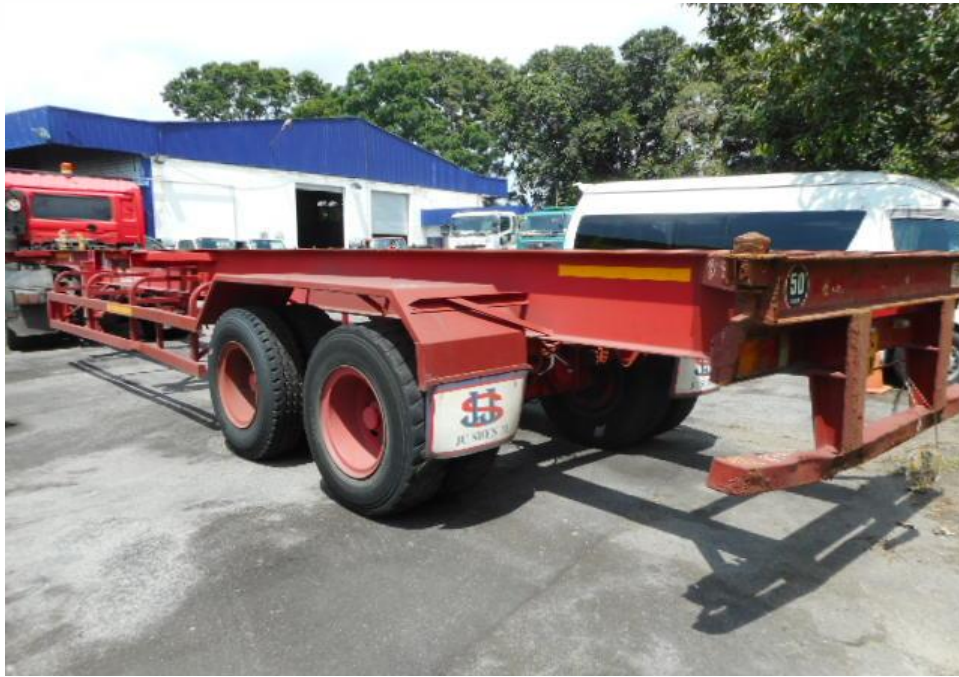
Photo 7 shows a general view of the trailer's left body at the time of my inspection. The Motor Truck was observed to be intact and unaffected by the accident.

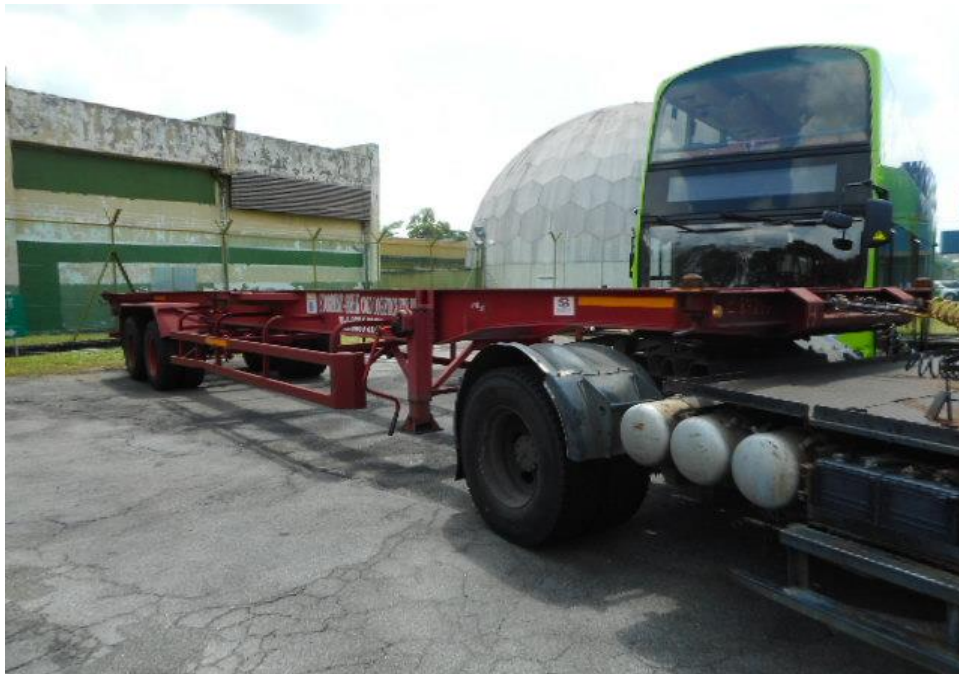
4. The mileage of the Motor Truck at the time of my inspection was 717,698km.
5. The Motor Truck was observed to sustain damaged on its Trailer's right portion. Its right body panel was damaged at the time of my inspection.

Photo 8 shows a general view of the trailer's right body at the time of my inspection. The Motor Truck was observed to sustain damaged on its Trailer's right portion. Its right body panel was damaged at the time of my inspection.

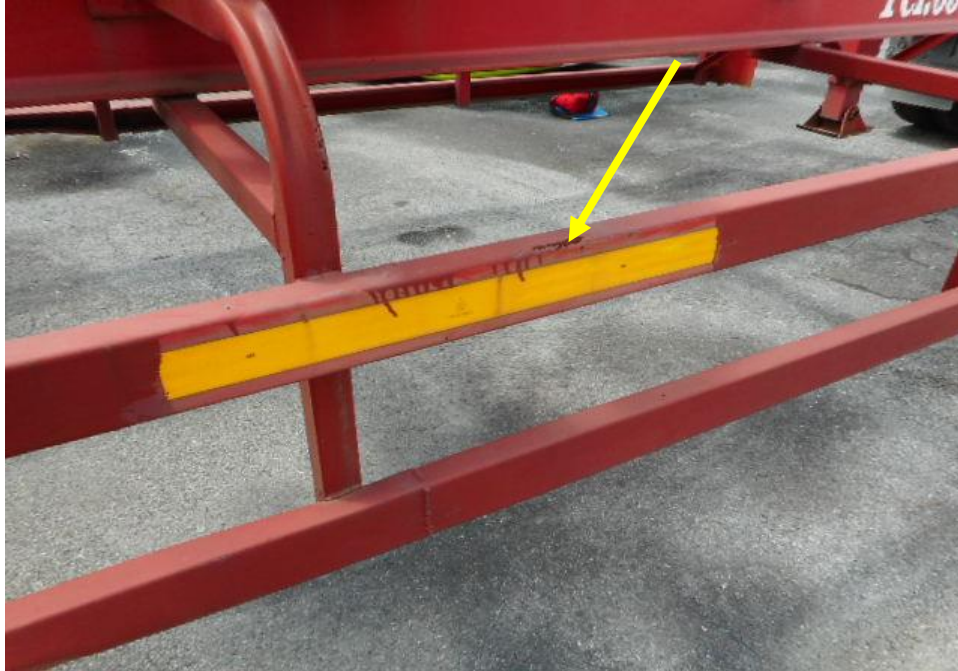
Photo 9 shows a close up view of the trailer's right body at the time of my inspection. The Motor Truck was observed to sustain damaged on its Trailer's right portion. Its right body panel (arrowed) was damaged at the time of my inspection.

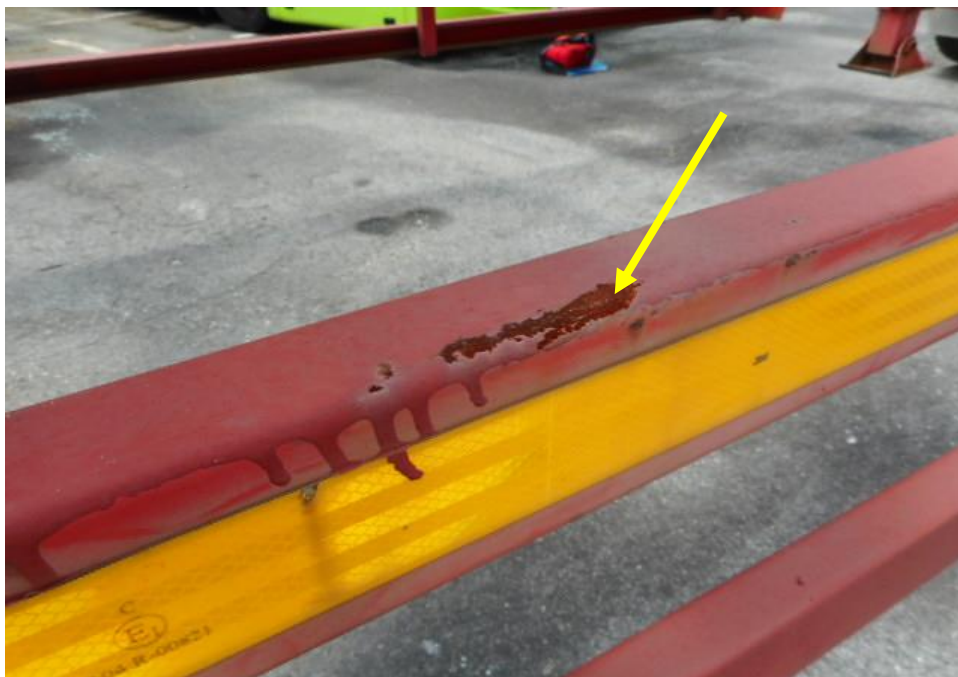
Photo 10 shows a close up view of the trailer's right body at the time of my inspection. The Motor Truck was observed to sustain damaged on its Trailer's right portion. Its right body panel (arrowed) was damaged at the time of my inspection.

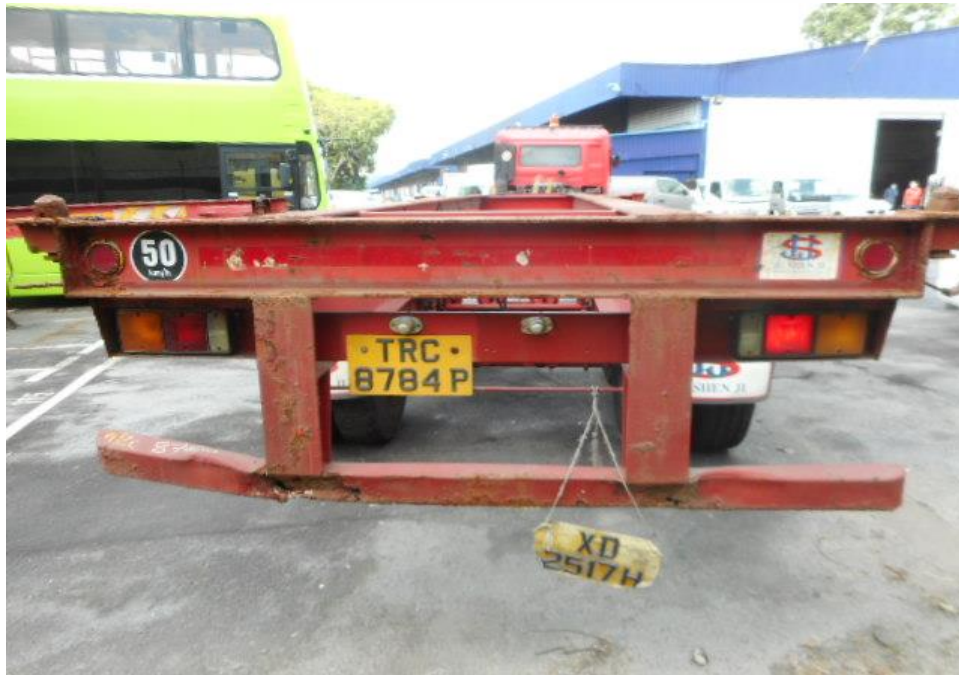
Photo 11 shows a general view of the trailer's rear body at the time of my inspection. The Motor Truck was observed to be intact.

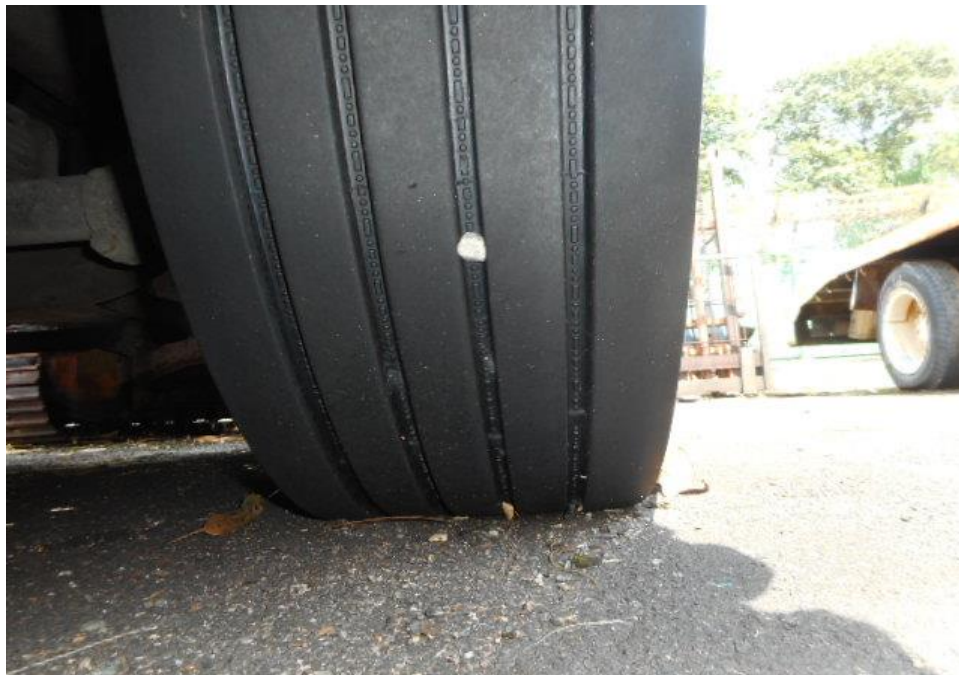
Photo 12 shows the condition of the front right tyre of the Motor Truck, which was observed to be in serviceable condition with remaining tread depth of approximately 9.2mm. The tyre, which was wrapped around standard steel wheel rim, was also observed to be sufficiently inflated for vehicular operation. There was no tear, cut or burst mark(s) on the outer and the inner sidewalls as well as across the tread of the 6 tyres that were fitted on the Motor Truck.

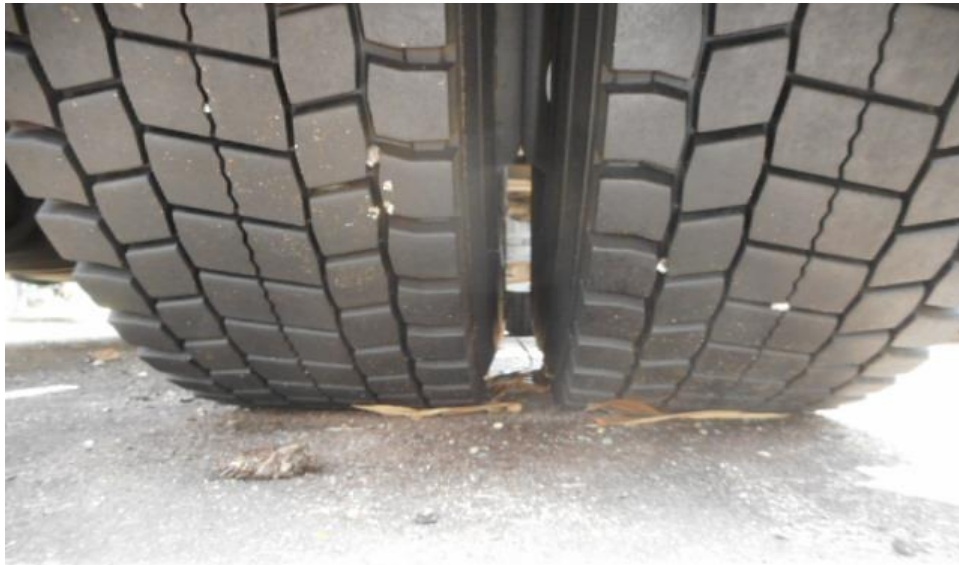
Photo 13 shows the condition of the rear right tyre of the Motor Truck, which was observed to be in serviceable condition with remaining tread depth of approximately 12.5mm. The tyre, which was wrapped around standard steel wheel rim, was also observed to be sufficiently inflated for vehicular operation.

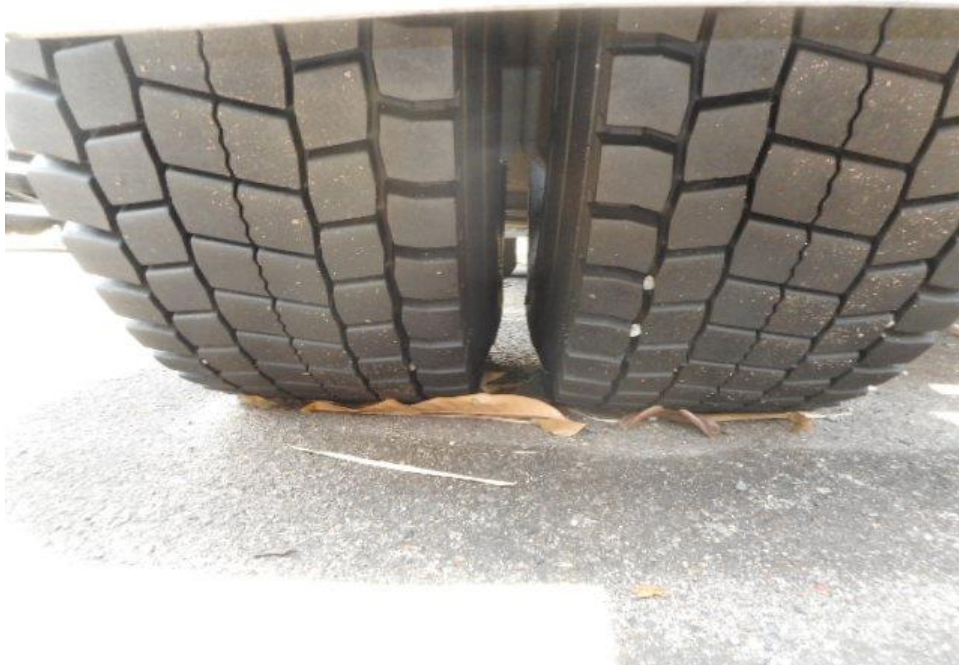
Photo 14 shows the condition of the rear left tyres of the Motor Truck, which was observed to be in serviceable condition with remaining tread depth of approximately 13.7mm. The tyres, which were wrapped around standard steel wheel rim, were also observed to be sufficiently inflated for vehicular operation. There was also no damage found on all 6 steel wheel rims of the Motor Truck.

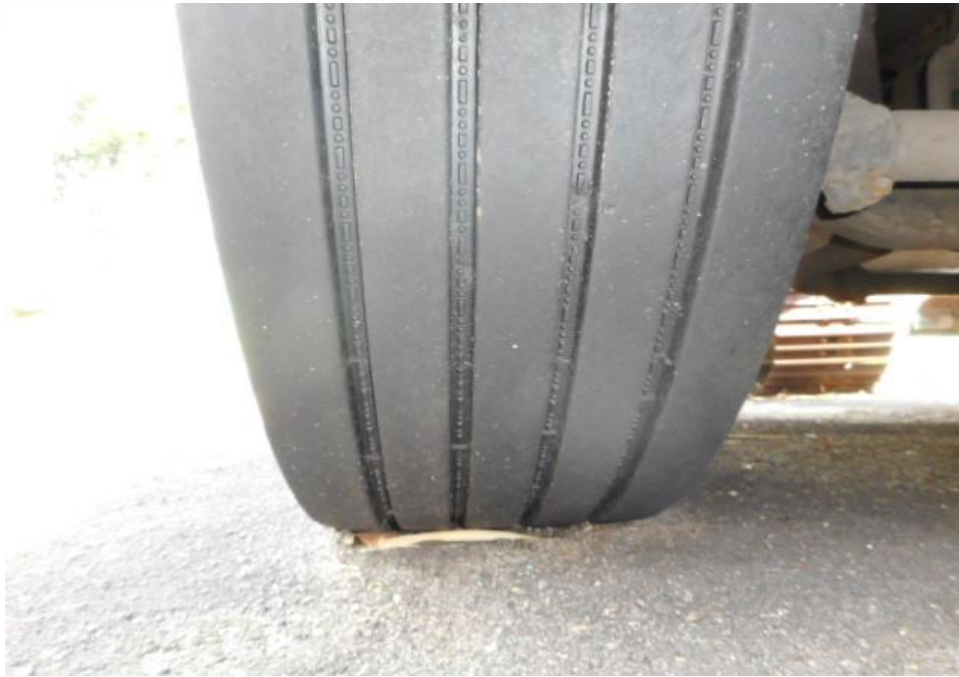
Photo 15 shows the condition of the front left tyres of the Motor Truck, which were observed to be in serviceable condition with remaining tread depth of approximately 9.4mm. There was also no tear, cut or burst mark(s) on the outer and the inner sidewalls as well as across the tread of the 6 tyres that were fitted on the Motor Truck.

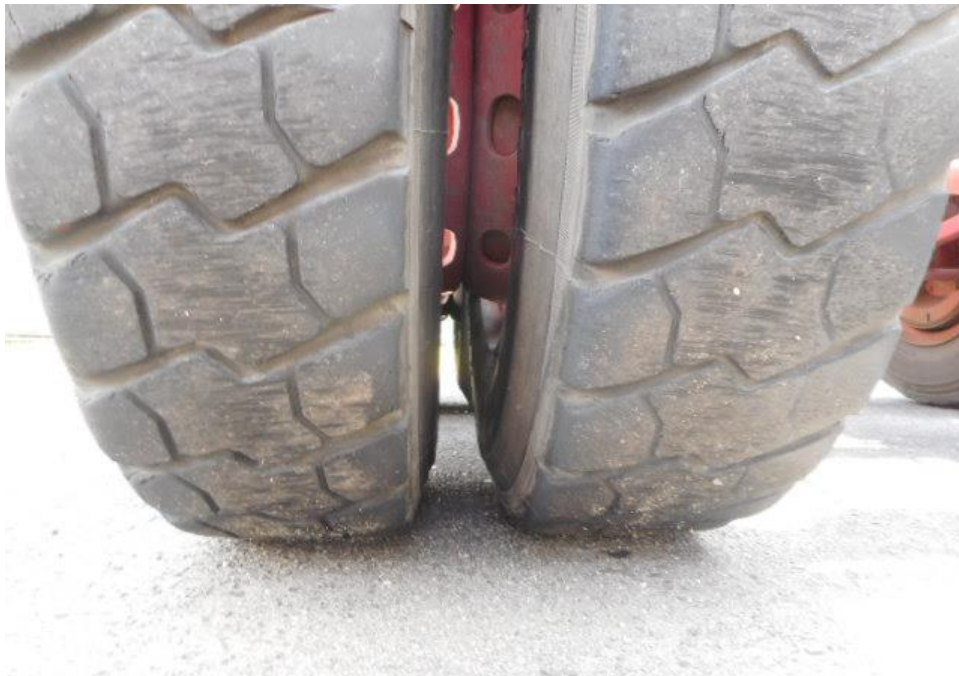
Photo 16 shows the condition of the right tyres of the trailer, which was observed to be in serviceable condition with remaining, tread depth of approximately 7.1mm. There was also no tear, cut or burst mark(s) on the outer and the inner sidewalls as well as across the tread of the 8 tyres that were fitted on the trailer.

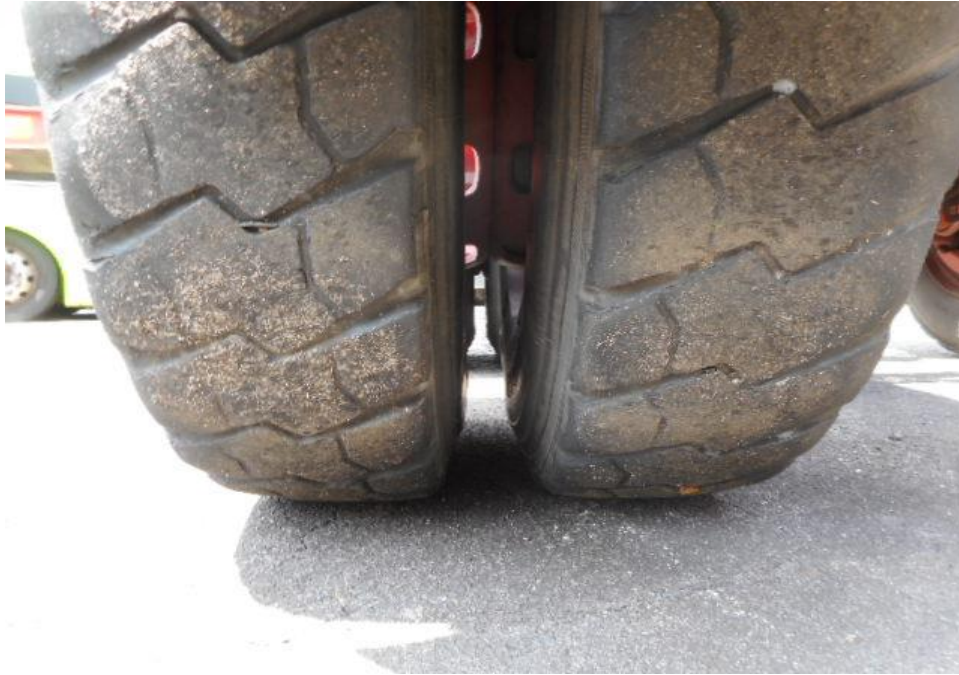
Photo 17 shows the condition of the left tyres of the trailer, which was observed to be in serviceable condition with remaining tread depth of approximately 4.2mm. There was also no tear, cut or burst mark(s) on the outer and the inner sidewalls as well as across the tread of the 8 tyres that were fitted on the trailer.

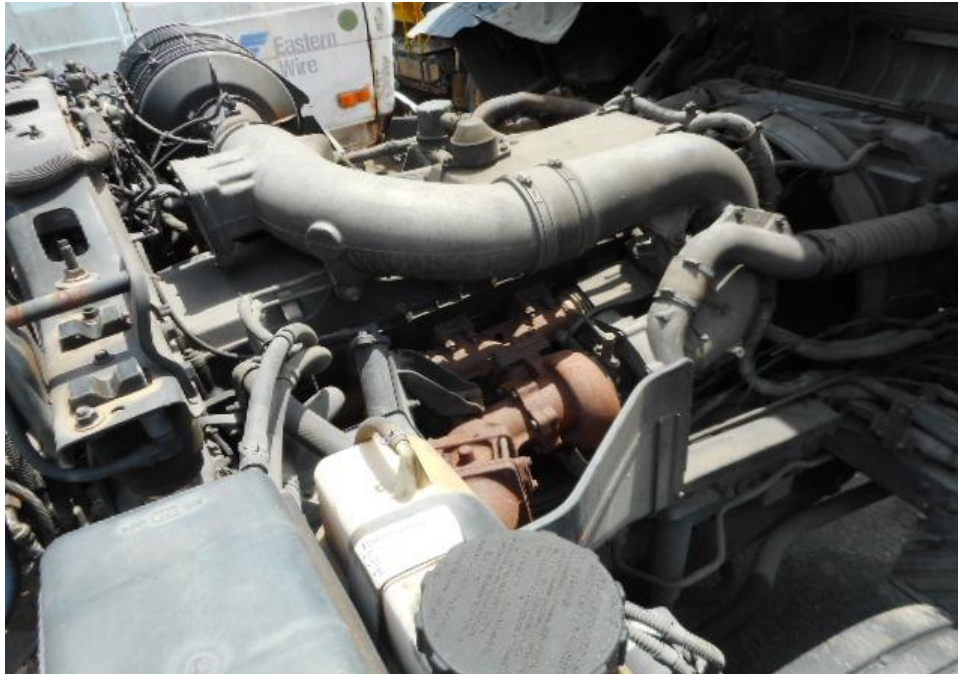
Photo 18 shows a general view of the Motor Truck's engine compartment, which was accessed by lifting the front cabin of the Motor Truck. The various parts and components inside the engine compartment were unaffected by the accident. There was also no sign(s) or indication(s) of fresh fluid leakage and/or fluid stain within the engine compartment

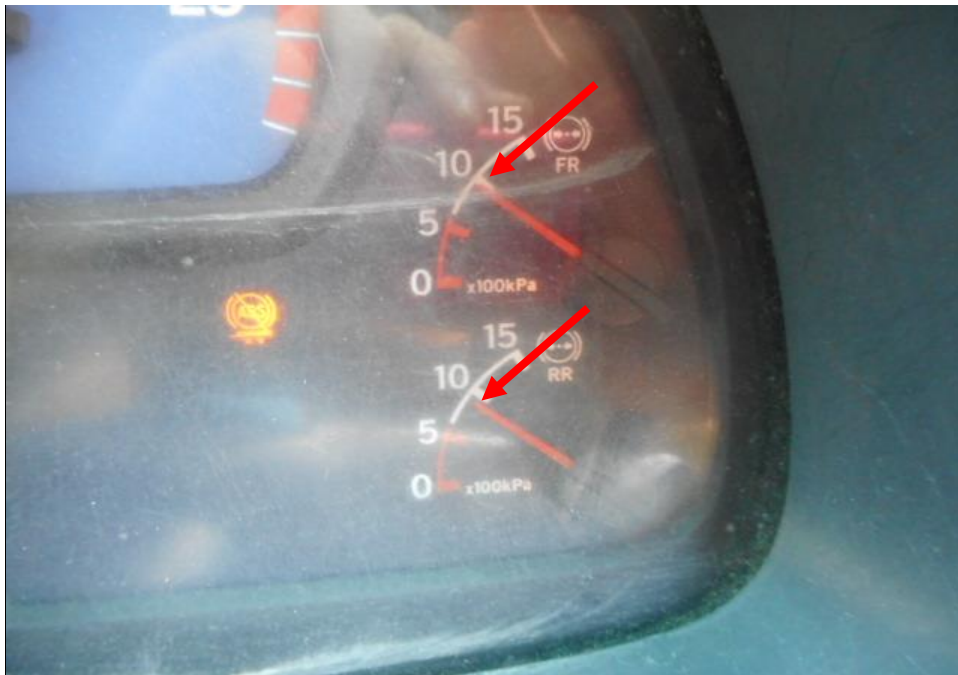
Photo 19 shows the air in the air brake cylinders of the Motor Truck at the time of my inspection. The air in the cylinder was observed to be of sufficient level & serviceable at the time of the accident.

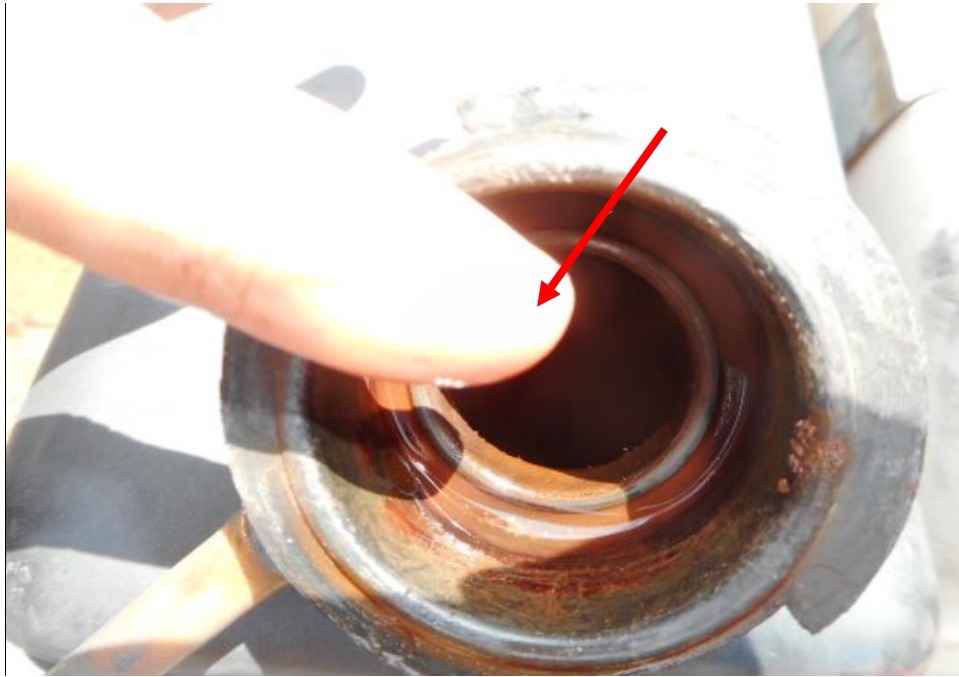
Photo 20 shows the engine coolant reservoir of the Motor Truck at the time of my inspection. The engine coolant was observed to be of sufficient level (arrowed) and without any visible contamination.

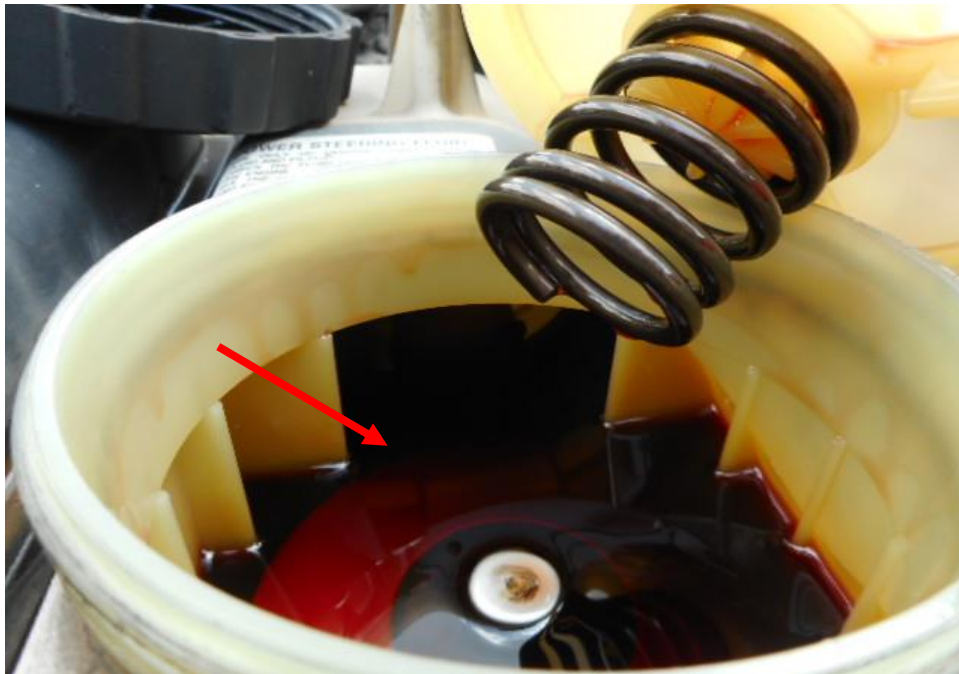
Photo 21 shows the power steering fluid reservoir of the Motor Truck at the time of my inspection. The power steering fluid was observed to be of sufficient level (arrowed) and without any visible contamination.

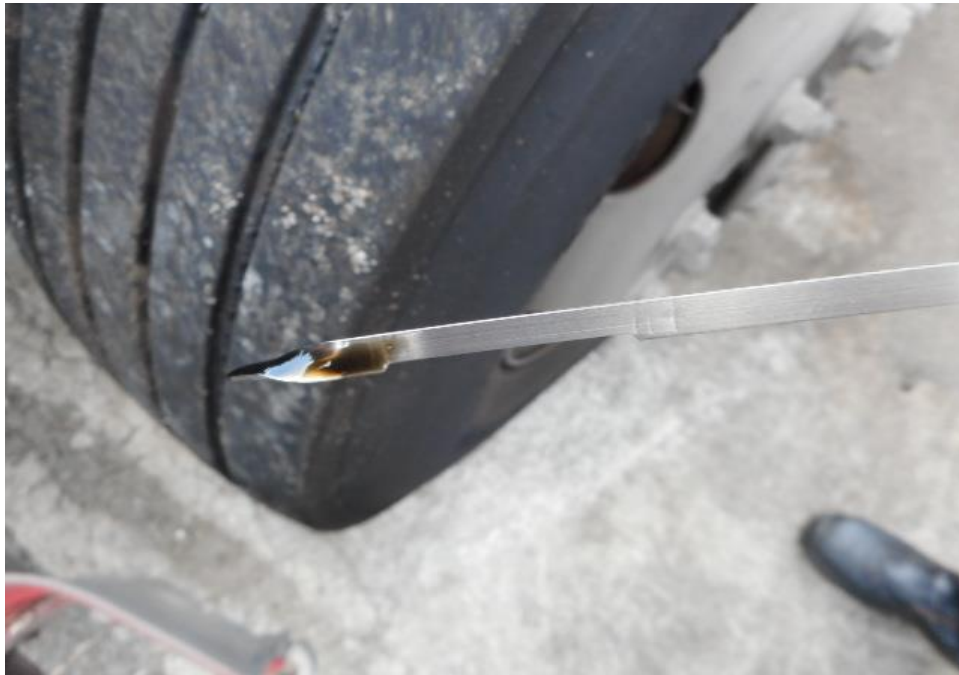
Photo 22 shows the engine oil dip stick of the Motor Truck at the time of my inspection. The engine oil was observed to be of insufficient level at the time of our inspection.

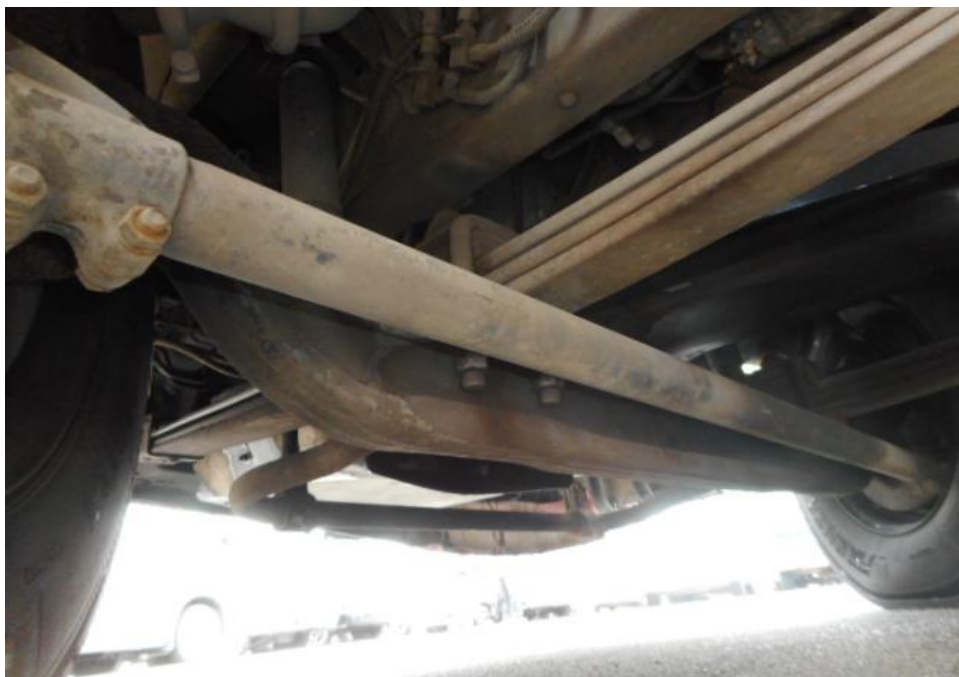
Photo 23 shows the undercarriage of the Motor Truck, at the area where the engine housing located. I did not find any sign(s) or indication(s) of fluid leak, however old fluid stain(s) was observed on the underside of the Motor Truck.

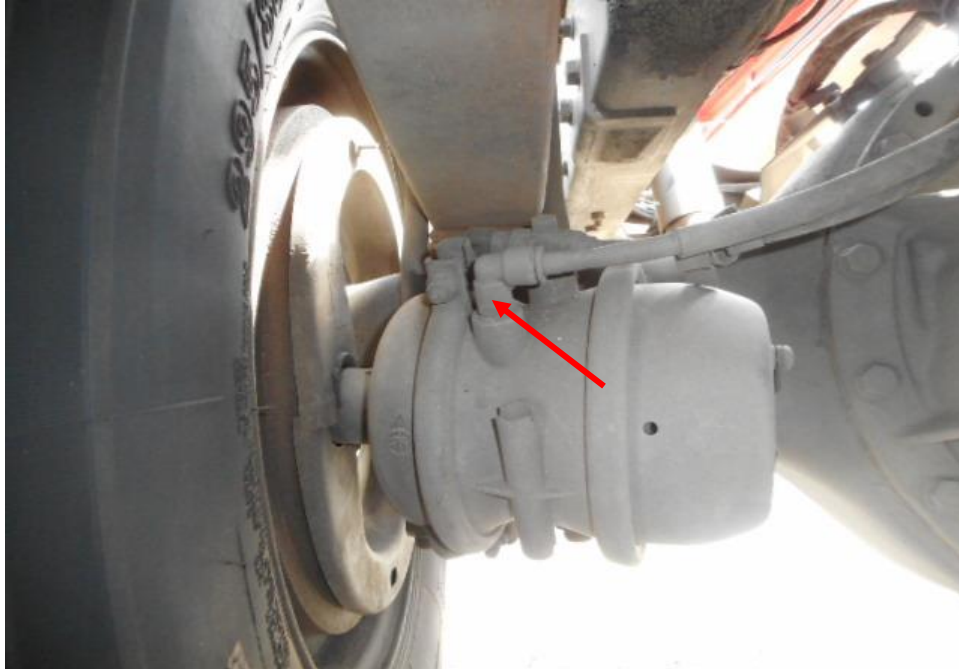
Photo 24 shows the brake pipe (arrowed) at the rear right wheel of the Motor Truck. I did not observe any leakage of brake fluid at the time of my inspection of the Motor Truck. My static tests of the Motor Truck's braking system, along with my visual examination of the various mechanical components in the braking system, had indicated that there was no internal leakage of pressure/vacuum. Hence the braking system of the Motor Truck was likely to be in serviceable condition at the material time of accident.

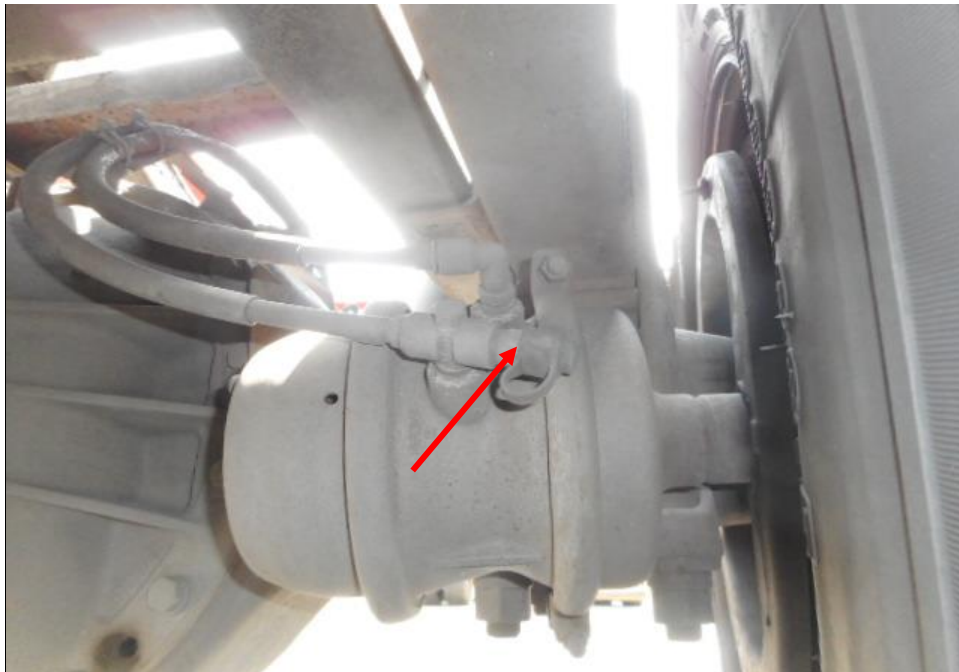
Photo 25 shows the brake pipe (arrowed) at the rear left wheel of the Motor Truck. I did not observe any leakage of brake fluid at the time of my inspection of the Motor Truck. My static tests of the Motor Truck's braking system, along with my visual examination of the various mechanical components in the braking system, had indicated that there was no internal leakage of pressure/vacuum. Hence the braking system of the Motor Truck was likely to be in serviceable condition at the material time of accident.

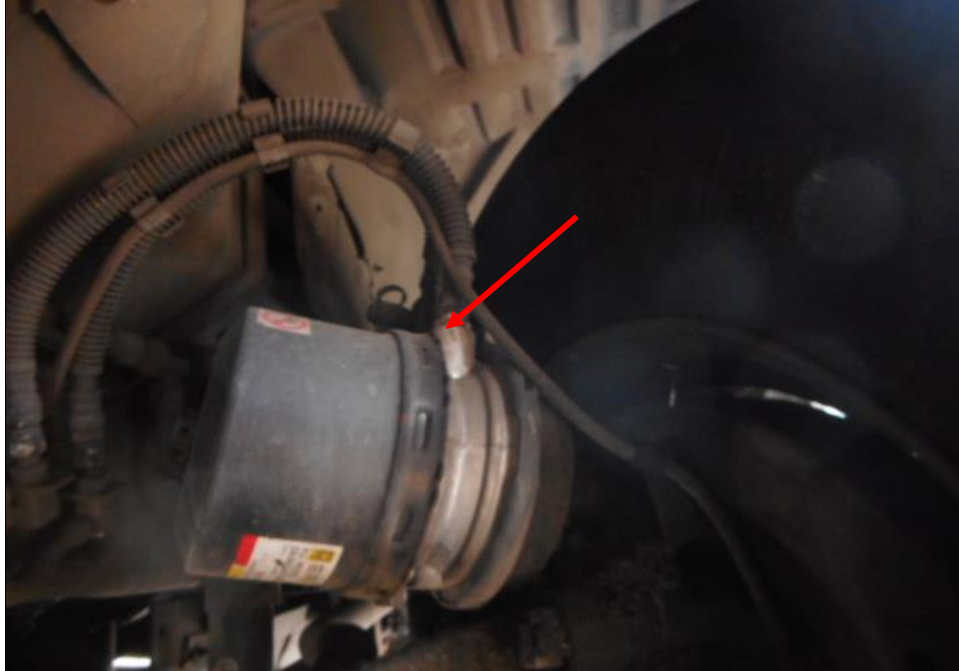
Photo 26 shows the brake pipe (arrowed) at the front right wheel of the Motor Truck. I did not observe any leakage of brake fluid at the time of my inspection of the Motor Truck. My static tests of the Motor Truck's braking system, along with my visual examination of the various mechanical components in the braking system, had indicated that there was no internal leakage of pressure/vacuum. Hence the braking system of the Motor Truck was likely to be in serviceable condition at the material time of accident.

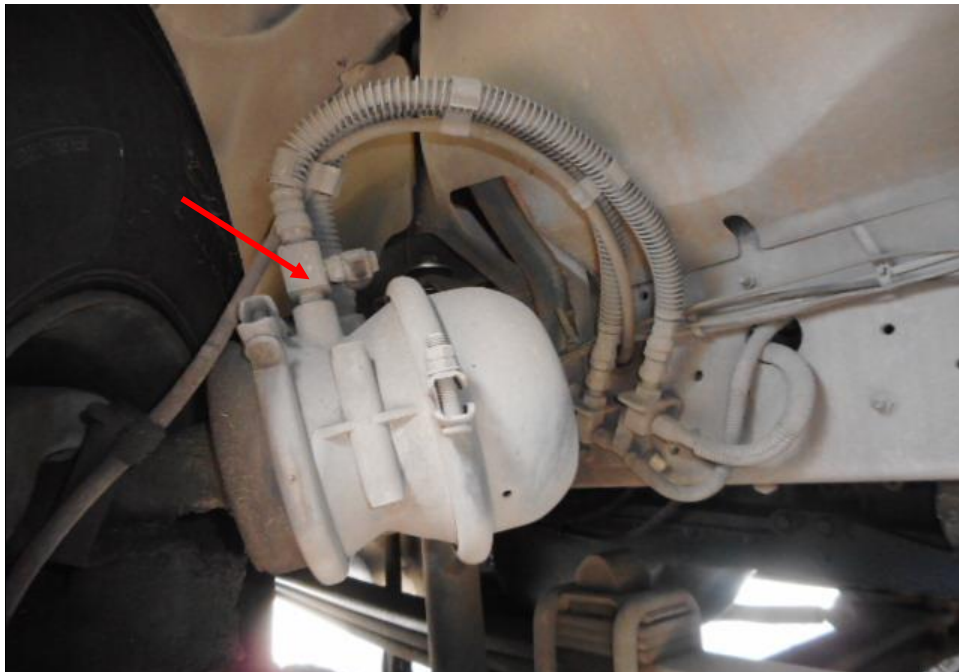
Photo 27 shows the brake pipe (arrowed) at the front left wheel of the Motor Truck. I did not observe any leakage of brake fluid at the time of my inspection of the Motor Truck. My static tests of the Motor Truck's braking system, along with my visual examination of the various mechanical components in the braking system had indicated that there was no internal leakage of pressure/vacuum. Hence the braking system of the Motor Truck was likely to be in serviceable condition at the material time of accident.

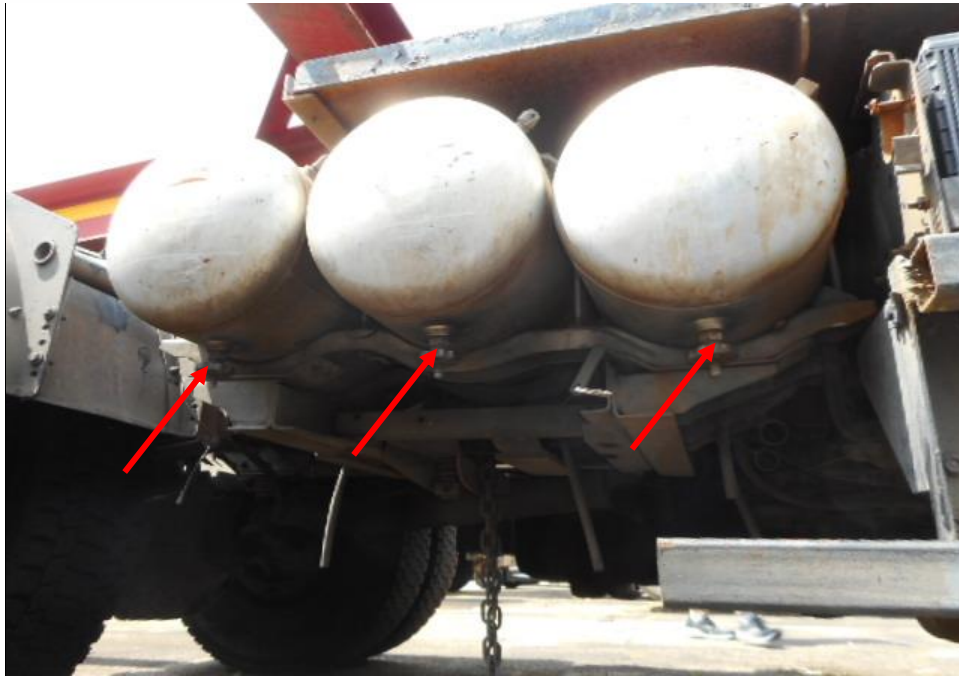
Photo 28 shows the air brake cylinders (arrowed) at the undercarriage of the Motor Truck. I did not observe any leakage of air brake fluid at the time of my inspection of the Motor Truck. My static tests of the Motor Truck's braking system, along with my visual examination of the various mechanical components in the braking system had indicated that there was no internal leakage of pressure/vacuum. Hence the braking system of the Motor Truck was likely to be in serviceable condition at the material time of accident.

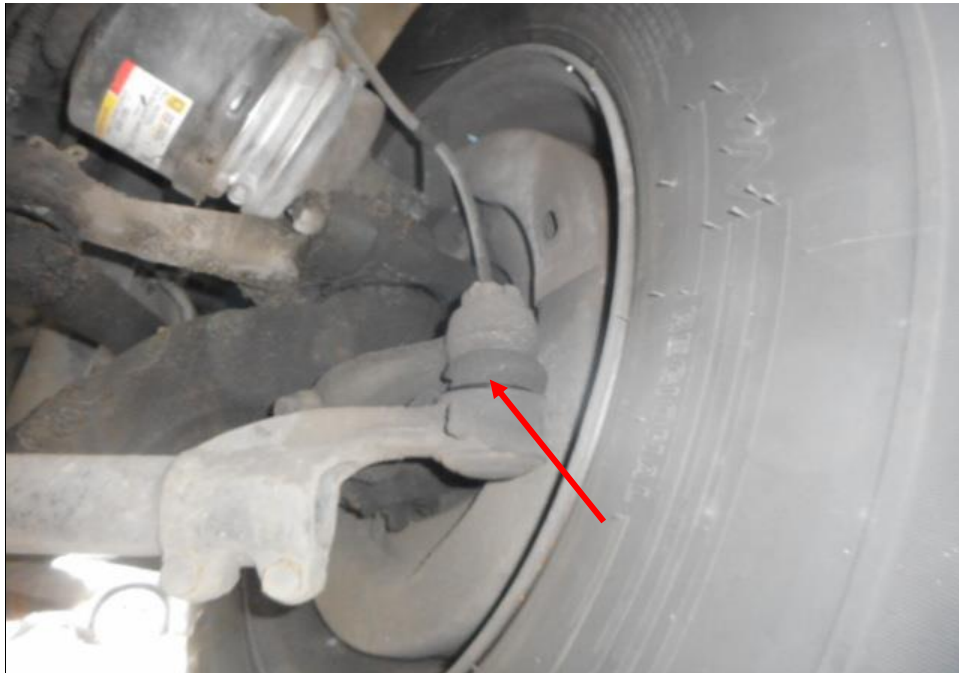
Photo 29 shows the various undercarriage components at the front right wheel of the Motor Truck, in particular the steering tie rod end (arrowed). The various steering components were all found to be intact, suggesting that the steering system of the Motor Truck was likely to be in serviceable condition at the material time of accident. There was also no sign of fluid stain(s) observed on the various undercarriage components.

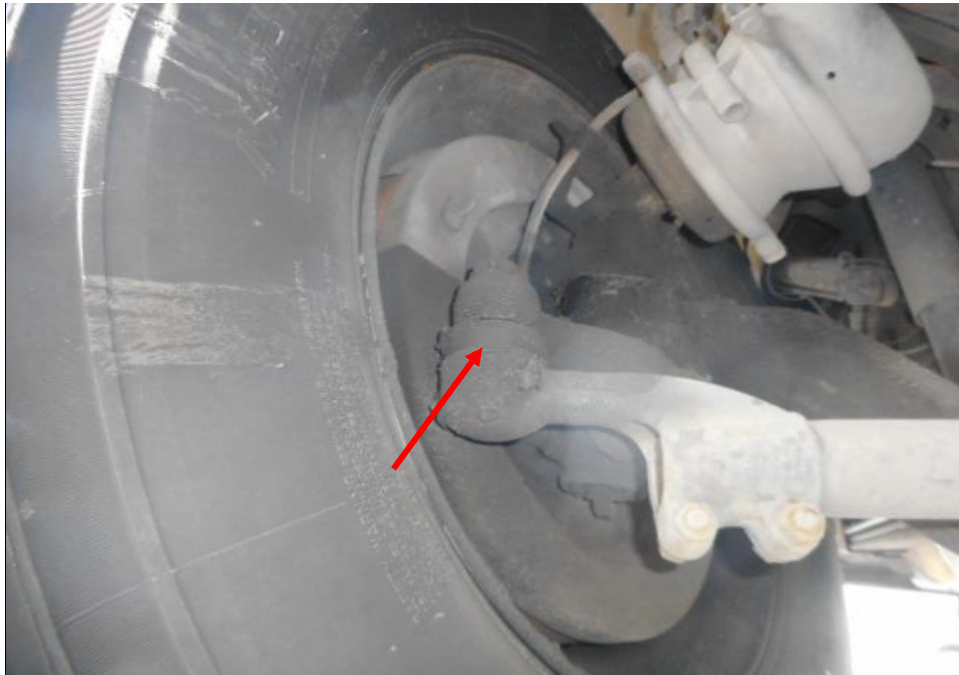
Photo 30 shows the various undercarriage components at the front left wheel of the Motor Truck, in particular the steering tie rod end (arrowed). The various undercarriage components of the Motor Truck were all found to be intact without any visible damage. There was also no sign of fluid stain(s) observed on the various undercarriage components.
