Your Ref: TP/IP/23985/2021
Our Ref : CI/TPD21007275/P

Fatal Accident Investigation Team

MECHANICAL INSPECTION REPORT OF MOTOR TRUCK XD 2517H

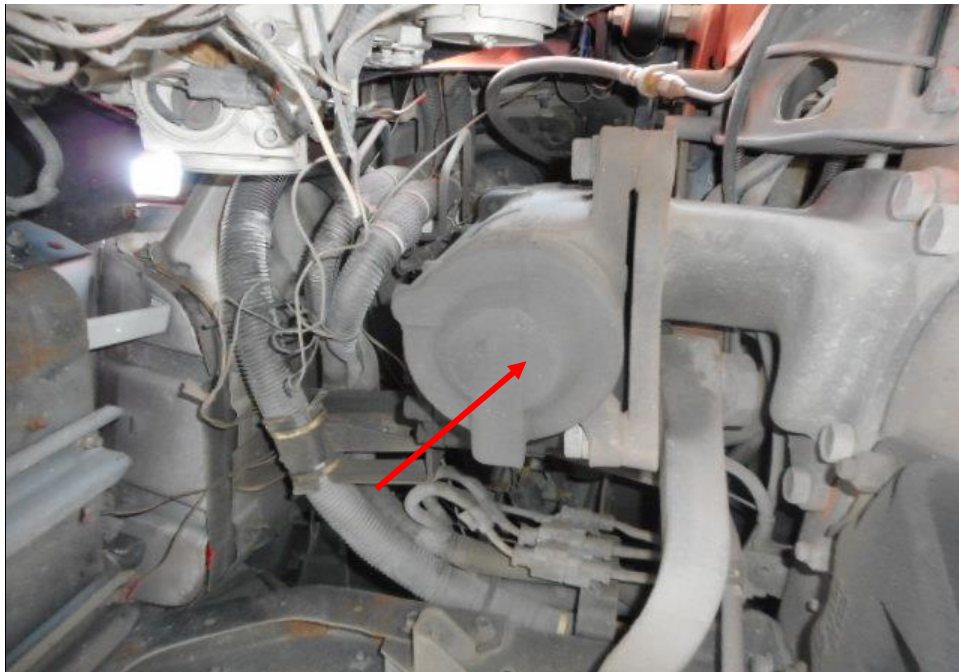
Photo 31 shows the steering box component (arrowed) at the undercarriage of the Motor Truck was found to be intact without any visible damage. There was also no sign of fluid stain(s) observed on the various undercarriage components.

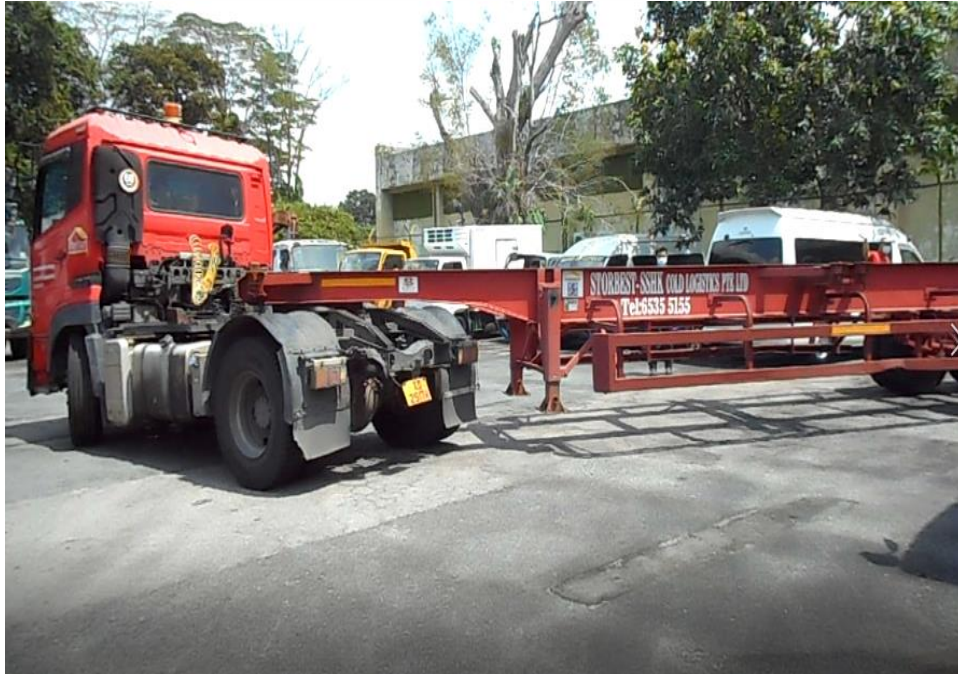
Photo 32 shows the front left wheel of the Motor Truck turned to its full right. During my steering system test, I did not experience any abnormal free play and/or resistance when I had turned the steering wheel towards full left and full right. This would suggest that the steering system of the Motor Truck was likely to be in serviceable condition at the material time of accident.
