Your Ref: TP/IP/26557/2021  
Our Ref : CI/TPD21007276/P

### **Fatal Accident Investigation Team**

### **MECHANICAL INSPECTION REPORT OF MOTOR TRAILER, JRF 6322**

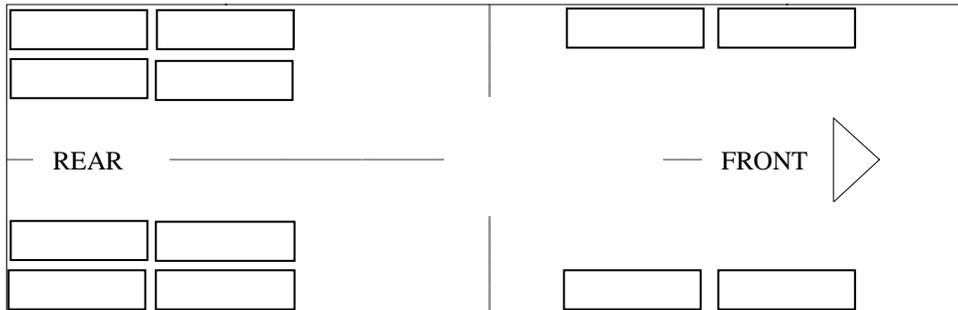
6. The 4 front tyres and 8 rear tyres of the Motor Trailer were observed to be in serviceable condition and sufficiently inflated for vehicular operation. I did not find any tear, cut or burst mark(s) on the outer and the inner sidewalls as well as across the tread of the 12 tyres of the Motor Trailer. The tyre brand, tyre size and remaining tread depth of the 12 tyres of the Motor Trailer were recorded as follows:-

Austone 295/80R22.5 (11.6mm)

Austone 295/80R22.5 (11.2mm)

Austone 295/80R22.5 (10.7mm)

Austone 295/80R22.5 (4.5mm)

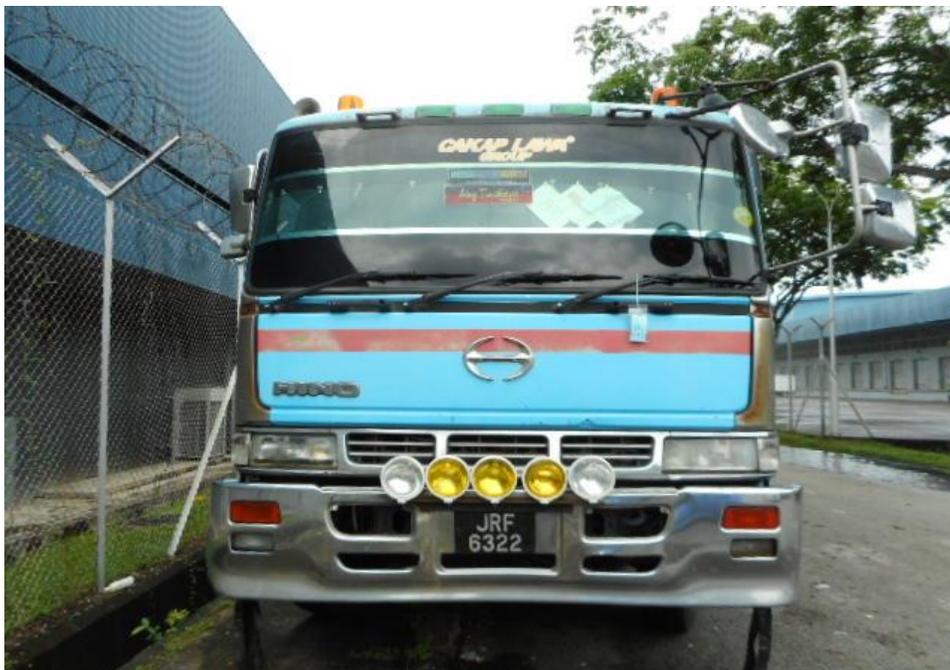
**Photo 1** shows a general view of the front body of the Motor Trailer at the time of my inspection. The Motor Trailer was observed to be intact and unaffected by the accident.

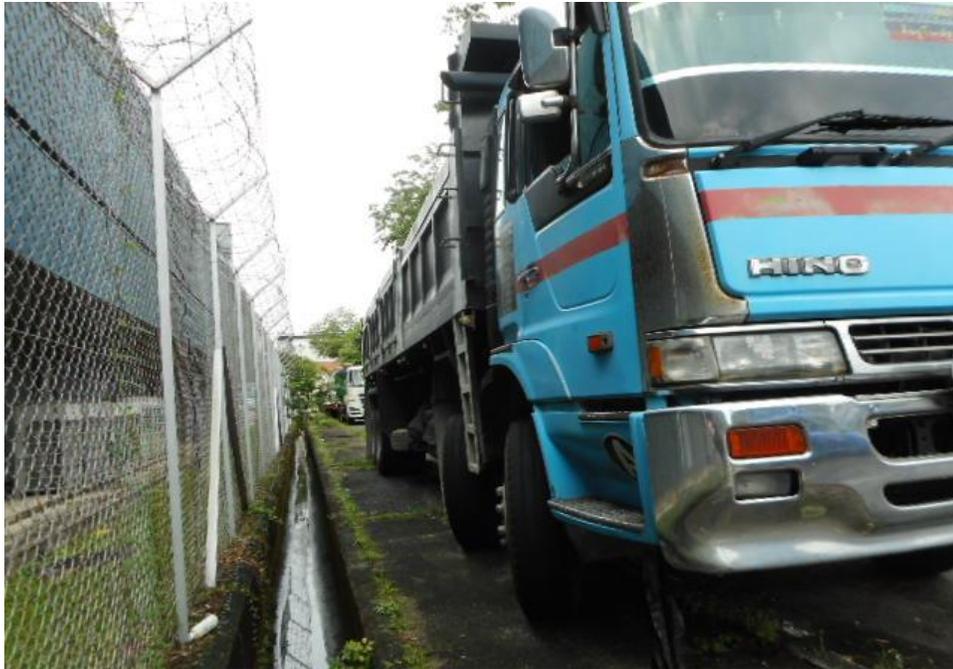
**Photo 2** shows a general view of the right body of the Motor Trailer at the time of my inspection. The Motor Trailer was observed to be intact and unaffected by the accident.

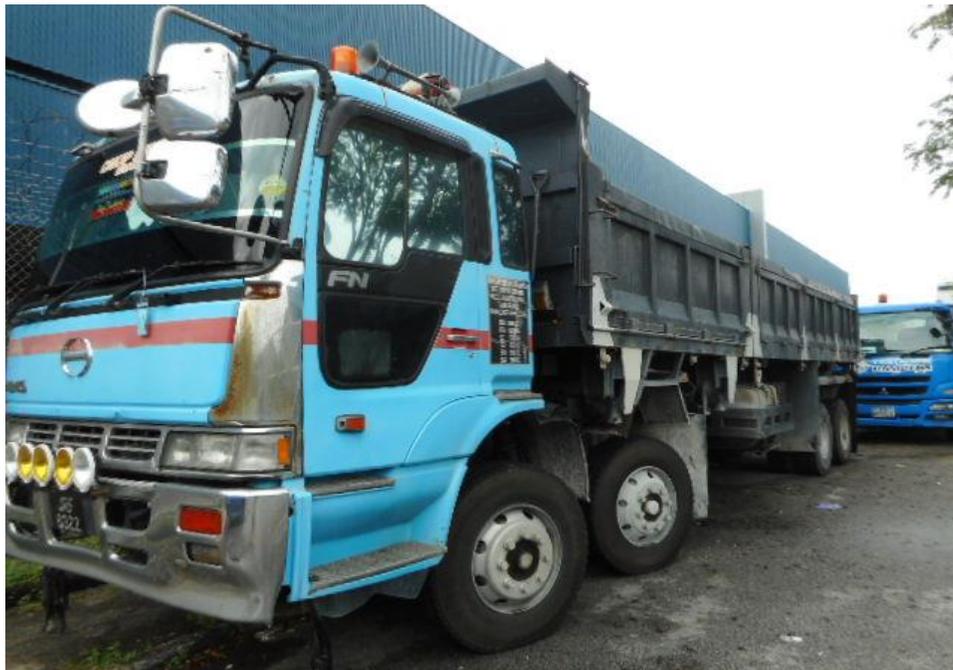
**Photo 3** shows a general view of the left body of the Motor Trailer at the time of my inspection. The Motor Trailer was observed to be intact and unaffected by the accident.

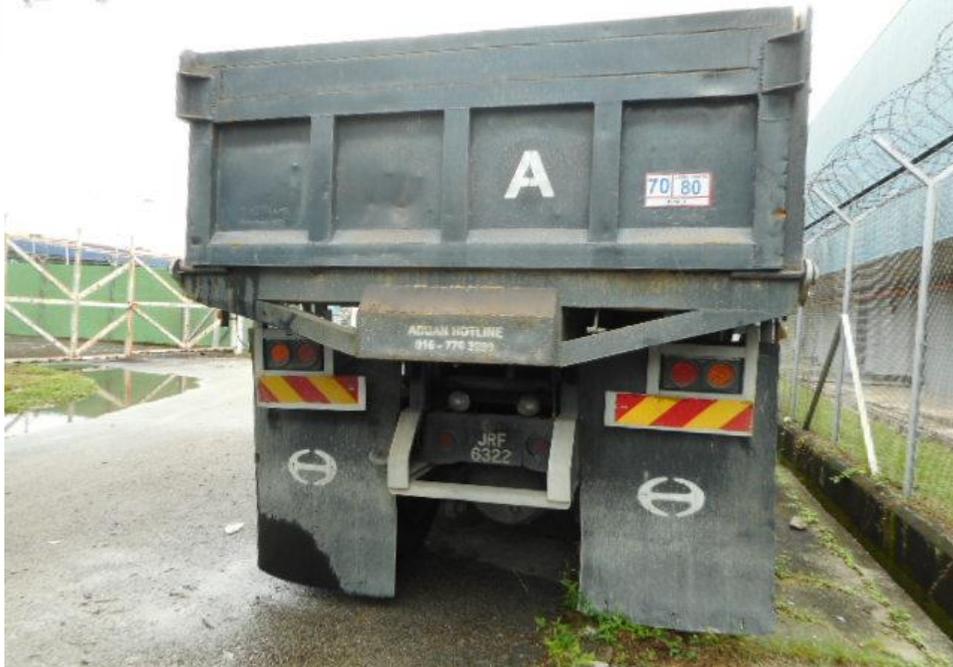
**Photo 4** shows a general view of the Motor Trailer's rear body at the time of my inspection. The Motor Trailer was observed to be intact and unaffected by the accident.

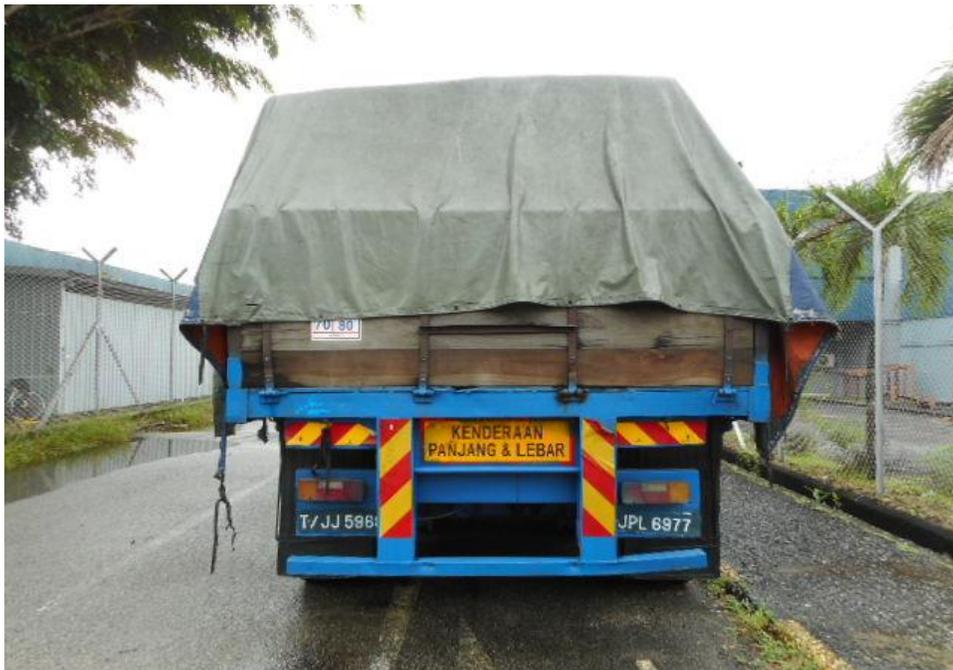
**Photo 5** shows a general view of the rear body at the time of my inspection. The Trailer was observed to be intact and unaffected by the accident.

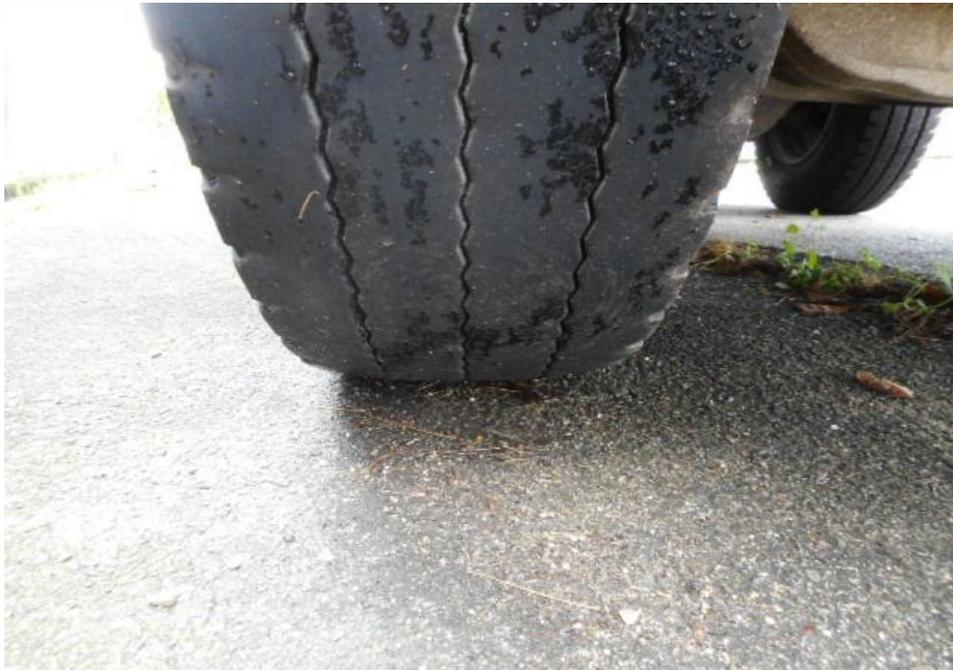
**Photo 6** shows the condition of the front right tyre of the Motor Trailer, which was observed to be in serviceable condition with remaining tread depth of approximately 4.5 mm. The tyre, which was wrapped around standard steel wheel rim, was also observed to be sufficiently inflated for vehicular operation. There was no tear, cut or burst mark(s) on the outer and the inner sidewalls as well as across the tread of the 10 tyres that were fitted on the Motor Trailer.

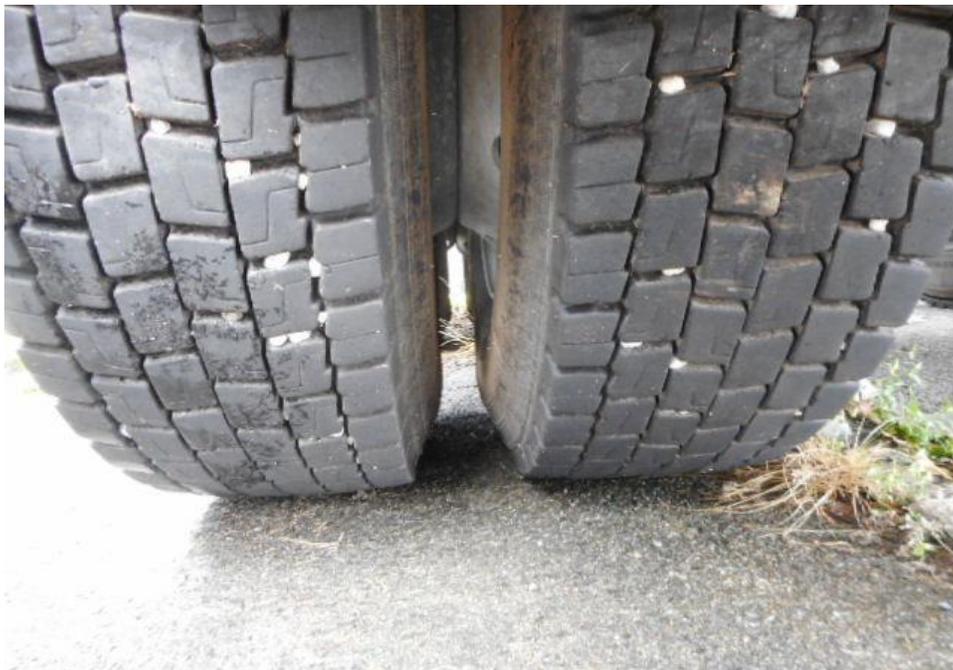
**Photo 7** shows the condition of the rear right tyre of the Motor Trailer, which was observed to be in serviceable condition with remaining tread depth of approximately 10.7mm. The tyre, which was wrapped around standard steel wheel rim, was also observed to be sufficiently inflated for vehicular operation.

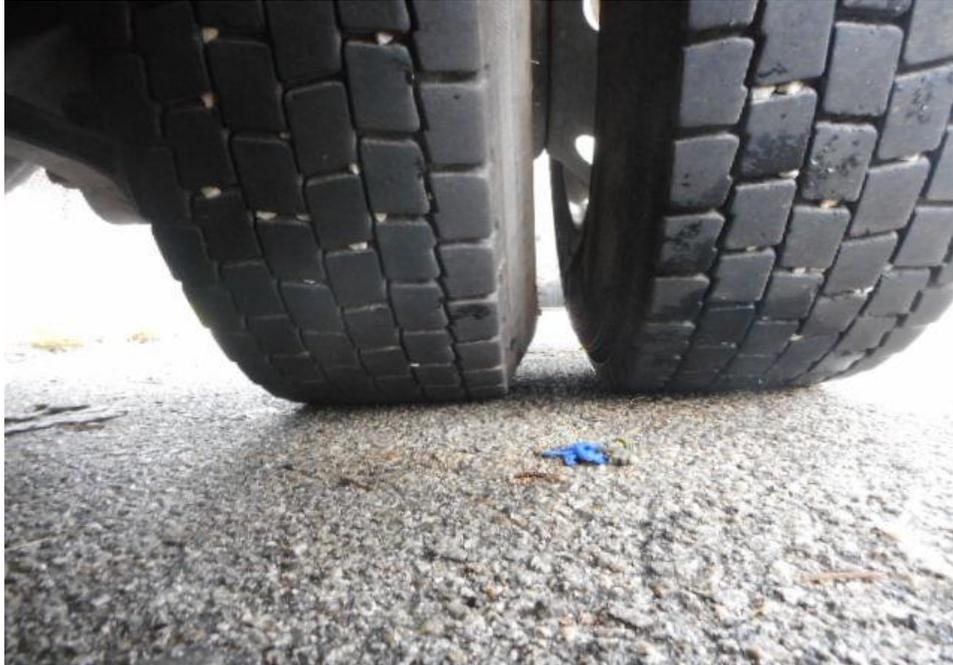
**Photo 8** shows the condition of the rear left tyres of the Motor Trailer, which was observed to be in serviceable condition with remaining tread depth of approximately 11.6mm. The tyres, which were wrapped around standard steel wheel rim, were also observed to be sufficiently inflated for vehicular operation. There was also no damage found on all 10 steel wheel rims of the Trailer.

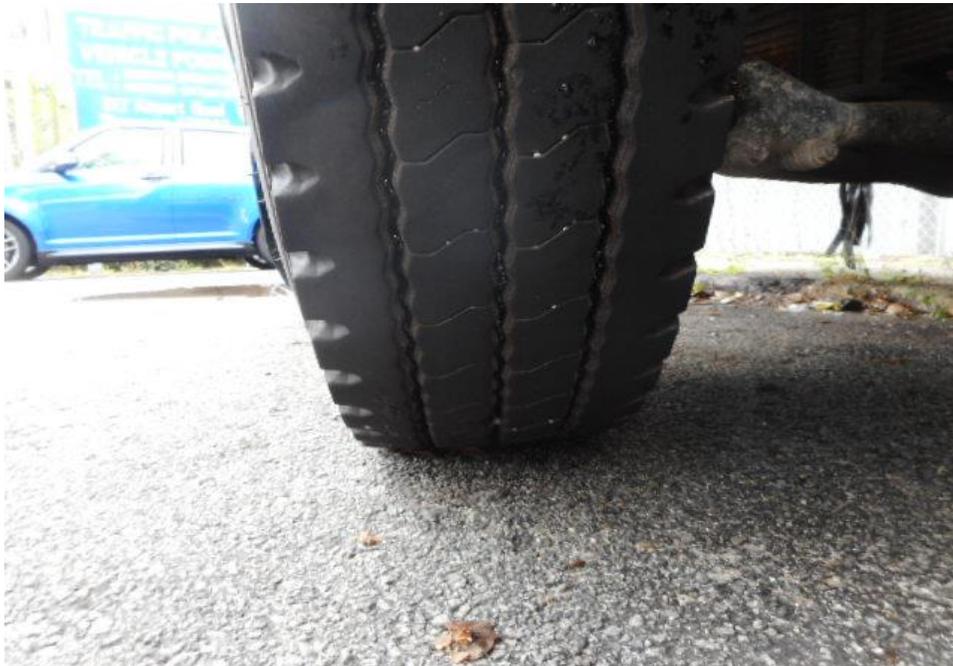
**Photo 9** shows the condition of the front left tyres of the Motor Trailer, which were observed to be in serviceable condition with remaining tread depth of approximately 11.2mm. There was also no tear, cut or burst mark(s) on the outer and the inner sidewalls as well as across the tread of the 10 tyres that were fitted on the Trailer.

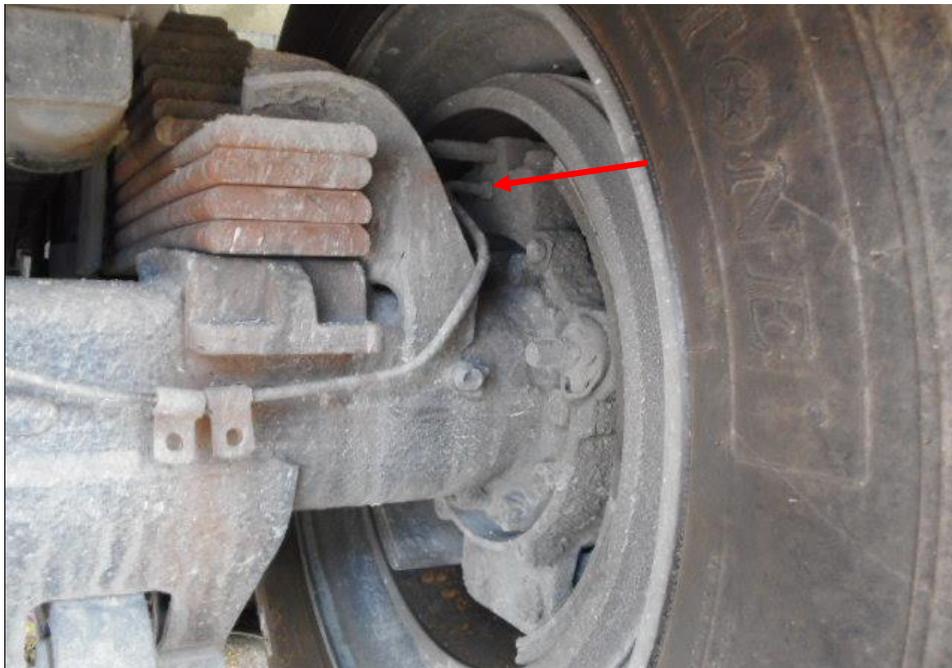
**Photo 10** shows the brake pipe (arrowed) at the rear right wheel of the Motor Trailer. I did not observe any leakage of brake fluid at the time of my inspection of the Motor Trailer. My visual examination of the various mechanical components in the braking system, had indicated that there was no internal leakage of pressure/vacuum and these components were generally in good condition.

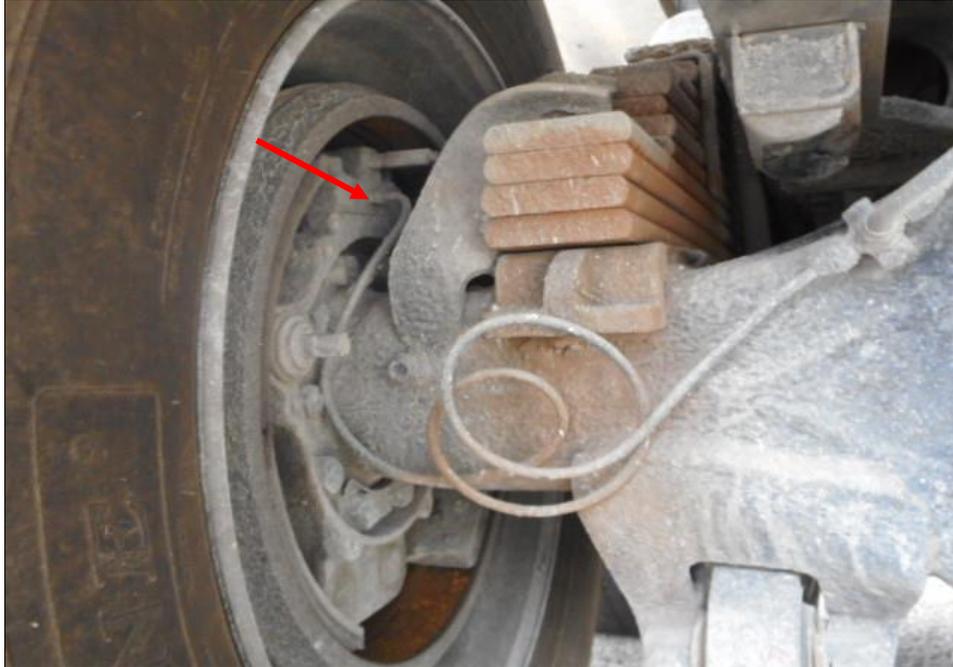
**Photo 11** shows the brake pipe (arrowed) at the rear left wheel of the Motor Trailer. I did not observe any leakage of brake fluid at the time of my inspection of the Motor Trailer. My static tests of the Motor Trailer's braking system, along with my visual examination of the various mechanical components in the braking system, had indicated that there was no internal leakage of pressure/vacuum and these components were generally in good condition.

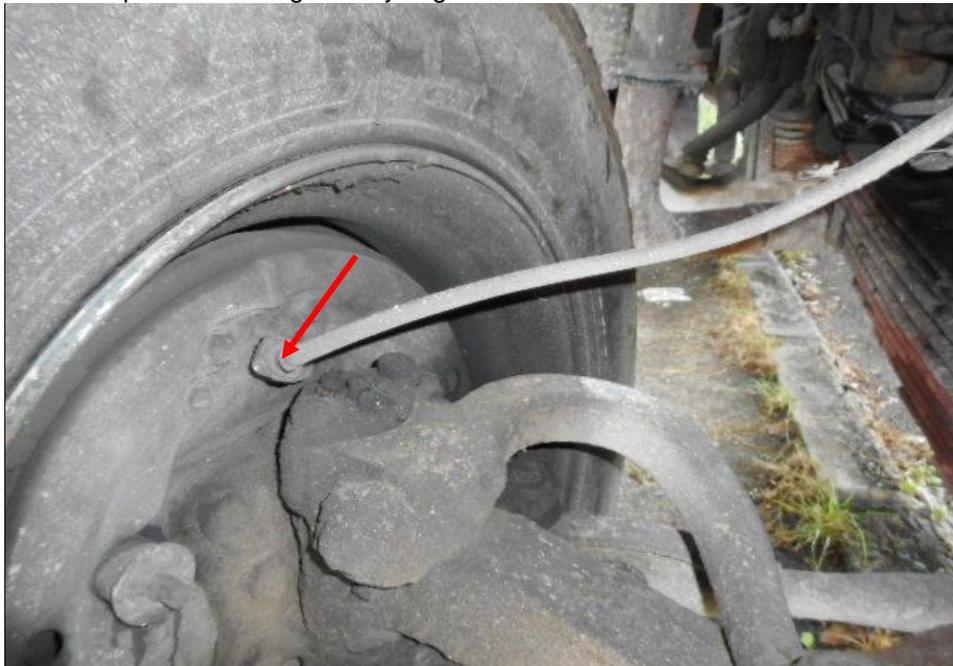
**Photo 12** shows the brake pipe (arrowed) at the front right wheel of the Motor Trailer. I did not observe any leakage of brake fluid at the time of my inspection of the Motor Trailer. My static tests of the Motor Trailer's braking system, along with my visual examination of the various mechanical components in the braking system, had indicated that there was no internal leakage of pressure/vacuum and these components were generally in good condition.

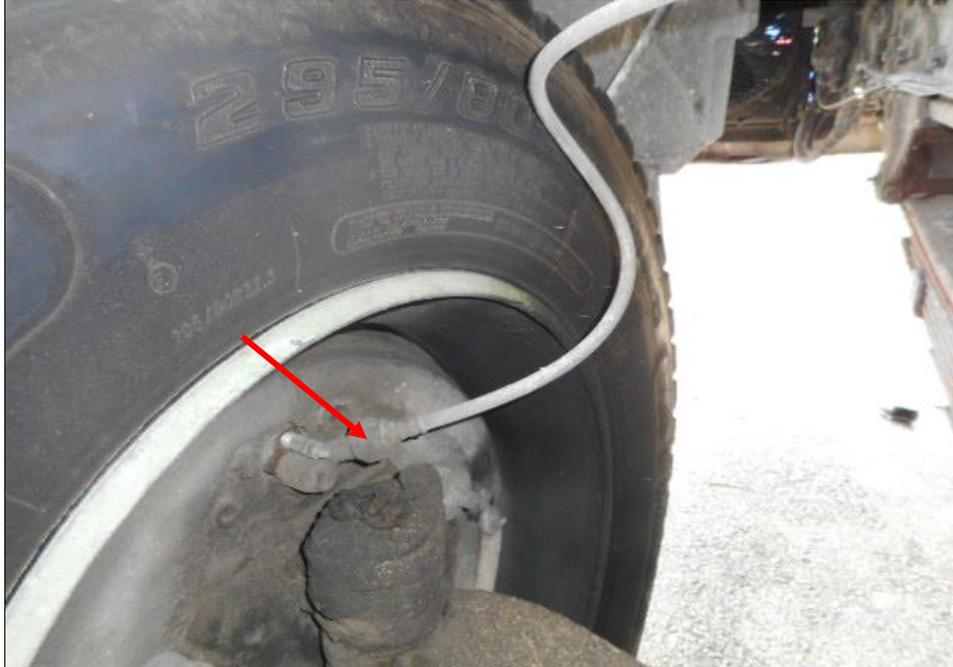
**Photo 13** shows the brake pipe (arrowed) at the front left wheel of the Motor Trailer. I did not observe any leakage of brake fluid at the time of my inspection of the Motor Trailer. My visual examination of the various mechanical components in the braking system had indicated that there was no internal leakage of pressure/vacuum and there components were generally in good condition.

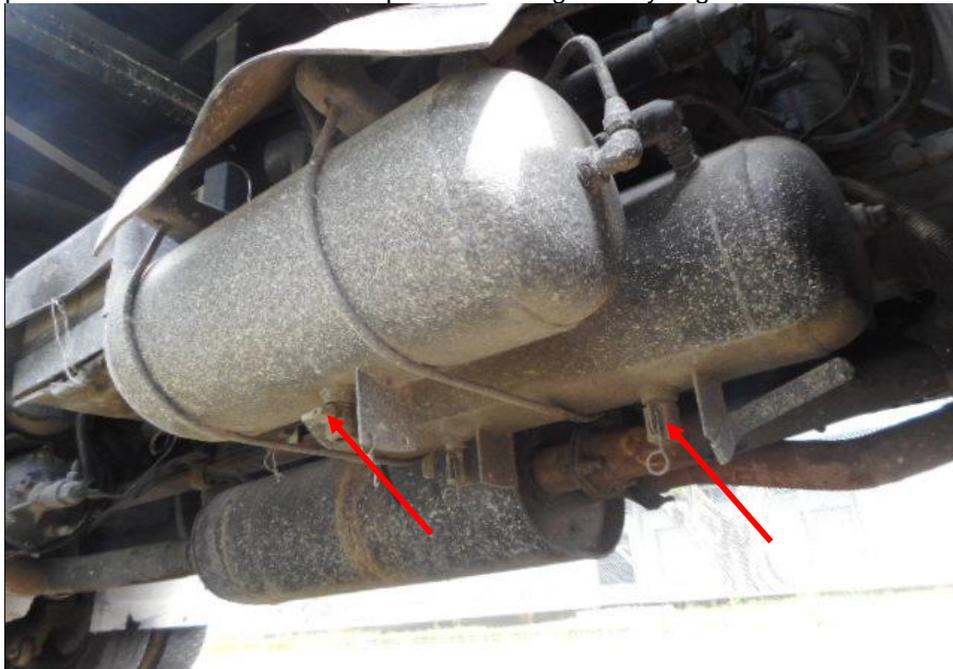
**Photo 14** shows the air brake cylinders (arrowed) at the undercarriage of the Motor Trailer. I did not observe any leakage of air brake fluid at the time of my inspection of the Motor Trailer. My visual examination of the various mechanical components in the braking system had indicated that there was no internal leakage of pressure/vacuum and there components were generally in good condition.

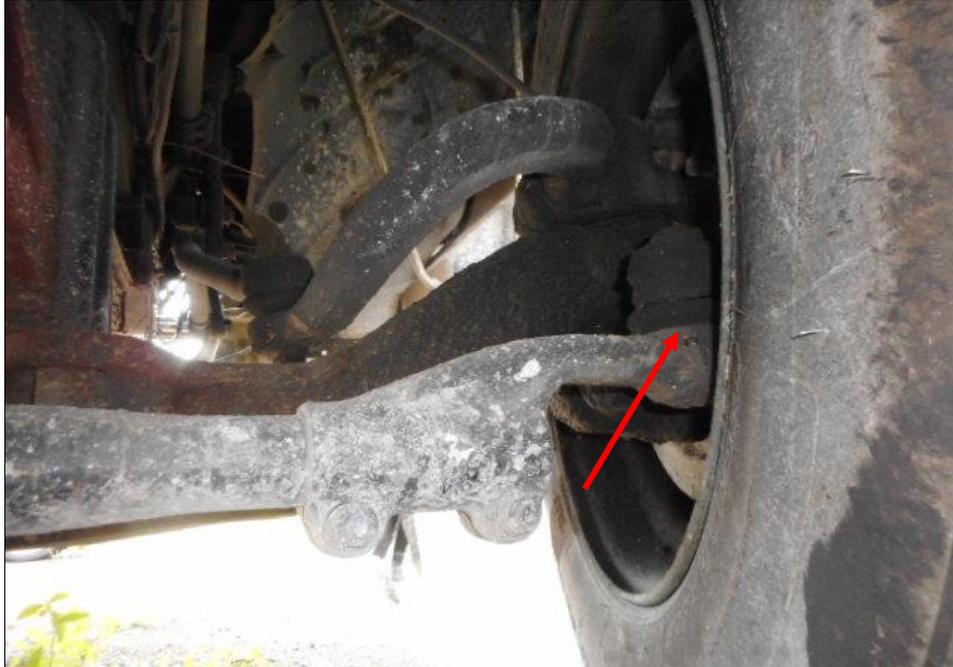
**Photo 15** shows the various undercarriage components at the front right wheel of the Motor Trailer, in particular the steering tie rod end (arrowed). The various steering components were all found to be intact, suggesting that the steering system of the Motor Trailer was likely to be in serviceable condition at the material time of accident. There was also no sign of fluid stain(s) observed on the various undercarriage components.

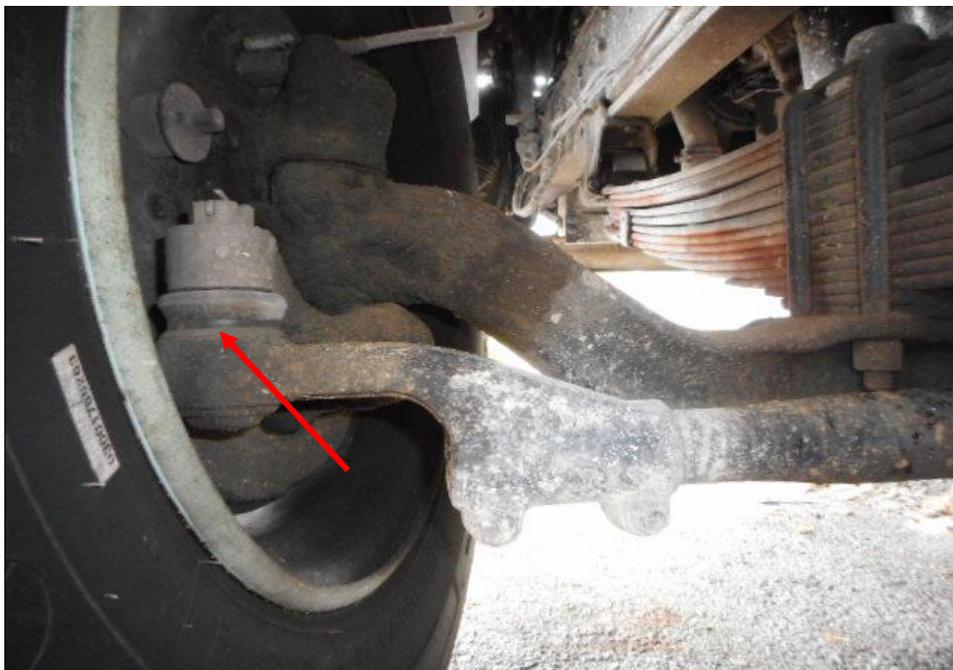
**Photo 16** shows the various undercarriage components at the front left wheel of the Motor Trailer, in particular the steering tie rod end (arrowed). The various undercarriage components of the Motor Trailer were all found to be intact without any visible damage. There was also no sign of fluid stain(s) observed on the various undercarriage components.

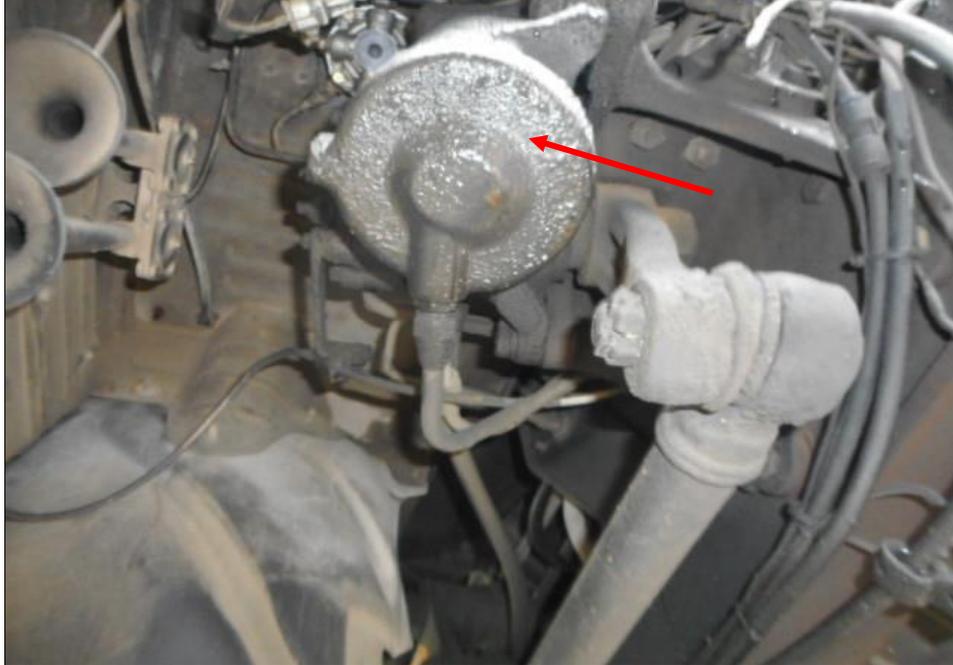
**Photo 17** shows the steering box component (arrowed) at the undercarriage of the Motor Trailer was found to be intact without any visible damage. There was also no sign of fluid stain(s) observed on the various undercarriage components.
