Your Ref: TP/IP/24847/2021  
Our Ref : CI/TPD21007277/P

**MECHANICAL INSPECTION REPORT OF POLICE TRUCK, YQ 2025E**

1. I refer to your request on 30<sup>th</sup> June 2021 to conduct a physical inspection of a Police Truck bearing registration number YQ 2025E (herein referred to as "**Police Truck**"), which was involved in a road traffic accident on 19<sup>th</sup> May 2021.
2. The objective of this inspection is to determine if there was any possible mechanical failure to the Police Truck that may have contributed to the accident.
3. Following the request, I had carried out a physical inspection of the Police Truck on 20<sup>th</sup> September 2021 at the premises of Traffic Police vehicle pound, 517 Airport Road Singapore 539942. I now set out below my observations and comments with respect to this inspection.

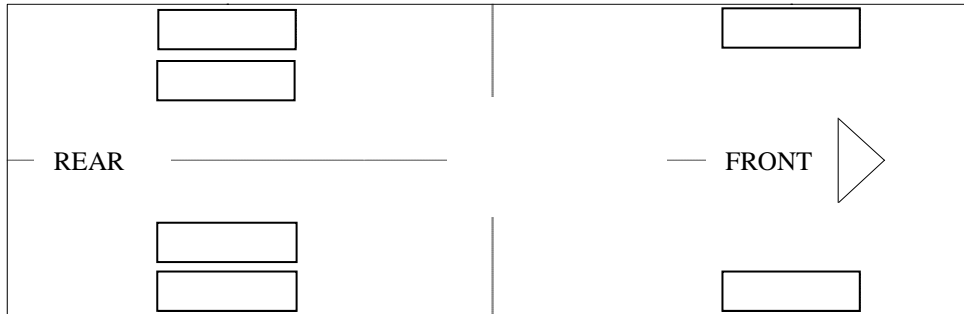
6. The 2 front tyres and 4 rear tyres of the Police Truck were observed to be in serviceable condition and sufficiently inflated for vehicular operation. I did not find any tear, cut or burst mark(s) on the outer and the inner sidewalls as well as across the tread of the 6 tyres of the Police Truck. The tyre brand, tyre size and remaining tread depth of the 6 tyres of the Police Truck were recorded as follows:-

Goodyear 275/70 R22.5 (14.2mm)

Goodyear 275/70 R22.5 (14.7mm)

Goodyear 275/70 R22.5 (14.5mm)

Goodyear 275/70 R22.5 (14.1mm)

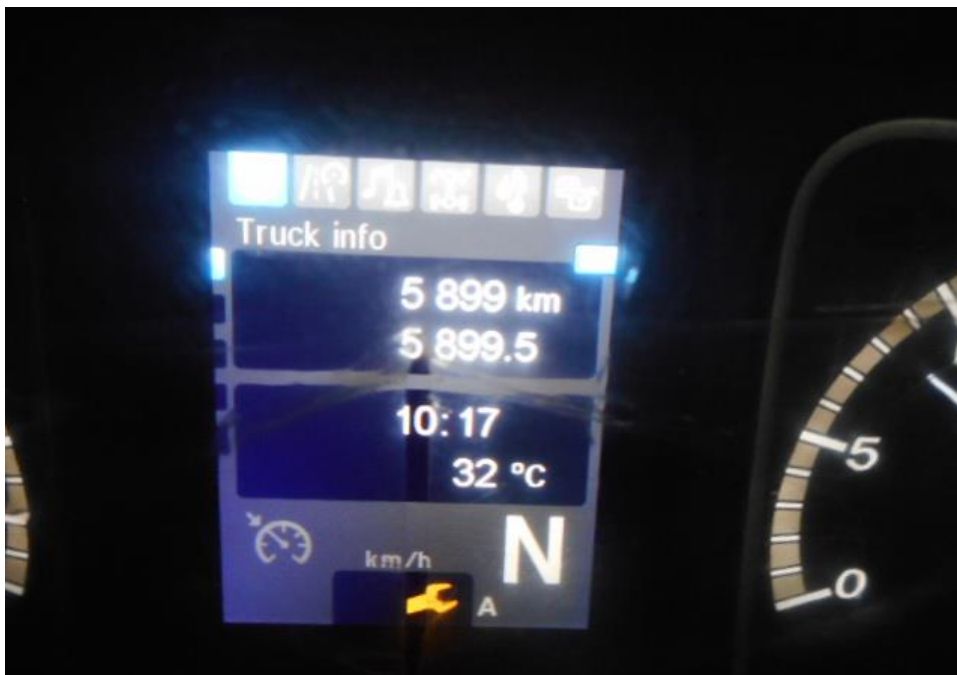
**Photo 1** shows a general view of the instrument cluster of the Police Truck at the time of my inspection. The mileage of the Police Truck was 5,899km

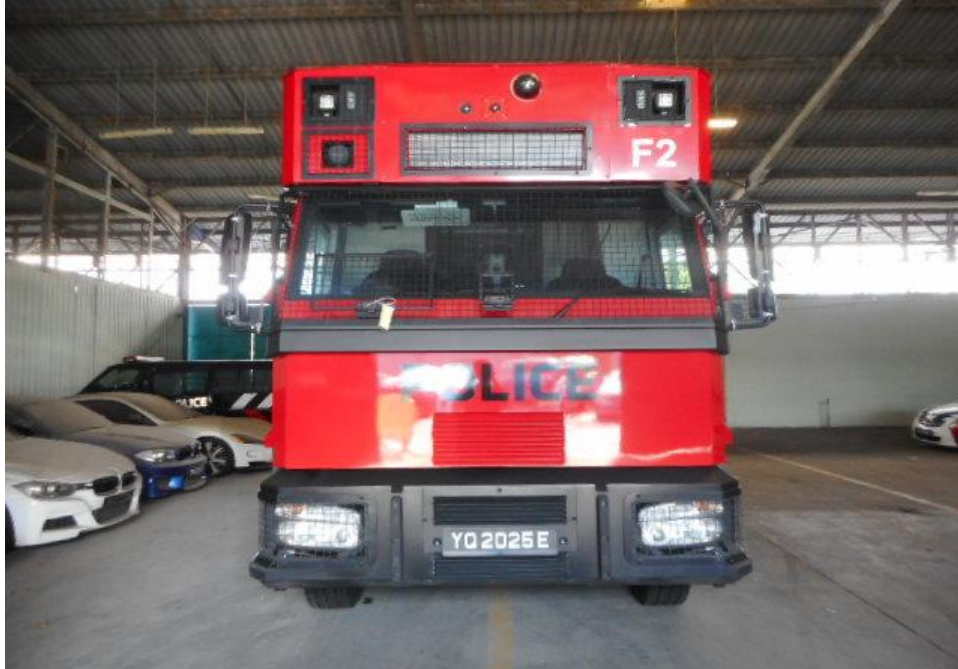
**Photo 2** shows a general view of the front body of the Police Truck at the time of my inspection. The Police Truck was observed to be intact and unaffected by the accident.

15. During the operational test, the various transmission gears of the Police Truck were able to be engaged without any difficulty by stepping on the clutch pedal and manually shifting the gear lever. There were no abnormal sounds heard and/or abnormal behaviour of the Police Truck’s engine system. It was able to move forward and backward normally. The braking system was also found to be in working condition as the Police Truck was able to slow down and come to a complete stop upon depressing of the brake pedal. See photo 2 & 25.

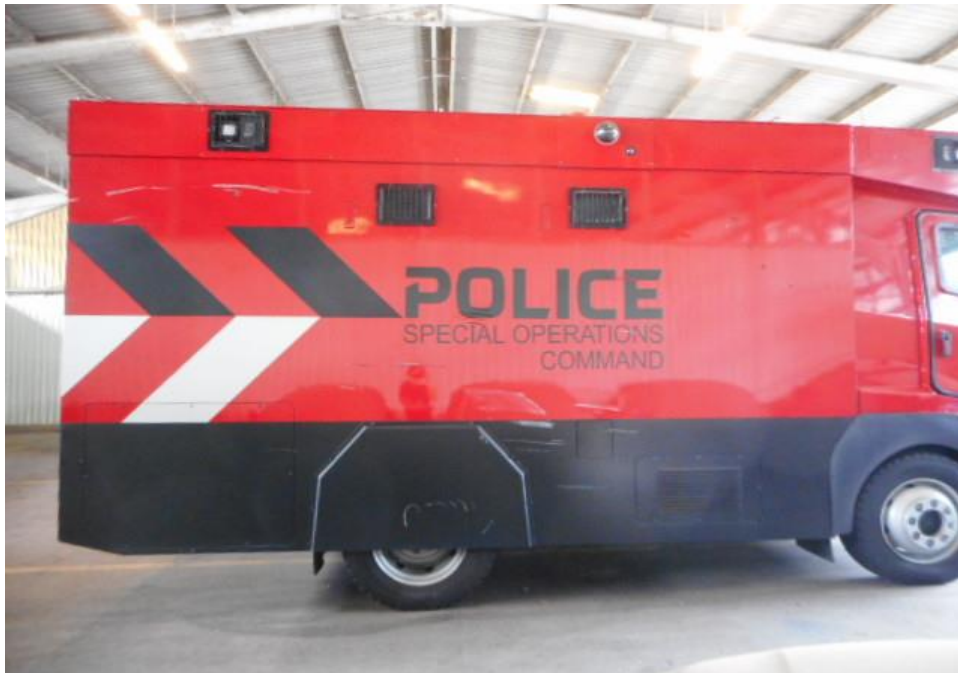
4. The mileage of the Police Truck at the time of my inspection was 5,899km.
5. The Police Truck was observed to sustain damaged on its right portion. Its right body panel was damaged at the time of my inspection.

**Photo 3** shows a general view of the front right body of the Police Truck at the time of my inspection. It appeared to have sustained damage at its right portion. Its right body panel were damage at the time of my inspection as a result of the accident.

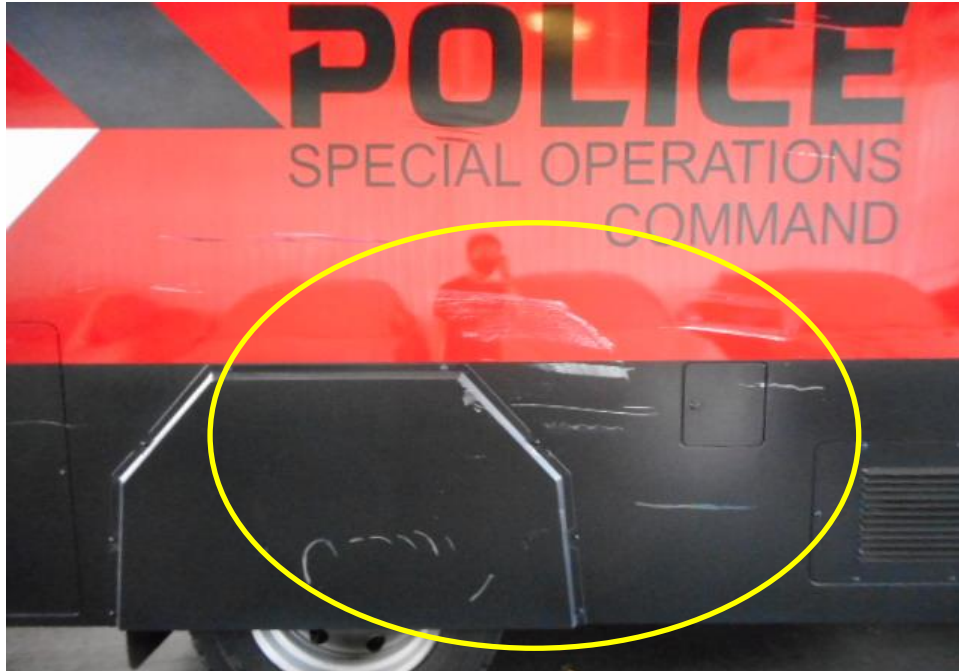
**Photo 4** shows a close up view of the Motor Lorry's right portion at the time of my inspection. It appeared to have sustained damage at its right portion. Its right body panel (circled) were damage at the time of my inspection as a result of the accident.

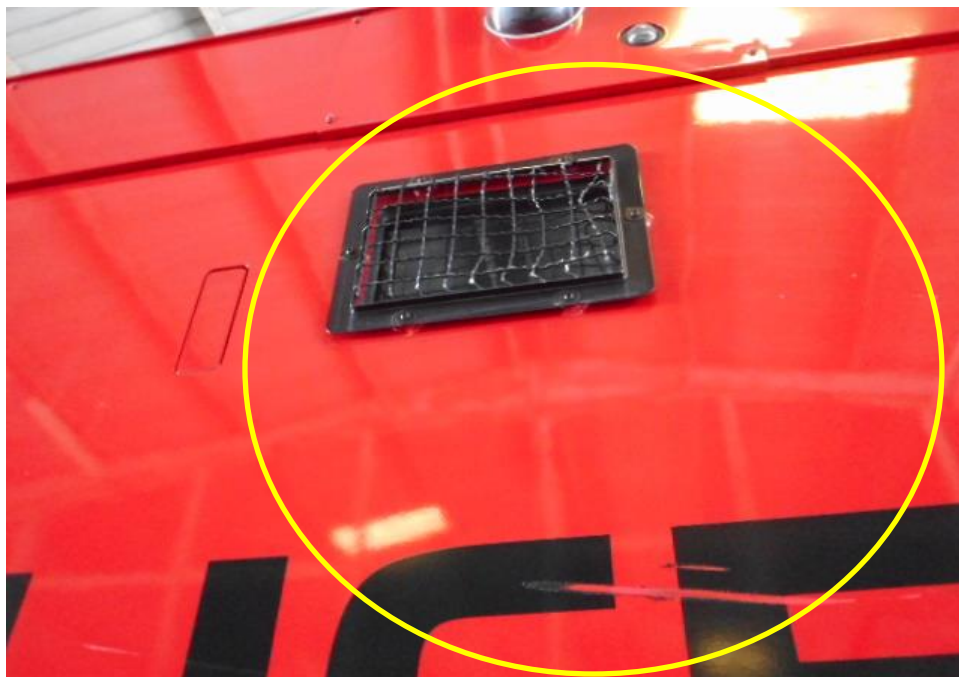
**Photo 5** shows a close up view of the Motor Lorry's right portion at the time of my inspection. It appeared to have sustained damage at its right portion. Its right body panel (circled) were damage at the time of my inspection as a result of the accident.

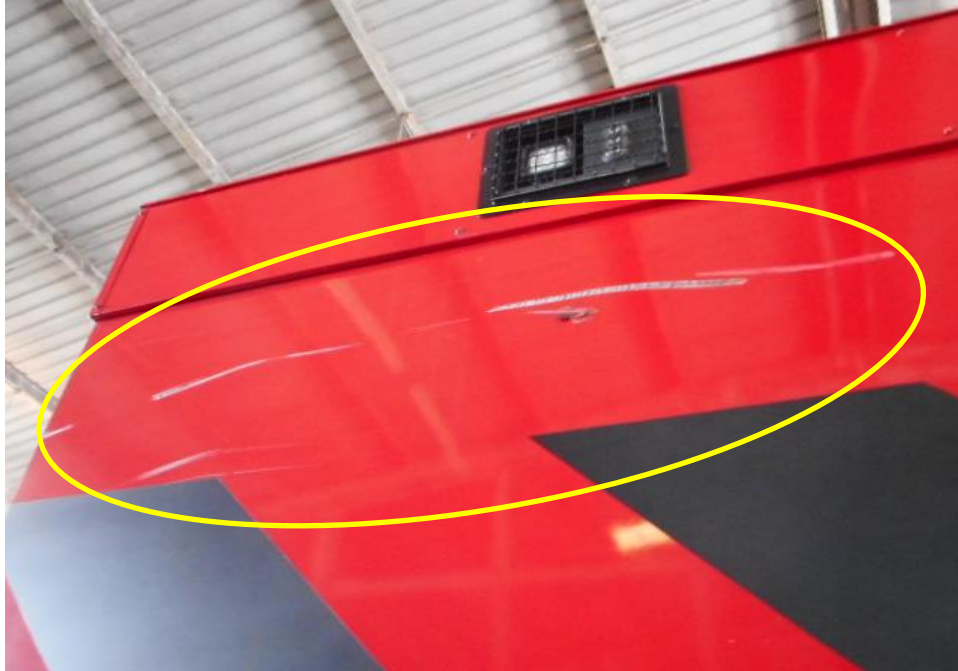
**Photo 6** shows a close up view of the Motor Lorry's right portion at the time of my inspection. It appeared to have sustained damage at its right portion. Its right body panel (circled) were damage at the time of my inspection as a result of the accident.

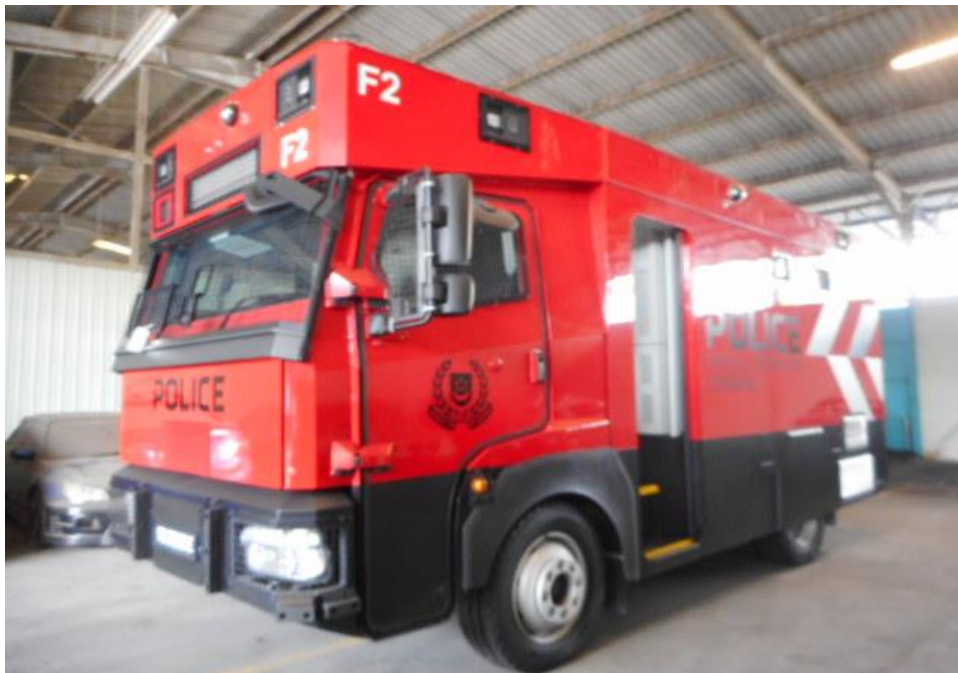
**Photo 7** shows a general view of the left portion of the Police Truck at the time of my inspection. The Police Truck was observed to be intact and unaffected by the accident.

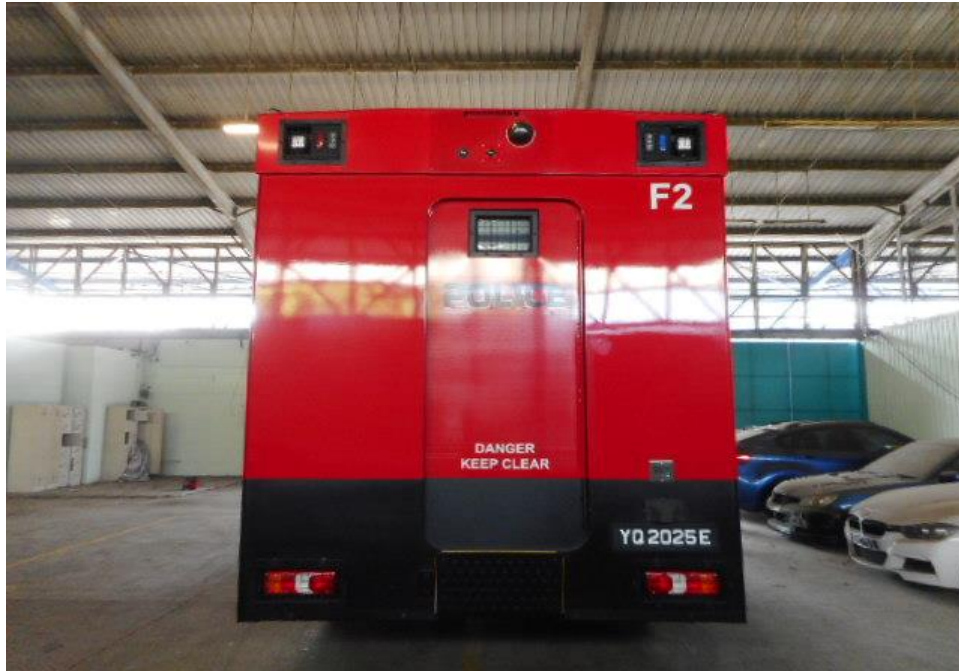
**Photo 8** shows a general view of the Police Truck's rear body at the time of my inspection. The Police Truck was observed to be intact and unaffected by the accident.

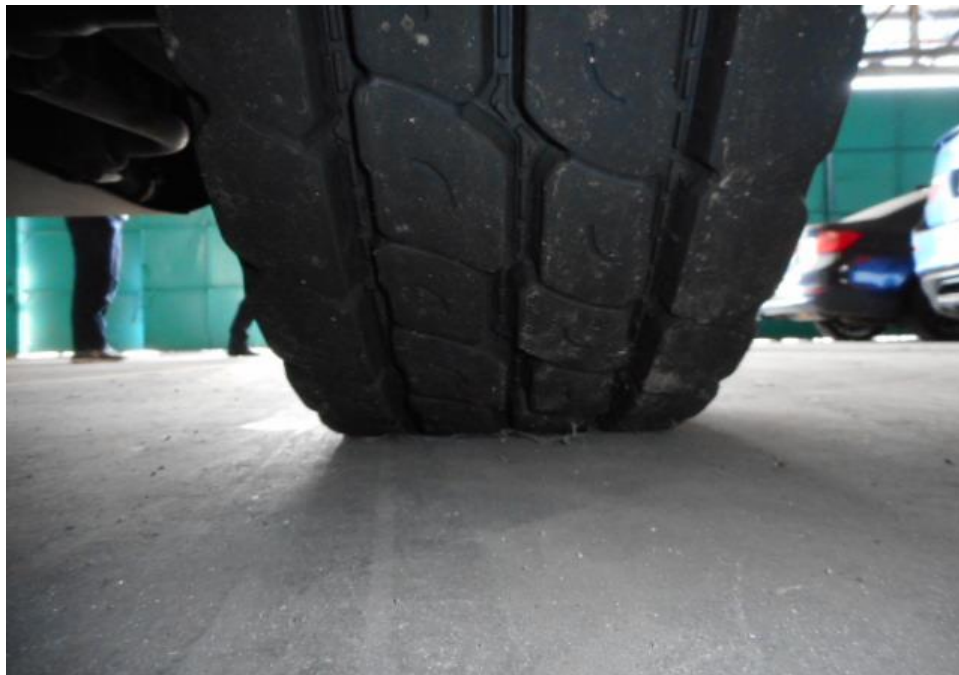
**Photo 9** shows the condition of the front right tyre of the Police Truck, which was observed to be in serviceable condition with remaining tread depth of approximately 14.1mm. The tyre, which was wrapped around standard steel wheel rim, was also observed to be sufficiently inflated for vehicular operation. There was no tear, cut or burst mark(s) on the outer and the inner sidewalls as well as across the tread of the 6 tyres that were fitted on the Police Truck.

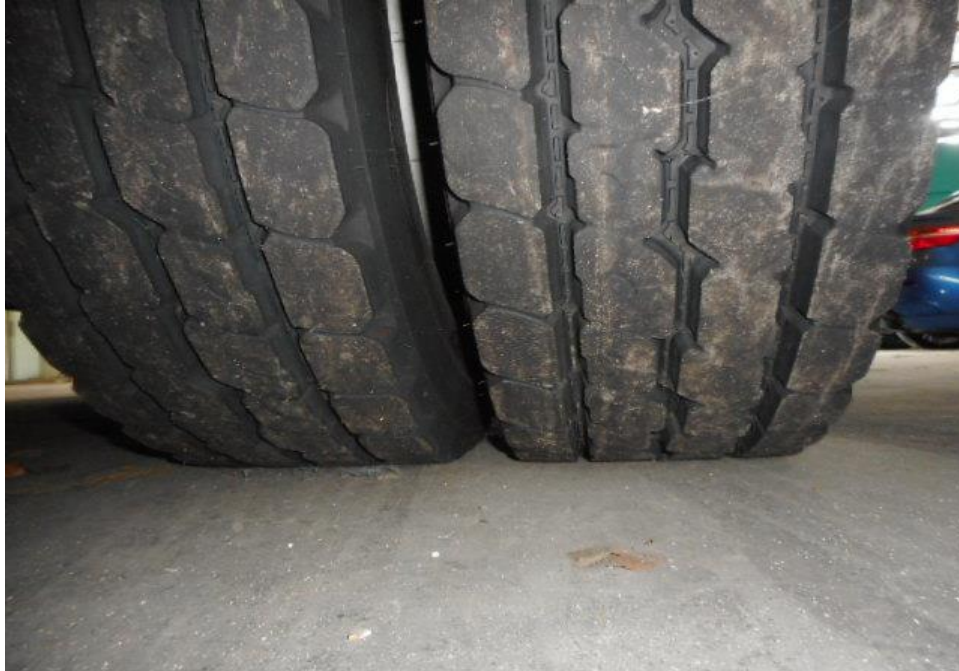
**Photo 10** shows the condition of the rear right tyre of the Police Truck, which was observed to be in serviceable condition with remaining tread depth of approximately 14.5mm. The tyre, which was wrapped around standard steel wheel rim, was also observed to be sufficiently inflated for vehicular operation.

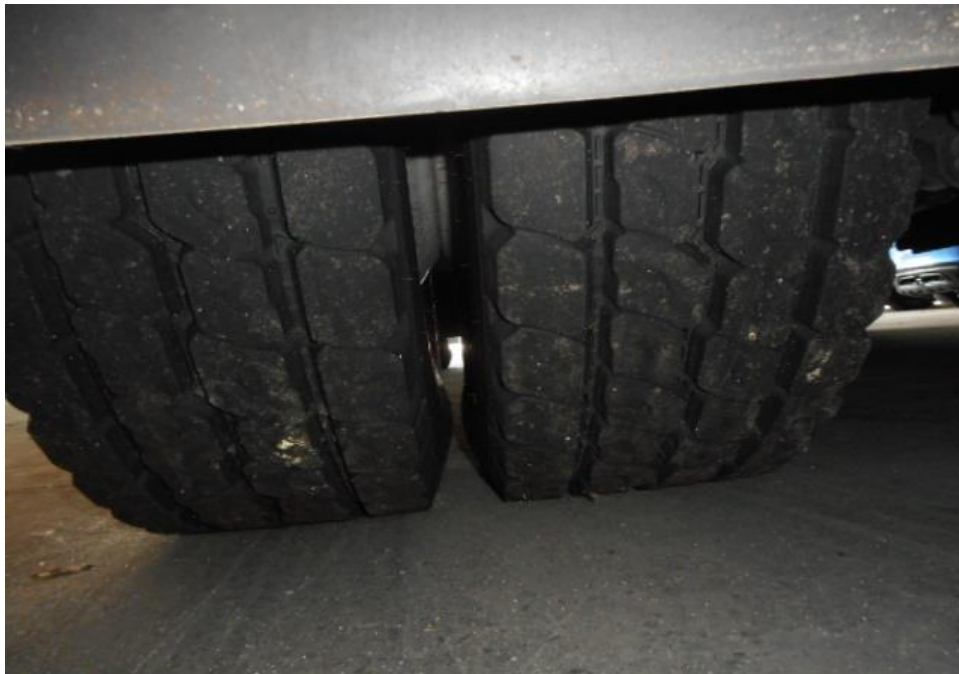
**Photo 11** shows the condition of the rear left tyres of the Police Truck, which was observed to be in serviceable condition with remaining tread depth of approximately 14.2mm. The tyres, which were wrapped around standard steel wheel rim, were also observed to be sufficiently inflated for vehicular operation. There was also no damage found on all 6 steel wheel rims of the Police Truck.

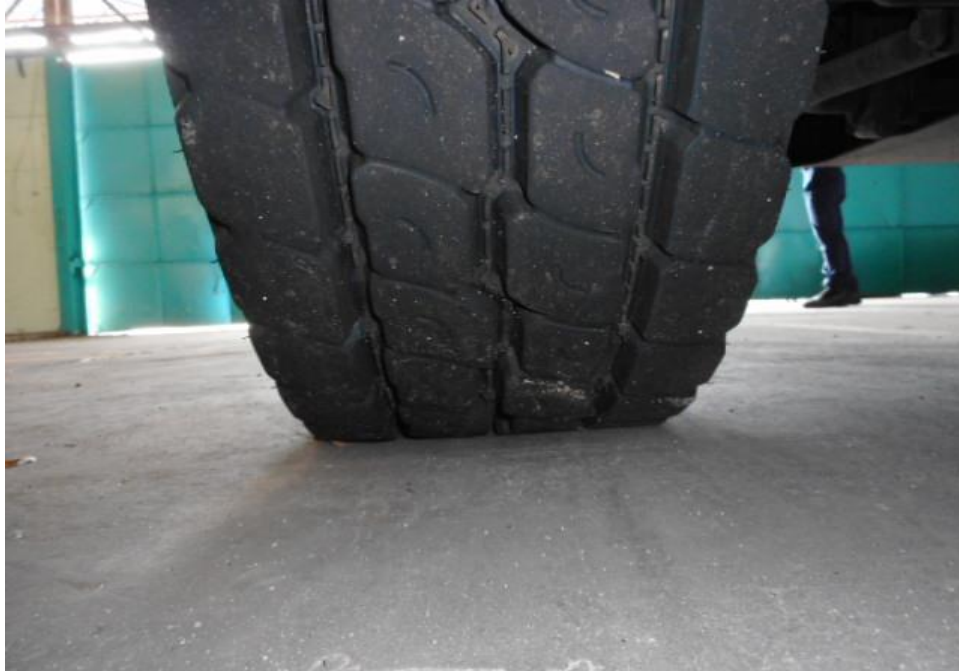
**Photo 12** shows the condition of the front left tyres of the Police Truck, which were observed to be in serviceable condition with remaining tread depth of approximately 14.7mm. There was also no tear, cut or burst mark(s) on the outer and the inner sidewalls as well as across the tread of the 6 tyres that were fitted on the Police Truck.

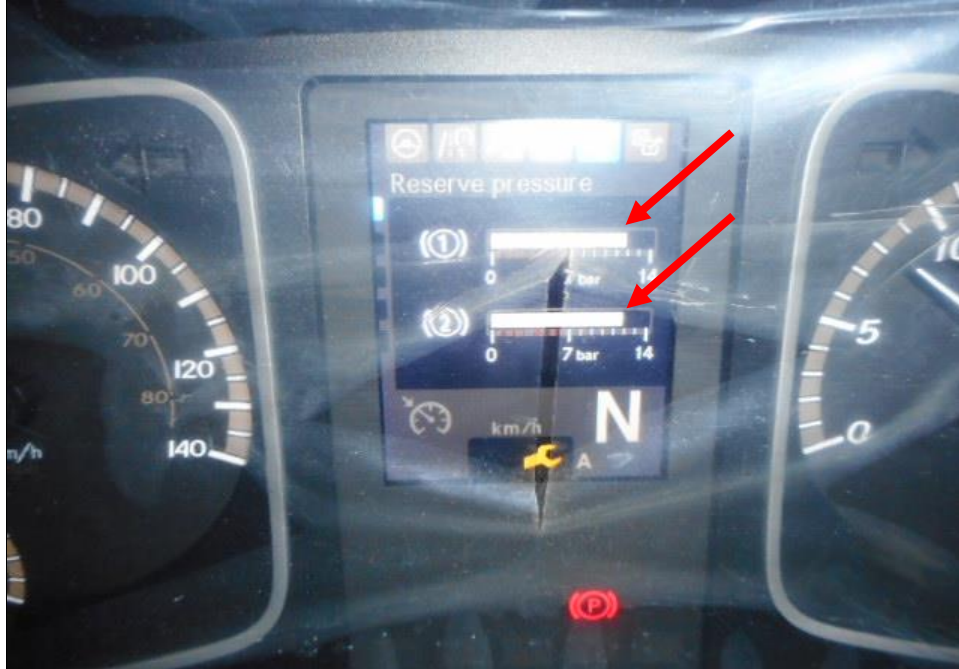
**Photo 13** shows the air in the air brake cylinders of the Police Truck at the time of my inspection. The air in the cylinder was observed to be of sufficient level & serviceable at the time of the accident.

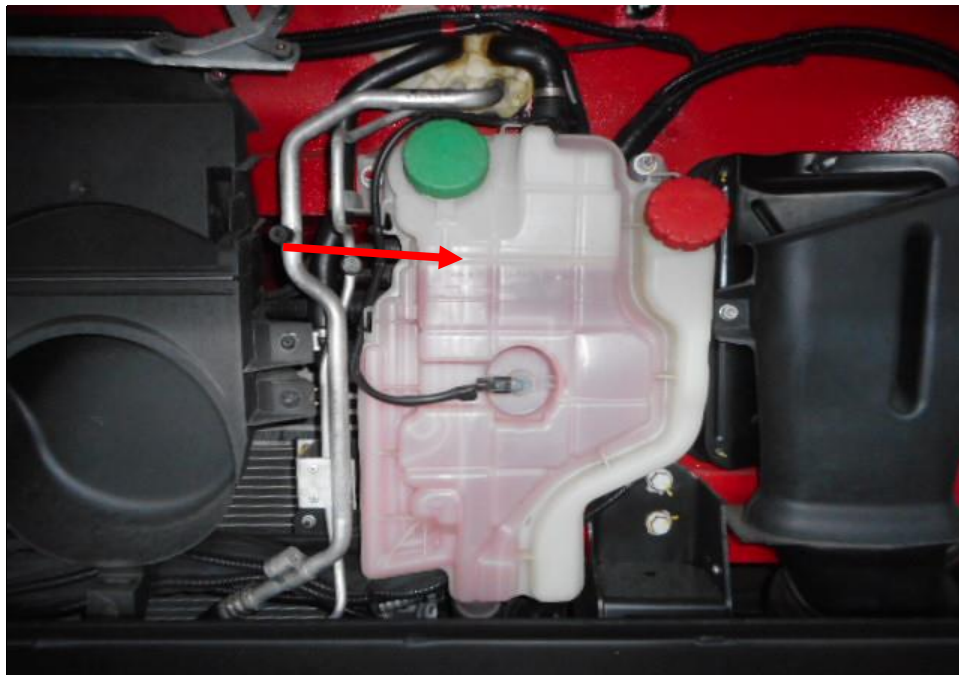
**Photo 14** shows the engine coolant reservoir of the Police Truck at the time of my inspection. The engine coolant was observed to be of sufficient level (arrowed) and without any visible contamination.

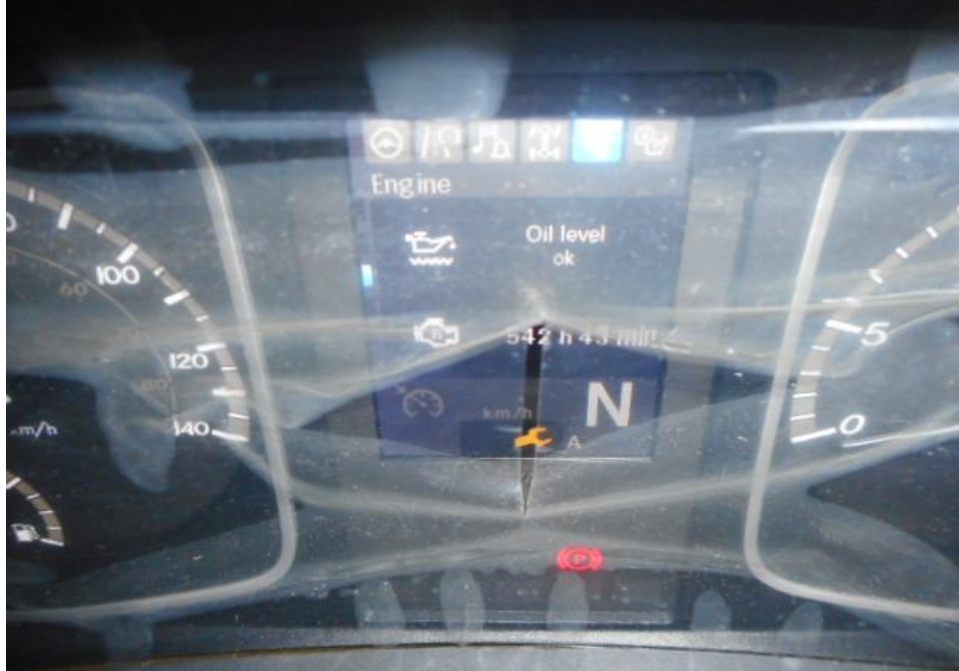
**Photo 15** shows the engine oil display of the Police Truck at the time of my inspection. The engine oil was observed to be of sufficient level at the time of our inspection.

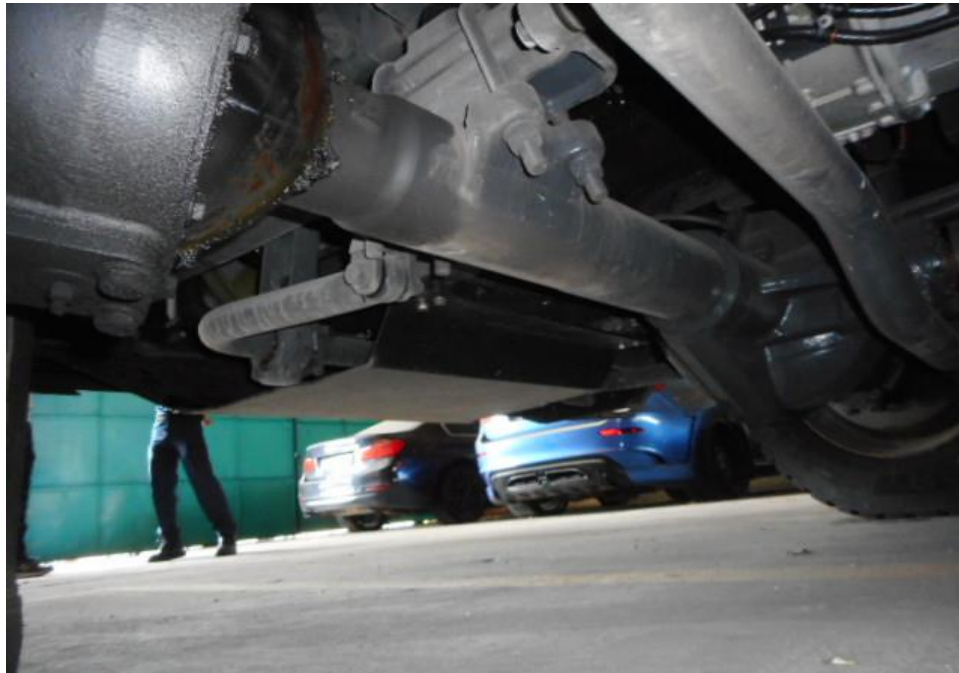
**Photo 16** shows the undercarriage of the Police Truck, at the area where the engine housing located. I did not find any sign(s) or indication(s) of fluid leak or fluid stain(s) on the underside of the Police Truck.

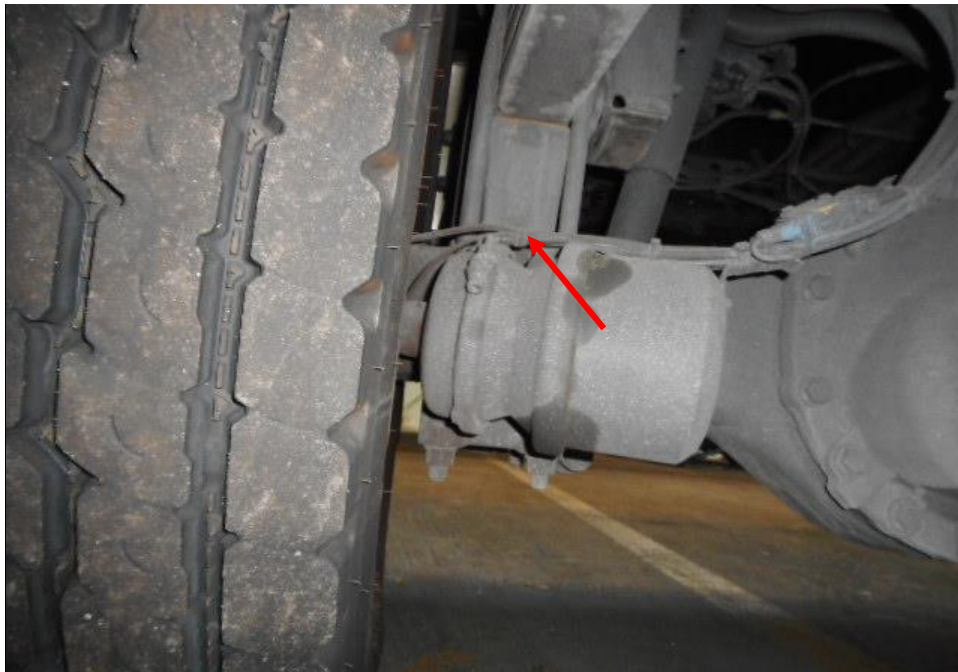
**Photo 17** shows the brake pipe (arrowed) at the rear right wheel of the Police Truck. I did not observe any leakage of brake fluid at the time of my inspection of the Police Truck. My static tests of the Police Truck's braking system, along with my visual examination of the various mechanical components in the braking system, had indicated that there was no internal leakage of pressure/vacuum. Hence the braking system of the Police Truck was likely to be in serviceable condition at the material time of accident.

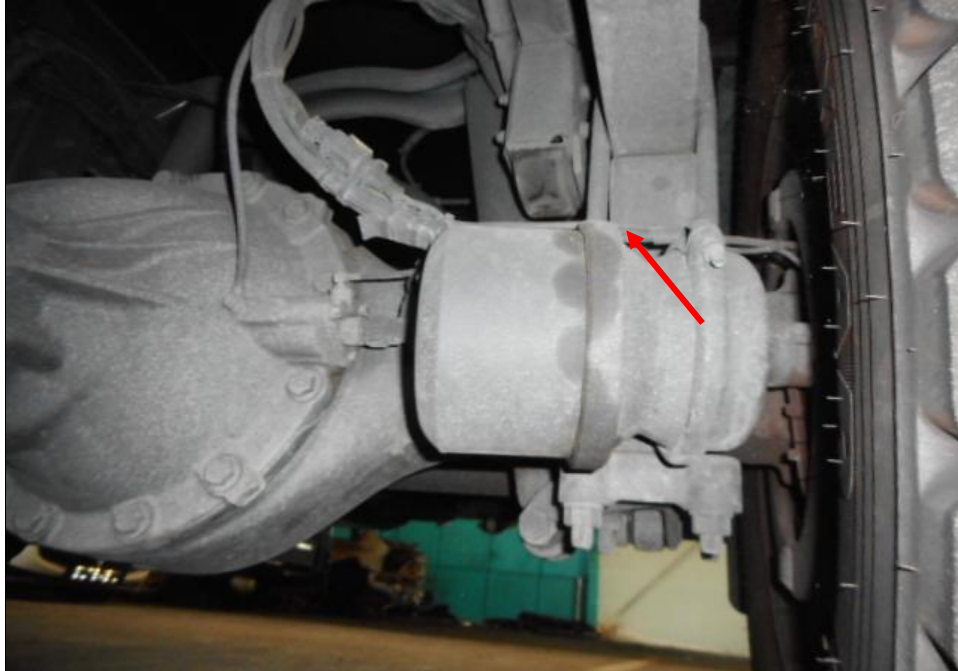
**Photo 18** shows the brake pipe (arrowed) at the rear left wheel of the Police Truck. I did not observe any leakage of brake fluid at the time of my inspection of the Police Truck. My static tests of the Police Truck's braking system, along with my visual examination of the various mechanical components in the braking system, had indicated that there was no internal leakage of pressure/vacuum. Hence the braking system of the Police Truck was likely to be in serviceable condition at the material time of accident.

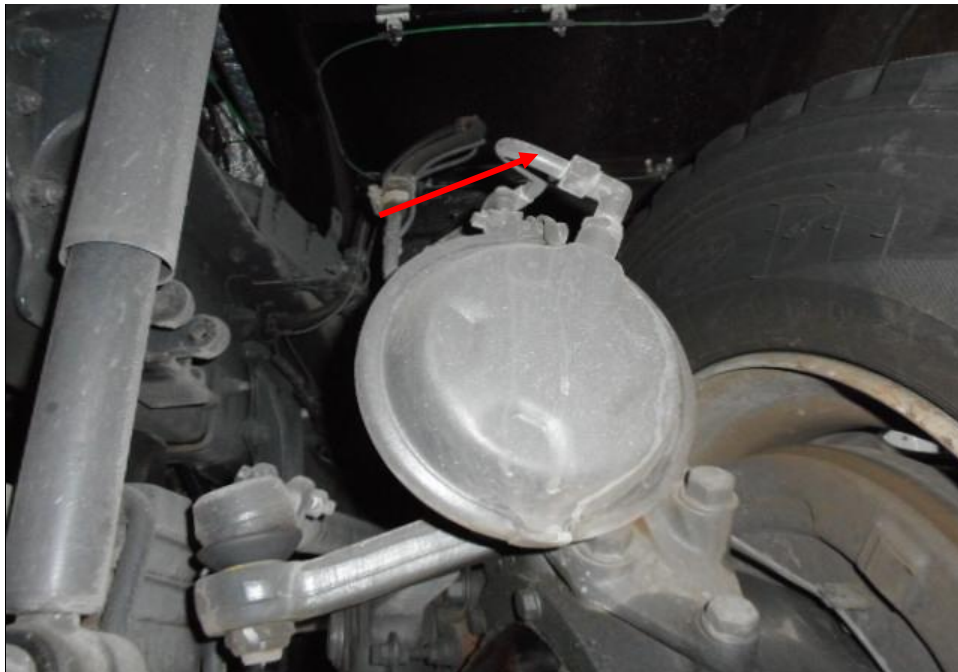
**Photo 19** shows the brake pipe (arrowed) at the front right wheel of the Police Truck. I did not observe any leakage of brake fluid at the time of my inspection of the Police Truck. My static tests of the Police Truck's braking system, along with my visual examination of the various mechanical components in the braking system, had indicated that there was no internal leakage of pressure/vacuum. Hence the braking system of the Police Truck was likely to be in serviceable condition at the material time of accident.

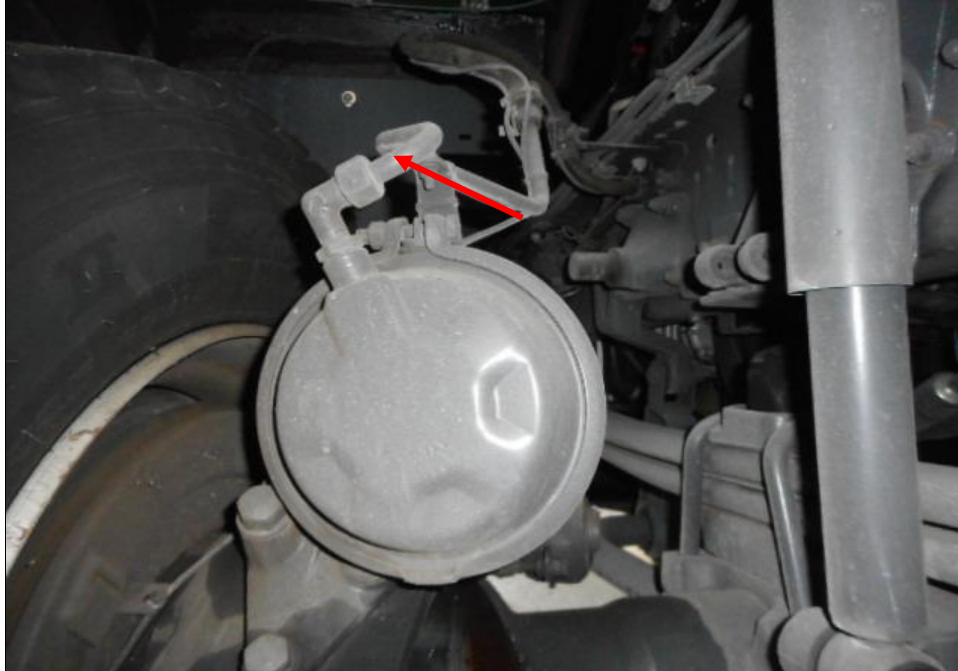
**Photo 20** shows the brake pipe (arrowed) at the front left wheel of the Police Truck. I did not observe any leakage of brake fluid at the time of my inspection of the Police Truck. My static tests of the Police Truck's braking system, along with my visual examination of the various mechanical components in the braking system had indicated that there was no internal leakage of pressure/vacuum. Hence the braking system of the Police Truck was likely to be in serviceable condition at the material time of accident.

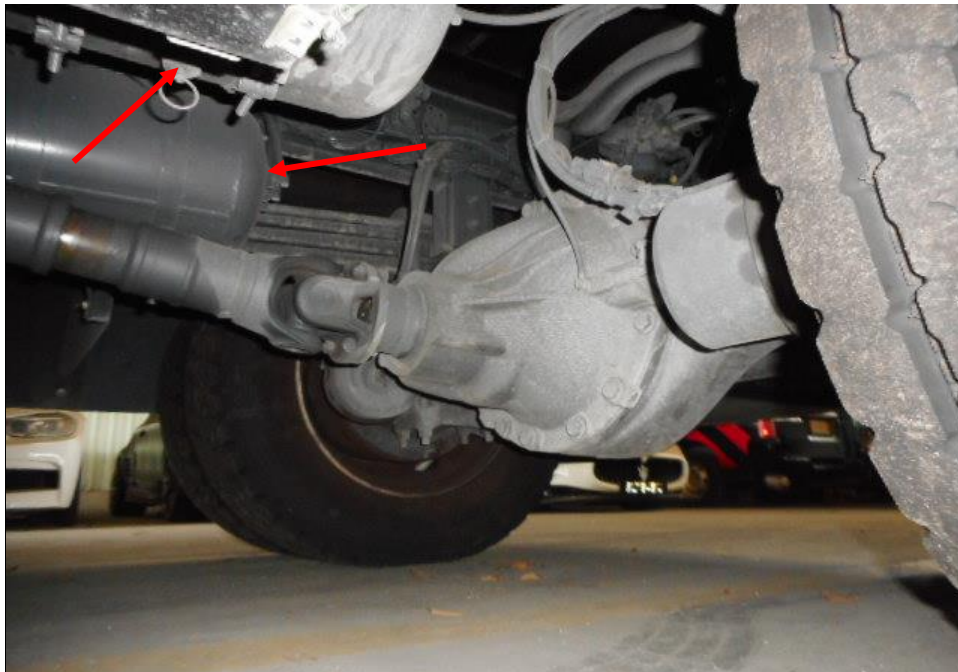
**Photo 21** shows the air brake cylinders (arrowed) at the undercarriage of the Police Truck. I did not observe any leakage of air brake fluid at the time of my inspection of the Police Truck. My static tests of the Police Truck's braking system, along with my visual examination of the various mechanical components in the braking system had indicated that there was no internal leakage of pressure/vacuum. Hence the braking system of the Police Truck was likely to be in serviceable condition at the material time of accident.

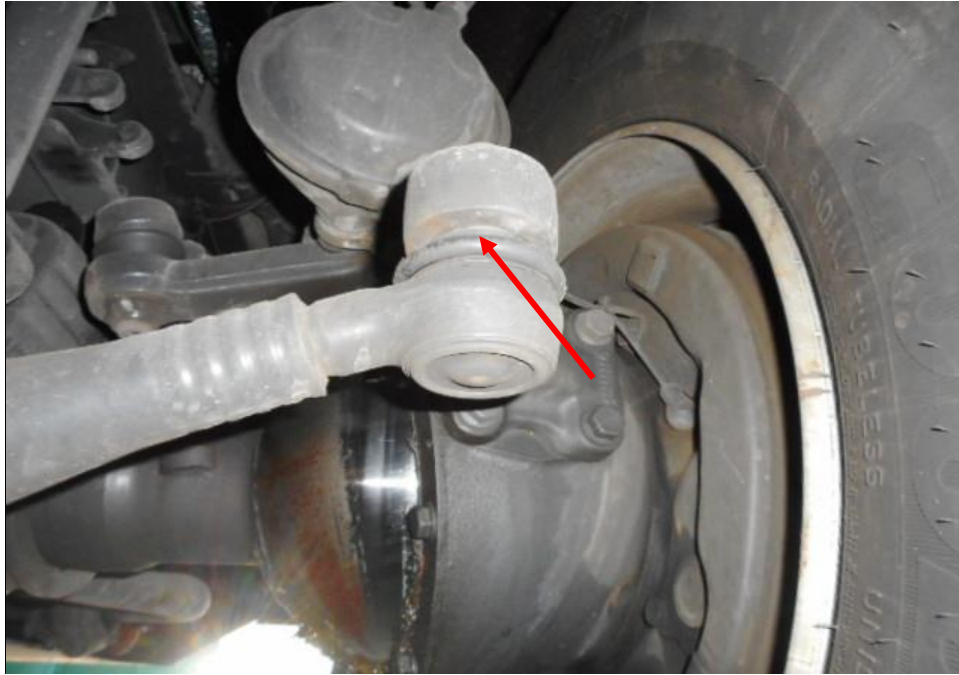
**Photo 22** shows the various undercarriage components at the front right wheel of the Police Truck, in particular the steering tie rod end (arrowed). The various steering components were all found to be intact, suggesting that the steering system of the Police Truck was likely to be in serviceable condition at the material time of accident. There was also no sign of fluid stain(s) observed on the various undercarriage components.

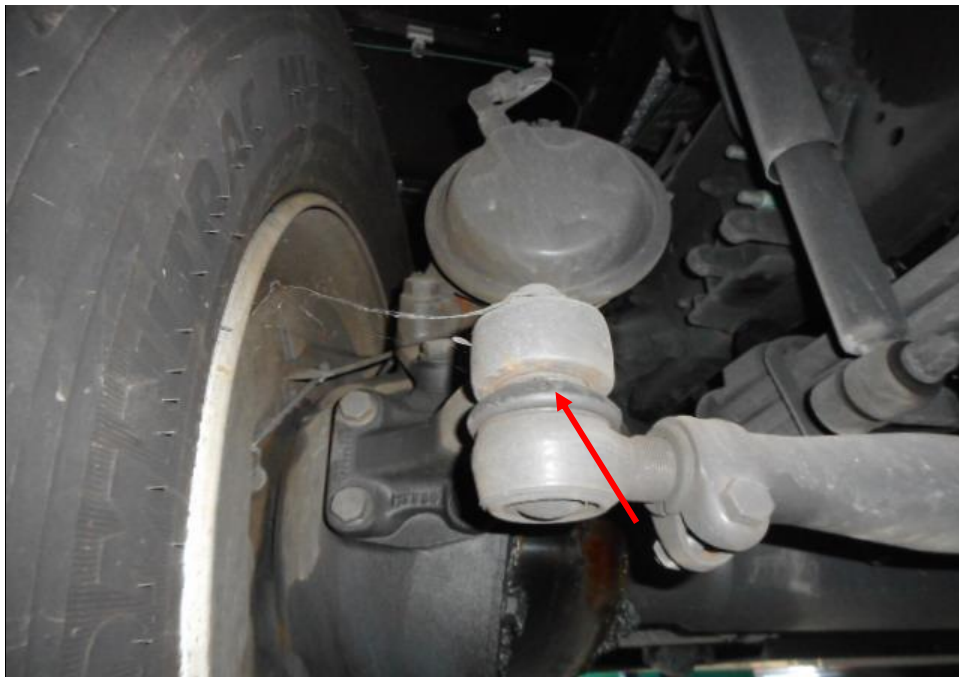
**Photo 23** shows the various undercarriage components at the front left wheel of the Police Truck, in particular the steering tie rod end (arrowed). The various undercarriage components of the Police Truck were all found to be intact without any visible damage. There was also no sign of fluid stain(s) observed on the various undercarriage components.

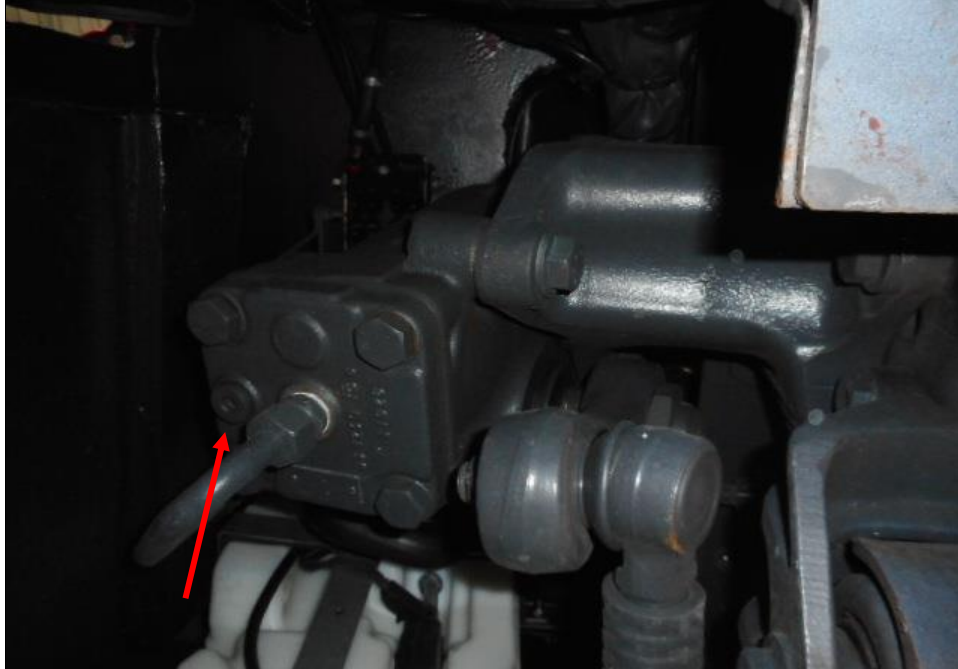
**Photo 24** shows the steering box component (arrowed) at the undercarriage of the Police Truck was found to be intact without any visible damage. There was also no sign of fluid stain(s) observed on the various undercarriage components.

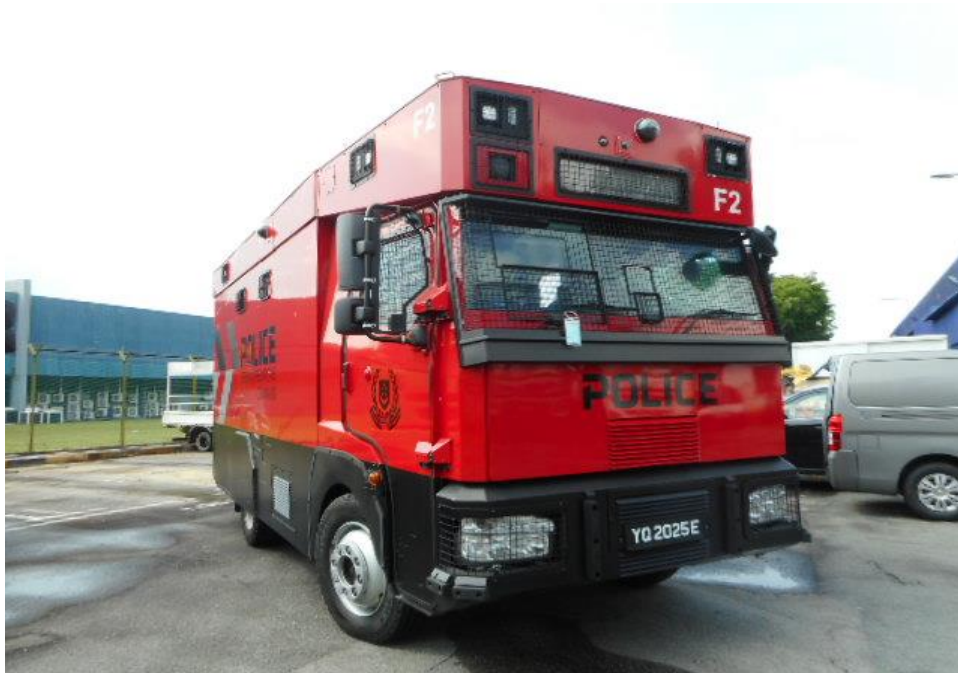
**Photo 25** shows the front right wheel of the Police Truck turned to its full left. During my steering system test, I did not experience any abnormal free play and/or resistance when I had turned the steering wheel towards full left and full right. This would suggest that the steering system of the Police Truck was likely to be in serviceable condition at the material time of accident.

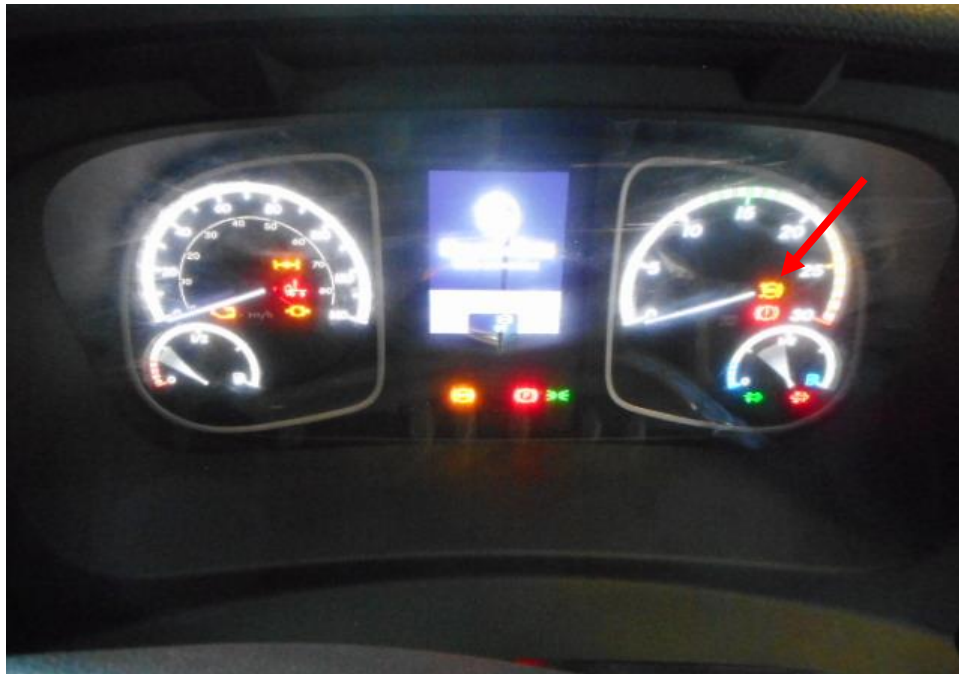
**Photo 26** shows the warning light for Anti-Lock Brake System (ABS) (arrowed) appearing on the instrument panel of the Police Truck during the self-test of its various electronic operating systems when its engine was cranked.

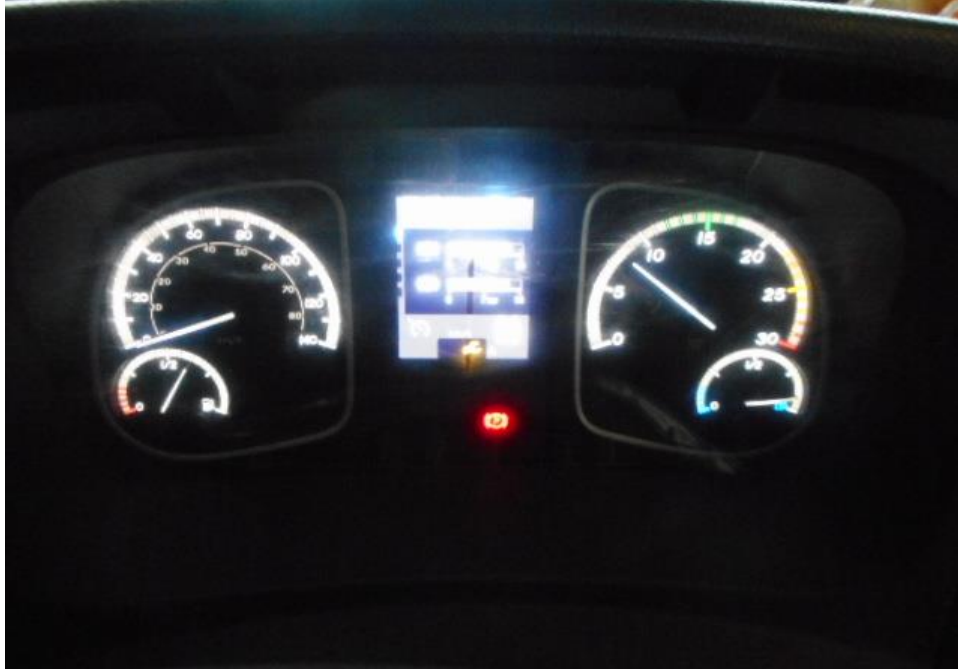
**Photo 27** shows no warning lights illuminated on the instrument panel of the Police Truck after the engine was cranked. This would suggest that there was no abnormality to the electronic operating system of the Police Truck, like the ABS and etc.
